Navajo Abandoned Uranium Mine Site Screen Report

NE Churchrock Quivira Mines (No. 1)

Navajo AUM Eastern Region

May 2009

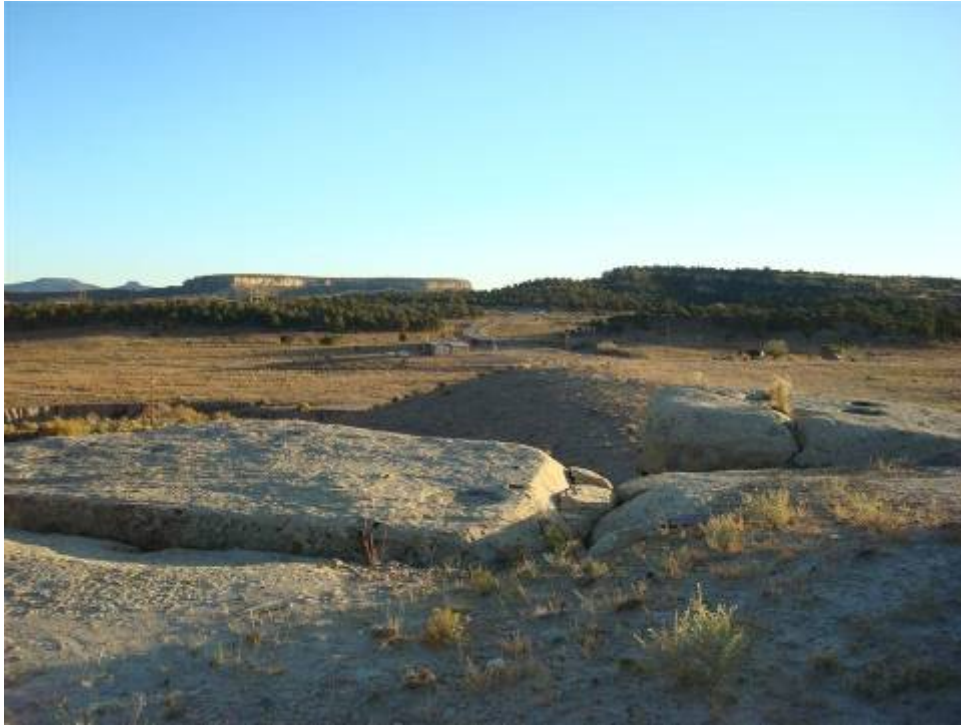
The mine appears to have had significant reclamation. No waste piles, adits, or other mine features were observed during the site visit.

Photo 1: NE Churchrock Quivira Mines (No.1) site, towards the south

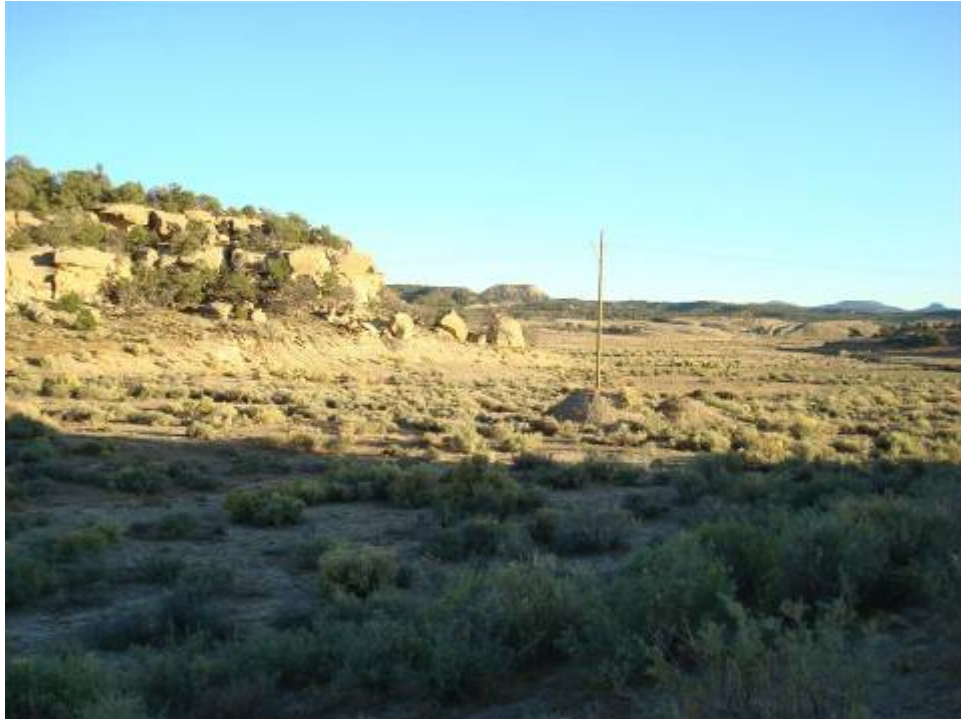
Photo 2: Original grade at power pole in northern portion of mine, towards the north

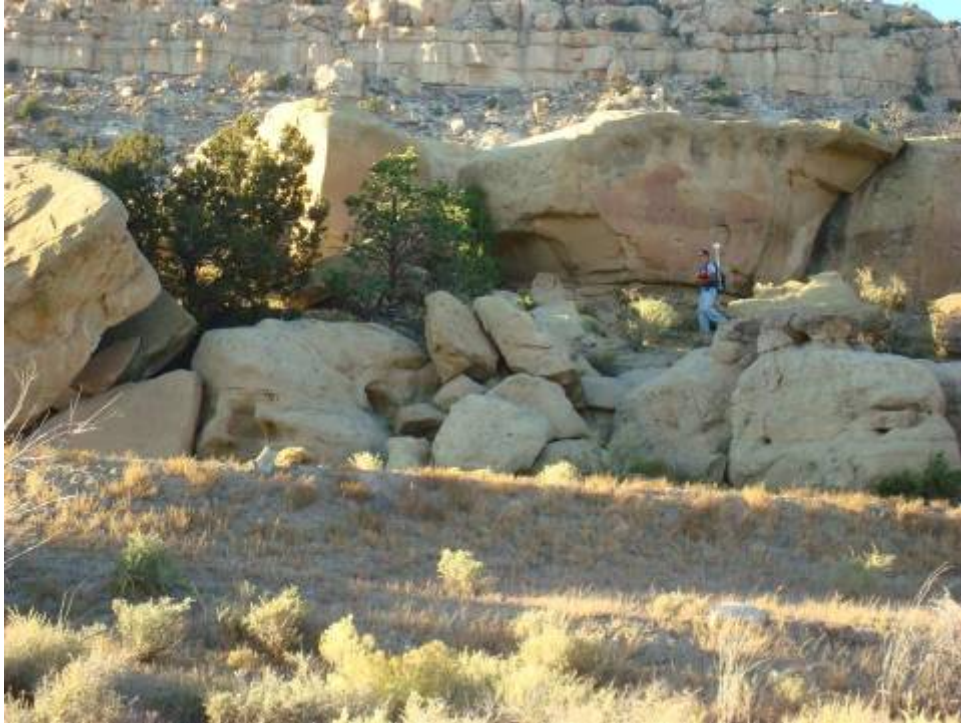
Photo 3: Survey of western mine boundary, towards the north

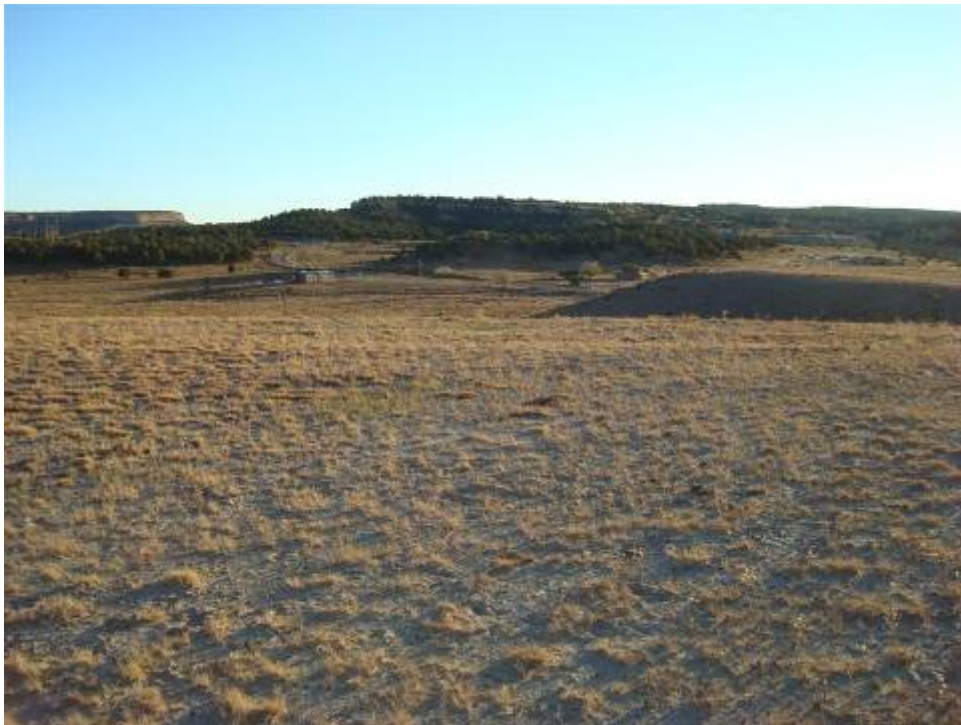
200 feet to 0.25 mile: Five residential compounds located within ¼ mile with the nearest being 680 feet south of the mine.

Photo 4: Southern portion of mine and residence located to the south

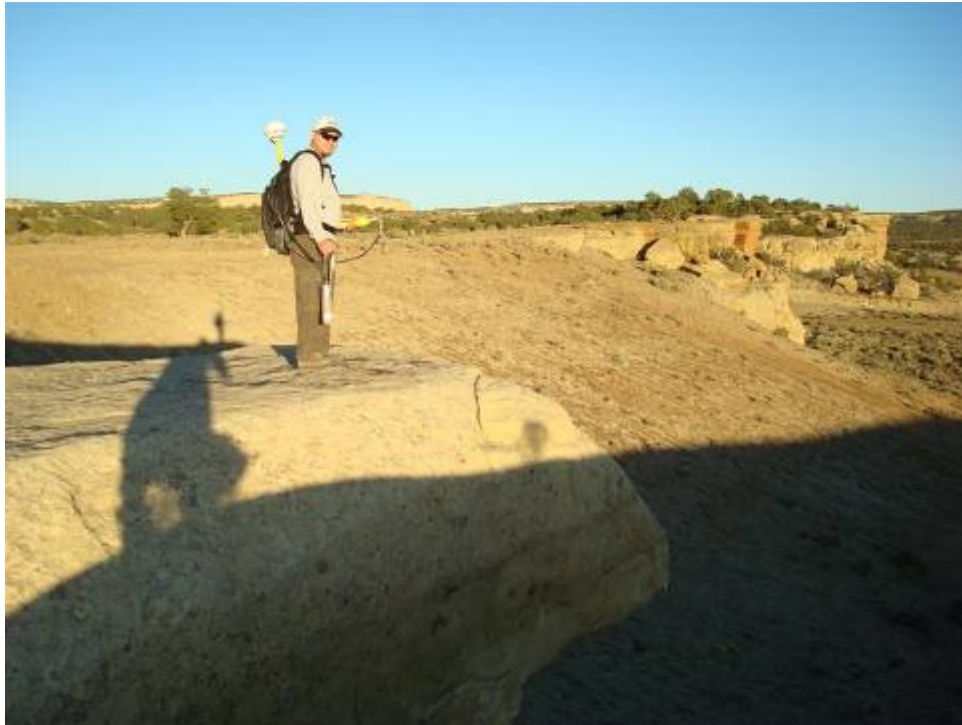
Photo 5: Survey of central portion of mine towards the east

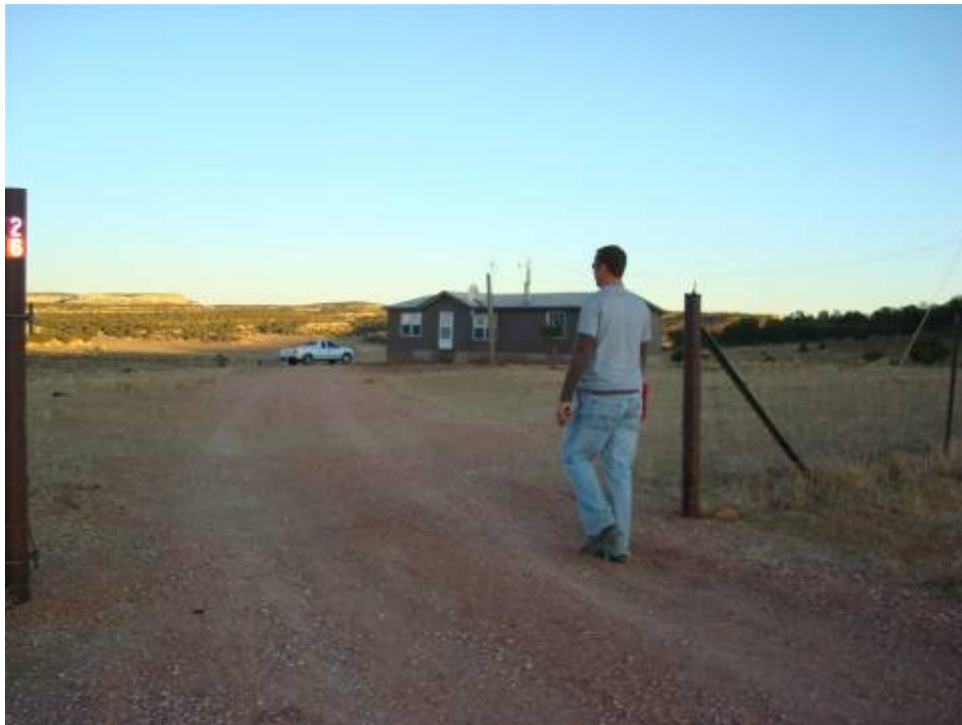
At what distance from the cap/seal is the nearest domestic structure located? 680 feet

Photo 6: Nearest residence located south of the mine.

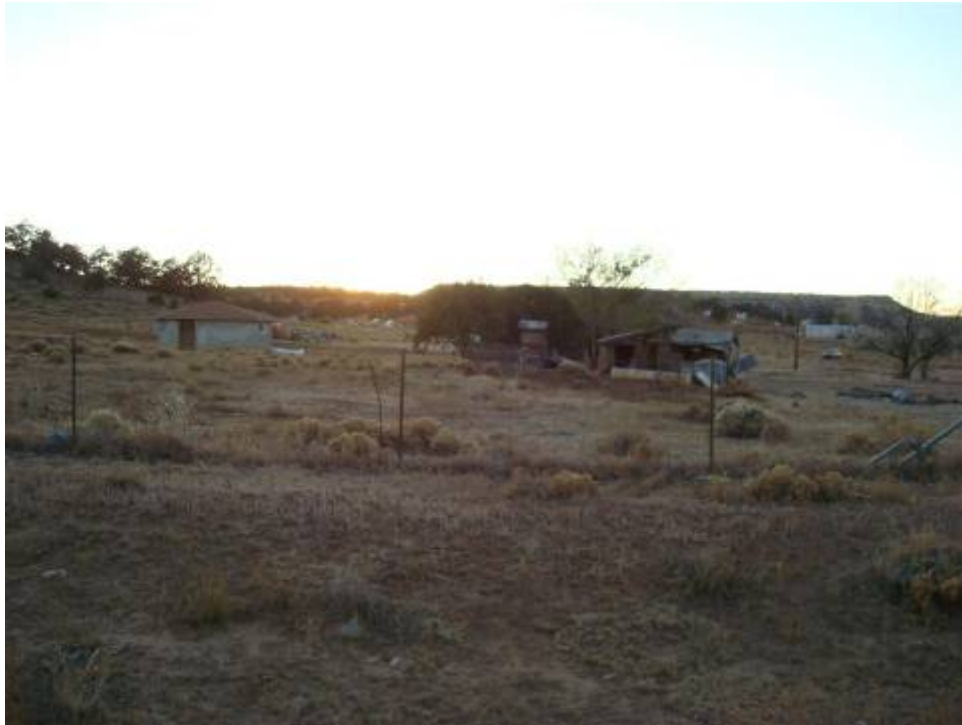
Photo 7: Residence located south of the mine.

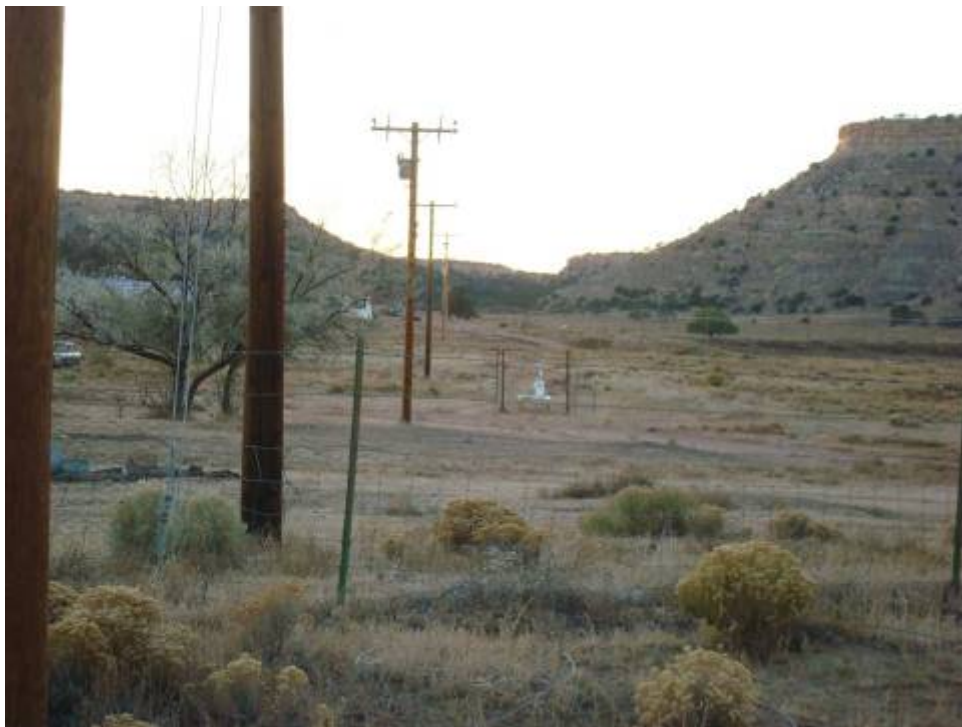
0 to 0.25 miles: Well located 630 feet south of the mine

At what distance from the cap/seal is the nearest domestic drinking water source? 630 feet

Photo 8: Well located between residences and mine.

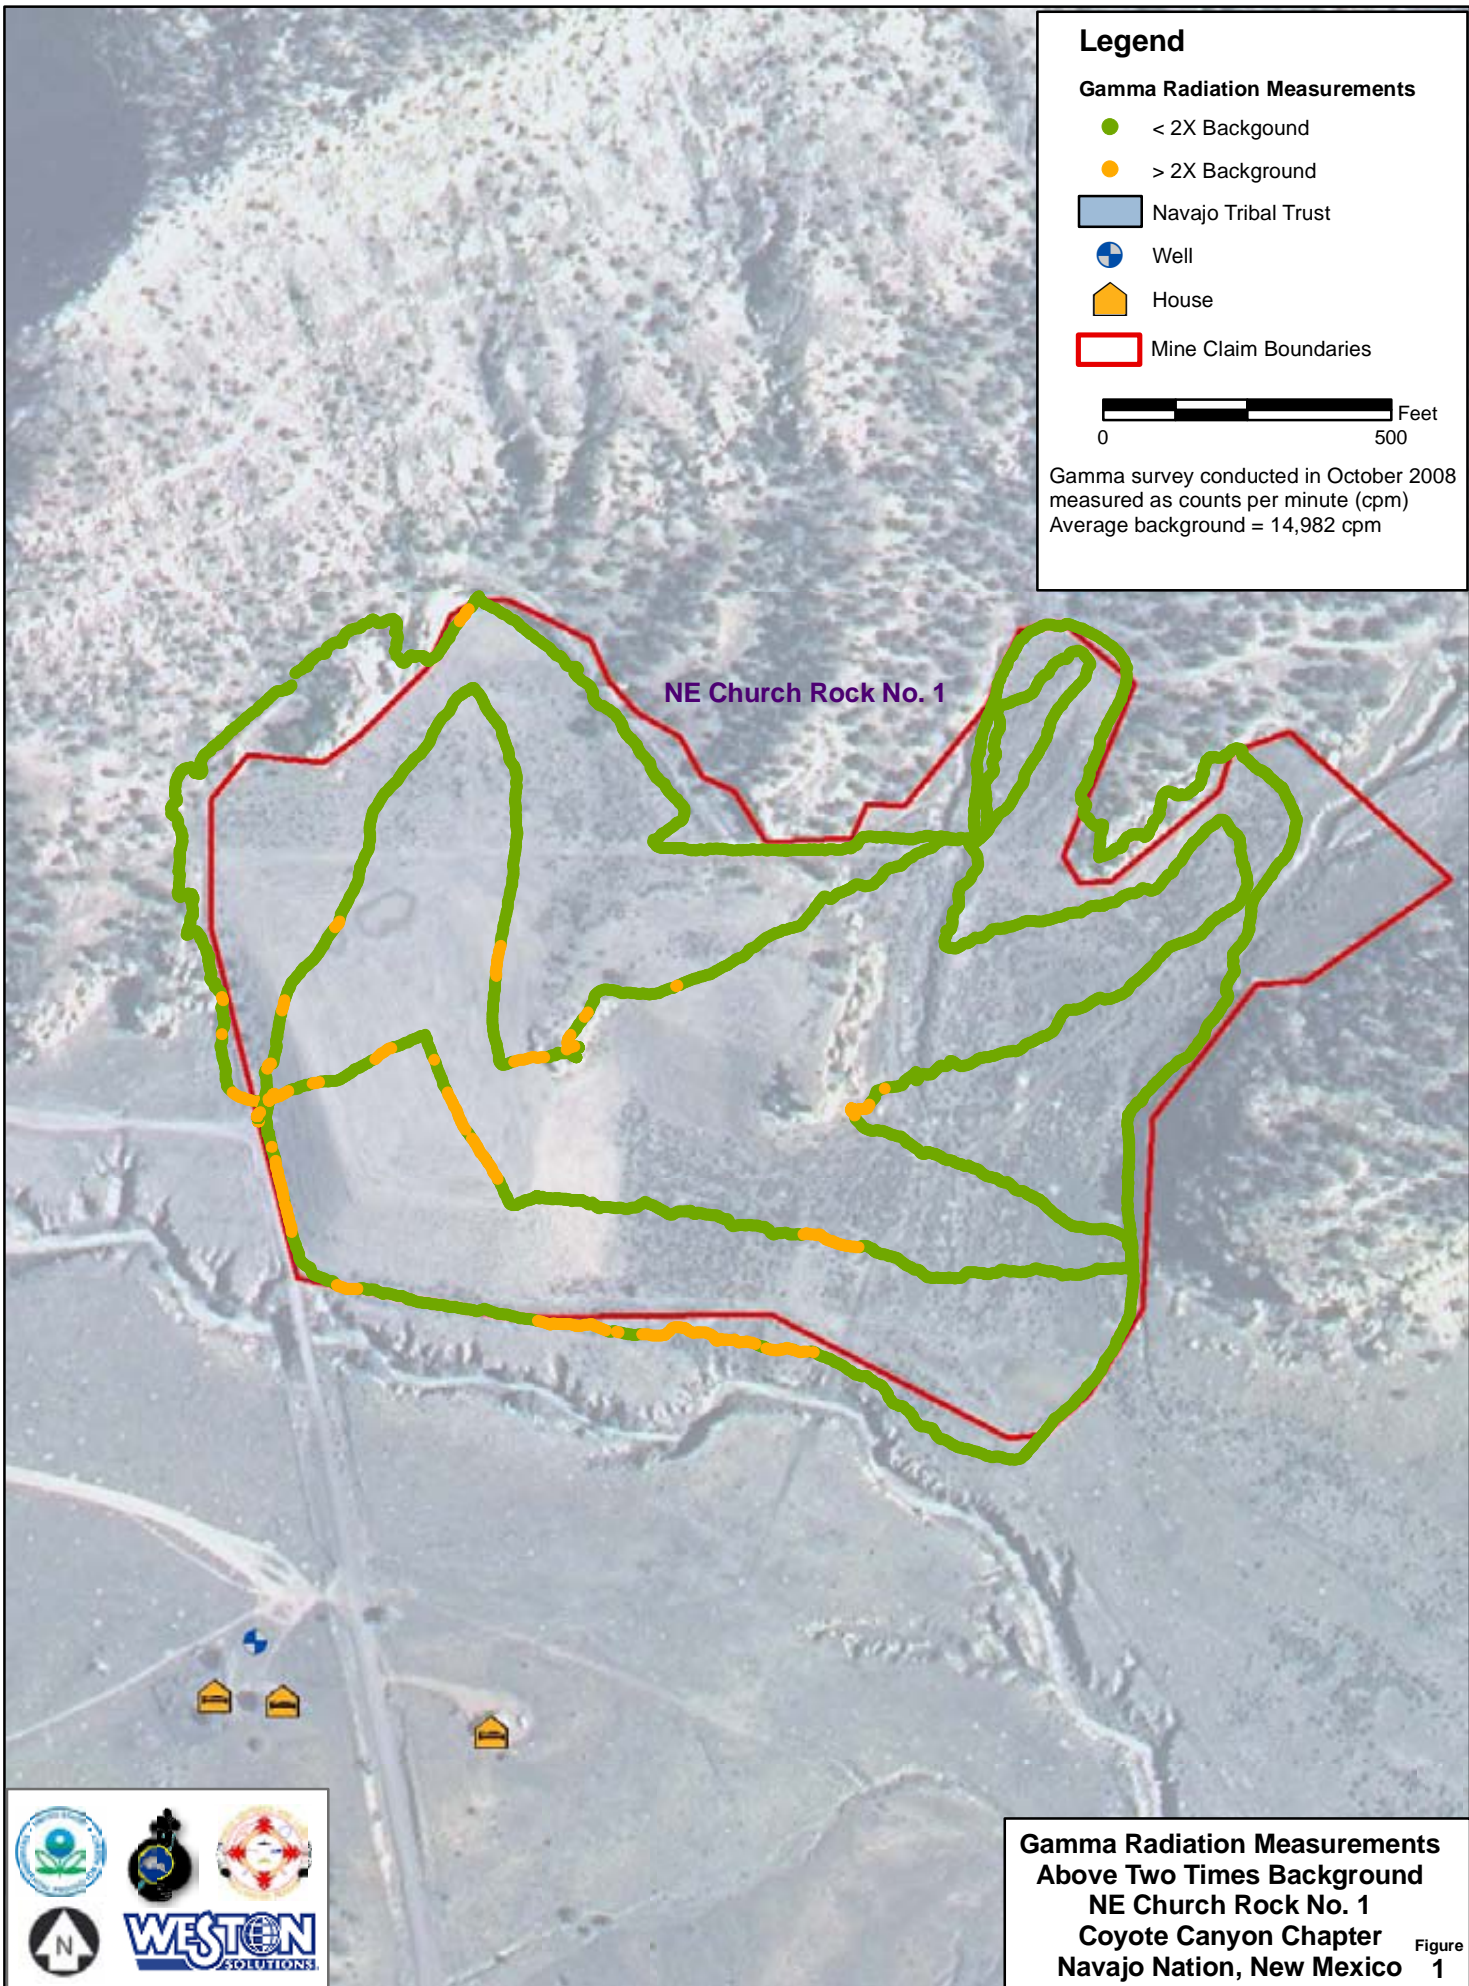
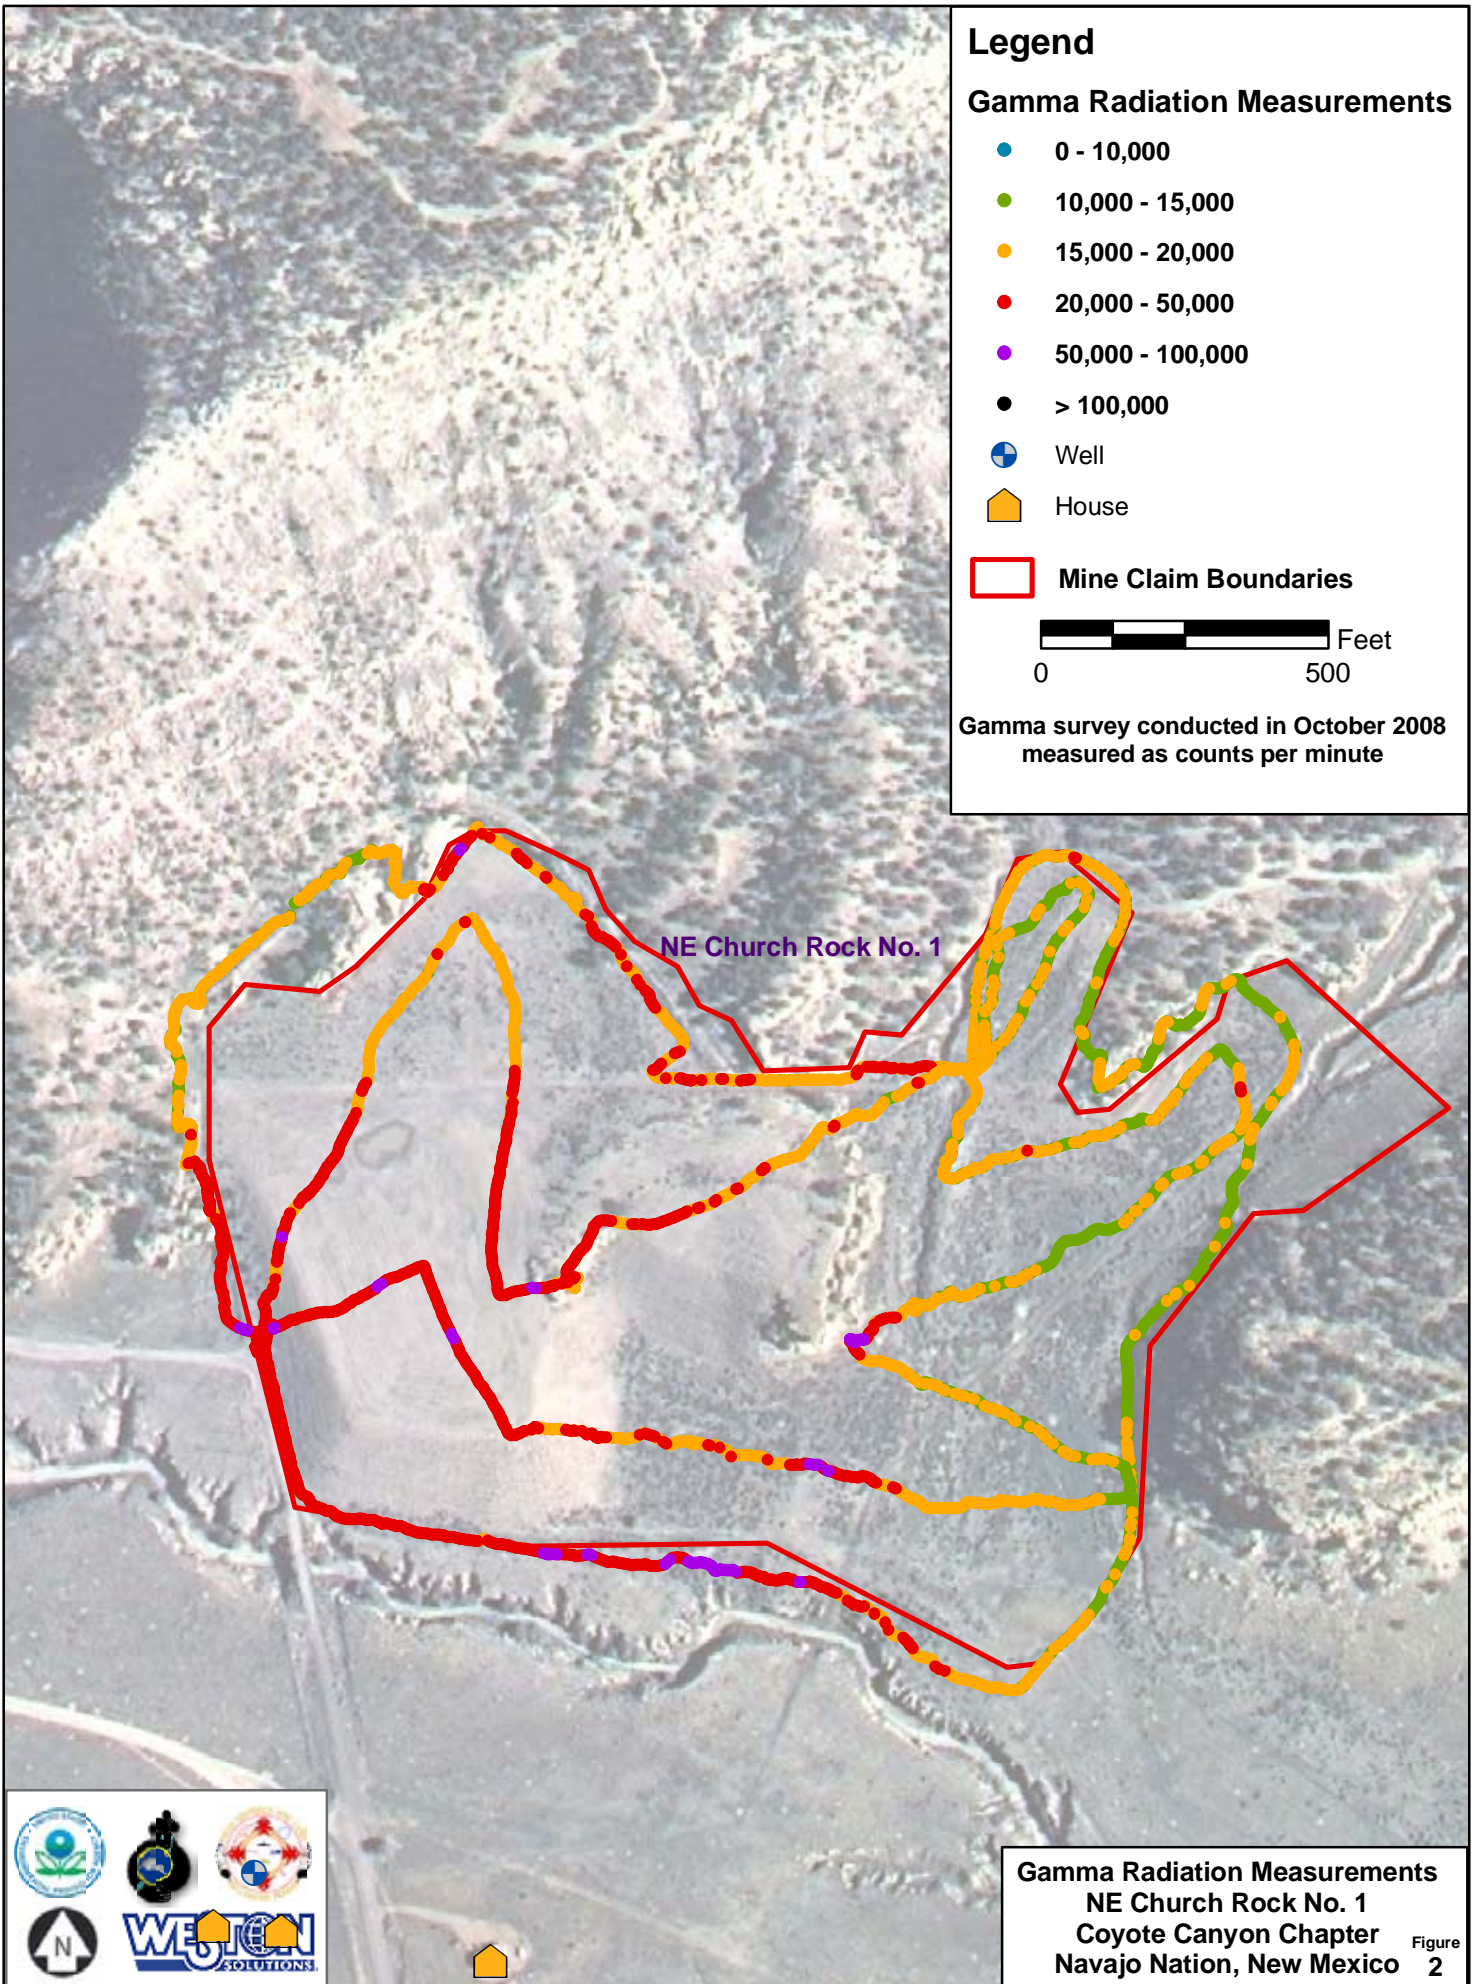
Gamma Radiation Measurements
NE Church Rock No. 1
Coyote Canyon Chapter
Navajo Nation, New Mexico

A total of 5,278 gamma radiation measurements were collected from mine sites, ranging from 10,249 cpm to 79,431 cpm. The measurements are represented in Figures 1 and 2.
