Purpose: RCRA Compliance Evaluation Inspection

Facility: **Consolidated Tire Recyclers, Inc.**

Date of Investigation: August 17, 2011

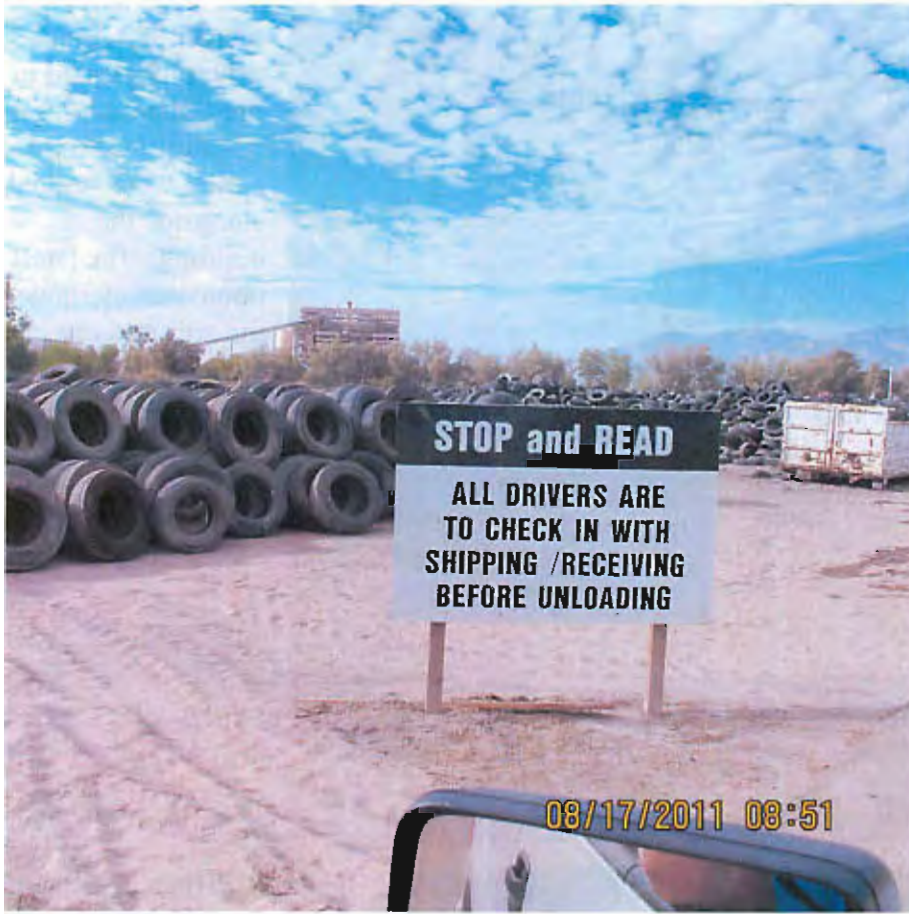
Some tire areas had been neatly stacked, and the overall height of the piles reduced. The latest photo survey shows they are still neatly stacked.

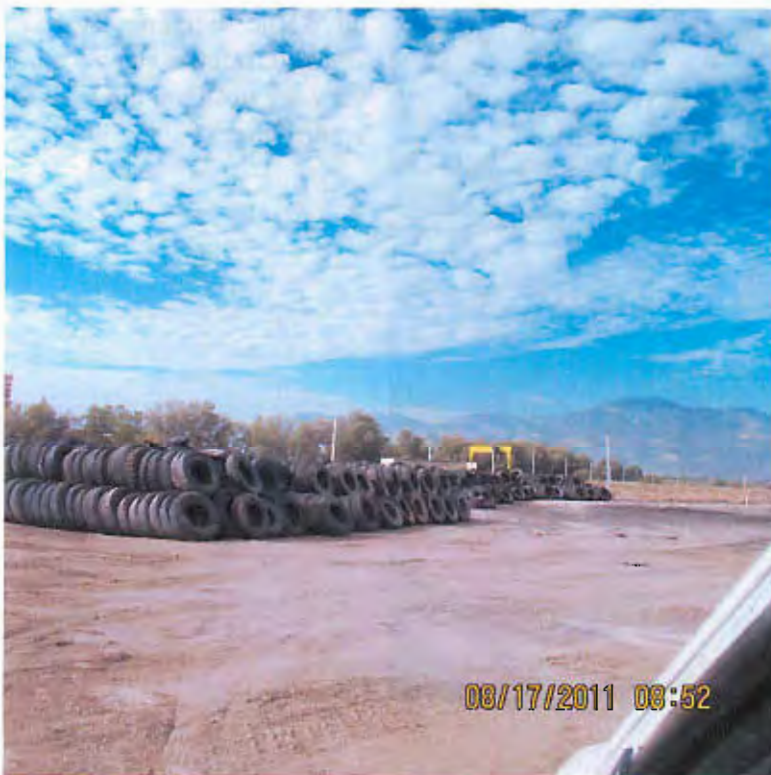
Stacked tires along south-east fence.

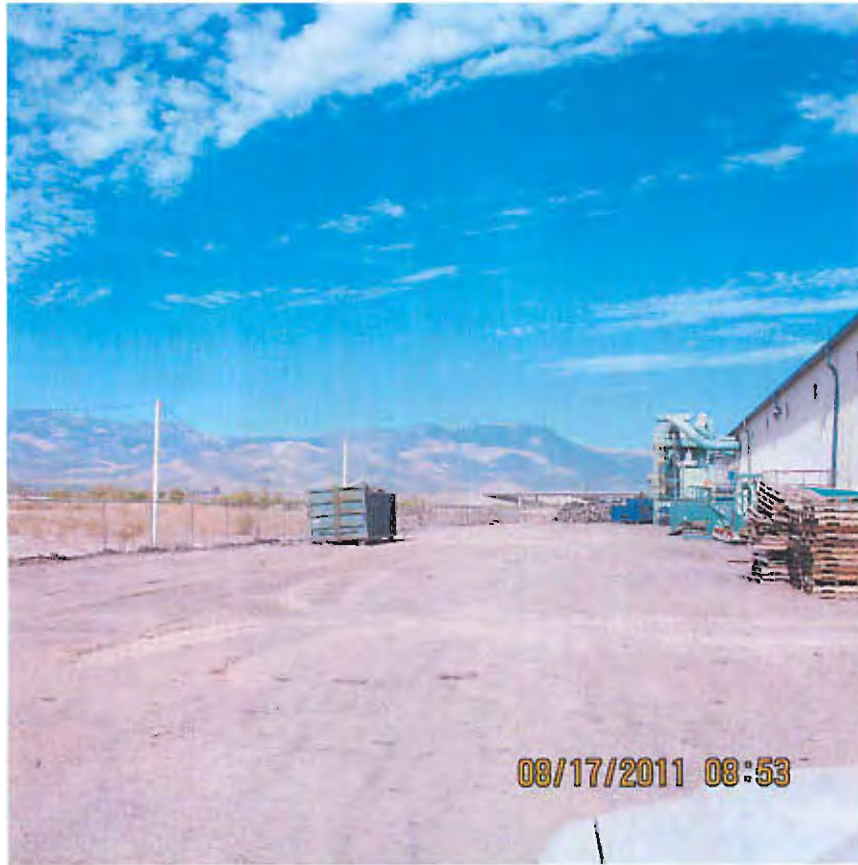
The south side of the facility had been generally cleared of tires, although some combustible wooden pallets were stacked alongside the building. The latest photo survey shows the area remains clear, and does not show any wooden pallets.

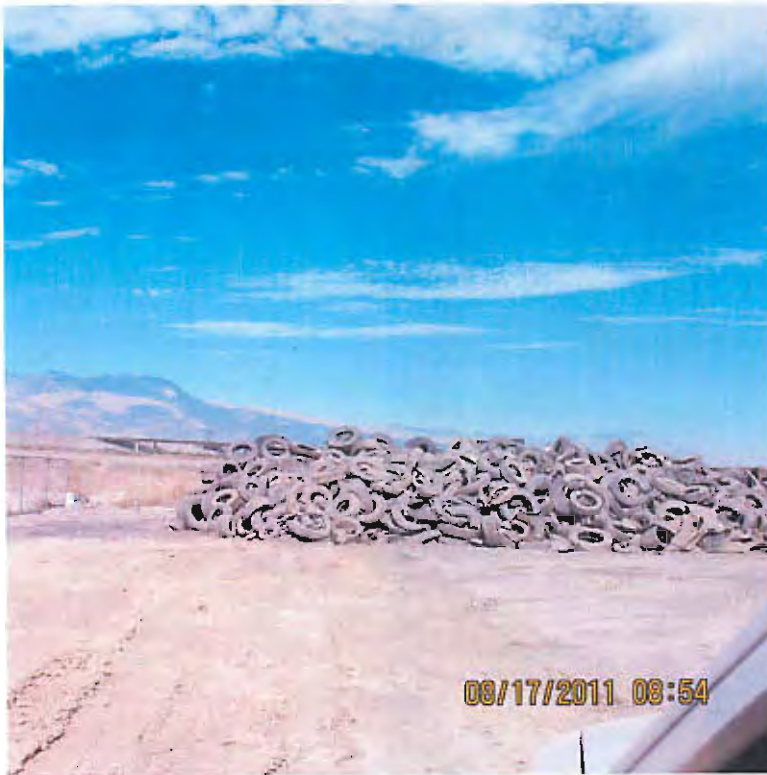
The tires in the southwest corner of the facility have since been neatly stacked, but the survey shows they are now too close to the south fence.

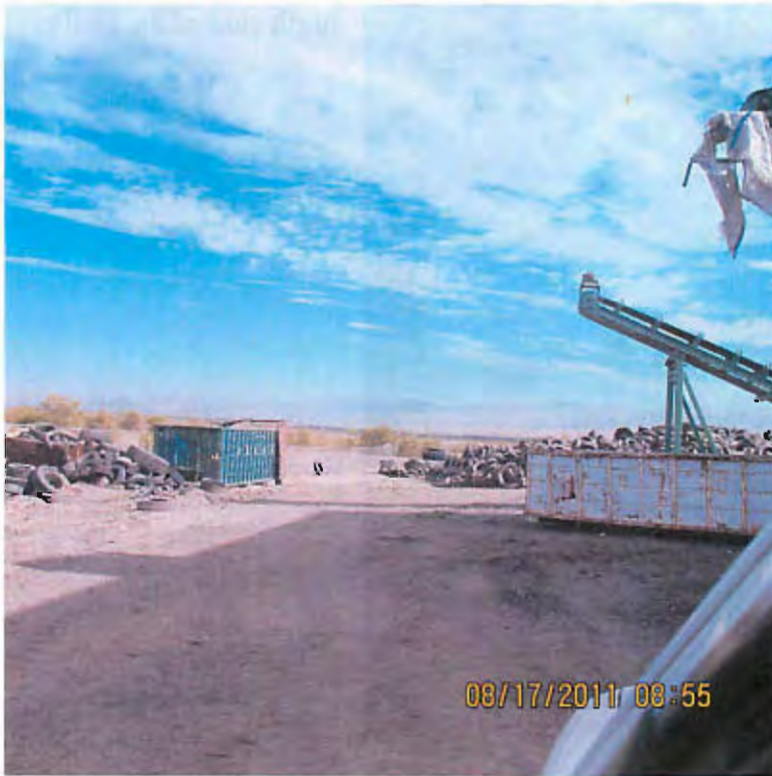
Tires near dumpsters had been placed directly along the middle of the west fence. According to facility representatives, these tires could not be crushed, and were present when they took over the facility. It was suggested during the inspection that if they could not process the tires at the site, they should remove them from the site. The current survey shows fewer tires there, but some material and mounted tires remains.

The tires visible in the background, in the NW corner of the facility, have since been moved farther from the west fence.

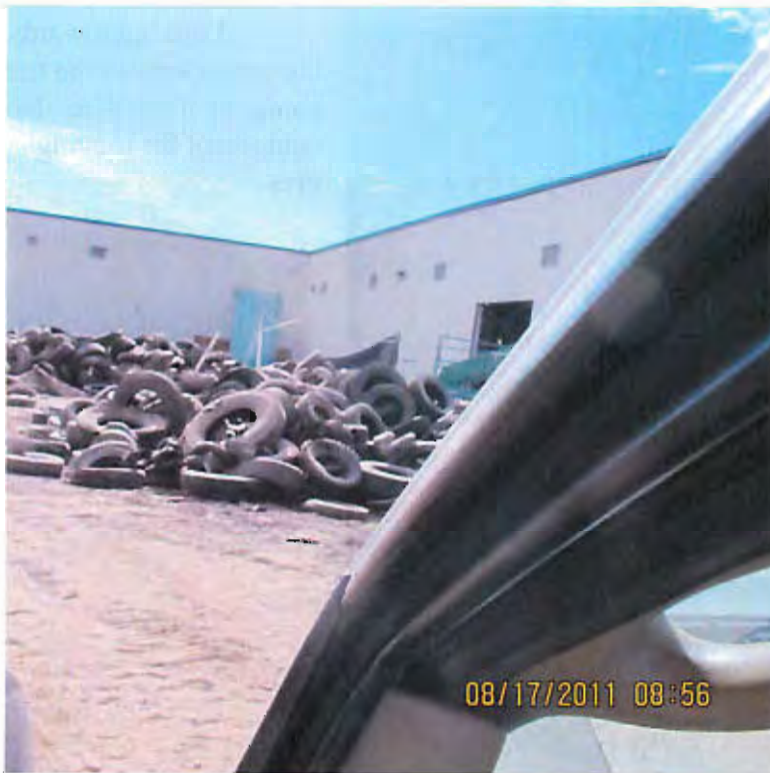
A significant number of tires remained in the loading area, leaning on and adjacent to the processing building. The current survey shows many tires remain in the same location.

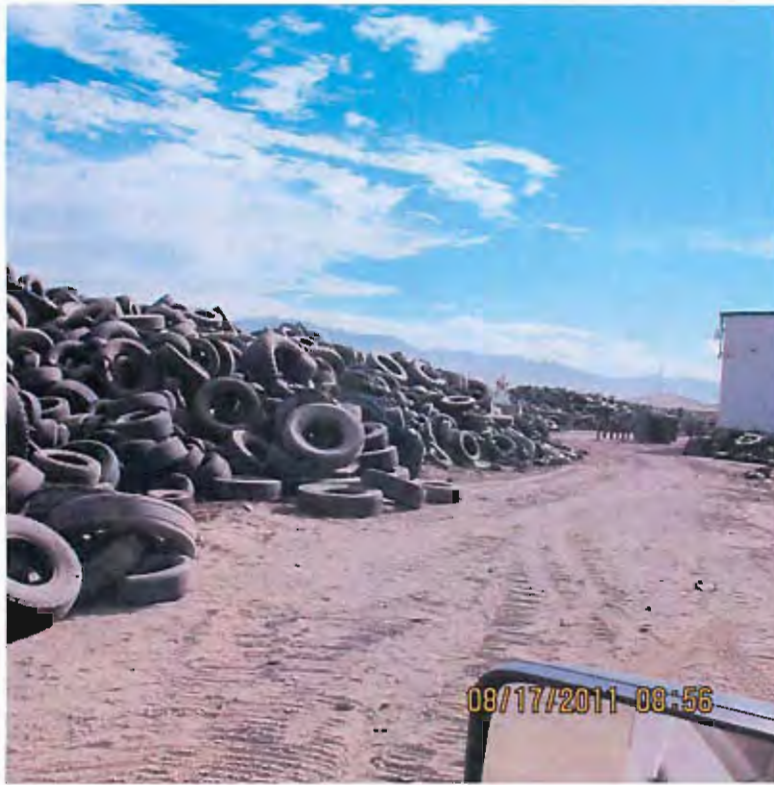
Tire pile along the north side of the facility.

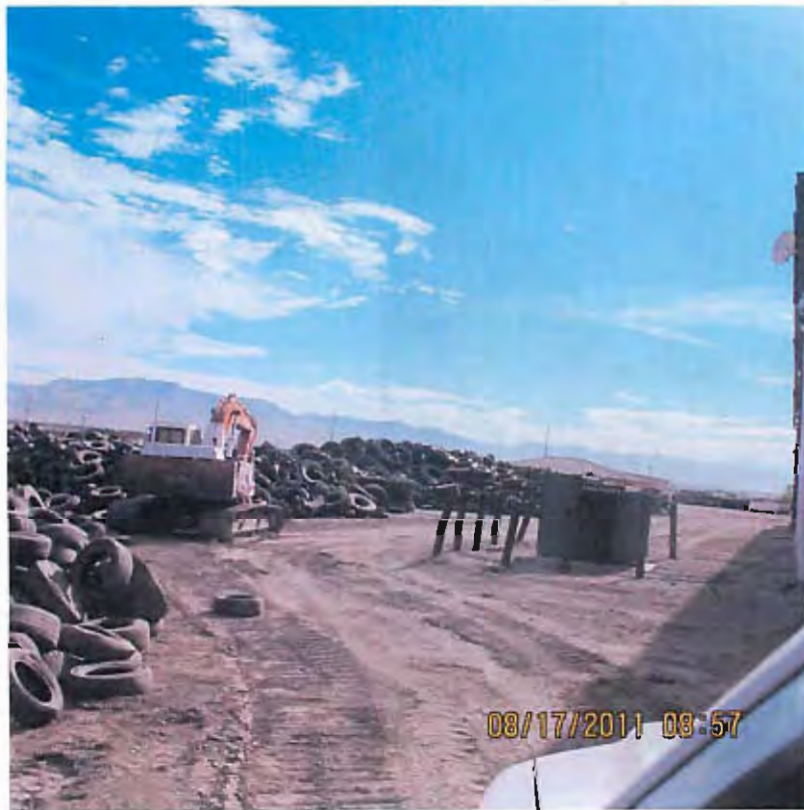
Looking towards the center area of the tires along the north side. Note equipment for moving tires.

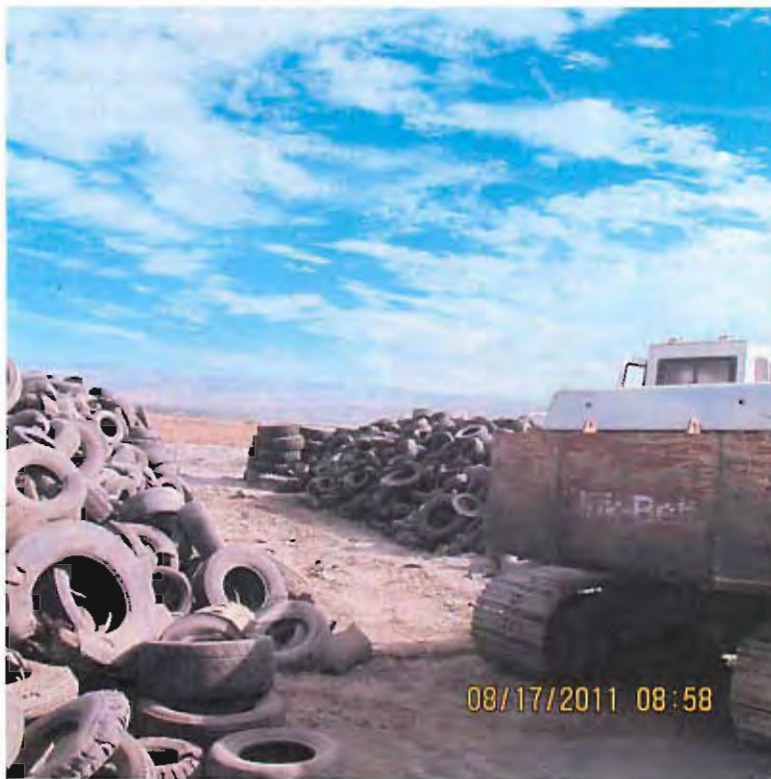
Aisle space between the rows is adequate for the tire equipment, but too narrow for fire trucks. The current survey shows a wider but still narrow lane.

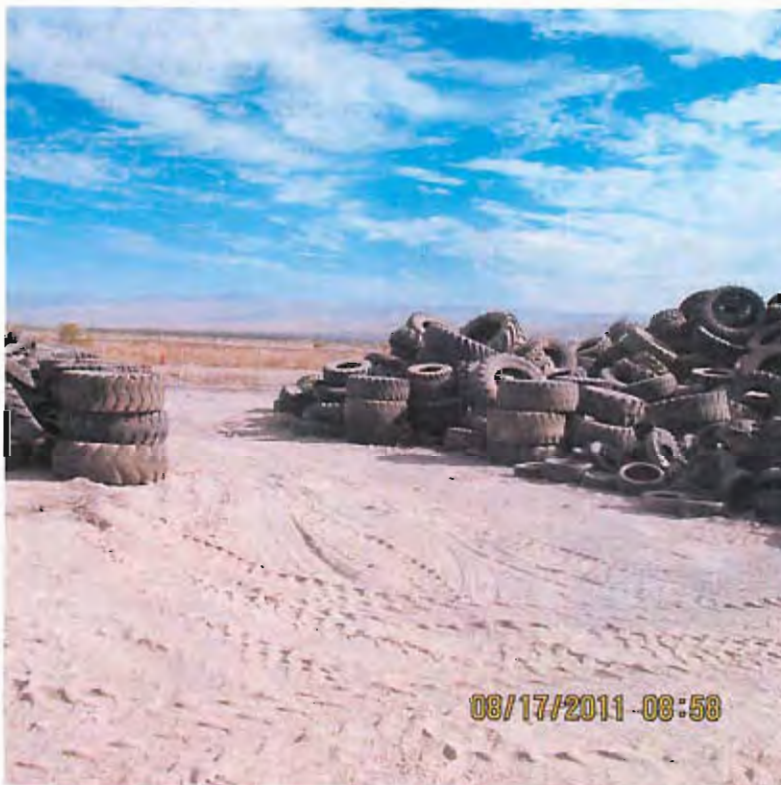
A second lane in the north tire pile area.

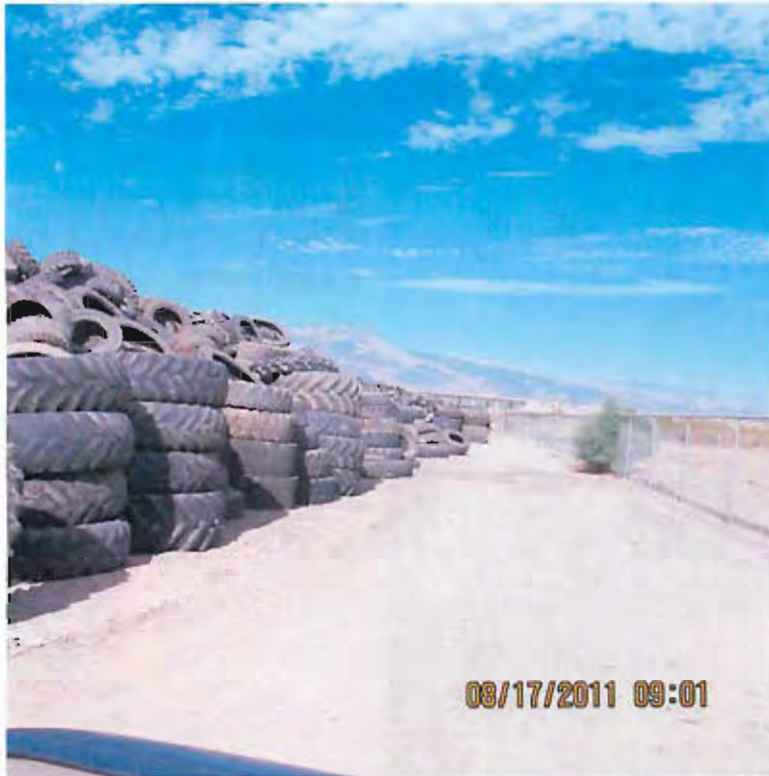
View between north tire pile and north facility fence. Although no tires are alongside the fence, there is not sufficient space for a fire truck to pass. The current survey appears the same.

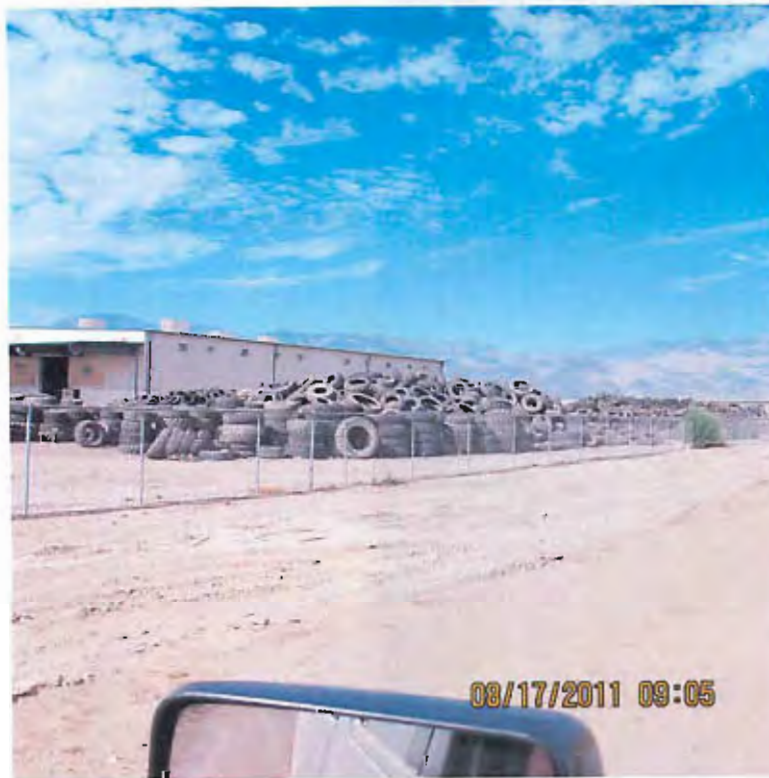
View of north tire pile from outside facility fence. These photos were taken by the CBMI compliance officer in the same spots she takes the weekly survey, to allow comparison over time.

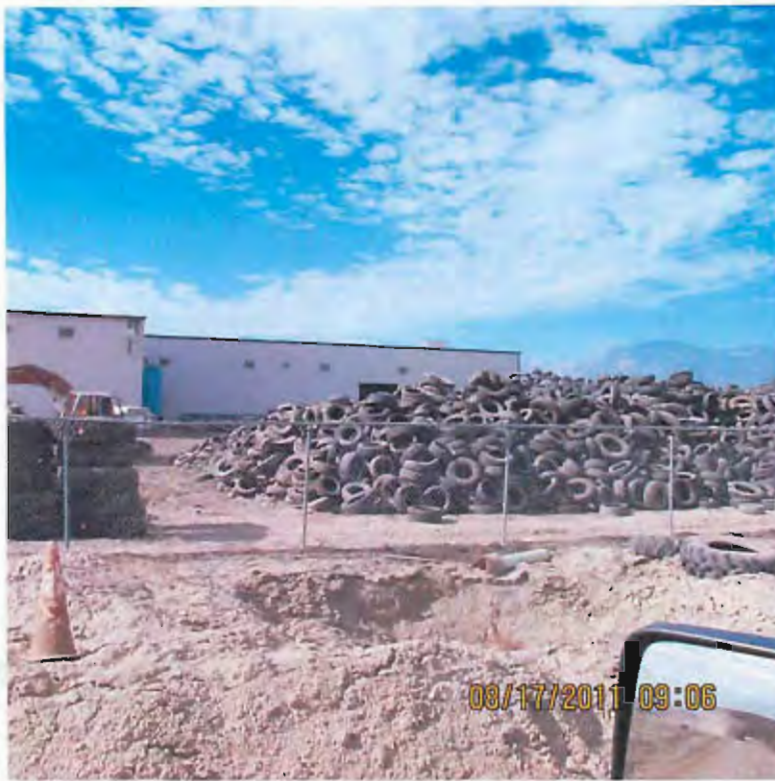
A view of the aisle with the tire handling equipment from outside the facility. The current survey photo is very similar. The tires outside of the fence, visible on the right, were placed to form a barrier for a hole that was excavated to repair piping.

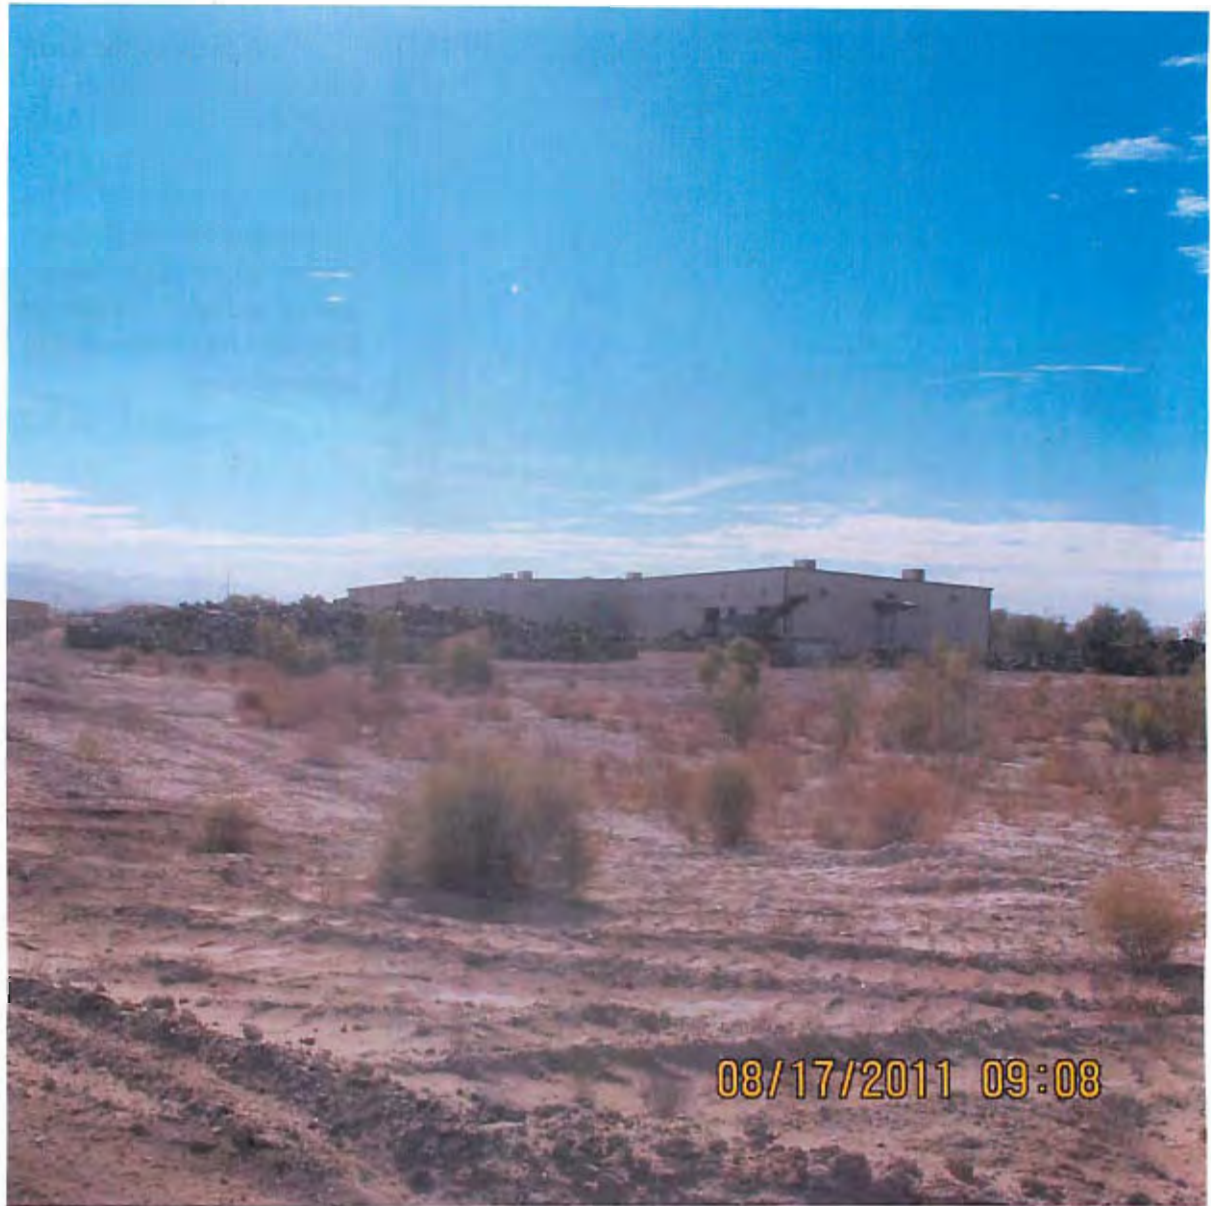
Overall view of the north and west sides of the facility, looking towards the east.

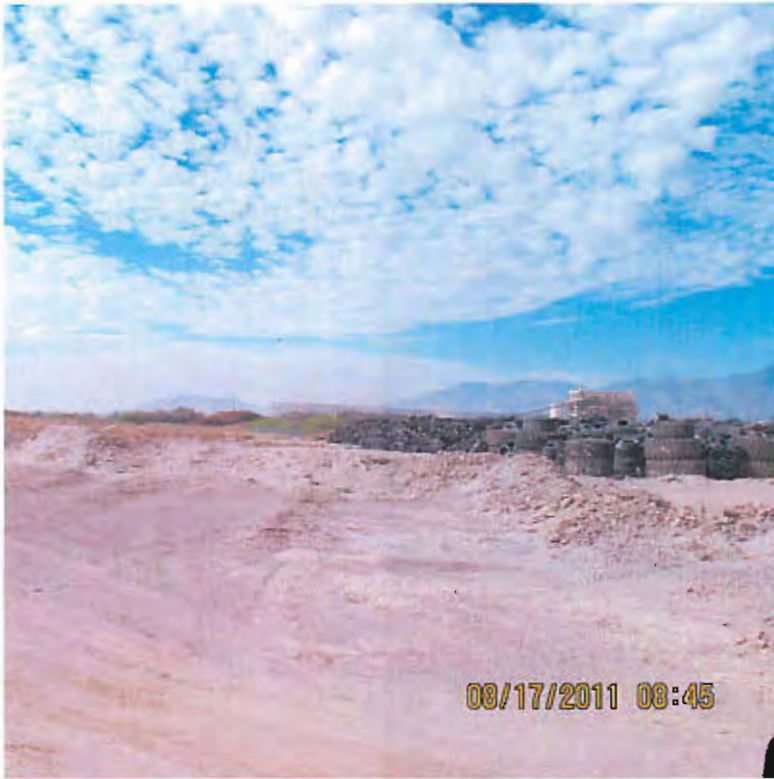
This photo shows the north-east corner of the former Specialty Alloys site.

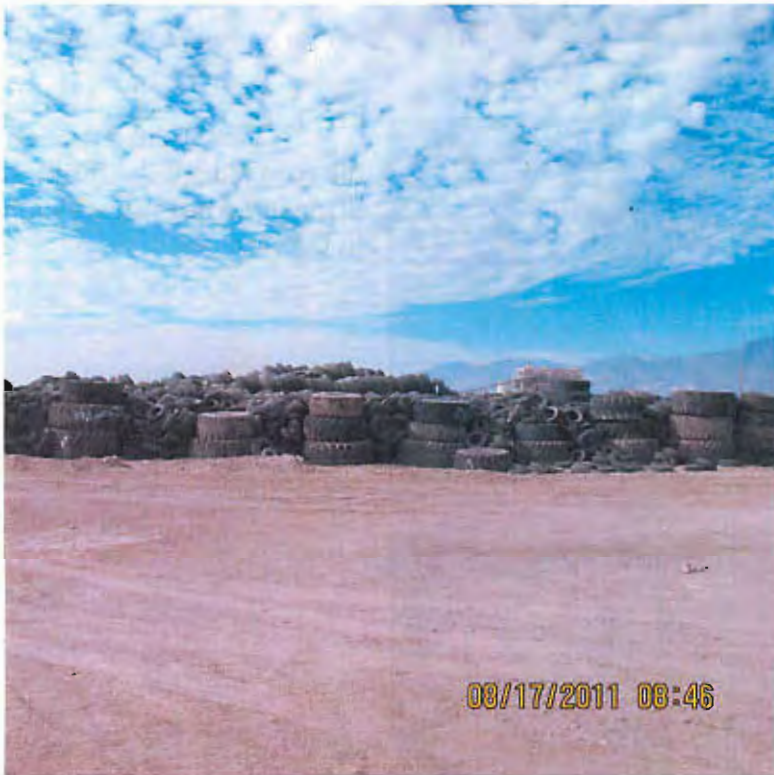
North-west corner of the former Specialty Alloys site.

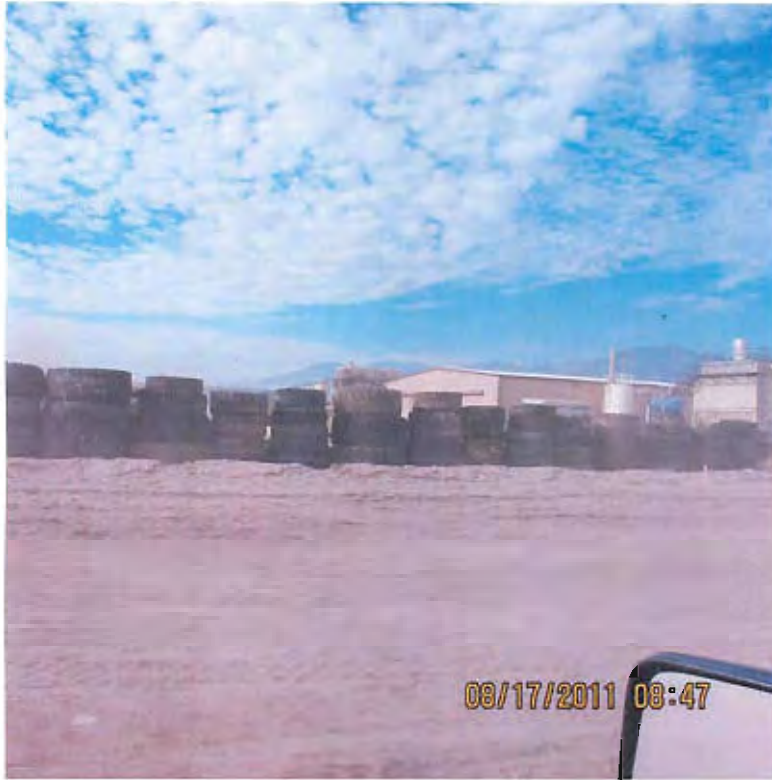
Truck tires along the west side of the former Specialty Alloys site.

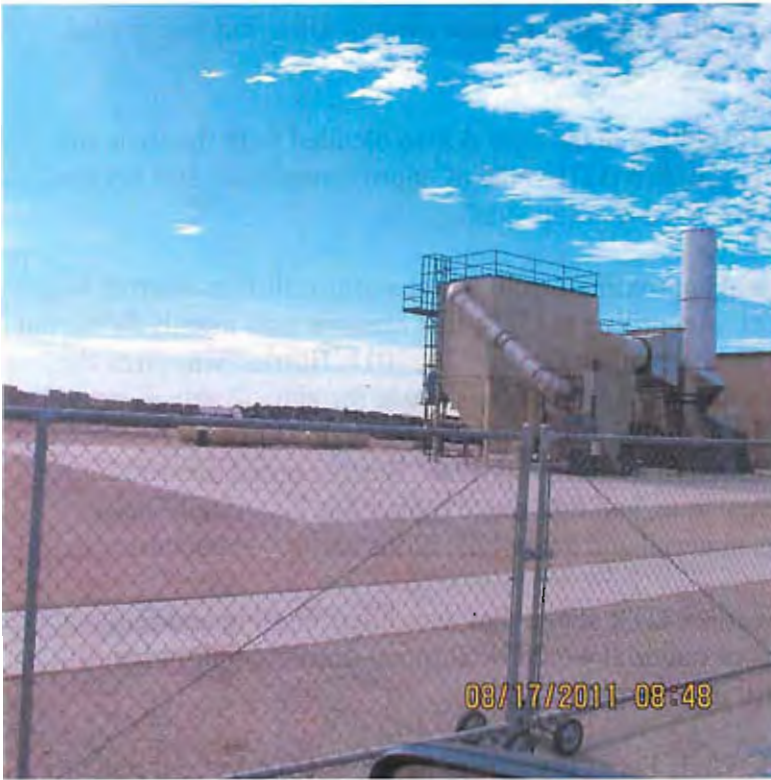
View from the same location, looking south-east.
