**U.S. Environmental Protection Agency, Region IX
CWA Compliance Office
Report of Clean Water Act Inspection**

Site Location: State Route 179 Improvement Project
Between Mile Posts 310.5 and 313.8
Oak Creek/Sedona, AZ

Date and Time of Visit: February 5, 2010, 8:30 a.m. – 1:30 p.m.

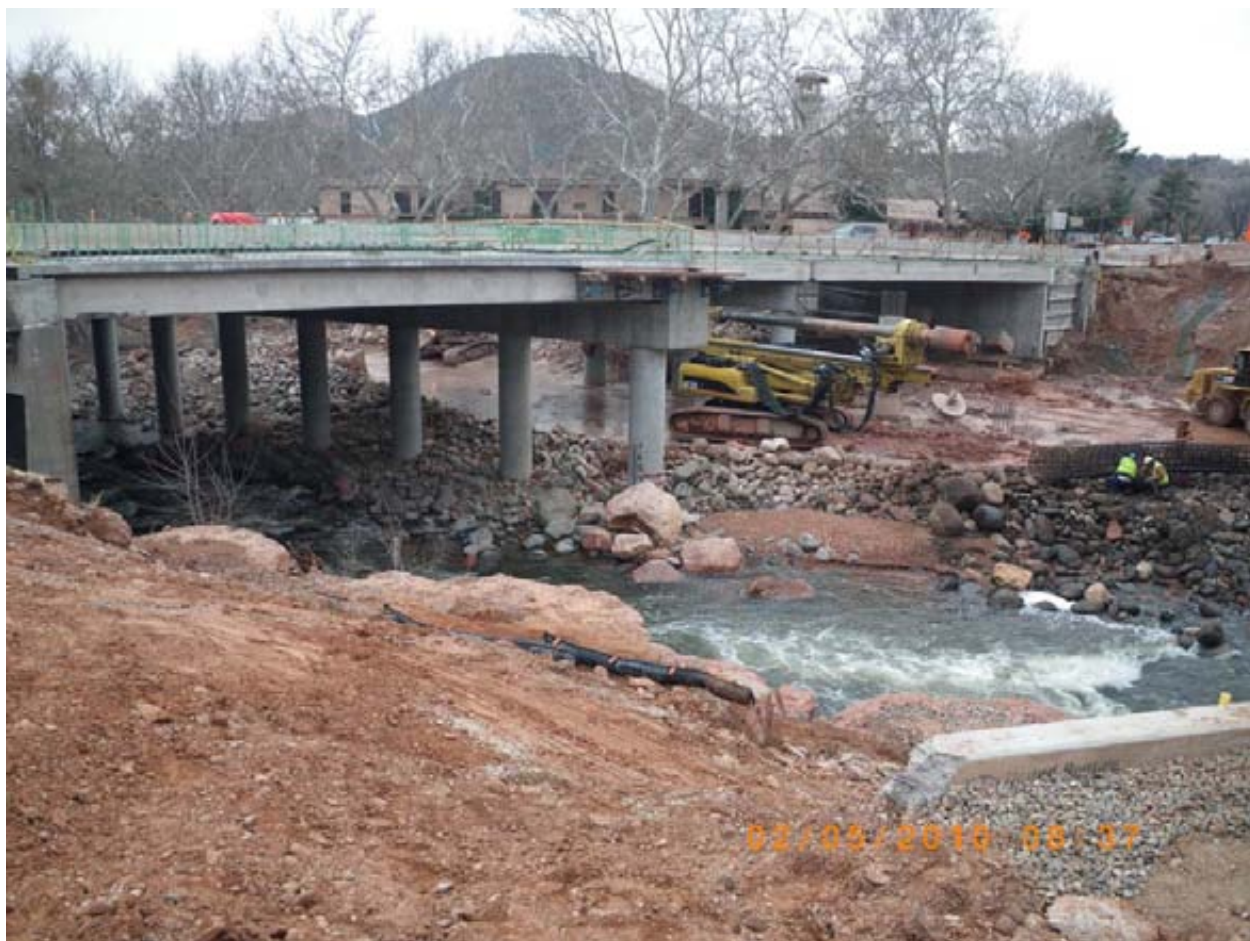
Observations: The inspection began at the eastern end of the pedestrian bridge, above the Garland slope. This slope is directly above the active channel (see Photos 0003, 0044). The slope was disturbed without adequate best management practices (BMPs) installed. At the foot of the slope were three 'gator-eels' (heavy logs to slow the flow of water). At the top of the slope, a small basin was installed to slow the flow of water (see Photo 0045). This basin was undersized, given the amount of run-on entering the site at this location. This slope has been unprotected since January 9, 2010, when ADOT/Fisher removed the last bridge abutment. Prior to the January 19-22 storm event, ADOT/Fisher installed three steel I-beams across the slope in an attempt to stabilize the slope. Because the I-beams served as dams rather than filters, they were inadequate and the slope eroded underneath and around the beams, discharging sediment to Oak Creek.

IMGP0003 – Taken from top of Garland (east) slope of Oak Creek, looking west toward Tlaquepaque (west) slope, Oak Creek's confined channel, and vehicular bridge. Note that steel girders have been removed from Garland slope after they were compromised during Jan 15-20th, 2010 storm. Gator eels installed at toe of slope.

ADOT/Fisher monitors the weather forecasts frequently. As the project involves work in an active stream channel, ADOT also monitors warming trends to determine when snow melt will result in increased flows. However, although rain was forecast for the weekend, ADOT/Fisher had not made plans to address the exposed Garland slope. During the inspection, I spoke with them at length about this area and made several suggestions for possible BMPs until the permanent retaining wall is constructed.

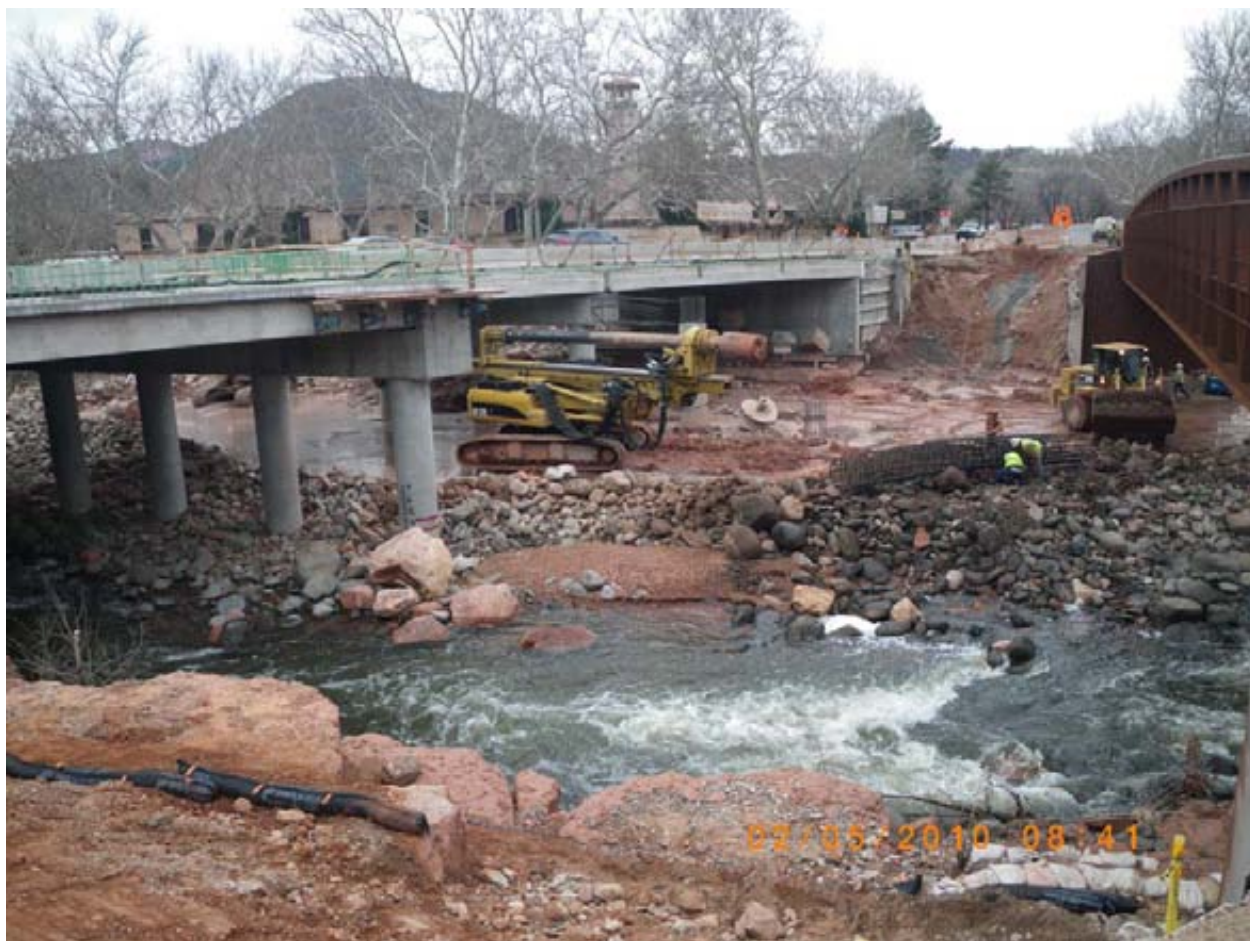
IMGP0004

IMGP0004, 05 – Taken from top of Garland slope of Oak Creek, looking west toward Oak Creek channel and vehicular and pedestrian/utility bridges. Note imported materials used to build coffer dam in creek bed.

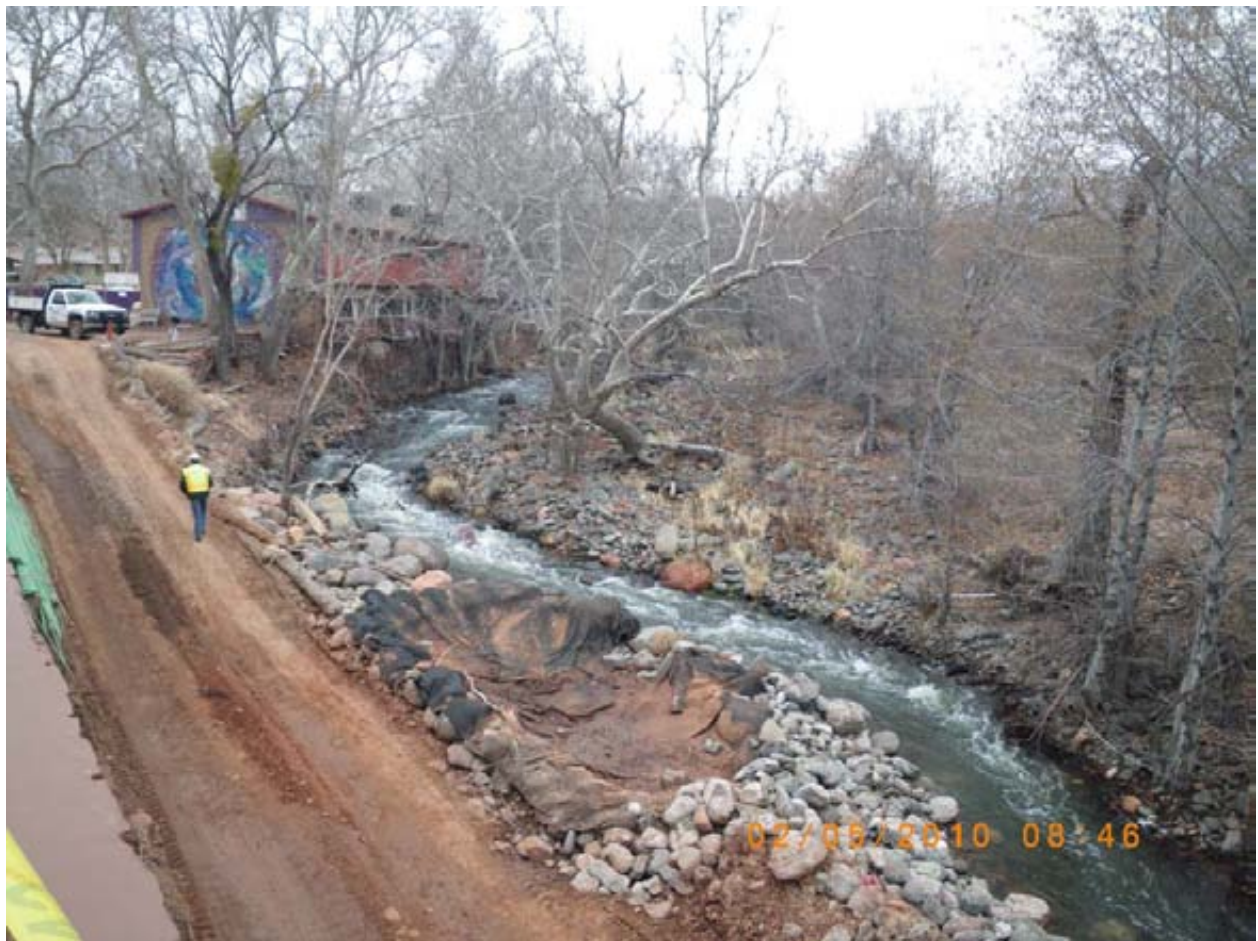
IMGP0006 – From north side of pedestrian bridge, looking north toward west braid of Oak Creek, upstream of bridges. Note sediment basin between creek and access road used for occasional filtering of sediment-laden water collected in coffer dam. Filter fabric is sagging from north side of basin, creating escape route for fine sediment. On-site contractors noted that this sediment basin has never over-topped.

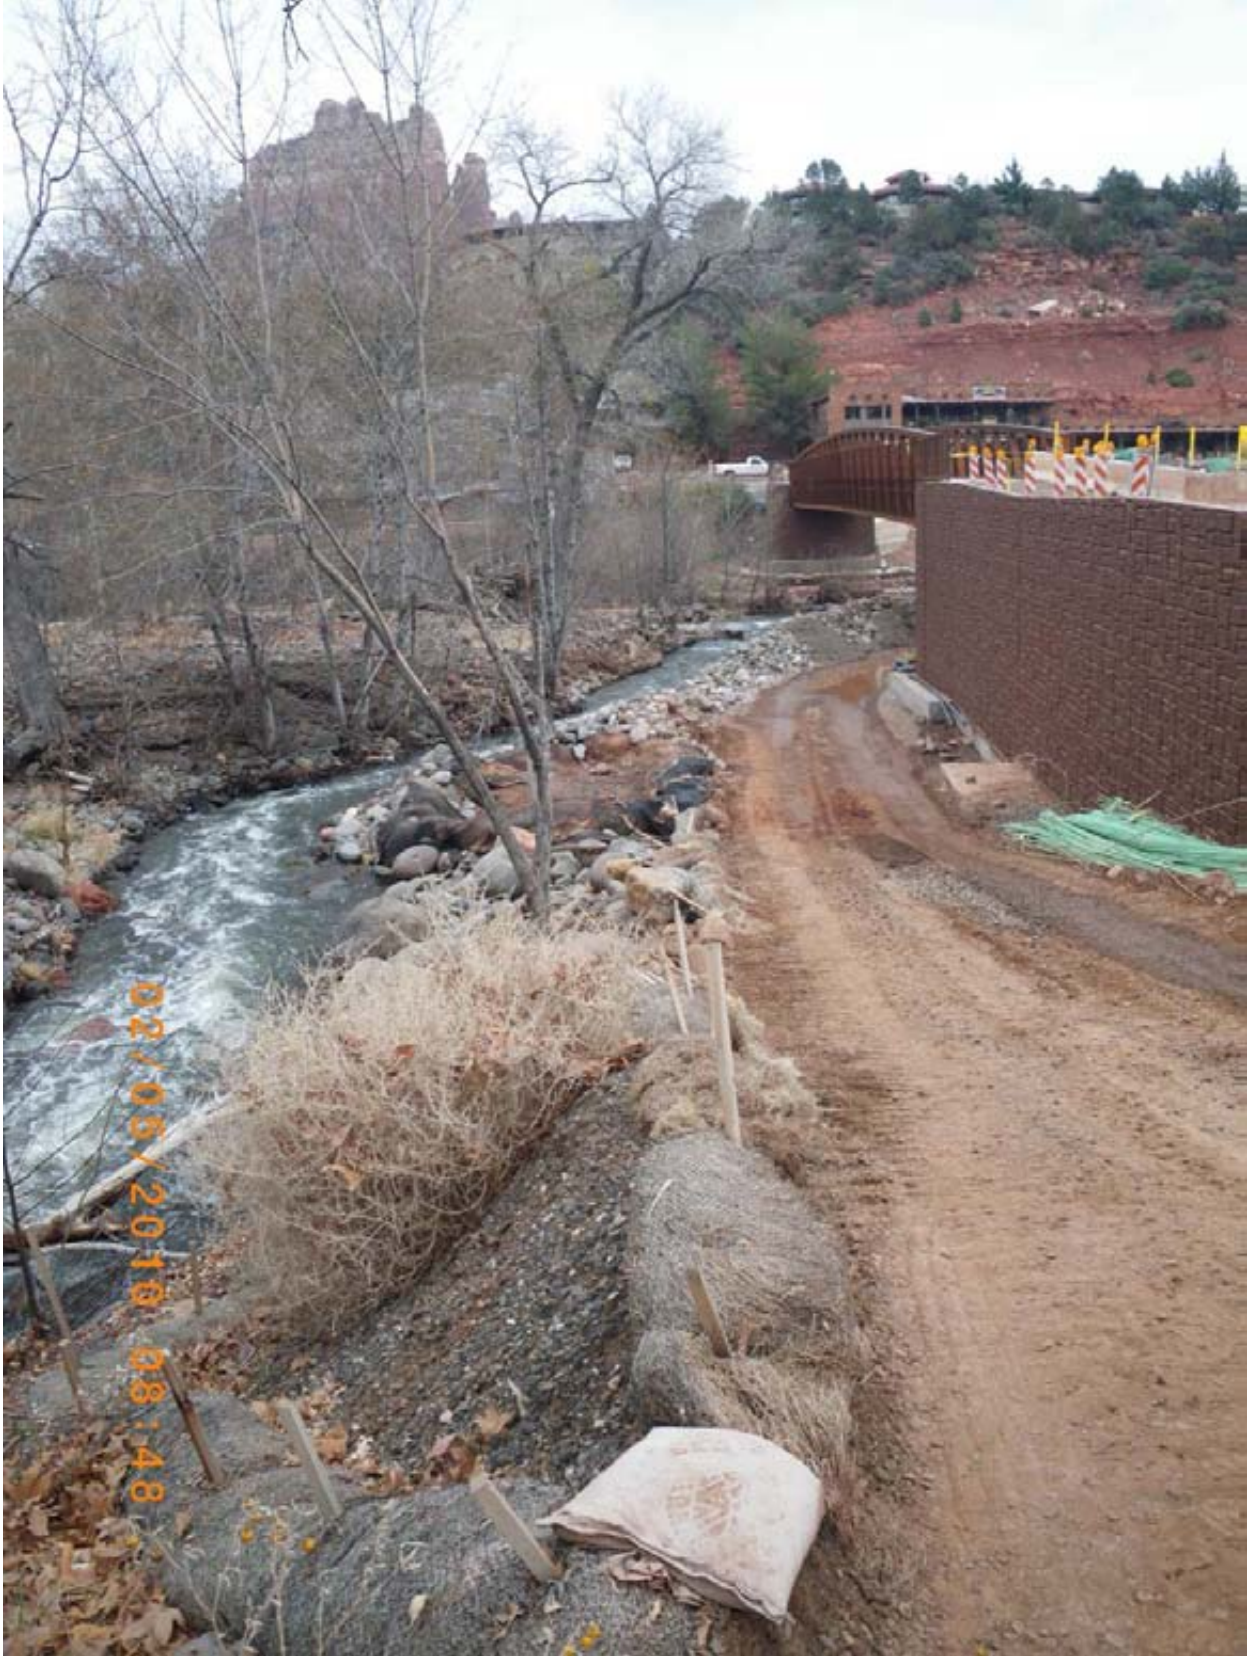
IMGP0007
6 of 86

IMGP0007 – From northwest corner of project site at top of access road, looking east toward Garland slope and pedestrian bridge. Note sediment from access road deposited on rock bank adjacent to creek.

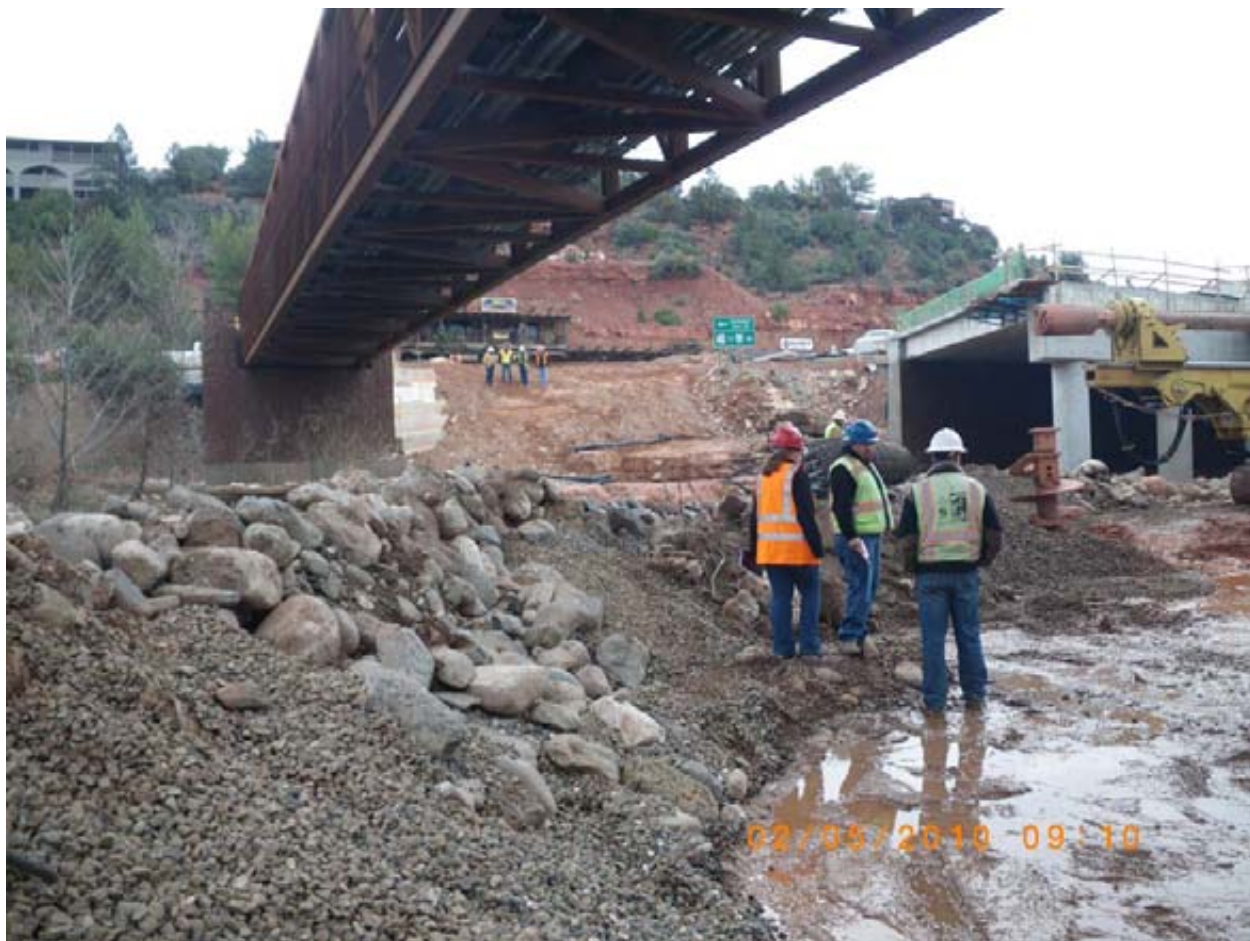
IMG0008

IMGP0008 – From under pedestrian bridge, west side of creek bed, facing Garland slope. Note imported boulders and gravel in creek bed work area.

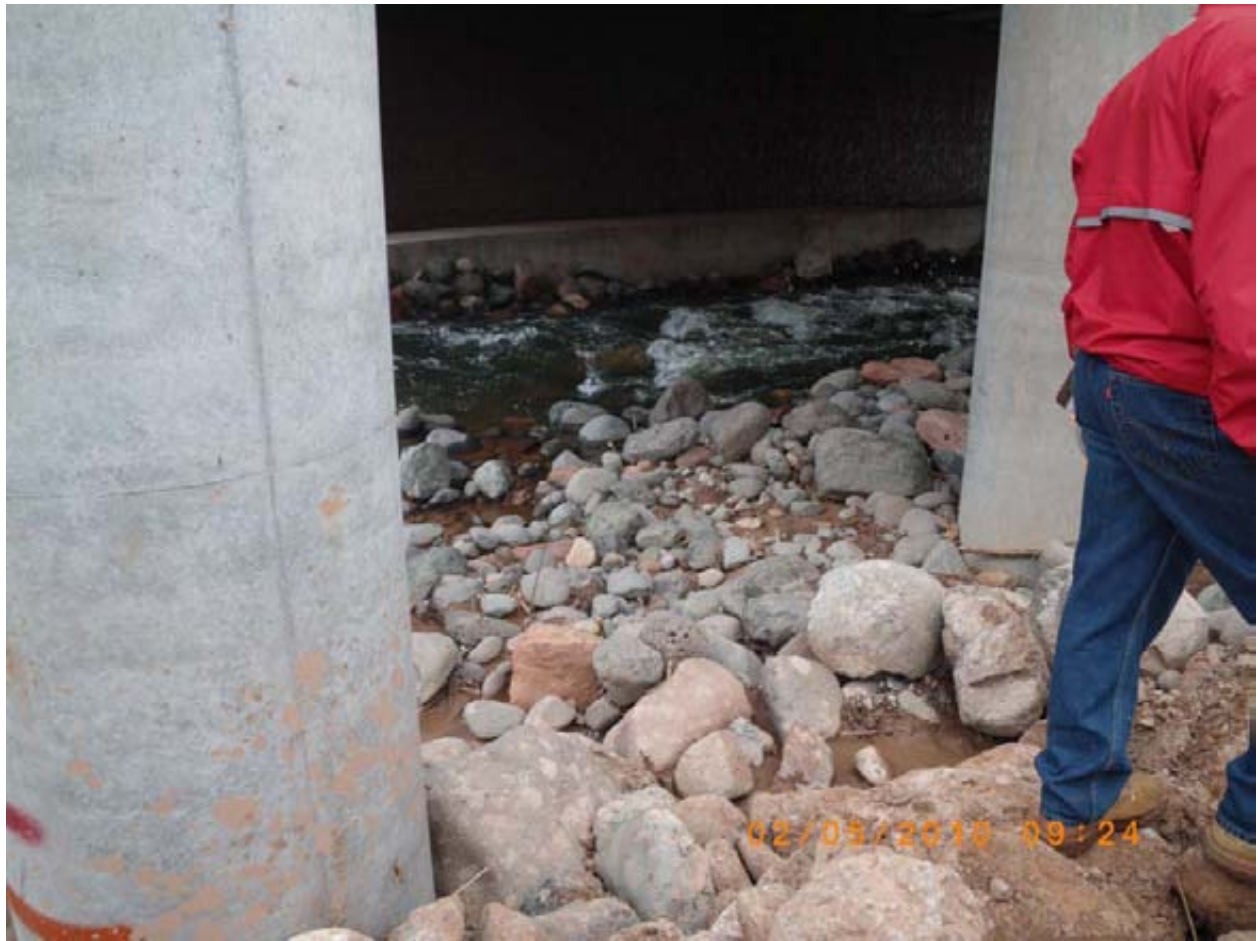
IMGP0021 – From west side of creek, northernmost pier of vehicular bridge, facing southeast. Creek flows from left to right of picture frame. Sediment is probably from the project.

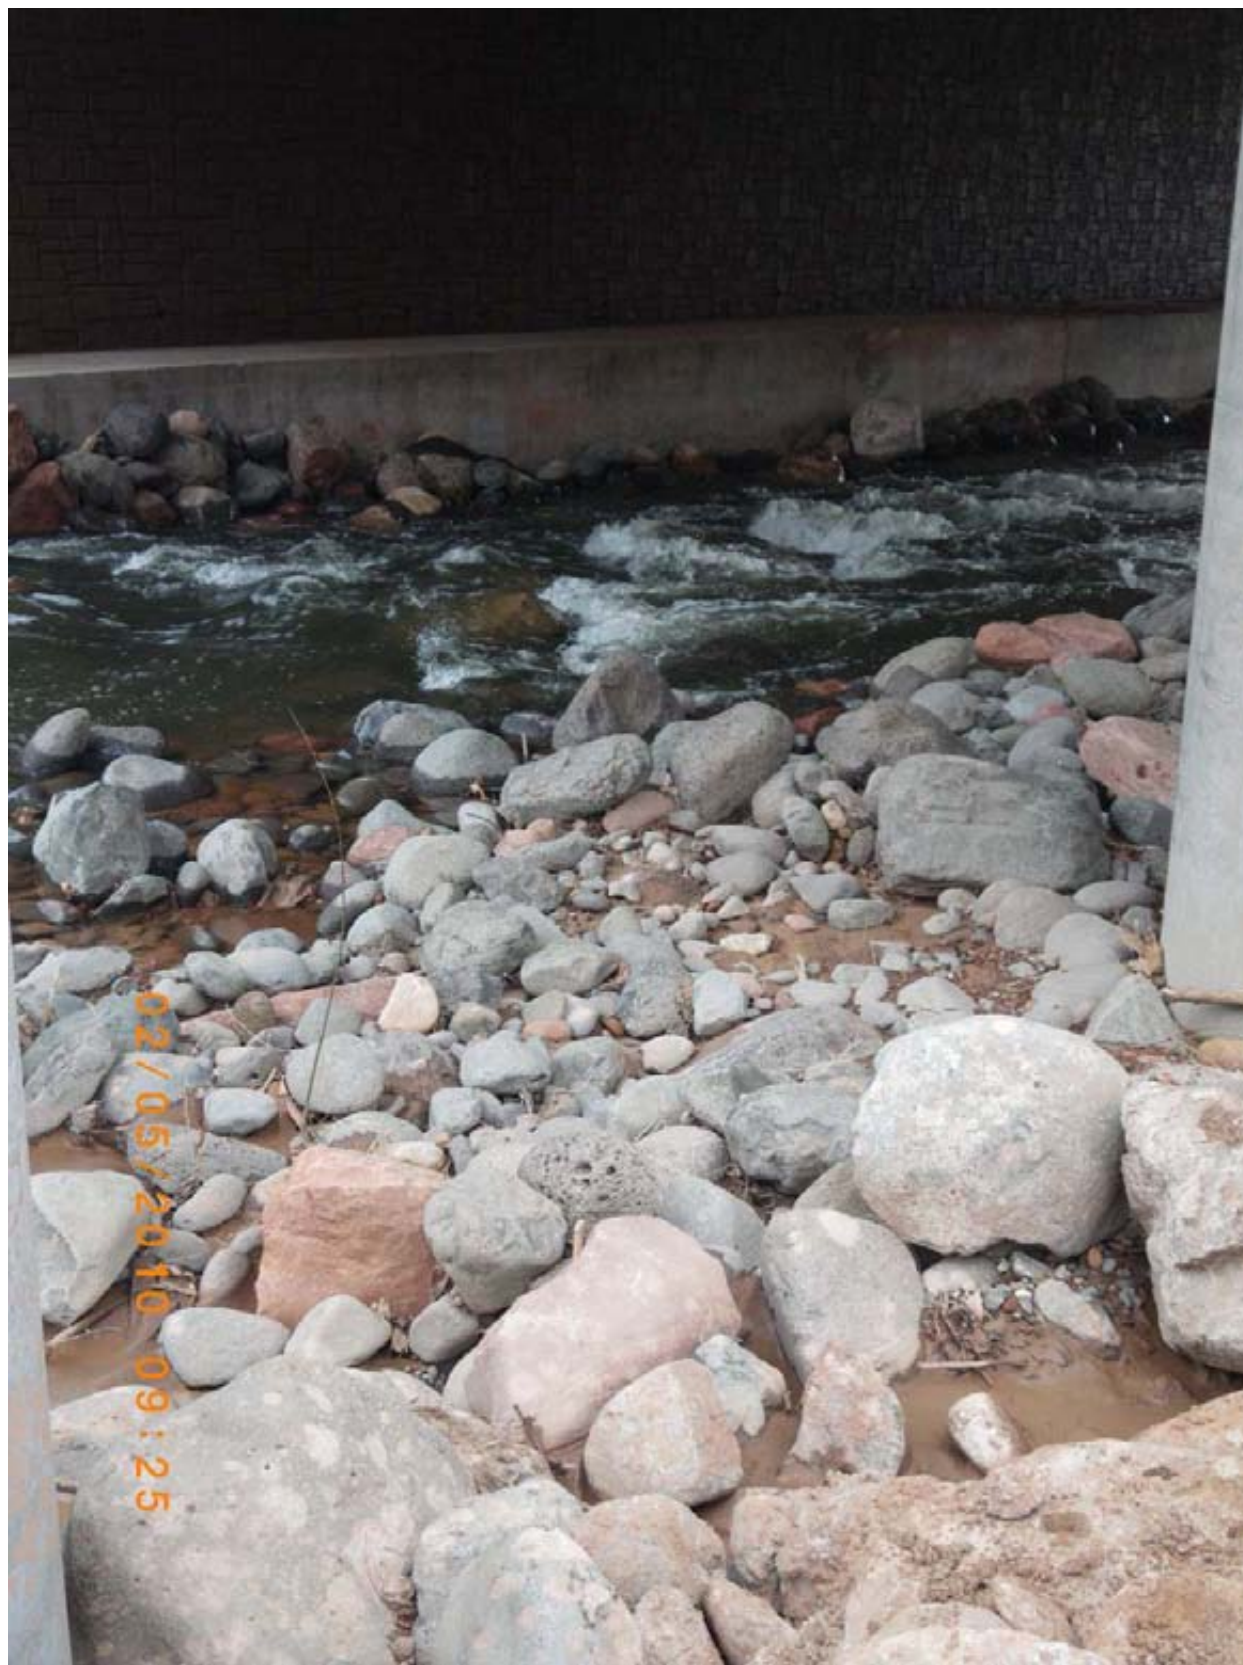
IMGP0022
21 of 86

IMGP0022 – Close-up of fine sediments from IMGP0021.

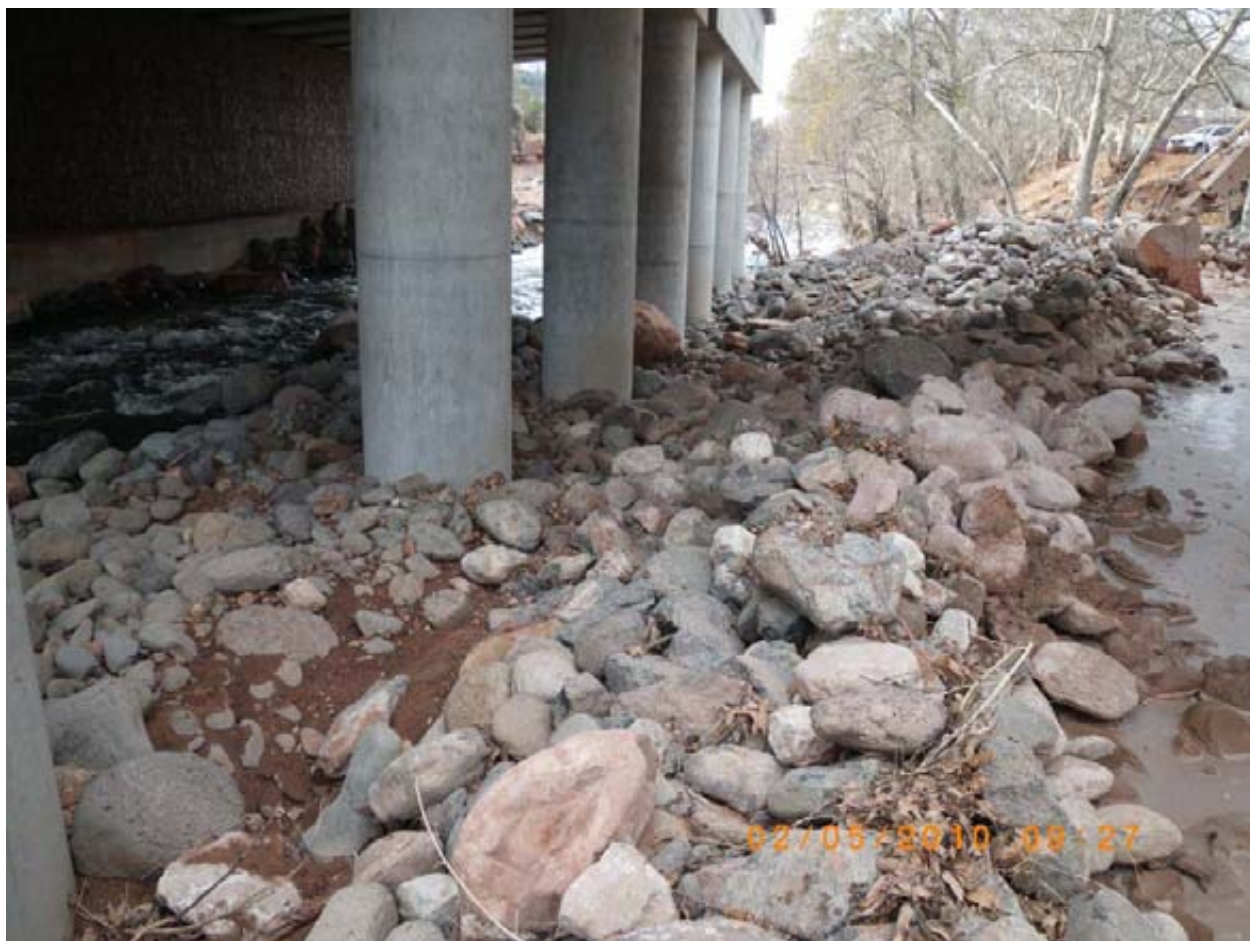
IMGP0023 – From top of coffer dam, facing south/downstream direction of Oak Creek (shown on left side of picture frame). Note fine sediments on creek side of coffer dam.

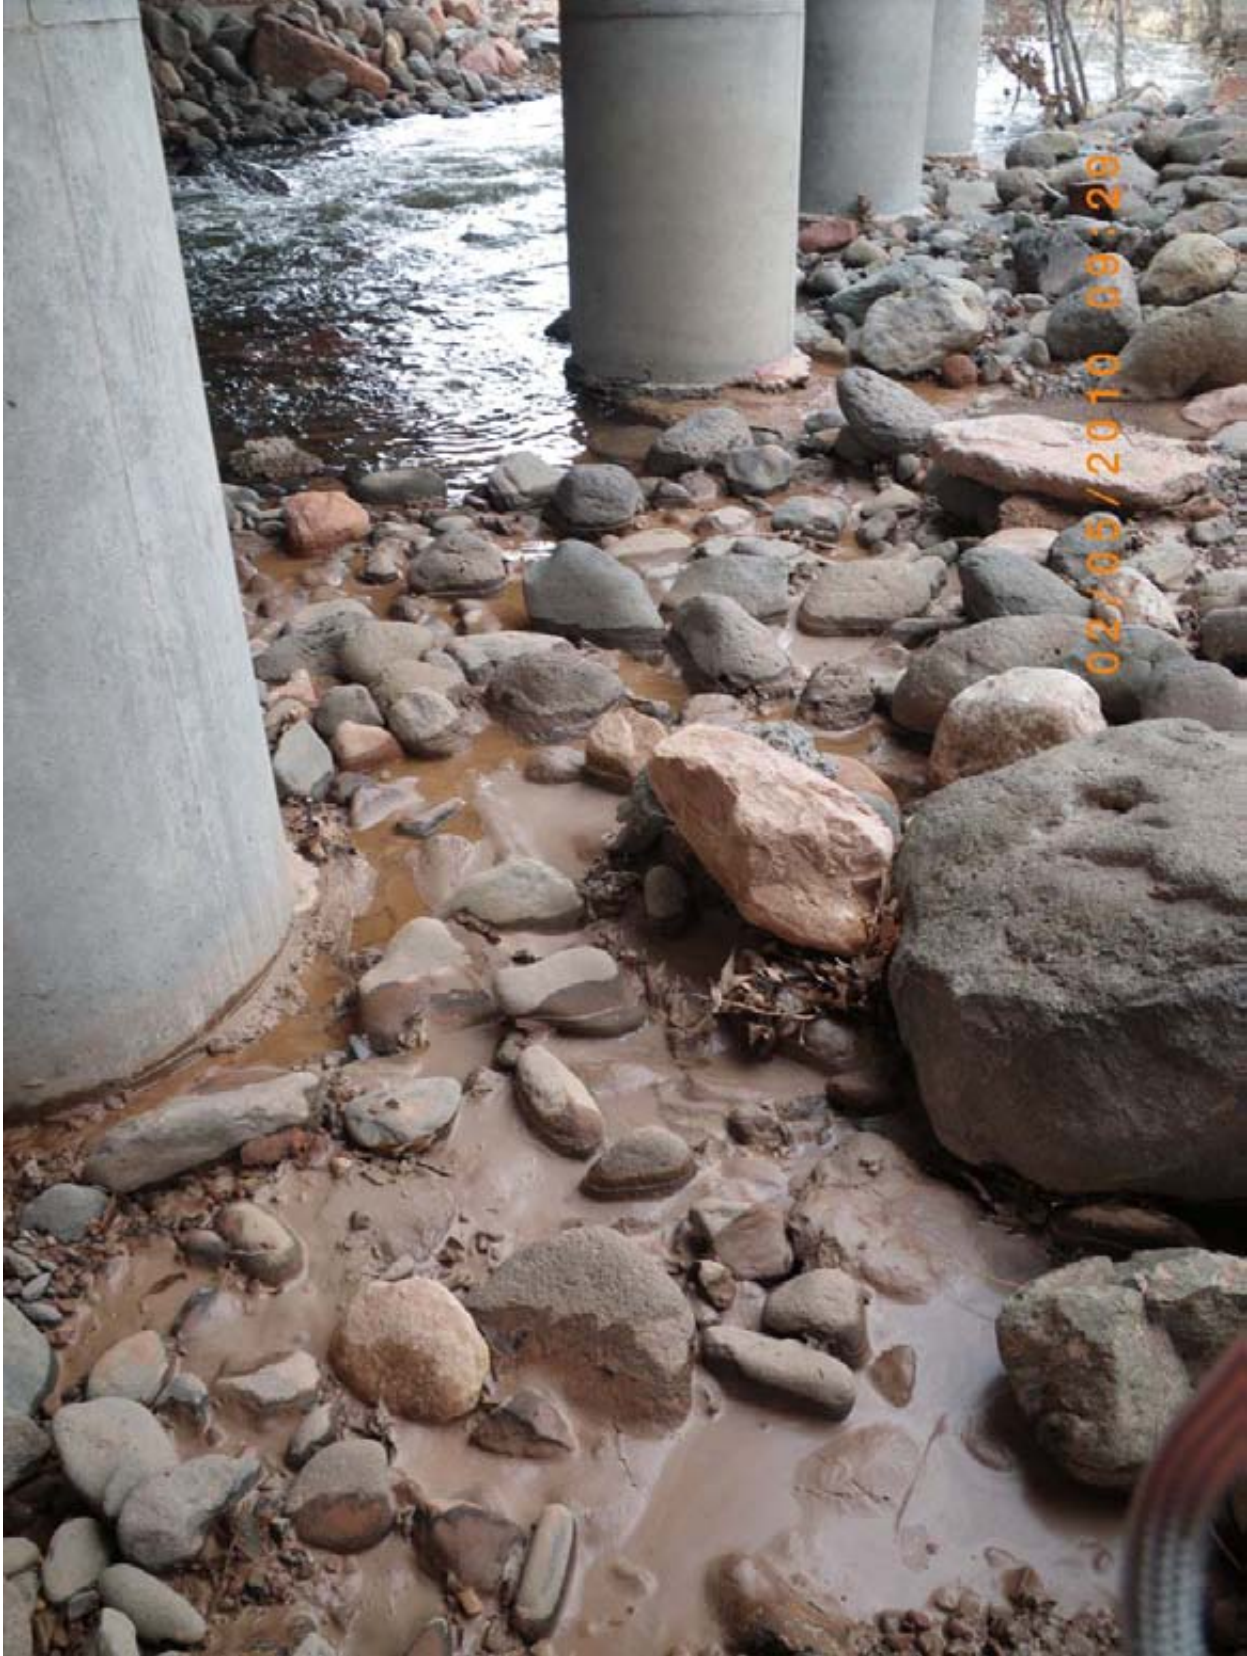
IMGP0024
23 of 86

IMGP0024 – Close-up of fine sediments from IMGP0023.

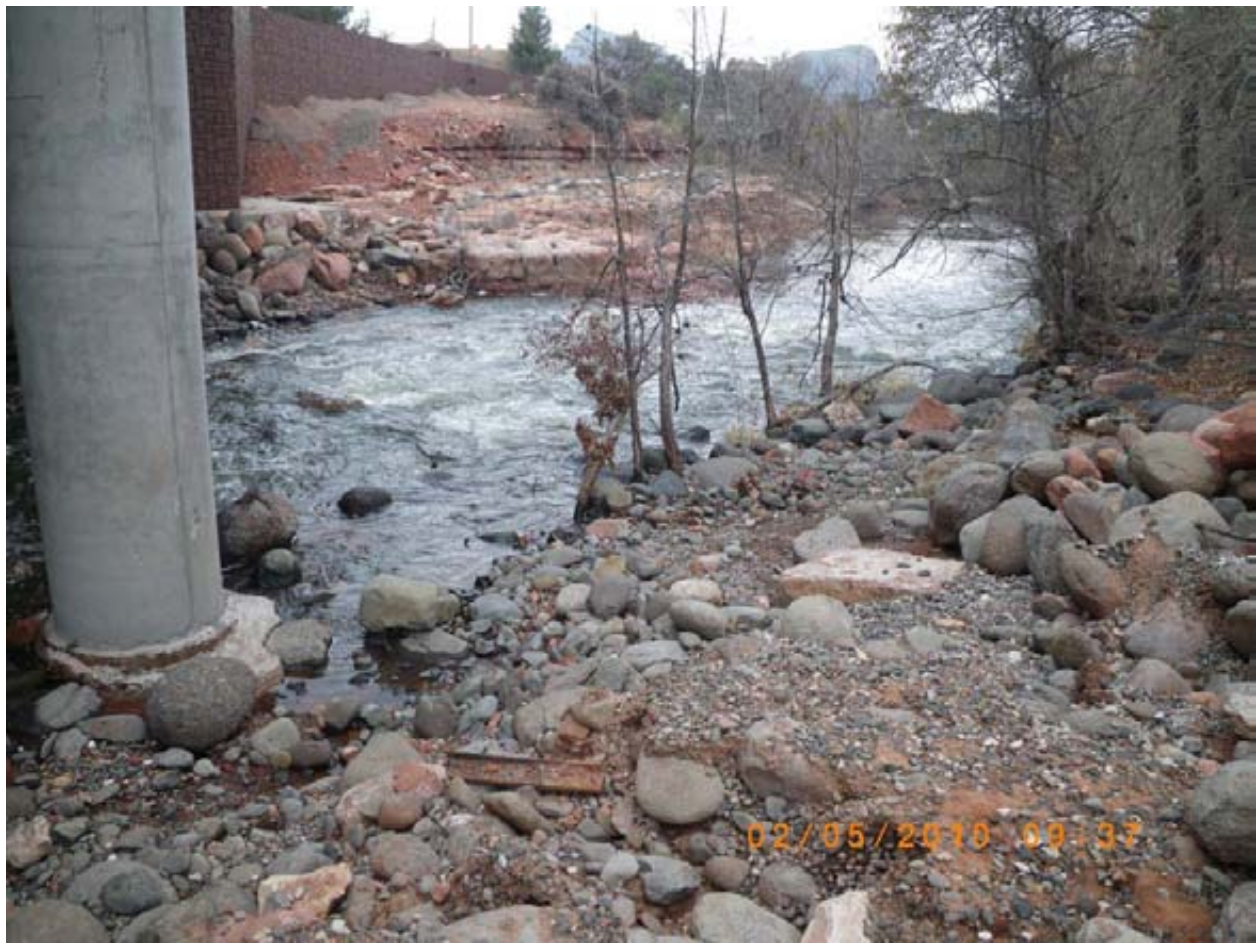
IMG0026

IMGP0026 – From west side of creek (southeast edge of coffer dam), facing southeast/downstream direction of Oak Creek. Note fine sediments in foreground.

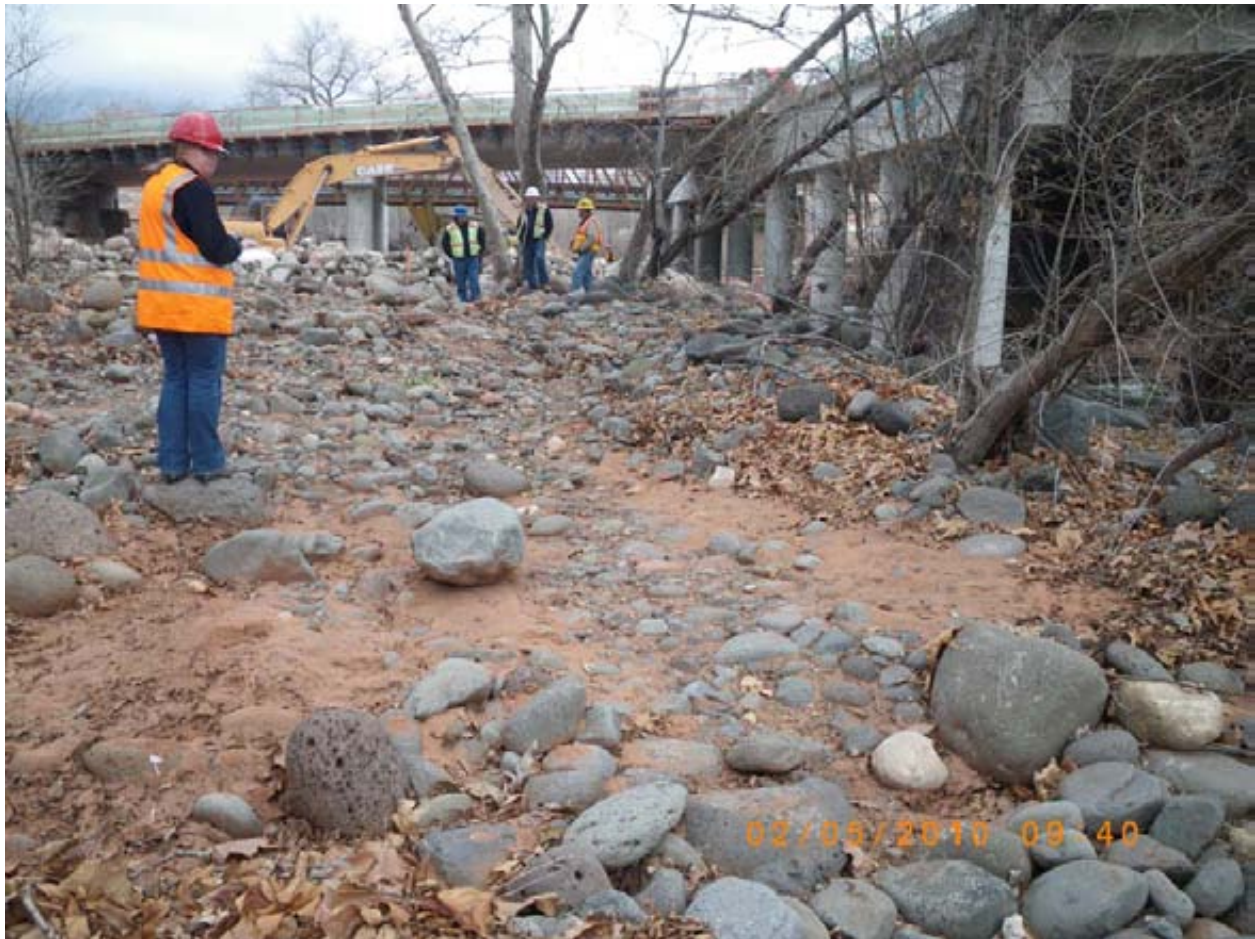
IMGP0027 – From west side of creek (southeast edge of coffer dam), facing north toward bridges. Note fine sediment.

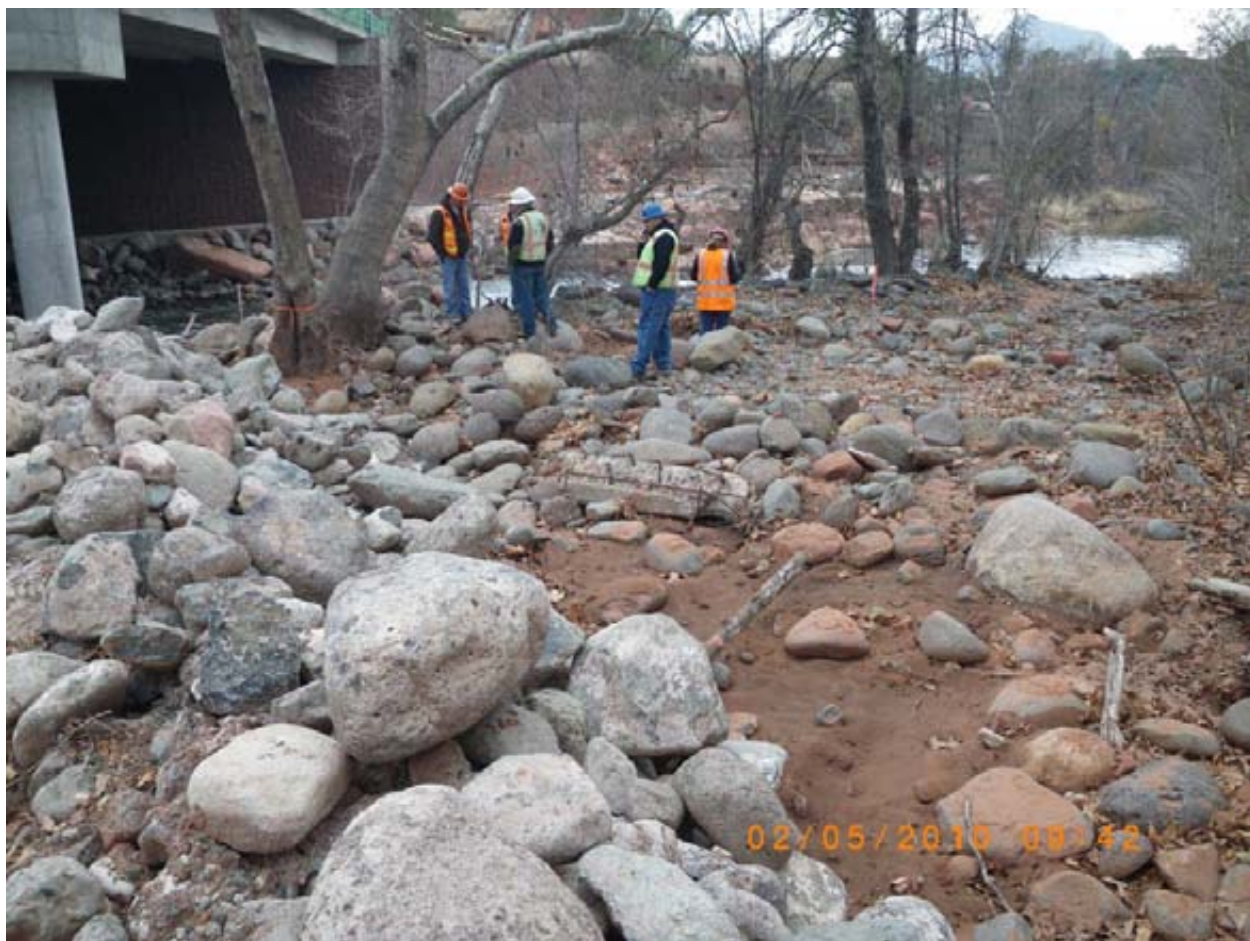
IMG0028

IMGP0028, 29 – From west side of creek (southwest edge of coffer dam) at end of grading work, facing southeast toward creek. Note fine sediments in foreground. Creek flows from left to right side of picture frame.

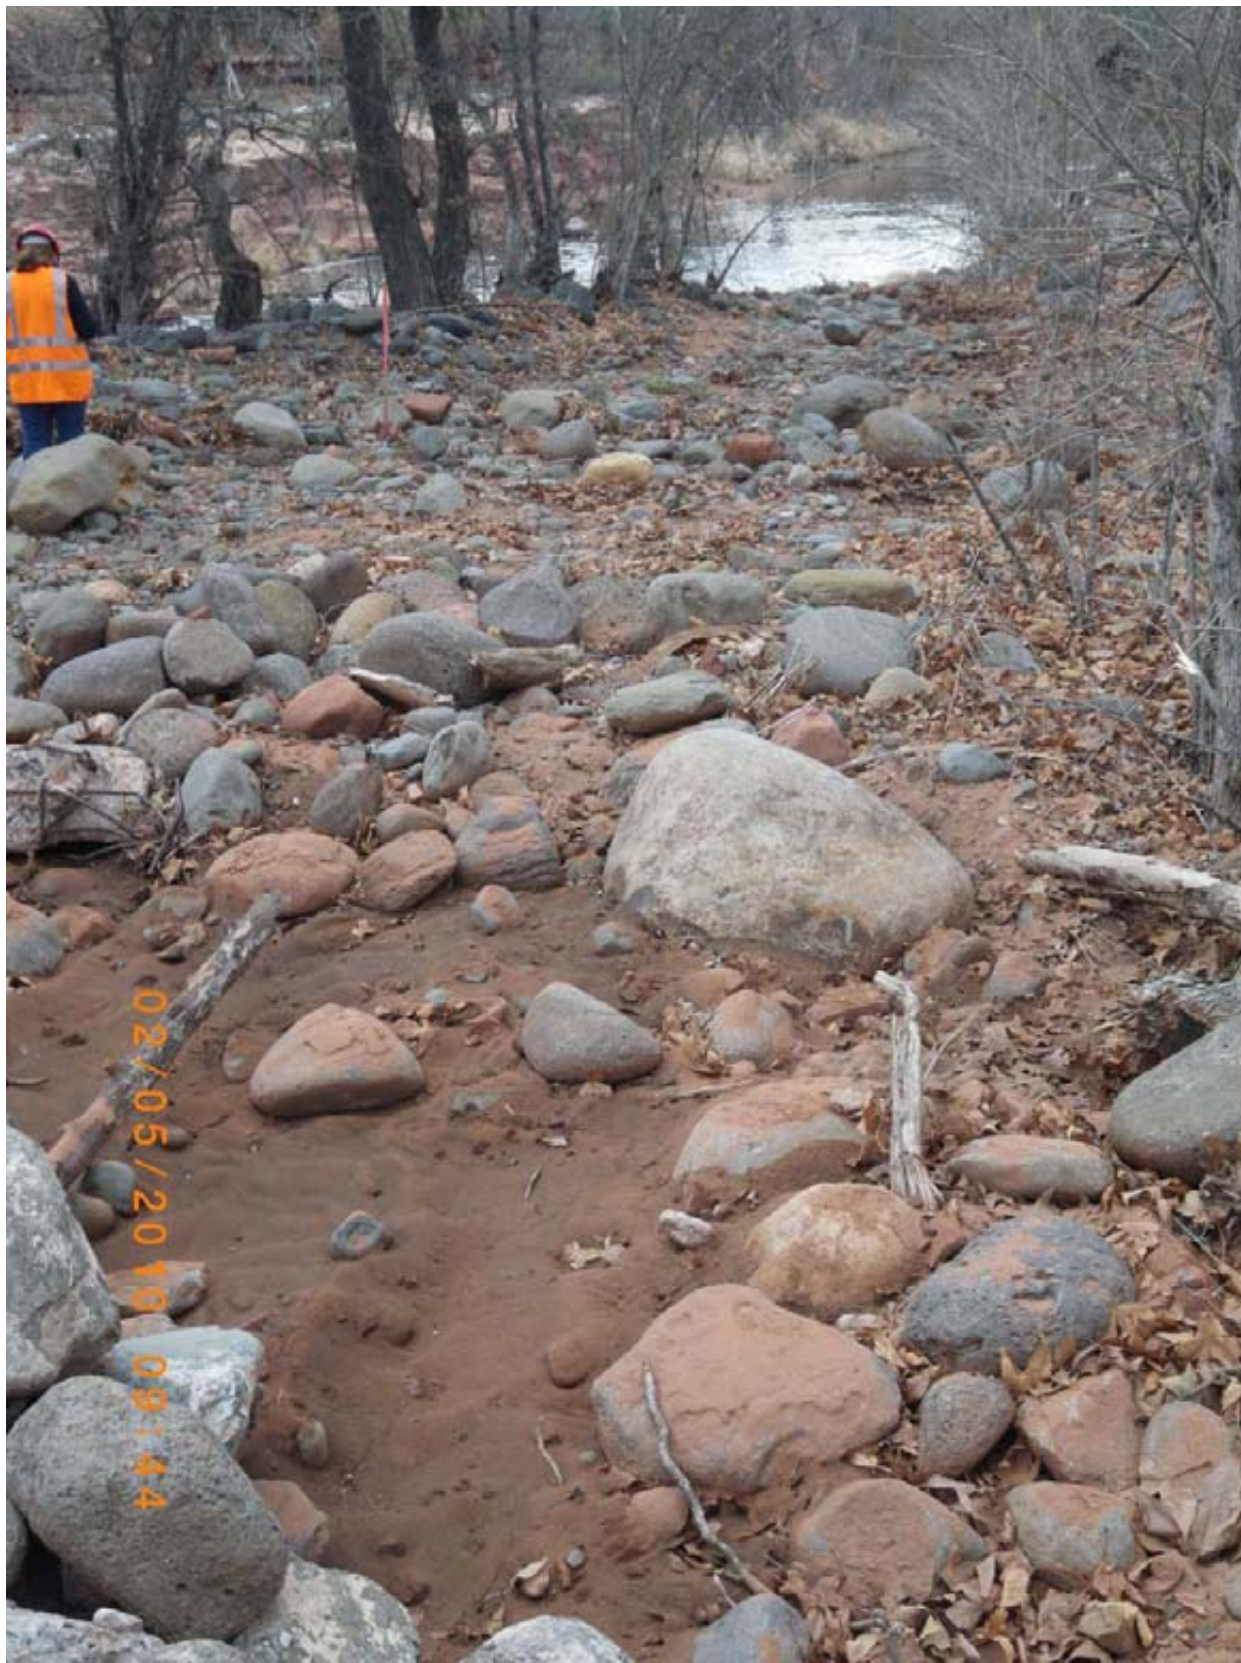
IMGP0030
29 of 86

IMGP0030 – From west side of creek at southern edge of coffer dam, facing southeast. Note fine sediment deposit in foreground.

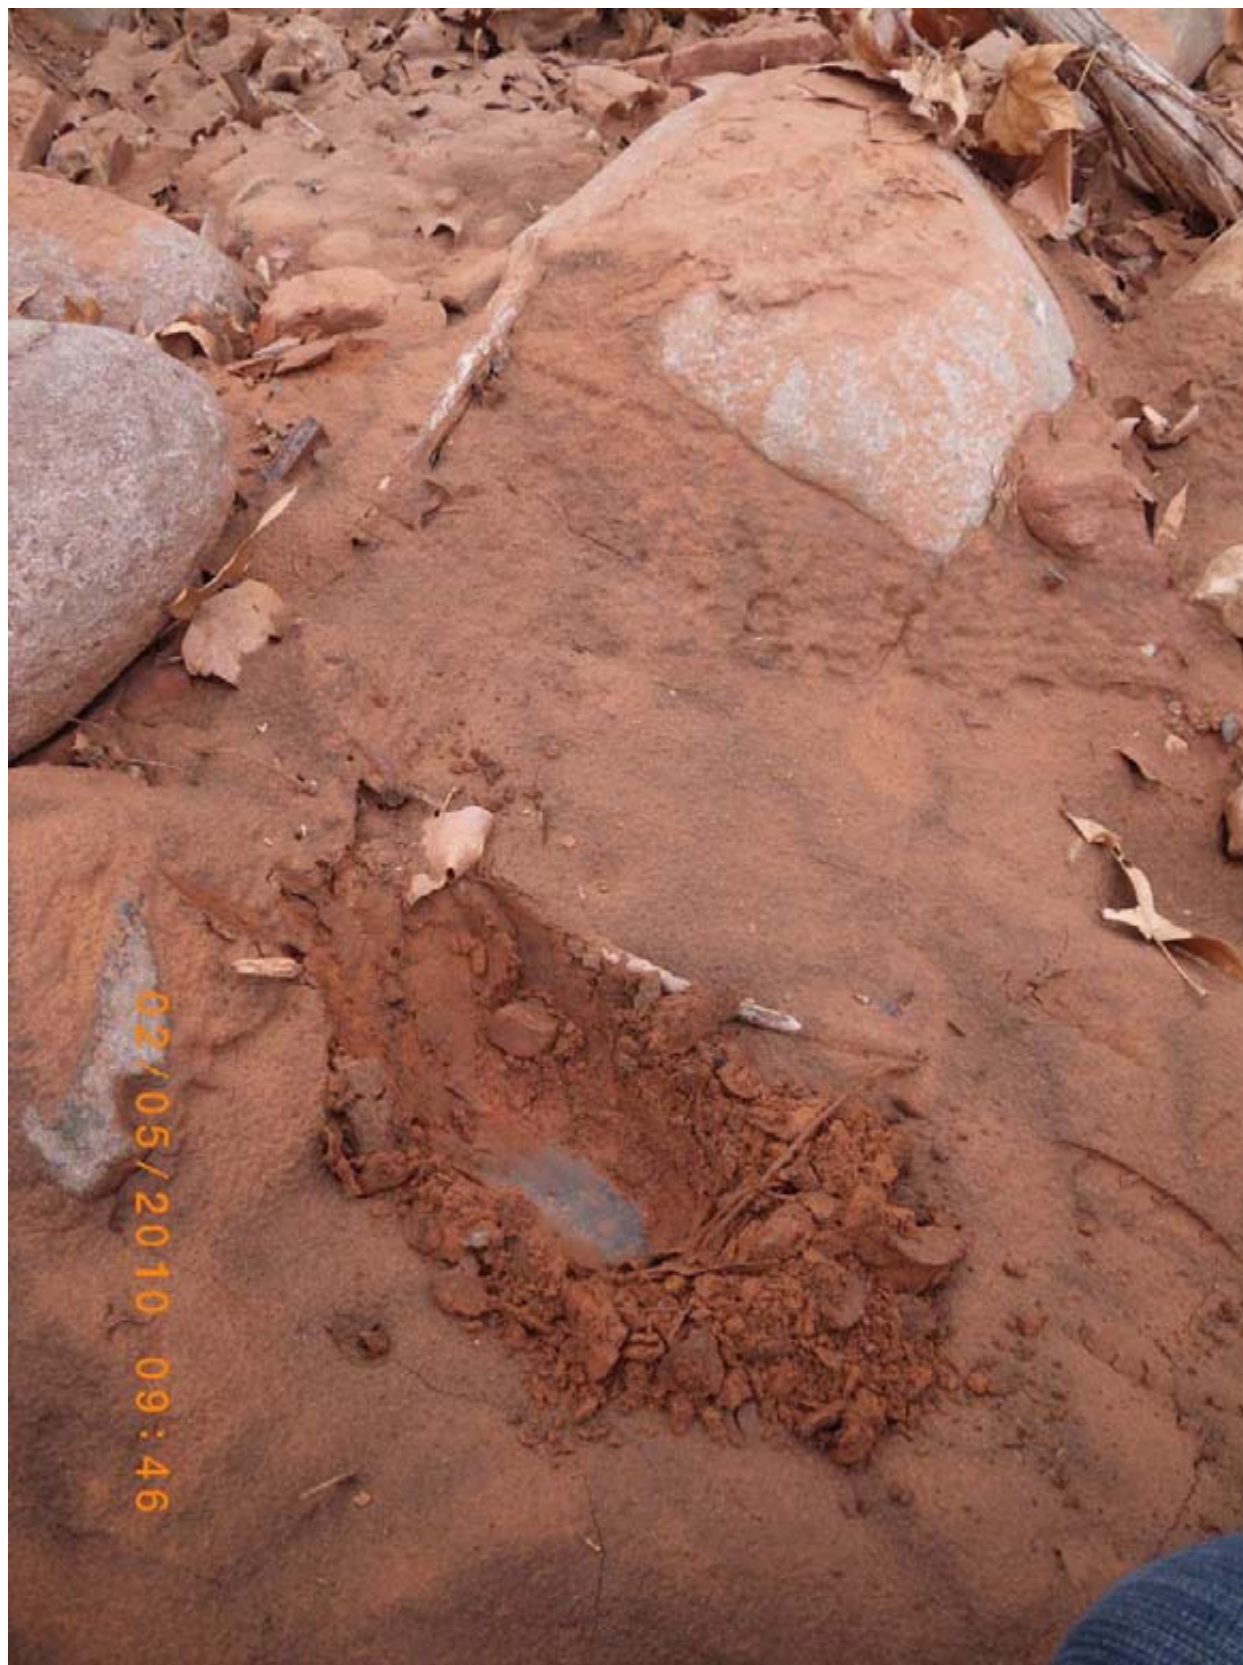
IMGP0031
30 of 86

IMGP0031 – Same as IMGP0030, showing depth of fine sediment deposit.

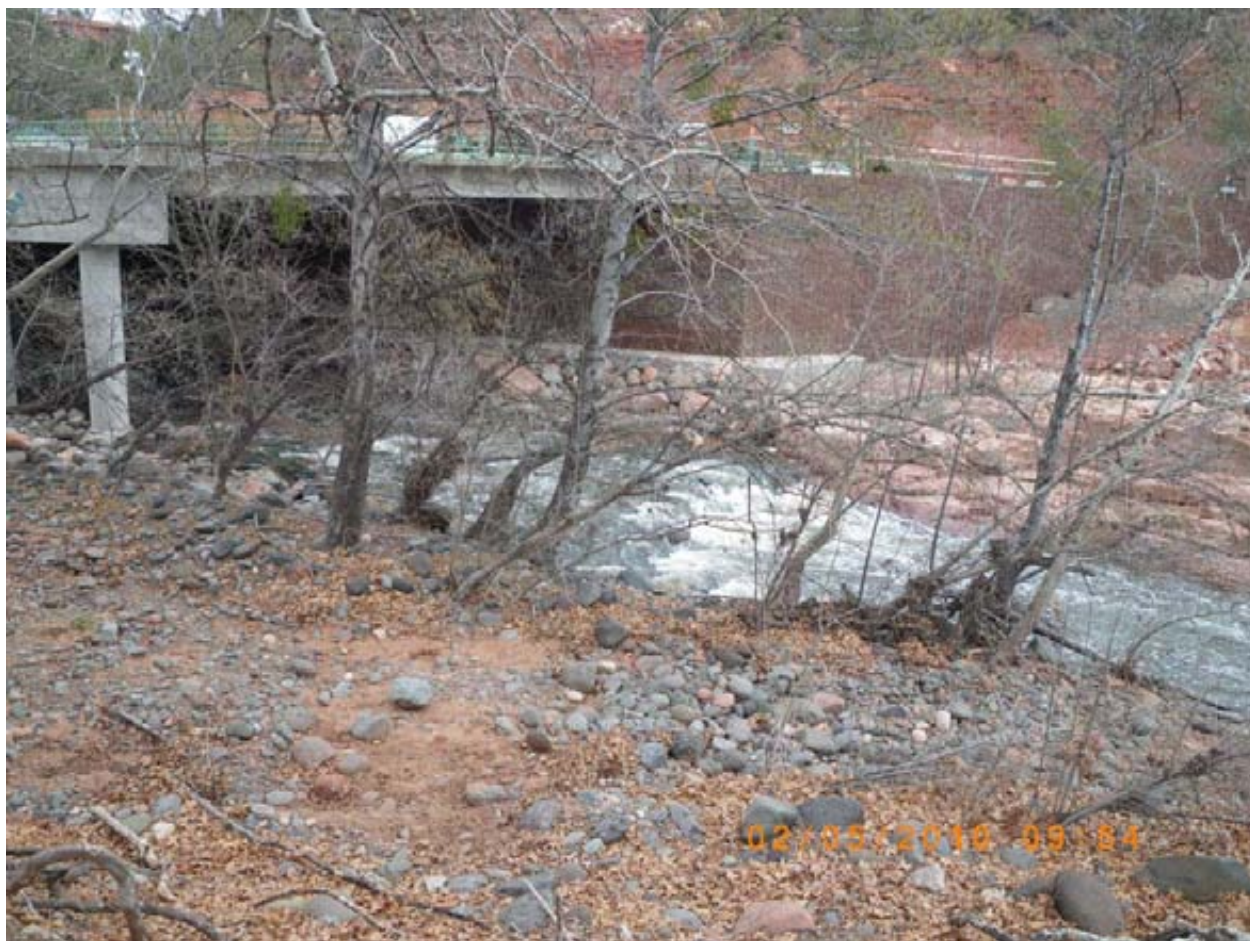
IMGP0035 – From west side of creek, facing northeast toward vehicular bridge. Note fine sediment deposit in foreground.
