**U.S. Environmental Protection Agency, Region IX
CWA Compliance Office
Report of Clean Water Act Inspection**

Site Location: State Route 179 Improvement Project
Between Mile Posts 310.5 and 313.8
Oak Creek/Sedona, AZ

Date and Time of Visit: February 5, 2010, 8:30 a.m. – 1:30 p.m.

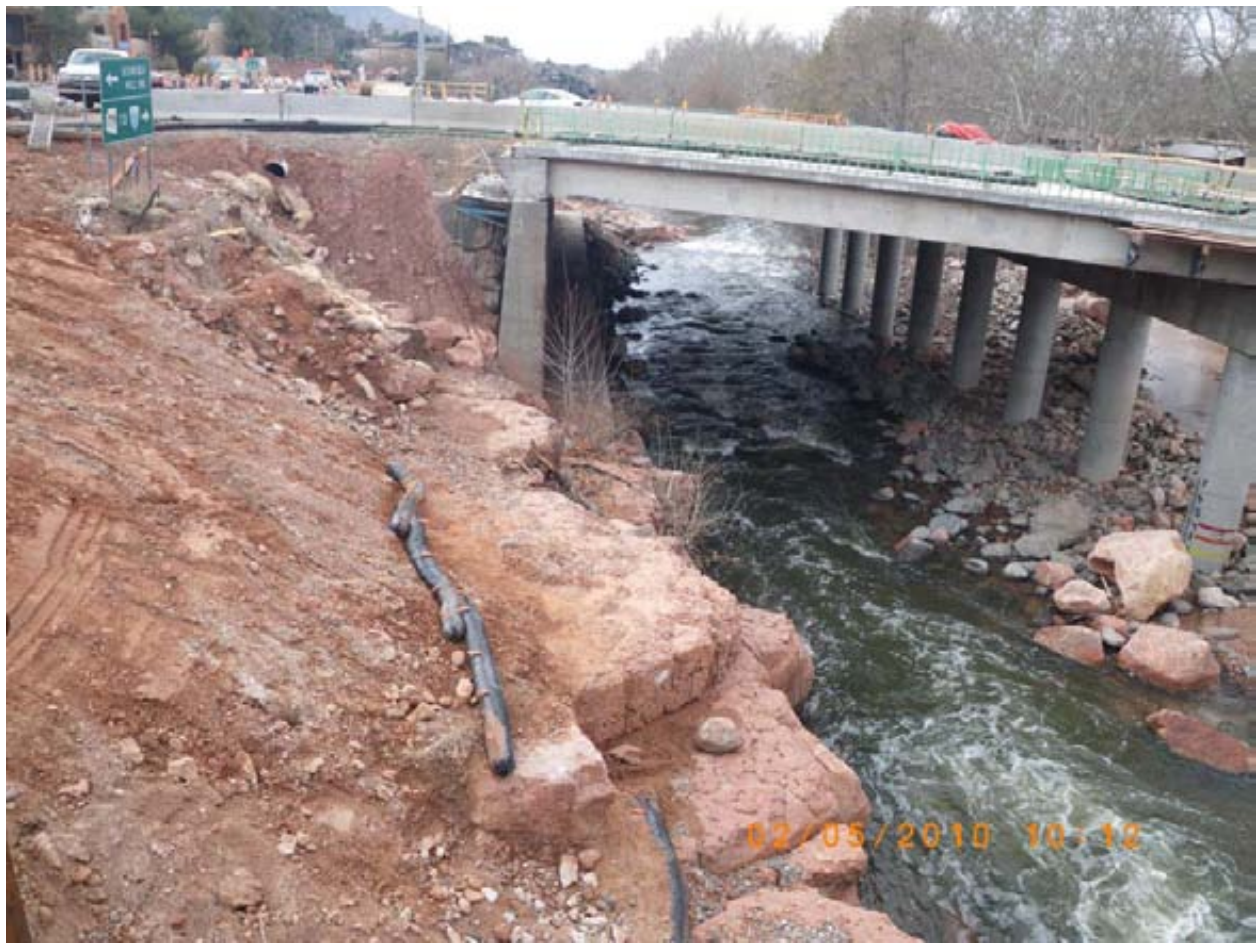
IMGP0044

Observations: The inspection began at the eastern end of the pedestrian bridge, above the Garland slope. This slope is directly above the active channel (see Photos 0003, 0044). The slope was disturbed without adequate best management practices (BMPs) installed. At the foot of the slope were three 'gator-eels' (heavy logs to slow the flow of water). At the top of the slope, a small basin was installed to slow the flow of water (see Photo 0045). This basin was undersized, given the amount of run-on entering the site at this location. This slope has been unprotected since January 9, 2010, when ADOT/Fisher removed the last bridge abutment. Prior to the January 19-22 storm event, ADOT/Fisher installed three steel I-beams across the slope in an attempt to stabilize the slope. Because the I-beams served as dams rather than filters, they were inadequate and the slope eroded underneath and around the beams, discharging sediment to Oak Creek.

IMG0044 – From east end of pedestrian bridge on Garland slope, facing south toward downstream direction of creek. Note ineffectiveness of gator eel BMPs to capture sediment on slope.

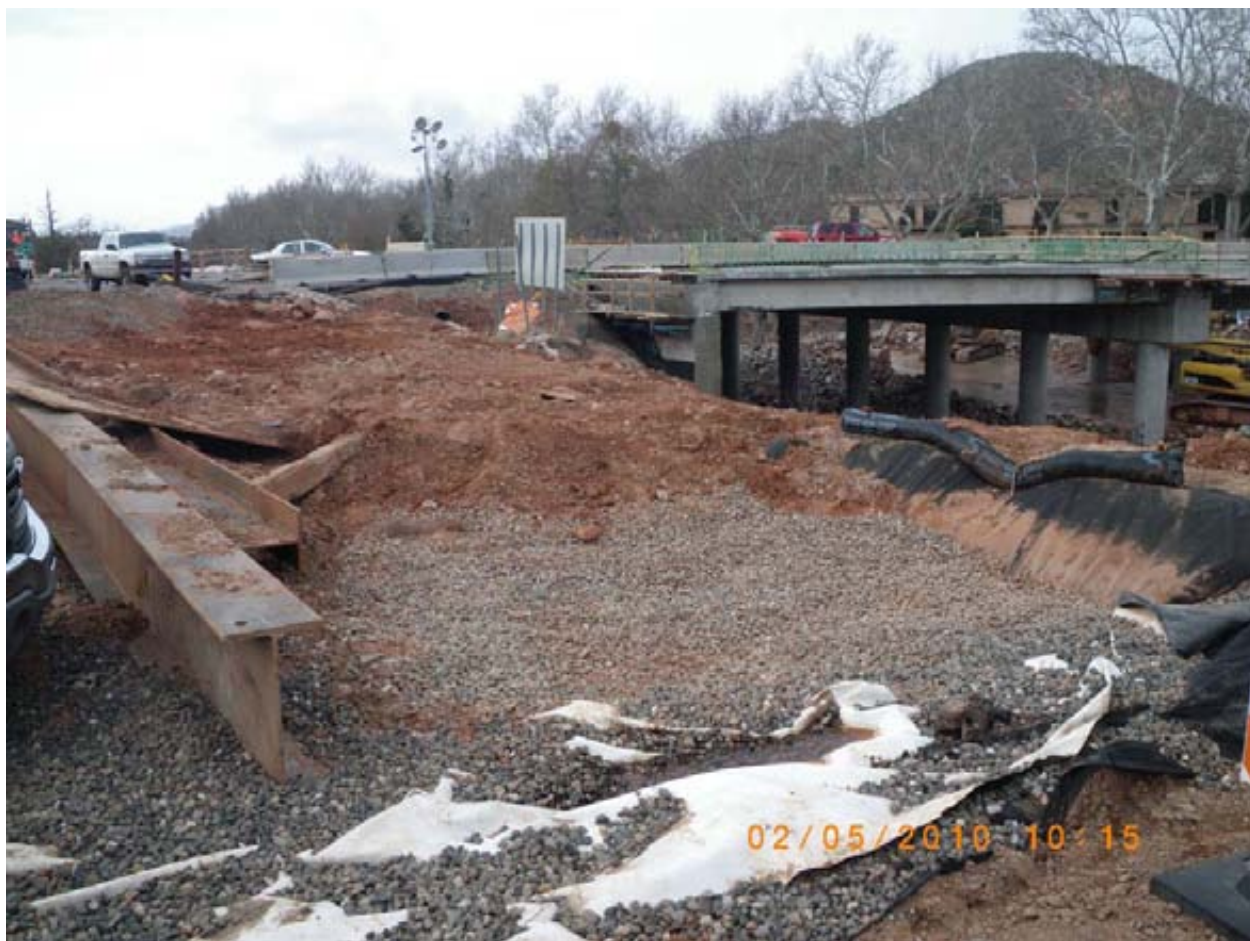
IMGP0045

IMG0045 – From east Garland slope, at end of pedestrian bridge, facing southwest toward vehicular bridge. Note undersized sediment basin in foreground and stacked I-beams, which were previously embedded in Garland slope, but failed as stabilization measure.

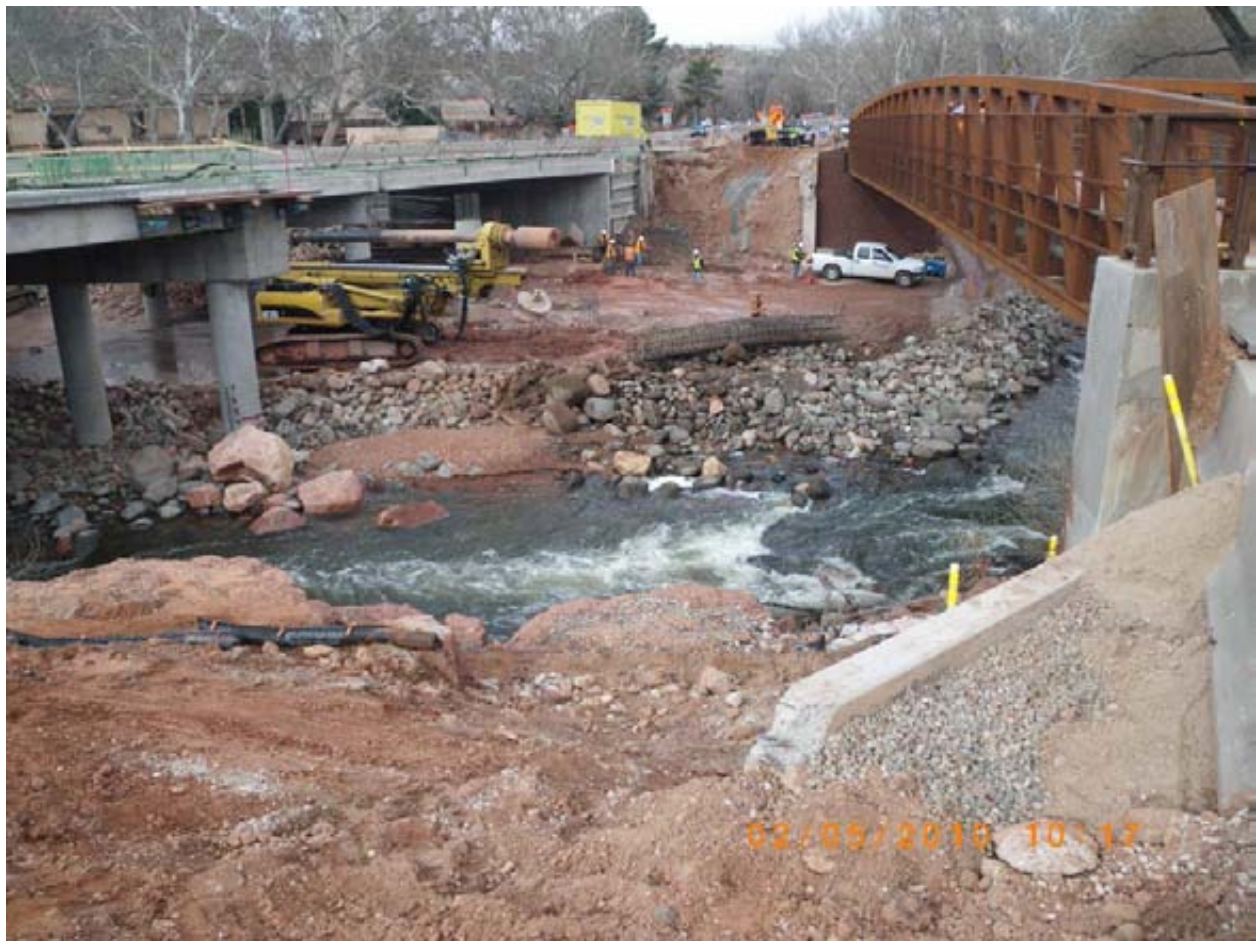
IMGP0046

is currently designed to function as a sediment basin (see Photo 0046). Prior to the January 19-22 storm event, ADOT/Fisher used small check dams in this area to filter the runoff before it entered Oak Creek. However, before the January storm event, large rocks (9-24") were brought into the site to serve as a coffer dam. These rocks will later be used in gabion baskets to be placed elsewhere on site. According to Harris, the emergency spillway on the coffer dam functioned as designed during the January storm event. However, the void spaces between the large cobbles and boulders are too large to serve as an effective filter. We observed large amounts of fines deposited on the downstream side of the coffer dam (see Photos 0024, 0027-32). Additionally, ¾" gravel was placed in the work area to provide a more stable work surface. According to Harris, after the last pylon is set, the channel will be dug out and this material will be removed as much as possible; however it is being pressed very deeply into the creek bed and will likely be very difficult to remove.

IMG0046 – From east Garland slope, between pedestrian and vehicular bridge abutments, facing west toward Tlaquepaque slope.

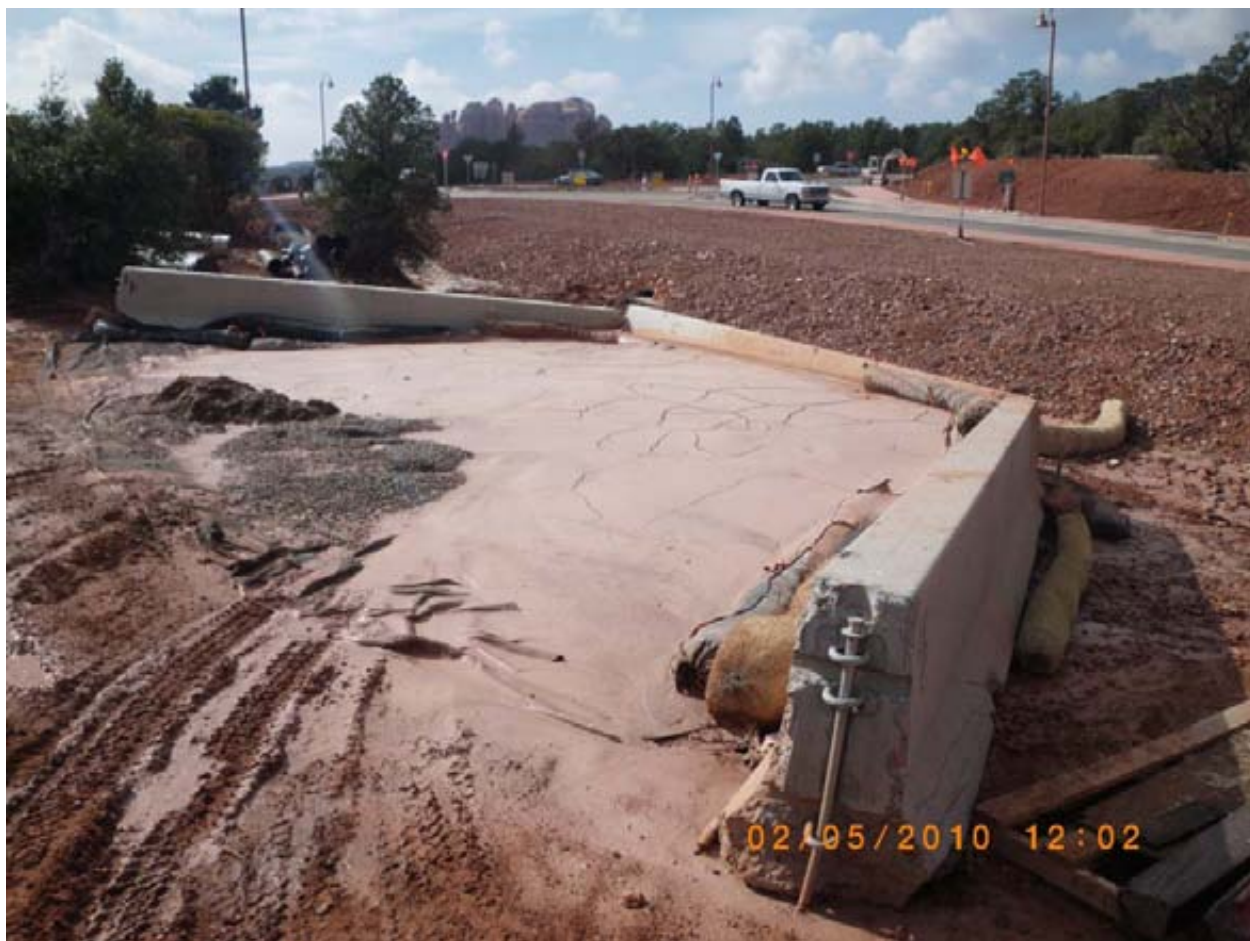
IMGP0047

The BMP in use during the inspection for this pump water discharge at the Chapel staging yard was a poorly designed settling basin (see Photos 0047, 0053, 0055, 0062, and 0064) that discharged to the sediment-laden drainage ditch described above. The basin was made of three K-rails and lined with filter-fabric wrapped sediment logs. However, the basin was over 90% full and sediment covered the sediment logs (see Photo 0055). According to Fisher, another pump delivery was scheduled for that afternoon, before the basin could be cleaned out and repaired. On February 5, 2010 (the day of the inspection) a BMP update sheet was placed in the SWPPP, describing this BMP. This could indicate that the SWPPP was not being updated in a timely fashion. As described above, this BMP is undersized and inadequate. I instructed ADOT/Fisher representatives

IMG0047 – Facing southwest. Water pumped from Oak Creek Bridge coffer dam area is transported here, filtered through makeshift check dam, and discharged into drainage ditch that flows north and east to unnamed tributary of Oak Creek. Check dam is constructed of three K-rails lined with filter fabric. The filter fabric is slumping, resulting in sediment discharge into drainage ditch.

on site to clean it out and suggested a range of options to repair the BMP before using it again. We also discussed moving this BMP to an upland area above the drainage ditch.

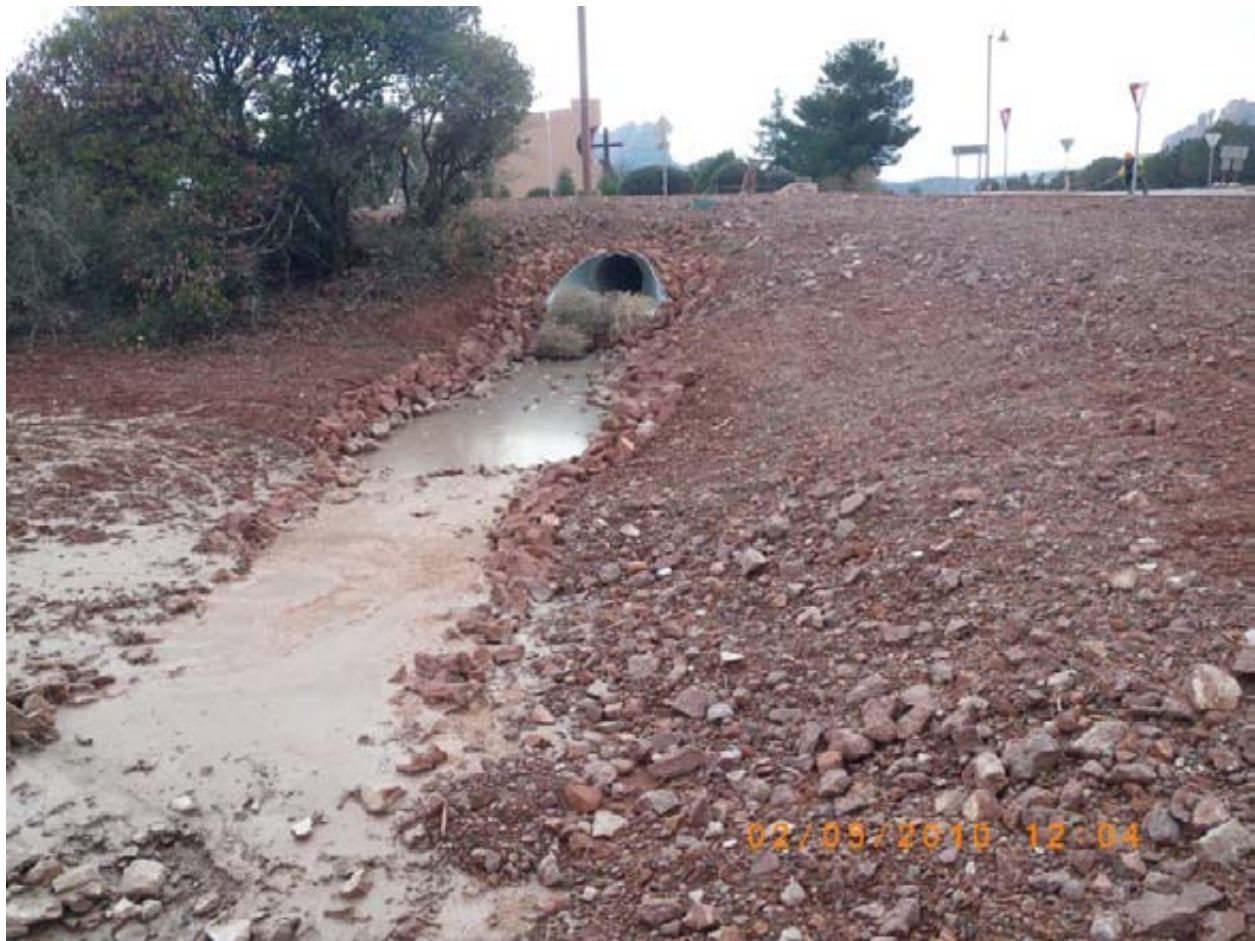
IMGP0048

IMG0048 – Facing south within drainage ditch toward culvert outlet. Note relatively clean water coming from Chapel Road culvert mixes with discolored water in foreground, where bridge crew previously discharged water pumped from coffer dam.

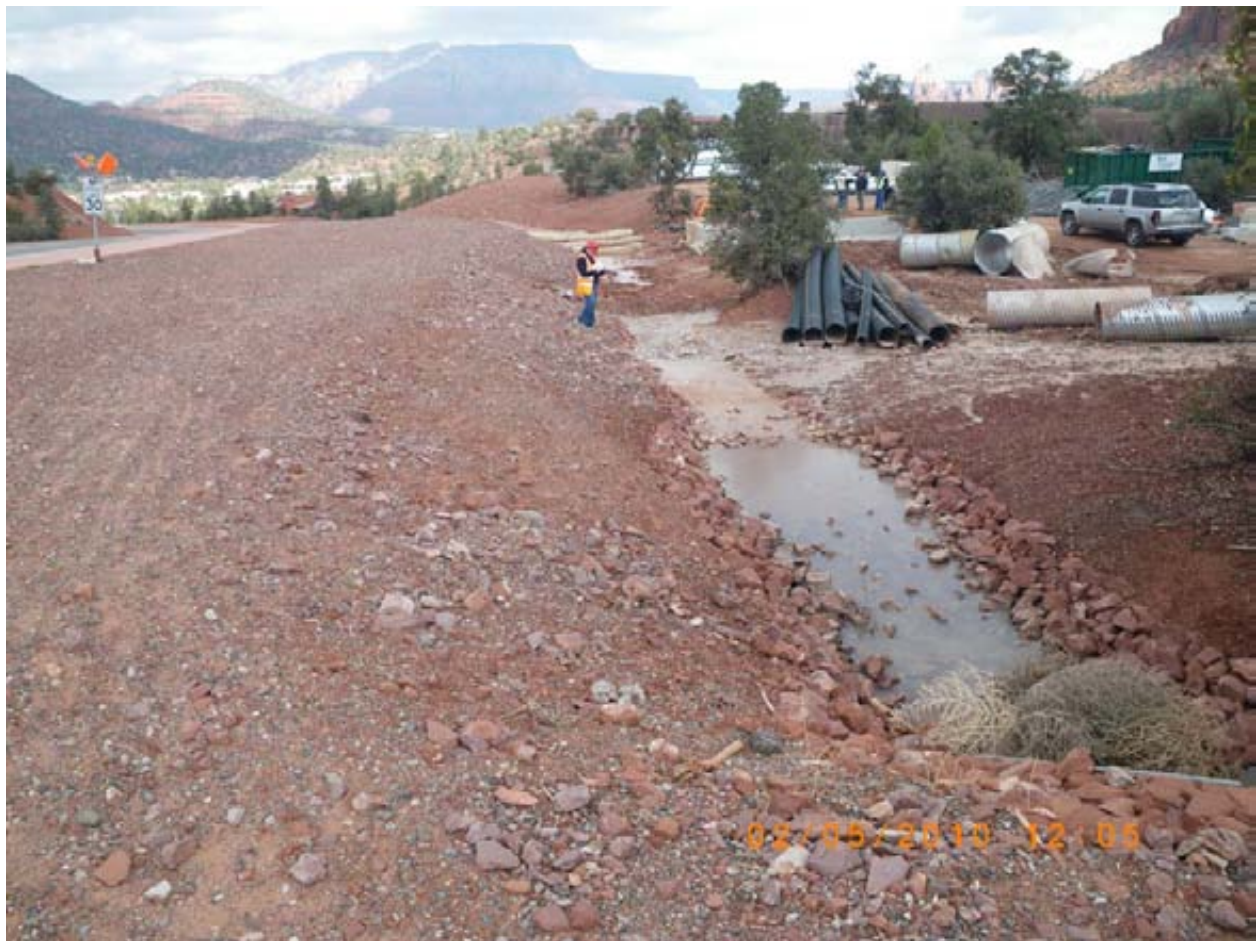
IMGP0049

IMG0049 – From top of culvert facing north. Note disarray of construction materials where pumped water was discharged through downstream straw wattles (recently replaced). K-rail check dam is located in background behind trees. Drainage ditch water flows north, from bottom to top of picture frame.

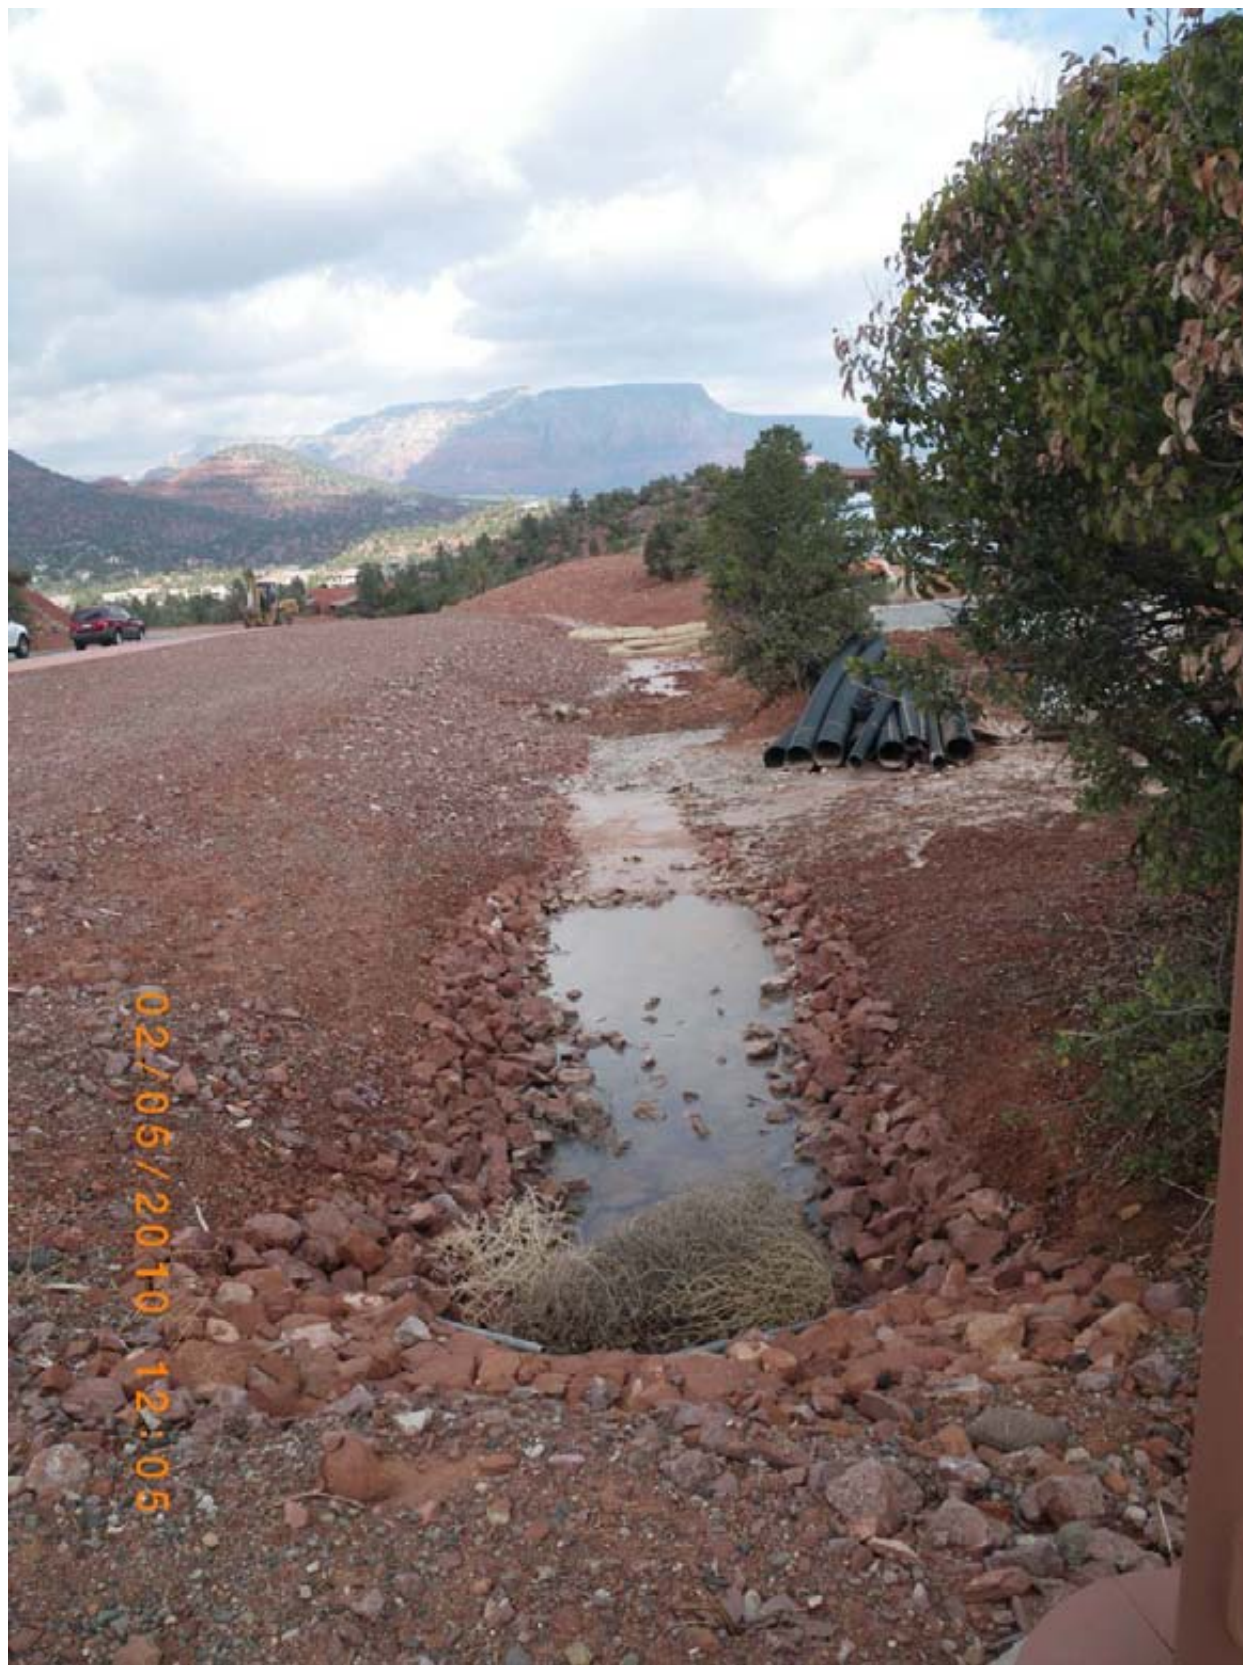
IMGP0050
49 of 86

IMG0050 – From top of Chapel Road culvert facing north. Note coir logs further down drainage ditch, installed since last rain event. Discharge of pump water blew out previous straw wattles in drainage ditch.

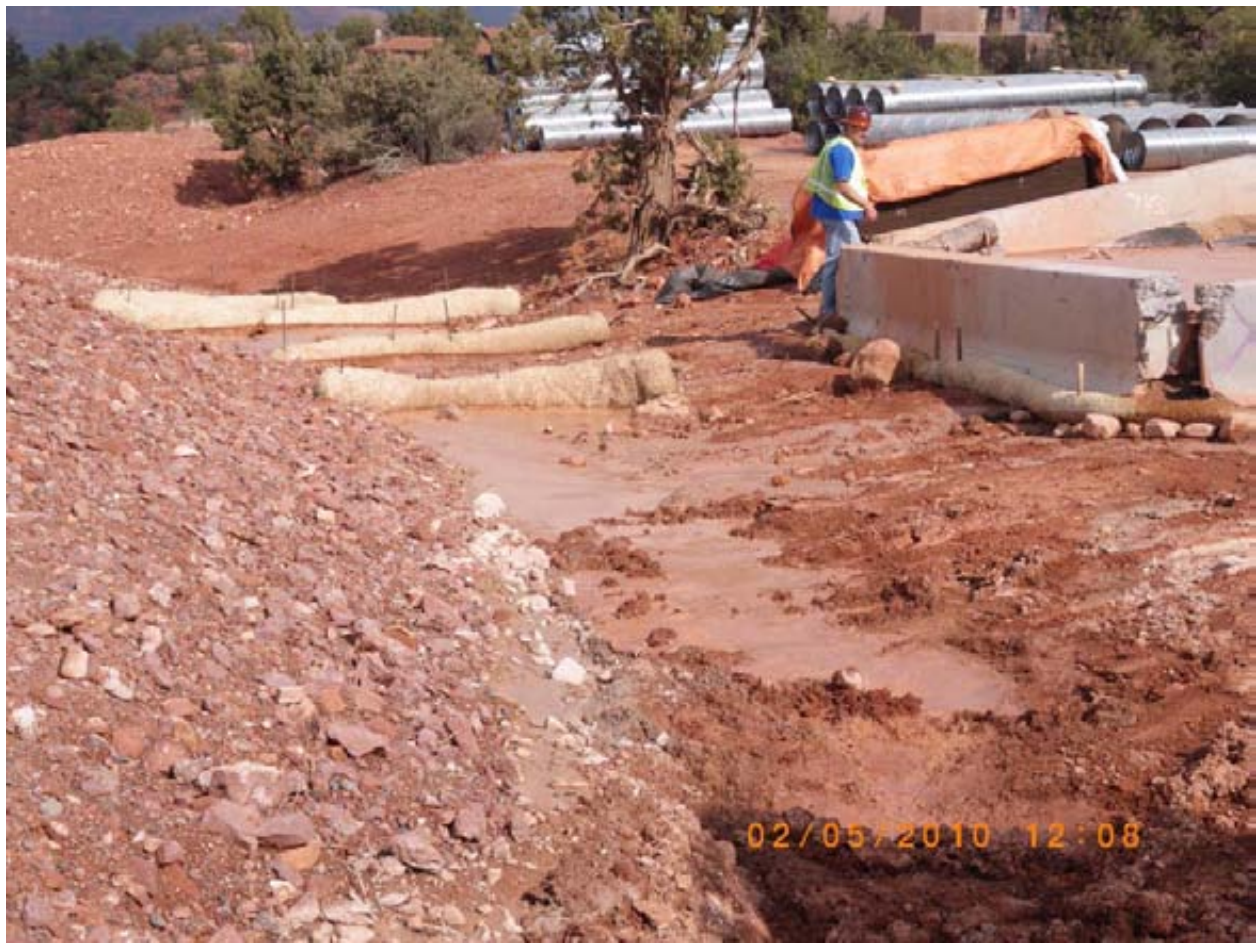
IMGP0053 – From west side of drainage ditch, facing northeast. Note discharges from check dam and fine sediments deposited in drainage ditch.

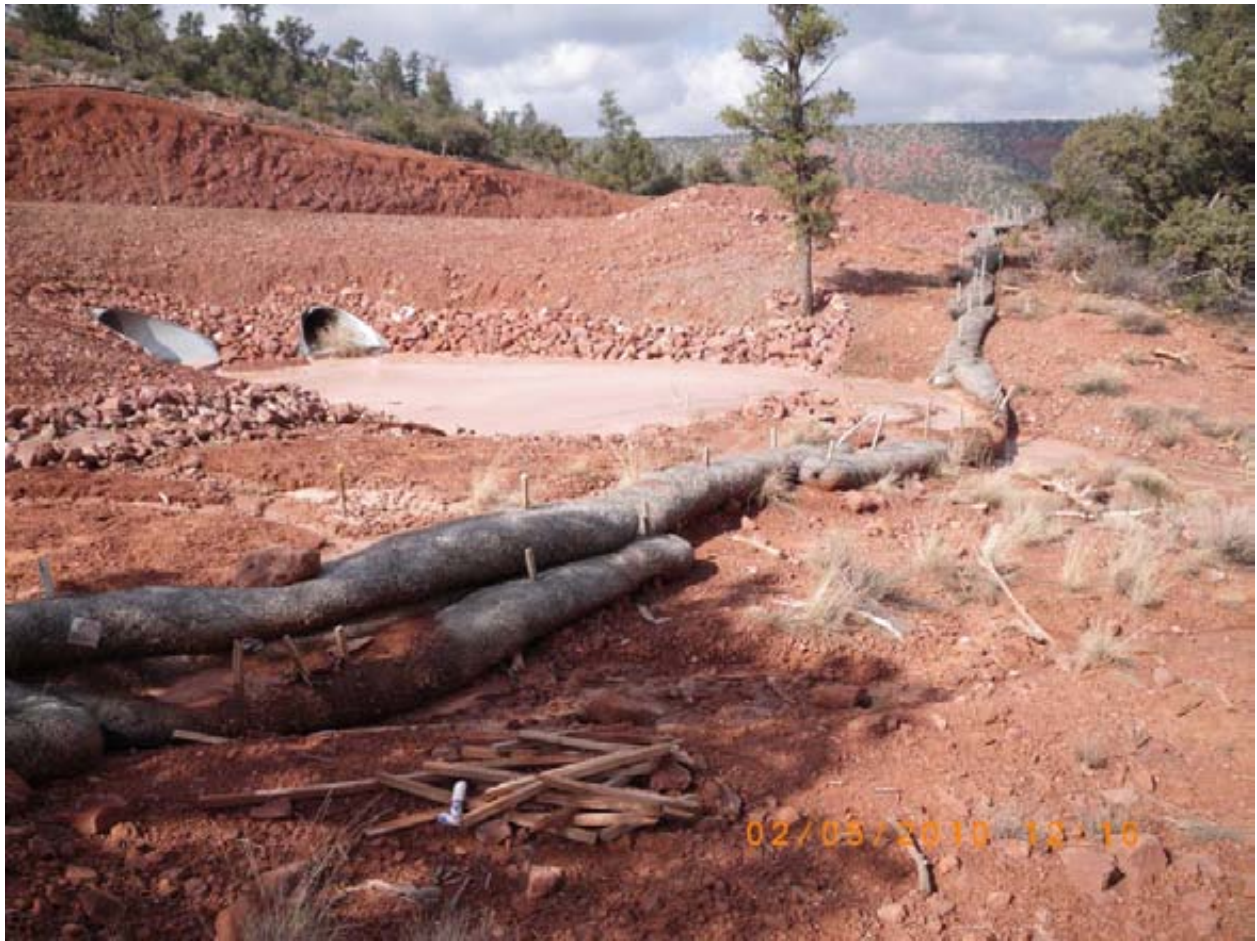
IMGP0058 – From east side of SR 179, north of Chapel Road intersection, facing northwest to SR 179 culverts. Culvert spillway is filled approximately 3-4' deep with fine sediments from upstream pump water discharge transported via the drainage ditch. Sediments overtopped the coir log, resulting in discharge to an unnamed tributary of Oak Creek (toward right side of picture frame).

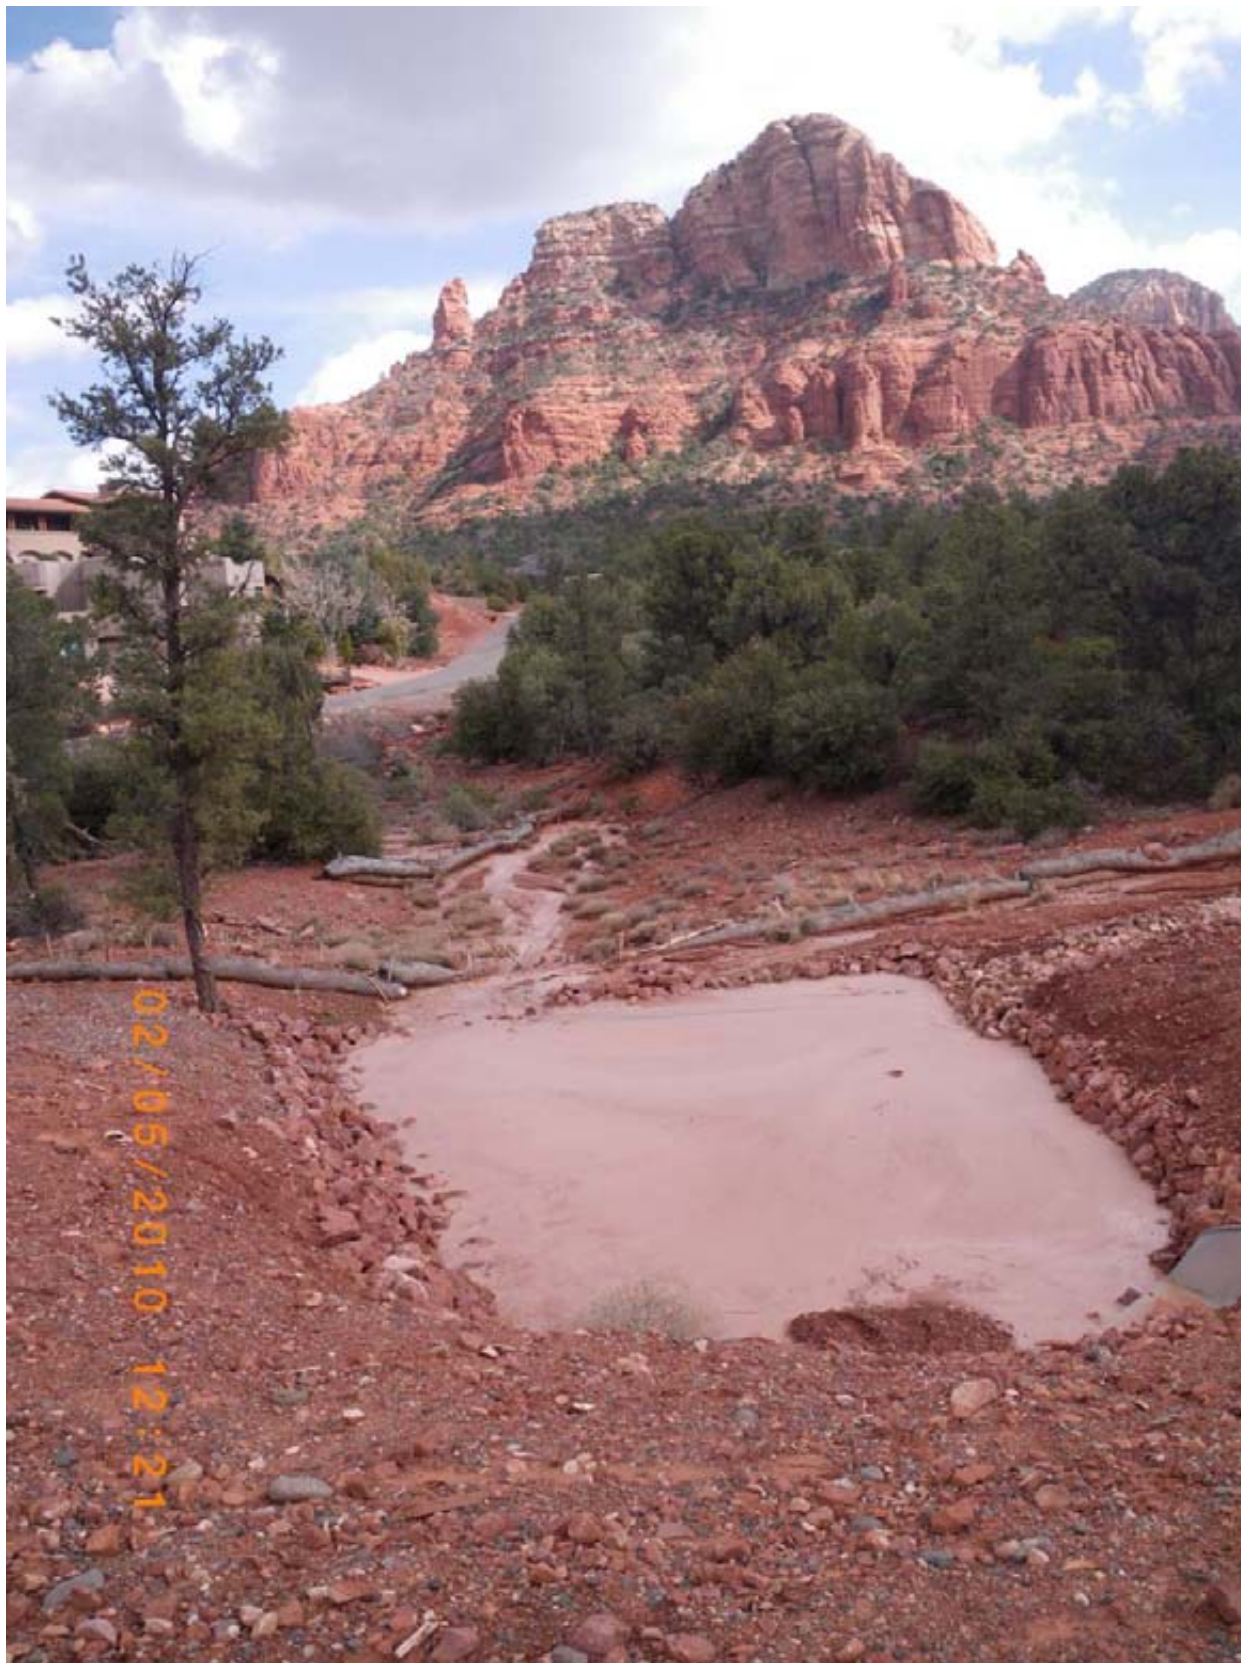
IMGP0061
60 of 86

IMGP0061 – Same as IMGP0059, facing east. Closer view of culvert spillway discharging offsite.

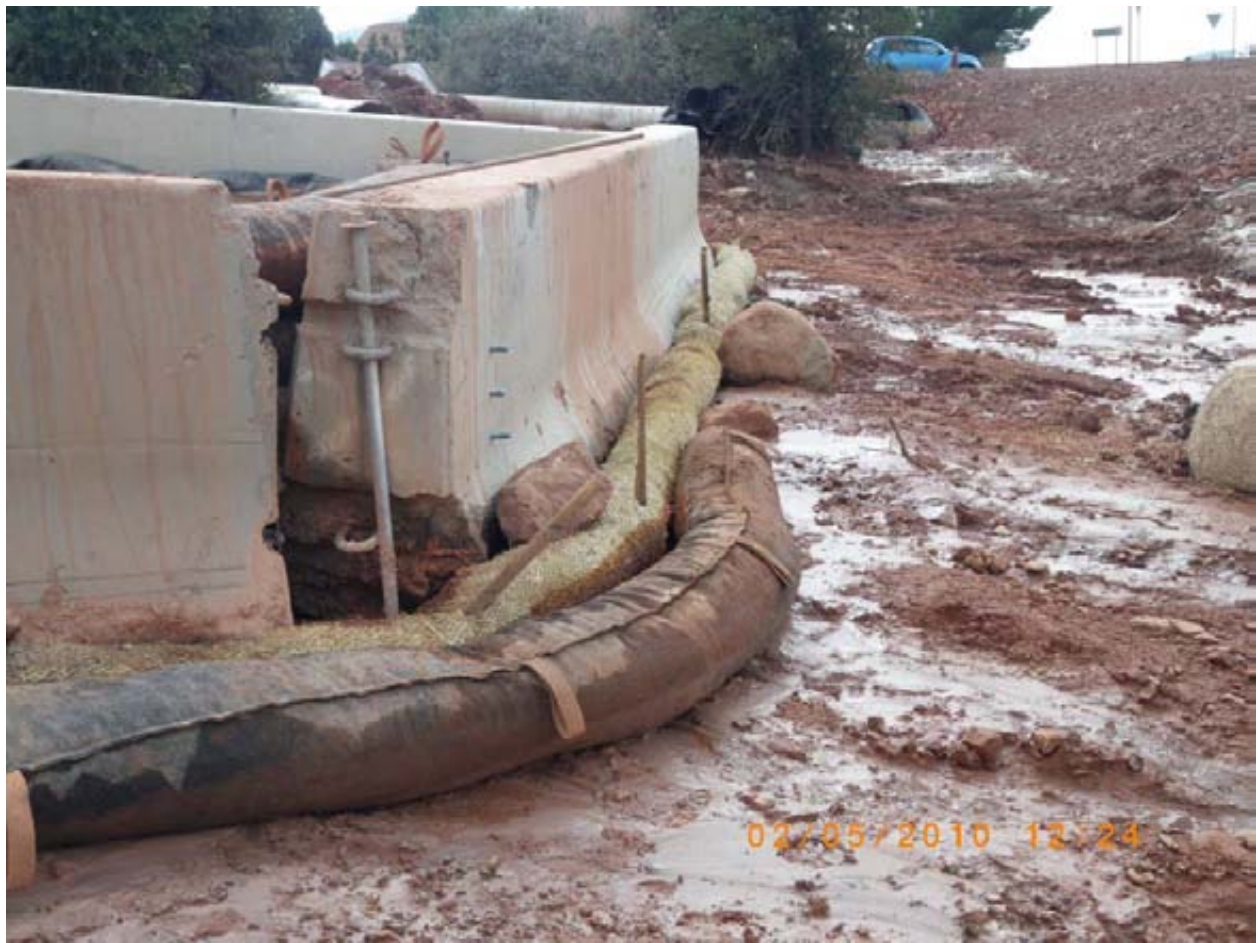
IMG0064

IMGP0064 – From northwest edge of check dam, within drainage ditch, facing north toward Chapel Road culvert. Note gap in K-rails and ineffectiveness of BMPs to filter fine sediments from check dam. Fine sediments are possibly overtopping check dam, evidenced by spill marks on K-rails.

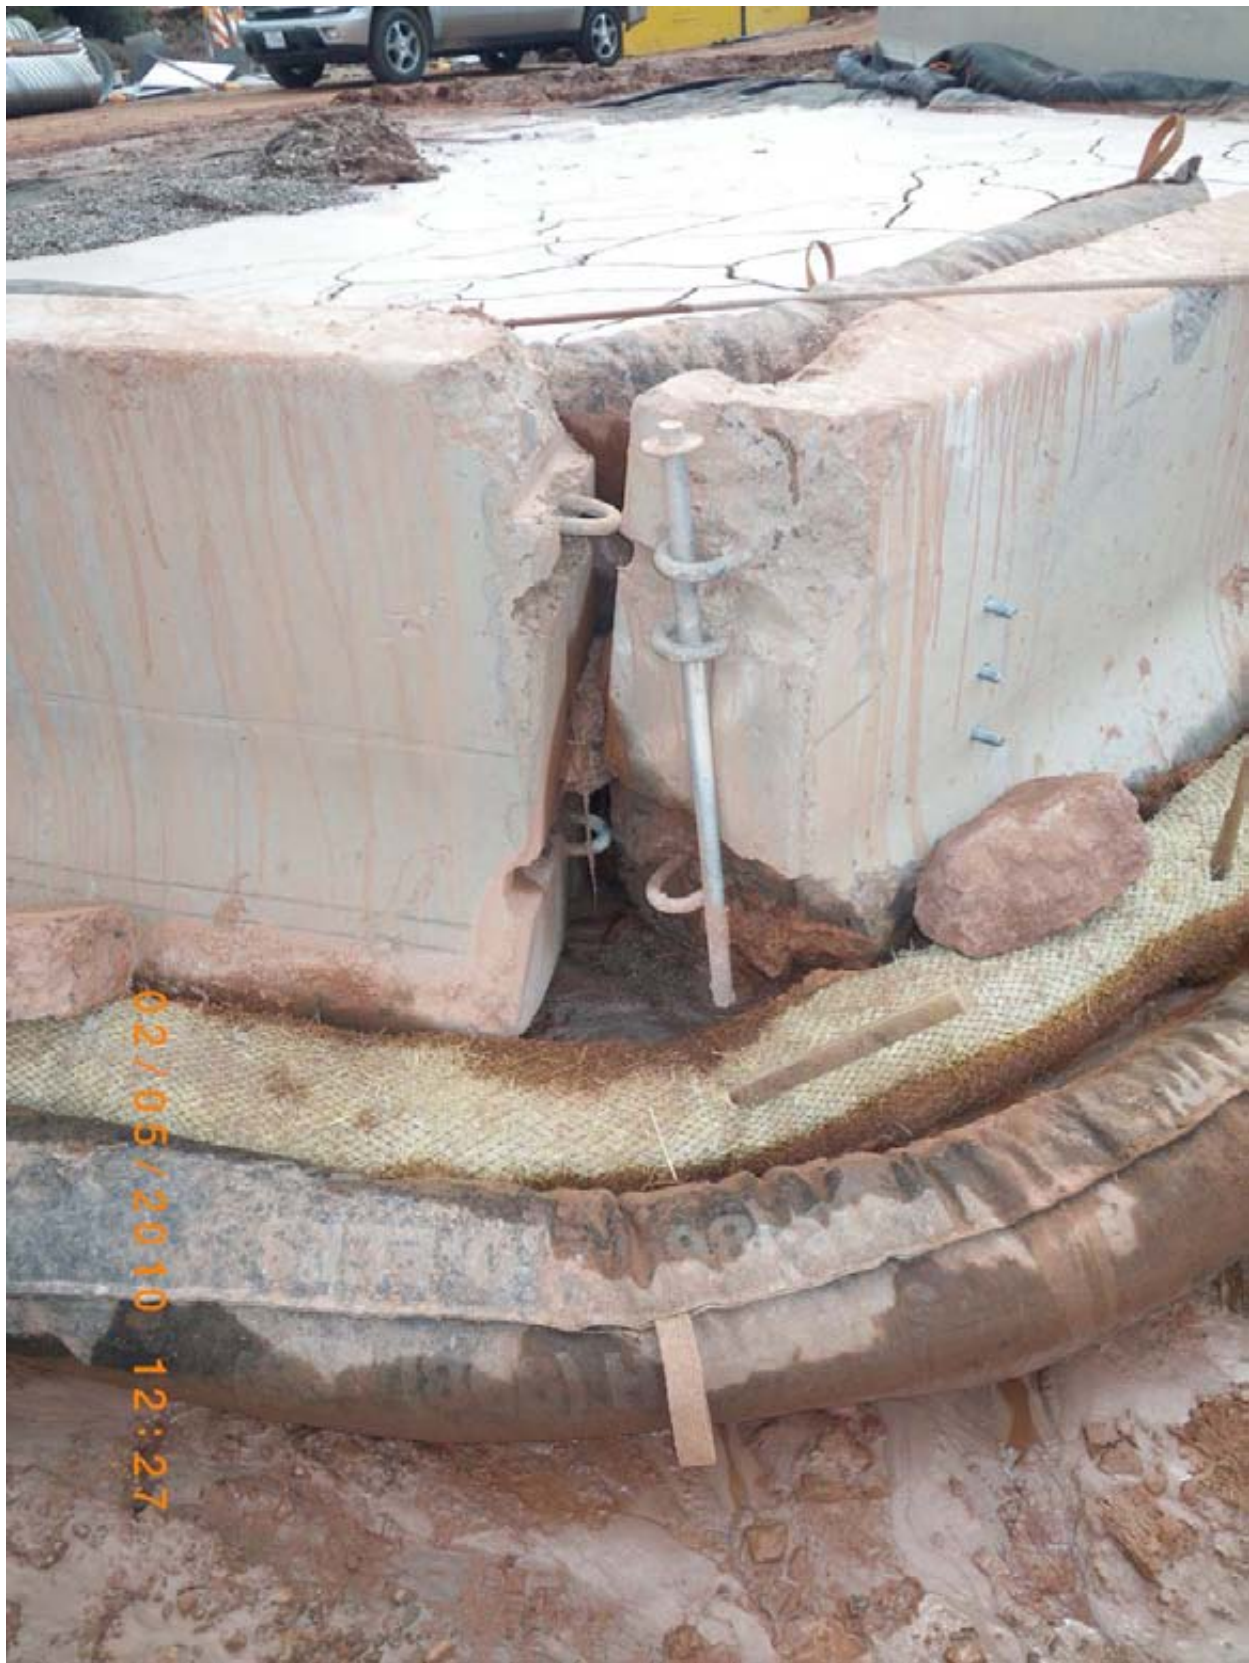
IMGP0065
64 of 86

IMGP0065 – Close-up of northwest edge of check dam, where filter fabric is slumping.

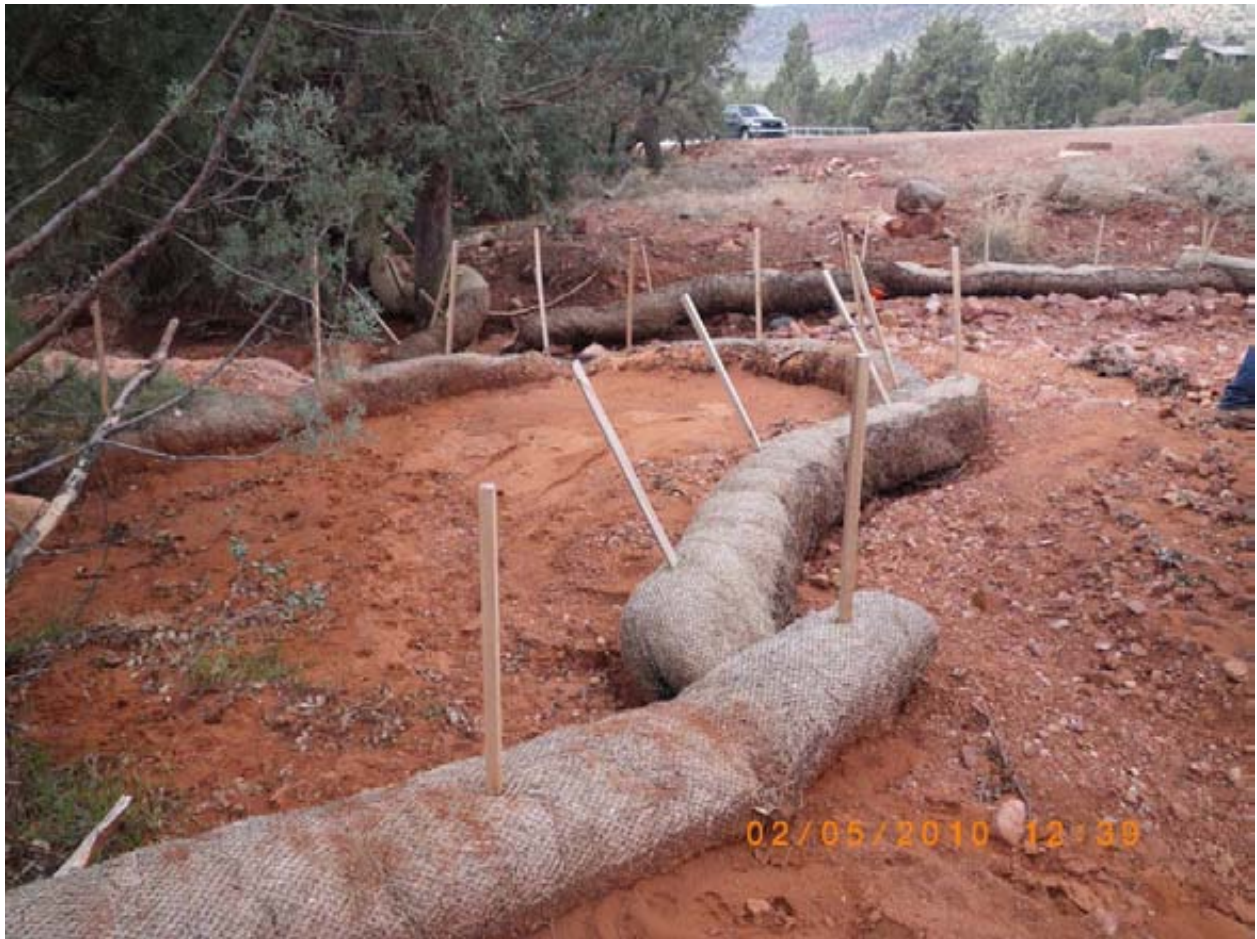
IMGP0066 – Facing south toward coir log check dam installed by ADOT out of the ROW. City of Sedona should maintain, evaluate for enforcement against private landowner.

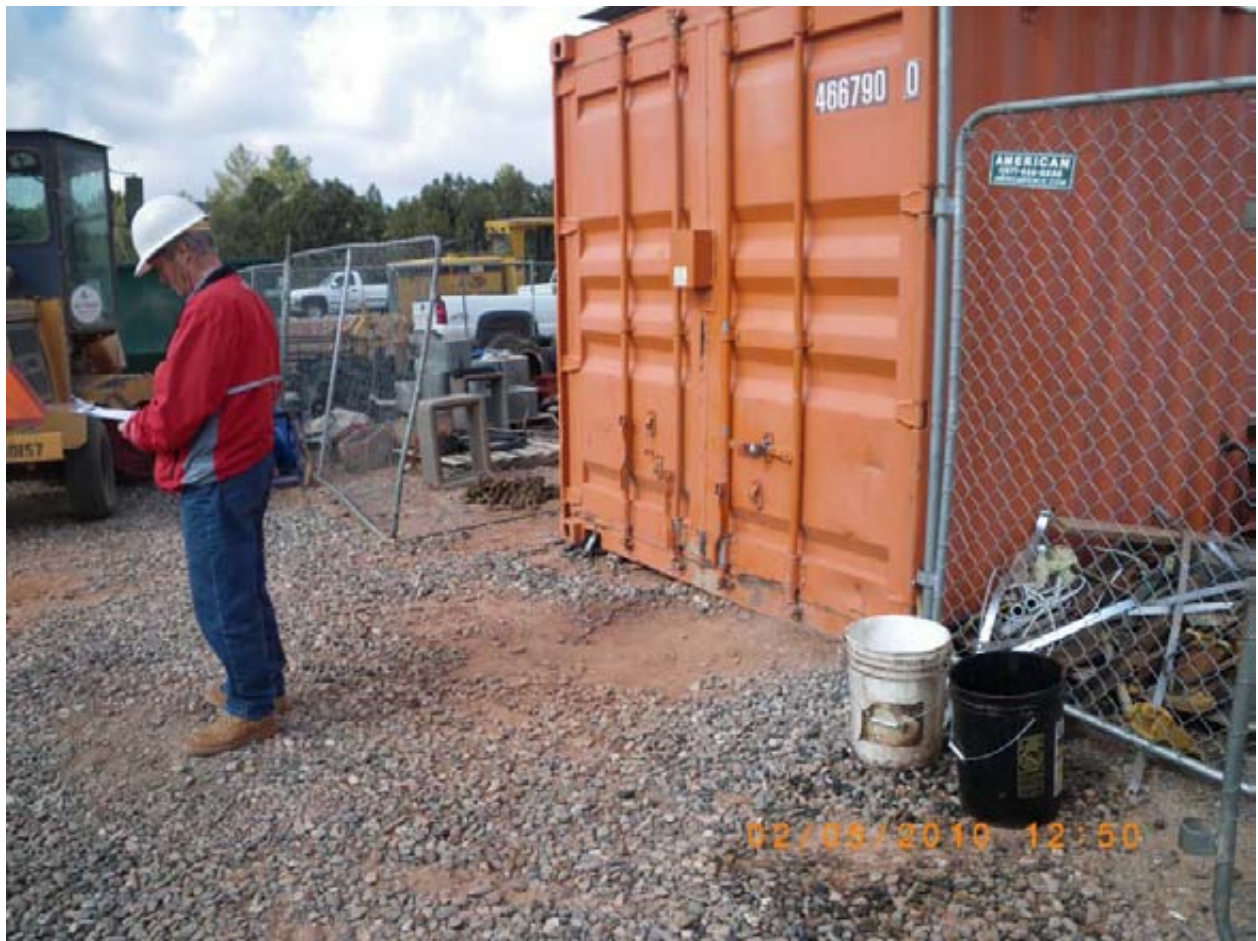
IMGP0070 – Facing west toward 179. Buckets in foreground contain an unknown oily waste.

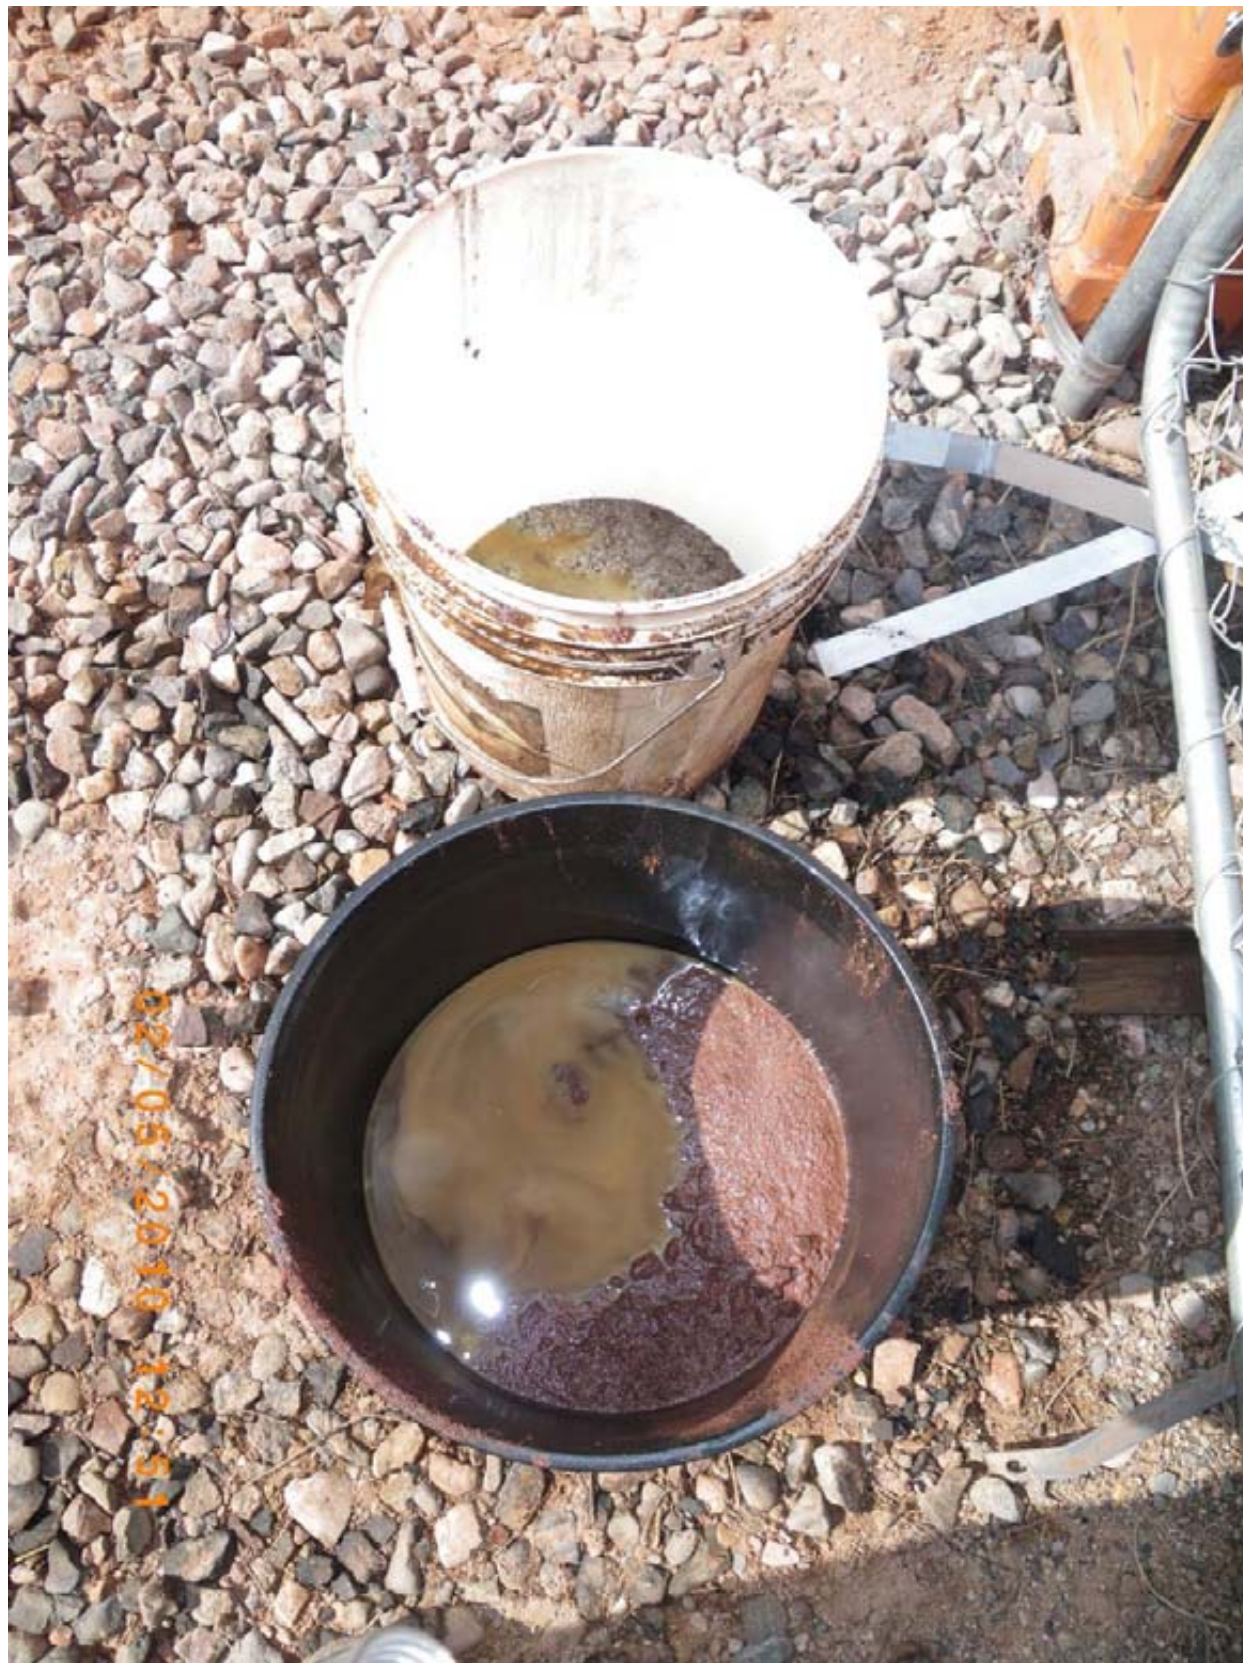
IMGP0071
70 of 86

IMGP0071 – Close-up view of contents in buckets from IMGP0070.
