**U.S. Environmental Protection Agency, Region IX
CWA Compliance Office
Report of Clean Water Act Inspection**

Site Location: State Route 179 Improvement Project
Between Mile Posts 310.5 and 313.8
Oak Creek/Sedona, AZ

Date and Time of Visit: February 5, 2010, 8:30 a.m. – 1:30 p.m.

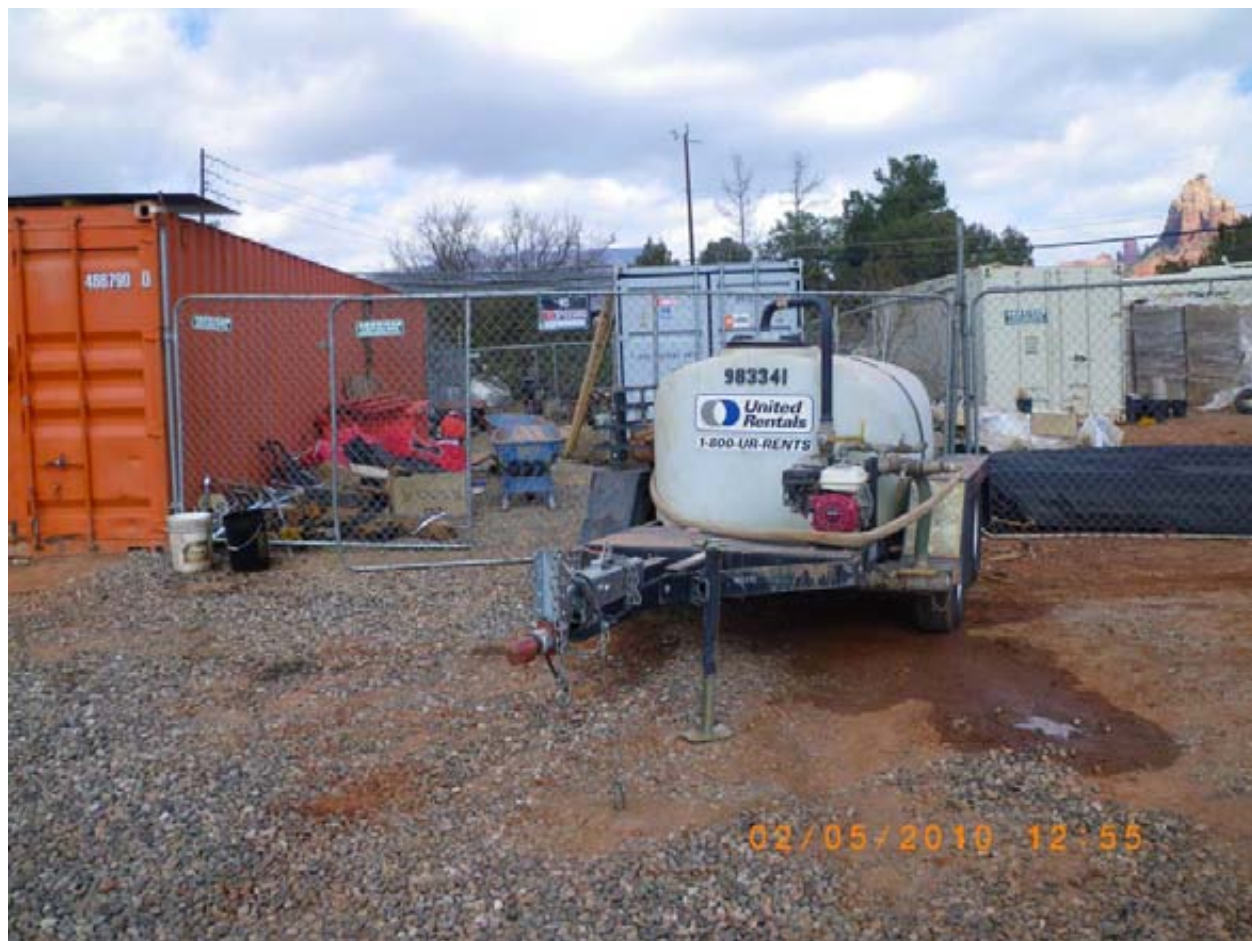
IMGP0074 – Facing north toward material storage area. Note spill in gravel/dirt road appears to come from water tank.

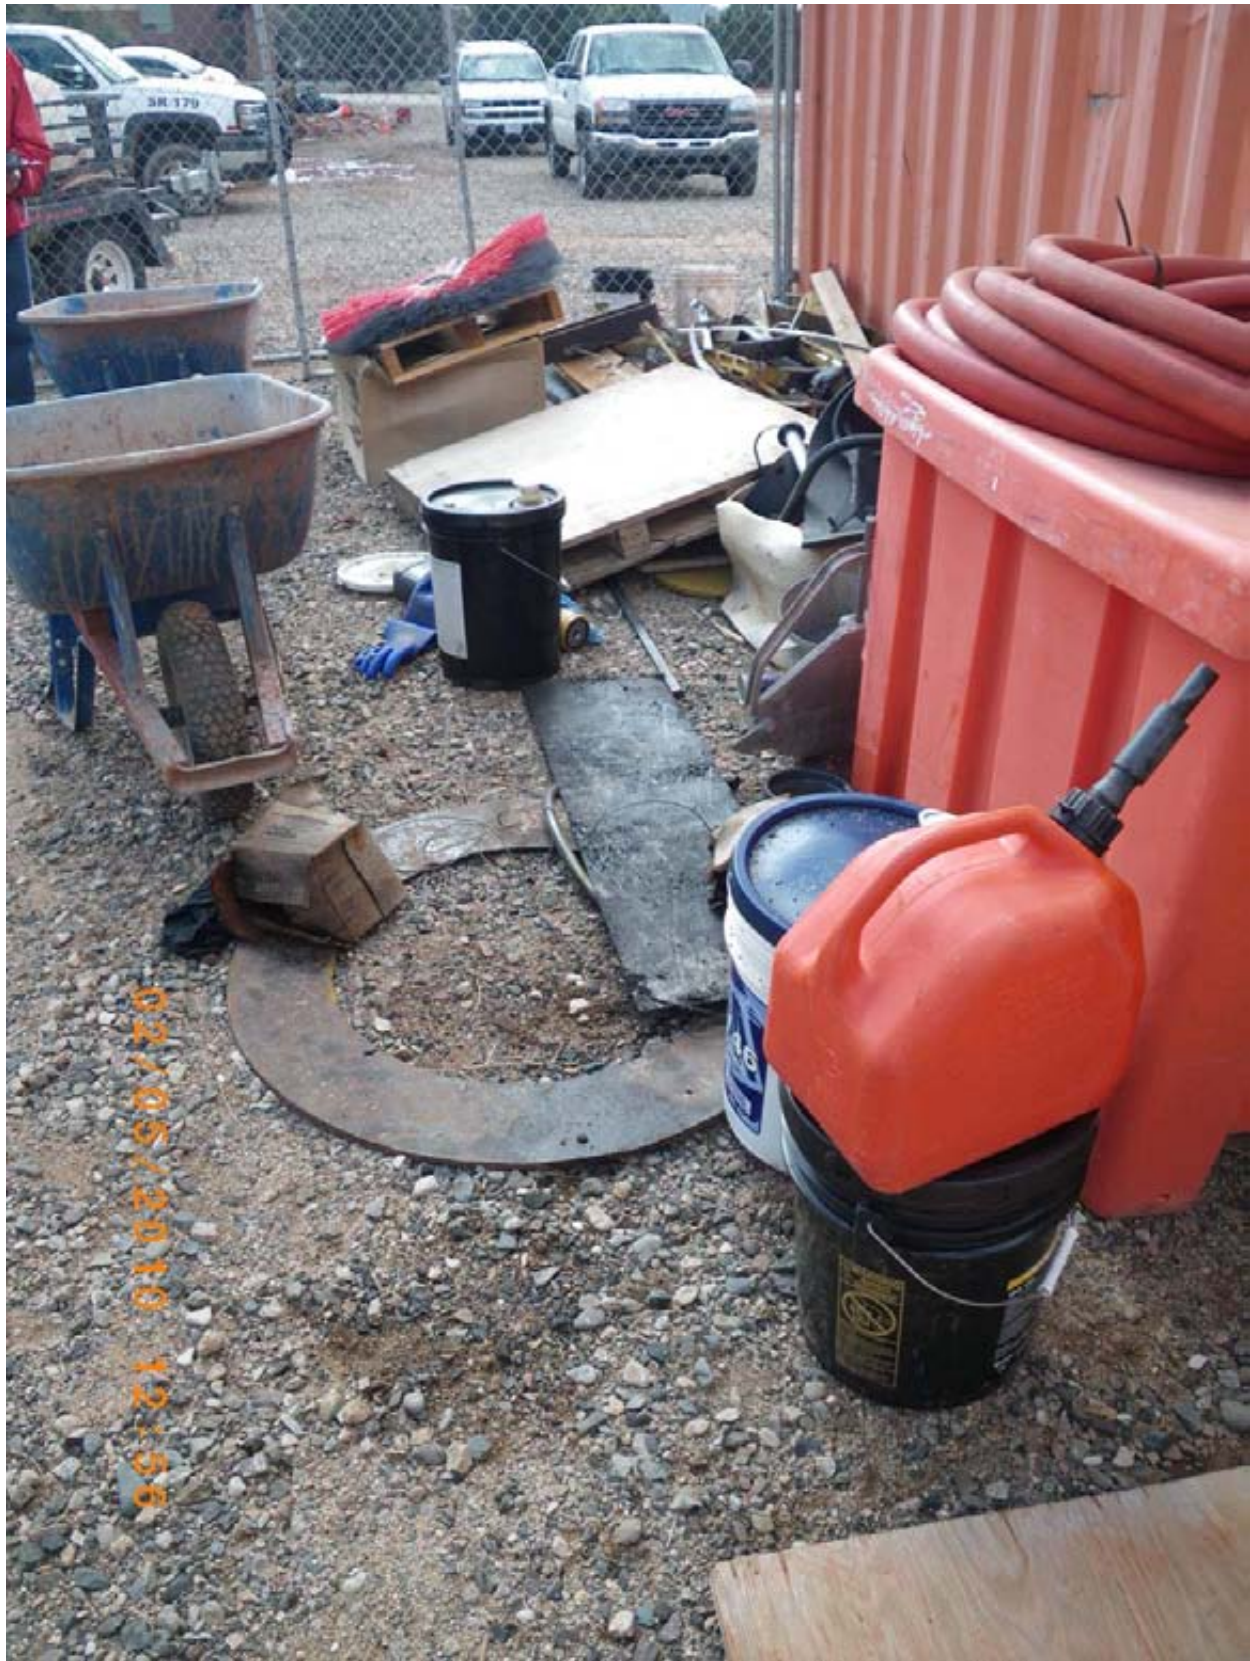
IMGP0075
74 of 86

IMGP0075 – Close-up of materials in fenced storage area. Note lack of secondary containment for potentially toxic substances in buckets.

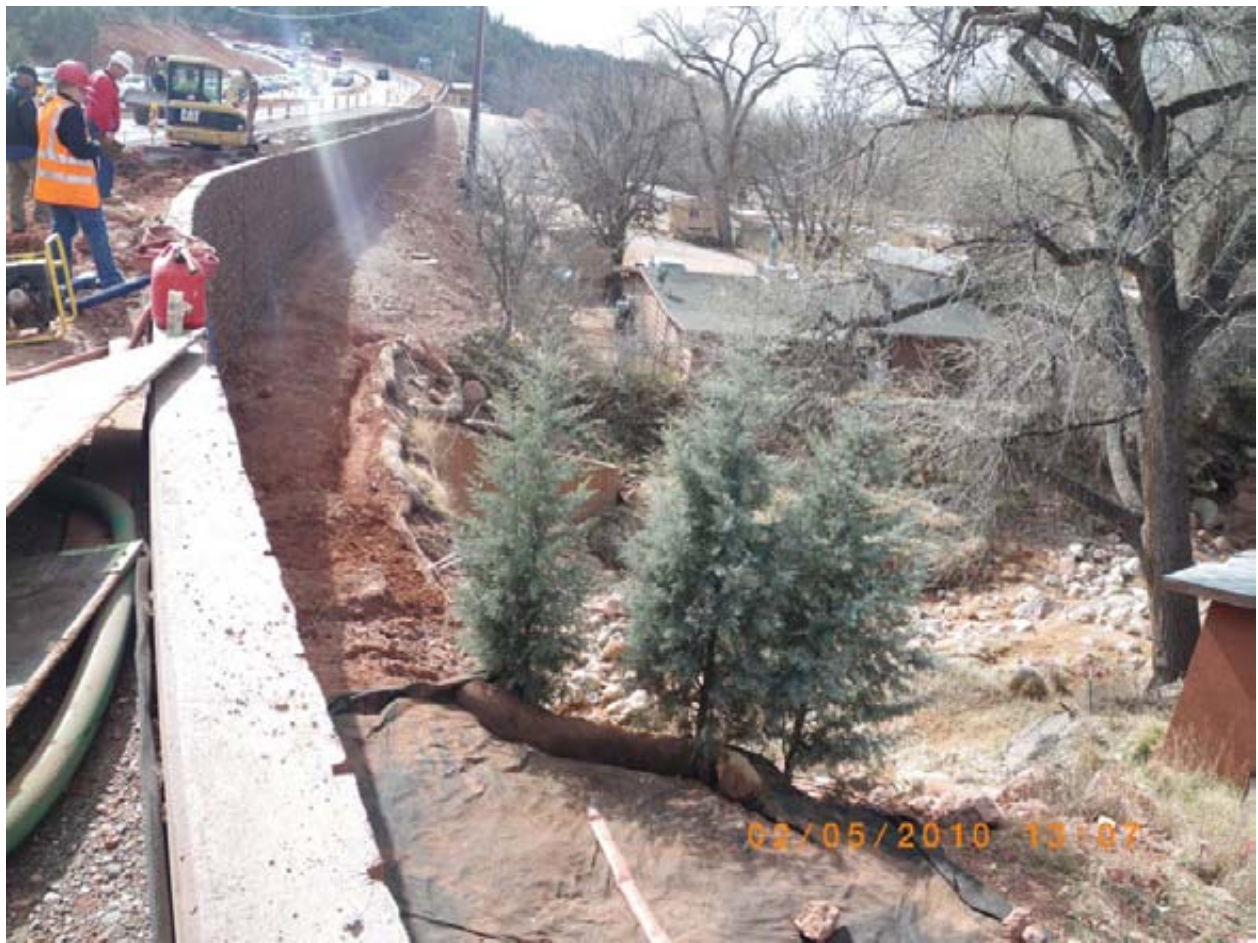
IMGP0078 – From west side of 179, facing south toward Morgan Wash. Note filter fabric in foreground to address concerns of sediment deposit in Morgan Wash.

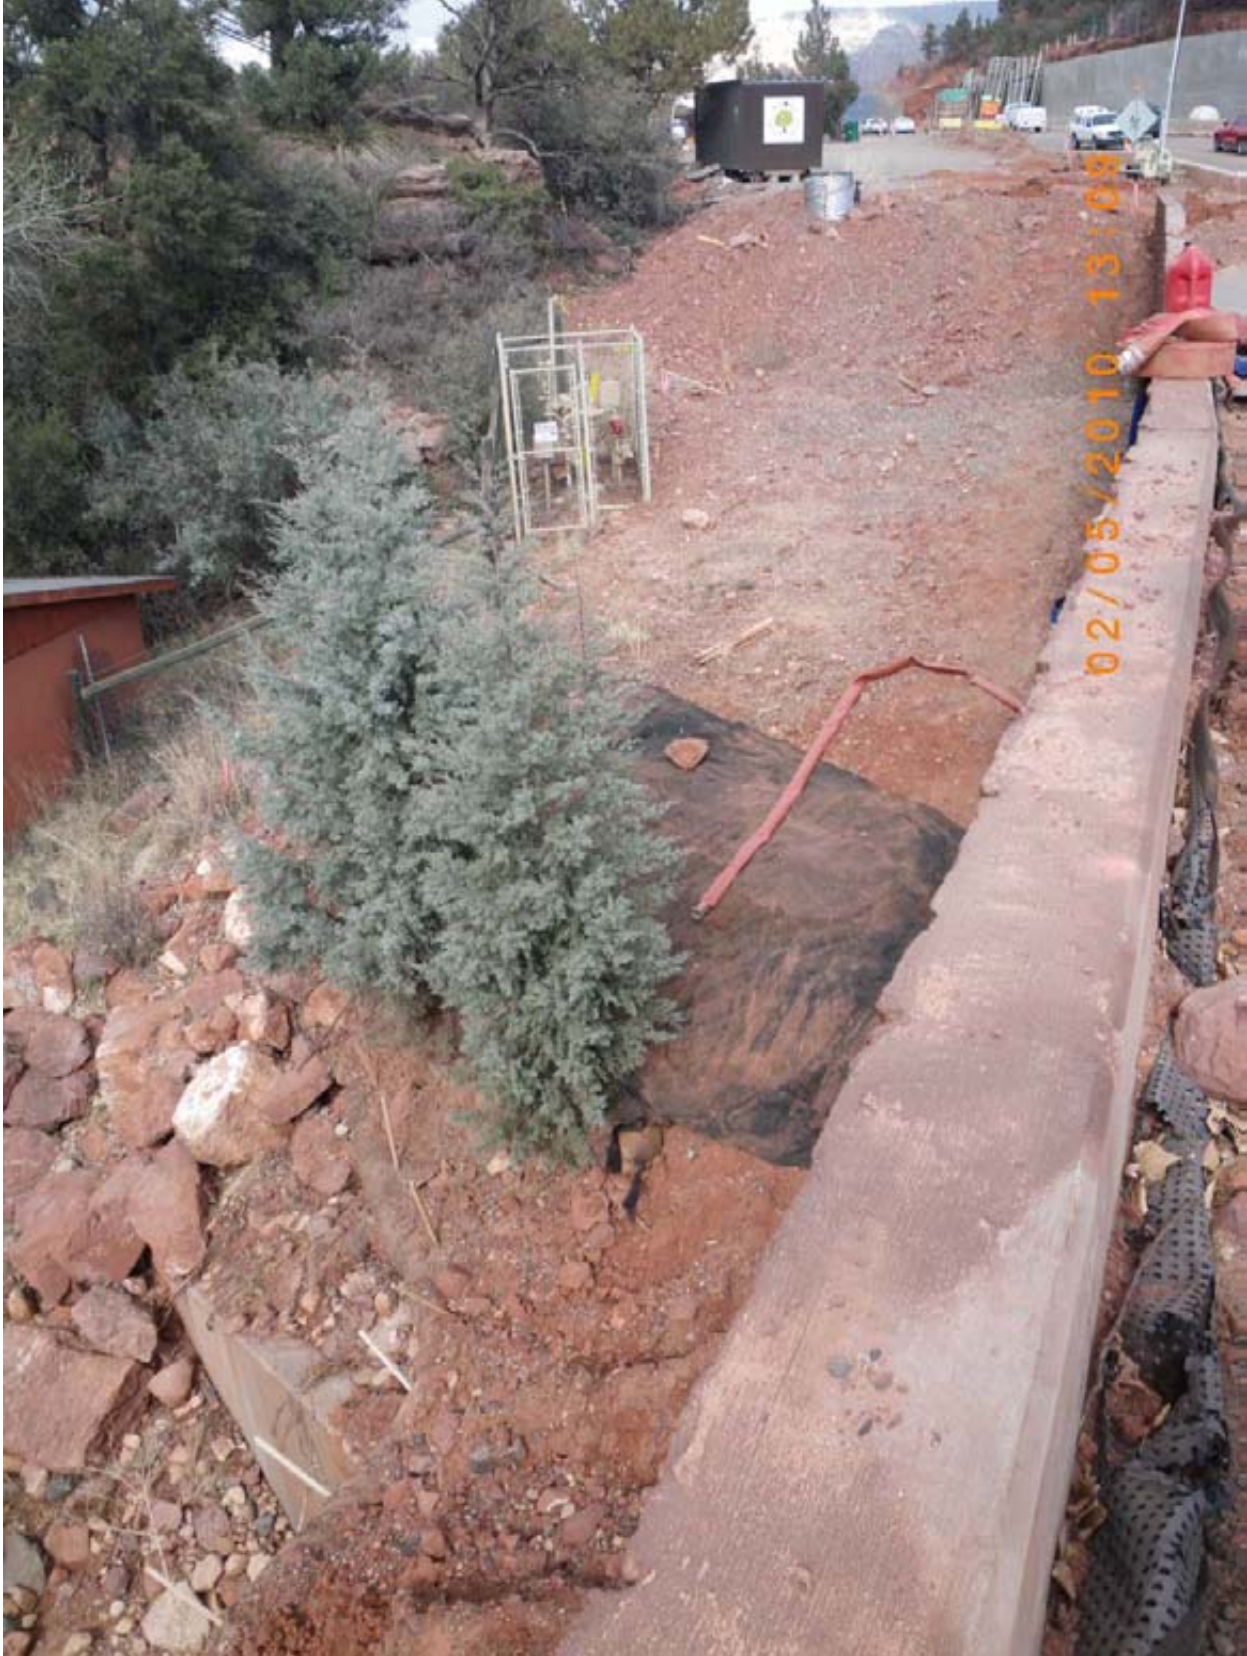
IMGP0079
78 of 86

ADOT/Fisher is also working on SR 179 above Morgan Wash, which flows less than ¼ mile to Oak Creek. We observed evidence of storm water pooling across the highway at this location. According to ADOT/Fisher, this storm water is pumped and discharged into a small filtering basin built into the slope above Morgan Wash (see Photos 0078-79). We did not observe any pumping or discharging during the inspection, but the filtering area appeared to be undersized. Additionally, water discharged from this area and the small filtering basin will cross disturbed soil before entering Morgan Wash (see Photo 0079).

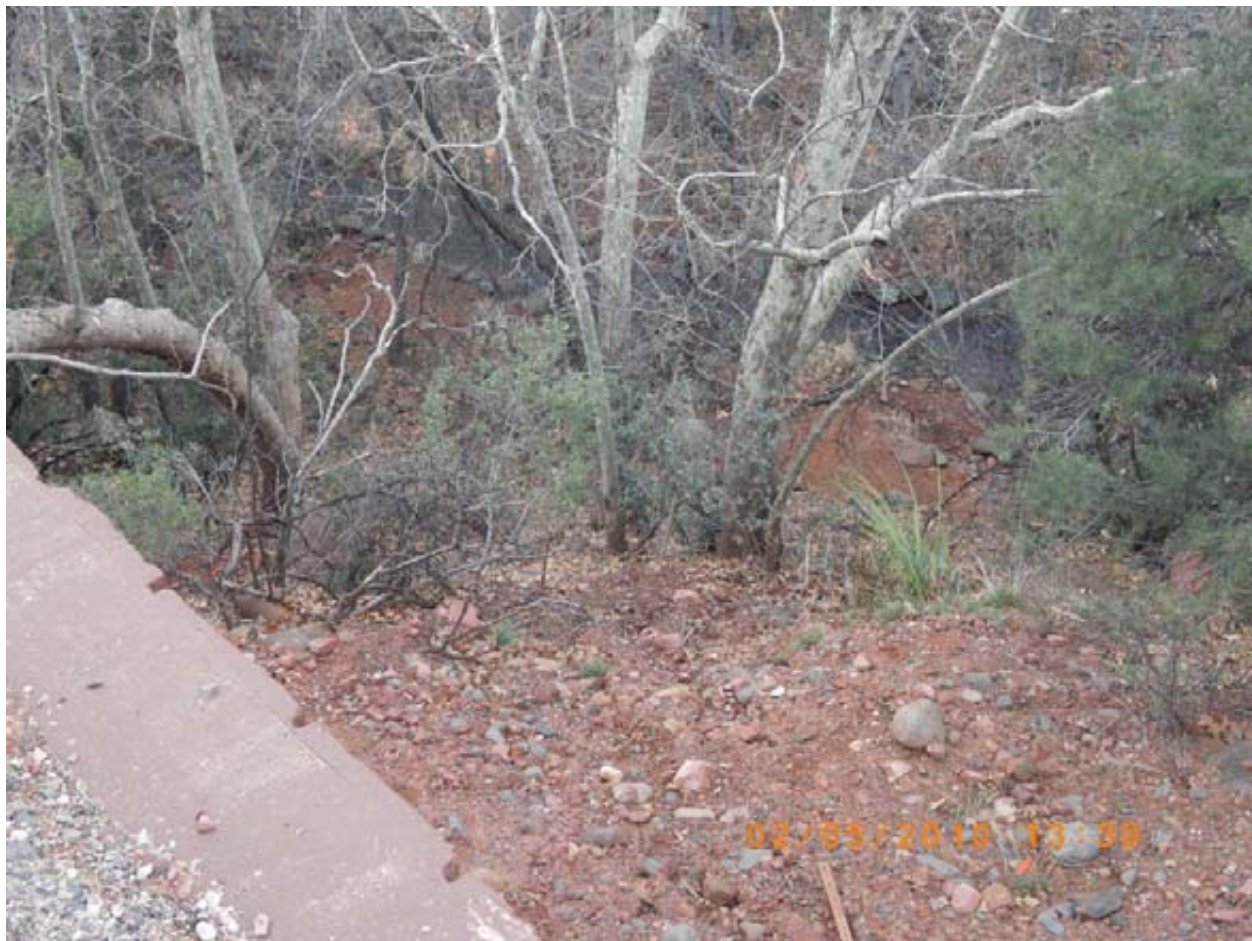
IMGP0087 – Facing southwest toward Oak Creek. Note potential fine sediment deposit (darker reddish color) along east banks of creek.
