Guam Waterworks Authority (VP0989)

SDWA Sanitary Survey

Northern System

NEIC Field Investigation Photographs

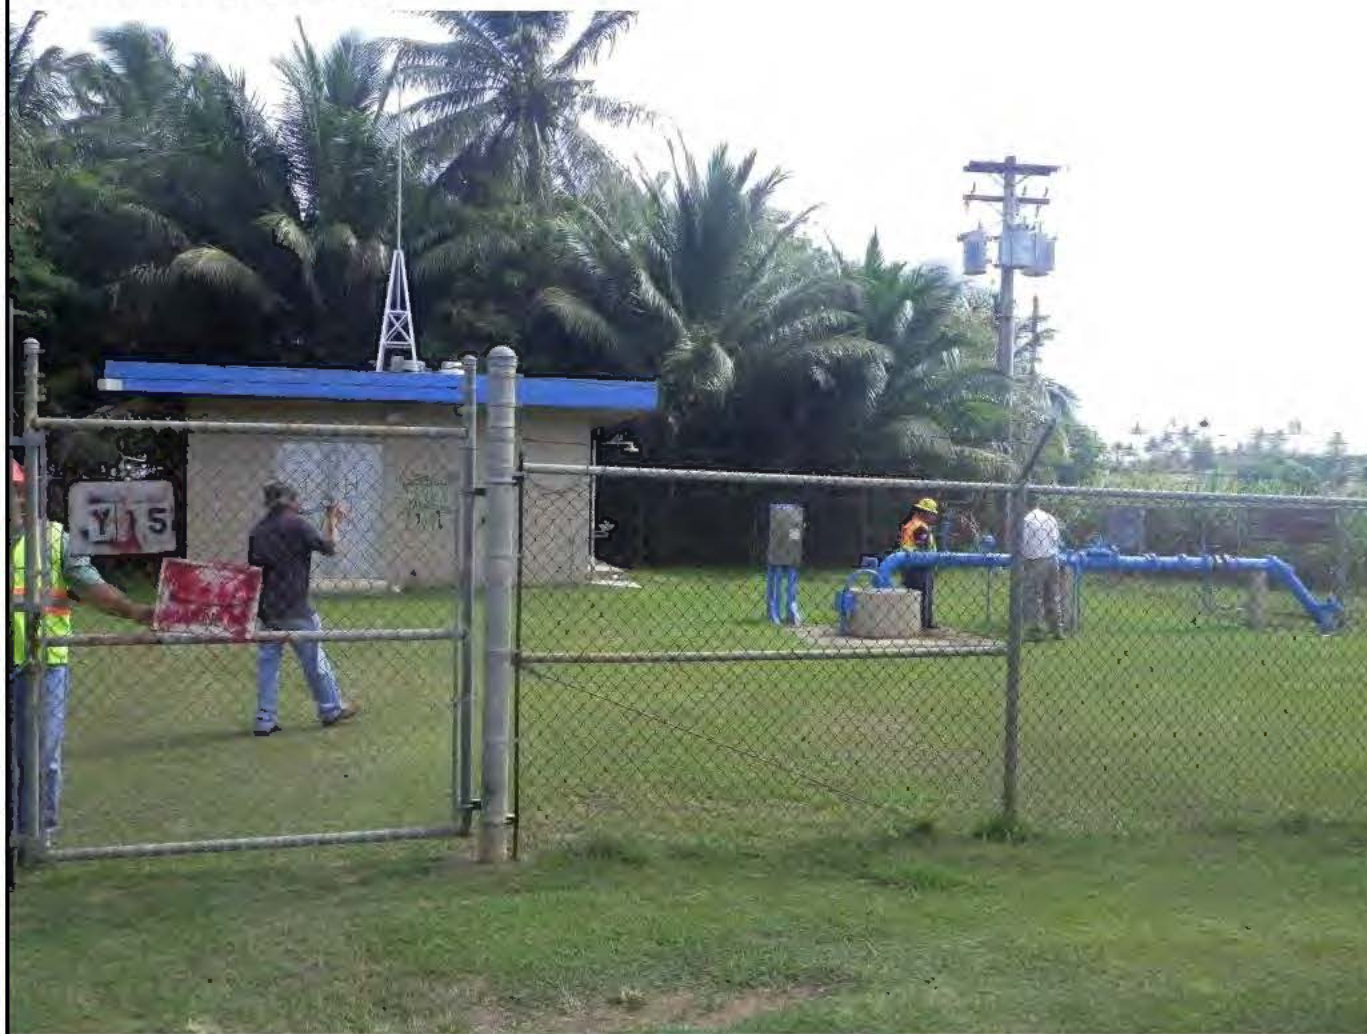
File Name: RIMG0110.JPG

Title	Guam Waterworks Authority (VP0989)
Subject	Northern System
Latitude	[REDACTED]
Longitude	[REDACTED]
Photo Direction	[REDACTED]
Elevation	[REDACTED]
Date Time Stamp	4/27/2012 9:37:55 AM
Photographer	K. Sable
Comment	Y 15 Well
Description	Overview of Y 15 well

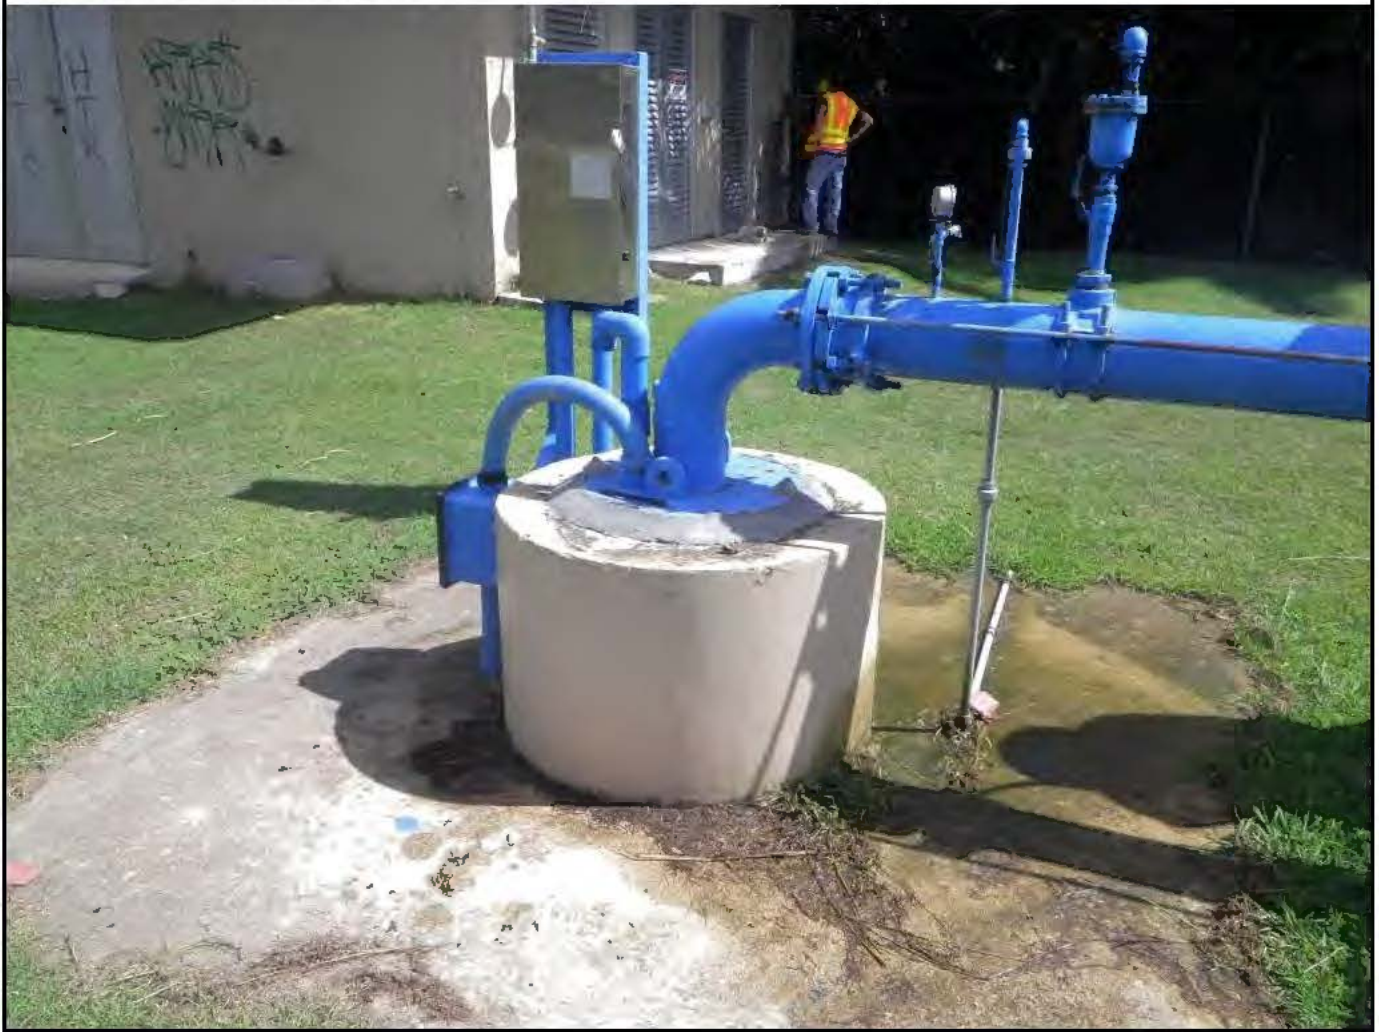
File Name: RIMG0111.JPG

Title	Guam Waterworks Authority (VP0989)
Subject	Northern System
Latitude	██████████
Longitude	██████████
Photo Direction	██████
Elevation	██████
Date Time Stamp	4/27/2012 9:42:40 AM
Photographer	K. Sable
Comment	Y 15 Well
Description	Y 15 well head

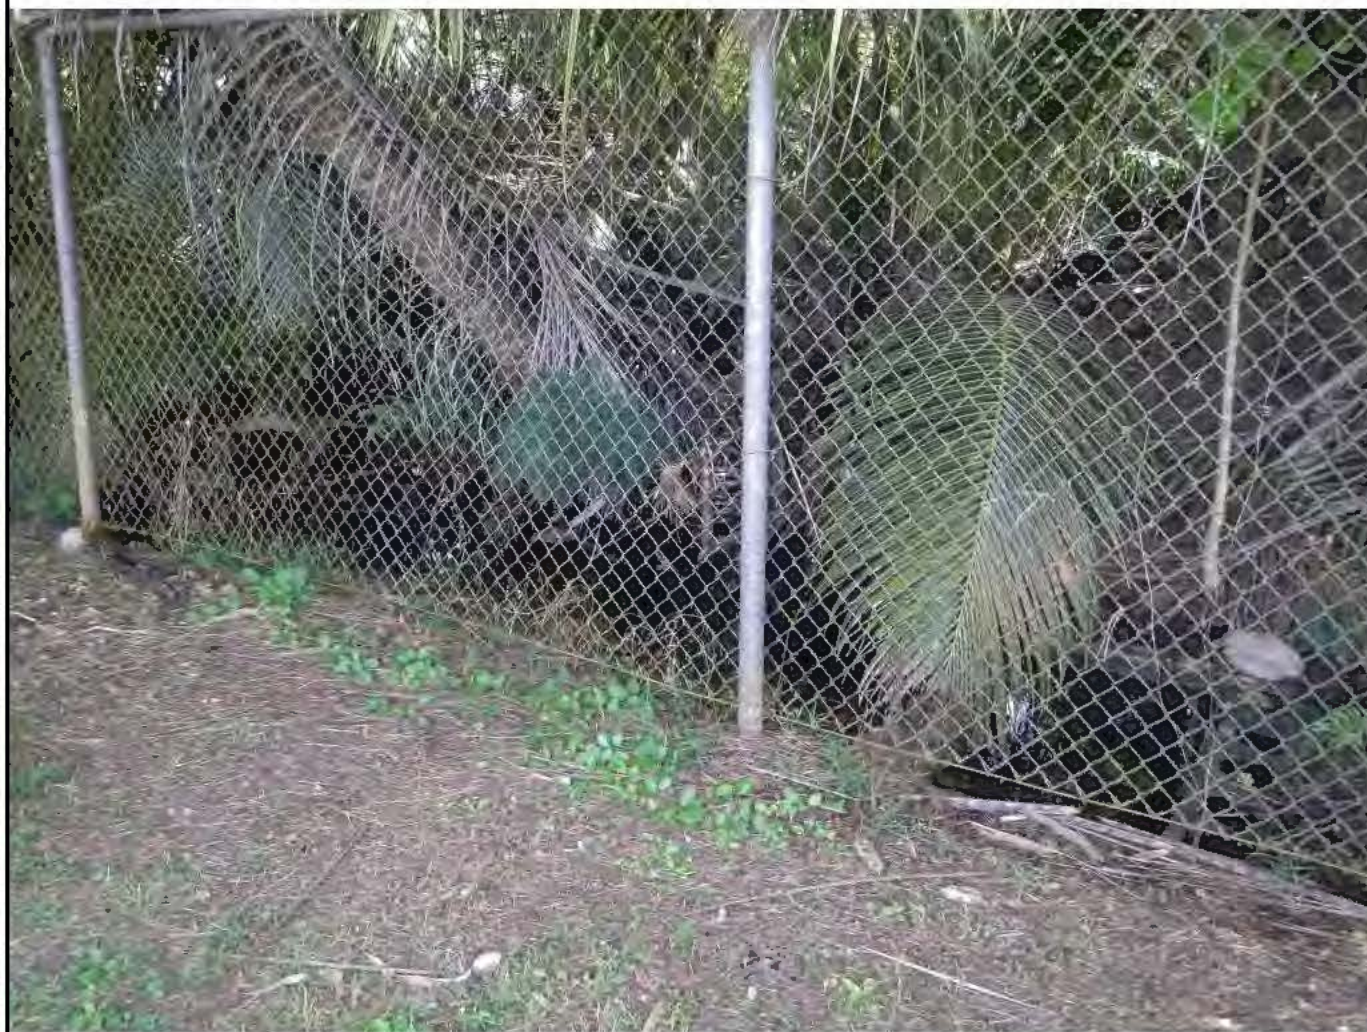
File Name: RIMG0112.JPG

Title	Guam Waterworks Authority (VP0989)
Subject	Northern System
Latitude	[REDACTED]
Longitude	[REDACTED]
Photo Direction	[REDACTED]
Elevation	[REDACTED]
Date Time Stamp	4/27/2012 9:47:15 AM
Photographer	K. Sable
Comment	Y 15 Well
Description	Bypass location

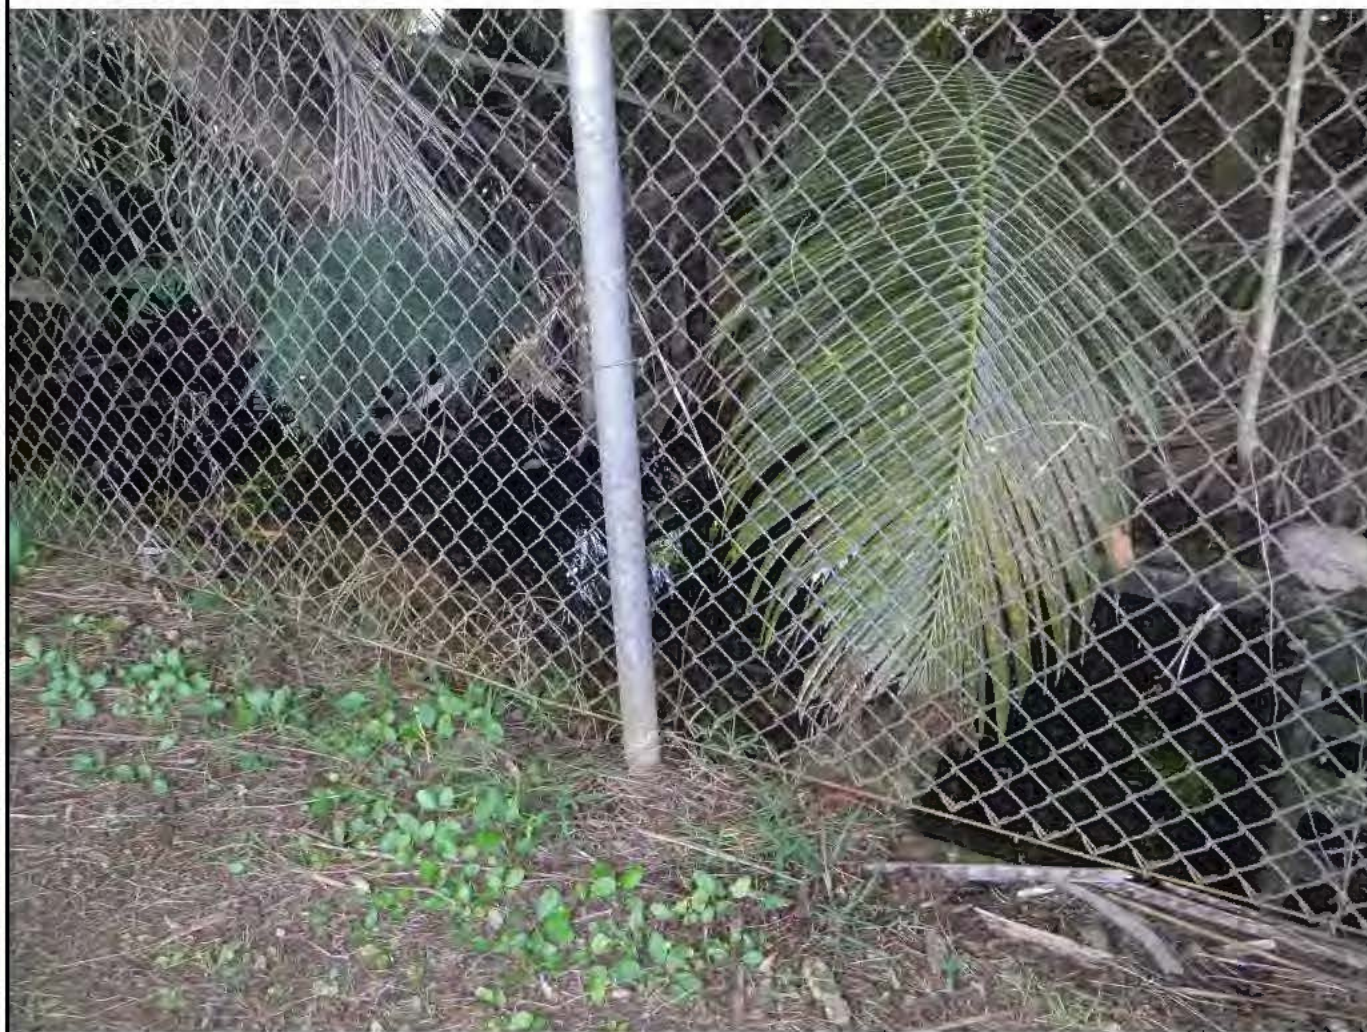
File Name: RIMG0113.JPG

Title	Guam Waterworks Authority (VP0989)
Subject	Northern System
Latitude	[REDACTED]
Longitude	[REDACTED]
Photo Direction	[REDACTED]
Elevation	[REDACTED]
Date Time Stamp	4/27/2012 9:47:26 AM
Photographer	K. Sable
Comment	Y 15 Well
Description	Close-up of bypass location

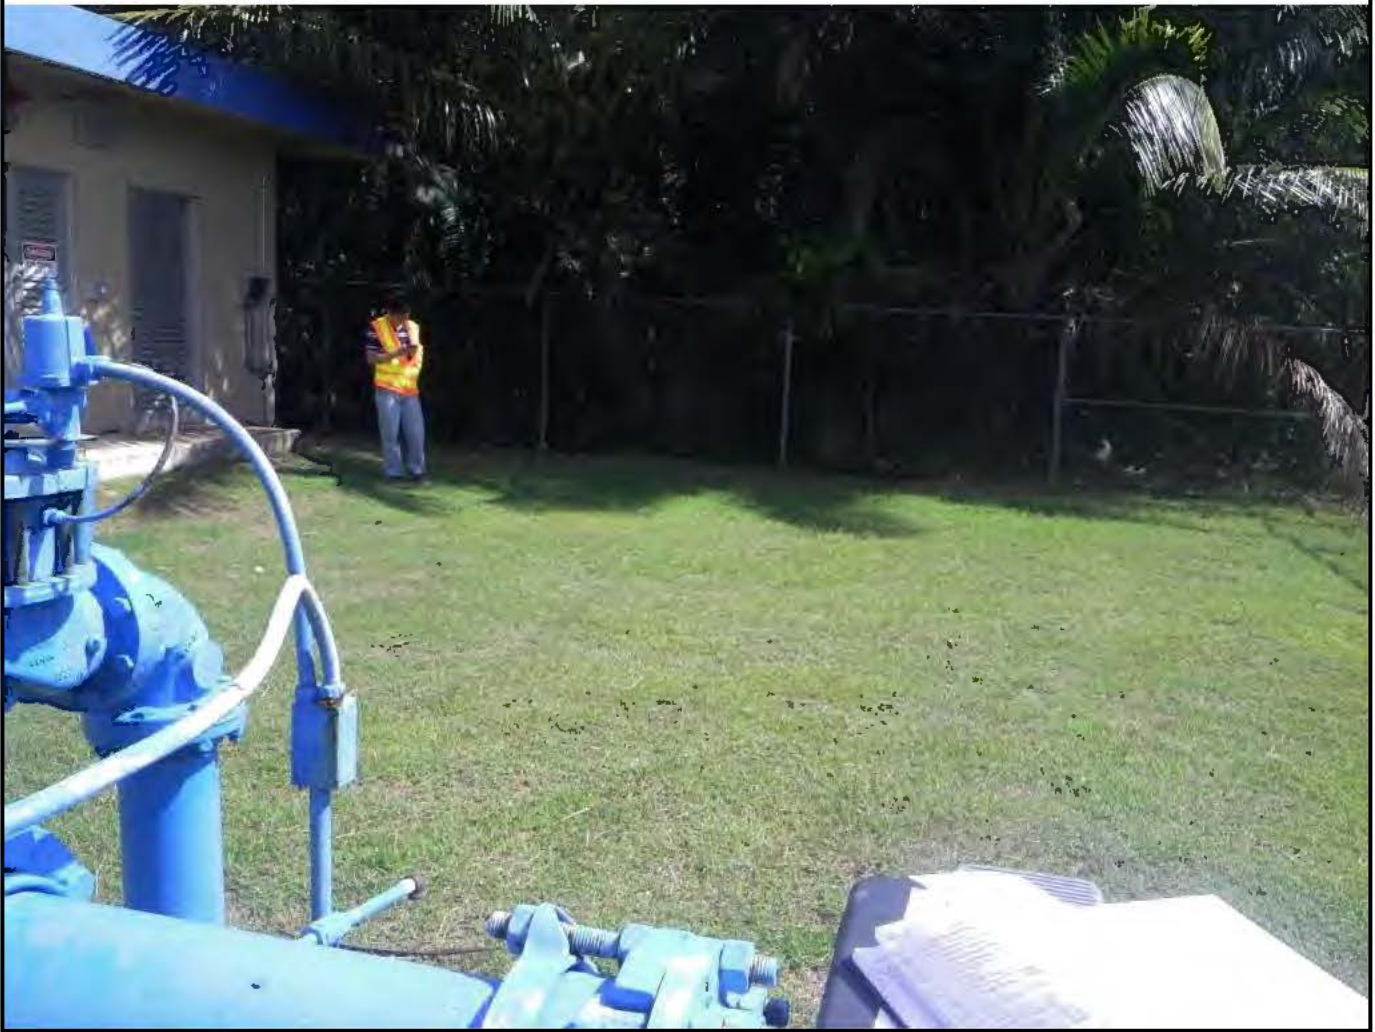
File Name: RIMG0114.JPG

Title	Guam Waterworks Authority (VP0989)
Subject	Northern System
Latitude	██████████
Longitude	██████████
Photo Direction	██████
Elevation	██████
Date Time Stamp	4/27/2012 9:48:24 AM
Photographer	K. Sable
Comment	Y 15 Well
Description	From bypass pipe toward bypass location

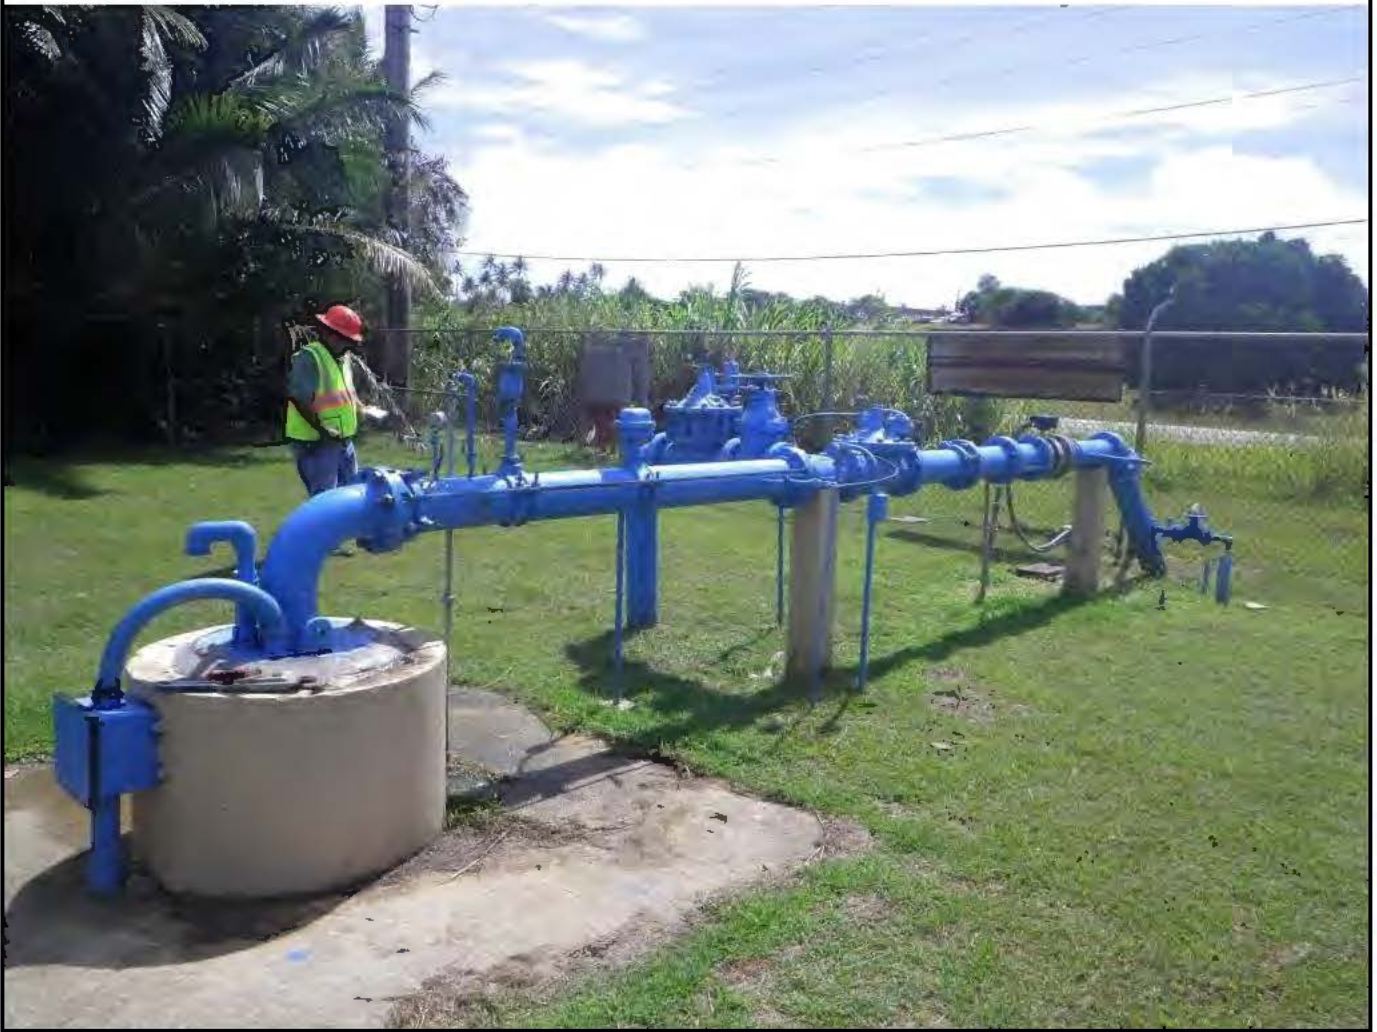
File Name: RIMG0115.JPG

Title	Guam Waterworks Authority (VP0989)
Subject	Northern System
Latitude	██████████
Longitude	██████████
Photo Direction	██████████
Elevation	██████████
Date Time Stamp	4/27/2012 9:54:13 AM
Photographer	K. Sable
Comment	Y 15 Well
Description	Well assembly

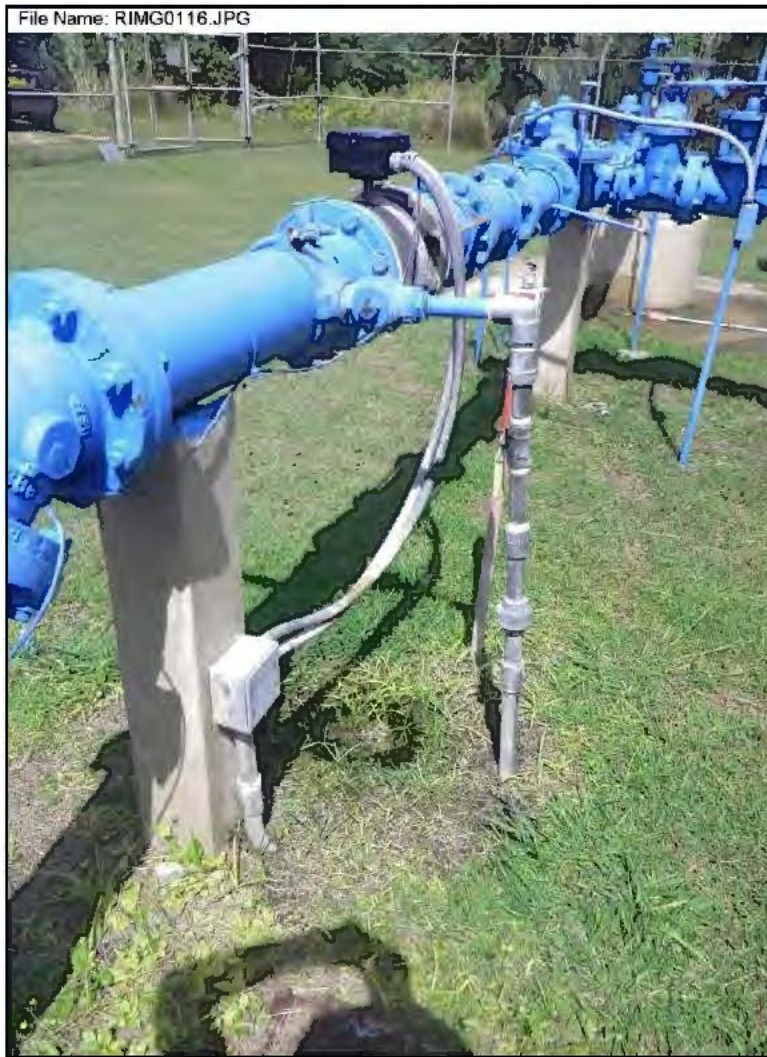
Attributes	
Title	Guam Waterworks Authority (VP0989)
Subject	Northern System
Latitude	[REDACTED]
Longitude	[REDACTED]
Photo Direction	[REDACTED]
Elevation	[REDACTED]
Date Time Stamp	4/27/2012 10:00:52 AM
Photographer	K. Sable
Comment	Y 15 Well
Description	Leak in well assembly chlorine make-up valve

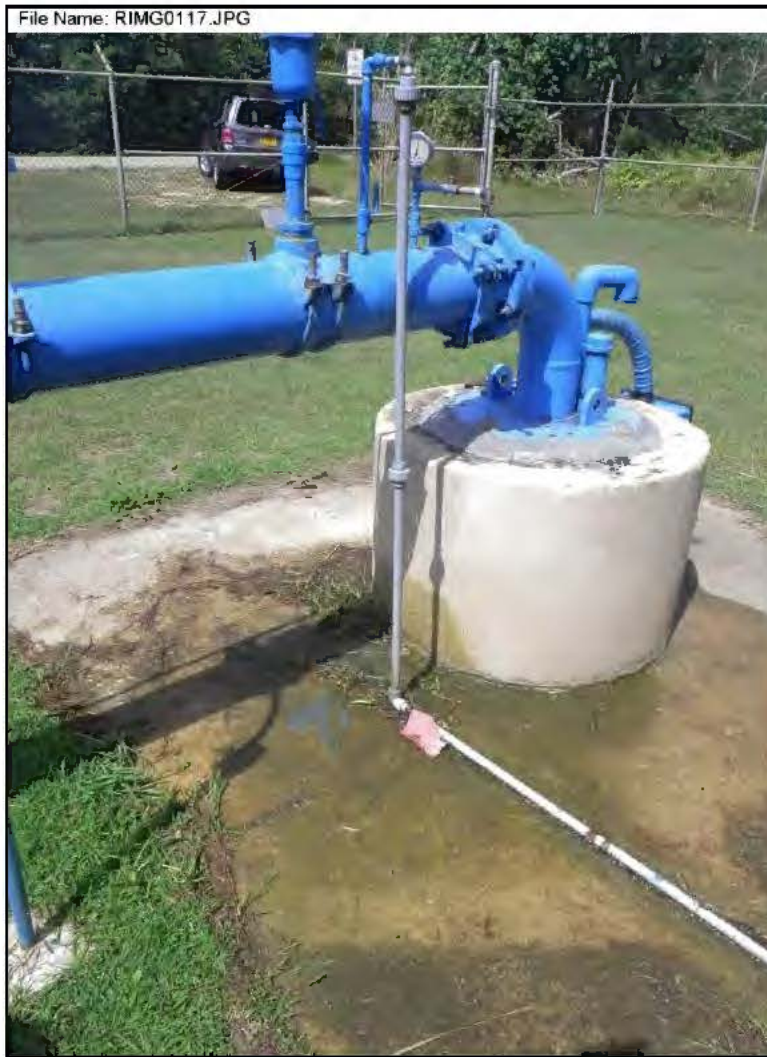
Attributes	
Title	Guam Waterworks Authority (VP0989)
Subject	Northern System
Latitude	[REDACTED]
Longitude	[REDACTED]
Photo Direction	[REDACTED]
Elevation	[REDACTED]
Date Time Stamp	4/27/2012 10:01:22 AM
Photographer	K. Sable
Comment	Y 15 Well
Description	Leak in well assembly

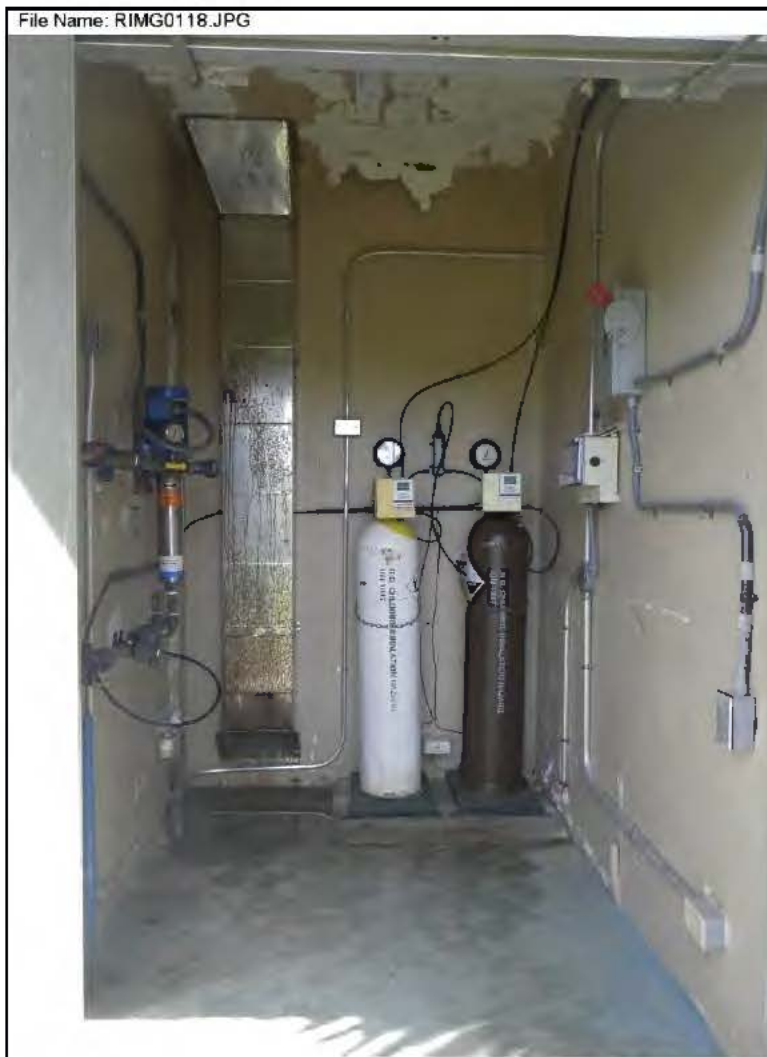
Attributes	
Title	Guam Waterworks Authority (VP0989)
Subject	Northern System
Latitude	[REDACTED]
Longitude	[REDACTED]
Photo Direction	[REDACTED]
Elevation	[REDACTED]
Date Time Stamp	4/27/2012 10:11:23 AM
Photographer	K. Sable
Comment	Y 15 Well
Description	Chlorine room

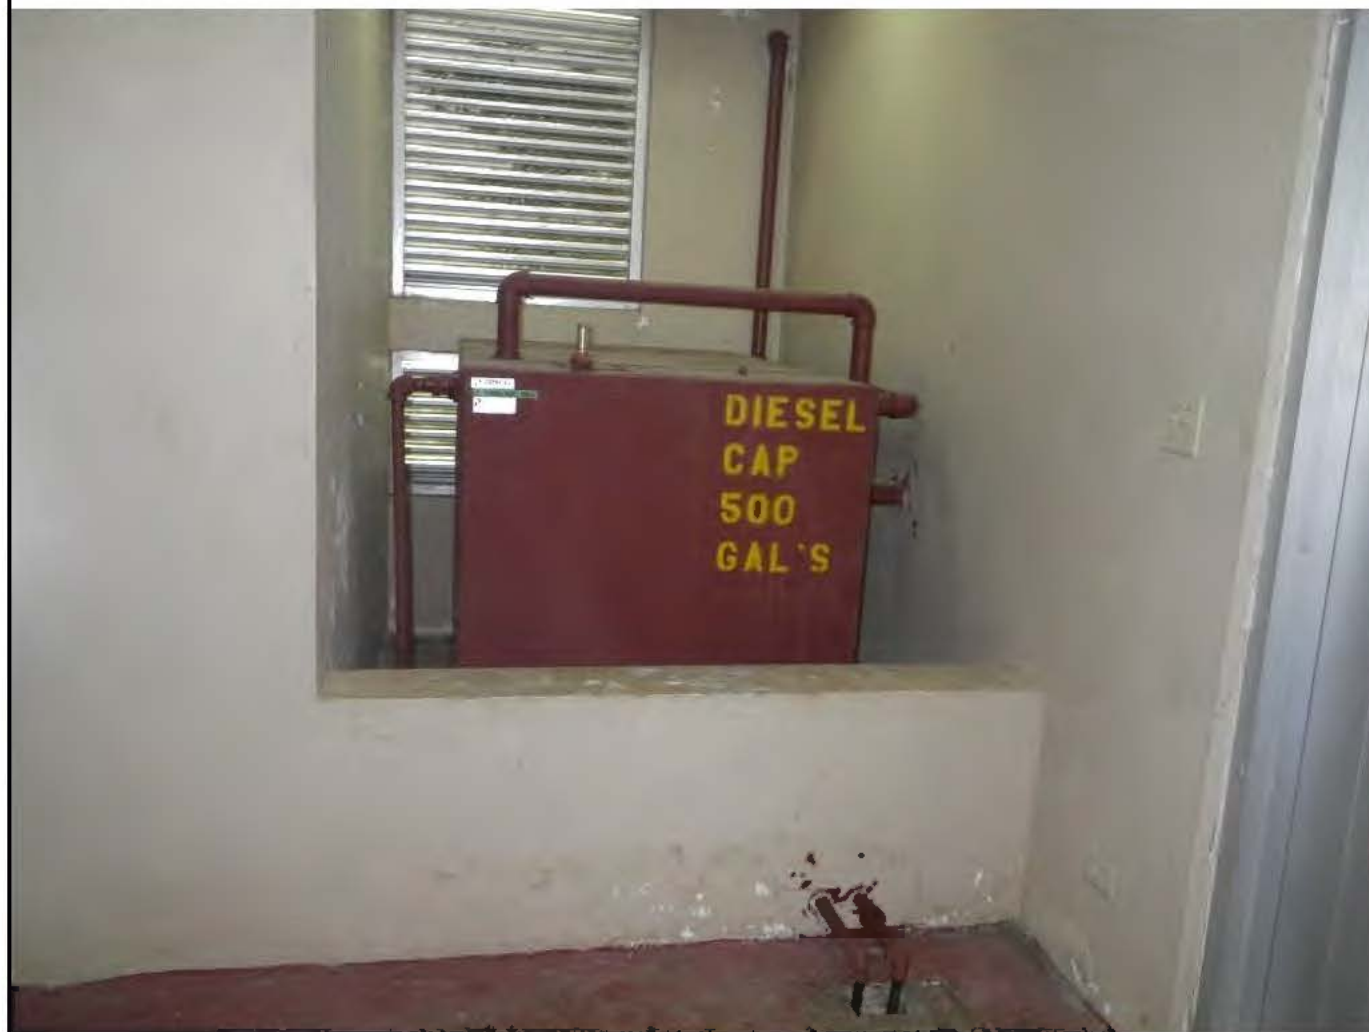
File Name: RIMG0120.JPG

Title	Guam Waterworks Authority (VP0989)
Subject	Northern System
Latitude	[REDACTED]
Longitude	[REDACTED]
Photo Direction	[REDACTED]
Elevation	[REDACTED]
Date Time Stamp	4/27/2012 10:15:52 AM
Photographer	K. Sable
Comment	Y 15 Well
Description	Generator diesel fuel tank

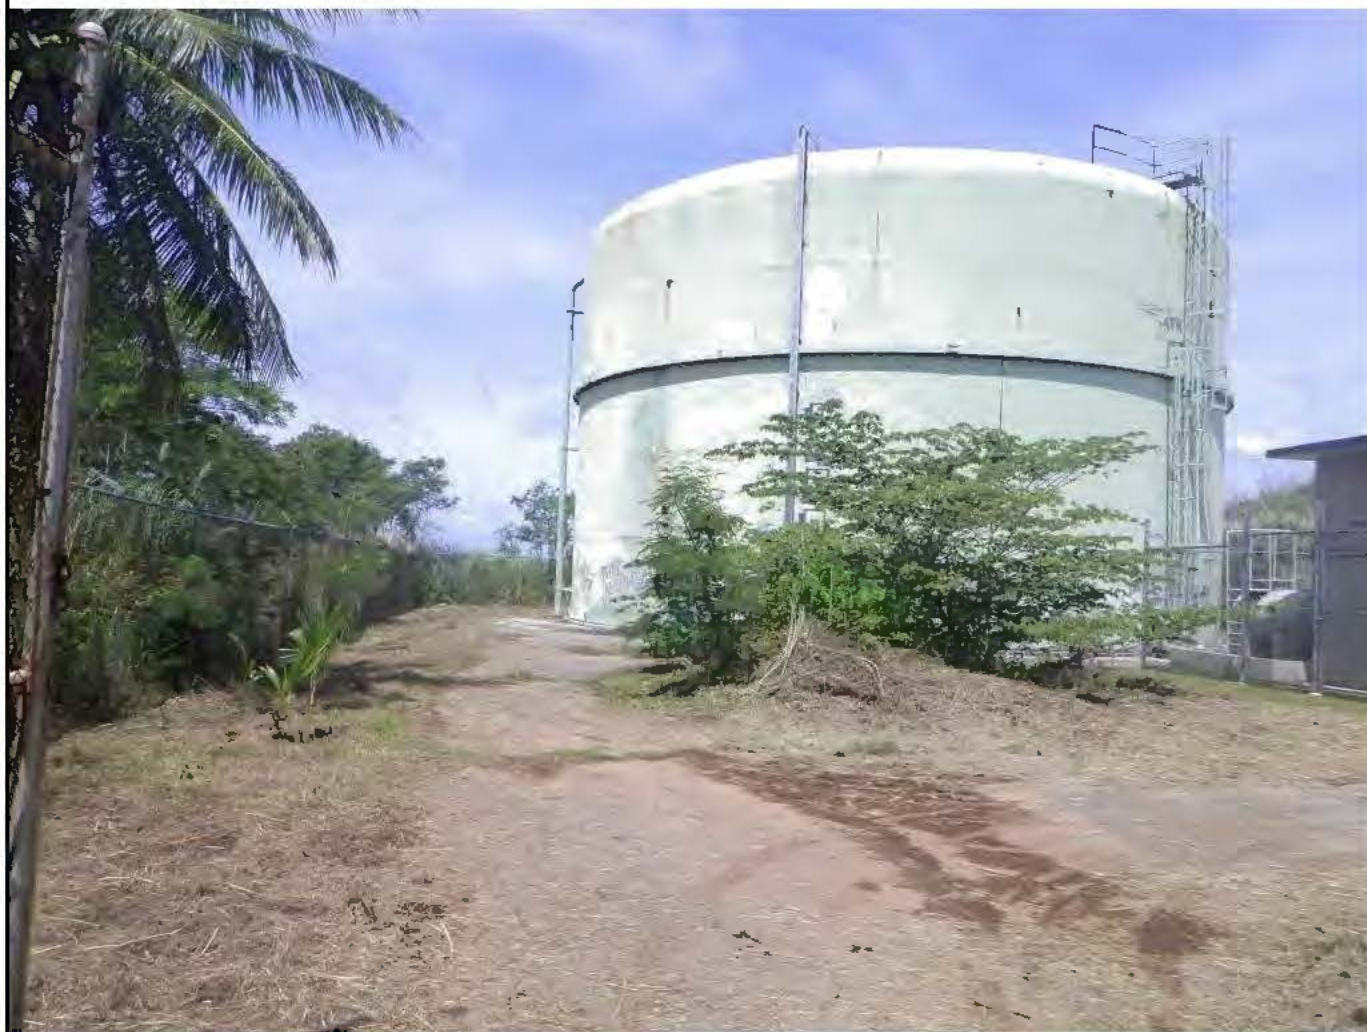
File Name: RIMG0121.JPG

Title	Guam Waterworks Authority (VP0989)
Subject	Northern System
Latitude	[REDACTED]
Longitude	[REDACTED]
Photo Direction	[REDACTED]
Elevation	[REDACTED]
Date Time Stamp	4/27/2012 10:28:00 AM
Photographer	K. Sable
Comment	Santa Rosa Tank
Description	Overview of tank

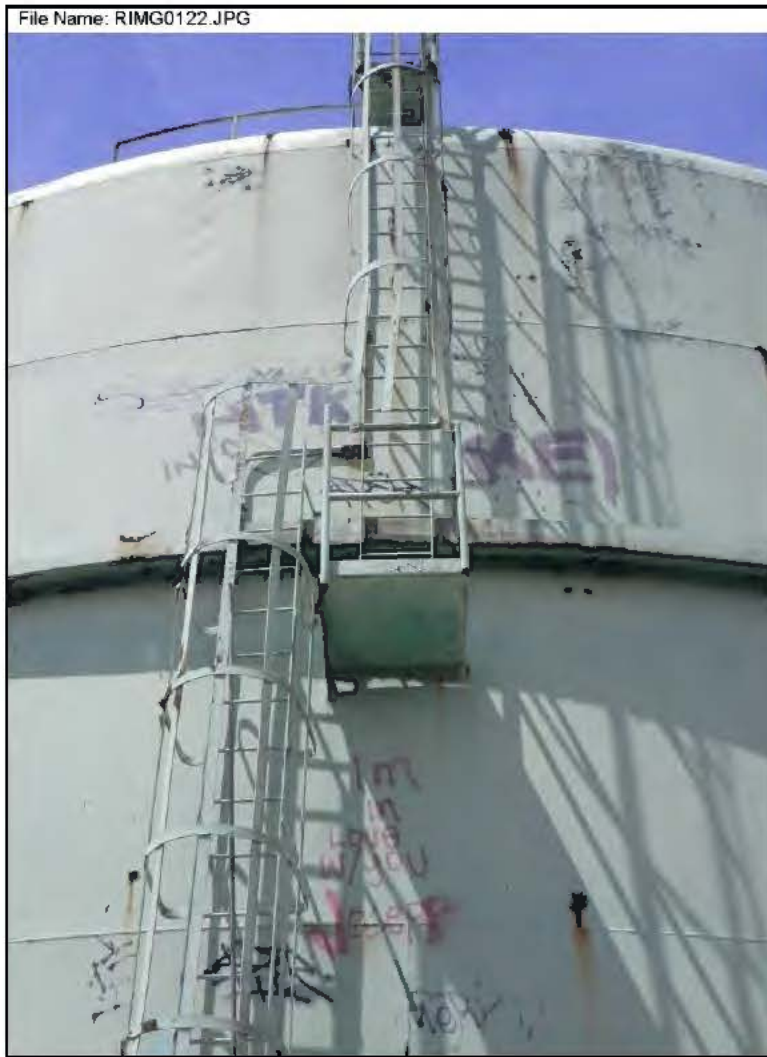
Attributes	
Title	Guam Waterworks Authority (VP0989)
Subject	Northern System
Latitude	[REDACTED]
Longitude	[REDACTED]
Photo Direction	[REDACTED]
Elevation	[REDACTED]
Date Time Stamp	4/27/2012 10:31:39 AM
Photographer	K. Sable
Comment	Santa Rosa Tank
Description	Degrading ladder with broken areas

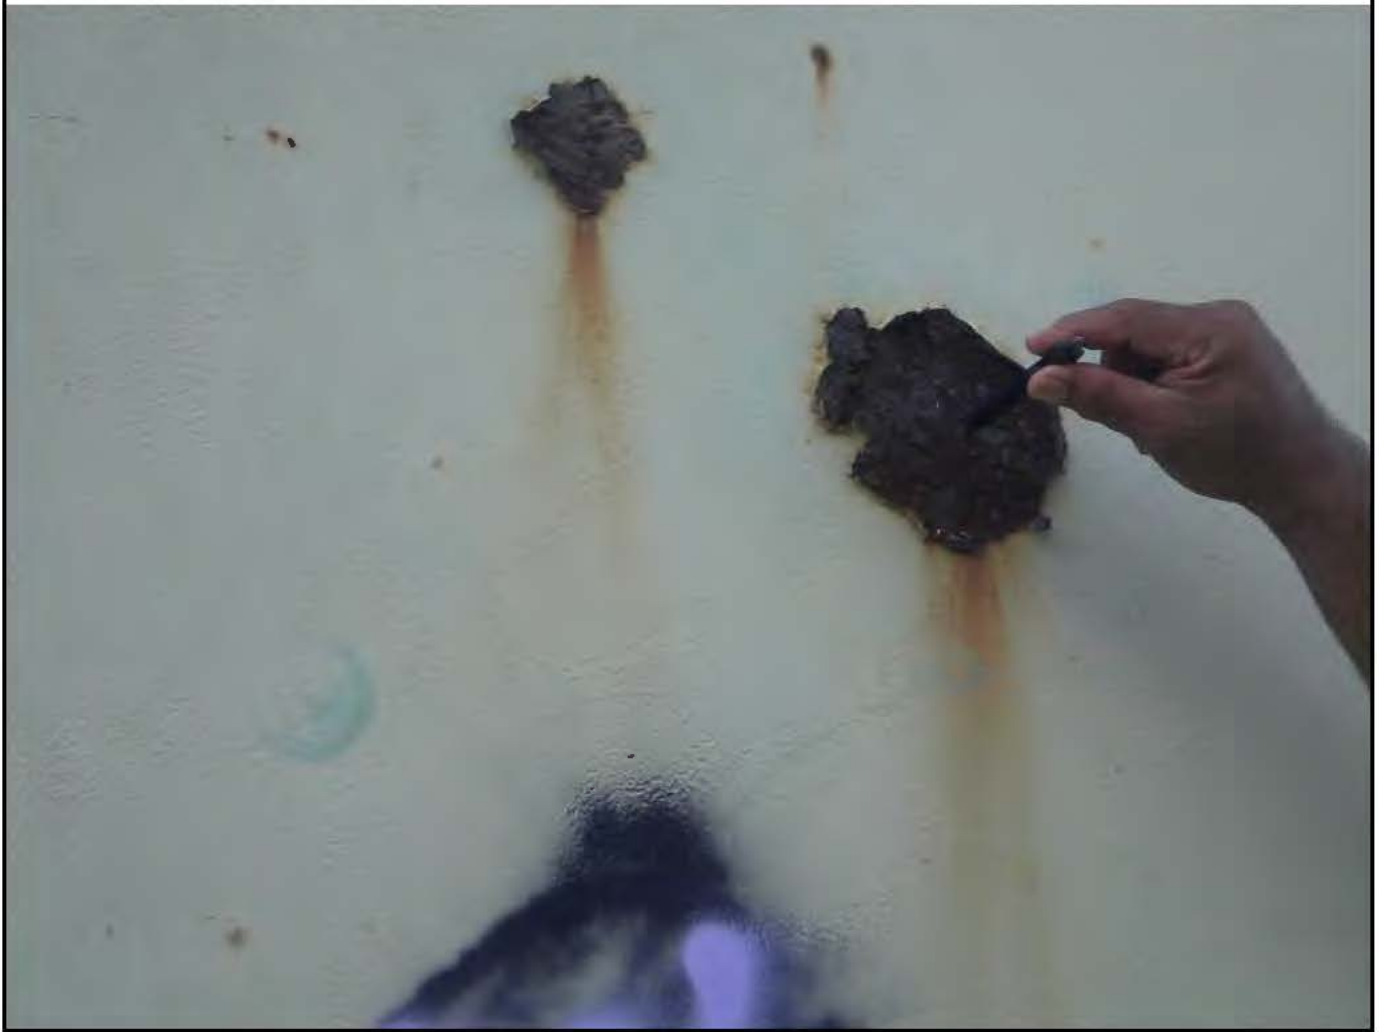
File Name: RIMG0123.JPG

Title	Guam Waterworks Authority (VP0989)
Subject	Northern System
Latitude	██████████
Longitude	██████████
Photo Direction	██████
Elevation	██████
Date Time Stamp	4/27/2012 10:33:25 AM
Photographer	K. Sable
Comment	Santa Rosa Tank
Description	Rust and deep pitting

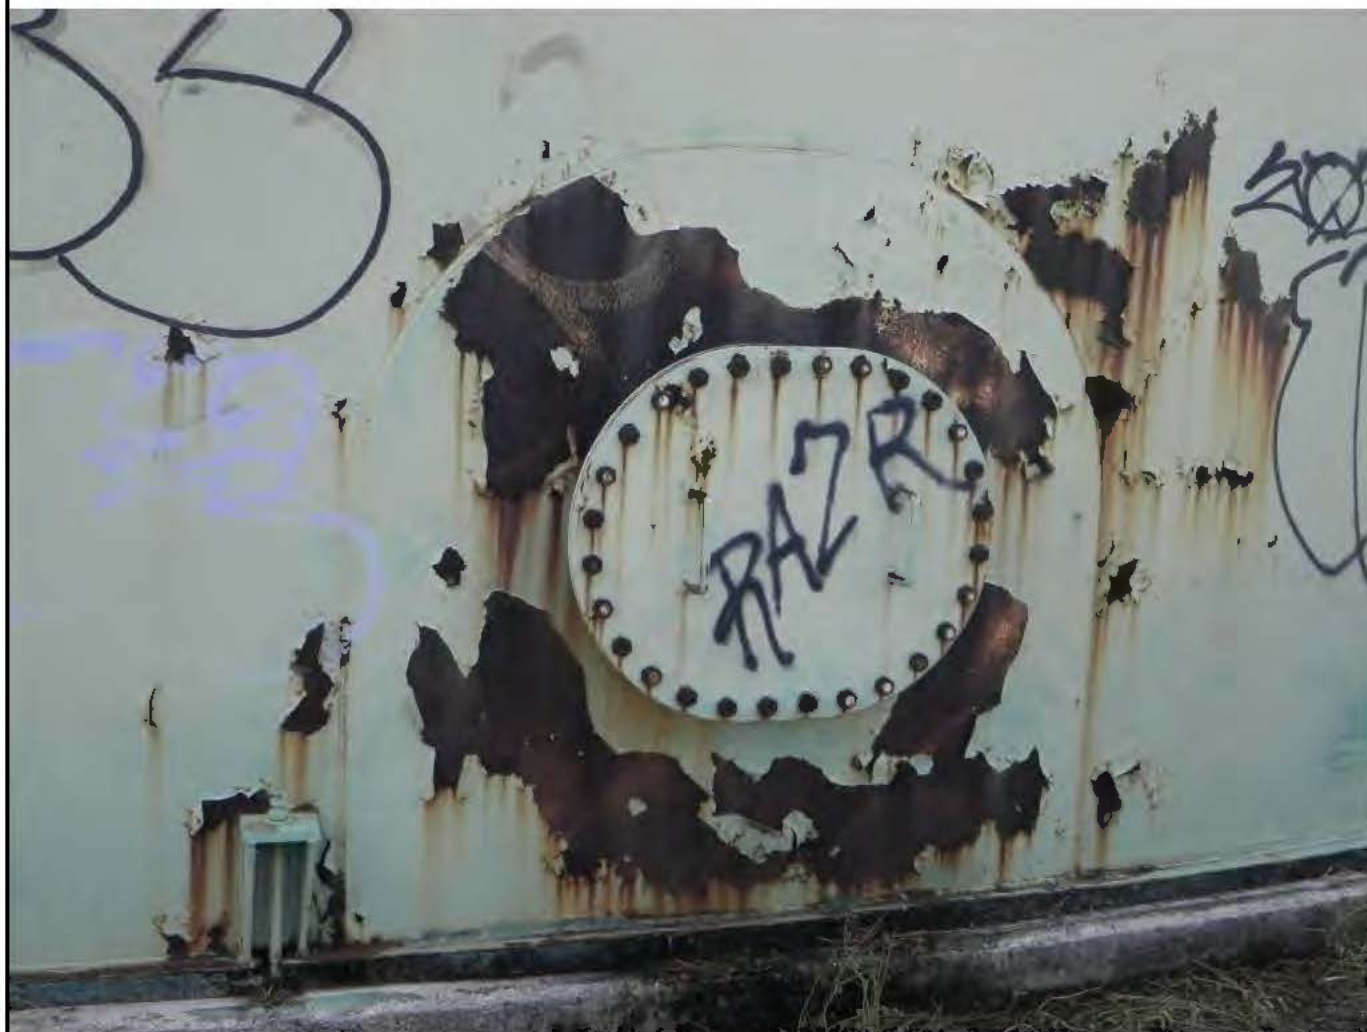
File Name: RIMG0124.JPG

Title	Guam Waterworks Authority (VP0989)
Subject	Northern System
Latitude	██████████
Longitude	██████████
Photo Direction	██████████
Elevation	██████████
Date Time Stamp	4/27/2012 10:35:16 AM
Photographer	K. Sable
Comment	Santa Rosa Tank
Description	Rust areas on tank

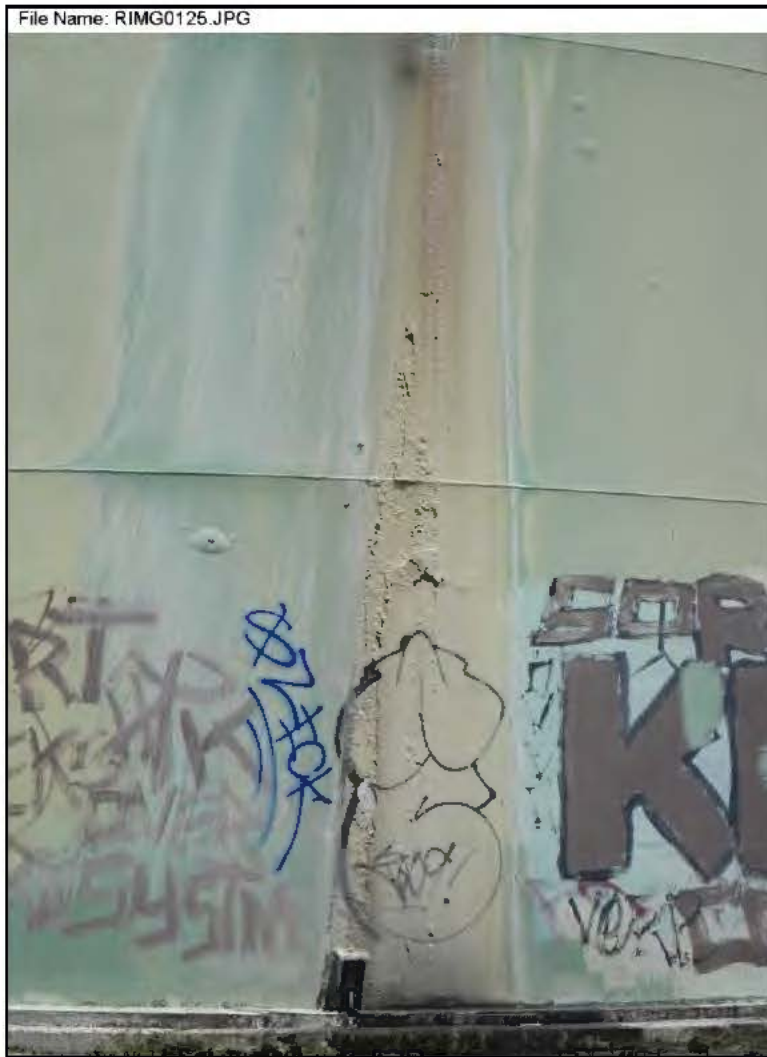
Attributes	
Title	Guam Waterworks Authority (VP0989)
Subject	Northern System
Latitude	[REDACTED]
Longitude	[REDACTED]
Photo Direction	[REDACTED]
[REDACTED]	[REDACTED]
Date Time Stamp	4/27/2012 10:39:30 AM
Photographer	K. Sable
Comment	Santa Rosa Tank
Description	Previously patched area with precipitate build-up on outside of tank

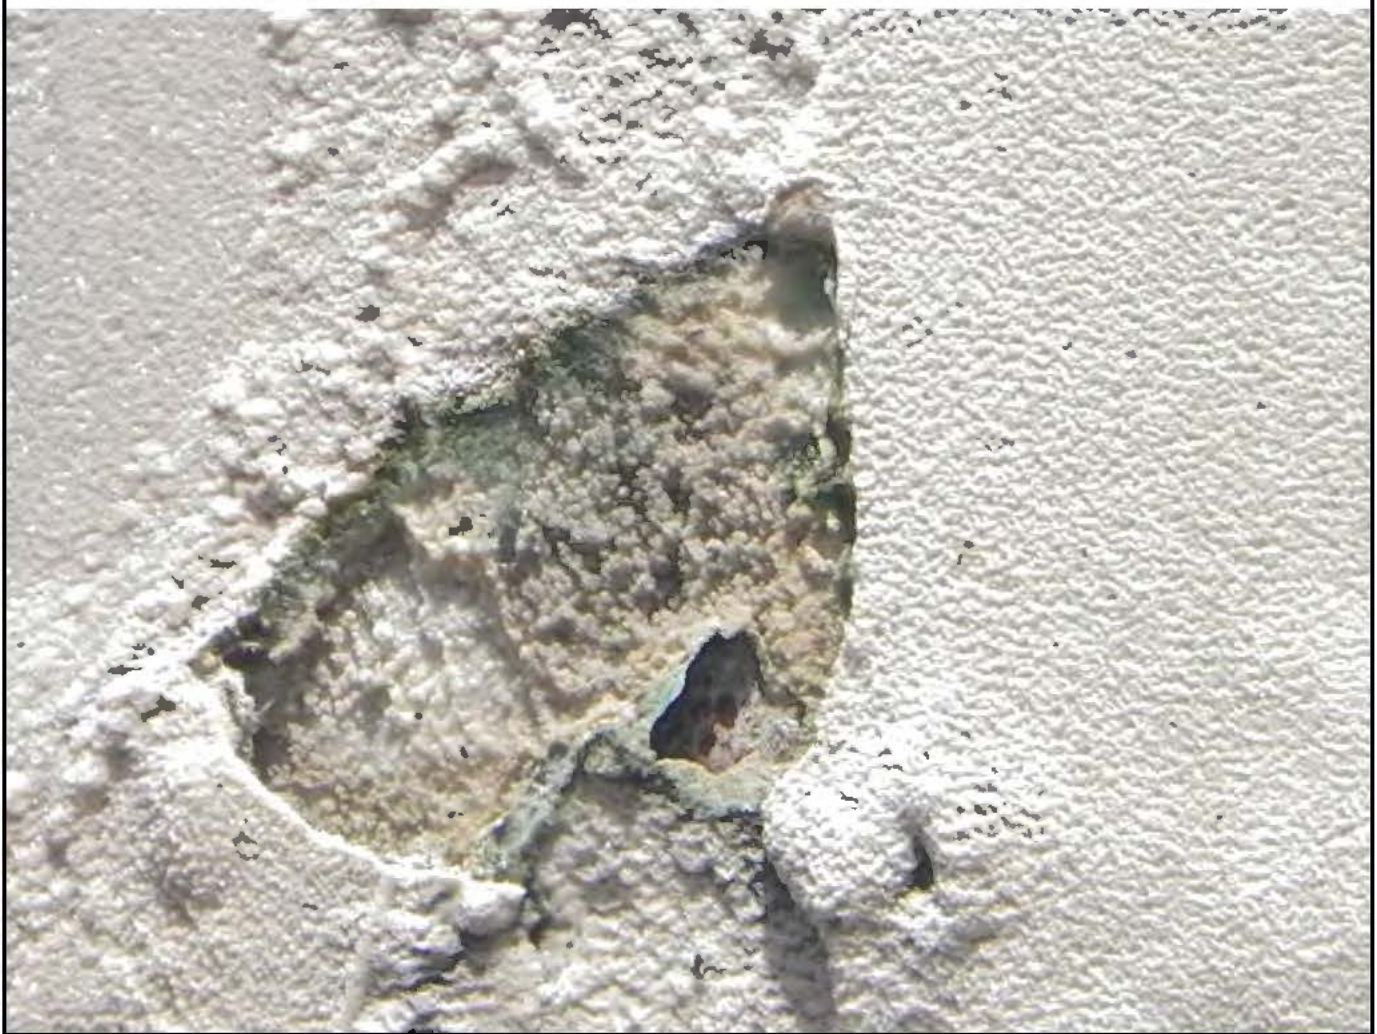
File Name: RIMG0127.JPG

Title	Guam Waterworks Authority (VP0989)
Subject	Northern System
Latitude	██████████
Longitude	██████████
Photo Direction	██████
Elevation	████
Date Time Stamp	4/27/2012 10:43:34 AM
Photographer	K. Sable
Comment	Santa Rosa Tank
Description	Close-up of previously patched area with build-up of precipitate

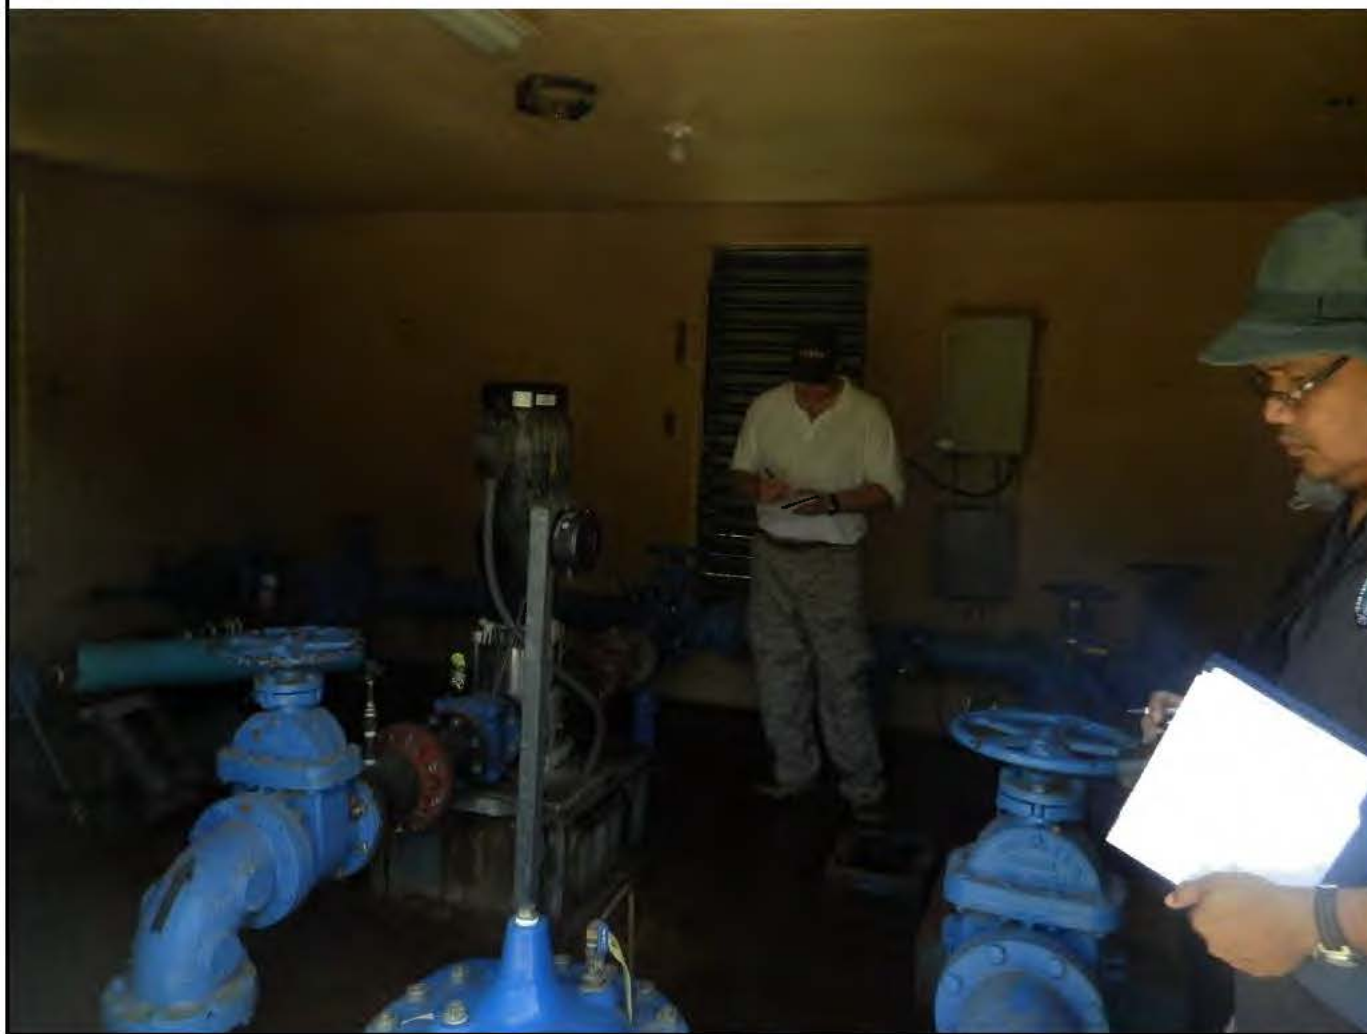
File Name: RIMG0128.JPG

Title	Guam Waterworks Authority (VP0989)
Subject	Northern System
Latitude	██████████
Longitude	██████████
Photo Direction	██████████
Elevation	██████
Date Time Stamp	4/27/2012 10:52:59 AM
Photographer	K. Sable
Comment	Santa Rosa Pump Station
Description	Overview of pump station
