Guam Waterworks Authority (VP0989)

SDWA Sanitary Survey

Northern System

NEIC Field Investigation Photographs

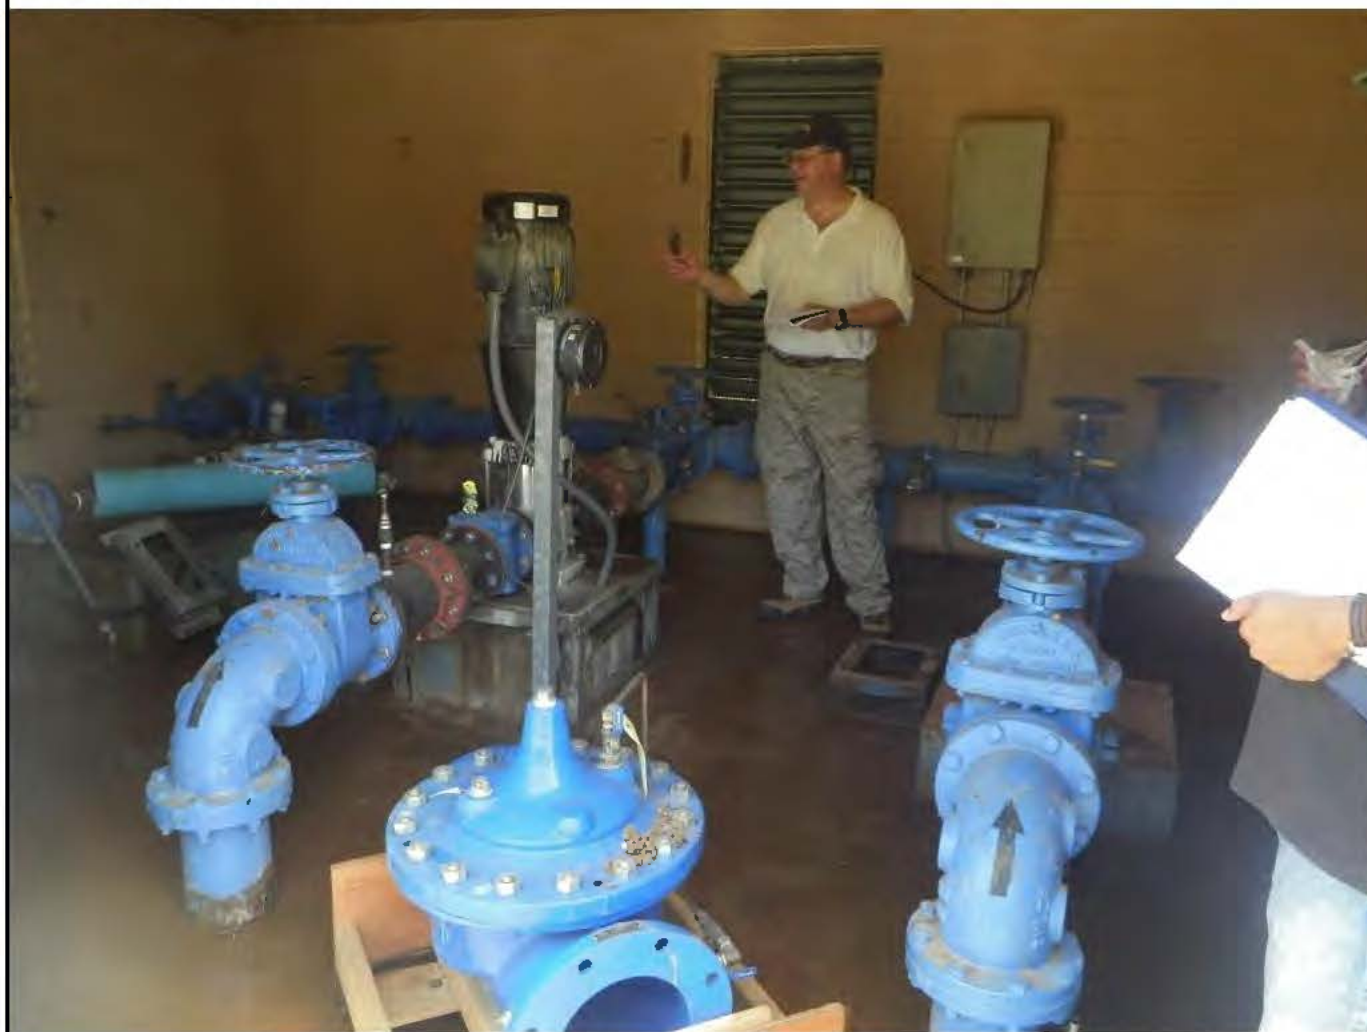
File Name: RIMG0129.JPG

Title	Guam Waterworks Authority (VP0989)
Subject	Northern System
Latitude	██████████
Longitude	██████████
Photo Direction	██████████
Elevation	██████████
Date Time Stamp	4/27/2012 10:53:05 AM
Photographer	K. Sable
Comment	Santa Rosa Pump Station
Description	Overview of pump station

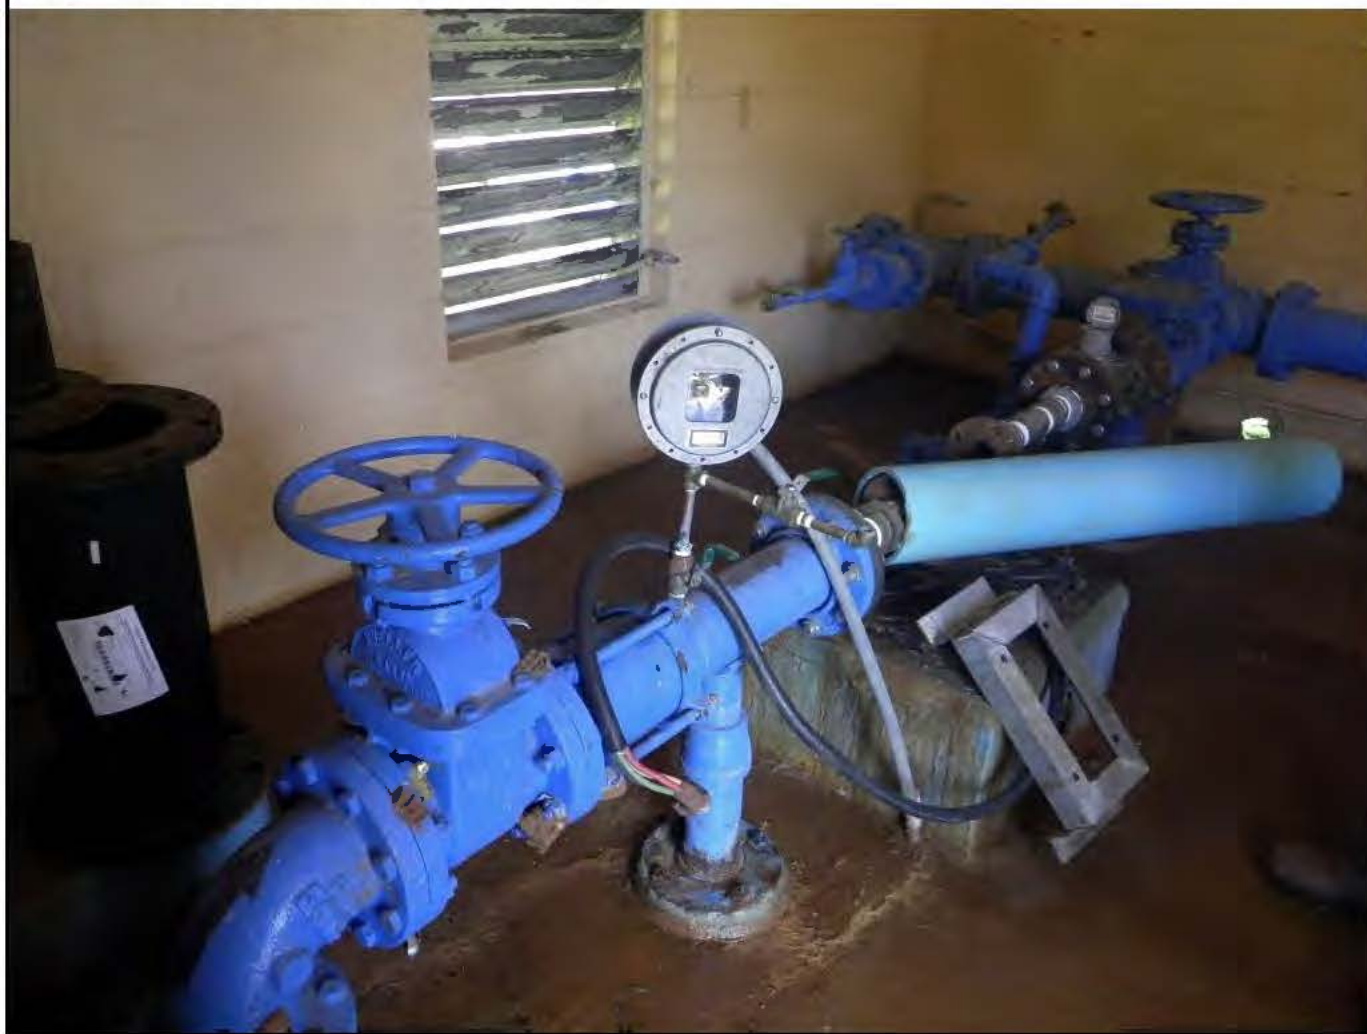
File Name: RIMG0130.JPG

Title	Guam Waterworks Authority (VP0989)
Subject	Northern System
Latitude	[REDACTED]
Longitude	[REDACTED]
Photo Direction	[REDACTED]
Elevation	745 ft
Date Time Stamp	4/27/2012 10:53:56 AM
Photographer	K. Sable
Comment	Santa Rosa Pump Station
Description	Missing motor

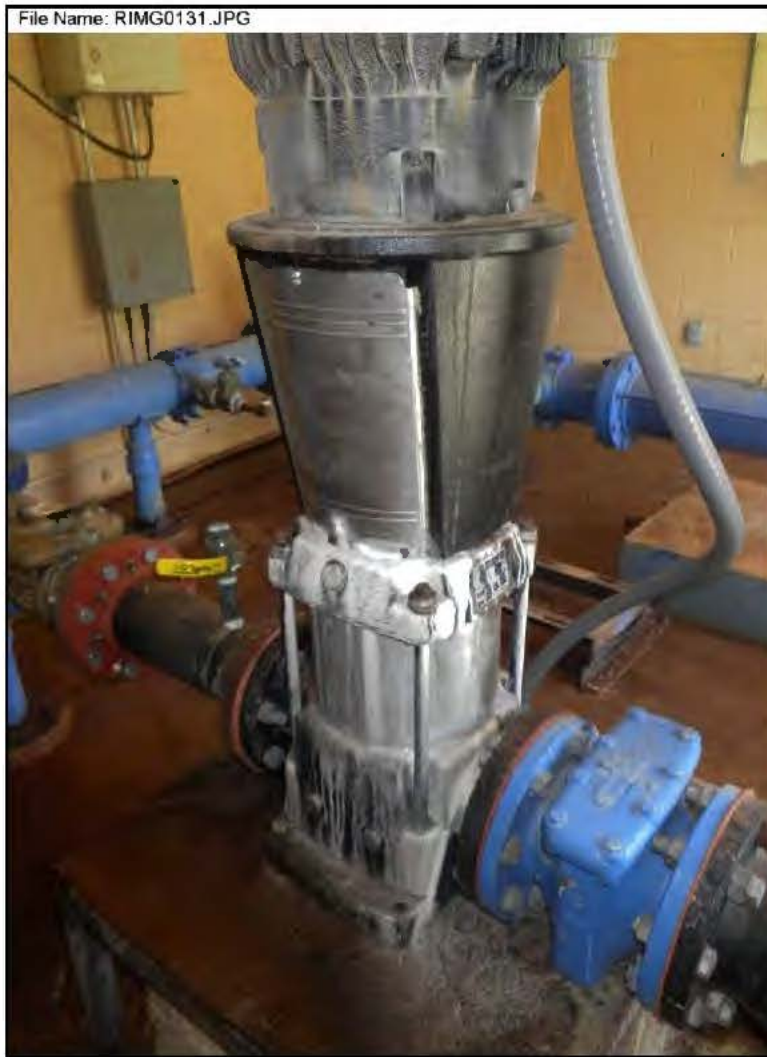
Attributes	
Title	Guam Waterworks Authority (VP0989)
Subject	Northern System
Latitude	██████████
Longitude	██████████
Photo Direction	██████
Elevation	██████
Date Time Stamp	4/27/2012 10:54:23 AM
Photographer	K. Sable
Comment	Santa Rosa Pump Station
Description	Leaking pump

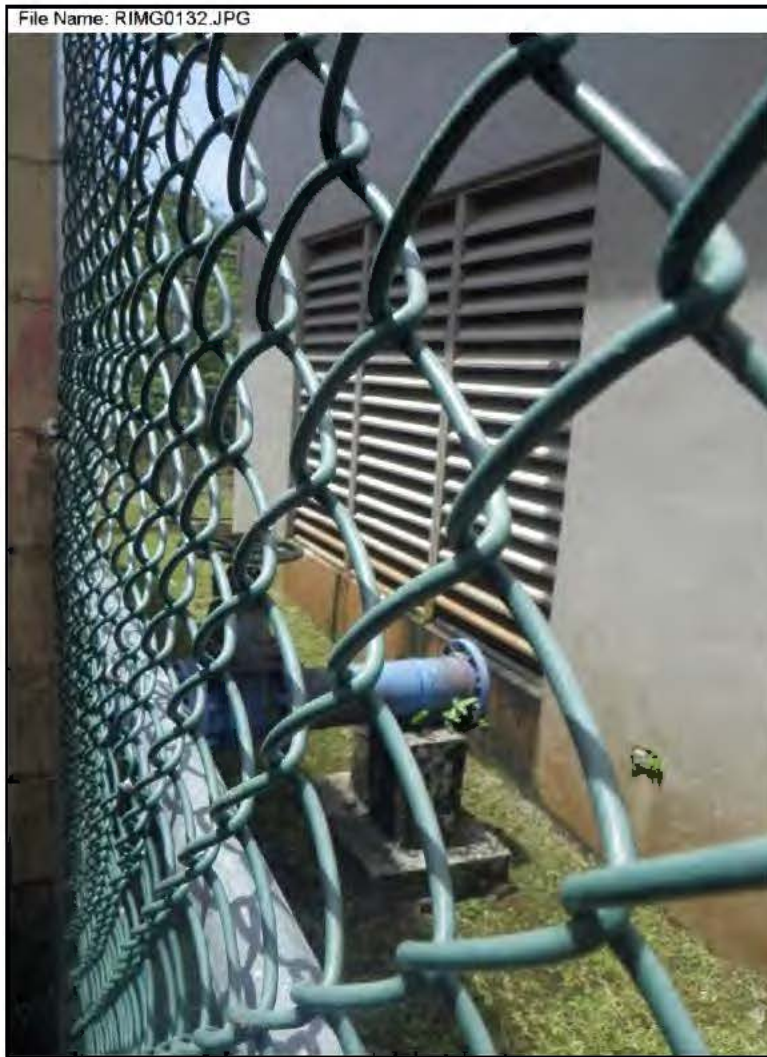
Attributes	
Title	Guam Waterworks Authority (VP0989)
Subject	Northern System
Latitude	[REDACTED]
Longitude	[REDACTED]
Photo Direction	[REDACTED]
Elevation	[REDACTED]
Date Time Stamp	4/27/2012 11:03:31 AM
Photographer	K. Sable
Comment	Santa Rosa Pump Station
Description	Bypass pipe facing power station

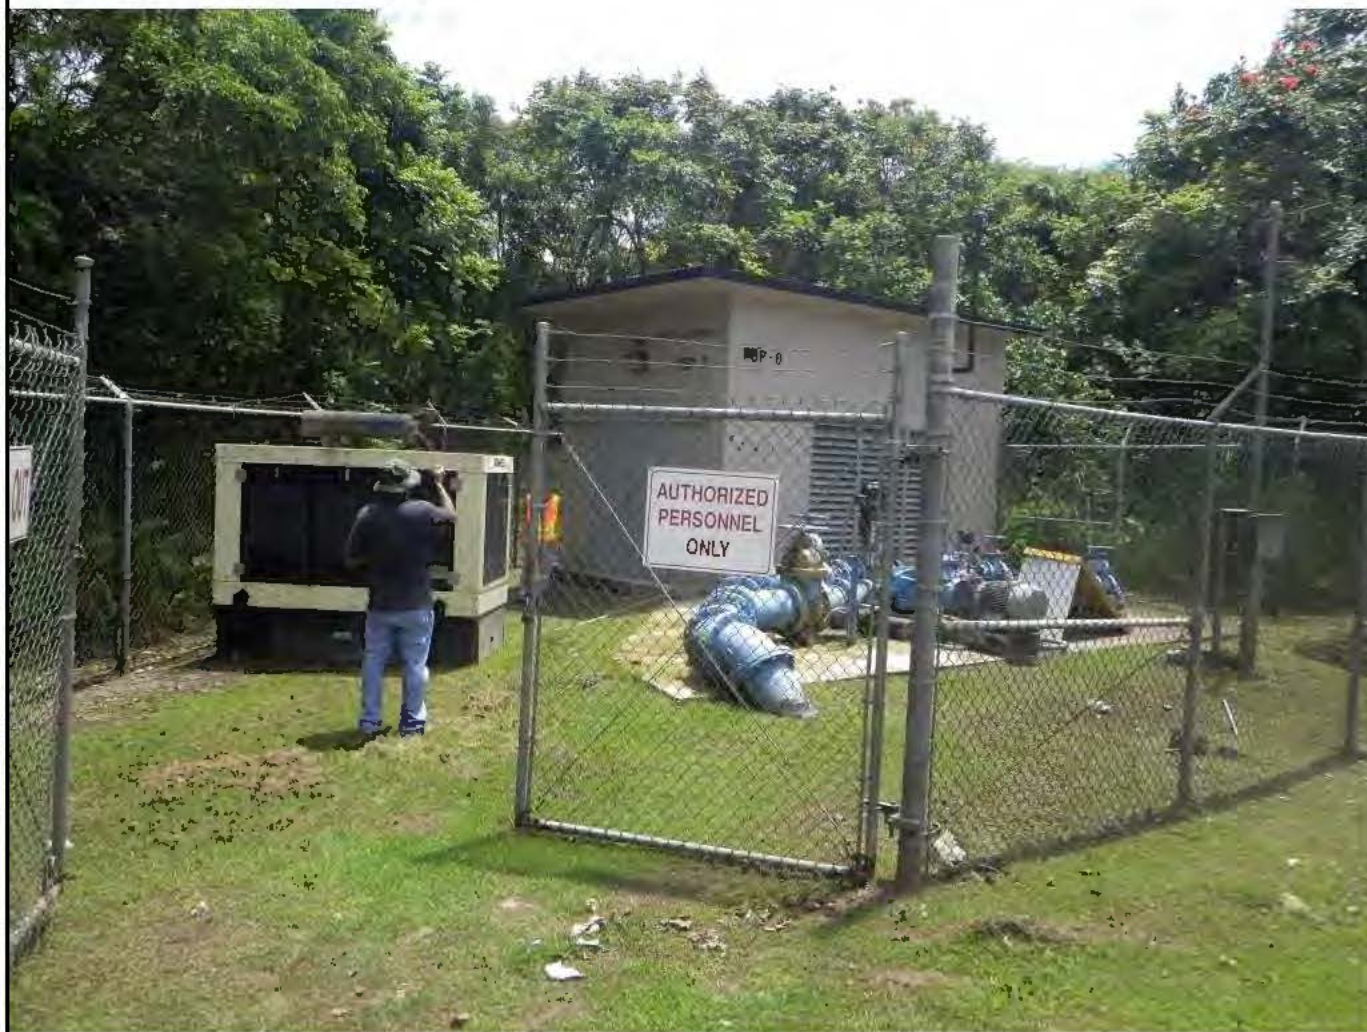
File Name: RIMG0133.JPG

Title	Guam Waterworks Authority (VP0989)
Subject	Northern System
Latitude	[REDACTED]
Longitude	[REDACTED]
Photo Direction	[REDACTED]
Elevation	[REDACTED]
Date Time Stamp	4/27/2012 11:13:34 AM
Photographer	K. Sable
Comment	Gayinero Pump Station
Description	Overview of pump station

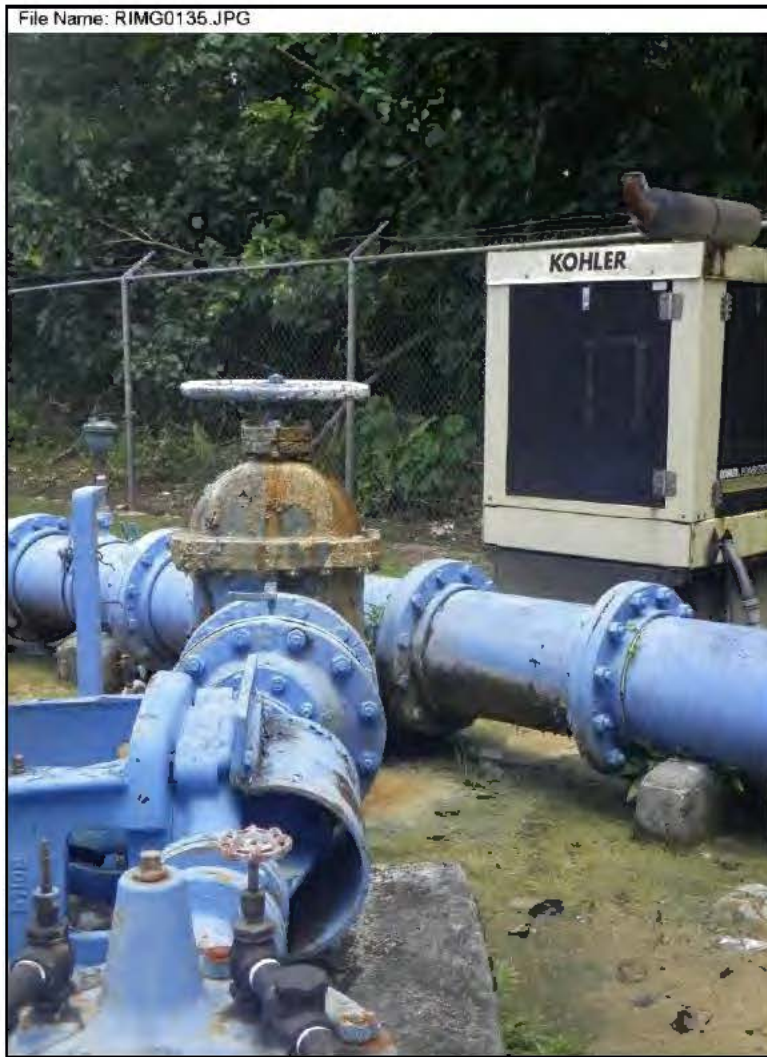
Attributes	
Title	Guam Waterworks Authority (VP0989)
Subject	Northern System
Latitude	[REDACTED]
Longitude	[REDACTED]
Photo Direction	[REDACTED]
Elevation	[REDACTED]
Date Time Stamp	4/27/2012 11:20:14 AM
Photographer	K. Sable
Comment	Gayinero Pump Station
Description	Leaking isolation valve in line # 2

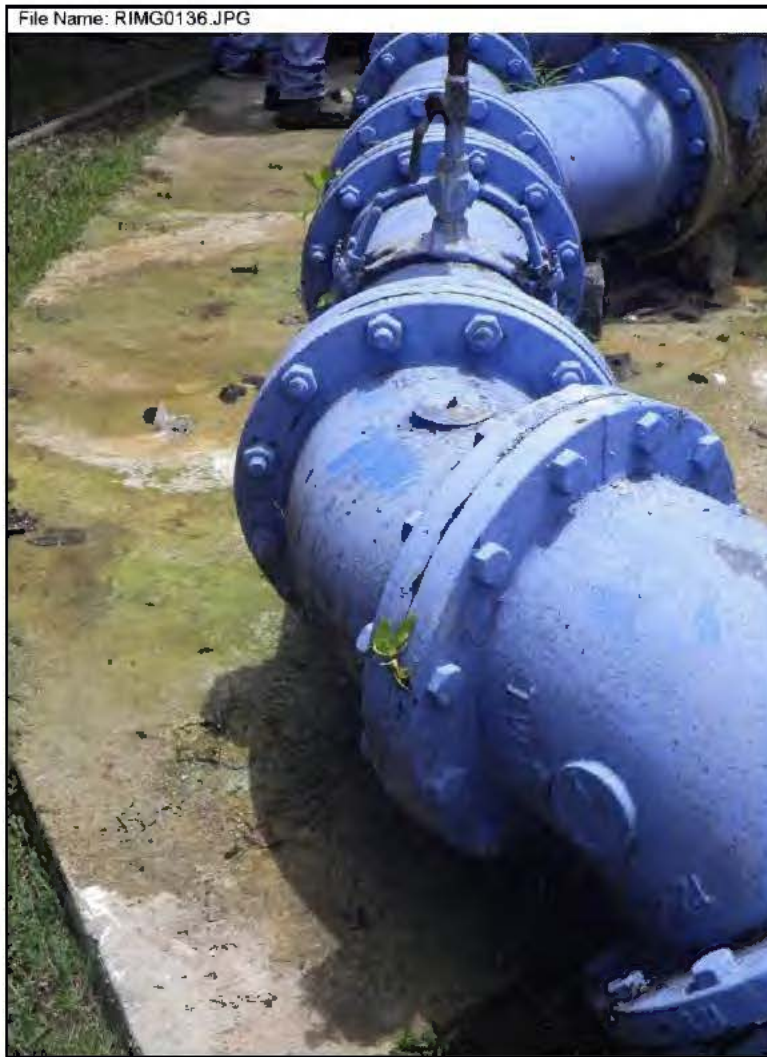
Attributes	
Title	Guam Waterworks Authority (VP0989)
Subject	Northern System
Latitude	[REDACTED]
Longitude	[REDACTED]
Photo Direction	[REDACTED]
Elevation	[REDACTED]
Date Time Stamp	4/27/2012 11:21:25 AM
Photographer	K. Sable
Comment	Gayinero Pump Station
Description	Vegetation growing out of pipe flange

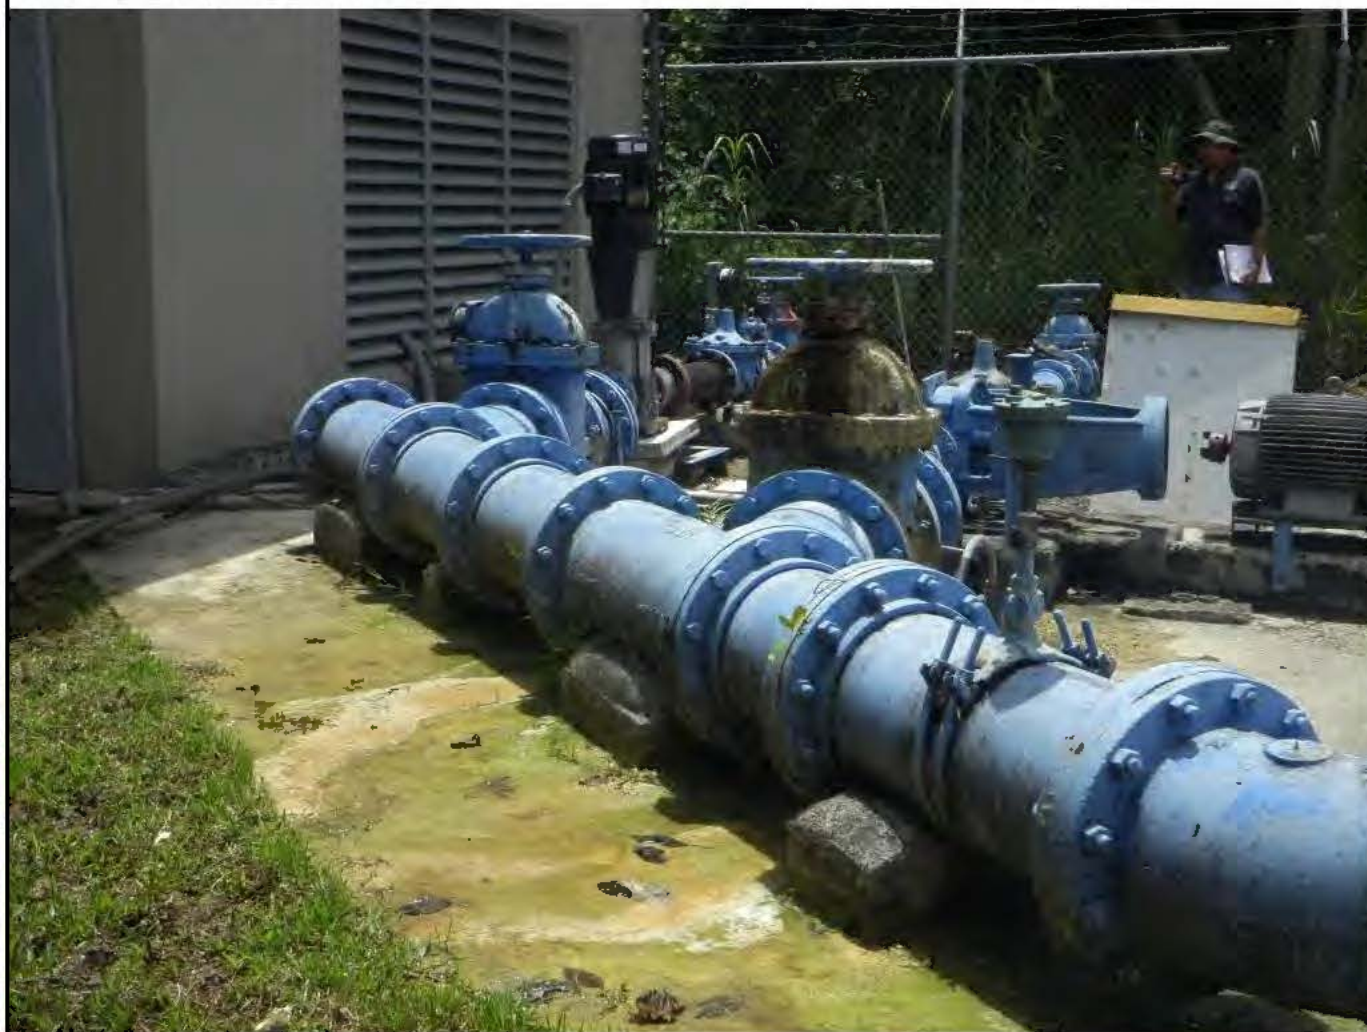
File Name: RIMG0137.JPG

Title	Guam Waterworks Authority (VP0989)
Subject	Northern System
Latitude	[REDACTED]
Longitude	[REDACTED]
Photo Direction	[REDACTED]
Elevation	[REDACTED]
Date Time Stamp	4/27/2012 11:22:17 AM
Photographer	K. Sable
Comment	Gayinero Pump Station
Description	Assembly overview

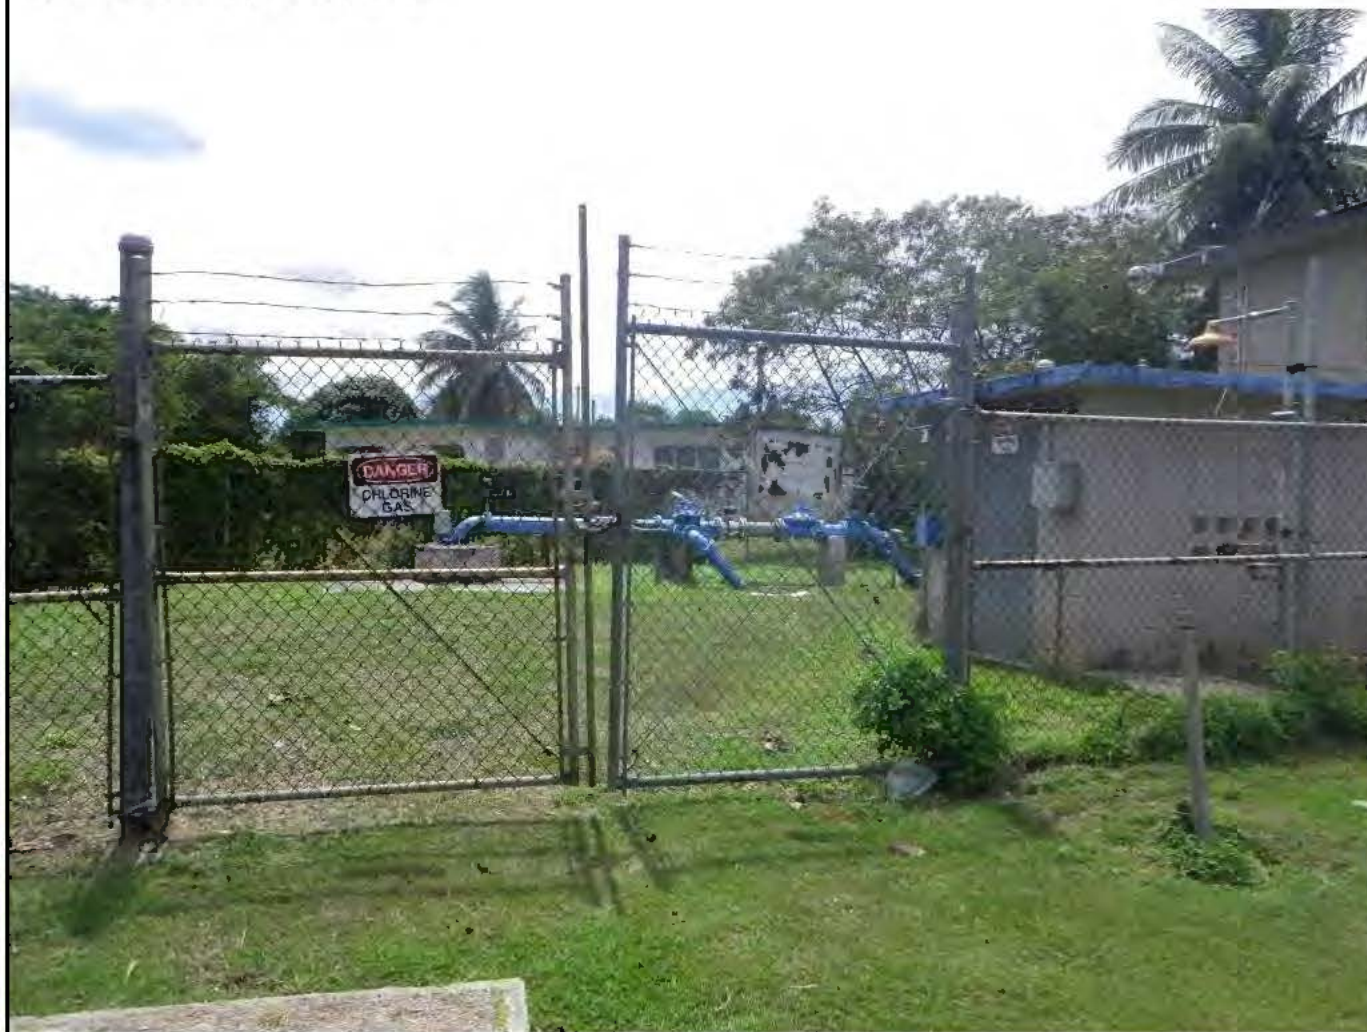
File Name: RIMG0139.JPG

Title	Guam Waterworks Authority (VP0989)
Subject	Northern System
Latitude	[REDACTED]
Longitude	[REDACTED]
Photo Direction	[REDACTED]
Elevation	[REDACTED]
Date Time Stamp	4/27/2012 1:36:30 PM
Photographer	K. Sable
Comment	Y 9 Well
Description	Overview of well

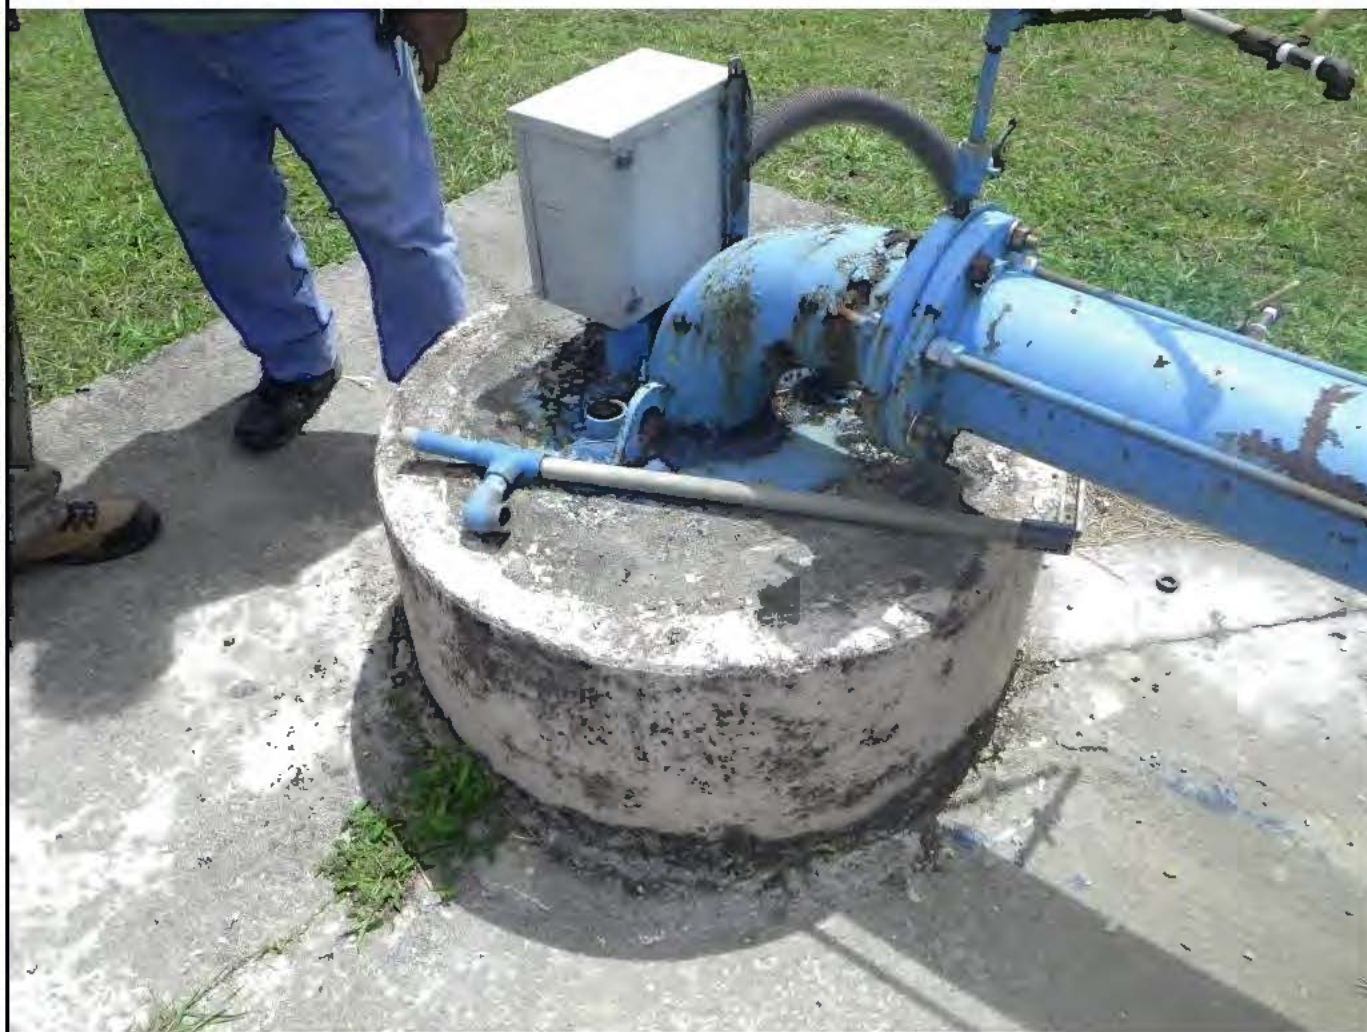
File Name: RIMG0140.JPG

Title	Guam Waterworks Authority (VP0989)
Subject	Northern System
Latitude	██████████
Longitude	██████████
Photo Direction	██████████
Elevation	██████
Date Time Stamp	4/27/2012 1:38:57 PM
Photographer	K. Sable
Comment	Y 9 Well
Description	Air vent

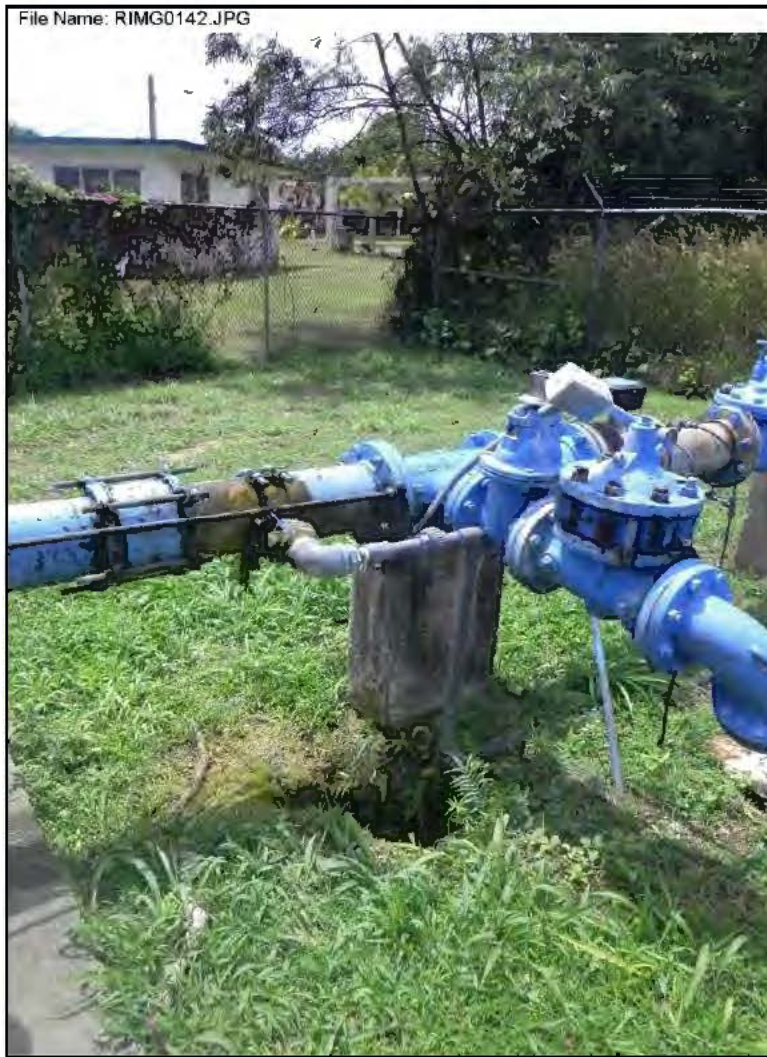
Attributes	
Title	Guam Waterworks Authority (VP0989)
Subject	Northern System
Latitude	[REDACTED]
Longitude	[REDACTED]
Photo Direction	[REDACTED]
Elevation	[REDACTED]
Date Time Stamp	4/27/2012 1:41:46 PM
Photographer	K. Sable
Comment	Y 9 Well
Description	Leaking inlet for suction line for chlorine

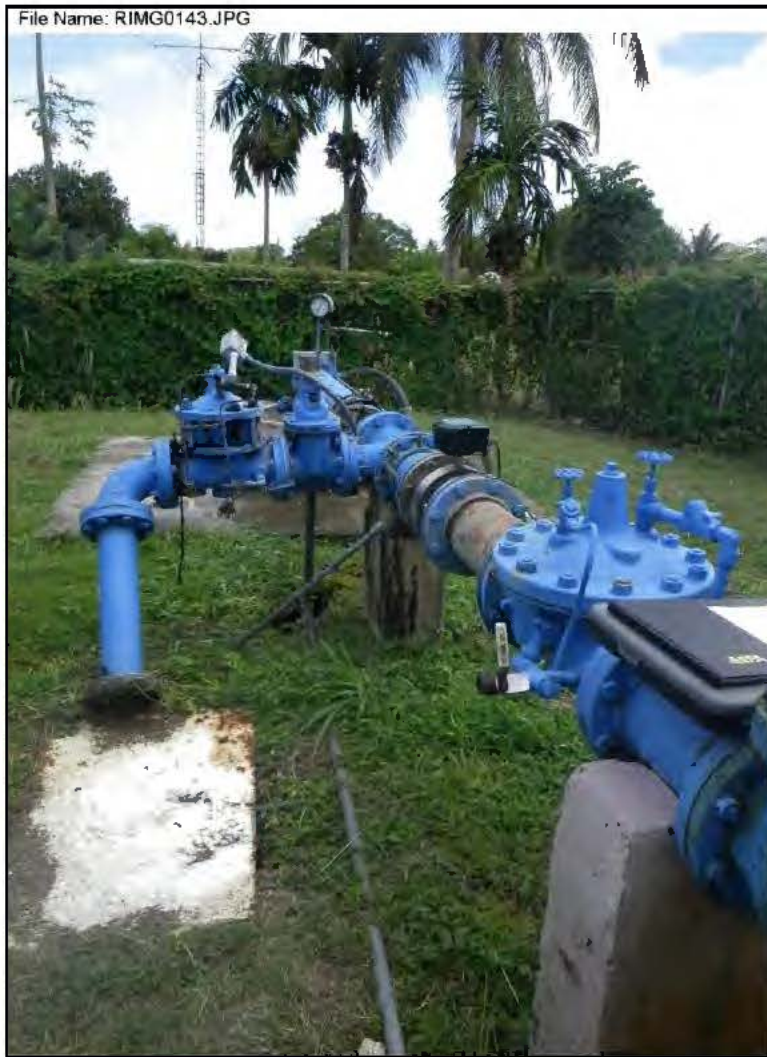
Attributes	
Title	Guam Waterworks Authority (VP0989)
Subject	Northern System
Latitude	[REDACTED]
Longitude	[REDACTED]
Photo Direction	[REDACTED]
Elevation	[REDACTED]
Date Time Stamp	4/27/2012 1:47:32 PM
Photographer	K. Sable
Comment	Y 9 Well
Description	Bypass assembly dead ending to the ground

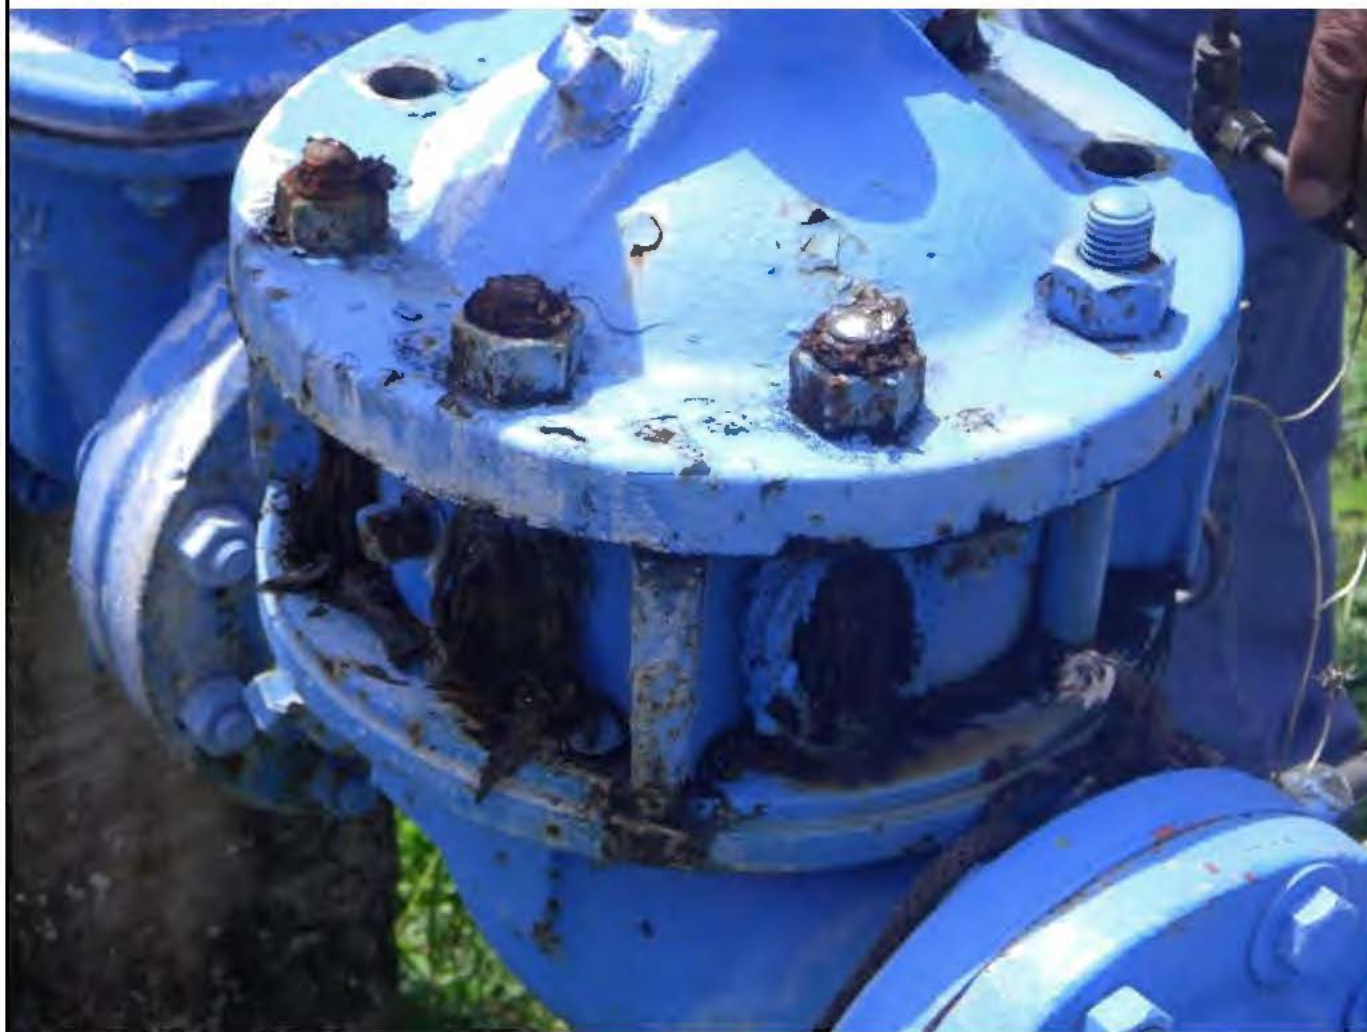
File Name: RIMG0144.JPG

Title	Guam Waterworks Authority (VP0989)
Subject	Northern System
Latitude	██████████
Longitude	██████████
Photo Direction	██████ /
██████████	██████
Date Time Stamp	4/27/2012 1:48:51 PM
Photographer	K. Sable
Comment	Y 9 Well
Description	Bypass valve rusting retaining bolts

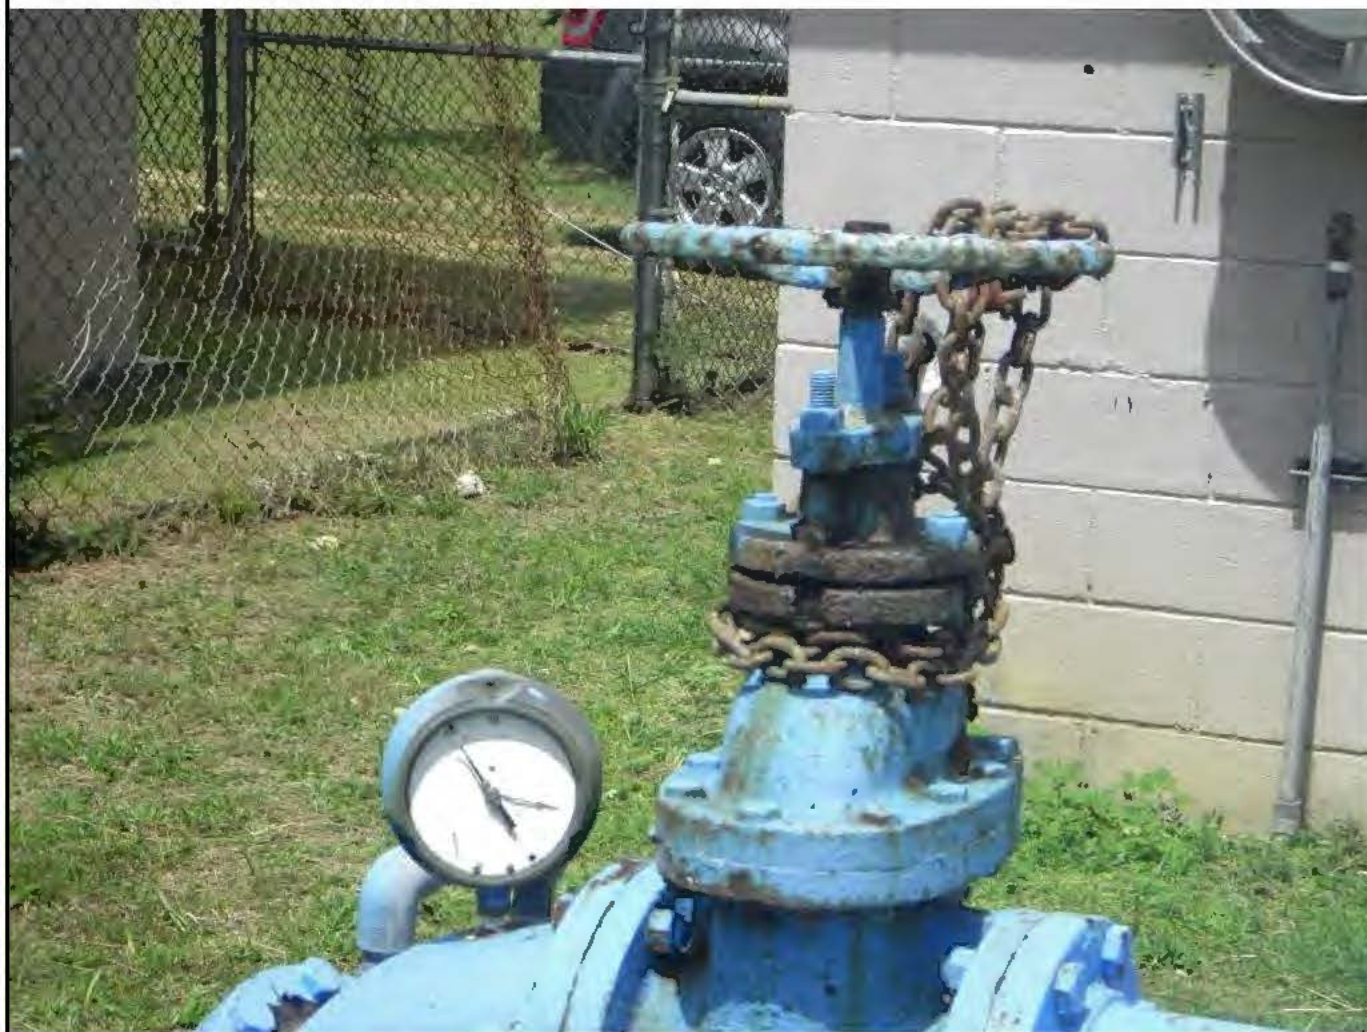
File Name: RIMG0145.JPG

Title	Guam Waterworks Authority (VP0989)
Subject	Northern System
Latitude	██████████
Longitude	██████████
Photo Direction	██████
Elevation	████
Date Time Stamp	4/27/2012 1:53:08 PM
Photographer	K. Sable
Comment	Y 9 Well
Description	Discharge line locked open

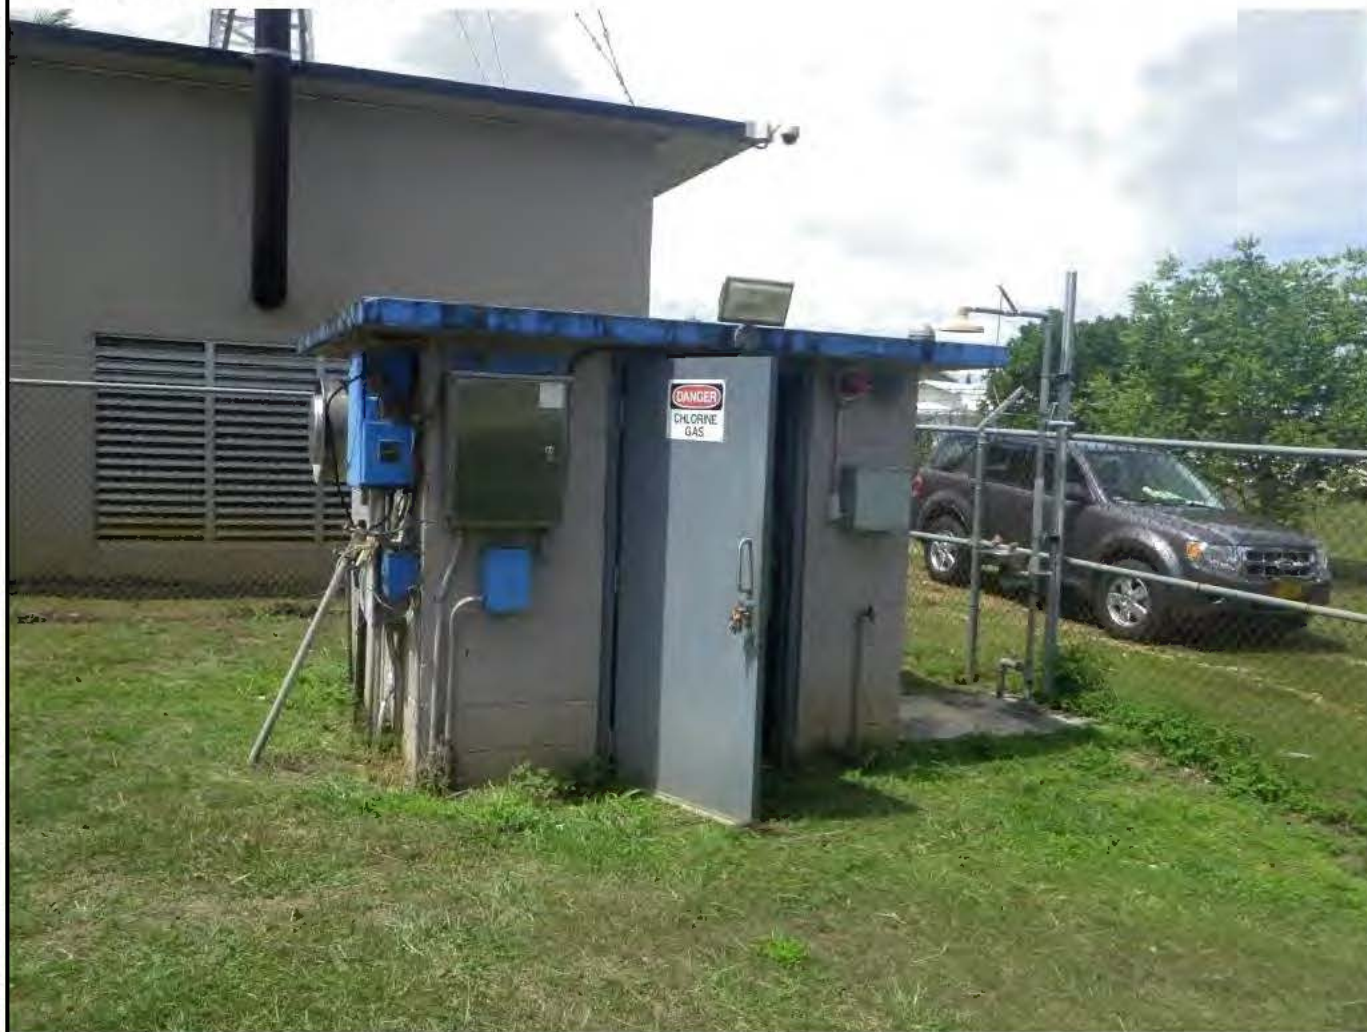
File Name: RIMG0146.JPG

Title	Guam Waterworks Authority (VP0989)
Subject	Northern System
Latitude	[REDACTED]
Longitude	[REDACTED]
Photo Direction	[REDACTED]
Elevation	[REDACTED]
Date Time Stamp	4/27/2012 1:56:30 PM
Photographer	K. Sable
Comment	Y 9 Well
Description	Chlorine building

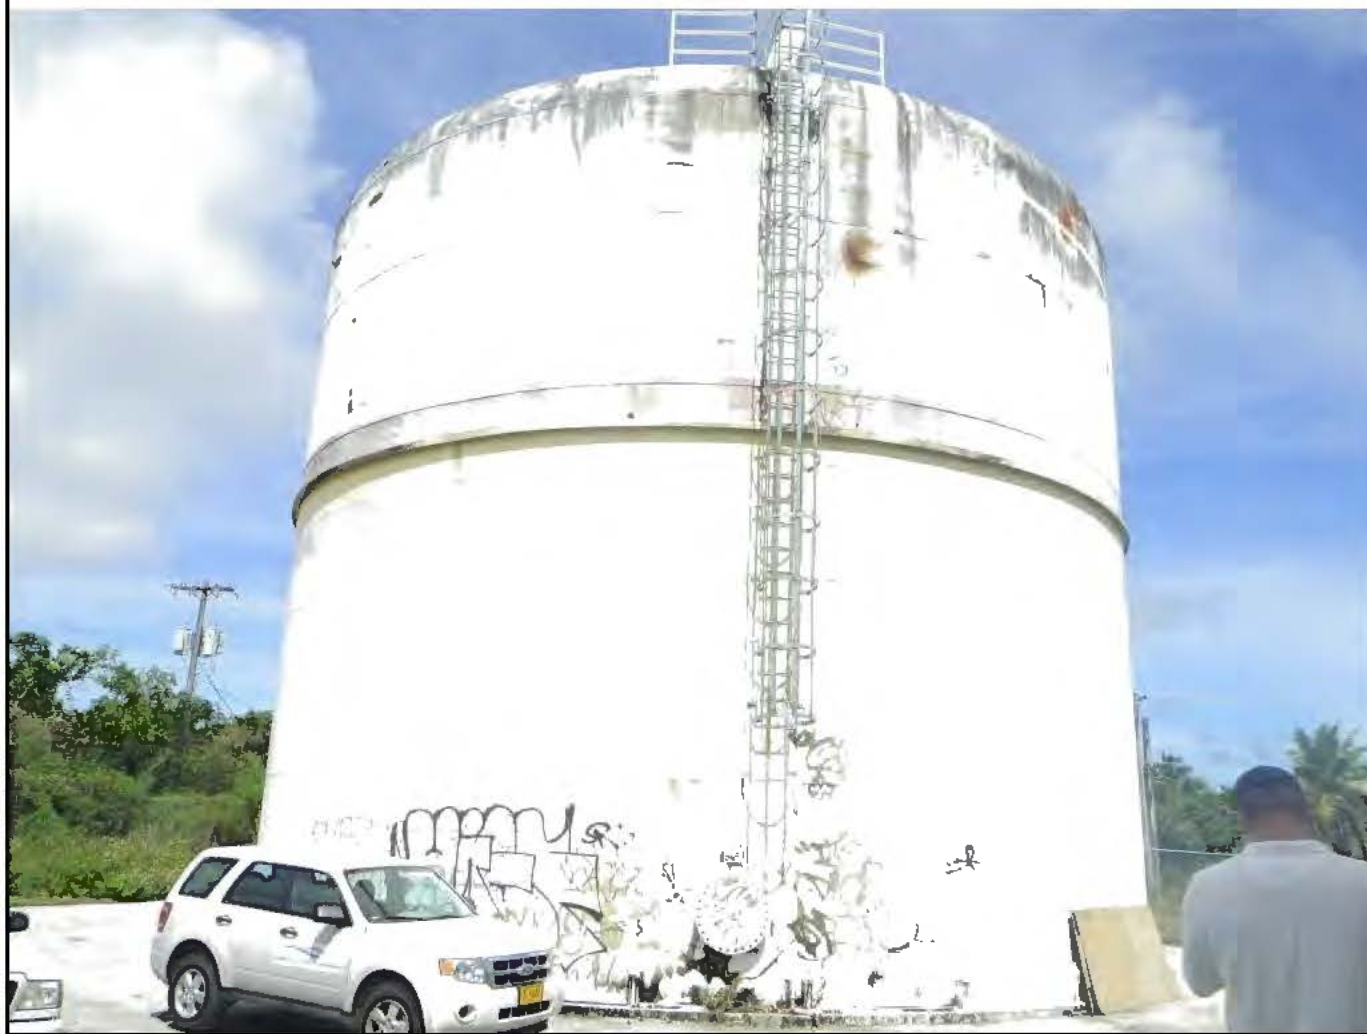
File Name: RIMG0147.JPG

Title	Guam Waterworks Authority (VP0989)
Subject	Northern System
Latitude	██████████
Longitude	██████████
Photo Direction	██████████
Elevation	██████████
Date Time Stamp	4/27/2012 2:17:53 PM
Photographer	K. Sable
Comment	Yigo # 1 Tank
Description	Overview of tank

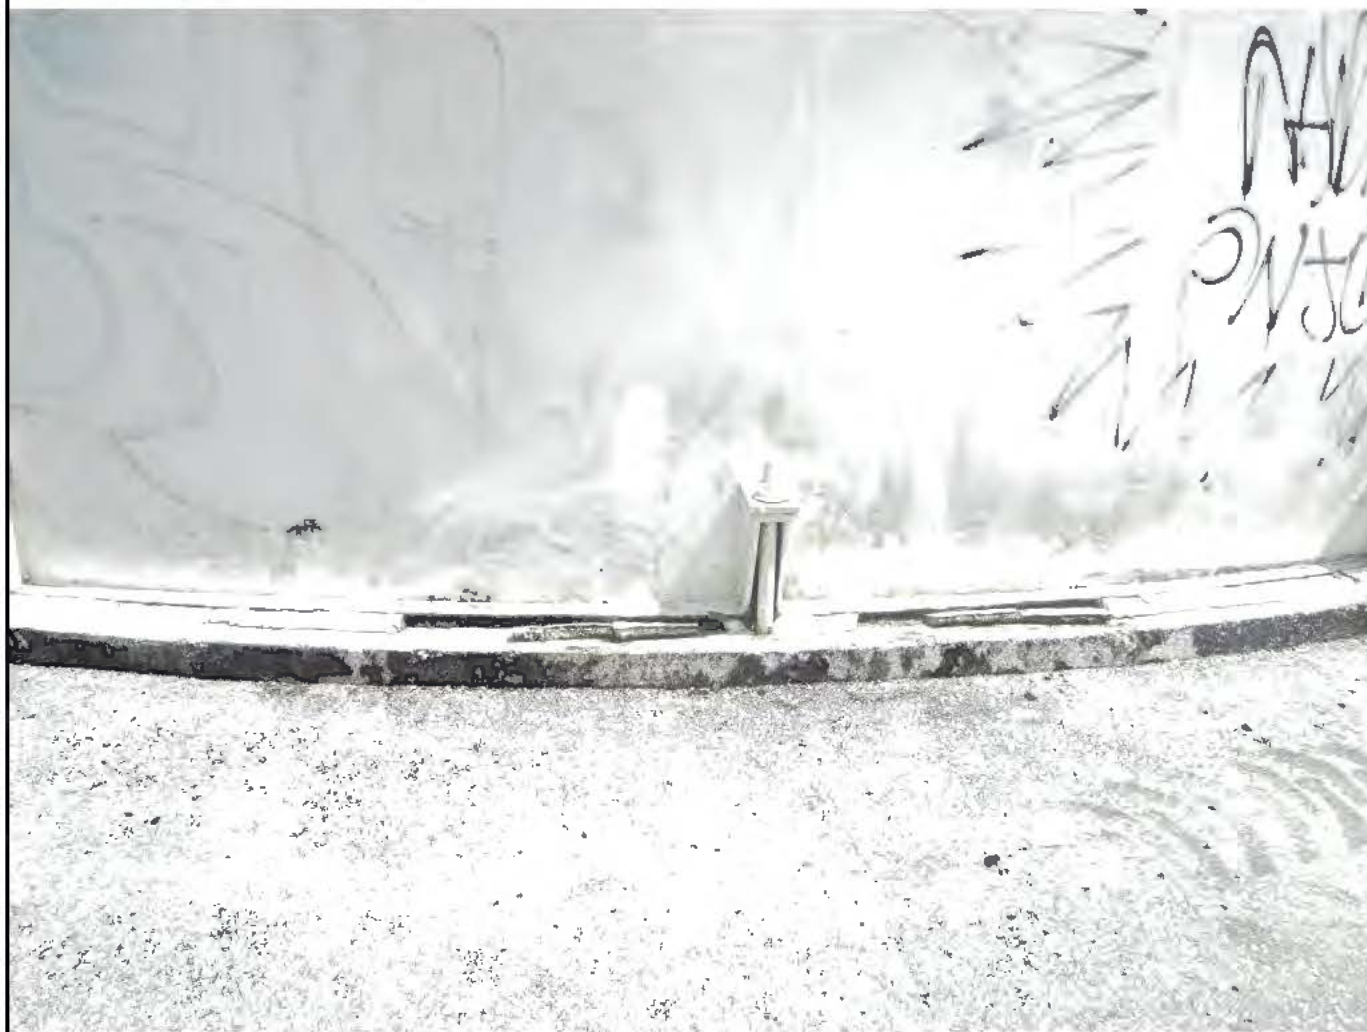
File Name: RIMG0149.JPG

Title	Guam Waterworks Authority (VP0989)
Subject	Northern System
Latitude	██████████
Longitude	██████████
Photo Direction	██████
Elevation	██████
Date Time Stamp	4/27/2012 2:23:04 PM
Photographer	K. Sable
Comment	Yigo # 1 Tank
Description	Concrete base on tank

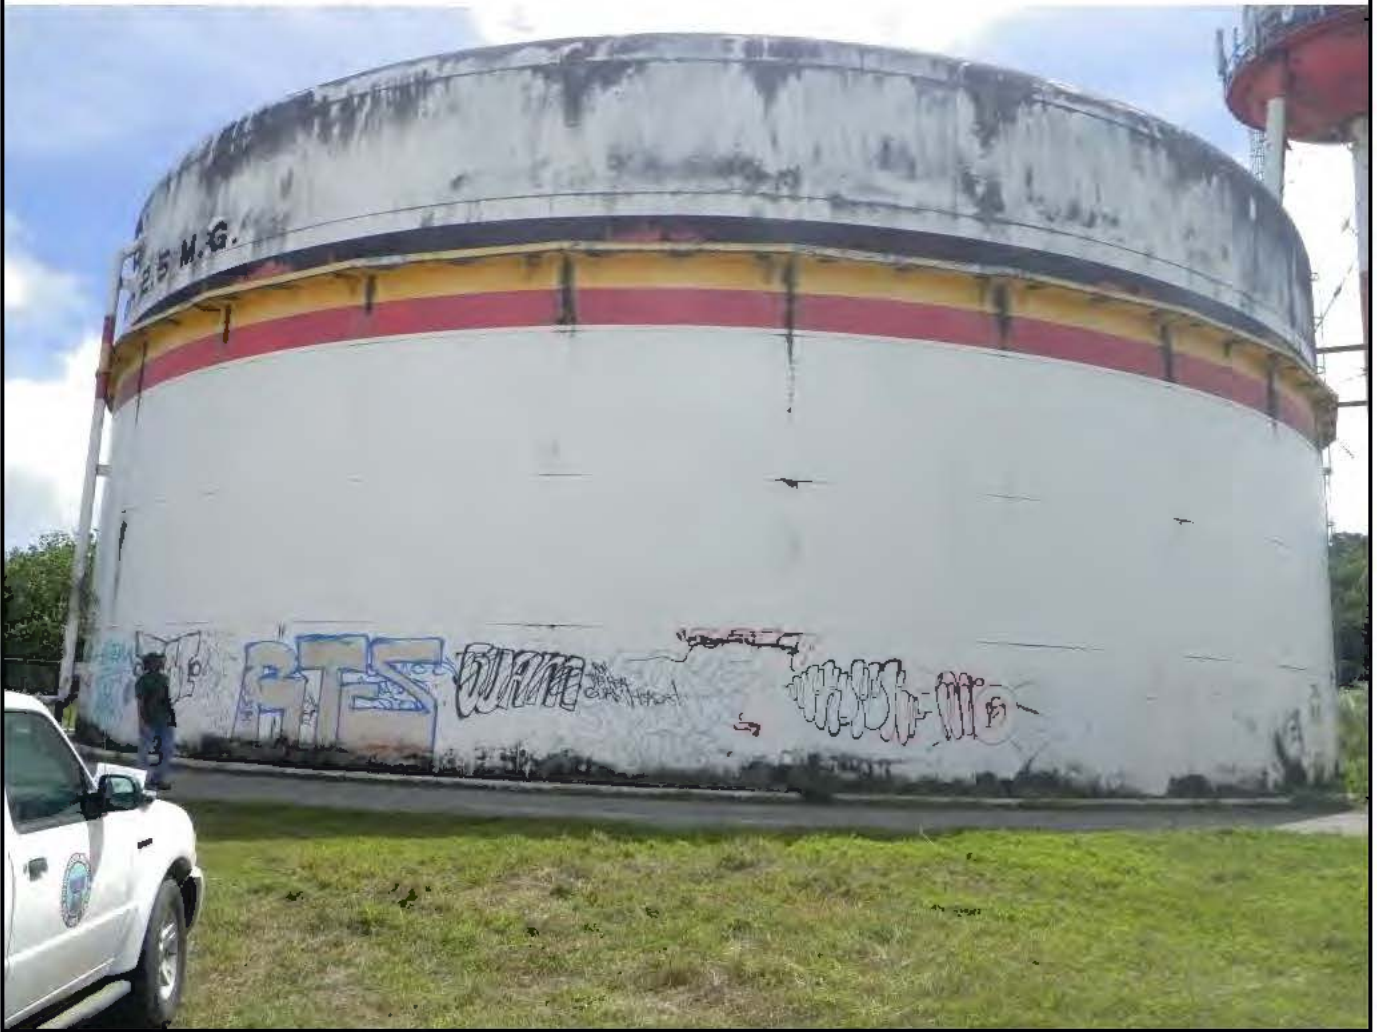
File Name: RIMG0150.JPG

Title	Guam Waterworks Authority (VP0989)
Subject	Northern System
Latitude	[REDACTED]
Longitude	[REDACTED]
Photo Direction	[REDACTED]
Elevation	[REDACTED]
Date Time Stamp	4/27/2012 2:24:56 PM
Photographer	K. Sable
Comment	Yigo # 2 Tank
Description	Overview of tank
