Guam Waterworks Authority (VP0989)

SDWA Sanitary Survey

Northern System

NEIC Field Investigation Photographs

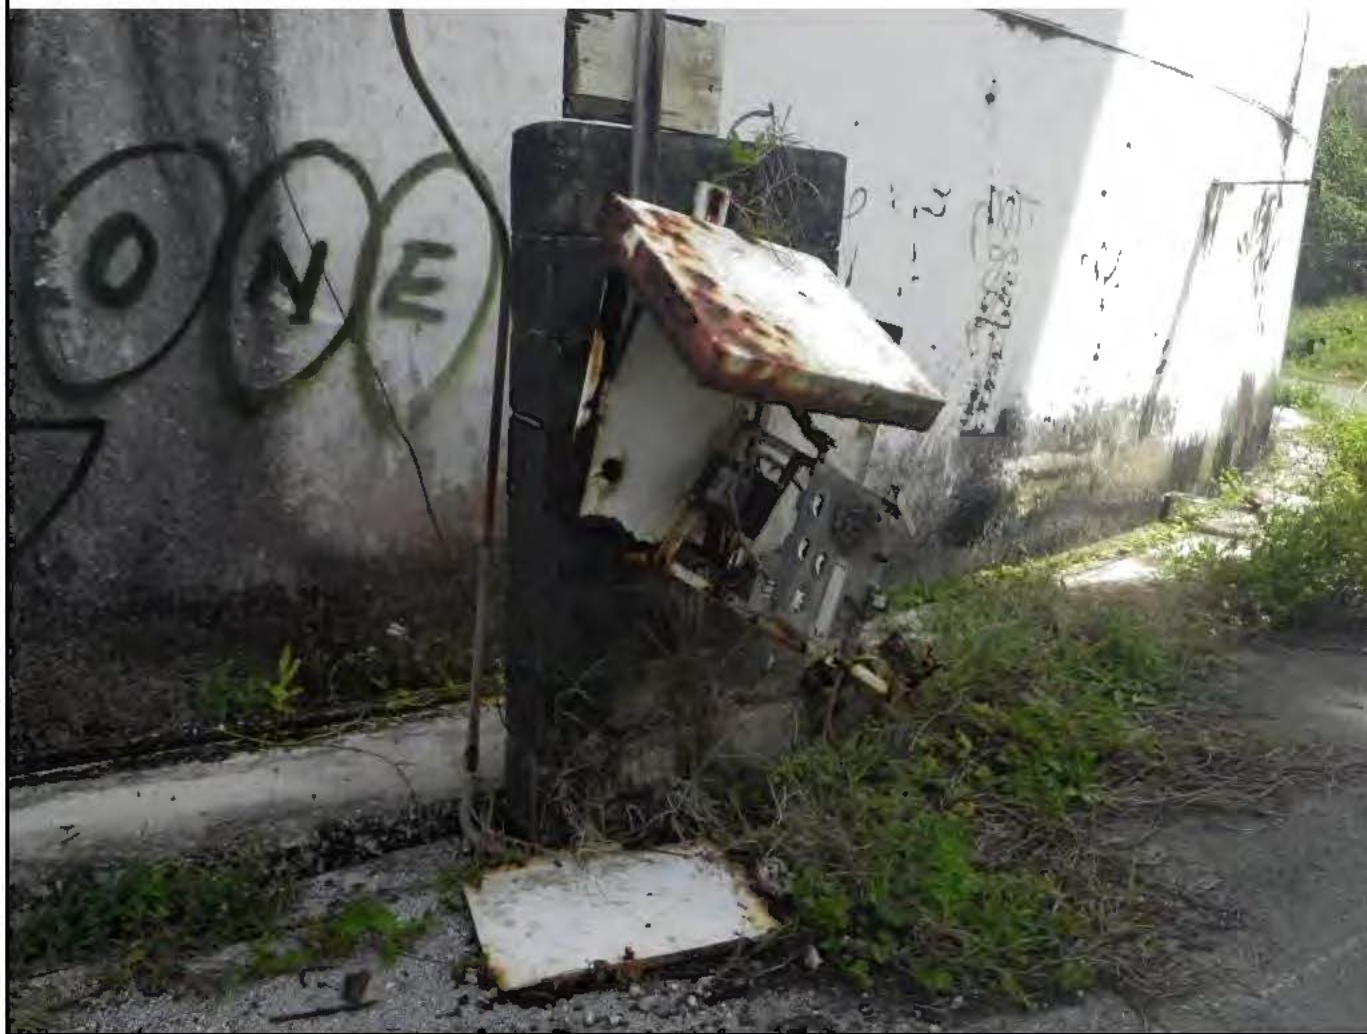
File Name: RIMG0151.JPG

Attributes	
Title	Guam Waterworks Authority (VP0989)
Subject	Northern System
Latitude	[REDACTED]
Longitude	[REDACTED]
Photo Direction	[REDACTED]
Elevation	[REDACTED]
Date Time Stamp	4/27/2012 2:28:06 PM
Photographer	K. Sable
Comment	Yigo # 2 Tank
Description	Cathodic protection

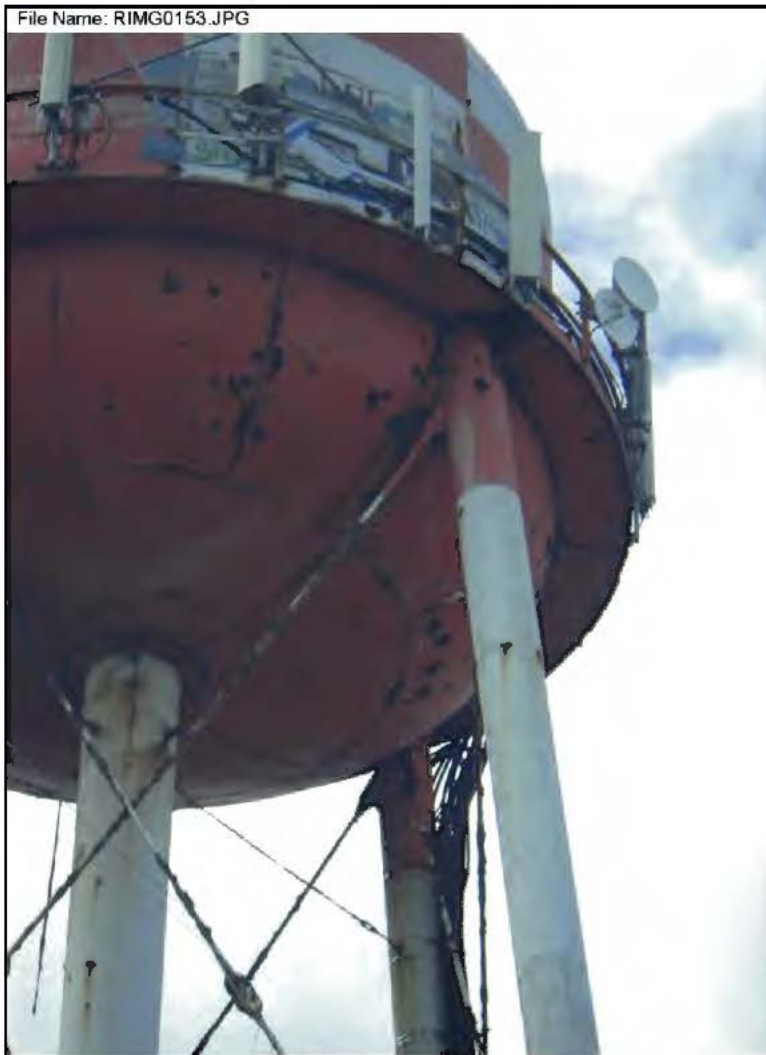
Attributes	
Title	Guam Waterworks Authority (VP0989)
Subject	Northern System
Latitude	[REDACTED]
Longitude	[REDACTED]
Photo Direction	[REDACTED]
Elevation	[REDACTED]
Date Time Stamp	4/27/2012 2:37:06 PM
Photographer	K. Sable
Comment	Yigo # 3 Elevated Tank
Description	Close-up of leak from tank

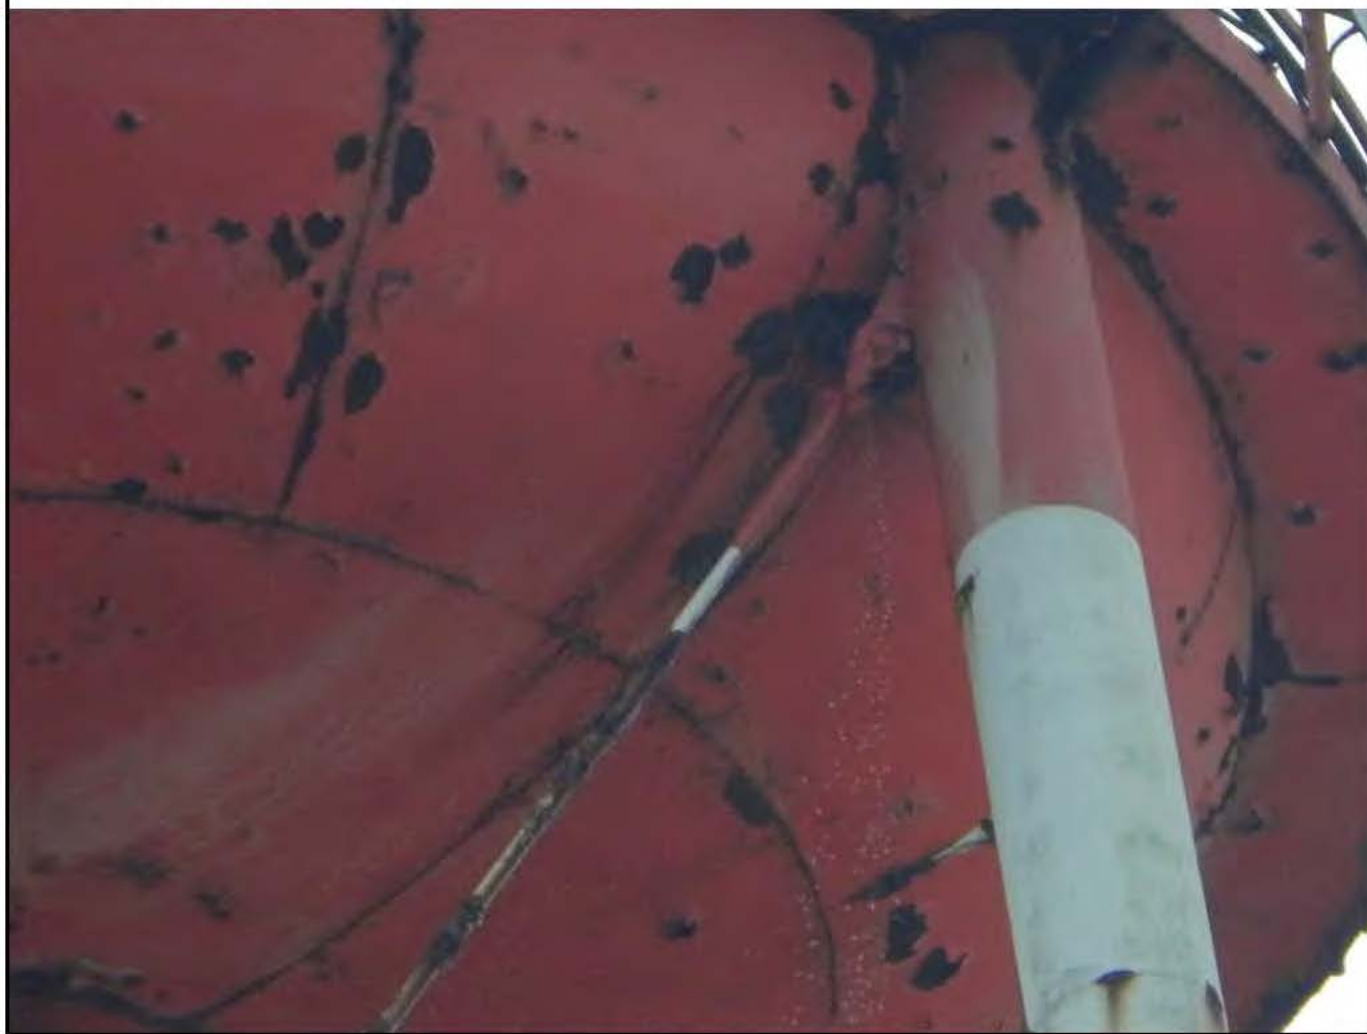
File Name: RIMG0154.JPG

Title	Guam Waterworks Authority (VP0989)
Subject	Northern System
Latitude	██████████
Longitude	██████████
Photo Direction	██████
Elevation	██████
Date Time Stamp	4/27/2012 2:37:27 PM
Photographer	K. Sable
Comment	Yigo # 3 Elevated Tank
Description	Close-up of leak from tank

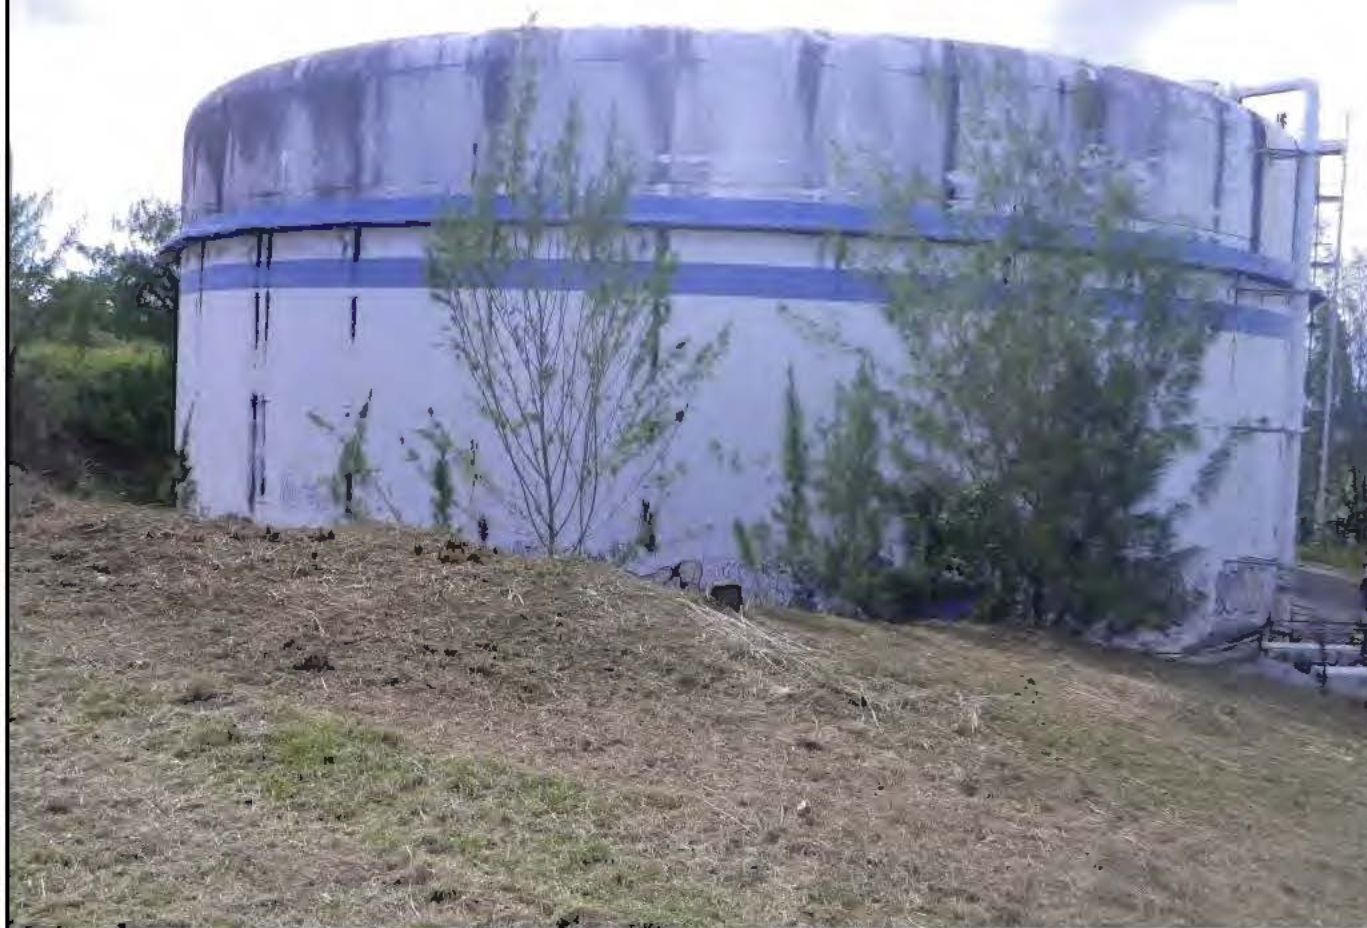
File Name: RIMG0155.JPG

Title	Guam Waterworks Authority (VP0989)
Subject	Northern System
Latitude	[REDACTED]
Longitude	[REDACTED]
Photo Direction	[REDACTED]
Elevation	[REDACTED]
Date Time Stamp	4/27/2012 3:17:04 PM
Photographer	K. Sable
Comment	Barrigada # 3 Tank
Description	Overview of tank

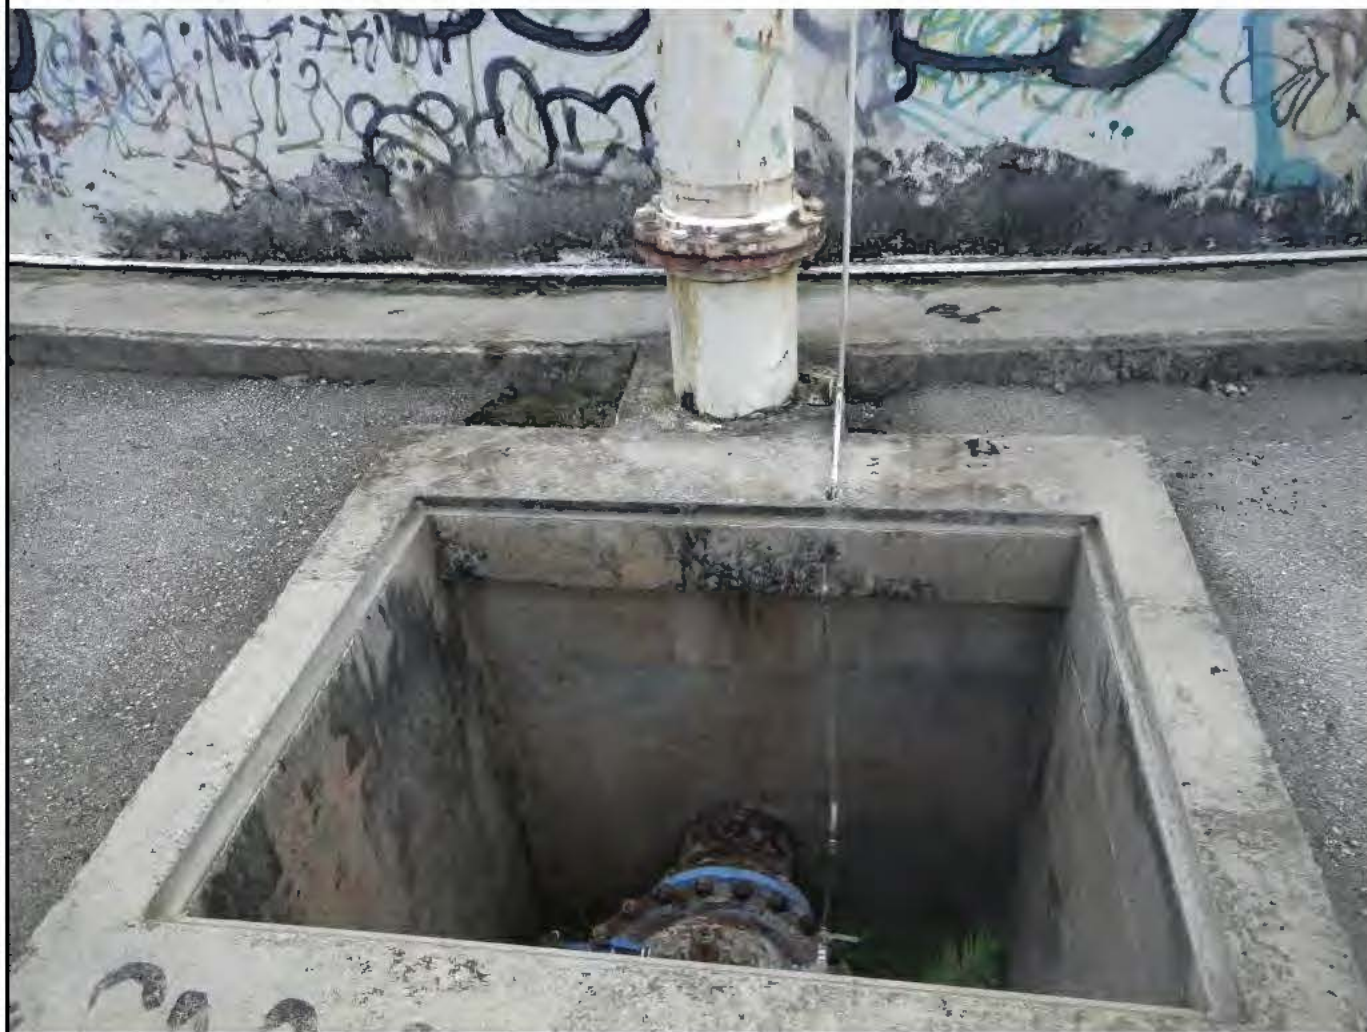
File Name: RIMG0156.JPG

Title	Guam Waterworks Authority (VP0989)
Subject	Northern System
Latitude	██████████
Longitude	██████████
Photo Direction	██████
Elevation	████
Date Time Stamp	4/27/2012 3:19:47 PM
Photographer	K. Sable
Comment	Barrigada # 3 Tank
Description	Inlet box

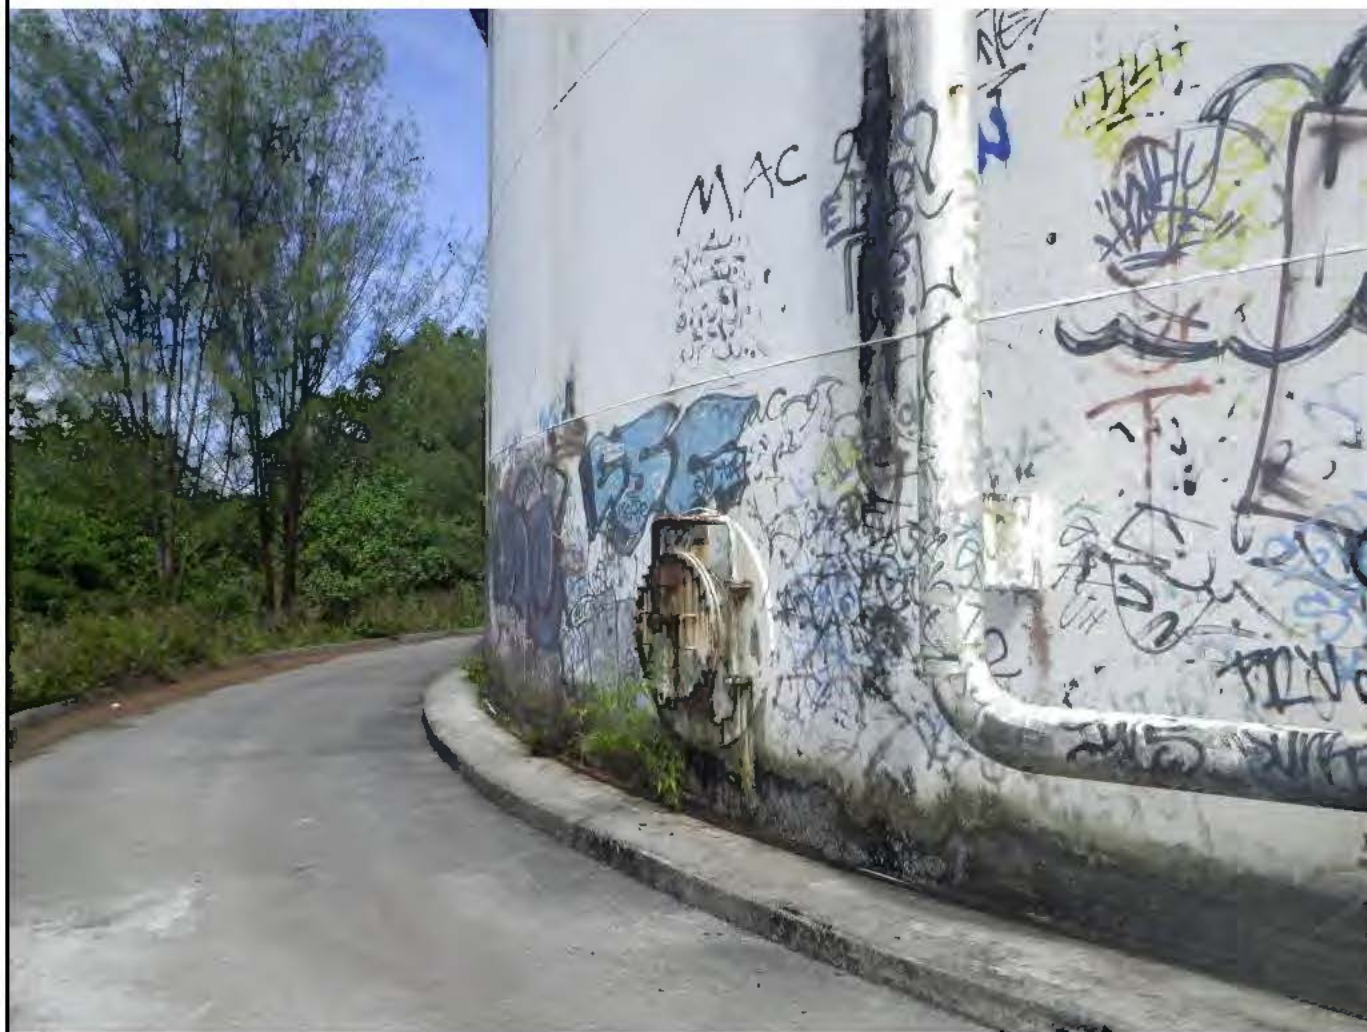
File Name: RIMG0158.JPG

Title	Guam Waterworks Authority (VP0989)
Subject	Northern System
Latitude	[REDACTED]
Longitude	[REDACTED]
Photo Direction	[REDACTED]
Elevation	[REDACTED]
Date Time Stamp	4/27/2012 3:21:50 PM
Photographer	K. Sable
Comment	Barrigada # 3 Tank
Description	Side of tank

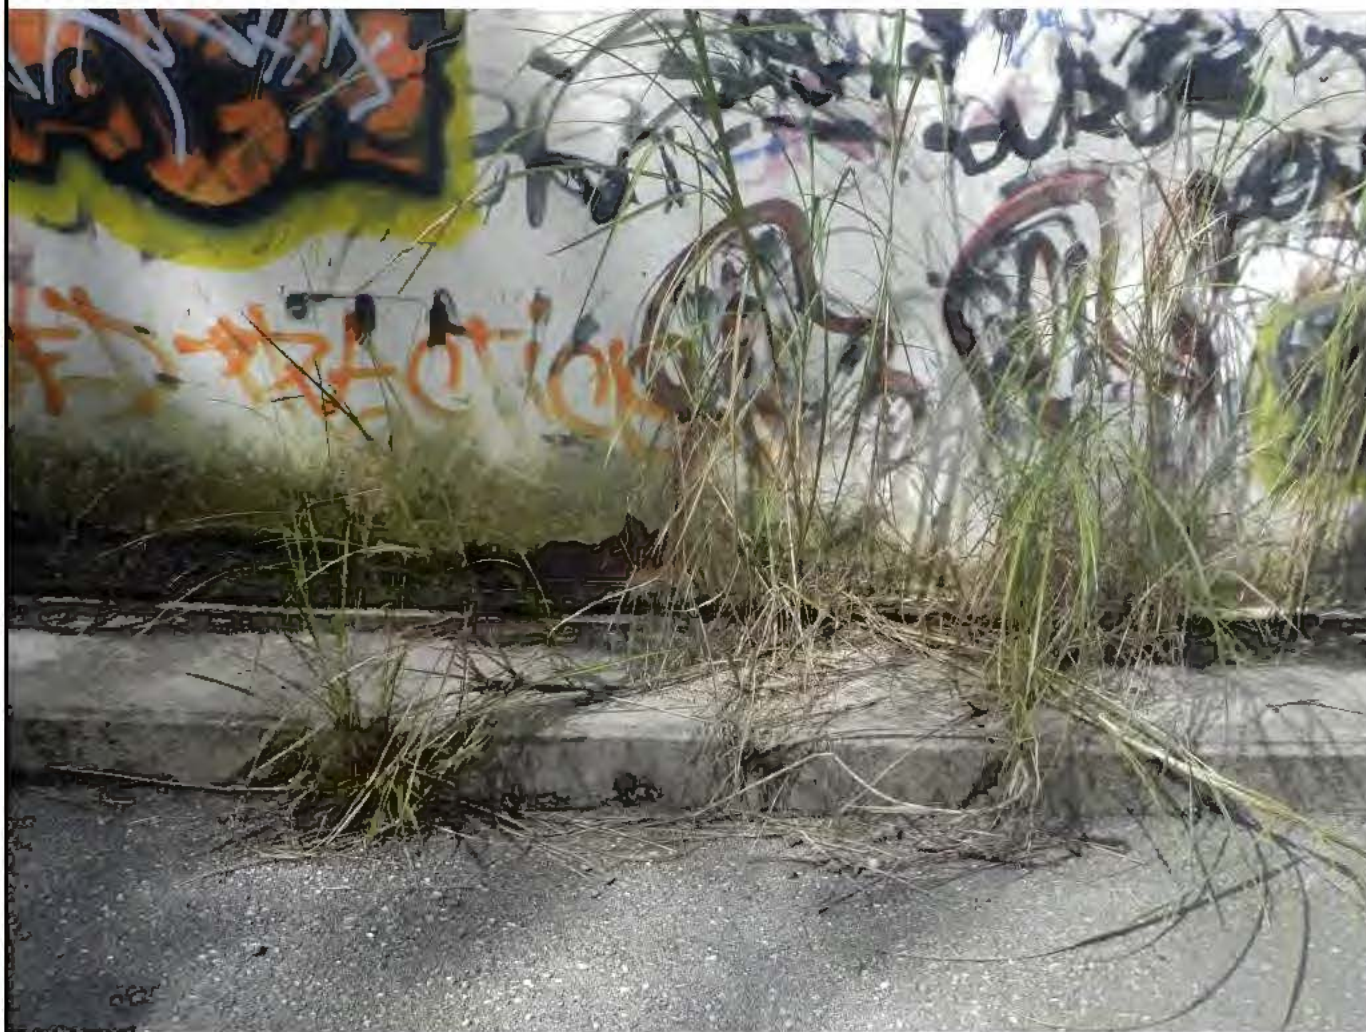
File Name: RIMG0159.JPG

Title	Guam Waterworks Authority (VP0989)
Subject	Northern System
Latitude	██████████
Longitude	██████████
Photo Direction	██████
Elevation	████
Date Time Stamp	4/27/2012 3:27:51 PM
Photographer	K. Sable
Comment	Barrigada # 3 Tank
Description	Damaged side of tank

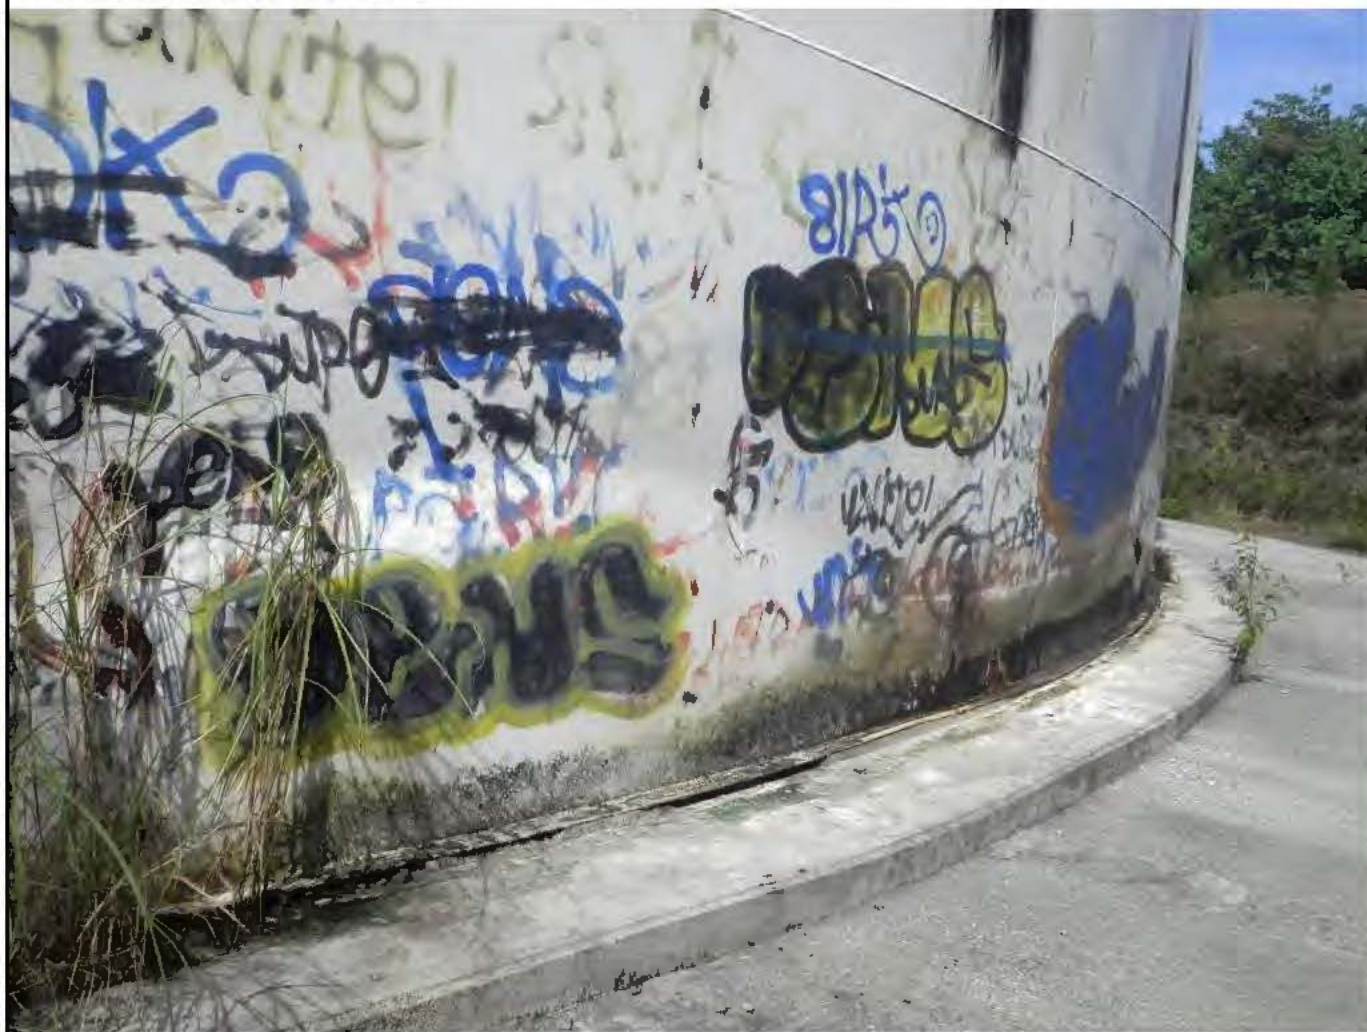
File Name: RIMG0160.JPG

Title	Guam Waterworks Authority (VP0989)
Subject	Northern System
Latitude	██████████
Longitude	██████████
Photo Direction	██████
Elevation	██████
Date Time Stamp	4/27/2012 3:28:00 PM
Photographer	K. Sable
Comment	Barrigada # 3 Tank
Description	Damaged side of tank

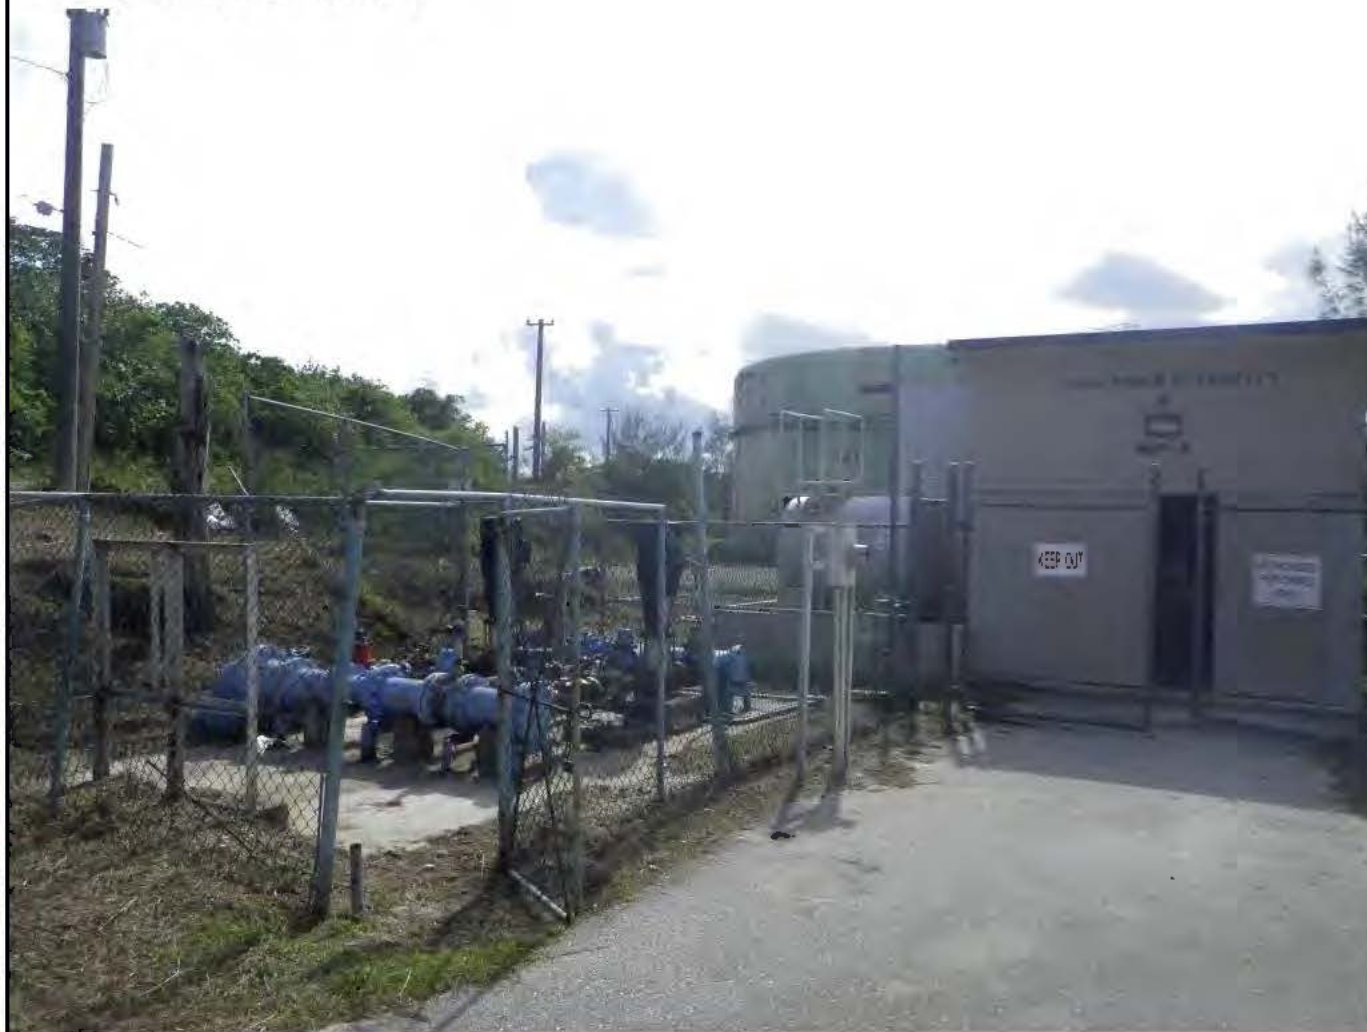
File Name: RIMG0161.JPG

Title	Guam Waterworks Authority (VP0989)
Subject	Northern System
Latitude	██████████
Longitude	██████████
Photo Direction	██████████
Elevation	██████
Date Time Stamp	4/27/2012 3:32:08 PM
Photographer	K. Sable
Comment	Hyundai Pump Station
Description	Overview of pump station

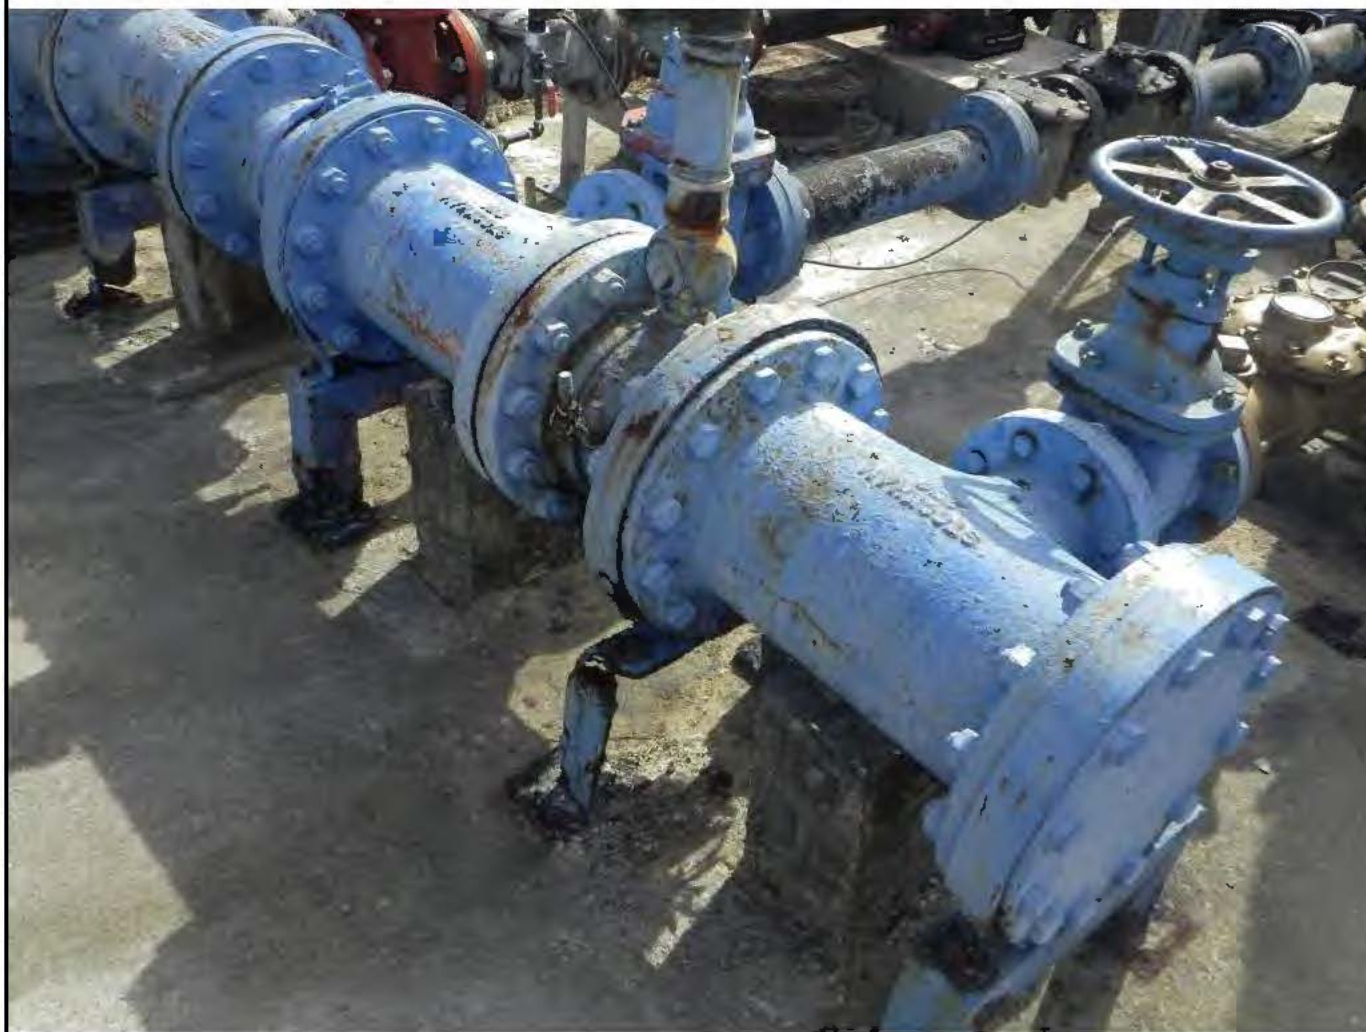
File Name: RIMG0162.JPG

Title	Guam Waterworks Authority (VP0989)
Subject	Northern System
Latitude	██████████
Longitude	██████████
Photo Direction	██████████
Elevation	██████
Date Time Stamp	4/27/2012 3:36:40 PM
Photographer	K. Sable
Comment	Hyundai Pump Station
Description	Rusted support

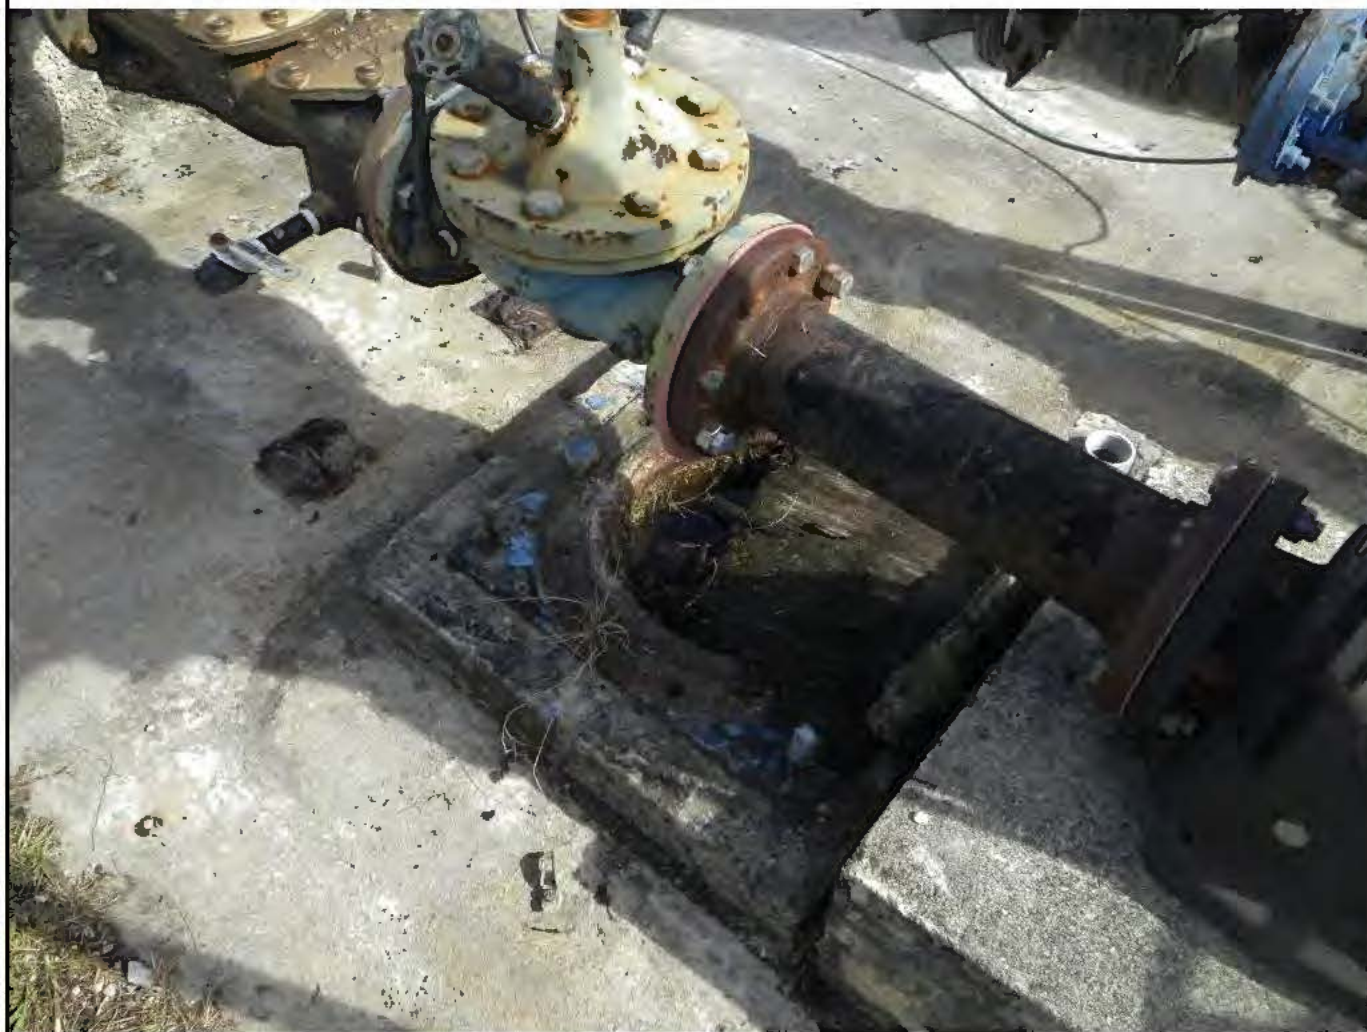
File Name: RIMG0163.JPG

Attributes	
Title	Guam Waterworks Authority (VP0989)
Subject	Northern System
Latitude	██████████
Longitude	██████████
Photo Direction	██████
Elevation	████
Date Time Stamp	4/27/2012 3:37:32 PM
Photographer	K. Sable
Comment	Hyundai Pump Station
Description	Hole where old pump was located

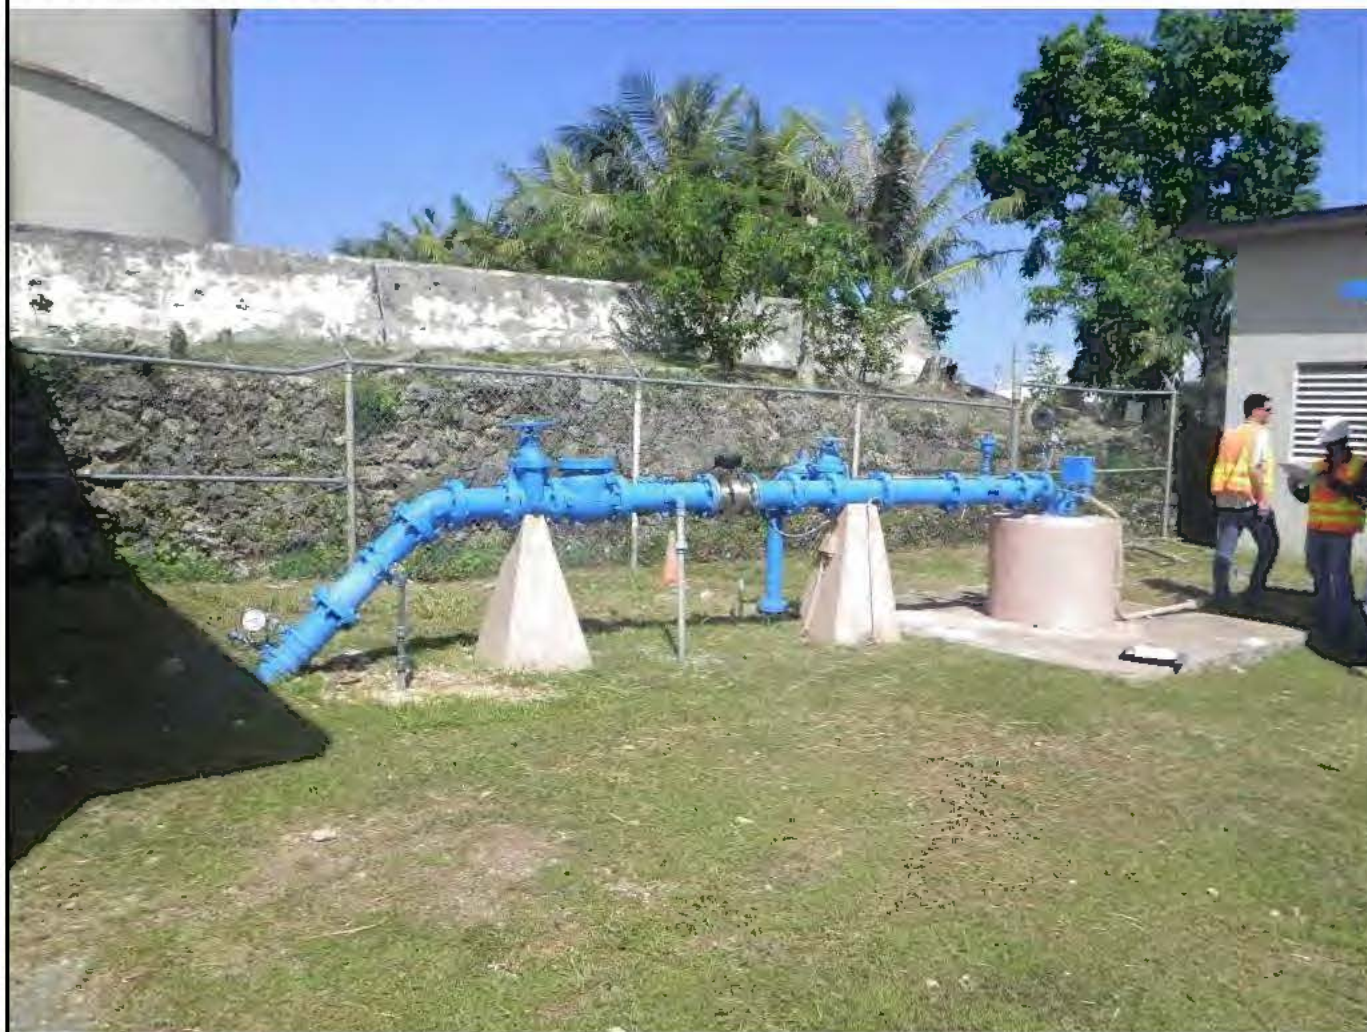
File Name: RIMG0164.JPG

Title	Guam Waterworks Authority (VP0989)
Subject	Northern System
Latitude	[REDACTED]
Longitude	[REDACTED]
Photo Direction	[REDACTED] /
Elevation	[REDACTED]
Date Time Stamp	4/30/2012 9:30:01 AM
Photographer	K. Sable
Comment	A 31 Well
Description	Well assembly

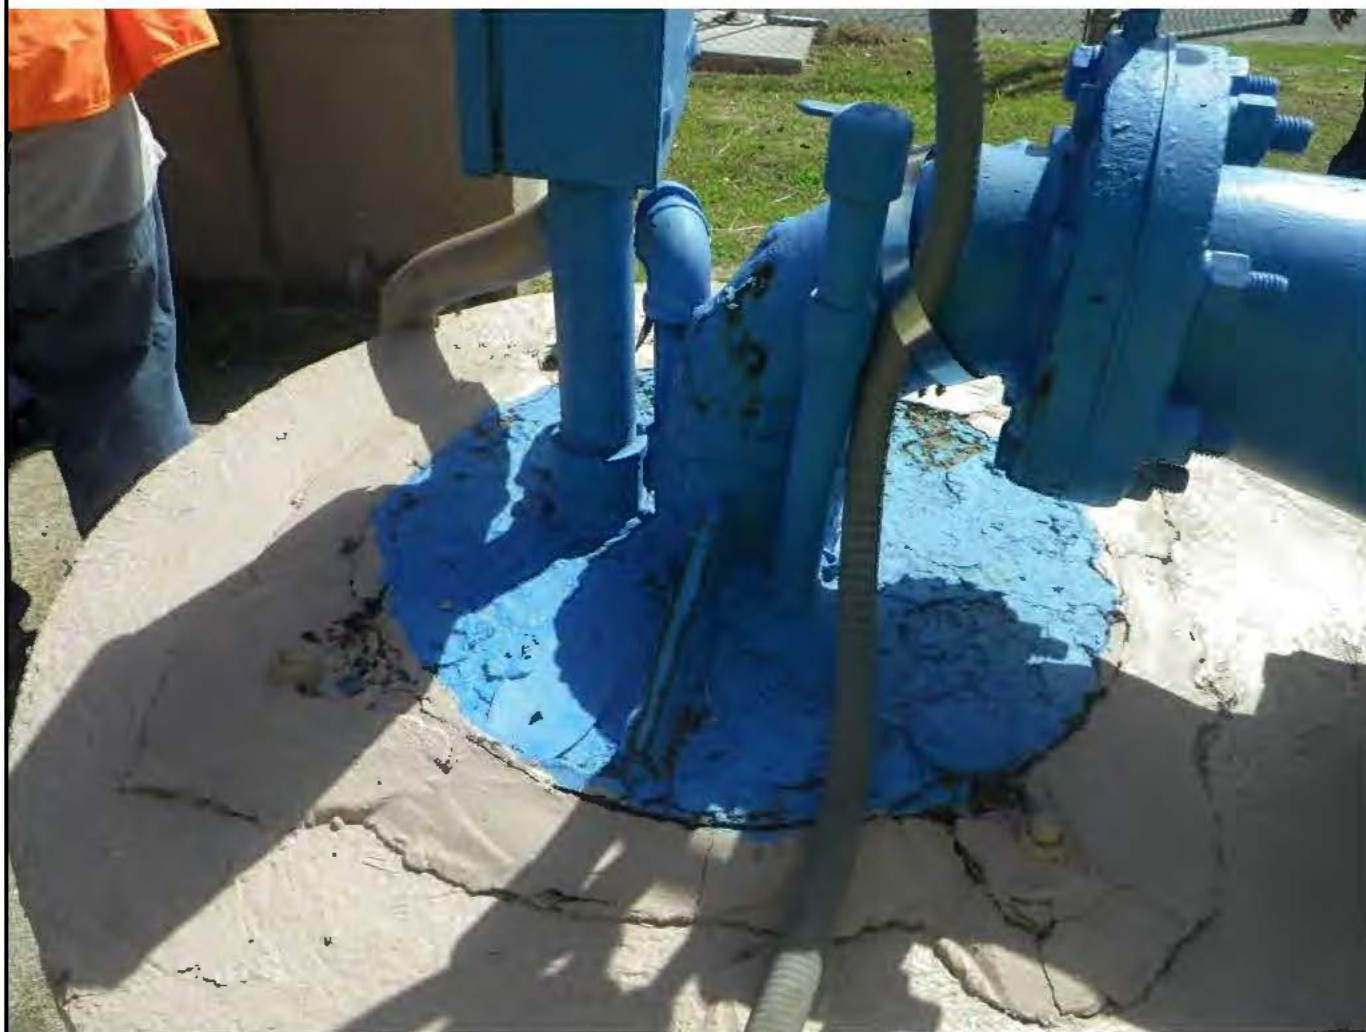
File Name: RIMG0165.JPG

Title	Guam Waterworks Authority (VP0989)
Subject	Northern System
Latitude	██████████
Longitude	██████████
Photo Direction	██████
██████	██████
Date Time Stamp	4/30/2012 9:30:52 AM
Photographer	K. Sable
Comment	A 31 Well
Description	Well head cracks and pitting

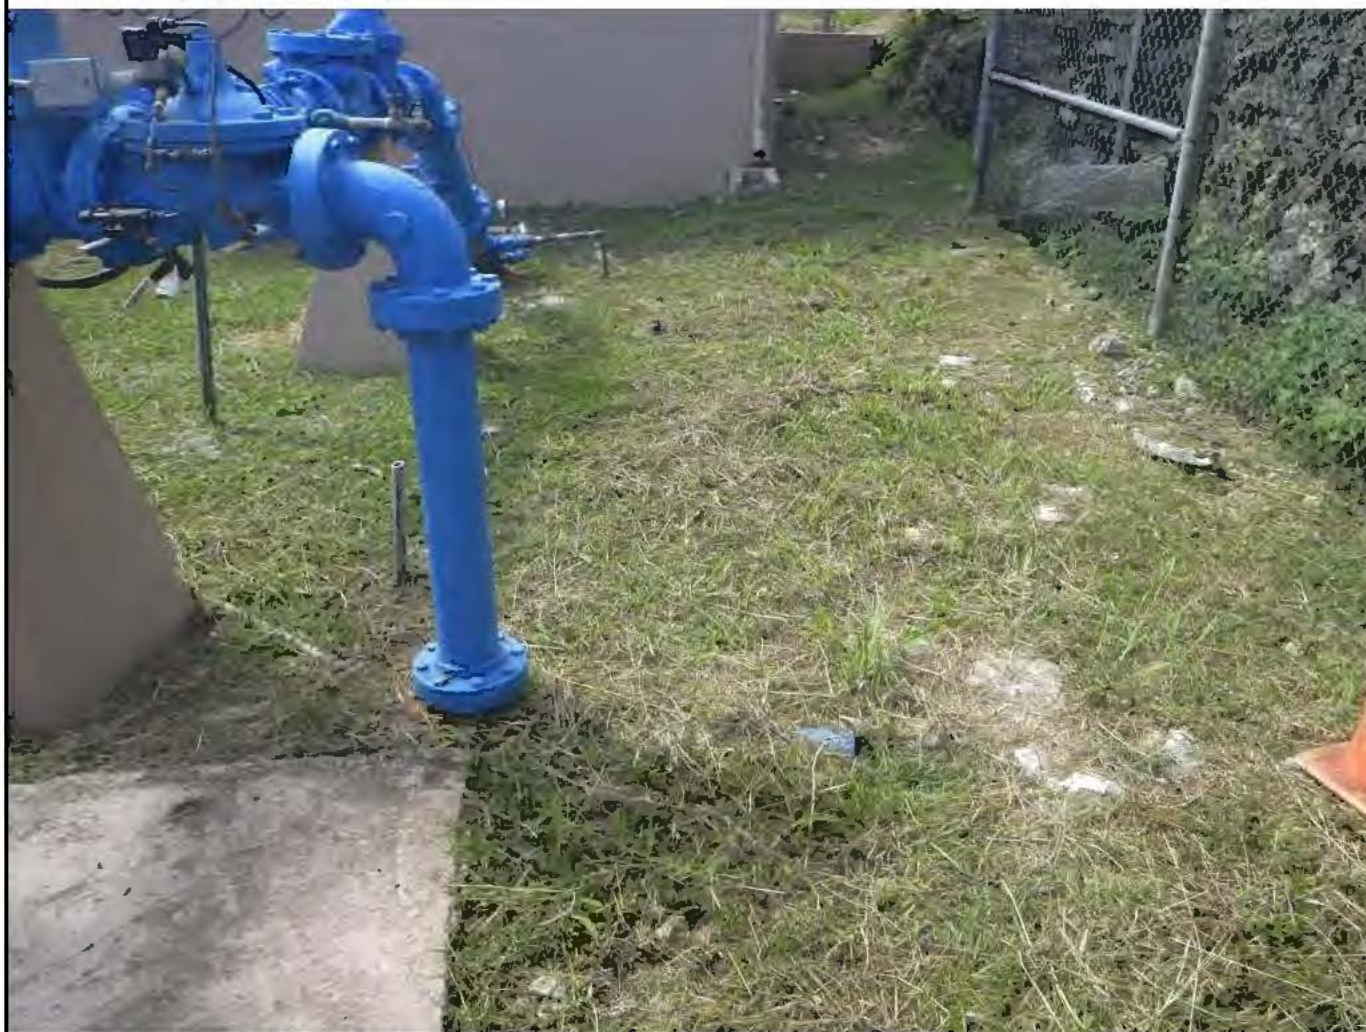
File Name: RIMG0166.JPG

Title	Guam Waterworks Authority (VP0989)
Subject	Northern System
Latitude	██████████
Longitude	██████████
Photo Direction	██████
██████	██████
Date Time Stamp	4/30/2012 9:34:58 AM
Photographer	K. Sable
Comment	A 31 Well
Description	Bypass valve to ground

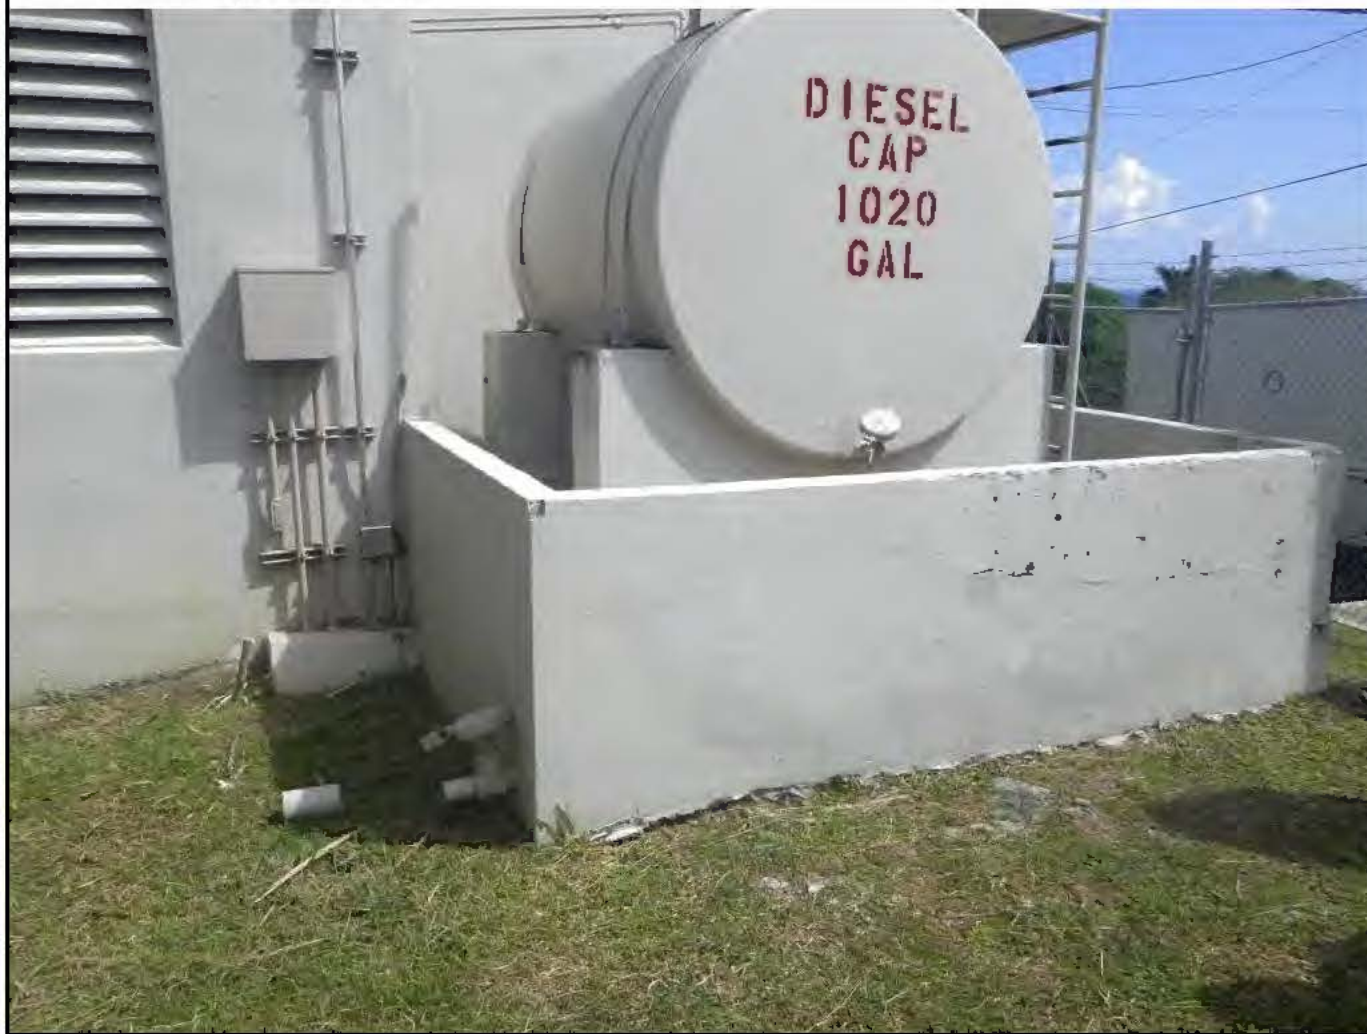
File Name: RIMG0168.JPG

Title	Guam Waterworks Authority (VP0989)
Subject	Northern System
Latitude	██████████
Longitude	██████████
Photo Direction	██████████
Elevation	██████
Date Time Stamp	4/30/2012 9:45:15 AM
Photographer	K. Sable
Comment	A 31 Well
Description	Diesel drain near well head

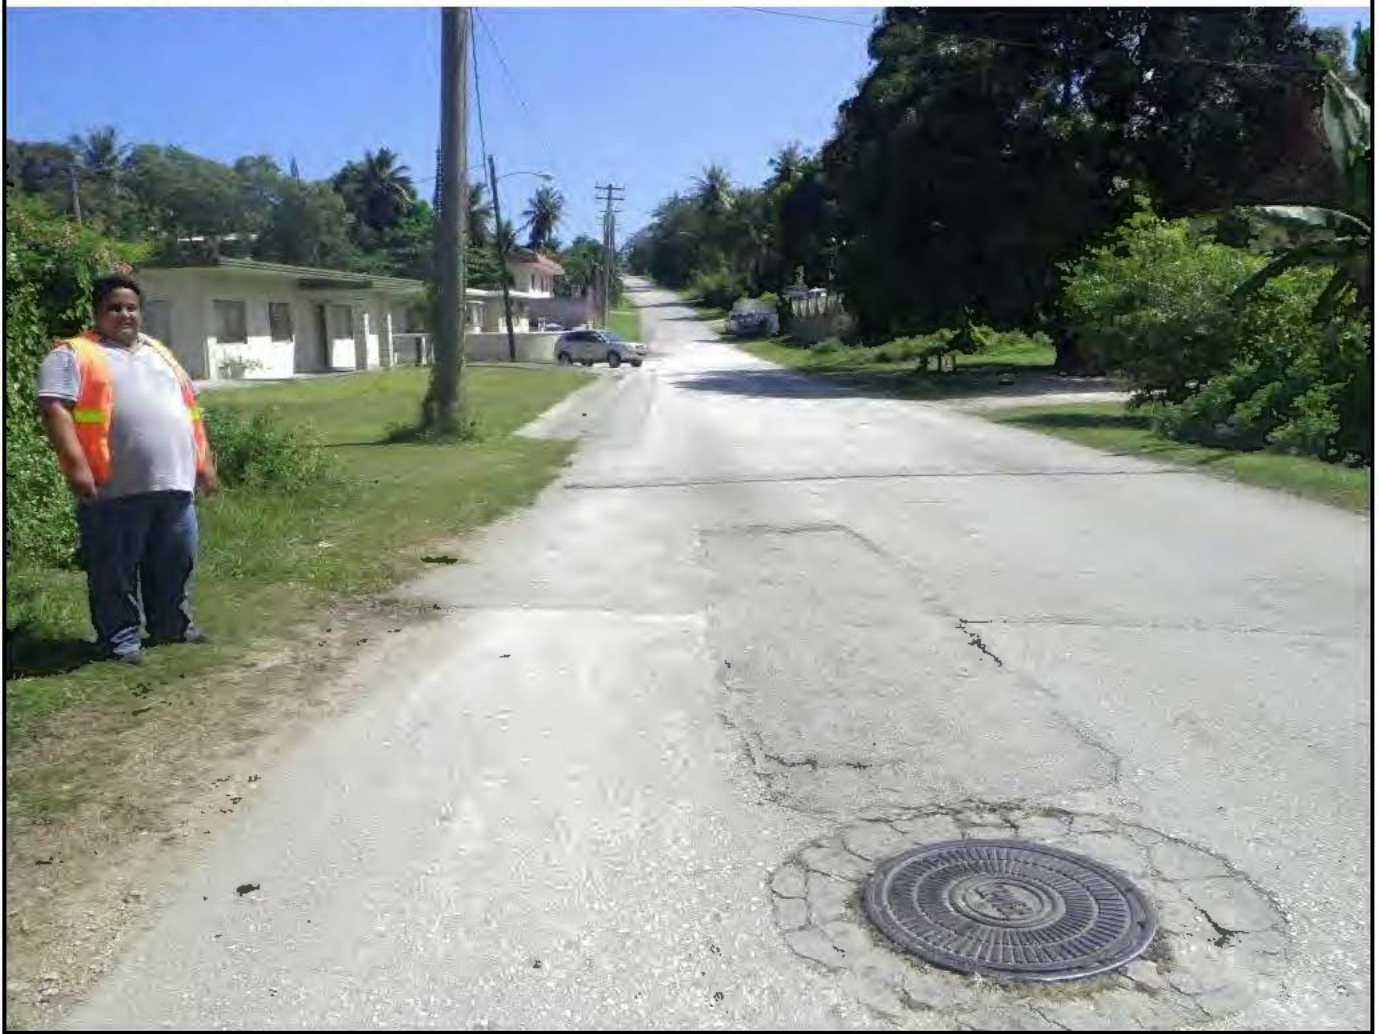
File Name: RIMG0171.JPG

Title	Guam Waterworks Authority (VP0989)
Subject	Northern System
Latitude	██████████
Longitude	██████████
Photo Direction	██████
Elevation	████
Date Time Stamp	4/30/2012 10:01:58 AM
Photographer	K. Sable
Comment	Manhole upstream of UIC ponding basin that has overflowed
Description	Manhole that has overflowed in the past
