Guam Waterworks Authority (VP0989)

SDWA Sanitary Survey

Northern System

NEIC Field Investigation Photographs

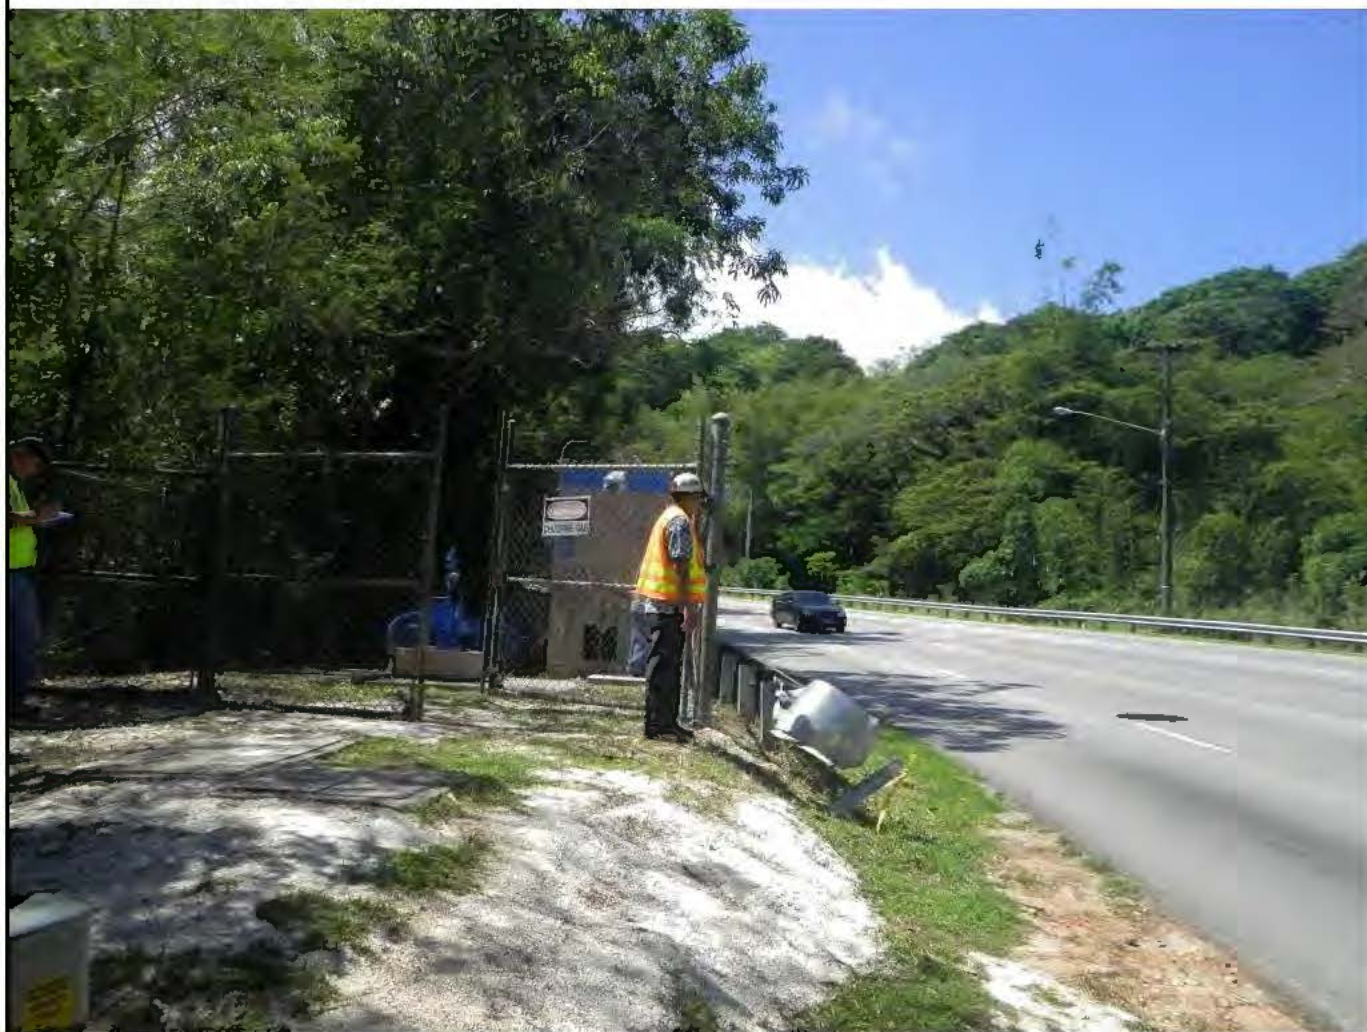
File Name: RIMG0173.JPG

Title	Guam Waterworks Authority (VP0989)
Subject	Northern System
Latitude	██████████
Longitude	██████████
Photo Direction	██████
Elevation	███
Date Time Stamp	4/30/2012 10:28:52 AM
Photographer	K. Sable
Comment	A 23 Well
Description	Well with nearby manhole along Route 4

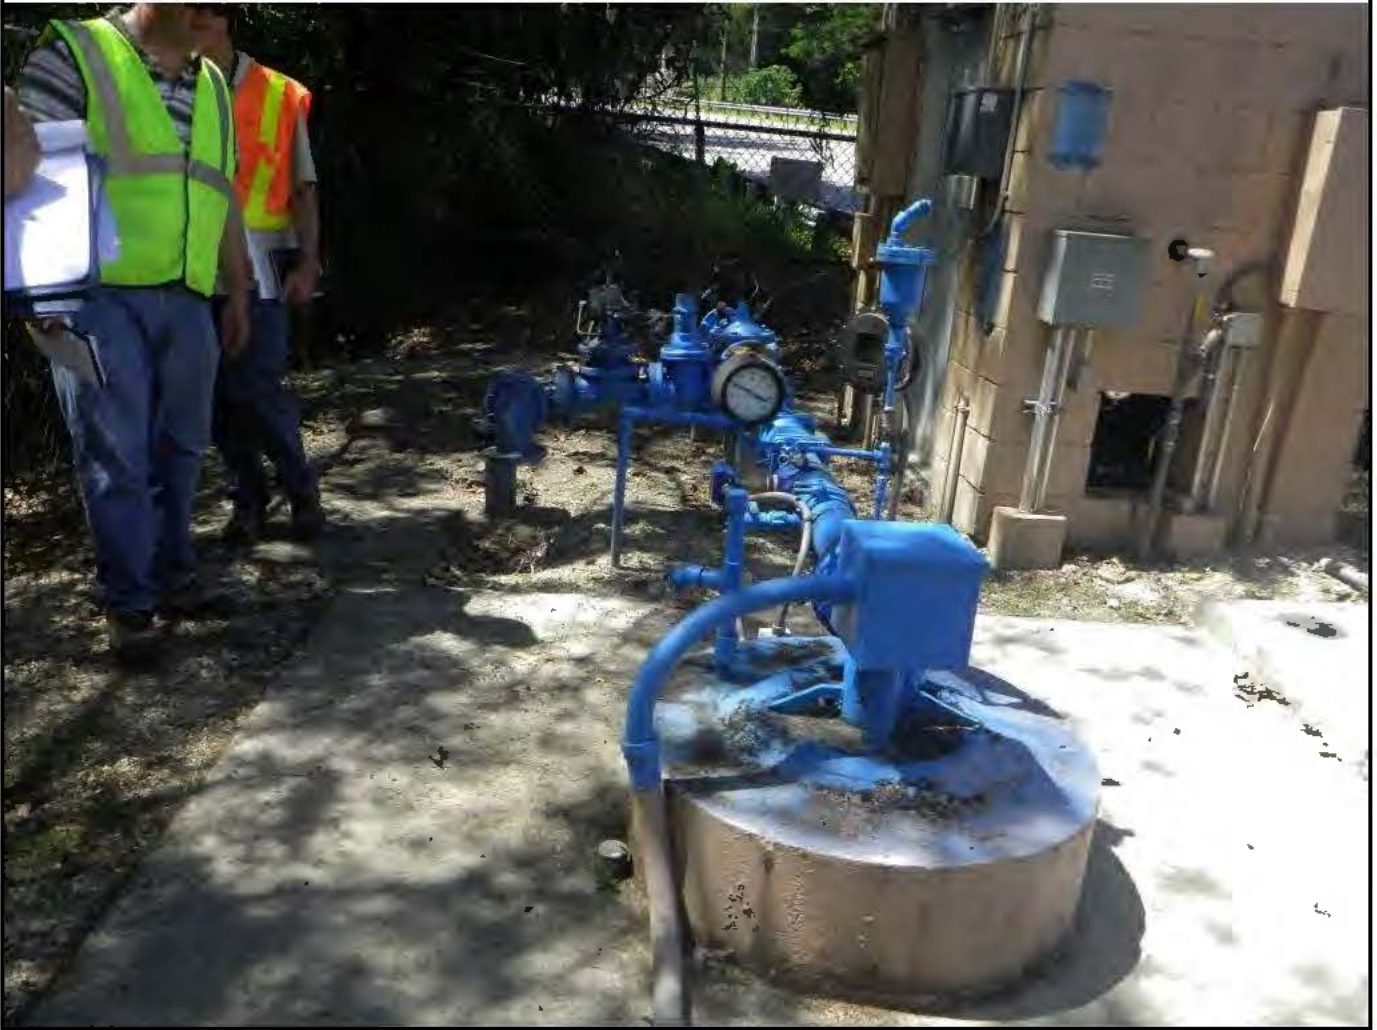
File Name: RIMG0174.JPG

Title	Guam Waterworks Authority (VP0989)
Subject	Northern System
Latitude	[REDACTED]
Longitude	[REDACTED]
Photo Direction	[REDACTED]
Elevation	[REDACTED]
Date Time Stamp	4/30/2012 10:30:39 AM
Photographer	K. Sable
Comment	A 23 Well
Description	Well assembly

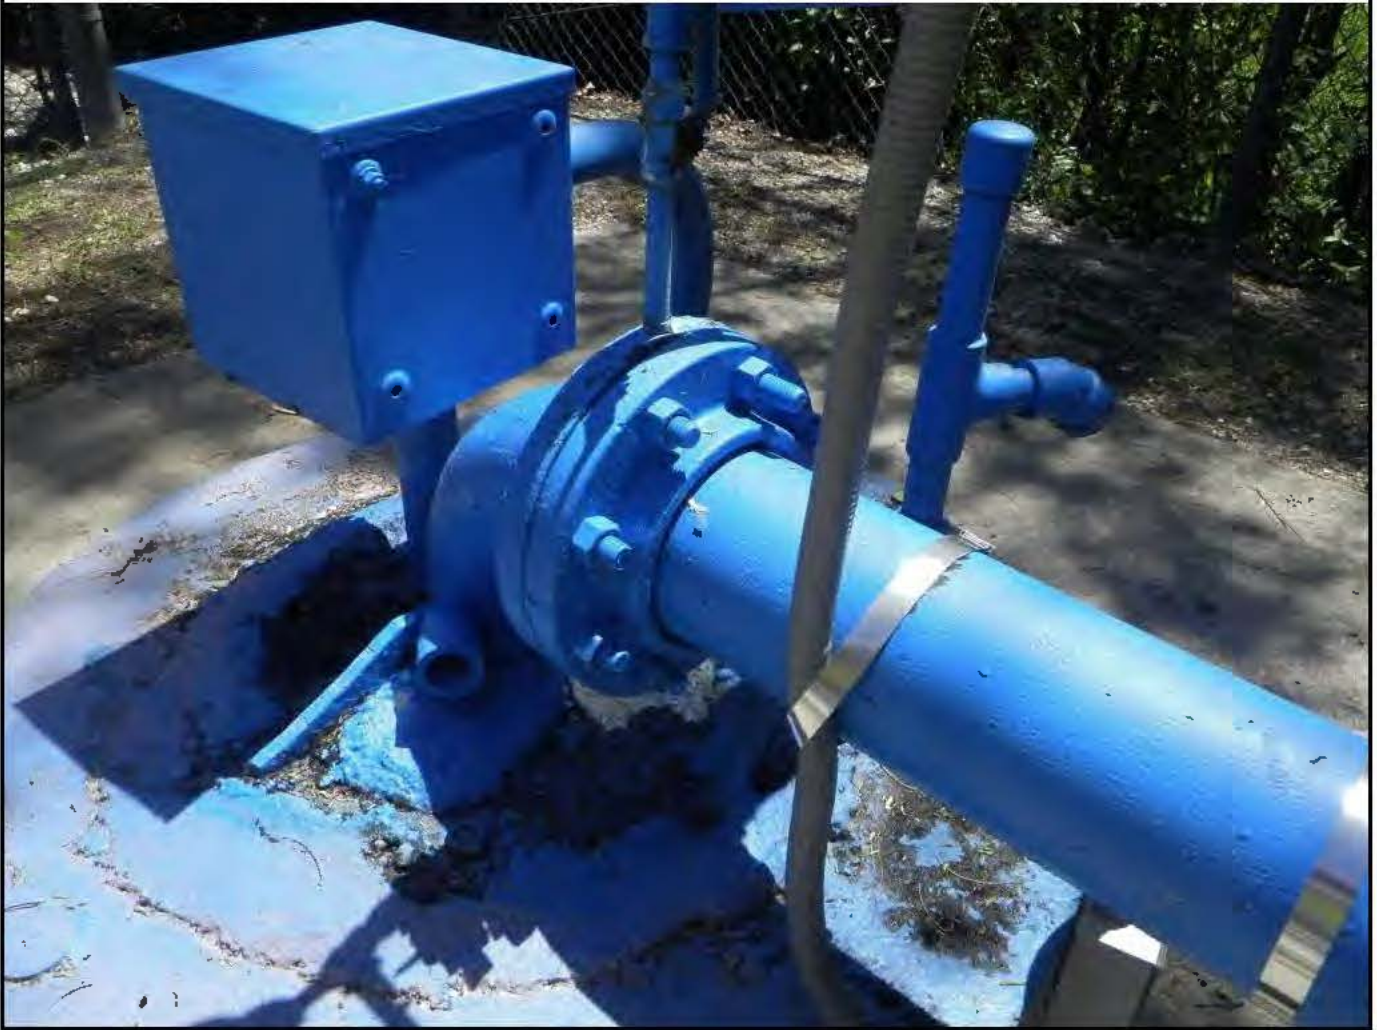
File Name: RIMG0175.JPG

Title	Guam Waterworks Authority (VP0989)
Subject	Northern System
Latitude	██████████
Longitude	██████████
Photo Direction	██████
Elevation	██
Date Time Stamp	4/30/2012 10:43:24 AM
Photographer	K. Sable
Comment	A 23 Well
Description	Question on number of air vents on well head

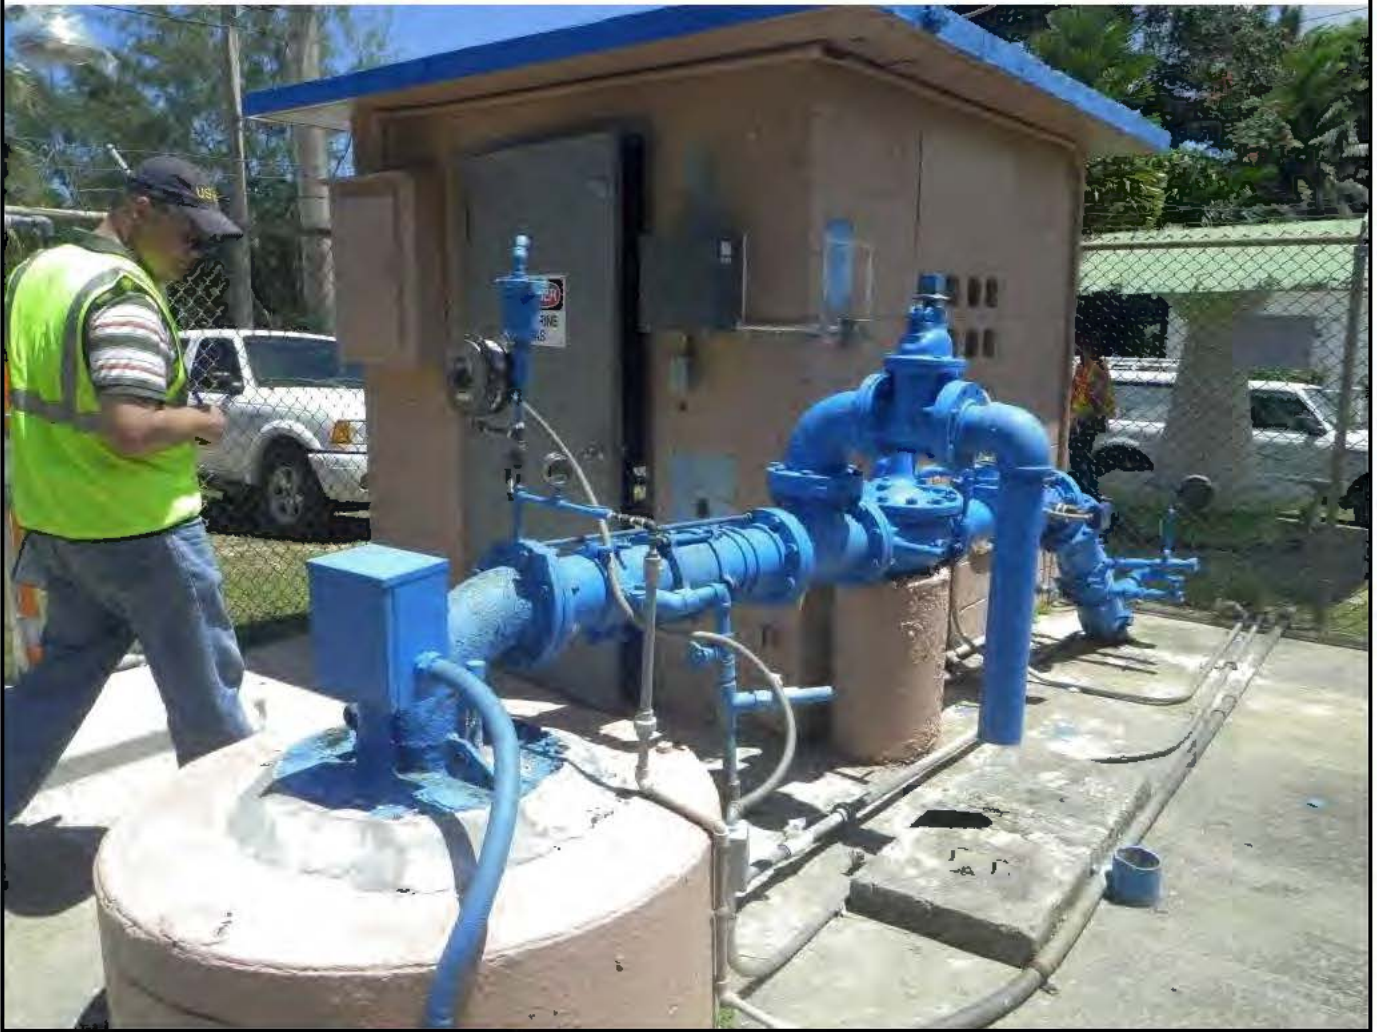
File Name: RIMG0179.JPG

Title	Guam Waterworks Authority (VP0989)
Subject	Northern System
Latitude	██████████
Longitude	██████████
Photo Direction	██████████
Elevation	██████
Date Time Stamp	4/30/2012 11:16:15 AM
Photographer	K. Sable
Comment	A 6 Well
Description	Well assembly

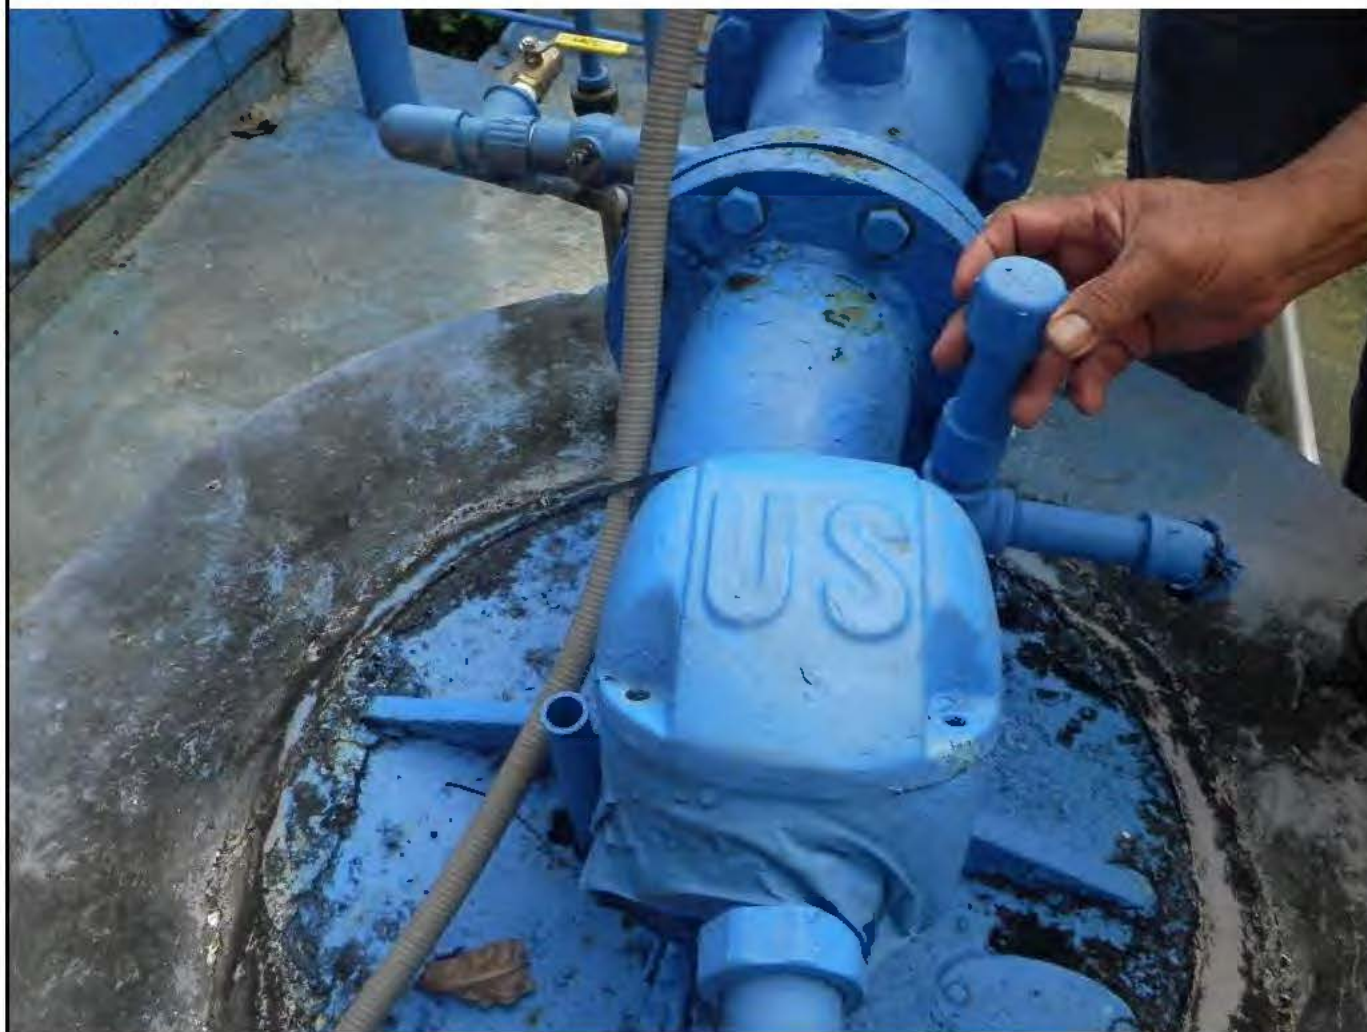
File Name: RIMG0180.JPG

Title	Guam Waterworks Authority (VP0989)
Subject	Northern System
Latitude	[REDACTED]
Longitude	[REDACTED]
Photo Direction	[REDACTED]
Elevation	[REDACTED]
Date Time Stamp	4/30/2012 1:29:22 PM
Photographer	K. Sable
Comment	A 1 Well
Description	Broken air valve

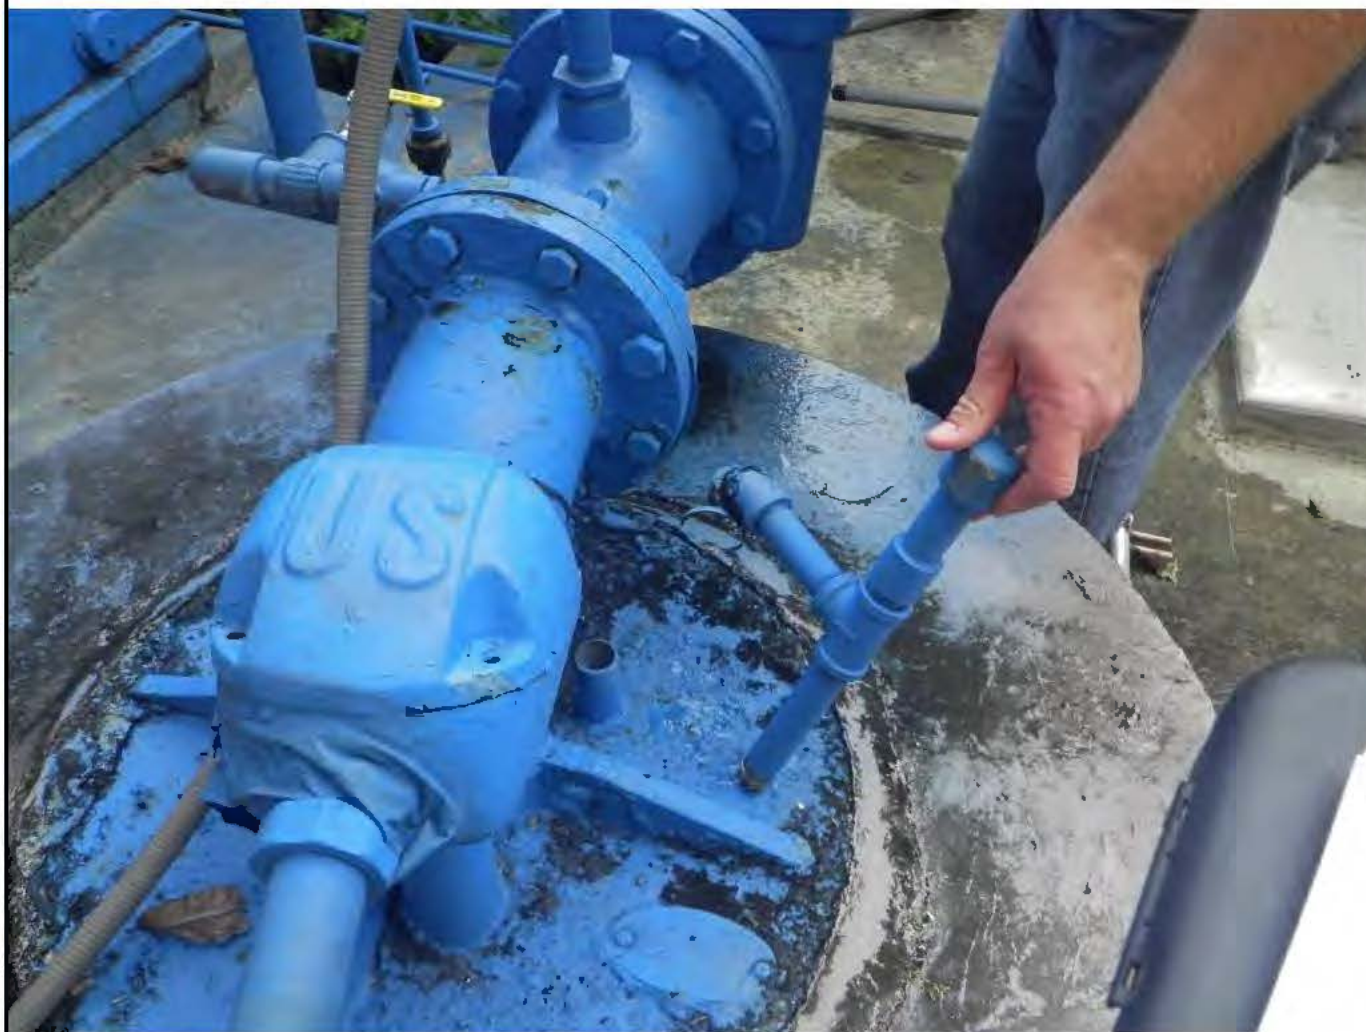
File Name: RIMG0181.JPG

Title	Guam Waterworks Authority (VP0989)
Subject	Northern System
Latitude	██████████
Longitude	██████████
Photo Direction	████
Elevation	████
Date Time Stamp	4/30/2012 1:29:55 PM
Photographer	K. Sable
Comment	A 1 Well
Description	Sounding tube

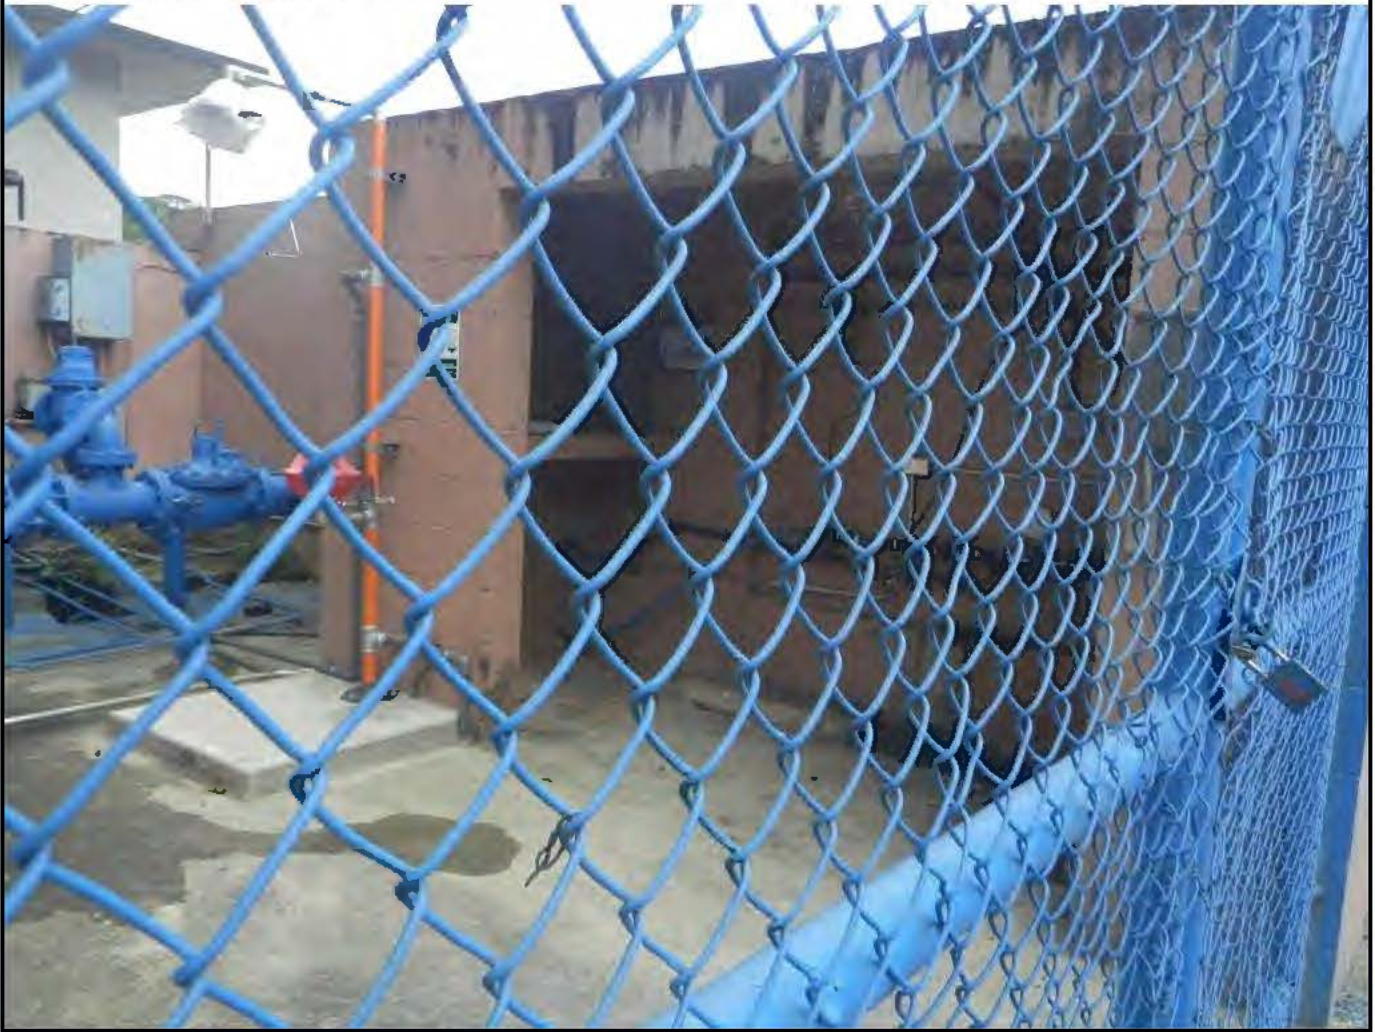
File Name: RIMG0183.JPG

Title	Guam Waterworks Authority (VP0989)
Subject	Northern System
Latitude	[REDACTED]
Longitude	[REDACTED]
Photo Direction	[REDACTED]
Elevation	[REDACTED]
Date Time Stamp	4/30/2012 1:40:37 PM
Photographer	K. Sable
Comment	A 1 Well
Description	Chlorine room without doors

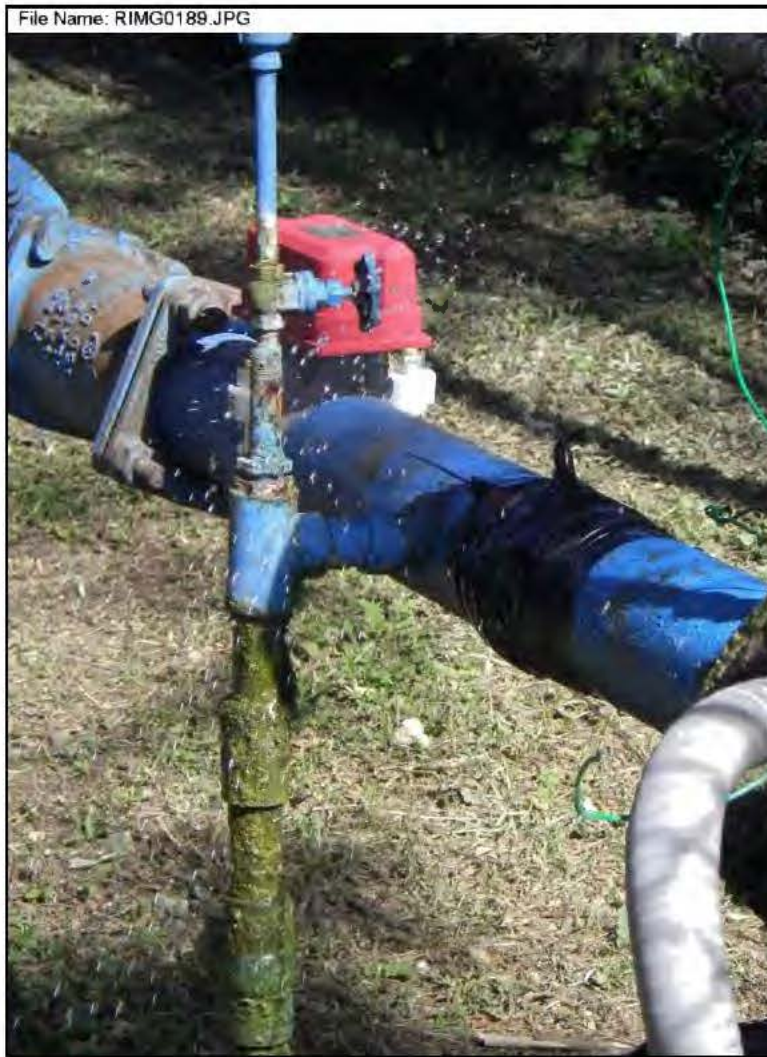
Attributes	
Title	Guam Waterworks Authority (VP0989)
Subject	Northern System
Latitude	██████████
Longitude	██████████
Photo Direction	██████
██████	██████
Date Time Stamp	4/30/2012 3:20:25 PM
Photographer	K. Sable
Comment	A 21 Well
Description	Close-up of leak

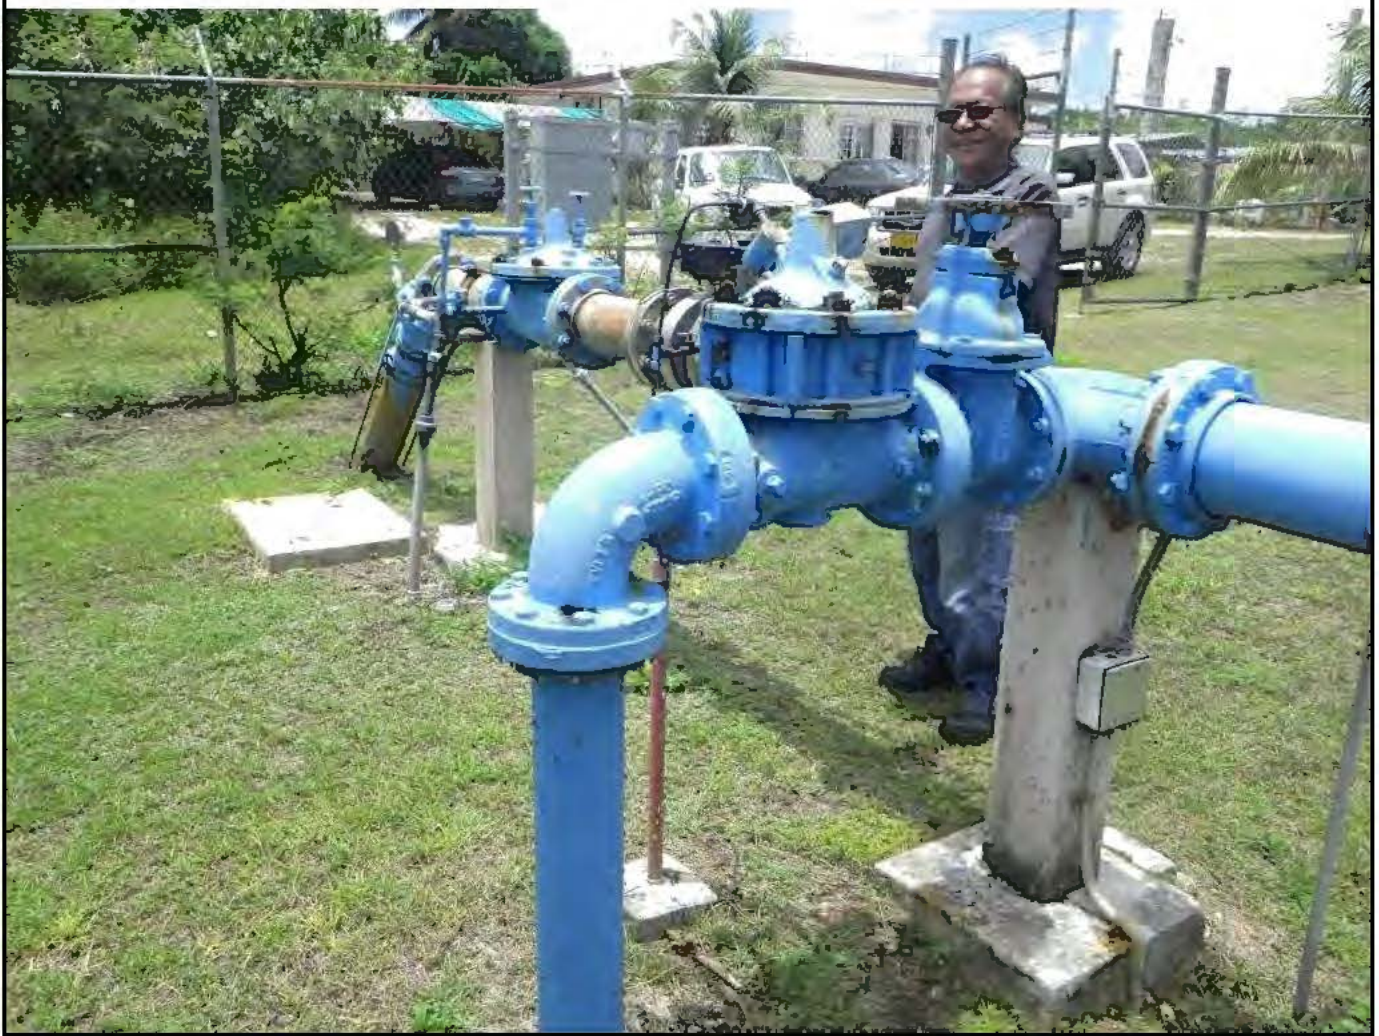
File Name: RIMG0195.JPG

Title	Guam Waterworks Authority (VP0989)
Subject	Northern System
Latitude	██████████
Longitude	██████████
Photo Direction	██████
Elevation	██████
Date Time Stamp	5/1/2012 12:37:55 PM
Photographer	K. Sable
Comment	F 13 Well
Description	Rusted bypass valve
