Guam Waterworks Authority (VP0989)

SDWA Sanitary Survey

Central System

NEIC Field Investigation Photographs

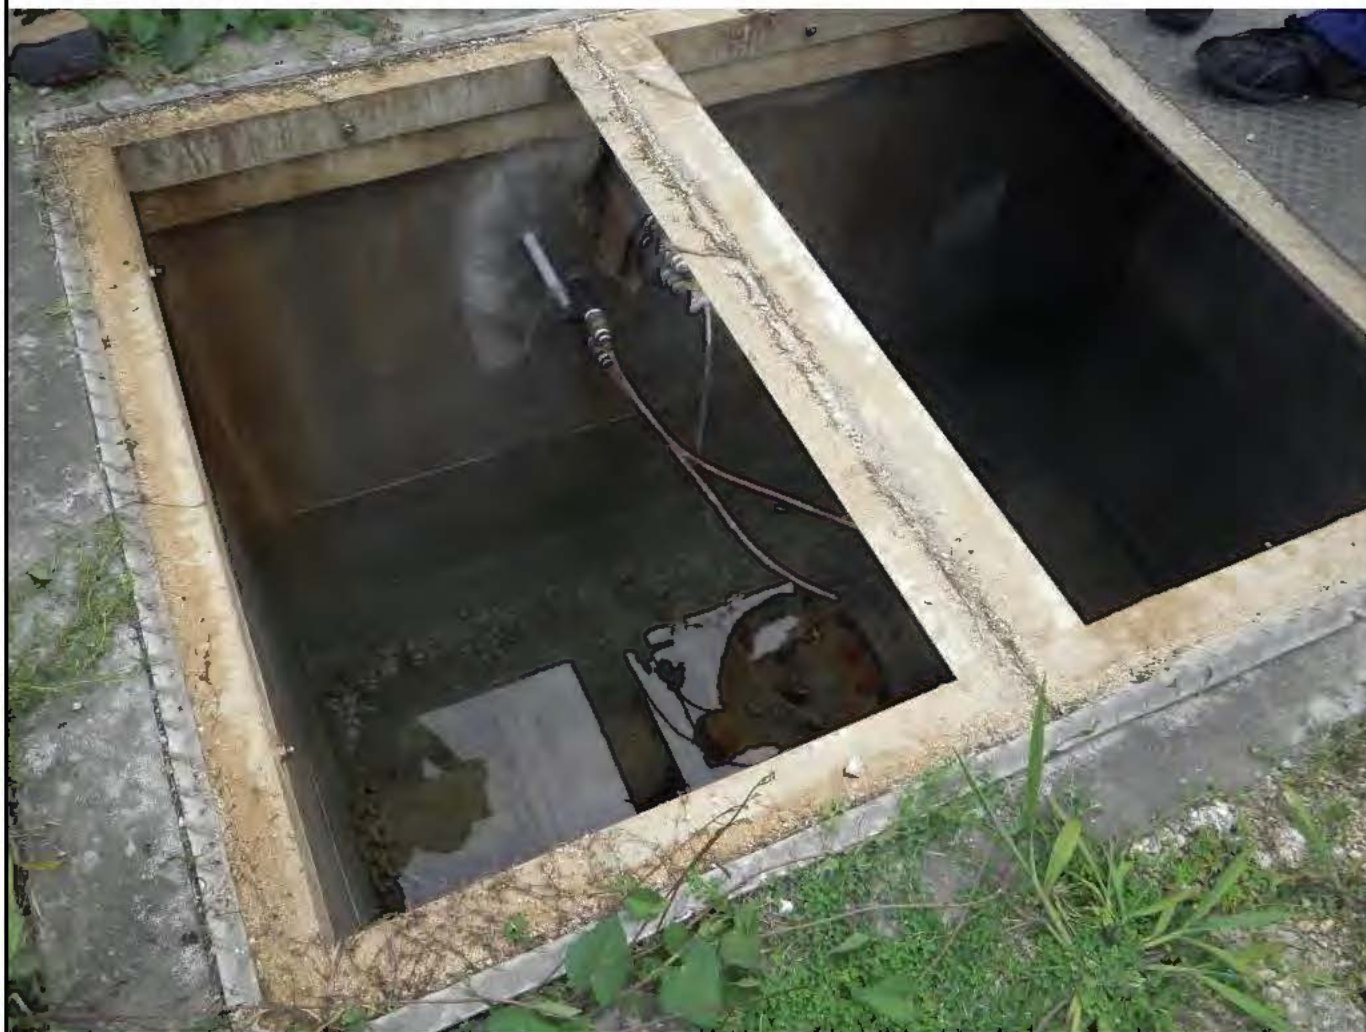
File Name: RIMG0101.JPG

Title	Guam Waterworks Authority (VP0989)
Subject	Central System
Latitude	██████████
Longitude	██████████
Photo Direction	██████
Elevation	████
Date Time Stamp	4/26/2012 3:40:51 PM
Photographer	K. Sable
Comment	Santa Rita Spring
Description	Water inlet pipe from Navy

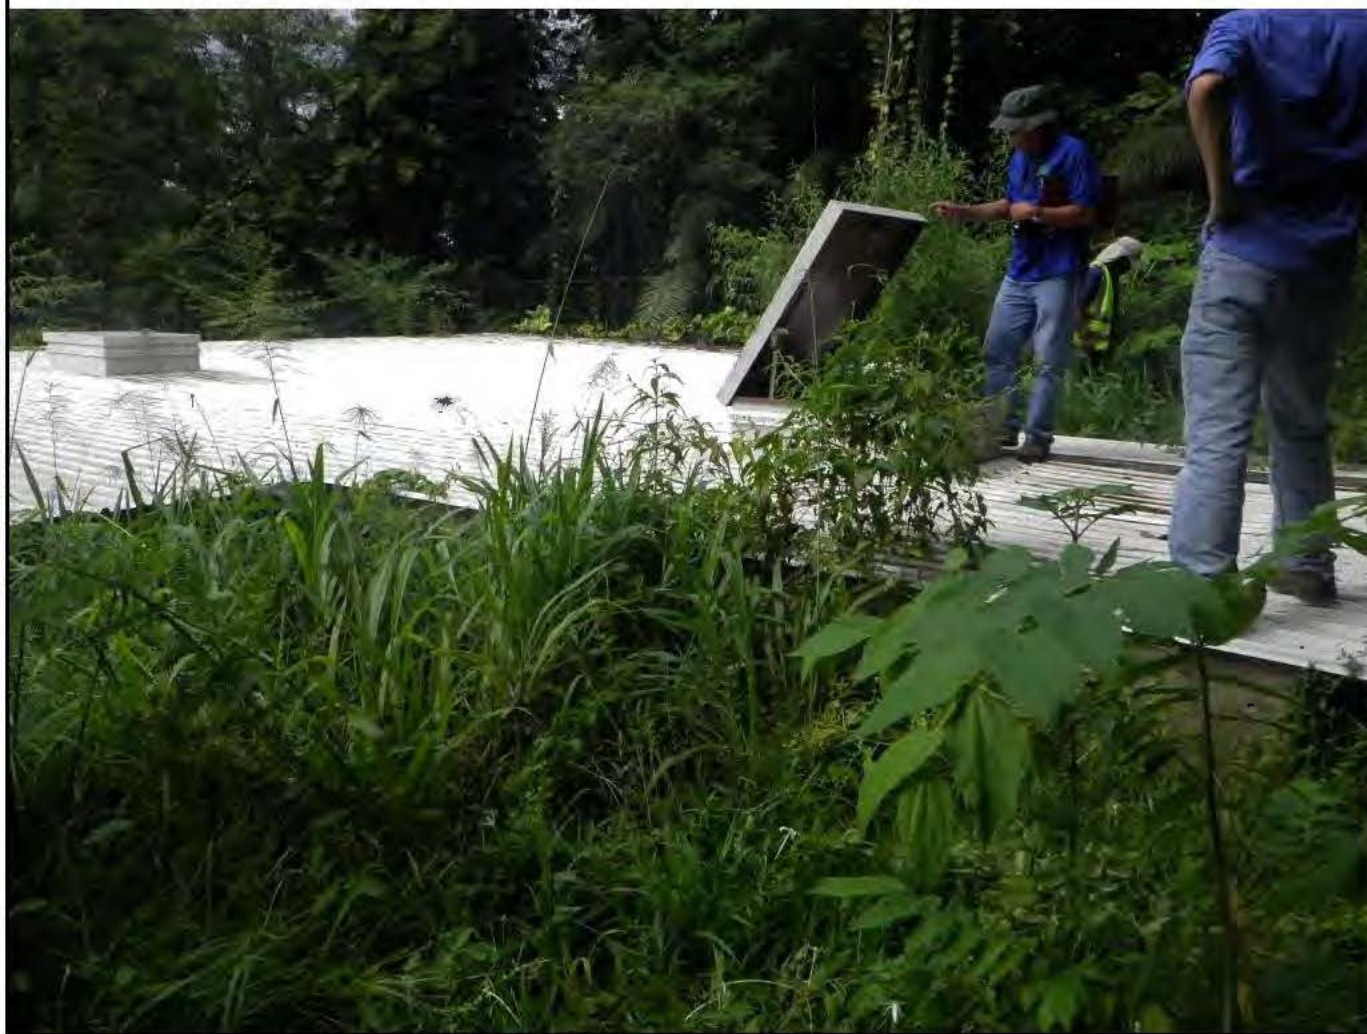
File Name: RIMG0102.JPG

Attributes	
Title	Guam Waterworks Authority (VP0989)
Subject	Central System
Latitude	[REDACTED]
Longitude	[REDACTED]
Photo Direction	[REDACTED]
Elevation	[REDACTED]
Date Time Stamp	4/26/2012 3:45:21 PM
Photographer	K. Sable
Comment	Santa Rita Spring
Description	Clear well with vegetation

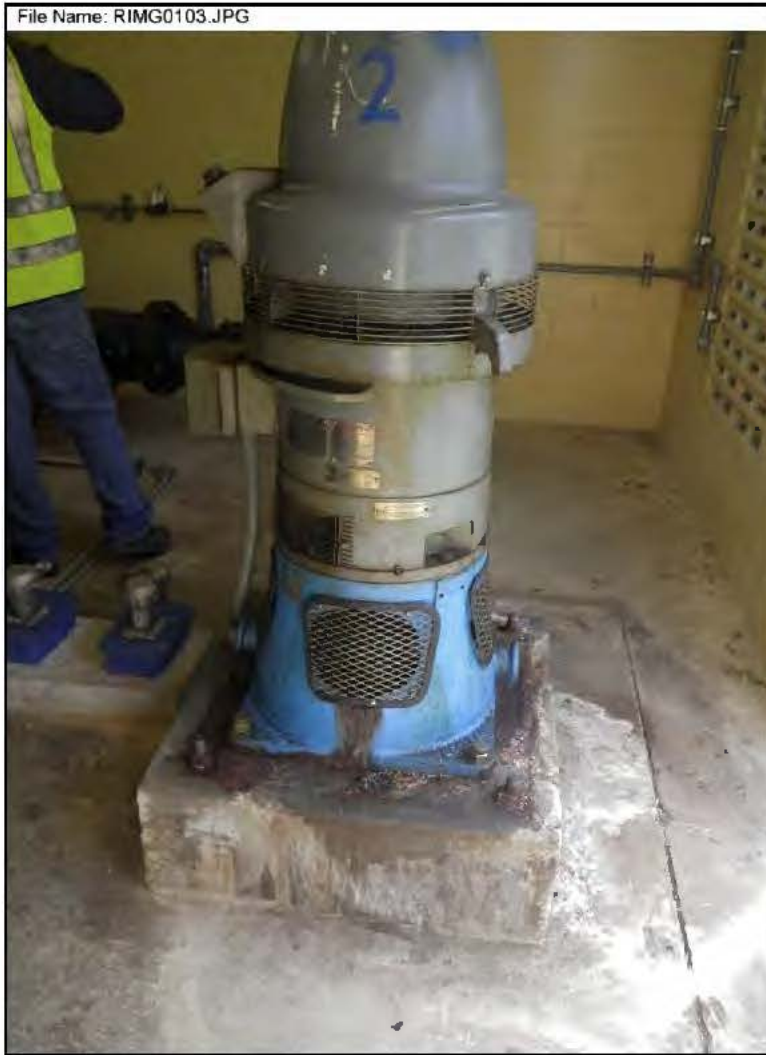
Attributes	
Title	Guam Waterworks Authority (VP0989)
Subject	Central System
Latitude	[REDACTED]
Longitude	[REDACTED]
Photo Direction	[REDACTED]
Elevation	[REDACTED]
Date Time Stamp	4/26/2012 3:50:58 PM
Photographer	K. Sable
Comment	Santa Rita Spring
Description	Pump # 2 leaking

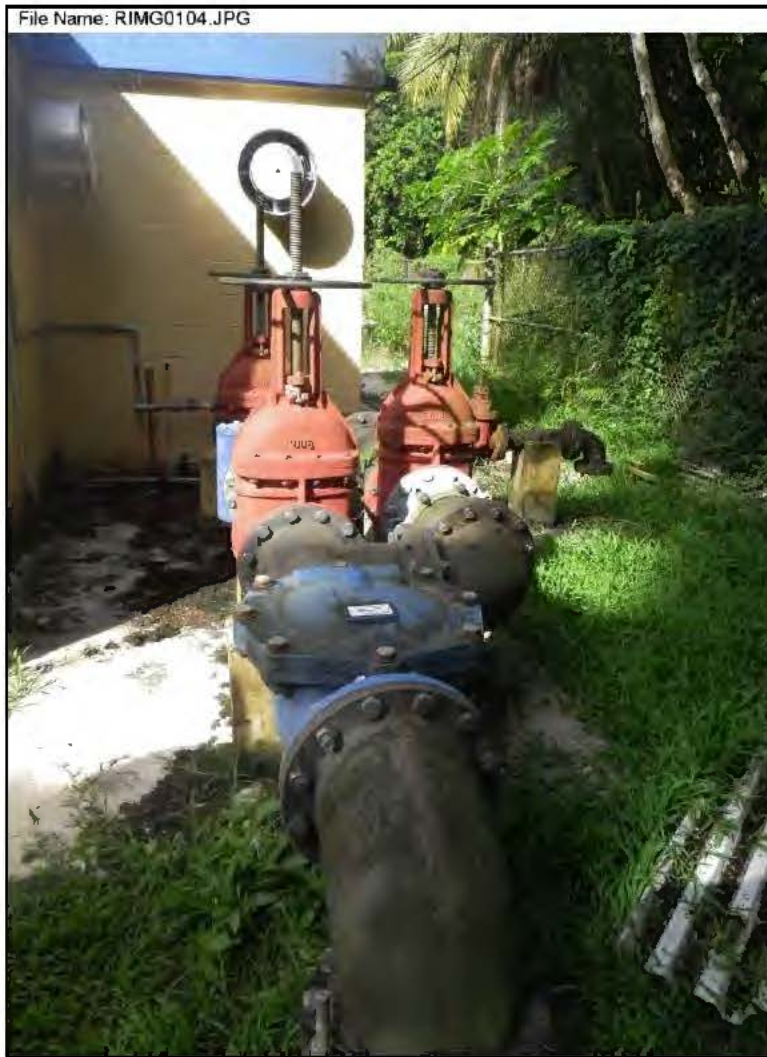
Attributes	
Title	Guam Waterworks Authority (VP0989)
Subject	Central System
Latitude	[REDACTED]
Longitude	[REDACTED]
Photo Direction	[REDACTED]
Elevation	[REDACTED]
Date Time Stamp	4/26/2012 3:55:36 PM
Photographer	K. Sable
Comment	Santa Rita Spring
Description	Assembly with bypass and water leaving spring

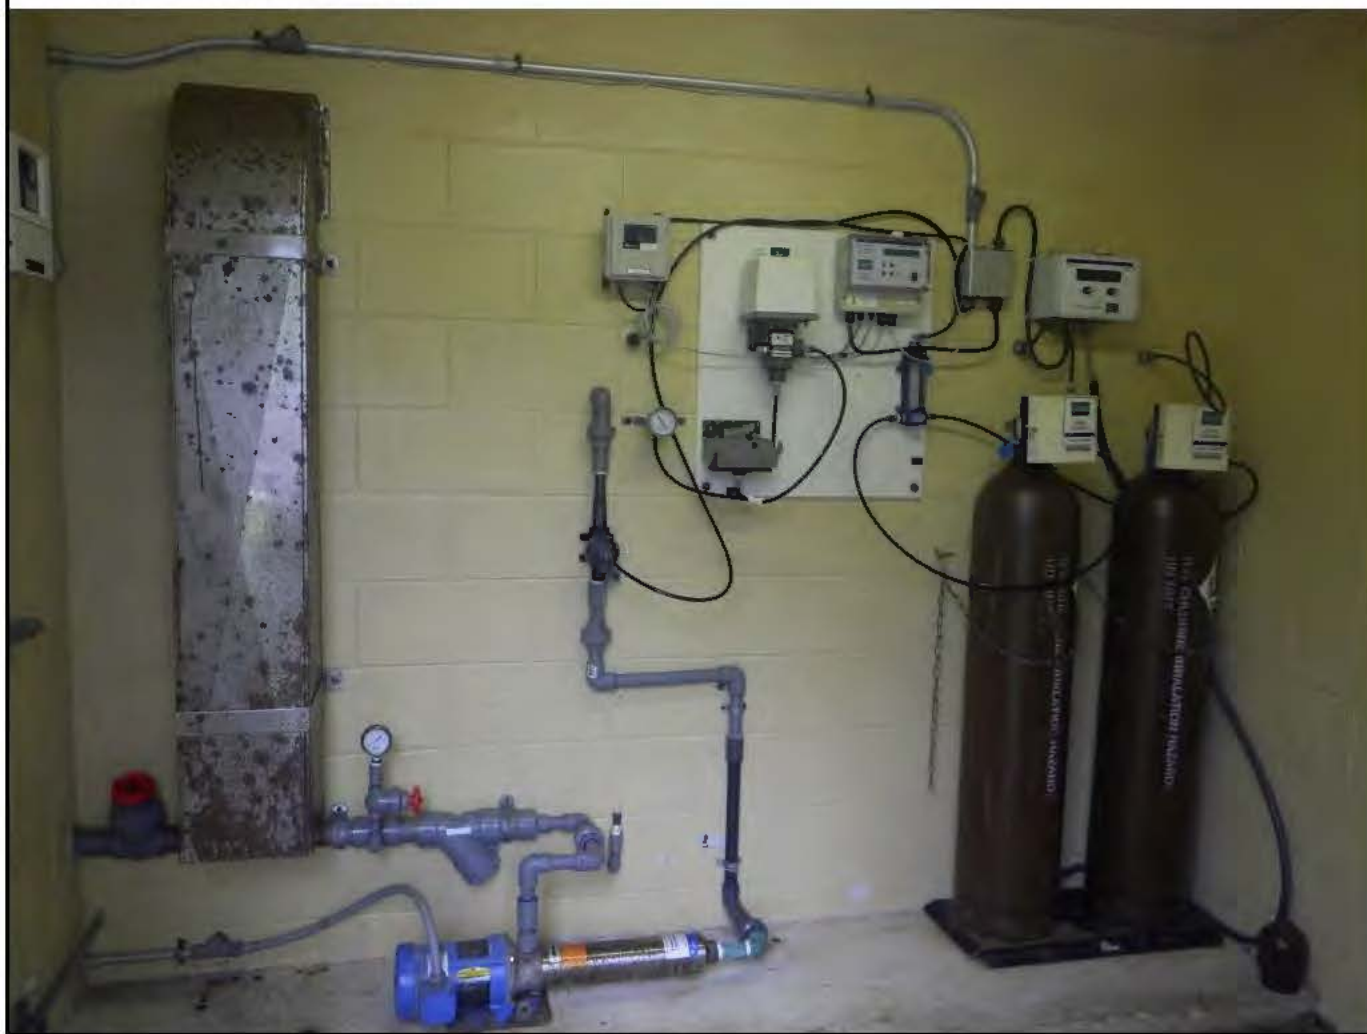
File Name: RIMG0105.JPG

Title	Guam Waterworks Authority (VP0989)
Subject	Central System
Latitude	██████████
Longitude	██████████
Photo Direction	██████
Elevation	██████
Date Time Stamp	4/26/2012 4:05:16 PM
Photographer	K. Sable
Comment	Santa Rita Spring
Description	Chlorine building

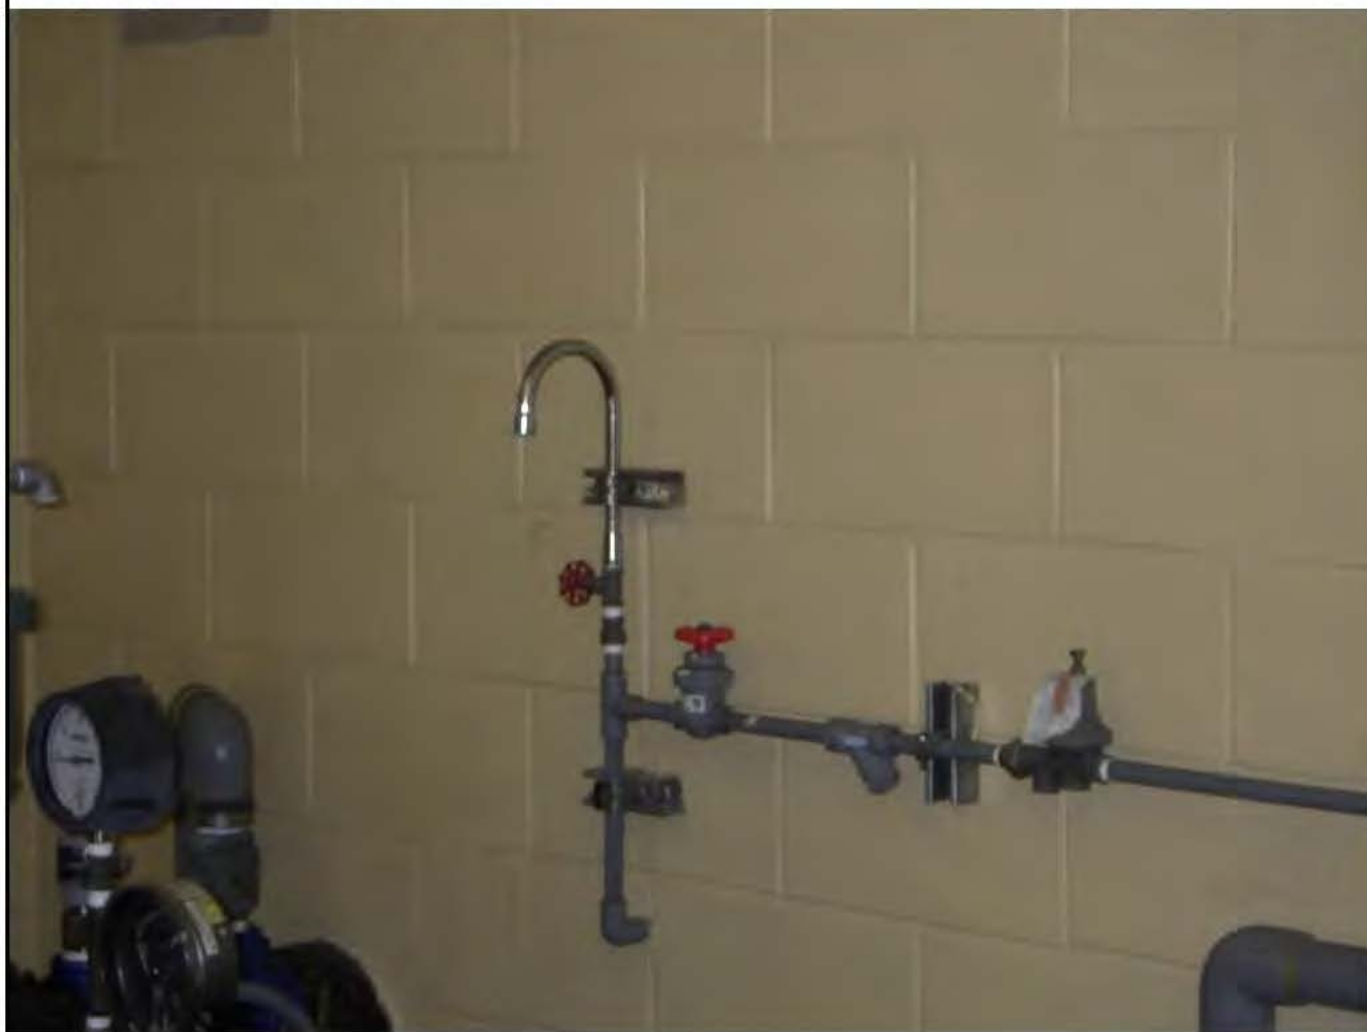
File Name: RIMG0106.JPG

Title	Guam Waterworks Authority (VP0989)
Subject	Central System
Latitude	██████████
Longitude	██████████
Photo Direction	██████████
Elevation	██████
Date Time Stamp	4/26/2012 4:05:53 PM
Photographer	K. Sable
Comment	Santa Rita Spring
Description	Sample tap for chlorine grab samples

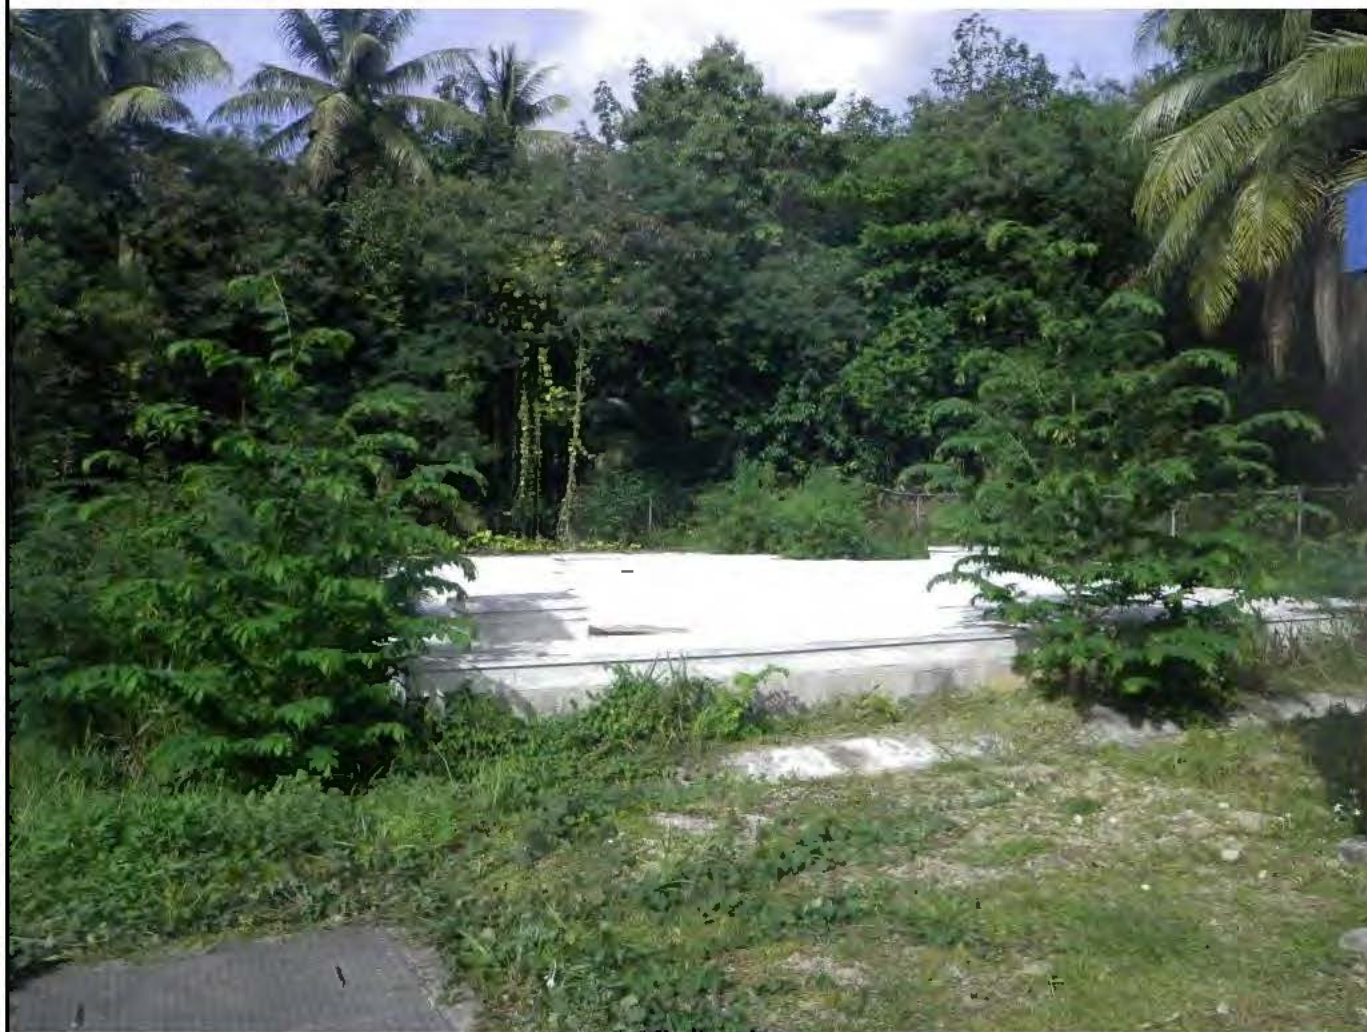
File Name: RIMG0107.JPG

Title	Guam Waterworks Authority (VP0989)
Subject	Central System
Latitude	██████████
Longitude	██████████
Photo Direction	██████
Elevation	████
Date Time Stamp	4/26/2012 4:07:13 PM
Photographer	K. Sable
Comment	Santa Rita Spring
Description	Vegetation around clear well

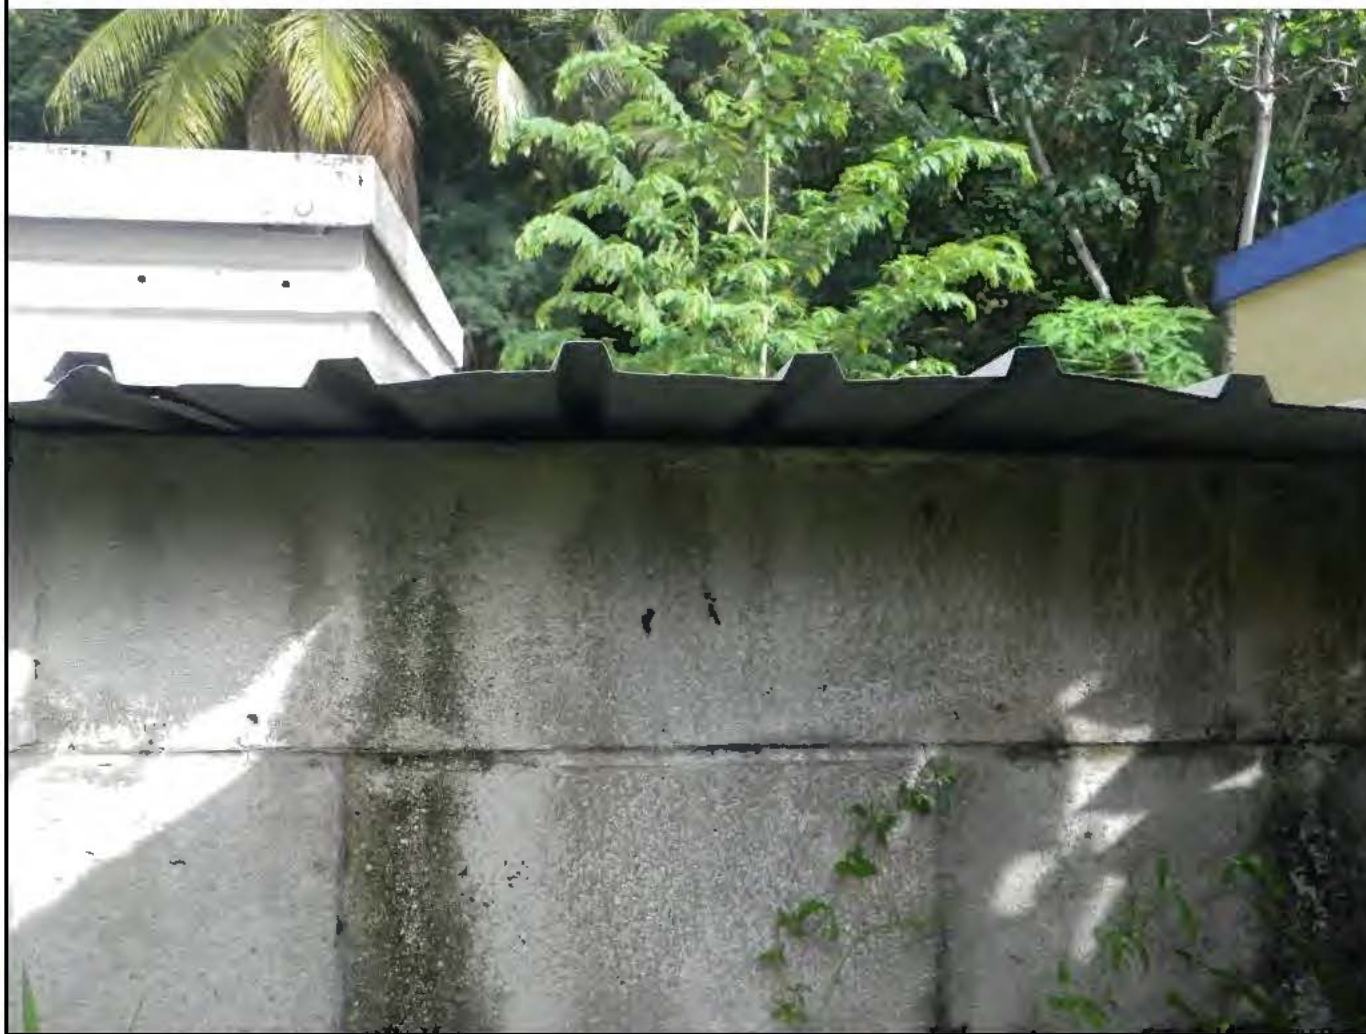
File Name: RIMG0108.JPG

Attributes	
Title	Guam Waterworks Authority (VP0989)
Subject	Central System
Latitude	██████████
Longitude	██████████
Photo Direction	██████
Elevation	████
Date Time Stamp	4/26/2012 4:14:23 PM
Photographer	K. Sable
Comment	Santa Rita Spring
Description	Gaps in clear well roof and wall

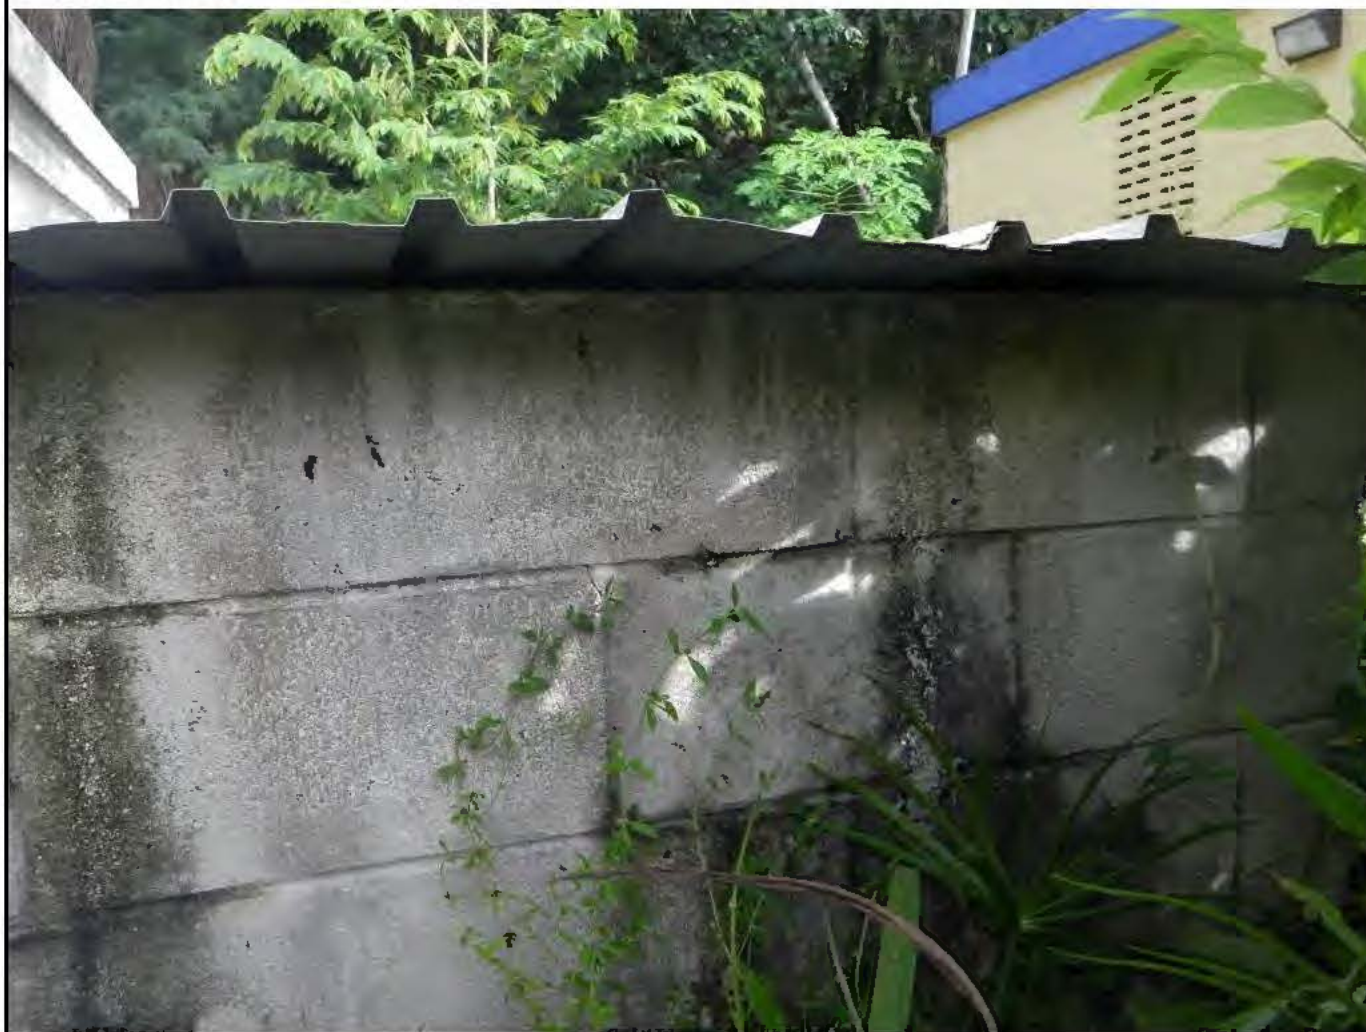
File Name: RIMG0109.JPG

Title	Guam Waterworks Authority (VP0989)
Subject	Central System
Latitude	██████████
Longitude	██████████
Photo Direction	██████
Elevation	████
Date Time Stamp	4/26/2012 4:14:33 PM
Photographer	K. Sable
Comment	Santa Rita Spring
Description	Gaps in clear well roof and wall

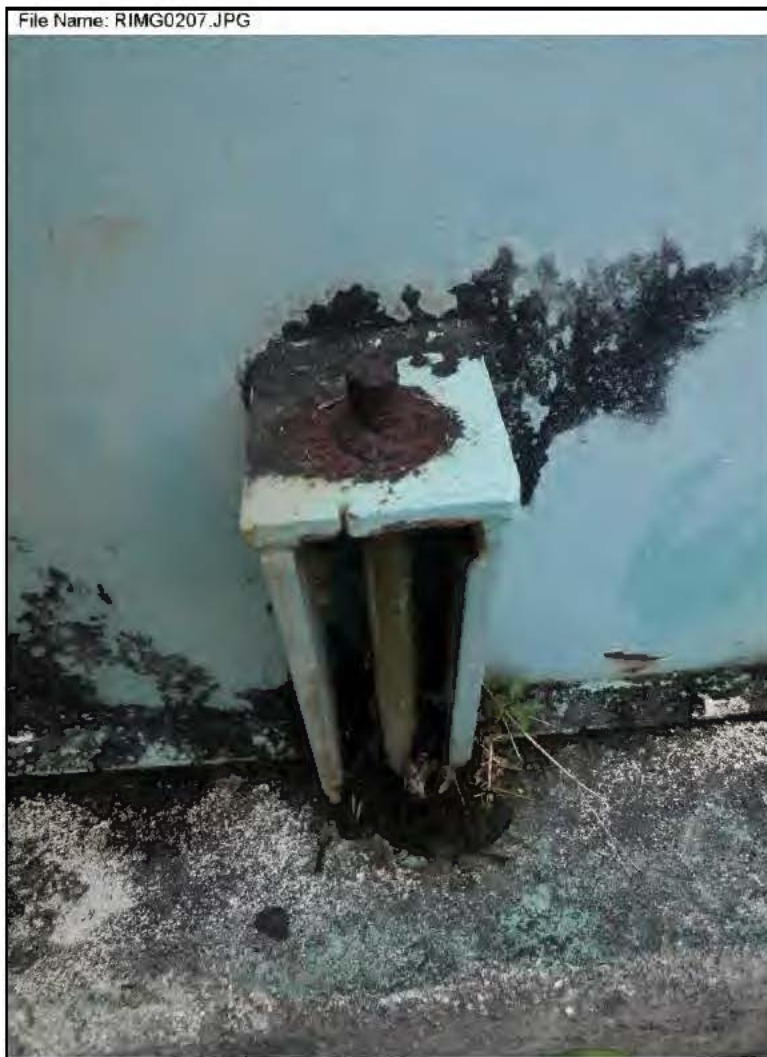
Attributes	
Title	Guam Waterworks Authority (VP0989)
Subject	Central System
Latitude	[REDACTED]
Longitude	[REDACTED]
Photo Direction	[REDACTED]
Elevation	[REDACTED]
Date Time Stamp	5/2/2012 1:06:50 PM
Photographer	K. Sable
Comment	Santa Rita Tank
Description	Welded, rusted anchor bolts

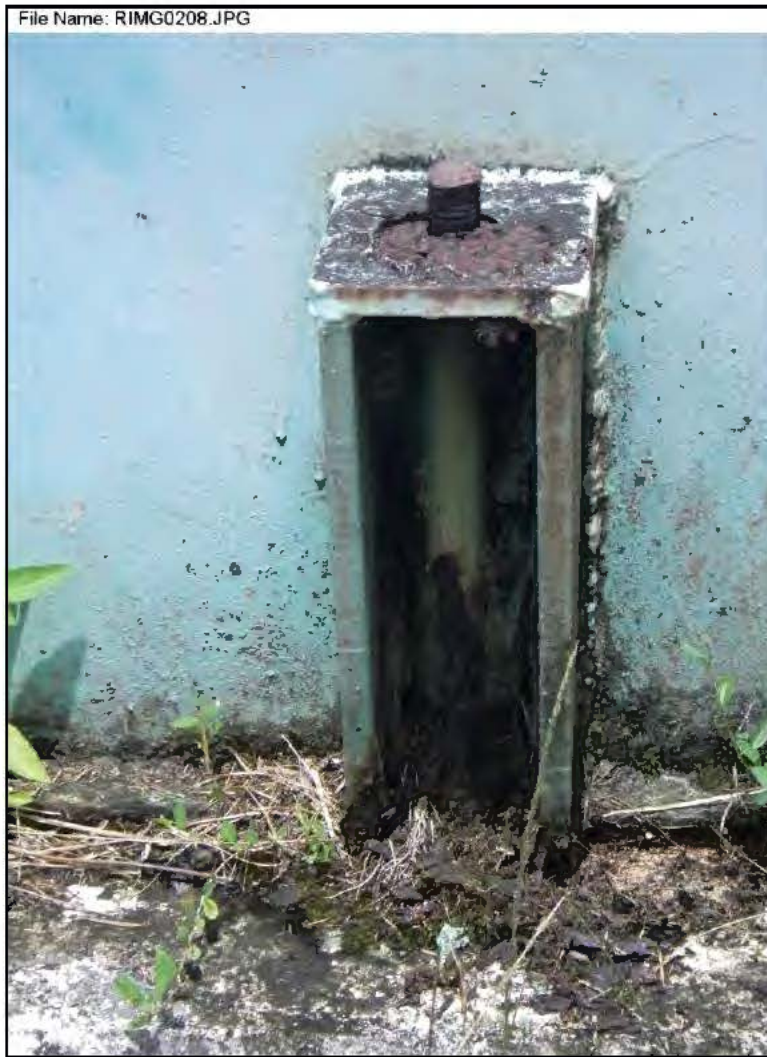
Attributes	
Title	Guam Waterworks Authority (VP0989)
Subject	Central System
Latitude	[REDACTED]
Longitude	[REDACTED]
Photo Direction	[REDACTED]
Elevation	[REDACTED]
Date Time Stamp	5/2/2012 1:11:08 PM
Photographer	K. Sable
Comment	Santa Rita Tank
Description	Welded, rusted anchor bolts

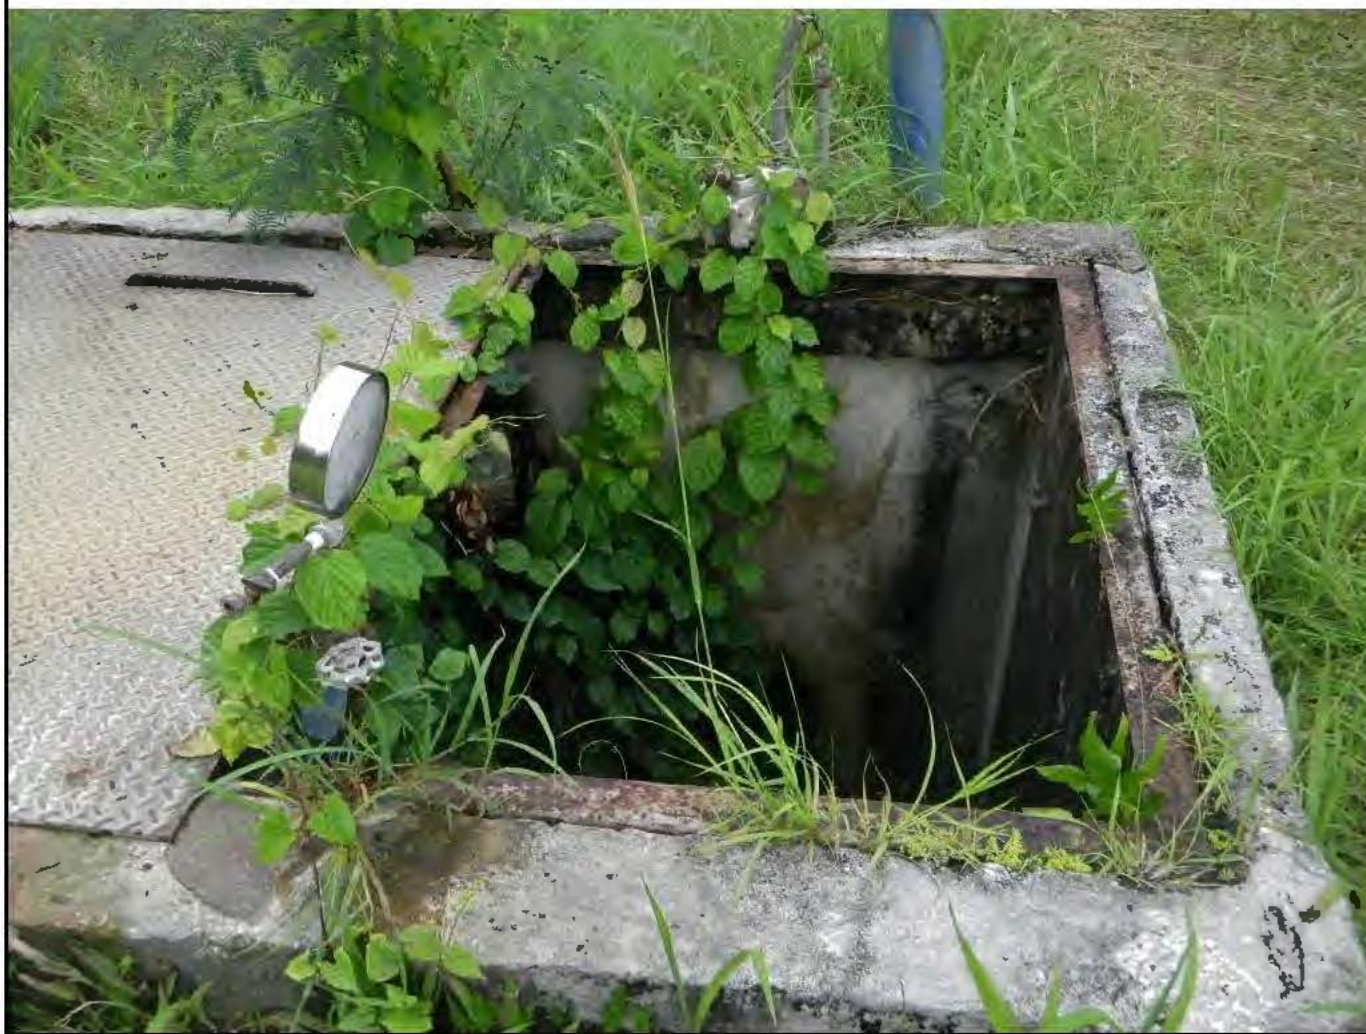
File Name: RIMG0209.JPG

Title	Guam Waterworks Authority (VP0989)
Subject	Central System
Latitude	[REDACTED]
Longitude	[REDACTED]
Photo Direction	[REDACTED]
Elevation	[REDACTED]
Date Time Stamp	5/2/2012 1:20:35 PM
Photographer	K. Sable
Comment	Santa Rita Tank
Description	Leaking valve with constant flow

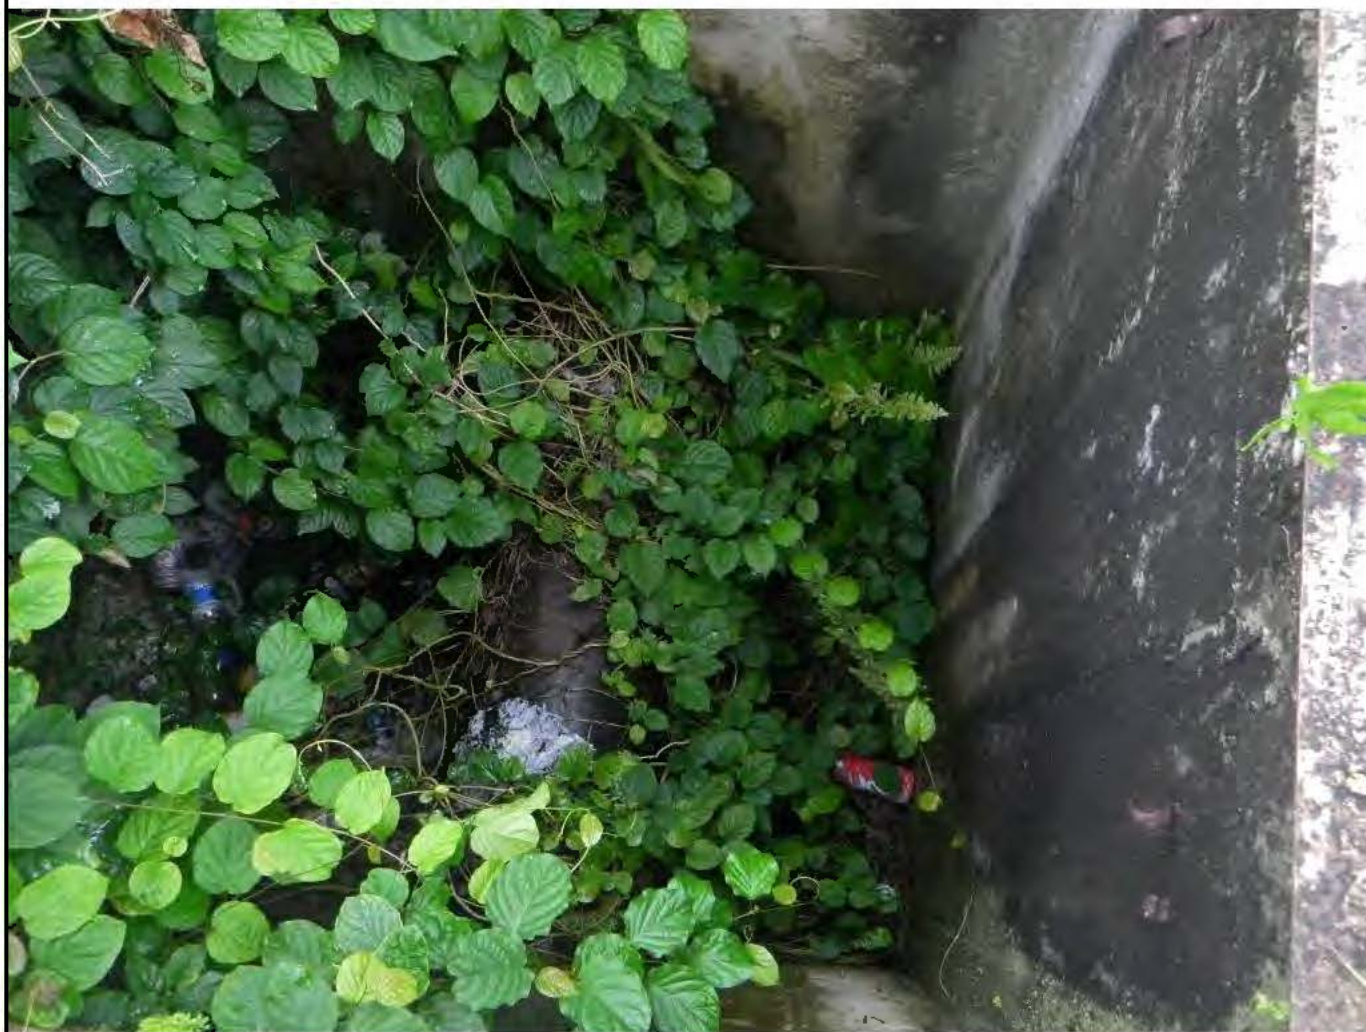
File Name: RIMG0210.JPG

Title	Guam Waterworks Authority (VP0989)
Subject	Central System
Latitude	[REDACTED]
Longitude	[REDACTED]
Photo Direction	[REDACTED]
Elevation	[REDACTED]
Date Time Stamp	5/2/2012 1:20:47 PM
Photographer	K. Sable
Comment	Santa Rita Tank
Description	Line containing leaking valve with constant flow

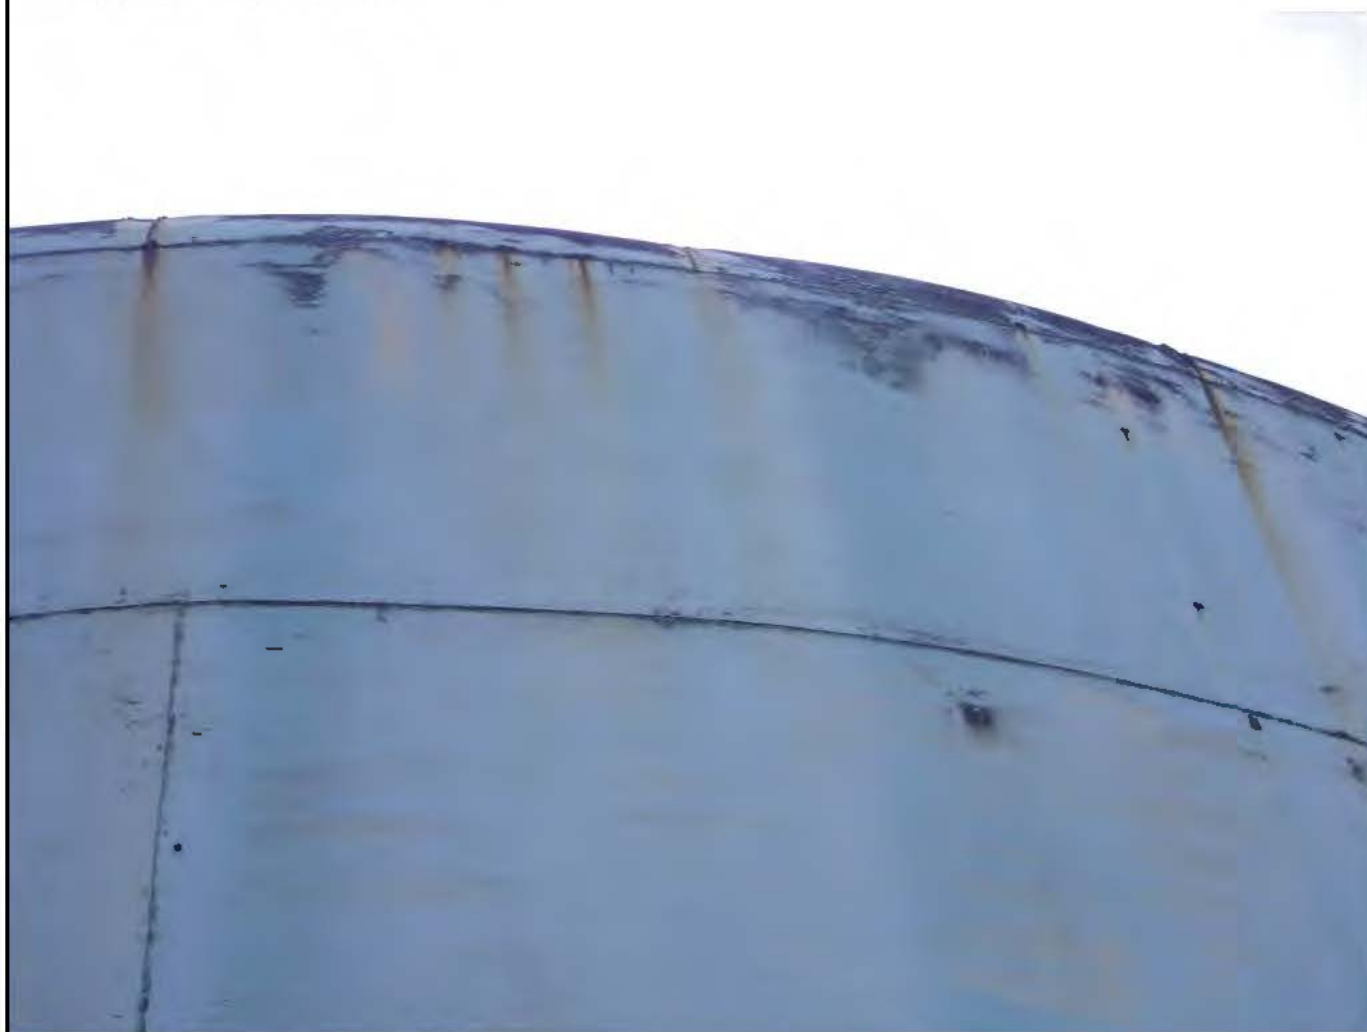
File Name: RIMG0211.JPG

Title	Guam Waterworks Authority (VP0989)
Subject	Central System
Latitude	[REDACTED]
Longitude	[REDACTED]
Photo Direction	[REDACTED]
Elevation	[REDACTED]
Date Time Stamp	5/2/2012 1:23:09 PM
Photographer	K. Sable
Comment	Santa Rita Tank
Description	Sucked in knuckles at top of tank

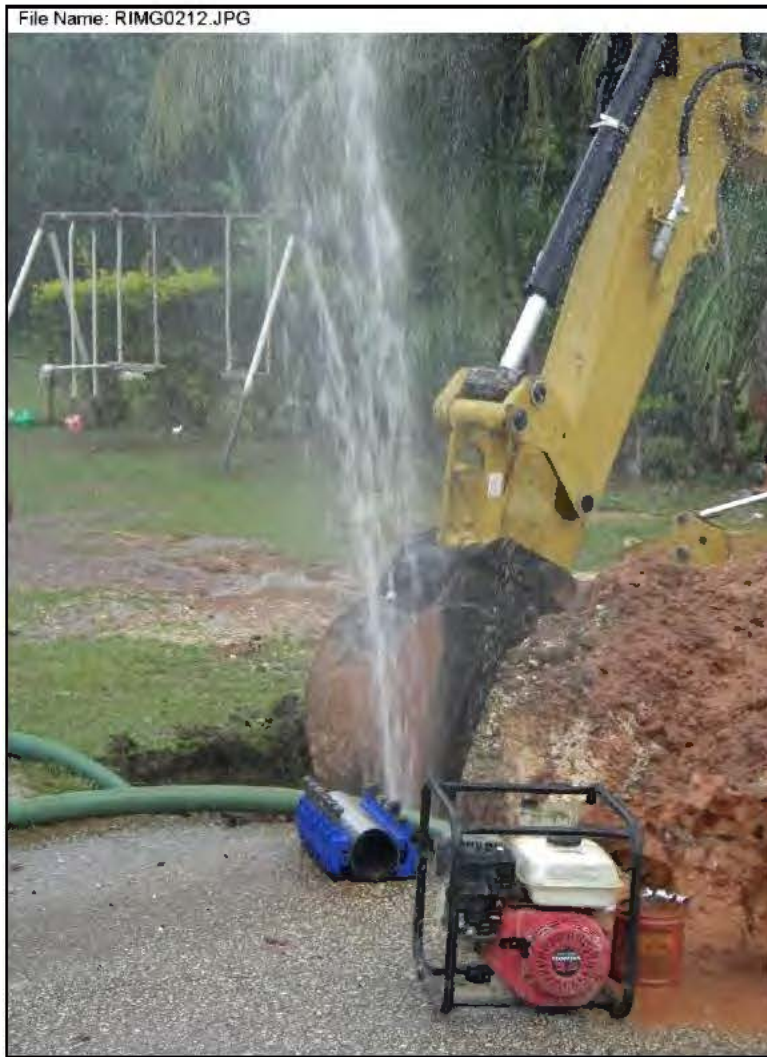
Attributes	
Title	Guam Waterworks Authority (VP0989)
Subject	Central System
Latitude	[REDACTED]
Longitude	[REDACTED]
Photo Direction	[REDACTED]
Elevation	[REDACTED]
Date Time Stamp	5/2/2012 1:35:05 PM
Photographer	K. Sable
Comment	Distribution System
Description	Water line repair

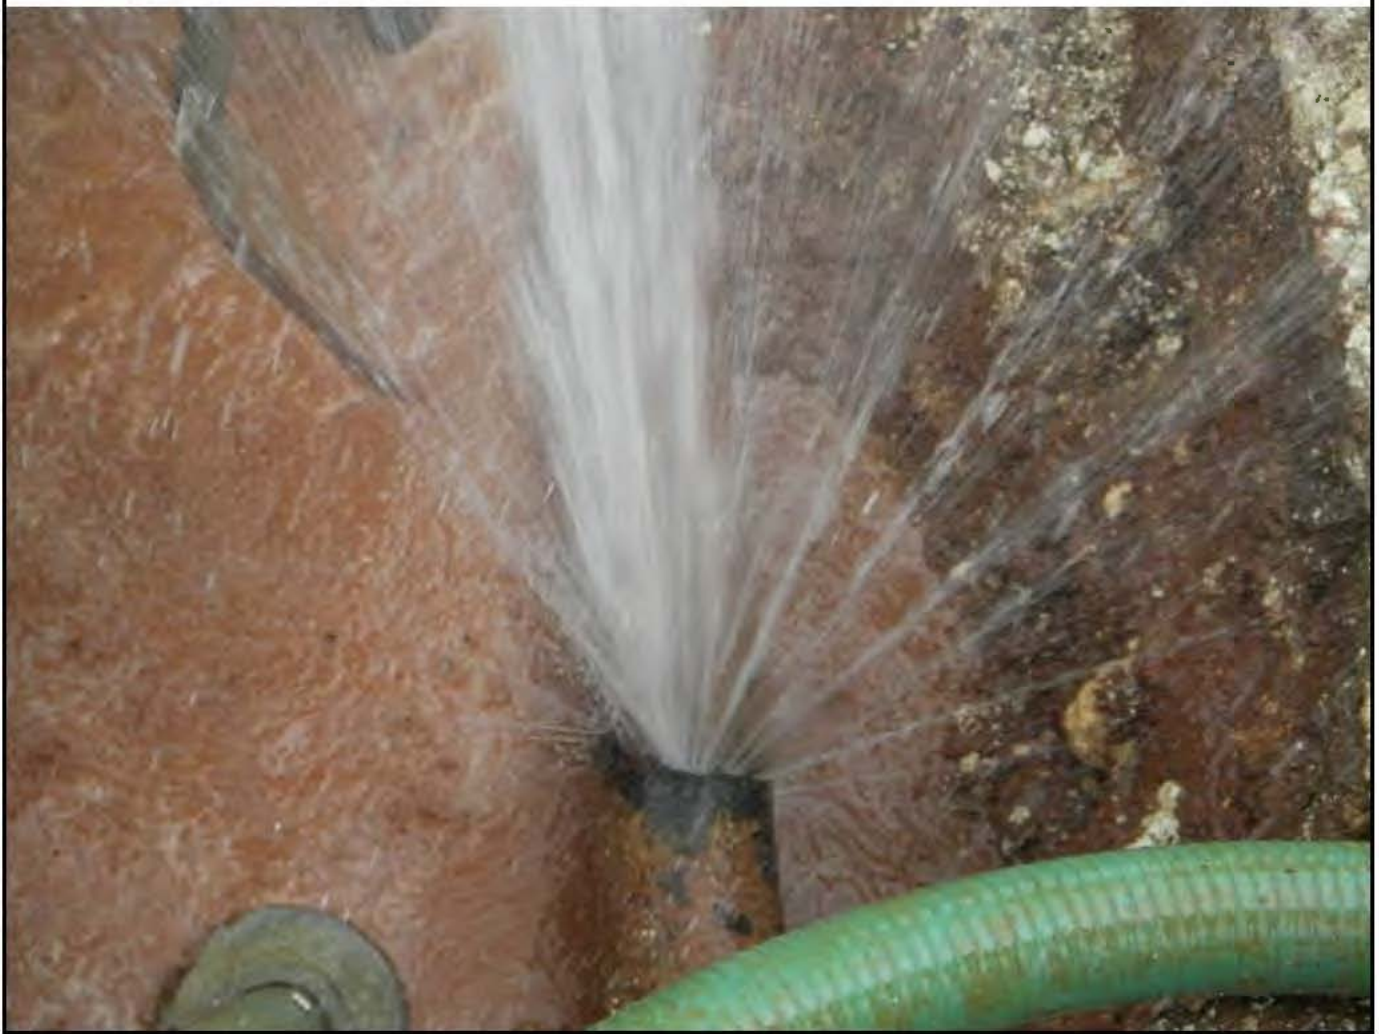
File Name: RIMG0213.JPG

Title	Guam Waterworks Authority (VP0989)
Subject	Central System
Latitude	██████████
Longitude	██████████
Photo Direction	██████████
Elevation	██████
Date Time Stamp	5/2/2012 1:36:02 PM
Photographer	K. Sable
Comment	Distribution System
Description	Water line repair

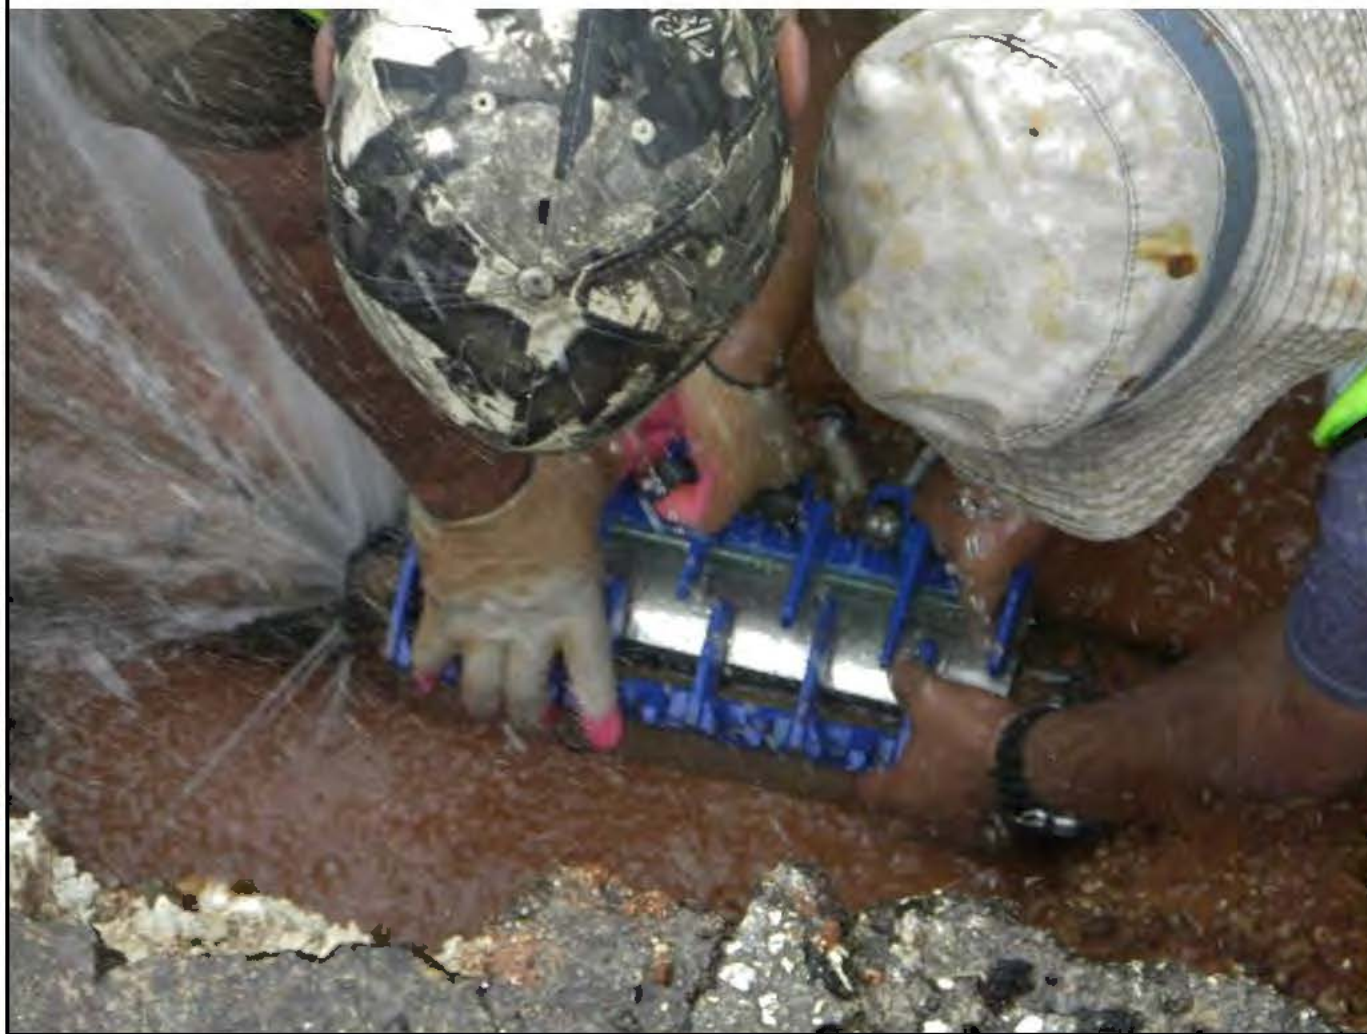
File Name: RIMG0214.JPG

Attributes	
Title	Guam Waterworks Authority (VP0989)
Subject	Central System
Latitude	██████████
Longitude	██████████
Photo Direction	██████
Elevation	██████
Date Time Stamp	5/2/2012 1:37:42 PM
Photographer	K. Sable
Comment	Distribution System
Description	Water line repair
