Guam Waterworks Authority (VP0989)

SDWA Sanitary Survey

Central System

NEIC Field Investigation Photographs

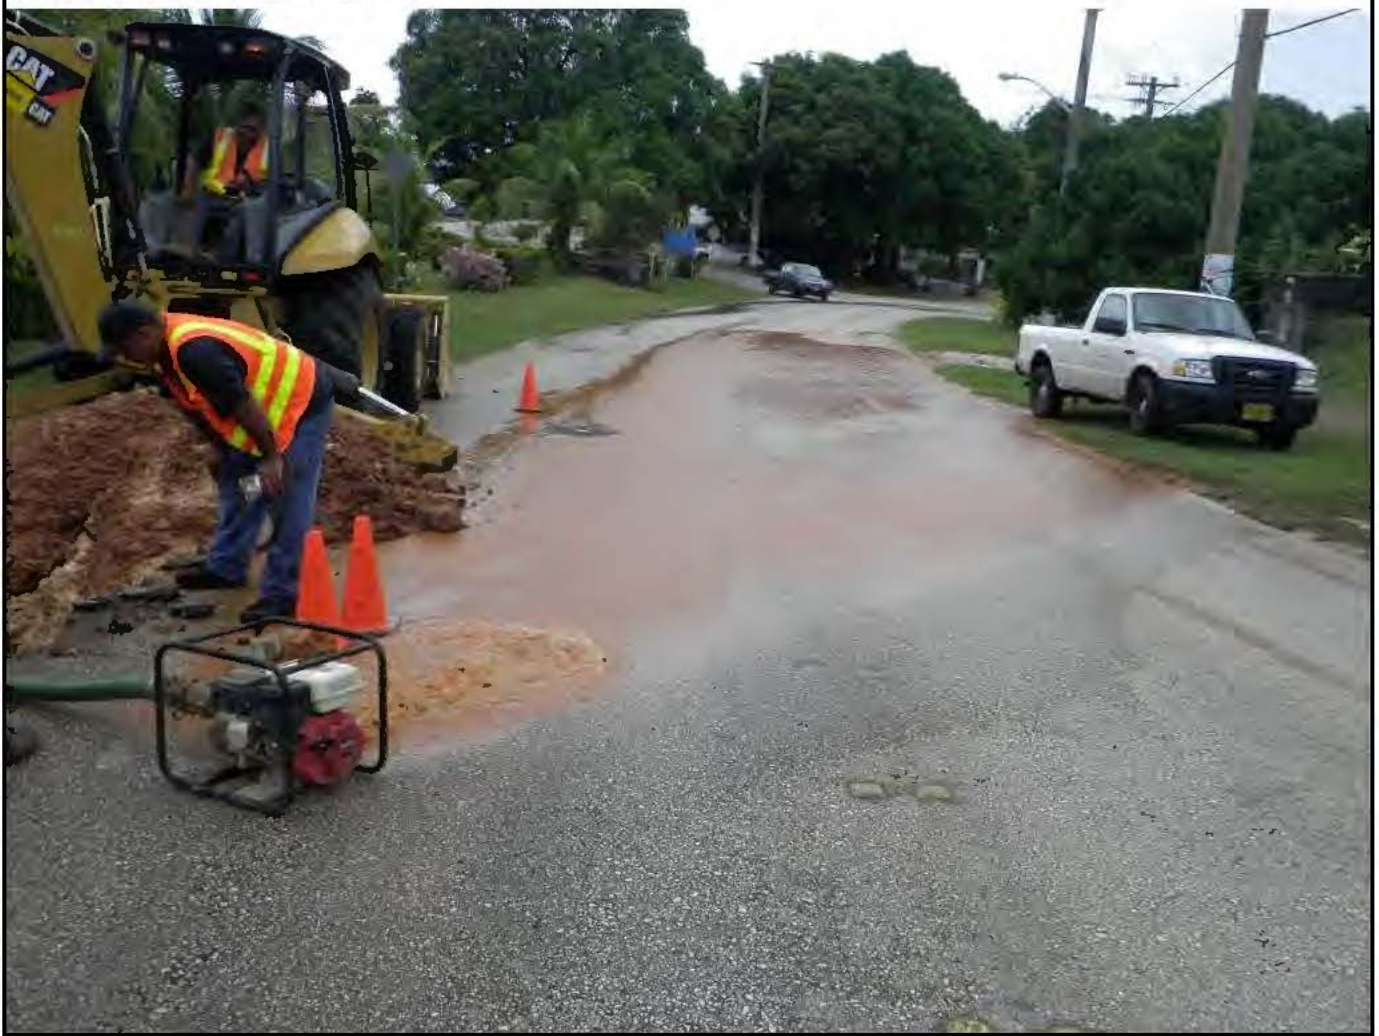
File Name: RIMG0215.JPG

Title	Guam Waterworks Authority (VP0989)
Subject	Central System
Latitude	██████████
Longitude	██████████
Photo Direction	██████████
Elevation	██████
Date Time Stamp	5/2/2012 1:39:45 PM
Photographer	K. Sable
Comment	Distribution System
Description	Water line repair

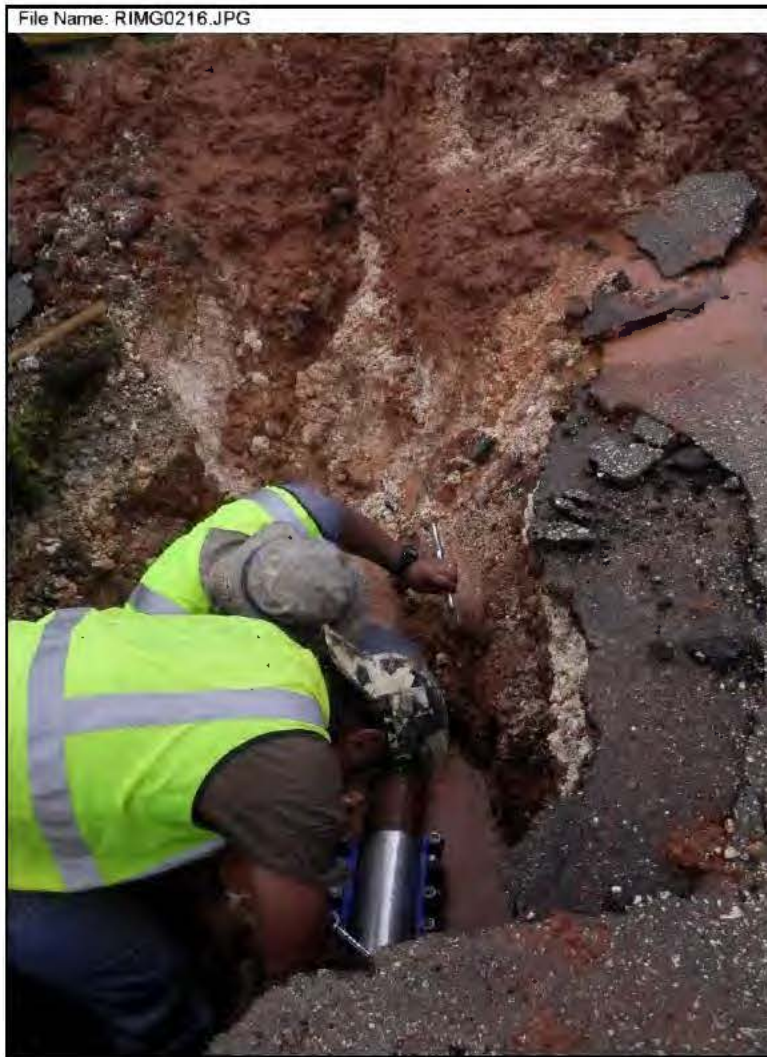
Attributes	
Title	Guam Waterworks Authority (VP0989)
Subject	Central System
Latitude	[REDACTED]
Longitude	[REDACTED]
Photo Direction	[REDACTED]
Elevation	[REDACTED]
Date Time Stamp	5/2/2012 1:39:59 PM
Photographer	K. Sable
Comment	Distribution System
Description	Water line repair
