Guam Waterworks Authority (VP0989)

SDWA Sanitary Survey

Southern System

NEIC Field Investigation Photographs

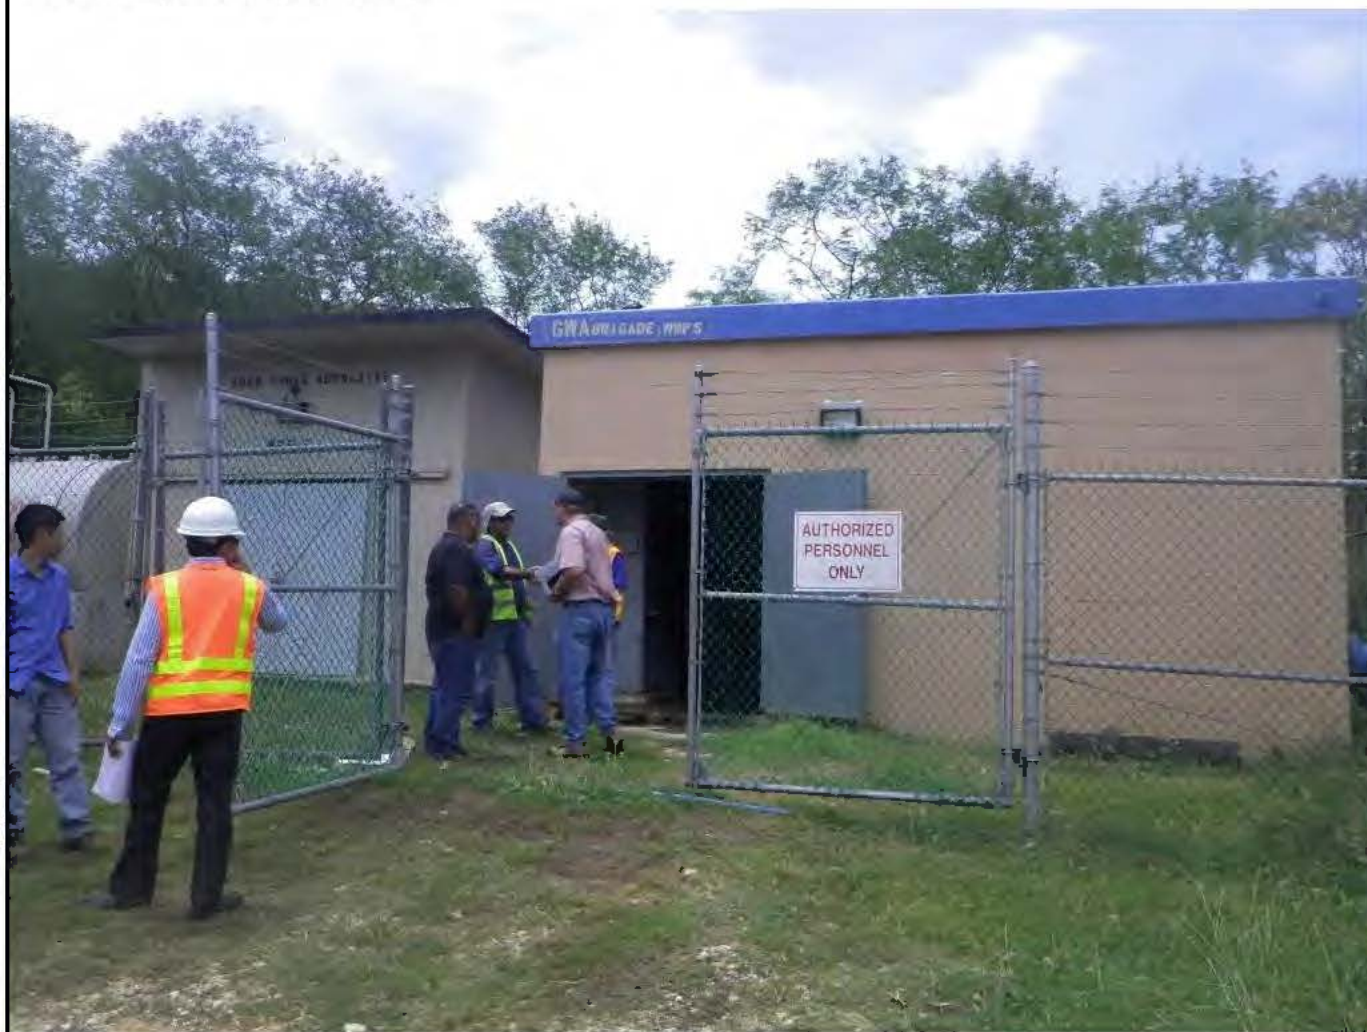
File Name: RIMG0074.JPG

Title	Guam Waterworks Authority (VP0989)
Subject	Southern System
Latitude	██████████
Longitude	██████████
Photo Direction	██████████
Elevation	██████
Date Time Stamp	4/26/2012 1:20:36 PM
Photographer	K. Sable
Comment	Brigade Pump Station
Description	Overview of Brigade pump station

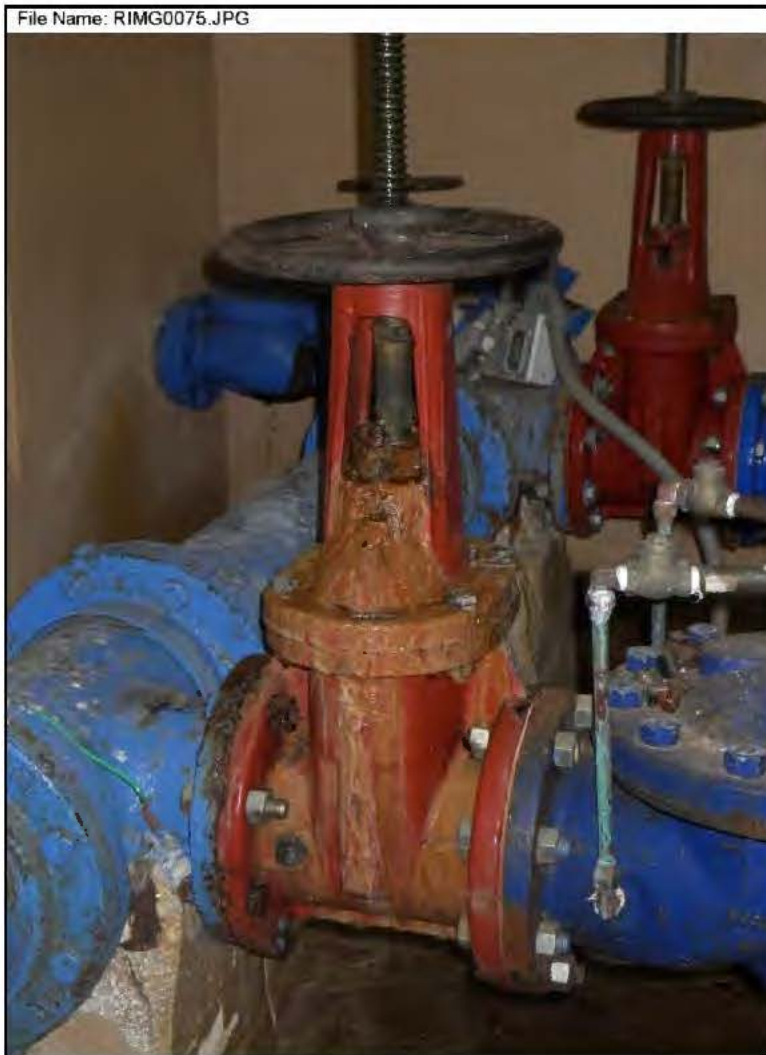
Attributes	
Title	Guam Waterworks Authority (VP0989)
Subject	Southern System
Latitude	[REDACTED]
Longitude	[REDACTED]
Photo Direction	[REDACTED]
Elevation	[REDACTED]
Date Time Stamp	4/26/2012 1:26:14 PM
Photographer	K. Sable
Comment	Brigade Pump Station
Description	Leaking gate valve on discharge line

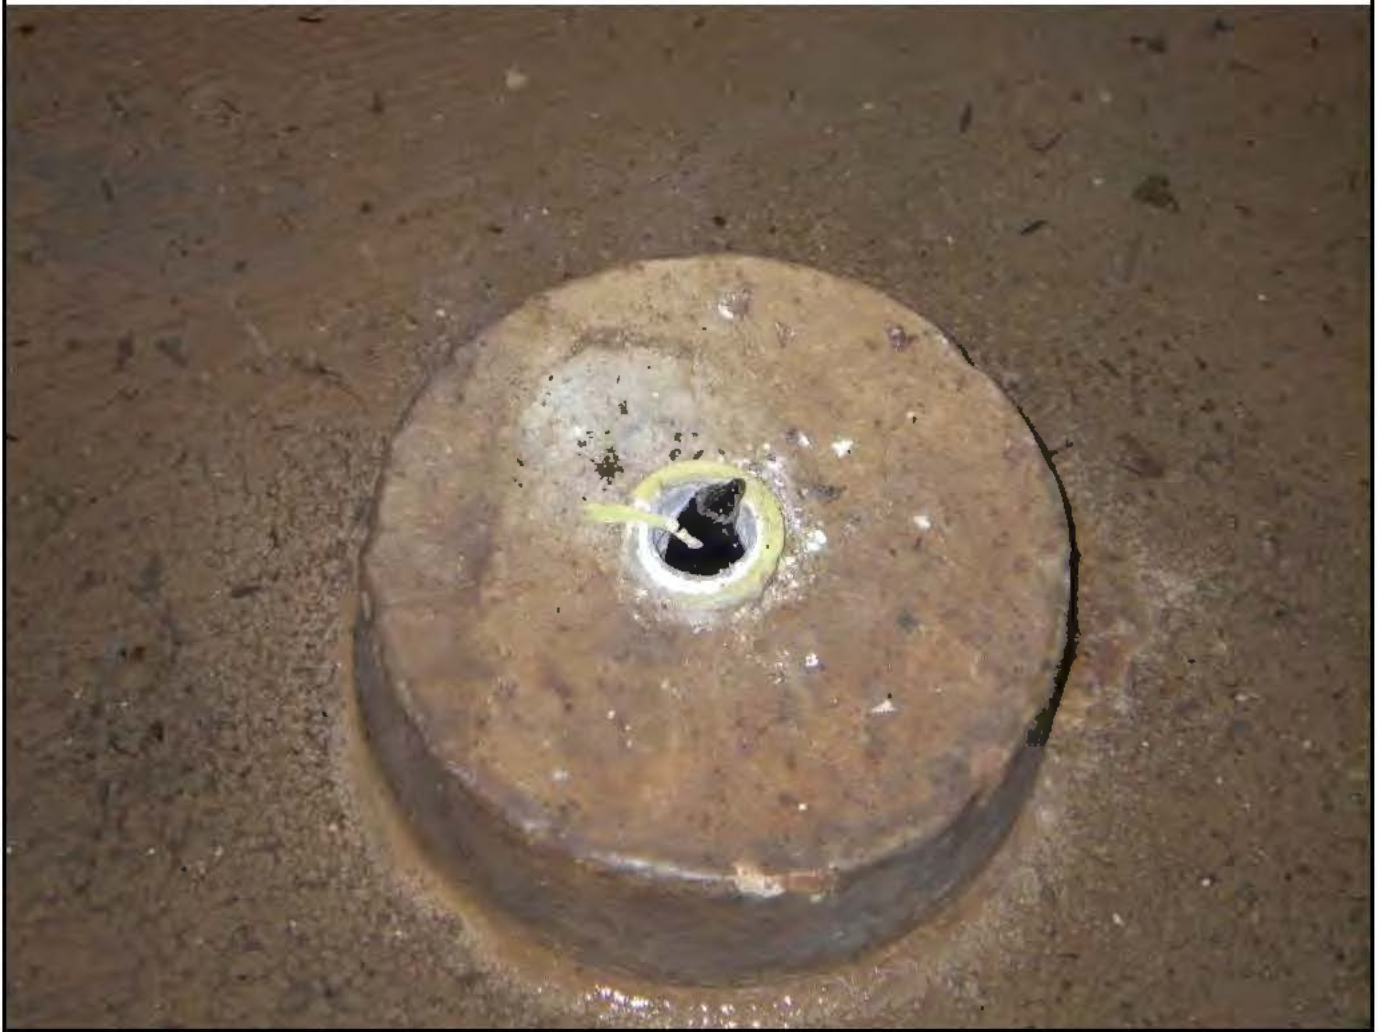
File Name: RIMG0076.JPG

Title	Guam Waterworks Authority (VP0989)
Subject	Southern System
Latitude	██████████
Longitude	██████████
Photo Direction	██
Elevation	██
Date Time Stamp	4/26/2012 1:27:08 PM
Photographer	K. Sable
Comment	Brigade Pump Station
Description	Hole in floor with electrical exposure

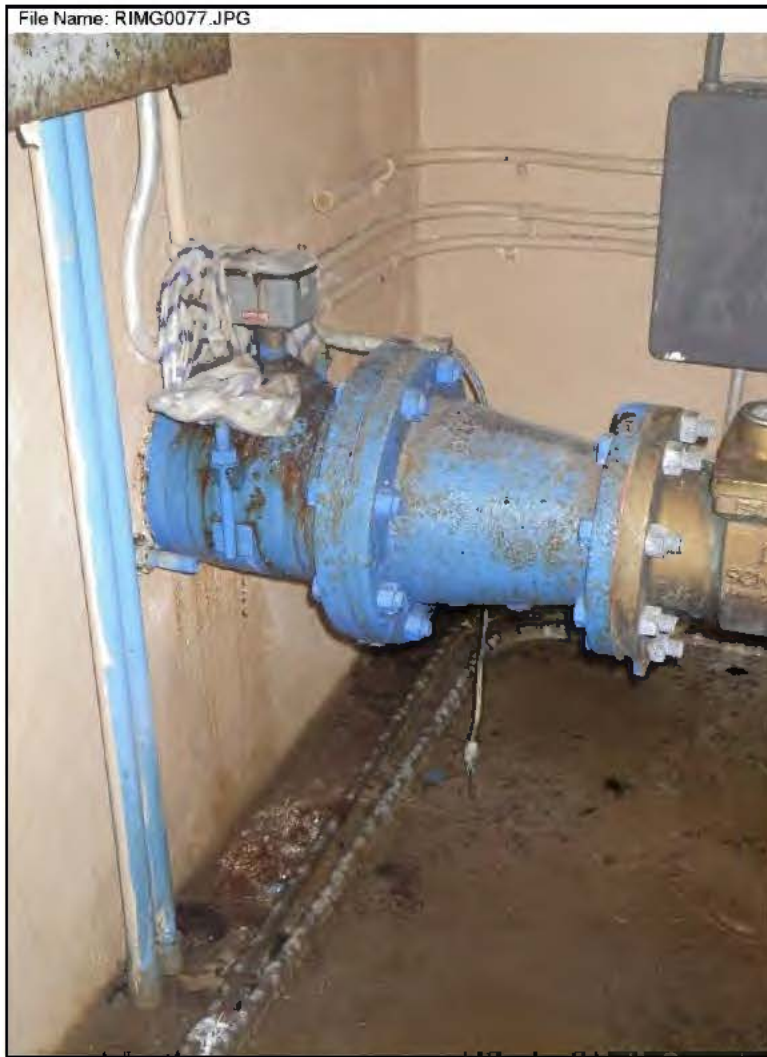
Attributes	
Title	Guam Waterworks Authority (VP0989)
Subject	Southern System
Latitude	[REDACTED]
Longitude	[REDACTED]
Photo Direction	[REDACTED]
Elevation	[REDACTED]
Date Time Stamp	4/26/2012 1:27:23 PM
Photographer	K. Sable
Comment	Brigade Pump Station
Description	Leaking discharge line where it exits station

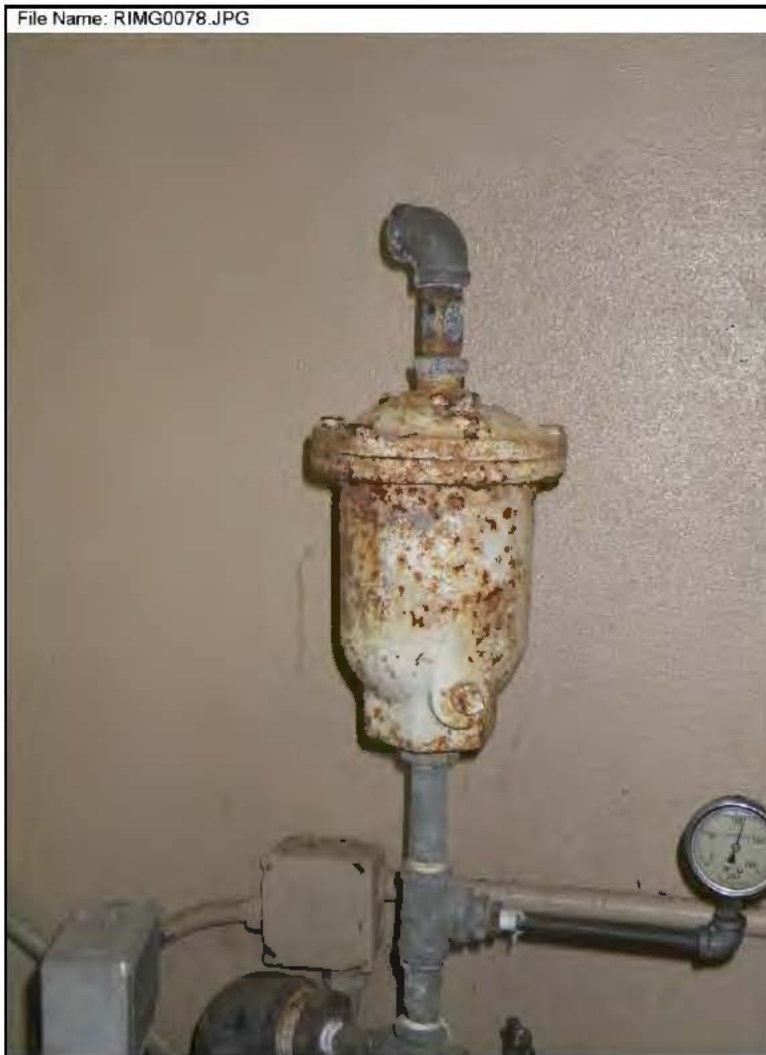
Attributes	
Title	Guam Waterworks Authority (VP0989)
Subject	Southern System
Latitude	[REDACTED]
Longitude	[REDACTED]
Photo Direction	[REDACTED]
Elevation	[REDACTED]
Date Time Stamp	4/26/2012 1:30:23 PM
Photographer	K. Sable
Comment	Brigade Pump Station
Description	Air relief assembly

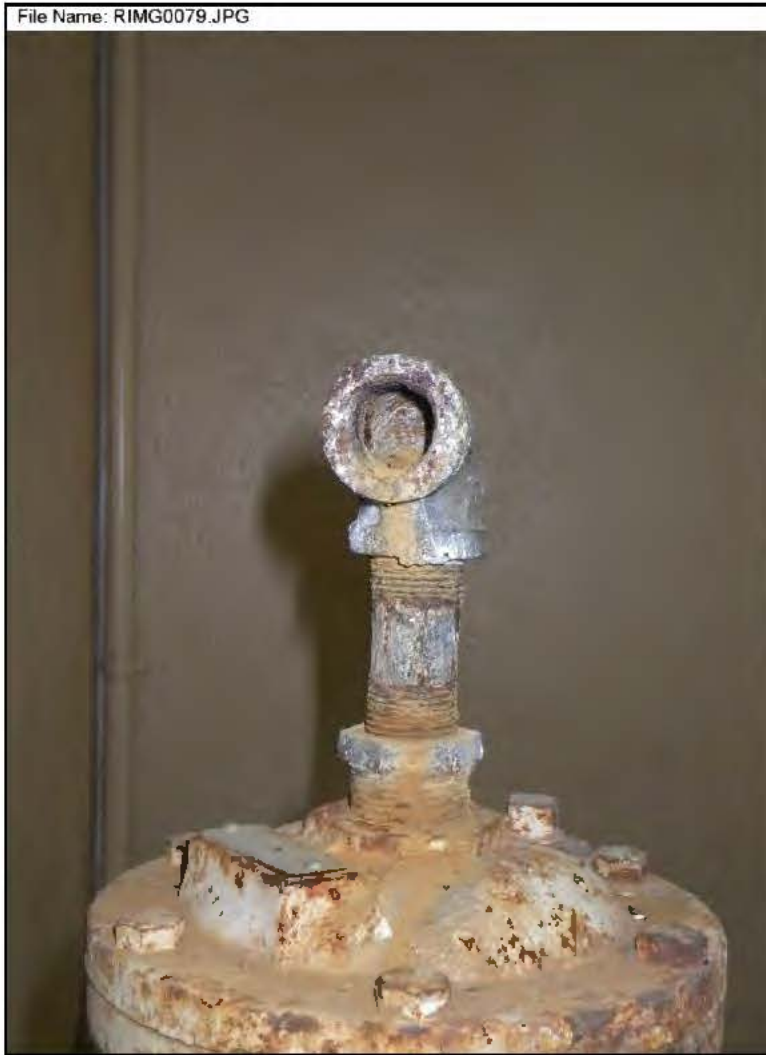
Attributes	
Title	Guam Waterworks Authority (VP0989)
Subject	Southern System
Latitude	██████████
Longitude	██████████
Photo Direction	██████
Elevation	██████
Date Time Stamp	4/26/2012 1:30:44 PM
Photographer	K. Sable
Comment	Brigade Pump Station
Description	Close-up air relief valve

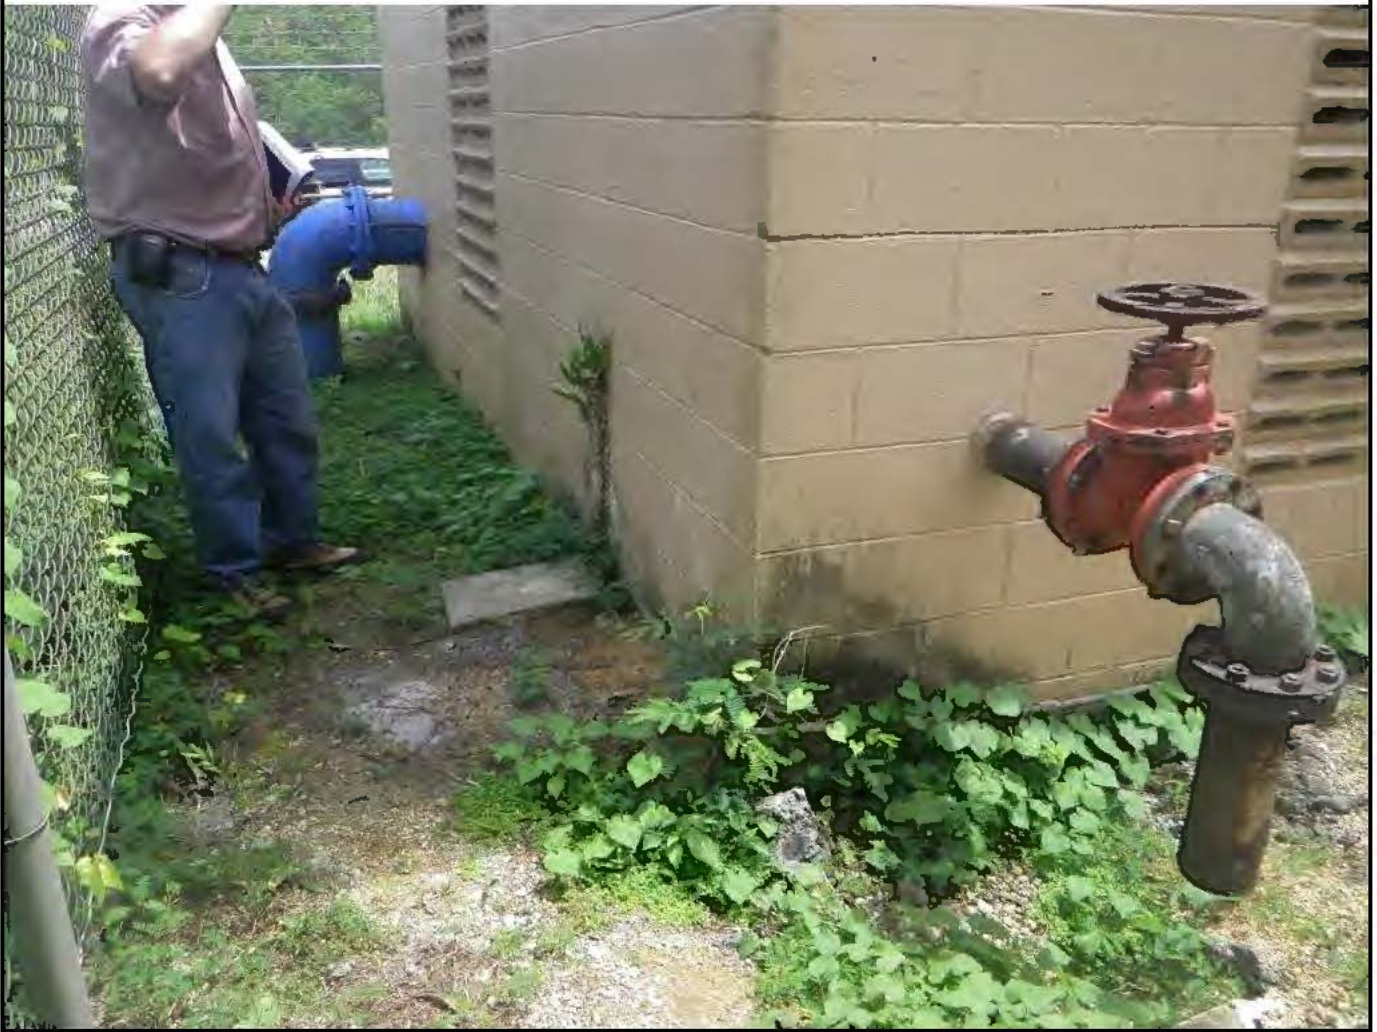
File Name: RIMG0080.JPG

Title	Guam Waterworks Authority (VP0989)
Subject	Southern System
Latitude	[REDACTED]
Longitude	[REDACTED]
Photo Direction	[REDACTED]
Elevation	[REDACTED]
Date Time Stamp	4/26/2012 1:34:00 PM
Photographer	K. Sable
Comment	Brigade Pump Station
Description	Bypass pipe exiting pump station which discharges to ground (right). Floor drain that discharges to ground (left).

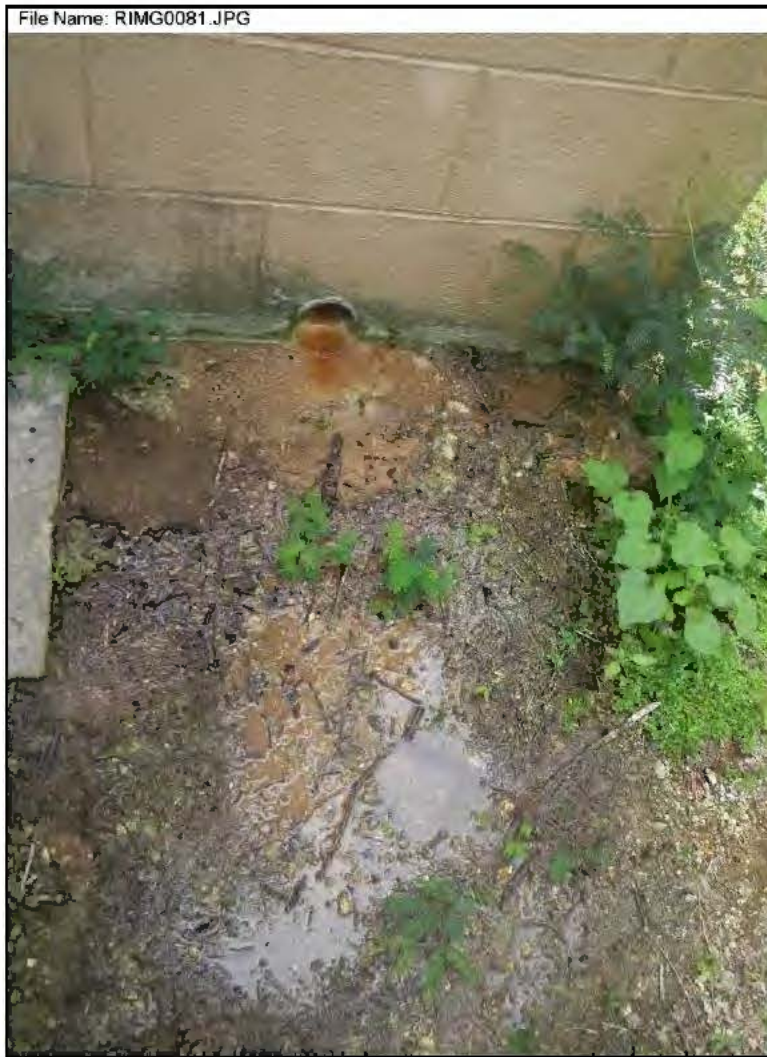
Attributes	
Title	Guam Waterworks Authority (VP0989)
Subject	Southern System
Latitude	[REDACTED]
Longitude	[REDACTED]
Photo Direction	[REDACTED]
Elevation	[REDACTED]
Date Time Stamp	4/26/2012 1:35:17 PM
Photographer	K. Sable
Comment	Brigade Pump Station
Description	Close-up of floor drain that discharges to ground

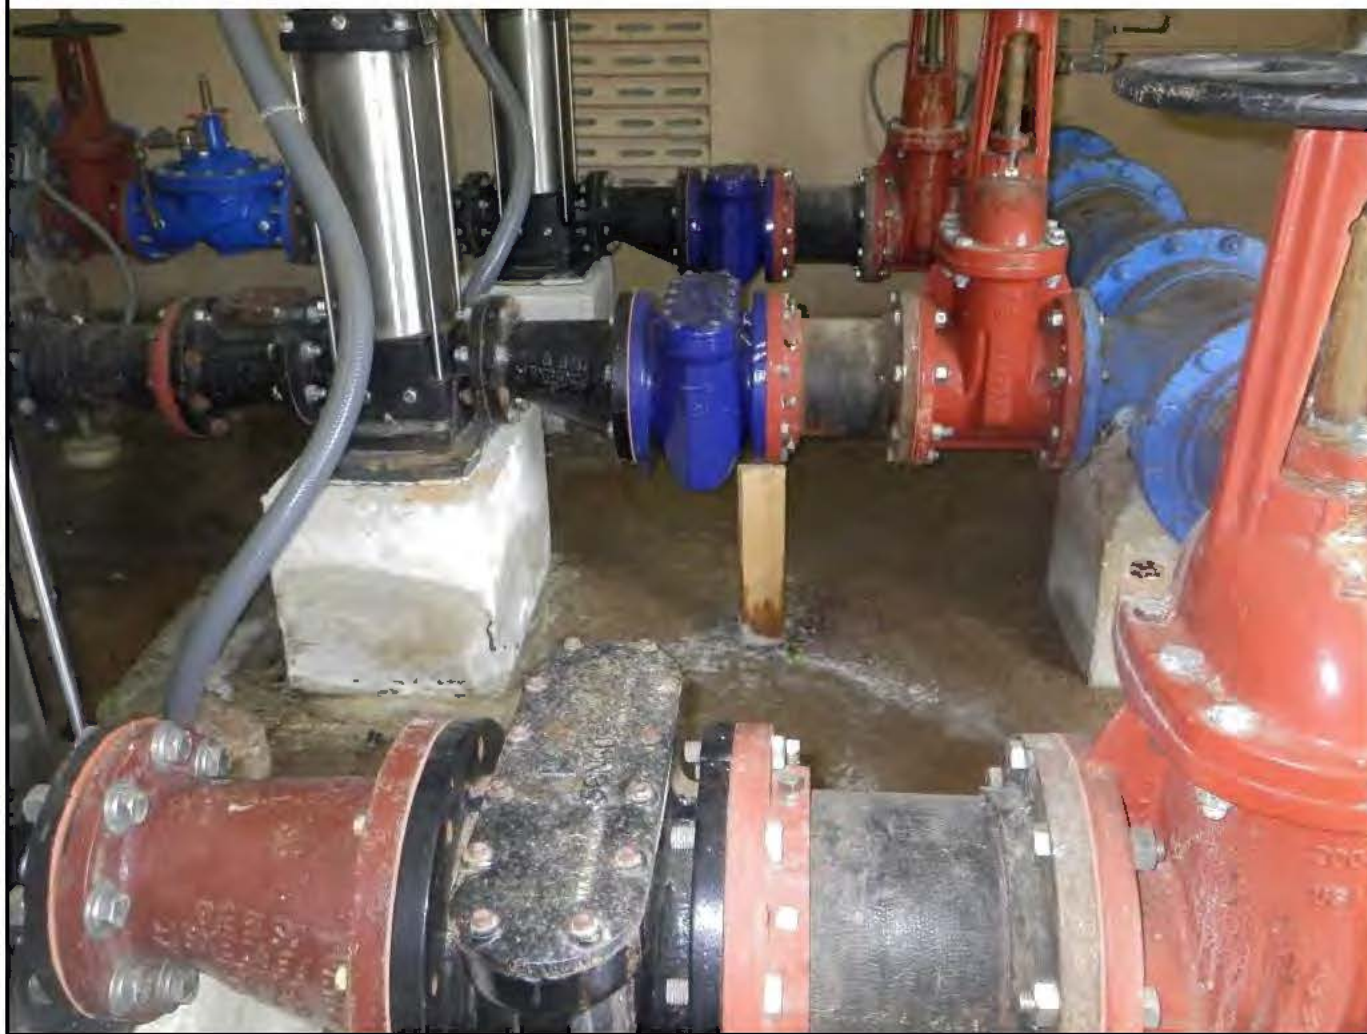
File Name: RIMG0082.JPG

Title	Guam Waterworks Authority (VP0989)
Subject	Southern System
Latitude	██████████
Longitude	██████████
Photo Direction	██████████
Elevation	██████████
Date Time Stamp	4/26/2012 1:36:30 PM
Photographer	K. Sable
Comment	Brigade Pump Station
Description	2 " x 4 " board supporting pipe

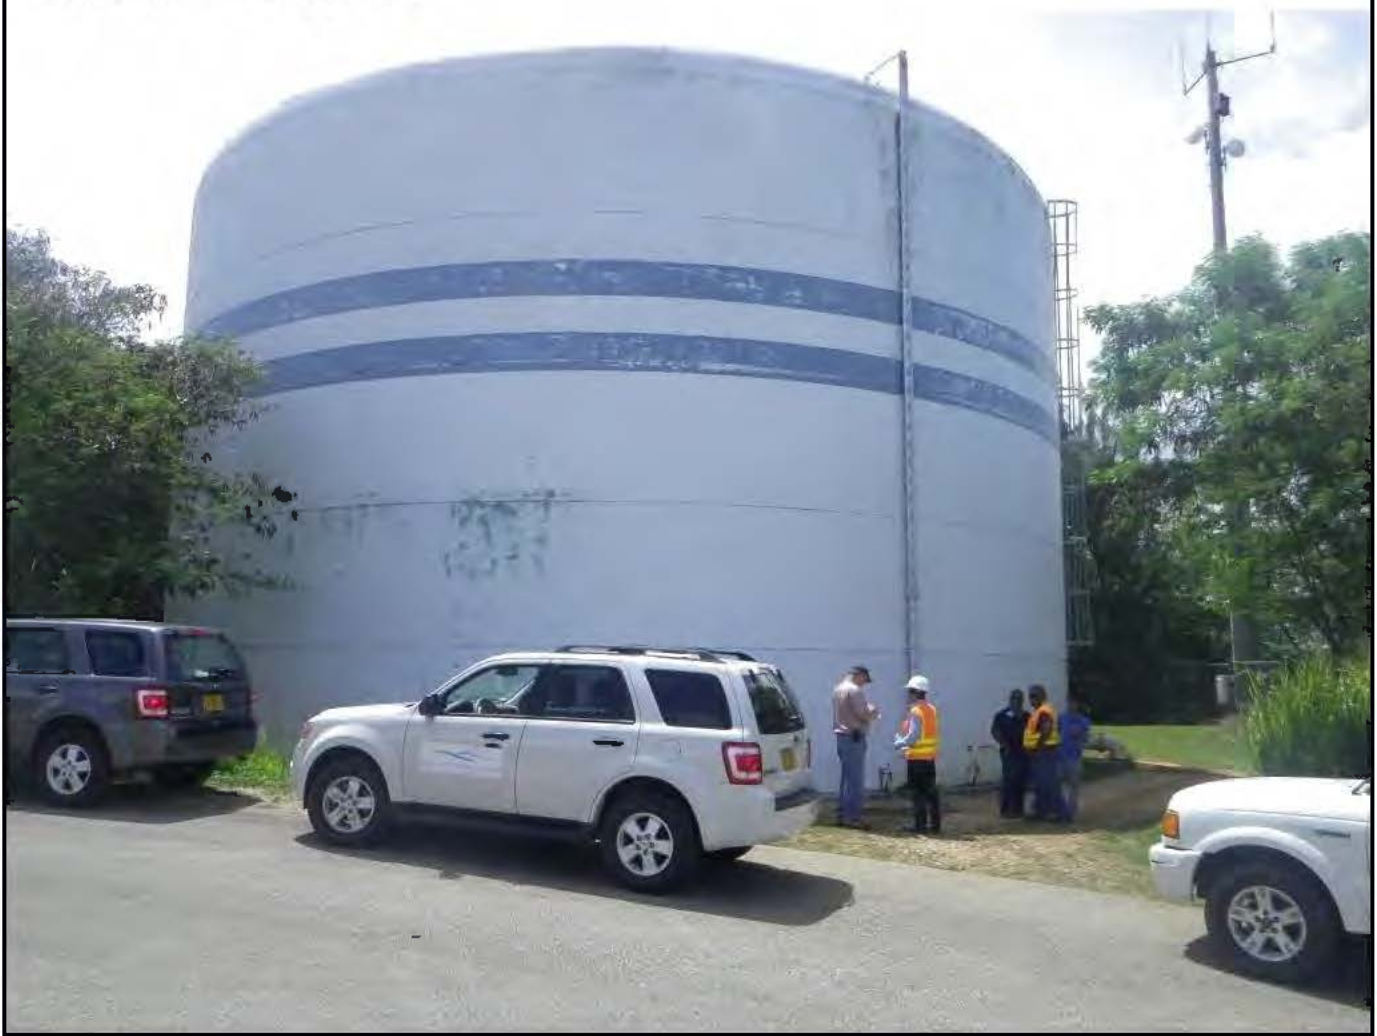
File Name: RIMG0083.JPG

Title	Guam Waterworks Authority (VP0989)
Subject	Southern System
Latitude	██████████
Longitude	██████████
Photo Direction	██████████
Elevation	██████████
Date Time Stamp	4/26/2012 1:57:18 PM
Photographer	K. Sable
Comment	Windward Hills Tank
Description	Overview of tank

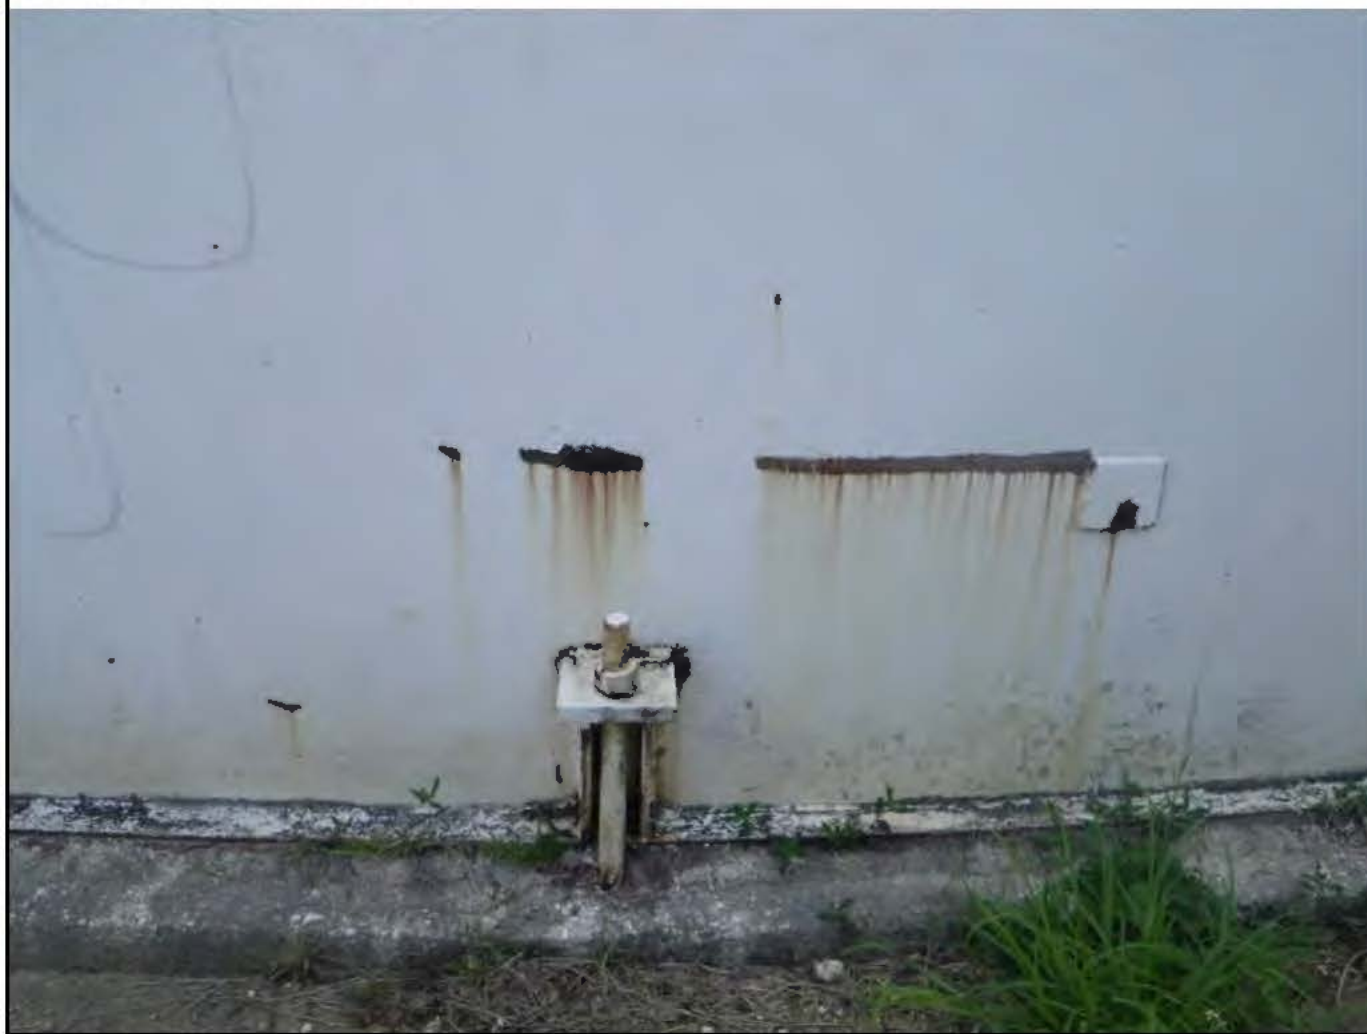
File Name: RIMG0084.JPG

Title	Guam Waterworks Authority (VP0989)
Subject	Southern System
Latitude	██████████
Longitude	██████████
Photo Direction	██████ /
Elevation	██████
Date Time Stamp	4/26/2012 1:58:51 PM
Photographer	K. Sable
Comment	Windward Hills Tank
Description	Rust on tank

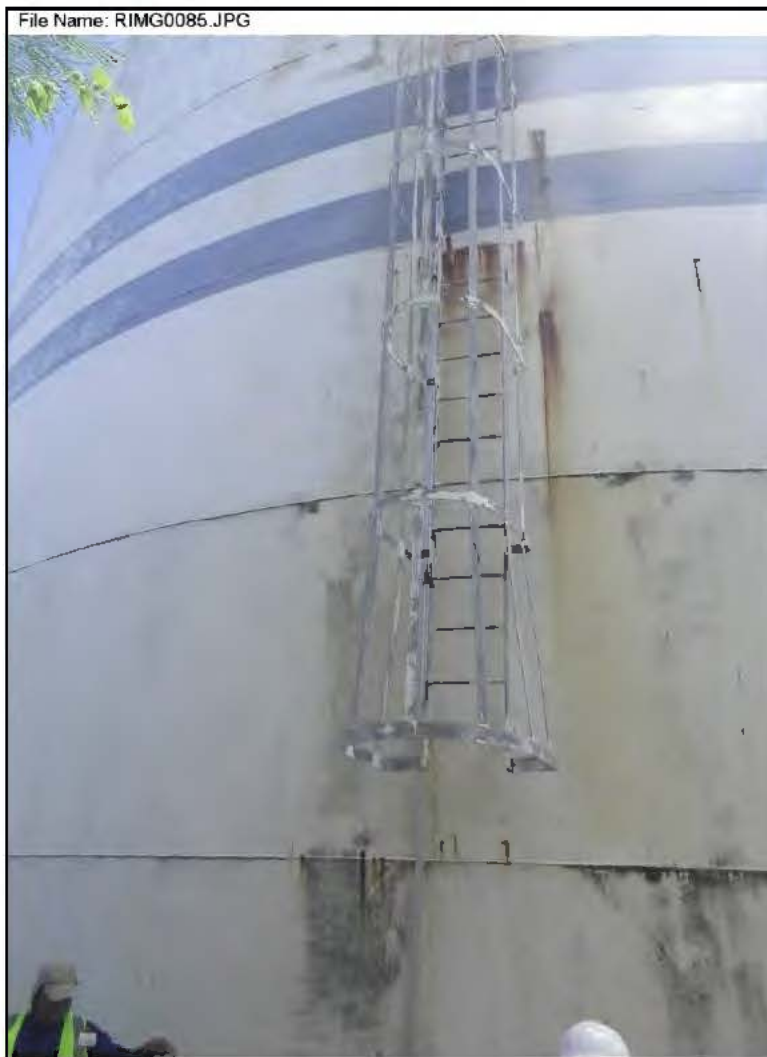
Attributes	
Title	Guam Waterworks Authority (VP0989)
Subject	Southern System
Latitude	[REDACTED]
Longitude	[REDACTED]
Photo Direction	[REDACTED]
Elevation	[REDACTED]
Date Time Stamp	4/26/2012 2:00:24 PM
Photographer	K. Sable
Comment	Windward Hills Tank
Description	Ladder

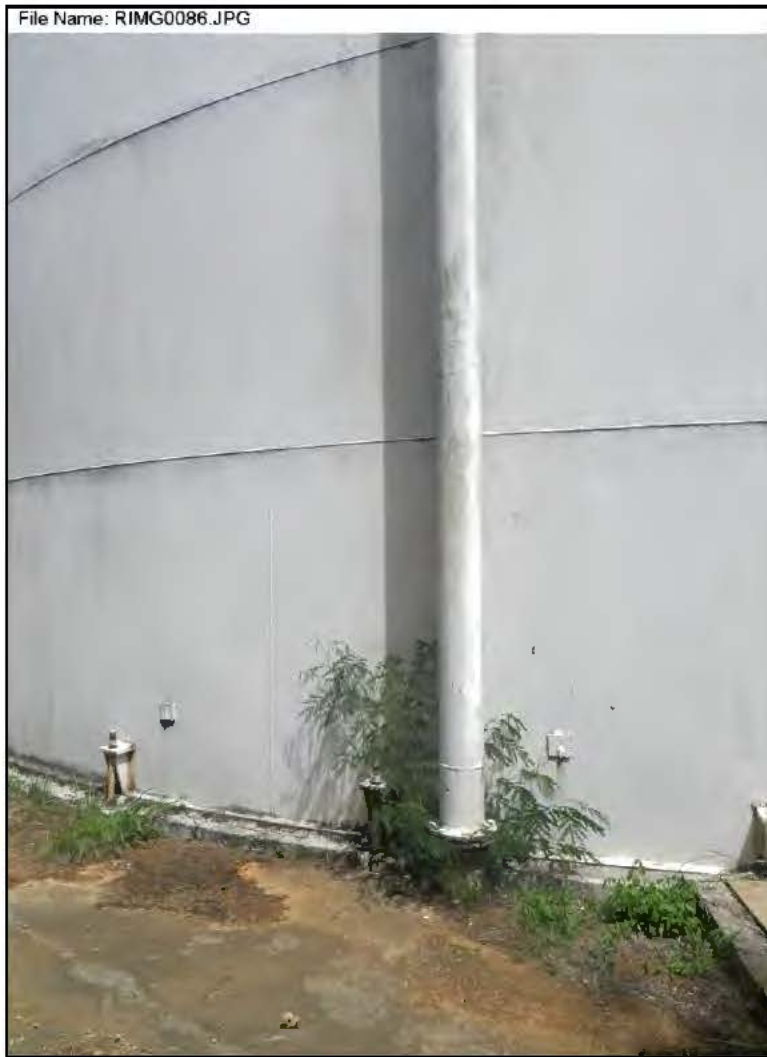
Attributes	
Title	Guam Waterworks Authority (VP0989)
Subject	Southern System
Latitude	[REDACTED]
Longitude	[REDACTED]
Photo Direction	[REDACTED]
Elevation	[REDACTED]
Date Time Stamp	4/26/2012 2:07:10 PM
Photographer	K. Sable
Comment	Windward Hills Tank
Description	Overflow pipe with vegetation

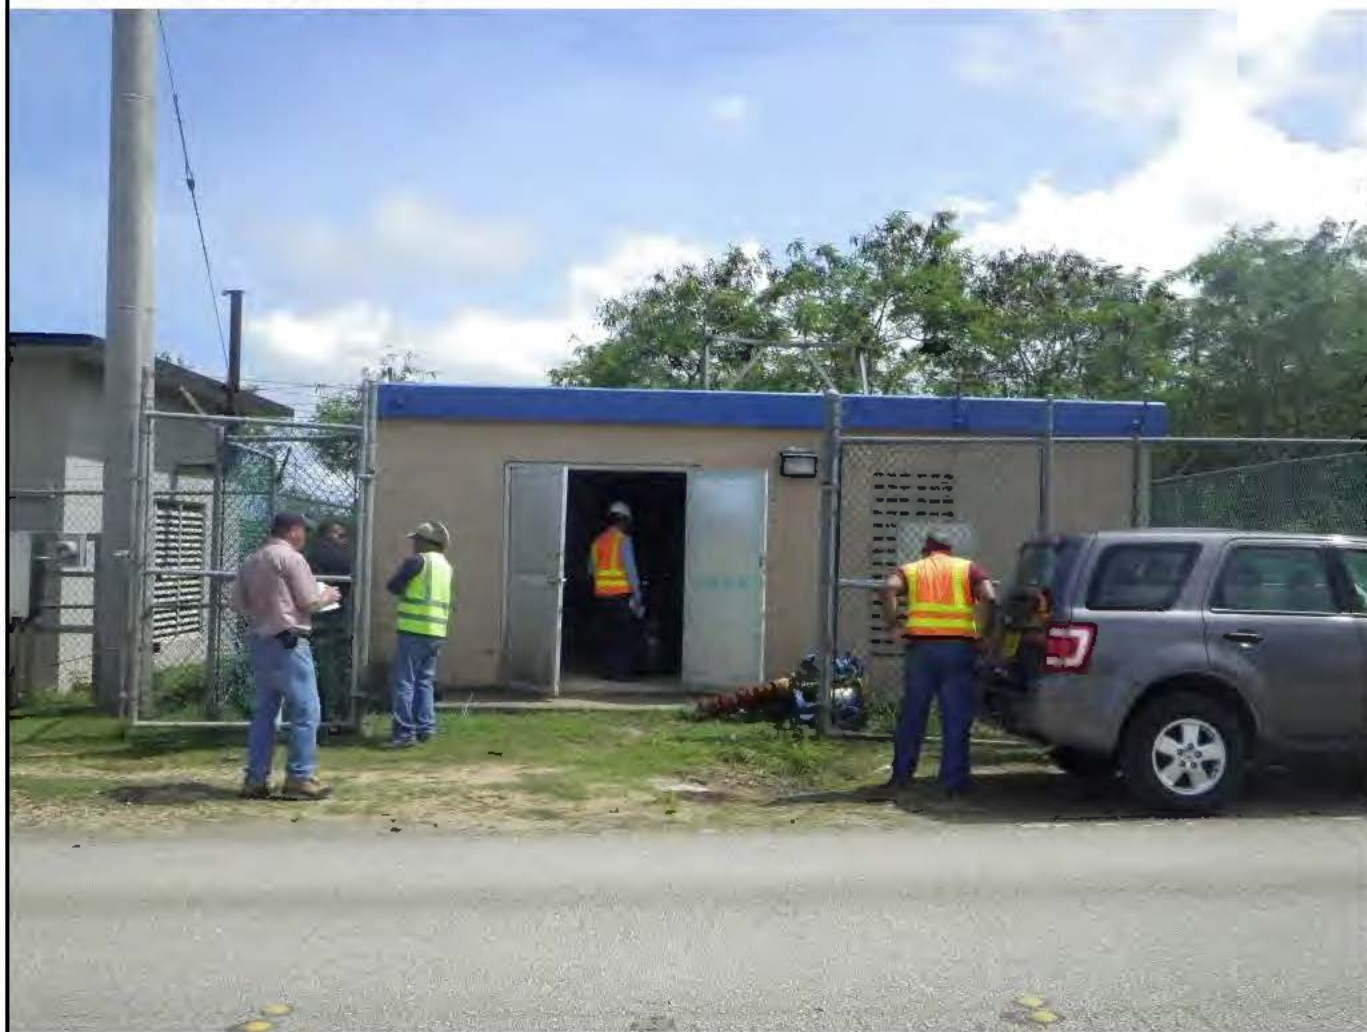
File Name: RIMG0087.JPG

Title	Guam Waterworks Authority (VP0989)
Subject	Southern System
Latitude	██████████
Longitude	██████████
Photo Direction	██████
Elevation	██████
Date Time Stamp	4/26/2012 2:21:45 PM
Photographer	K. Sable
Comment	Windward Hills Pump Station
Description	Pump station building

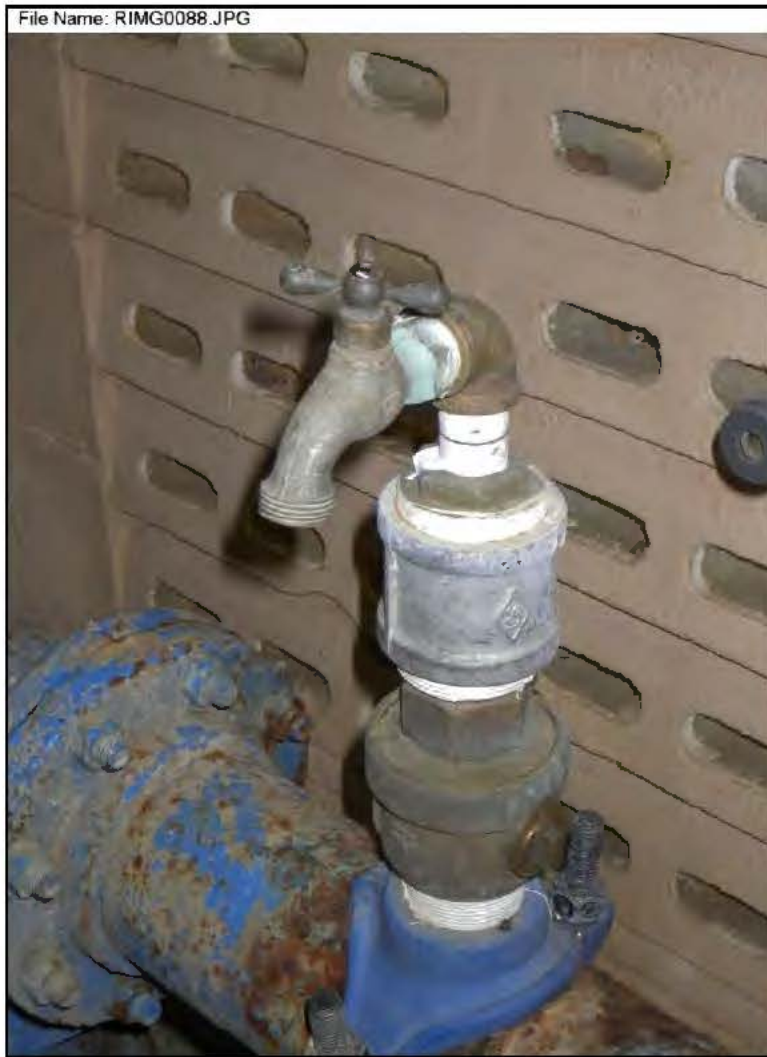
Attributes	
Title	Guam Waterworks Authority (VP0989)
Subject	Southern System
Latitude	[REDACTED]
Longitude	[REDACTED]
Photo Direction	[REDACTED]
Elevation	[REDACTED]
Date Time Stamp	4/26/2012 2:26:49 PM
Photographer	K. Sable
Comment	Windward Hills Pump Station
Description	Sample tap

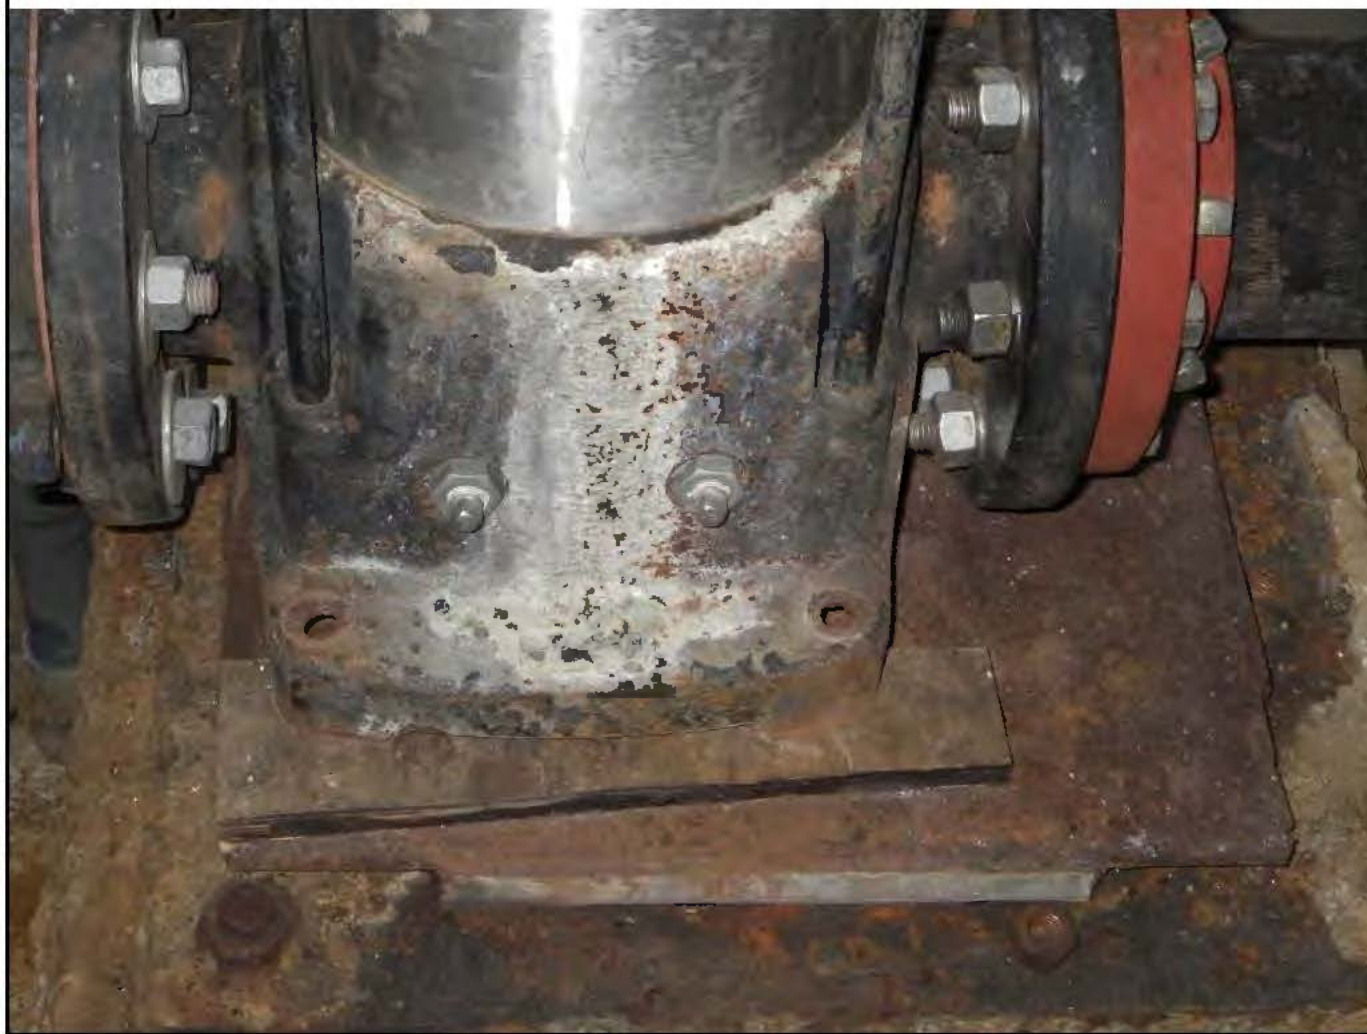
File Name: RIMG0089.JPG

Title	Guam Waterworks Authority (VP0989)
Subject	Southern System
Latitude	██████████
Longitude	██████████
Photo Direction	██████
Elevation	████
Date Time Stamp	4/26/2012 2:27:16 PM
Photographer	K. Sable
Comment	Windward Hills Pump Station
Description	No bolts on pump # 1

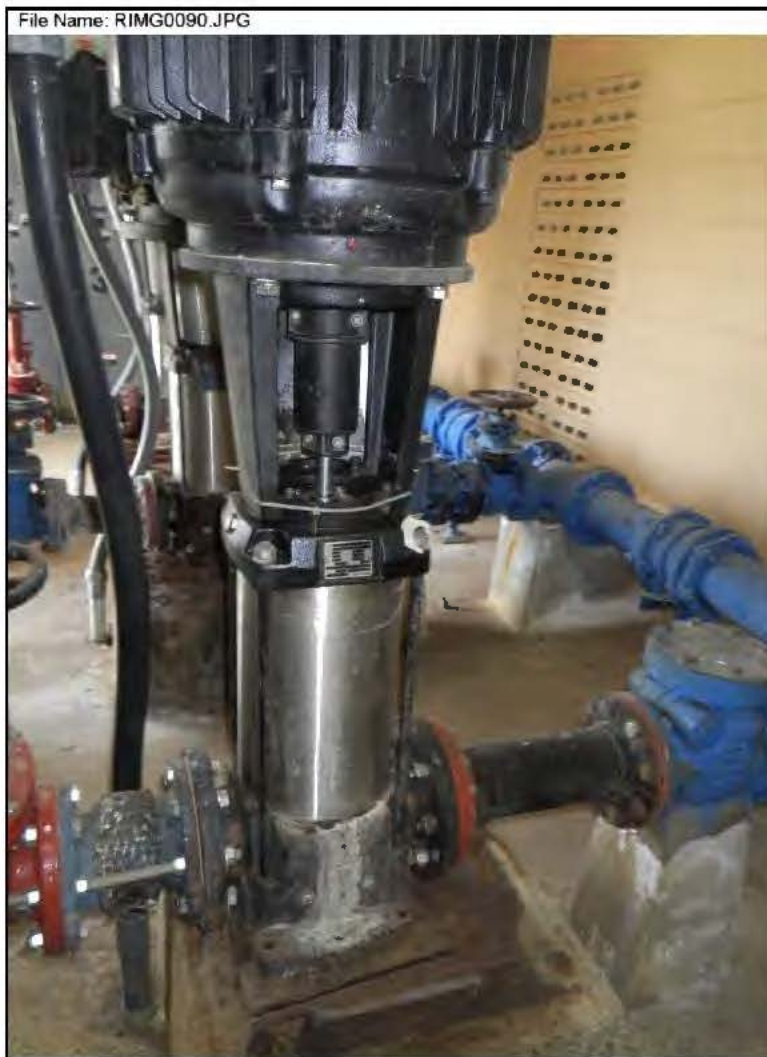
Attributes	
Title	Guam Waterworks Authority (VP0989)
Subject	Southern System
Latitude	██████████
Longitude	██████████
Photo Direction	██████
Elevation	████
Date Time Stamp	4/26/2012 2:27:59 PM
Photographer	K. Sable
Comment	Windward Hills Pump Station
Description	Pump # 1 open to running parts

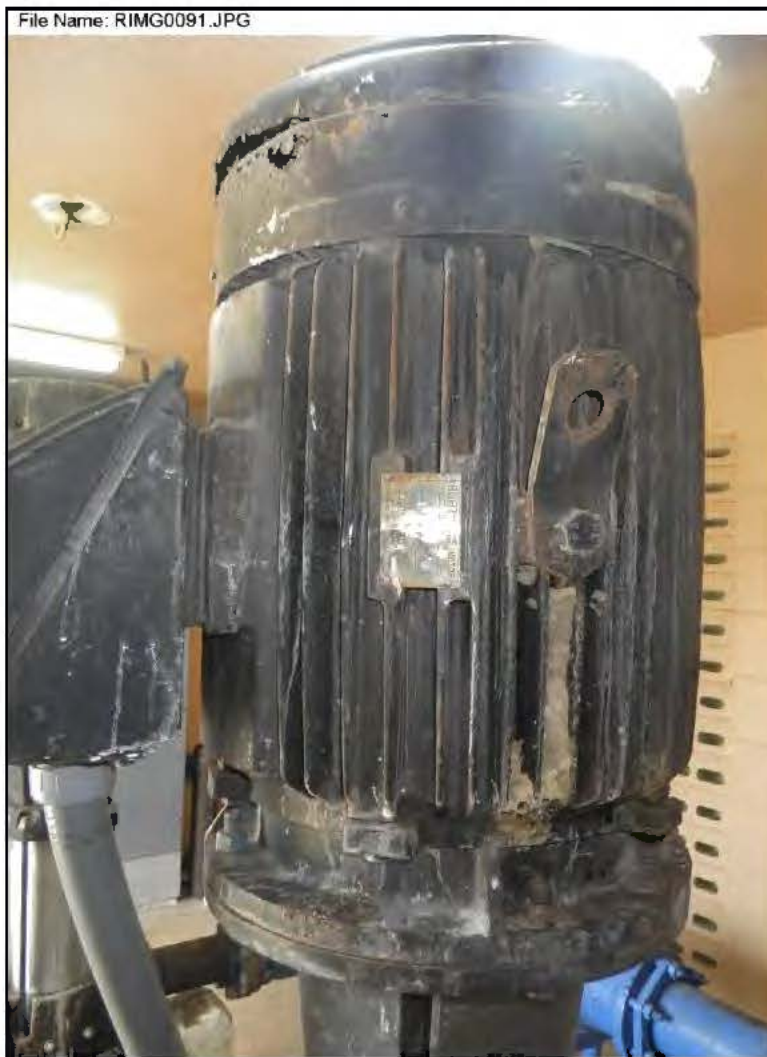
Attributes	
Title	Guam Waterworks Authority (VP0989)
Subject	Southern System
Latitude	[REDACTED]
Longitude	[REDACTED]
Photo Direction	[REDACTED]
Elevation	[REDACTED]
Date Time Stamp	4/26/2012 2:29:02 PM
Photographer	K. Sable
Comment	Windward Hills Pump Station
Description	Pump # 2 wasp nests and corrosion

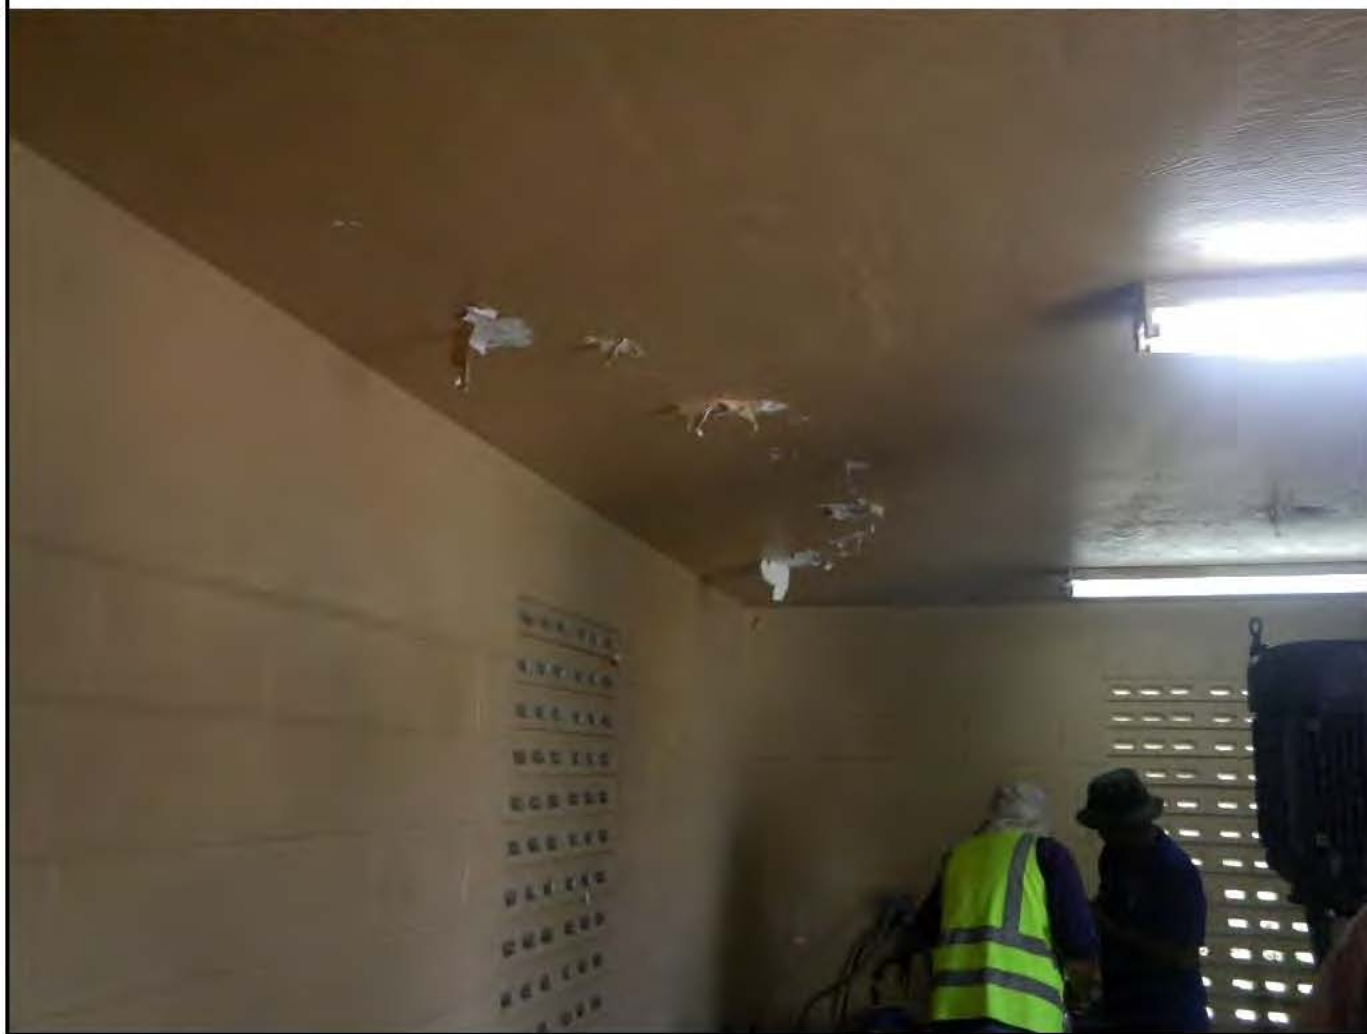
File Name: RIMG0092.JPG

Title	Guam Waterworks Authority (VP0989)
Subject	Southern System
Latitude	██████████
Longitude	██████████
Photo Direction	██████████
Elevation	██████
Date Time Stamp	4/26/2012 2:29:30 PM
Photographer	K. Sable
Comment	Windward Hills Pump Station
Description	Ceiling paint corrosion
