Guam Waterworks Authority (VP0989)

SDWA Sanitary Survey

Southern System

NEIC Field Investigation Photographs

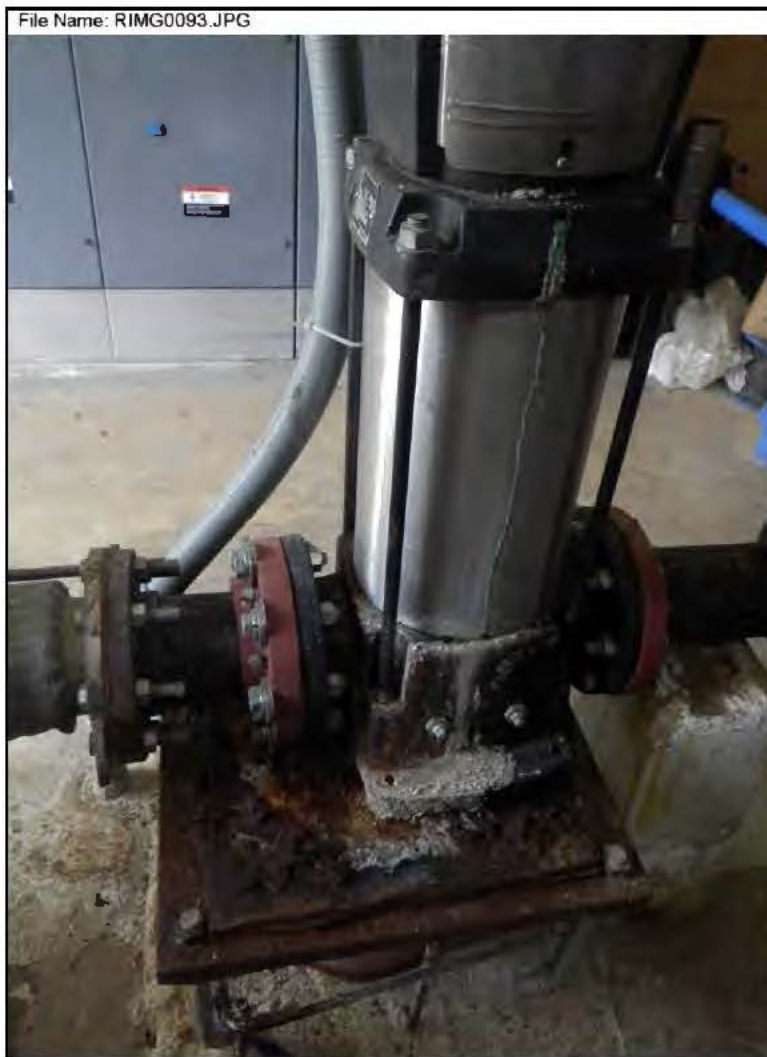
Attributes	
Title	Guam Waterworks Authority (VP0989)
Subject	Southern System
Latitude	[REDACTED]
Longitude	[REDACTED]
Photo Direction	[REDACTED]
Elevation	[REDACTED]
Date Time Stamp	4/26/2012 2:29:53 PM
Photographer	K. Sable
Comment	Windward Hills Pump Station
Description	Pump # 3 leak and corrosion

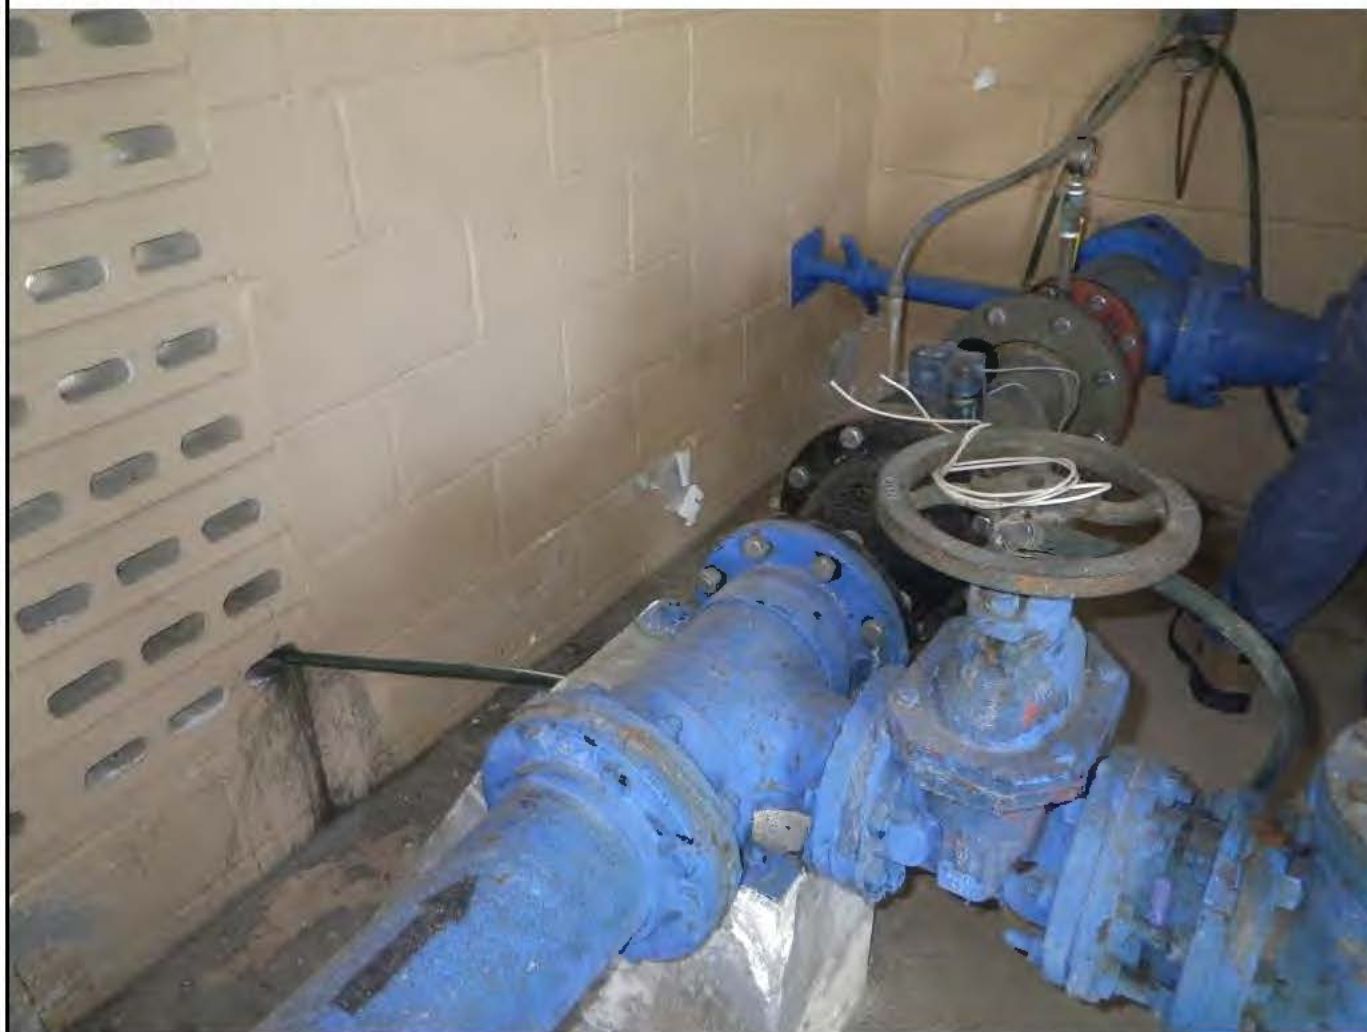
File Name: RIMG0094.JPG

Title	Guam Waterworks Authority (VP0989)
Subject	Southern System
Latitude	██████████
Longitude	██████████
Photo Direction	██████████
Elevation	██████
Date Time Stamp	4/26/2012 2:31:30 PM
Photographer	K. Sable
Comment	Windward Hills Pump Station
Description	Outside hose pulled through window

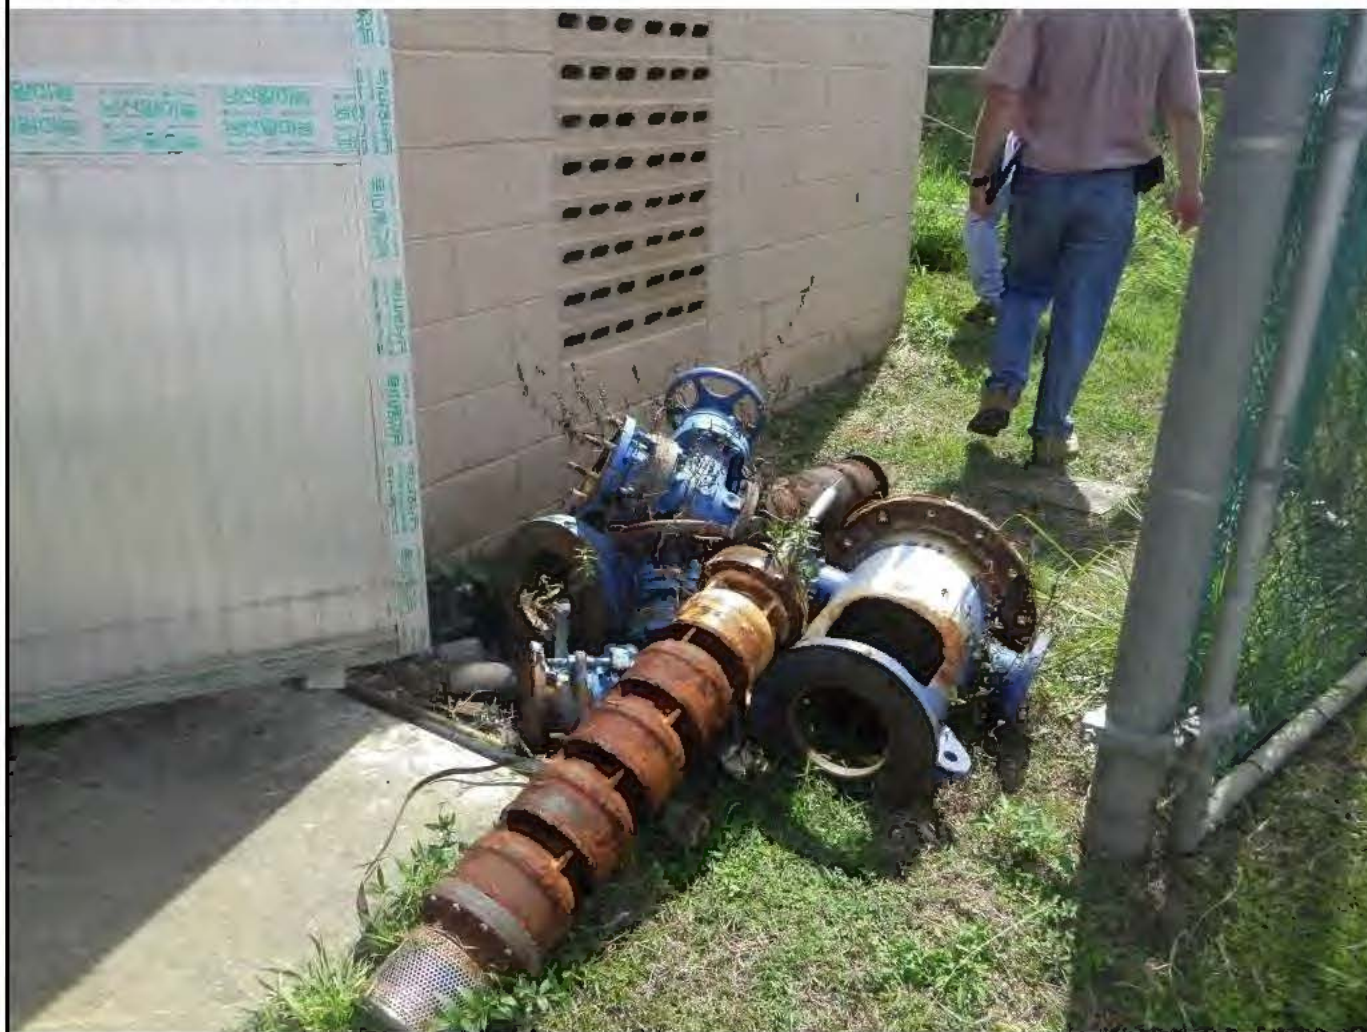
File Name: RIMG0095.JPG

Title	Guam Waterworks Authority (VP0989)
Subject	Southern System
Latitude	[REDACTED]
Longitude	[REDACTED]
Photo Direction	[REDACTED]
Elevation	[REDACTED]
Date Time Stamp	4/26/2012 2:33:11 PM
Photographer	K. Sable
Comment	Windward Hills Pump Station
Description	Stockpile of debris outside pump station

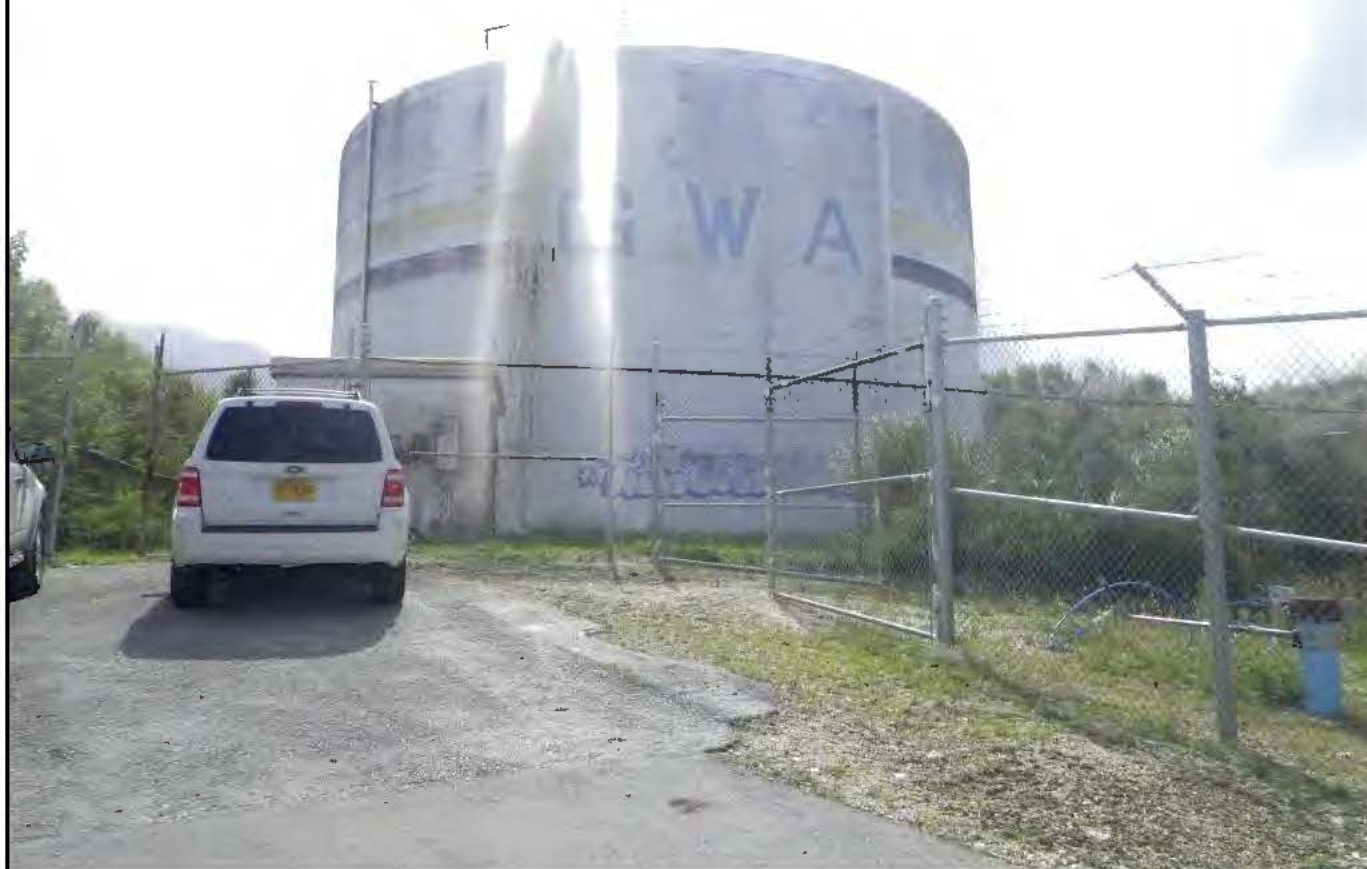
File Name: RIMG0096.JPG

Title	Guam Waterworks Authority (VP0989)
Subject	Southern System
Latitude	██████████
Longitude	██████████
Photo Direction	██████████
Elevation	██████
Date Time Stamp	4/26/2012 2:59:48 PM
Photographer	K. Sable
Comment	Sinifa Tank
Description	Overview of tank

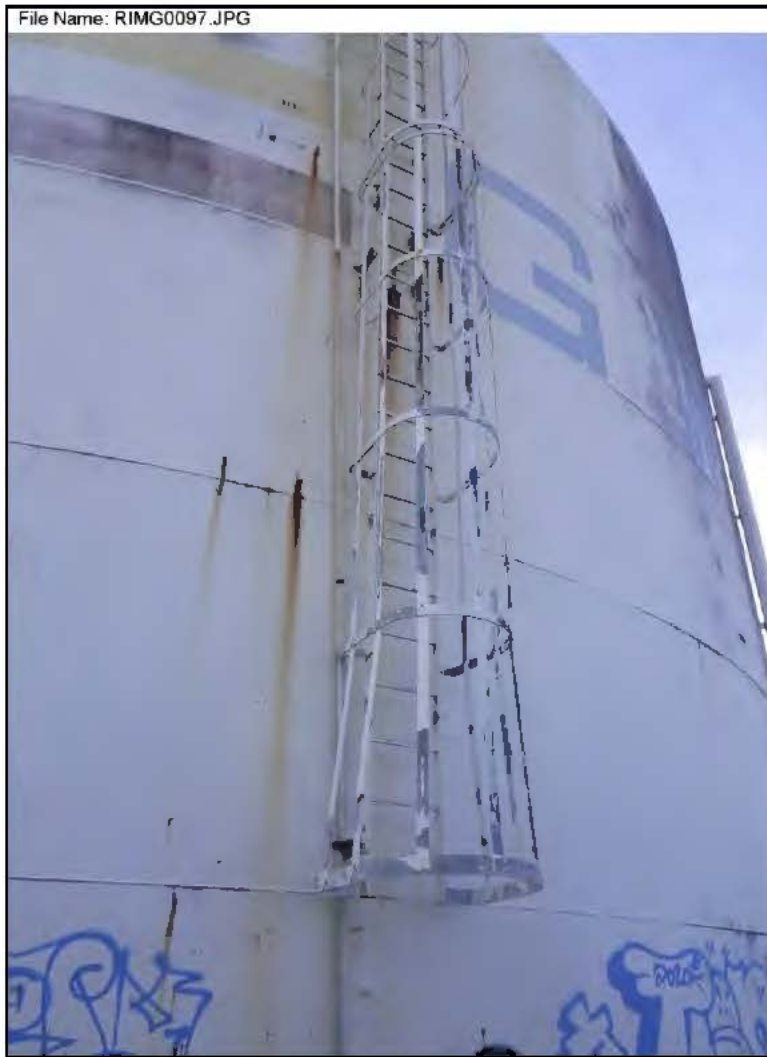
Attributes	
Title	Guam Waterworks Authority (VP0989)
Subject	Southern System
Latitude	[REDACTED]
Longitude	[REDACTED]
Photo Direction	[REDACTED]
Elevation	[REDACTED]
Date Time Stamp	4/26/2012 3:02:27 PM
Photographer	K. Sable
Comment	Sinifa Tank
Description	Access ladder

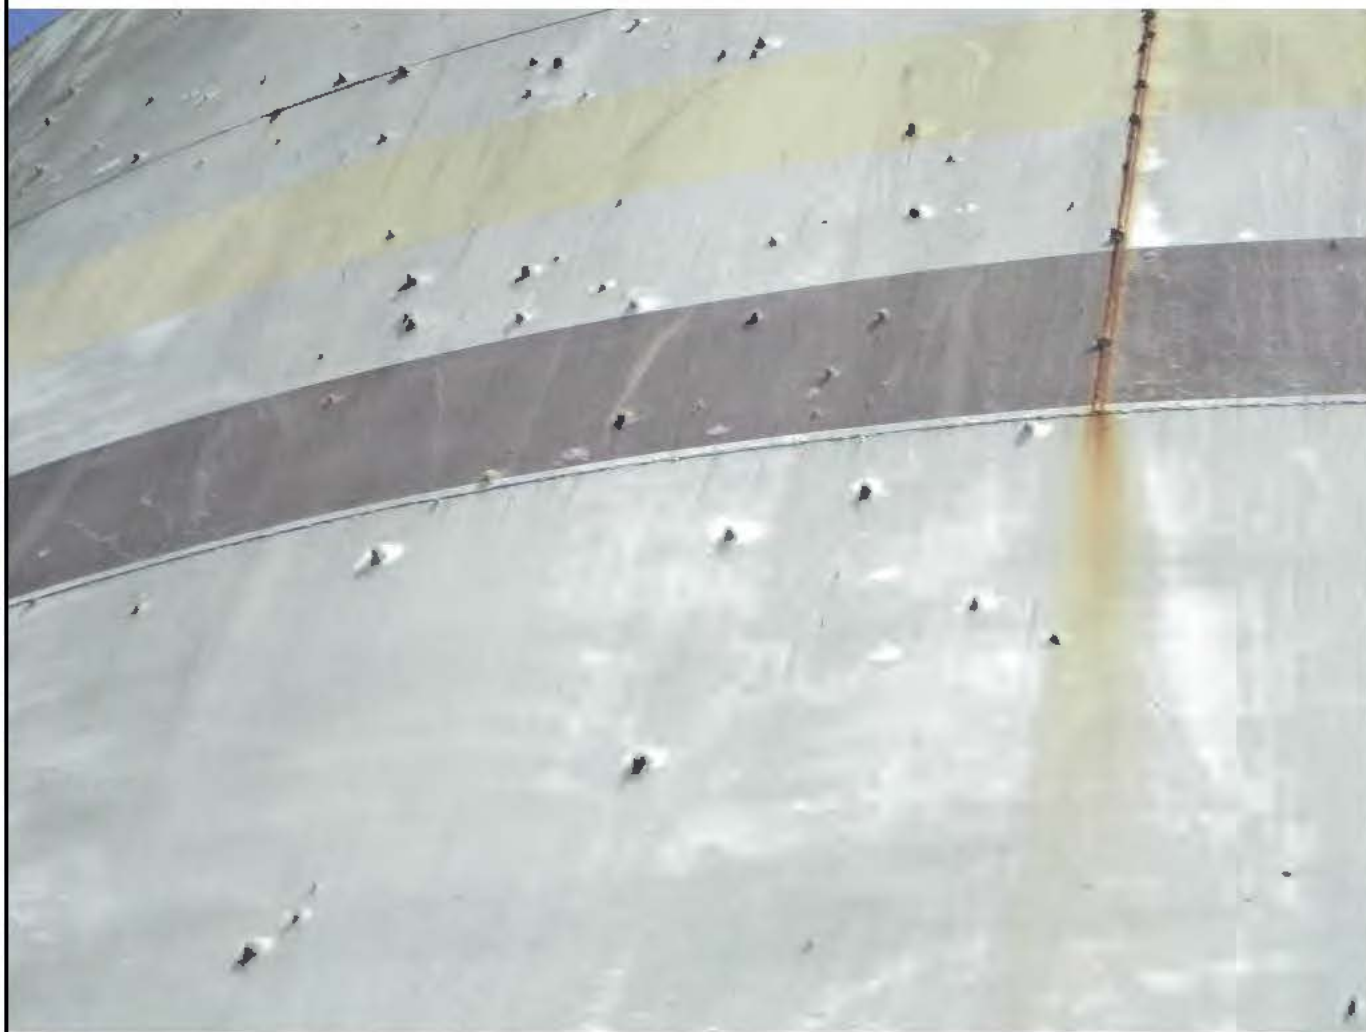
File Name: RIMG0099.JPG

Title	Guam Waterworks Authority (VP0989)
Subject	Southern System
Latitude	██████████
Longitude	██████████
Photo Direction	██████
Elevation	████
Date Time Stamp	4/26/2012 3:06:38 PM
Photographer	K. Sable
Comment	Sinifa Tank
Description	Moss clumps on side of tank

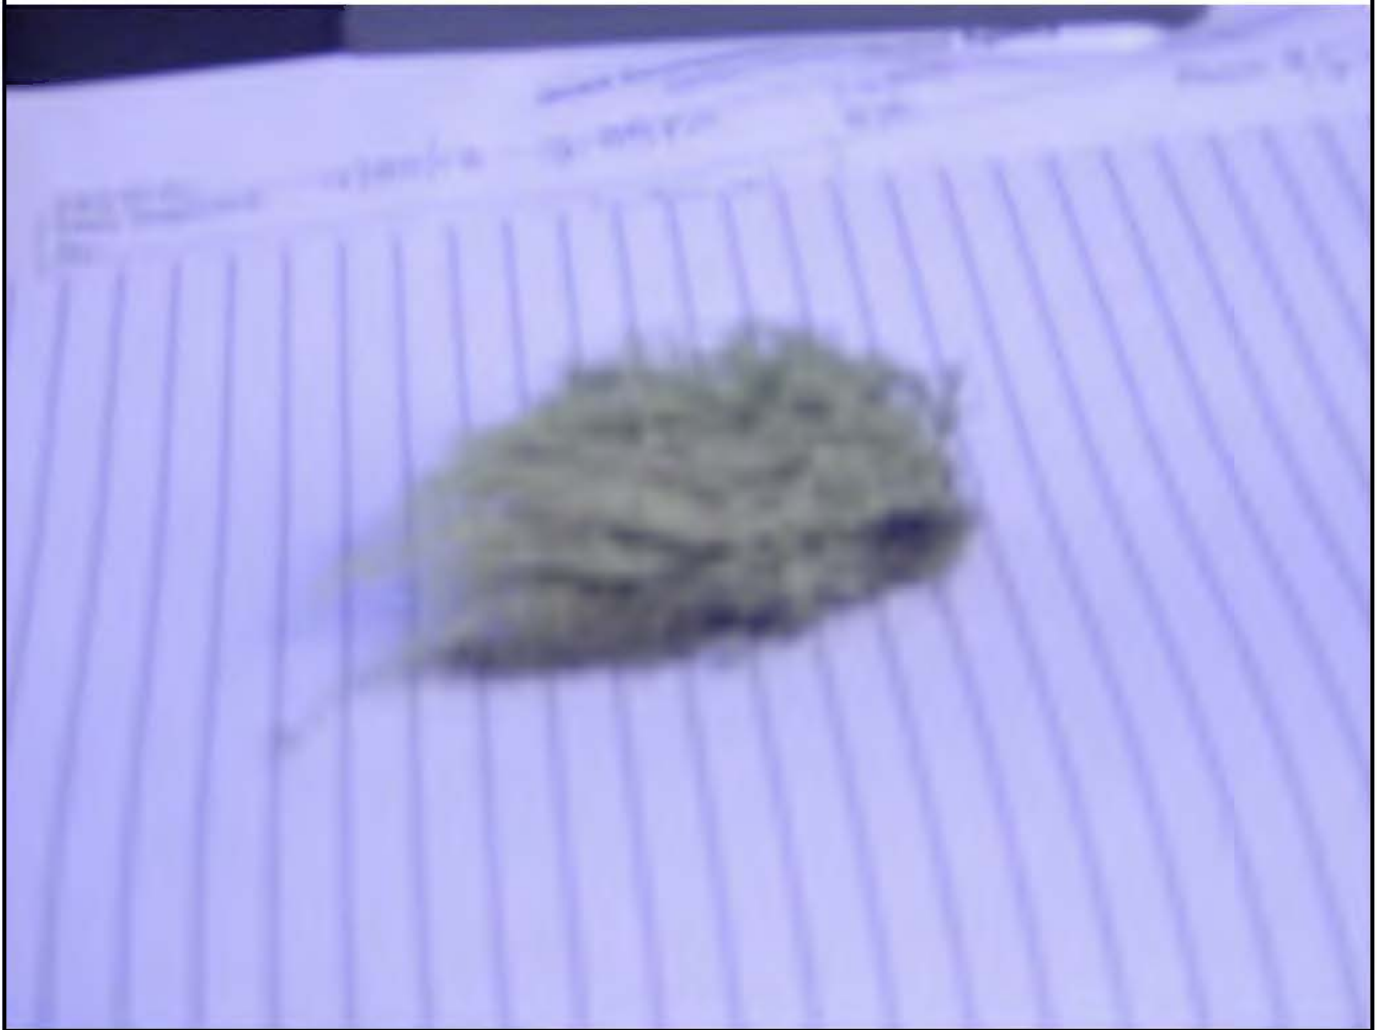
File Name: RIMG0100.JPG

Title	Guam Waterworks Authority (VP0989)
Subject	Southern System
Latitude	[REDACTED]
Longitude	[REDACTED]
Photo Direction	[REDACTED]
Elevation	[REDACTED]
Date Time Stamp	4/26/2012 3:07:40 PM
Photographer	K. Sable
Comment	Sinifa Tank
Description	Moss clump close-up

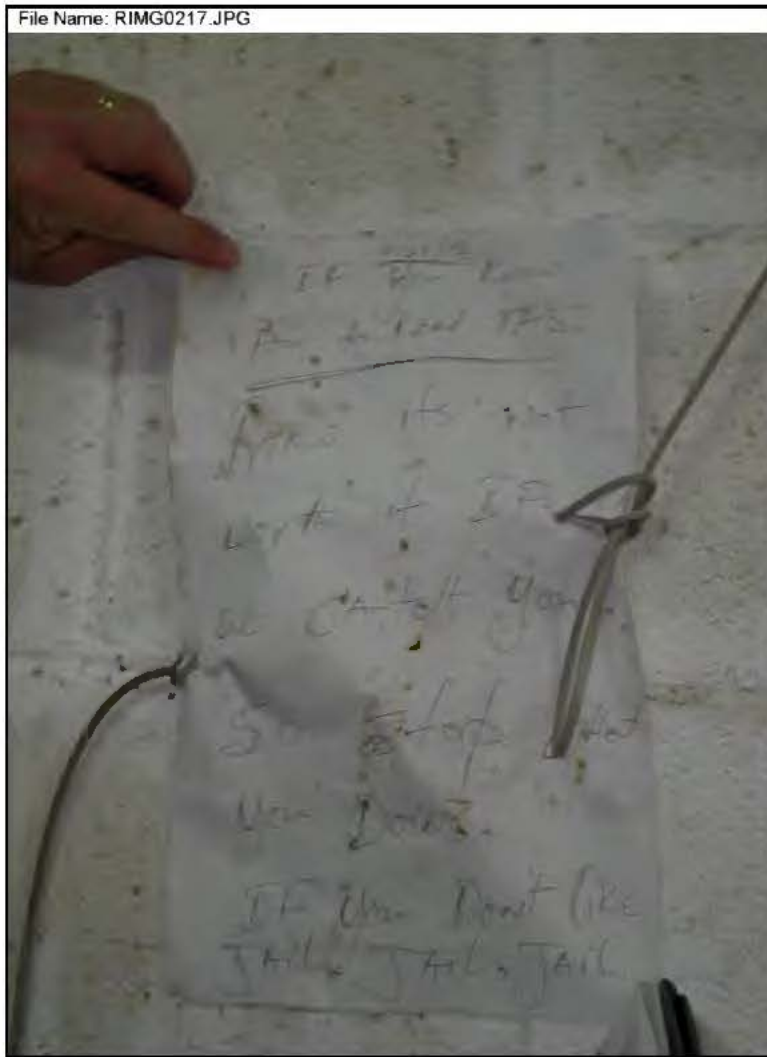
Attributes	
Title	Guam Waterworks Authority (VP0989)
Subject	Southern System
Latitude	[REDACTED]
Longitude	[REDACTED]
Photo Direction	[REDACTED]
Elevation	[REDACTED]
Date Time Stamp	5/2/2012 2:13:31 PM
Photographer	K. Sable
Comment	Agate # 1 Pump Station
Description	Sign for vandals posted inside pump station

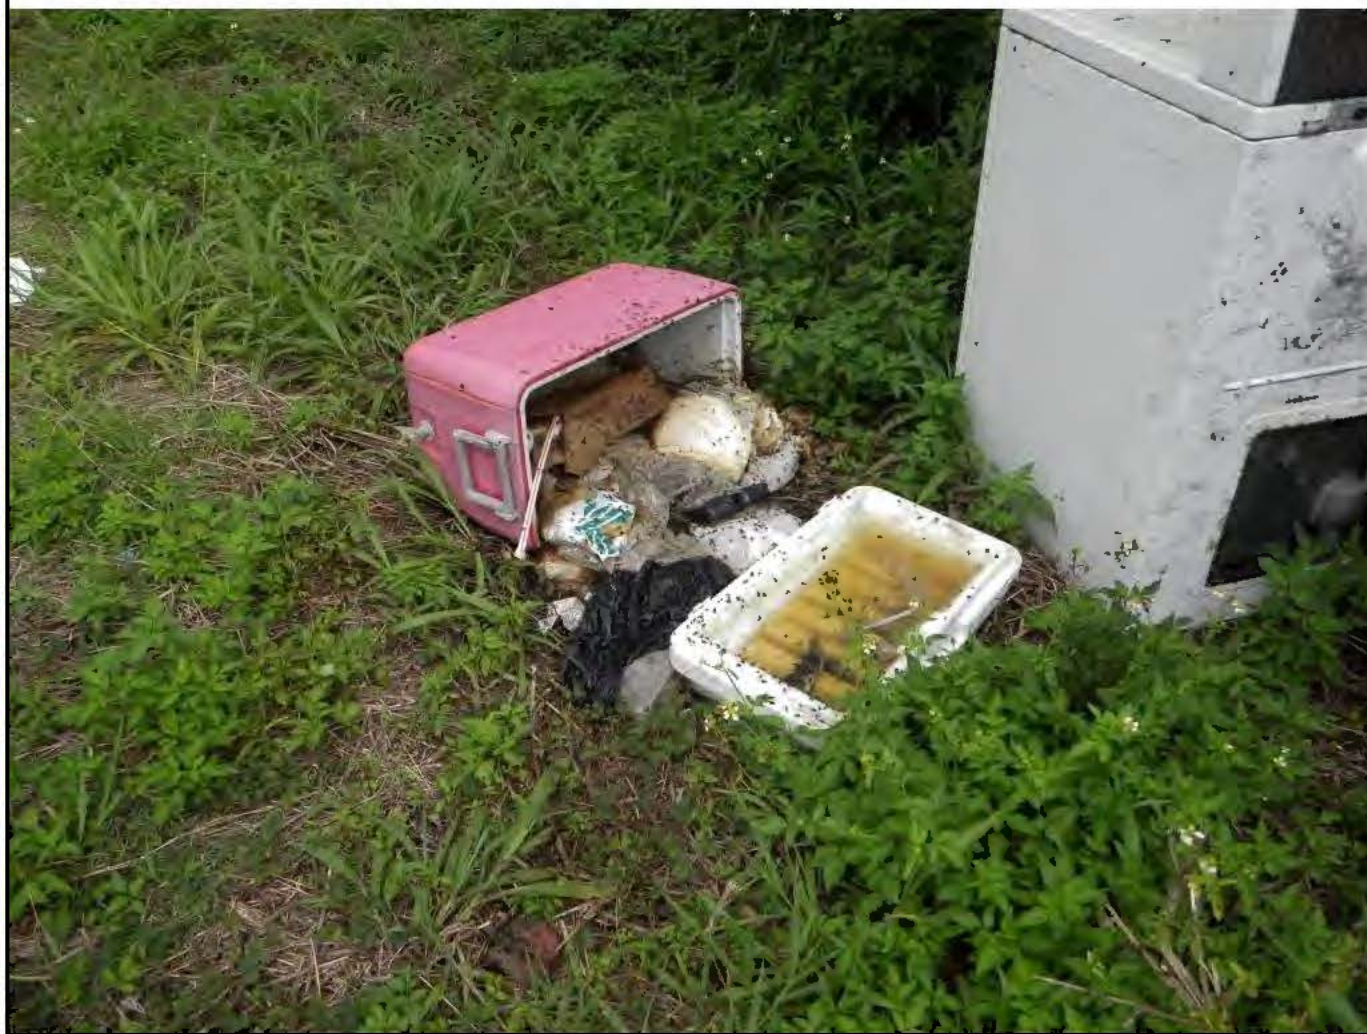
File Name: RIMG0218.JPG

Title	Guam Waterworks Authority (VP0989)
Subject	Southern System
Latitude	[REDACTED]
Longitude	[REDACTED]
Photo Direction	[REDACTED]
Elevation	[REDACTED]
[REDACTED]	[REDACTED] 2:56:34 PM
Photographer	D. Parker
Comment	Umatac Tank
Description	Cooler with rotting food adjacent to tank

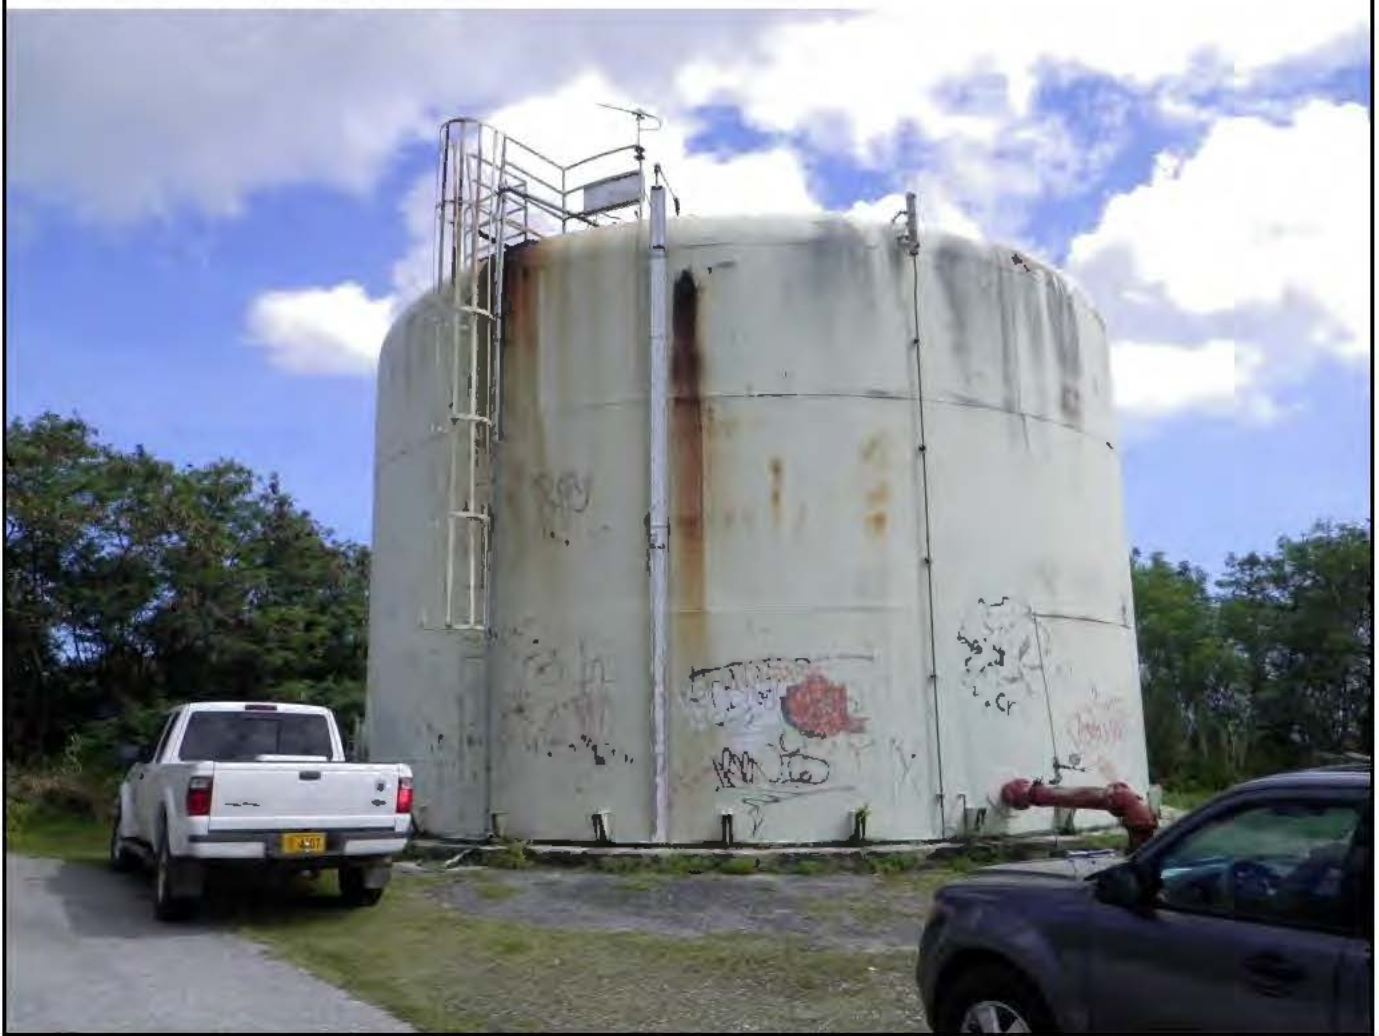
File Name: RIMG0219.JPG

Title	Guam Waterworks Authority (VP0989)
Subject	Southern System
Latitude	[REDACTED]
Longitude	[REDACTED]
Photo Direction	[REDACTED]
Elevation	[REDACTED]
Date Time Stamp	5/2/2012 2:57:09 PM
Photographer	K. Sable
Comment	Umatac Tank
Description	Overview of tank

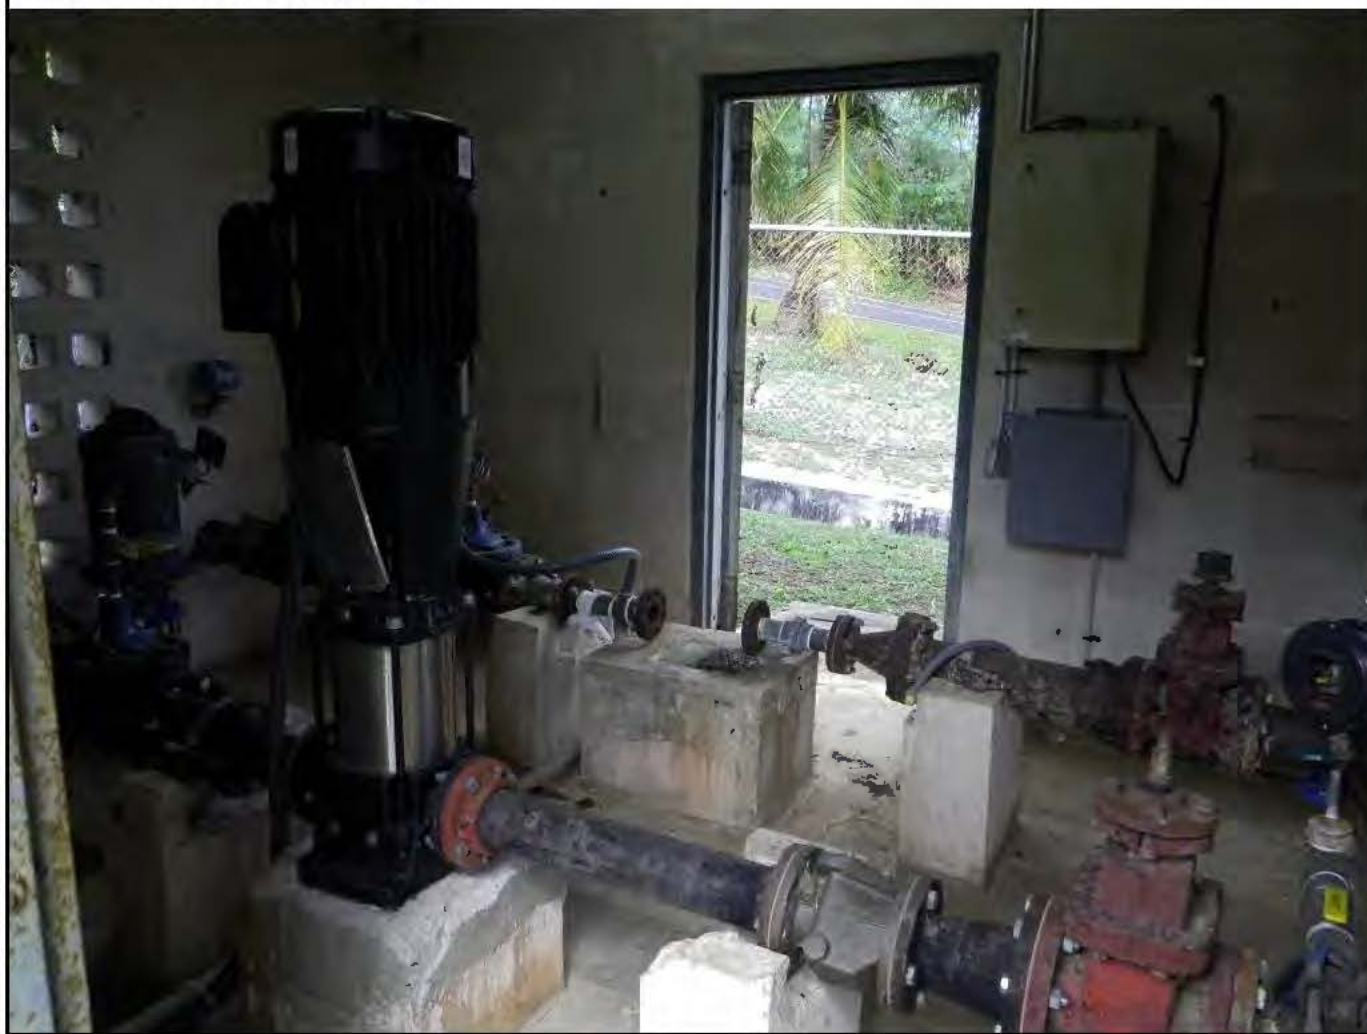
File Name: RIMG0220.JPG

Title	Guam Waterworks Authority (VP0989)
Subject	Southern System
Latitude	██████████
Longitude	██████████
Photo Direction	██████
Elevation	████
Date Time Stamp	5/2/2012 3:08:01 PM
Photographer	K. Sable
Comment	Umatac # 2 Pump Station
Description	Overview

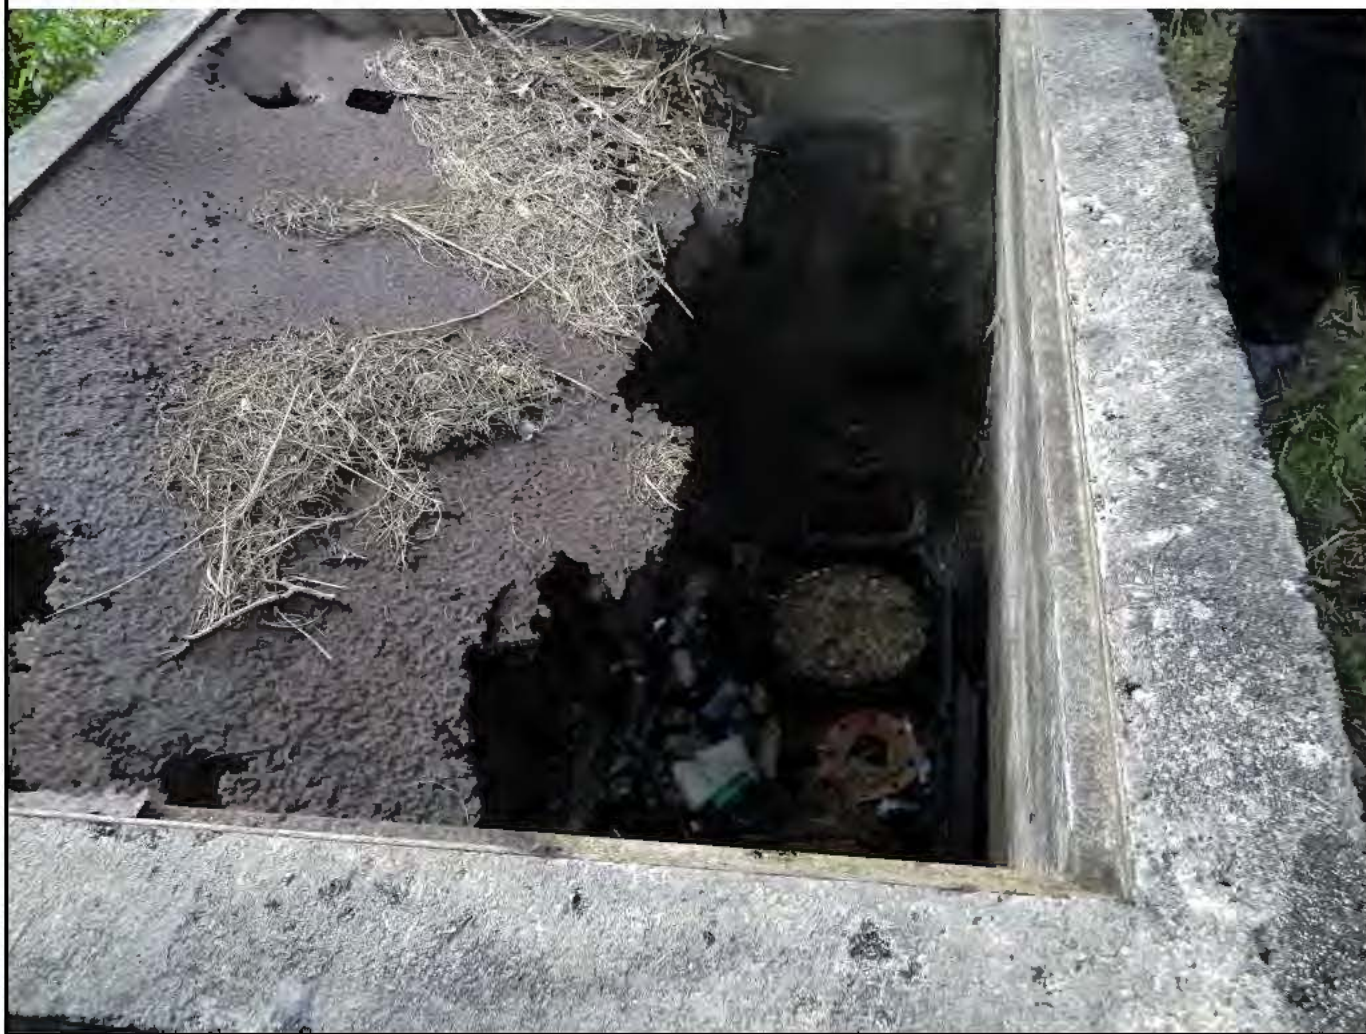
File Name: RIMG0221.JPG

Title	Guam Waterworks Authority (VP0989)
Subject	Southern System
Latitude	██████████
Longitude	██████████
Photo Direction	██████
Elevation	████
Date Time Stamp	5/2/2012 3:39:44 PM
Photographer	K. Sable
Comment	Pigua Tank
Description	Inlet and outlet box

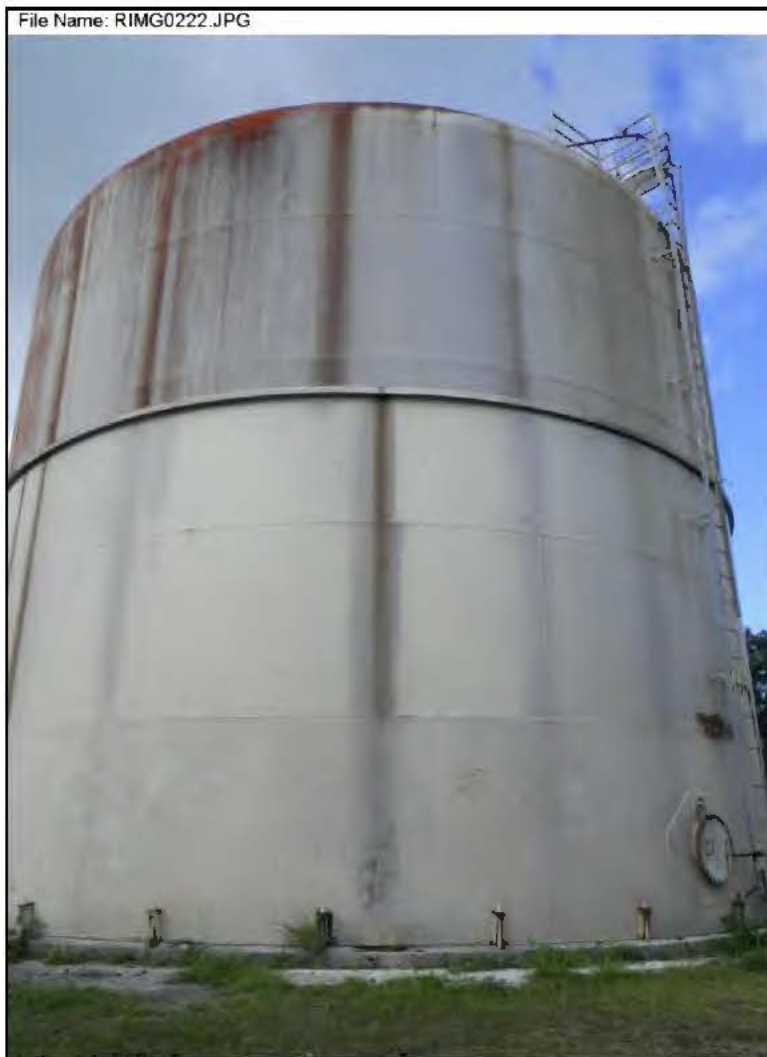
Attributes	
Title	Guam Waterworks Authority (VP0989)
Subject	Southern System
Latitude	[REDACTED]
Longitude	[REDACTED]
Photo Direction	[REDACTED]
Elevation	[REDACTED]
Date Time Stamp	5/2/2012 3:40:07 PM
Photographer	K. Sable
Comment	Pigua Tank
Description	Overview of tank

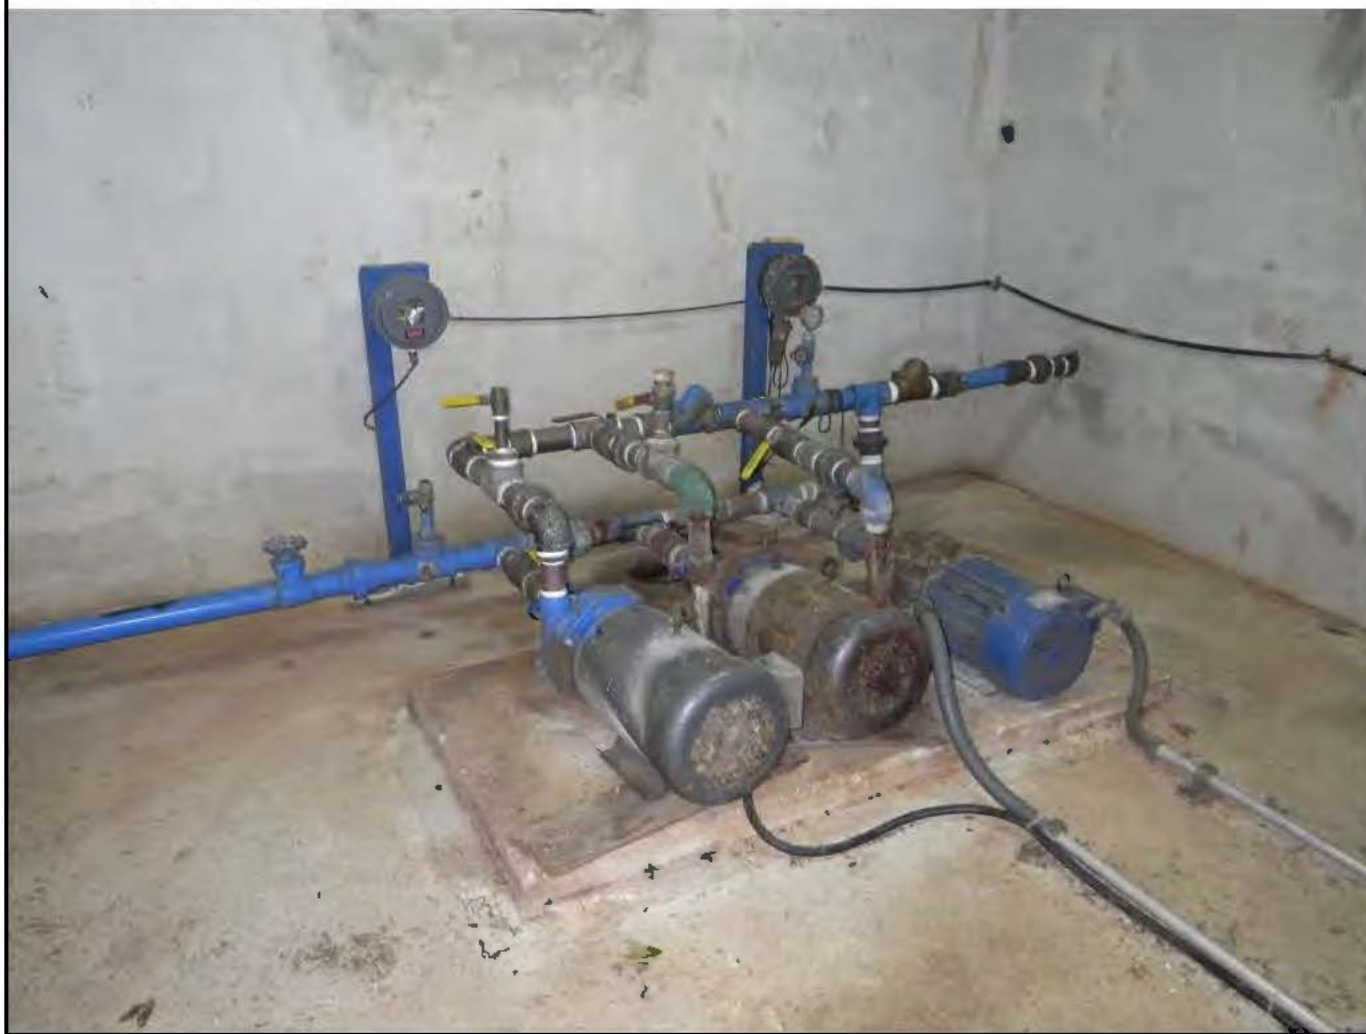
File Name: RIMG0223.JPG

Title	Guam Waterworks Authority (VP0989)
Subject	Southern System
Latitude	██████████
Longitude	██████████
Photo Direction	████
Elevation	████
Date Time Stamp	5/2/2012 3:50:40 PM
Photographer	K. Sable
Comment	Pigua Pump Station
Description	Overview

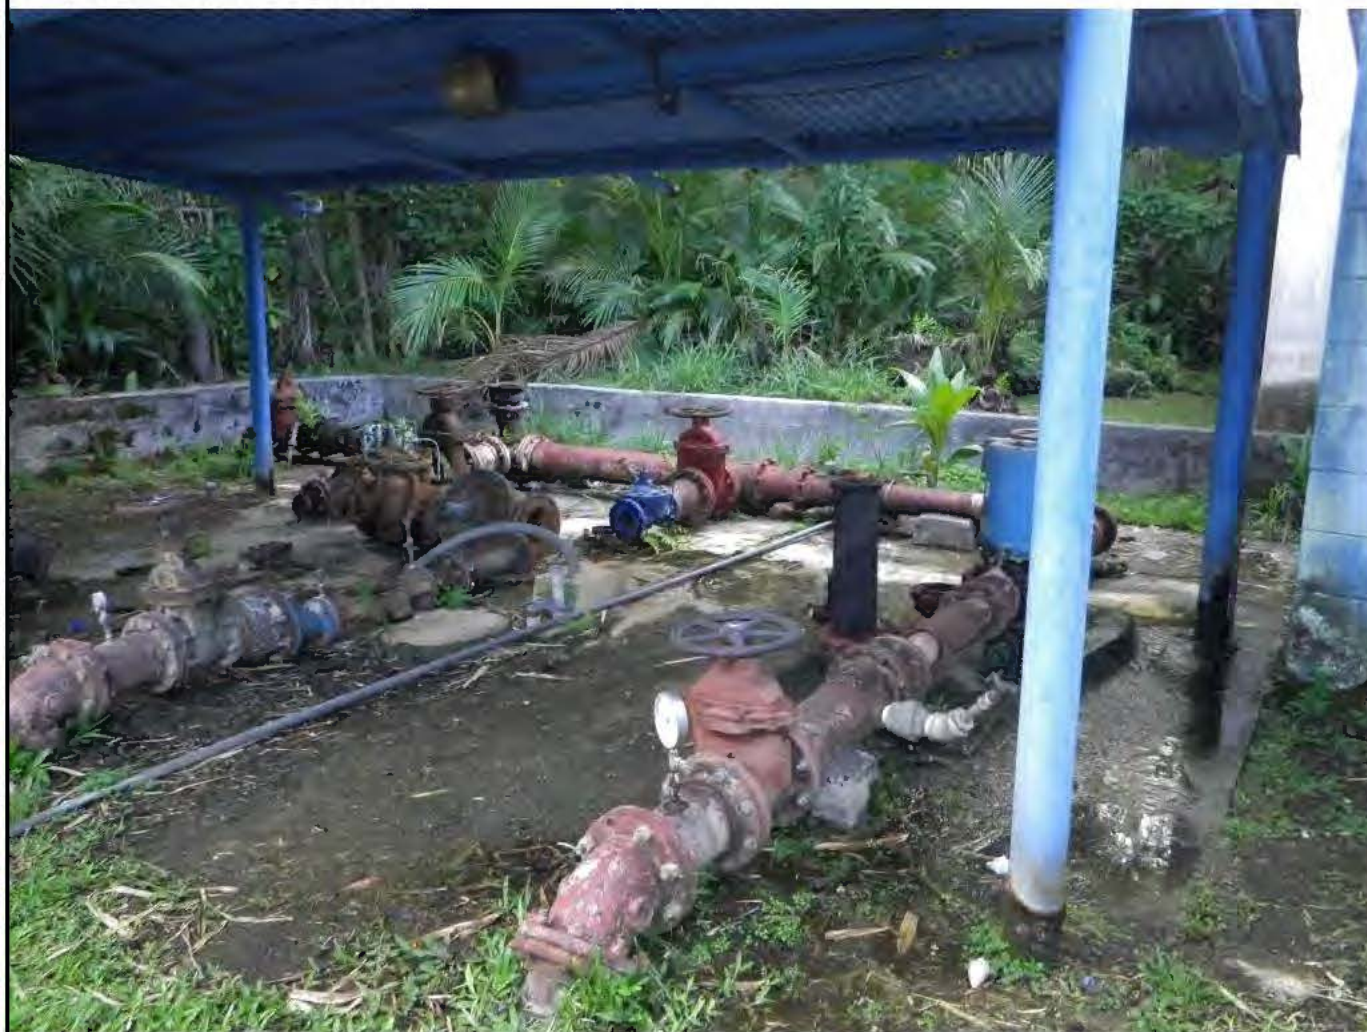
File Name: RIMG0224.JPG

Title	Guam Waterworks Authority (VP0989)
Subject	Southern System
Latitude	██████████
Longitude	██████████
Photo Direction	██████
Elevation	████
Date Time Stamp	5/2/2012 4:04:52 PM
Photographer	K. Sable
Comment	Geus Pump Station
Description	Overview

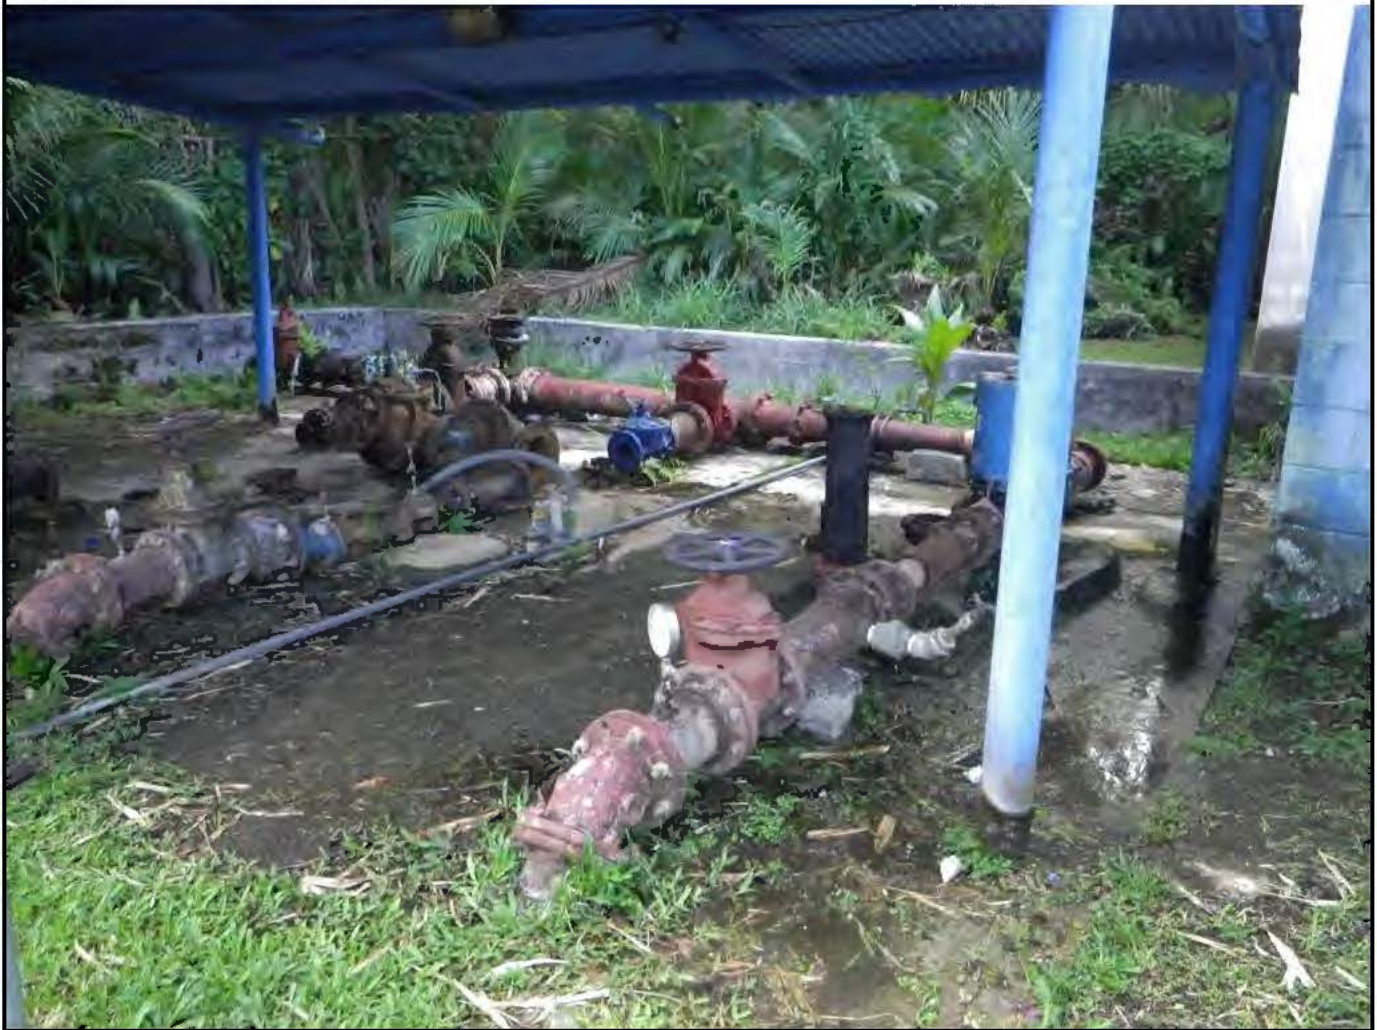
File Name: RIMG0225.JPG

Title	Guam Waterworks Authority (VP0989)
Subject	Southern System
Latitude	██████████
Longitude	██████████
Photo Direction	██████████
Elevation	████
Date Time Stamp	5/2/2012 4:05:14 PM
Photographer	K. Sable
Comment	Geus Pump Station
Description	Overview

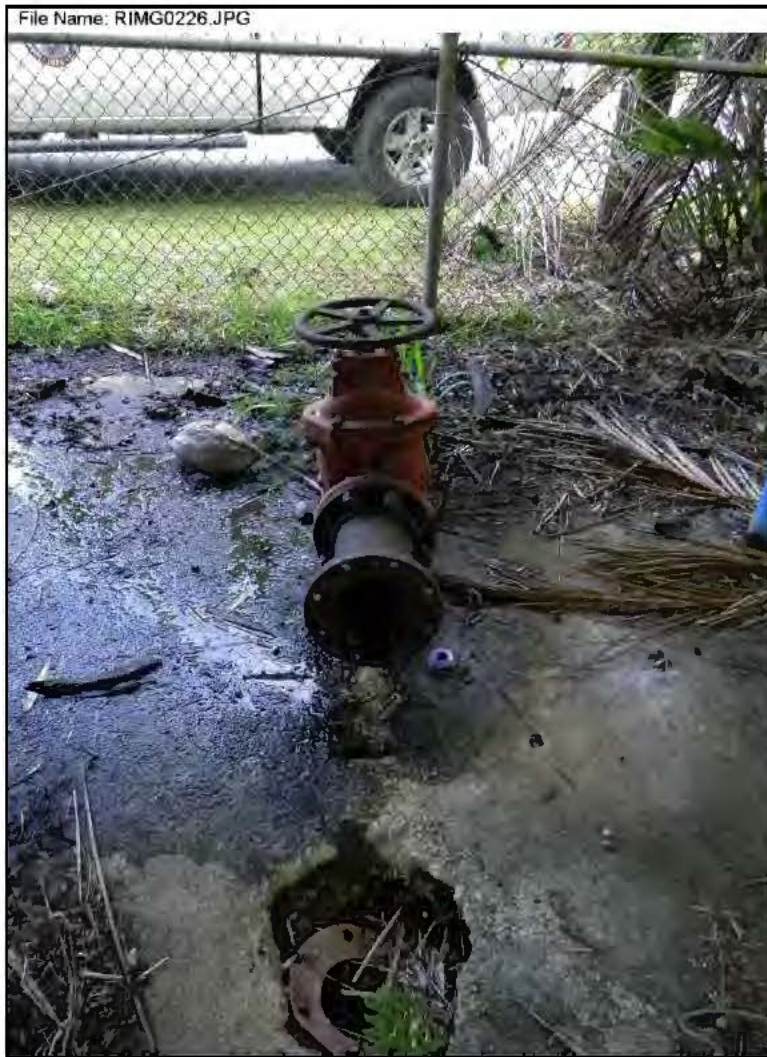
Attributes	
Title	Guam Waterworks Authority (VP0989)
Subject	Southern System
Latitude	[REDACTED]
Longitude	[REDACTED]
Photo Direction	[REDACTED]
Elevation	[REDACTED]
Date Time Stamp	5/2/2012 4:07:06 PM
Photographer	K. Sable
Comment	Geus Pump Station
Description	Broken line # 3
