Guam Waterworks Authority (VP0989)

SDWA Sanitary Survey

Southern System

NEIC Field Investigation Photographs

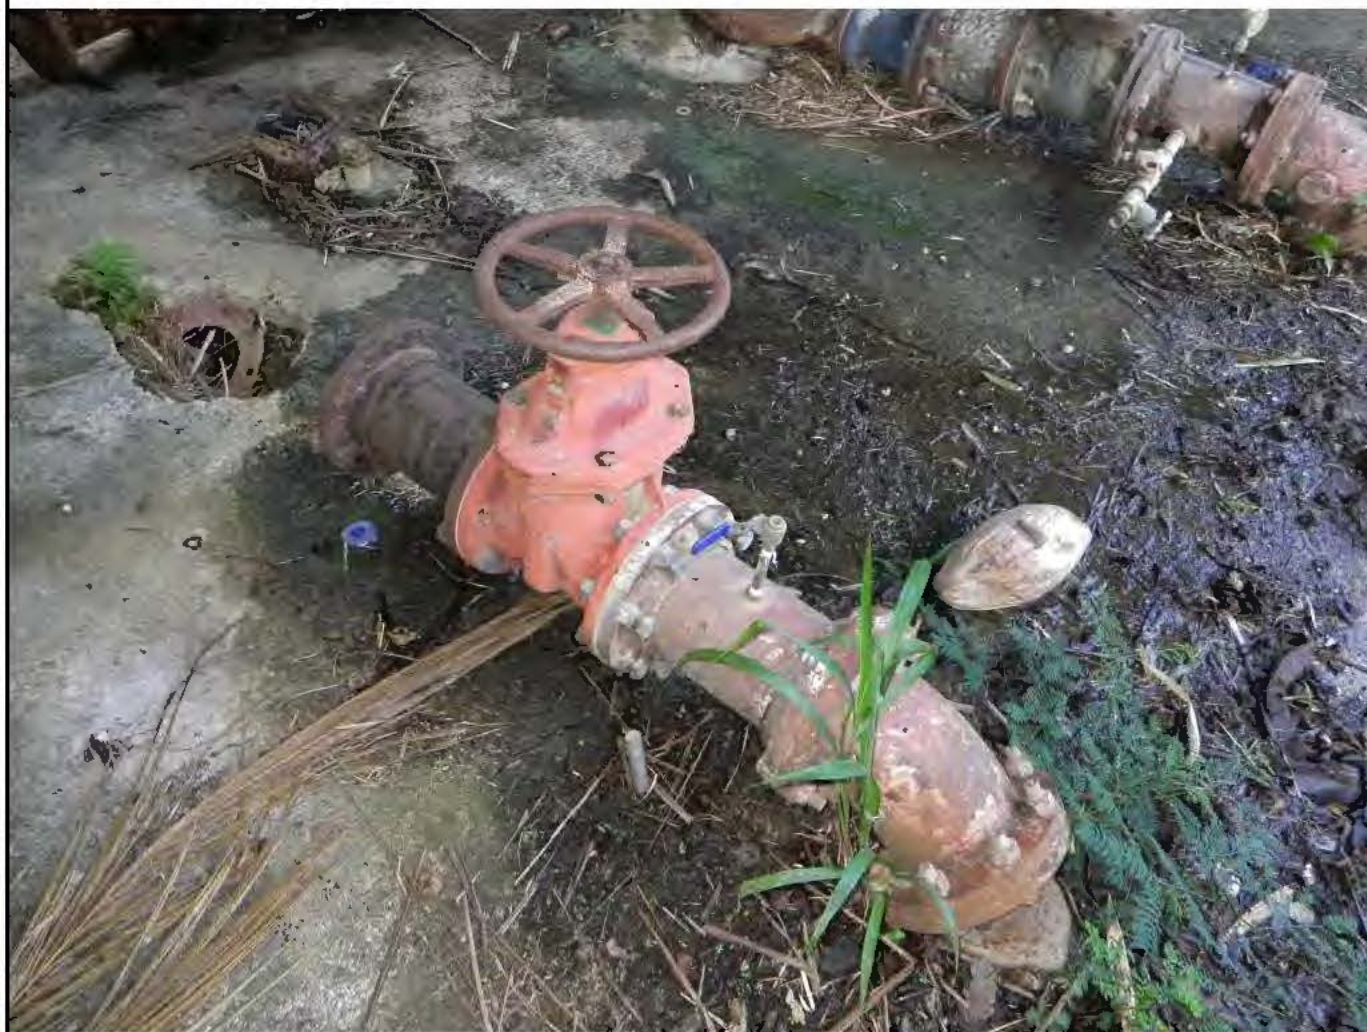
File Name: RIMG0227.JPG

Attributes	
Title	Guam Waterworks Authority (VP0989)
Subject	Southern System
Latitude	██████████
Longitude	██████████
Photo Direction	██████
Elevation	████
Date Time Stamp	5/2/2012 4:07:30 PM
Photographer	K. Sable
Comment	Geus Pump Station
Description	Broken line # 3 facing other direction

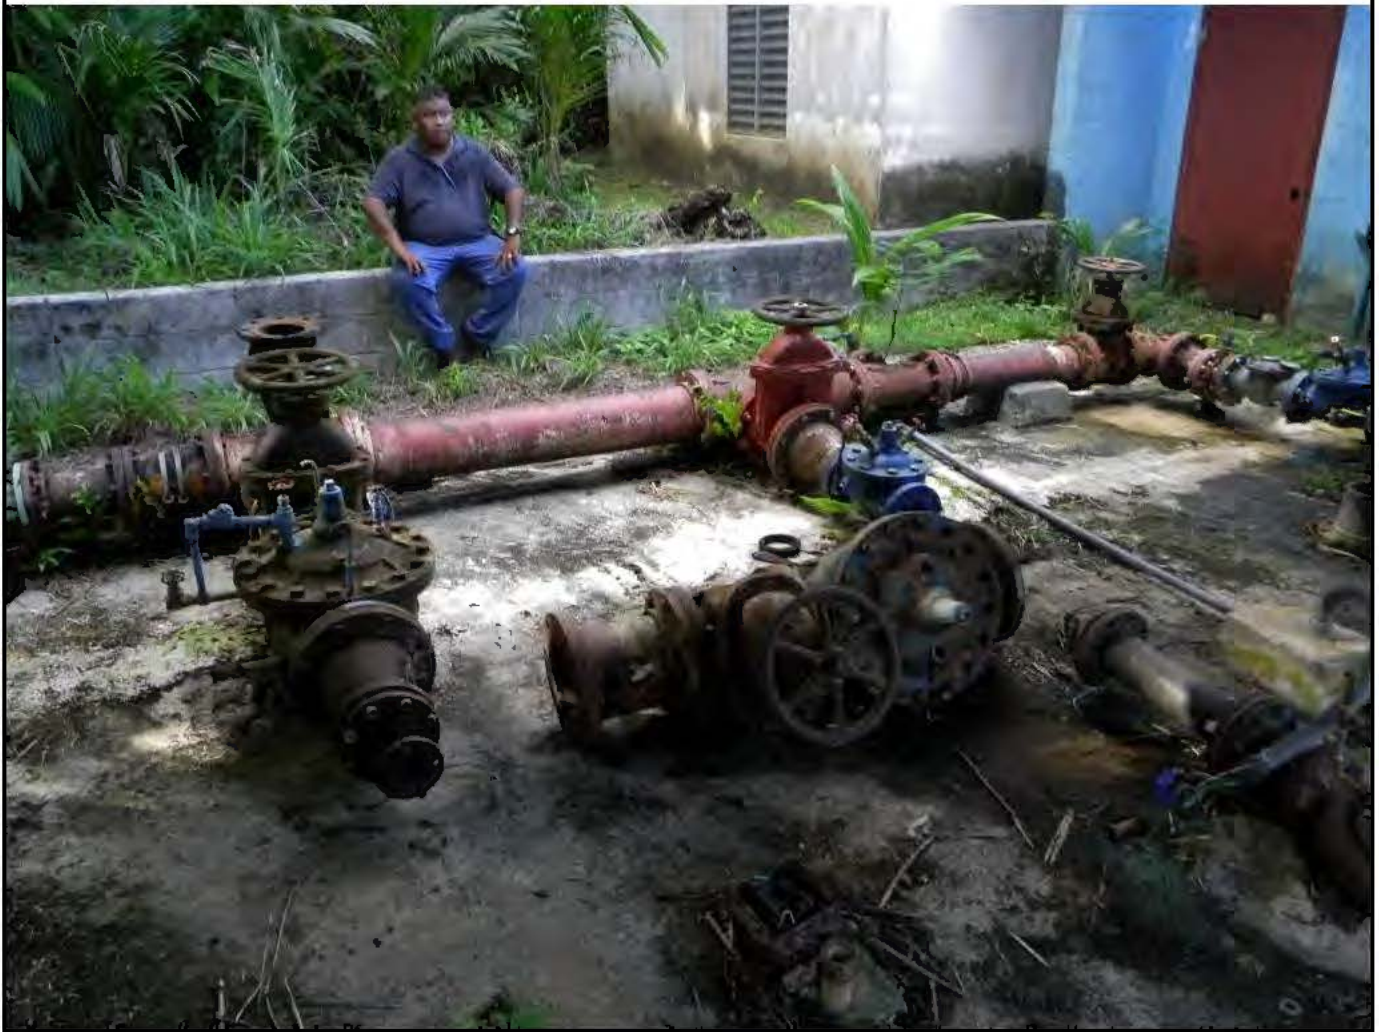
File Name: RIMG0228.JPG

Attributes	
Title	Guam Waterworks Authority (VP0989)
Subject	Southern System
Latitude	██████████
Longitude	██████████
Photo Direction	██
Elevation	██
Date Time Stamp	5/2/2012 4:07:51 PM
Photographer	K. Sable
Comment	Geus Pump Station
Description	Overview

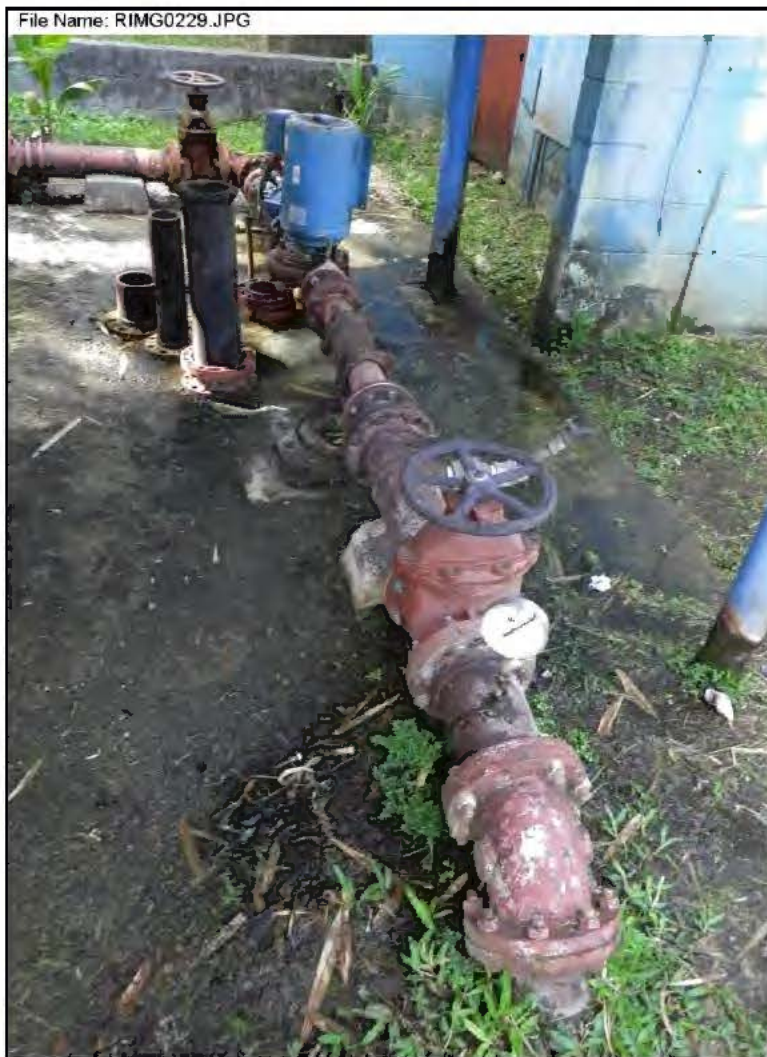
Attributes	
Title	Guam Waterworks Authority (VP0989)
Subject	Southern System
Latitude	██████████
Longitude	██████████
Photo Direction	██████
Elevation	████
Date Time Stamp	5/2/2012 4:08:11 PM
Photographer	K. Sable
Comment	Geus Pump Station
Description	Pump and line # 1

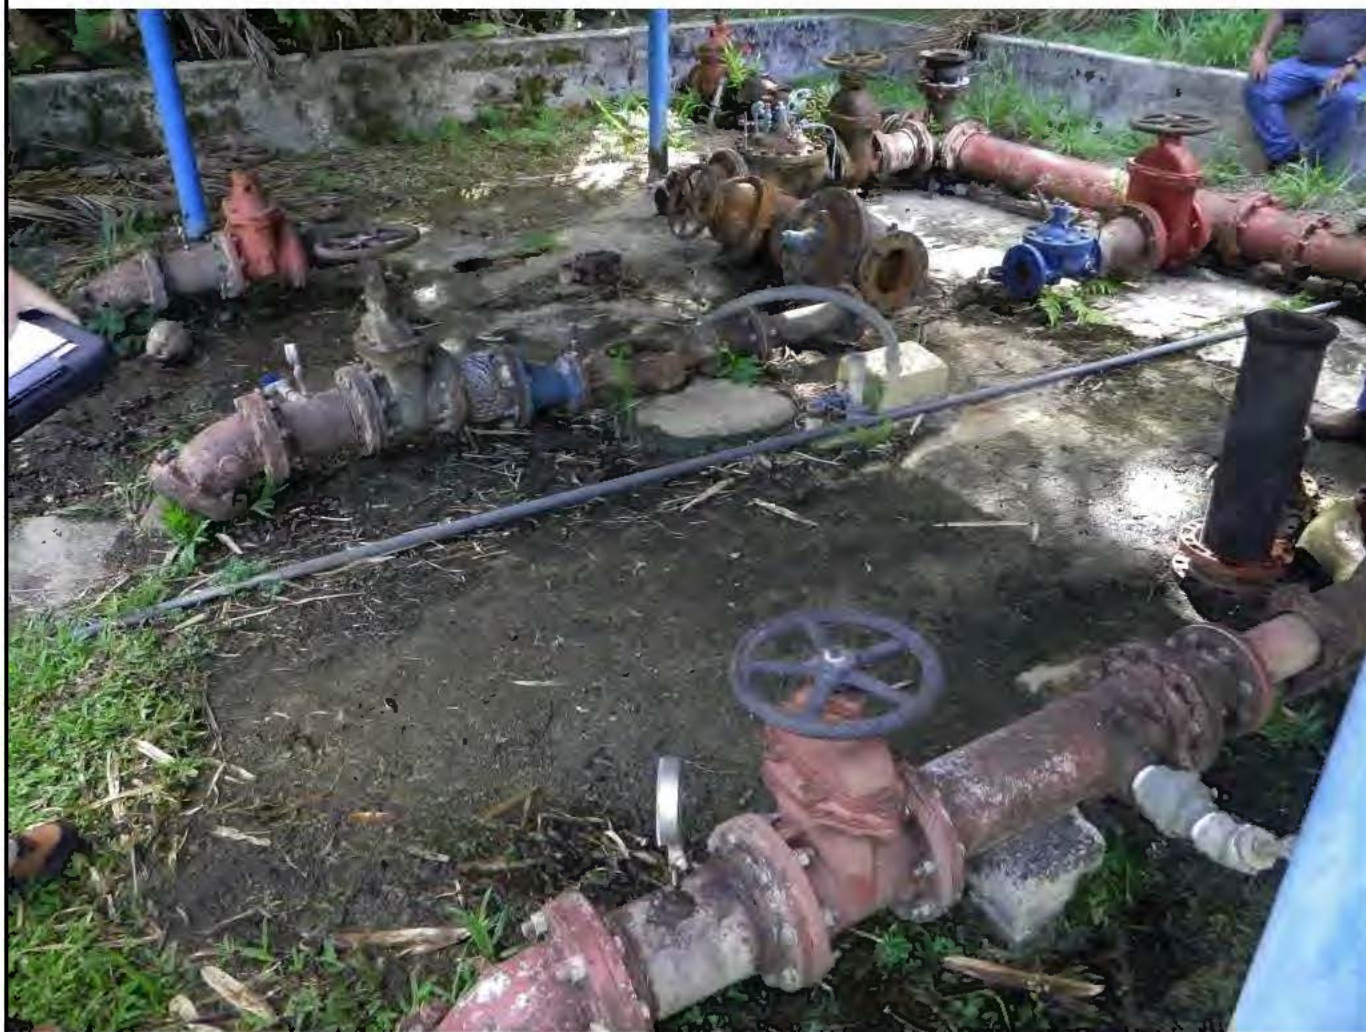
File Name: RIMG0230.JPG

Title	Guam Waterworks Authority (VP0989)
Subject	Southern System
Latitude	██████████
Longitude	██████████
Photo Direction	██████
Elevation	███
Date Time Stamp	5/2/2012 4:08:33 PM
Photographer	K. Sable
Comment	Geus Pump Station
Description	Overview

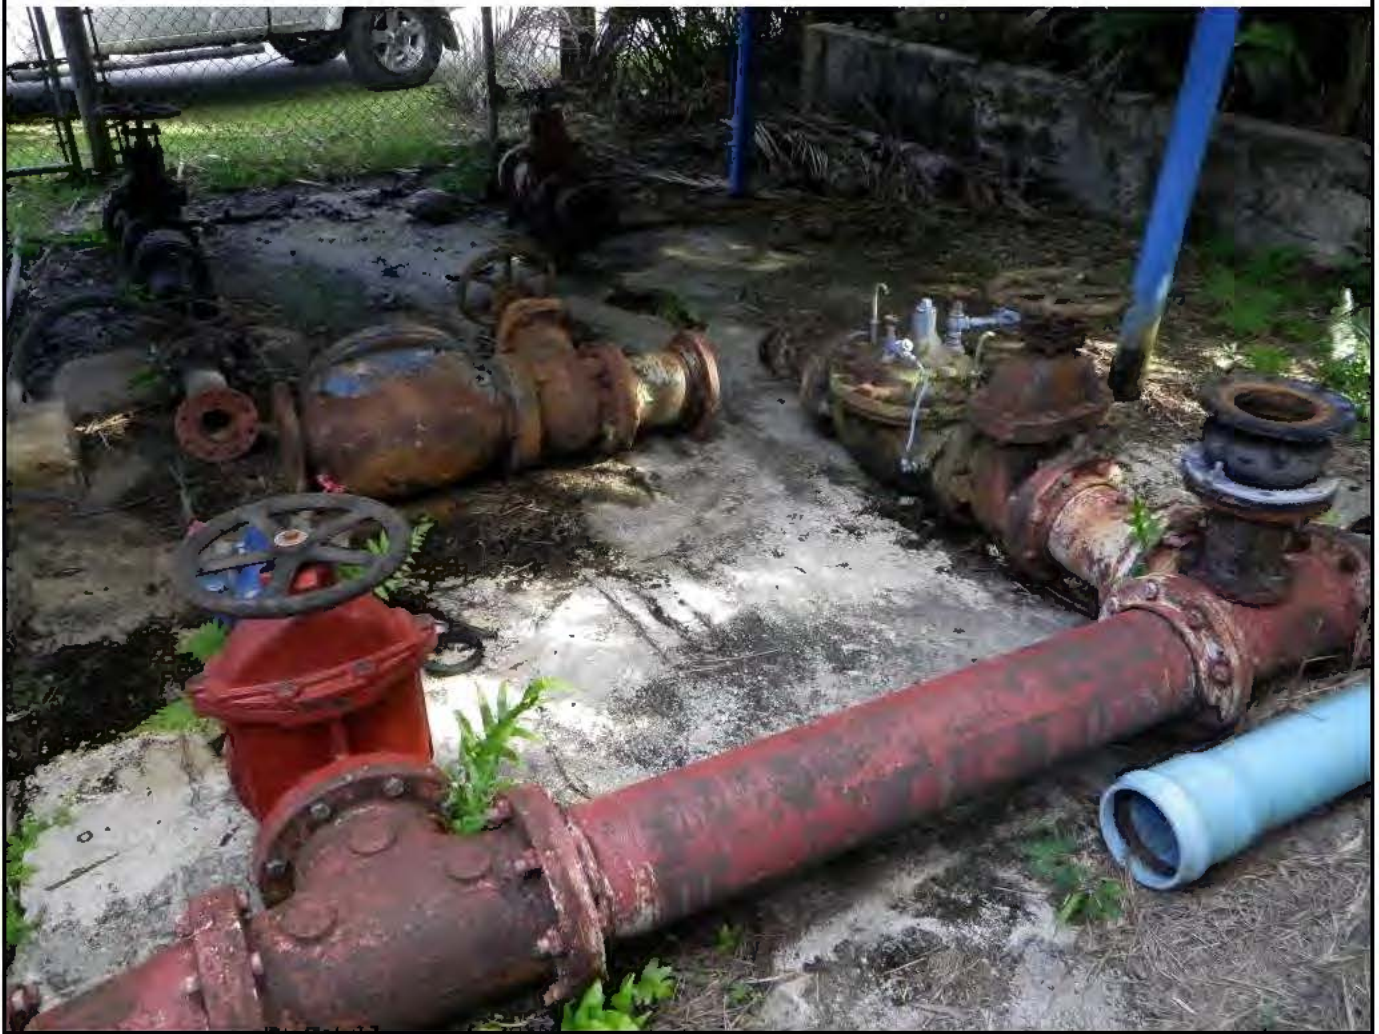
File Name: RIMG0231.JPG

Title	Guam Waterworks Authority (VP0989)
Subject	Southern System
Latitude	[REDACTED]
Longitude	[REDACTED]
Photo Direction	[REDACTED]
Elevation	[REDACTED]
Date Time Stamp	5/2/2012 4:09:04 PM
Photographer	K. Sable
Comment	Geus Pump Station
Description	Line # 2 and line # 3

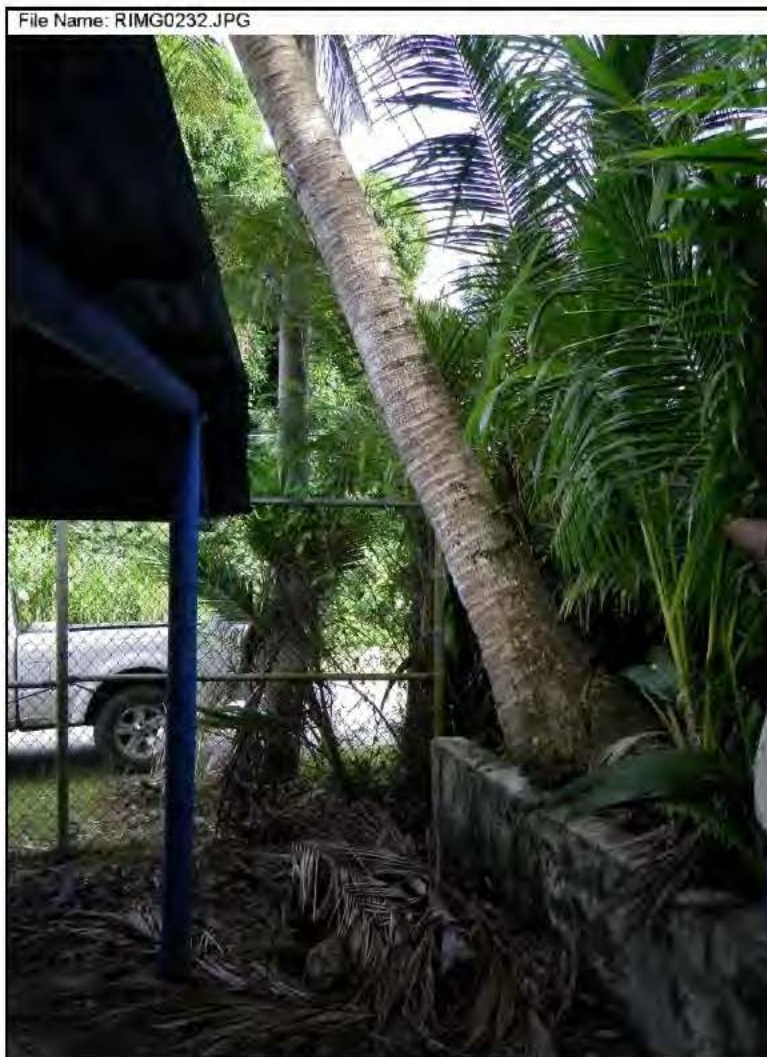
Attributes	
Title	Guam Waterworks Authority (VP0989)
Subject	Southern System
Latitude	[REDACTED]
Longitude	[REDACTED]
Photo Direction	[REDACTED]
Elevation	[REDACTED]
Date Time Stamp	5/2/2012 4:17:57 PM
Photographer	K. Sable
Comment	Geus Pump Station
Description	Palm tree growing into wall

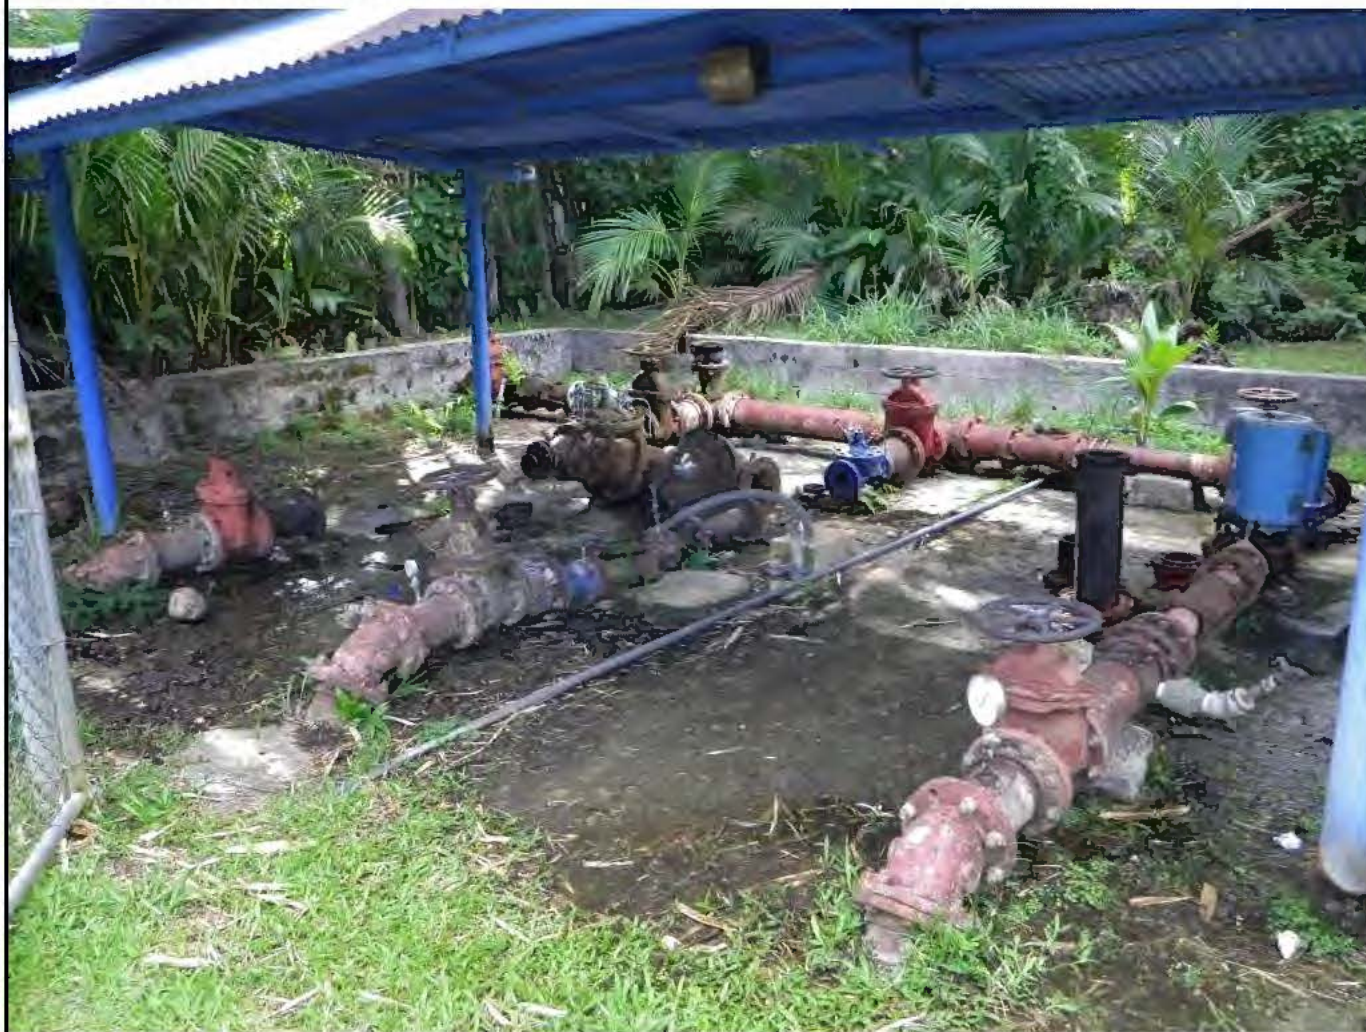
File Name: RIMG0233.JPG

Title	Guam Waterworks Authority (VP0989)
Subject	Southern System
Latitude	██████████
Longitude	██████████
Photo Direction	██████████
Elevation	██████
Date Time Stamp	5/2/2012 4:21:16 PM
Photographer	K. Sable
Comment	Geus Pump Station
Description	Overview
