Appendix D
Construction Program Site Visit Reports

Thomes Creek Bridge Project
Site Visit Date: 10/13/2009

**Caltrans MS4 (SWRCB Order No. 99-06-DWQ)
Thomes Creek Bridge Project
Caltrans District 2**

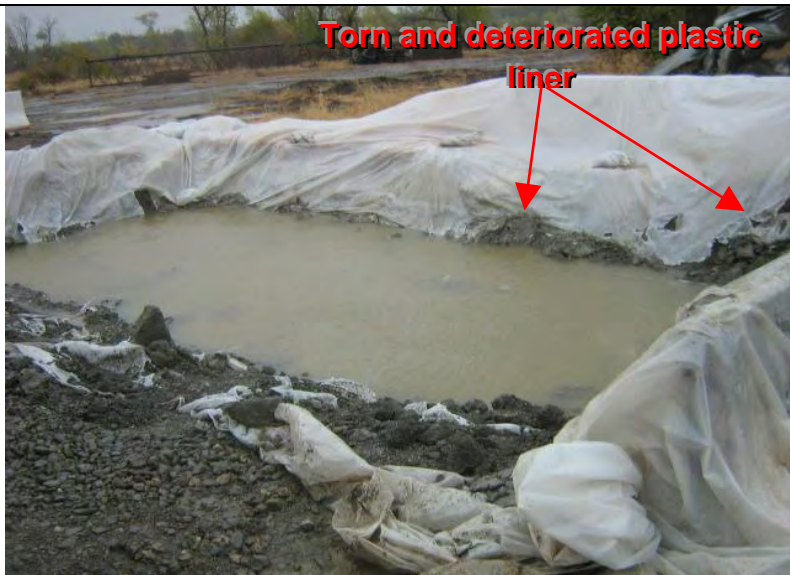
Photograph 1 – Concrete washout unmaintained (e.g., torn and deteriorated plastic liner)

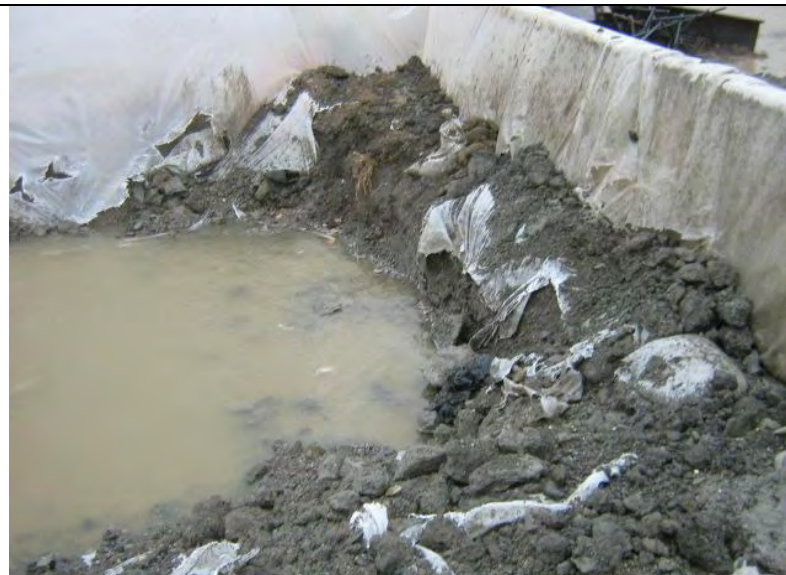
Photograph 2 – Close-up view of unmaintained (e.g., torn and deteriorated) concrete washout plastic liner

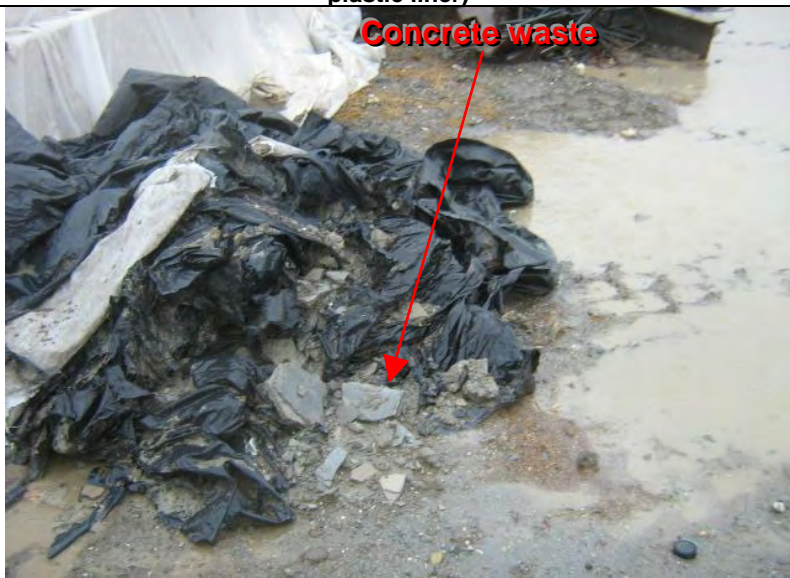
Photograph 3 – Concrete waste on the ground surface directly adjacent to the concrete washout

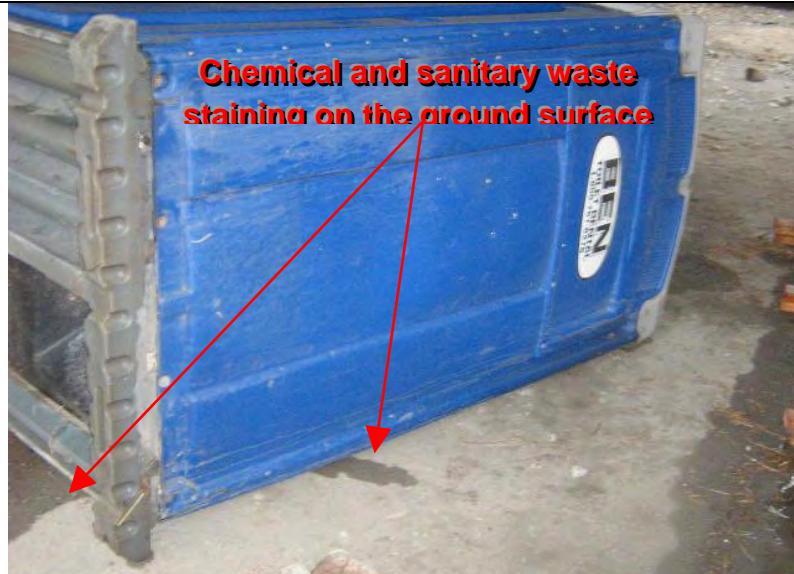
Photograph 14 – Visible chemical and sanitary waste staining on the ground surface

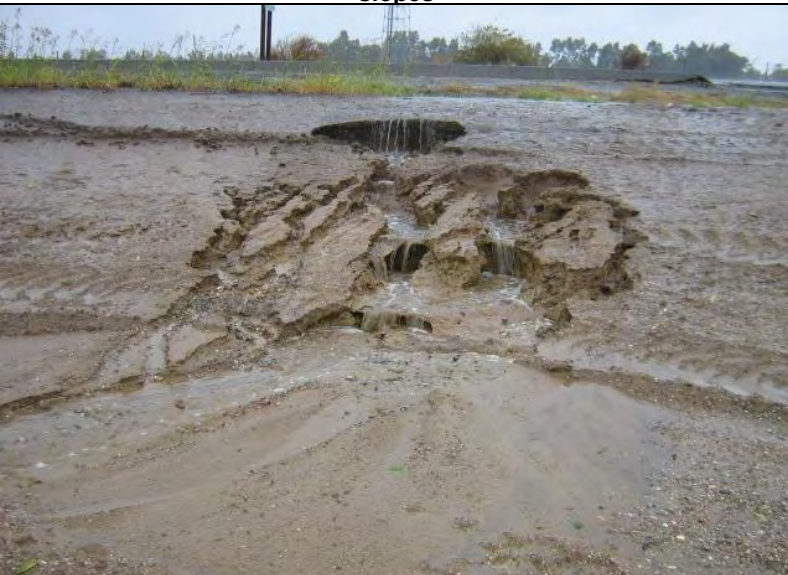
Photograph 3 – Sediment basin embankment slope erosion (e.g., gully formation) and failure

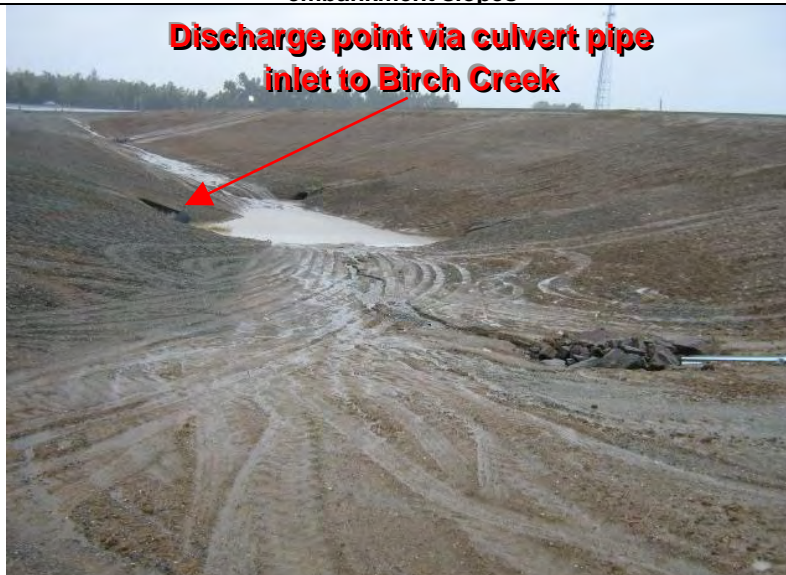
Photograph 4 – Adequate BMPs had not been implemented to prevent the discharge of sediment to the culvert inlet/drainage pipe leading to Birch Cr.

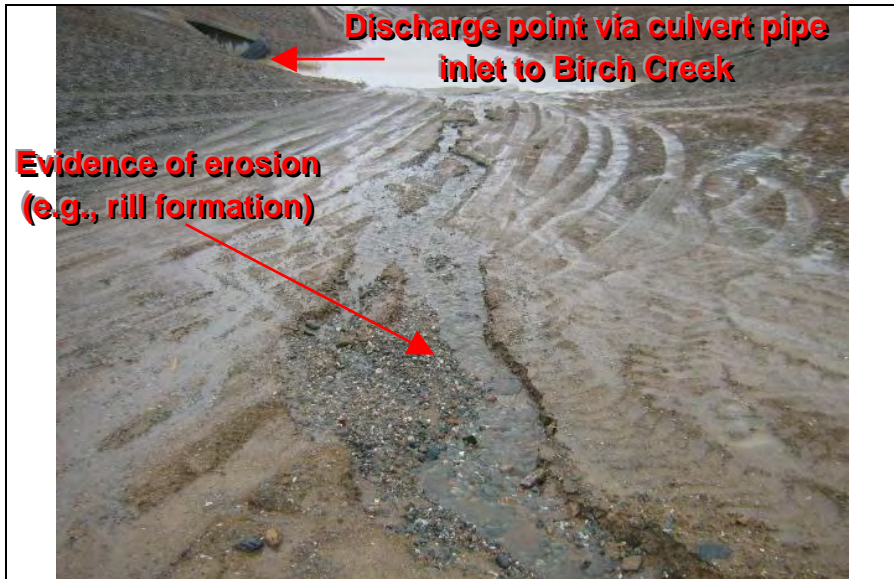
Photograph 5— Close-up of area in Photograph 4 depicting erosion (e.g., rill formation) and inadequate BMPs located adjacent to discharge point

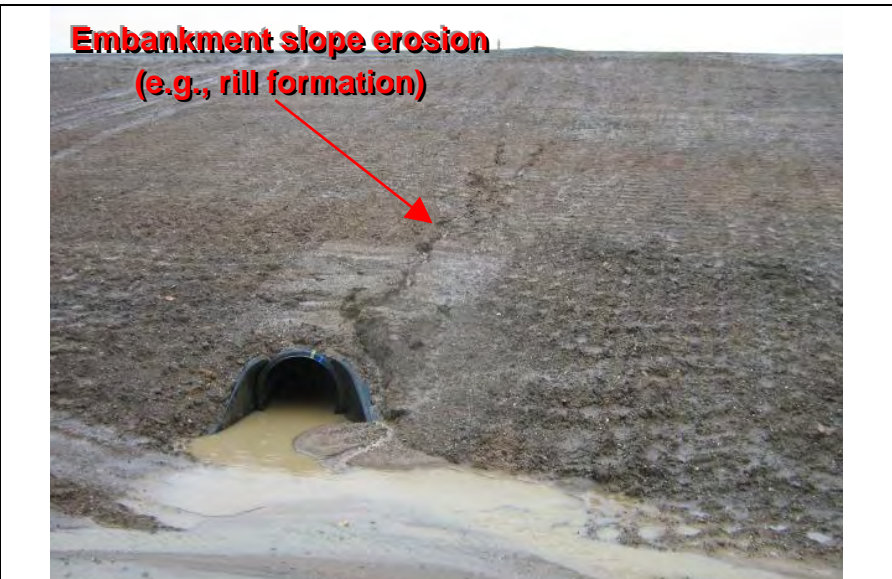
Photograph 6 – Embankment slope erosion (e.g., rill formation)

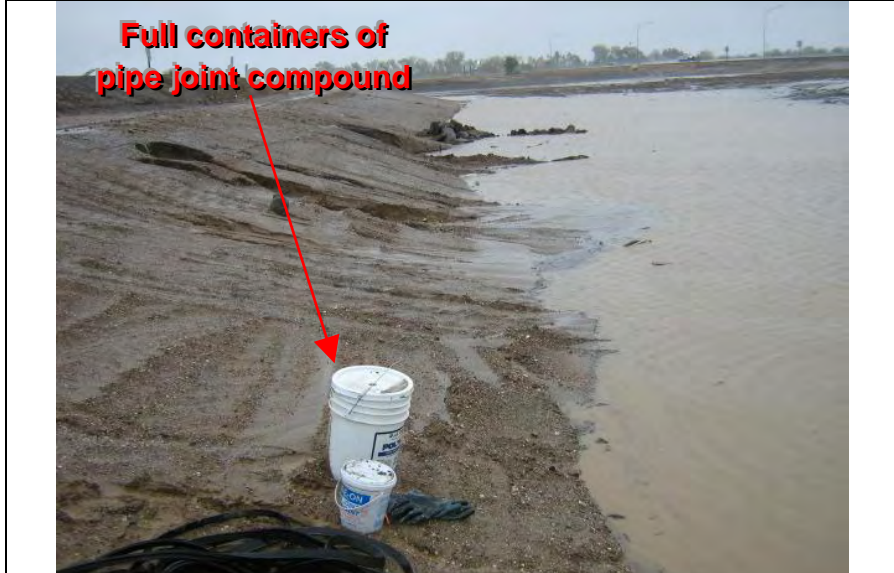
Photograph 7—Pipe joint compound located in the eastern sediment basin

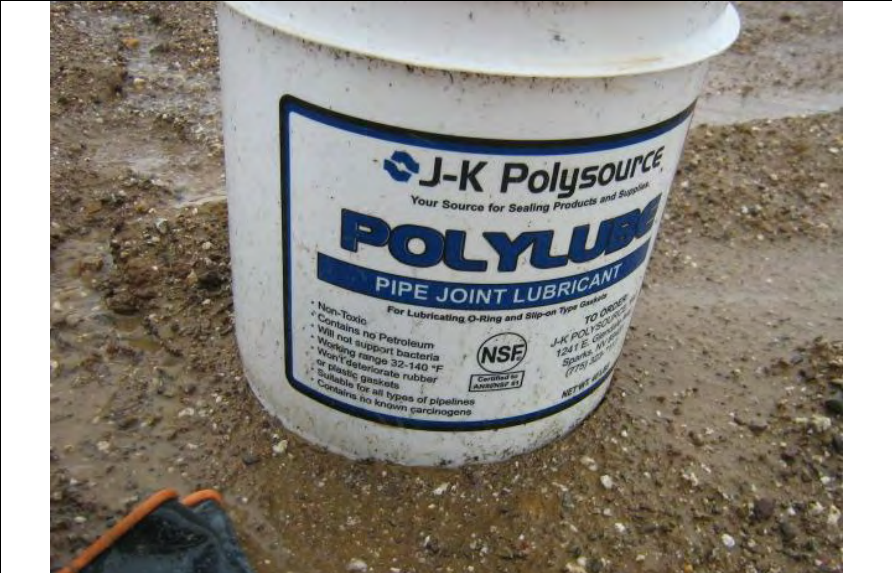
Photograph 8 – Close-up view of the full container of pipe joint compound in the eastern sediment basin

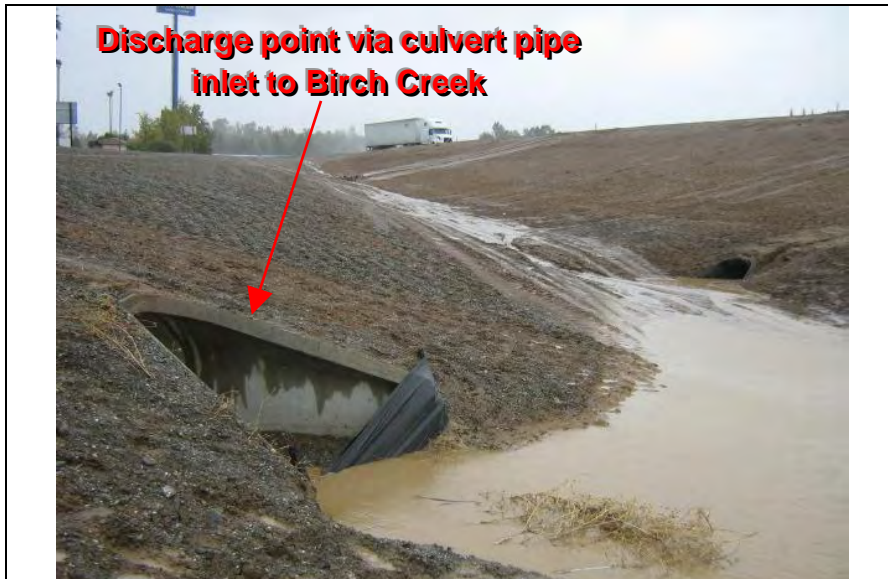
Photograph 9—Discharge point, culvert inlet and drainage pipe leading to Birch Creek

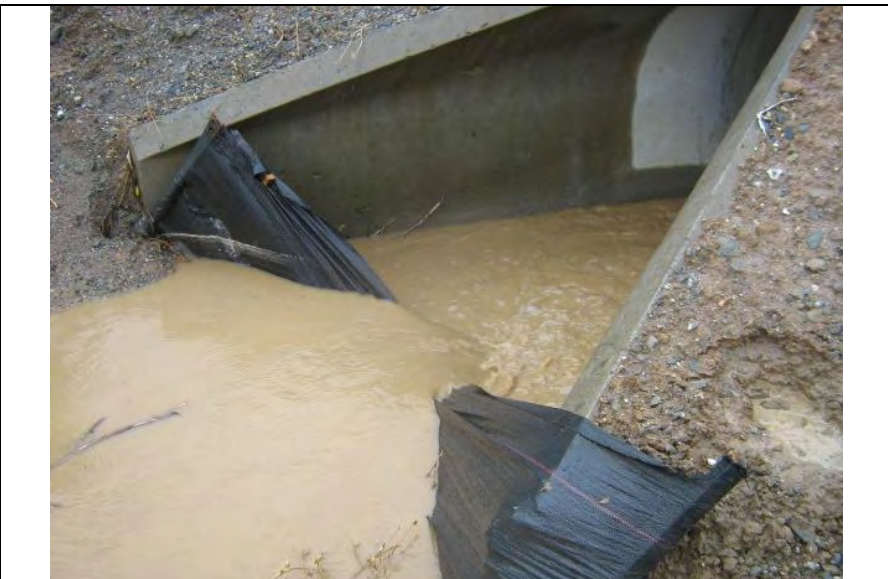
Photograph 10 – Inappropriate BMP selection (e.g., silt fence implemented in area of concentrated flow) and discharge of sediment laden runoff

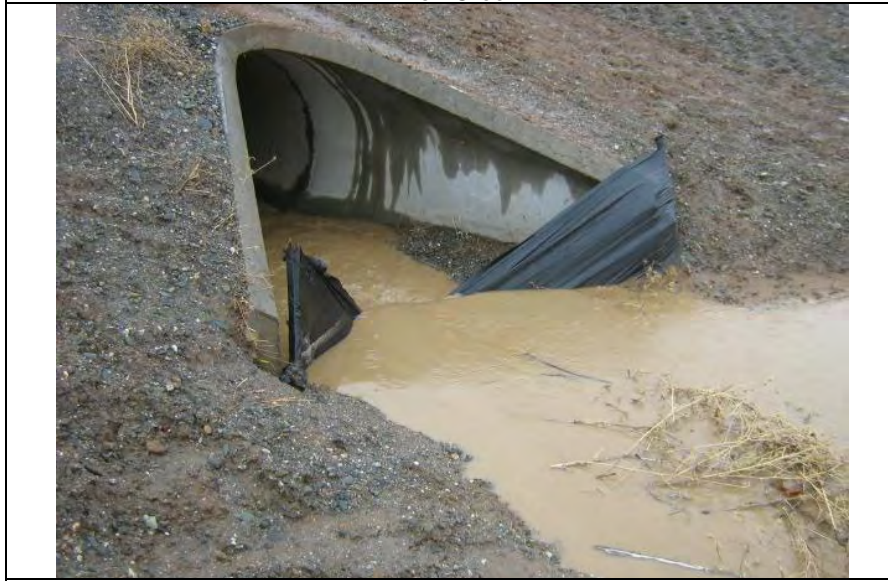
Photograph 11— Collapsed silt fence BMP and discharge of sediment laden runoff

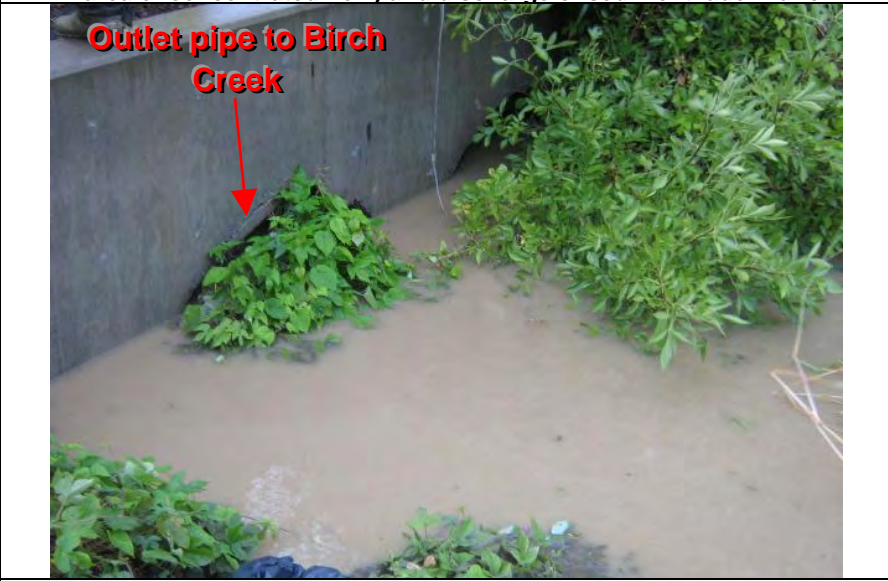
Photograph 12 – View of outlet pipe from Photograph 11 leading to Birch Creek

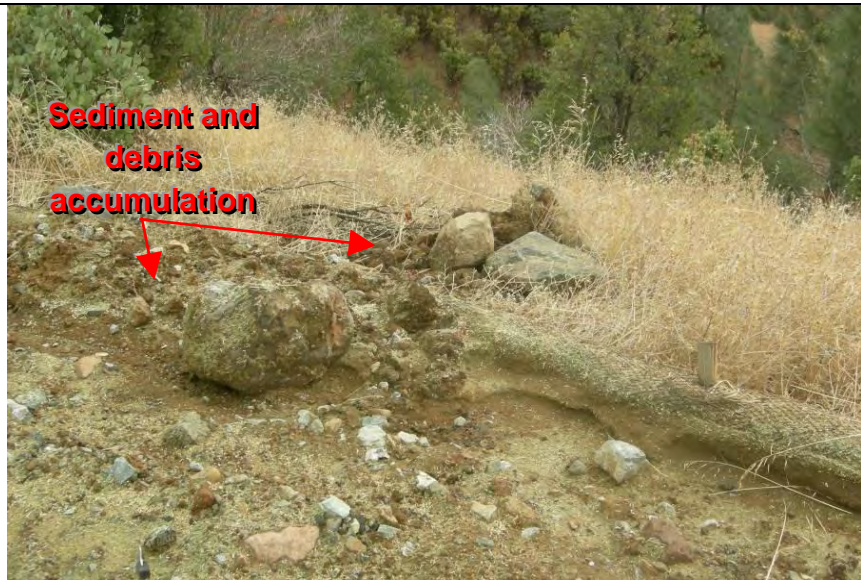
Photograph 1 – Perimeter control failure at the former staging area

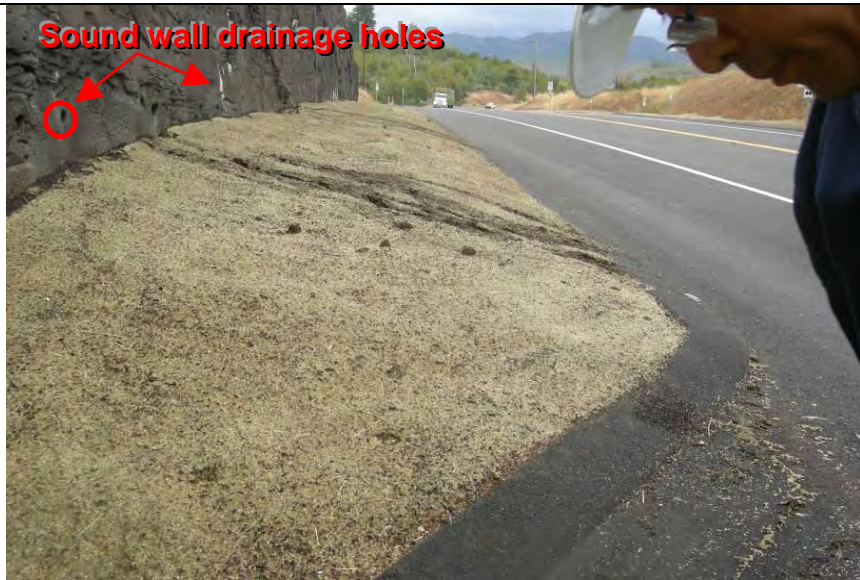
Photograph 2 – Run-off causing erosion along the highway shoulder

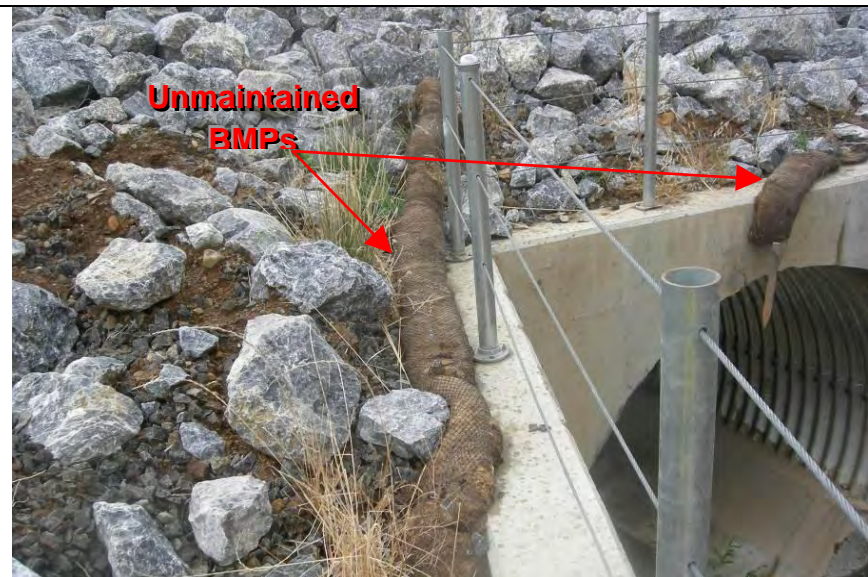
Photograph 8 – Inadequate straw wattle BMP maintenance at drainage pipe inlet

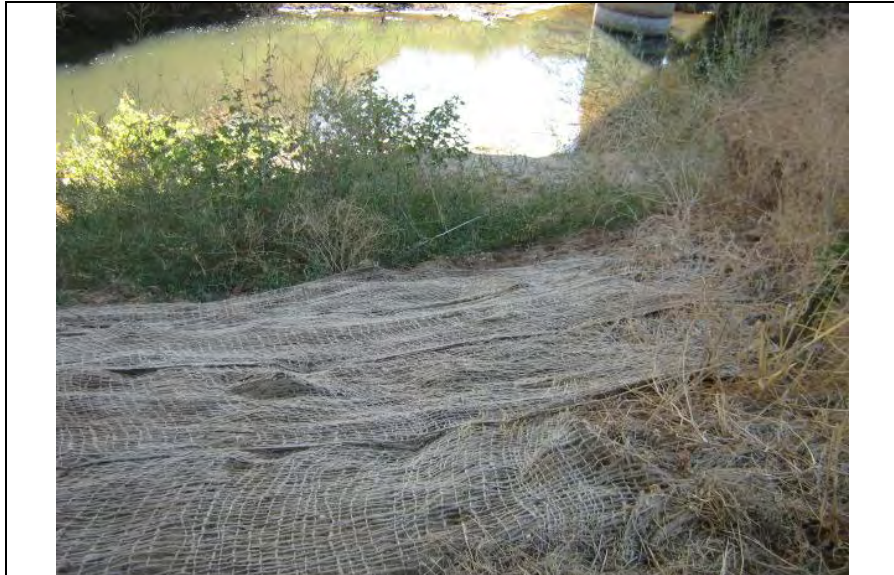
Photograph 1 – Erosion control blanket not properly installed (e.g., improper overlap – not shingled downgradient) adj. to Bear River at top.

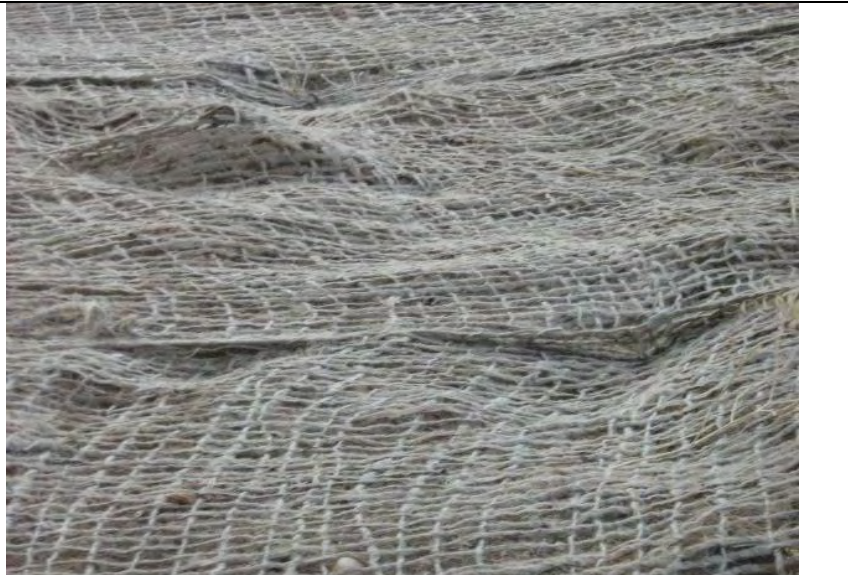
Photograph 2 – Close-up of Photograph 1 looking down-gradient.

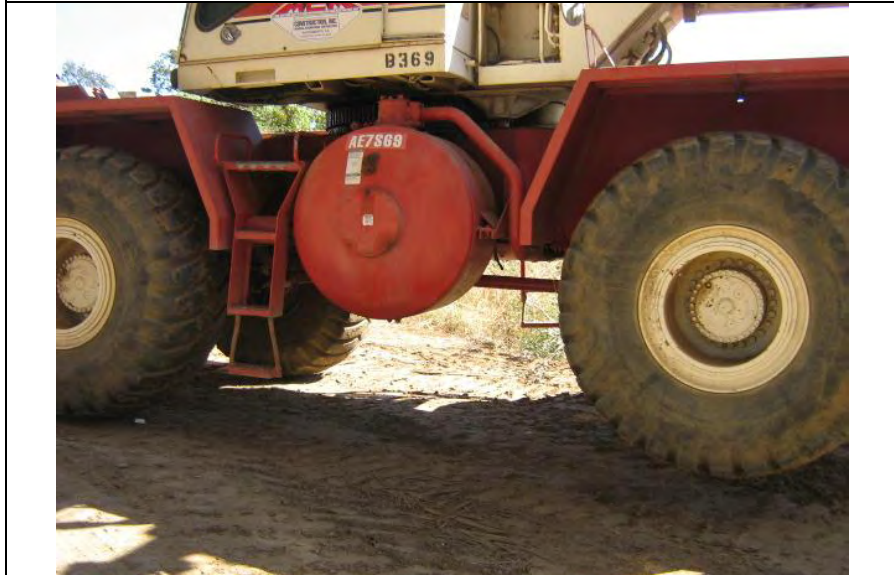
Photograph 3 – Equipment with petroleum product leaking onto ground surface (see Photograph 4 for close-up view).

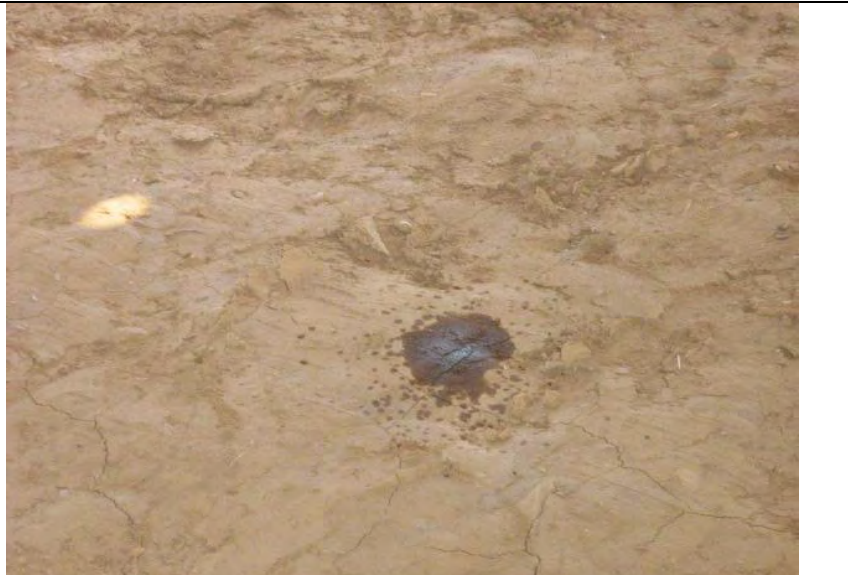
Photograph 4 – Close-up view of petroleum product on ground surface

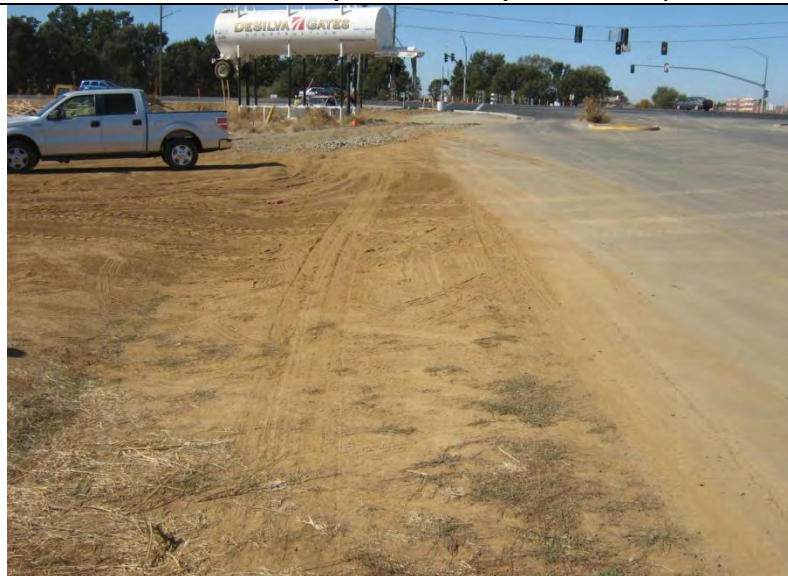
Photograph 12 – Tracking control BMPs not implemented for disturbed area of contractor parking. Observed sediment transport to roadway

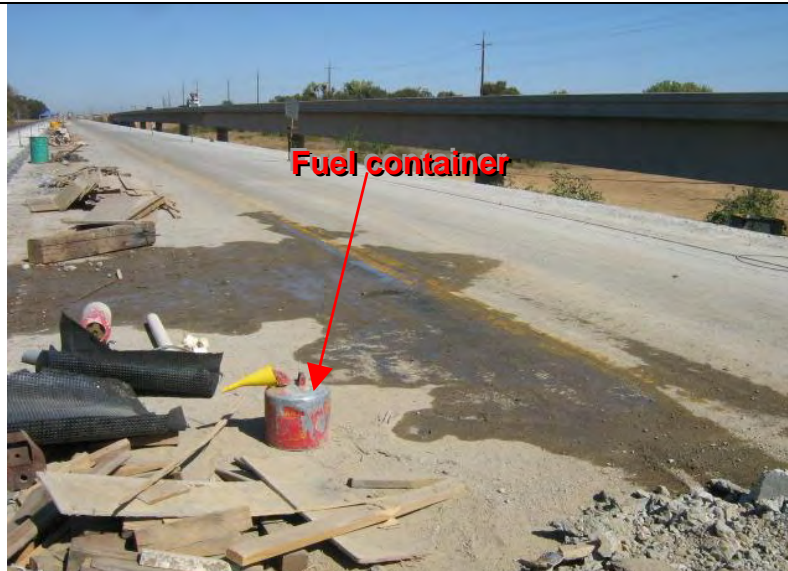
Photograph 18 – Inadequate materials handling and storage

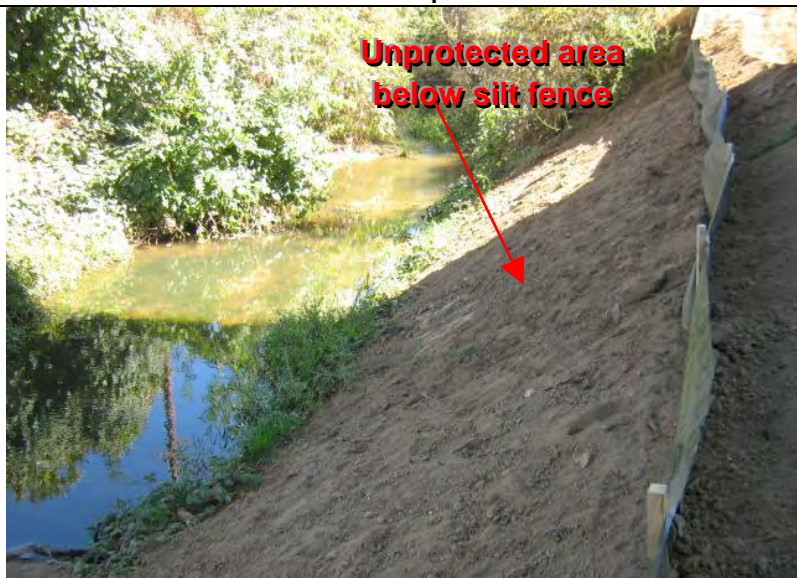
Photograph 19 – Unstabilized slope area adjacent to Yankee Slough

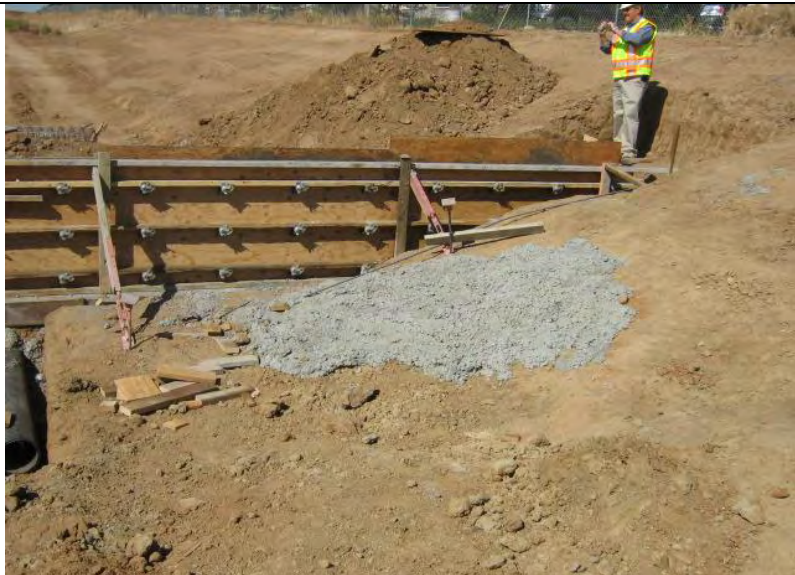
Photograph 1 – Improper concrete waste disposal practices

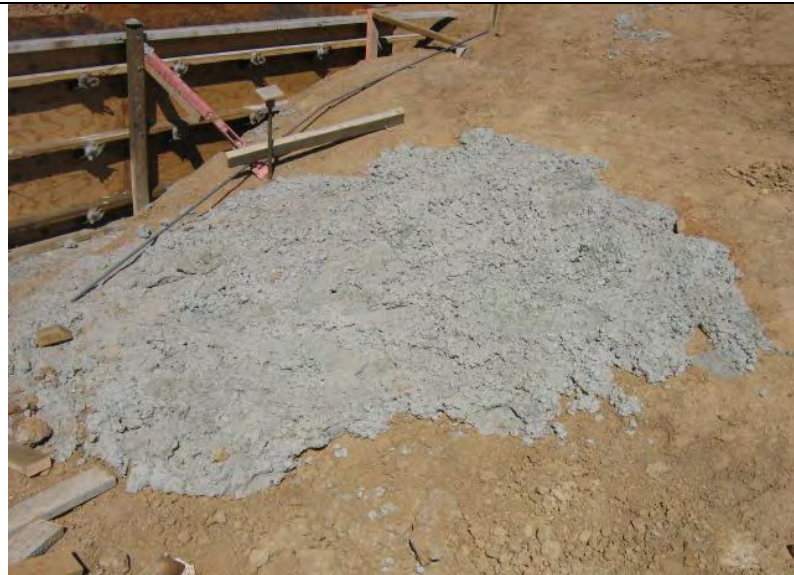
Photograph 2 – Close-up of Photograph 1

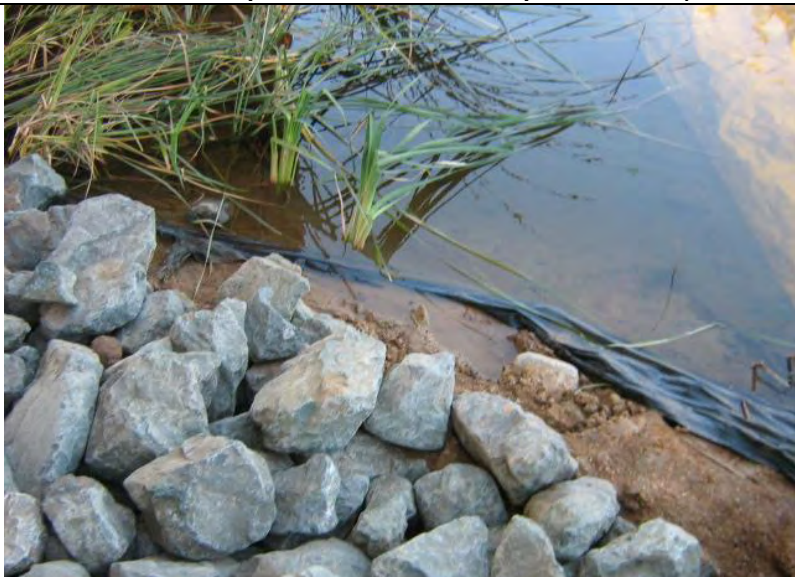
Photograph 7 – Badly deteriorated silt fence BMP located in/adjacent to North Ingram Slough

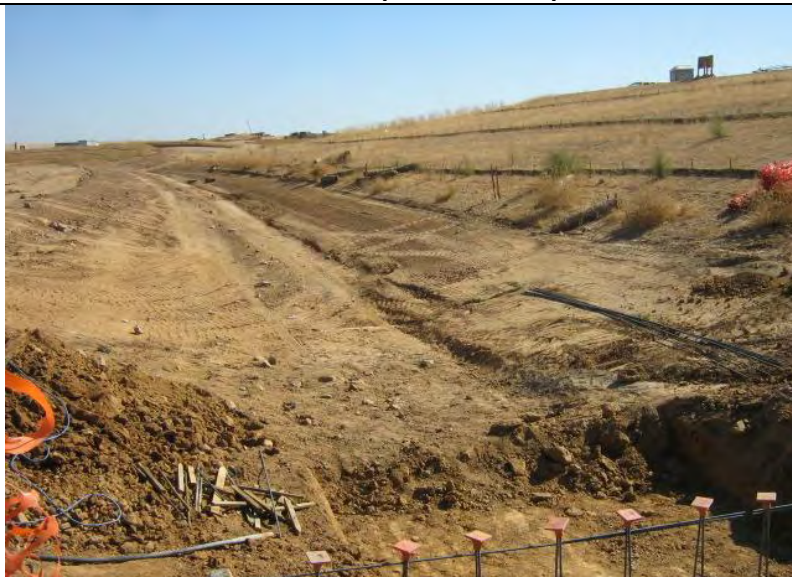
Photograph 8 – Disturbed conveyance channel with no slope run-on BMPs or erosion and sediment control BMPs near the S. Ingram Slough.

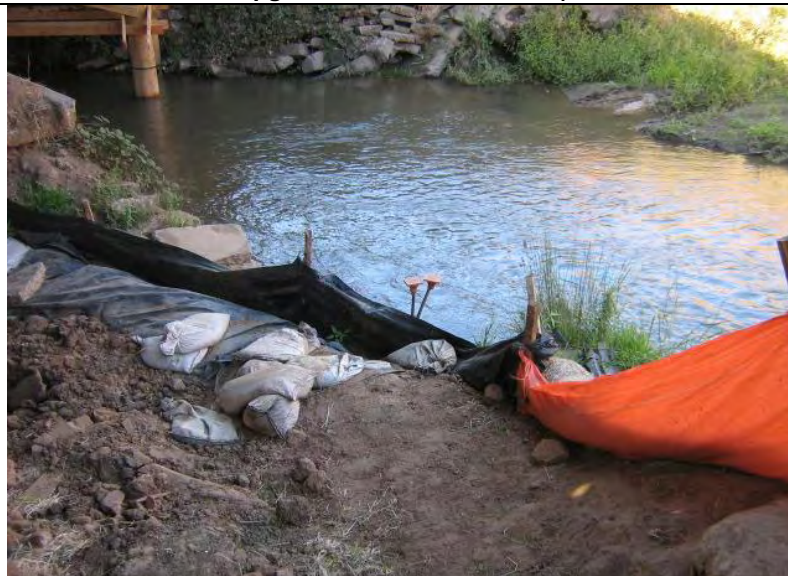
Photograph 12 – Silt Fence BMP not adequately maintained (e.g., down in areas; deteriorated) adjacent to Auburn Ravine

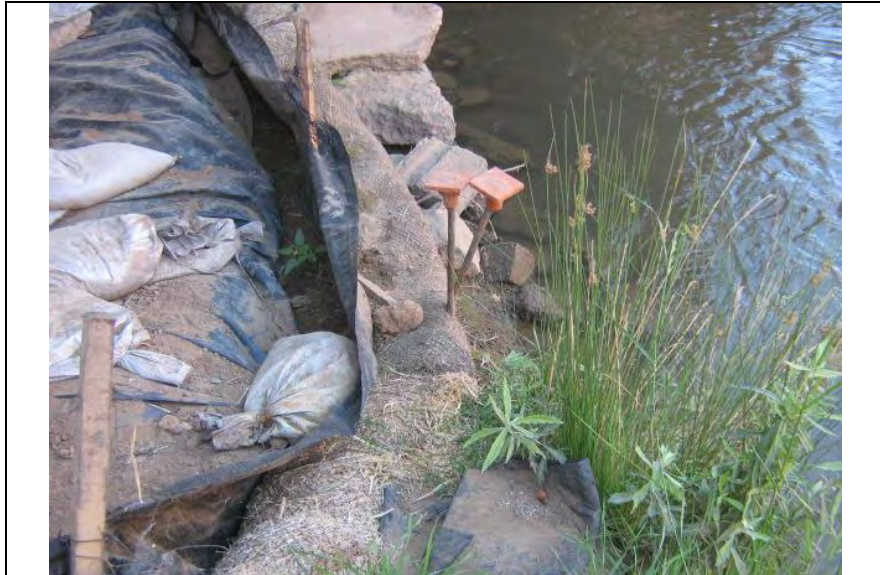
Photograph 13 – Differing vantage point from Photograph 12 depicting unmaintained Silt Fence BMP adjacent to Auburn Ravine

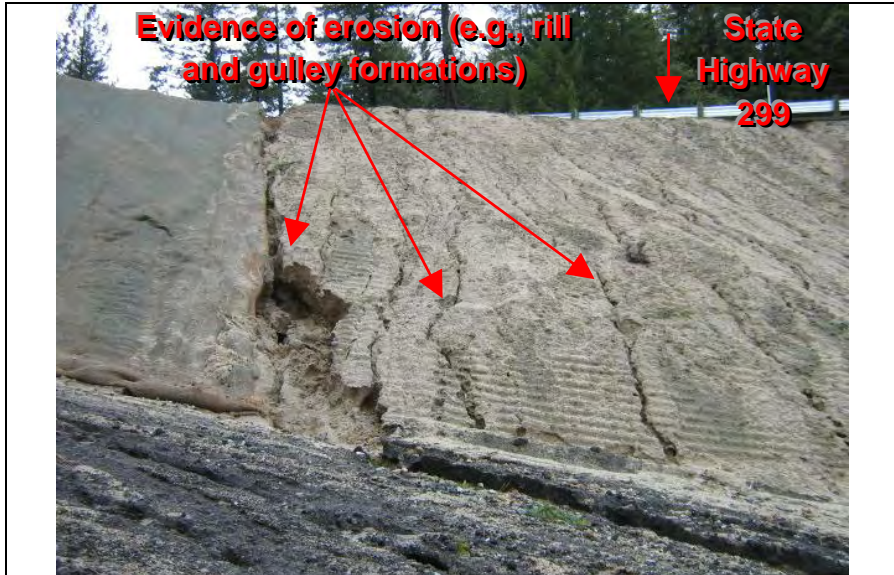
Specifically, adequate BMPs were not implemented to prevent the discharge of sediment from the field constructed sediment basins (see [Photograph 9](#)) and from disturbed slope areas adjacent to State Highway 299 (see [Photographs 1 and 2](#)). Visible evidence of a runoff event discharging sediment to the field constructed sediment basin No. 2 (see [Photographs 2 and 3](#)) and beyond the basin to the unnamed tributary of Crystal Creek (see [Photographs 4 through 8](#)) was observed. Visible evidence of a runoff event discharging sediment to the two field constructed sediment basins and sediment accumulation in the basins was observed during the inspection (see [Photographs 9 through 12](#)); and within the outlet conveyance channel (see [Photographs 4 and 7](#)) which subsequently drains to the unnamed tributary to Crystal Creek (see [Photographs 5, 6 and 8](#)).

Photograph 1 – Disturbed slope areas adjacent to State Highway 299 with evidence of erosion (e.g., rill and gully formations)

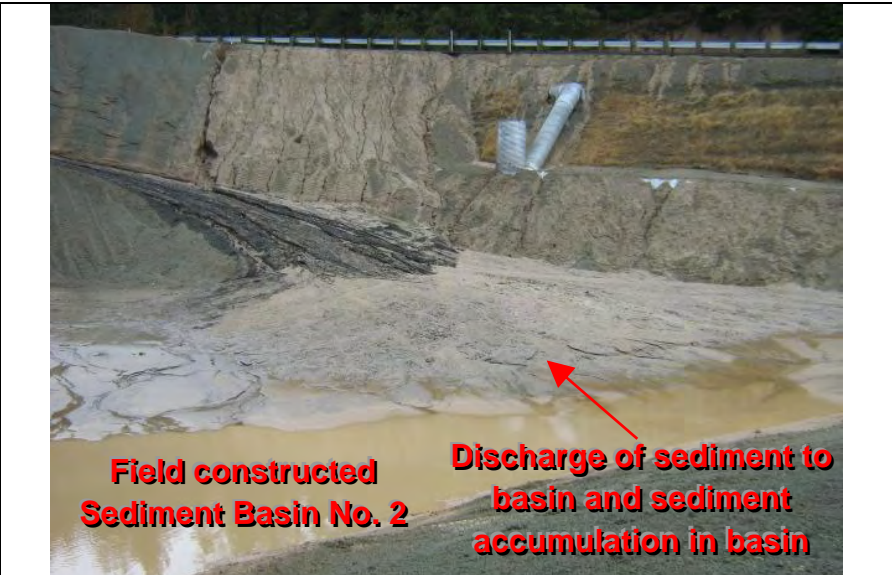
Photograph 2 – Discharge of sediment from disturbed slope area to field constructed sediment basin and sediment accumulation in the basin

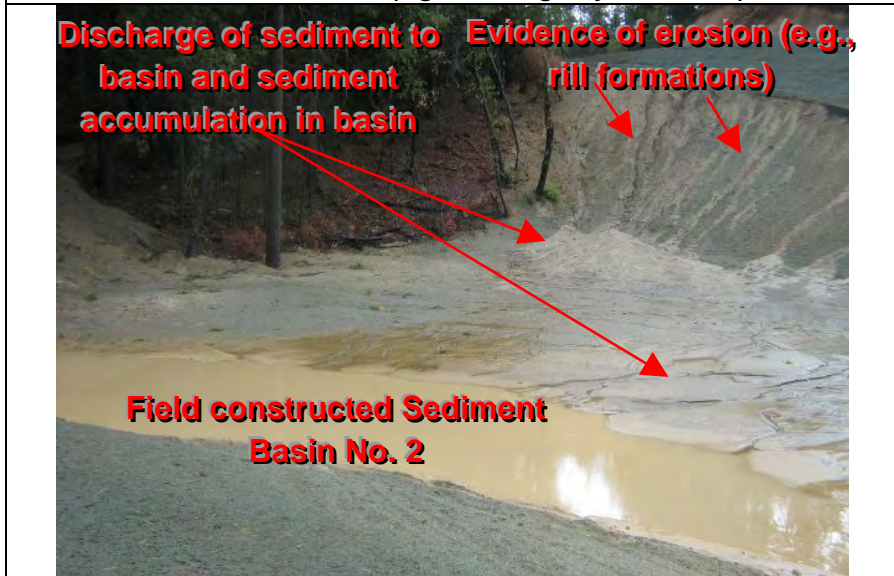
Photograph 3 – Sediment basin embankment slope erosion (e.g., rill and gully formation) and sediment accumulation in the basin

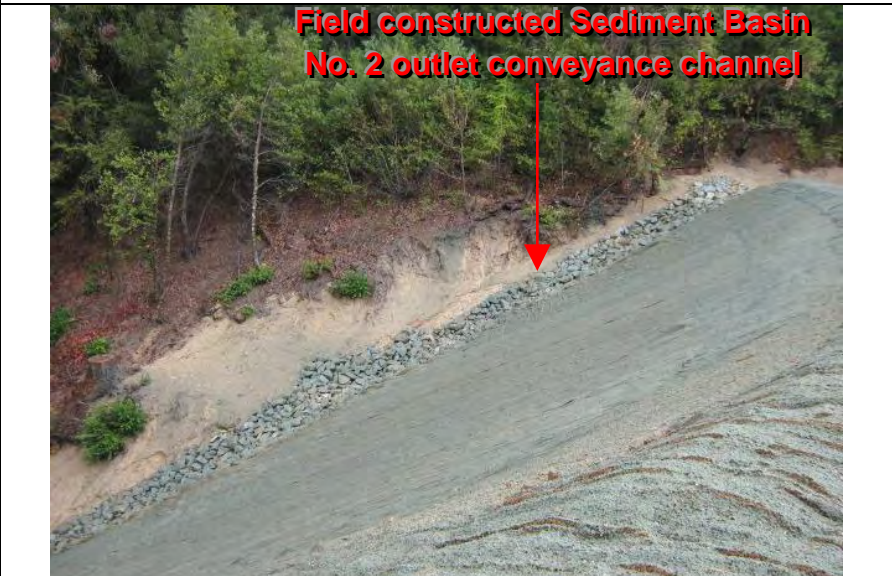
Photograph 4 – Vantage point of the outlet conveyance channel for the field constructed sediment basin No. 2

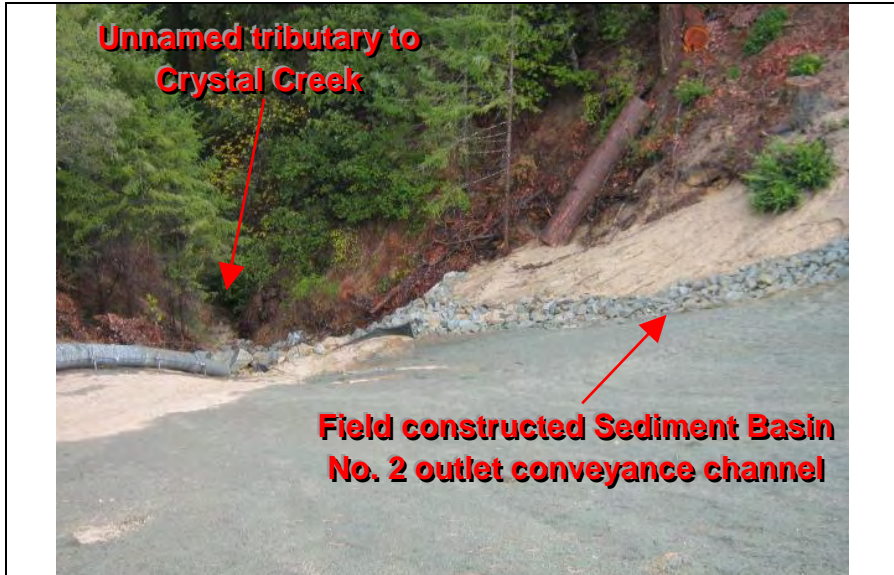
Photograph 5— View of sediment basin No. 2 outlet conveyance channel and confluence with the unnamed tributary to Crystal Creek

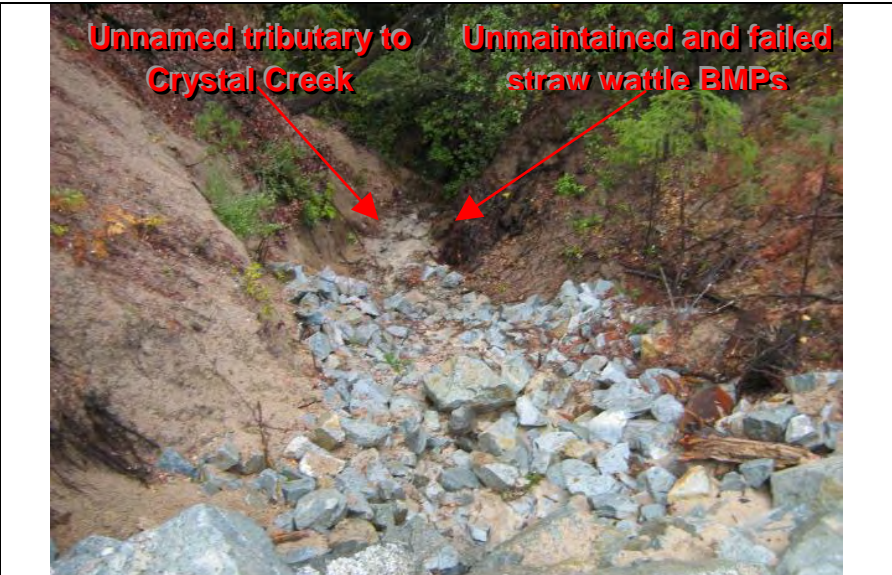
In addition to the up-gradient disturbed areas contributing sediment to and beyond the field constructed basins No. 1 and No. 2, adequate BMPs were not implemented below the basin No. 2 rip-rap outlet conveyance channel (see [Photograph 6](#)), at the base of the field constructed sediment basin No. 2 outer embankment slope (see [Photographs 13 through 15](#)), below field constructed sediment basin No. 1 culvert outlet pipe (see [Photograph 16](#)), and on disturbed slope areas adjacent to the rip-rap outlet conveyance channel. It should be noted that the sediment basins were field constructed, as provided by Caltrans District No. 2 representatives, and it was not known whether the basins were designed and constructed according to the Caltrans Pollution Prevention Design Guide (PPDG).

improper BMPs selection for an area of concentrated flow from the field constructed sediment basin No. 2 outlet conveyance channel (see [Photographs 6 and 8](#)). The silt fence BMPs implemented below the field constructed sediment basin No. 2 embankment slope were placed under a culvert pipe, had collapsed in areas, and evidence of sediment transport beyond the silt fence BMP to the unnamed tributary was observed (see [Photographs 13 through 15](#)). Adequate BMPs had not been implemented for flow dissipation below the field constructed sediment basin No. 1 culvert outlet pipe. Evidence of erosion (e.g., gully formation) and embankment undercutting was observed (see [Photograph 16](#)). Furthermore, BMPs were not implemented for disturbed slope areas adjacent to the rip-rap outlet conveyance channel which drains to the unnamed tributary to Crystal Creek (see [Photograph 17](#)). As a result, there was a discharge of sediment to the unnamed tributary which subsequently drains to Crystal Creek. Prohibition A.1 of the Permit states the “discharge of runoff from construction sites containing pollutants which have not been reduced using BAT for toxic pollutants and BCT for conventional pollutants to waters of the United States is prohibited.”

Photograph 6 – Close-up view of sediment basin No. 2 rip-rap outlet conveyance channel to unnamed tributary to Crystal Creek

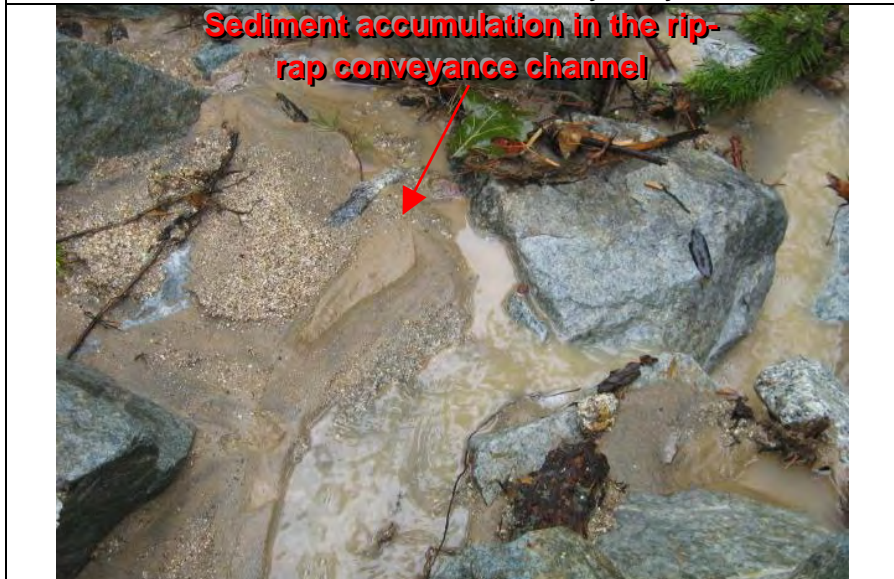
Photograph 7—Visible evidence of sediment accumulation in the rip-rap outlet conveyance channel which drains to the unnamed tributary

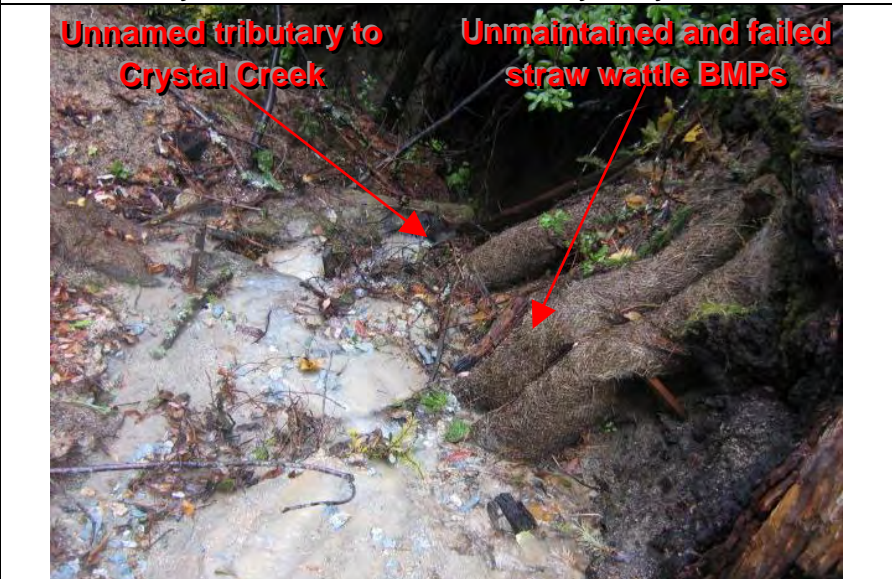
Photograph 8 – Visible evidence of the discharge of sediment to the unnamed tributary to Crystal Creek, and failed straw wattle BMPs observed

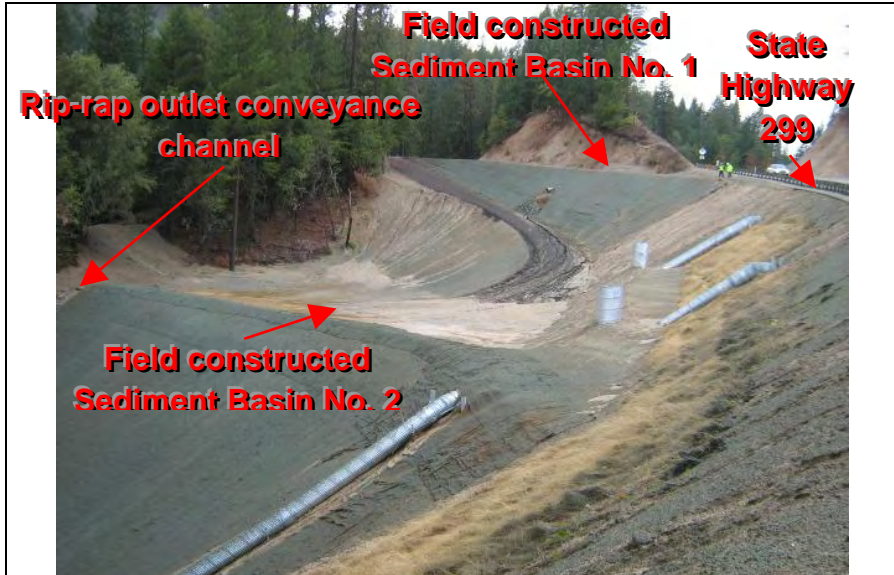
Photograph 9—Vantage point photograph depicting location of field constructed sediment basins No. 1 and No. 2 and their outlet.

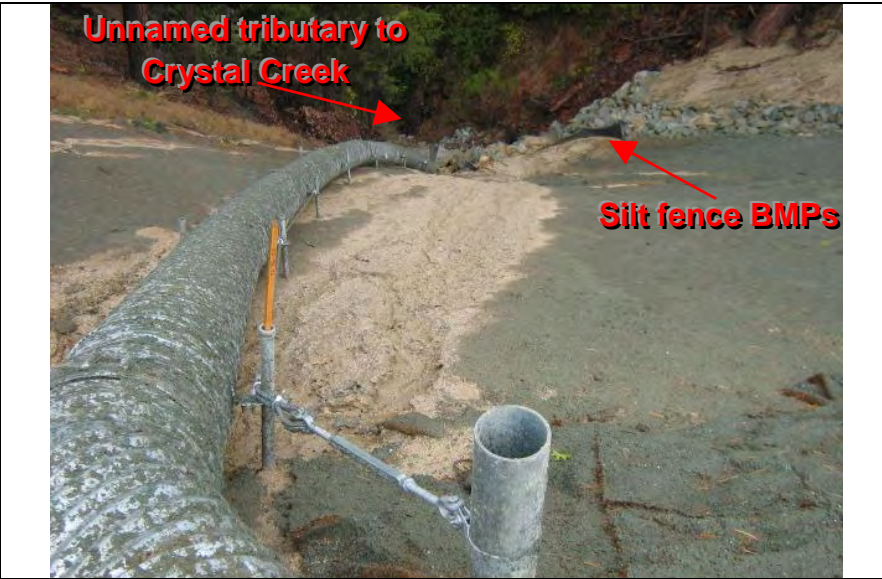
Photograph 13—Adequate BMPs were not implemented to prevent the discharge of sediment from upgradient disturbed slope areas

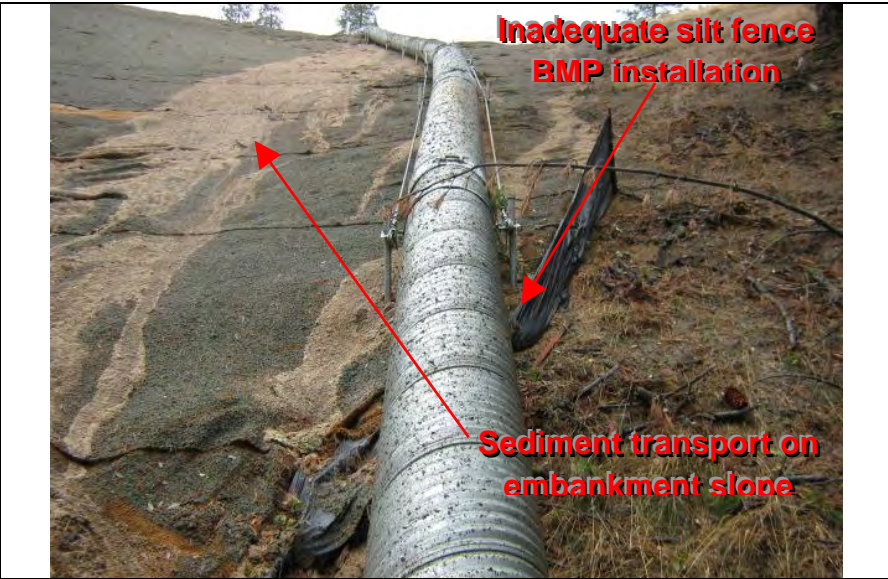
Photograph 14 – Evidence of sediment transport on the embankment slope of the field constructed sediment basin No. 2. Inadequate silt fence BMP installation under culvert pipe

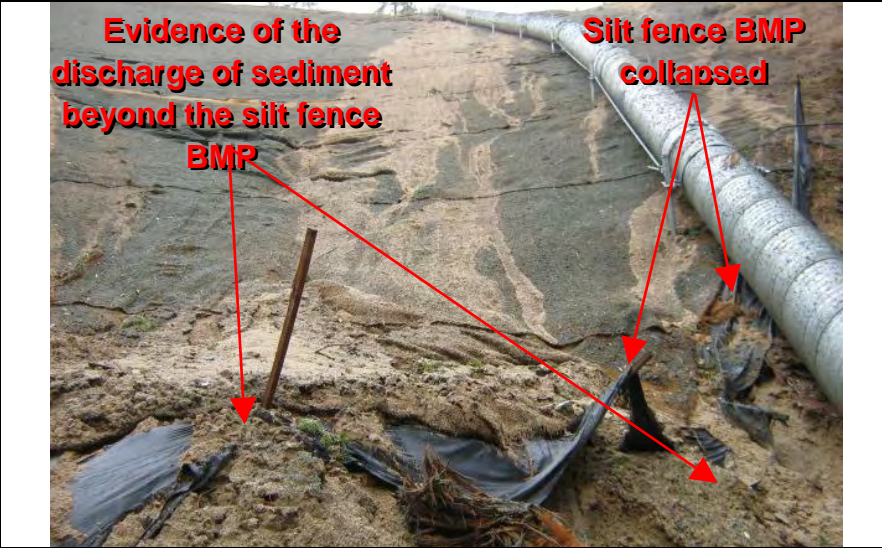
Photograph 15—SF BMPs were not adequately maintained (e.g., collapsed in areas) to prevent the discharge of sediment to the unnamed tributary.
