Appendix D
Construction Program Site Visit Reports

Thomes Creek Bridge Project
Site Visit Date: 10/13/2009

**Caltrans MS4 (SWRCB Order No. 99-06-DWQ)
Thomes Creek Bridge Project
Caltrans District 2**

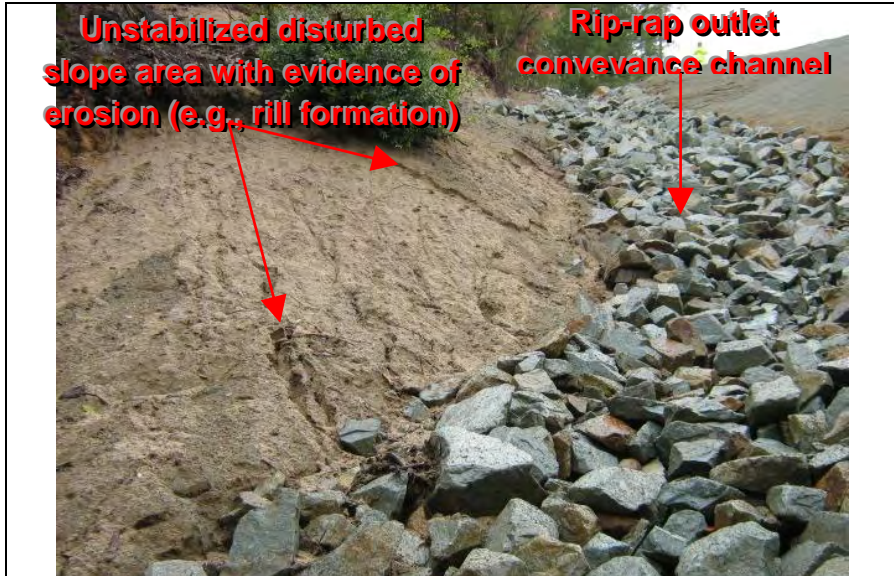
Photograph 17—Adequate BMPs were not implemented to prevent the discharge of sediment from disturbed slope area adjacent to the rip-rap conveyance channel which drains to the unnamed tributary.

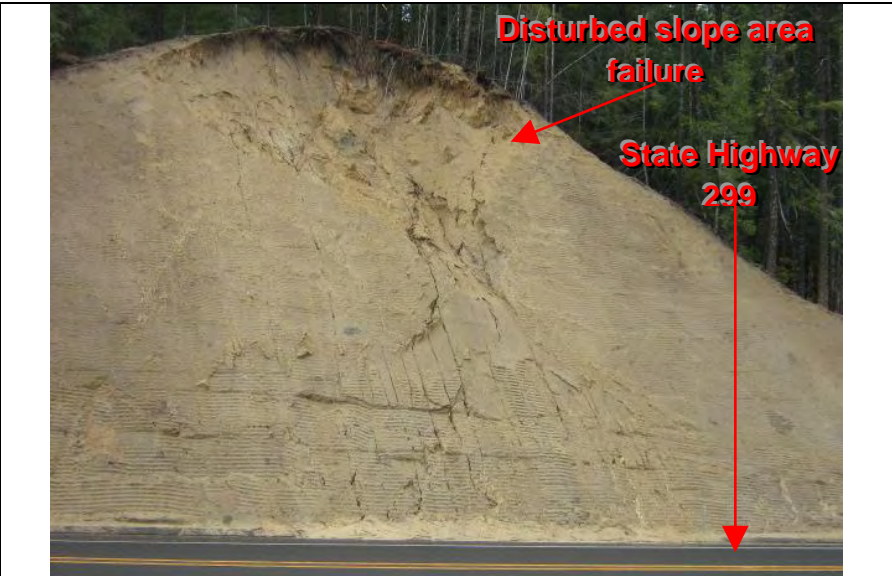
Photographs 18 – Adequate BMPs were not implemented to prevent the discharge of sediment from a disturbed cut slope area adjacent to State Highway 299.

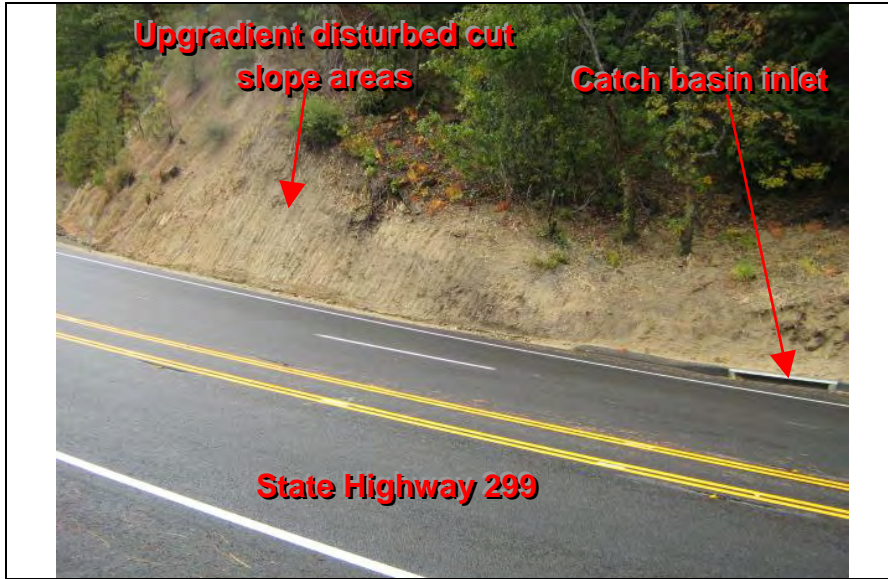
Photograph 21—BMPs were not implemented to prevent the discharge of sediment from up-gradient disturbed cut slope areas to catch basin inlets.

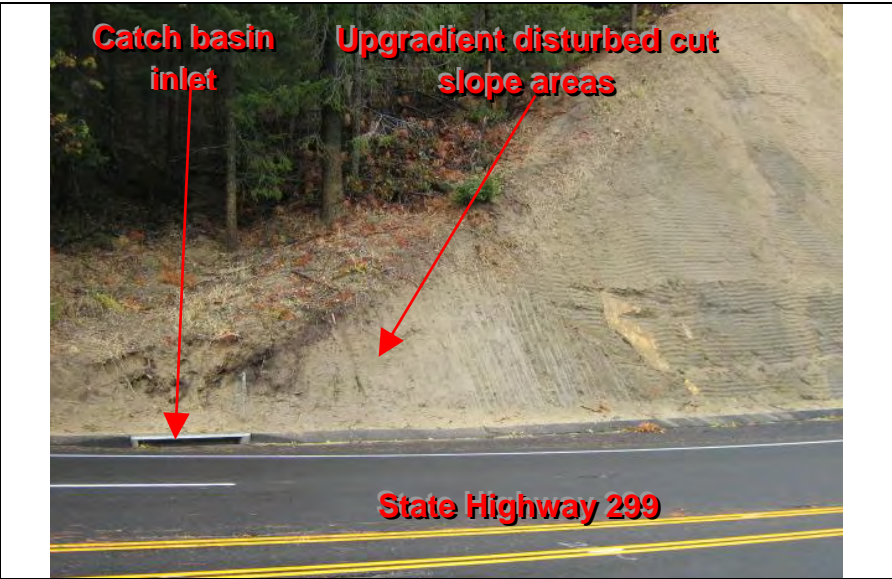
Photographs 22 – BMPs were not implemented to prevent the discharge of sediment from upgradient disturbed cut slope areas to catch basin inlets.

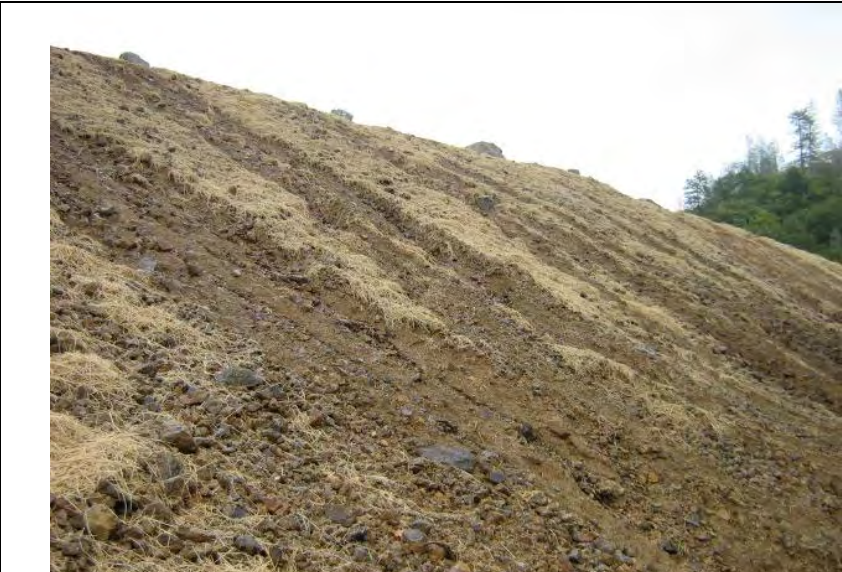
Photograph 1 – Evidence of erosion and slope failure on disturbed slope areas draining to Crystal Creek on the south side of State Highway 299

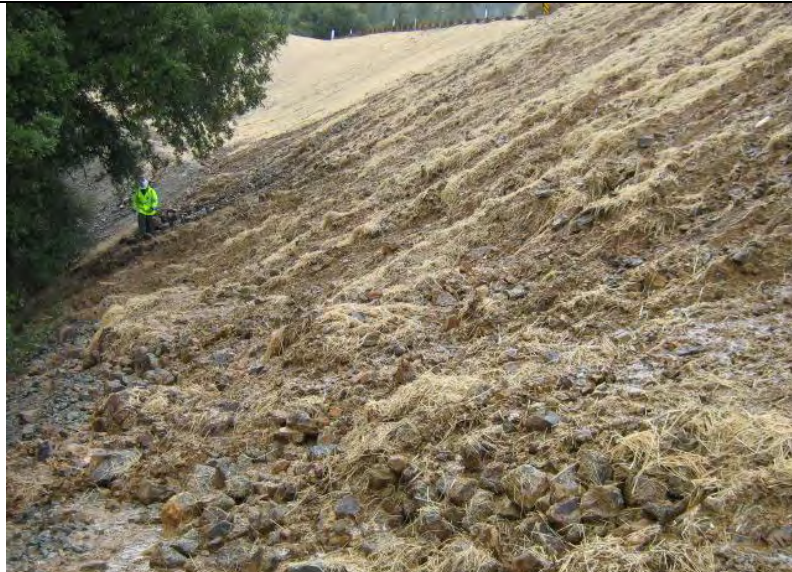
Photograph 2 – Evidence of erosion and slope failure on disturbed slope areas draining to Crystal Creek on the south side of State Highway 299

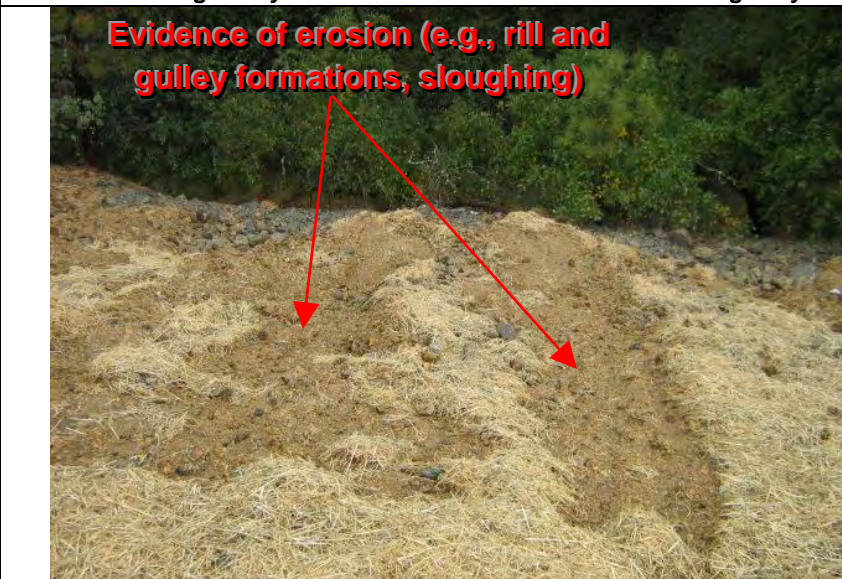
Photograph 3 – Evidence of erosion (e.g., rill and gully formation) and sediment transport from the disturbed slope failure

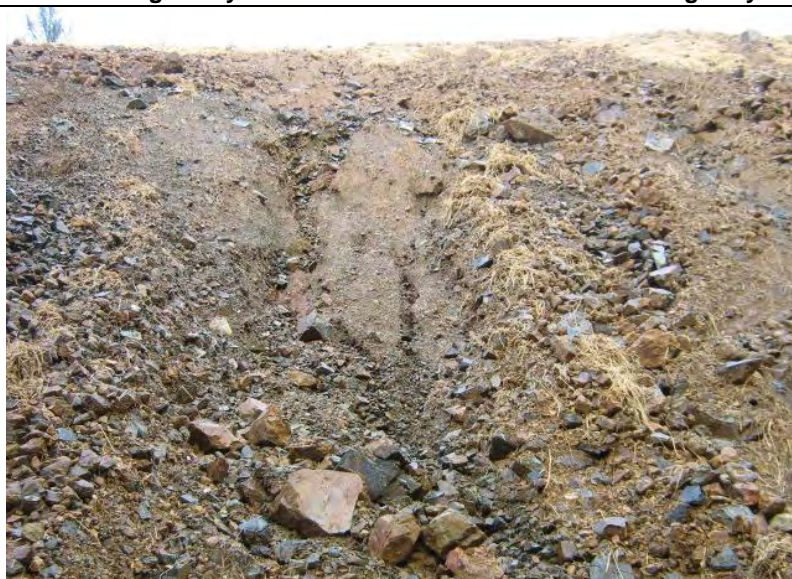
Photograph 4 – Visible evidence of erosion (e.g., rill and gully formation) on the disturbed slope area draining to Crystal Creek

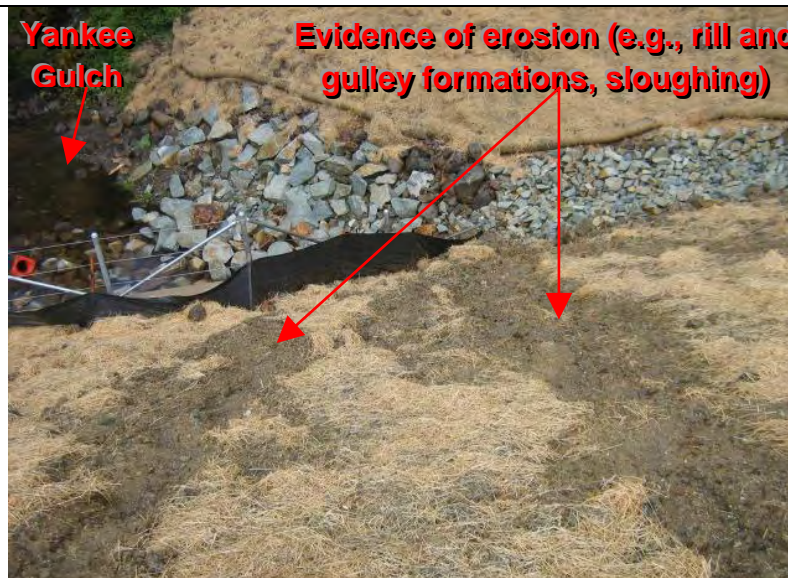
Photograph 8 – Evidence of erosion (e.g., rill and gully formation) and sediment transport from the disturbed slope failure

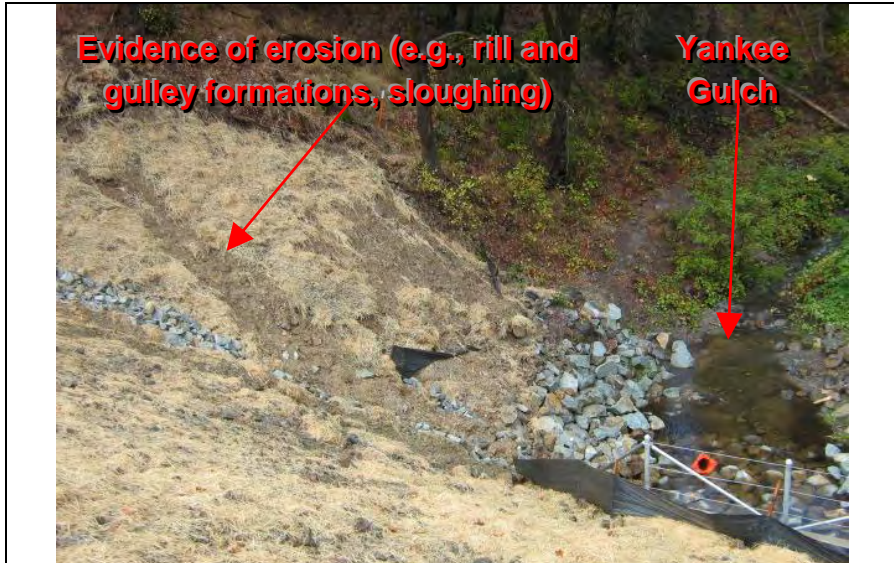
Photograph 9— Evidence of erosion (e.g., rill and gully formation) and sediment transport from the disturbed slope failure

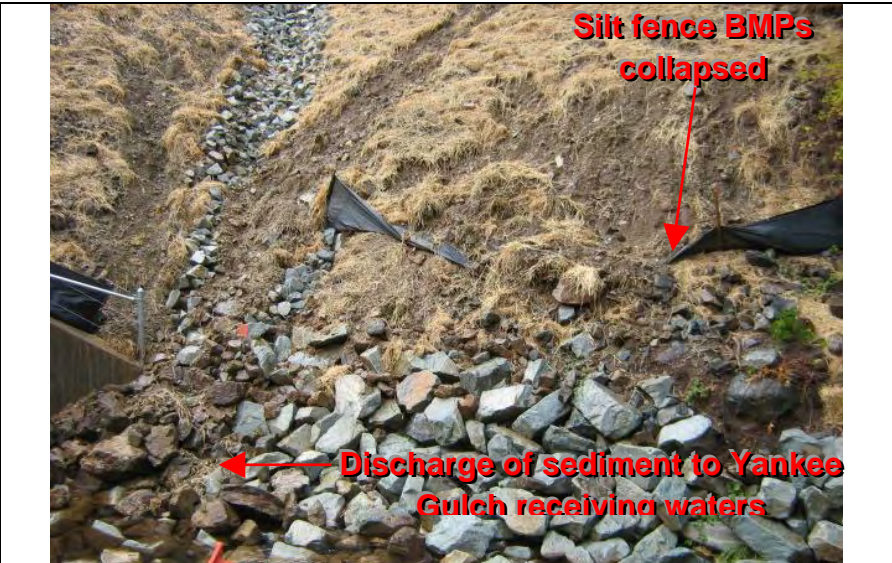
Photograph 10 – Silt fence BMPs collapsed in areas and evidence of the discharge of sediment to Yankee Gulch

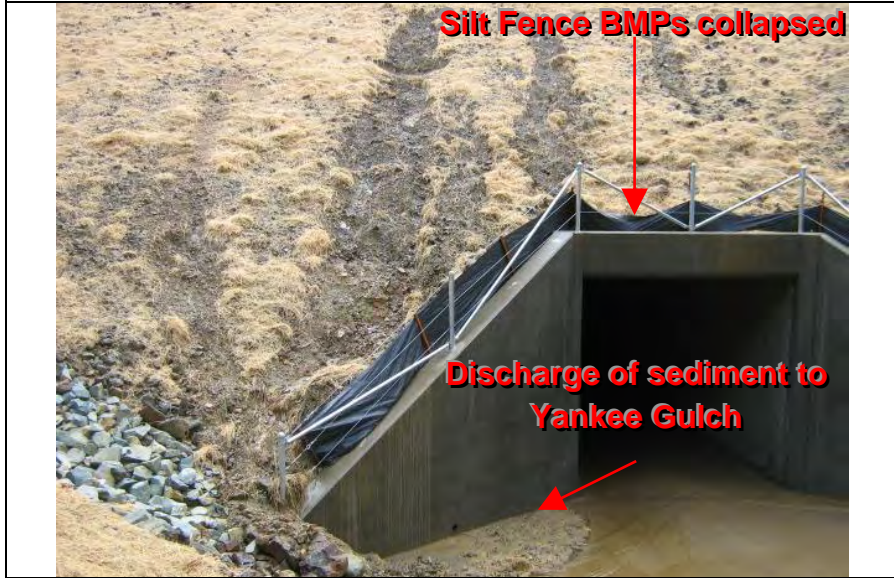
Photograph 11—Visible evidence of slope failure and the discharge of sediment to Yankee Gulch receiving water

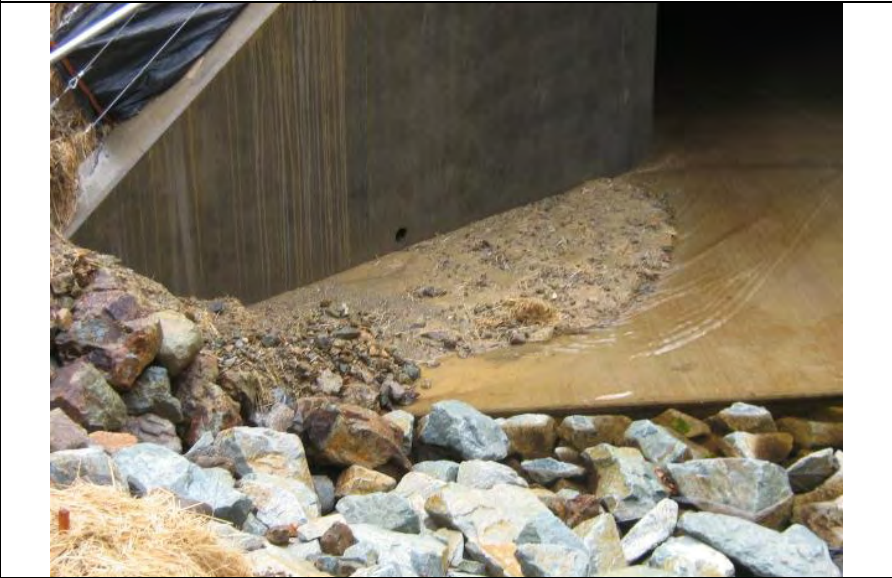
Photograph 12 – Close-up view of Photograph 11 depicting the discharge of sediment and sediment accumulation in Yankee Gulch

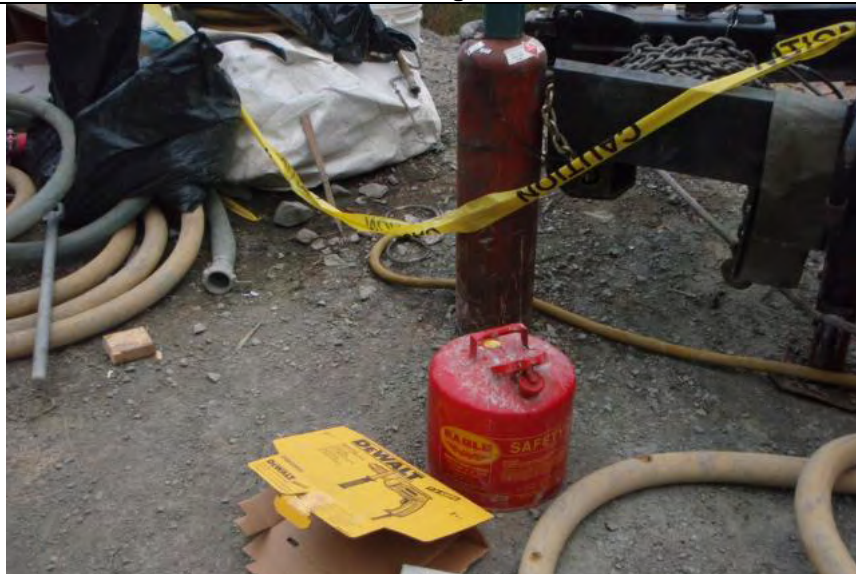
Photograph 11— Example of gas container not stored within secondary containment

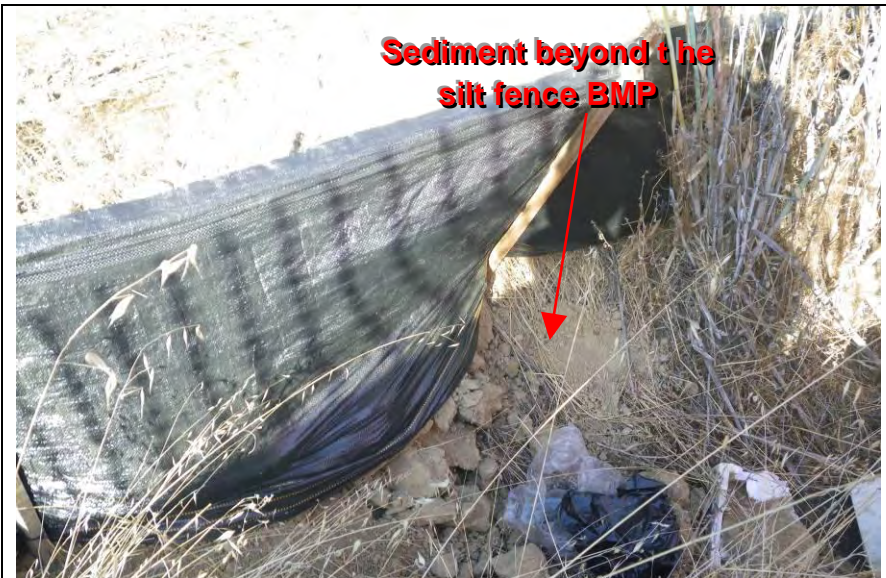
Photograph 5— Failure of first tier of silt fence shown in Photograph 4

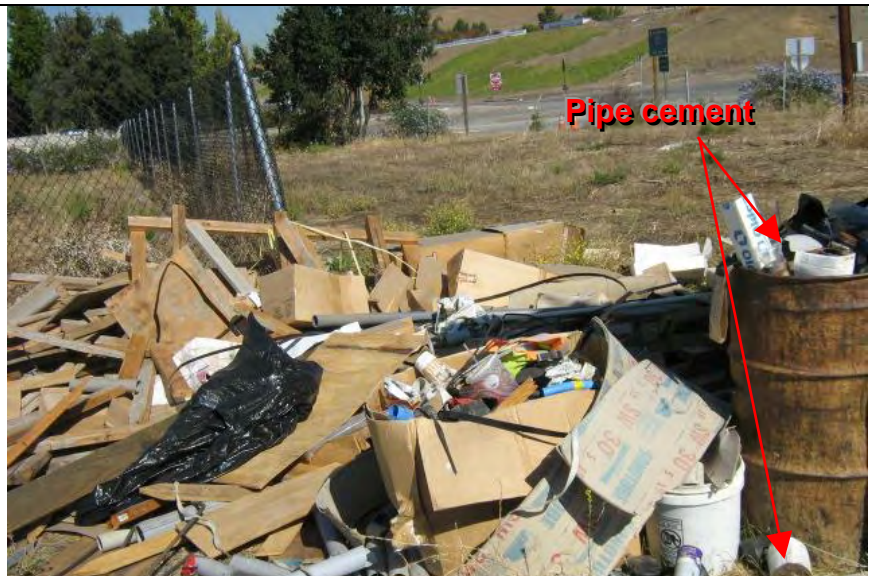
Photograph 1 – Construction wastes and chemicals improperly disposed

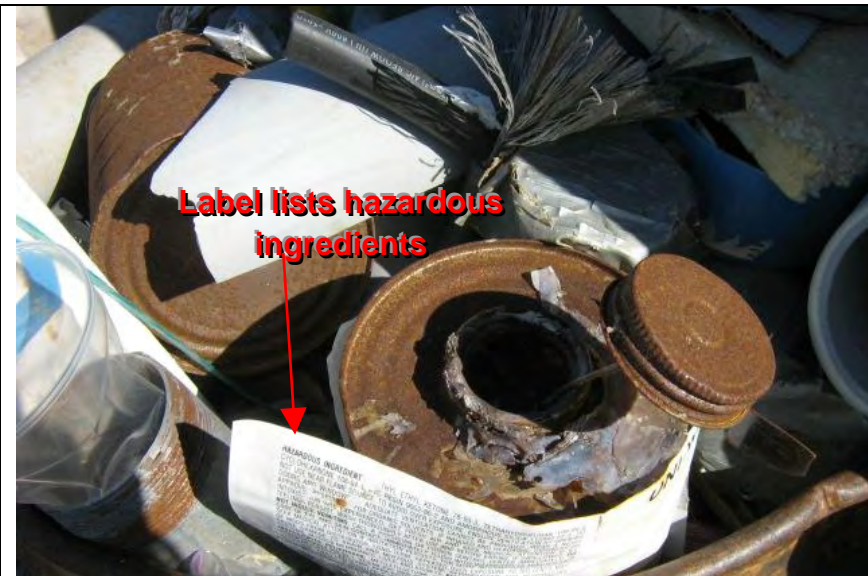
Photograph 2 – Close-up view showing open containers of pipe cement

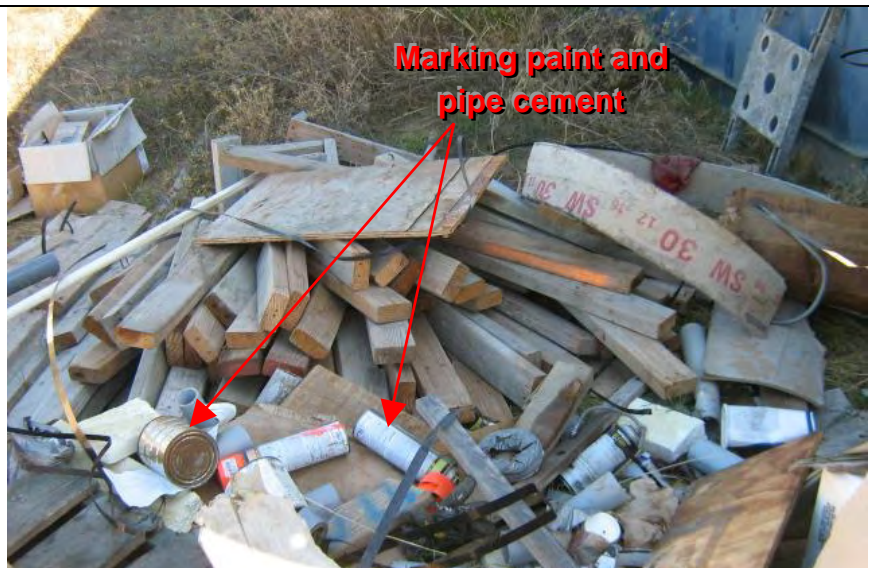
Photograph 3 – Construction wastes and chemicals improperly disposed

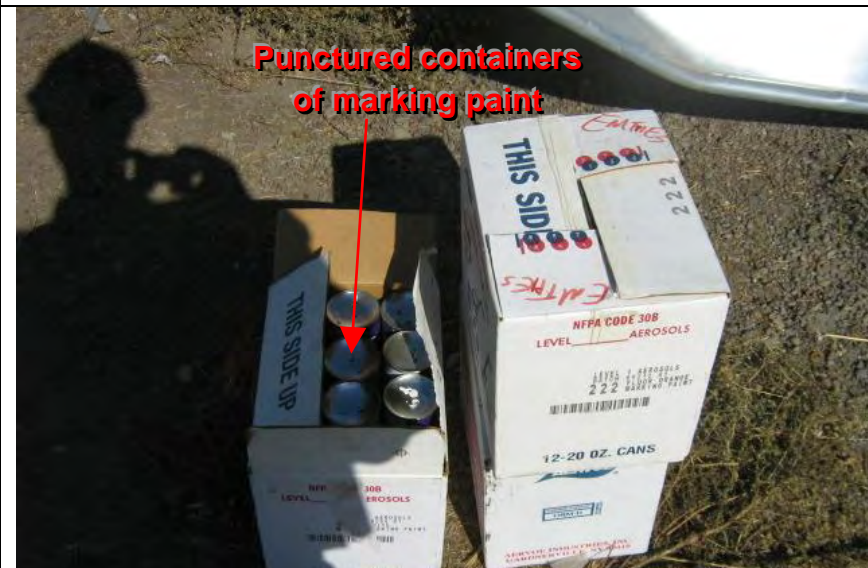
Photograph 4 – Construction wastes and chemicals improperly disposed

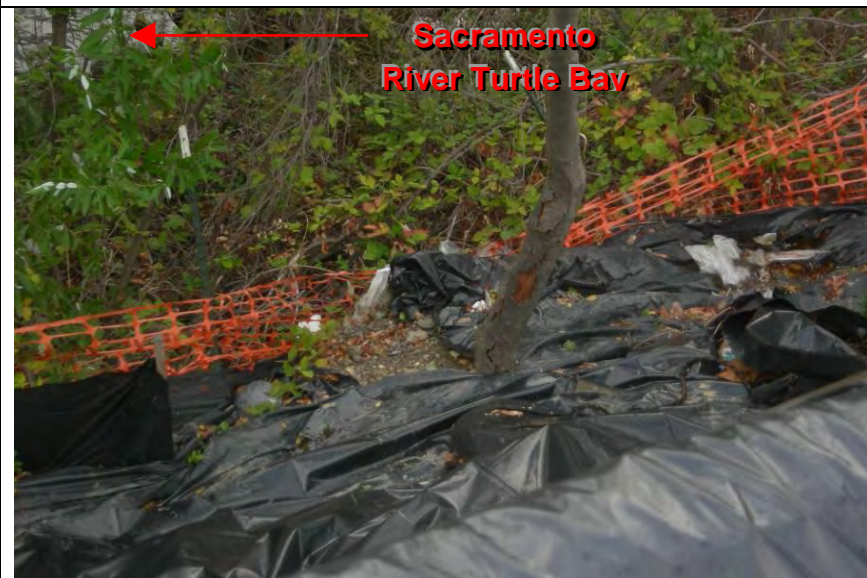
In an area along the northern portion of Interstate 5 and east of the Auditorium Drive Bridge, a perimeter control silt fence located at the toe of the slope had failed (see Photographs 2 and 3). As a result, there was potential for the discharge of sediment offsite into the Sacramento River Turtle Bay Park (see Photograph 3).

Photograph 3 – View of deteriorated slope stabilization BMP and collapsed silt fence in Photograph 2

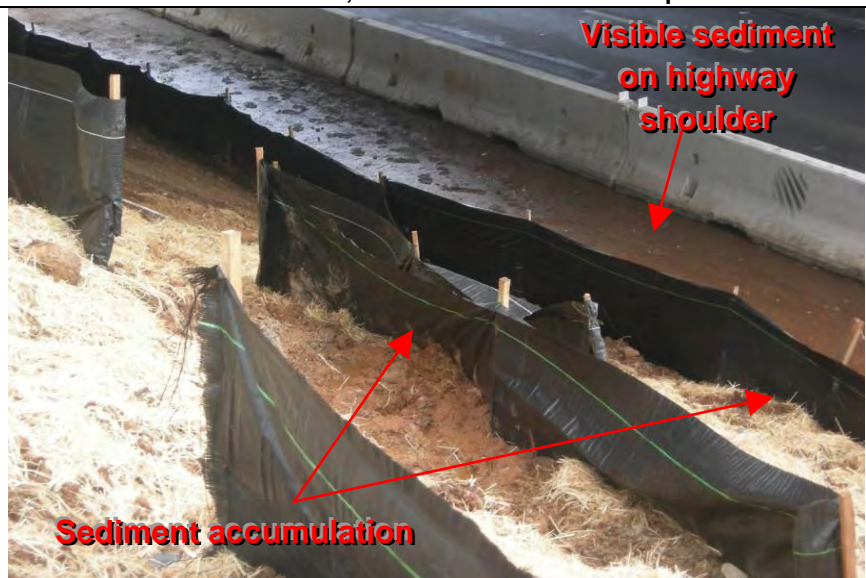
Adequate BMPs were not implemented for disturbed areas associated with the disturbed slope area under the Auditorium Drive Bridge overpass replacement and construction. Specifically, silt fence BMPs had accumulated sediment to approximately half the exposed silt fence height in several areas (see Photograph 4). Although three tiers of silt fence had been installed for BMP redundancy, the tiers were in need of maintenance (see Photograph 4), and sediment was visible beyond the BMPs on the highway shoulder.

Photograph 4 – Silt fence on the north side of I-5, view facing south-southeast

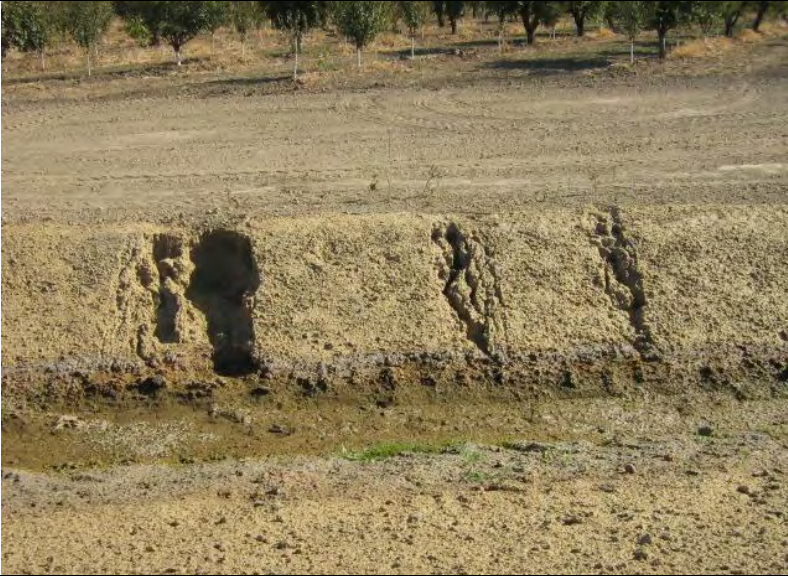
Photograph 17 – Evidence of previous erosion (e.g., rill/gulley formation) was observed on the adjacent roadway drainage swale slopes (West side).

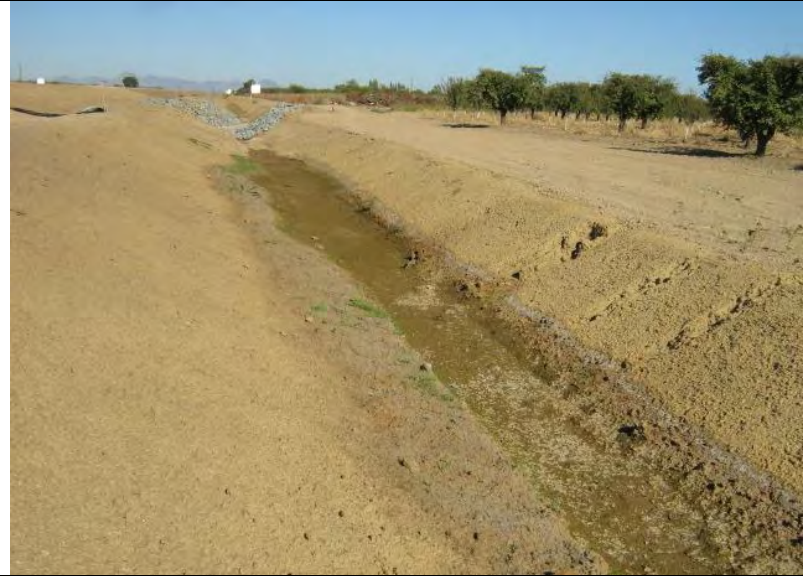
Photograph 18 – Vantage point view of Photograph 17. Adjacent roadway swale drains to irrigation channel near top of Photograph.

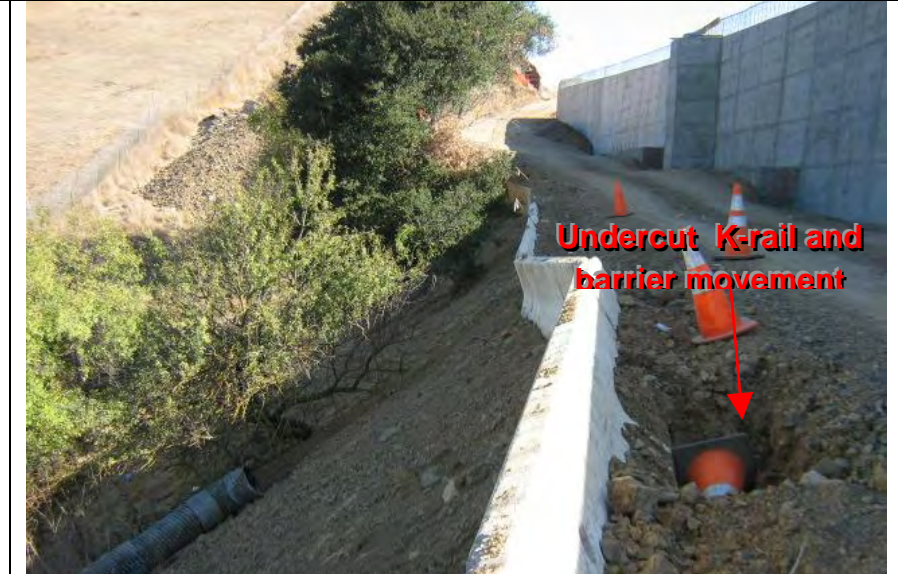
Photograph 2 – Failed fill slope along access road

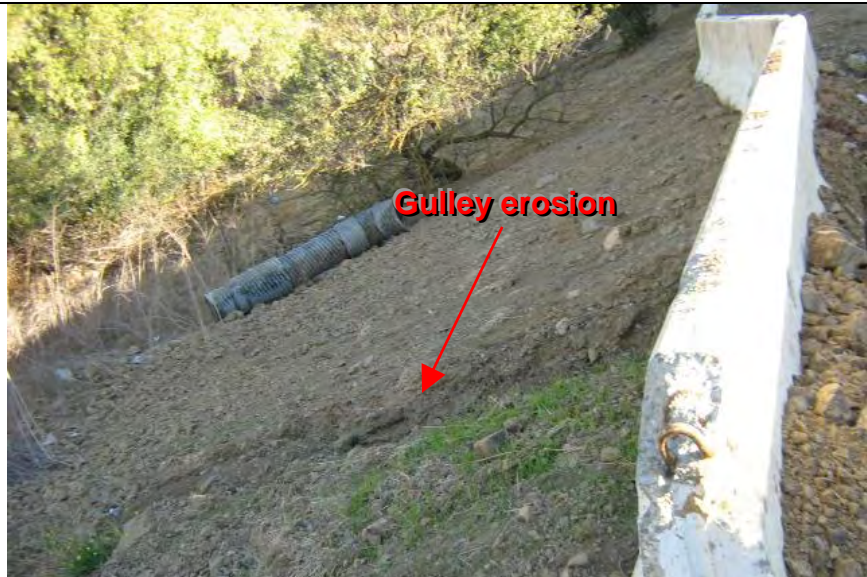
Photograph 3 – Slope erosion below undercut K-rail shown in Photograph 2

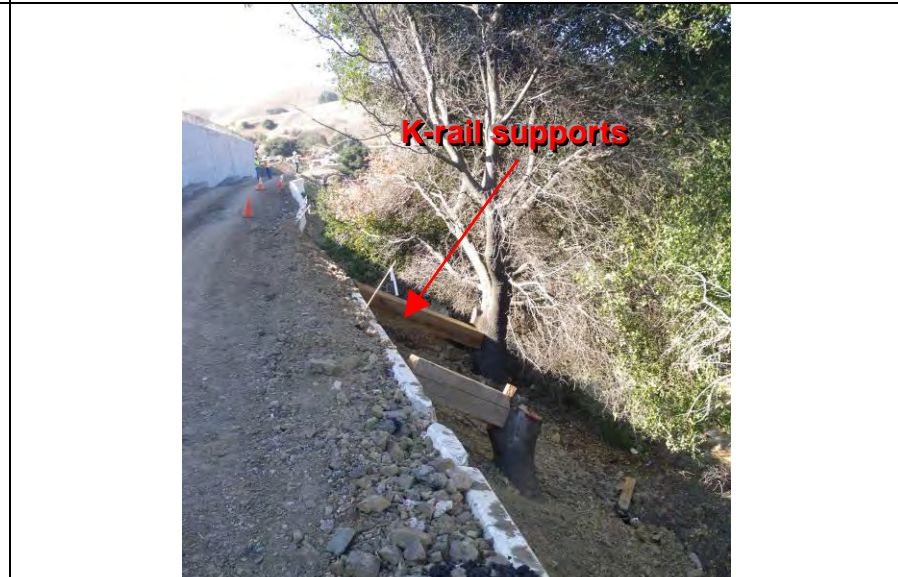
Photograph 4 – Failed area along access road

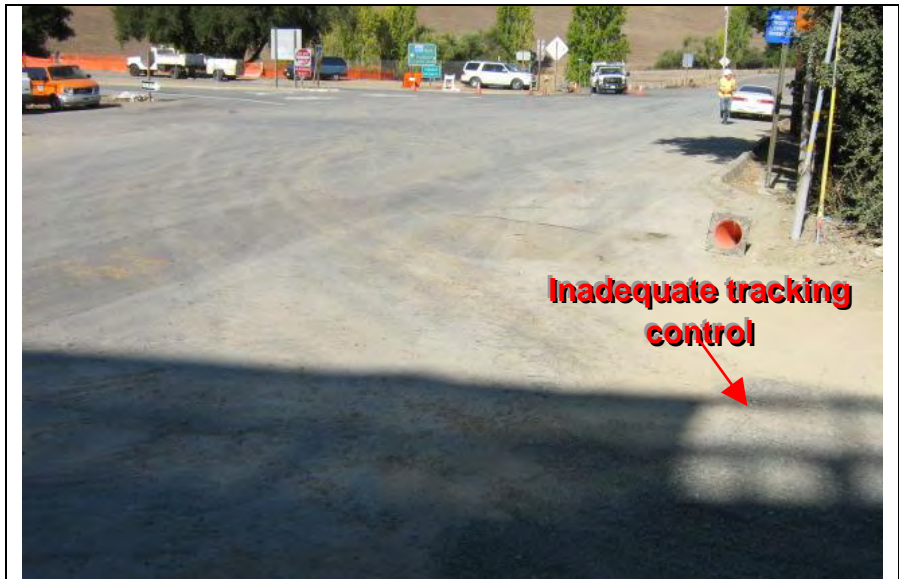
Photograph 9— Sediment conveyed onto roadway
