Appendix E

Maintenance Program Site Visit Reports

Site Visit No. 16

Willow Creek Highway Maintenance Facility
Site Visit Date: 10/22/2009

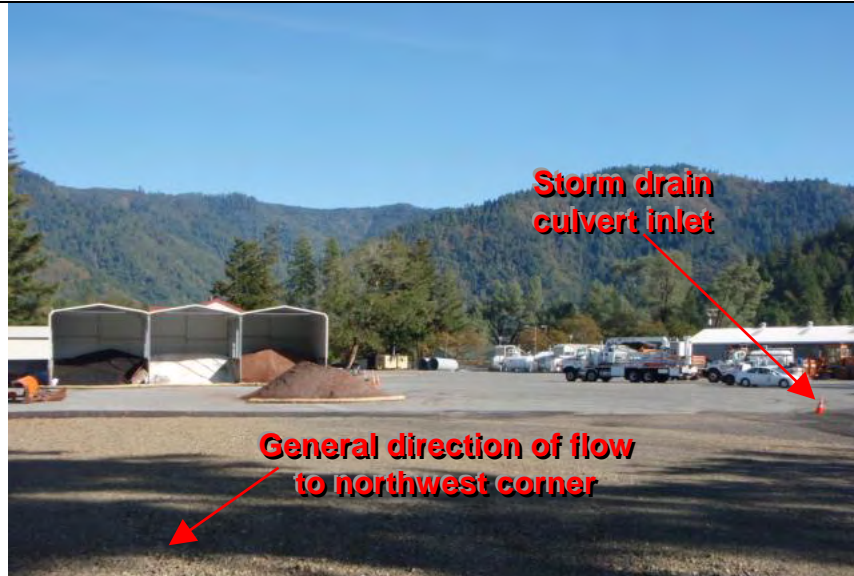
Photograph 1 – View from northwest corner of the facility

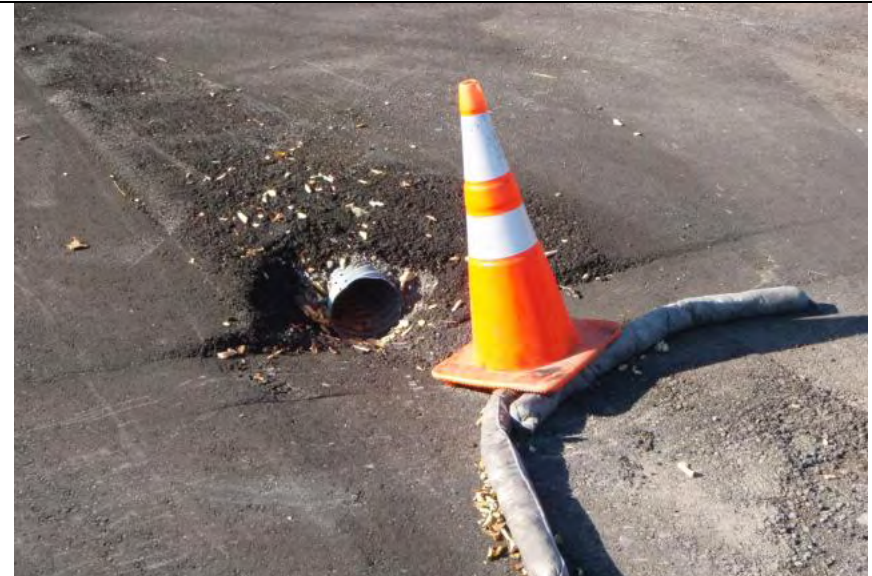
Photograph 2 – Culvert inlet that flows to northwest corner of facility

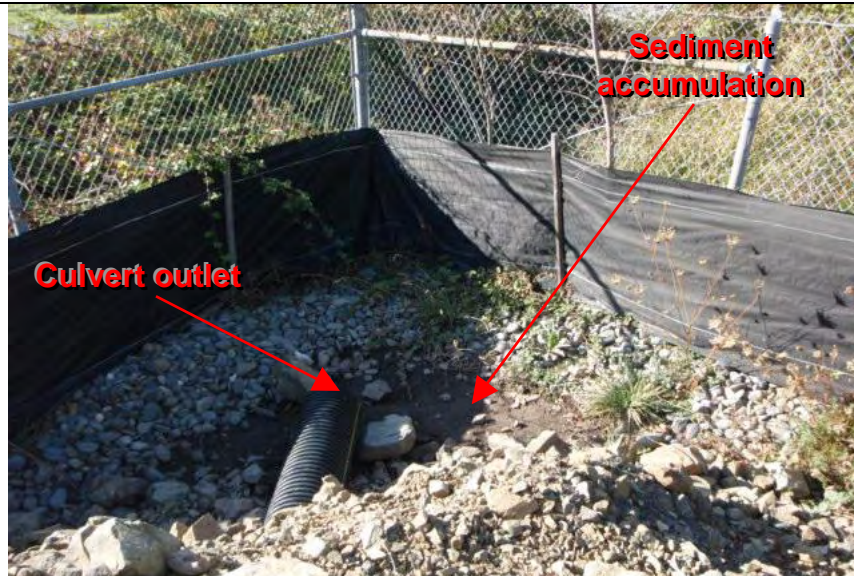
Provision I.3.b of the Permit requires Caltrans to provide appropriate site-specific BMPs for all maintenance facilities. As explained by the Highway Maintenance Supervisor, most of the storm water runoff at the facility flows to the northwest corner of the facility either by overland flow or through a culvert inlet and pipe (see [Photographs 1, 2 and 3](#)). He added that storm water runoff does not generally discharge off-site from this location to the adjacent PG&E facility but rather ponds and remains as standing water until it infiltrates into the ground or evaporates. Nonetheless, evidence of sediment discharged to the northwest corner of the facility was observed (see [Photograph 3](#)). Furthermore, a silt fence BMP had been installed in the concentrated flow pathway of the culvert outlet, was not entrenched into the ground, and had been installed backwards (see [Photographs 3 and 4](#)).

Photograph 3 – Culvert outlet to northwest corner of facility (Note: Silt fence BMP installed backwards)

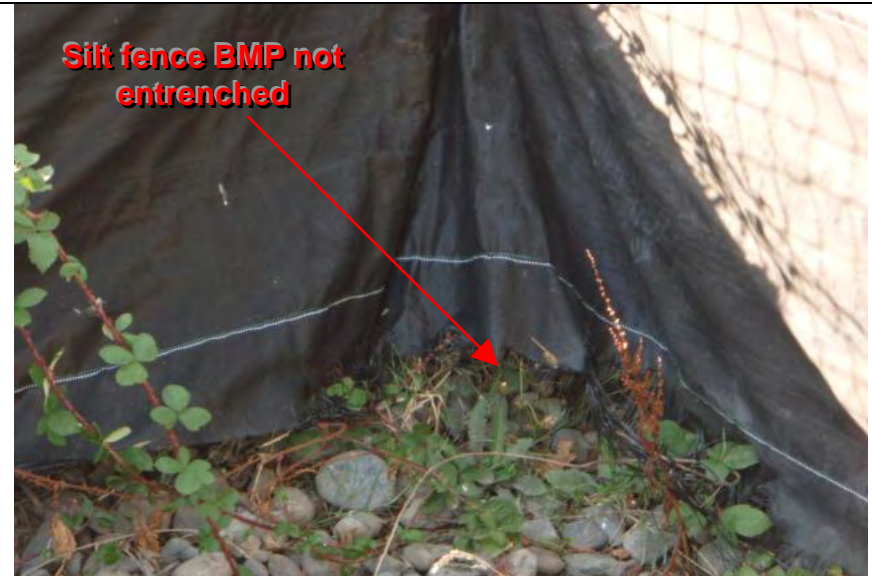
Photograph 4 – Closer view of silt fence BMP shown in Photograph 3

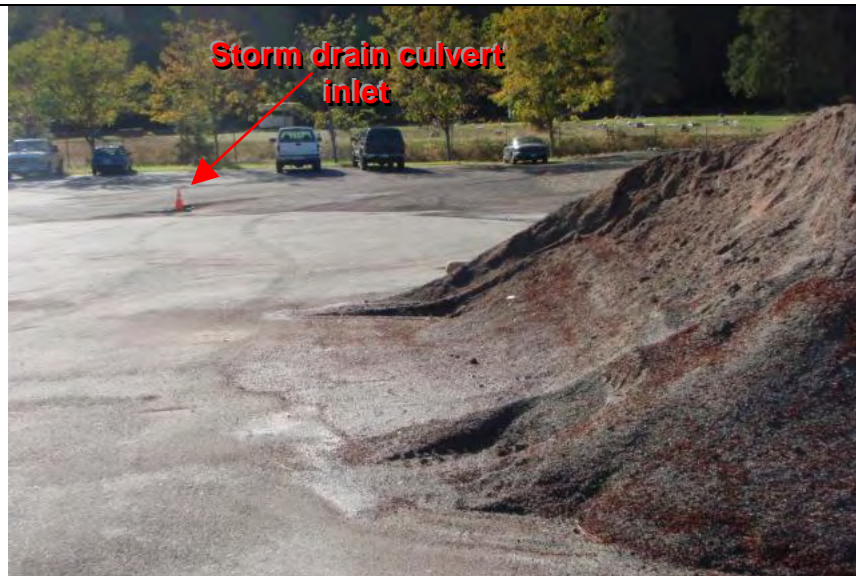
In addition, a stockpile of roadway abrasives was stored up-gradient of the storm drain culvert inlet in an uncovered area, and on the impervious ground surface (see [Photograph 5](#)). Straw wattle BMPs had been placed around the stockpile on the downslope side; however, the straw wattles were improperly installed on the impervious surface of the facility, and therefore were not properly entrenched in the ground to retain the stockpiled materials (see [Photograph 6](#)). Furthermore, what appeared to be a salt residue was observed around the stockpile which indicated that the stockpile itself contained salt, or the straw wattles had previously been used for the containment of a salt-bearing product (see [Photograph 7](#)). As a result, there was a potential for the discharge of stockpiled materials to the storm drain culvert inlet and subsequently off-site. Although placed under cover, a second stockpile containing salt also had a straw wattle BMP improperly installed on the impervious ground surface (see [Photographs 8 and 9](#)). Straw wattle BMPs are not intended to control salt products or other pollutants that will dissolve upon contact with water. As a result, adequate BMPs were not implemented for stockpile management.

Photograph 5— Stockpile of sand and ash mixture up-gradient of inlet

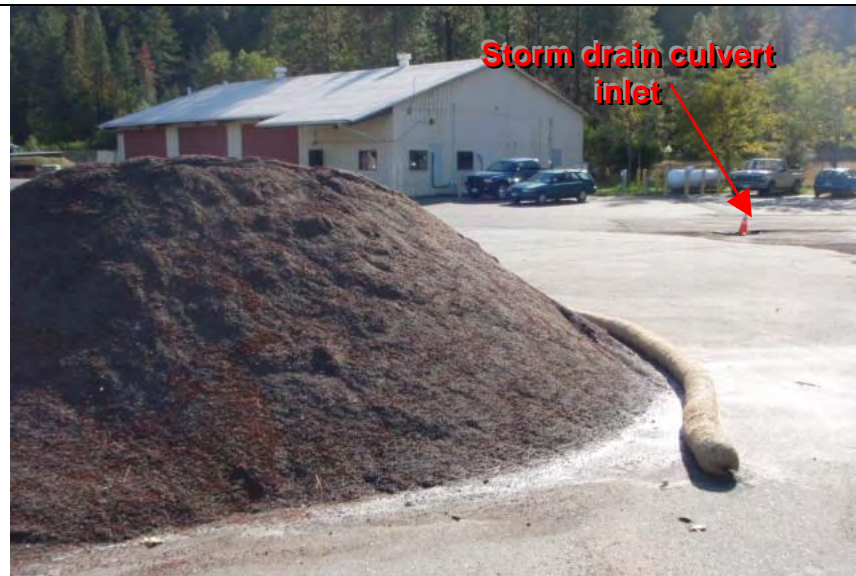
Photograph 6 – Inappropriate application of straw wattle BMP

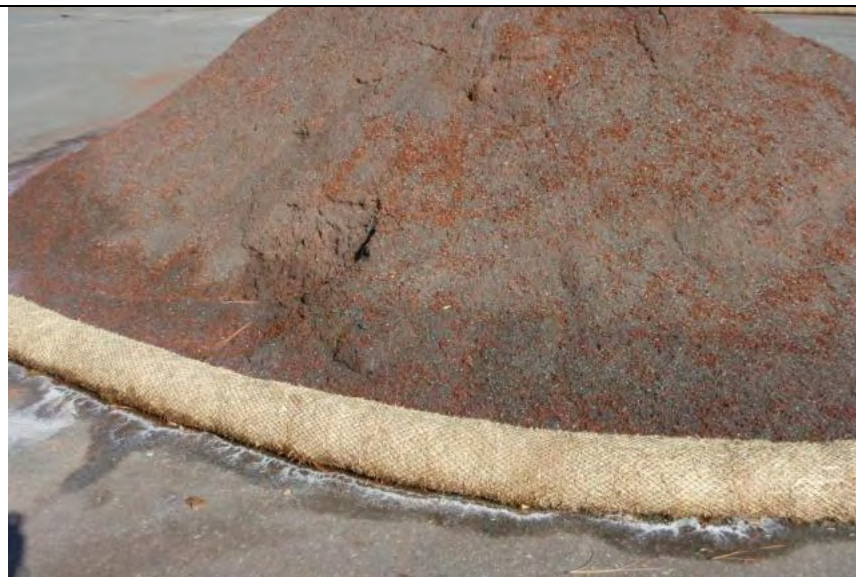
Photograph 7— Closer view of straw wattle BMP around stockpile
(Note: Apparent salt residue)

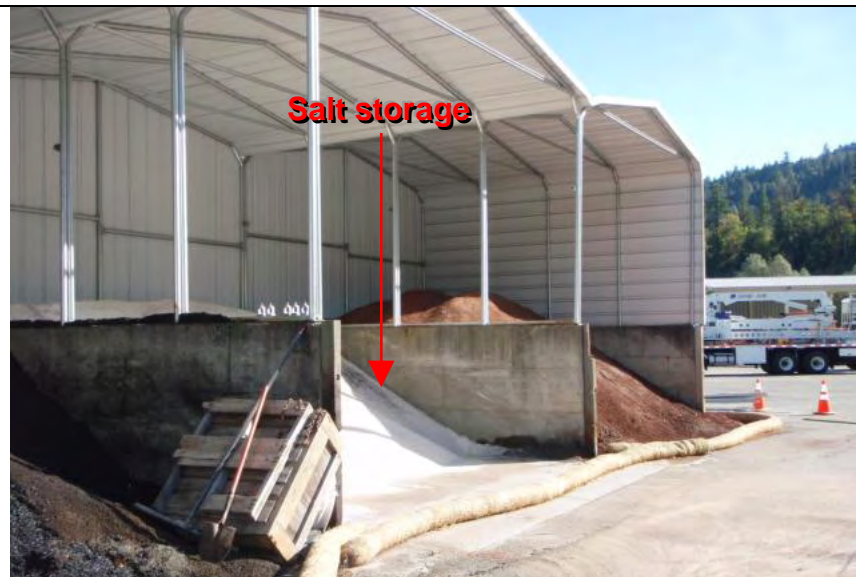
Photograph 8 – Inappropriate application of straw wattle BMP

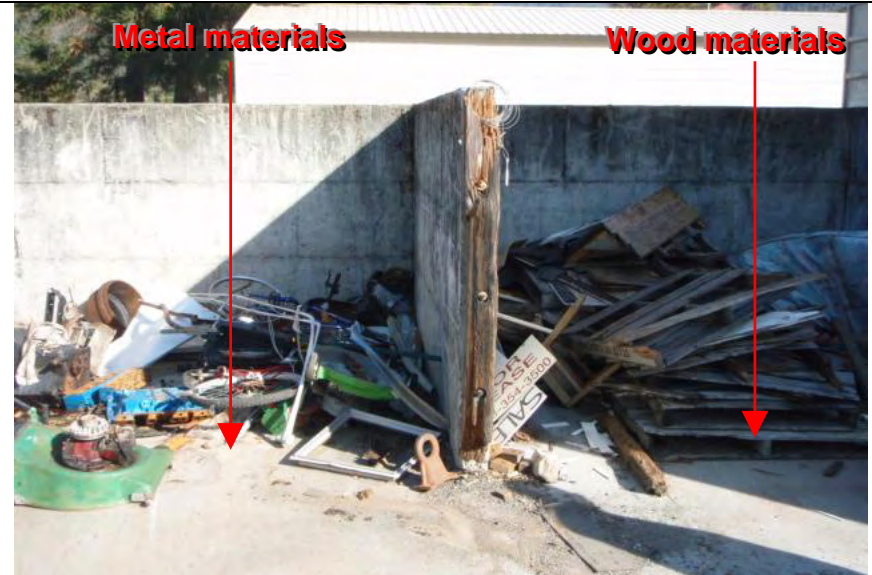
The facility has a dedicated area for storage of materials picked up from the highway system by maintenance crews. The area is segregated to provide an area for wood-based materials and another area for metal-based materials (see [Photograph 10](#)). According to the Highway Maintenance Supervisor, an engine block from an automobile had been deposited in the metal-bearing materials storage area earlier on day of the inspection (see [Photograph 11](#)). It appeared that the engine block still contained automotive fluids or petroleum products that had leaked onto the impervious ground surface in the storage area (see [Photograph 11](#)). The storage area is not covered and does not have a berm for containment. As a result, there was a potential for the contribution of pollutants to storm water runoff and the subsequent discharge of pollutants off-site.

Photograph 10 – Storage area for materials picked up from the highways (Note: Area is uncovered and not bermed)

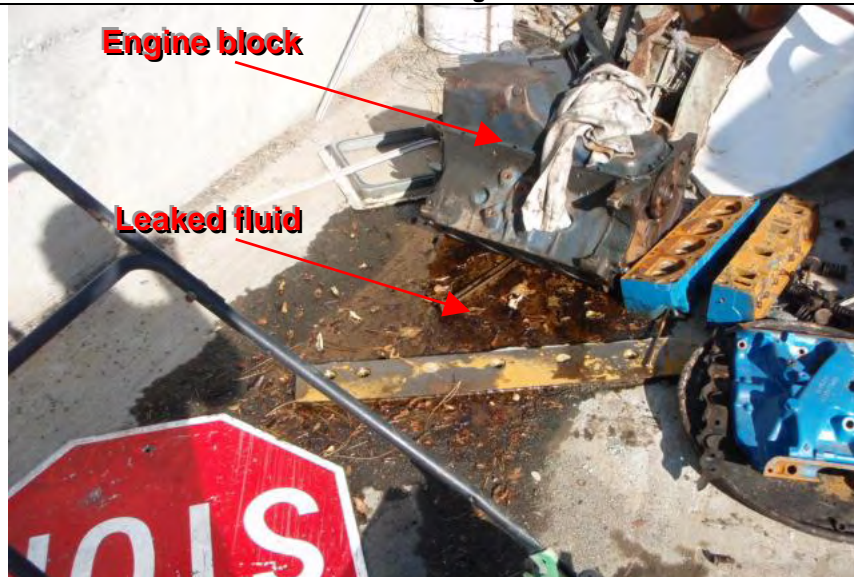
Photograph 11— Engine block stored in metal material storage area (Note: Fluid on impervious ground surface)

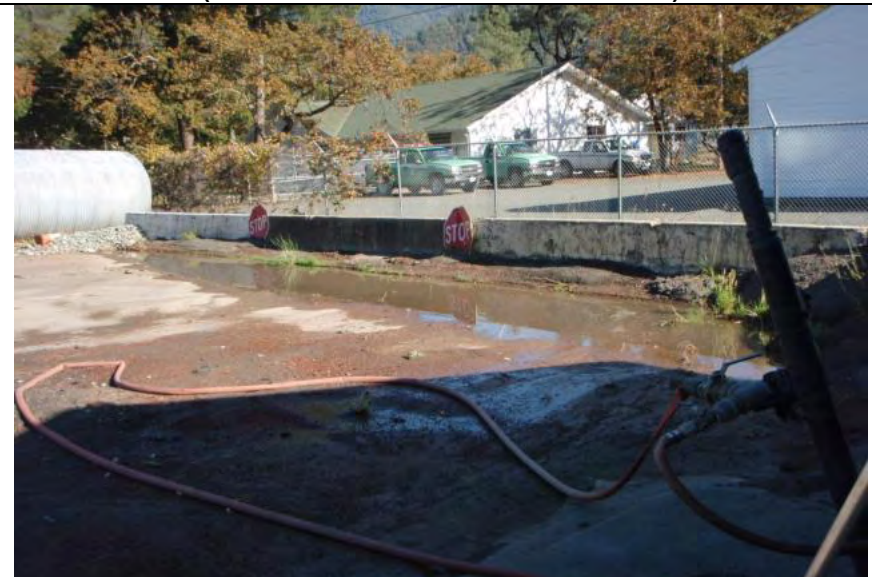
Although the facility is equipped with a designated and covered vehicle and equipment wash rack, a bermed area toward the southern end of the facility is used for truck bed washing (see [Photograph 12](#)). An area of wet soil was observed on the backside of the bermed area adjacent to a drainage ditch that flows off-site to the south (see [Photographs 13 and 14](#)). As a result, there was a potential for the discharge of pollutants to the drainage ditch, a component of the Caltrans MS4, and subsequently off-site. Appendix D of the Caltrans SWMP, Section 2.15.1, Vehicle and Equipment Cleaning, states “when possible, truck beds should be cleaned using dry cleanup technique (sweep up or shovel out).”

Photograph 12 – Bermed area used for truck bed washing

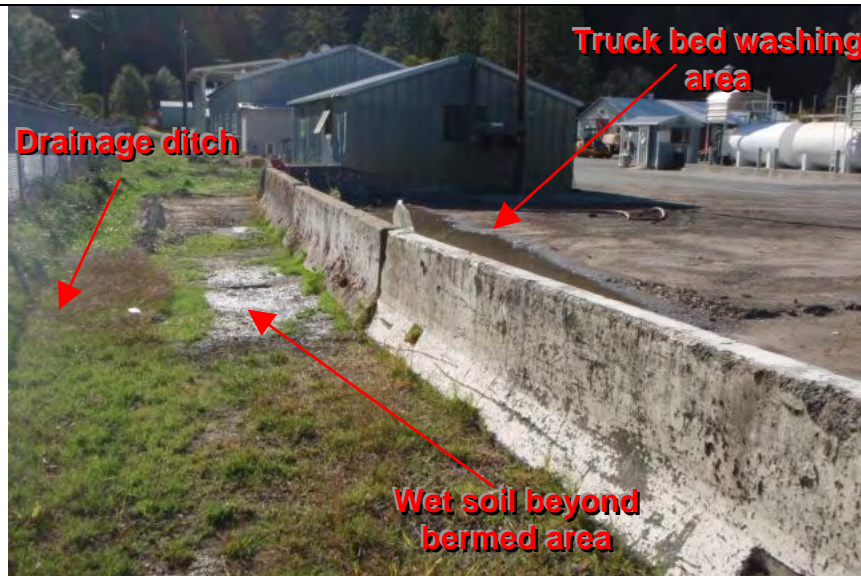
Photograph 13 – Another view of area used for truck bed washing

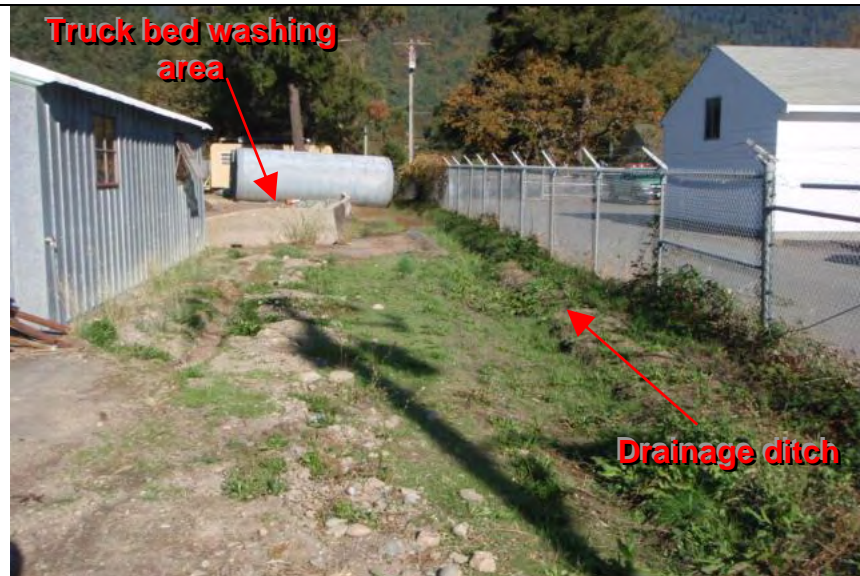
Photograph 14 – View of drainage ditch along southern edge of facility

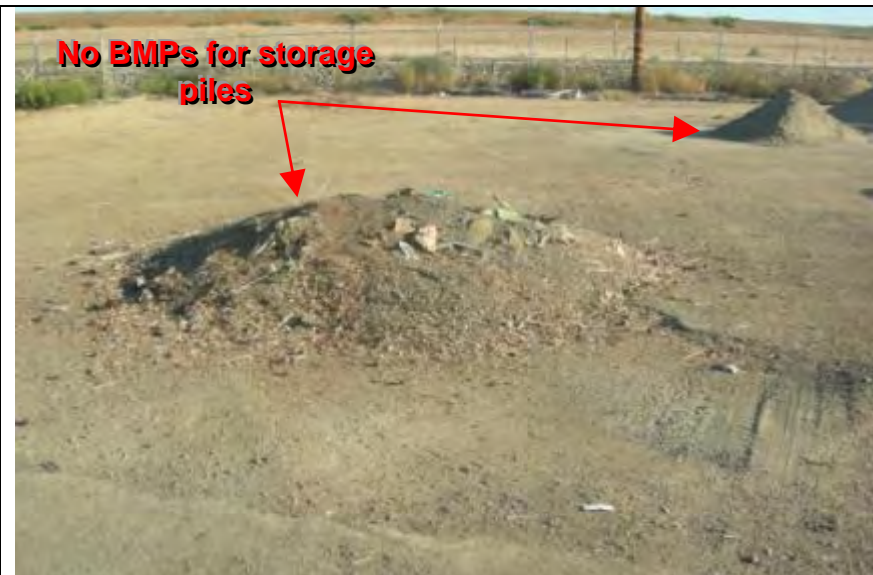
Photograph 1 – View of sweeper waste storage pile at the Marysville Maintenance Station

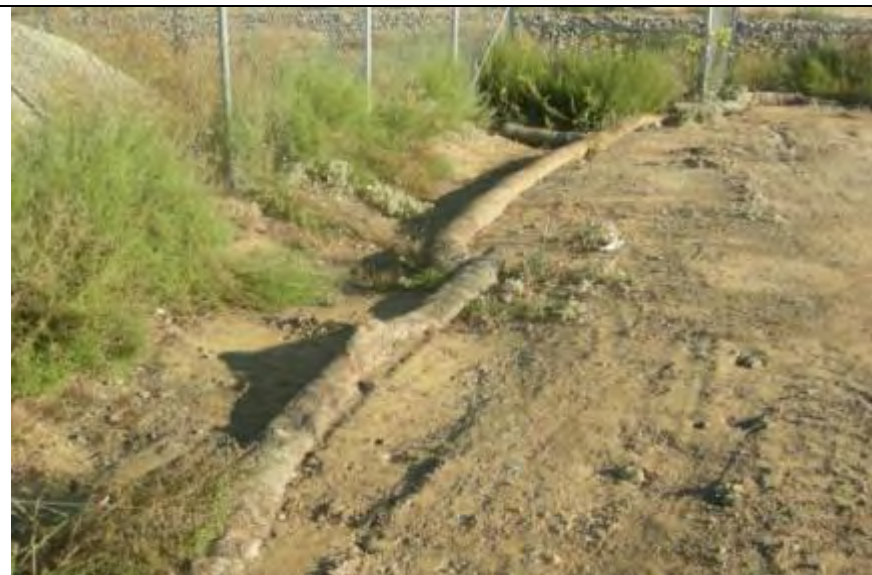
Photograph 2 – View of straw wattle BMPs, not adequately installed

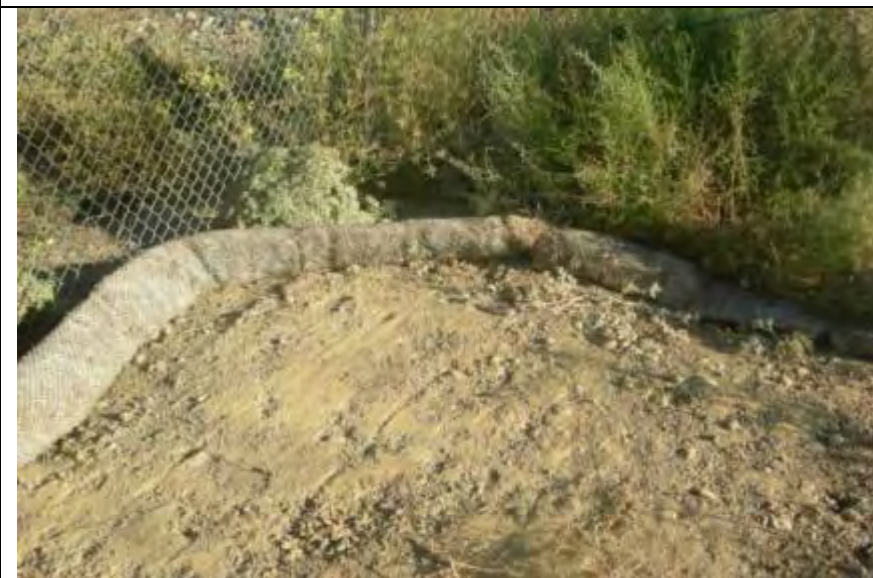
Photograph 3 – Close up view of straw wattle installation shown in Photograph 2

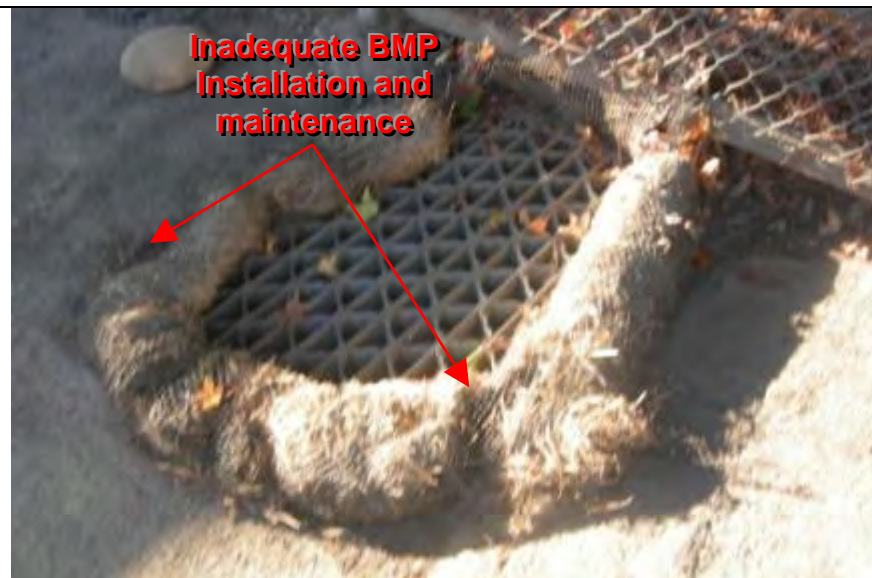
Provision I.3.b of the Permit requires Caltrans to provide appropriate site-specific BMPs for all maintenance facilities. Coverage and containment BMPs had not been implemented for a sweeper waste stockpile in the northwest portion of the facility (see Photograph 1). Although straw wattles had been installed along the perimeter of the maintenance yard, the straw wattles were not properly installed or maintained. Specifically, the straw wattles utilized along the northwestern perimeter of site, adjacent to the FEMA Ditch Project, were not properly entrenched or anchored (see Photographs 2 and 3). Additionally, straw wattles utilized at the storm drain inlets at the southern perimeter of site were installed on an impervious surface and, therefore, were not properly entrenched or anchored to create an adequate seal (see Photographs 4 and 5).

Photograph 4 – Storm drain inlet on the east side of the Marysville Maintenance Station office building

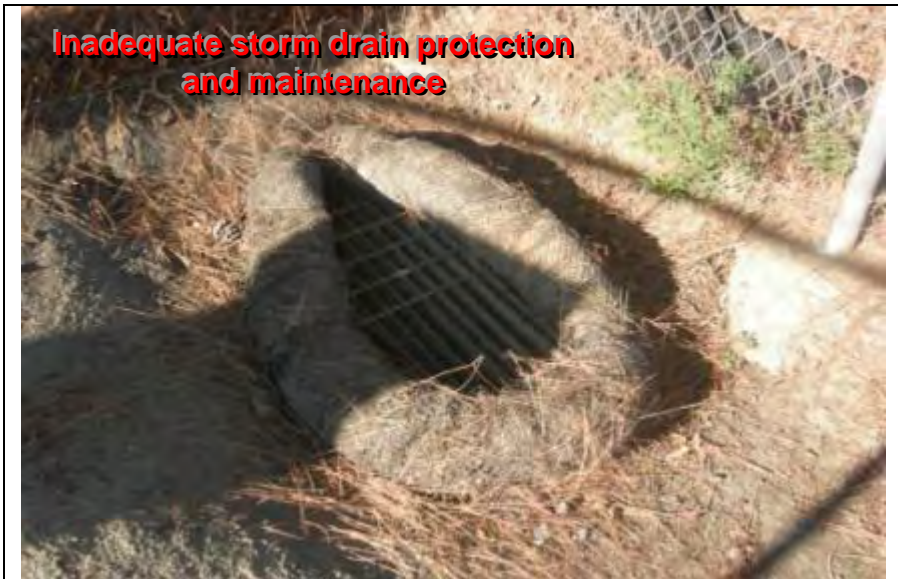
**Inadequate storm drain protection
and maintenance**

**Photograph 5— Storm drain inlet to the west of the Marysville Maintenance
Station office building**

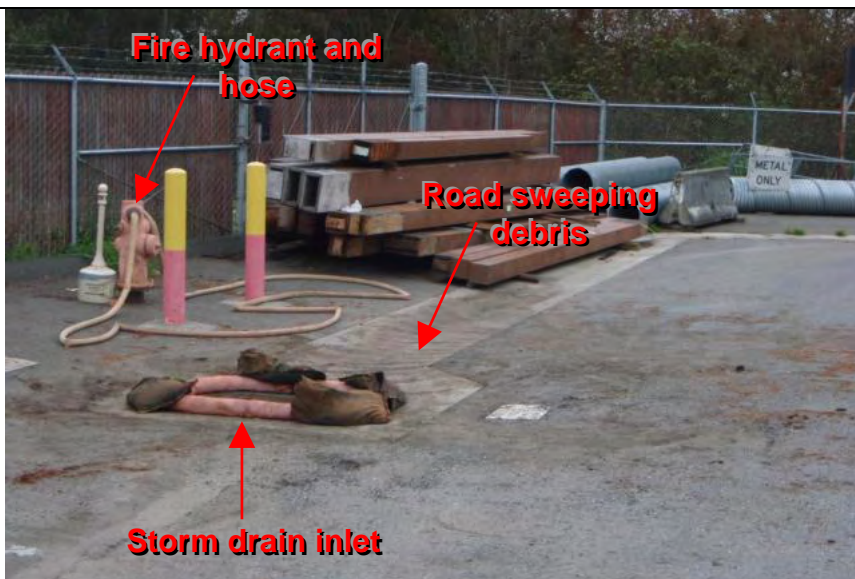
Photograph 3 – Area in northwest corner of facility used for road sweeper washing. (Note: Pollutant accumulation around storm drain inlet)

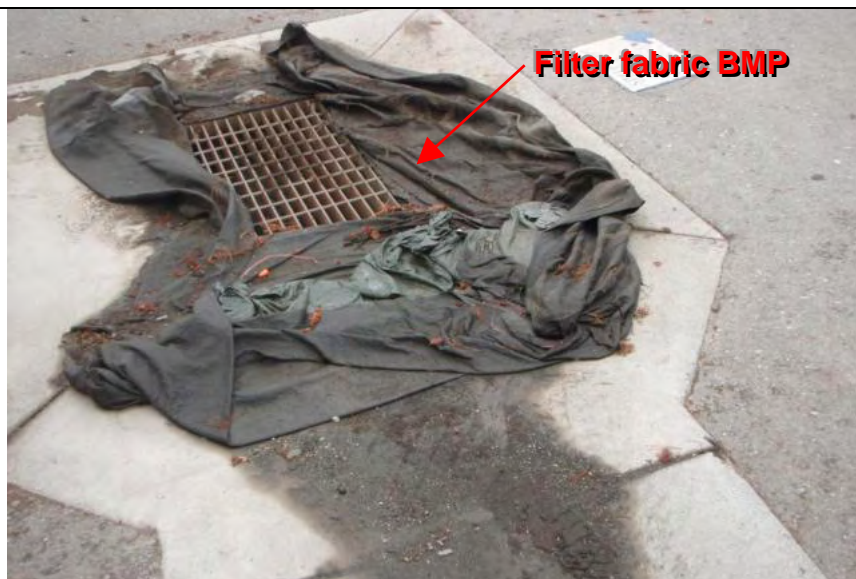
Filter fabric had been installed in one of the adjacent storm drain inlets and absorbent booms had been placed around the other inlet (see [Photographs 4 and 5](#)). However, the BMPs implemented for inlet protection were not properly maintained and significant pollutant accumulation was observed around the inlets. Furthermore, sand bags containing debris had been used for weights on top of the absorbent booms placed around one of the storm drain inlets, and several of the bags were no longer securely closed (see [Photograph 6](#)).

Photograph 4 – Second storm drain inlet near road sweeper washing area. Inlet is just out of the picture to the bottom left of Photograph 3.

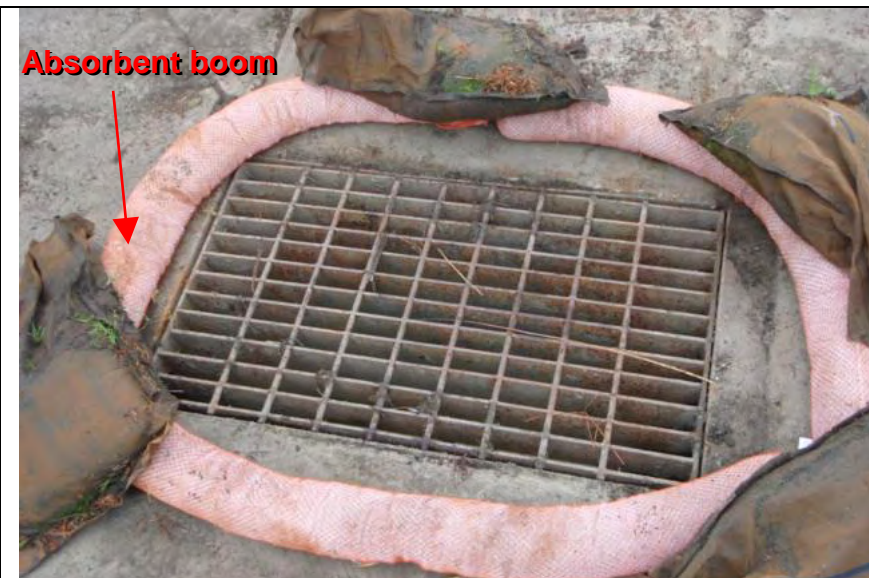
Photograph 5— Closer view of storm drain inlet shown in Photograph 3

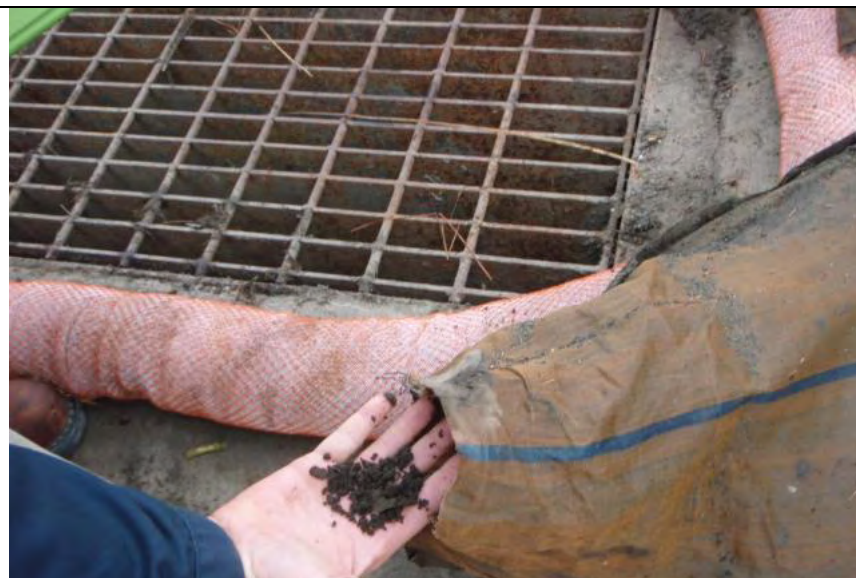
Photograph 6 – View of debris contained in bags used for securing absorbent booms

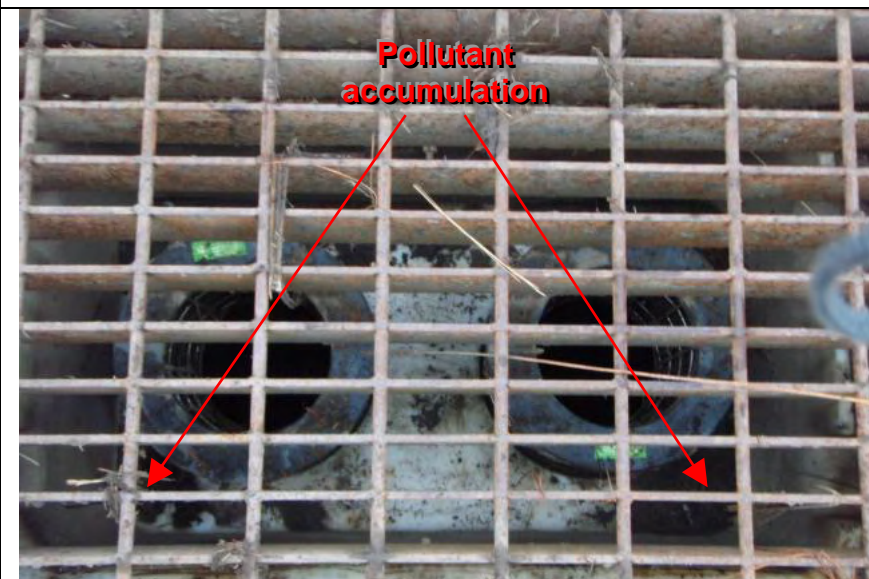
Although storm drain inlets at the facility were equipped with filters, evidence of pollutant accumulation was observed within one of the storm drain inlets near the road sweeper washing area (see [Photograph 7](#)), which indicated that an unknown quantity of sweeper wash water had been discharged to the MS4. The discharge location of the storm drain inlets associated with the road sweeper washing area was unclear. Prohibition A.7 of the Permit states “wastes or wastewater from road sweeping vehicles or from other maintenance or construction activities shall not be discharged to any surface waters or to any storm drain leading to surface water bodies.”

Photograph 7— View into storm drain inlet shown in Photographs 3, 5 & 6

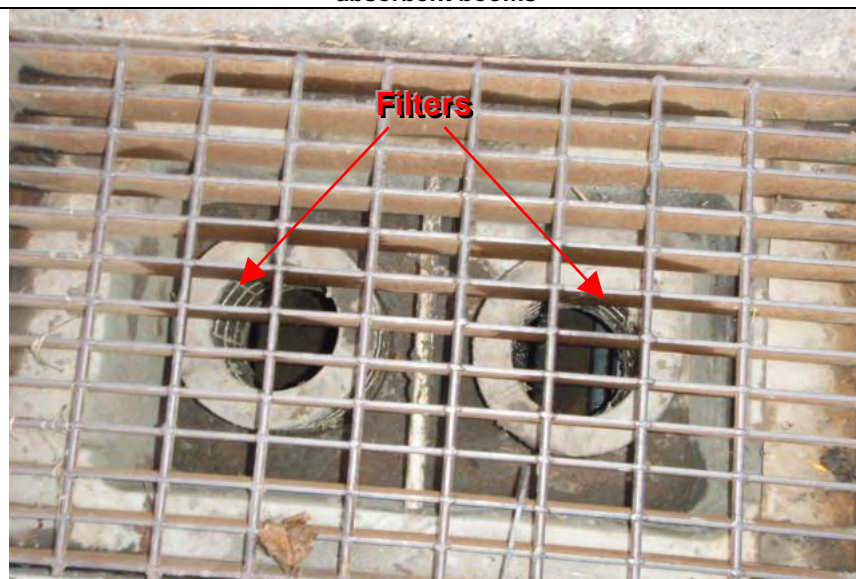
Additional storm drain inlet filters at the facility (see [Photograph 8](#)) did not appear to have been recently cleaned or maintained and debris accumulation was observed in the filter units and inlets (see [Photograph 9](#)). It was not clear when maintenance had been last performed on the filters.

Photograph 8 – View into another storm drain inlet at the facility

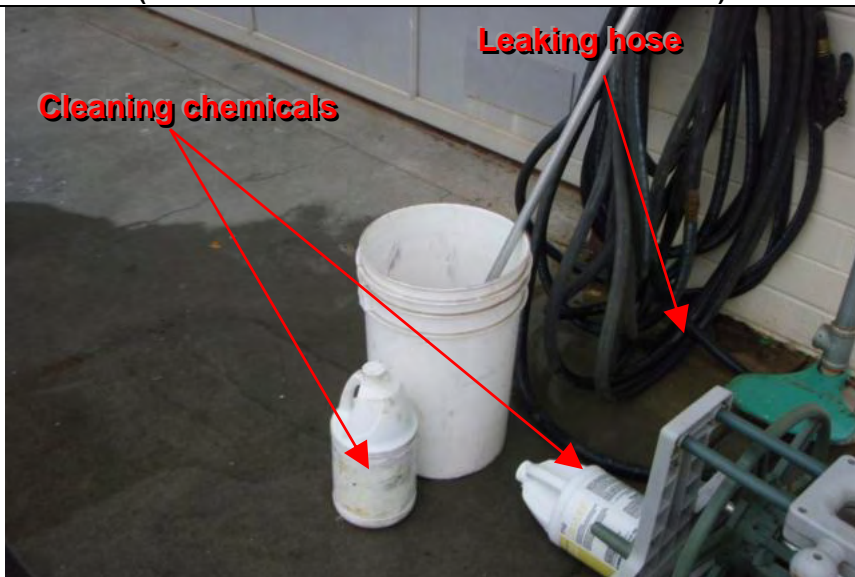
Two containers of a cleaning agent were improperly stored adjacent to a concrete drainage swale and leaking hose along the eastern side of the facility (see Photograph 11). The containers were not stored within secondary containment, and as a result, there was a potential for the contribution of wash water and pollutants to storm water runoff, and subsequently to a down-gradient storm drain inlet (see Photograph 12).

Photograph 11— Cleaning/washing chemicals stored on impervious ground surface adjacent to leaking hose

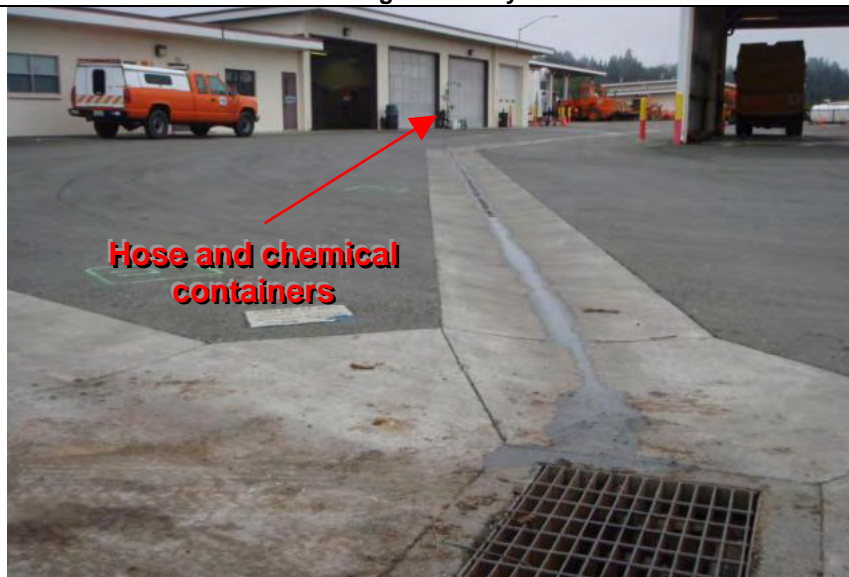
Photograph 12— View from down-gradient storm drain inlet to location of hose and chemical containers pictured in Photograph 11

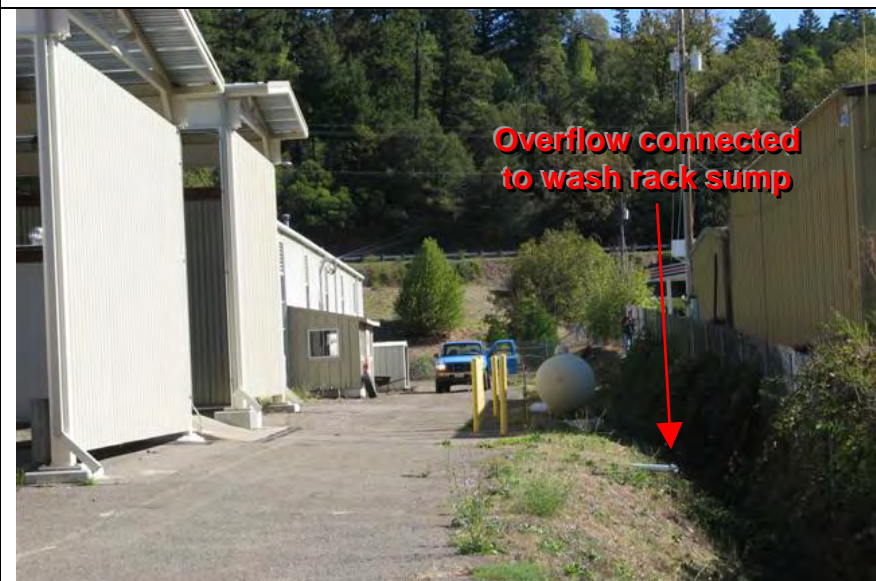
Photograph 3 – Sump overflow leading to drainage ditch

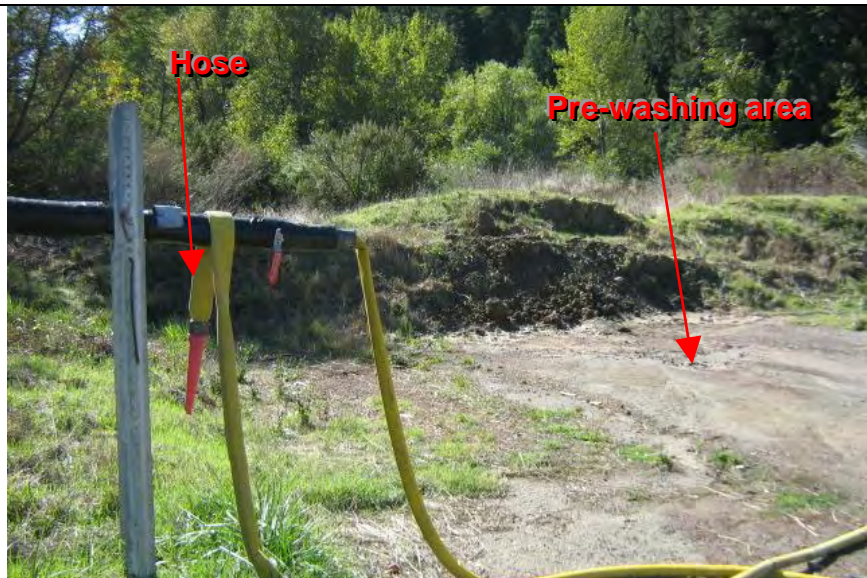
Despite the availability of the designated wash rack, a vehicle pre-washing area was observed in the lower yard (see [Photograph 5](#)). The lower yard is located west of the main office and maintenance facility, in much closer proximity to the South Fork Eel River. The pre-washing area is not equipped to properly capture, treat, re-use, or dispose of vehicle wash water and associated pollutants. Additionally, a berm installed down-gradient of the vehicle pre-washing area showed signs of standing water and had been damaged (see [Photographs 6 and 7](#)).

Photograph 5— Vehicle pre-washing area in the lower yard

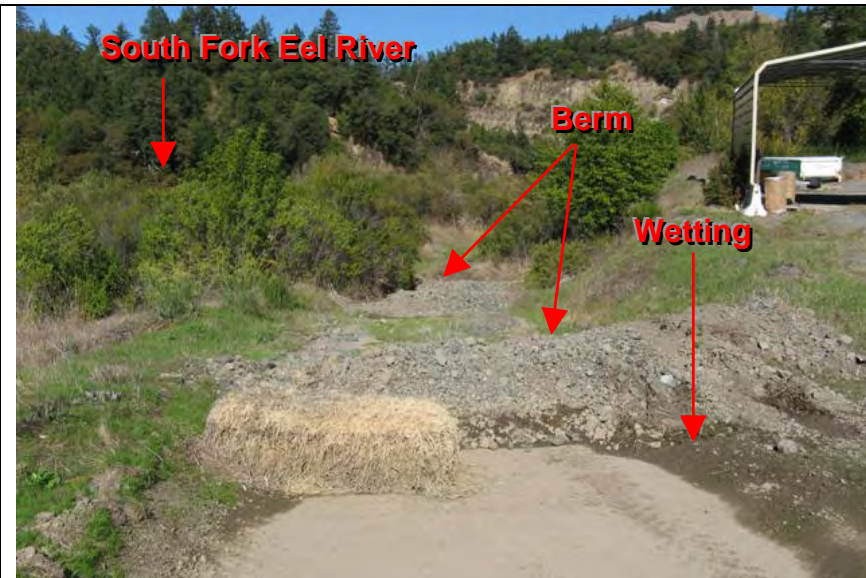
Photograph 6 – View down-gradient of pre-washing area

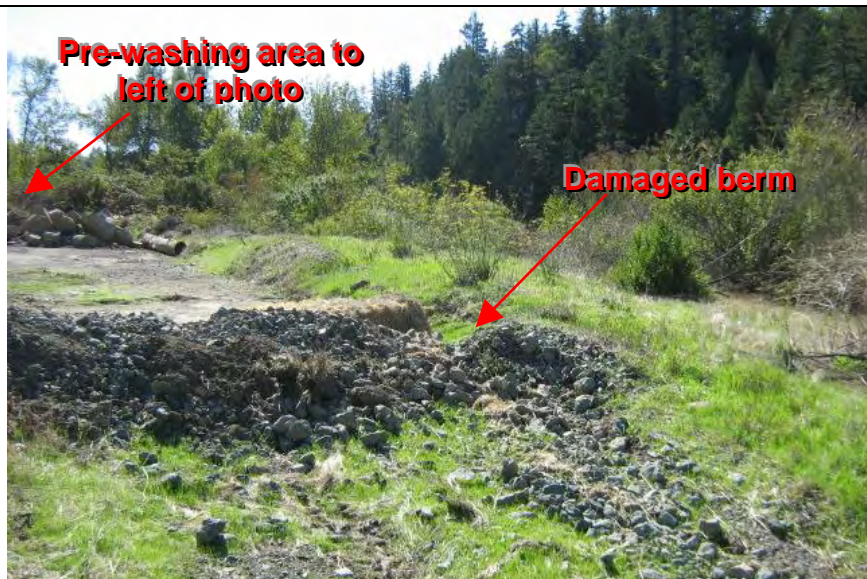
Photograph 7— Damaged berm shown in Photograph 6

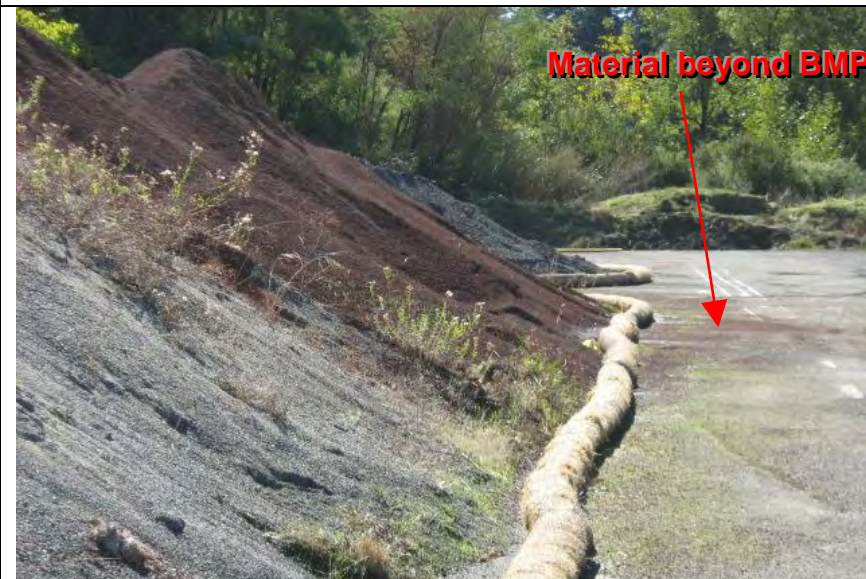
In addition, straw wattle BMPs used for stockpile management were improperly installed on impervious surfaces throughout the facility and were not properly entrenched in the ground to retain the stockpiled materials (see [Photographs 8 and 9](#)). Although located under cover, a second stockpile area containing salt also had a straw wattle BMP improperly installed on an impervious surface (see [Photograph 9](#)). Furthermore, straw wattle BMPs are not intended to control salt products or other pollutants that will dissolve upon contact with water. As a result, adequate BMPs were not implemented for stockpile management.

Photograph 8 – Inappropriate application of wattles on impervious surface

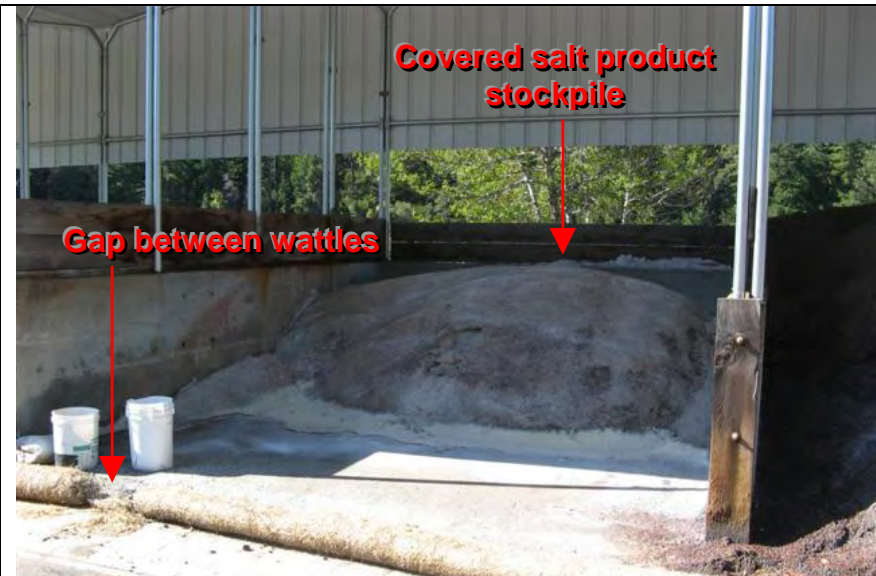
Photograph 9— Inappropriate application of wattles

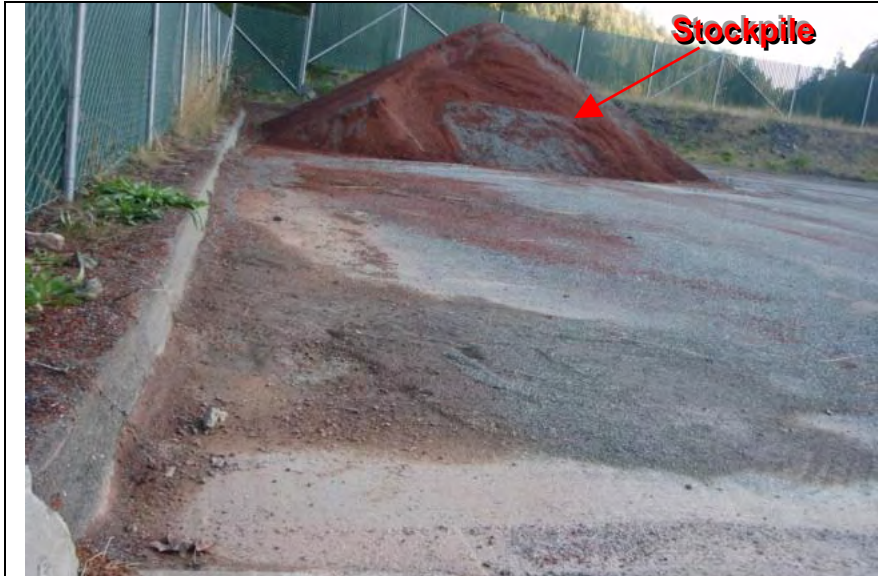
Photograph 1 – Stockpile without BMPs for coverage or containment

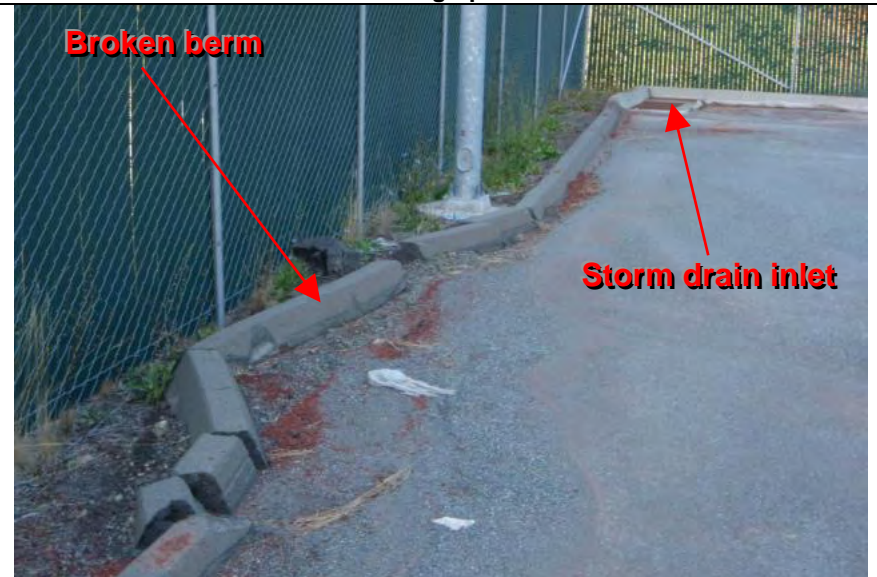
In addition, a 10 to 20 foot section of the berm along the northern perimeter of the site was not intact and accumulated roadway abrasives were observed adjacent to the failed berm (see Photograph 4). Roadway abrasives were also observed on the impervious ground surface in other various areas at the facility and beyond the perimeter fenceline (see Photographs 5, 6 and 7). As a result, there was a discharge of pollutants beyond the bermed perimeter, and the potential for subsequent off-site discharge.

Photograph 4 – Broken berm along northern perimeter of facility
(Note: Accumulation of roadway abrasives adjacent to berm)

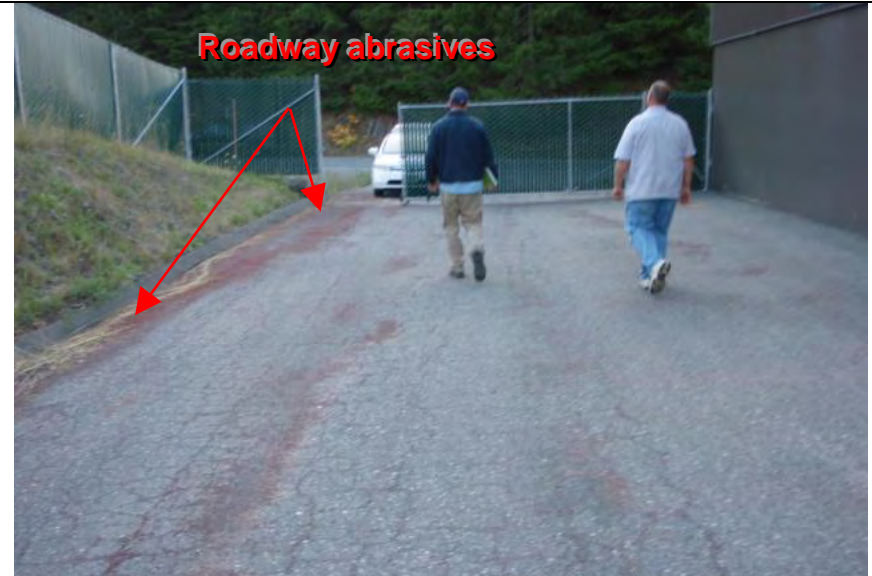
Photograph 6 – Roadway abrasives on impervious ground surface

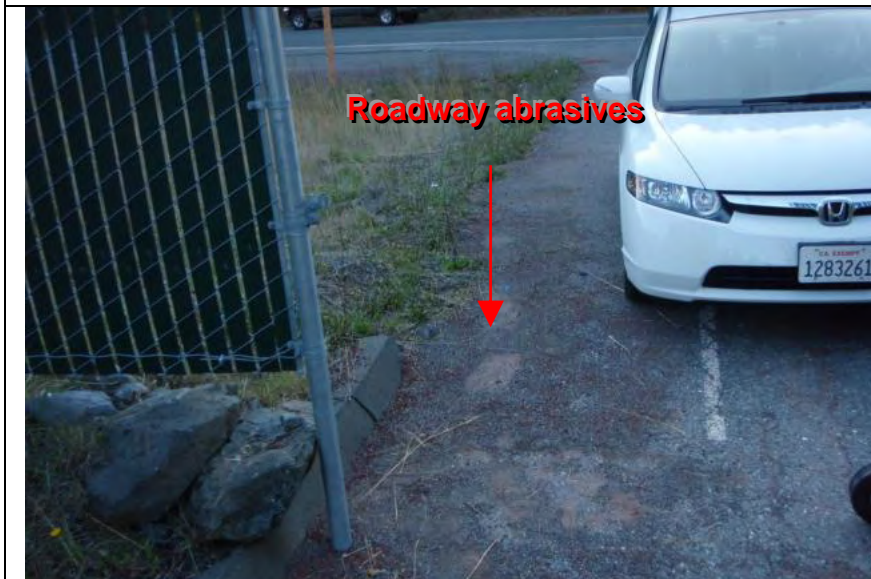
Photograph 7— Roadway abrasives outside facility entrance

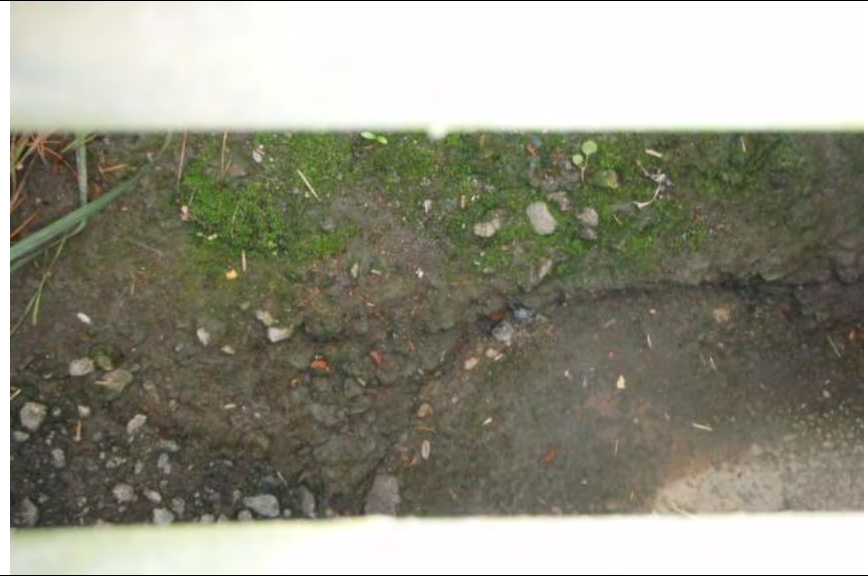
Provision I.3.b of the Permit requires Caltrans to provide appropriate site-specific BMPs for all maintenance facilities. A significant amount of sediment accumulation was observed within a storm drain inlet at the facility that did not appear to have been recently cleaned (see Photographs 1 and 2). As explained by the Highway Maintenance Supervisor, storm drain inlets at the facility flow to the drainage ditch in the southeast corner of the facility (see Photograph 3). He added that storm water runoff does not generally discharge off-site from this location but rather ponds and remains as standing water until it infiltrates into the ground. Nonetheless, evidence of sediment discharged to the drainage ditch as well as sediment accumulation within the culvert pipe that discharges to the southeast corner of the facility was observed (see Photograph 5). Furthermore, a silt fence BMP had been installed in the flow pathway of the culvert outlet and was not entrenched into the ground to retain sediment and prevent failure (see Photograph 3).

Photograph 2 – View into storm drain inlet pictured in Photograph 1
(Note: Sediment accumulation within inlet)

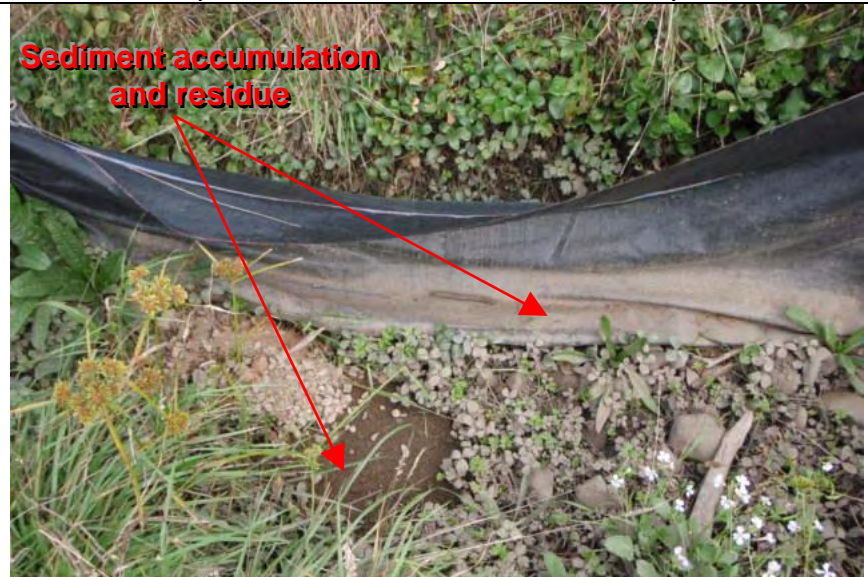
Photograph 4 – Closer view of silt fence BMP shown in Photograph 3
