Appendix E

Maintenance Program Site Visit Reports

Site Visit No. 16

Willow Creek Highway Maintenance Facility
Site Visit Date: 10/22/2009

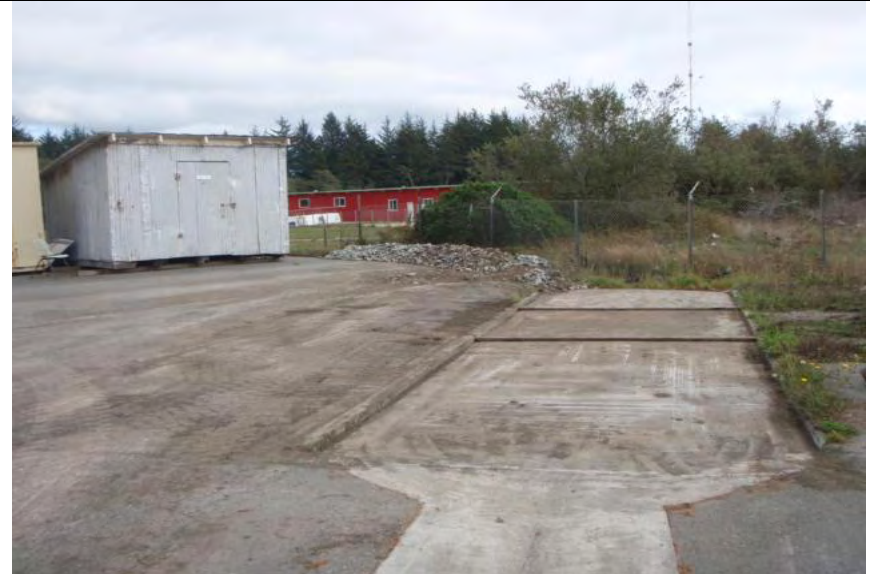
In addition, a significant amount of sediment accumulation was observed on the impervious ground surface near the southeast corner of the facility (see Photographs 6 and 7). As explained by the Highway Maintenance Supervisor, the area was used as a temporary stockpile location for washout material from front loaders and dump trucks. Whether the equipment washout operation was conducted with dry or wet processes was unclear. Appendix D of the Caltrans SWMP, Section 2.15.1, Vehicle and Equipment Cleaning, states “when possible, truck beds should be cleaned using dry cleanup technique (sweep up or shovel out).” It should also be noted that the stockpile area was located directly in the flow pathway of the surface drainage system at the facility (see Photograph 8). As a result, there was a potential for the discharge of sediment and other pollutants to the drainage ditch along the southern edge of the facility (see Photograph 9).

Photograph 6 – Area used for stockpiling washout material
(Note: Sediment accumulation on impervious ground surface)

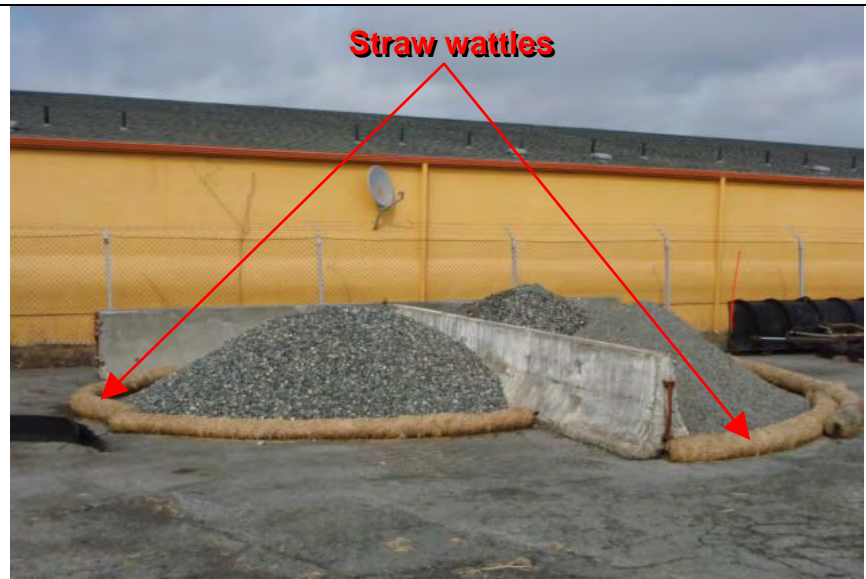
In addition, straw wattle BMPs used for stockpile management were improperly installed on impervious surfaces at the facility, and therefore were not properly entrenched in the ground to retain the stockpiled materials (see Photograph 10).

Photograph 10 – Inappropriate application of wattles on impervious surface

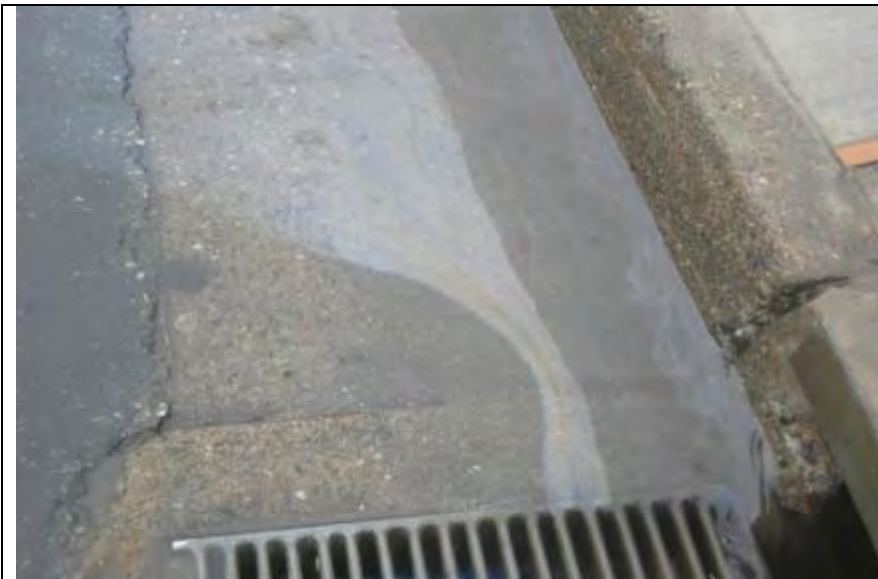
Provision I.3.b of the Permit requires Caltrans to provide appropriate site-specific BMPs for all maintenance facilities. A visible sheen was observed flowing into the storm drain located along the curb and gutter line of the northern portion of the rest area (see Photographs 1 and 2). The Caltrans Maintenance representative stated that an oil water separator BMP had been installed at this location because it drained directly into Shasta Lake. However, site plans or maintenance activity schedules were not produced to confirm that the treatment BMP was installed at this location.

Photograph 1 – Visible sheen entering storm drain
