Attachment 1

**Attachment 3
Photograph Log**

Photograph Log for EPA's December 3, 2010 Electrochem Solutions RCRA and CWA Inspection

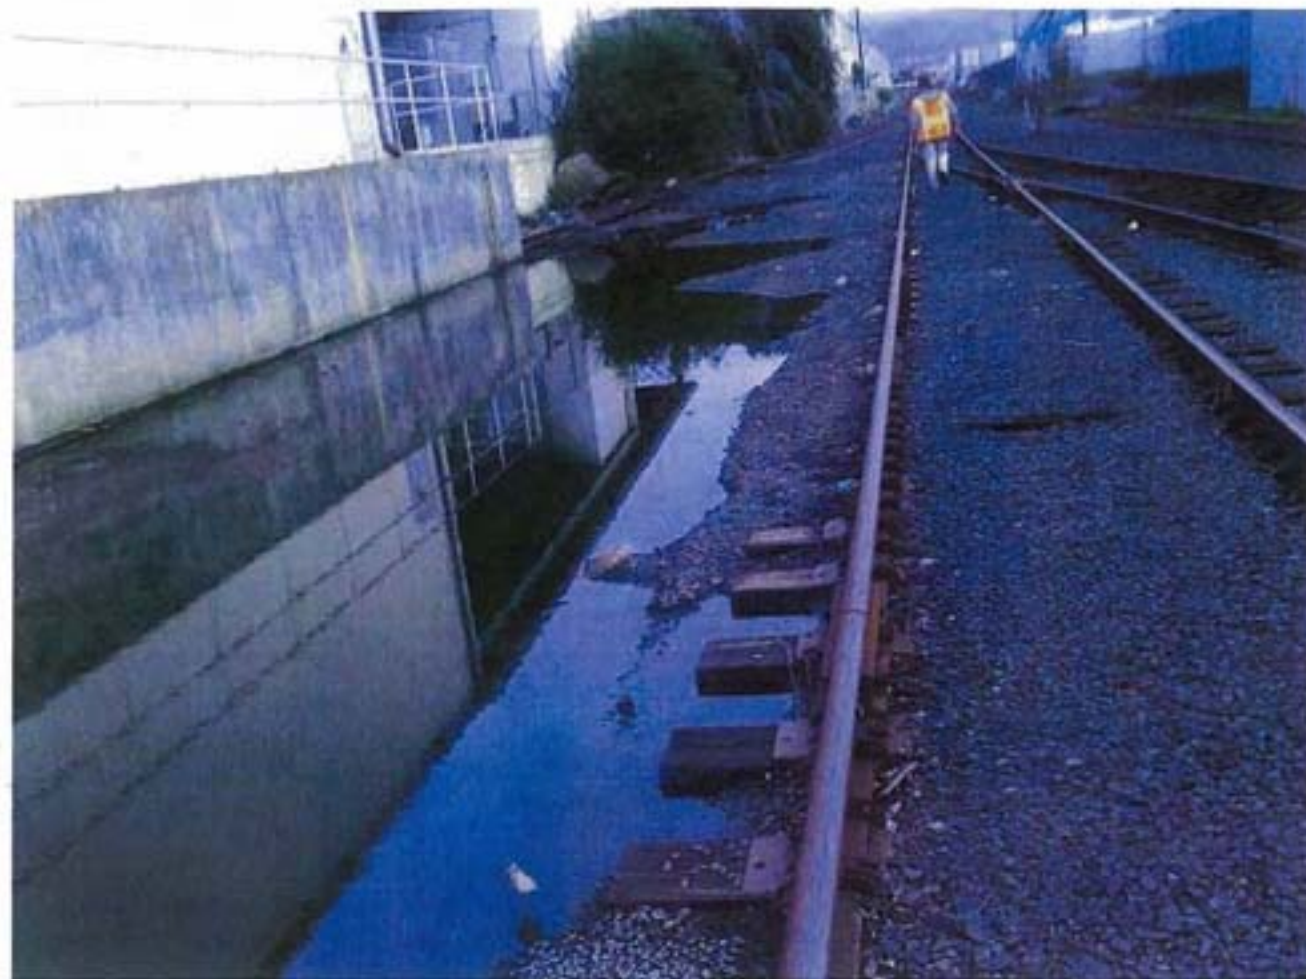
Storm water ponding rail spur 12-9-10

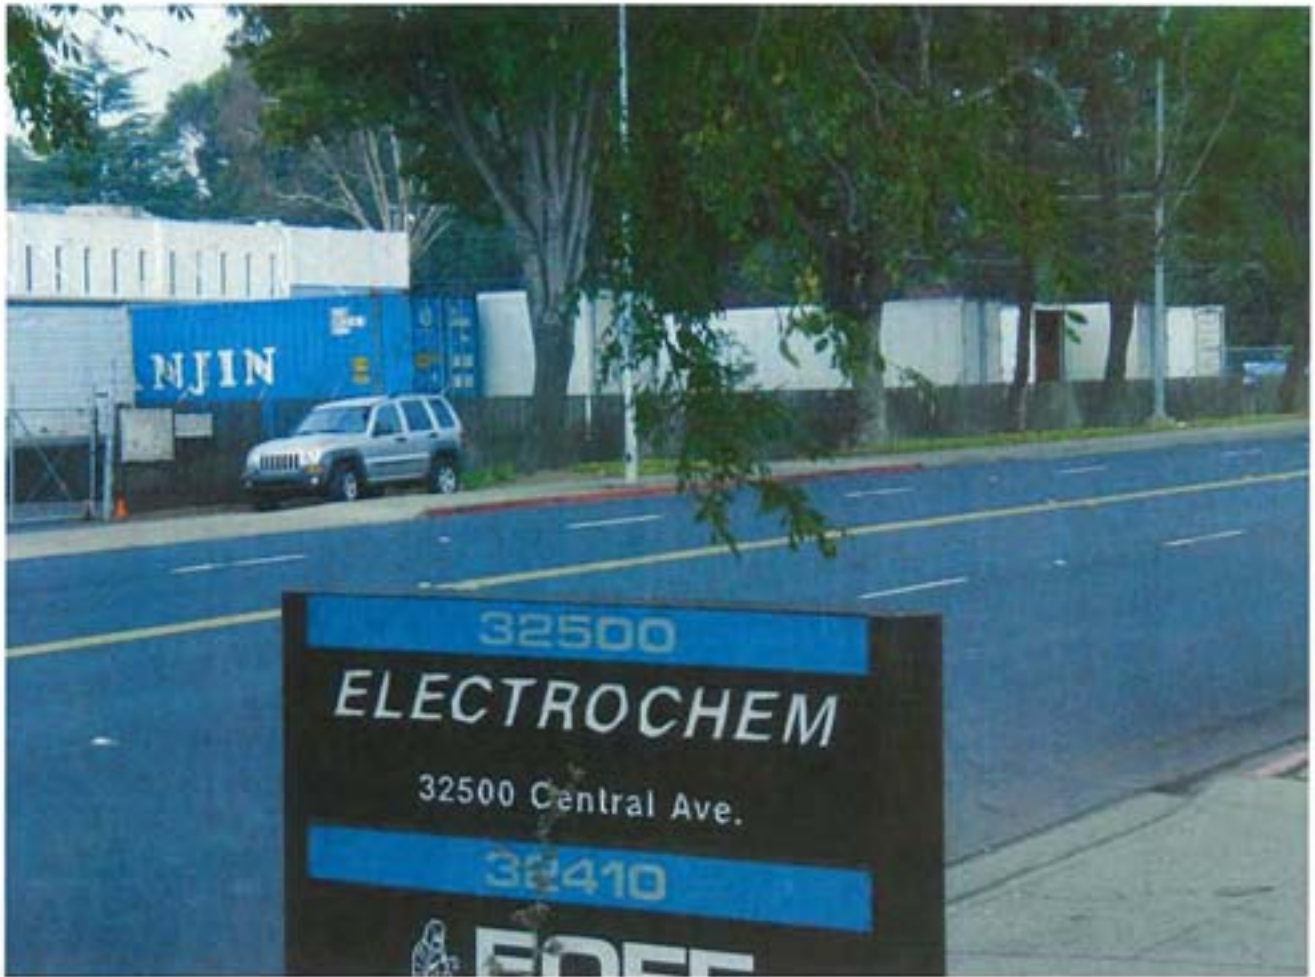
PC030001

001. Outdoor sign for Electrochem Solutions.
002. Production Room: All of the contents in the flammable cabinet are solvents used in the production process.

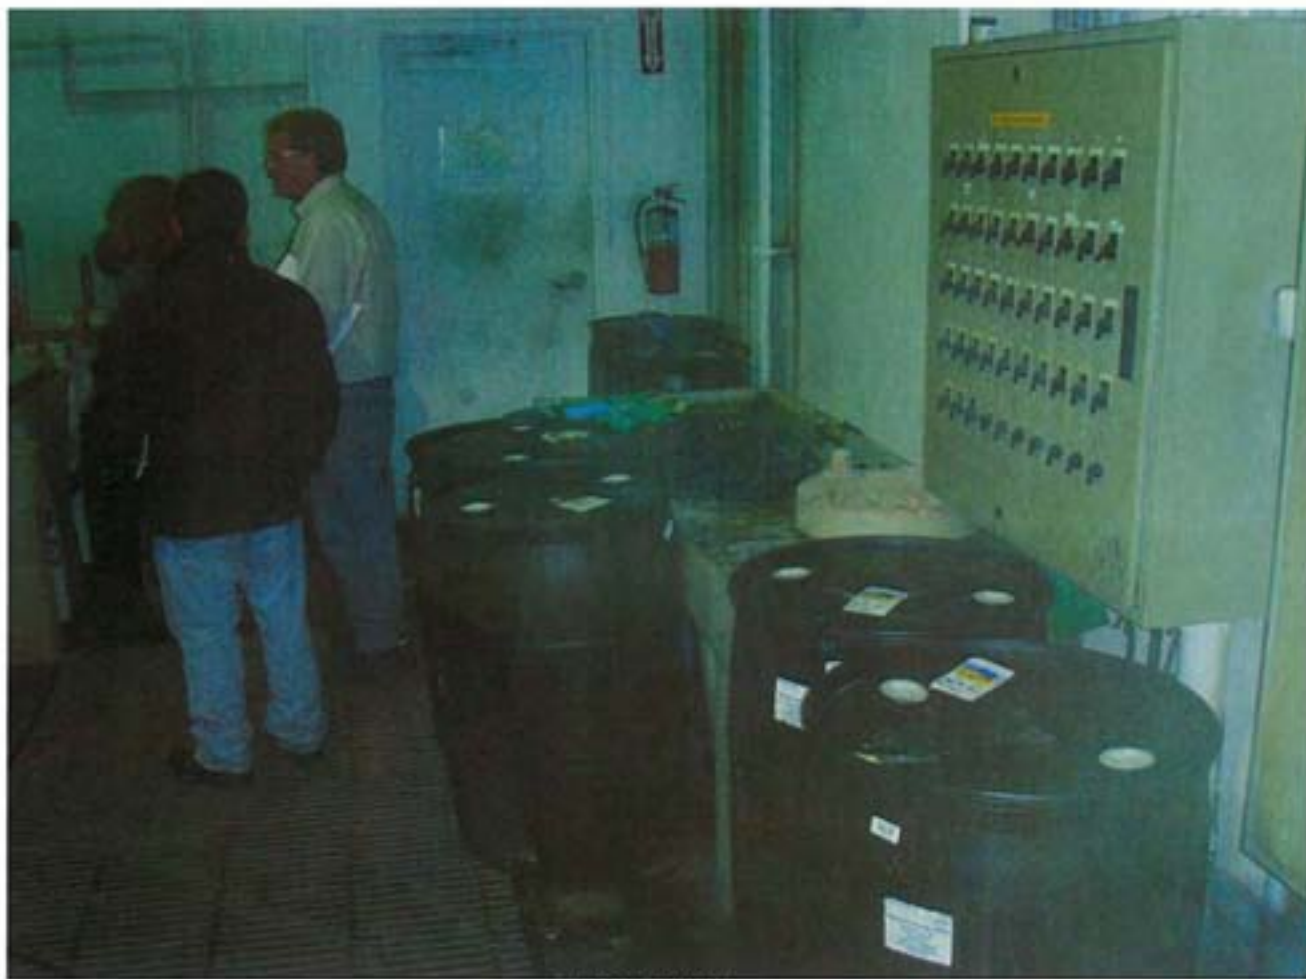
PC030005

005. Main Wet Processing Area: Six 55-gallon containers of gold strip (cyanide) including the two containers in the previous photograph. Four containers are labeled with the waste name and accumulation start dates.

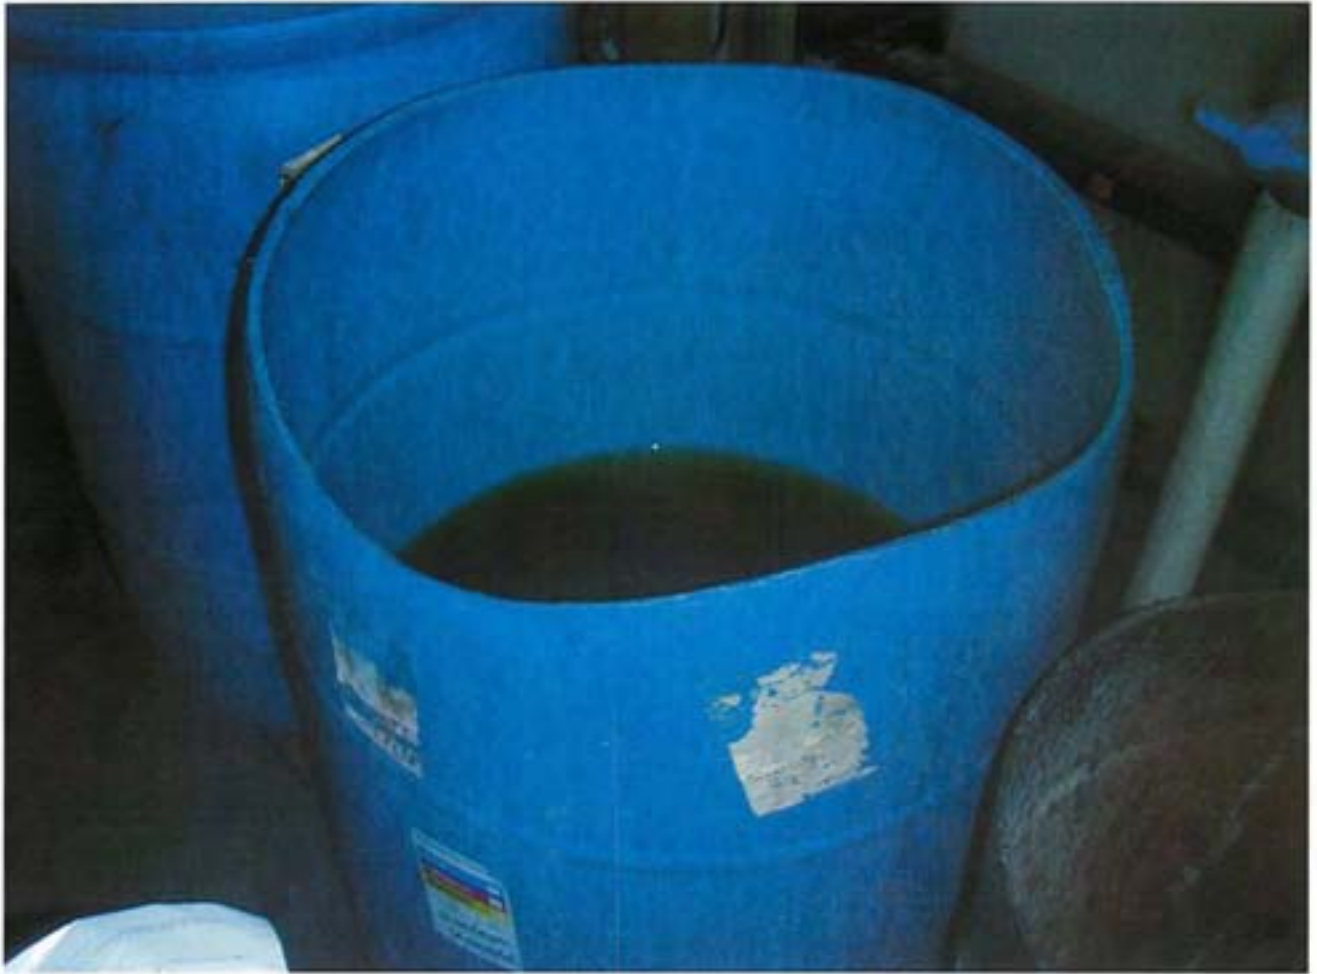
PC030016

016. Anodizing Area: Open, cut top 55-gallon container labeled "water waste." The label has no accumulation start date or other required labeling information.

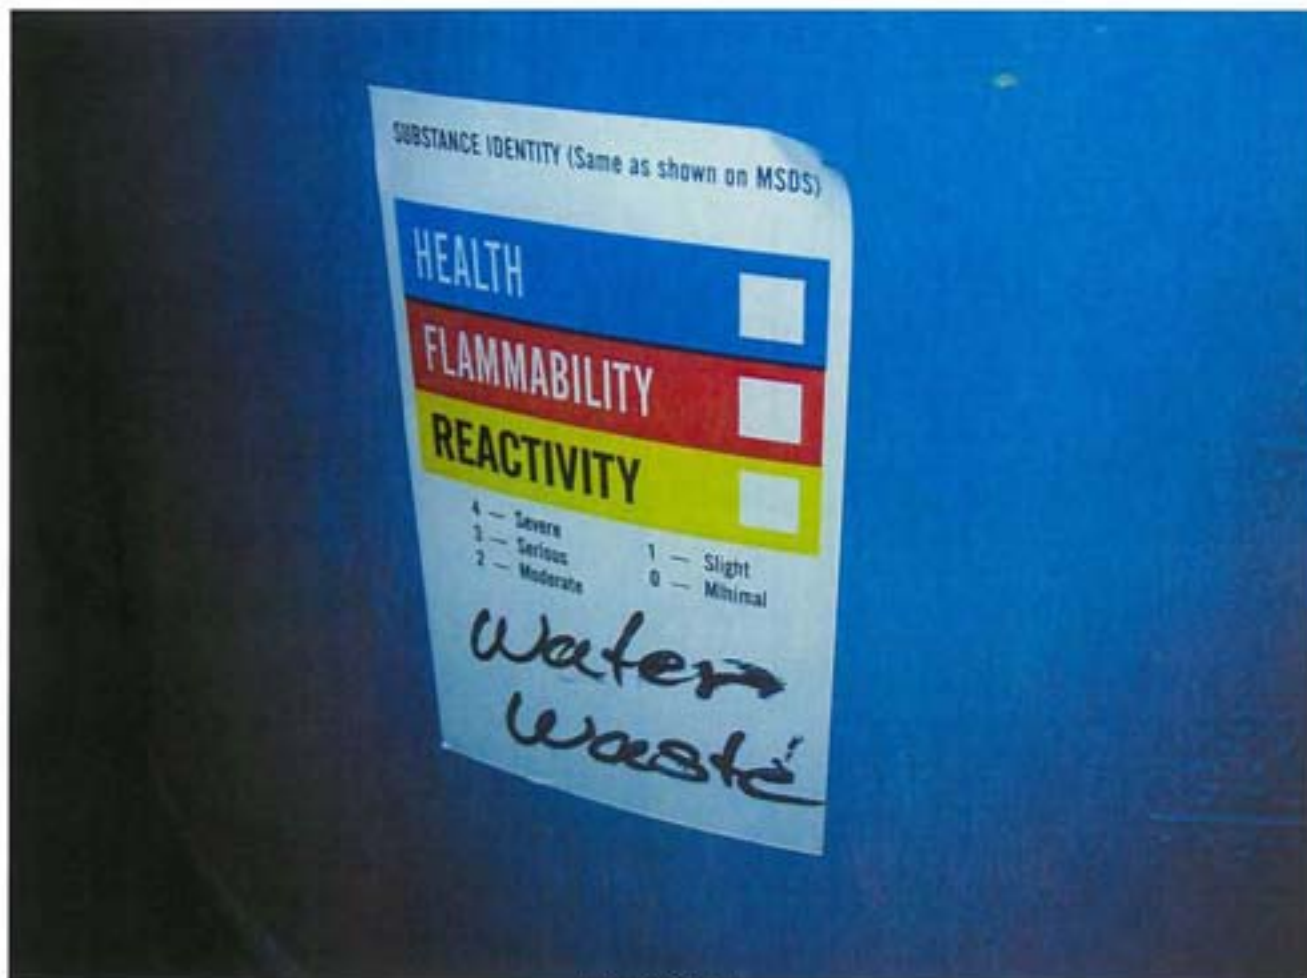
PC030017

017. Anodizing Area: Close up of the label on the 55-gallon container in the previous photograph.
018. Anodizing Area: Inside of trash can containing contaminated gloves.

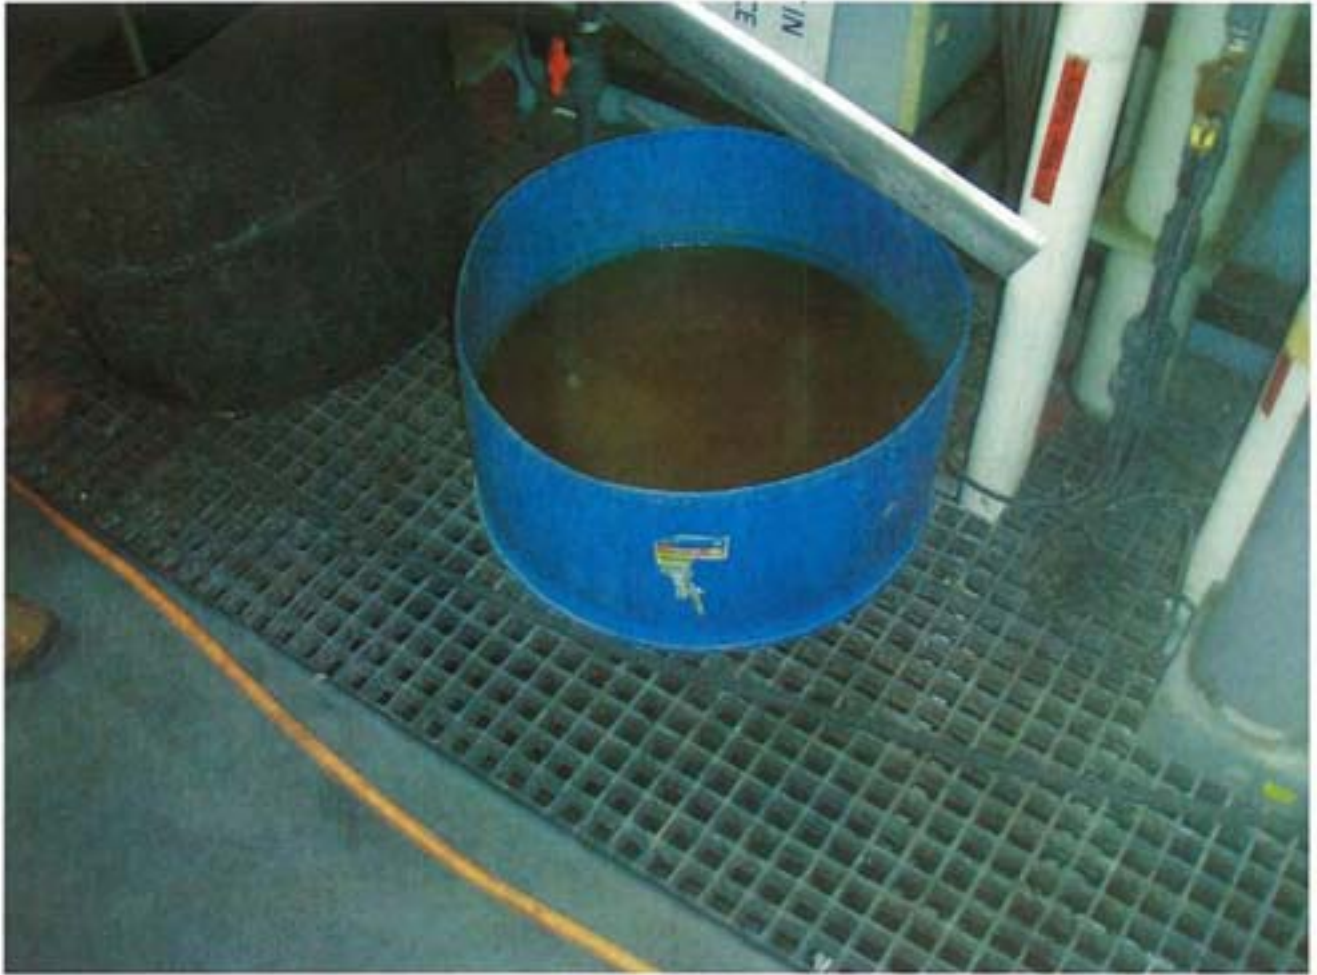
PC030019

019. Anodizing Area: Open and unlabeled cut 55-gallon container. Facility representative stated that it contained dichromate waste water.
020. Anodizing Area: Open cut top 55-gallon container labeled "rinse water." Facility representative stated that it contained nitric acid and 40% nickel strip wastewater.

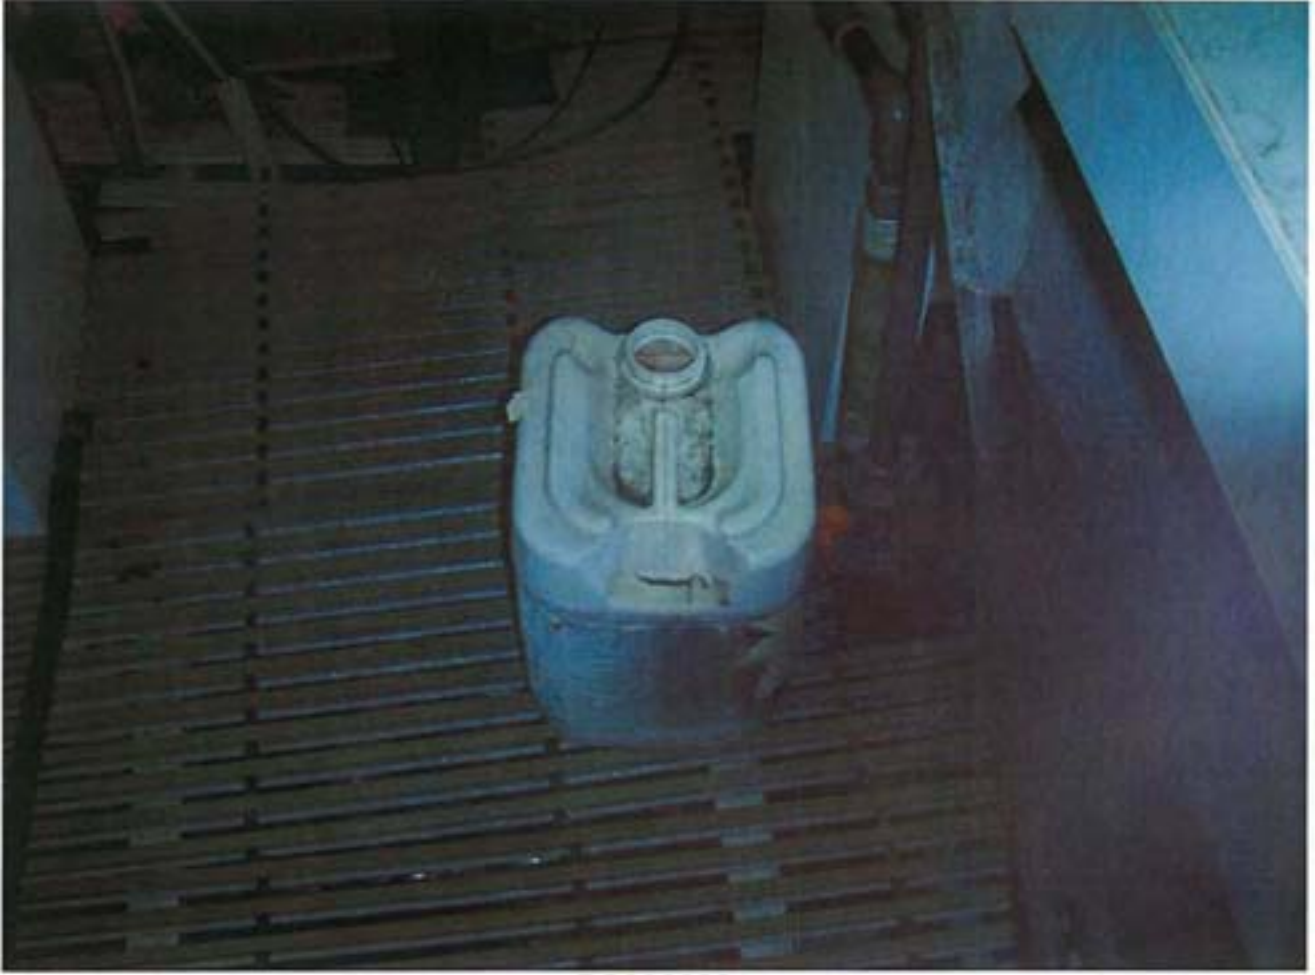
PC030022

022. Anodizing Area: An open 5-gallon container of unknown substance.
023. Anodizing Area: Open cut top 55-gallon container labeled "waste water." Facility representative stated it was placed in the location to collect rain water from a leak in the roof.

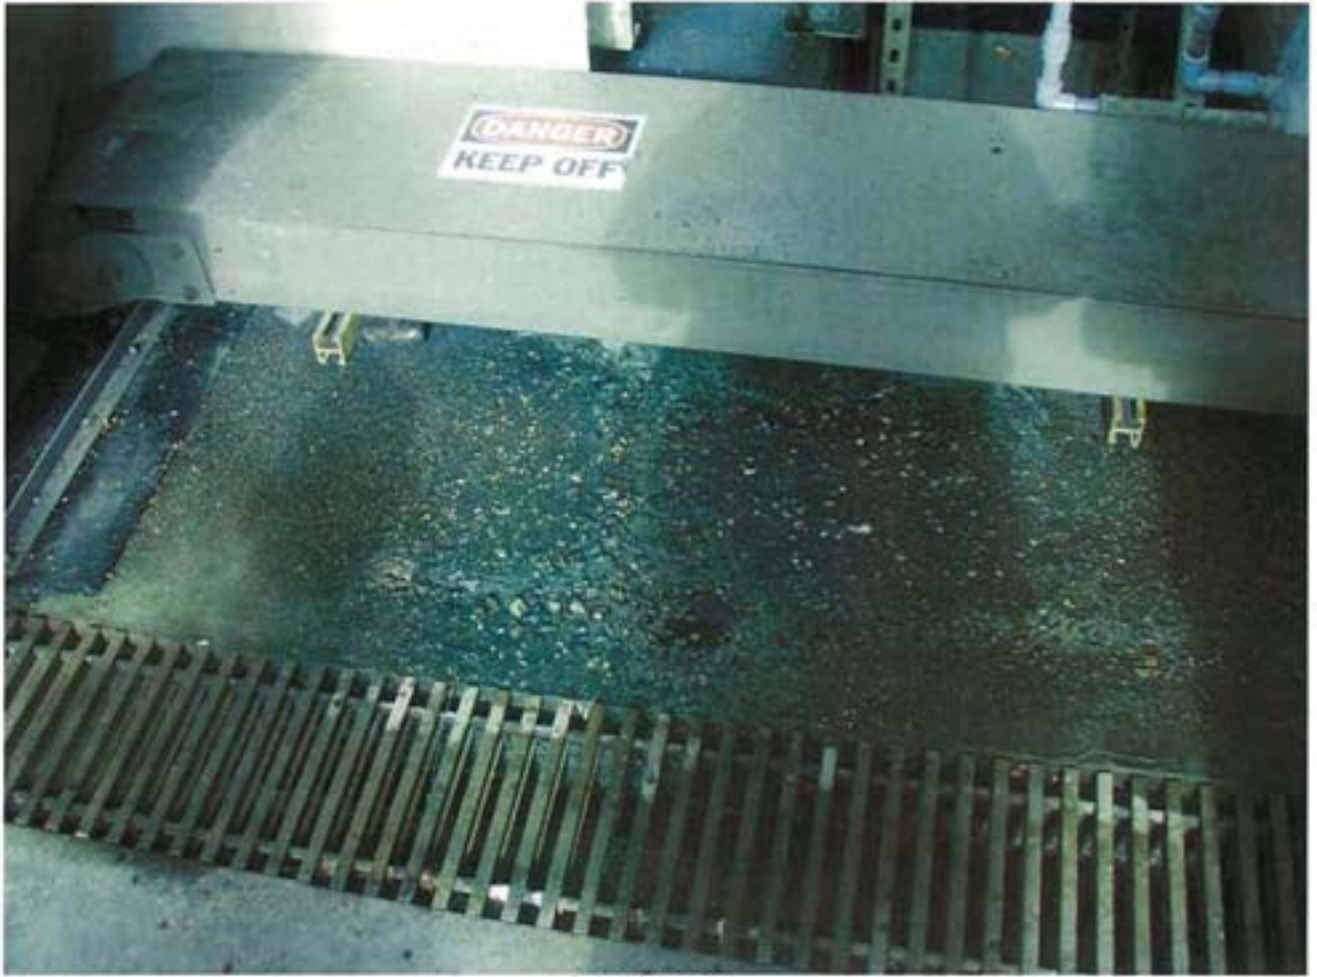
PC030026

024. Utility Room: Nine 55-gallon containers of glycol product. Note: the bungs on two of the containers were open.
025. Utility Room: Leaking pipes.
026. Utility Room: Concrete under leaking pipes in previous photograph is corroded.

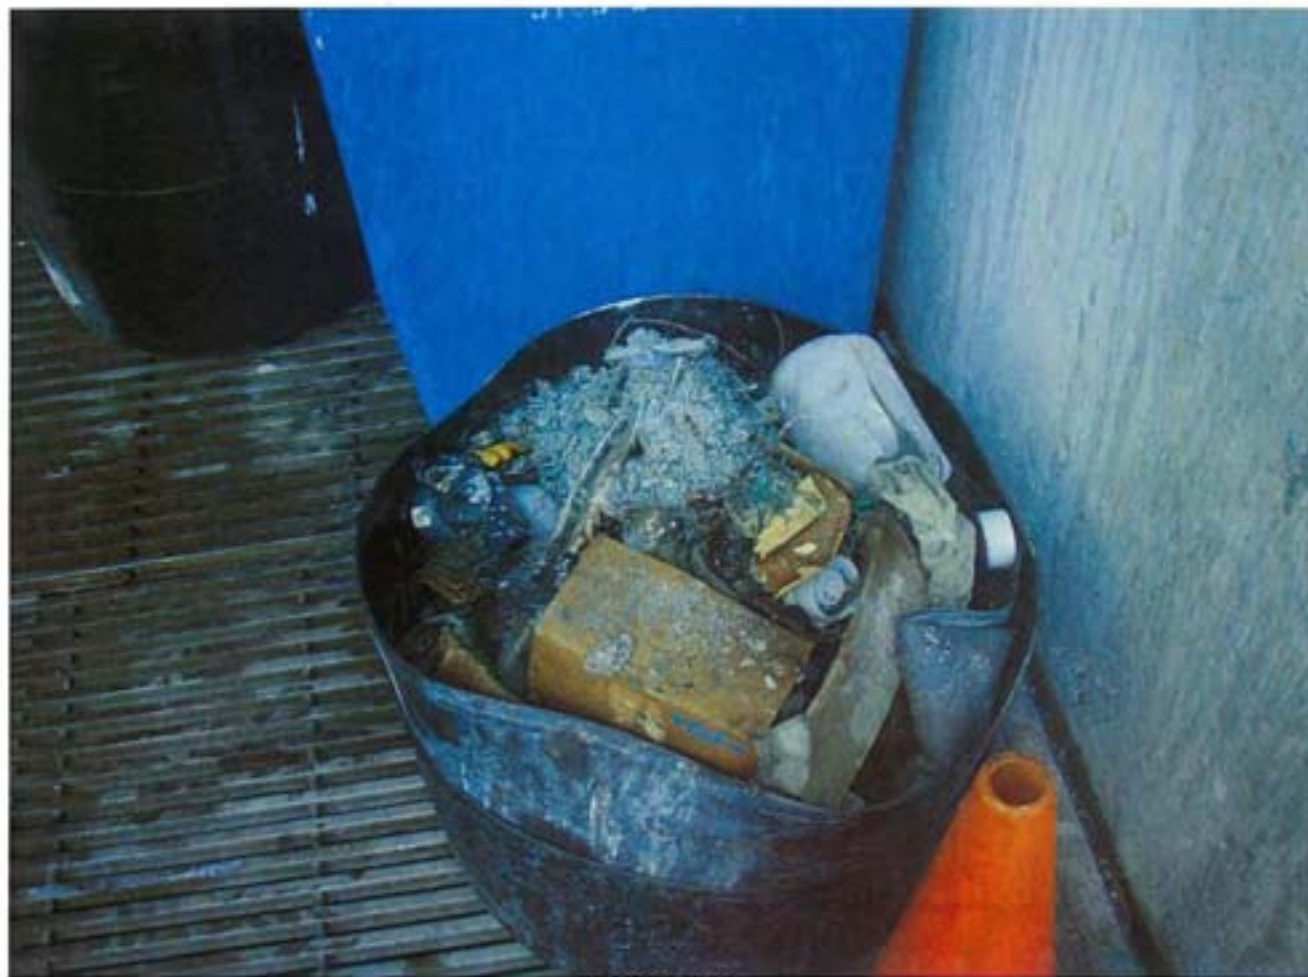
PC030032

032. Water Treatment and Equipment Area: An open top cut 55-gallon container with waste material.
033. Water Treatment and Equipment Area: Close up view of the three open and cut top 55 gallon containers in photograph 029.

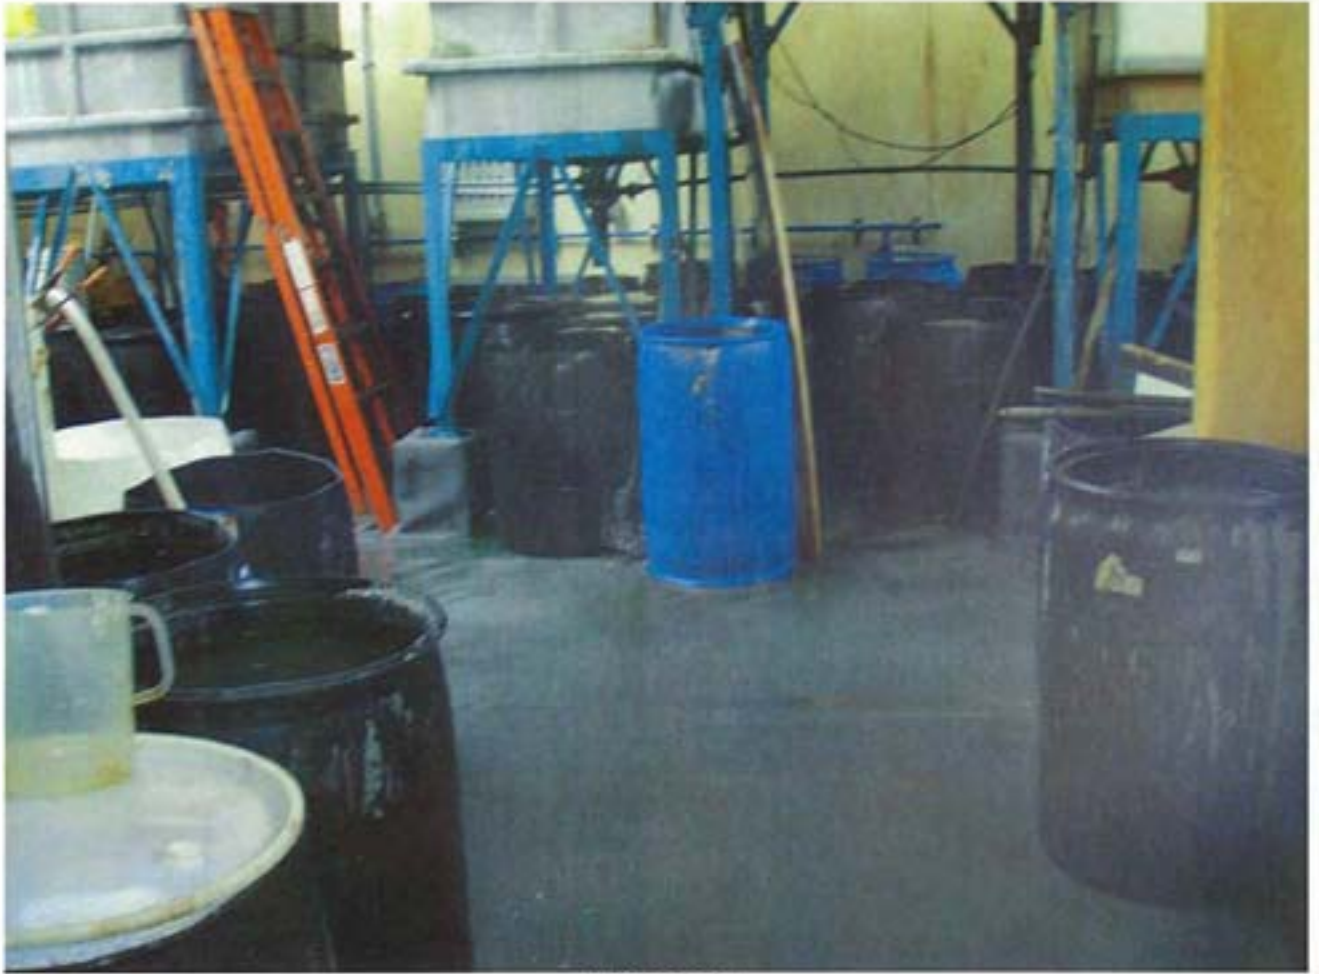
PC030034

034. Bulk Waste Processing Area: View of the area from the entryway from the Water Treatment and Equipment Area. Note: numerous containers are open and unlabeled.

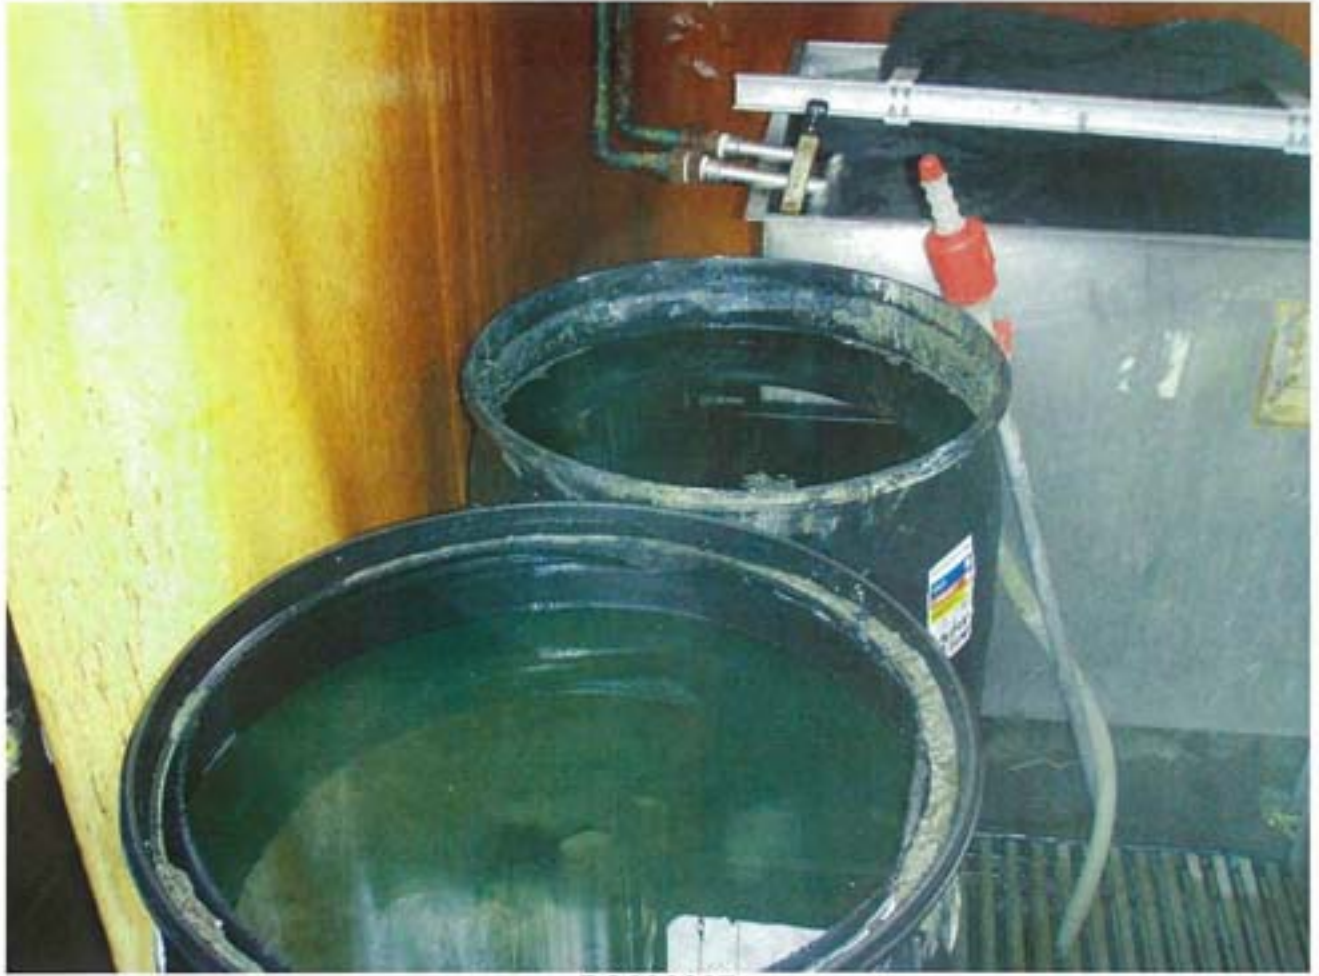
PC030037

037. Bulk Waste Processing Area: Two open top 55-gallon containers. One of the containers is labeled "water etch."
038. Bulk Waste Processing Area: One open top 55-gallon container labeled "sludge."

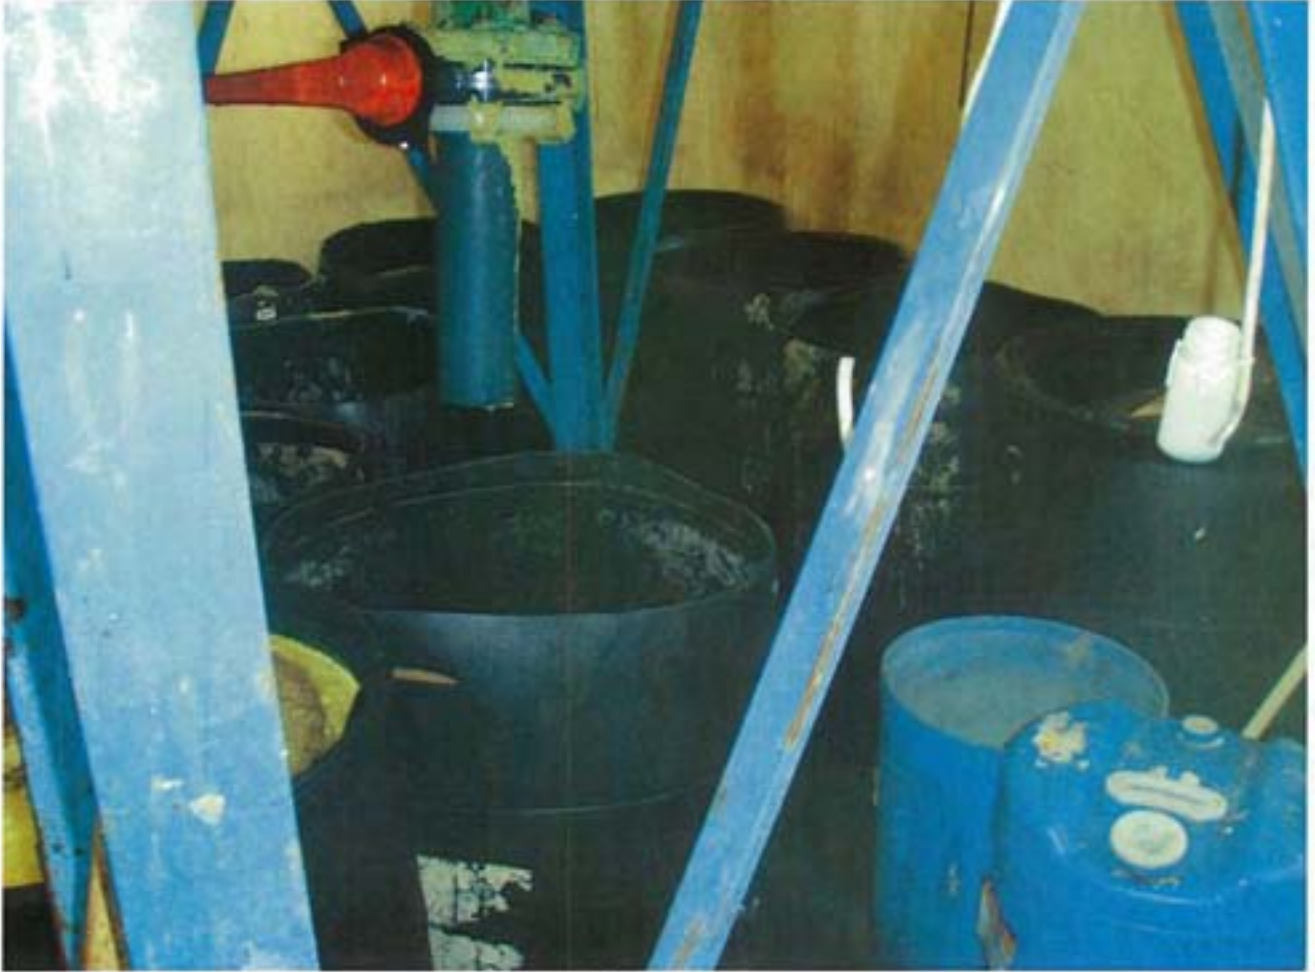
PC030040

039. Bulk Waste Processing Area: Three open top 55-gallon containers placed near the fence, bypassing the sump and perimeter wall.
040. Bulk Waste Processing Area: Ten open top 55-gallon containers and one 5-gallon open container and one 5-gallon closed container.

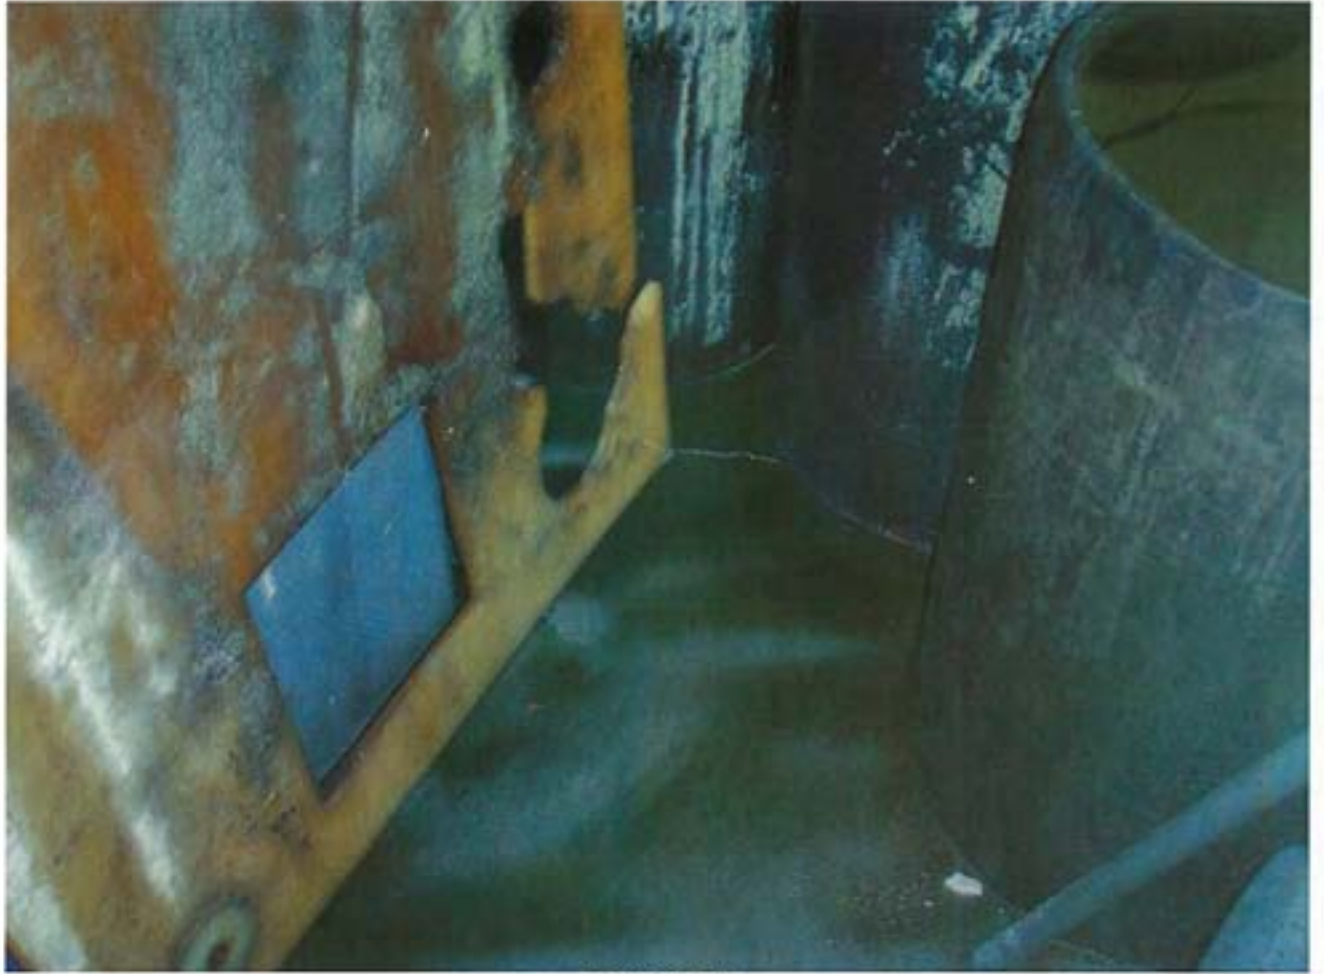
PC030042

041. Bulk Waste Processing Area: Approximately fourteen open top 55-gallon containers.
042. Bulk Waste Processing Area: Liquid observed on the floor in the area. The floor is lined, although torn in some locations.

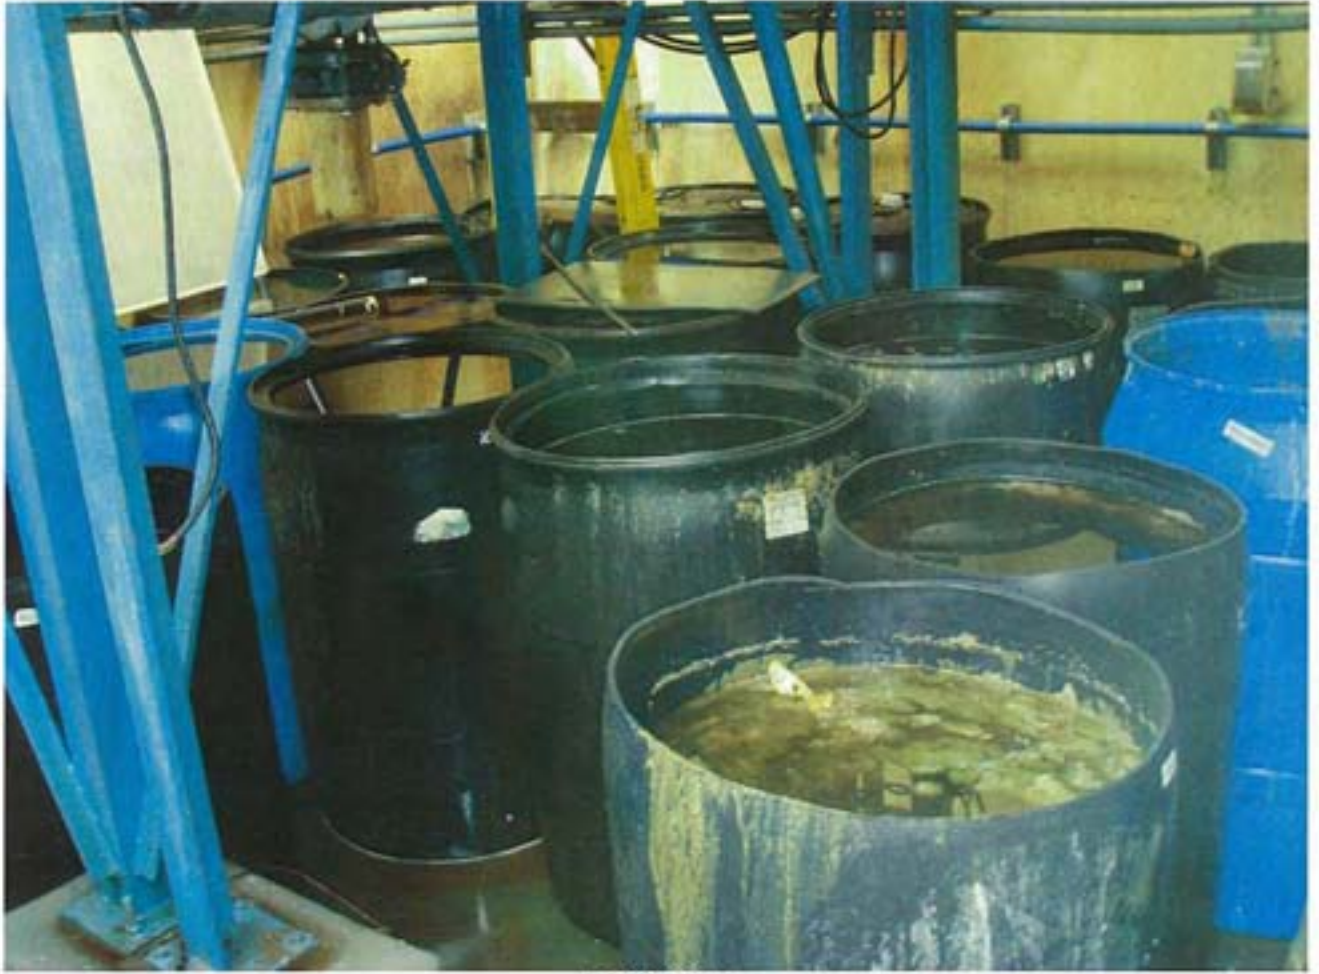
PC030044

043. Bulk Waste Processing Area: Approximately seventeen open top 55-gallon containers.
044. Bulk Waste Processing Area: Approximately seventeen open top 55-gallon containers. Note: liquid on the ground.

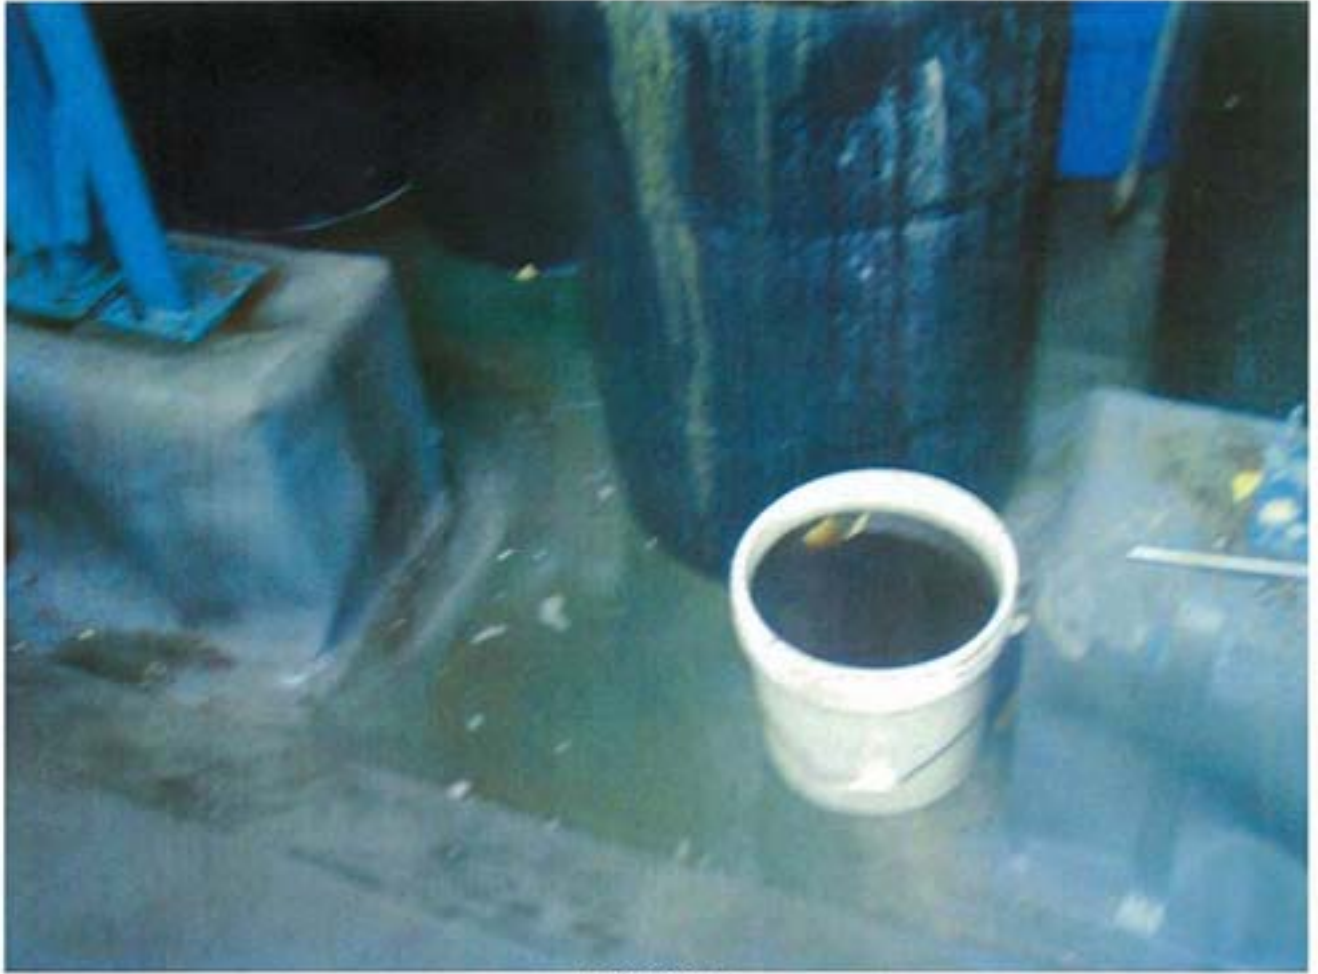
PC030045

045. Bulk Waste Processing Area: An open top 5-gallon container. Note: liquid on the ground.
046. Bulk Waste Processing Area: Filter press. Open tray with liquid underneath press.

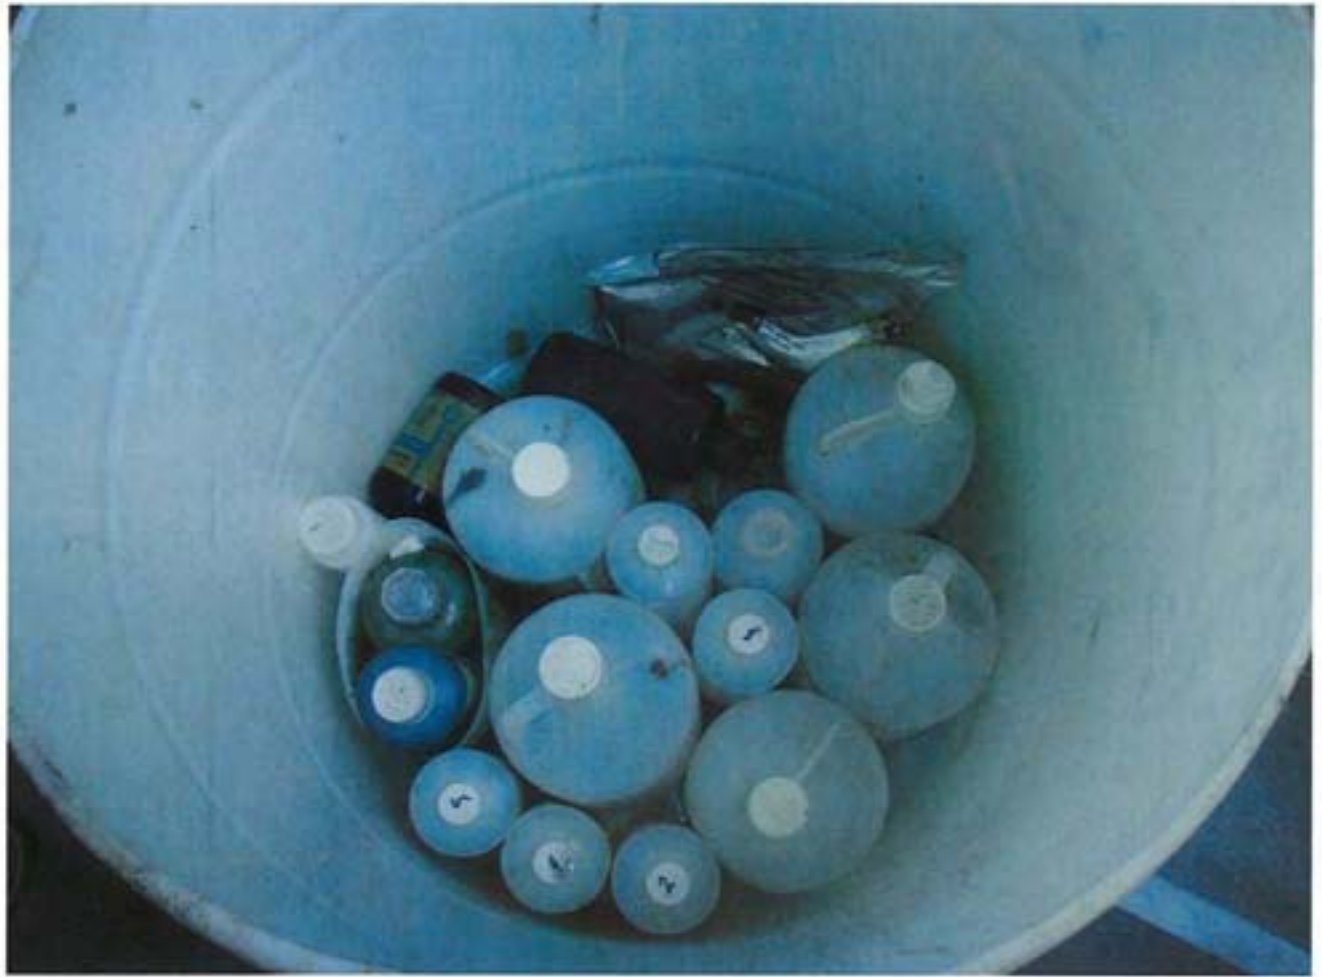
PC030052

051. Bulk Waste Processing Area: Hazardous waste label on bin of F007 waste. The accumulation start date is 12/1/10.
052. Bulk Waste Processing Area: An open 55-gallon container with various unlabeled containers inside.

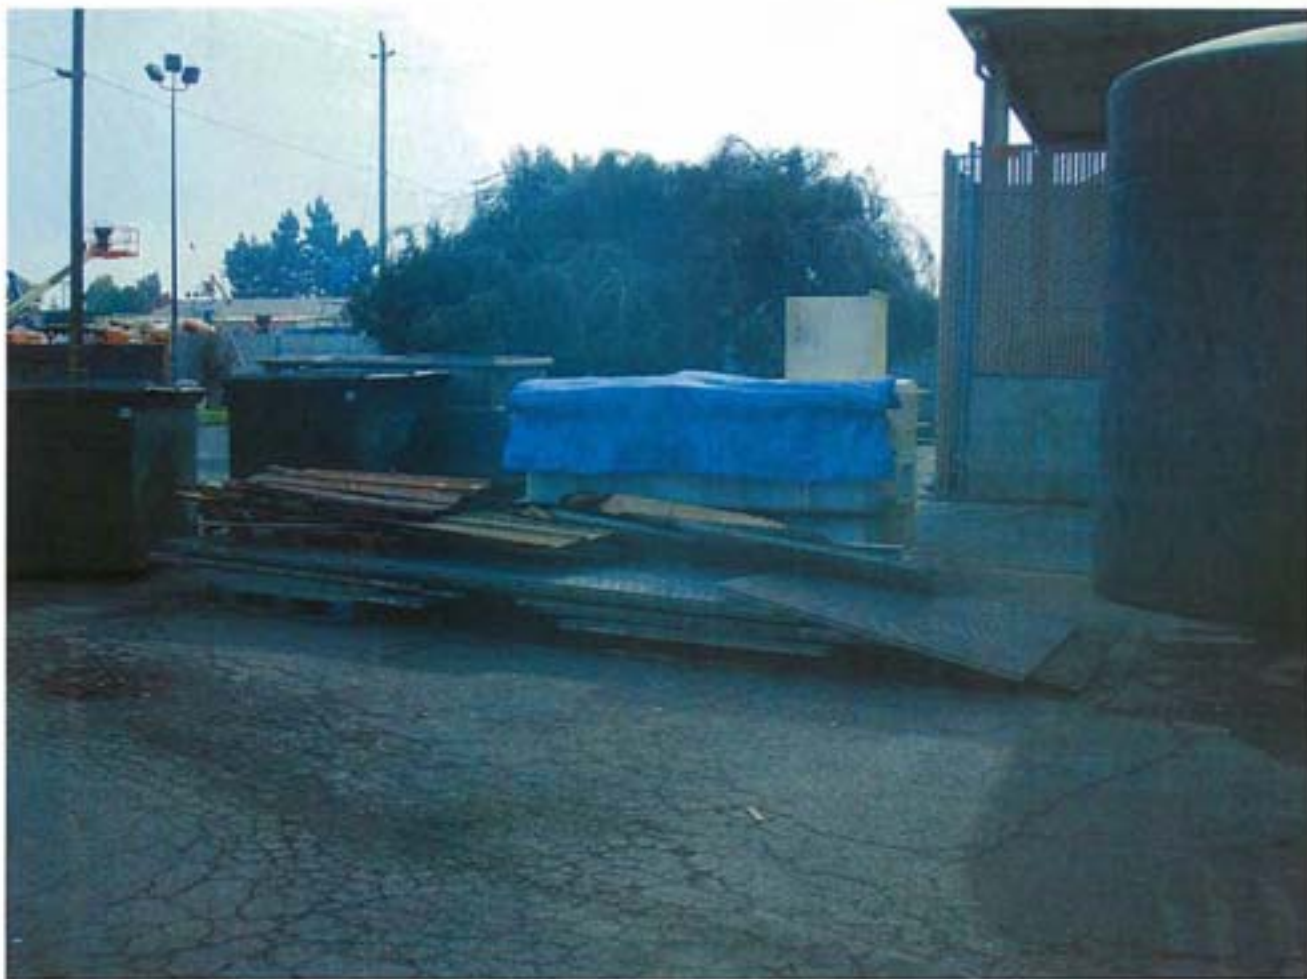
PC030056

055. Outdoor Area: View from backside of the building.
056. Outdoor Area: Obsolete plating fixtures adjacent to trash bins.
057. Outdoor Area: Area immediately adjacent to the Water Treatment and Equipment Area. Note area slopes towards outdoor area. The area is wet from inside the building down to the Di water tanks.
