Attachment 1

**Attachment 3
Photograph Log**

Photograph Log for EPA's December 3, 2010 Electrochem Solutions RCRA and CWA Inspection

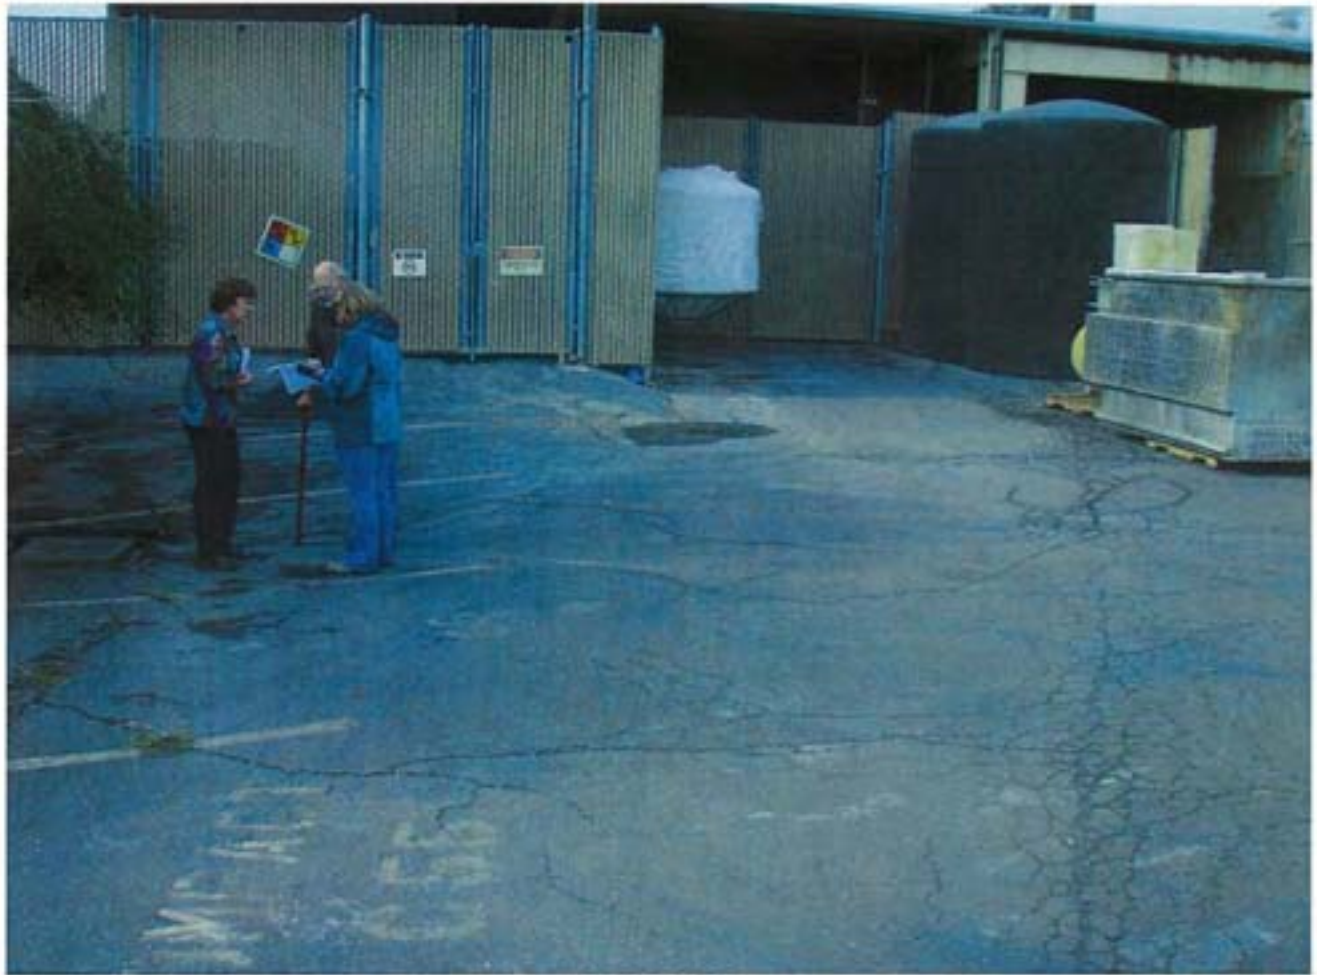
PC030059

058. Outdoor Area: storm drain approximately 30 feet from the back of the building.
059. Outdoor Area: View of storm drain in relationship to the building. Closest part of the building is the Less than 90-day Hazardous Waste Accumulation Area (Waste Chemical Storage).

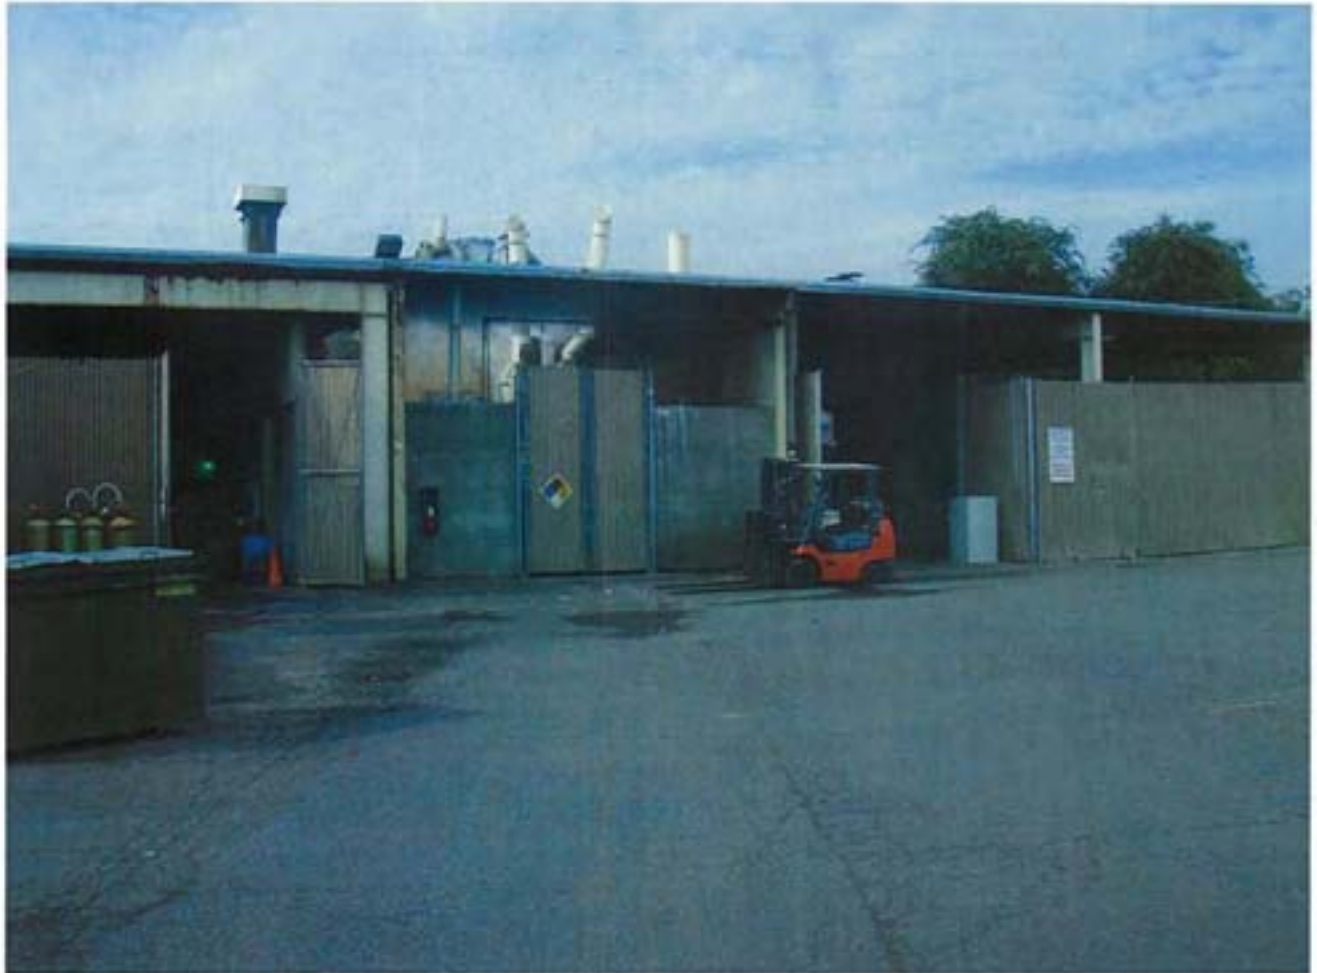
PC030060

060. Outdoor Area: View from the outdoor area the Water Treatment and Equipment Area, Bulk Waste Processing Area, and Maintenance Shop. Note puddle of liquid near forklift and Water Treatment and Equipment Area.

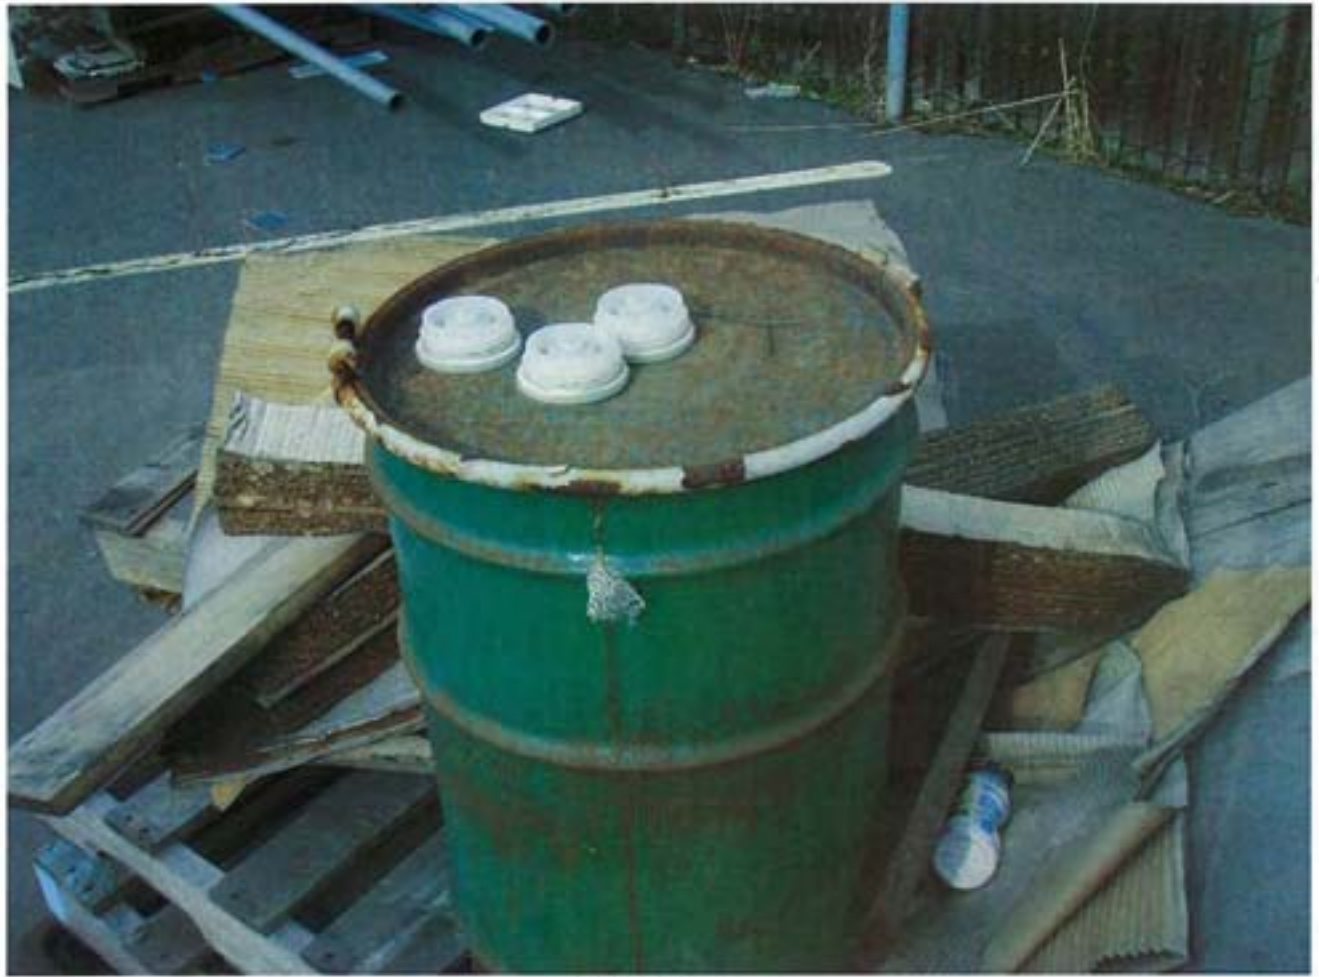
PC030061

061. Outdoor Area: Empty container and debris behind storage trailer.
062. Outdoor Area: Open garbage bin with debris and open containers inside.
063. Outdoor Area: Open garbage bin behind storage trailers as seen in previous photograph.

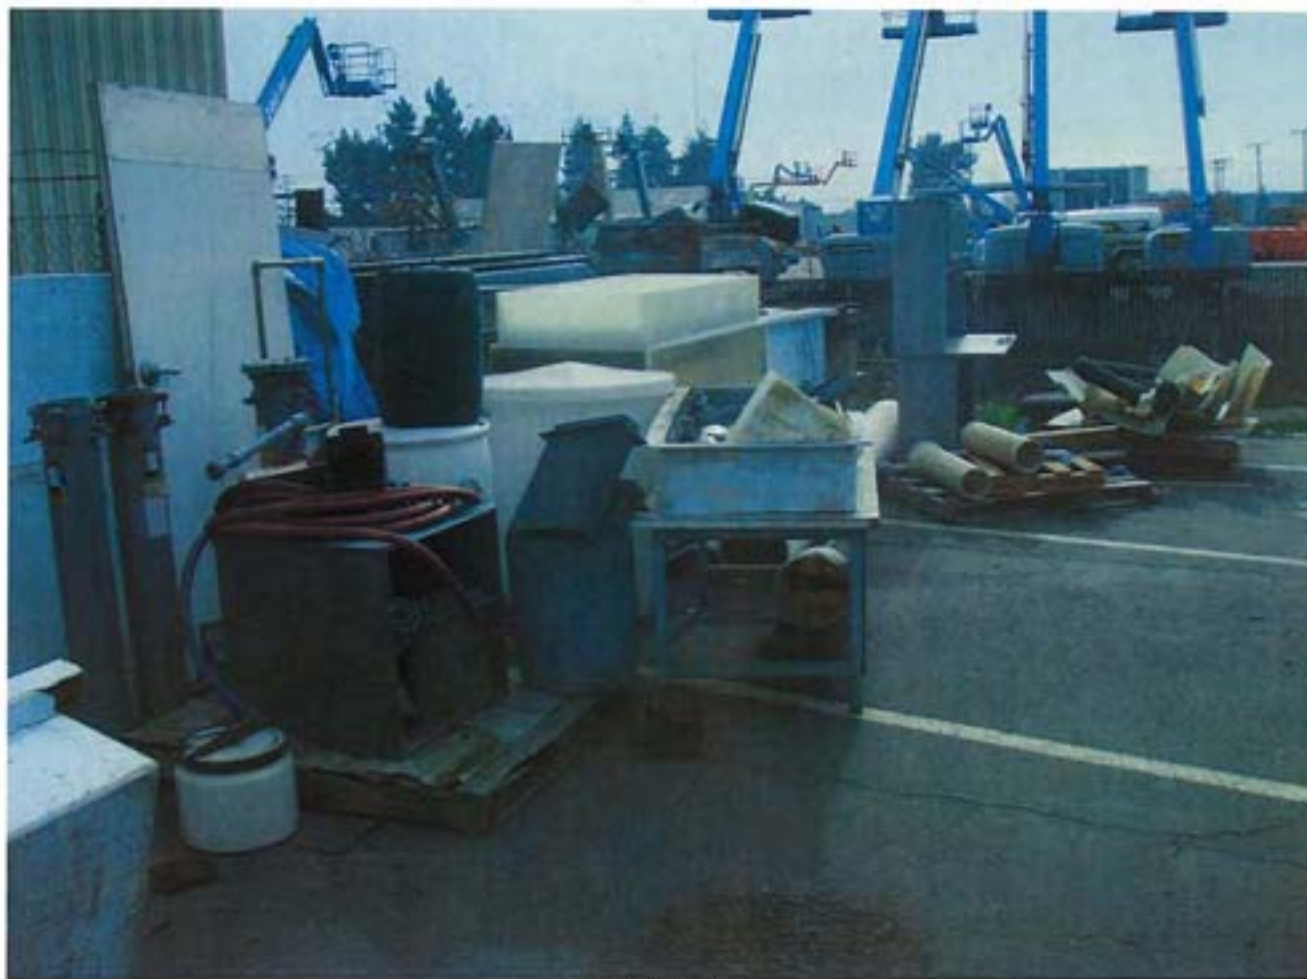
PC030064

064. Outdoor Area: Obsolete equipment and fixtures stored behind the storage trailers.
065. Outdoor Area: Shredded containers and other debris stored behind the storage trailers.

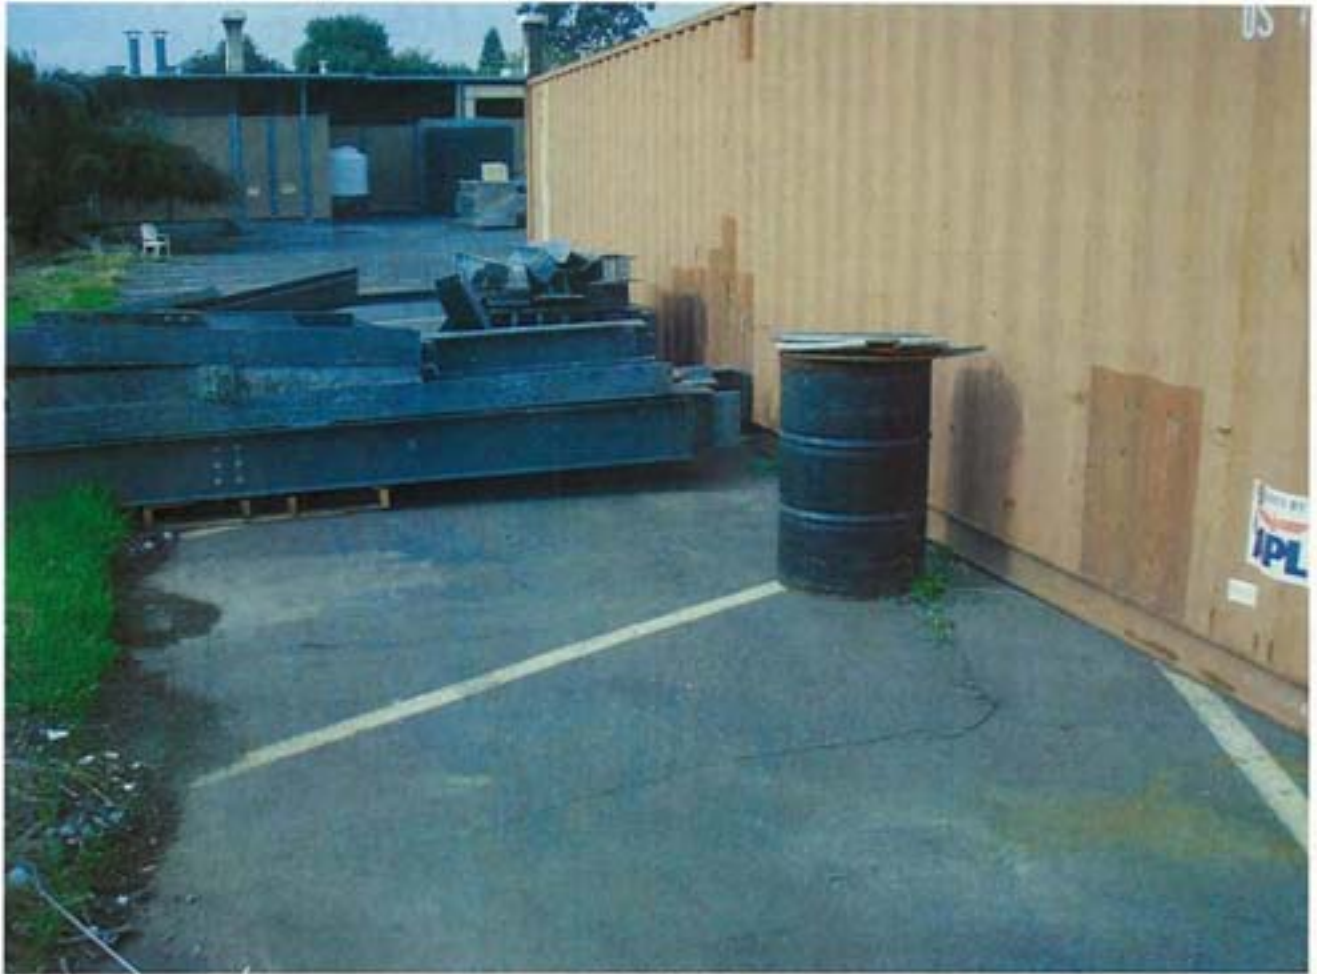
PC030066

066. Outdoor Area: Metal parts and a 55-gallon container of scrap metal next to storage trailers.
067. Outdoor Area: Obsolete equipment and fixtures stored behind the storage trailers.

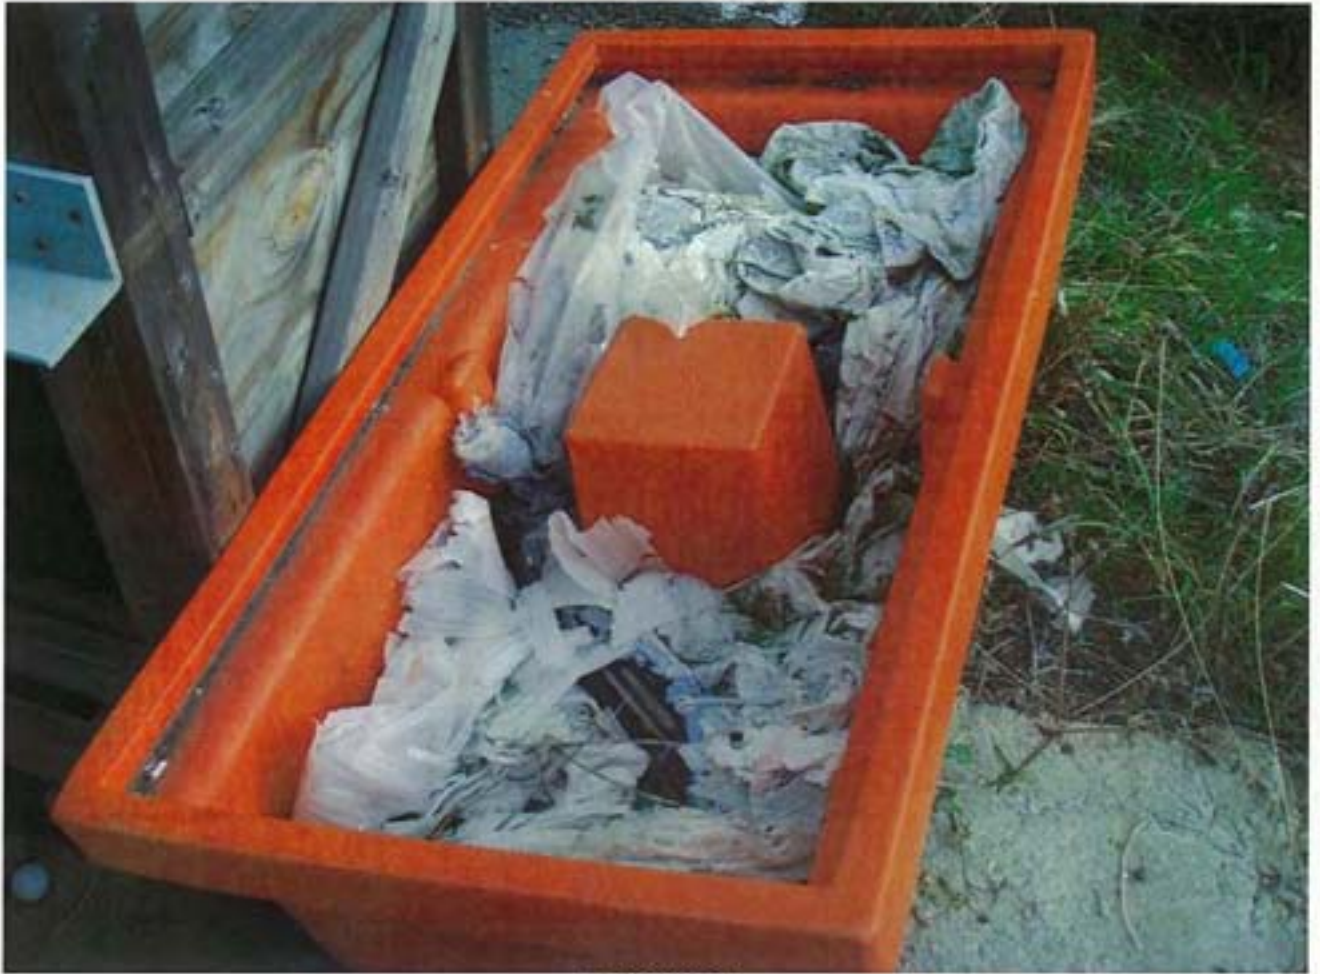
PC030068

068. Outdoor Area: Obsolete process tank containing unknown liquid .
069. Outdoor Area: Discarded plating bath with unknown liquid inside.
070. Water Treatment and Equipment Area: Sample box and pH meter for sewer discharge.

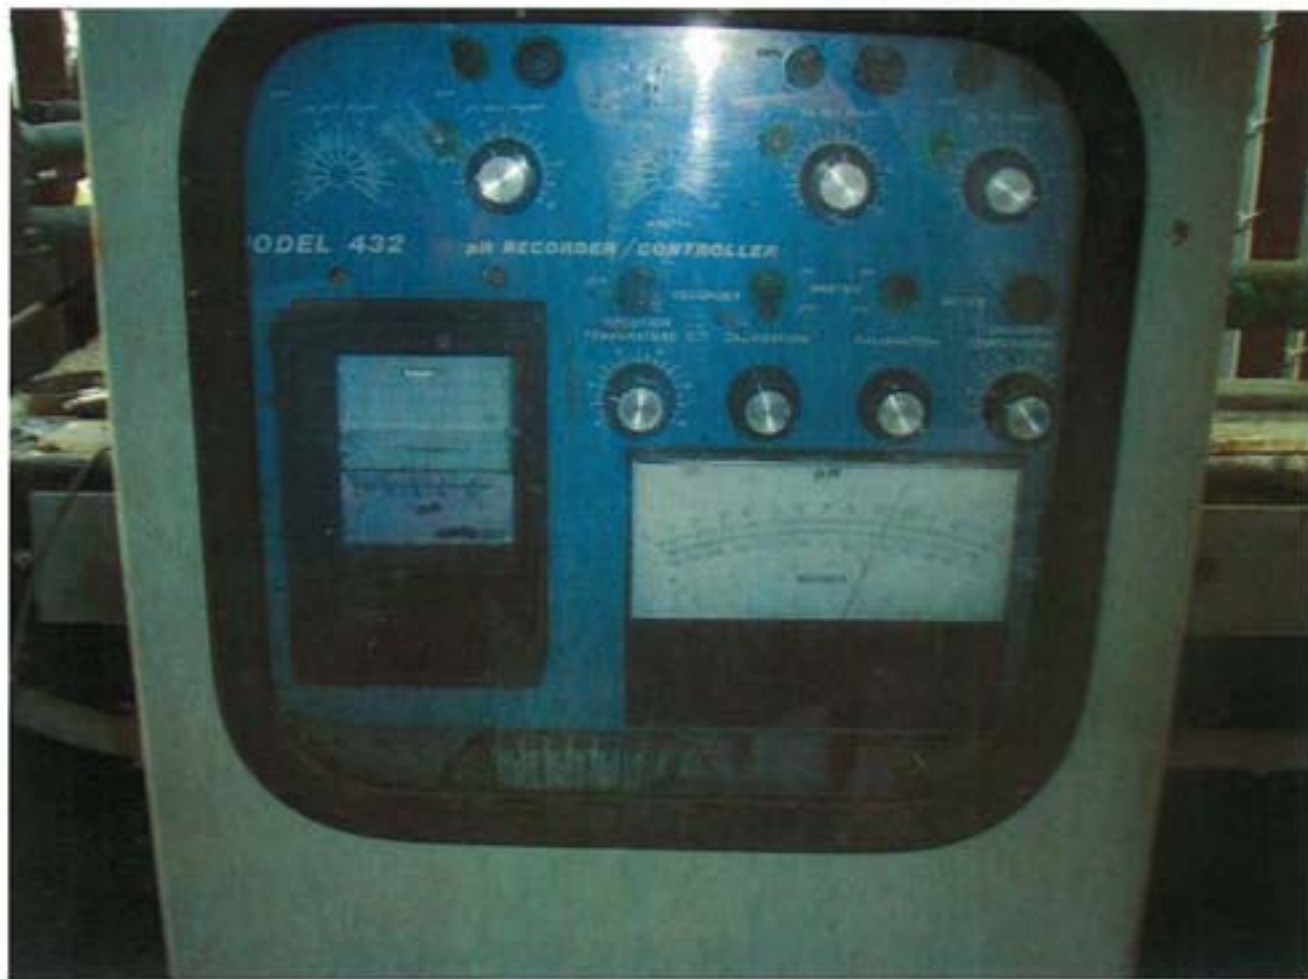
PC030071

071. Water Treatment and Equipment Area: Close up of pH meter. Note: the pH meter is not functioning.
072. Less than 90-day Hazardous Waste Accumulation Area (Waste Chemical Storage): Area is lined. There are approximately thirty 55-gallon containers and approximately two 5-gallon containers in the photograph. Containers along the short wall are open and labeled as "filters" and "liners." The floor in this area is stained, but lined. Many labels on the containers could not be read. One container label in view reads "nickel strip" and another states "gold alodine."

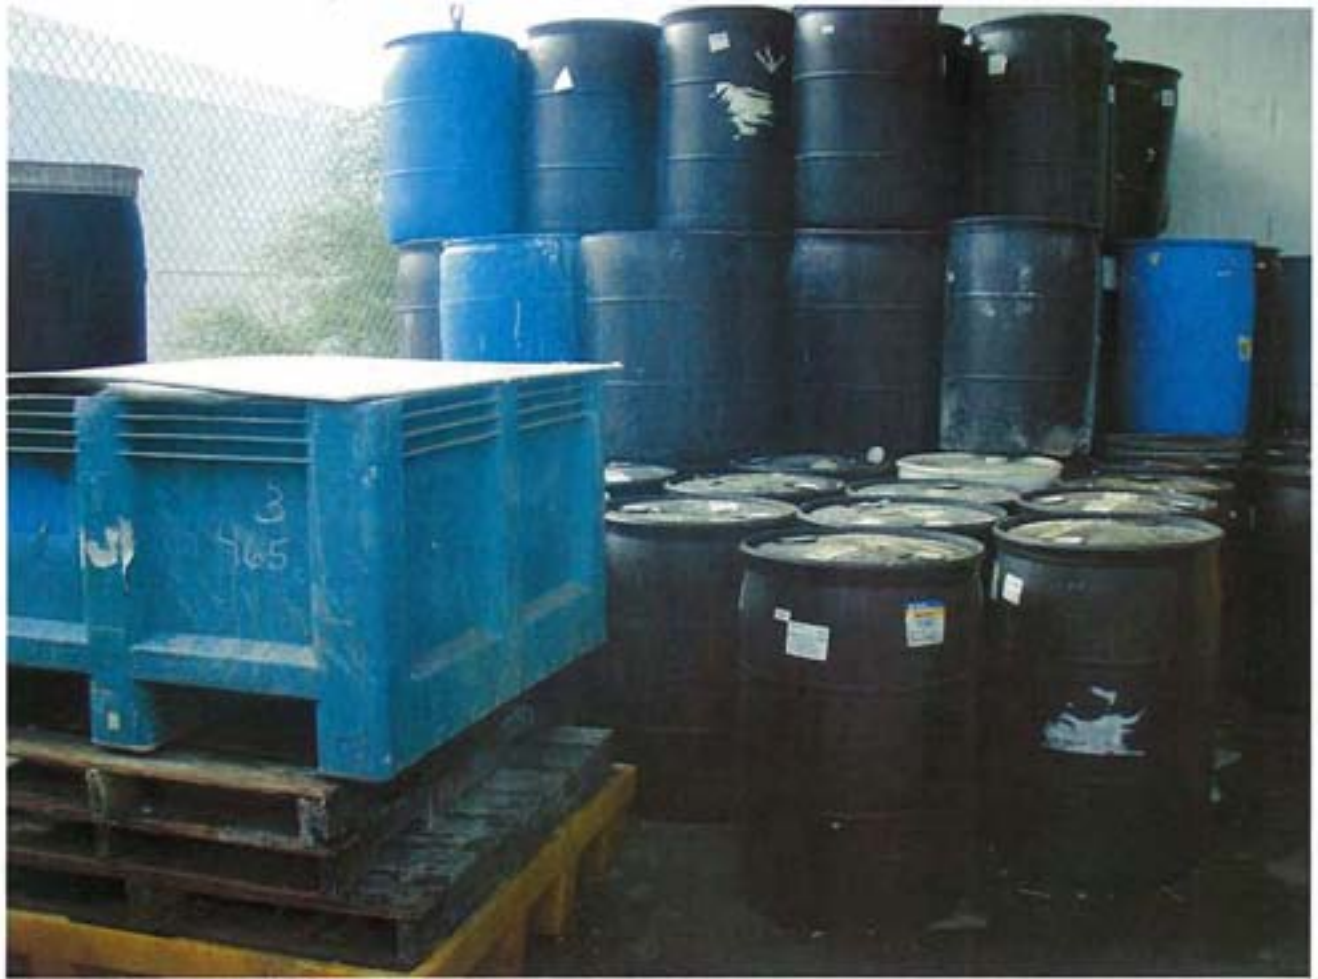
PC030073

073. Less than 90-day Hazardous Waste Accumulation Area (Waste Chemical Storage): Approximately forty 55-gallon containers and in some places triple stacked. A bin with a sheet of wood on top is located in the foreground.

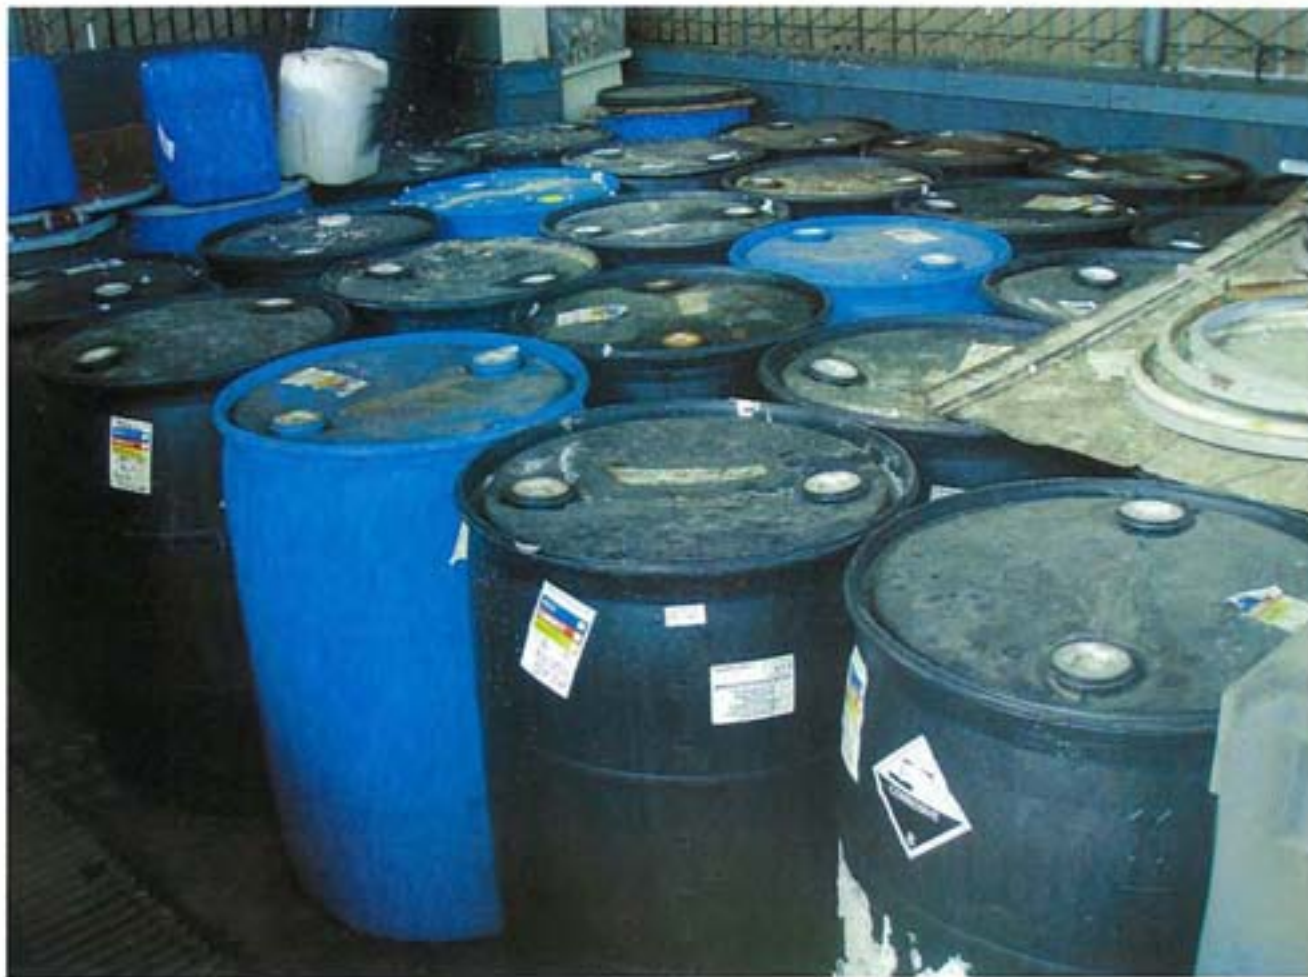
PC030074

074. Less than 90-day Hazardous Waste Accumulation Area (Waste Chemical Storage): Approximately twenty-five 55-gallon containers. Many labels on the

- containers could not be read. One container label in view states "nickel strip" and the other states "gold alodine."
075. Less than 90-day Hazardous Waste Accumulation Area (Waste Chemical Storage): One hazardous waste label partially in view on one of the containers states "resin waste."

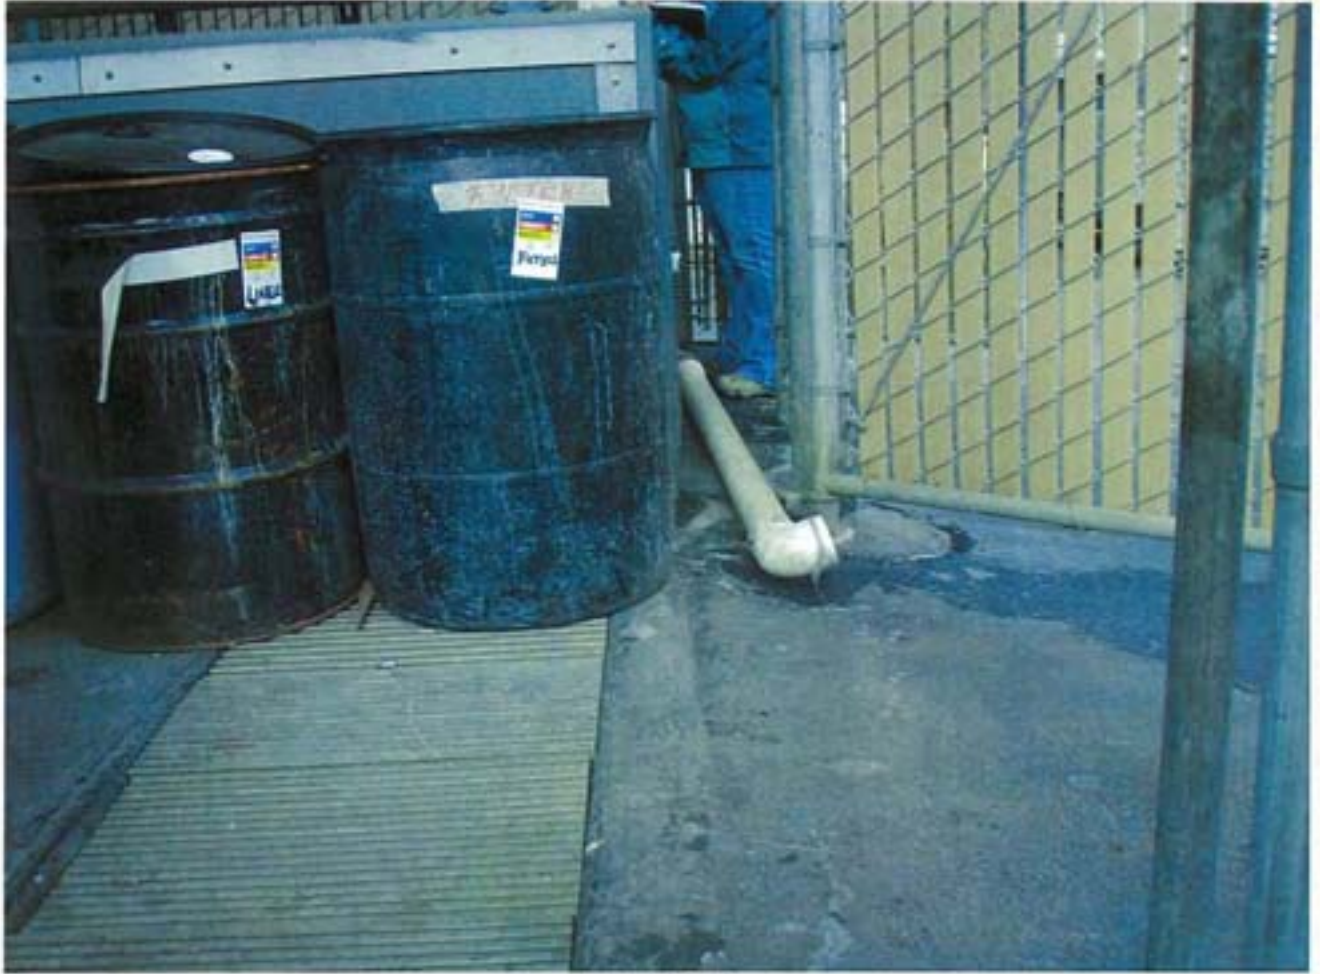
PC030076

076. Less than 90-day Hazardous Waste Accumulation Area (Waste Chemical Storage): Slot drain located along entry to the storage area. Note that containers are stored on top of drain. Piping from rain gutter drains at the entry of the storage area. Note white-colored pavement from roof drain.

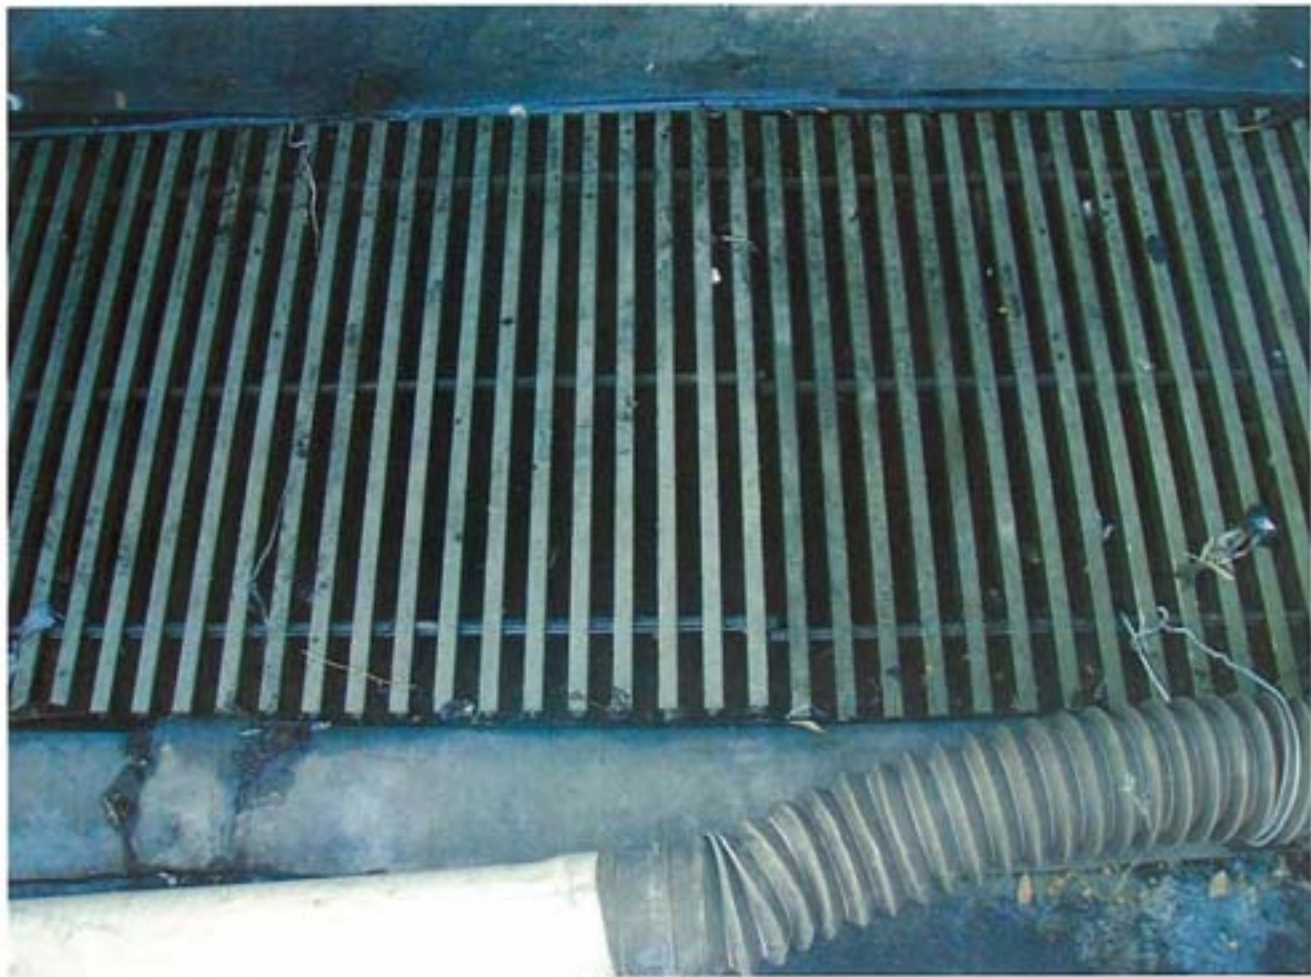
PC030077

077. Less than 90-day Hazardous Waste Accumulation Area (Waste Chemical Storage): Slot drain is full of liquid.
078. Less than 90-day Hazardous Waste Accumulation Area (Waste Chemical Storage): One of three 55-gallon container of cyanide waste filter label has an accumulation start date of 8/4/10.

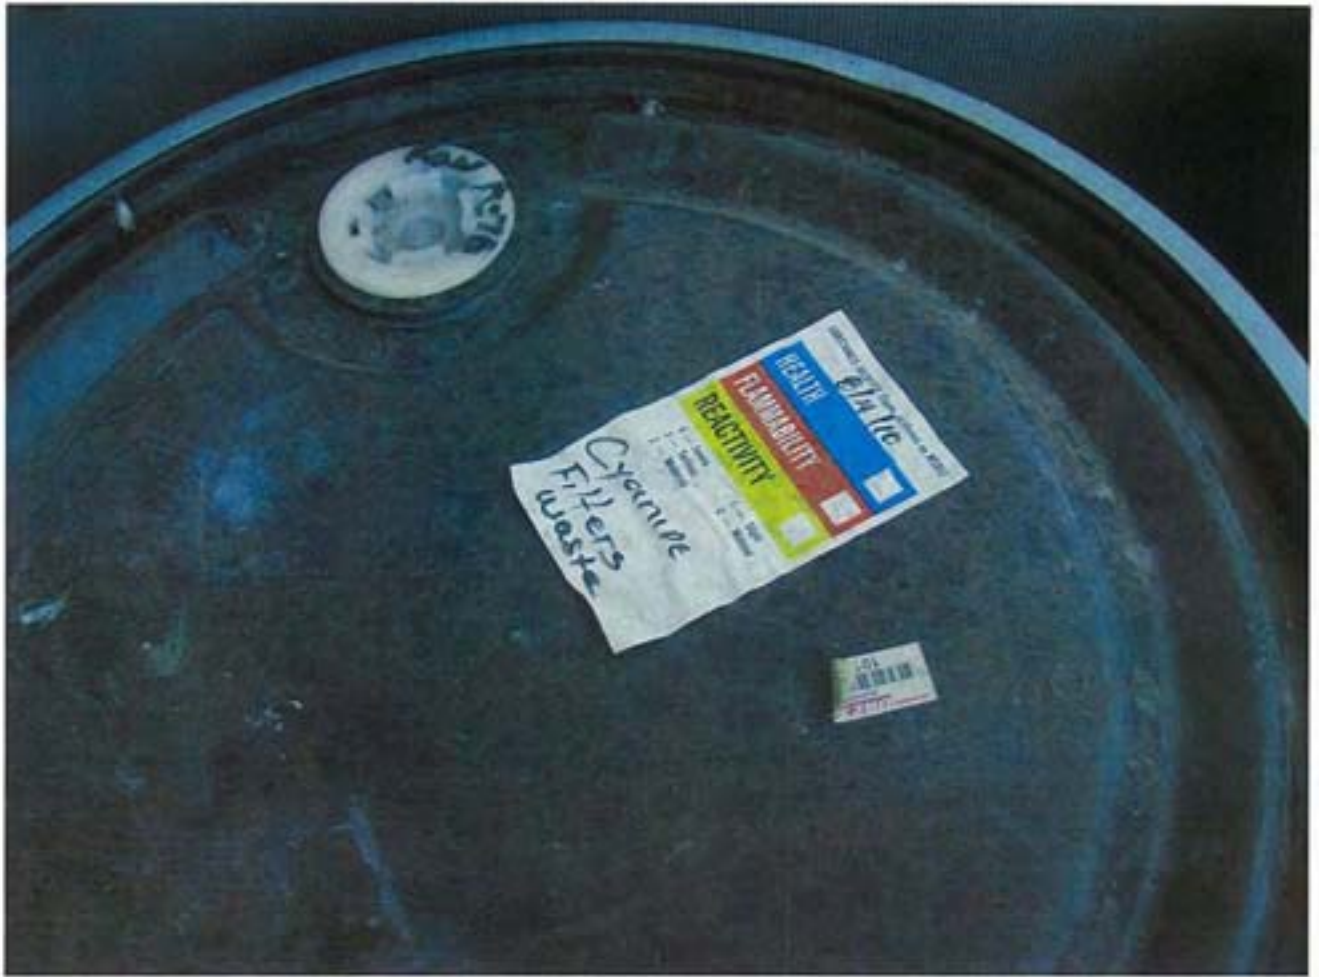
PC030081

081. Less than 90-day Hazardous Waste Accumulation Area (Waste Chemical Storage): One of three 55-gallon container of cyanide waste filter label has an accumulation start date of 8/4/10.

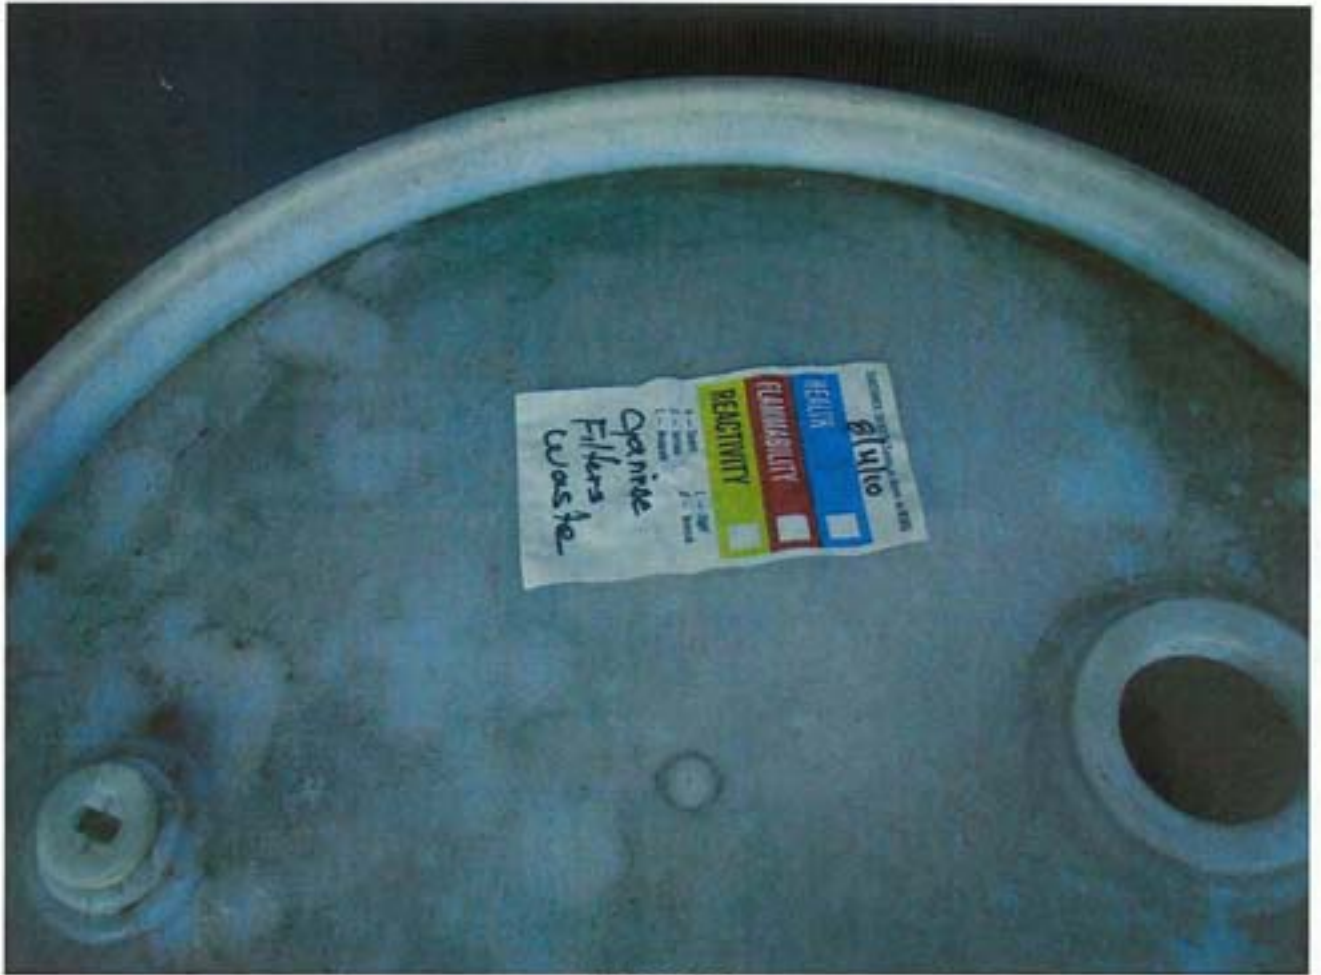
PC030082

082. Less than 90-day Hazardous Waste Accumulation Area (Waste Chemical Storage): One of three 55-gallon container of cyanide waste filter label has an accumulation start date of 8/4/10. Note: the bung on the container is open.

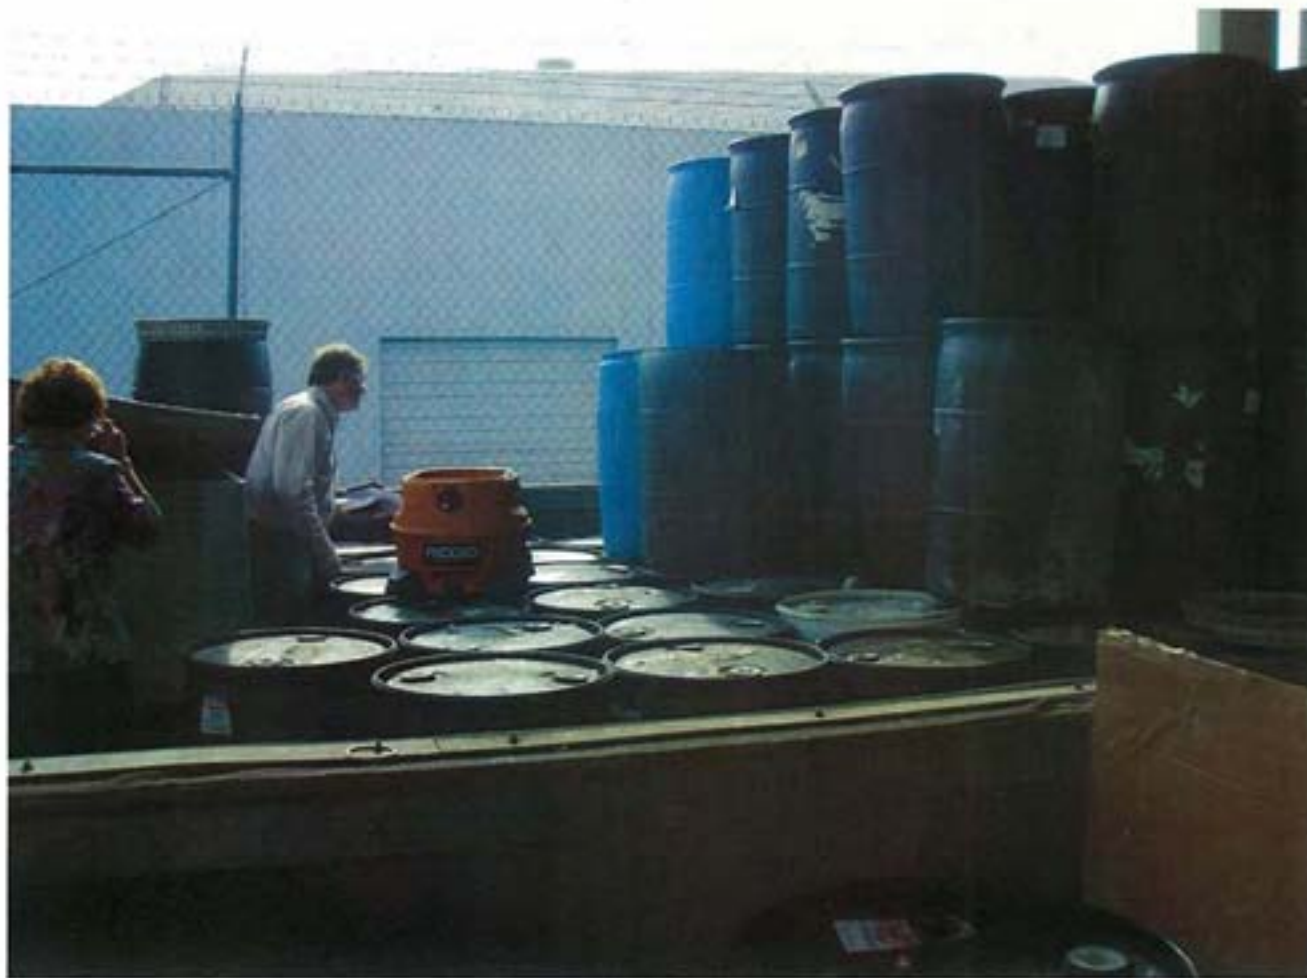
PC030083

083. Less than 90-day Hazardous Waste Accumulation Area (Waste Chemical Storage): Another view of the triple stacked 55-gallon containers seen in photograph 073.

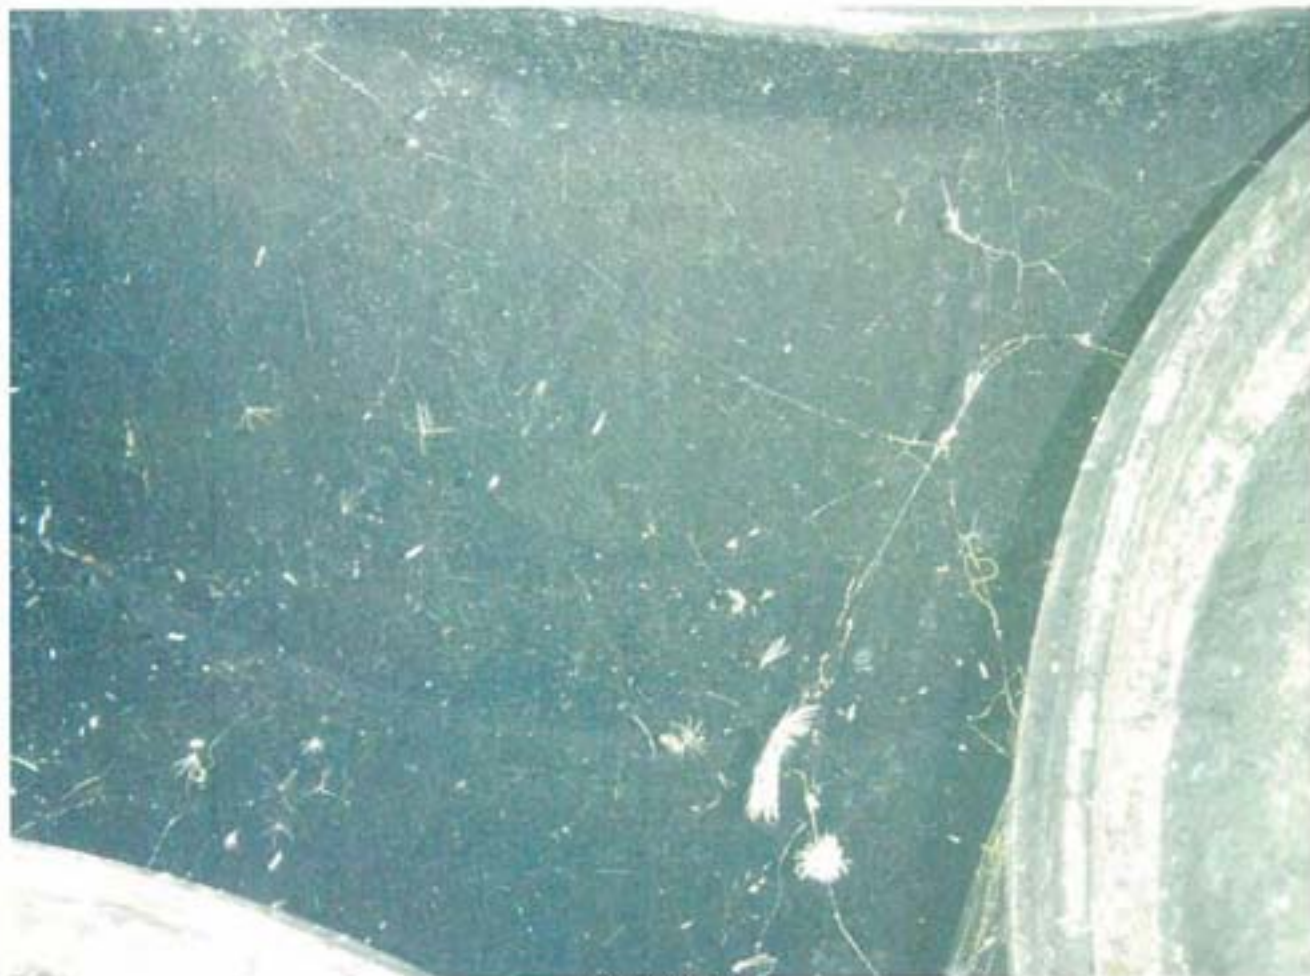
PC030085

085. Less than 90-day Hazardous Waste Accumulation Area (Waste Chemical Storage): No label in view on the 55-gallon container. Note: the bird waste on container (*photograph taken by John Schofield*).

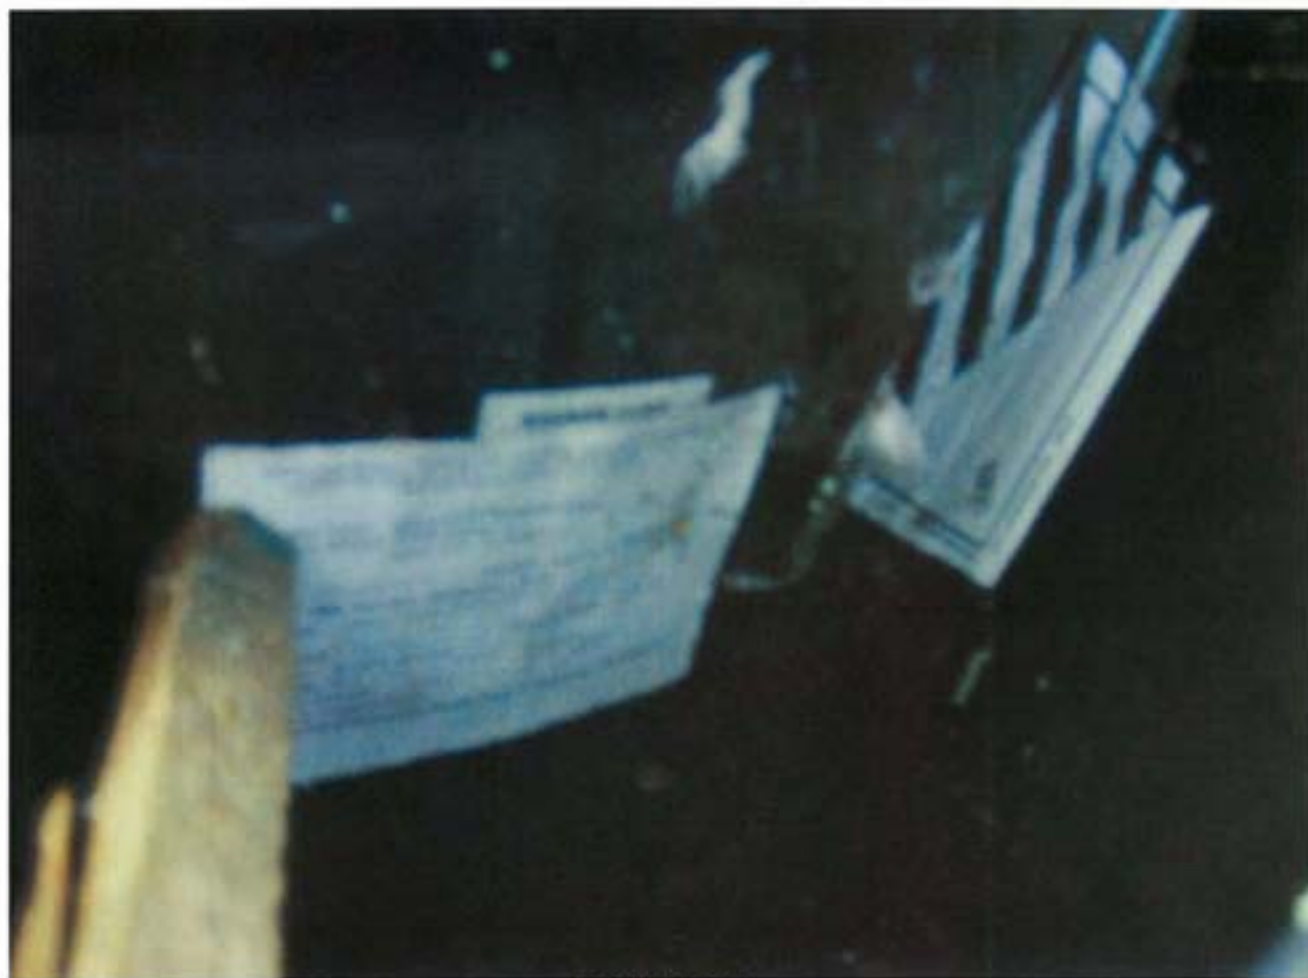
PC030087

087. Less than 90-day Hazardous Waste Accumulation Area (Waste Chemical Storage): Label in view on the 55-gallon container, but picture is blurred. Note: the bird waste on container (*photograph taken by John Schofield*).

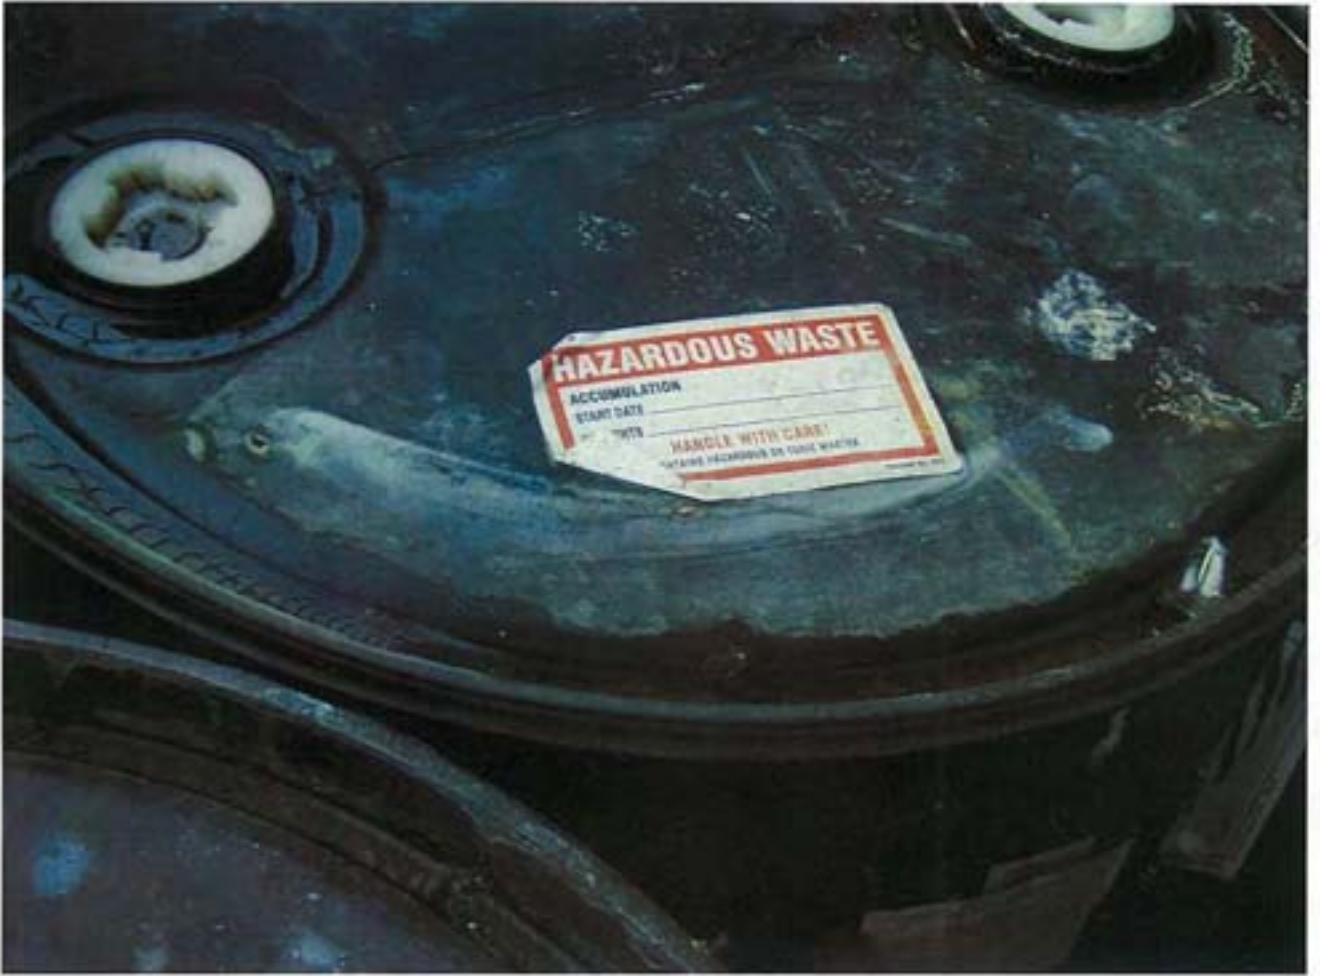
PC030089

089. Less than 90-day Hazardous Waste Accumulation Area (Waste Chemical Storage): Same 55-gallon container in photograph 084. Note that the container has liquid on top and is corroded (*photograph taken by John Schofield*).
