Attachment 1

**Attachment 3
Photograph Log**

Photograph Log for EPA's December 3, 2010 Electrochem Solutions RCRA and CWA Inspection

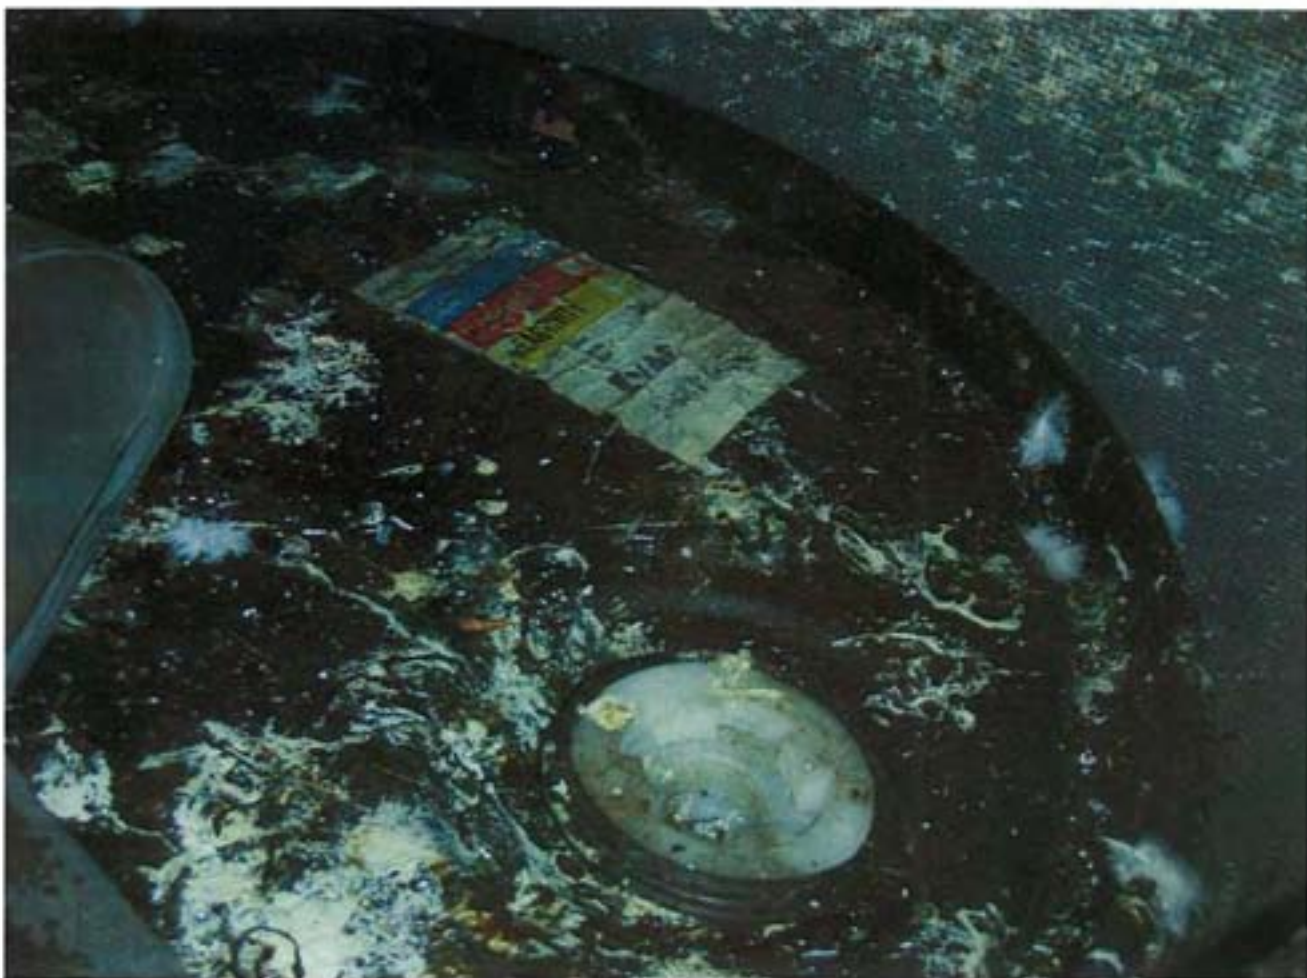
PC030090

090. Less than 90-day Hazardous Waste Accumulation Area (Waste Chemical Storage): 55-gallon container is covered with bird waste. Label is smudged (*photograph taken by John Schofield*).

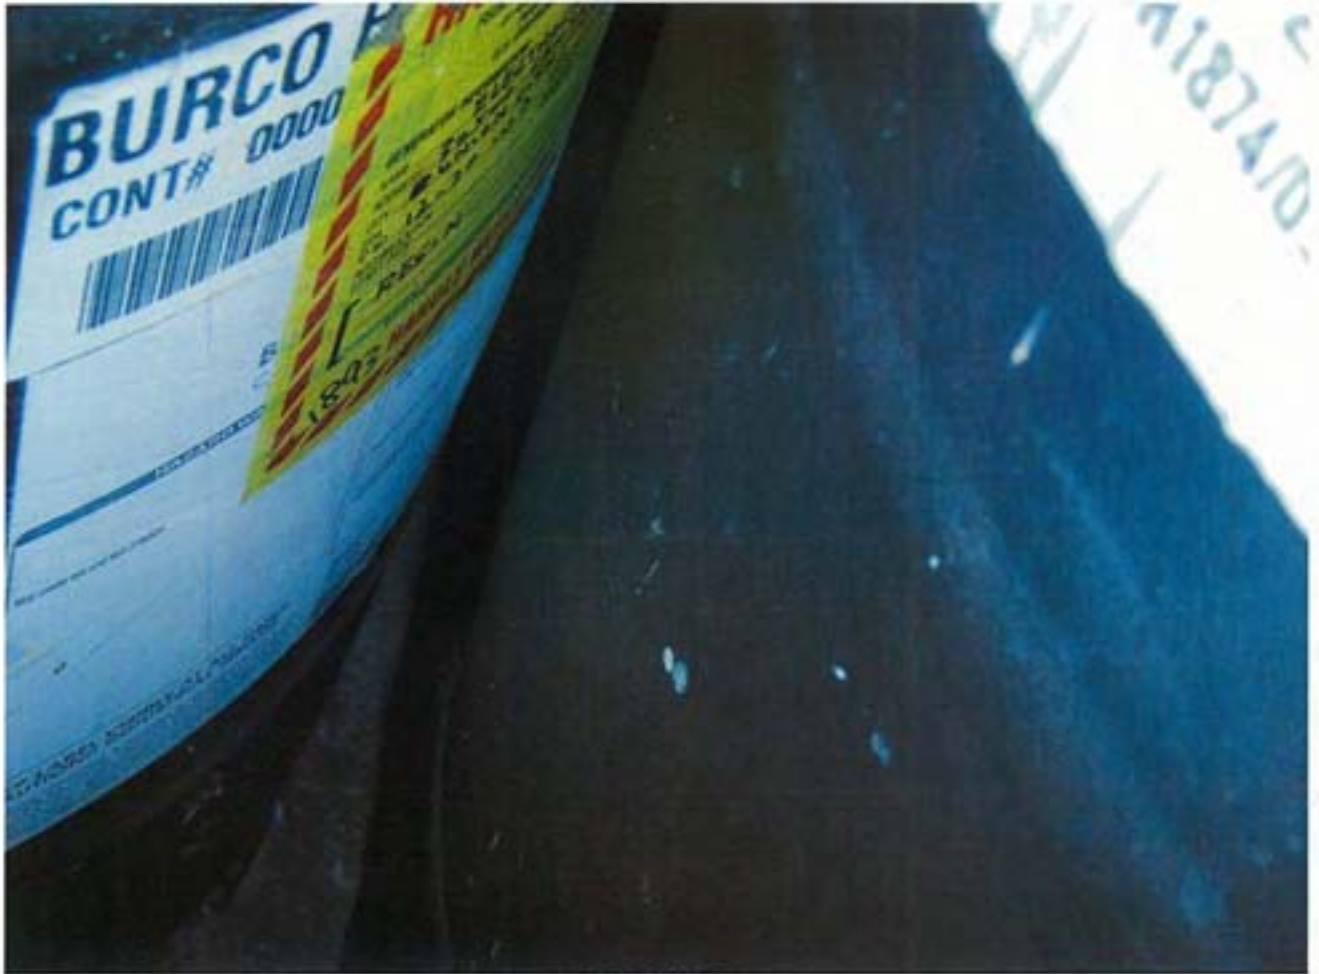
PC030092

092. Less than 90-day Hazardous Waste Accumulation Area (Waste Chemical Storage): Same as photograph 075, a label on a 55-gallon container of hazardous waste is partially in view and states the material is "resin" (*photograph taken by John Schofield*).

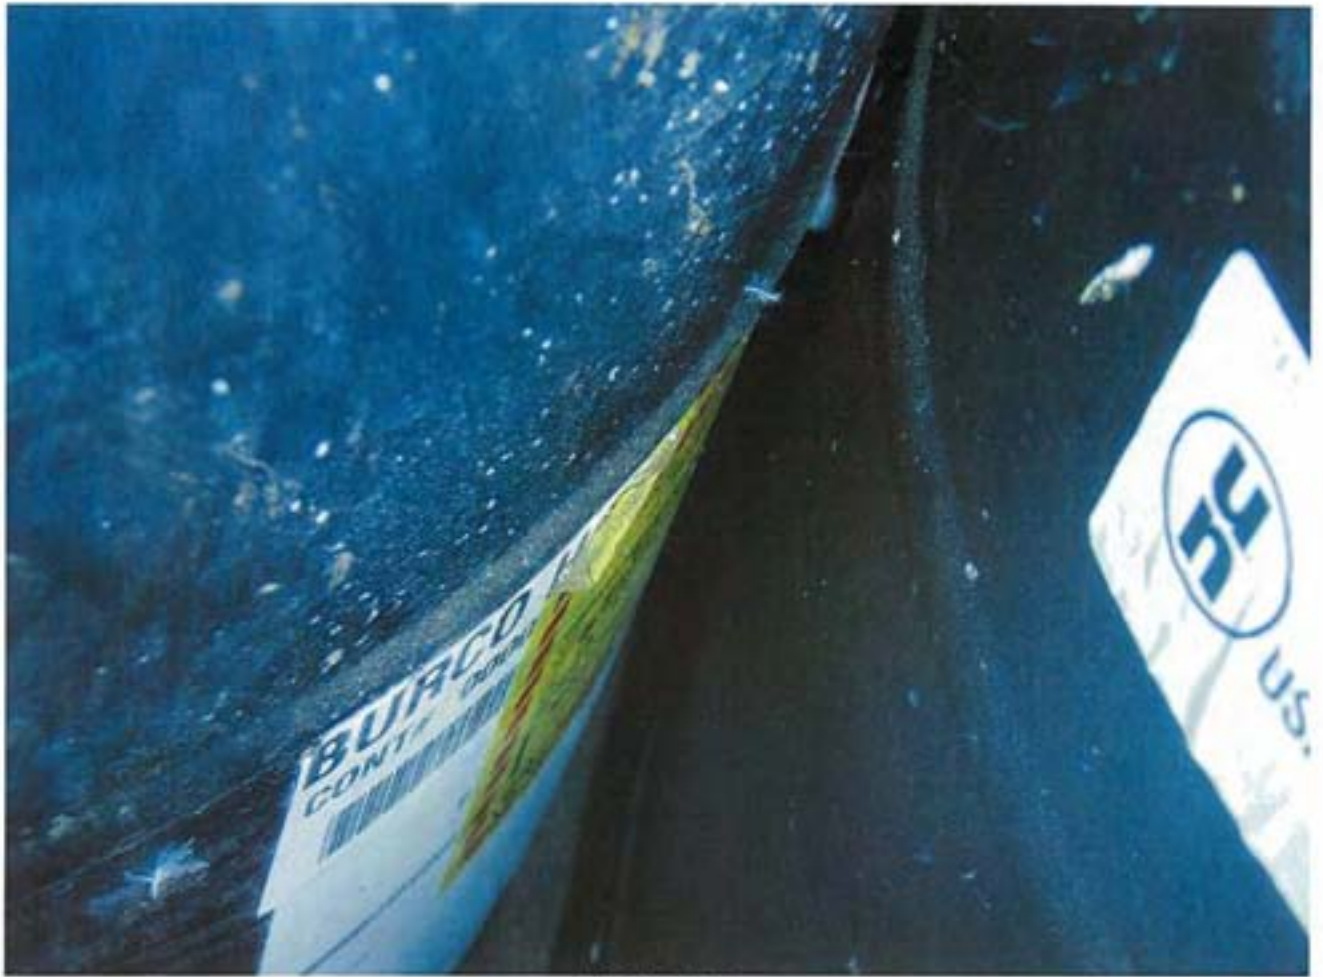
PC030093

093. Less than 90-day Hazardous Waste Accumulation Area (Waste Chemical Storage): Same container as previous photograph (*photograph taken by John Schofield*).

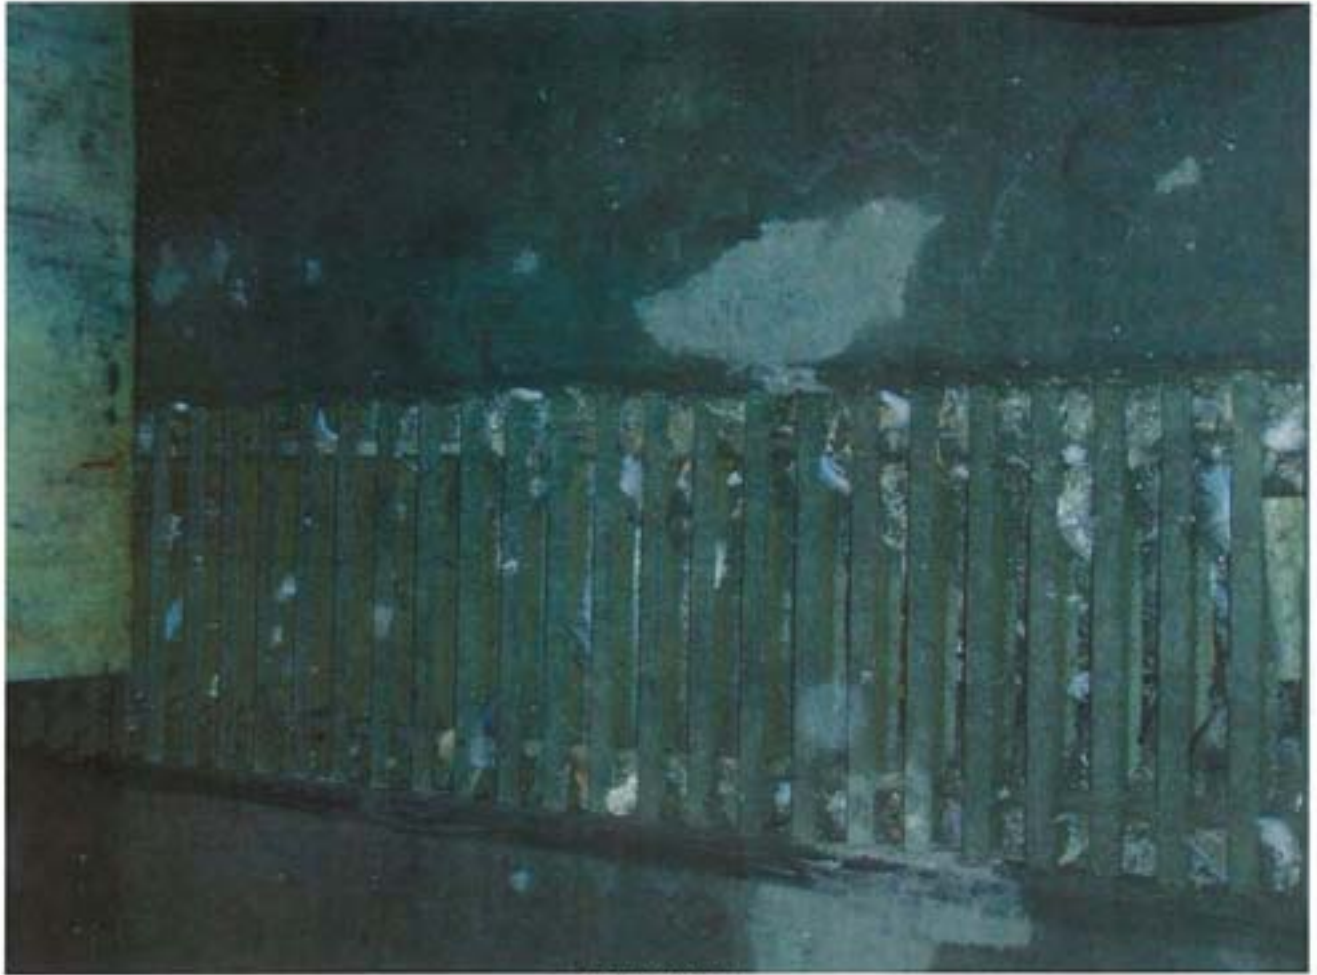
PC030097

097. Less than 90-day Hazardous Waste Accumulation Area (Waste Chemical Storage): Slot drain in middle of storage area is full of bird waste (*photograph taken by John Schofield*).

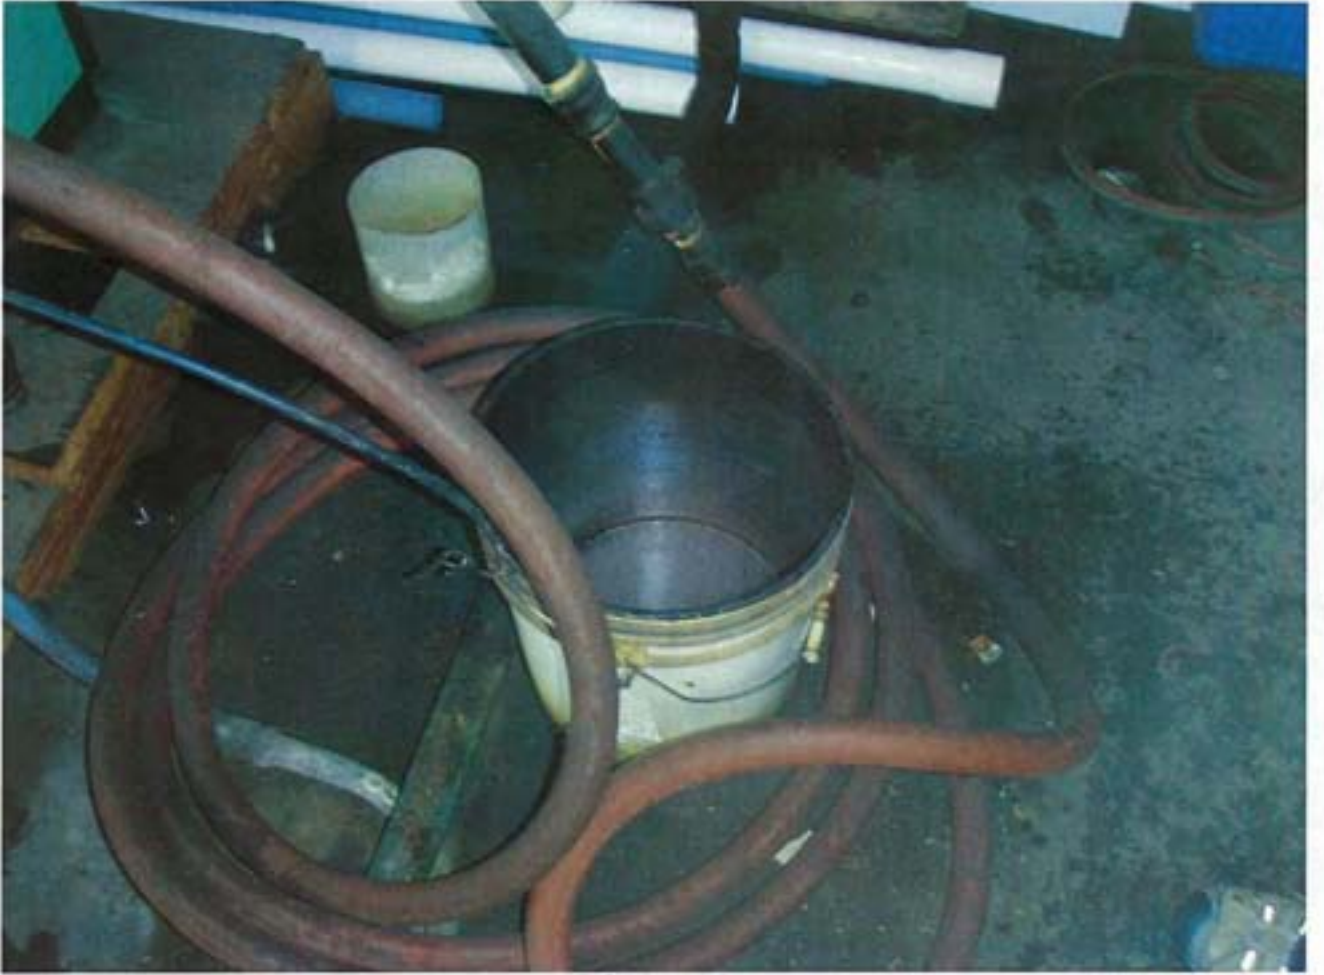
PC030098

098. Maintenance Shop: Open 5-gallon container of unknown substance.
099. Maintenance Shop: Two 2-gallon containers labeled as "oil."
100. Maintenance Shop: A 5-gallon container captures liquid from a machine.

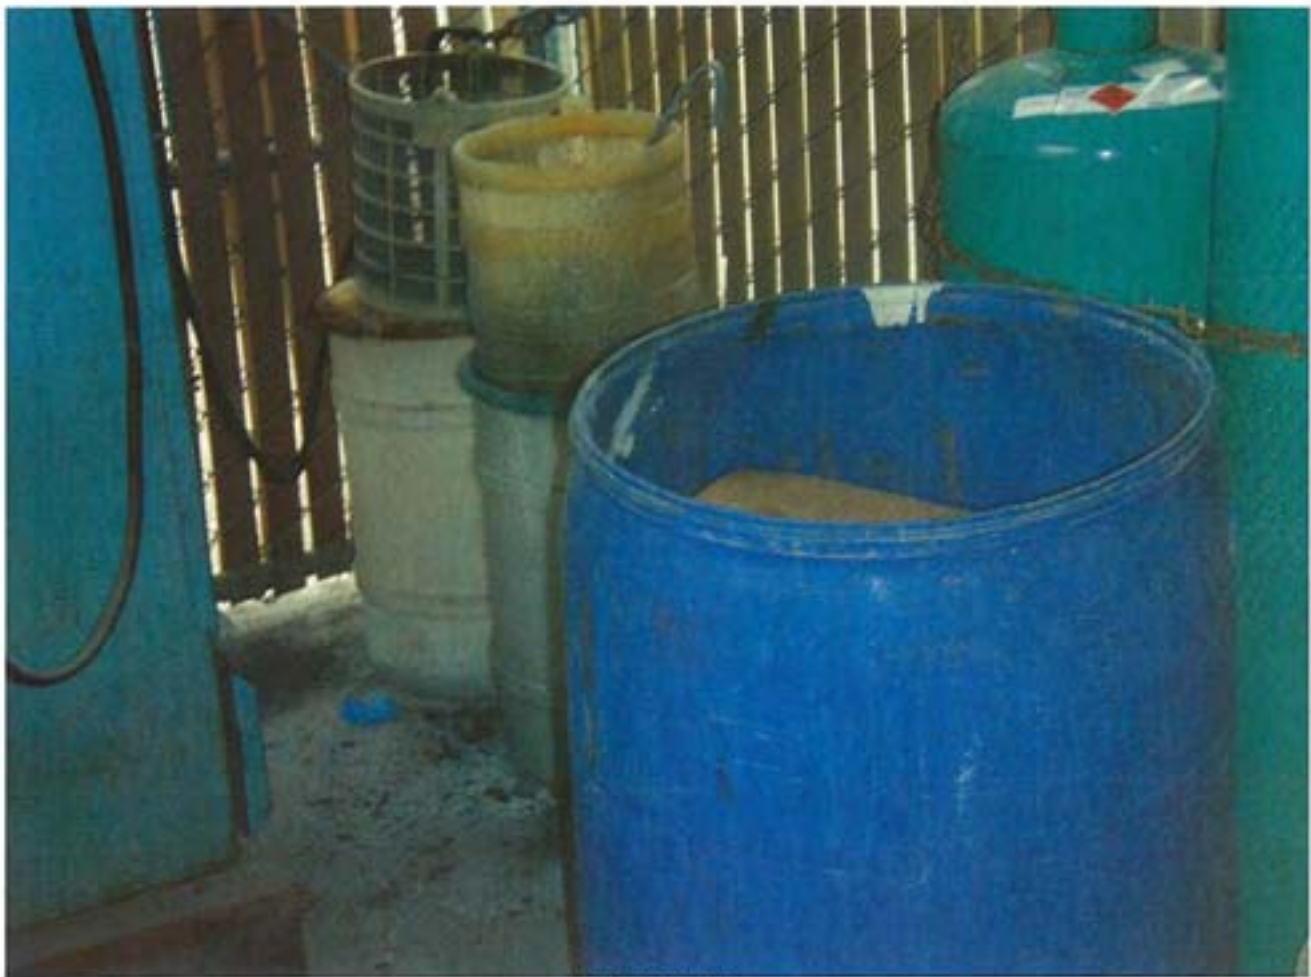
PC030101

101. Maintenance Shop: An open 55-gallon container with debris inside.
102. Maintenance Shop: An open 5-gallon container of unknown material.
103. Maintenance Shop: Four 5-gallon open containers of product sand.

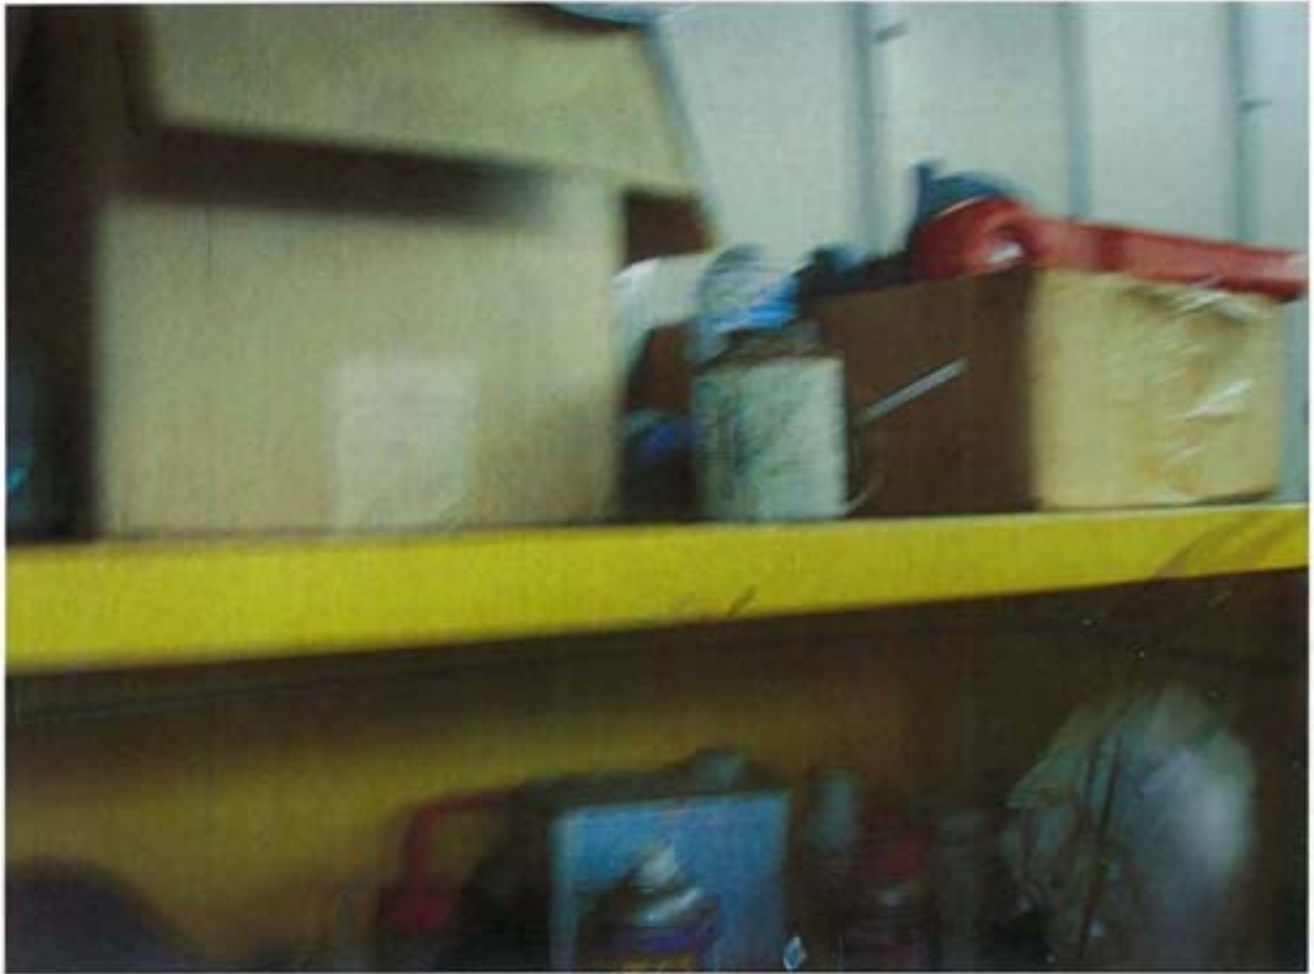
PC030104

104. Maintenance Shop: Product in the flammable cabinet. Picture is blurred.
105. Maintenance Shop: Same as previous photograph.
106. Maintenance Shop: Unlabeled product containers in the flammable cabinet.

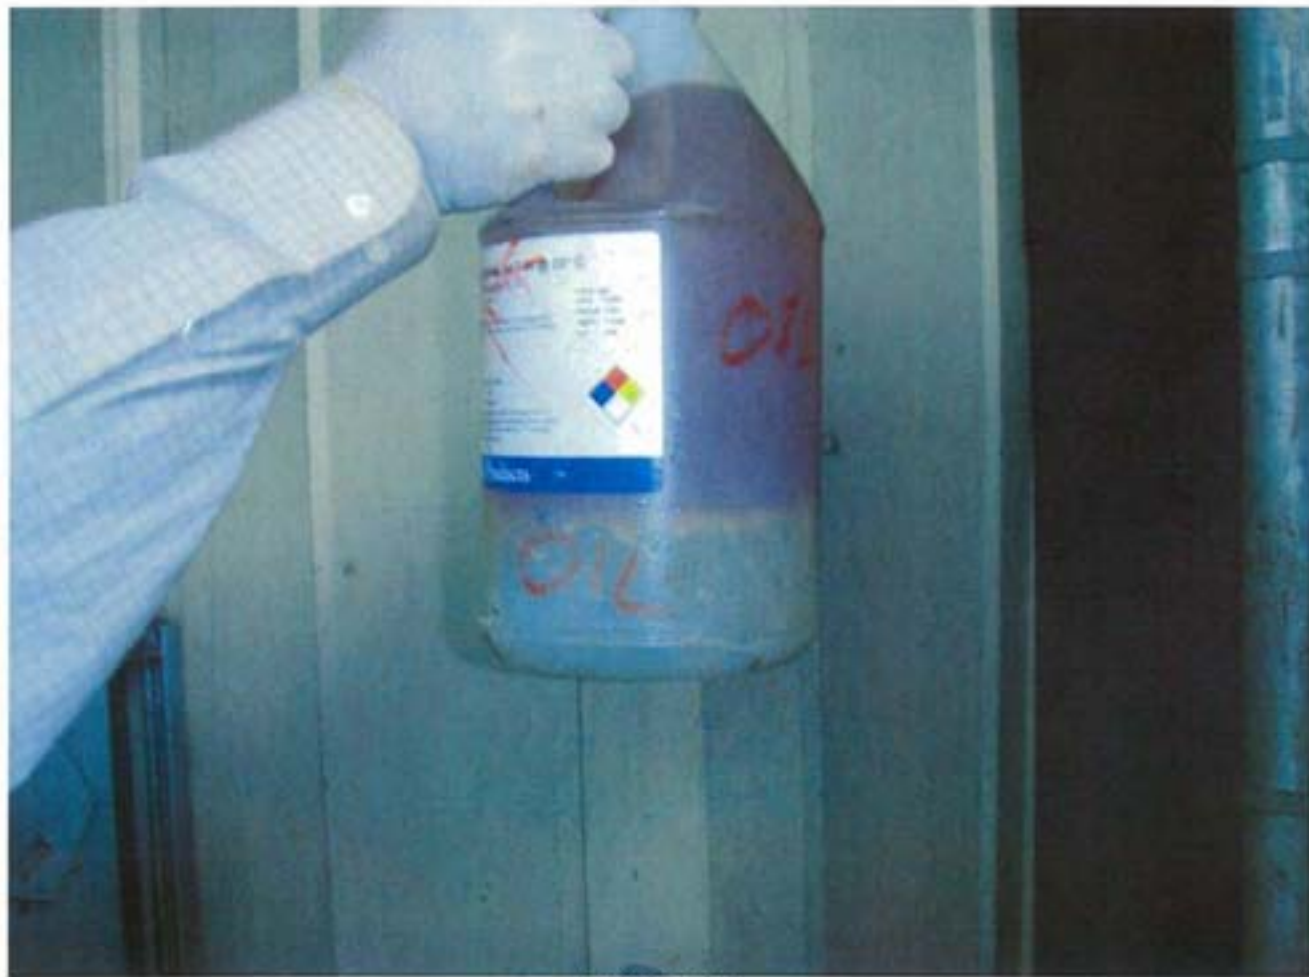
PC030108

107. Maintenance Shop: Unlabeled product containers in the flammable cabinet.
108. Maintenance Shop: 2-gallon container labeled as "oil." Same container in photograph 099.

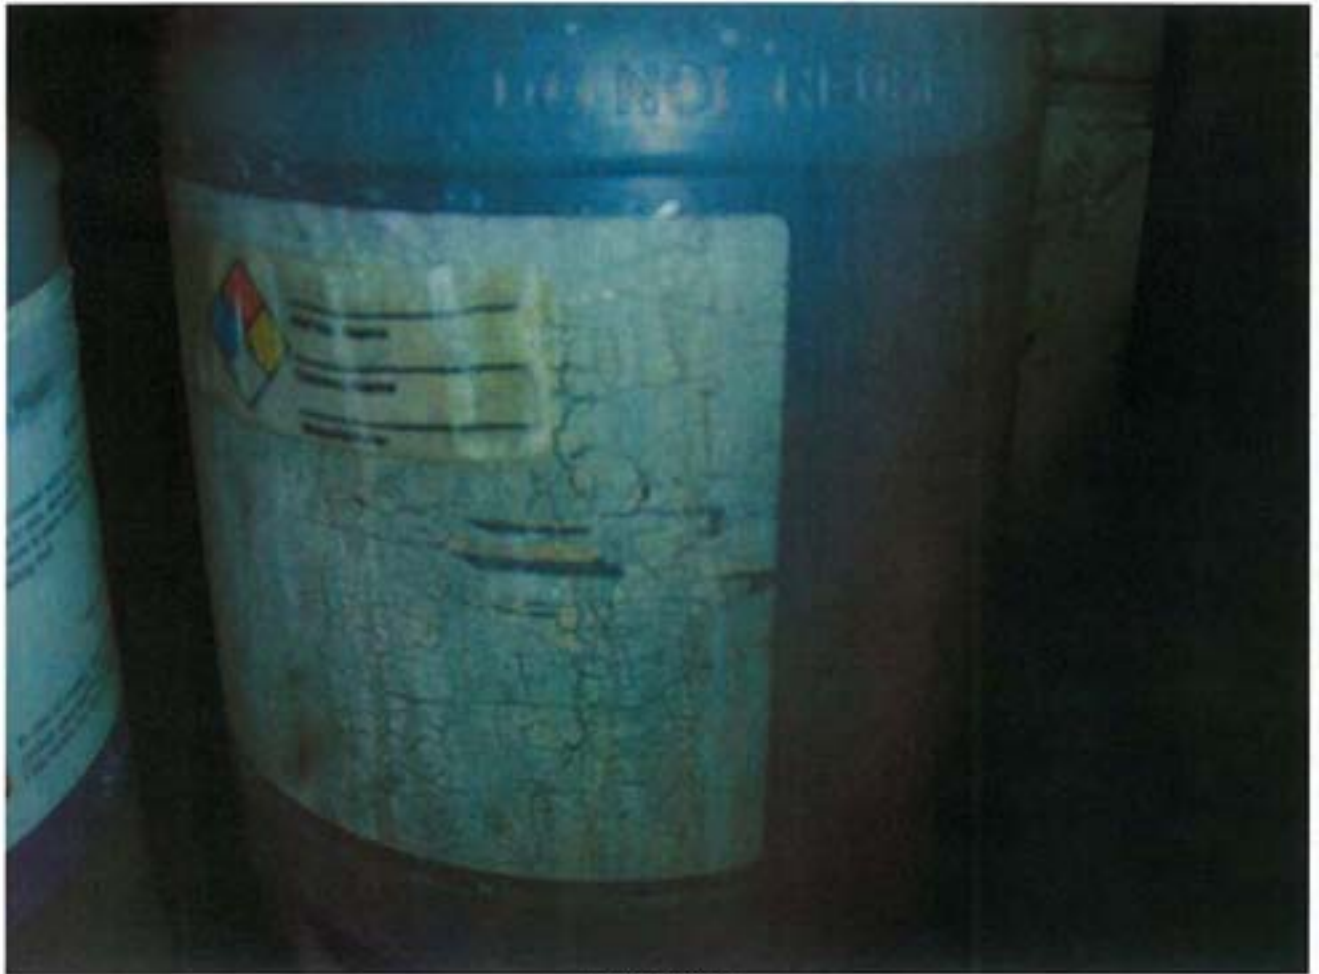
PC030111

111. Chemical Storage: Close up of one of the 2-gallon containers in the previous photograph.
112. Chemical Lab: Trash can containing contaminated gloves.

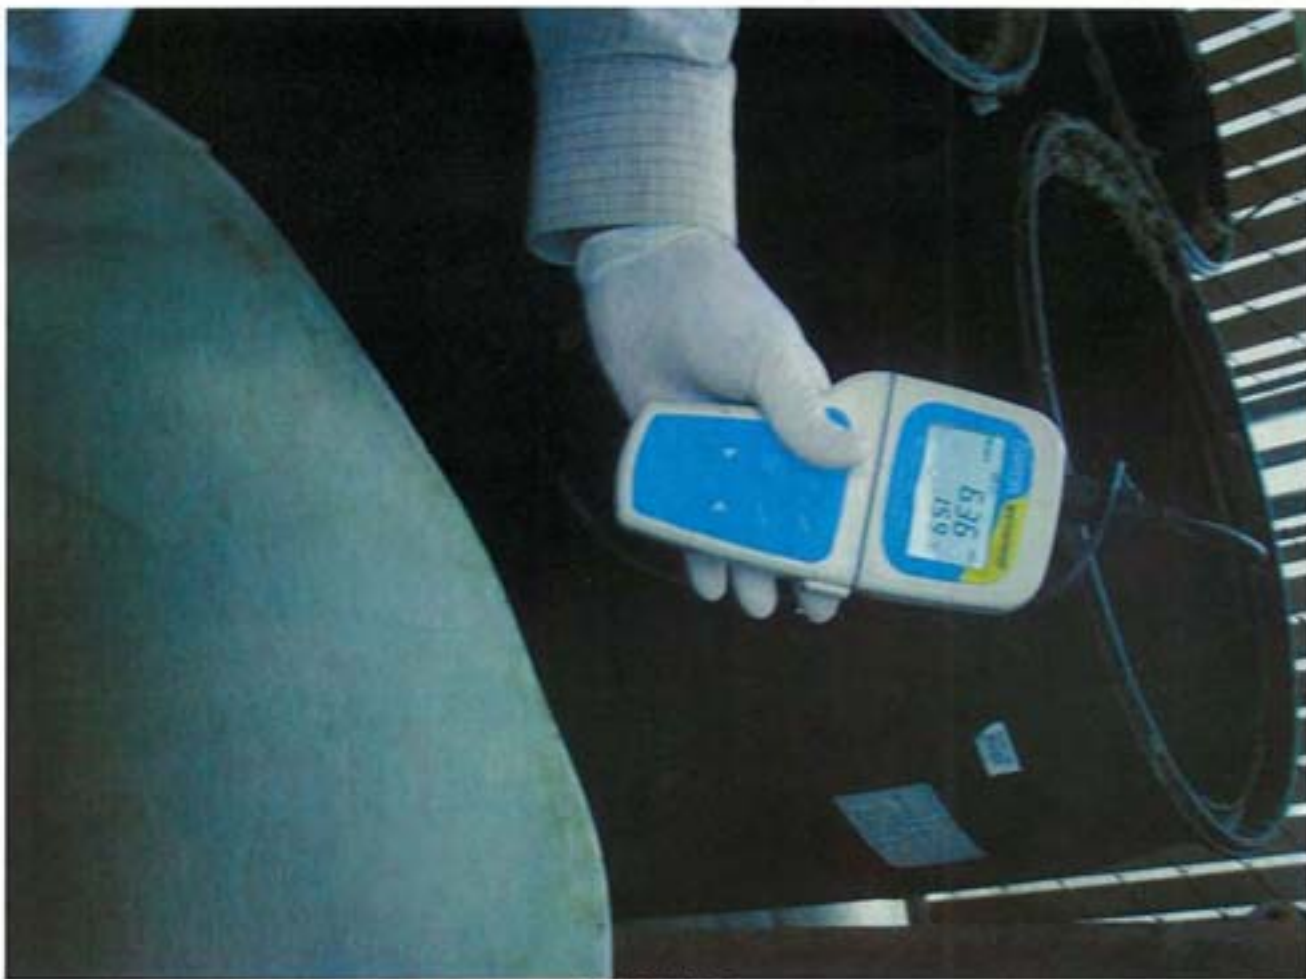
PC030120

119. Photograph of tear in liner Bulk Waste Processing Area (*photograph taken by Chris Boykin*).
120. John Schofield monitoring pH levels in hazardous waste treatment container located in the Bulk Waste Processing Area (*photograph taken by Chris Boykin*).
