UNITED STATES ENVIRONMENTAL PROTECTION AGENCY
REGION IX
75 Hawthorne Street
San Francisco, CA 94105-3901

Subject: Findings of Violations and Order for Compliance
EPA Docket No. CWA-309(a)-11-006

On December 3, 2010, the U.S. Environmental Protection Agency (EPA) conducted a Clean Water Act compliance inspection at Electrochem Solutions' facility located at 32500 Central Avenue in Union City, CA. A copy of the inspection report is enclosed.

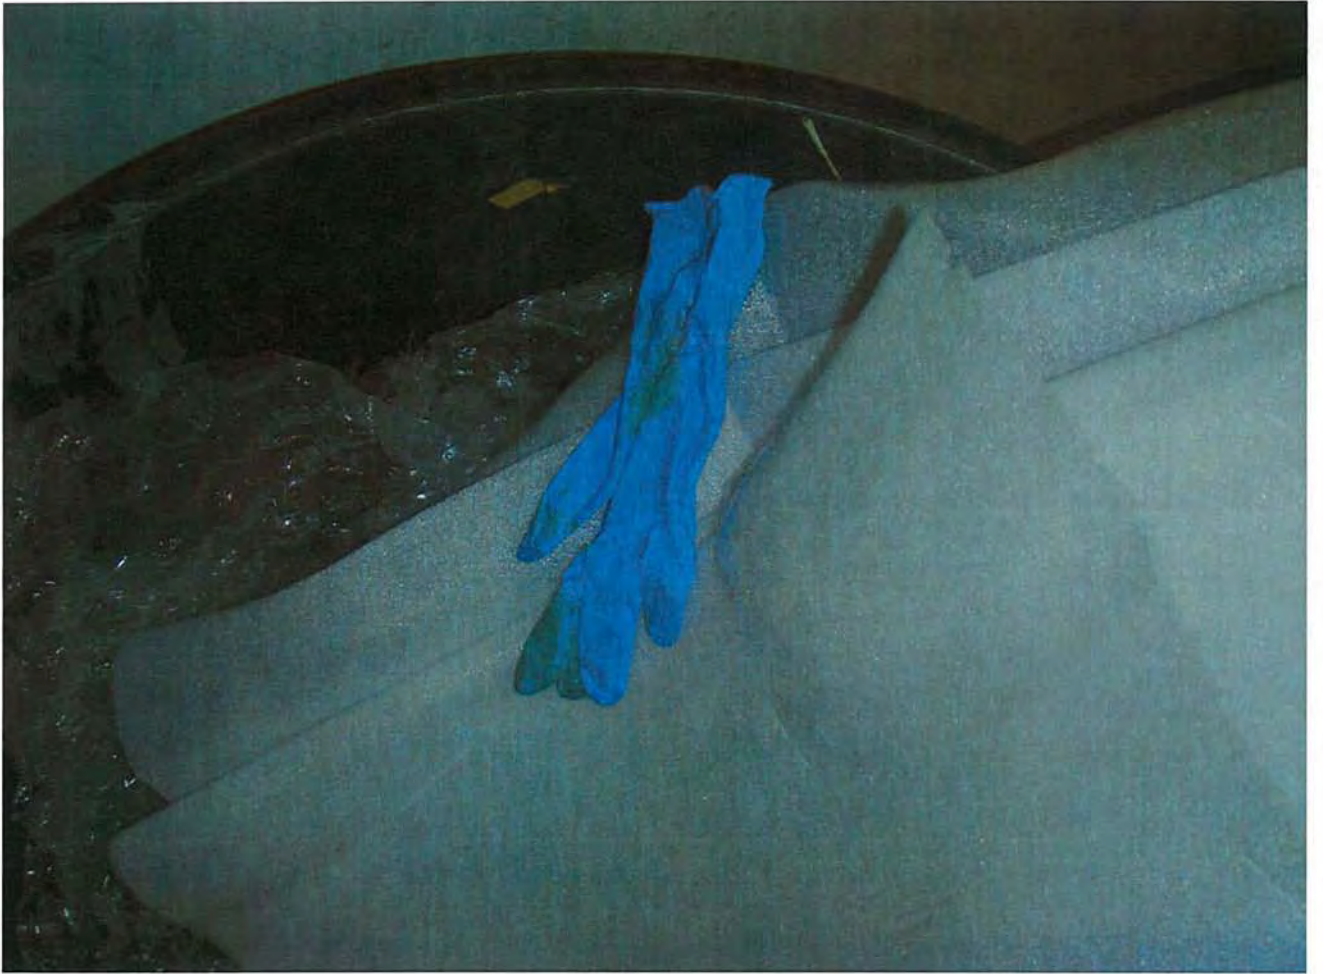
PC030003

003. Production Room: Solid waste trash container. Contaminated gloves and wipes observed within the trash container. Note: staining on glove.
004. Main Wet Processing Area: Two unlabeled 55-gallon containers of used gold strip (cyanide).

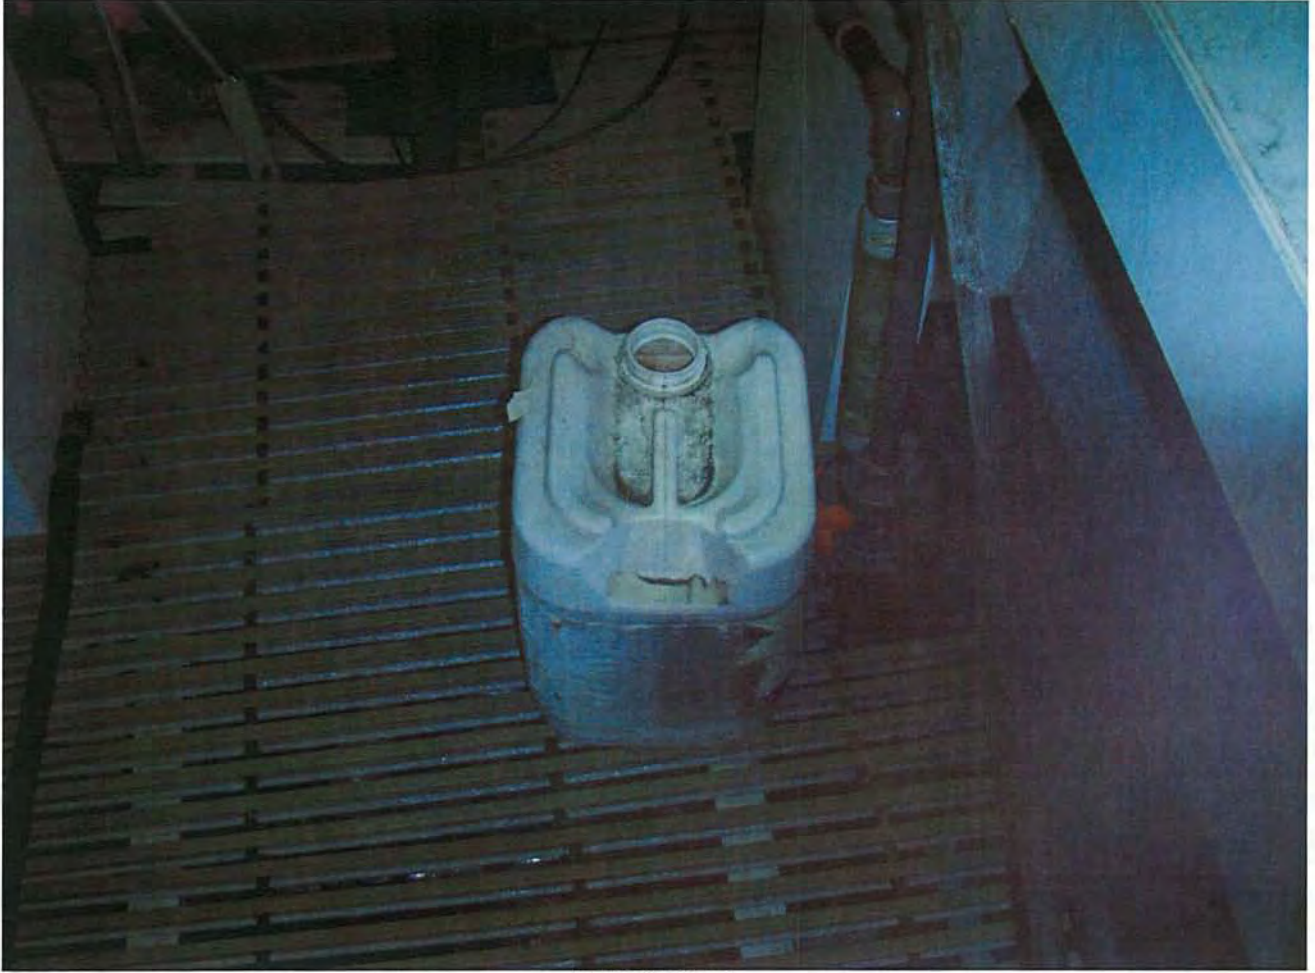
PC030022

022. Anodizing Area: An open 5-gallon container of unknown substance.
023. Anodizing Area: Open cut top 55-gallon container labeled "waste water." Facility representative stated it was placed in the location to collect rain water from a leak in the roof.

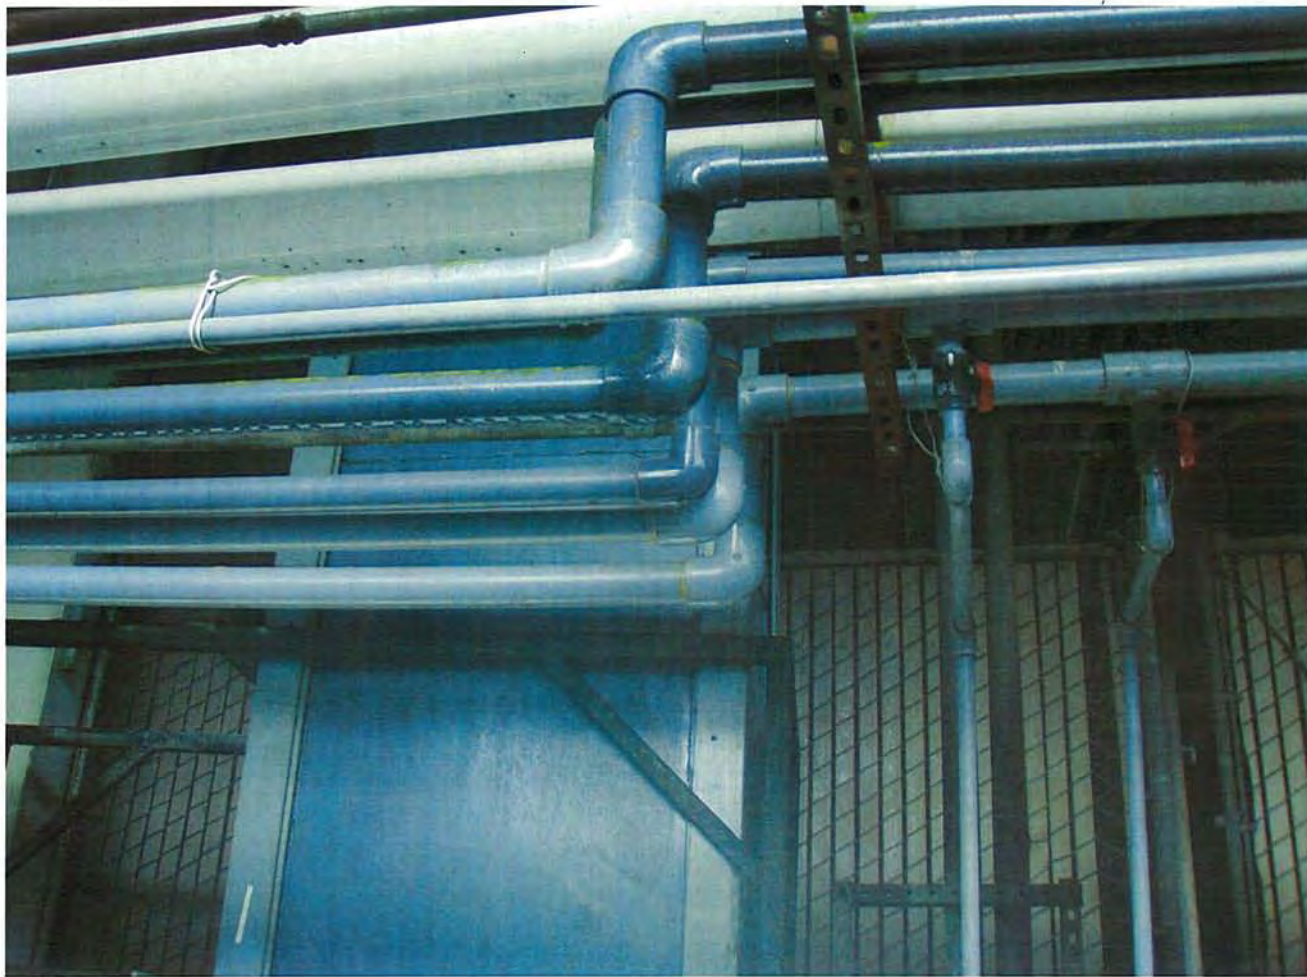
PC030025

024. Utility Room: Nine 55-gallon containers of glycol product. Note: the bungs on two of the containers were open.
025. Utility Room: Leaking pipes.
026. Utility Room: Concrete under leaking pipes in previous photograph is corroded.

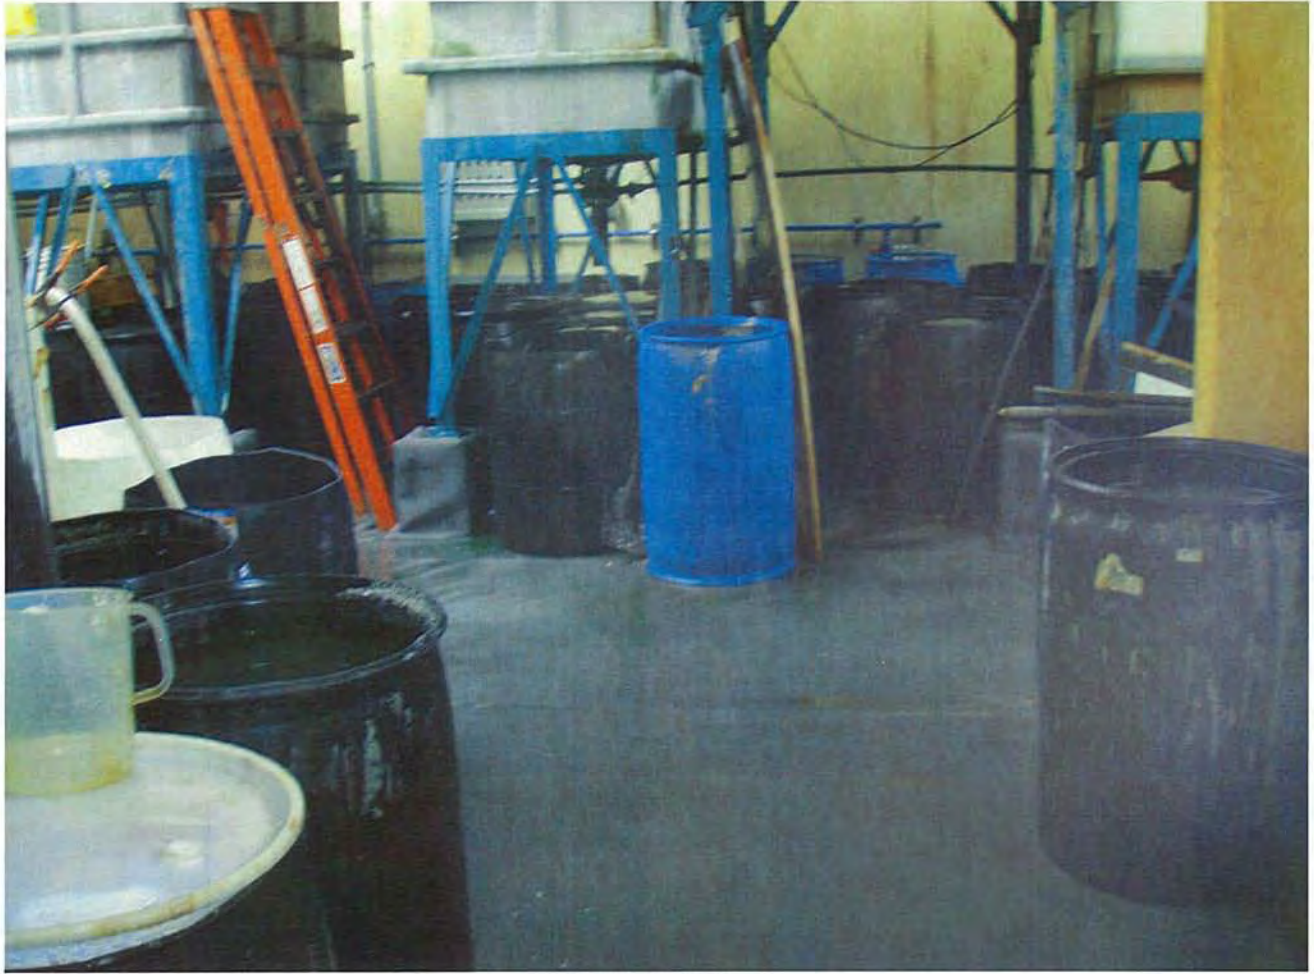
PC030034

During the inspection we observed 89 open 55-gallon containers of RCRA hazardous wastes and 10-15 smaller open containers (5-15 gallons) of RCRA hazardous wastes (see Attachment 3: PC030034, 036-039, 040-041, 043-044). According to the facility operator, this material was both undergoing treatment and waiting for treatment. The containers were full, uncovered and not placed on containment pallets. Additionally, the outsides of many of the barrels were covered with spilled or splashed material. The floor of the bulk waste treatment room was lined with rubber; however, the rubber mat was torn in several locations, allowing liquid to pool underneath the mat (see Attachment 3: PC030119). Additionally, the floor was wet and in some areas, the unknown liquid was 2-3 inches deep (see Attachment 3: PC030034, 042, 044-045).

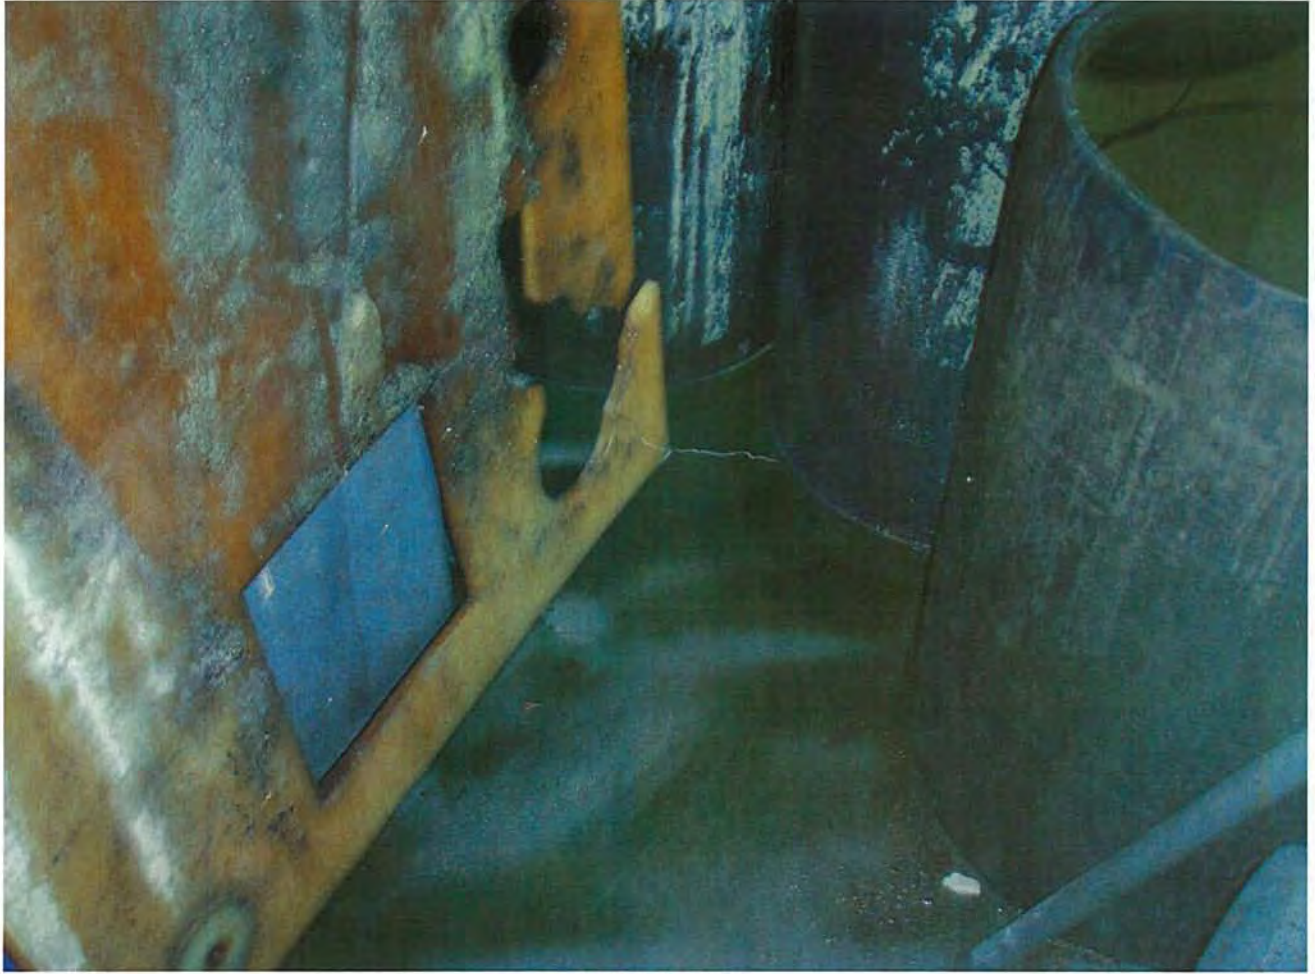
PC030042

041. Bulk Waste Processing Area: Approximately fourteen open top 55-gallon containers.
042. Bulk Waste Processing Area: Liquid observed on the floor in the area. The floor is lined, although torn in some locations.

24. Within 21 days of receipt of this Order, Respondent shall submit a report demonstrating that they have provided adequate secondary containment at the bulk waste treatment area. The report shall include photographs of the bulk waste treatment area, the containment area showing corrected conditions and all drawings, calculations, and manifests in order to show that secondary containment is adequate to contain the volume of material located in the bulk waste treatment area.

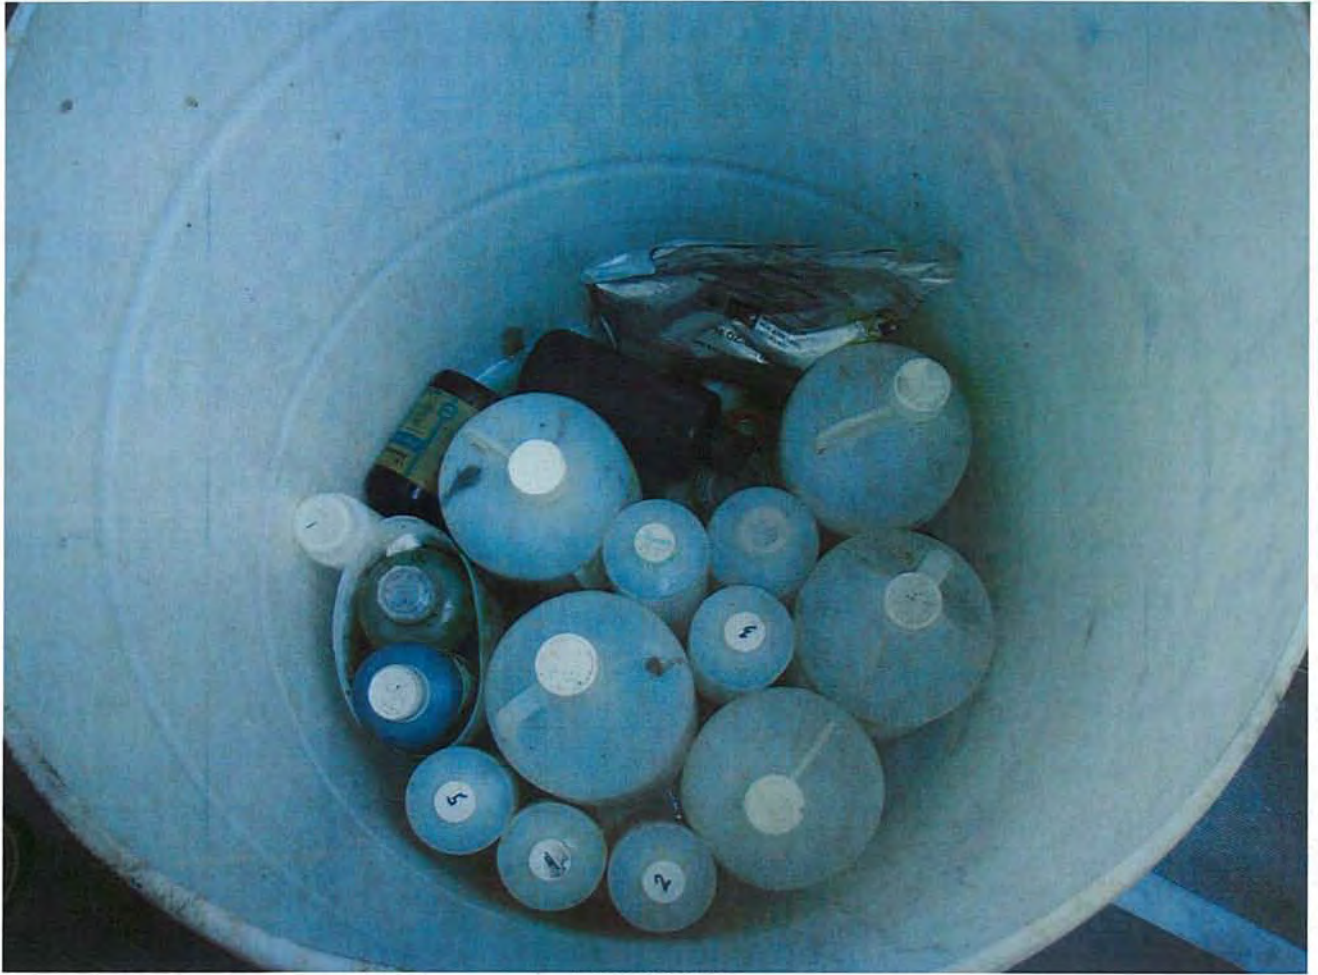
PC030052

051. Bulk Waste Processing Area: Hazardous waste label on bin of F007 waste. The accumulation start date is 12/1/10.
052. Bulk Waste Processing Area: An open 55-gallon container with various unlabeled containers inside.

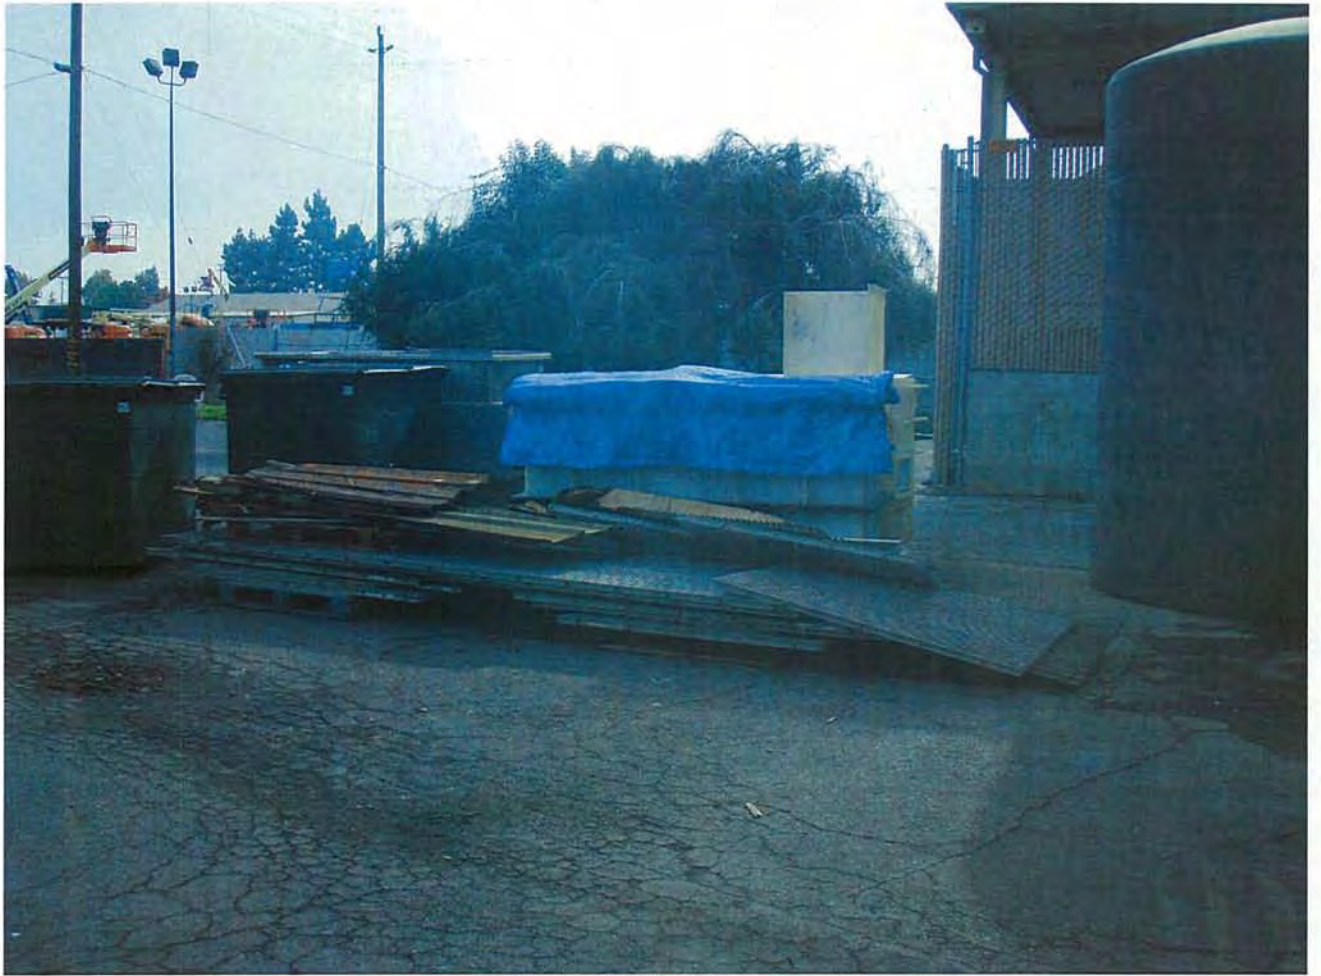
PC030056

General Yard: The pavement throughout the yard was generally deteriorating, especially the area around the eastern storm drain (see Attachment 3: PC030056-060). Additionally, obsolete equipment was stored throughout the yard, with a heavy concentration along the southeastern end of the property (see Attachment 3: PC030061-069). Old process tanks were located in this area. Attachment 3: PC030069 shows an old processing tank approximately $\frac{1}{4}$ full of unknown material.

Rusting metal parts and process tanks were stored approximately 15 feet from the eastern storm drain (see Attachment 3: PC030056). The facility operator indicated that this material was being sold for scrap and had only been staged there for a short period of time. During the inspection, the inspectors observed workers start to load the material into trucks.

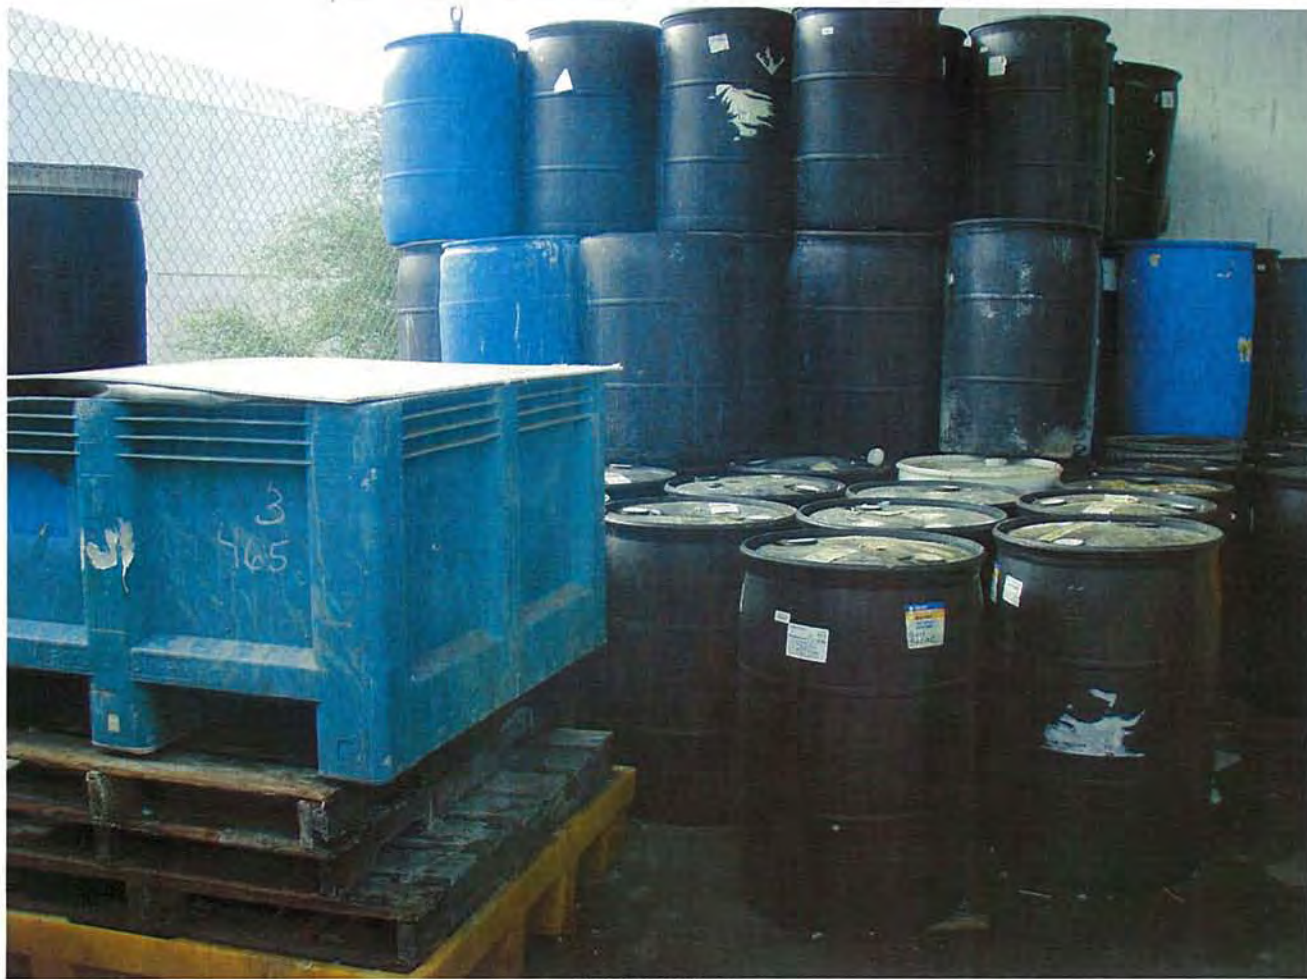
PC030073

90-day Hazardous Waste Storage Area: Electrochem maintains a separate, fenced, and covered less than 90-day hazardous waste accumulation area located outside the waste-treatment area, about 30 feet from the eastern storm drain (see Attachment 3: PC030080). Additionally, this accumulation area is separated into two parts with cyanide wastes located in small area segregated from all other wastes. The larger area is used to accumulate containerized D006, D007, and non-RCRA hazardous wastes (see Attachment 3: PC030072 through PC030074).

073. Less than 90-day Hazardous Waste Accumulation Area (Waste Chemical Storage): Approximately forty 55-gallon containers and in some places triple stacked. A bin with a sheet of wood on top is located in the foreground.

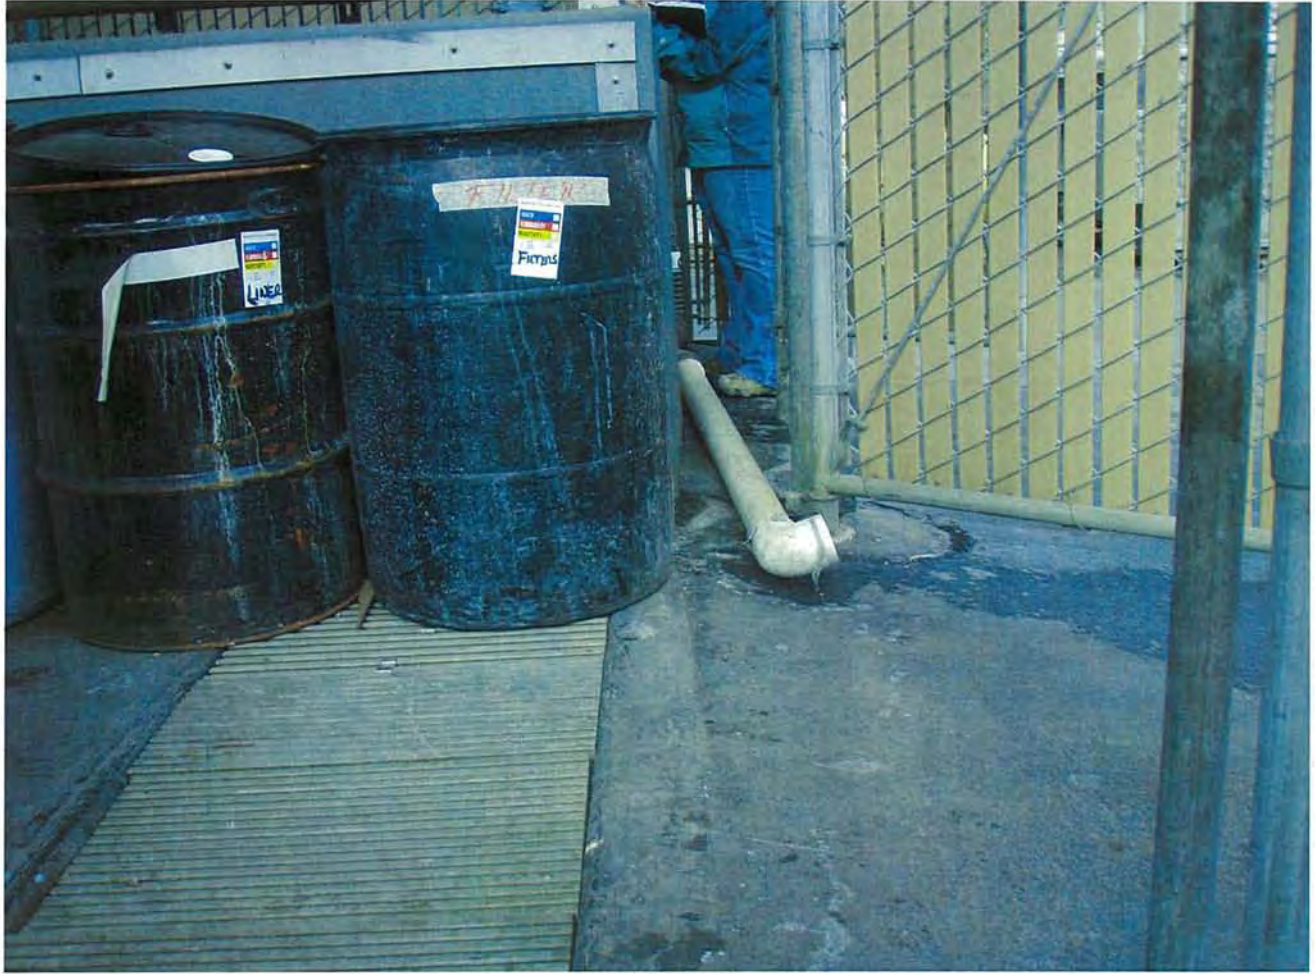
PC030076

The less than 90-day hazardous waste accumulation area is surrounded by a wall, approximately three feet high, on three sides and a sump along the front. The wall appeared to be intact, but it was difficult to see due to the fact that the storage area was full of hazardous waste containers and empty containers (see Attachment 3: PC030073-74, 083). The sump along the front was full of liquid and sludge-like materials (see Attachment 3: PC030077, 079, 097). Additionally, containers of waste were placed outside the sump area (see Attachment 3: PC030076). The roof drains are connected to a plastic pipe and directed toward the storm drain. The discharge from these roof drains has discolored the pavement (see Attachment 3: PC030076).

076. Less than 90-day Hazardous Waste Accumulation Area (Waste Chemical Storage): Slot drain located along entry to the storage area. Note that containers are stored on top of drain. Piping from rain gutter drains at the entry of the storage area. Note white-colored pavement from roof drain.

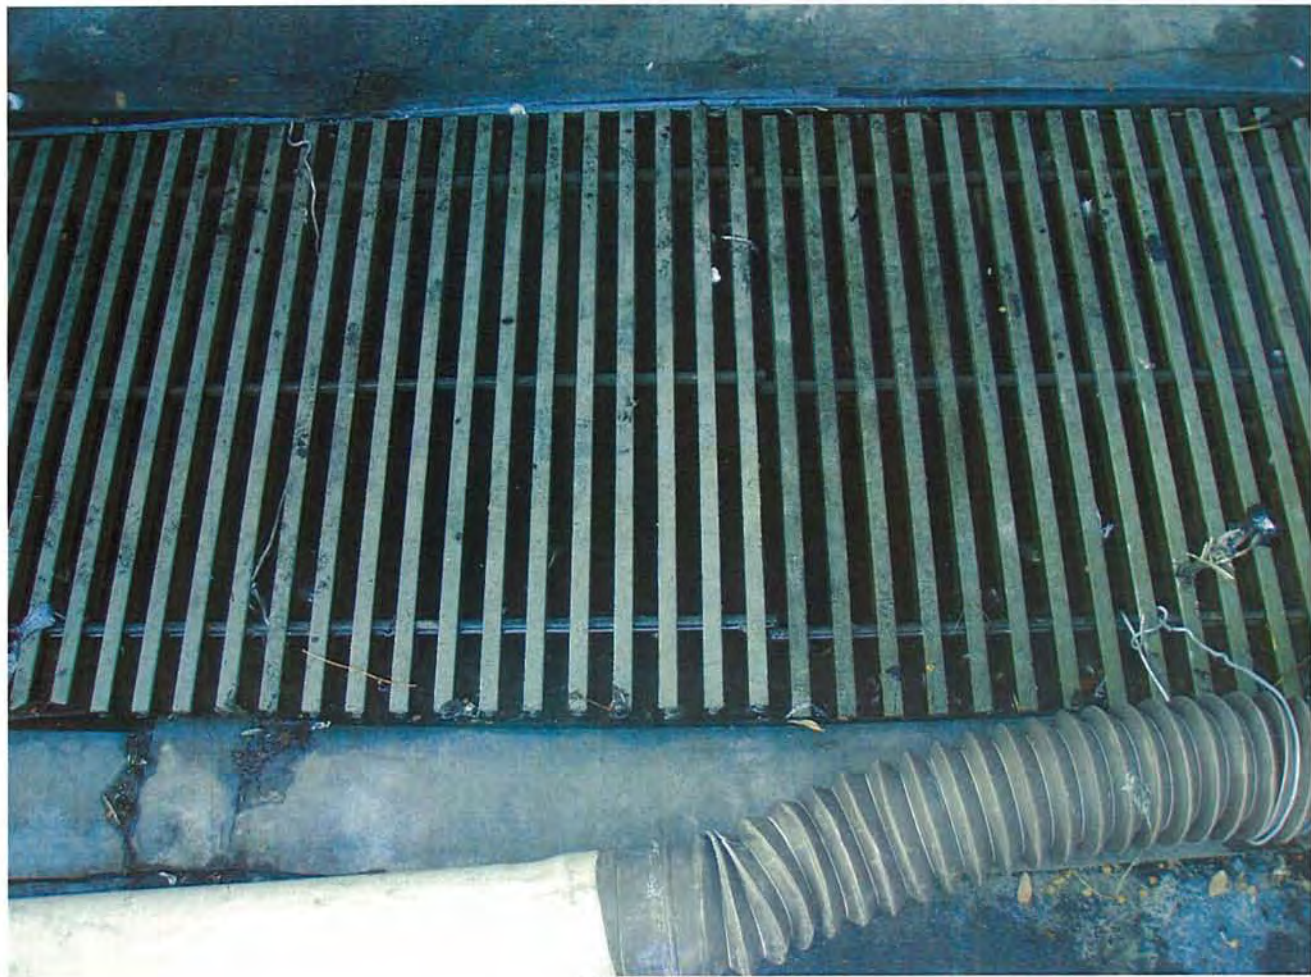
PC030077

3. Failing to maintain BMPs at the 90-day hazardous waste storage area by allowing the sump to become full of sludge and unknown liquids; and
 4. Failing to implement adequate good housekeeping BMPs to ensure that process wastewater and obsolete materials are not contributing pollutants to storm water discharges.

077. Less than 90-day Hazardous Waste Accumulation Area (Waste Chemical Storage): Slot drain is full of liquid.
078. Less than 90-day Hazardous Waste Accumulation Area (Waste Chemical Storage): One of three 55-gallon container of cyanide waste filter label has an accumulation start date of 8/4/10.

26. With 21 days of receipt of this order, Respondent shall ensure that the sump surrounding the 90-day Hazardous Waste Storage Area is cleaned and properly functioning. Respondent shall also submit photos and a report to EPA within 21 days certifying that this has been completed.

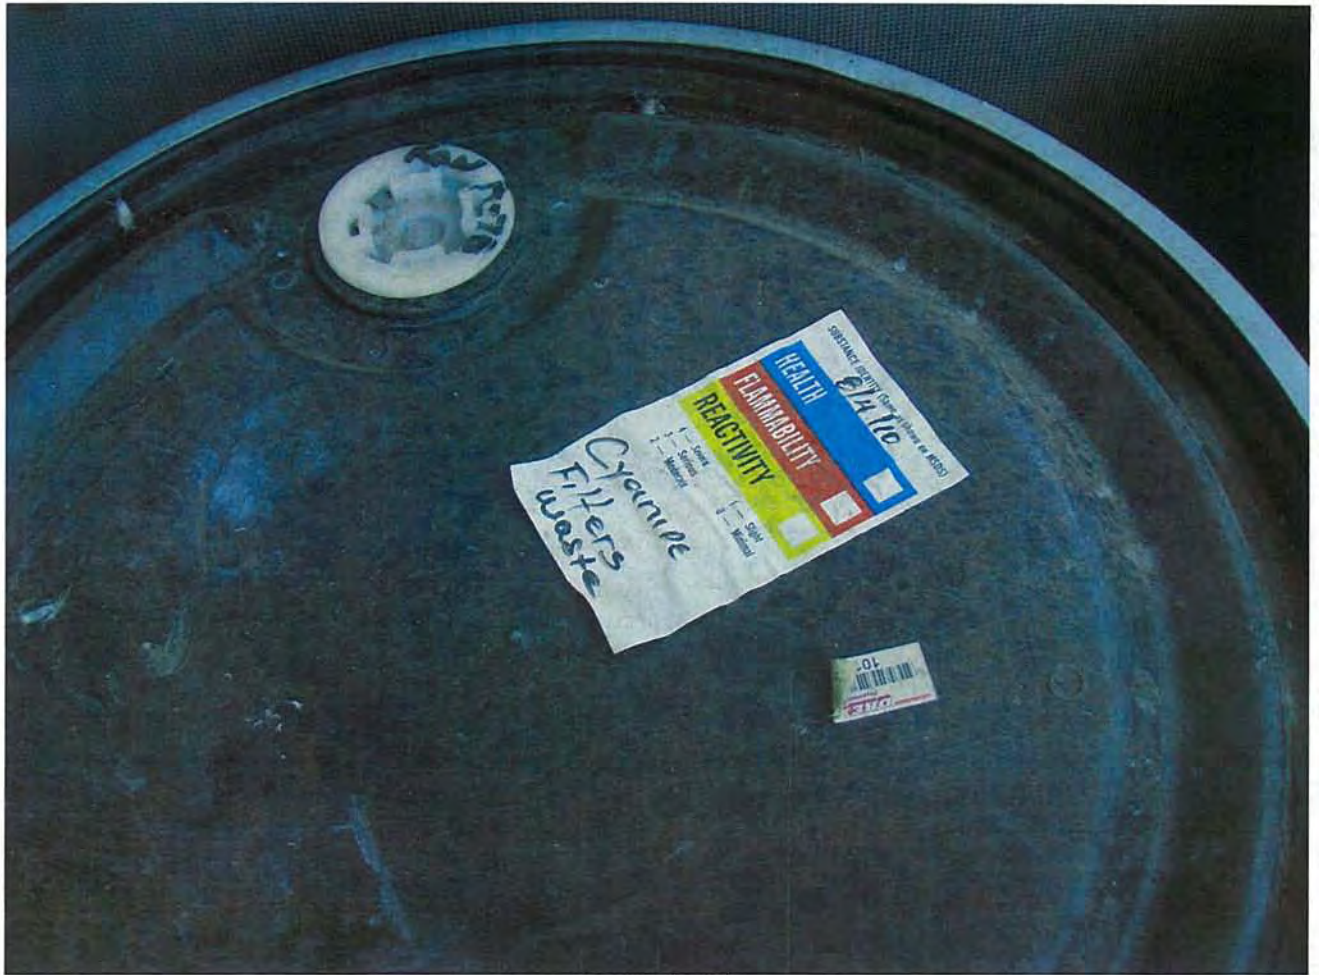
PC030081

081. Less than 90-day Hazardous Waste Accumulation Area (Waste Chemical Storage): One of three 55-gallon container of cyanide waste filter label has an accumulation start date of 8/4/10.

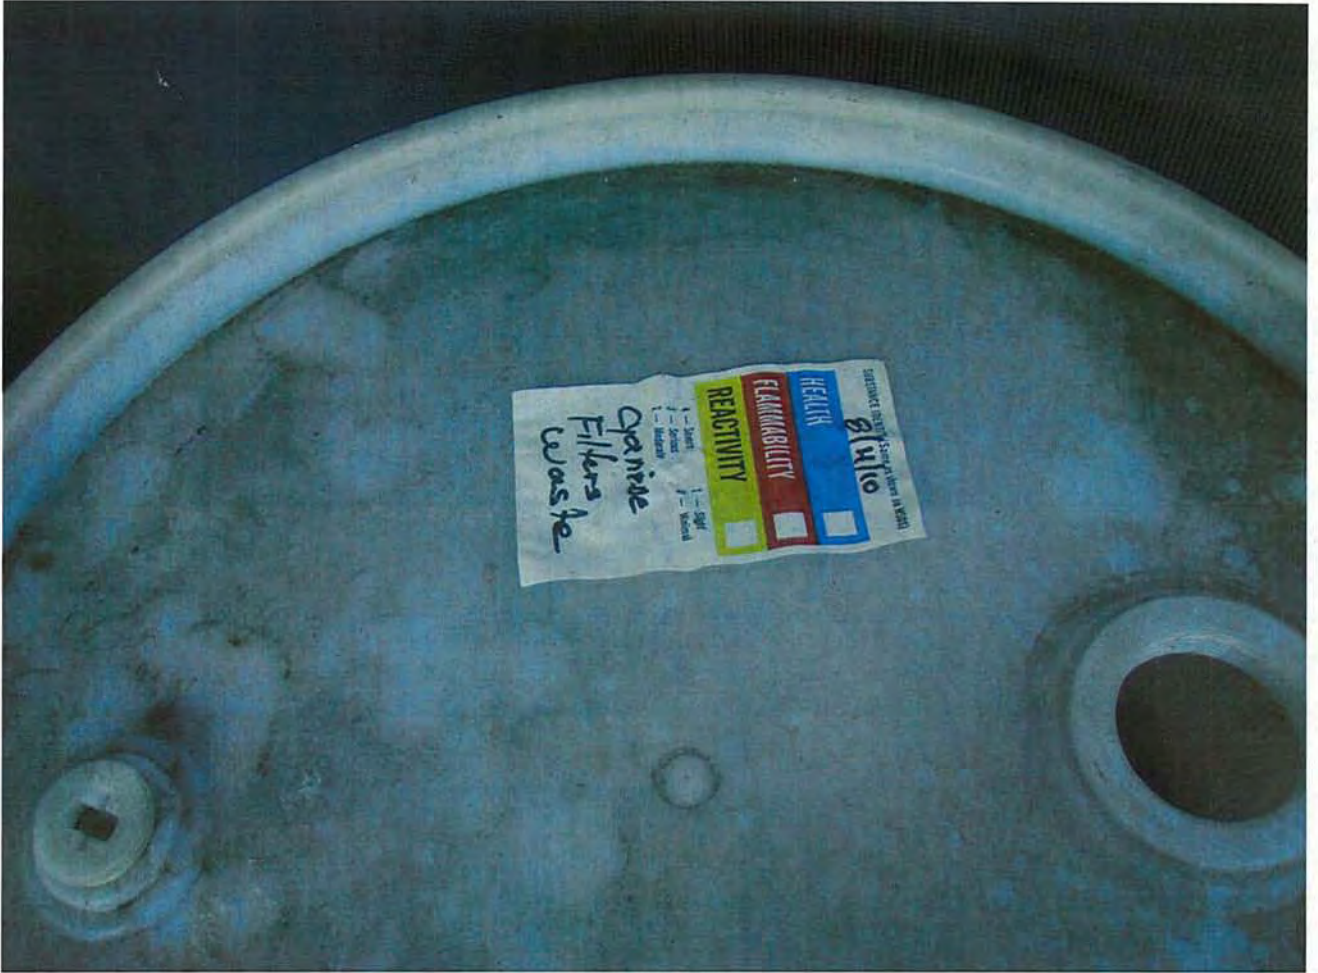
PC030082

082. Less than 90-day Hazardous Waste Accumulation Area (Waste Chemical Storage): One of three 55-gallon container of cyanide waste filter label has an accumulation start date of 8/4/10. Note: the bung on the container is open.

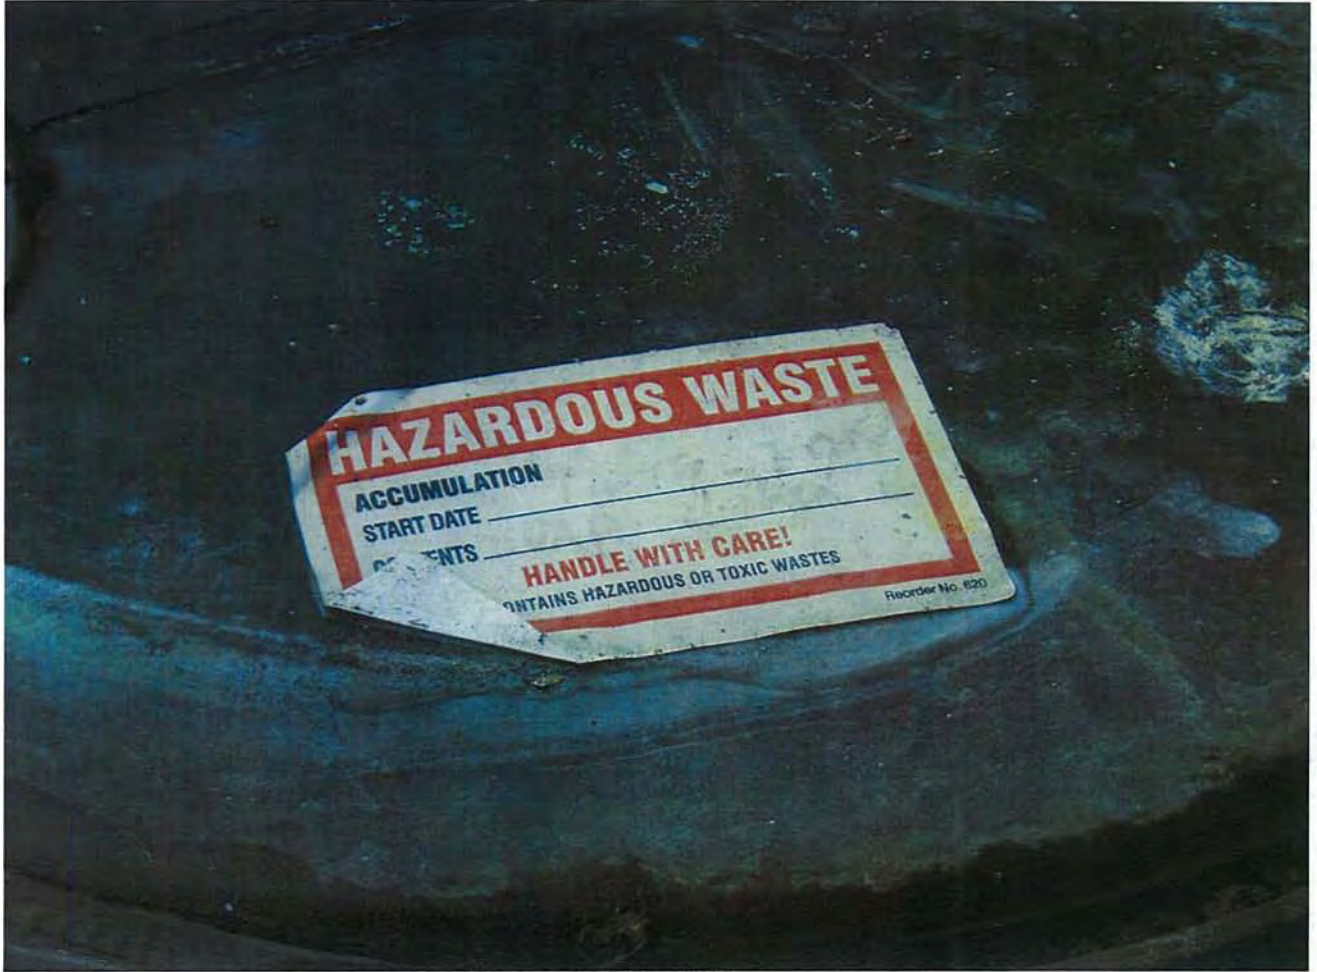
PC030084

084. Less than 90-day Hazardous Waste Accumulation Area (Waste Chemical Storage): A label seen on one of the 55-gallon containers is faded and appears to have an accumulation start date of 1/19/09. Note: container is corroded (*photograph taken by John Schofield*).

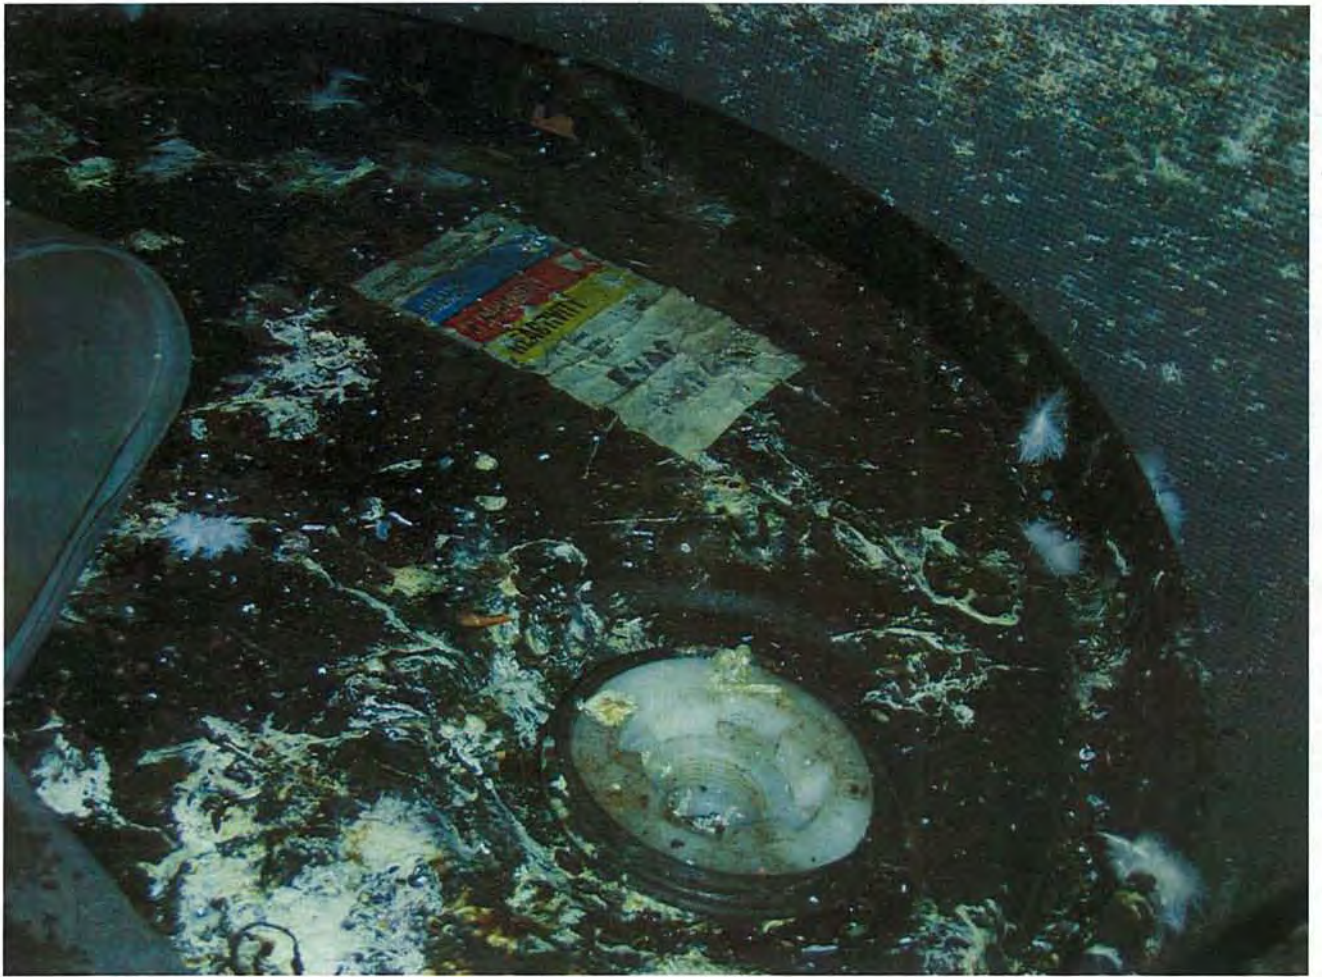
PC030090

090. Less than 90-day Hazardous Waste Accumulation Area (Waste Chemical Storage): 55-gallon container is covered with bird waste. Label is smudged (*photograph taken by John Schofield*).

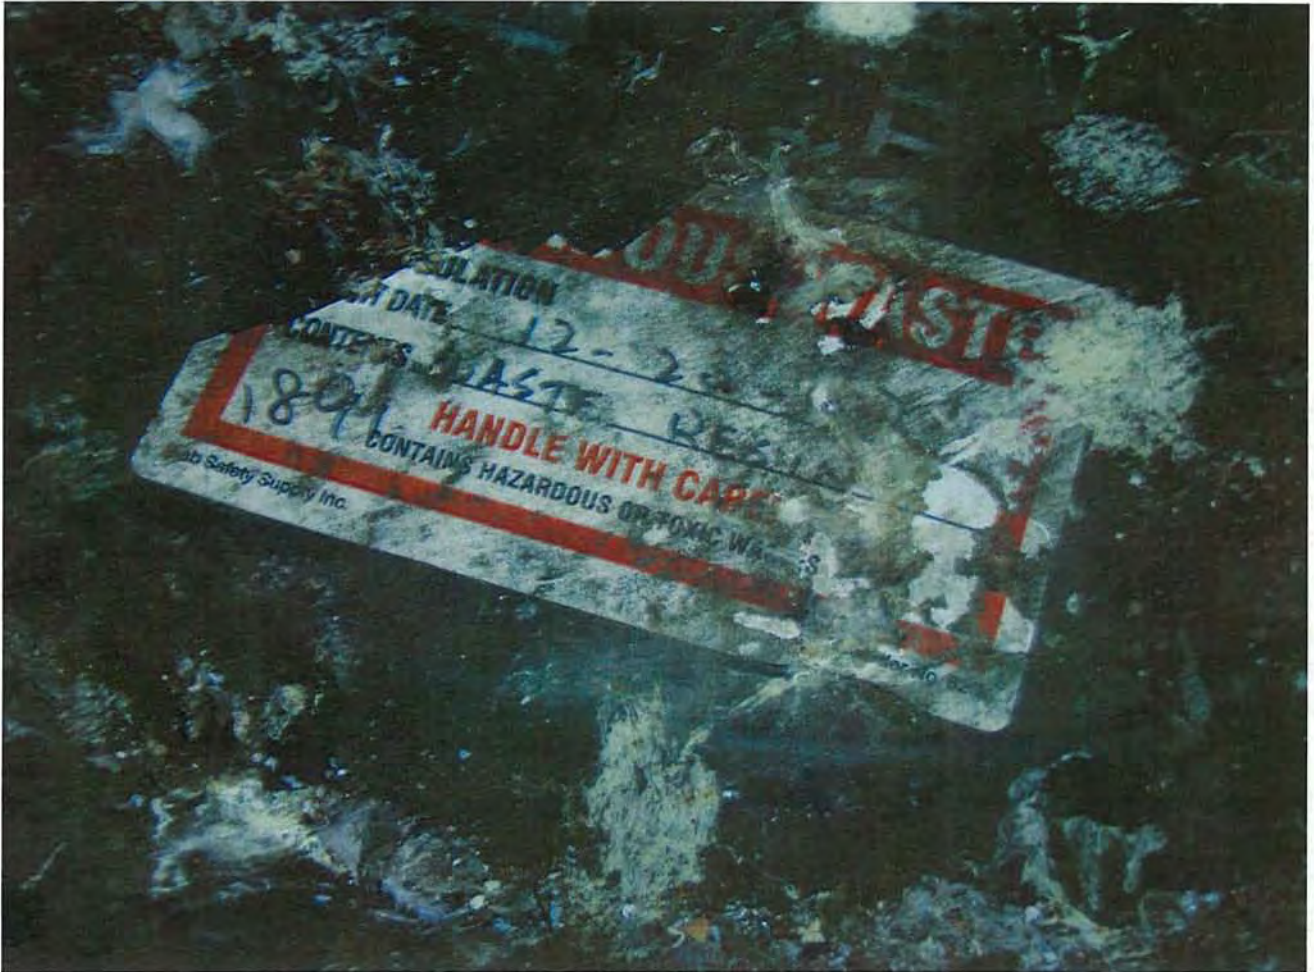
PC030091

091. Less than 90-day Hazardous Waste Accumulation Area (Waste Chemical Storage): Label on a 55-gallon container covered with bird waste. The label is blurred but the accumulation start date starts with 12/20 and states the material is "waste resin" (*photograph taken by John Schofield*).

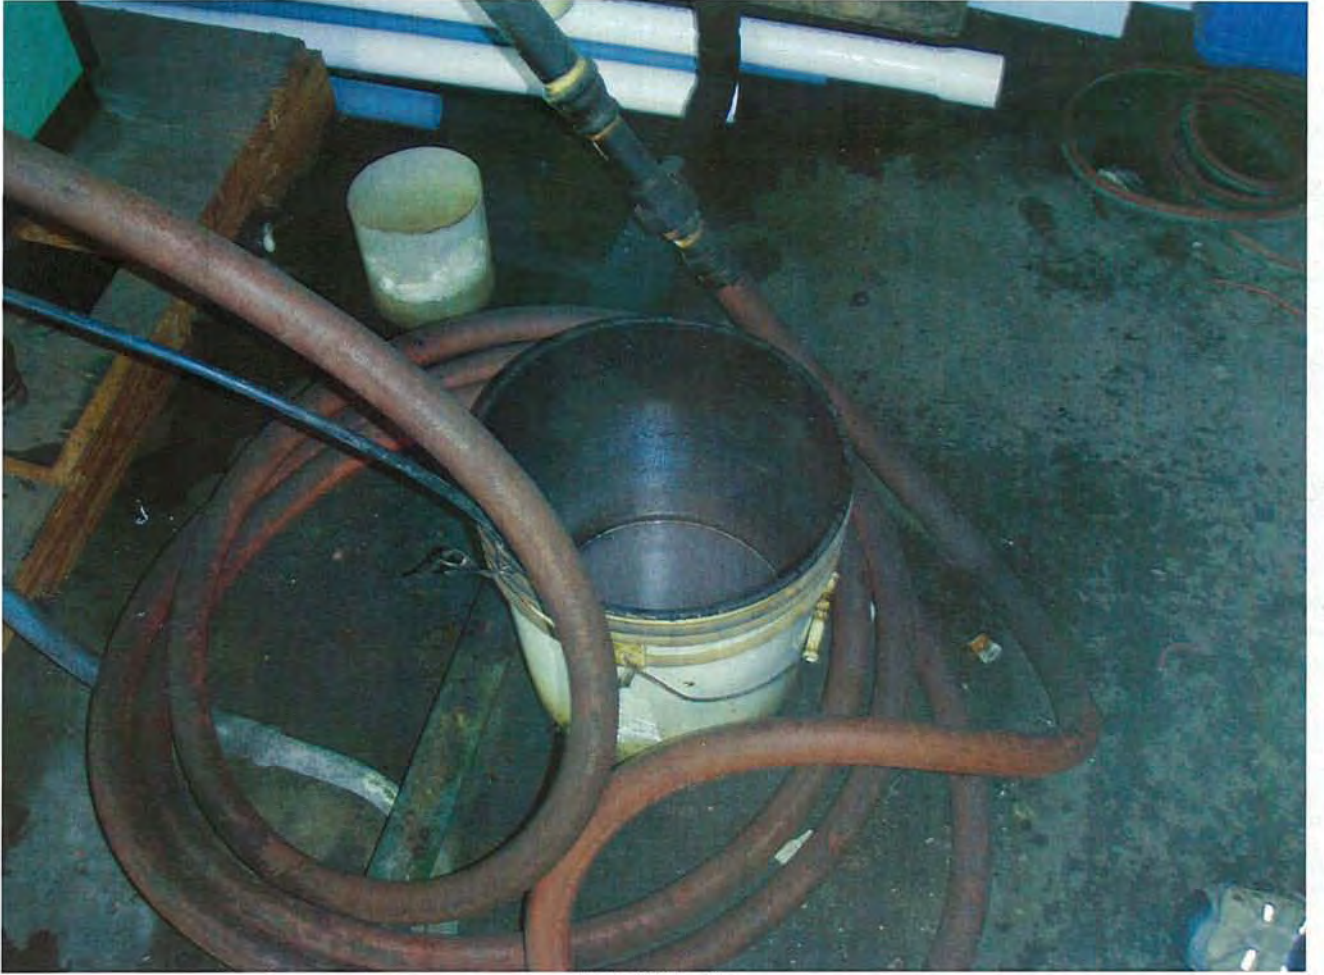
PC030098

Maintenance Shop: Electrochem has a maintenance shop to maintain forklifts and other machinery. The shop is covered and fenced and partially bermed with a six-inch berm. During the inspection, the inspectors noted a large amount of obsolete equipment and open, unlabelled five-gallon buckets of oily waste (see Attachment 3: PC030098-103).
