Re: September 28-29, 2010 Clean Water Act Inspections

NPDES DIAGNOSTIC EVALUATION INSPECTION

NPDES Permittee: American Samoa Power Authority

Dates of Inspection: 09/28/2010 Utulei Sewage Treatment Plant Inspection
09/28/2010 Sewer Collection System Inspection
09/29/2010 Fogagogo-Tafuna Sewage Treatment Plant Inspection

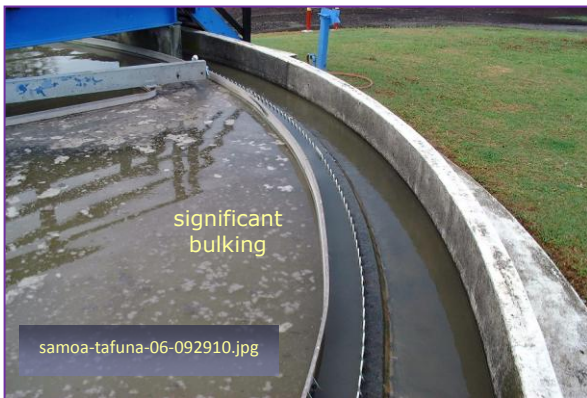
Photo #3: Tafuna STP – Clarigester No.2
Taken By: Greg V. Arthur
Date: 09/29/10

observed to be in working order. The one exception, Clarigester No.2, had bulking sludge. According to ASPA representatives, the bulking sludge is caused by the introduction of restaurant grease, collected island-wide from the school lunch program, and delivered by pumper truck for disposal into only the Clarigester No.2. See Table 3 on page 27 of this report for the statistical summaries of the influent and effluent sampling at Tafuna.

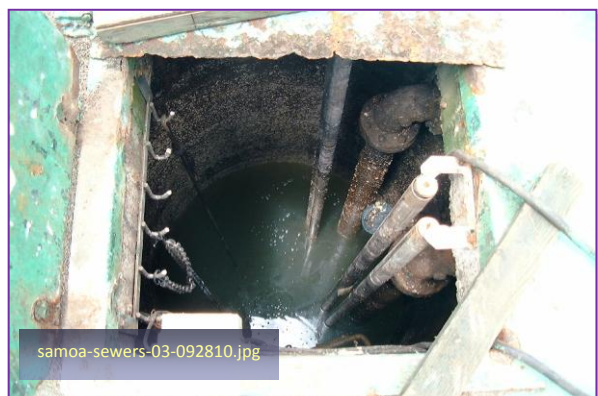
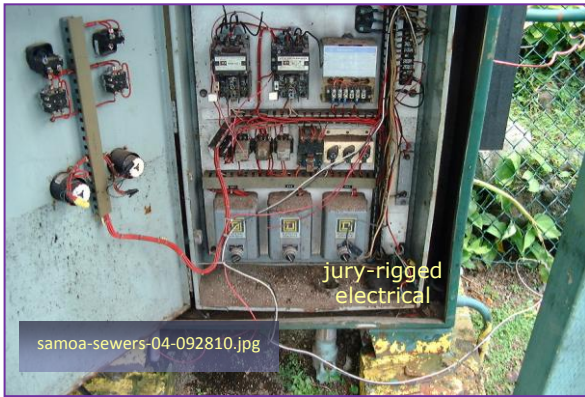
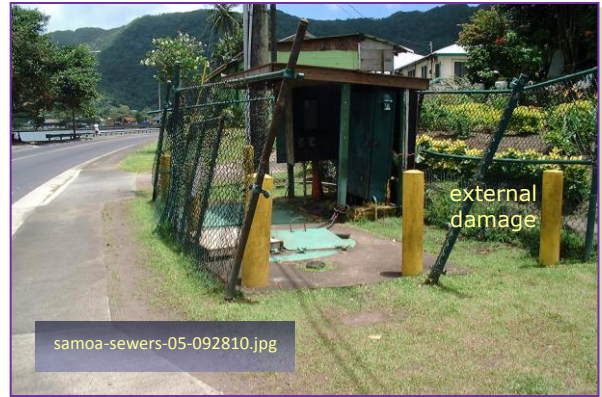
Photo #12: Satala Lift Station (Utulei service area)
Taken By: Greg V. Arthur
Date: 09/28/10

ASPA Lift Stations	Discharge	Capacity (gpd)	Condition on September 28-29, 2010	
Atu'u	Utulei STP	2 @ 200	good	fully operational as designed
Satala	Utulei STP	2 @ 200	poor	tsunami damaged electrical controls
Korea House	Utulei STP	2 @ 300	poor	tsunami damaged electrical controls
Fatumafuti	Utulei STP	2 @ 200	good	fully operational as designed
Matafao School	Utulei STP	not assessed	n/a	not assessed during this inspection
Fagaalu	Utulei STP	not assessed	n/a	not assessed during this inspection
Special Ed	Utulei STP	2 @ 200	good	fully operational as designed
Malaloloa Main	Utulei STP	3 @ 900	poor	prior damaged electrical controls
Utulei STP Inlet	Utulei Ocean Outfall	2@900 / 2@1600	good	fully operational as designed
Coconut No.1	Tafuna STP	2 @ 200	good	fully operational - high inflow
Coconut No.2	Tafuna STP	2 @ 200	good	fully operational as designed
Coconut No.3	Tafuna STP	2 @ 200	fair	one pump inoperable

- ASPA should complete the repair or replacement of Utulei Clarigester No.1, the tsunami-damaged Satala and Korea House lift stations, and the Malaloloa main lift station.
- ASPA should complete the lift station installations of SCADA remote sensing telemetry.

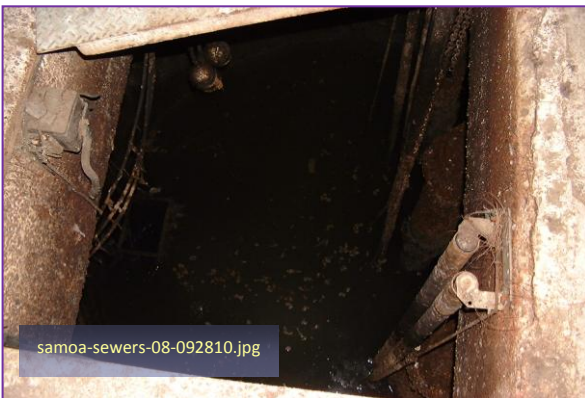
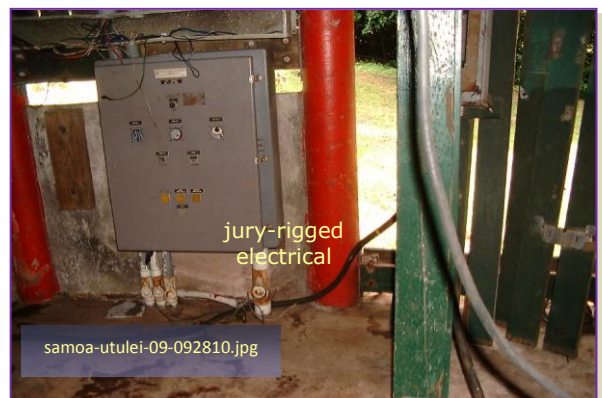
Photo #15: Malaloloa Main Lift Station (To Utulei)
Taken By: Greg V. Arthur
Date: 09/28/10

- + All lift stations were functioning.
- Three lift stations had tsunami damage to their electrical controls and perimeter fencing.
- One low lying lift station showed evidence from silt of high inflow from a nearby road.
- The Malaloloa lift station control panel bypass was observed in 2007, 2009, and 2010.
- + All pumps except one were found operational and in working condition.
- + There was little evidence of concrete spalling around and within any of the lift stations.
- + Metal frames, covers, and hardware were painted and functioning.

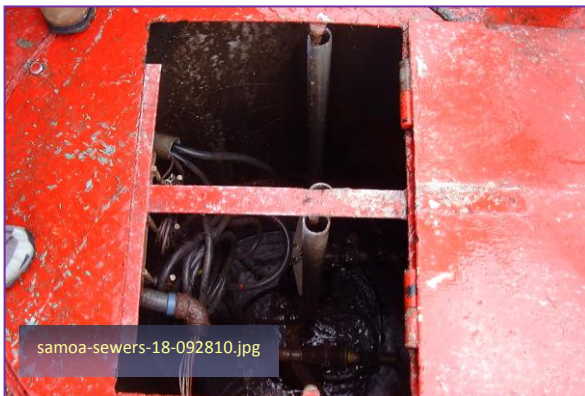
Photo #23: Andy Lift Station (Tafuna service area)
Taken By: Greg V. Arthur
Date: 09/28/10

Andy	Tafuna STP	2 @ 200	fair	pump outlet not seated
Sagamea	Tafuna STP	2 @ 200	fair	flange connections not tightened
Papa Stream	Tafuna STP	2 @ 450	good	fully operational as designed
Skill Center	Tafuna STP	2 @ 300	good	fully operational as designed
Airport	Tafuna STP	2 @ 300	good	fully operational as designed
Lavatai	Tafuna STP	not assessed	n/a	not assessed during this inspection
Fogagogo	Tafuna STP	not assessed	n/a	not assessed during this inspection
Vaitele Main	Tafuna STP	3 @ 900	good	fully operational as designed
Tafuna STP Inlet	Tafuna Ocean Outfall	2@400 / 2@900	good	fully operational as designed
Three remote lift stations to unpermitted outfalls at Aunu'u Island, Leone High School, Fagaitua High School.
