**Re: September 29, 2010 Clean Water Act Inspection  
And Termination of EPA Administrative Order CWA-309(a)**

**NPDES COMPLIANCE EVALUATION INSPECTION**

NPDES Permittee: MYD Samoa, Inc.

Facility: Satala Shipyard  
P.O. Box 7684, Pago Pago, Tutuila Island, American Samoa  
(NPDES Permit No. AS0020026)

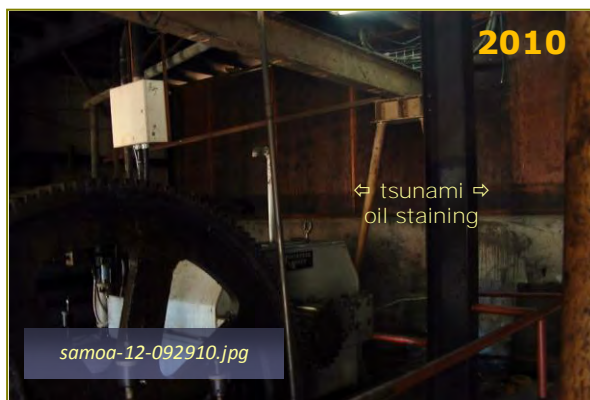
On the date of this inspection, evidence of unrepaired damage from the tsunami included failure of both ends of the 3000-ton dry dock seawall, destruction of the outboard wind break curtains, deck planking loss, and the washout of the winch gear box lubricating pit. See Photos #1, #2, #3, and #4 in Section 1.5 of this report on pages 8 and 9.

Photo #1: Engine Winch Room – 6' tsunami levels  
Taken By: Greg V. Arthur  
Date: 09/29/10

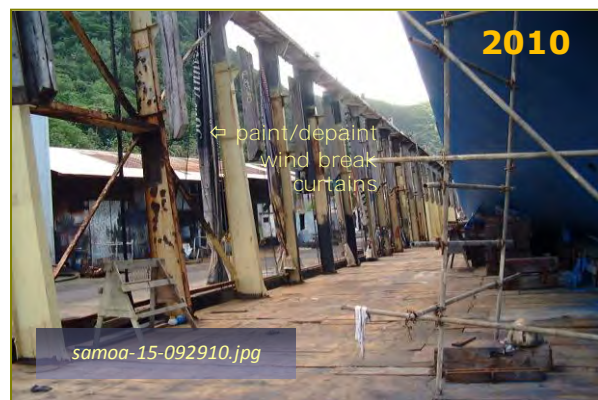
On the day of this inspection, these BMPs were observed to have not been effectively deployed. In particular, (1) some plywood decking was damaged exposing some gaps to the harbor beneath; (2) the deck was not swept; (3) there were deposits of grit on the deck and adjacent piers; and (4) the wind break curtains were missing on the windward side of the dry dock. Spent grit blown to the dock edges cannot be captured until MYD Samoa installs new curtains. See Photos #2, #3, and #4 in Section 1.5 on pages 8 and 9.

- Dry dock Drainage – Rainfall runoff can drain through the gaps in the dry dock decking or directly to into the open gap over the harbor between the uncurbed dry dock and the pier. Deposits of spent blasting grit were observed on the 3000-ton dry dock. The deposits of spent grit onto the surrounding pier landings indicates that MYD Samoa grit blasted without unfurling wind break curtains. See Photos #2, #3, and #4 in Section 1.5 on pages 8 and 9.

Photo #2: 3000-Ton Dry Dock – wind break curtains  
Taken By: Greg V. Arthur  
Date: 09/29/10

- MYD Samoa must, to the greatest extent practical, seal the dry dock deck in order to prevent the loss of any solids into the harbor through gaps in the decking, always deploy curtains to capture all spent blasting grit on the dry dock, and after each shift keep the dry dock deck swept, clean, and in order.
- MYD Samoa must repair the tsunami-damaged curbing, and install either curbing or drainage trenching around the dry docks.
- MYD Samoa must, to the greatest extent practical, minimize storm water contact with all process equipment, materials, debris, and wastes.

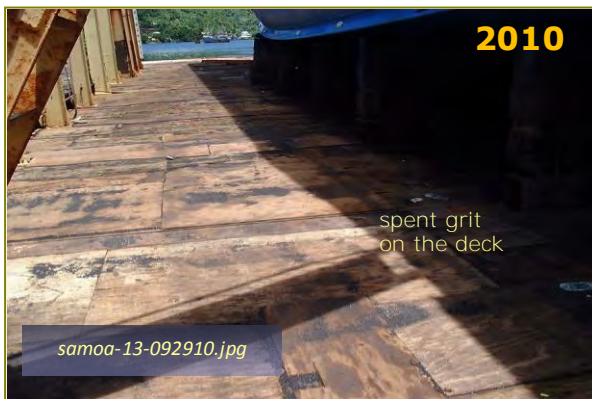
Photo #3: 3000-Ton Dry Dock Decking – Sept 2010  
Taken By: Greg V. Arthur  
Date: 09/29/10

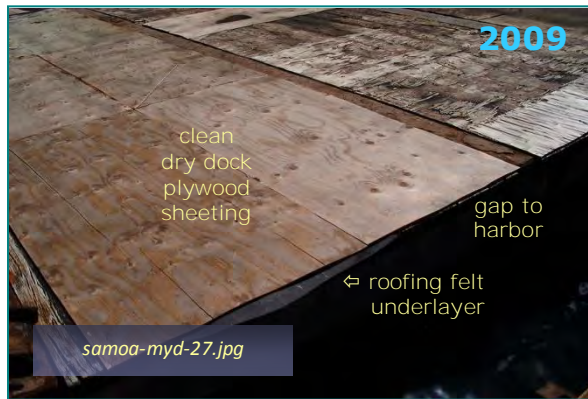
Photo #4: 3000-Ton Dry Dock Decking – April 2009  
Taken By: Greg V. Arthur  
Date: 04/27/09

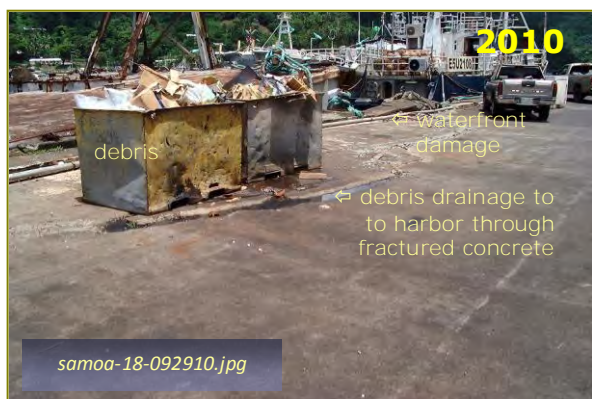
South Dock - Ships berthing takes place next to the shipyard in an area called the South Dock extending south of the 3000-ton Dry Dock and the harbor, within the storm water drainage watershed referred to as Catch Basin #3. Extensive unrepaired tsunami-caused damage to the South Dock sea wall was still evident with structural concrete fracturing along the waterfront, and debris, excavation soils, and scrap awaiting removal. See Photos #5 and #6 in Section 1.5 of this report on page 9.

- Catch Basin #3 Drainage – Catch Basin #3 includes the South Dock and the pier side landings between the fabrication and machining buildings and the 3000-ton dry dock. Catch Basin #3 was observed to have deposits of spent blasting grit on the landing north of the dry dock, and tsunami-related excavation soils and debris bins uncovered and exposed to contact with rainfall run-off. There were no materials, scrap, or debris stored outside and around the fabrication and machining buildings, and no boat repair work done by the ship crews on the South Dock. There is curbing along the South Dock but not on the pier around the 3000-ton dry dock. Around the dry dock, the landing slants toward the open gap over the harbor between the uncurbed pier and the dry dock. Most of the drainage collects to a sump outfitted with siphon overflows to a short canal leading to the harbor, and designated as discharge point NPDES-003. However, tsunami damage to the South Dock fractured the pavement and curbing, and some drainage drains through cracks to the harbor. No sheen was observed in the canal and harbor around NPDES-003. See Photos #5, #6, and #14 in Section 1.5 on pages 9 and 10.

Photo #5: Catch Basin #3 – South Dock  
Taken By: Greg V. Arthur  
Date: 09/29/10

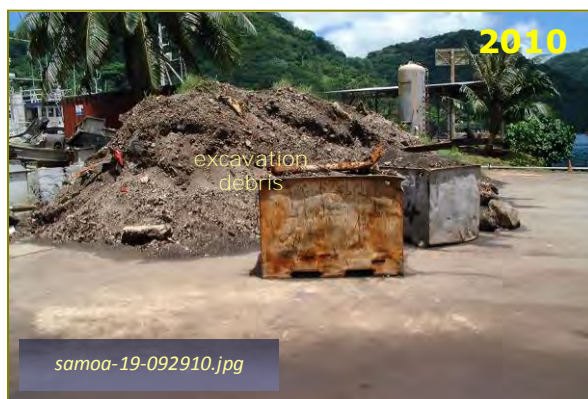
Photo #6: Catch Basin #3 – South Dock  
Taken By: Greg V. Arthur  
Date: 09/29/10

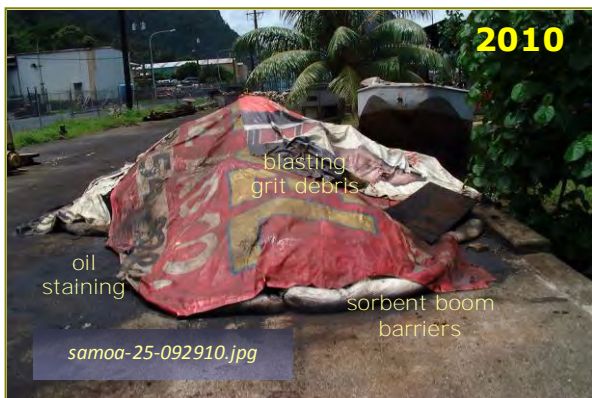
800-Ton Cradle Dry Dock - The smaller of the two dry docks was found on this inspection to be decommissioned and awaiting repair as it was in the previous year, with additional unrepaired tsunami-caused damage, and debris accumulation around and under the dry dock. The landings around the 800-ton dry dock are within the storm water drainage watershed referred to as Catch Basin #1. MYD Samoa hopes to repair and commission the 800-ton dry dock back into service at an undetermined future date. The design of this dry dock is similar to the larger one. See Photos #7 and #8 in Section 1.5 of this report on page 9.

- Catch Basin #1 Drainage – Catch Basin #1 includes the piers and landings around the 800-ton dry dock and two buildings. Catch Basin #1 was observed to have significant pollutant sources left exposed to contact with storm water run-off and to have tsunami-damaged curbing along the waterfront. In particular, there were (1) uncovered trash and barrel piles, (2) a covered but ineffectively boomed grit debris pile, (3) oil staining on the pavement leading from the blasting grit debris pile to the uncurbed gap around the 800-ton dry dock, (4) oil staining on the concrete near the discharge sump, and (5) tsunami-damaged curbing along the waterfront west of the discharge sump. With intact curbing, Catch Basin #1 drainage collects into a discharge sump outfitted with siphon overflows to the harbor, designated as discharge point NPDES-001. On the date of this inspection, no oily drainage was observed flowing into and through the discharge sump and no sheen was observed in the harbor around NPDES-001. See Photos #7, #8, #9, #10, #11, and #12 in Section 1.5 on pages 9 and 10.

Photo #7: Catch Basin #1 – near 800-ton dry dock  
Taken By: Greg V. Arthur  
Date: 09/29/10

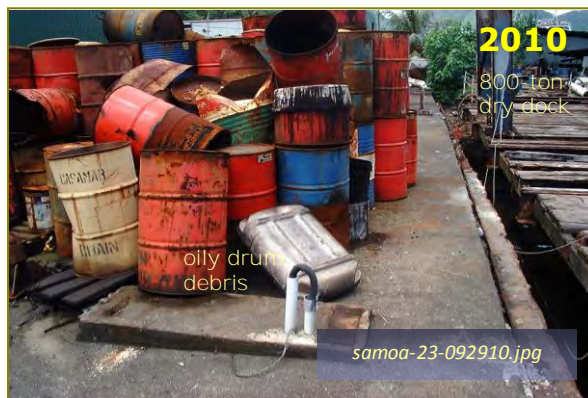
Photo #8: Catch Basin #1 – near 800-ton dry dock  
Taken By: Greg V. Arthur  
Date: 09/29/10

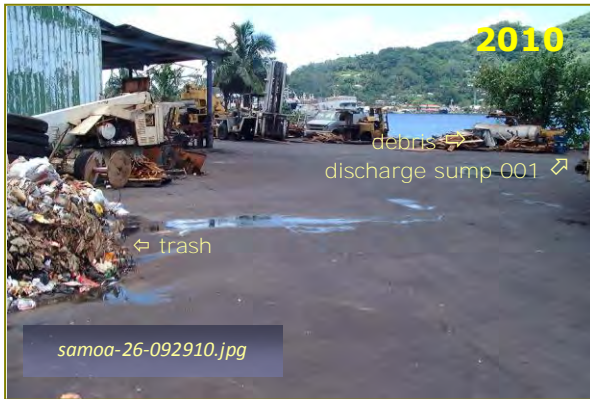
Photo #9: Catch Basin #1 - Sept 2010  
Taken By: Greg V. Arthur  
Date: 09/29/10

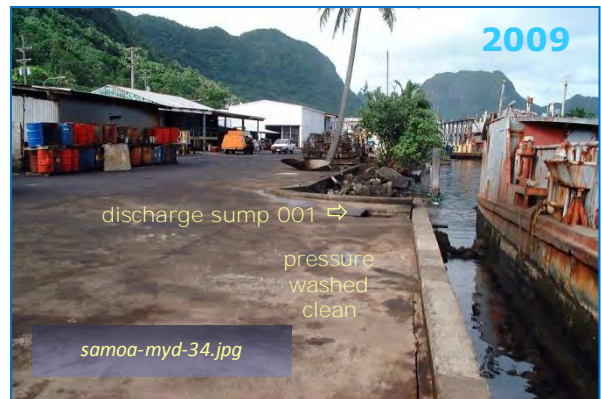
Photo #10: Catch Basin #1 - April 2009  
Taken By: Greg V. Arthur  
Date: 04/30/09

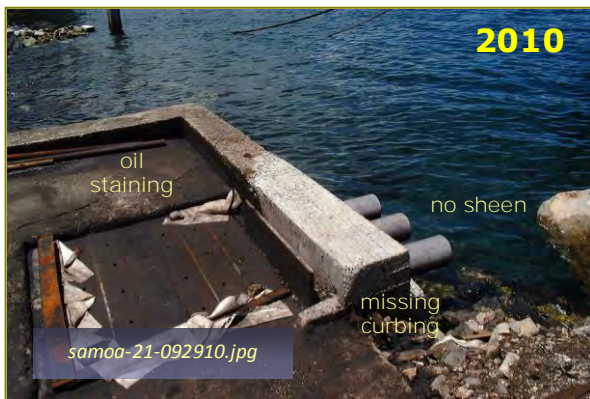
Photo #11: Catch Basin #1 - discharge sump 001  
Taken By: Greg V. Arthur  
Date: 09/29/10

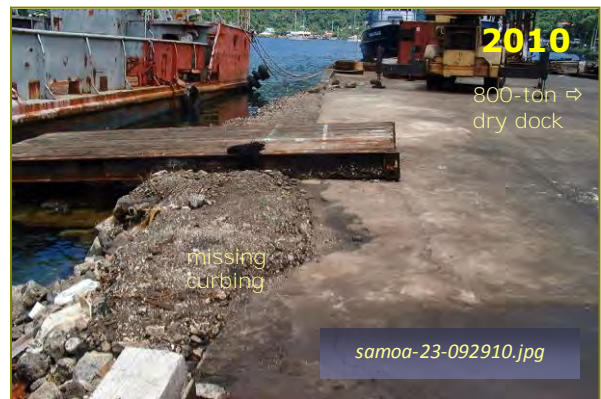
Photo #12: Catch Basin #1 - damaged waterfront  
Taken By: Greg V. Arthur  
Date: 09/29/10

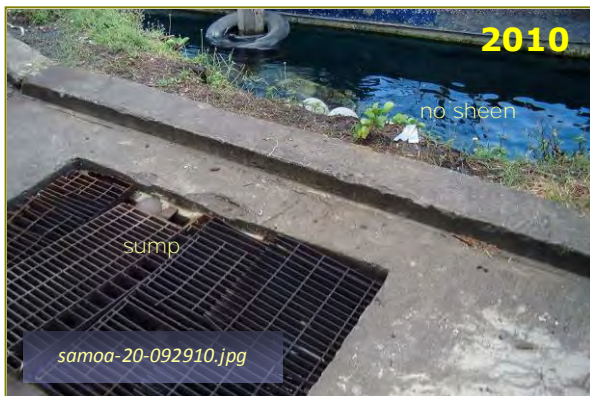
and cleaned, with no other significant pollutant sources exposed to contact with rainfall run-off. There is curbing along the open harbor but not on the pier around the 3000-ton dry dock. The drainage collects to a sump outfitted with siphon overflows to the harbor, designated as discharge point NPDES-002. No sheen was observed in the harbor around NPDES-002. See Photo #13 in Section 1.5 on page 10.

Photo #13: Discharge Sump 002 - Sept 2010  
Taken By: Greg V. Arthur  
Date: 09/29/10

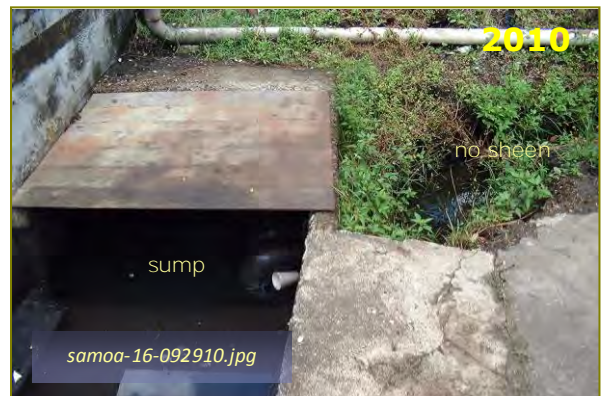
Photo #14: Discharge Sump 003 - Sept 2010  
Taken By: Greg V. Arthur  
Date: 09/29/10

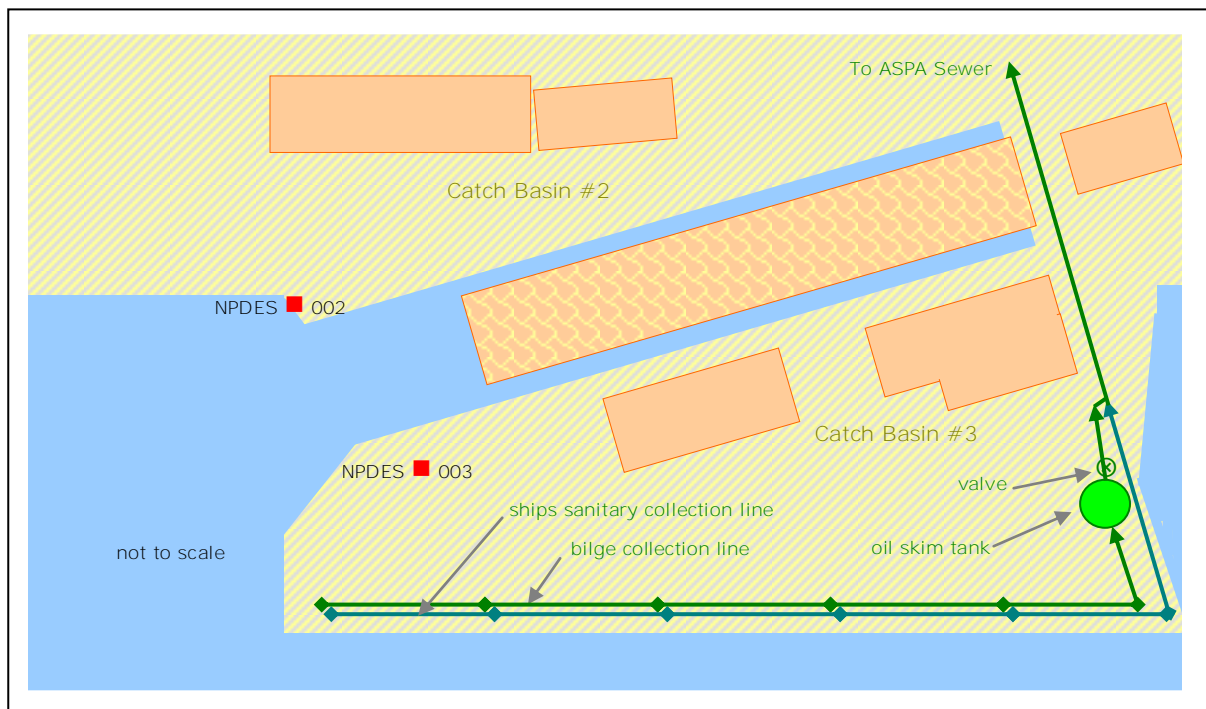
**Figure 3.2.8**  
Schematic of Possible Upgrades - Shipboard Wastewater Handling

no shipyard facilities to handle vessel-related wastewaters. Although ships continue to generate shipboard wastewaters while in dock, there was no observed evidence of discharge from shipboard sources. MYD Samoa further indicates that no shipboard wastewaters are accepted, and that they would consider the connection of dock facilities to the ASPA sewers.

- MYD Samoa should consider providing a connection for ships sanitary wastewaters to the ASPA domestic sewer system. See Figure 3.2.8 on page 18 of this report.
