SOUTHERN ILLINOIS POWER COOPERATIVE IMPOUNDMENT INFORMATION

INSPECTION REPORT

SOUTH FLY ASH POND DAM

IDNR-OWR PERMIT NO. 19403
DAM I.D. NO. IL50100

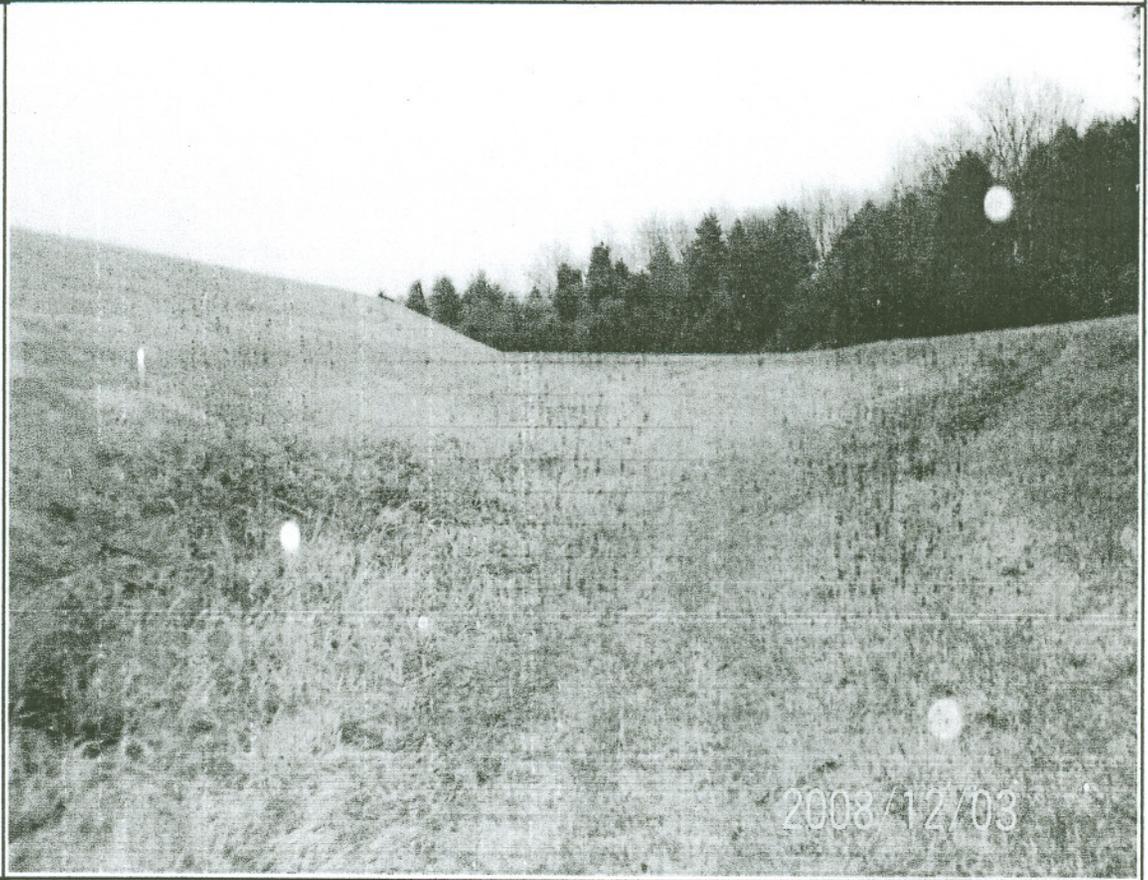
ITEM	CONDITION	DEFICIENCIES	RECOMMENDED REMEDIAL MEASURES AND IMPLEMENTATION SCHEDULE
Animal Damage	N.E.		
Embankment Drainage Ditches	M.M.	Downstream drainage ditch standing water	Investigate the cause. Re-grade ditch to get to drain. Re-inspect to ensure there is no seepage.
Vegetative Cover	G.C.		
Other (Name)			
Other			
Other

Looking at area needing
grading.

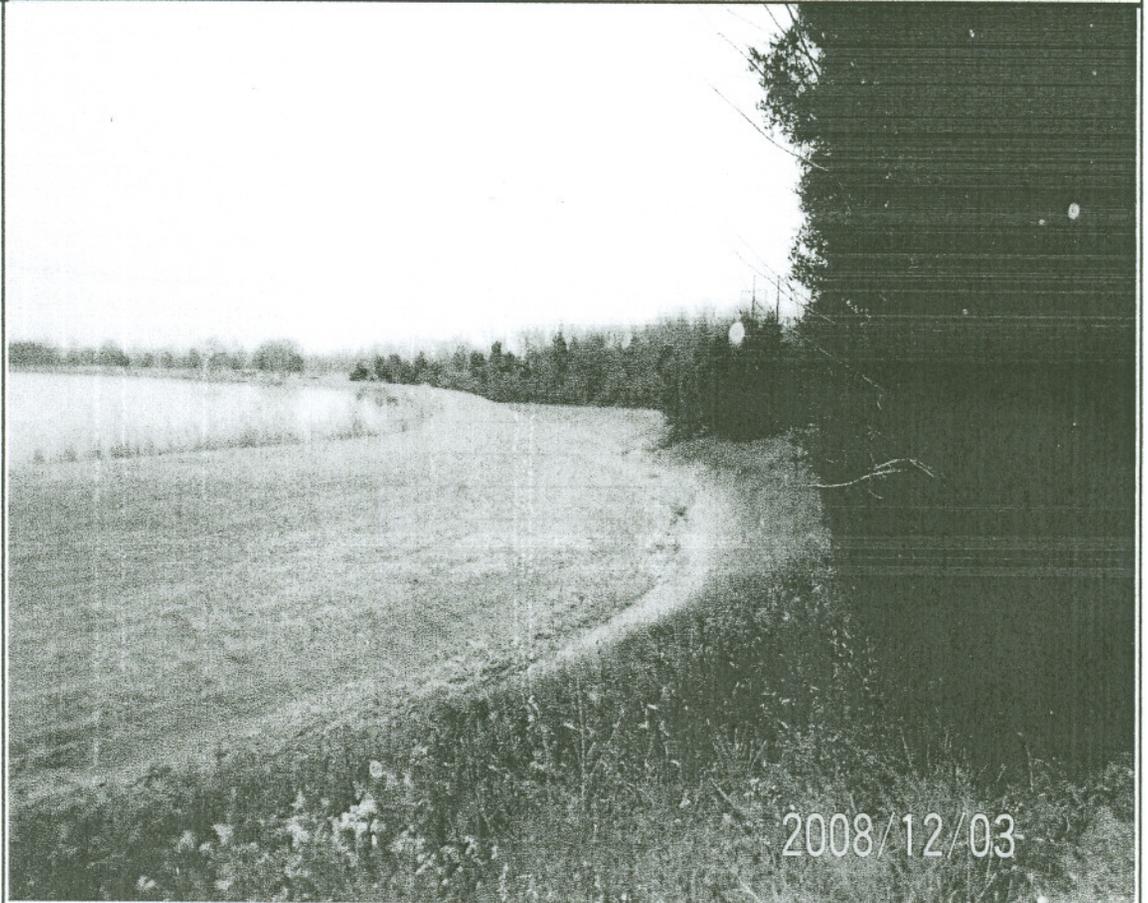
Looking East along dam

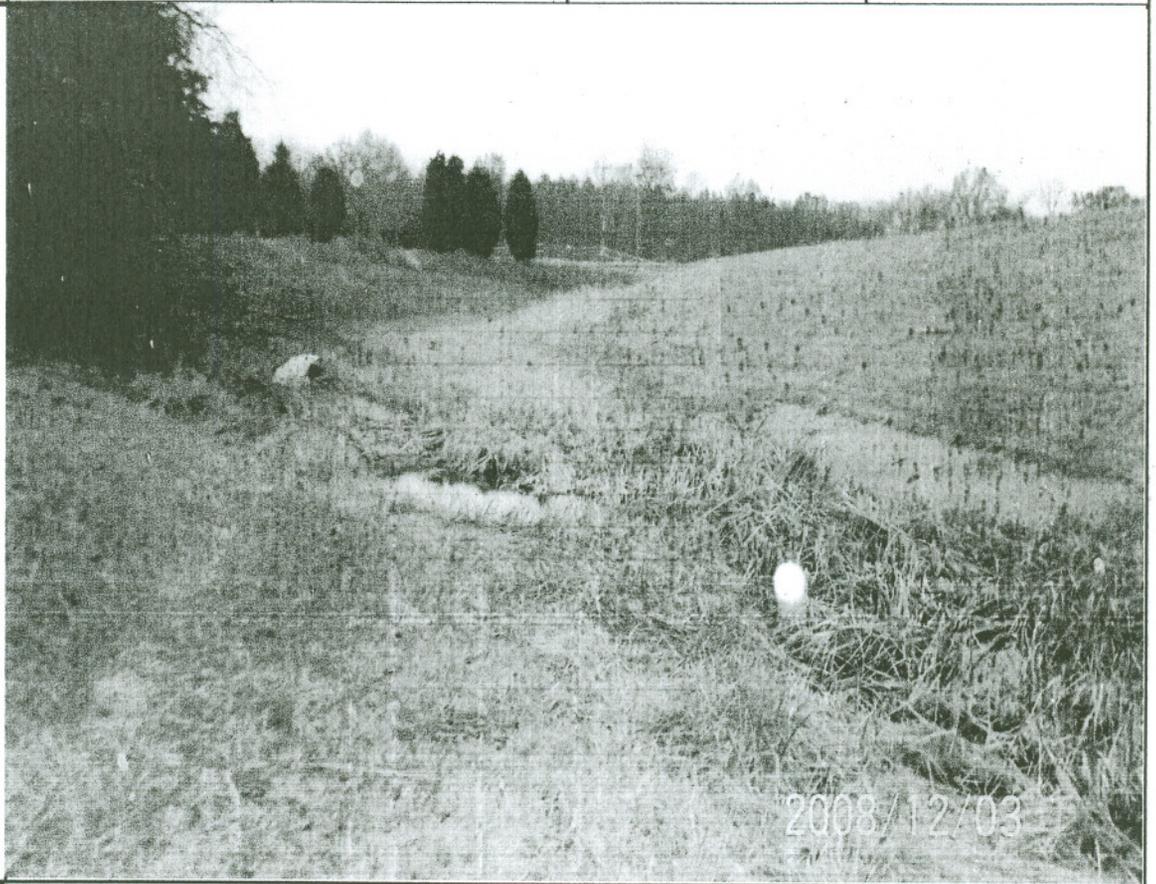
Looking west at area
needing grading

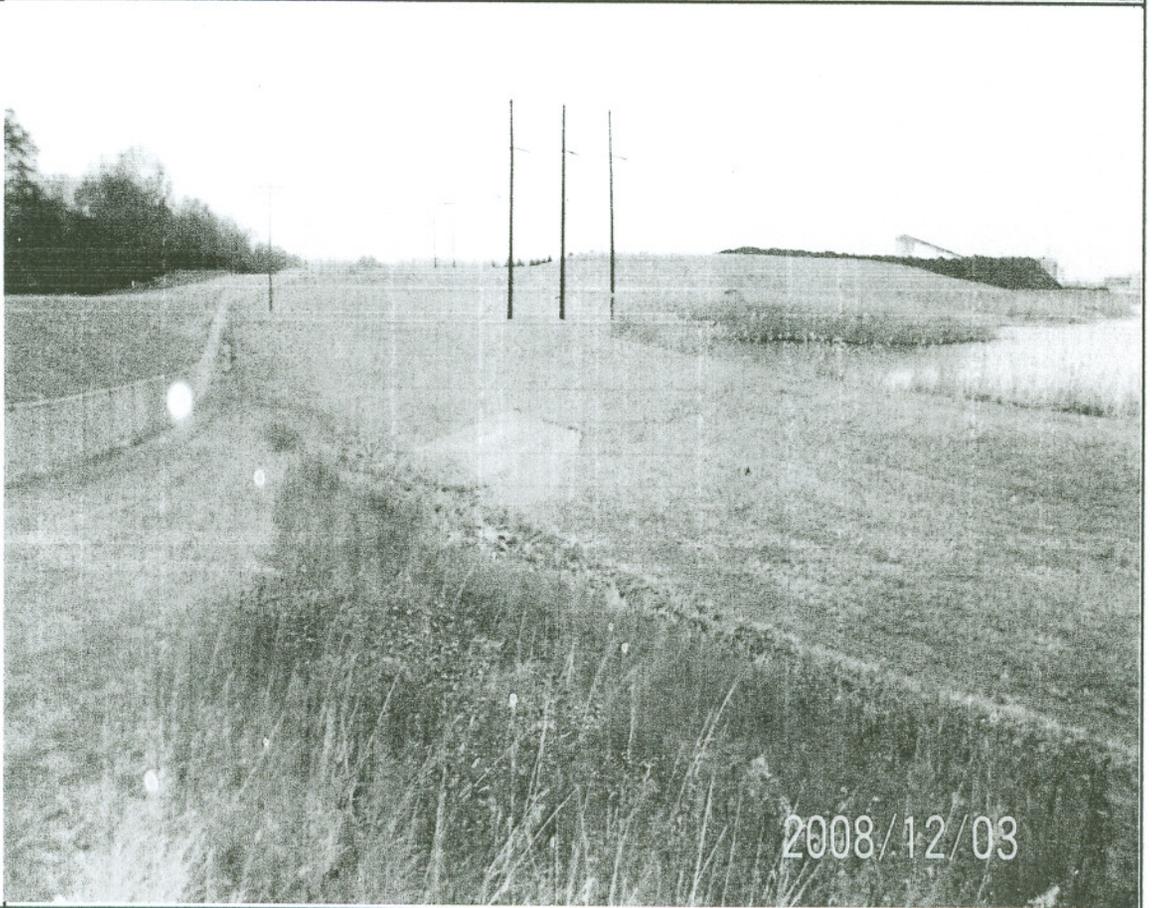
Looking at North-West
side

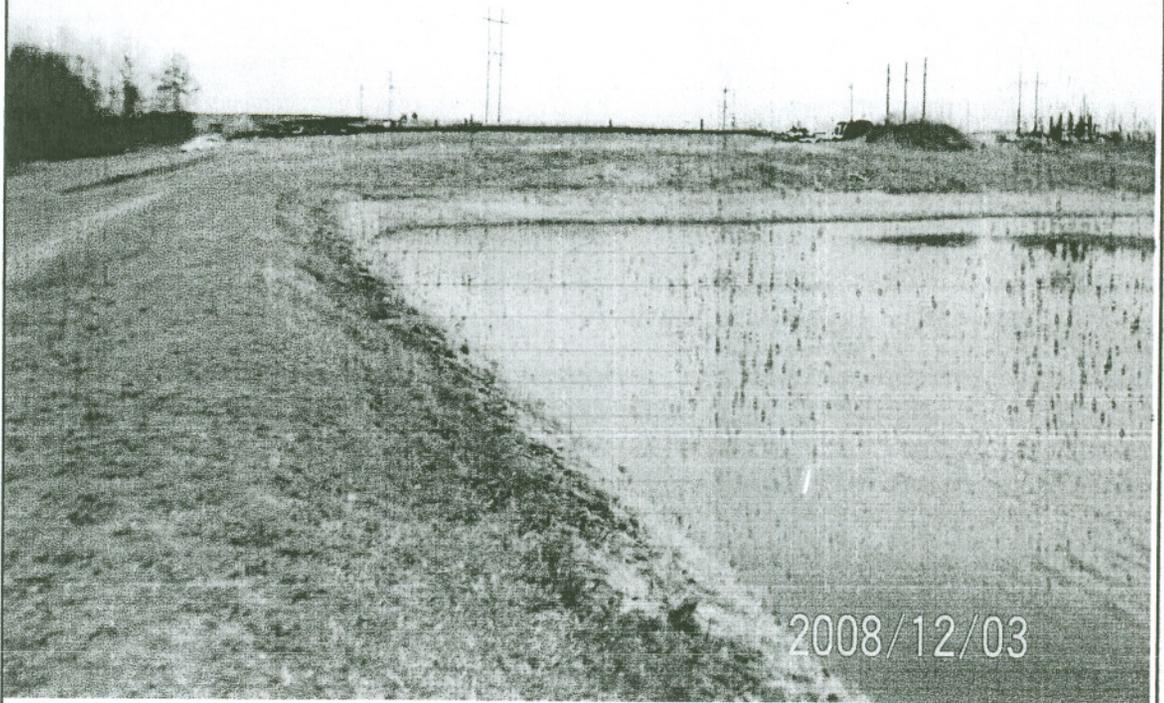
Looking East

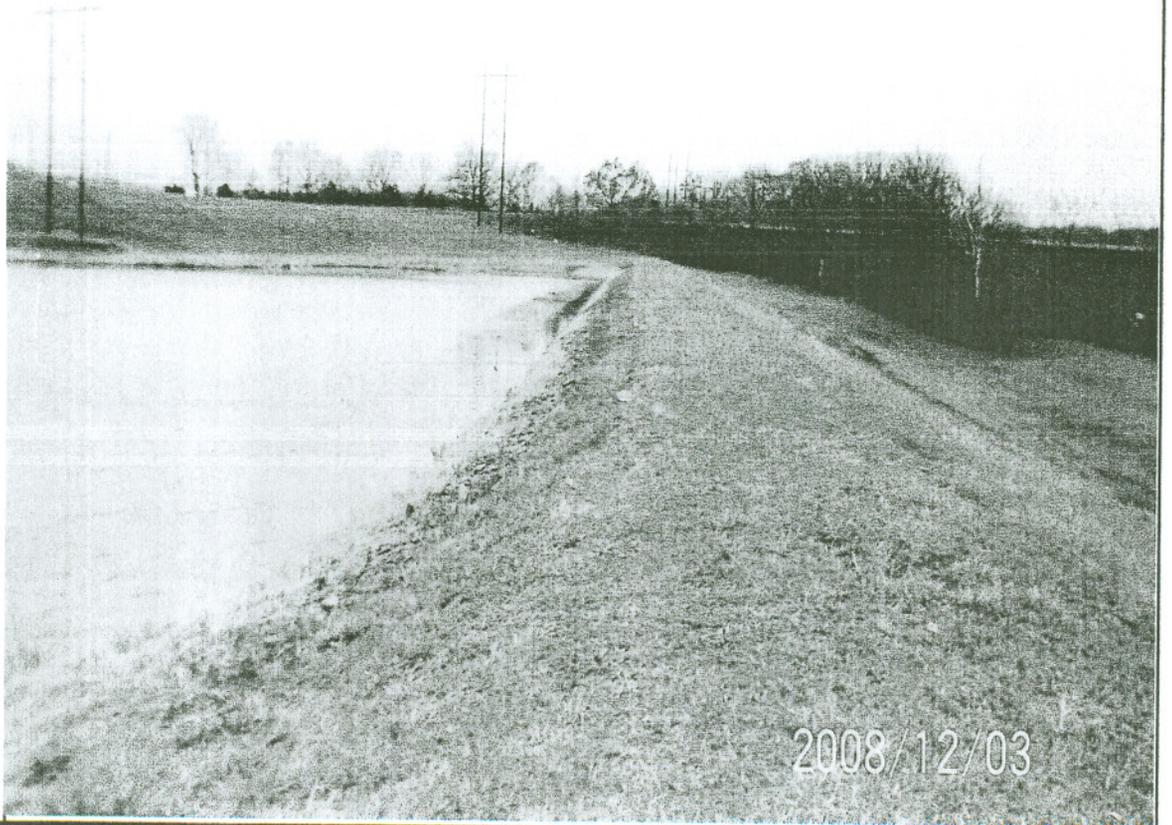
Looking West along North
levee
