## **Coal Combustion Residue Impoundment Round 11 - Dam Assessment Report**

Bull Run Fossil Plant (#002) CCR Impoundment Areas 1, 2, 2A Tennessee Valley Authority Clinton, Tennessee

United States Environmental Protection Agency Office of Resource Conservation and Recovery

Dewberry & Davis, LLC Fairfax, Virginia

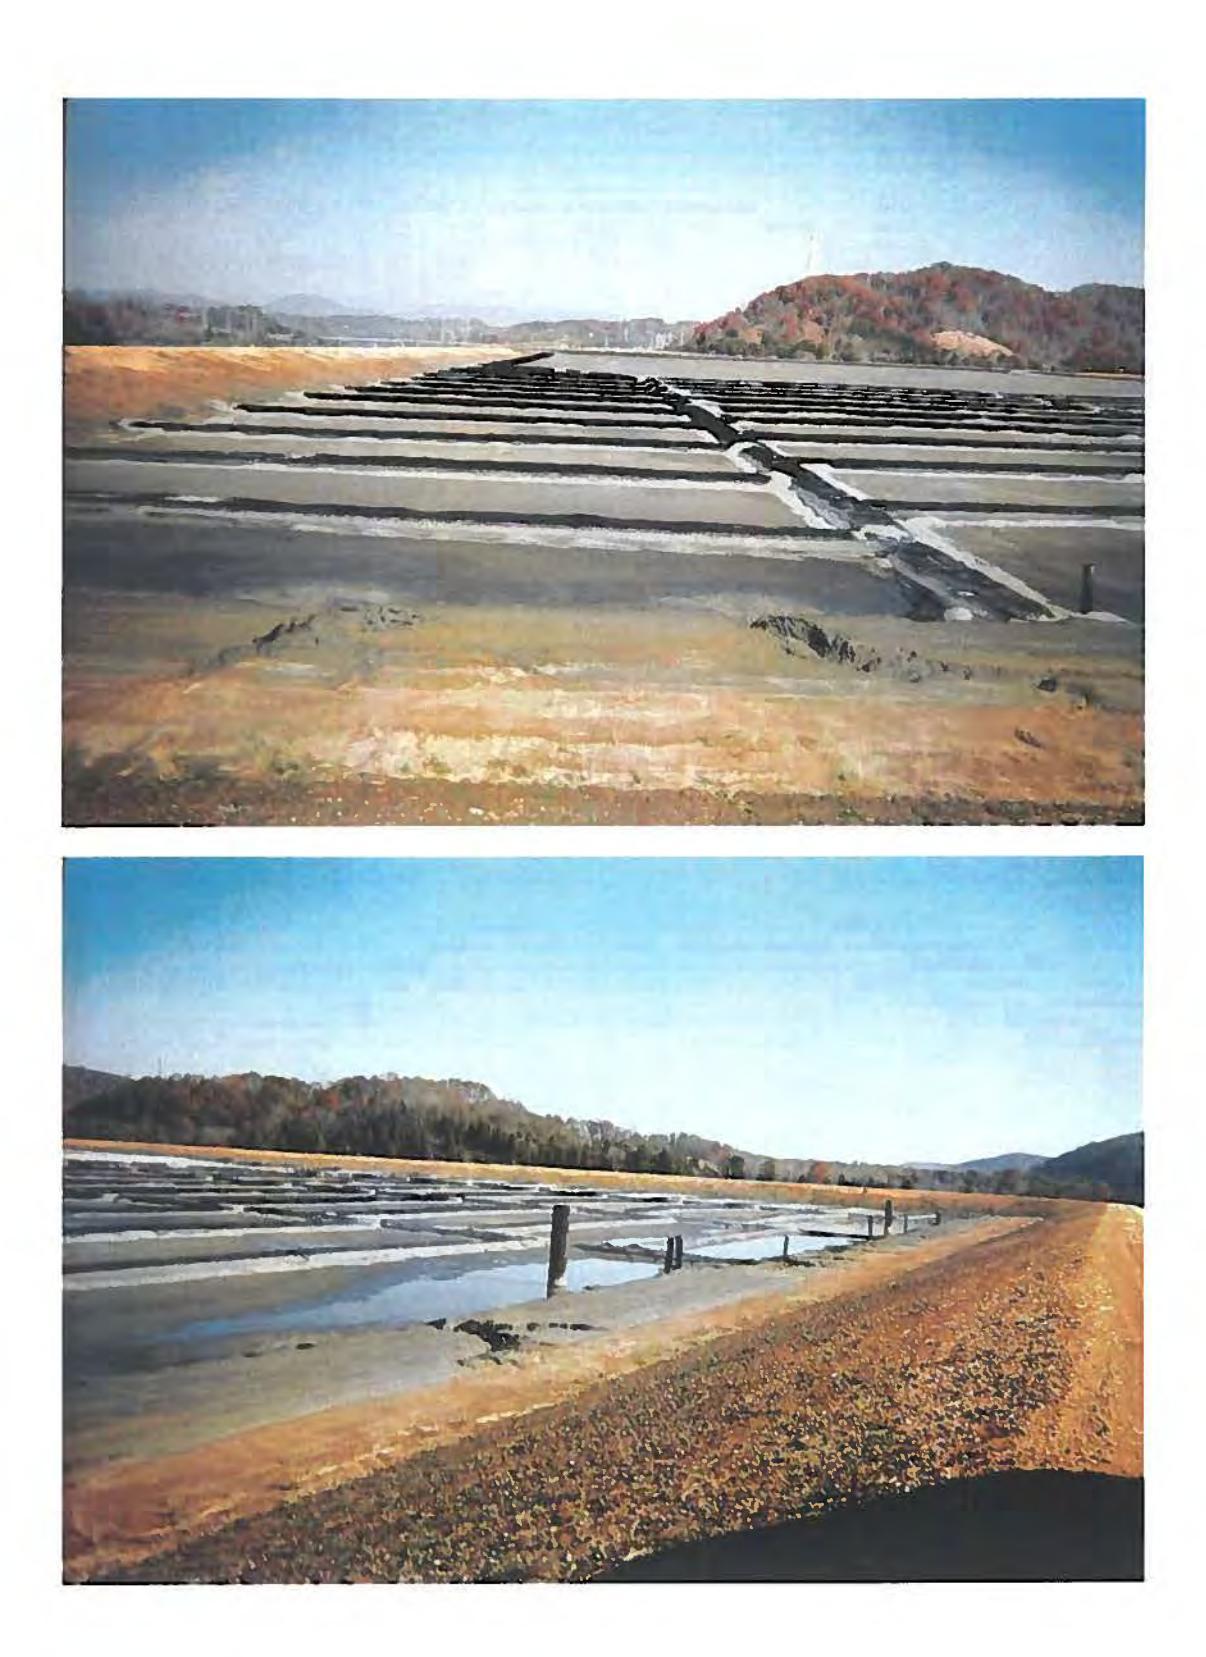
Figure 5. Area 2A – Gypsum Disposal Area – Bottom Drainage Systems

Notes on Sheet 4 of 6 contained within Reference 7 calls for a clay plug/shoulder to be constructed along the interior toe of the embankment, immediately south of the 12-inch header pipe. The dimensions of this plug were presumably modified as per recommendations from Geosyntec and are presented on the last page of Reference 7. Reference 7 also includes two drawings (10W298-5A and 10W298-27A) prepared by Geosyntec with recommendations to change the bottom drainage system by installing drainage collection pipes wrapped in gravel and geotextile filter fabric. Figure 5 presents photos of the modified bottom drainage system. These photos were obtained from TVA's FY2009 Annual Report of Waste Disposal Areas at the Bull Run Fossil Plant.

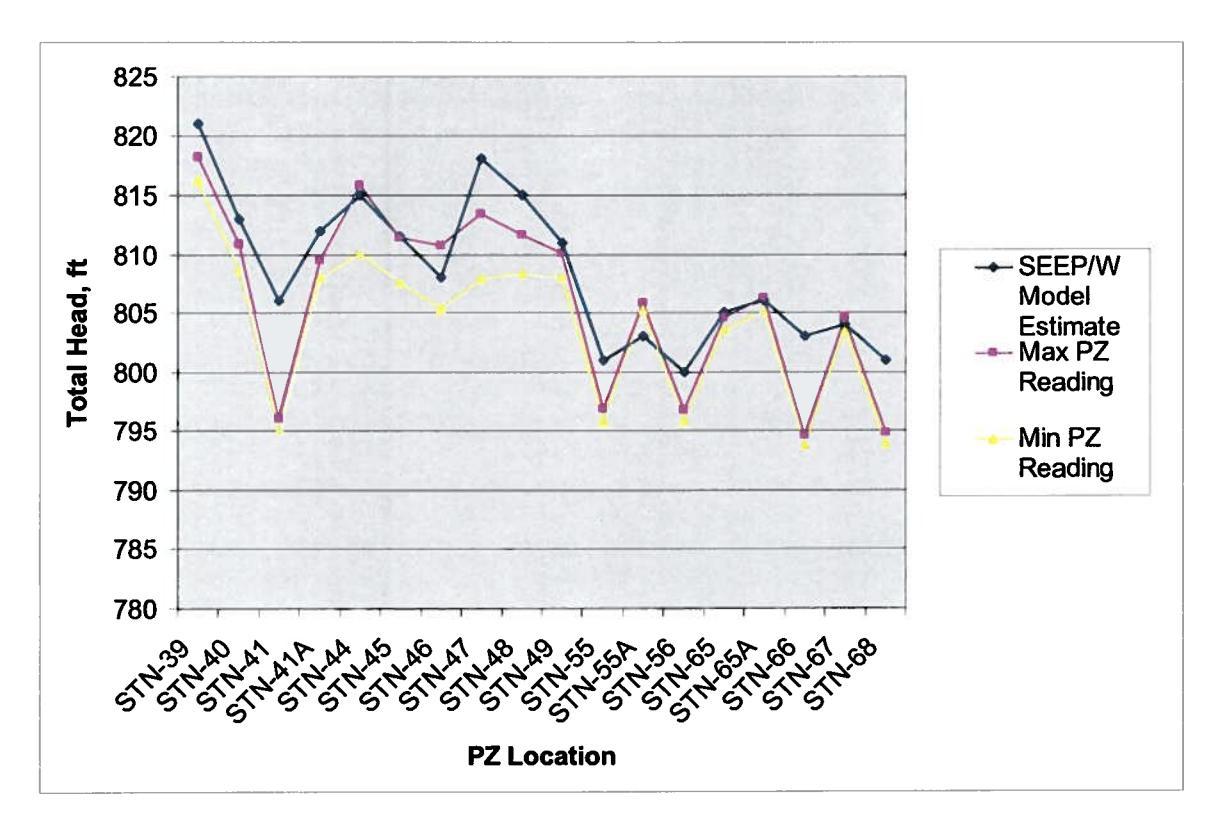
# Figure 6. Comparison between the field piezometer readings and total head predicted by the SEEP/W model

As previously discussed, piezometer data has been collected for the past seven months. Figure 6 shows a comparison between the maximum and minimum piezometer readings over the past seven months and the SEEP/W predicted total head at these piezometer locations.
