Report of Dam Safety Assessment of Coal Combustion Surface Impoundments Westar Energy Tecumseh Energy Center, Clinton, IA

AMEC Project No. 3-2106-0183.0001

November 2010

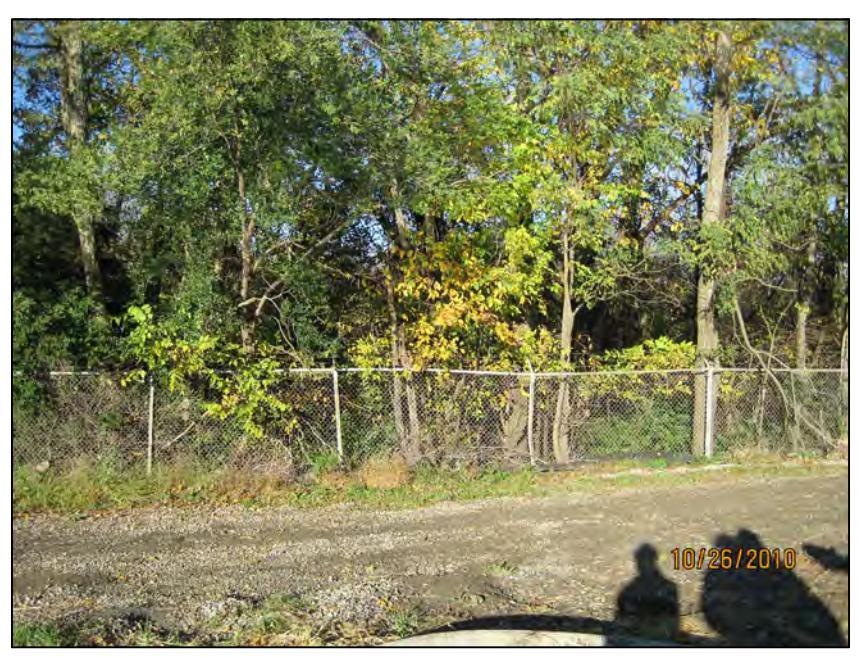
1-12 CENTRAL WEST SIDE LOOKING WEST AT TREES ON UPSTREAM SLOPE OUTSIDE FENCE

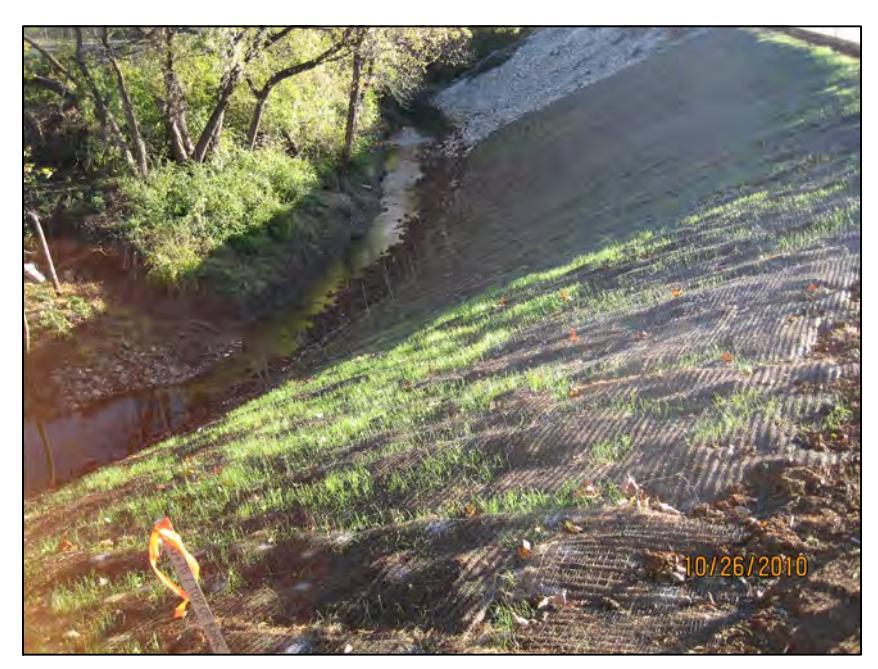
1-13

LOOKING NORTHEAST FROM NORTH CREST AT TECUMSEH CREEK AND AREA OF TREE/VEGETATION REMOVAL AND REPAIR ON DOWNSTREAM SLOPE

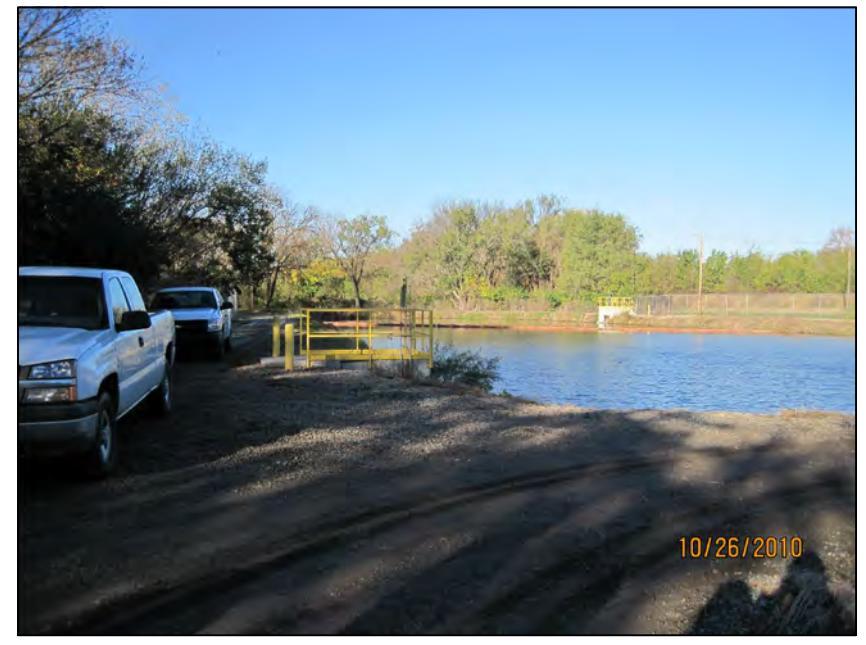
1-14 LOOKING SOUTH AT AREA 1 NORTH EMBANKMENT DOWNSTREAM REPAIR

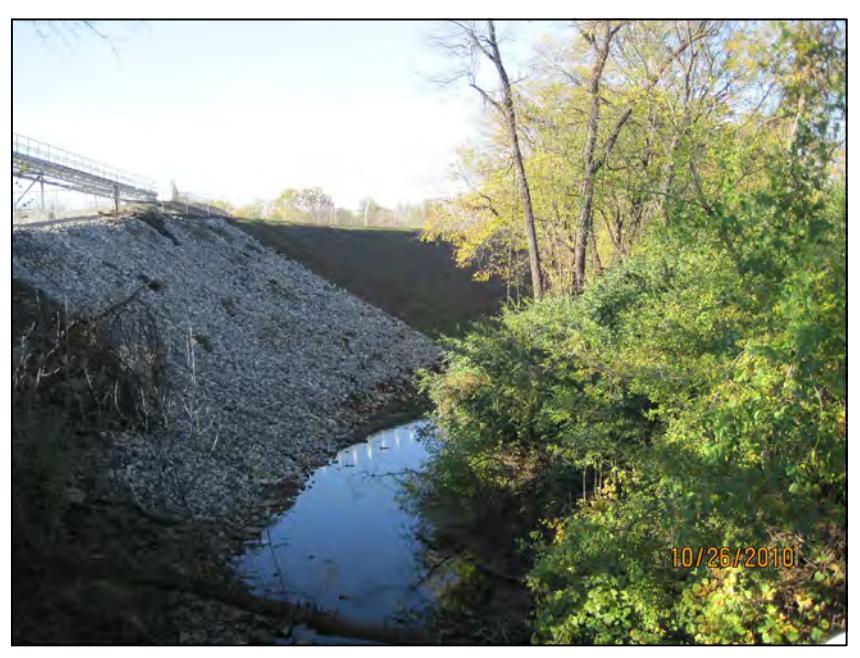
1-16 LOOKING SOUTHWEST AT AREA 1 NORTH EMBANKMENT DOWNSTREAM SLOPE REPAIR AREA

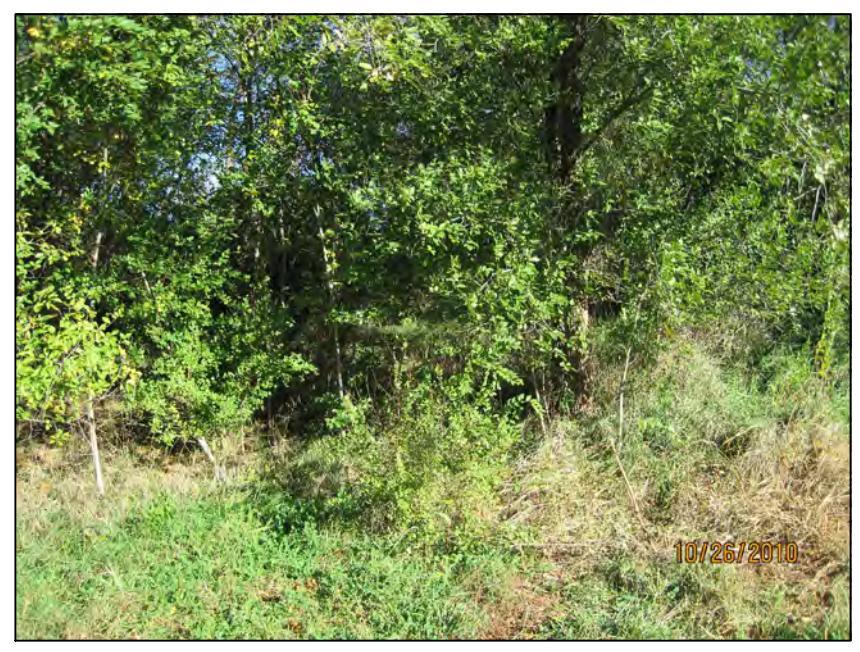
1-17 LOOKING NORTH AT TREES/VEGETATION ON DOWNSTREAM TOE OF SOUTHWEST EMBANKMENT

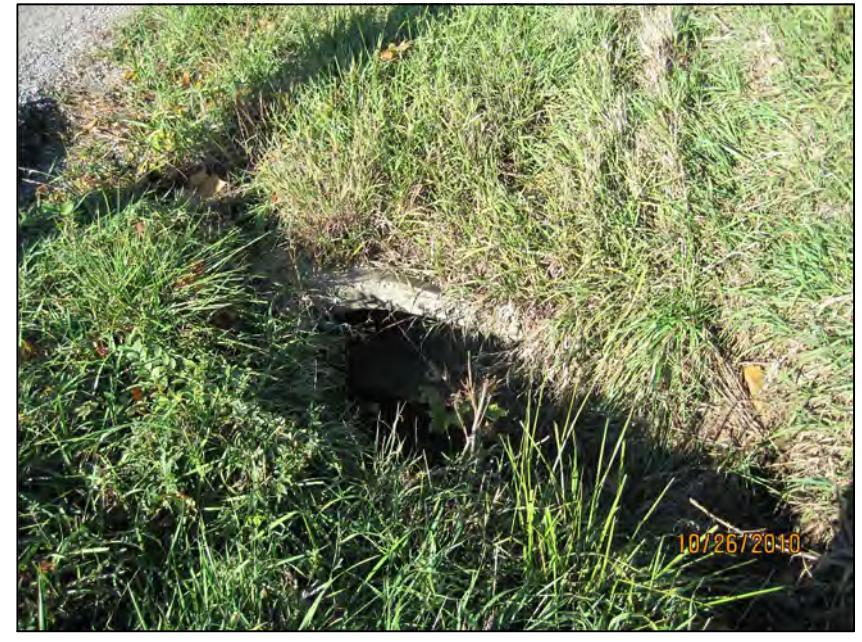
1-21 ROADWAY SWALE AT DOWNSTREAM EMBANKMENT TOE OF SLOPE

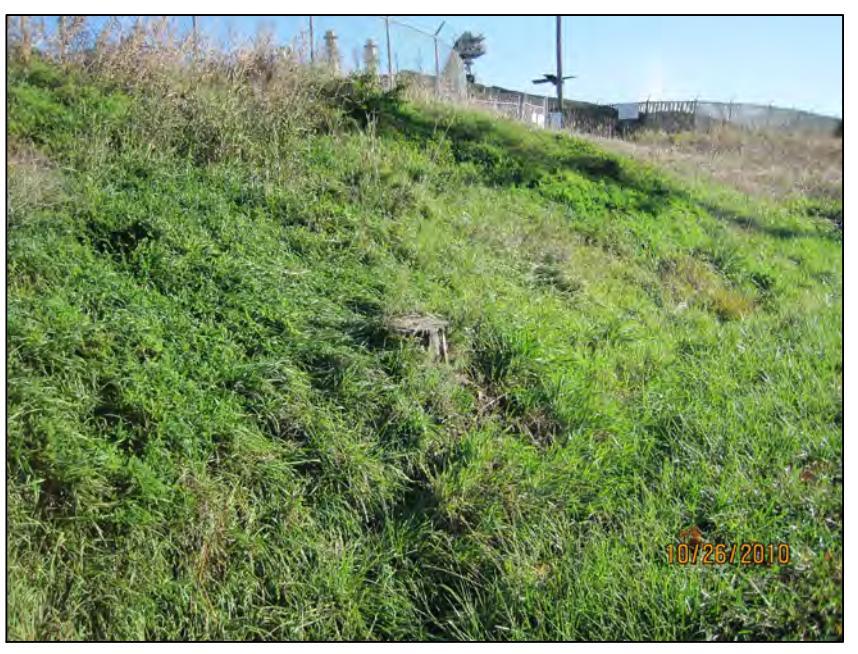
2-22 STUMP ON DOWNSTREAM EMBANKMENT FACE

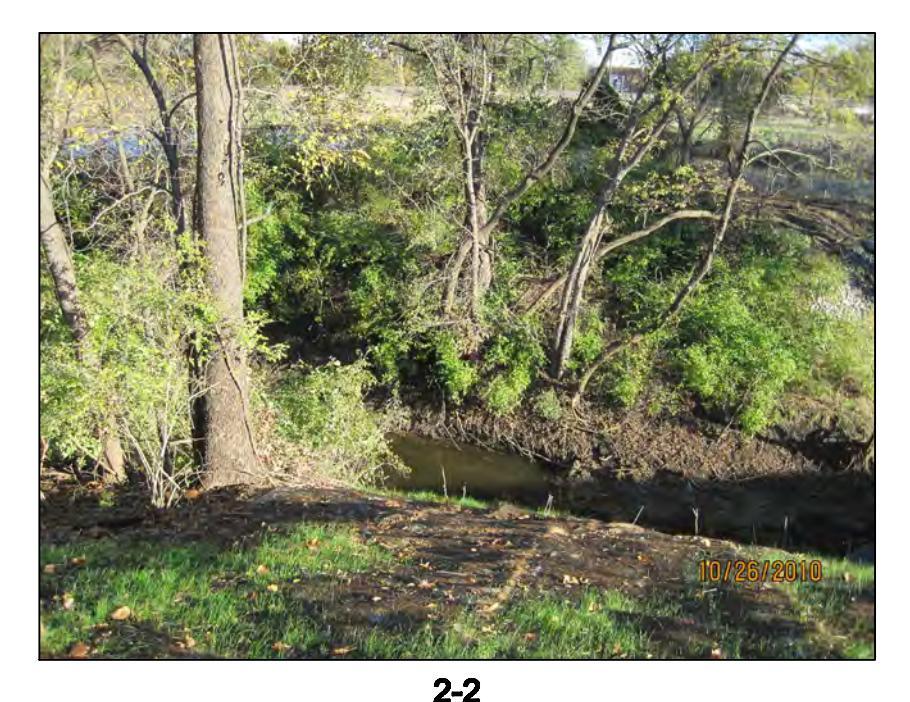
LOOKING NORTH FROM NORTH CREST AT AREA 2 SOUTH EMBANKMENT AND EXISTING VEGETATION AND TREE COVER

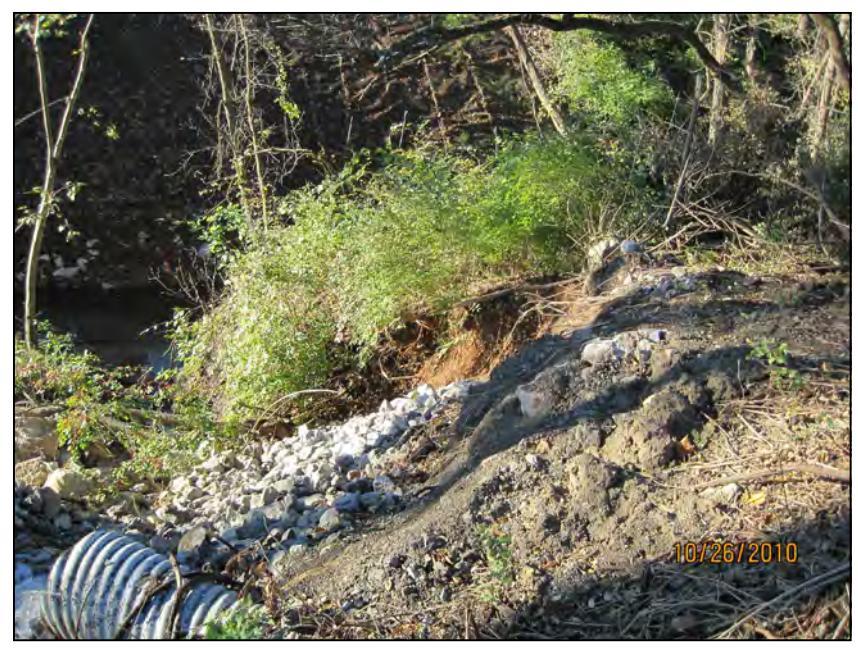
2-5 VEGETATION AND TREES ADJACENT TO KPDES OUTFALL

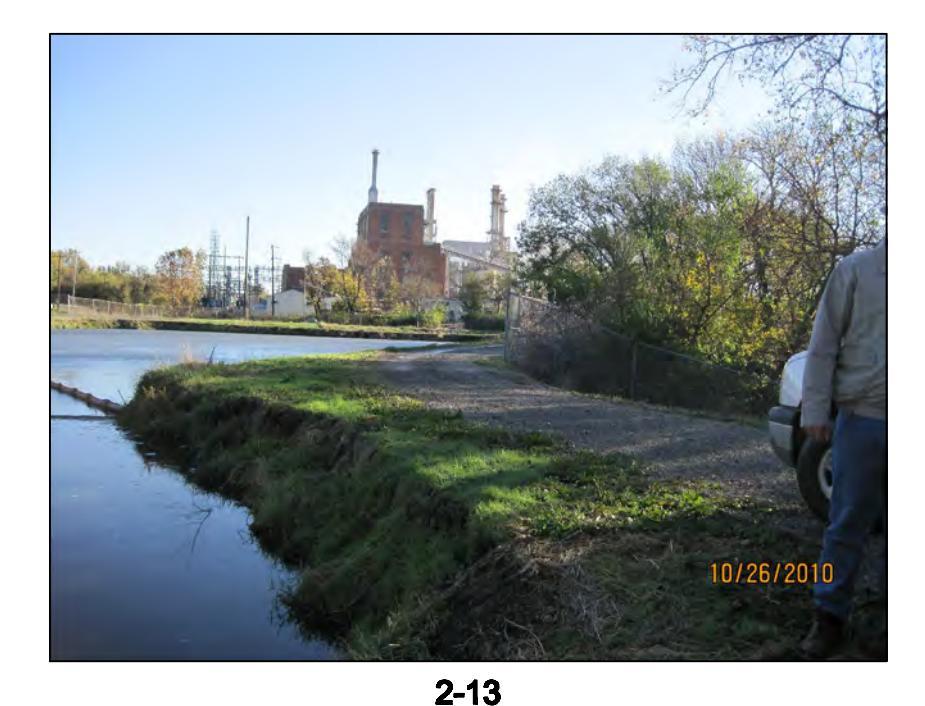
LOOKING EAST ACROSS POND AND SOUTHERN EMBANKMENT CREST-TREES AND VEGETATION VISIBLE ON DOWNSTREAM EMBANKMENT

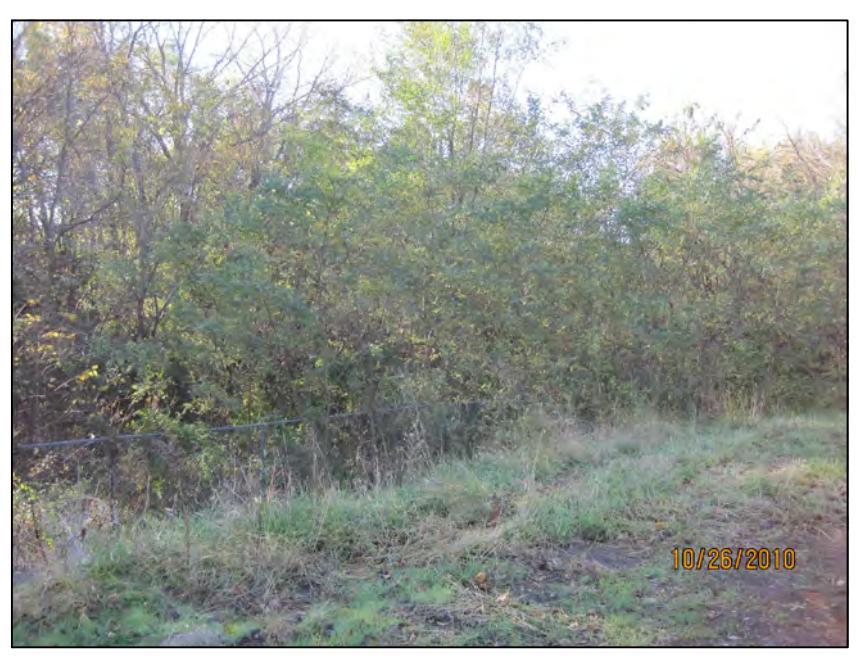
2-16 LOOKING SOUTHWEST AT TREES/VEGETATION OUTSIDE DOWNSTREAM EMBANKMENT
