Restoration of Tidally Restricted Salt Marshes Rumney Marsh in Massachusetts:

Balancing Flood Protection with Marsh
Restoration by use of Self-Regulating Tidegates

Edward Reiner - EPA New England

New England Association of
Environmental Biologists
March 17, 2010
Newport, RI

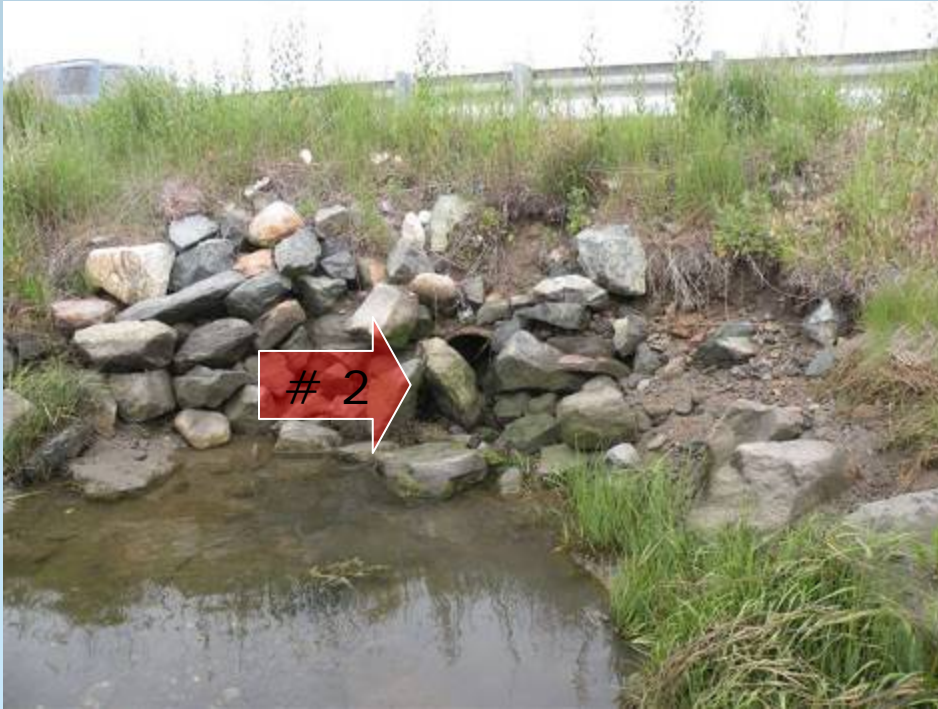
Culvert Problems

Riprap Blocking Culvert
Inlet

Culvert Outlet
Blocked

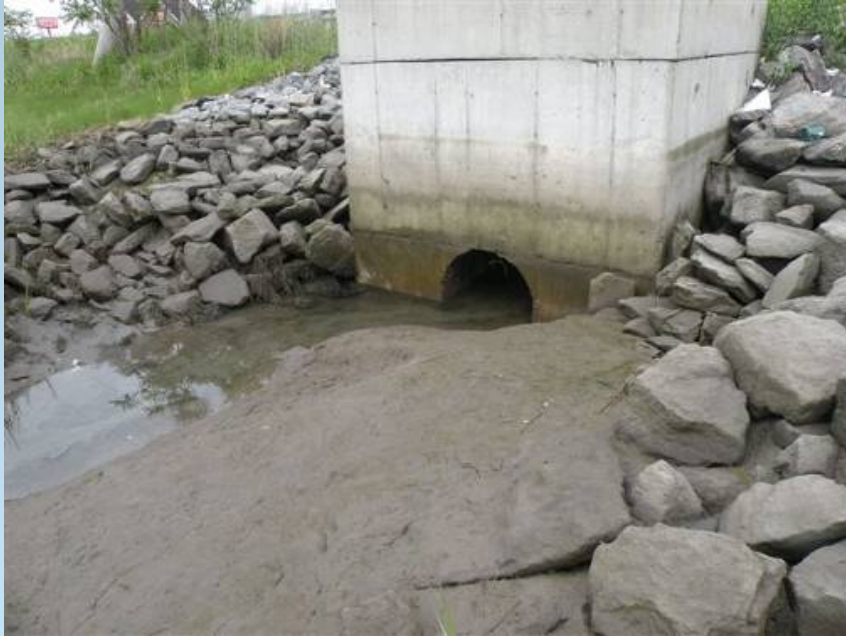
SRT 3 Inlet

Sediment Problems

Sediment Removal
and Pipe Repairs are Needed

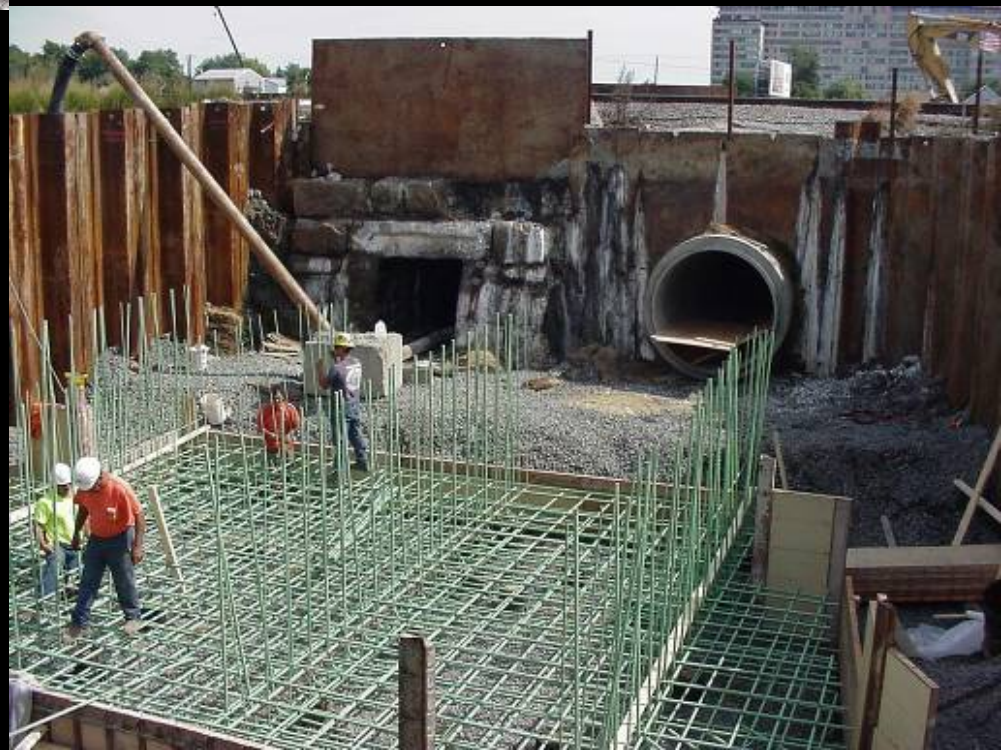
Engineering Error

The concrete vault was too narrow to allow correct SRT adjustment

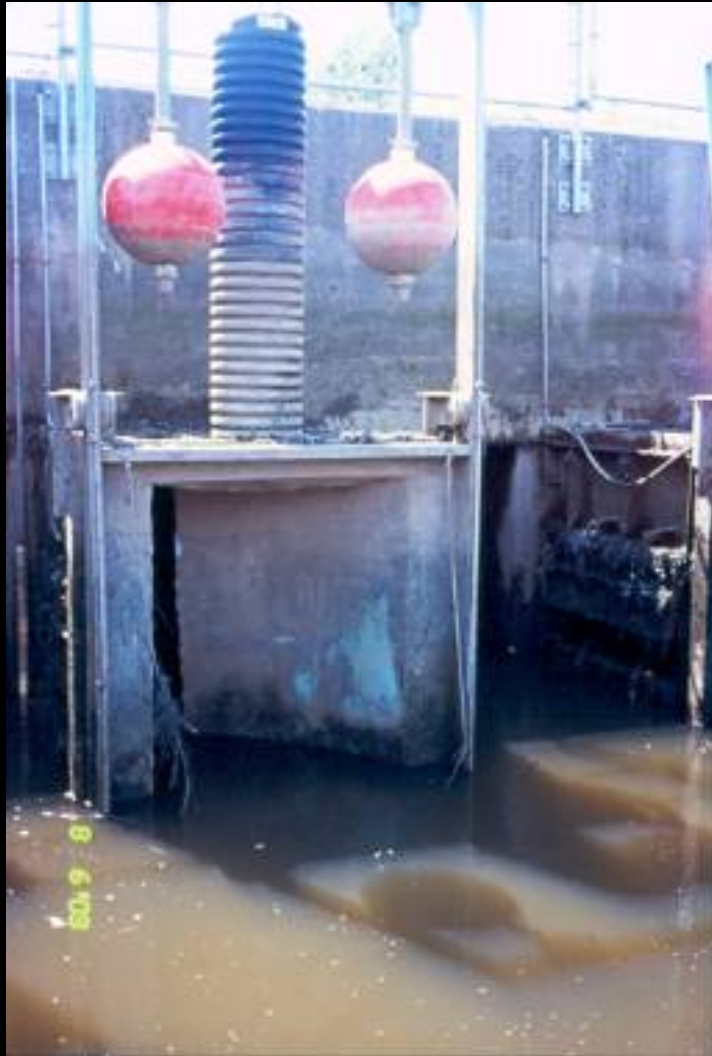
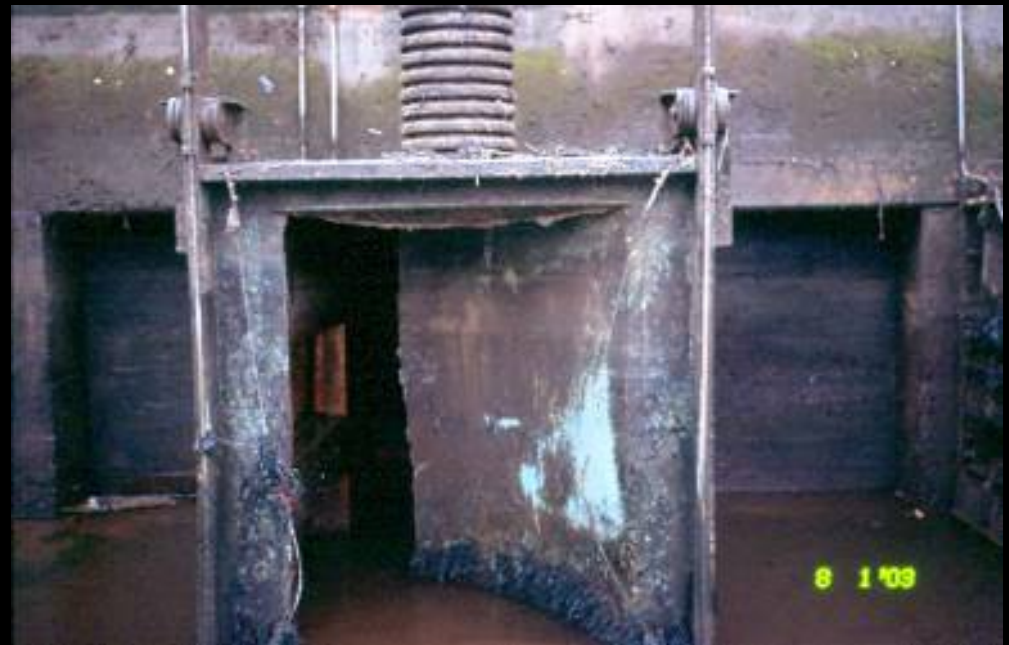
Manufacturing Design Error

Replacement Gates

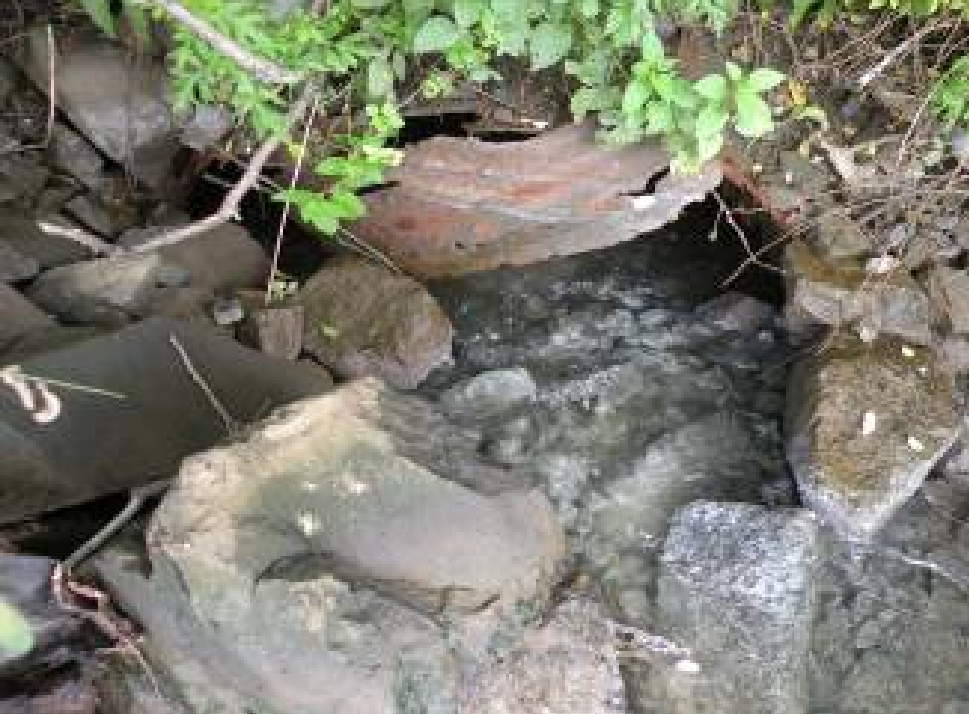
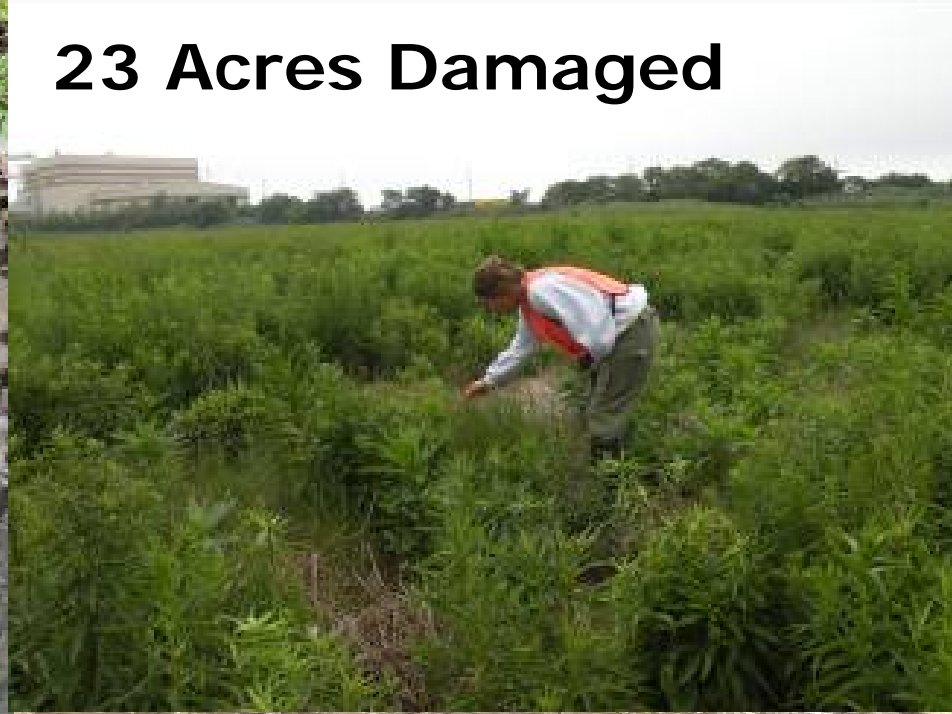
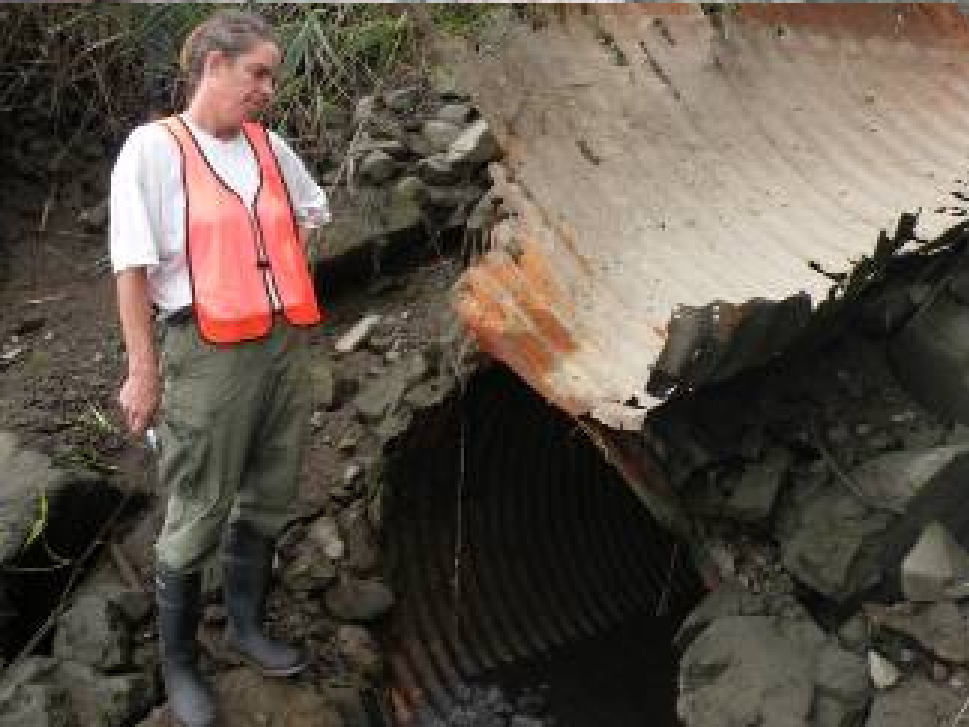
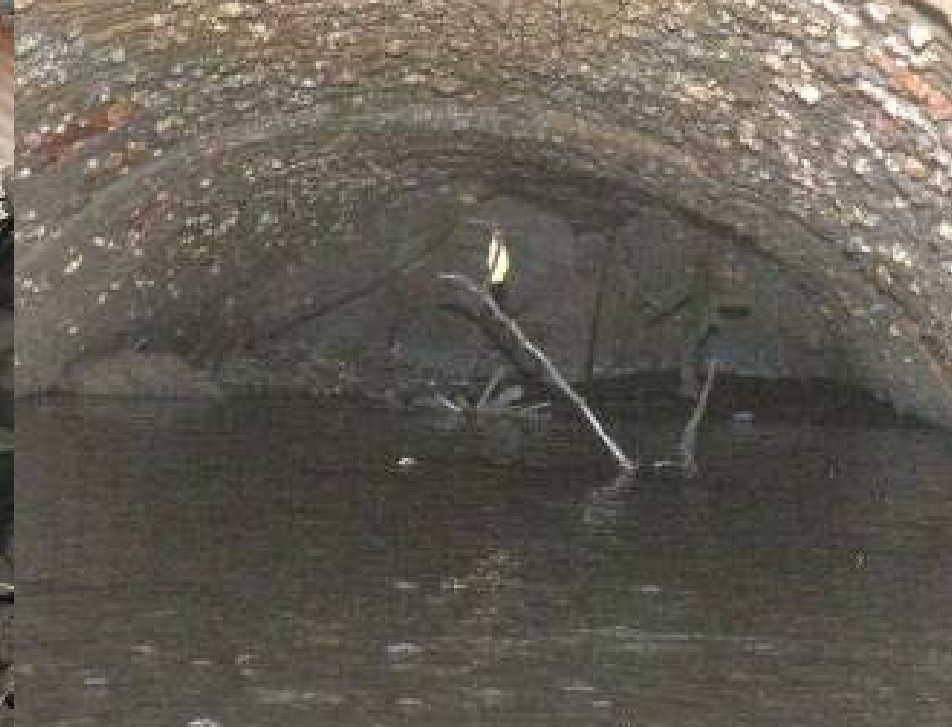
23 Acres Damaged

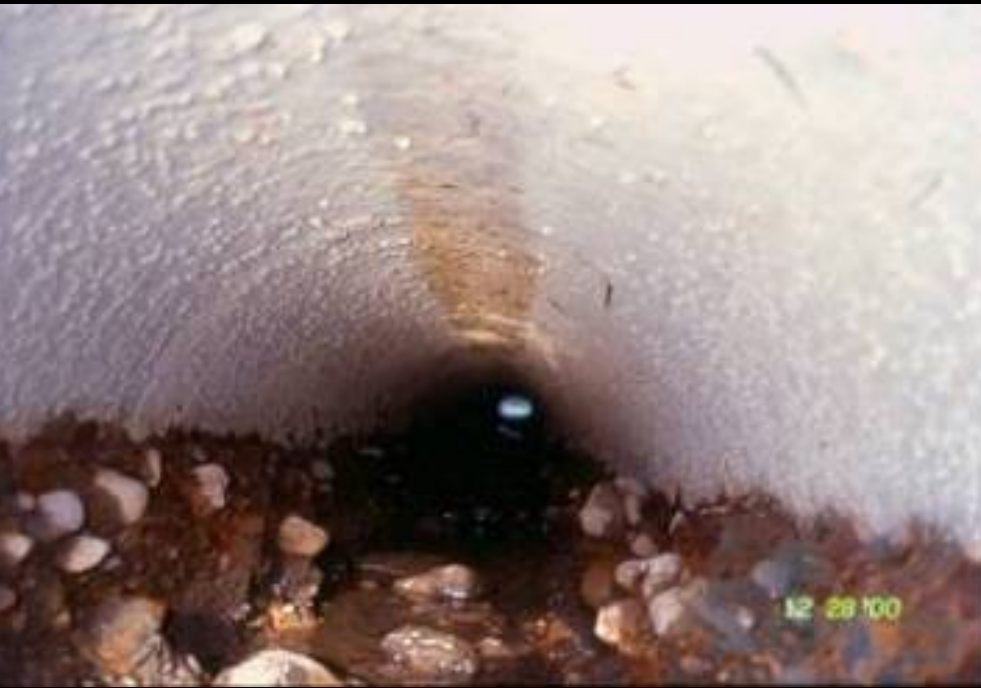
24" Round Culvert
(inadequate flow)

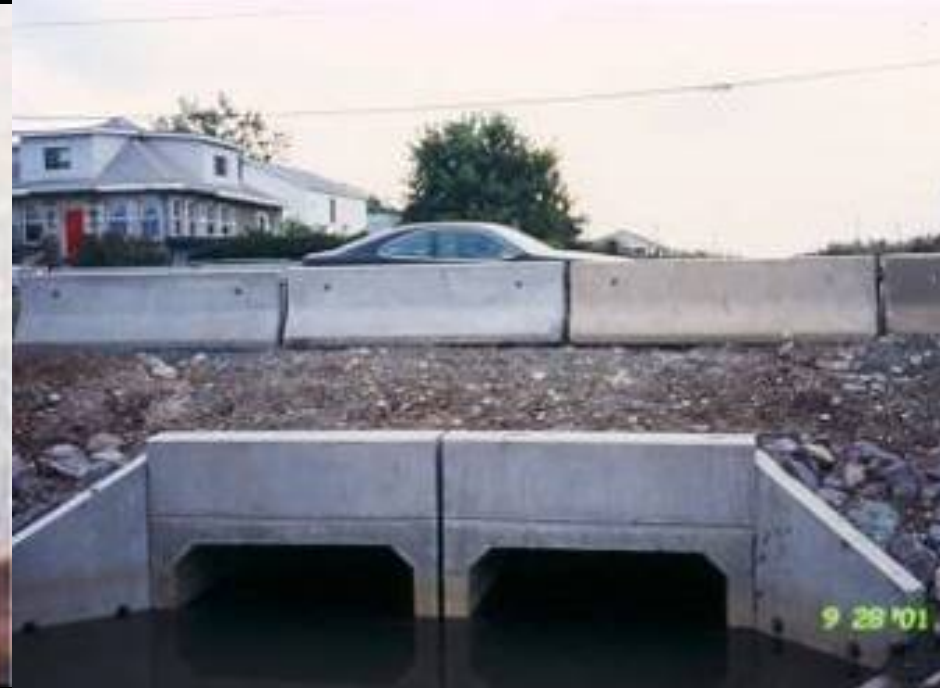
New Twin Box Culvert
(adequate flow)

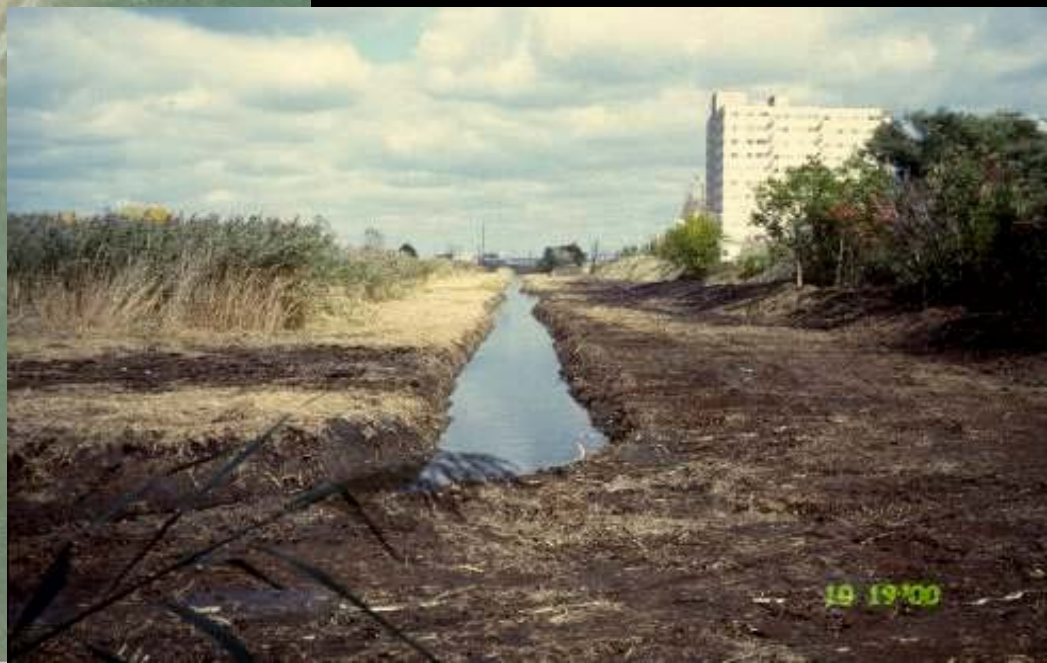
Insufficient
Culverts

Route 1A
Culverts 3, 5 & 6
Need
Replacement

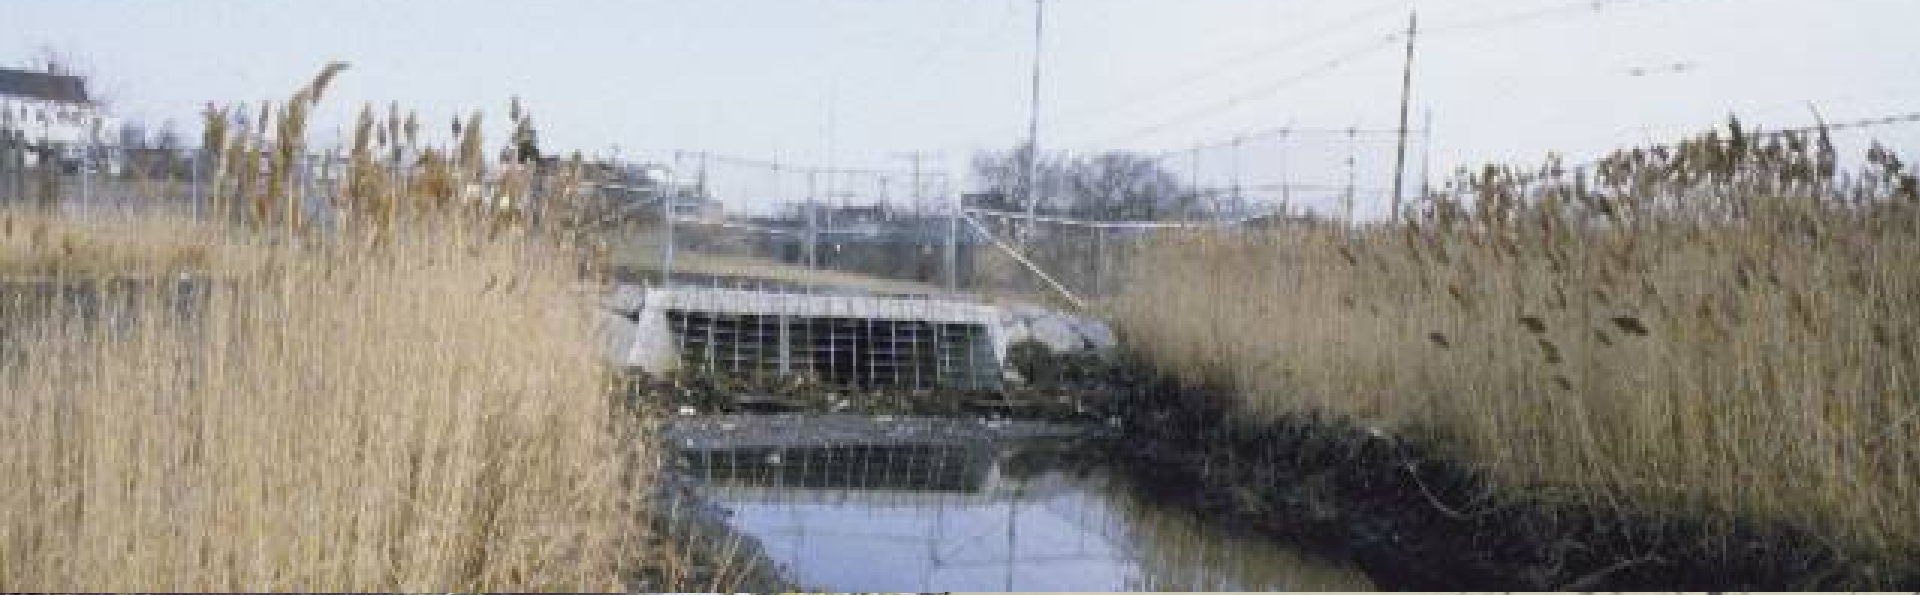
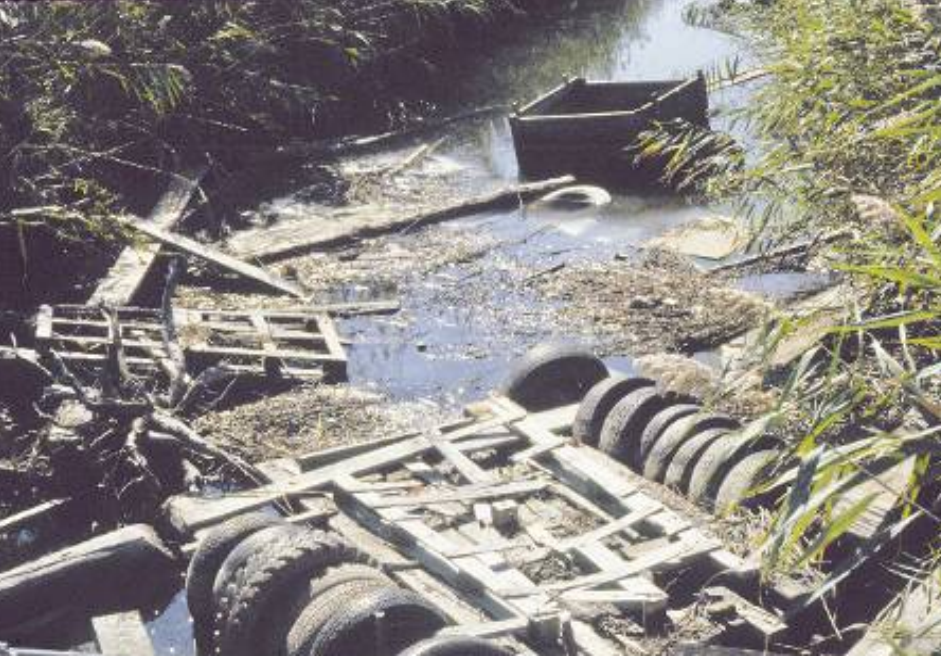
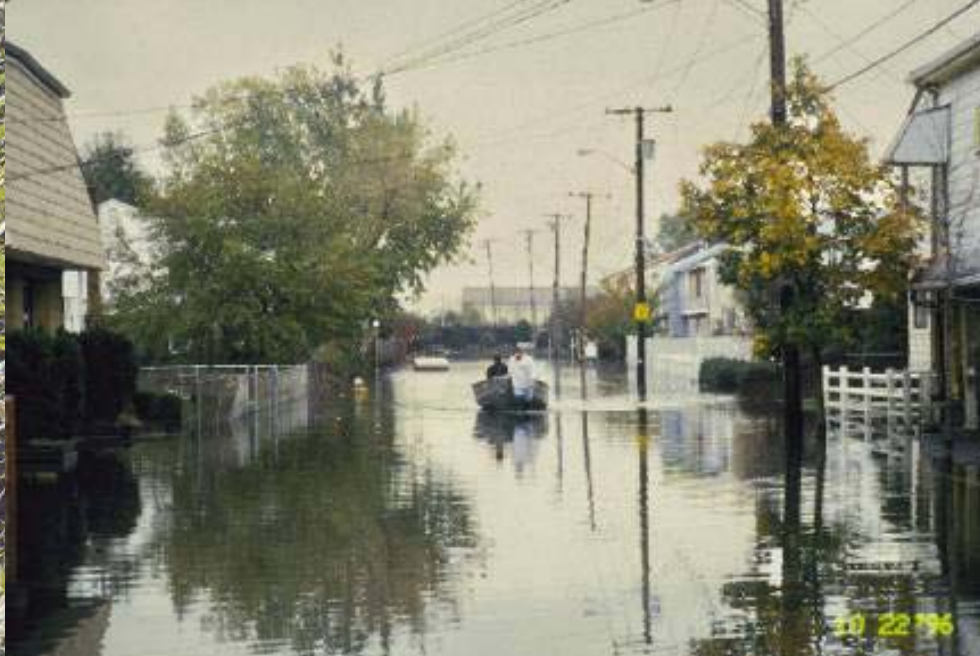
Trash Racks Require Cleaning
