EPA Dive Surveys to Support Superfund pre- and post-Dredging Data Needs, 2004-2011

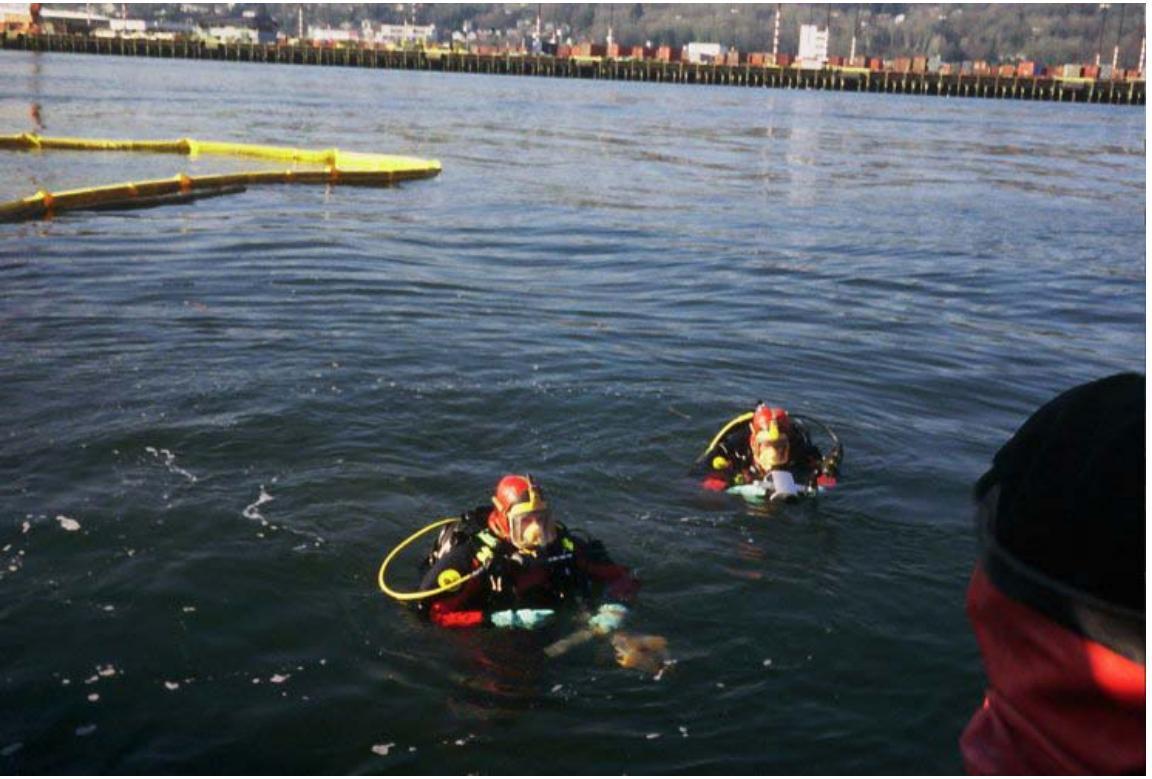
Divers preparing to conduct a video survey in the Duwamish East Waterway.

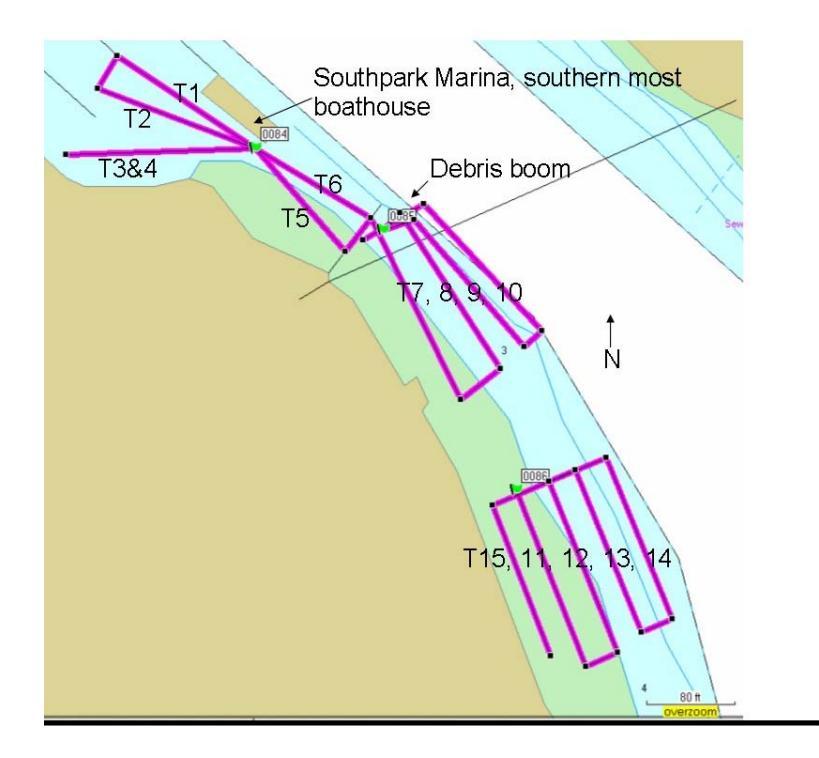
T117 Survey area

At T117, diver investigations included surveying transects pictured below and relaying objects found to the project manager.

At T117, divers found very little debris except at the toe of the bank slope in the marina.
