EPA Region 10 Dive Unit

Disposal of Dredged-material at Open-water Sites 1979-2013

Chetco ODMDS

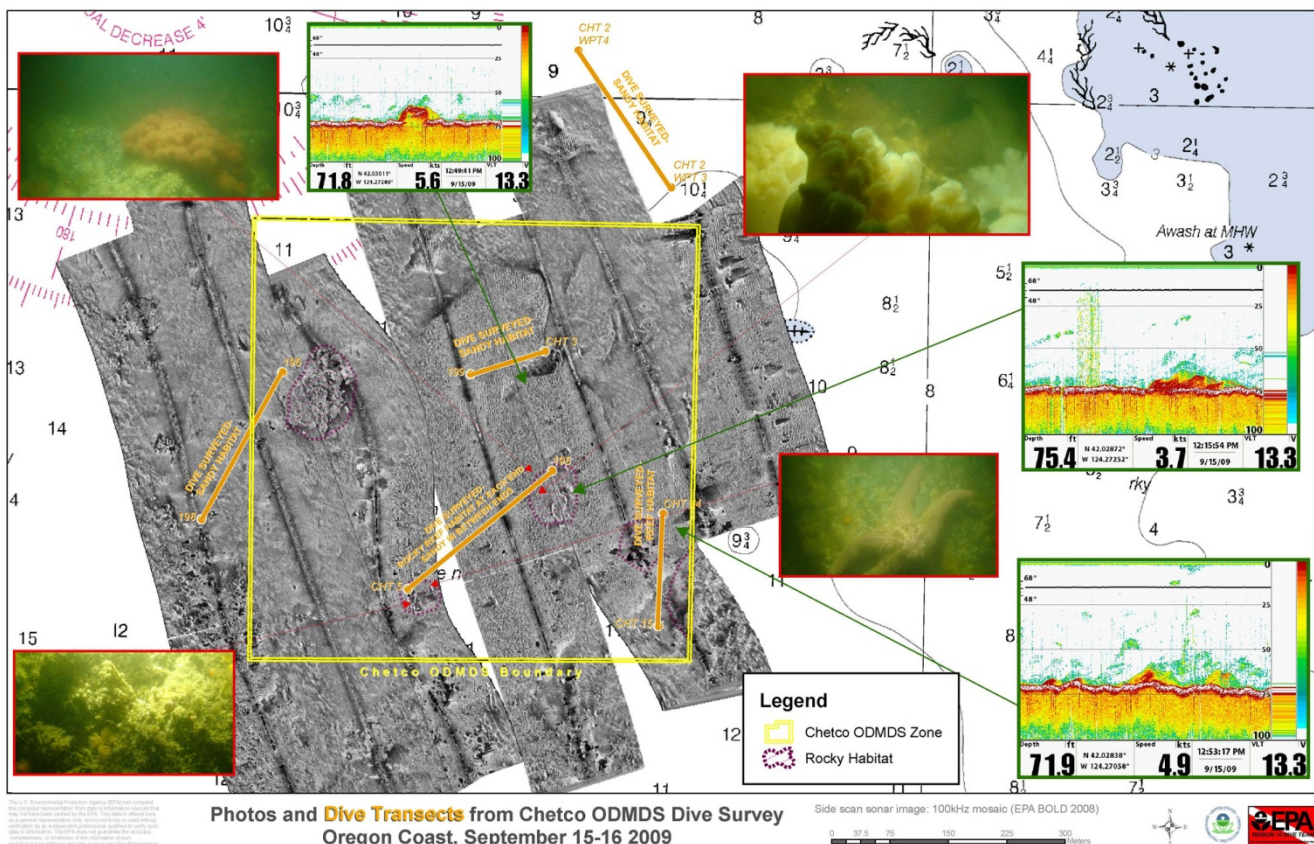
2008 sidescan of the Chetco River ODMDS off the OSV Bold

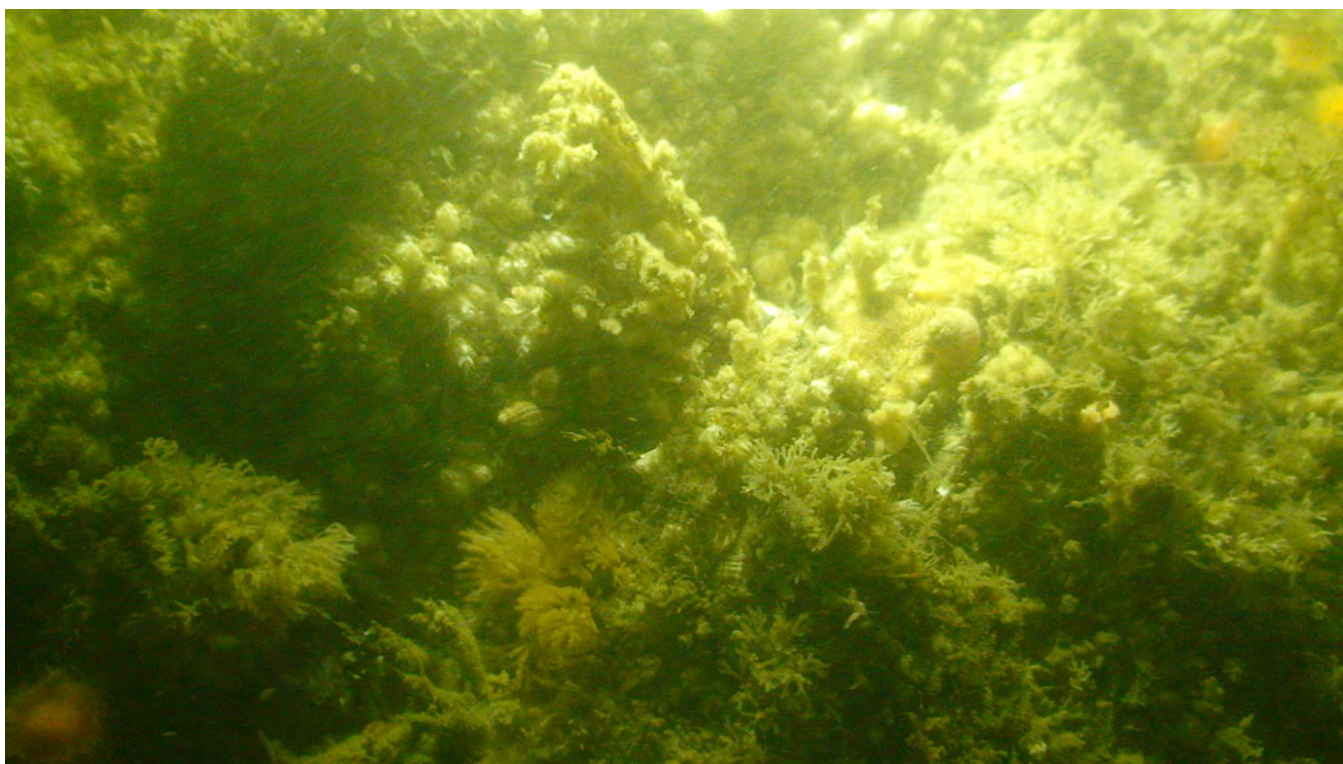
Photo of a variety of marine life, including hydroids (brown plant looking material) and whelks. This photo was taken near the center of the ODMDS on a large reef area. The improved 2 foot visibility was found over one meter above the seafloor, away from the moving sand on the bottom.

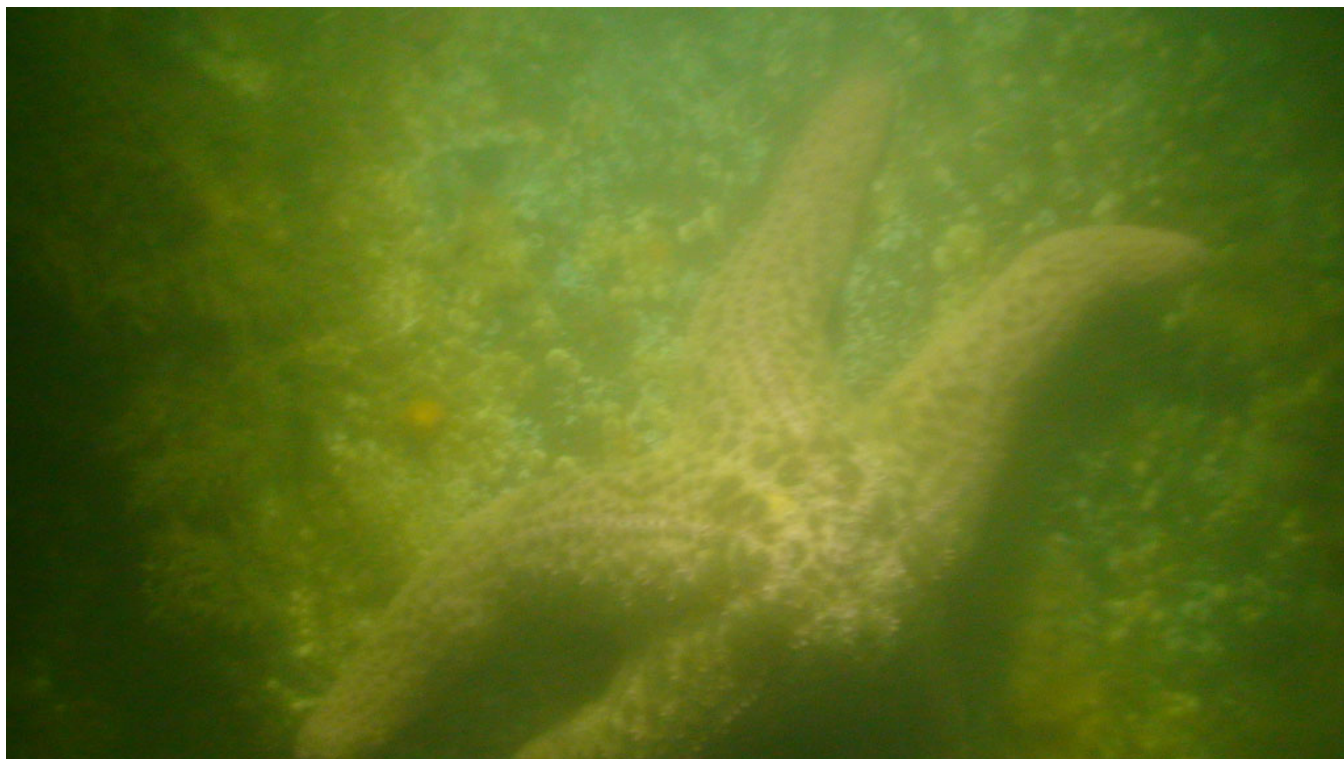
View of a seastar (*Pisaster brevispinus*) attached to the rocky reef within the ODMDS

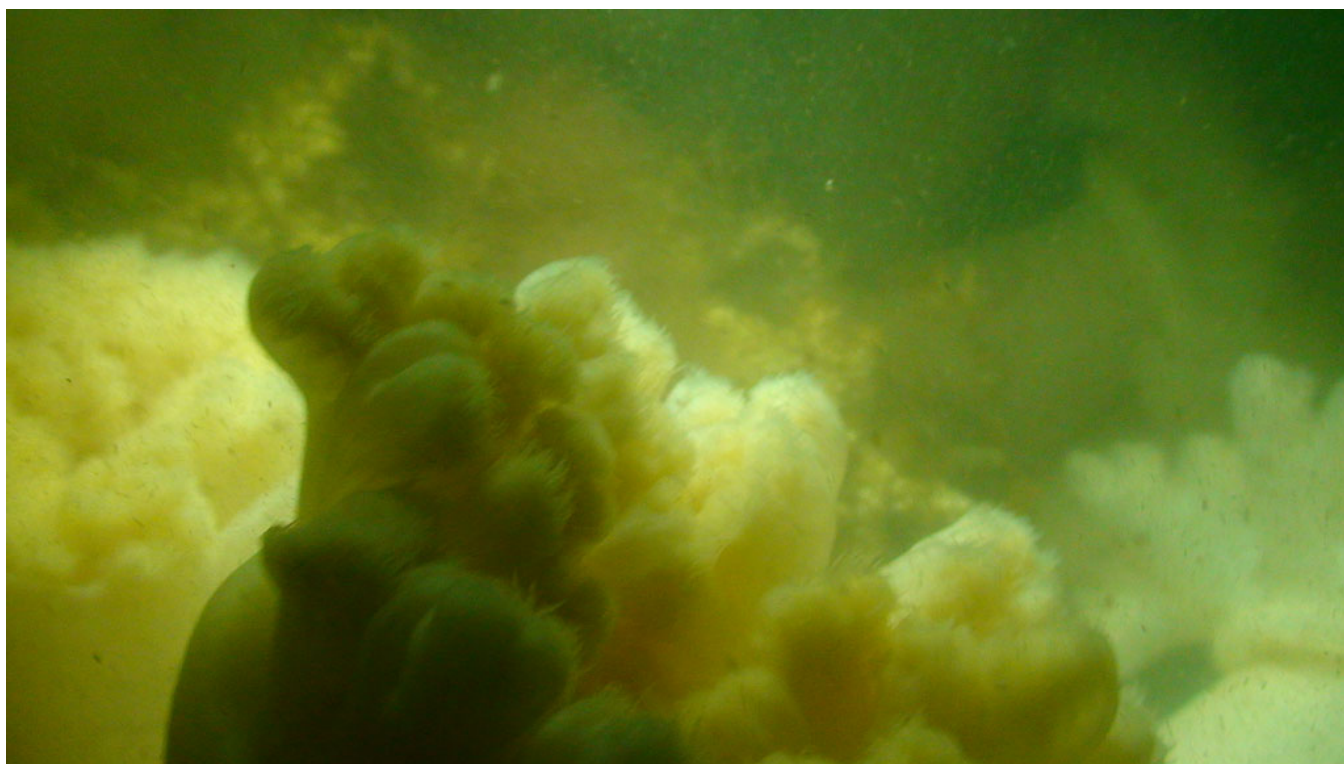
Photo of a variety of anemones attached to the reef.

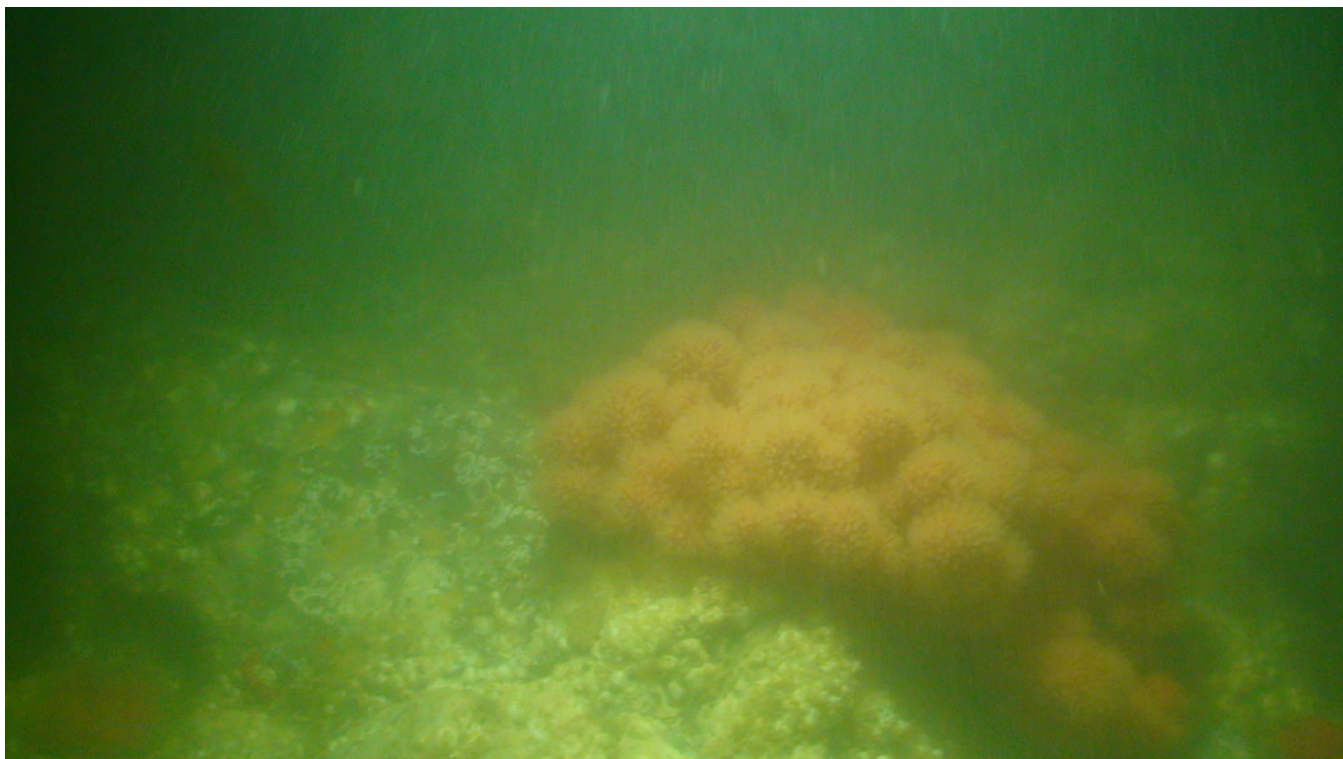
Photo of soft coral (*Gersemia rubiformis*) attached to the reef.
