US EPA ARCHIVE DOCUMENT

# Situation Photo Log

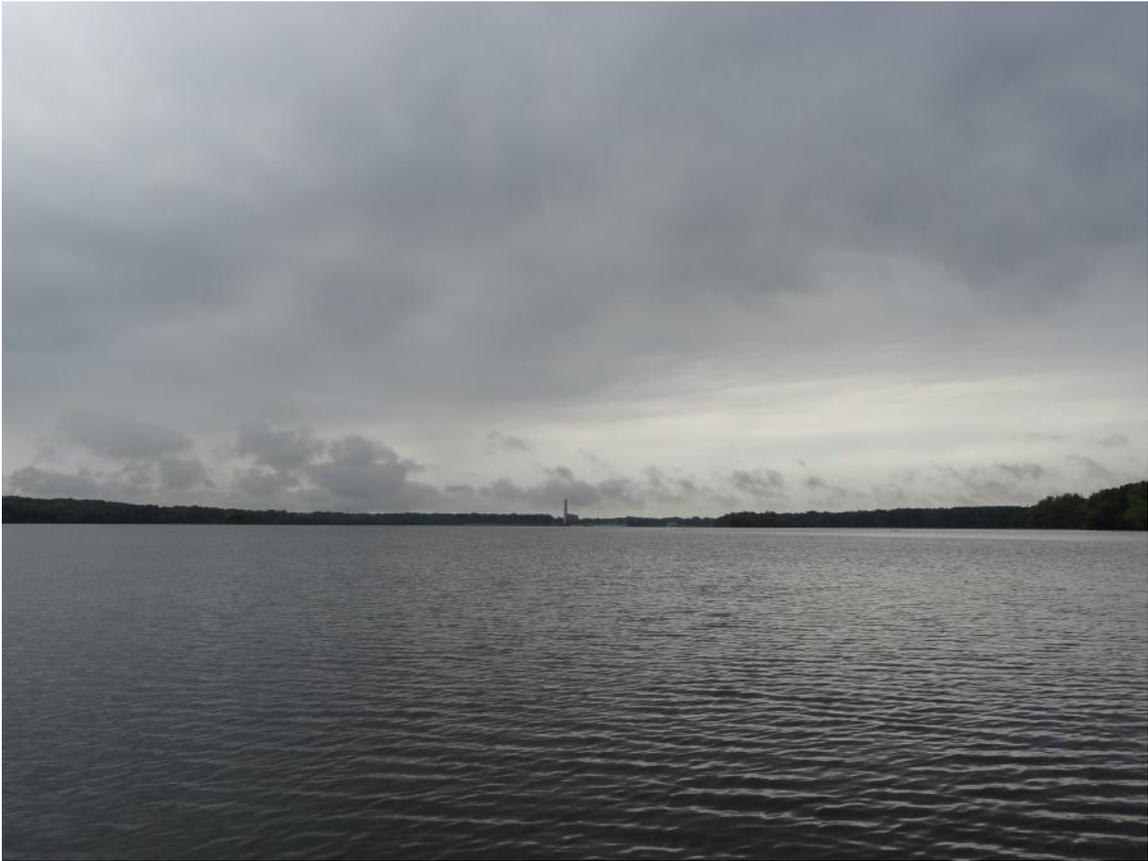
1. Morrow Lake no sheen observed in main channel.

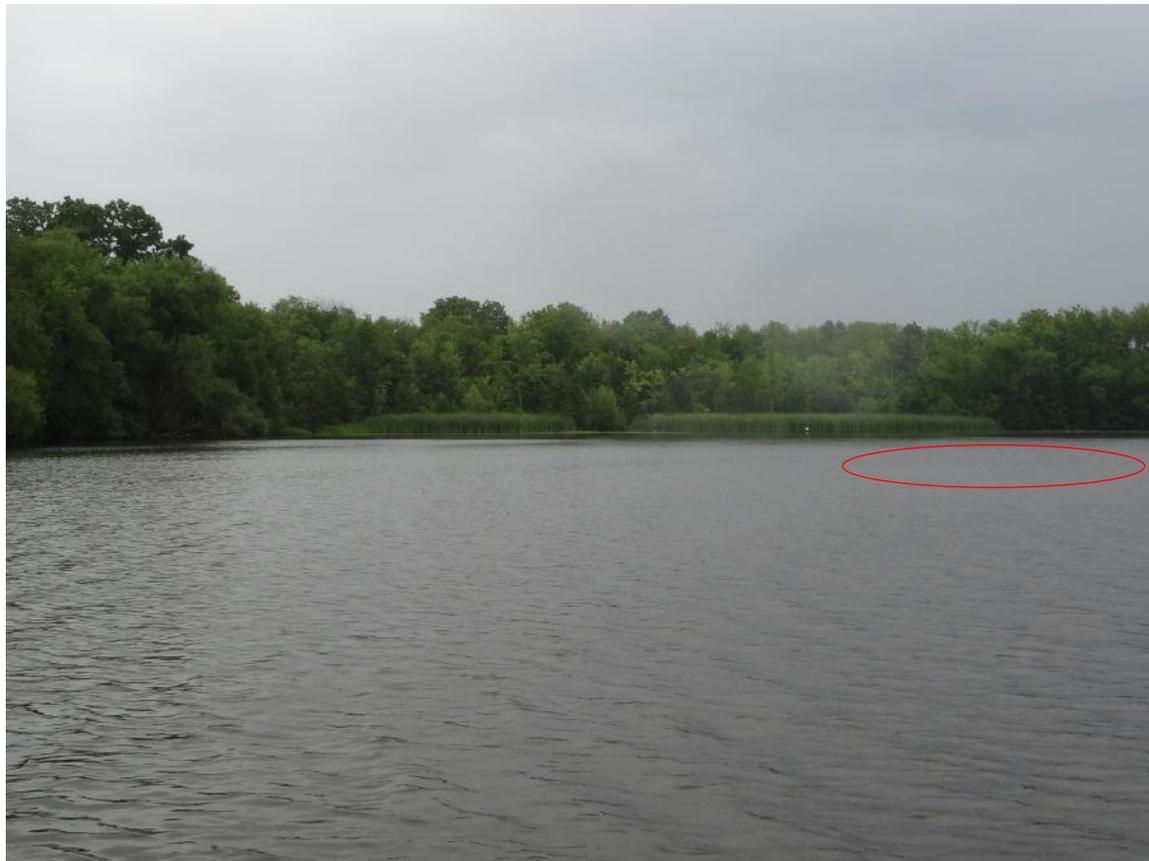
2. Morrow Lake North Cove, area where sheen was observed.

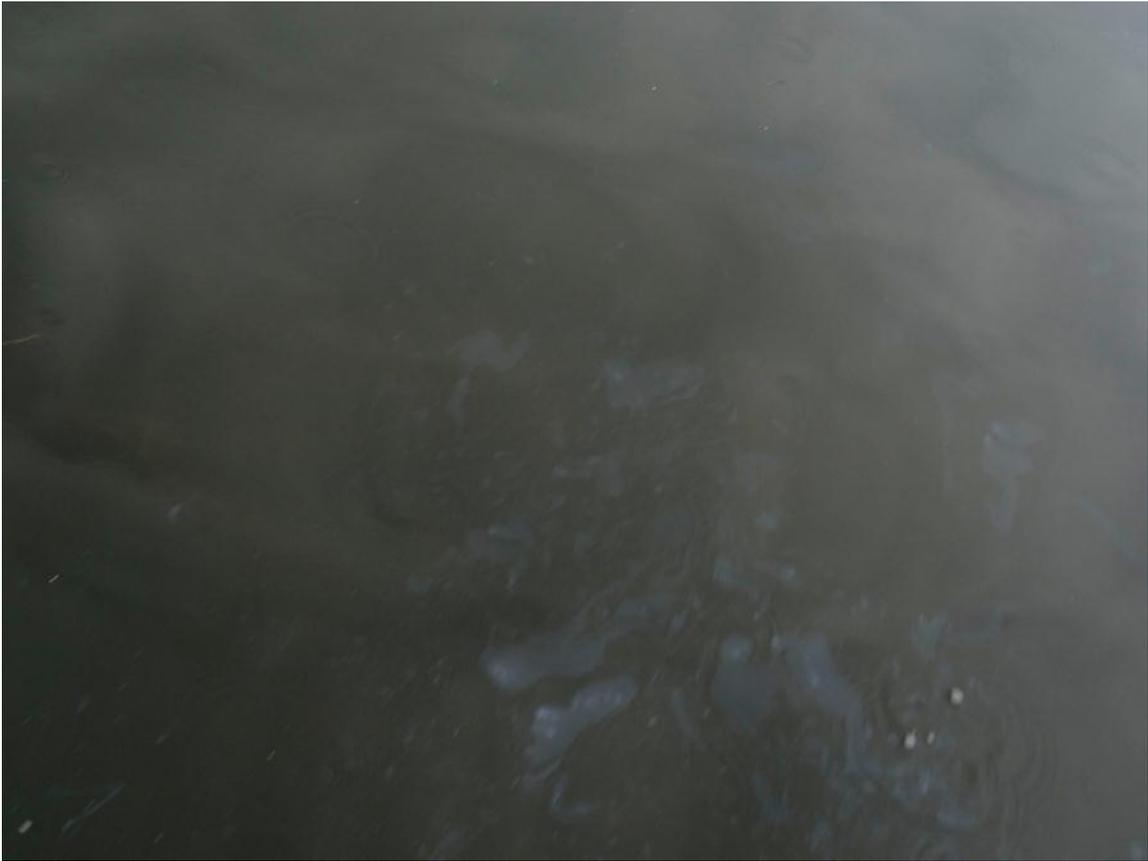
3. Morrow Lake North Cove, sheen observed.

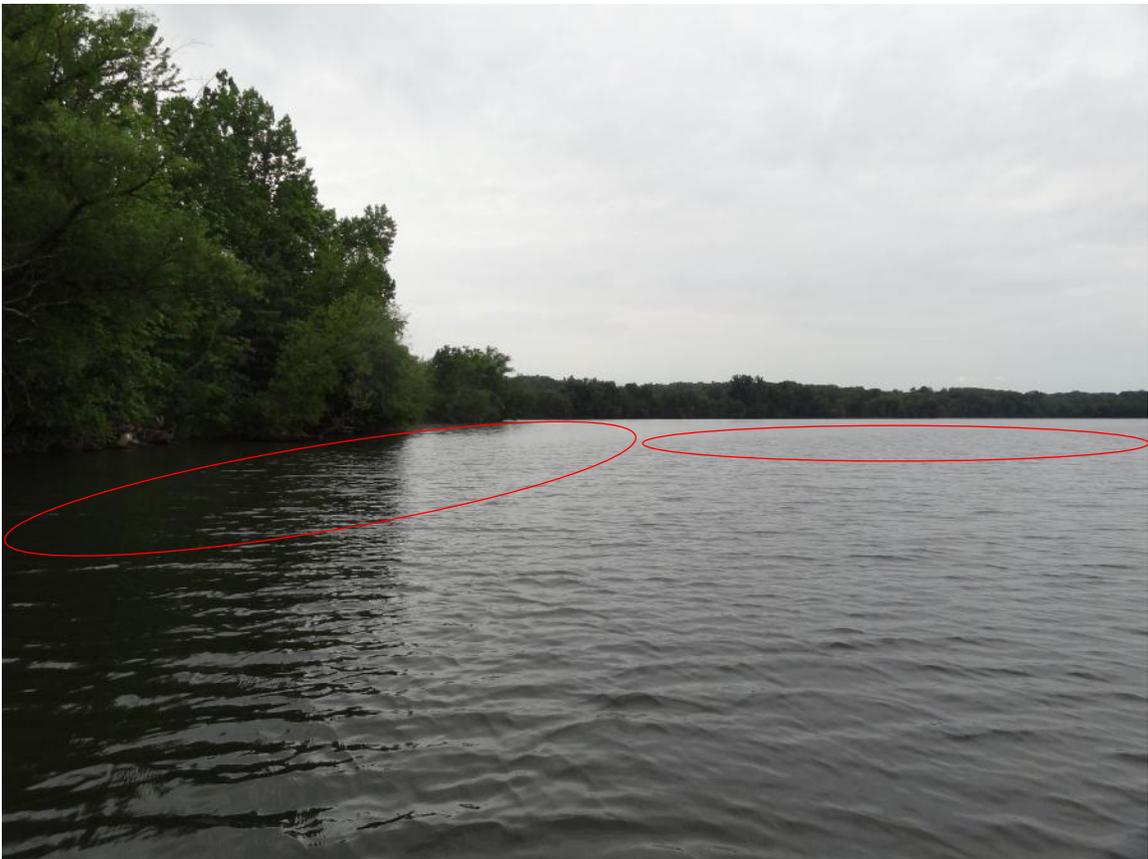
4. Morrow Lake South Cove, areas where sheen was observed.

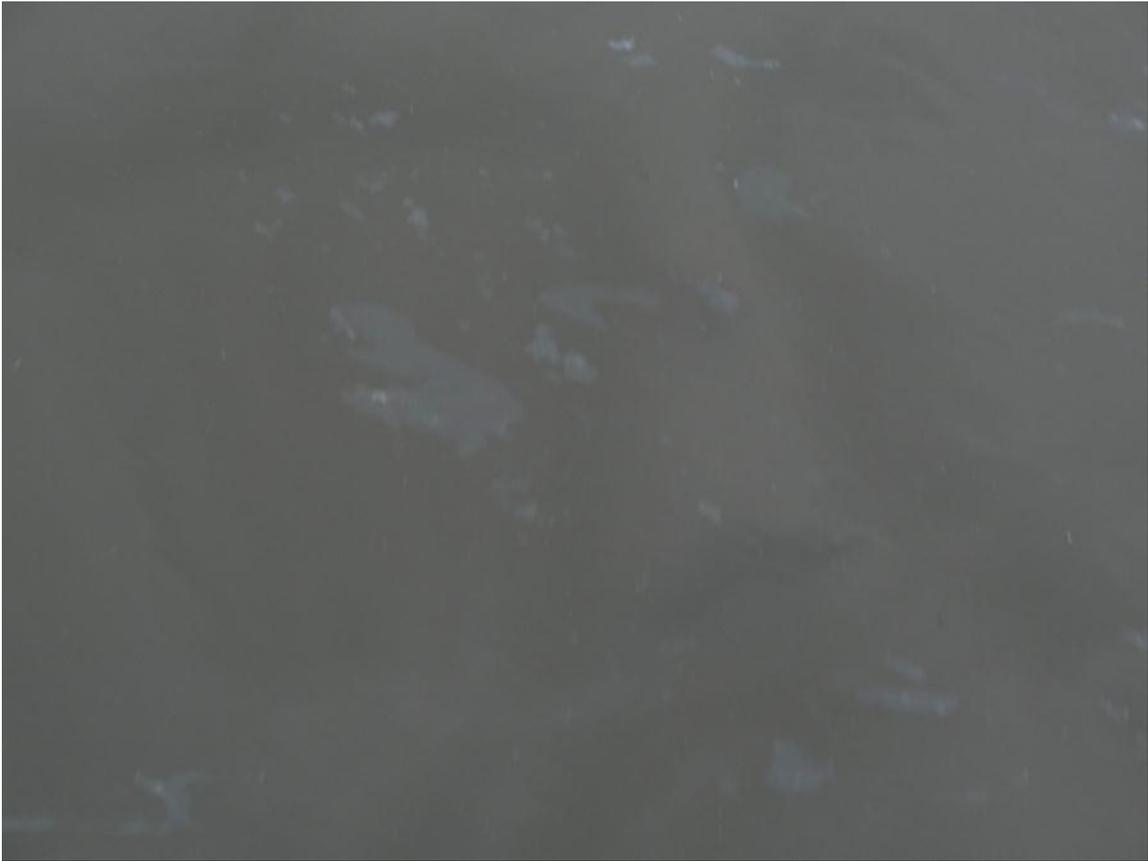
5. Morrow Lake South Cove, sheen observed.

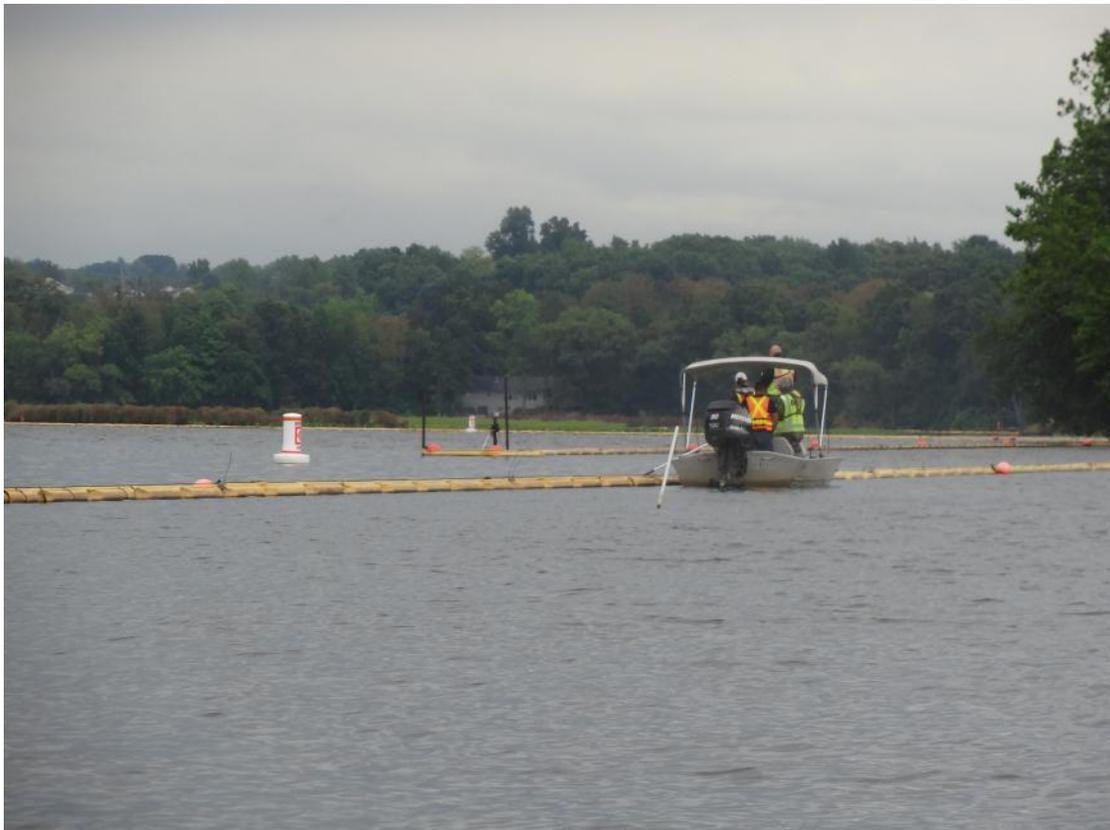
6. Morrow Lake Delta observed poling crew.

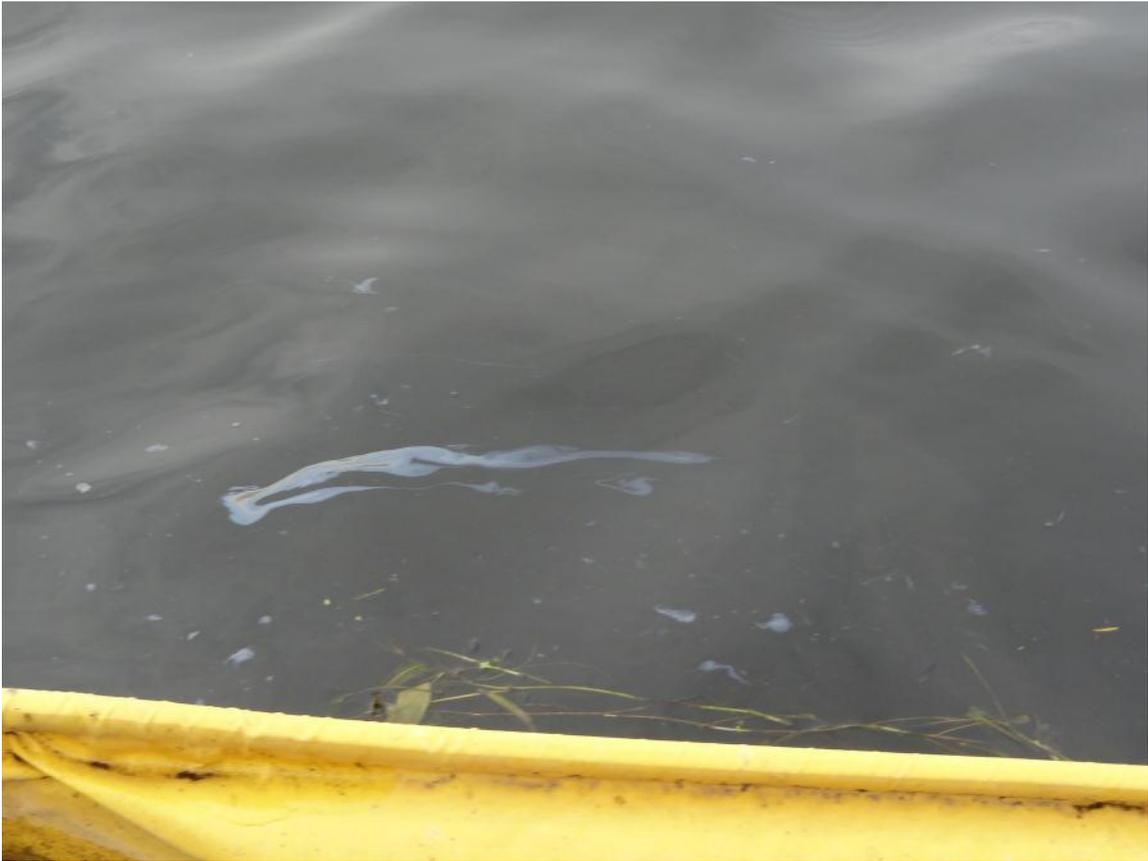
7. Morrow Lake Delta observed sheen along Gate C.

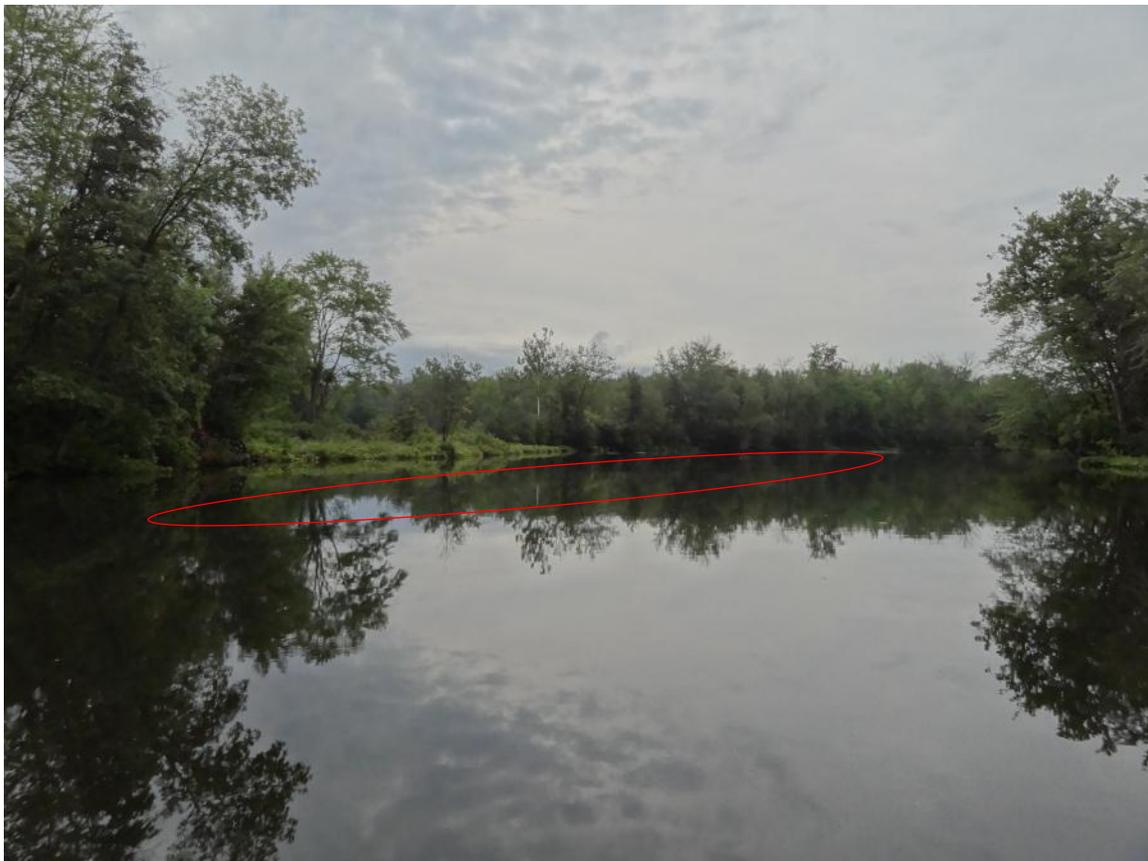
8. MP36.25 – MP 36.50 LDB area where sheen was observed, operations was notified.

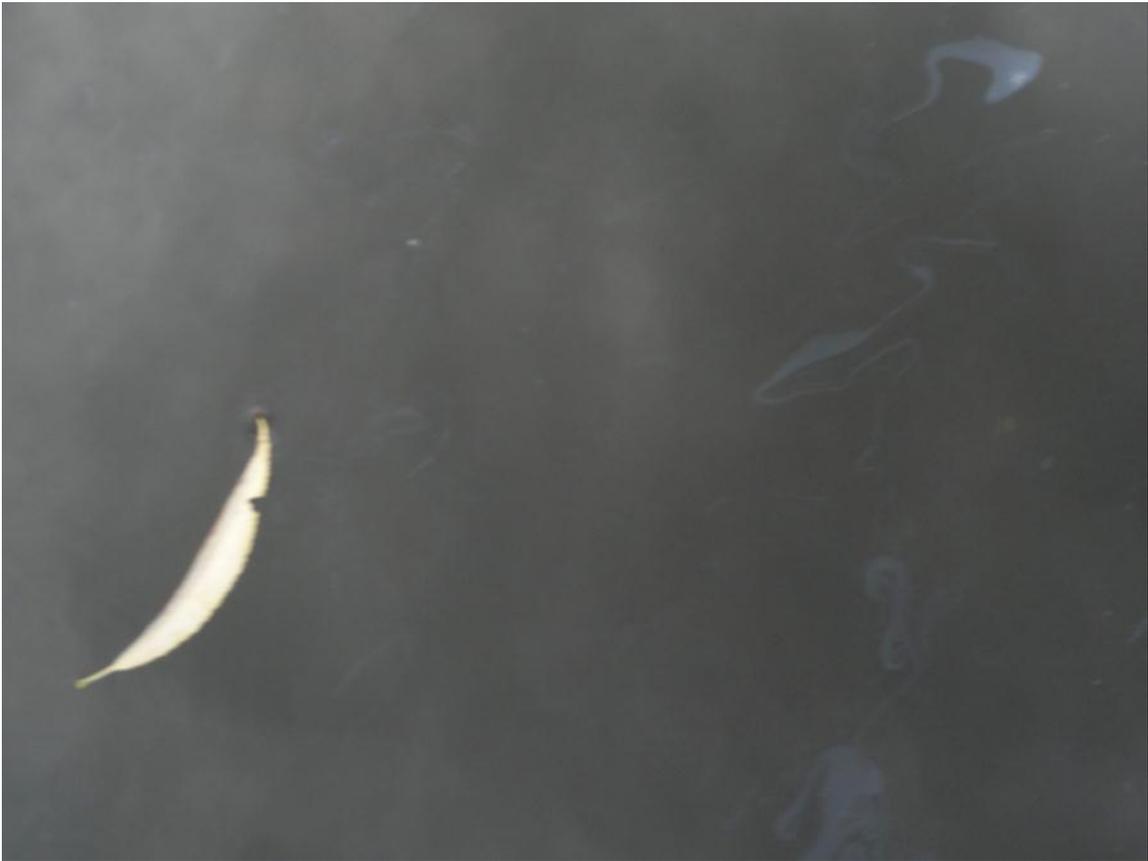
9. MP 36.35 LDB sheen observed.

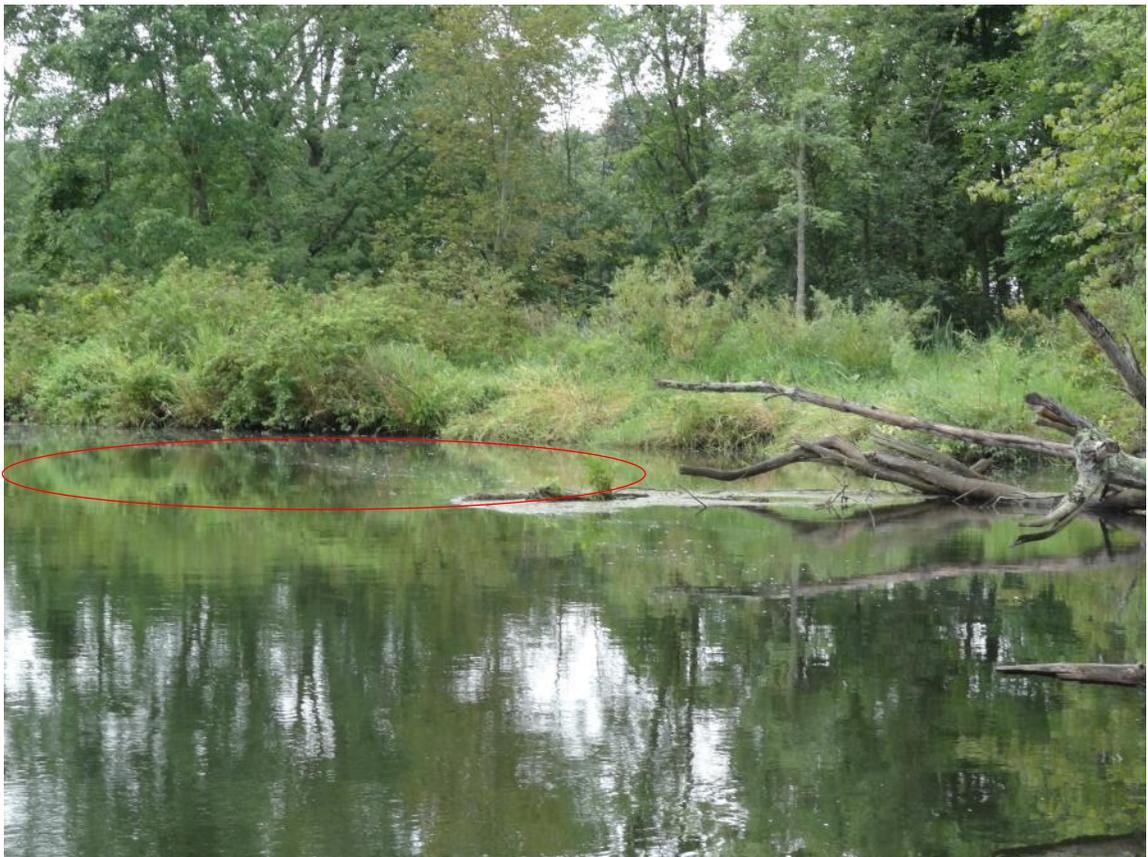
10. MP36.25 RDB area where sheen was observed.

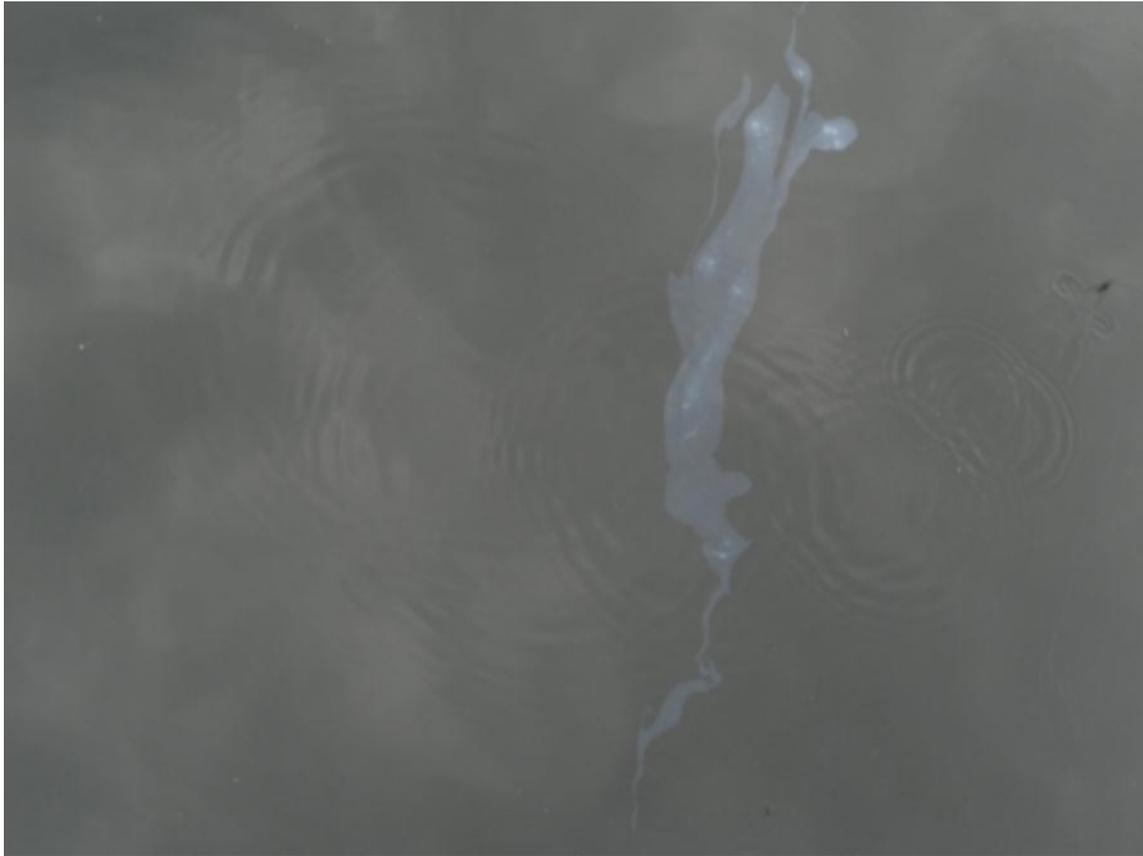
11. MP36.25 RDB sheen observed.

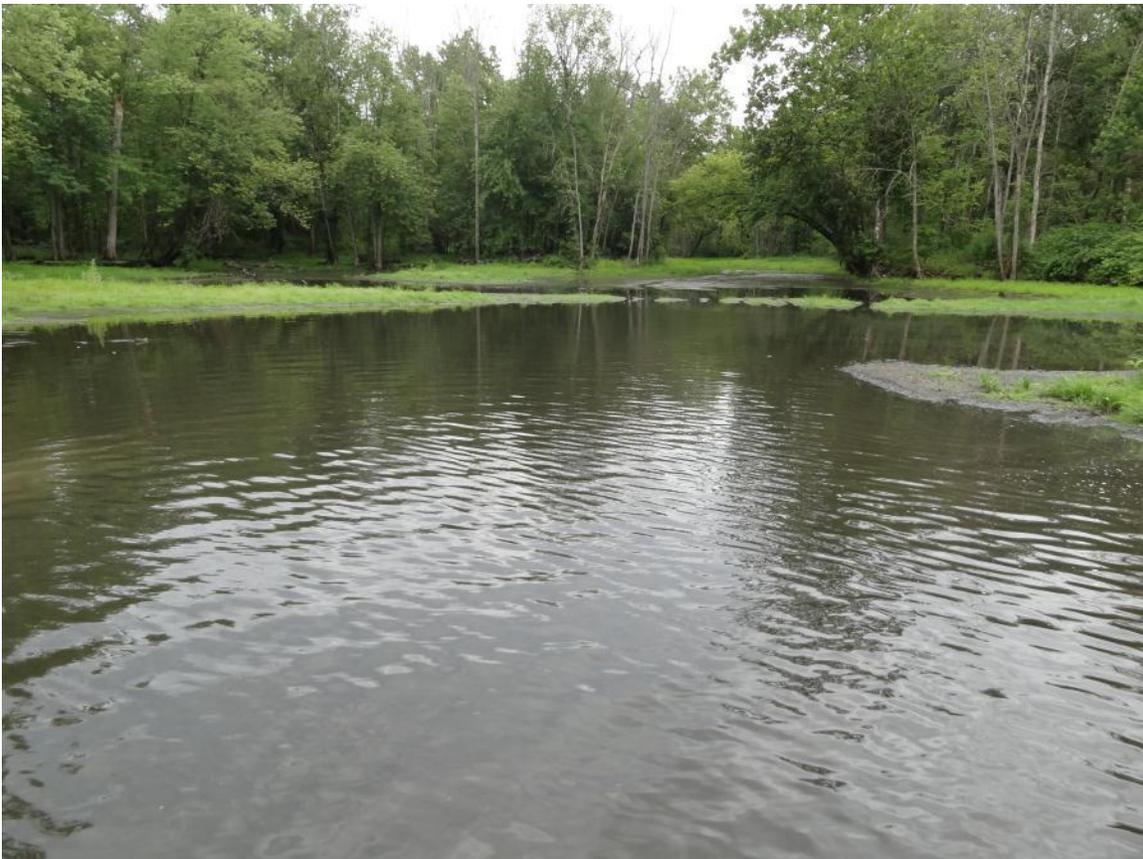
12. MP30.8 LDB no sheen observed.

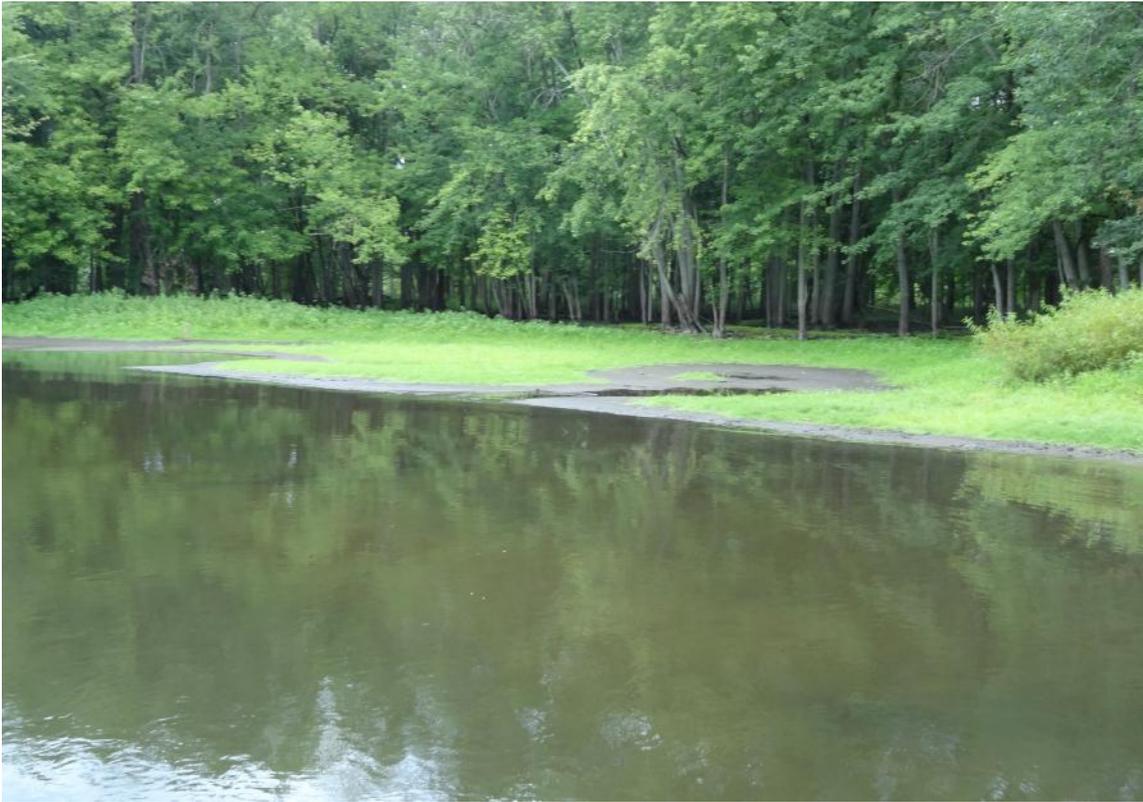
**13. MP28.00 LDB no sheen observed.**

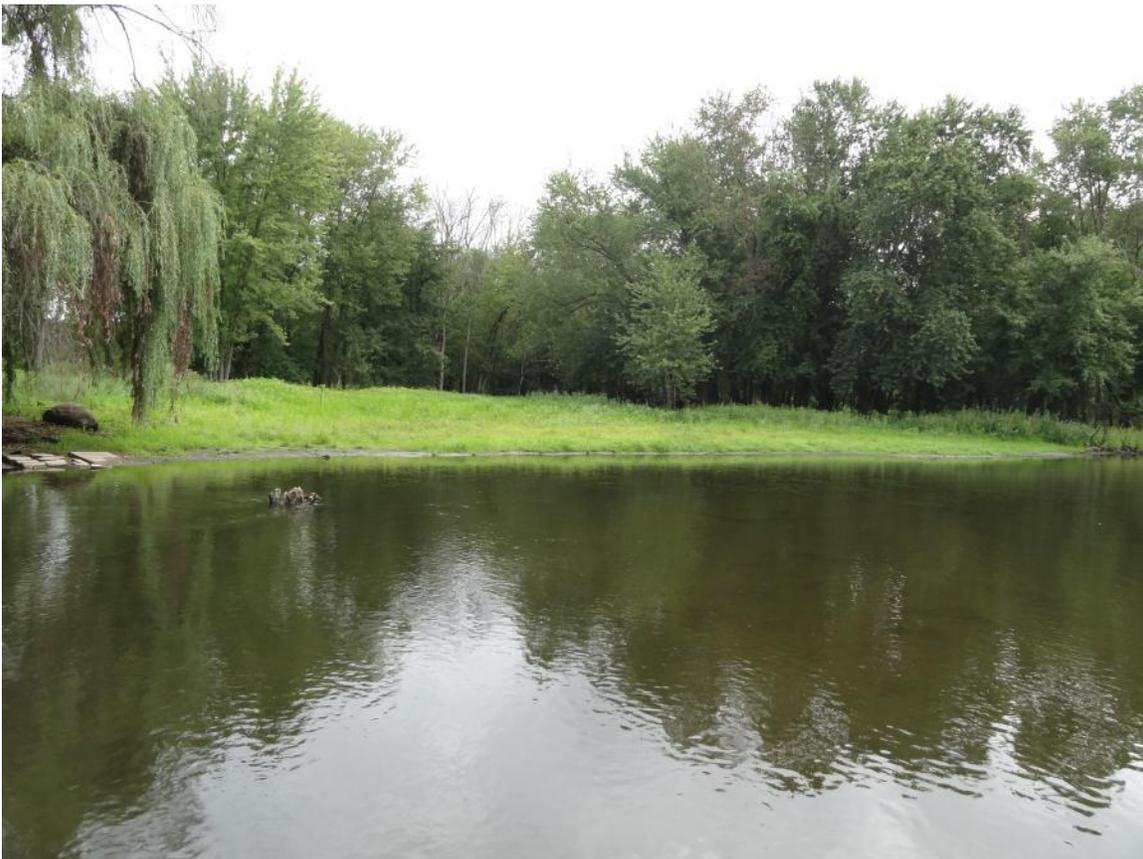
**14. MP26.75 RDB no sheen observed.**

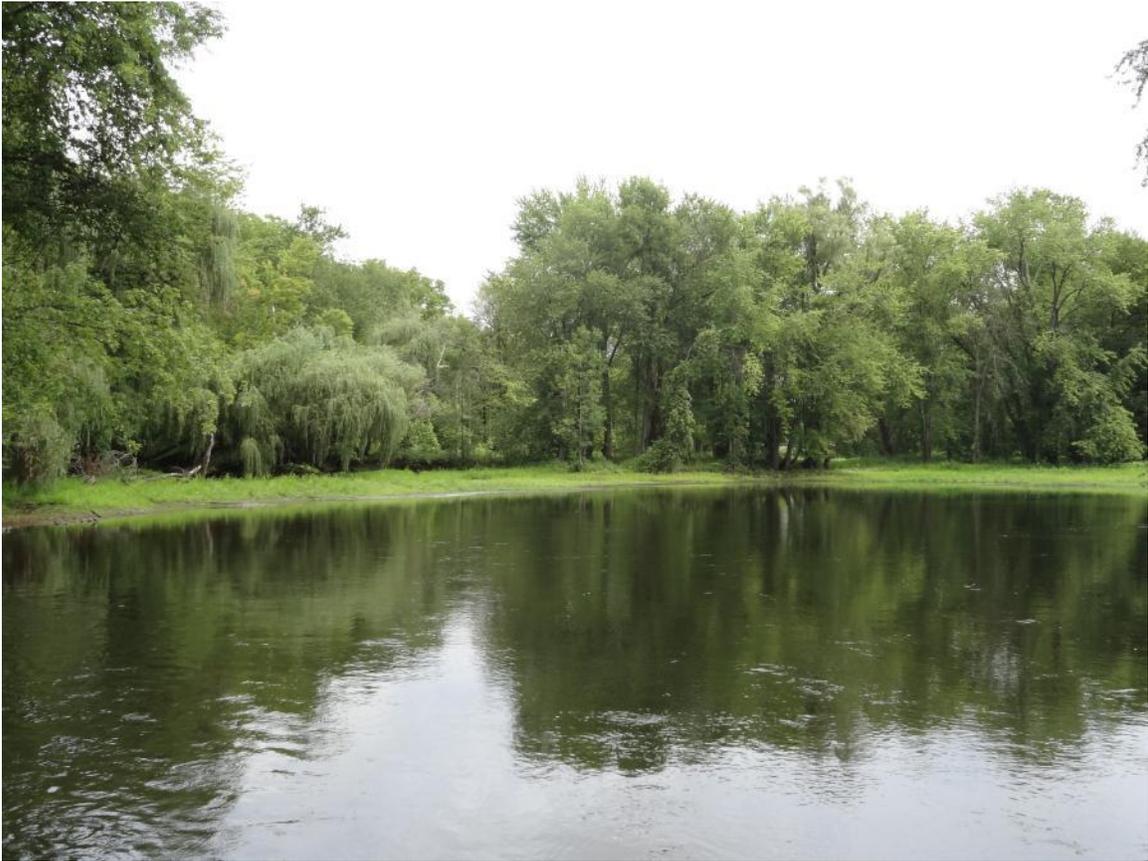
15. MP26.25 RDB sheen observed, sweep boat in area.

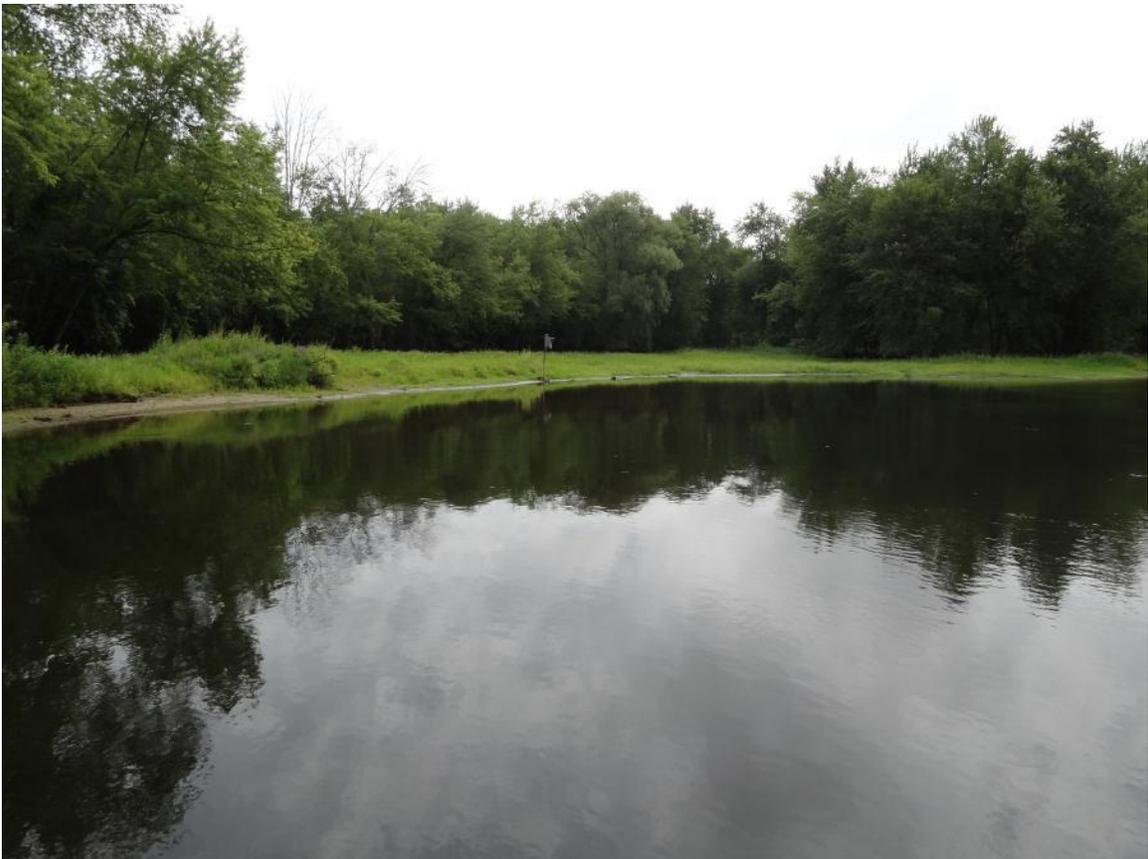
16. MP26.00 RDB no sheen observed.

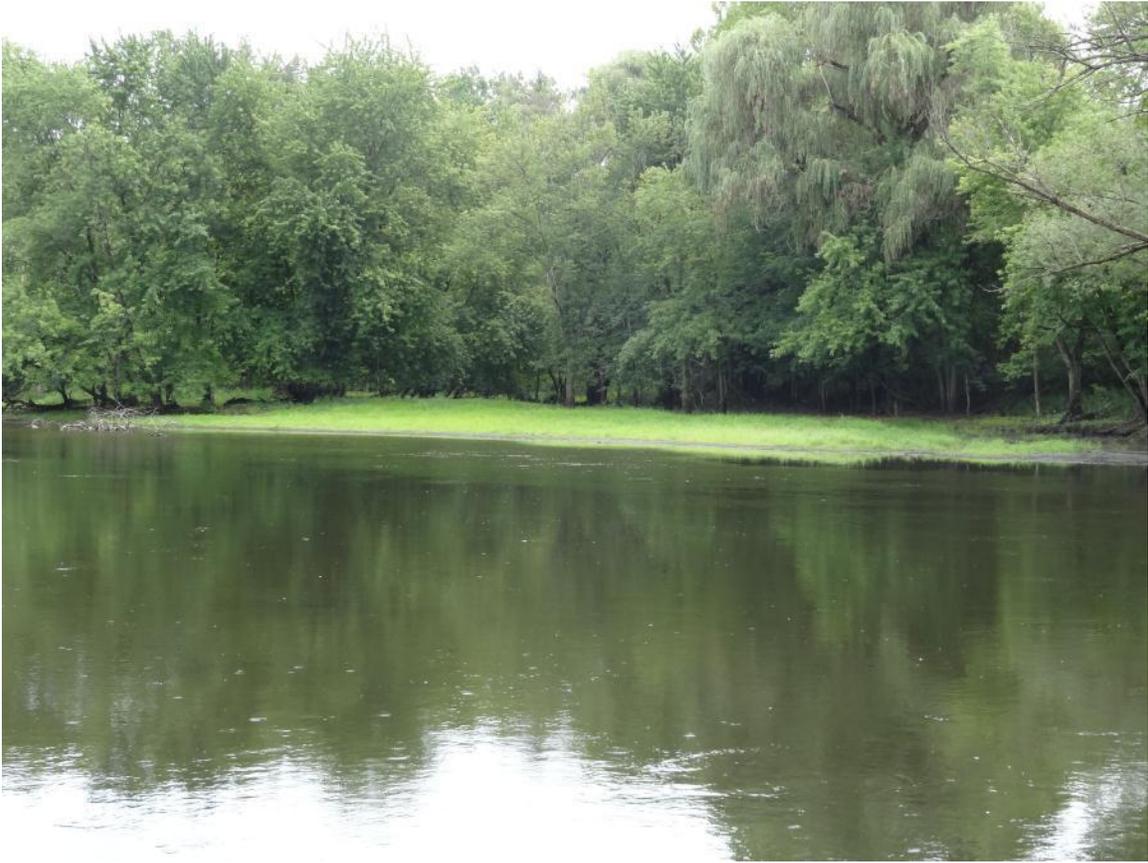
17. MP24.75 LDB no sheen observed.

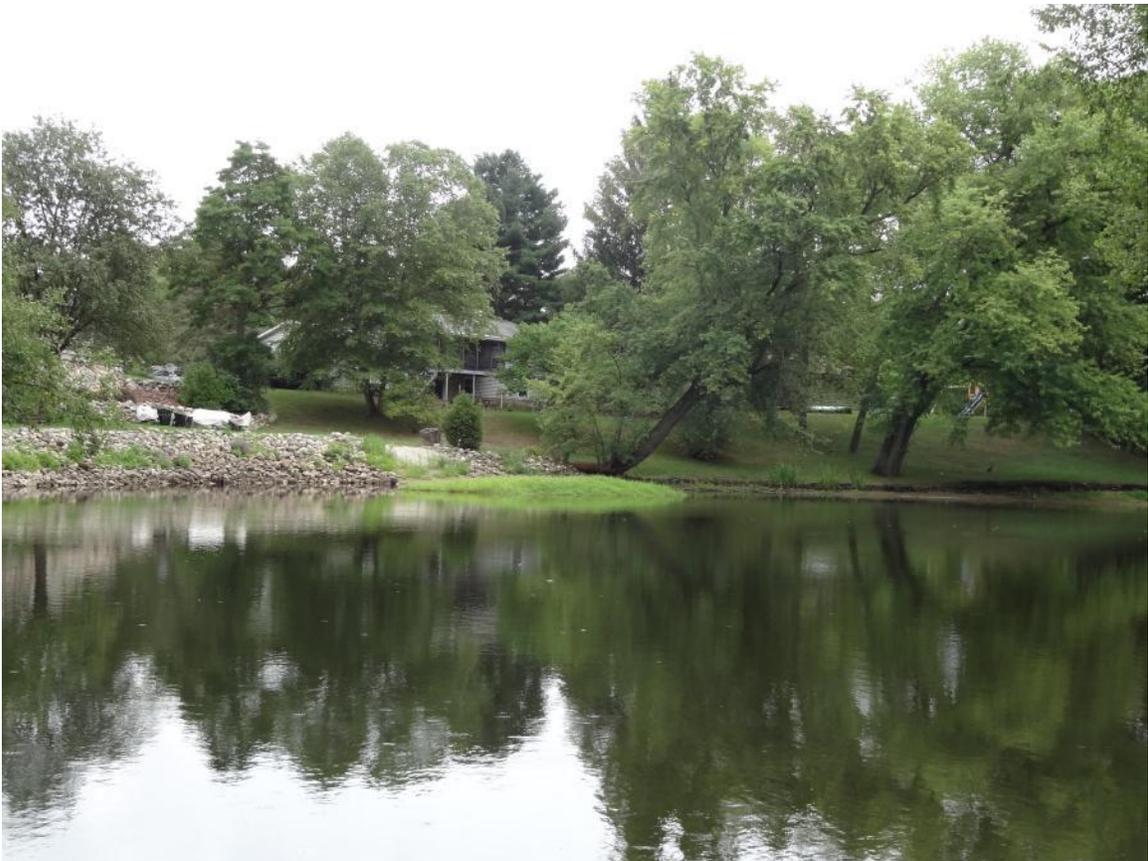
18. MP23.10 RDB no sheen observed.

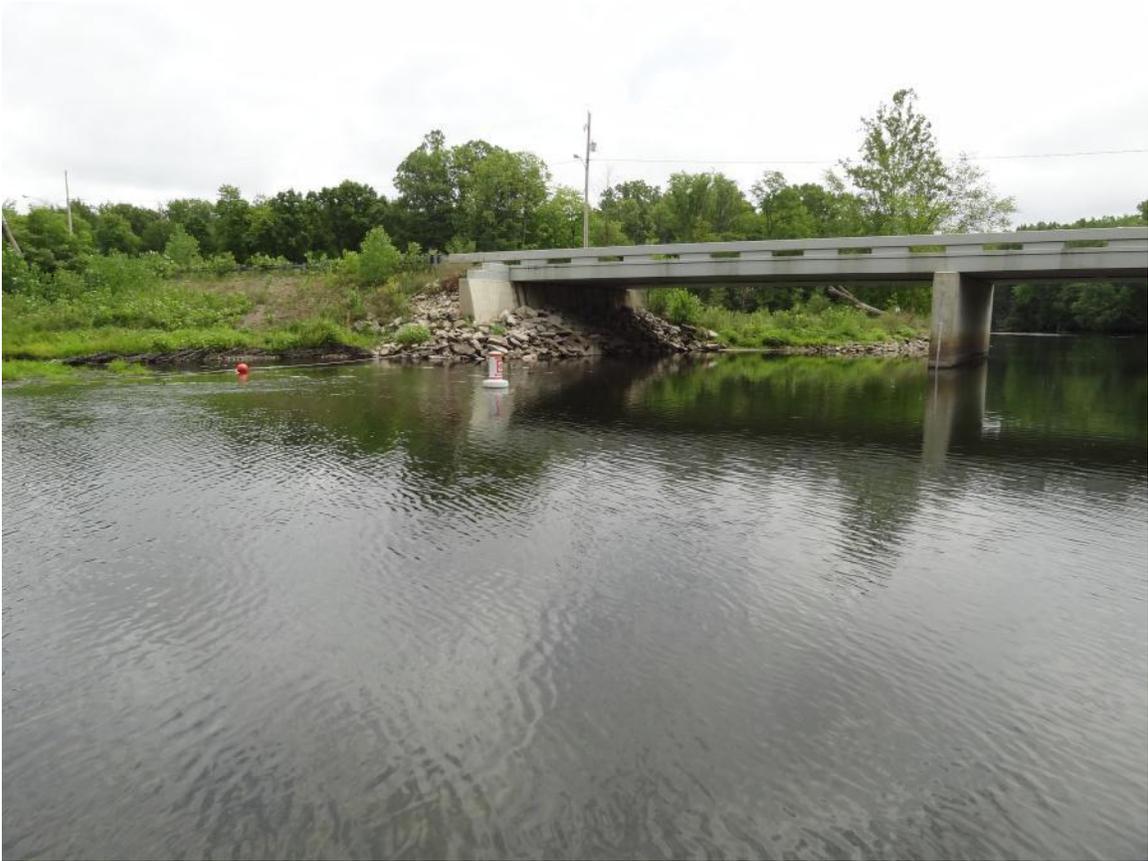
19. MP21.50 RDB sheen observed, sweep boat in area.

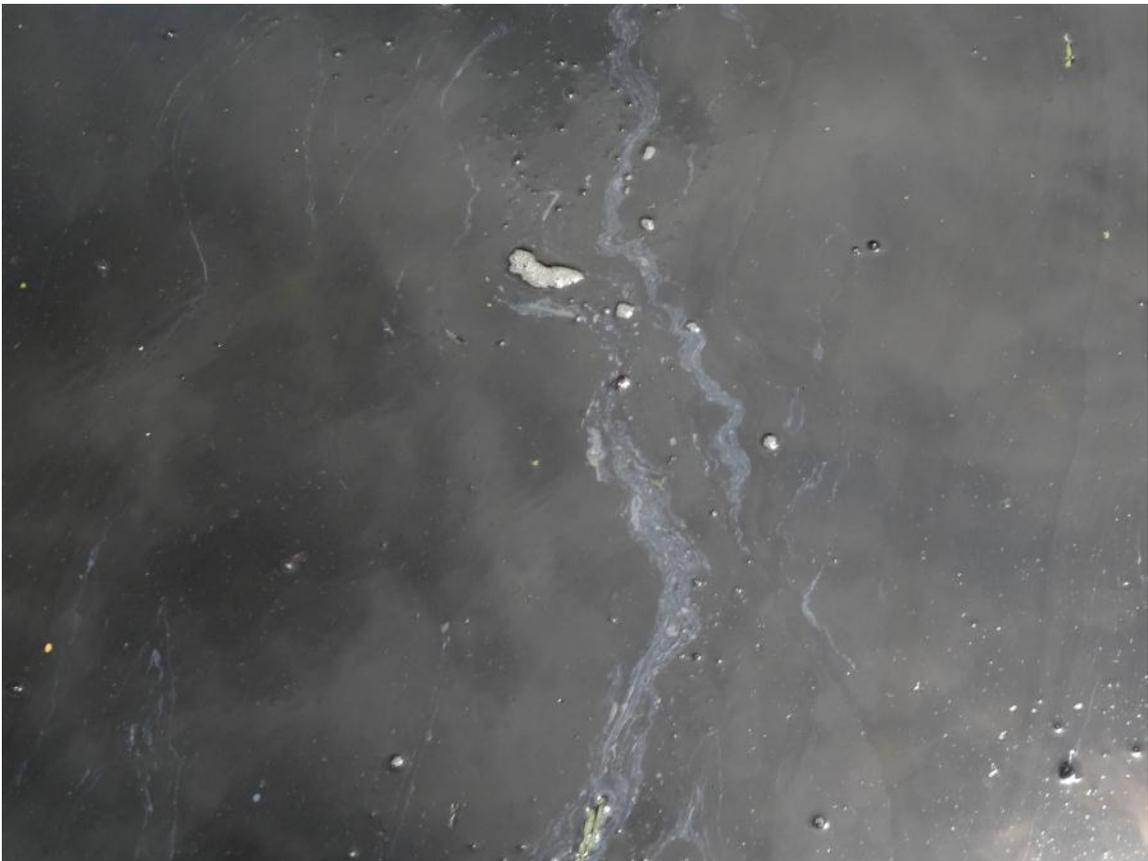
20. MP 21.50 sheen observed.

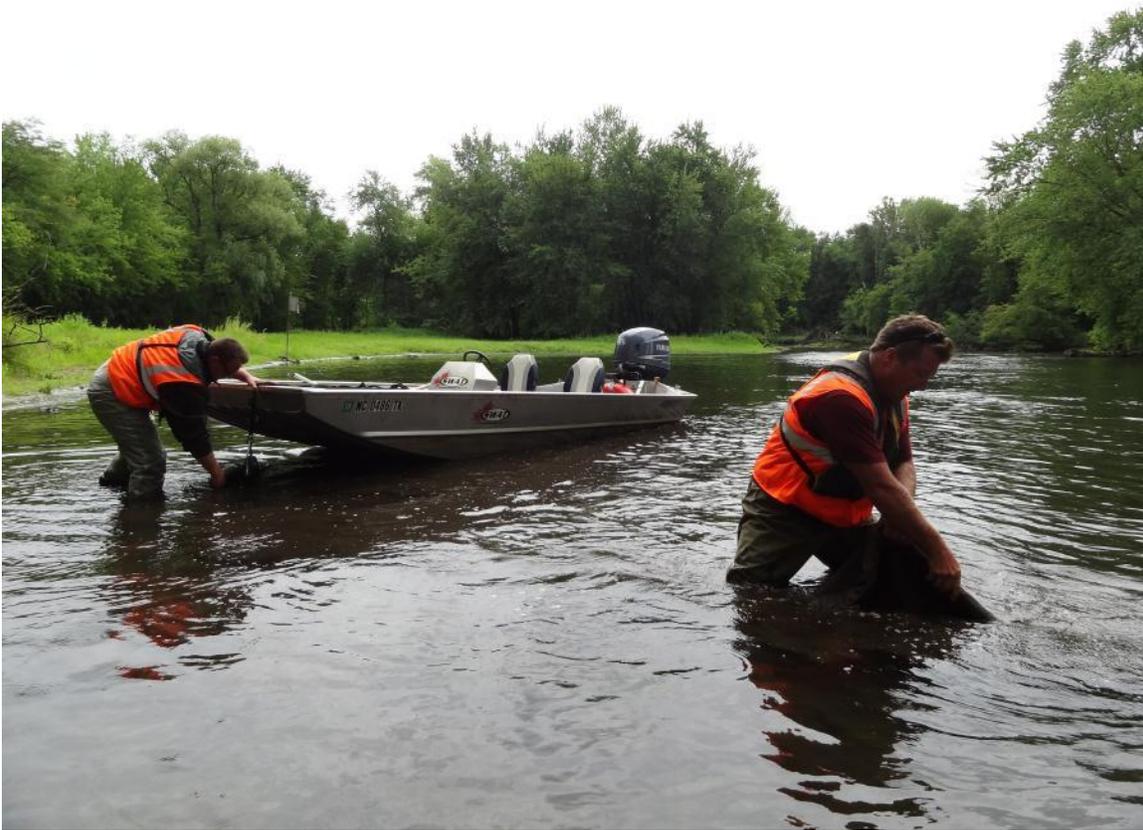
21. MP26.00 RDB, SWAT crew pulling sediment curtain.

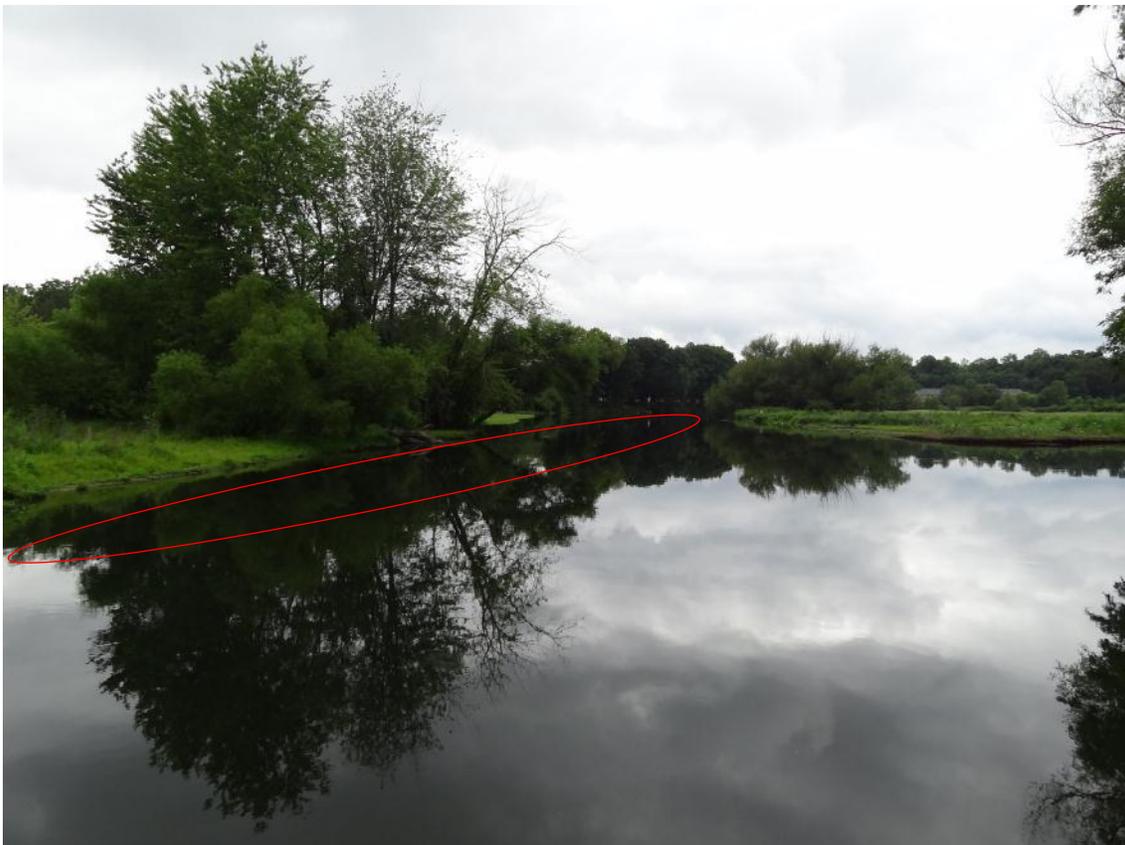
22. MP15.00 – MP 15.50 LDB area where sheen was observed, sweep boat not warranted.

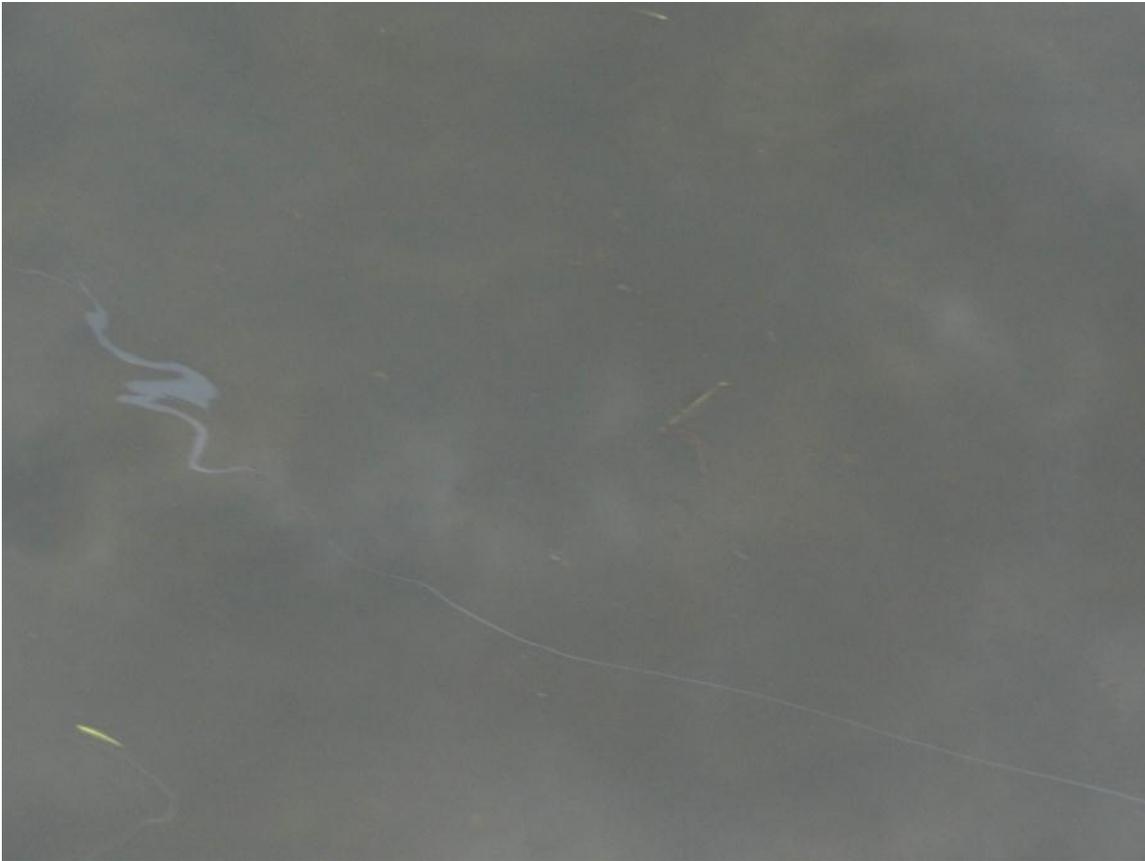
23. MP15.25 LDB sheen observed.
