US EPA ARCHIVE DOCUMENT

# Situation Photo Log

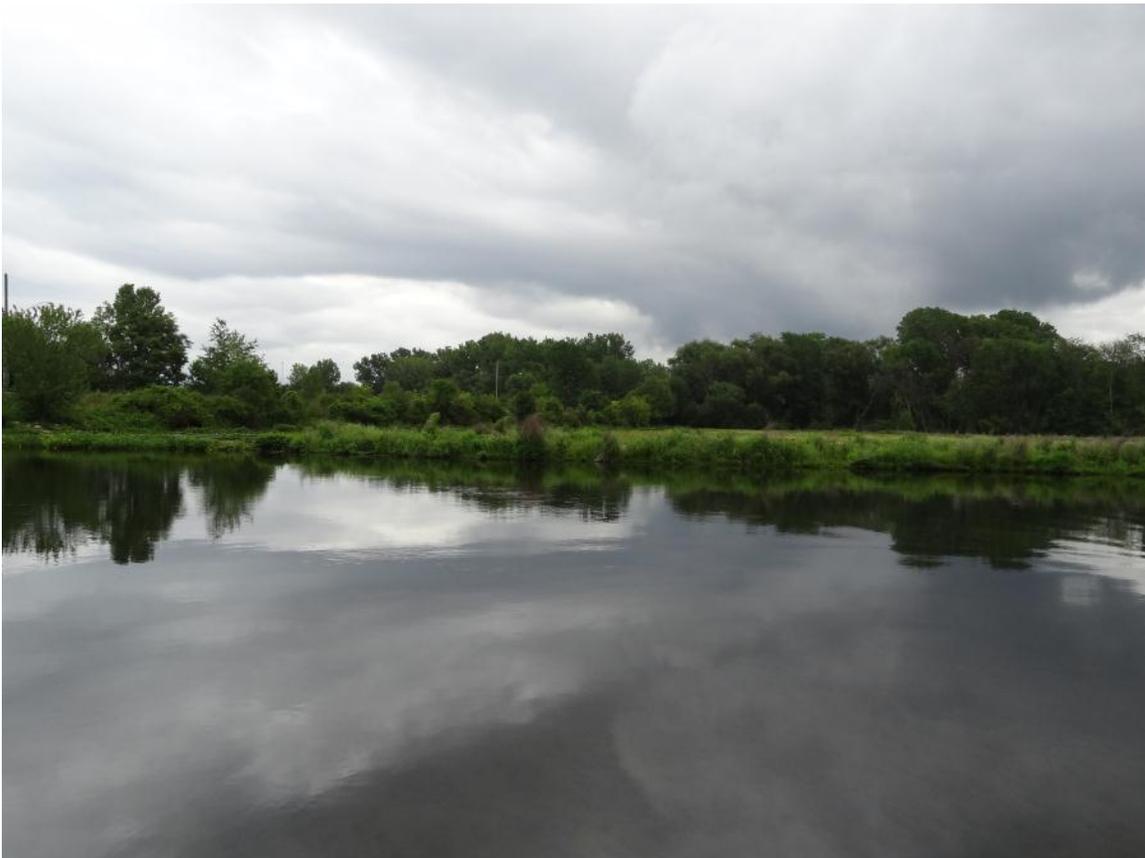
24. South Mill Pond sheen observed, no sweep boat warranted.

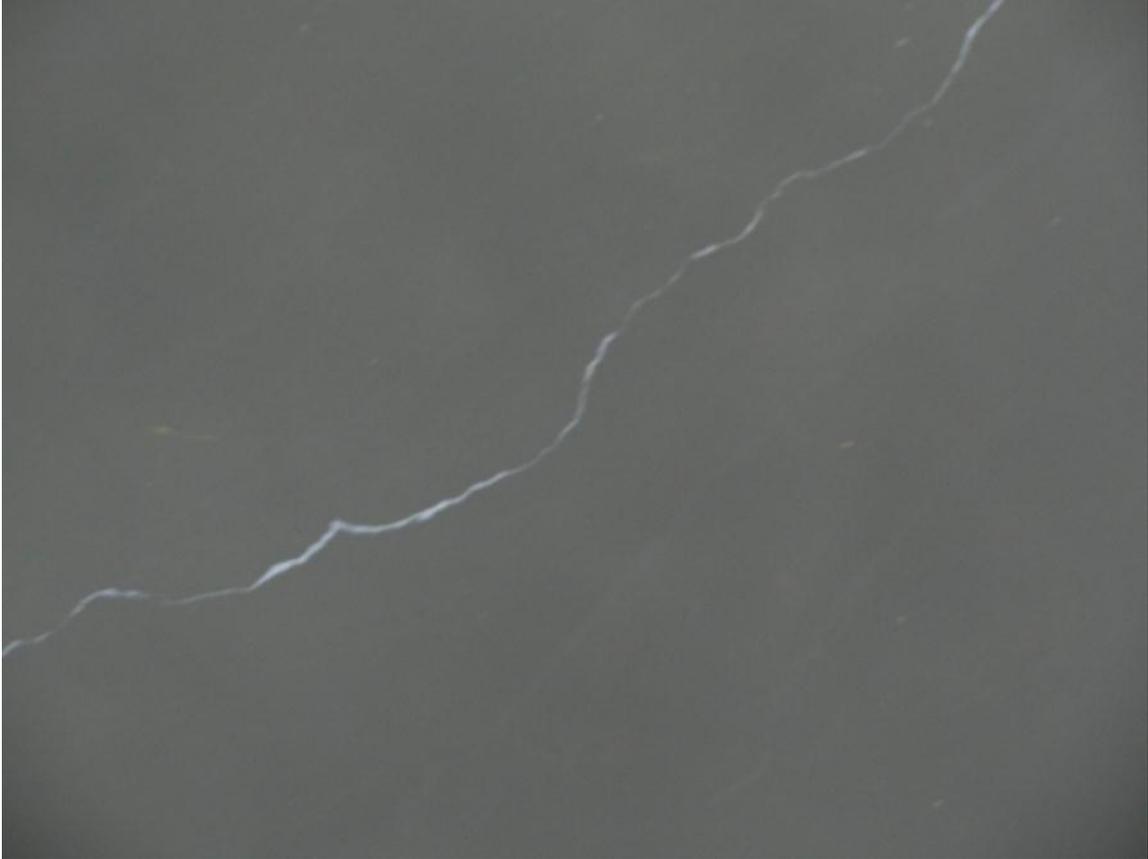
25. South Mill Pond sheen observed.

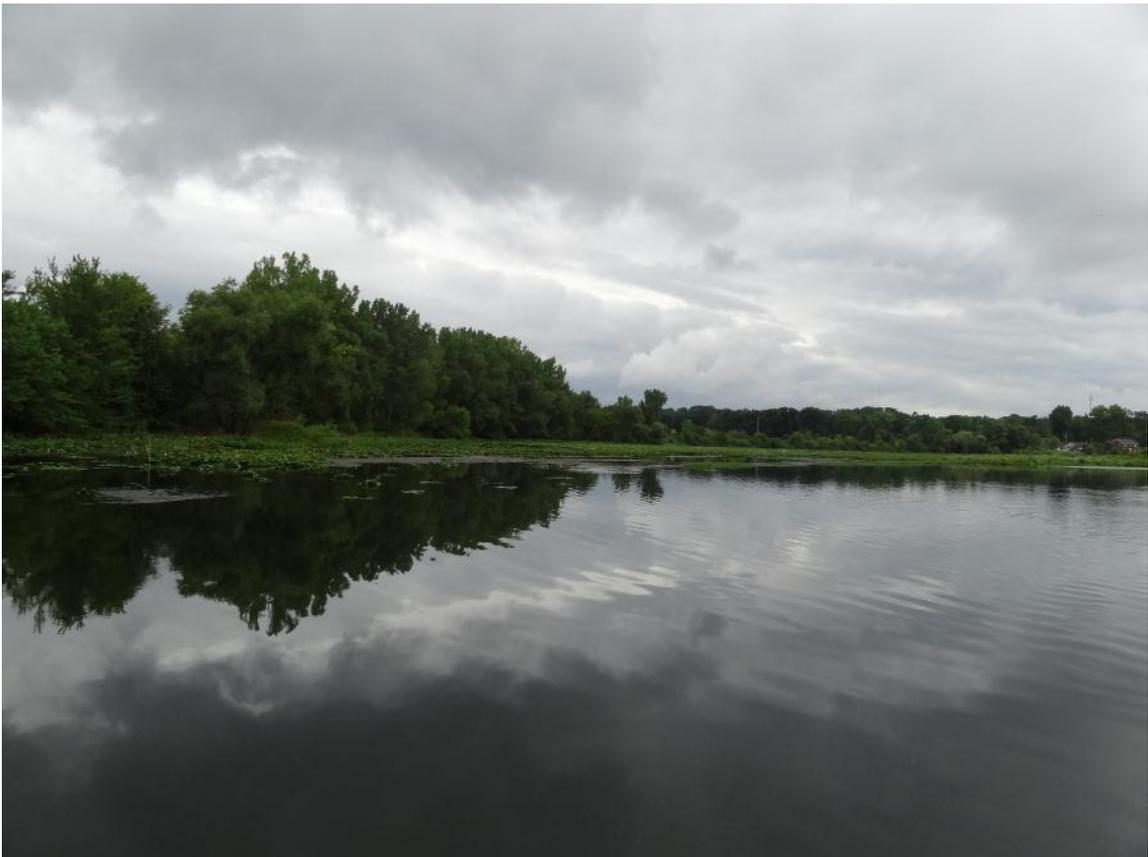
26. North Mill Pond sheen observed, sweep boat not warranted.

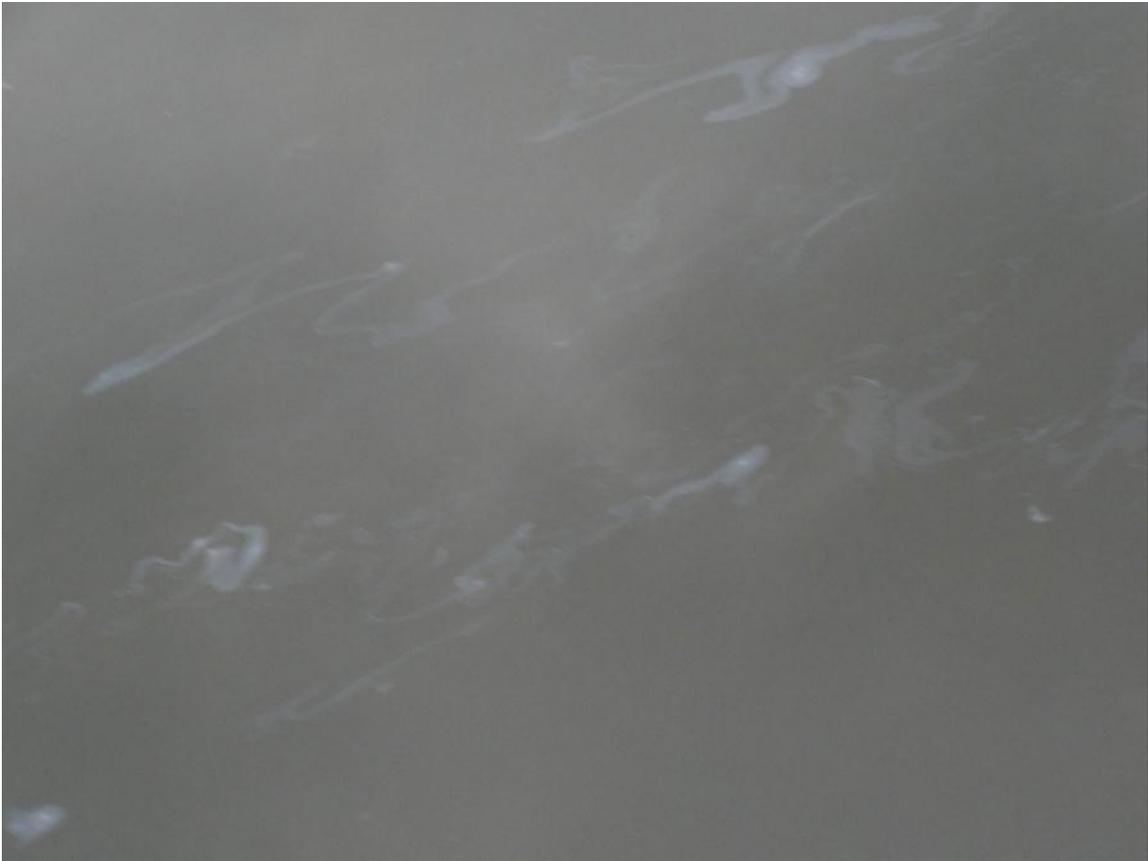
27. North Mill Pond, sheen observed.

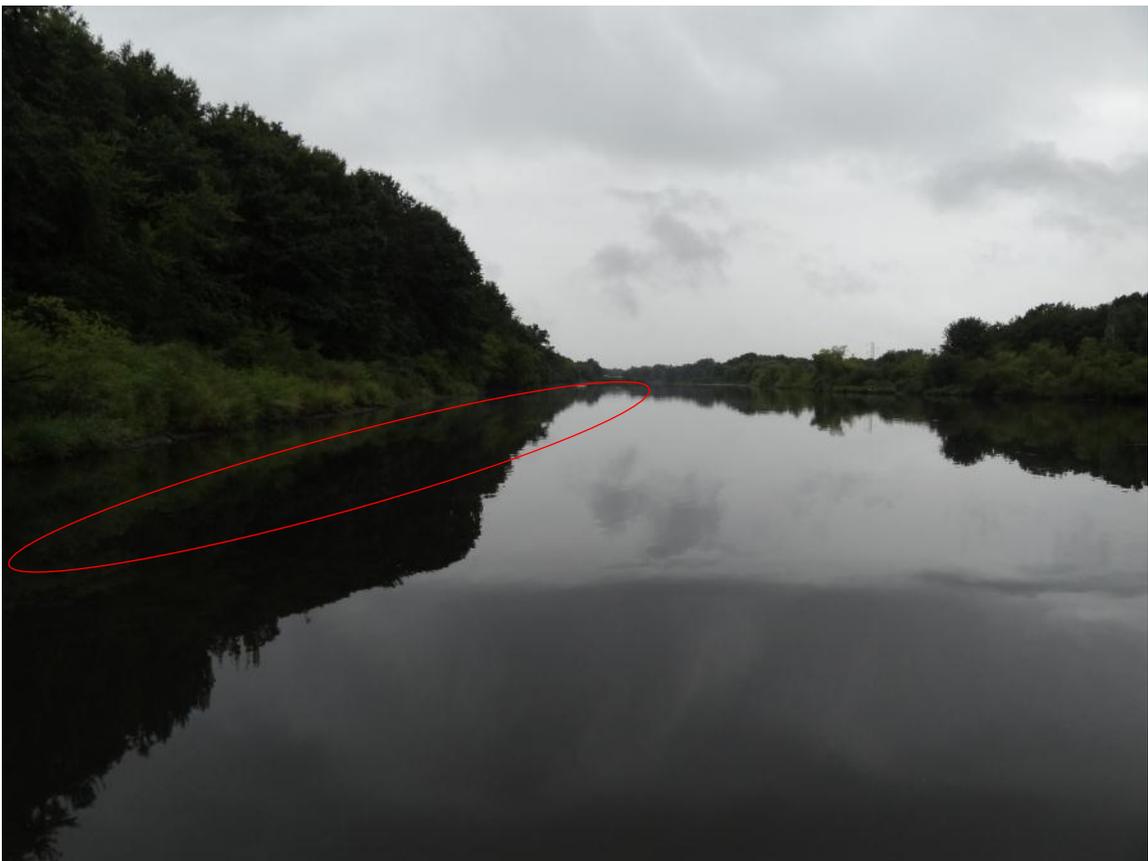
28. MP5.25 – MP5.63 LDB are where sheen was observed, sweep boat in area.

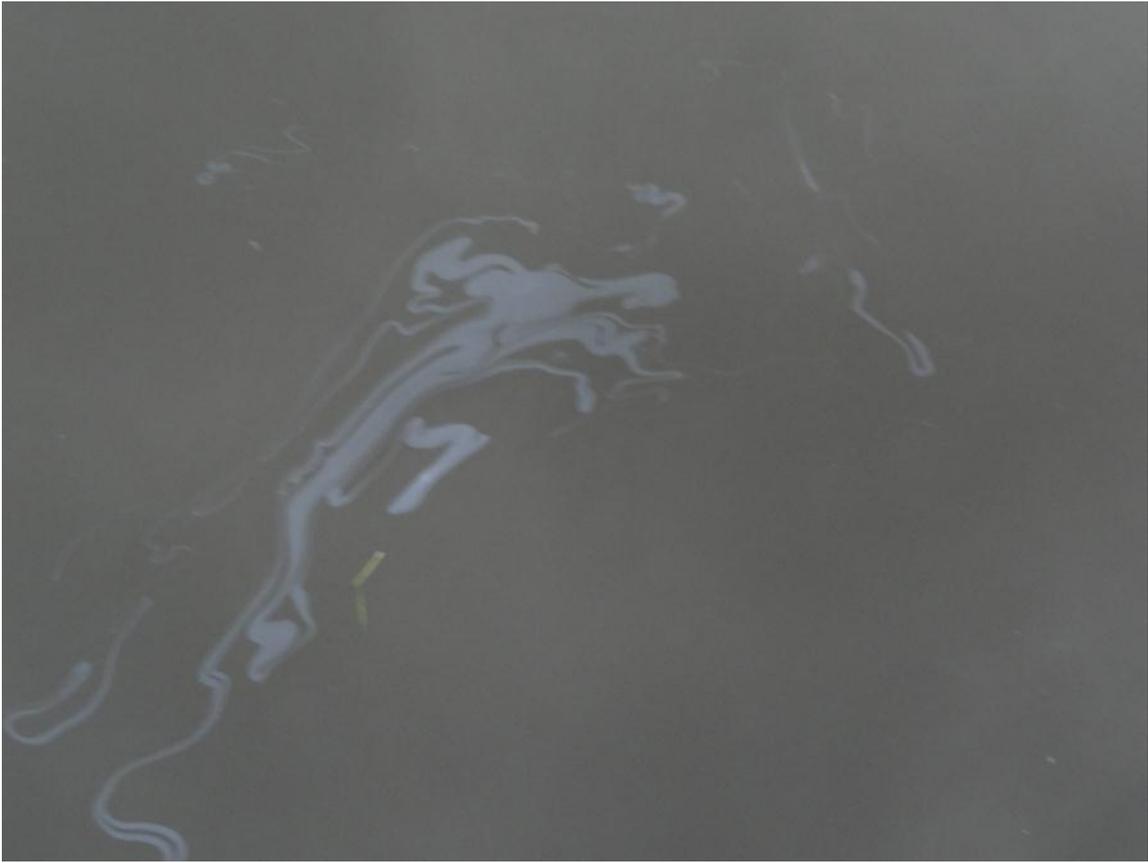
29. MP5.30 LDB sheen observed.

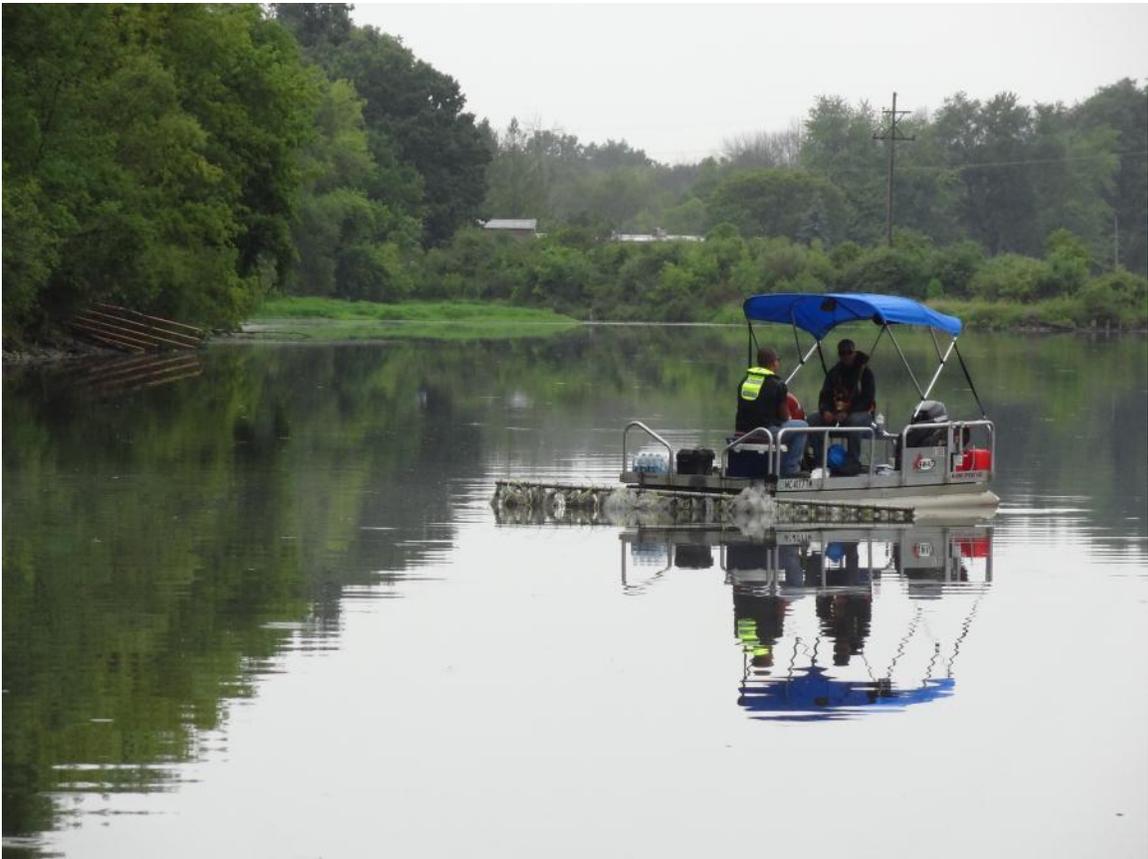
30. MP 5.50 LDB observed sweep boat.

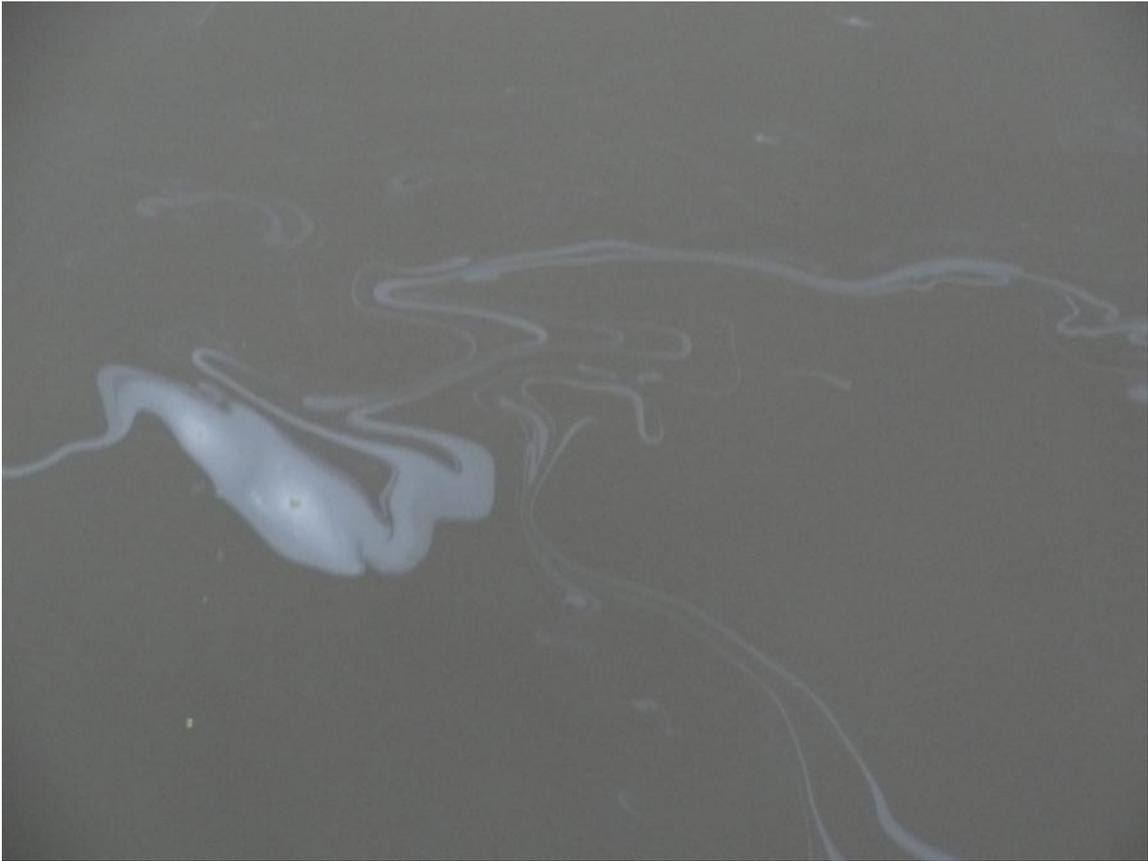
31. MP5.55 LDB sheen and tar globule observed.

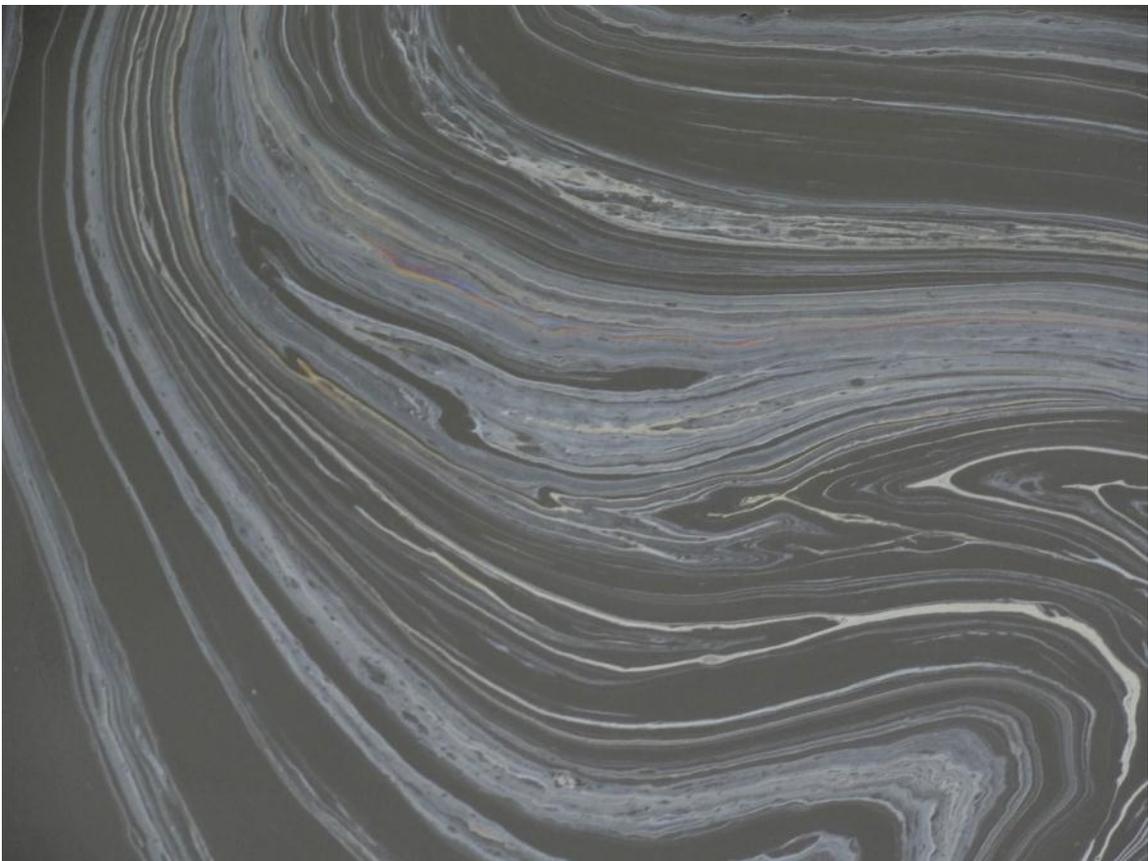
32. MP 5.63 LDB sheen observed.

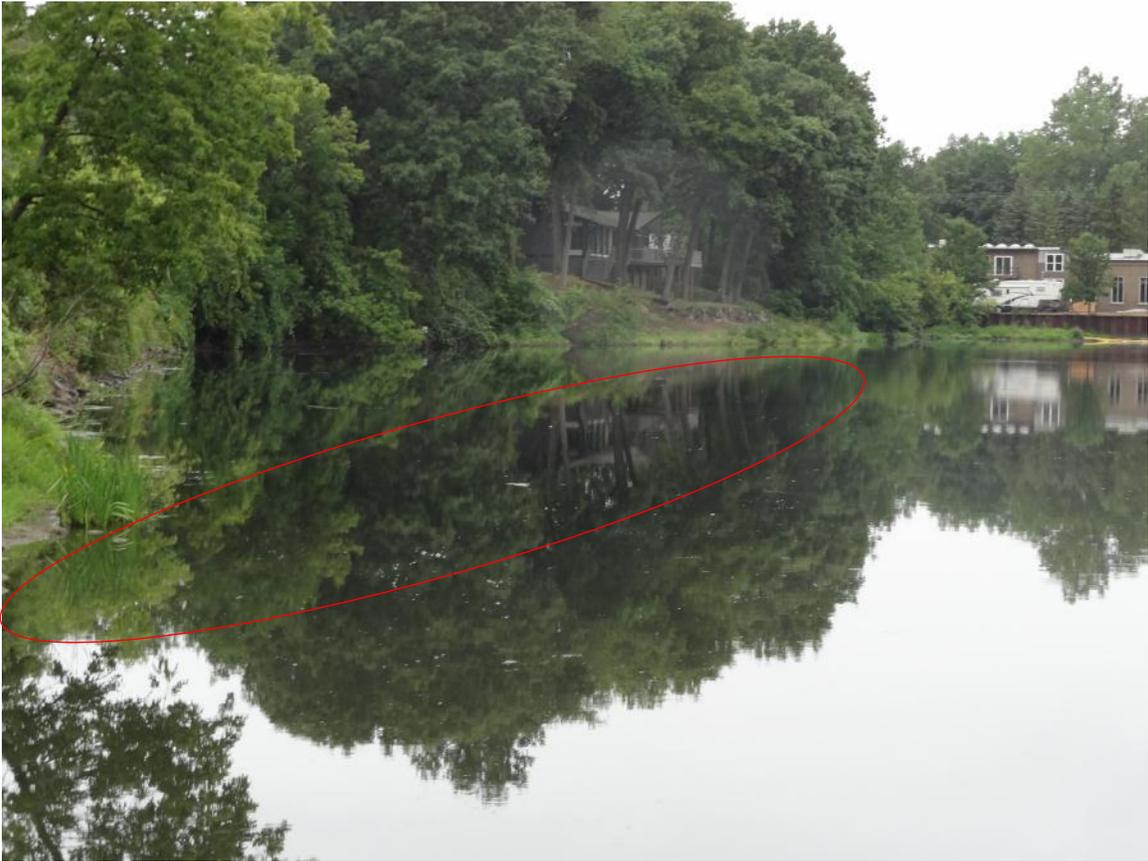
33. MP5.63 – Control Point LDB area where sheen was observed, sweep boat in area.

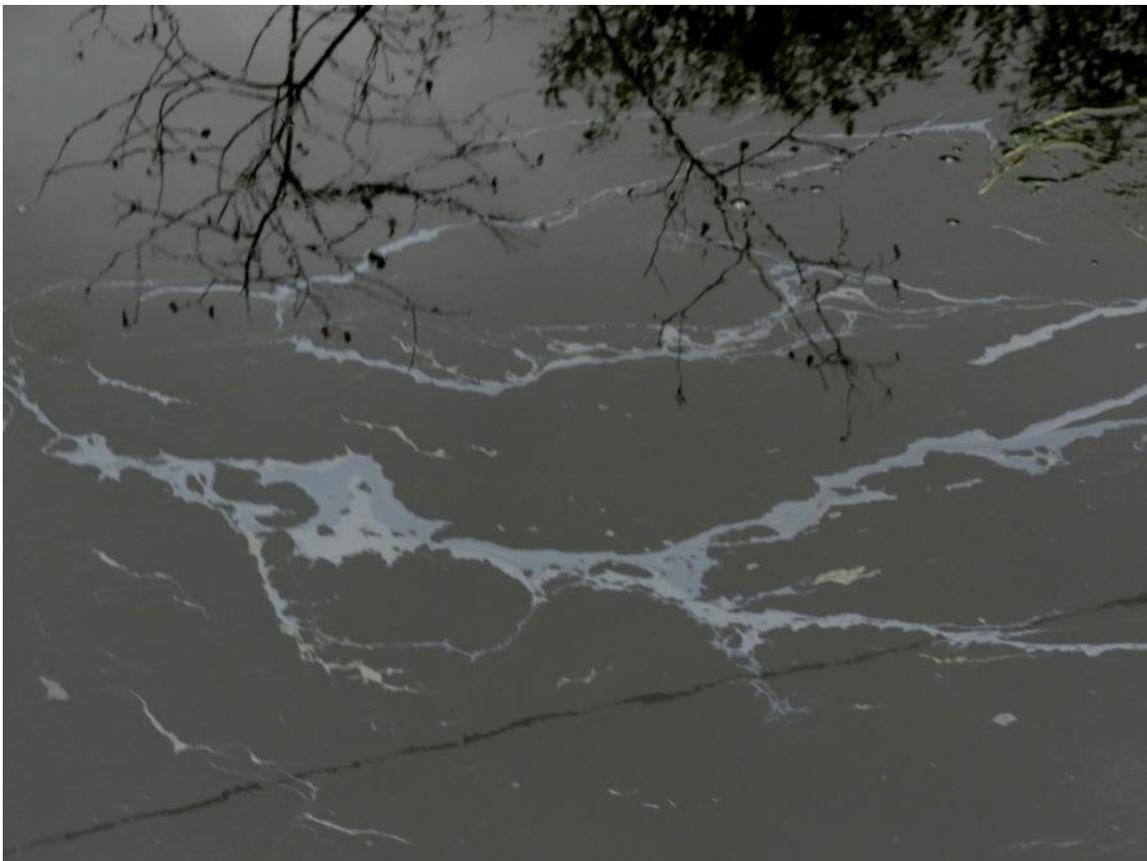
34. MP5.65 LDB sheen observed.

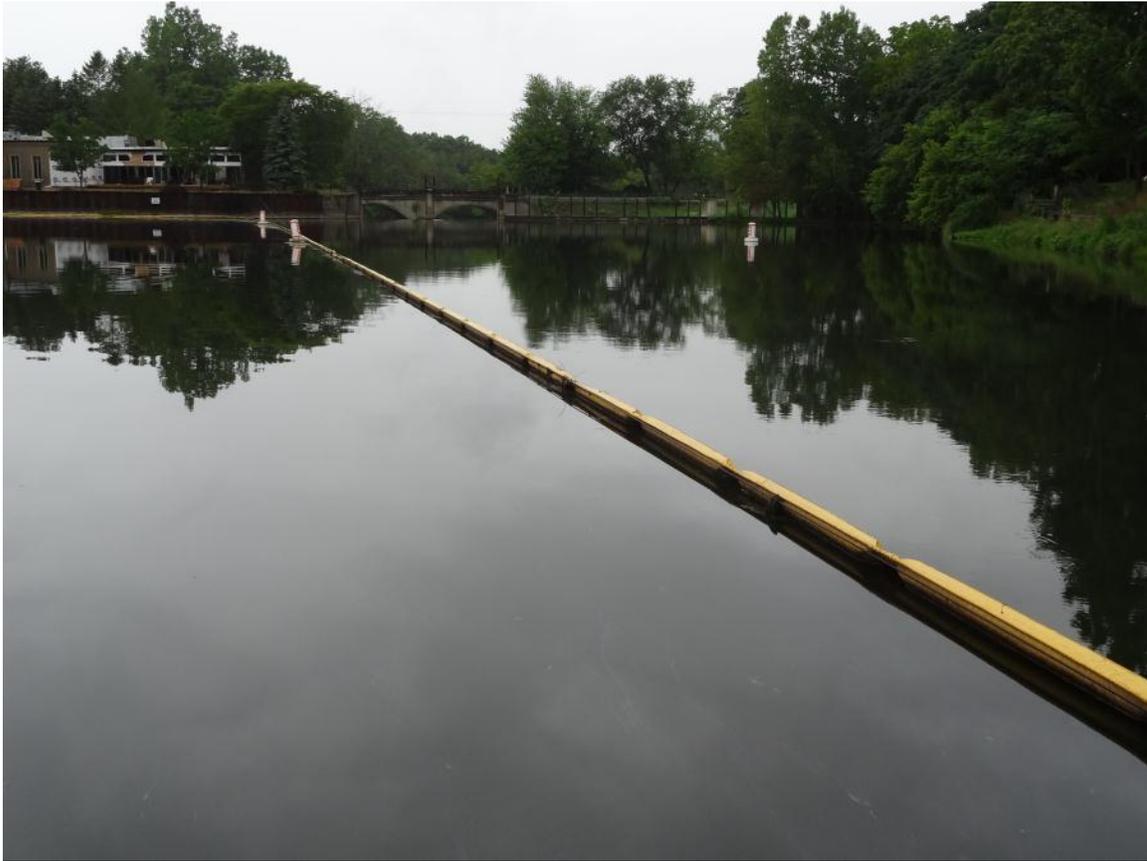
35. Ceresco Dam Control Point sheen observed, sweep boat in area.

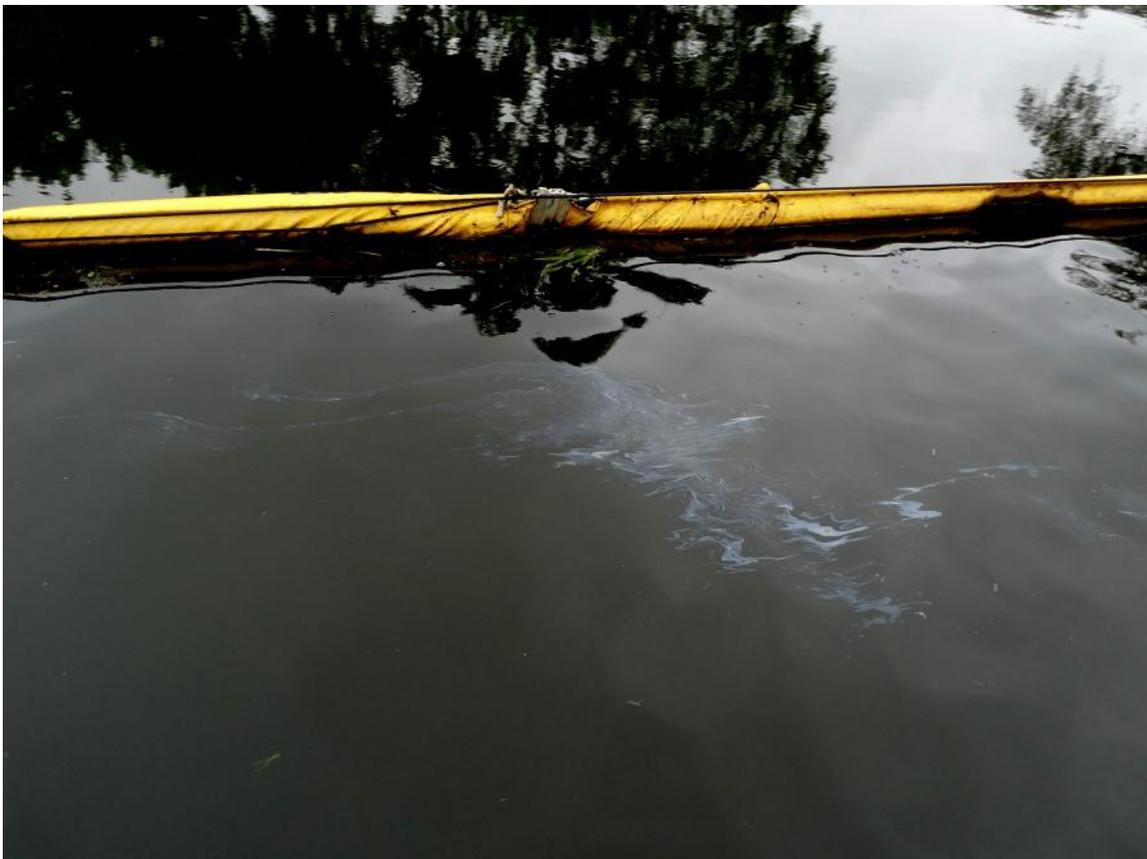
36. Ceresco Dam sheen observed along control point.
