Environmental Technology Verification Report

VJ TECHNOLOGIES IXS HIGH FREQUENCY INTEGRATED X-RAY GENERATOR ALTERNATIVE TECHNOLOGY FOR SEALED SOURCE RADIOGRAPHY CAMERAS

Prepared by
Battelle

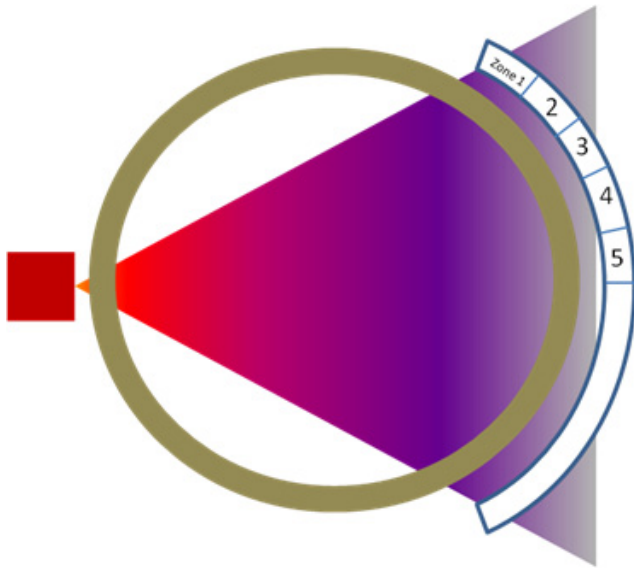
Figure 3-2. Assessment zones in the circumferential direction for Pipe Sample 1 weld with five zones shown as examples.

For interpretation, the images containing the weld and the natural corrosion area from Pipe Sample 1 were used to assess the weld integrity. When assessing the weld, the image was divided into 10 equal zones (see Figure 3-2 for example zone placement) by the evaluator. Within each zone the weld was evaluated for root, crown, slag, and porosity defects. The weld was under insulation. Results for the radiography camera and the VJ Technologies IXS High Frequency Integrated X-Ray Generator are presented in Tables 6-1 through 6-3. Results in the tables are presented for the 90° view, with difference in the 0° view noted. Based on previous characterization, the actual weld defects were noted to be incomplete penetration (IP) in all 10 zones. No other defects were determined.

Both devices noted IP in most of the 10 zones. Both the radiography camera and the x-ray device images, as interpreted by Mistras, indicated that there was one inch of acceptable weld in Zone 5. The Mistras representative was not able to determine weld defects in Zones 1 and 10 for the VJ Technologies IXS High Frequency Integrated X-Ray Generator images, while the VJ Technologies representative was able to determine IP in these zones using their proprietary software. Neither the radiography camera, nor the x-ray device found crown or slag defects on the weld, which is in agreement with the actual weld anomalies. The radiography camera image

indicated porosity in Zones 2, 3, 5, and 7. Porosity was noted in Zones 5, 6, and 7 in the interpretations of the VJ Technologies IXS High Frequency Integrated X-Ray Generator images.

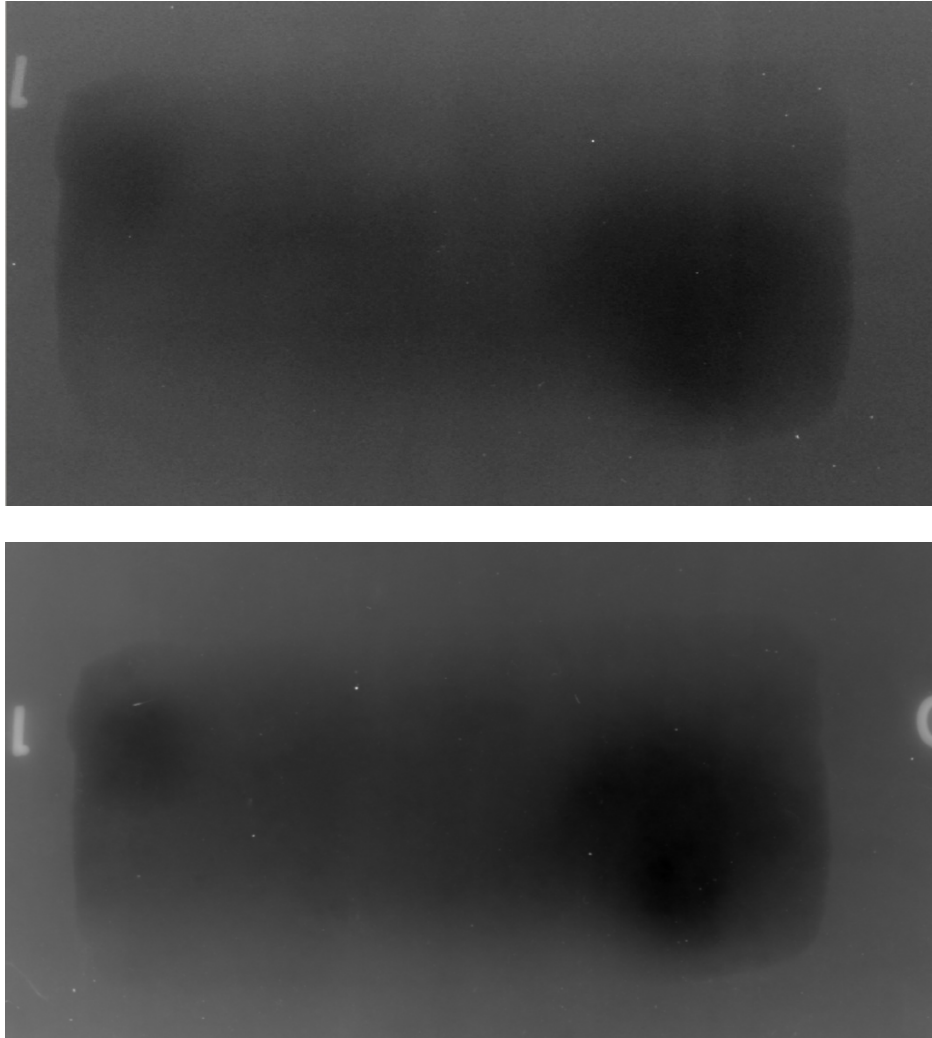
Figure 6-1. A comparison of radiography camera (top) and VJ Technologies IXS High Frequency Integrated X-Ray Generator (bottom) images with identical image processing applied.

Both the radiography camera and the VJ Technologies IXS High Frequency Integrated X-Ray Generator were able to show the defect patches, natural corrosion, and weld under the insulation, as well as the defects on uninsulated pipe. Raw images were comparable in quality for non-contact images, as shown in Figure 6-1. After applying VJ Technologies ADE software to refine images, the x-ray technology images were clearer than those without adjustment. Figure 6-2 provides an example.

For defect P1-23, there were three pits in the defect. The radiography camera identified two pits, while the VJ Technologies IXS High Frequency Integrated X-Ray Generator identified all three pits. Depth measurements could only be determined for one defect using the x-ray device (P1-7) and two defects using the radiography camera (P1-7 and P1-11). These depth measurements were made based on the apparent depth of the patch and associated pits from the profile image. Depth measurements were not determined using the interior pipe wall, as would normally be done. Both the radiography camera and the x-ray device had difficulties detecting the interior pipe wall on the images. This led to an inability to make depth measurements on the defects. It

was suggested that the inability to detect the interior pipe wall could be related to the diameter of the pipes. The pipes used were larger in diameter than those typically imaged using the radiography and x-ray cameras.

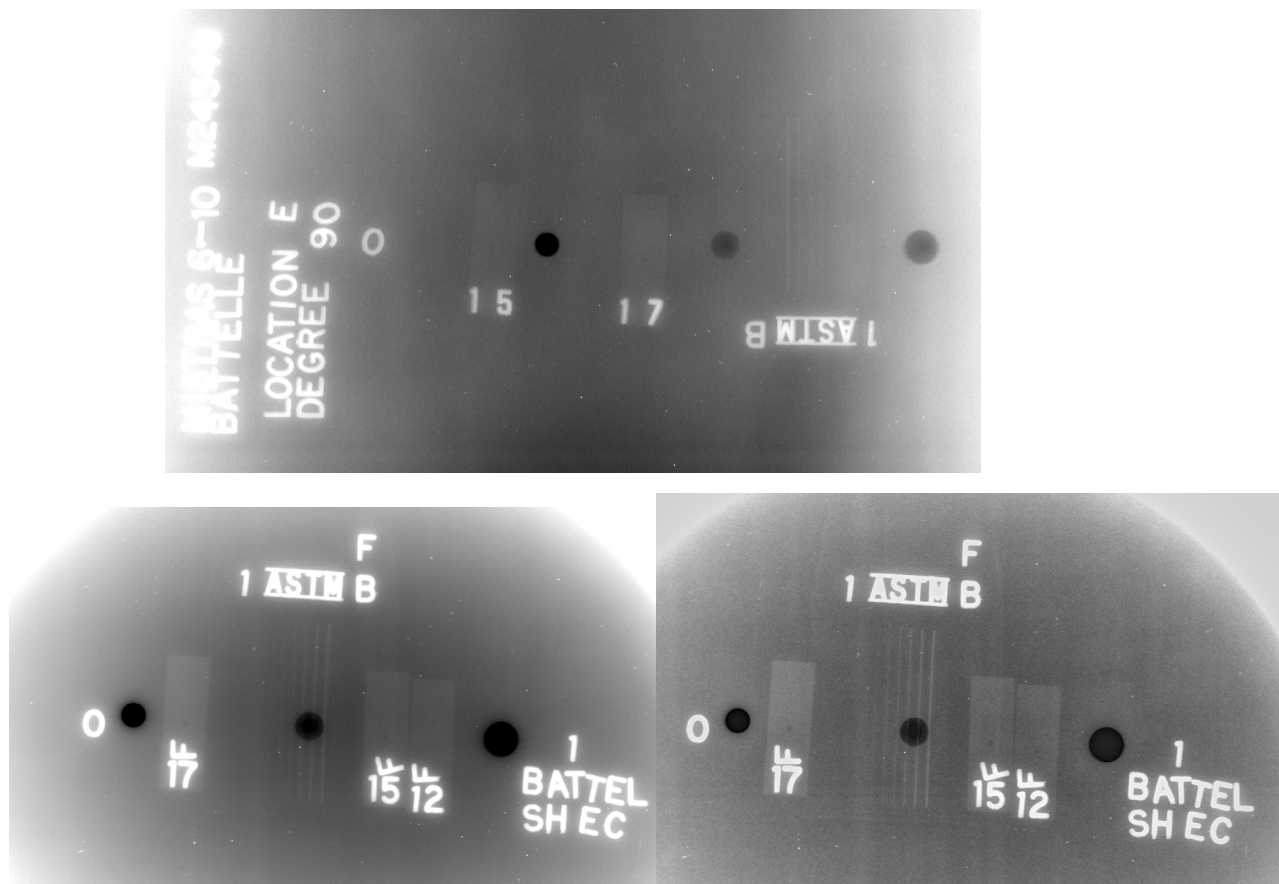
Figure 6-3. Pipe Sample 2 contact images for radiography camera (top) and VJ Technologies IXS High Frequency Integrated X-Ray Generator without adjustment (bottom left) and with ADE adjustment (bottom right).

For the contact images on Pipe Sample 2, the VJ Technologies IXS High Frequency Integrated X-Ray Generator provided a clearer image of the defects (see Figure 6-3). This is evidenced by the fact that more wires from the ASTM B wire pack were visible on the x-ray image (5 wires visible) than the radiography camera image (4 wires visible). The three simulated defects were well-defined in the x-ray image and the 2T holes in the penetrameter were readily visible.

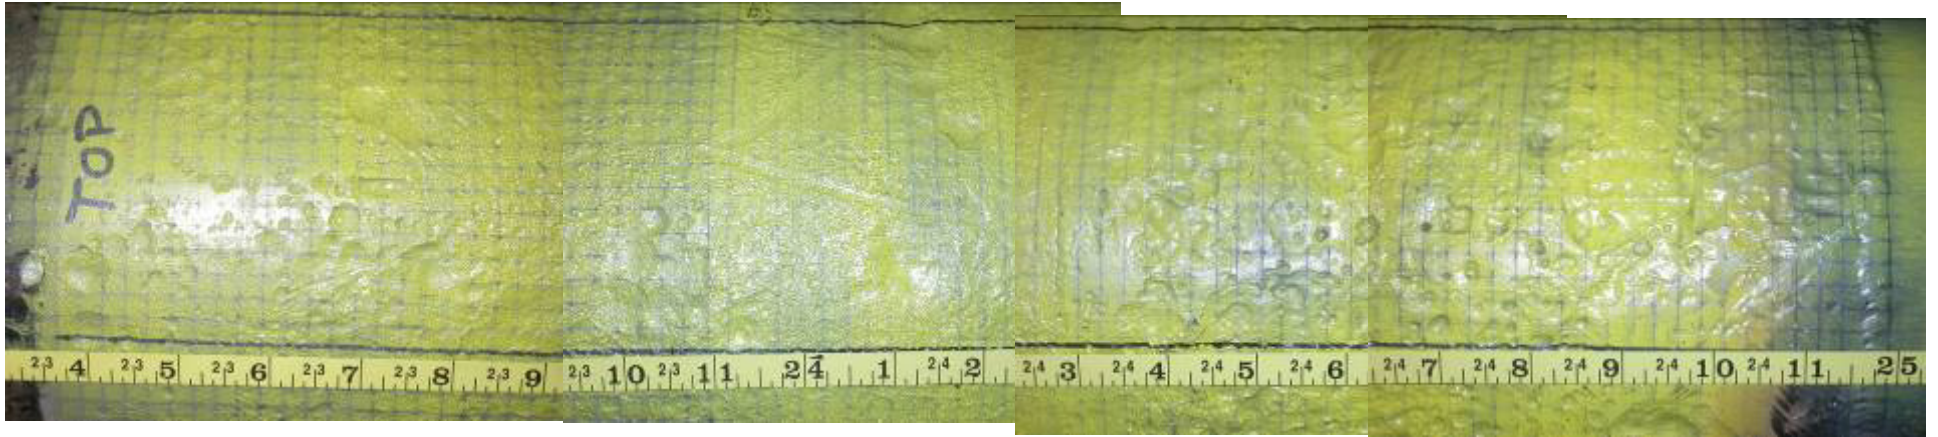
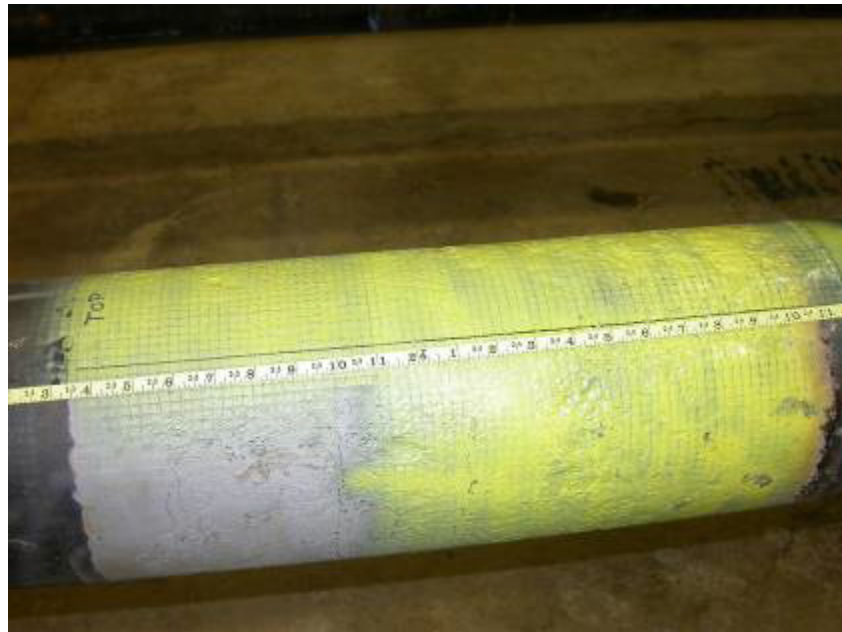
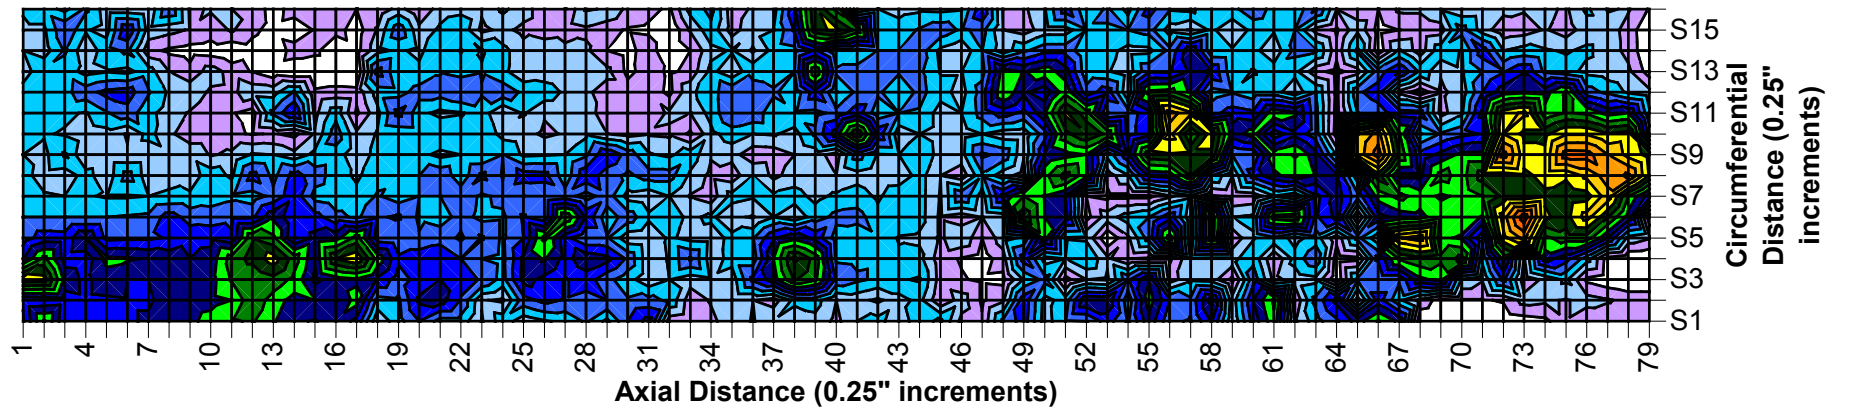
Figure A-4. Defect P1-9 (P1-NC1)

Both the radiography camera and the VJ Technologies IXS High Frequency Integrated X-Ray Generator were able to detect the natural corrosion area under the insulation on Pipe Sample 1. Pictures and details on the defect as determined in a previous characterization study prior to this verification test can be found in Appendix A. Tables 6-4 and 6-5 present the qualitative assessment of the natural corrosion area based on images from the radiography camera and the VJ Technologies IXS High Frequency Integrated X-Ray Generator using both the 90 ° view (Table 6-4) and the 0 ° view (Table 6-5). VJ Technologies did not provide interpretations of the natural corrosion area for the 0 ° view. The interpretations were based on contrast that was apparent in the image, not actual measurements. As with the qualitative assessment of the weld, the natural corrosion area was separated into 10 equal zones for its evaluation. Actual corrosion level assessments based on the previous characterization of Pipe Sample 1 are provided in each table. As noted in Section 3.4.1, the level of corrosion in the natural corrosion area was assessed based on the following guidelines:
