Corrosion in STP Sumps

What Causes It
and What Can Be
Done About It?

By John Wilson, Ph.D., U.S. EPA ORD
(And His Co-Authors)

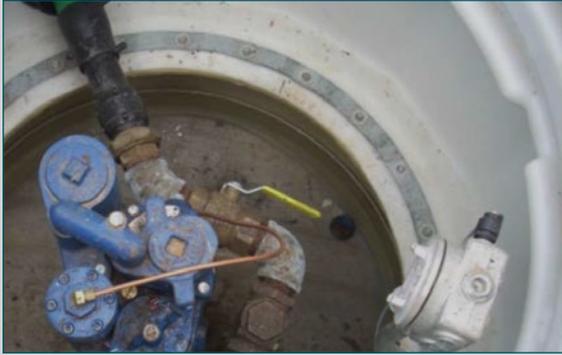
Sump 9, 0.33 mg/L

Comparison of corrosion in sumps with low and high measurable concentrations of acetate in the passive diffusion samplers.
