# ***Interim Final WTC Residential Confirmation Cleaning Study***

## **Volume 1**

110 Liberty St.  
New York, NY

**U.S Environmental Protection Agency, Region 2**  
New York City Response and Recovery Operations  
290 Broadway  
New York, NY 10007-1866  
May 2003

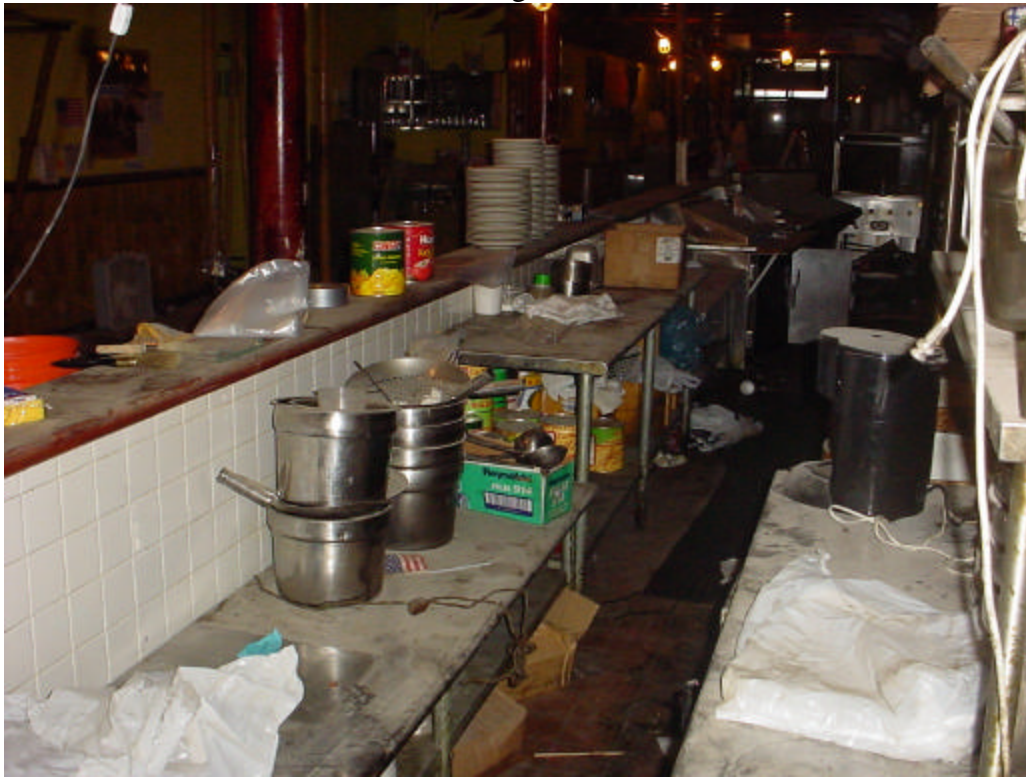
Lemongrass Grill  
Dsc00042

Pre-Cleaning Conditions

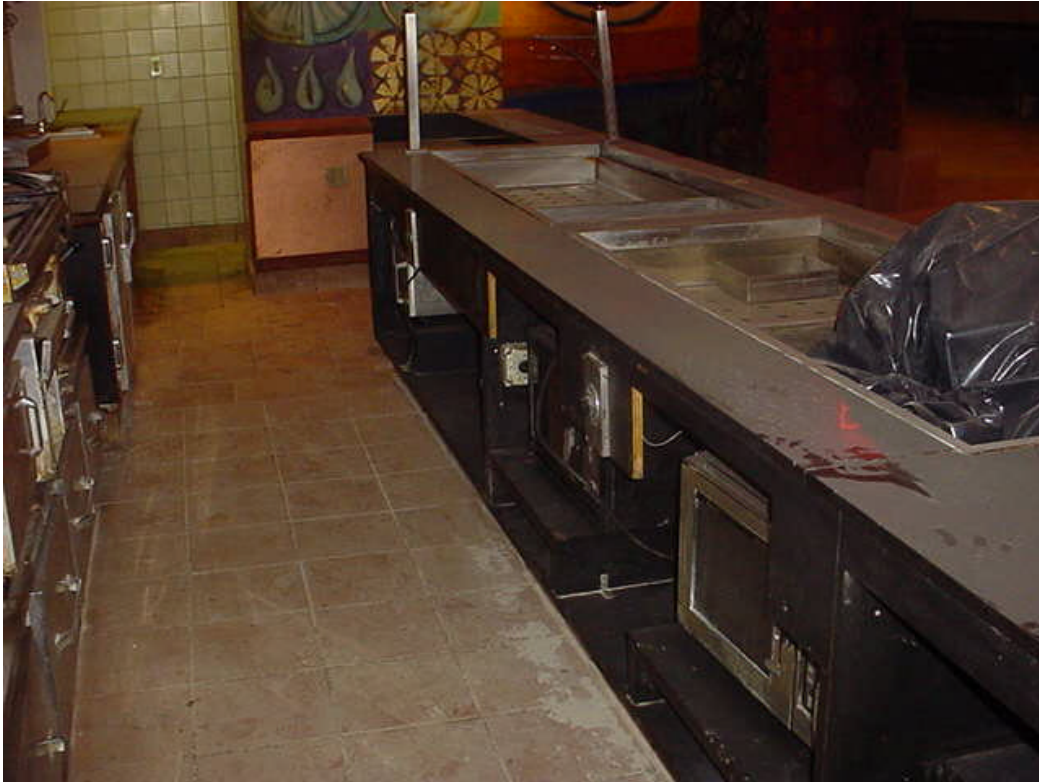
The Food Exchange  
081502-D2-011

Pre-Cleaning Conditions

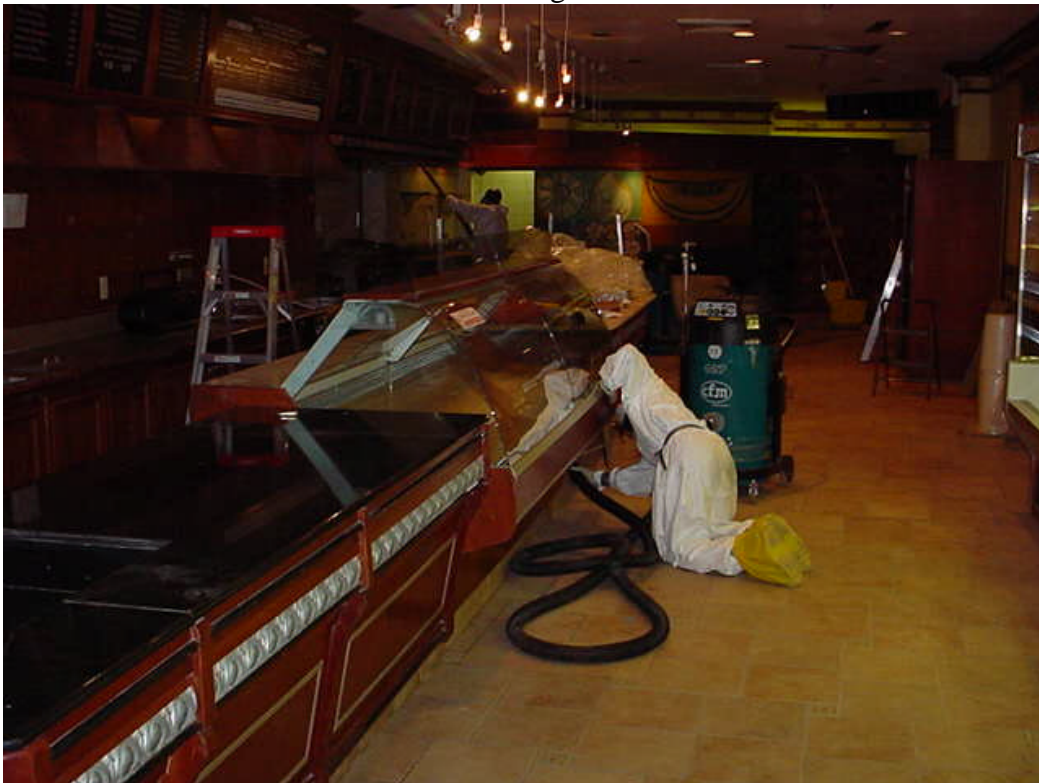
The Food Exchange  
081602-006

Vacuuming Dust

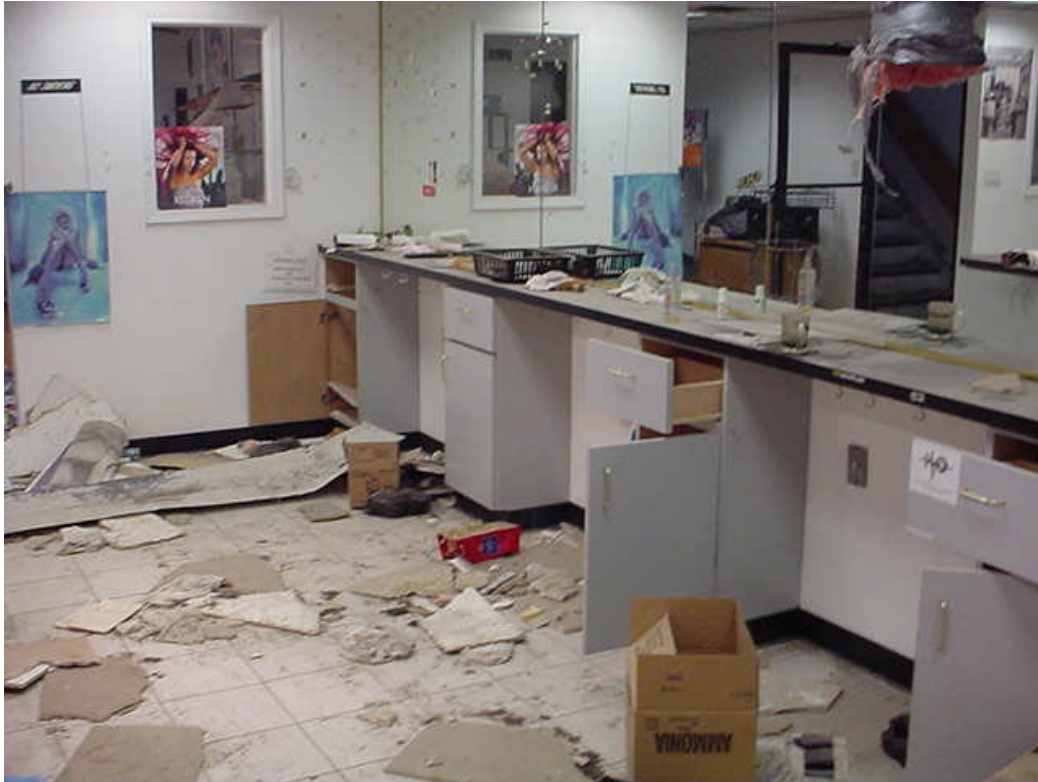
Barber Shop  
090902-018

Pre-Cleaning Conditions

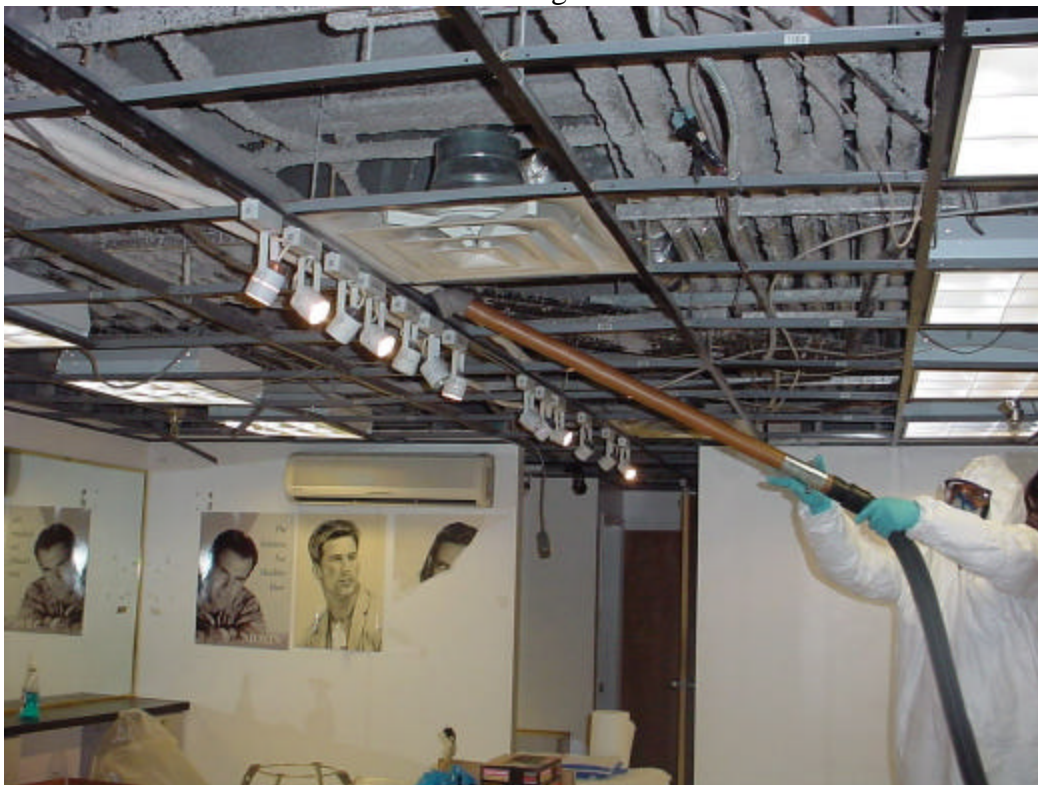
Barber Shop  
091702-006

Vacuuming Dust

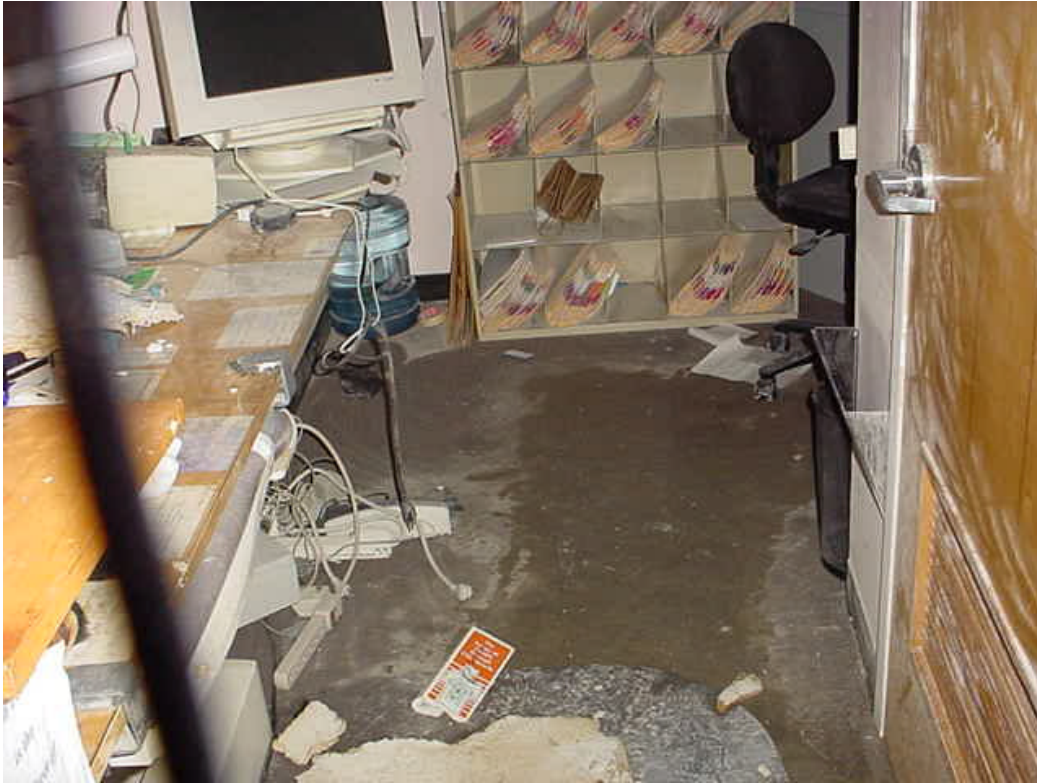
Chiropractor's Office  
062102-D1-011

Pre-Cleaning Conditions

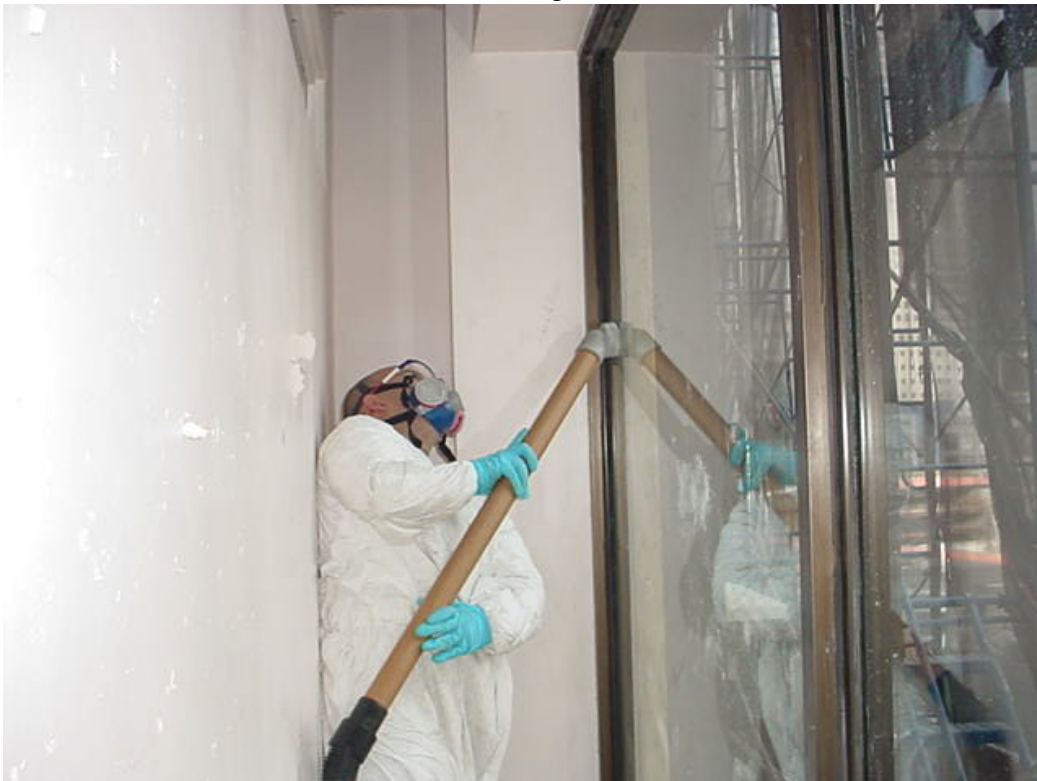
Chiropractor's Office  
072402-011

Vacuuming Dust

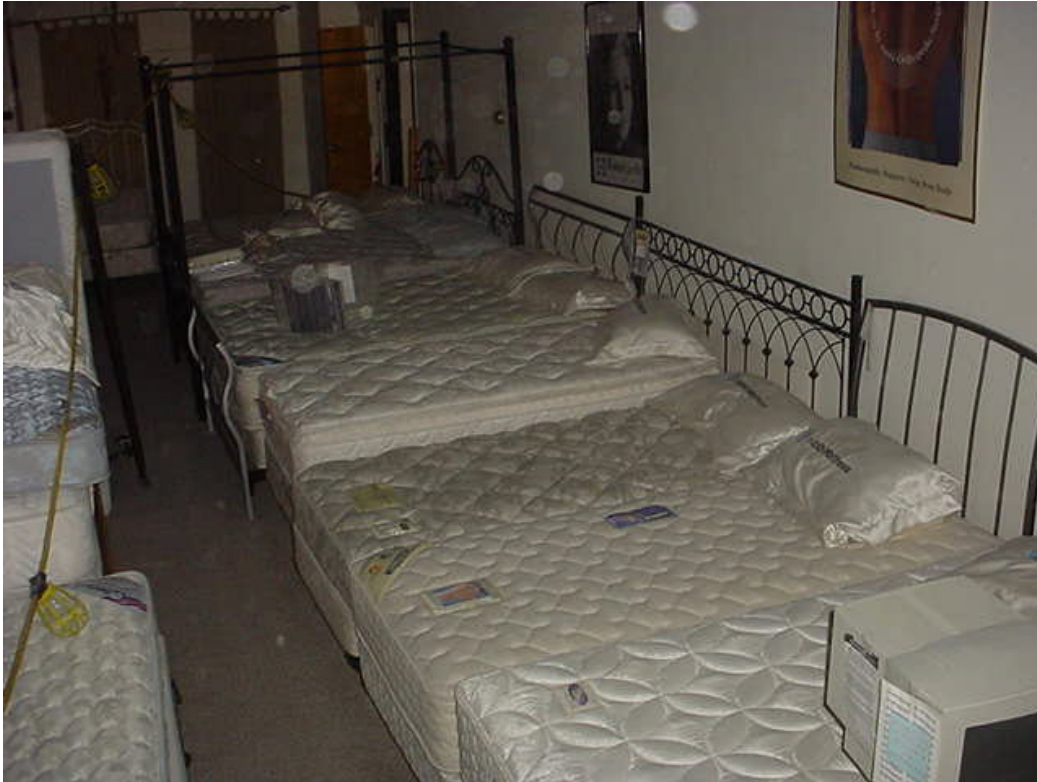
Mattress Store  
062102-D1-027

Pre-Cleaning Conditions

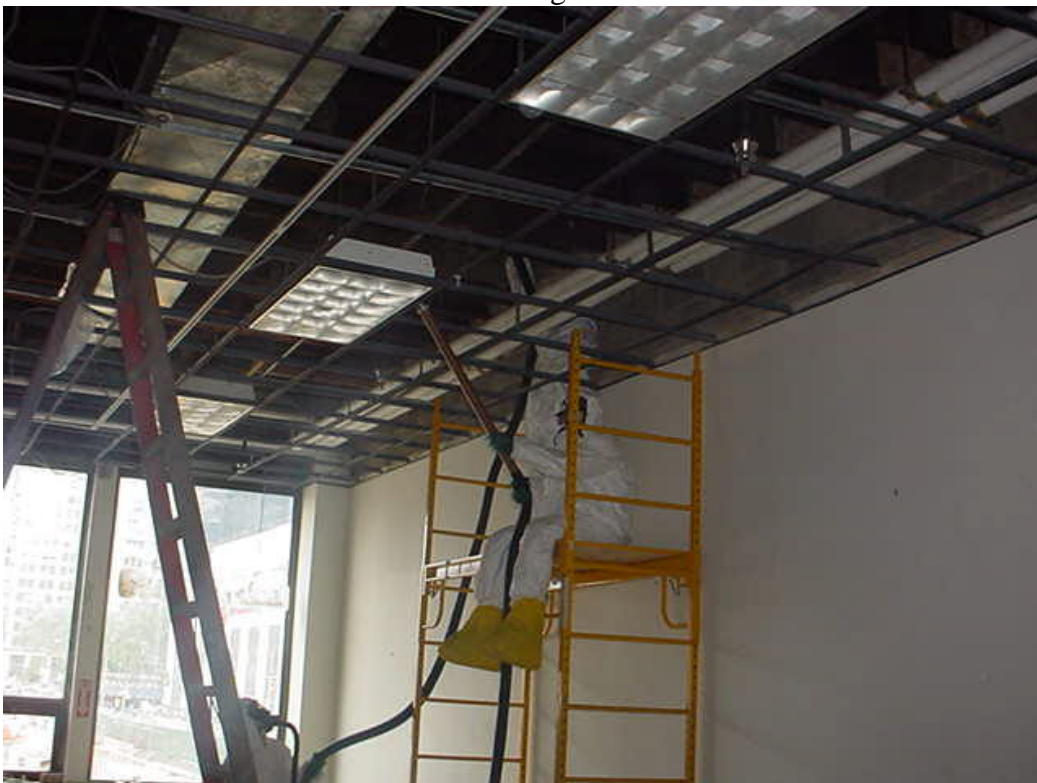
Mattress Store  
071802-009

Vacuuming Dust

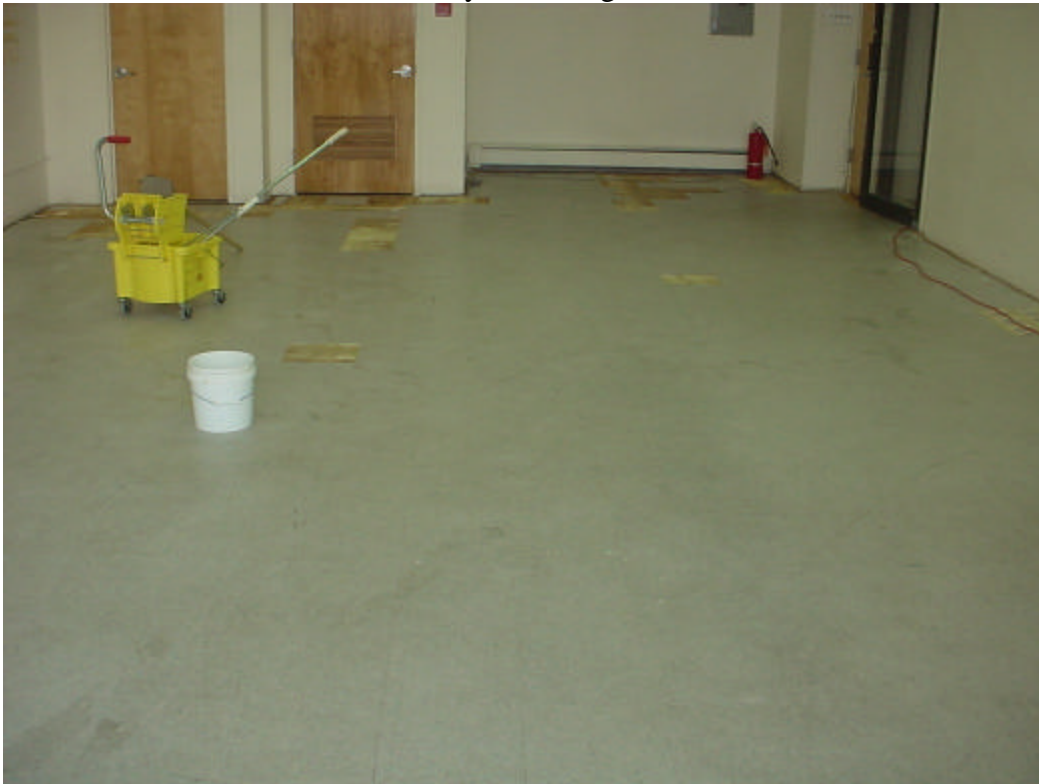
Mattress Store  
100102-005

“Water Only” Washing of Floor

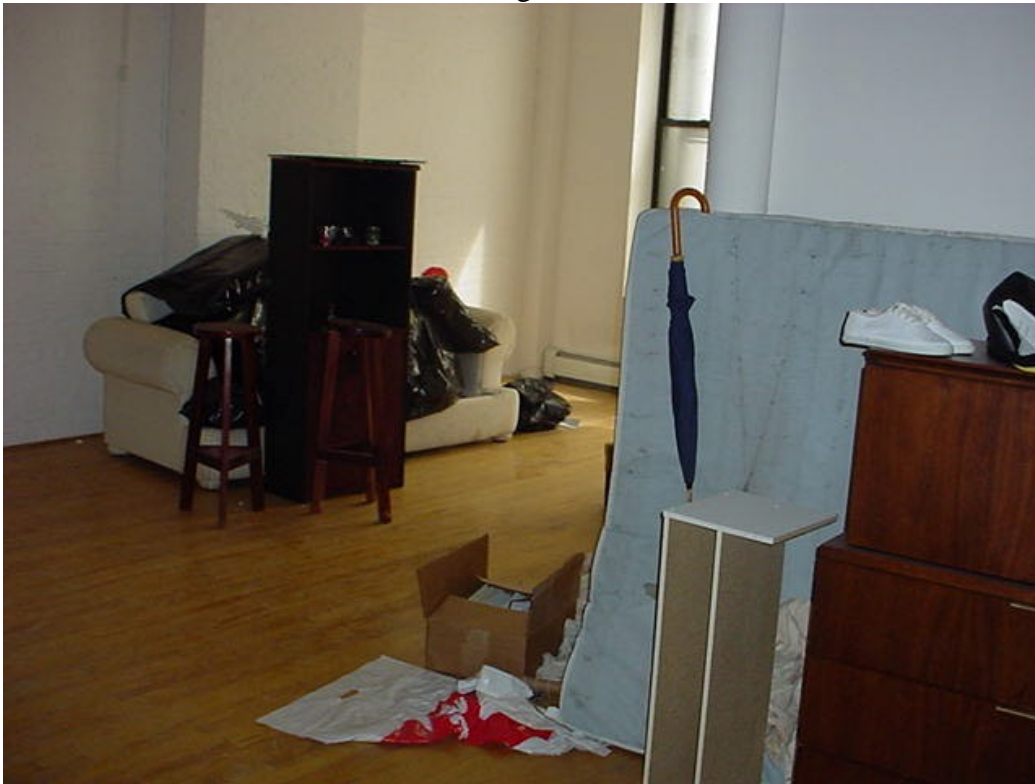
Unit 2A  
062102-D1-006

Pre-Cleaning Conditions

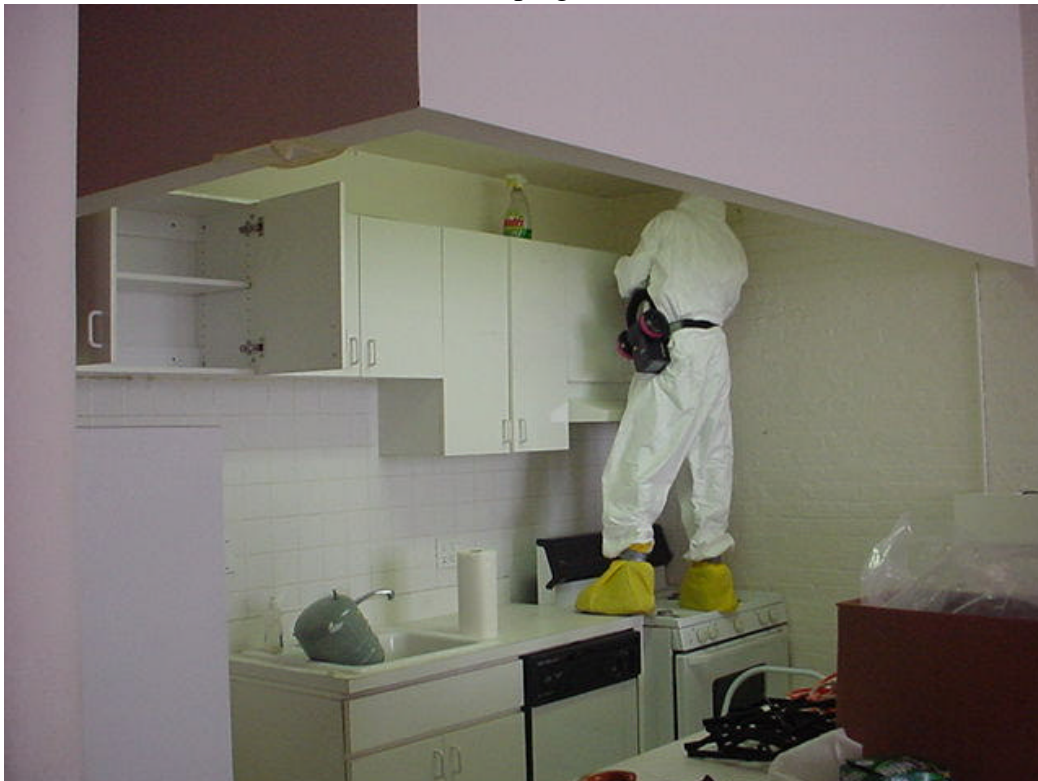
Unit 2A  
071602-001

Wet Wiping Dust

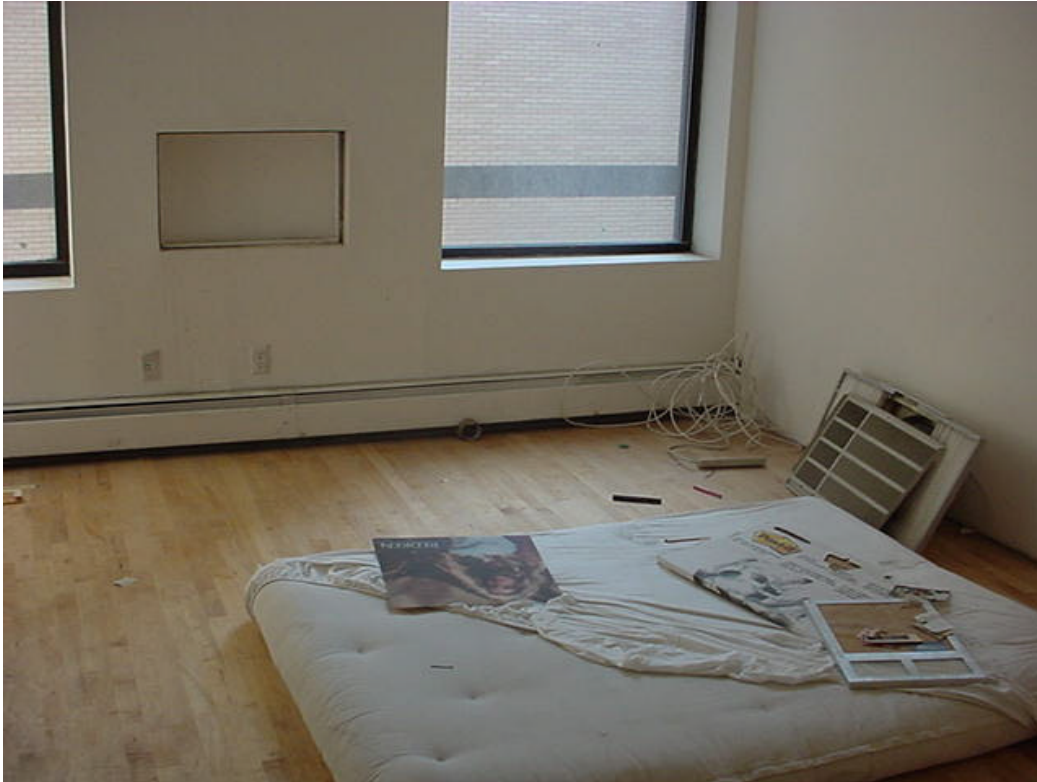
Unit 2B  
062102-D2-011

Pre-Cleaning Conditions

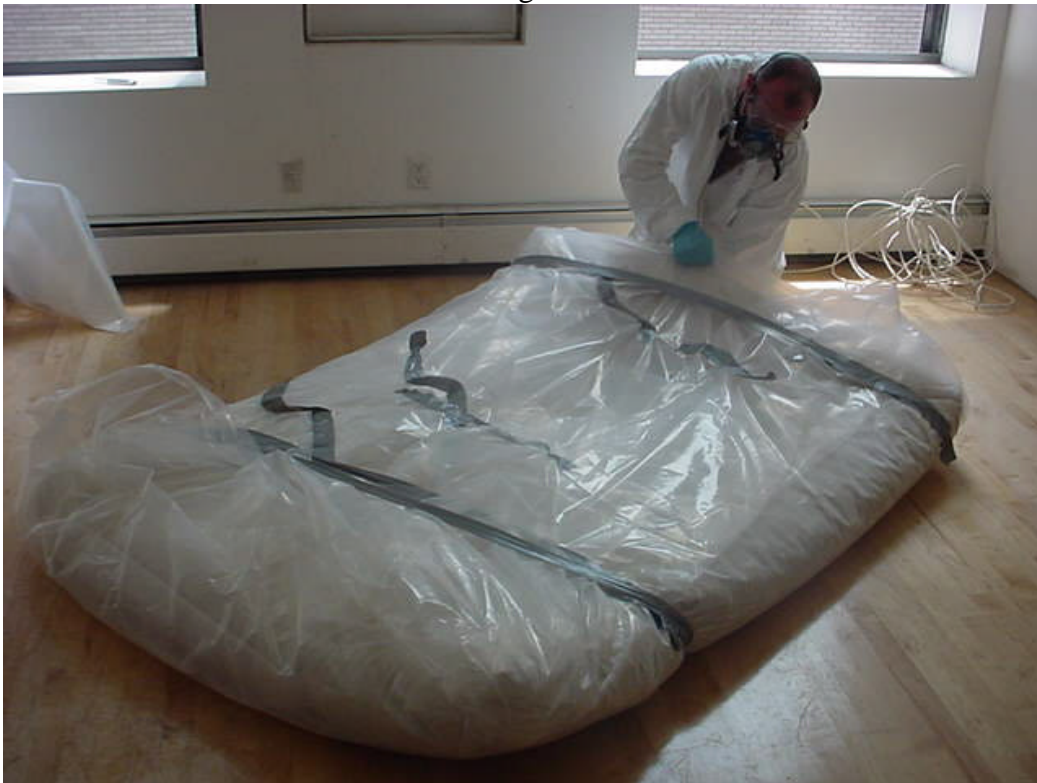
Unit 2B  
062802-006

Pre-Cleaning Conditions

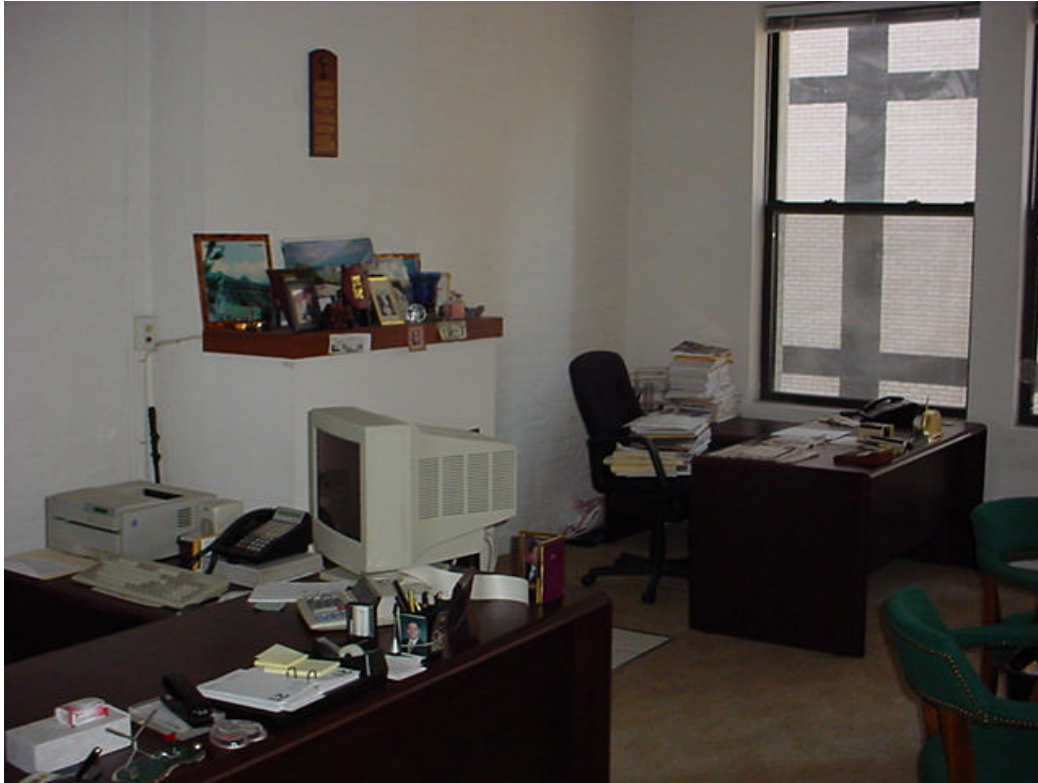
Unit 3A  
Dsc00261

Pre-Cleaning Conditions

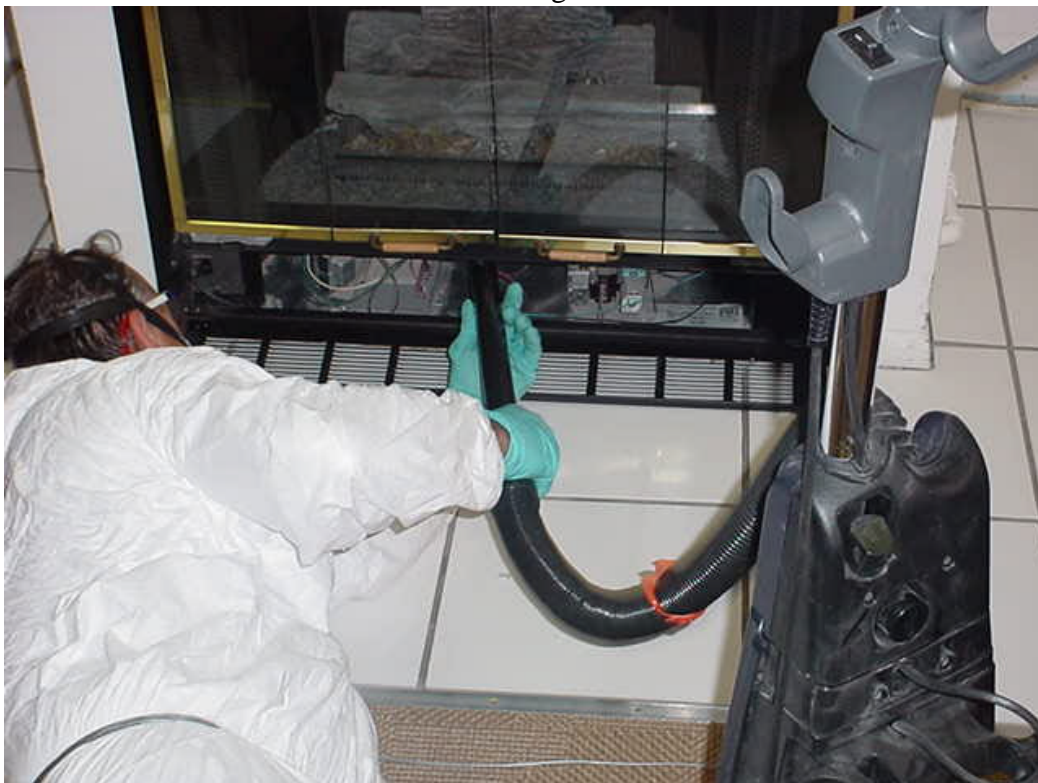
Unit 3A  
071802-002

Vacuuming Dust

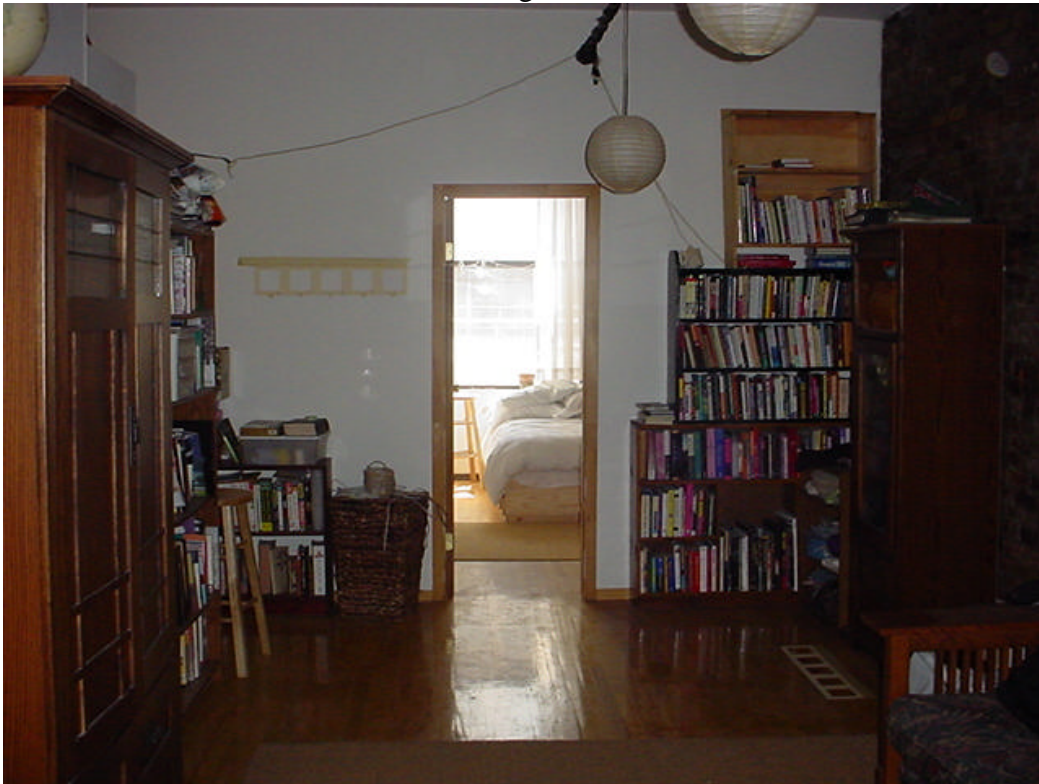
Unit 3B  
Dsc00230

Pre-Cleaning Conditions

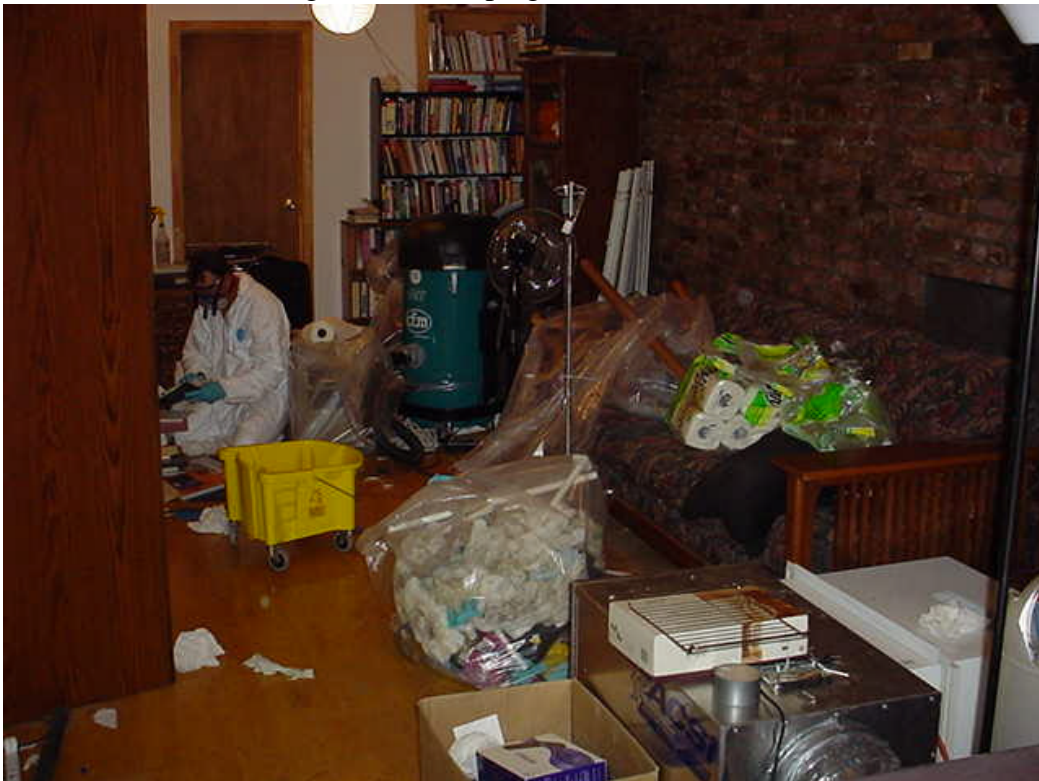
Unit 3B  
072502-010

Vacuuming and Wet Wiping Dust from Personal Items

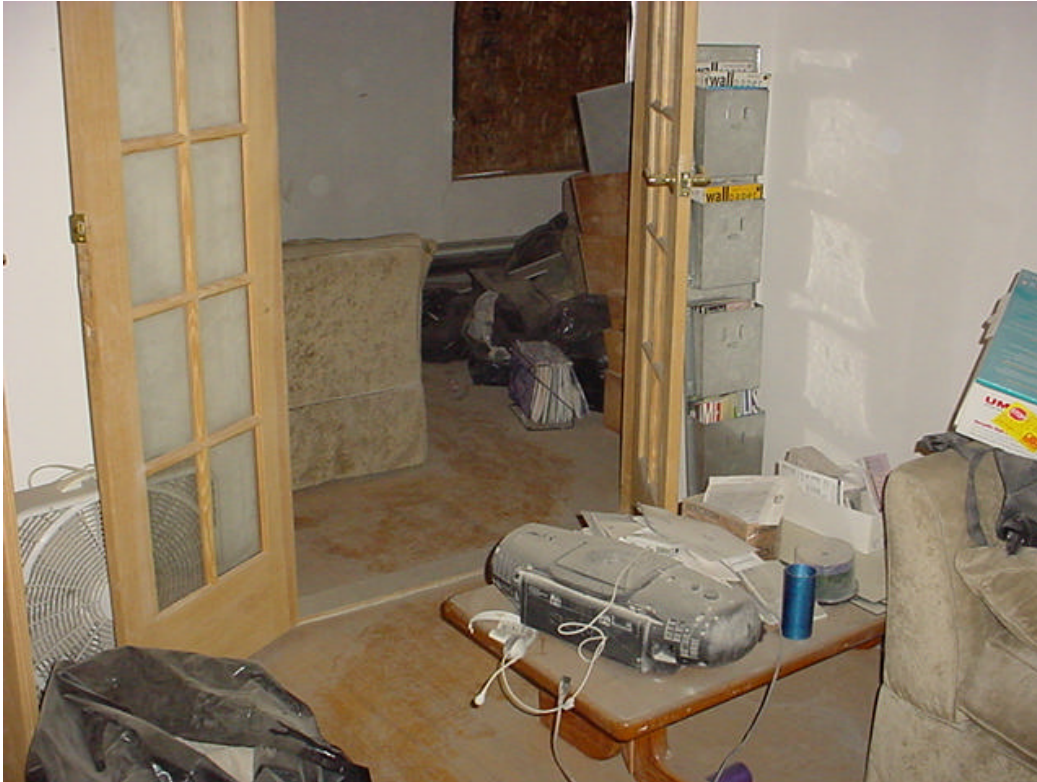
Unit 3C  
Dsc00321

Pre-Cleaning Conditions

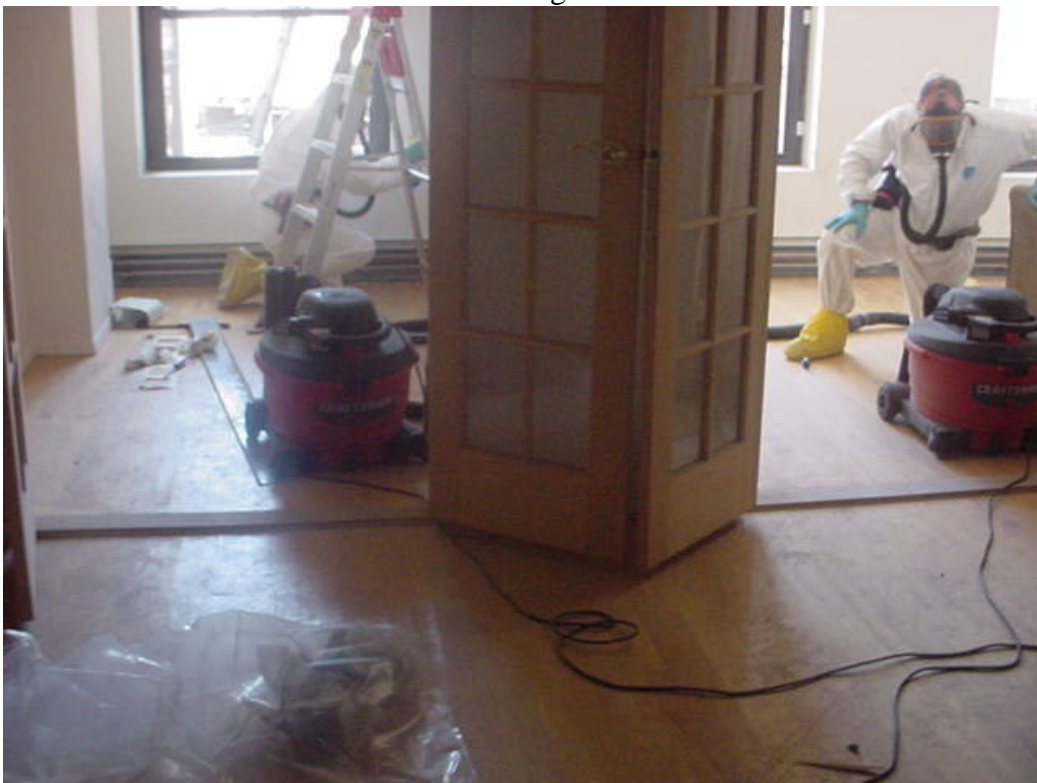
Unit 3C  
071102-018

Vacuuming Dust

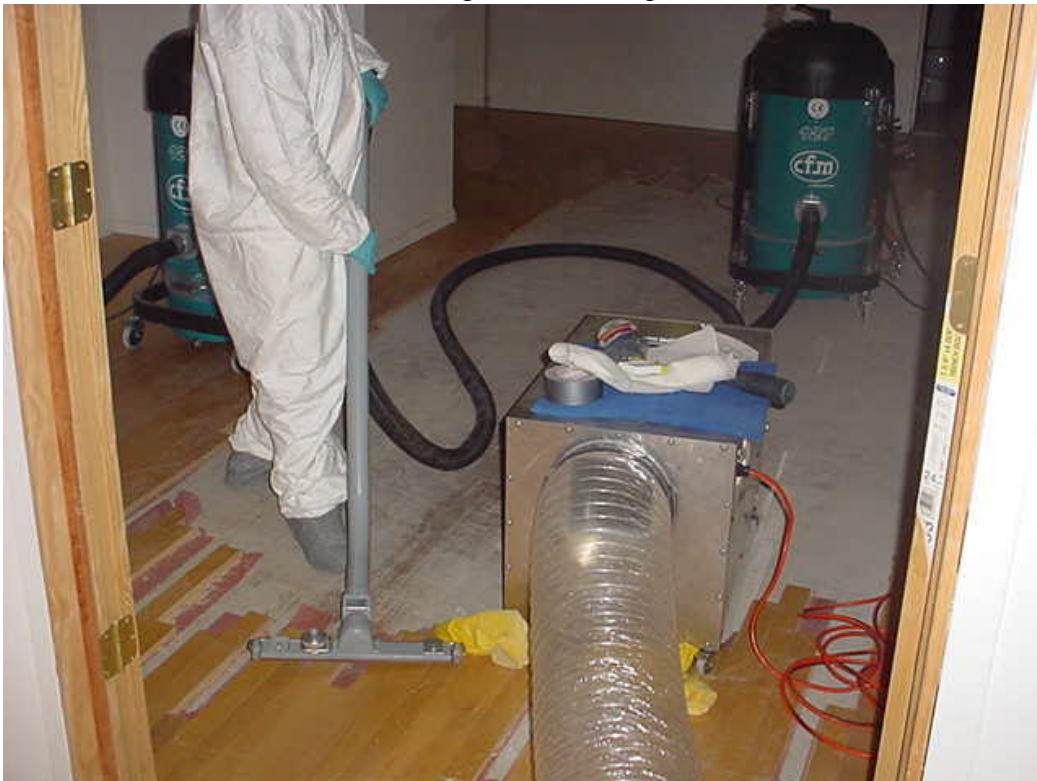
Unit 3C  
091202-003

3<sup>rd</sup> Cleaning – Vacuuming Dust

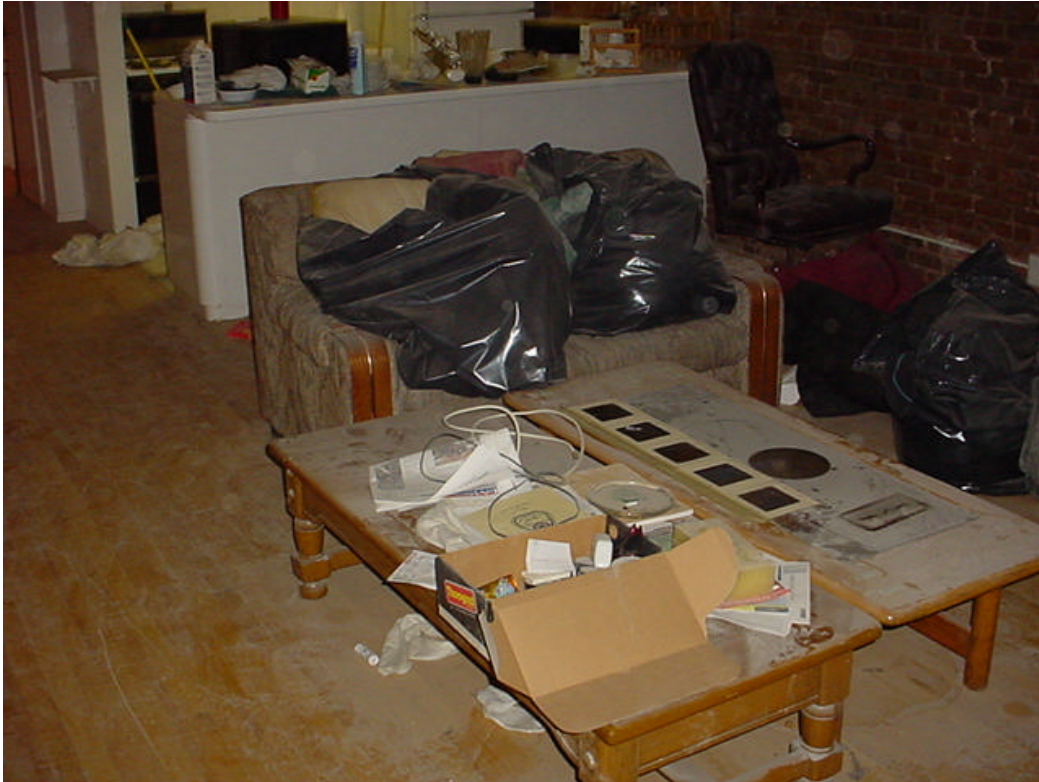
Unit 3D  
Dsc00366

Pre-Cleaning Conditions

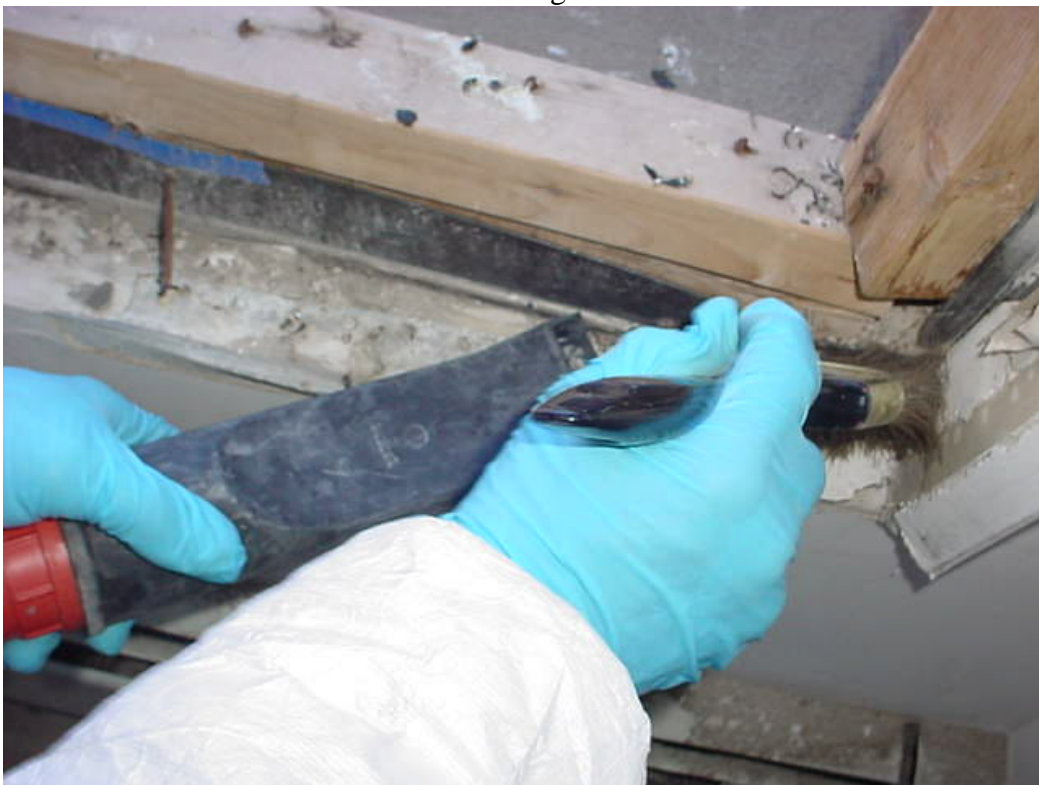
Unit 3D  
071102-010

Vacuuming Dust

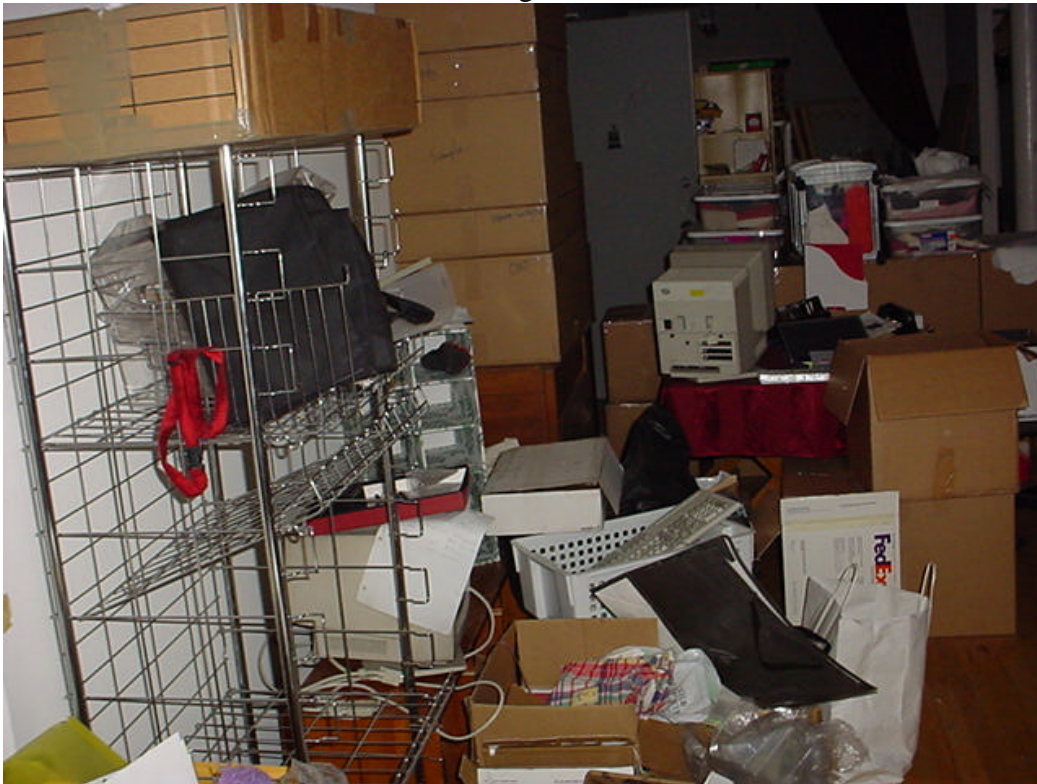
Unit 4A  
061902-Dsc00017

Pre-Cleaning Conditions

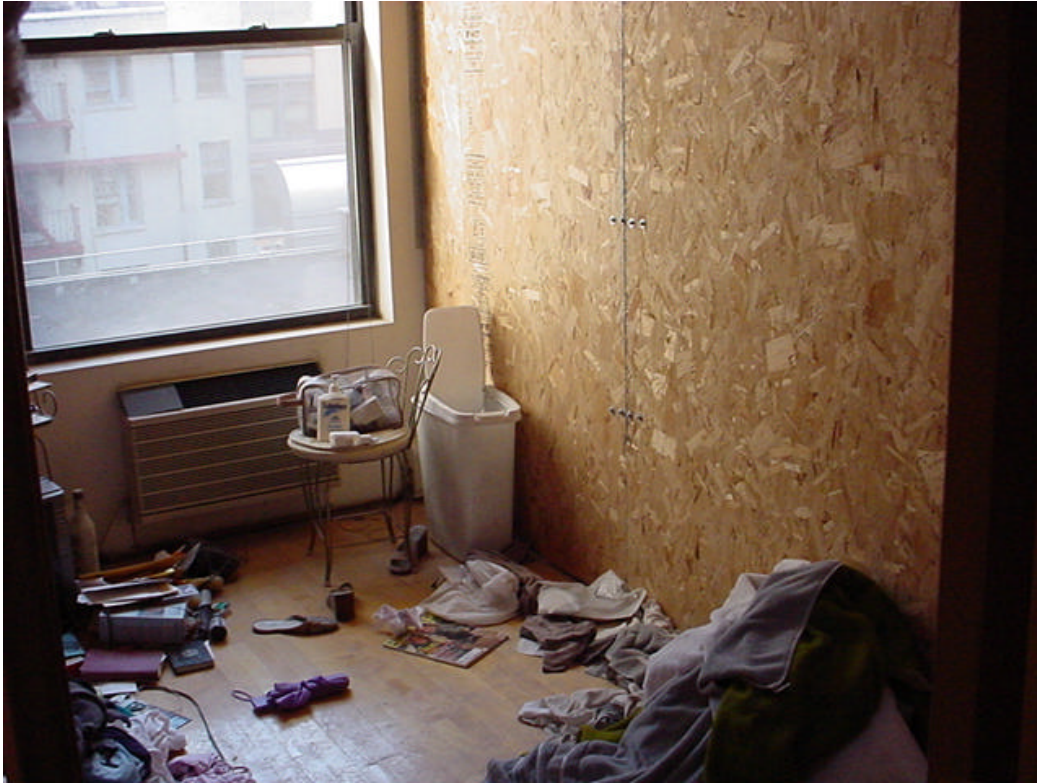
Unit 4B  
061902-Dsc00109

Pre-Cleaning Conditions

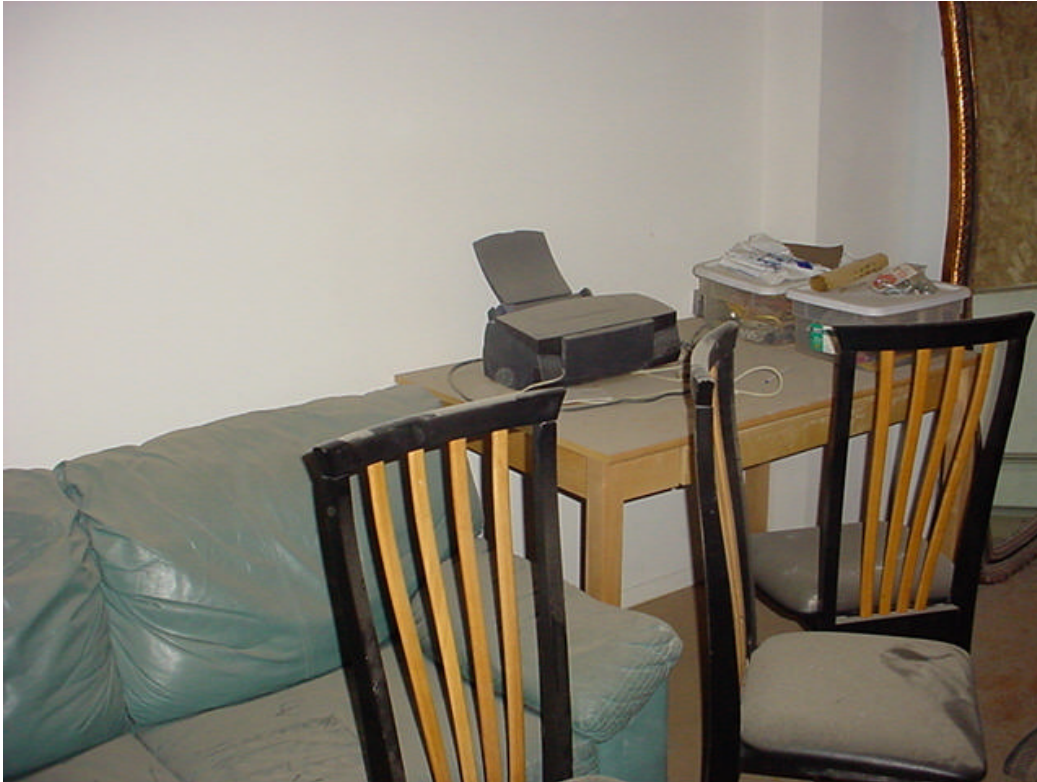
Unit 4C  
061902-Dsc00189

Pre-Cleaning Conditions

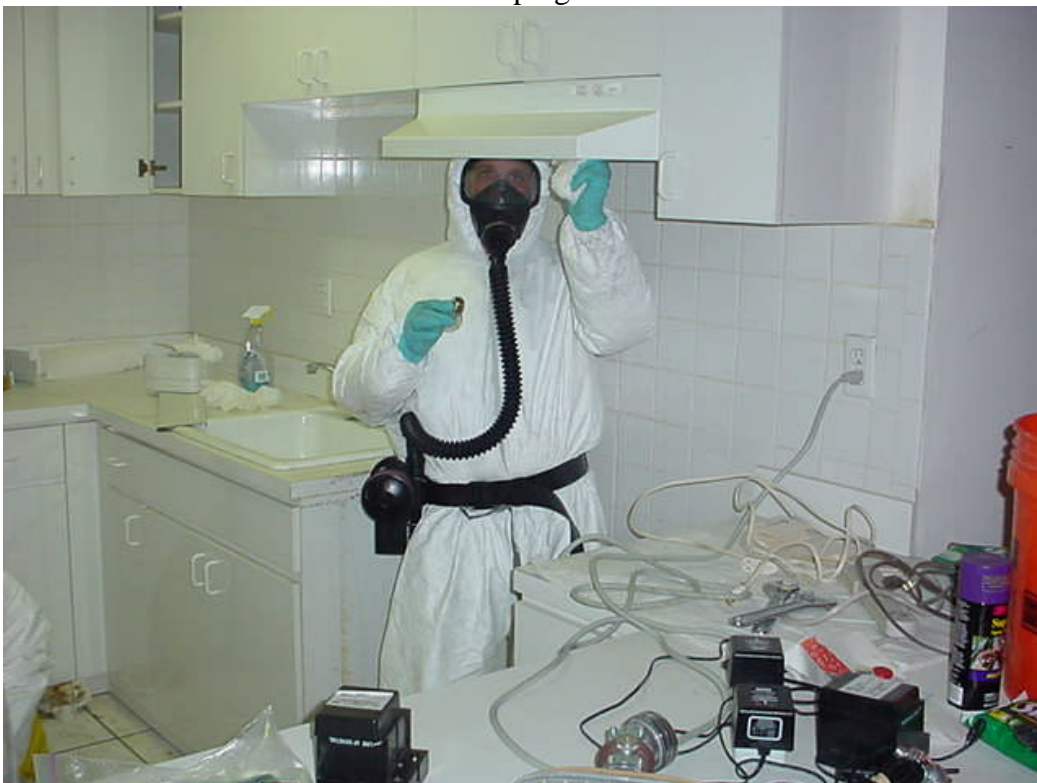
Unit 4C  
070802-001

Wet Wiping Dust

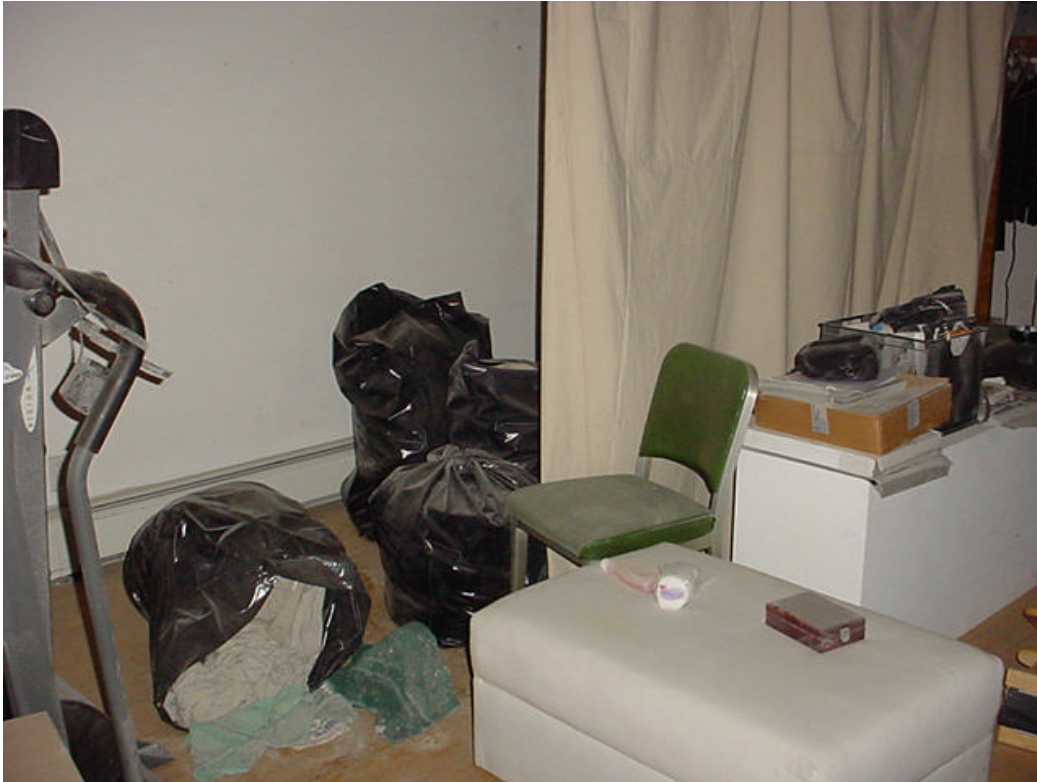
Unit 4D  
061902-Dsc00149

Pre-Cleaning Conditions
