# ***Interim Final WTC Residential Confirmation Cleaning Study***

## **Volume 1**

110 Liberty St.  
New York, NY

**U.S Environmental Protection Agency, Region 2**  
New York City Response and Recovery Operations  
290 Broadway  
New York, NY 10007-1866  
May 2003

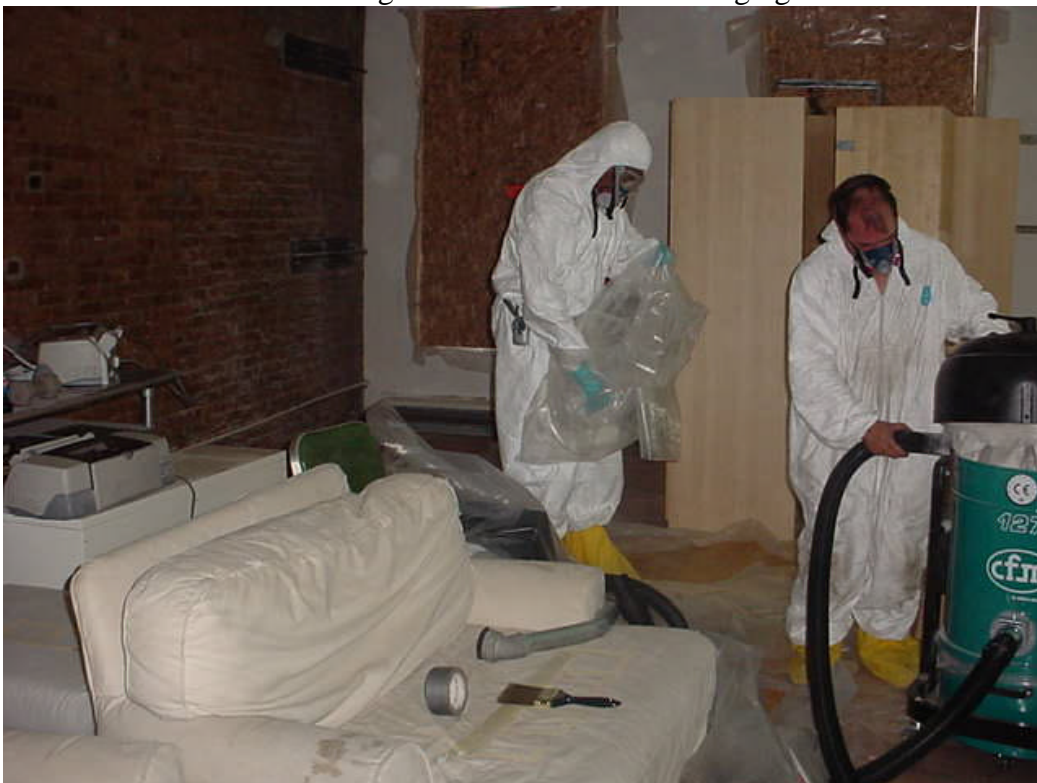
Unit 4D  
070102-004

Vacuuming Dust from Personal Belongings

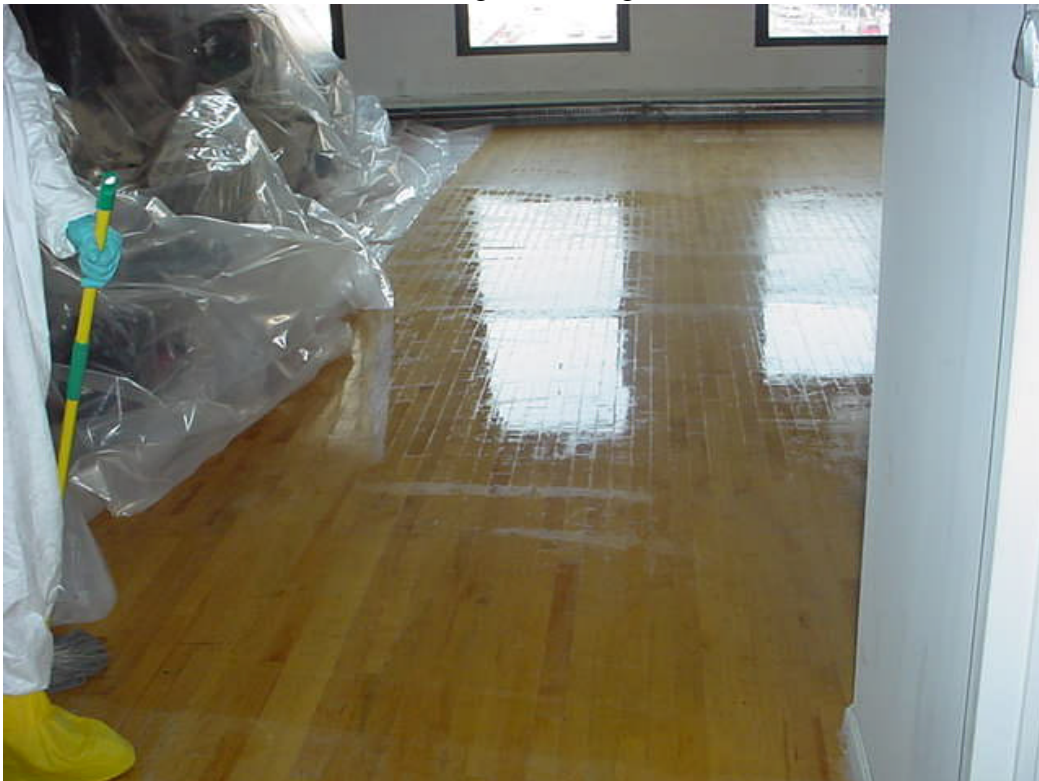
Unit 4D  
081302-005

2<sup>nd</sup> Cleaning – Washing Floor

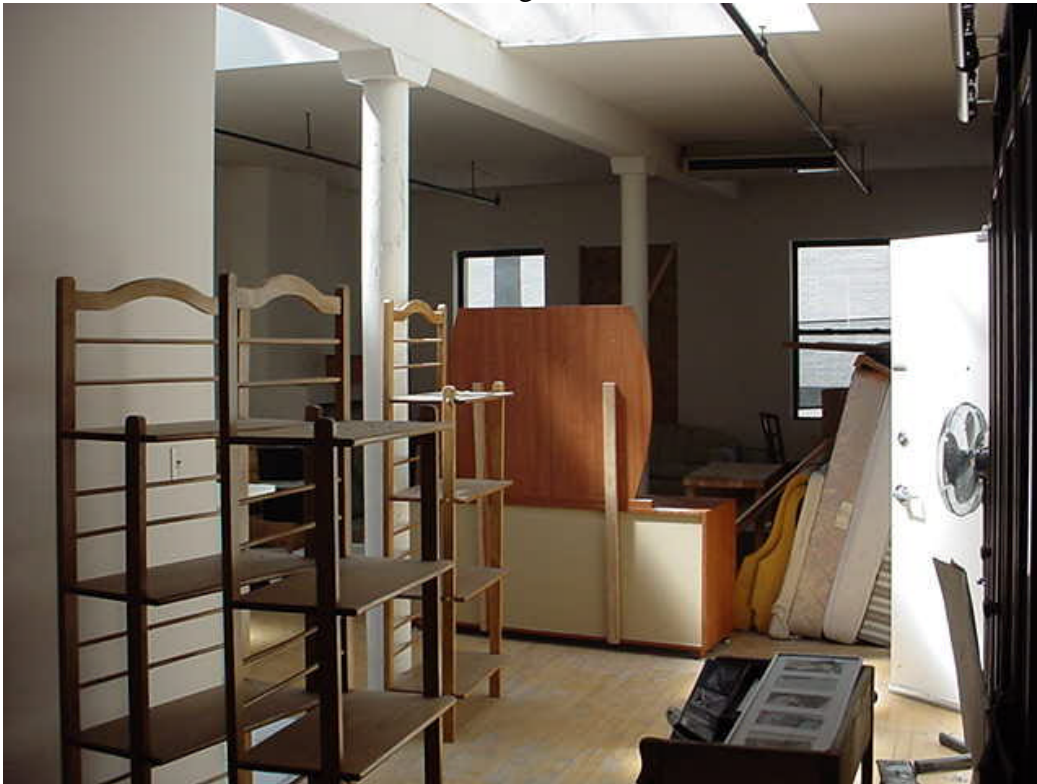
Unit 5A  
061802-D2-030

Pre-Cleaning Conditions

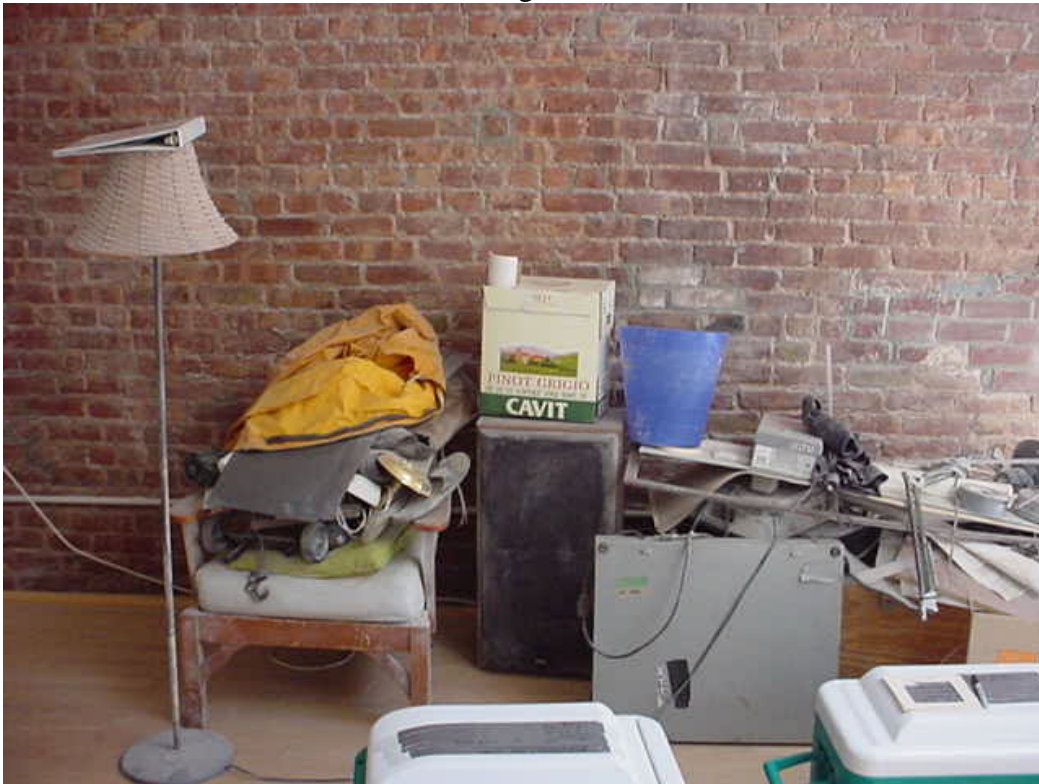
Unit 5C  
061802-D1-020

Pre-Cleaning Conditions

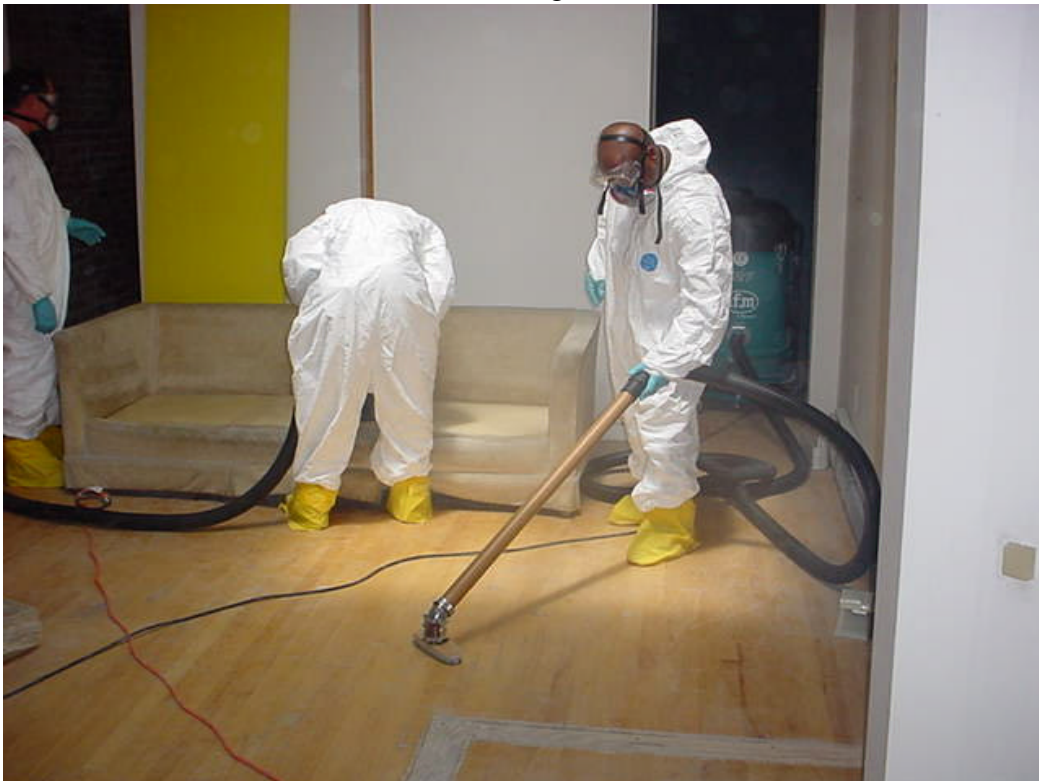
Unit 5C  
062802-009

Vacuuming Dust

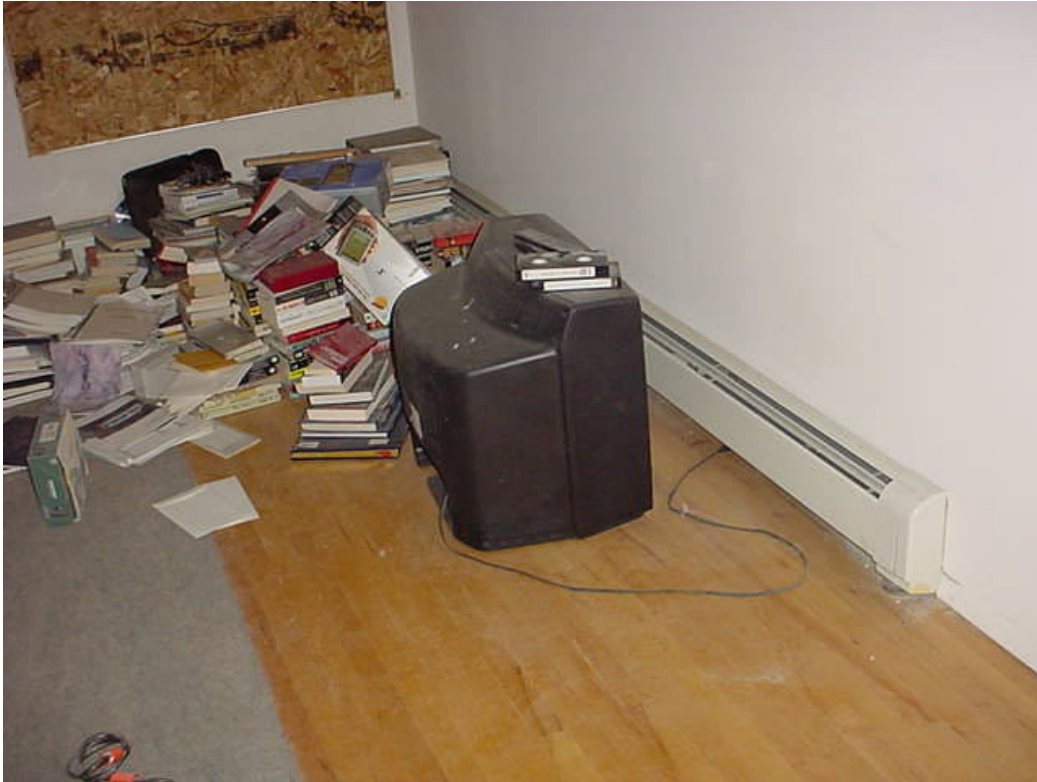
Unit 5D  
061802-D2-021

Pre-Cleaning Conditions

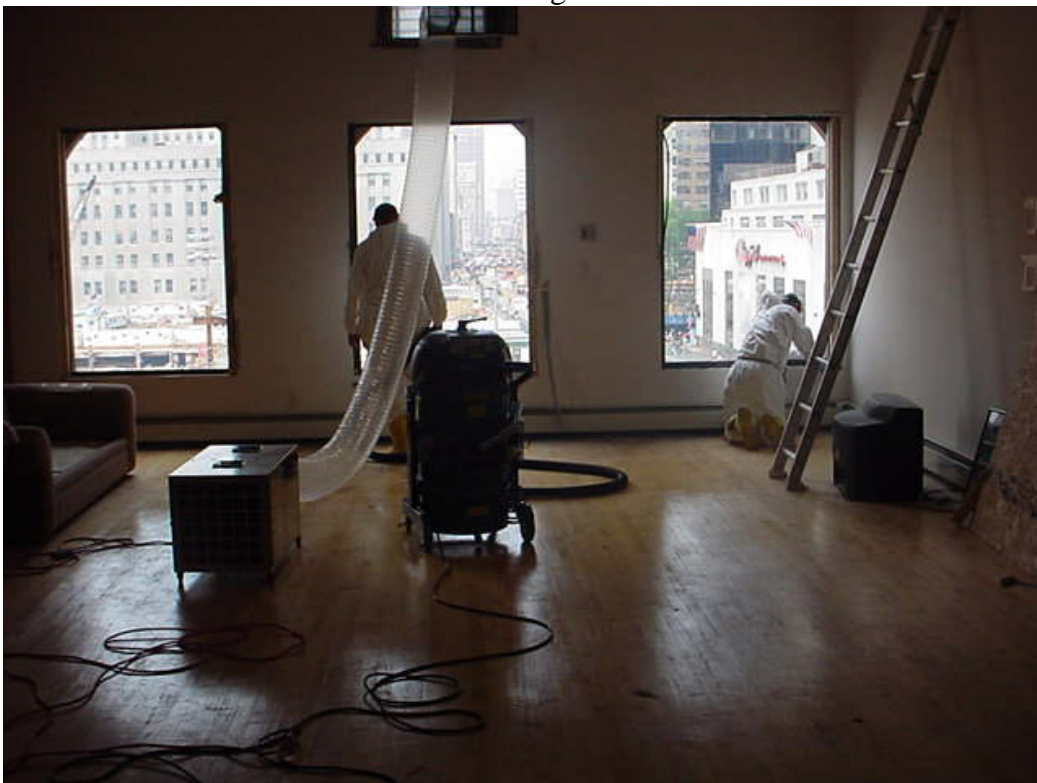
Unit 5D  
062602-019

Vacuuming Dust

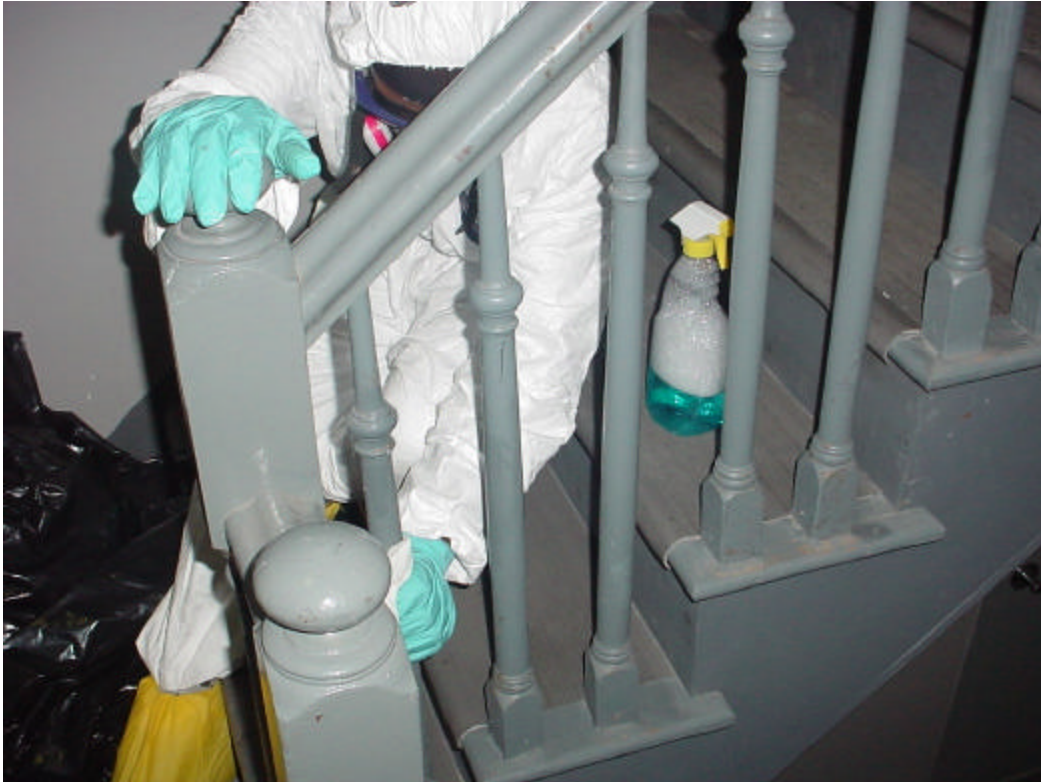
Common Areas  
092502-S.stairs-003

Wet Wiping Dust
