2. Summary of Research Relevant to the D.C. Lead Issue

2.2 Lead Pipe Scale Analysis

2.3 DCWASA Circulation Pipe Loop Studies

2.4 Washington Aqueduct Flow-Through Pipe Loop Studies

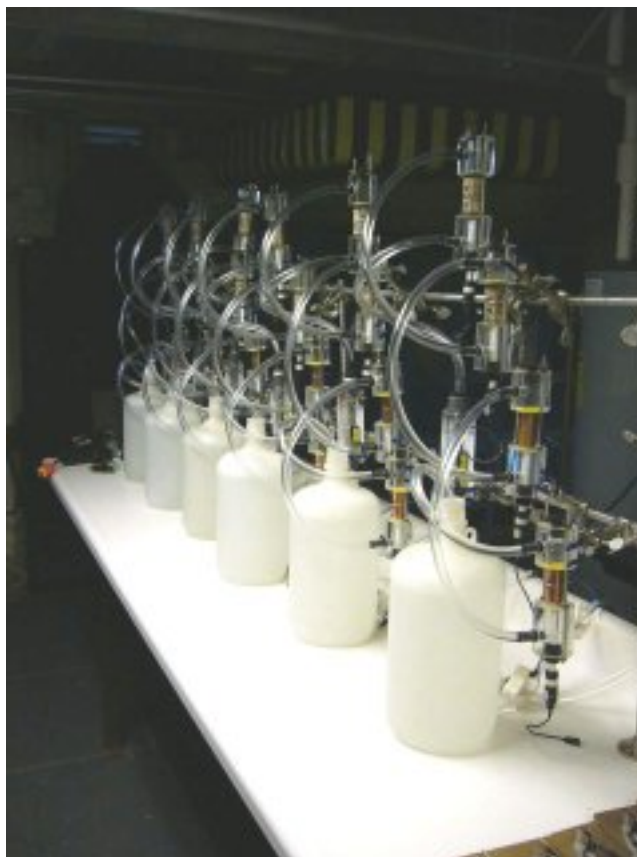
Exhibit 2.3.1 Photograph of Electrochemical Polarization Cell Used in the EC Pipe Loop System

A total of 12 circulation loops, comprising six EC loops and six stagnation loops, were constructed to test the various corrosion control strategies. Exhibit 2.3.1 is a photograph of the EC pipe loops. Exhibit 2.3.2 is a schematic of the stagnation loops.

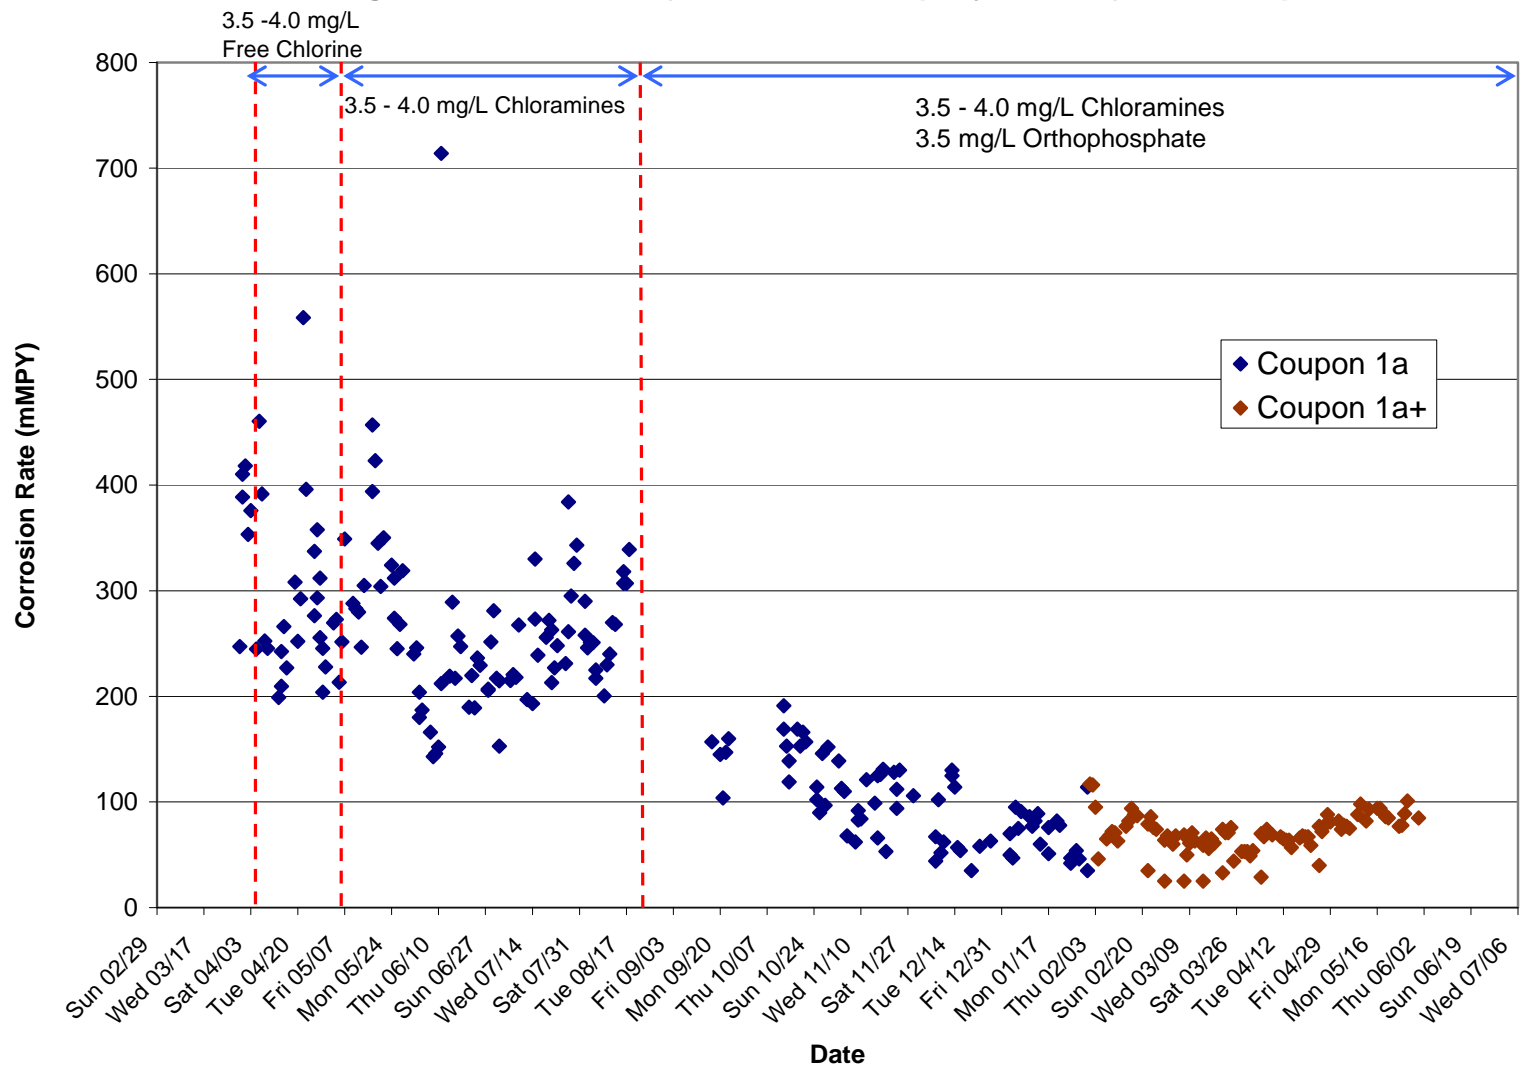
Exhibit 2.3.6 Change in Corrosion Rate (Measured in mils per year, MPY) for EC Loop Number 1

All loops show substantial and continuous reductions in lead leaching resulting from the orthophosphate treatment. Results from the EC loops were similar and showed a comparable although slightly delayed initial reduction in EC corrosion rate with the orthophosphate treatment. Exhibit 2.3.6 is an example of the corrosion rates measured for Pipe Loop Number 1.

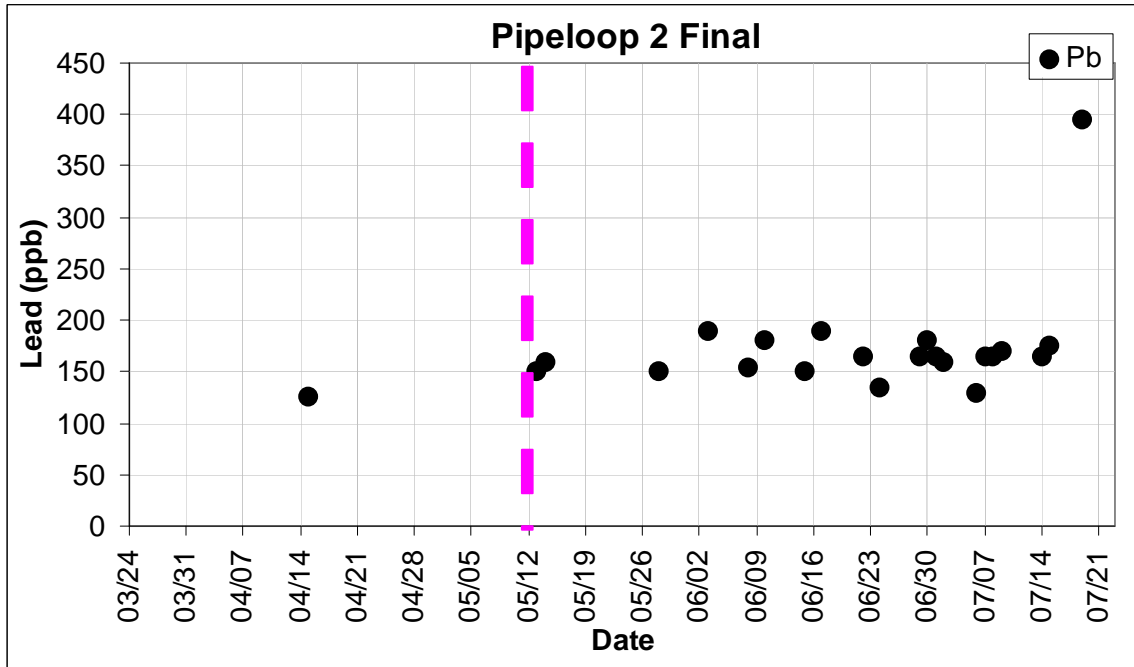
Exhibit 2.3.7 Results from Pipe Loop 2 (March 2004 - July 2004)

A second important finding regarding the screening of corrosion control strategies is that other corrosion strategies *did not* reduce lead release rates under chloramines conditions. Exhibit 2.3.7 shows total lead concentration for Pipe Loop 2, which was treated with lime to raise the calcium carbonate precipitation potential. This potential strategy did not appear to have any impact on lead release. Exhibit 2.3.8 shows total lead concentration for Pipe Loop 4, which was initially fed a 50/50 ortho/polyphosphate blend at between 1 and 2 mg/L. Lead release in this loop fell slightly, but very little in comparison to the orthophosphate loops. In 2006, Stannous Chloride was tested in Pipe Loop 5. Preliminary results show an increase in total and dissolved lead concentrations.

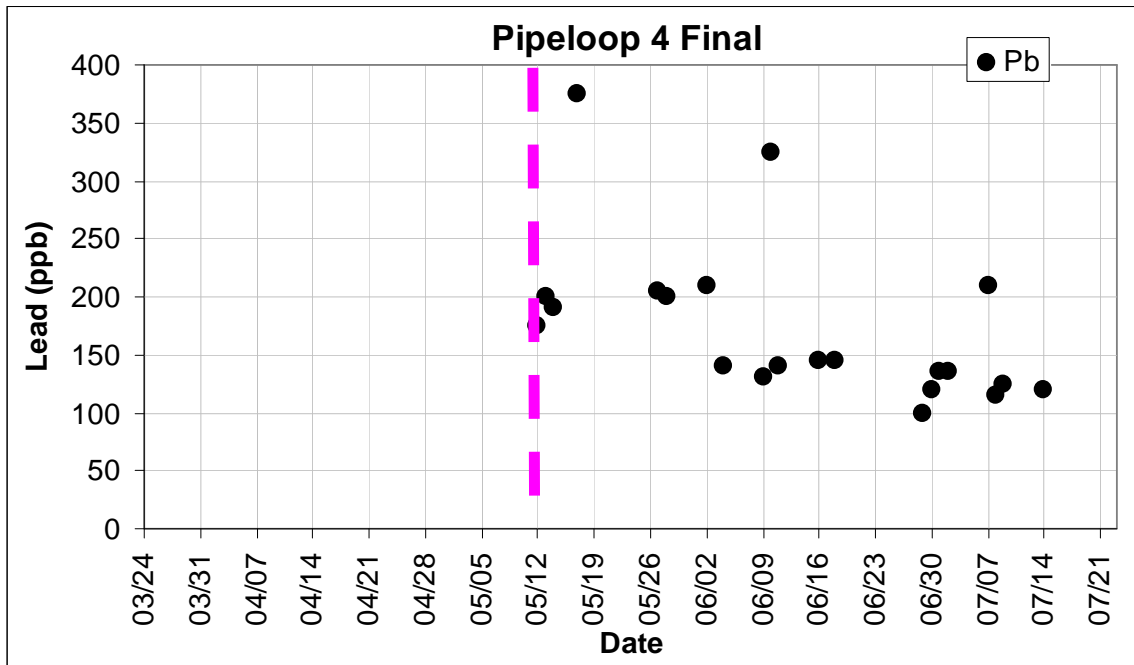
Exhibit 2.3.8 Results from Pipe Loop 4 (March 2004 - July 2004)

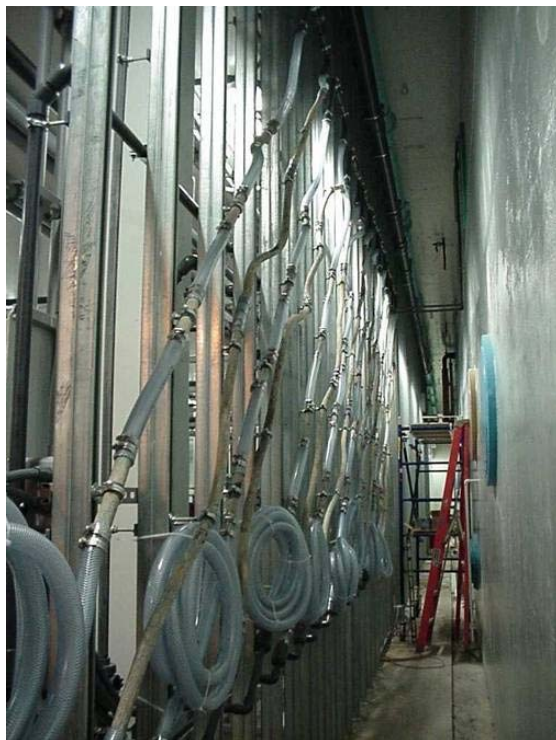
Exhibit 2.4.2 Photograph of the pipe rack elements installed at the Dalecarlia Water Treatment Plant

The pipe loops were operated on a 16-hour flow period, followed by an 8-hour stagnation period. Unlike the DCWASA system, water was not recirculated within the loop and exchanged on a daily basis. Instead, all WA racks were a single pass-through operation. The flow-through pipe loop facilities were operated seven days per week. Periodic water quality samples were collected Monday through Friday and delivered to the WA Laboratory for analyses. The standard analysis set consisted of the following:

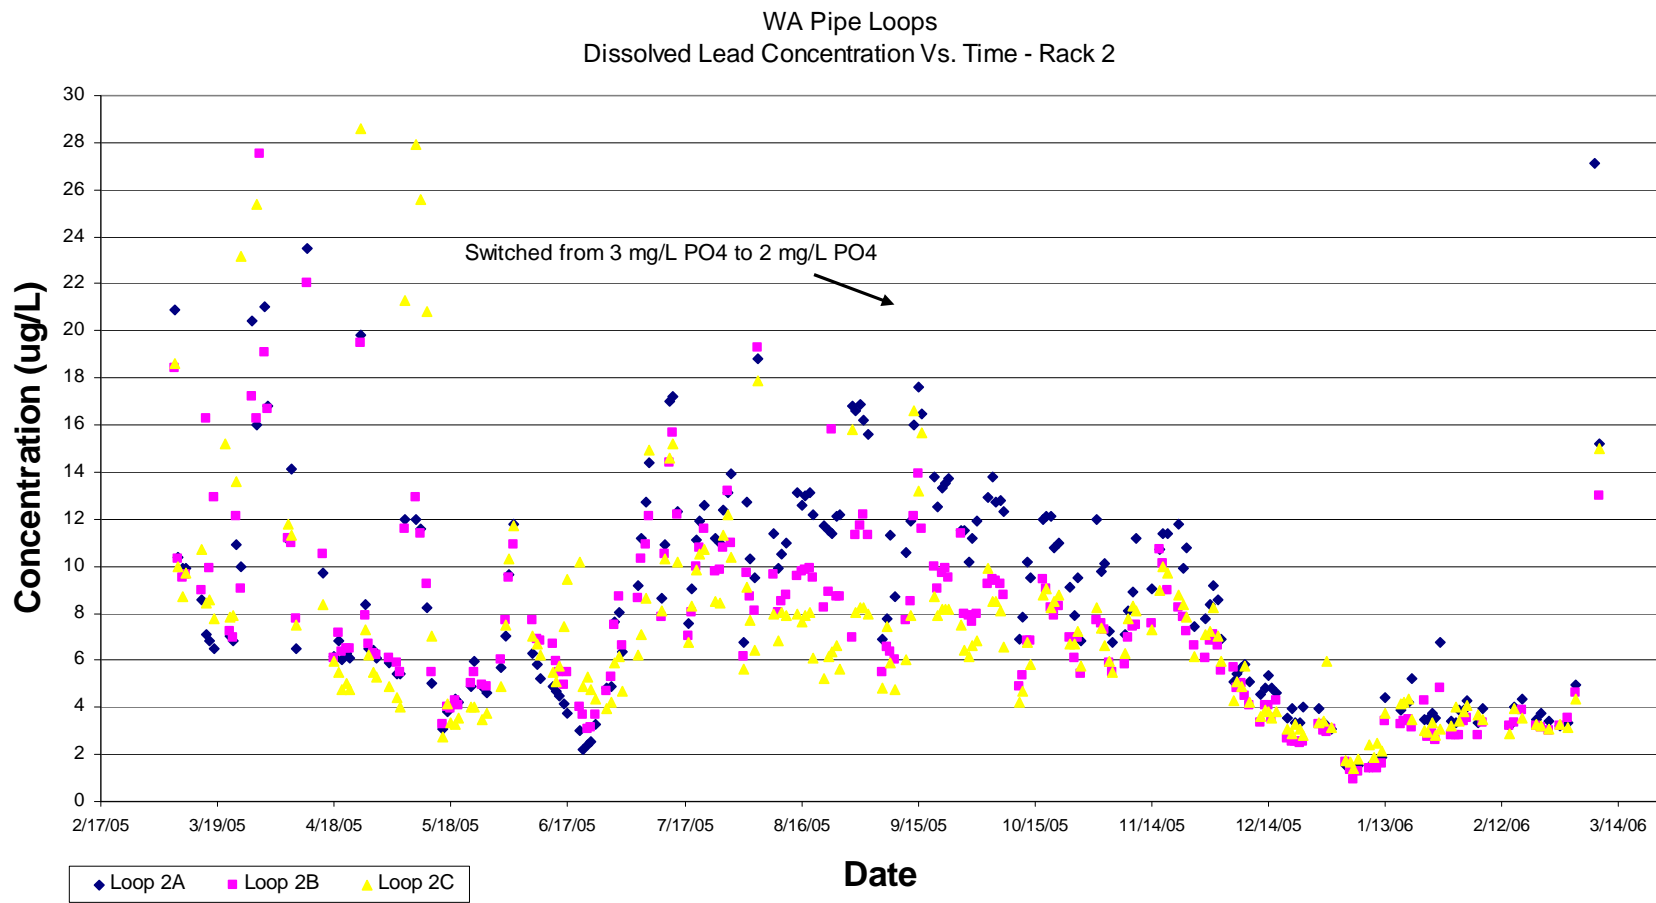
Exhibit 2.4.3b Dissolved Lead Results for Rack 2: Decrease Orthophosphate Over Time

The results from Racks 2, 3, 6, and 7 confirm the effectiveness of orthophosphate treatment. The time needed to observe meaningful reductions in lead was longer than for the DCWASA circulation loops, although this may be attributable to the high orthophosphate dose of 10 mg/L used to accelerate results in the DCWASA loops. Total and dissolved lead both before and during orthophosphate treatment are generally lower in the WA loops compared to the DCWASA loops. However, the relative proportion of particulate lead in the WA loops was substantially greater than in the DCWASA loops. Only after substantial treatment with orthophosphate did the proportion of the particulate lead in the WA loops diminish. The presence of the higher particulate fraction may suggest a difference in loop fabrication techniques or handling of the LSL specimens prior to fabrication. Also, the pipe loops used in the WA study were allowed to dry out, while DCWASA's pipe loops remained wet. This may account for differences between the study results.

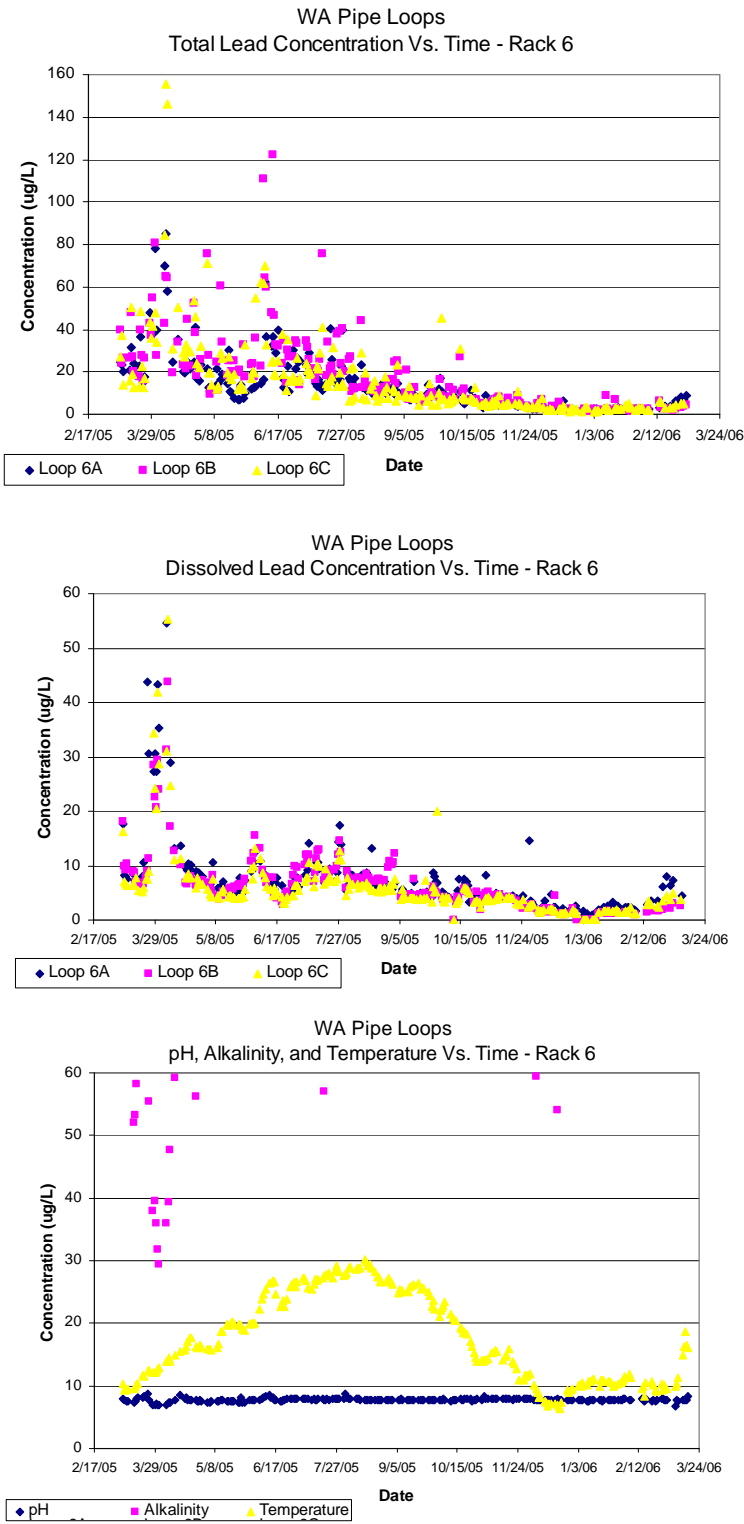
Exhibit 2.4.5a Results for Rack 6, High Chloramine Dose

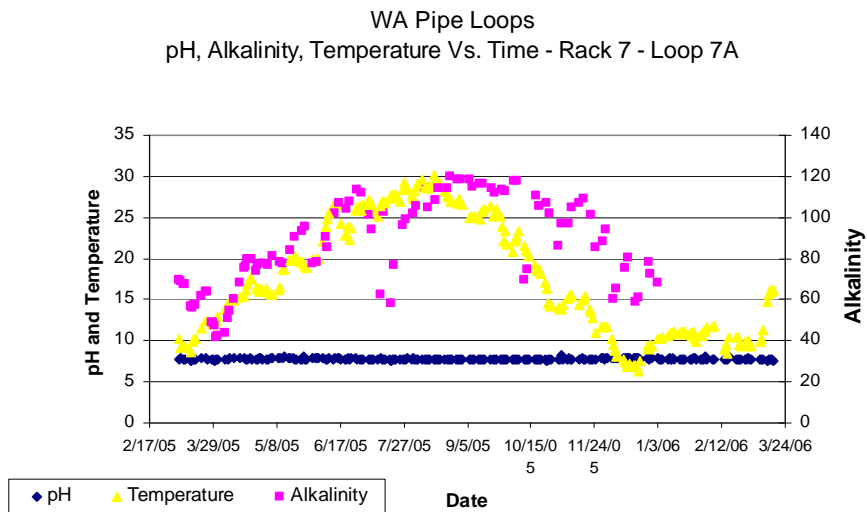
Exhibit 2.4.6a Results for Rack 7, Finished Water Control

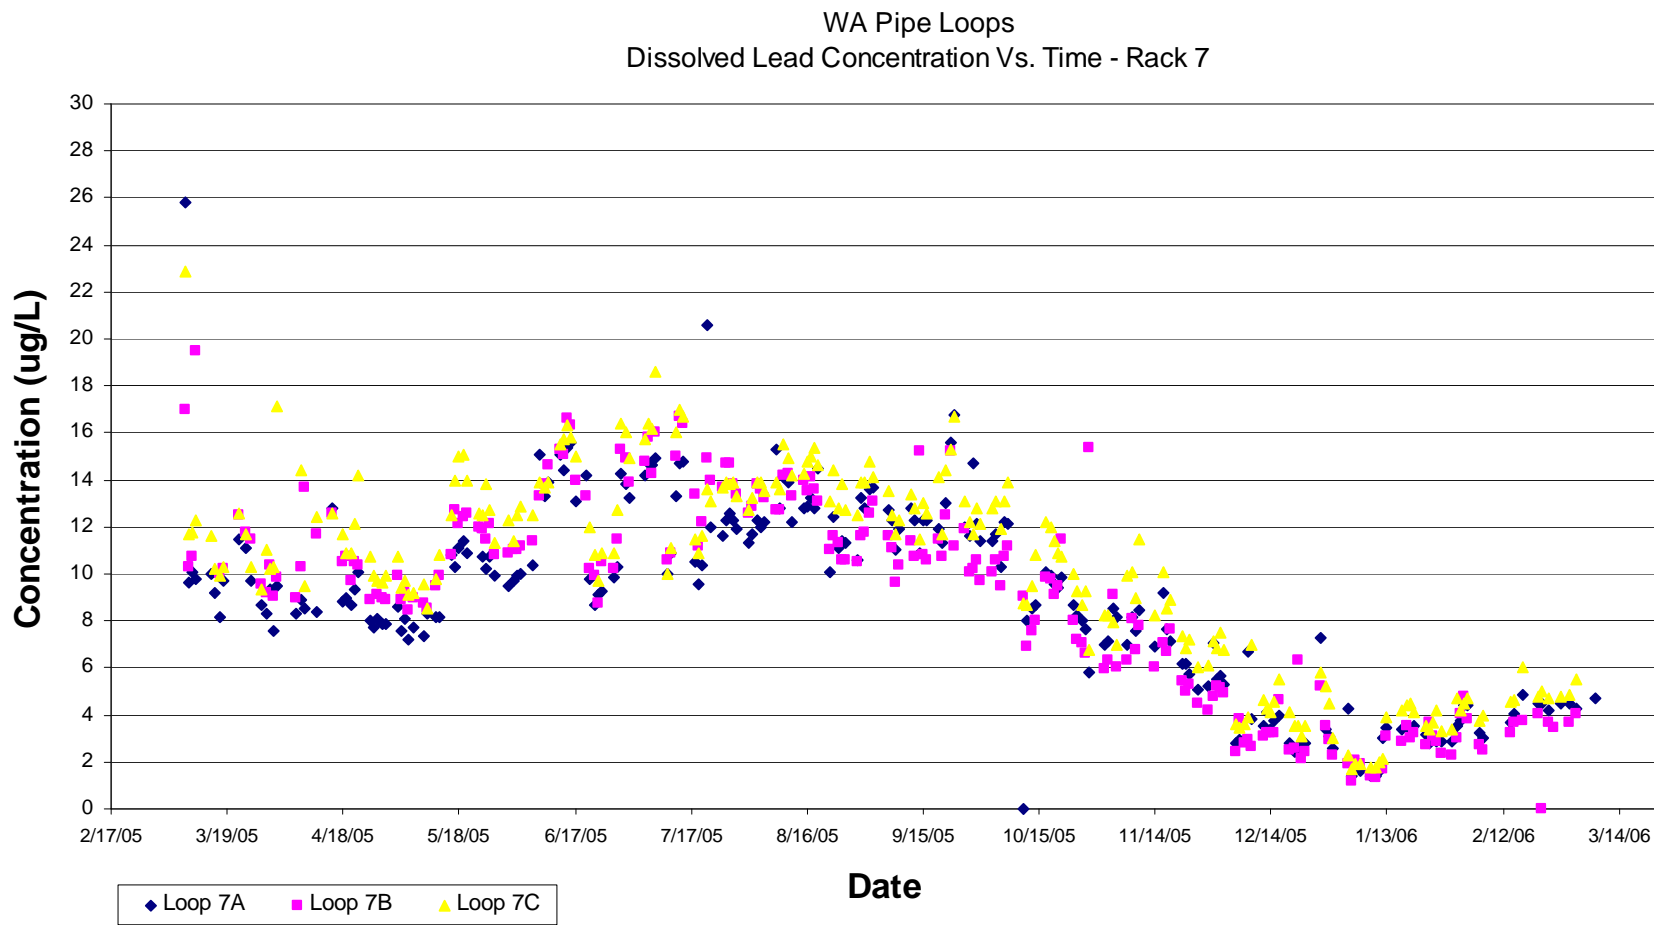
Exhibit 2.4.6.b Dissolved Lead for Rack 7, Finished Water Control

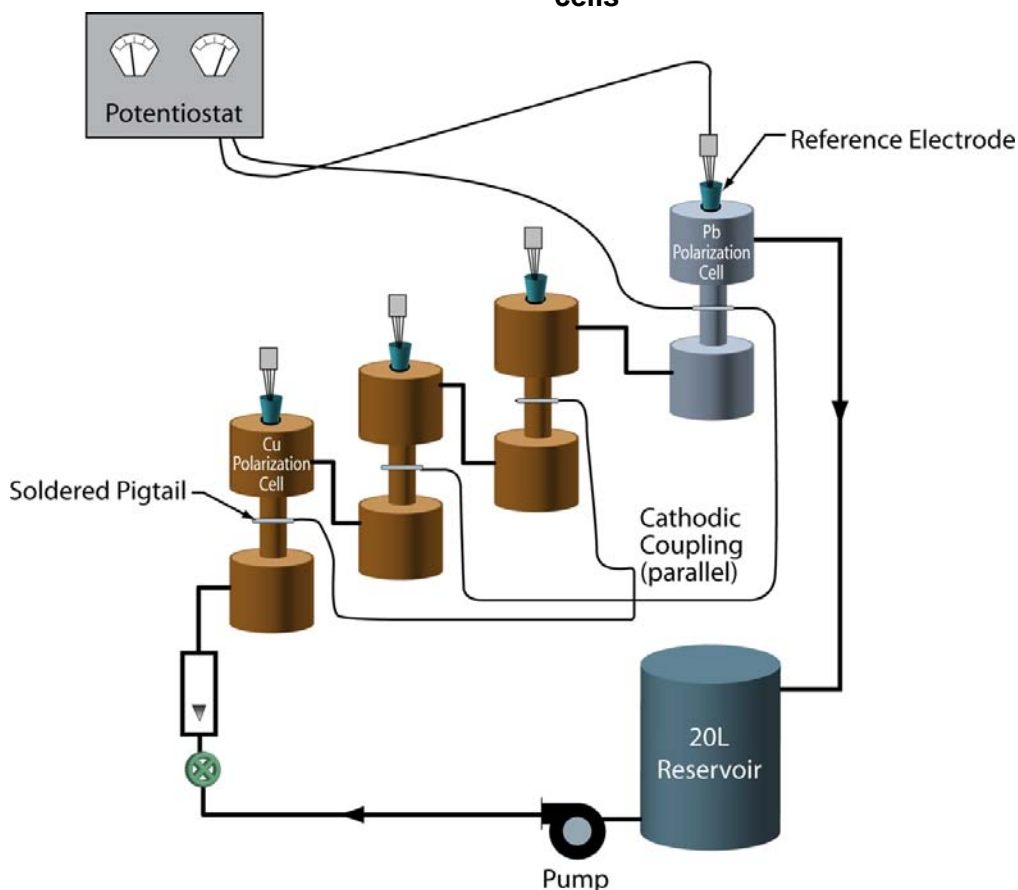
Exhibit 2.5.3 Schematic of a typical pipe rig configuration using indirectly coupled cells

relates primarily to the ability to control cathode/anode ratios. It is critical to the appreciation of the galvanic-couple concern to understand that it is not the contact of dissimilar metals, per se, that creates the corrosion risk. Rather, corrosion risk is created by the fact that the cathodic surface (the more electropositive metal), if present in abundance, can affect a shift in the surface potential of the anodic surface, and any meaningful shift in the anodic surface in a more positive direction generates a higher corrosion rate on that surface. A second approach to galvanic testing utilized longer segments of LSLs and copper pipe coupled together in a manner similar to an actual partial LSL replacement. Because these pipe specimens are in direct contact, this type of testing is referred to as *directly coupled* pipe specimens. This form of testing yielded the most useful results about the nature of the galvanic couple formed between copper and LSL sections. The schematic presented in Exhibit 2.5.3 shows the arrangement of the individual cells, hydraulics and electrical connections for the indirectly coupled cells. Exhibit 2.5.4 presents a schematic showing the same for the directly coupled cells.
