MORE PRECISE ASSESSMENT OF BENTHIC CONDITIONS IN DELAWARE BAY

Combining probability survey data with acoustic habitat maps for more precise assessment of benthic conditions in Delaware Bay

A different approach is being used by the Delaware Estuary Benthic Community Characterization and Mapping Project

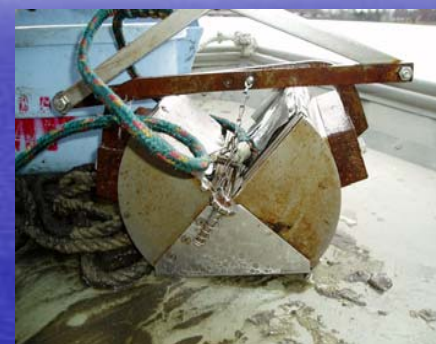
Using acoustic technology to collect bathymetric and sediment classification data

- RoxAnn Seabed Classification
- Chirp Sub-bottom Profiler
- Multibeam bathymetry system
- Field verification (sediment and biology)

Bottom
Roughness

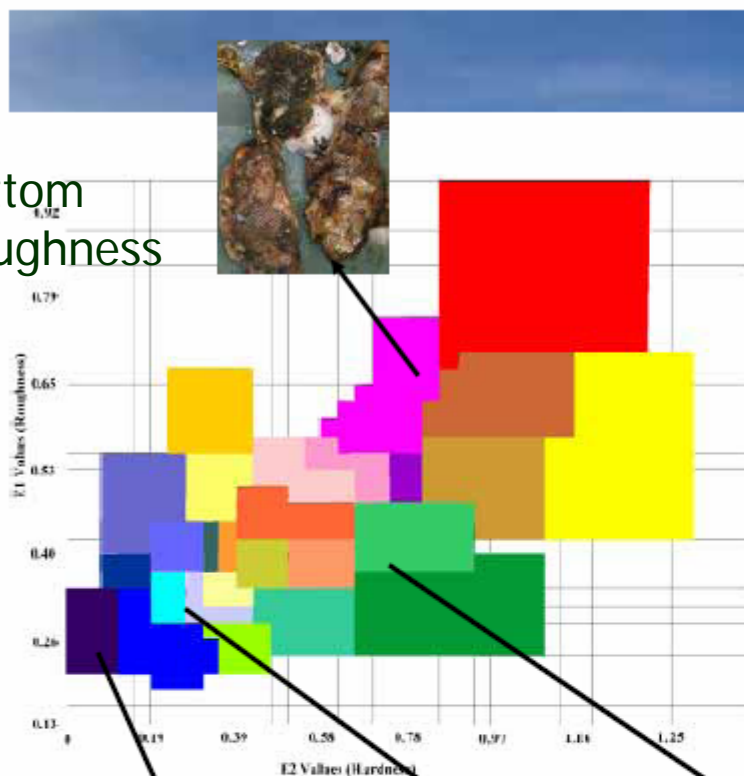
Bottom Hardness

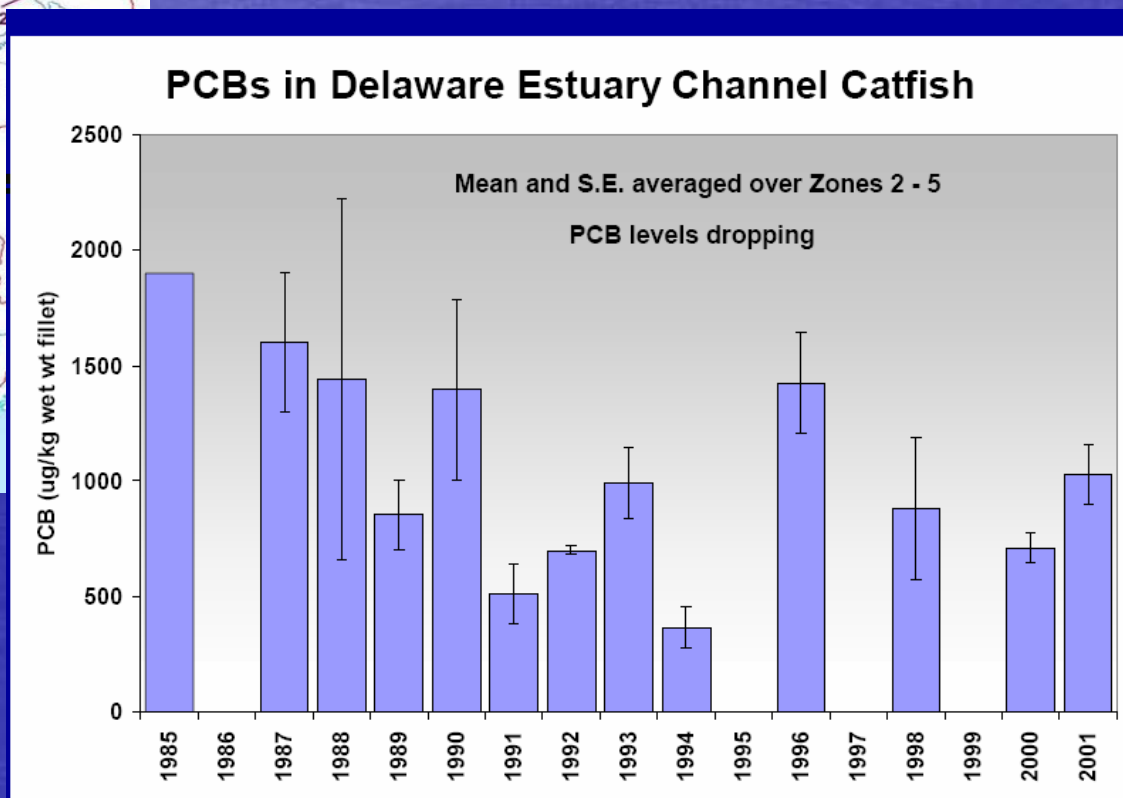
PCB Levels have fallen for a number of species , but rate of decline is slowing.

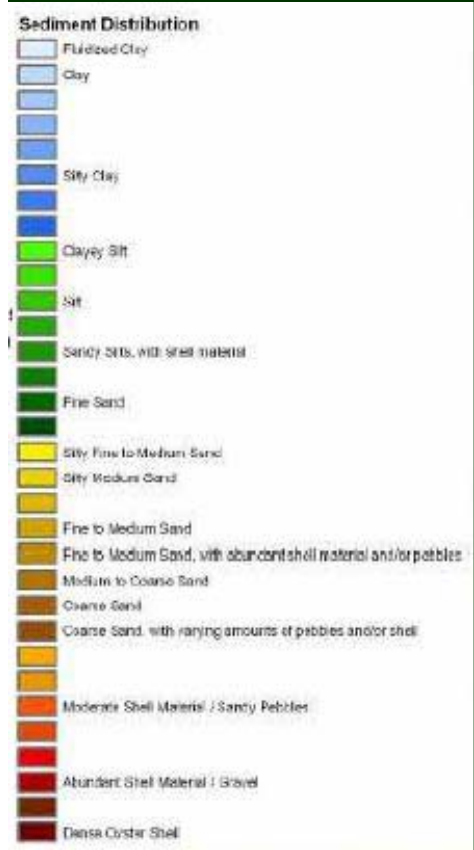
Detailed information on benthic communities, and sediment chemistry can be combined with habitat maps

Re-analysis of information on benthic conditions from probability surveys and habitat maps. Additional sampling in 2008.
