Cooperative Efforts to Use *In-situ* Burning in Empire, LA, in an Intermediate Marsh Following Hurricanes Katrina and Rita

Amy Merten, Ph.D.
NOAA Scientific Support/Biological Assessment
7600 Sandpoint Way, NE, Building 3
Seattle, WA 98103
amy.merten@noaa.gov

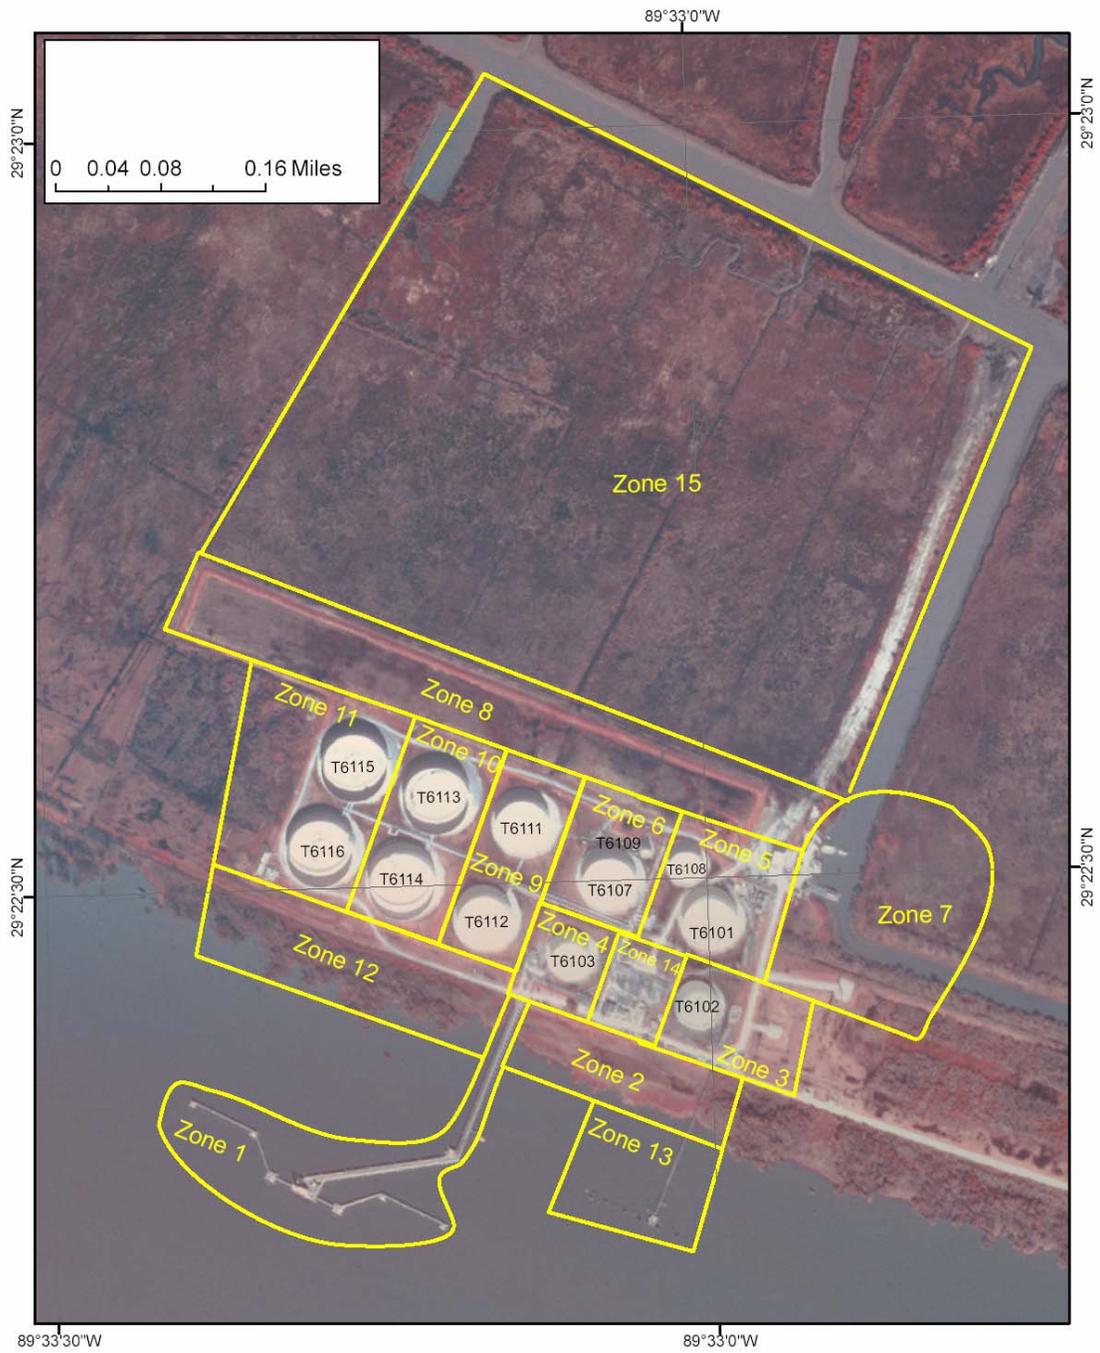
Figure 1. Chevron Pipeline; Empire Facility – Zone Map. Heaviest oiling occurred in the south-east of zone 15.

Day 1 (October 12, 2005): The burn plan was initiated at 1300. The weather conditions were adequate for the burn to proceed (variable N/NE wind, less than 10 mph, partly cloudy, 85°F). The tidal conditions were such that there was adequate water in the marsh. In the upper marsh salinity was ~ 1 – 6 ppt (parts per thousand), and 1 ppt in the lower marsh. Fire teams had marked out Zones and created fire breaks with air boats on October 11th. The site was clearly marked out with flagging at each corner to aid with reference and communication, and to provide wind direction information to the teams. Prior to the burn, fire teams were deployed to their respective stations, and began wetting down the east berm of Zone 1, and the berm of the retention pond. As a safety precaution, all other activities at the facility were ceased on burn day, and the cleanup crews were staged onboard vessels located on the Mississippi River to the South of the Facility (Figure 1, Zone 1). After areas were wetted down, the “go” signal was given via VHF radio at 1330.

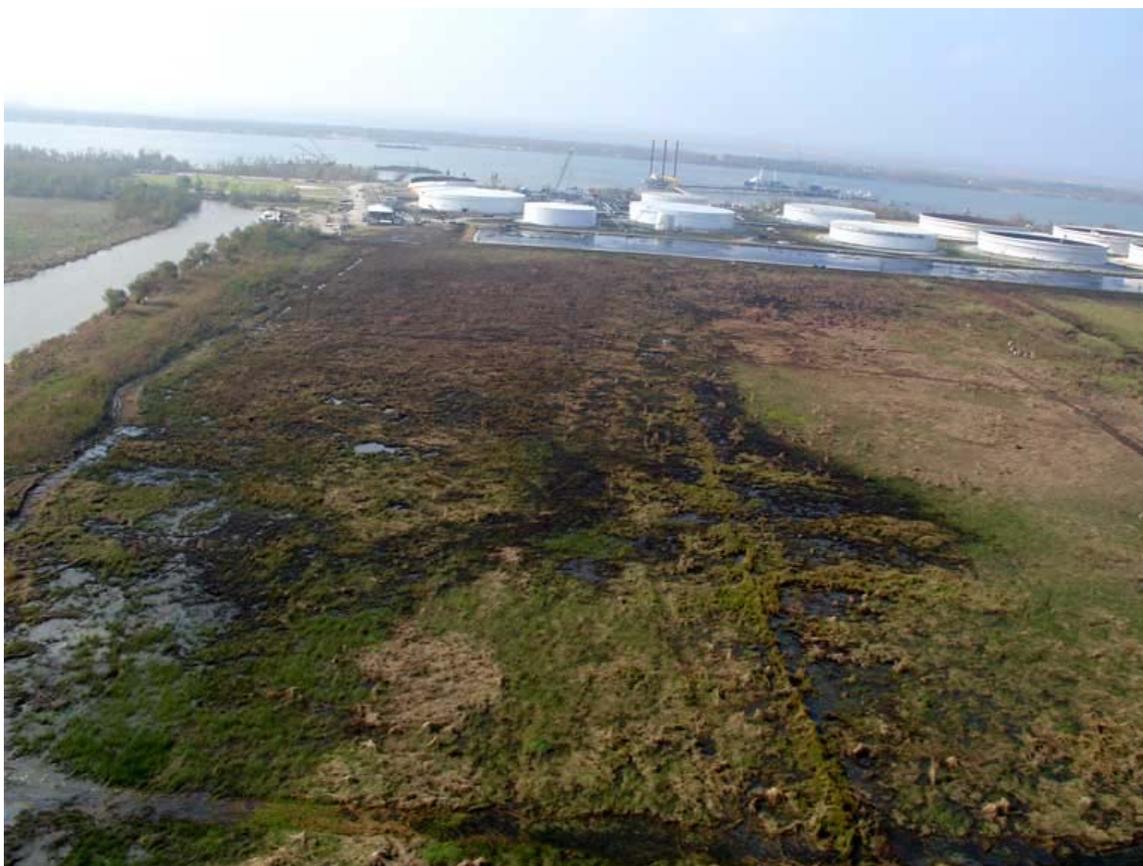
Figure 2. Oiled marsh north of facility (October 10, 2005).

Five weeks post-Katrina: During several aerial surveys since Hurricane Rita, heavily oiled marsh was observed adjacent to the Chevron Empire facility (Figure 2). On October 6th, the Environmental Unit Team, ground surveyed the impacted marsh to delineate approximate amounts of pooled or mobile oil on the water surface, vegetation, and sediment, and to provide cleanup recommendations to the Unified Command. The marsh was divided into six zones containing oiled marsh and potentially burnable areas (Figure 3). After providing cleanup recommendations to Chevron and the Unified Command, a more thorough survey was conducted on October 10th by Chevron and the Environmental Unit Team. The survey found the following:

Overall, the burn was successful in terms of removing heavily oiled areas with a burn efficiency estimated to be roughly 80-90% removal. The burn confirmed visual characterization of the oil as burnable, however, this was also due to the oiled condition of the vegetation. The above ground vegetation in Zone 1 and 4 was dead and dry due to the oiling duration and concentration. Thus, the burn was sustained by the oil on the vegetation, and the dry state of the vegetation itself. This is confirmed by comparing Zones 2 and 5 where the oiling was moderate and the vegetation was variable in that there were pockets of dead vegetation within areas of live vegetation. See Figure 2, pre-burn conditions and Figure 16, post-burn conditions.

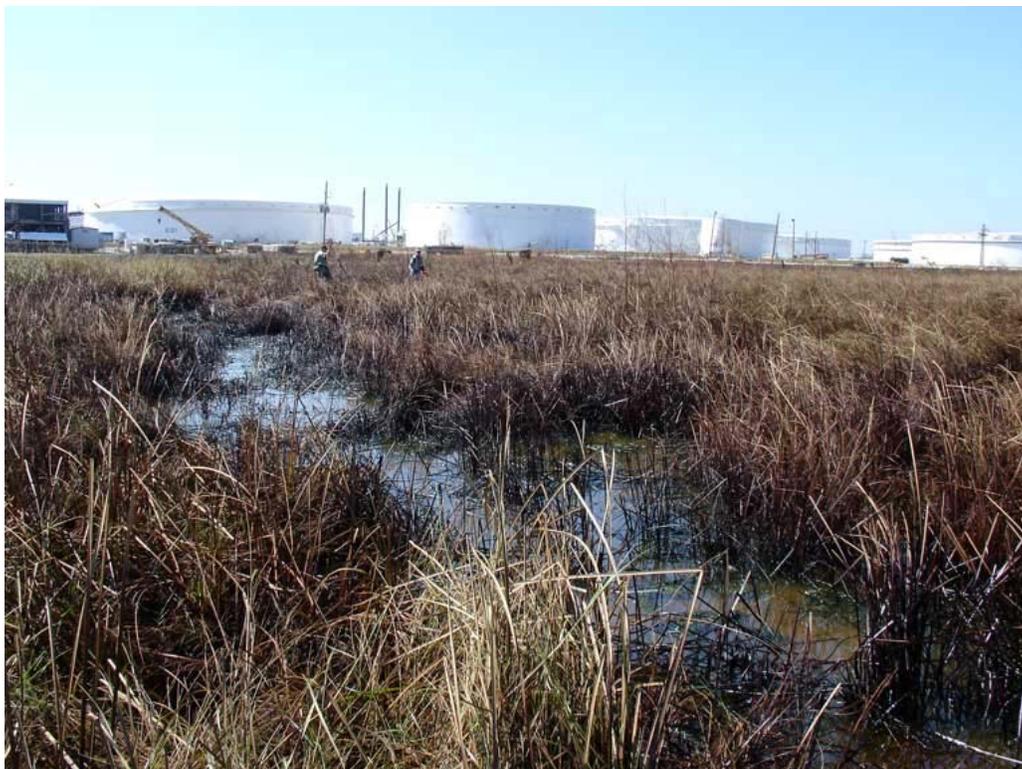
Figure 4. Two Days, pre-burn (October 10, 2005). Example of heavily oiled vegetation in Burn Zone 1. Note the lack of green vegetation.

1. Dominant species composition. The area most heavily impacted (Burn Zones 1 and 4) was an intermediate to high marsh environment dominated by *Spartina patens*, *Scirpus olneyi*, and *Distichlis spicata*. (See Figures 4-5).
2. Description of oil weathered state and oiled vegetation: The marsh contained trapped oil in the thick vegetation that was easily mobilized when agitated. Surprisingly, the oil was relatively “fresh” in characteristics such as odor, viscosity, lack of emulsification, and its propensity to remobilize off of the oiled vegetation onto the water surface. The

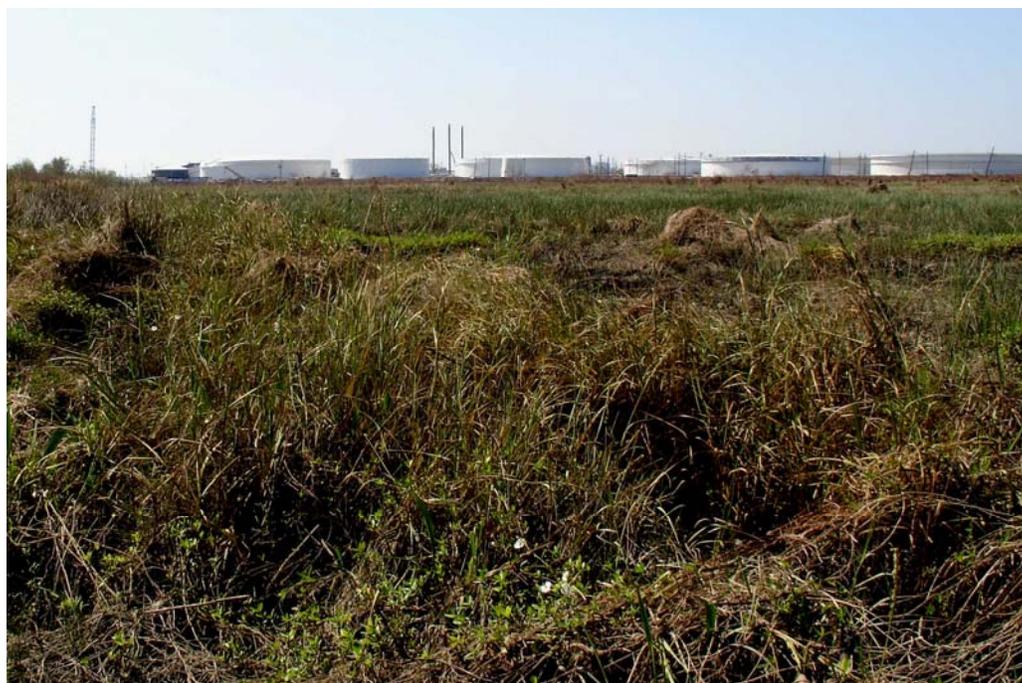
Figure 5. Two days pre-burn (October 10, 2005), standing at the border of Zones 2 and 3, facing South overlooking Zone 2. Note the amount of green vegetation compared to Zone 1.

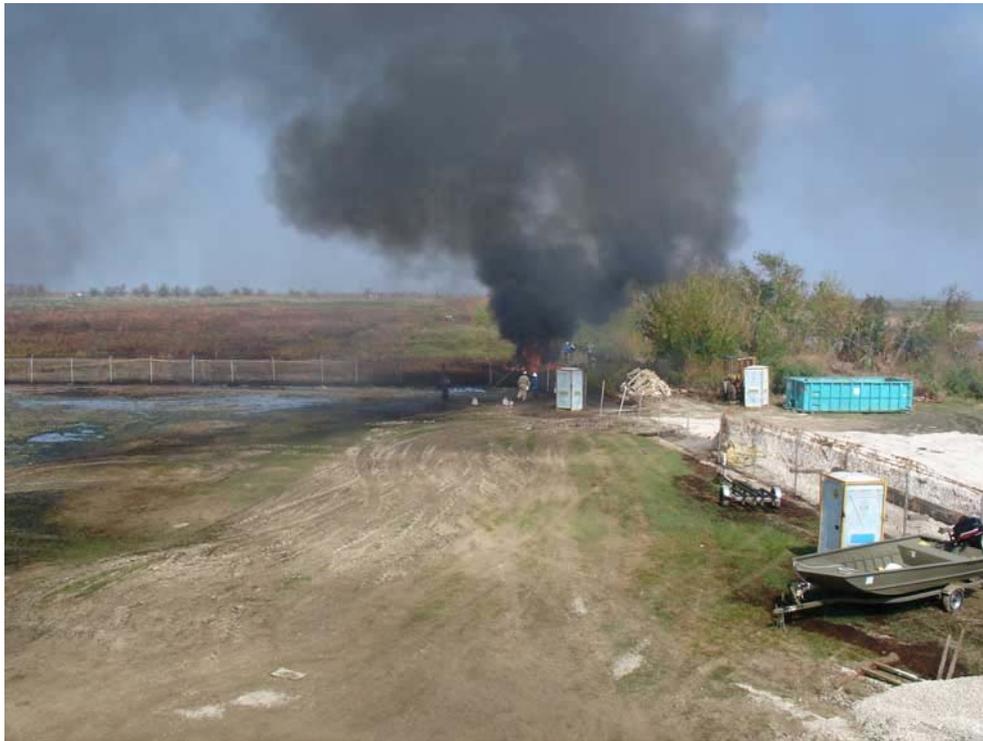
Figure 6. Day 1. One minute post-start of burn (October 12, 2005). Facing the oiled marsh from the Chevron Bunkhouse. The burn was started in the SE corner of burn Zone 1.

facility fence line. However, the control burn became “the burn” (Figure 6). The source of ignition was a propane torch. The fire started immediately, and quickly became a sustained fire producing large amounts of black smoke (Figure 7). Because of the intensity, loft and direction of the smoke plume, Chevron had moved all of the crew members to the MSRC GULF RESPONDER, and moved further down-river for the duration of the burn.

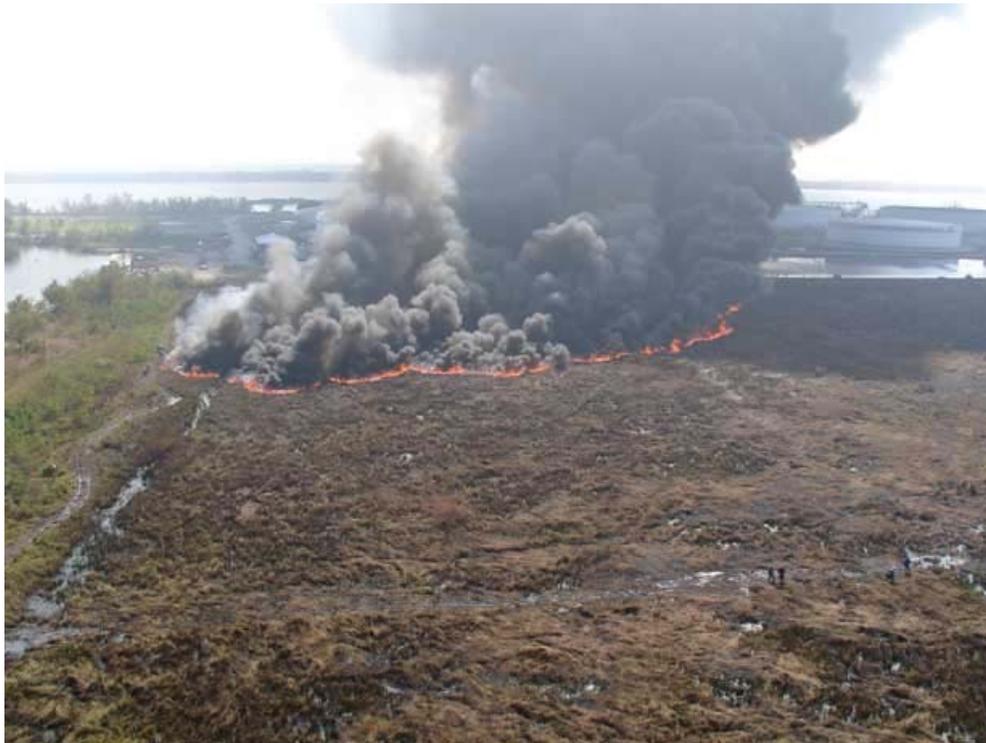
Figure 7. Aerial photo 1.25 hours into the burn (October 12, 2005). The fire has burned about a third of Zone 1, and has crossed the boundary into Zone 4. The people standing in the bottom right hand corner of the photo are behind the fire breaks of Zone 1.

The fire quickly engulfed the oiled area and burned rapidly to the west from Zone 1 into Zone 4. The burn speed was more controlled as it burned upwind (north across Zone 1 to Zone 2, and across Zone 4 to 5). At 1440 (1.1 hours into the burn), 90% of Zone 1, and 25% of Zone 5 had burned (Figure 7). Flames were observed to be as high as 30 feet, continuous across the burn Zone, with a plume loft of approximately 500 – 1000 feet (See Figure 7). Around 1500, the burn was progressing faster to the west, and with more intensity than predicted, and all teams were evacuated to a safe zone inside the facility, according to the plan. The burn crossed the power lines, and burned ~100 feet beyond the original fire break on the west edge of Zone 4. However, once the fire ran out of pooled oil, and oiled vegetation, it quickly turned to white smoke, and burned out. After the fire was mostly out, airboats snuffed out the remaining flames.

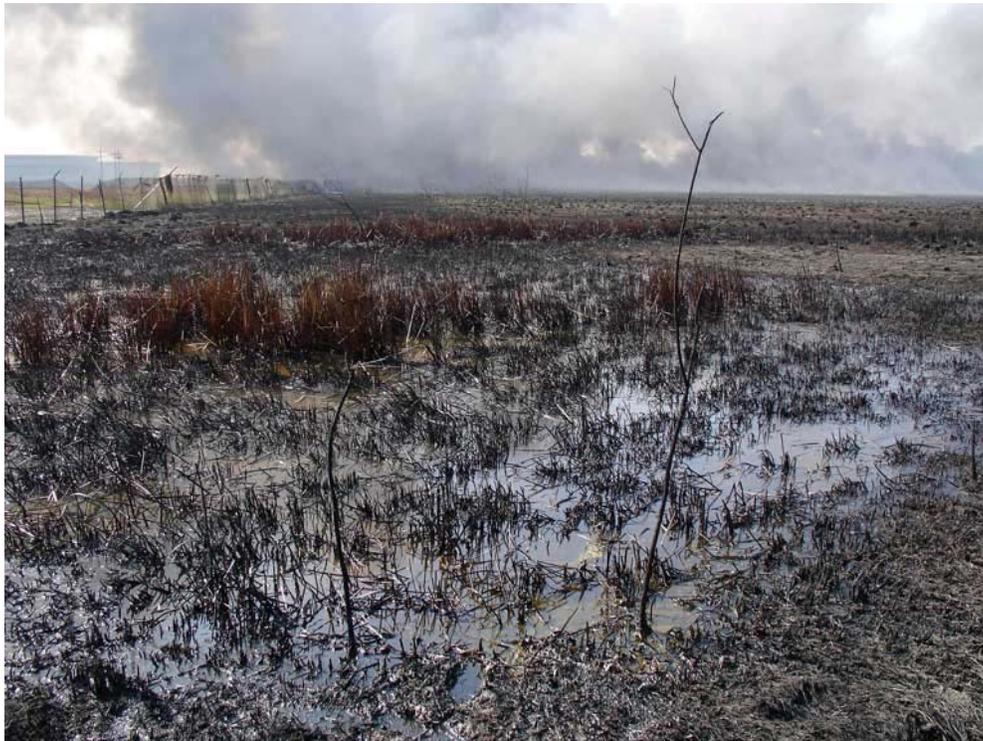
Figure 8. Post-Burn, Day 1 (October 12, 2005), standing in the Zone 1. This was a heavily oiled pocket of floating oil, and the remaining above vegetation (*Scirpus*).

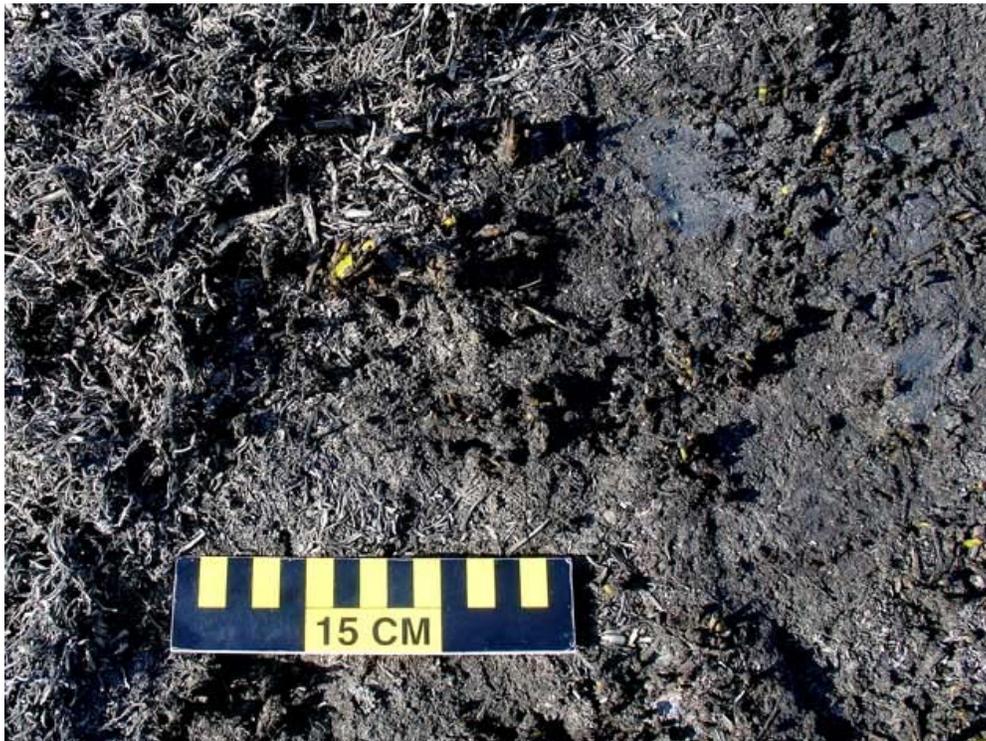
Figure 9, Post Post-Burn, Day 1 (October 12, 2005), standing in the Zone 1. Note the green roots (*Distichilis*).

In Zones 1 and 4, subsurface oiling was observed, mainly in crab burrows. This oil was not burned, and cannot be burned, and will remain in the environment. Removing this oil would require excavation of the top 5 cm of sediment, and is NOT recommended because of physical destruction of the marsh structure. The subsurface oiling will be agitated from tidal action, and light sheening will be expected. Recovery should be through passive means, and foot traffic should be minimized. Foot traffic will drive the oil deeper into the substrate, delaying the natural removal and degradation of the remaining oil. This phenomenon is not as prevalent in Zones 2 and 5, but is in discrete pockets (Figures 14 and 15). Most of the above ground remaining vegetation contained water content that prevented total combustion. Obviously, there is more above ground vegetation remaining in Zones 2 and 5 than 1 and 4 (Figure 16). This is due to different degrees of oiling, water content of the vegetation, standing water levels, and differences in fire intensities (a function of the degree of oiling and plant water content). Despite the more acute effects in Zones 1 and 4, the root systems of the plants were observed to be unburned (Figure 9). Because the root systems were left in tact, the prediction for recovery of vegetation is high.

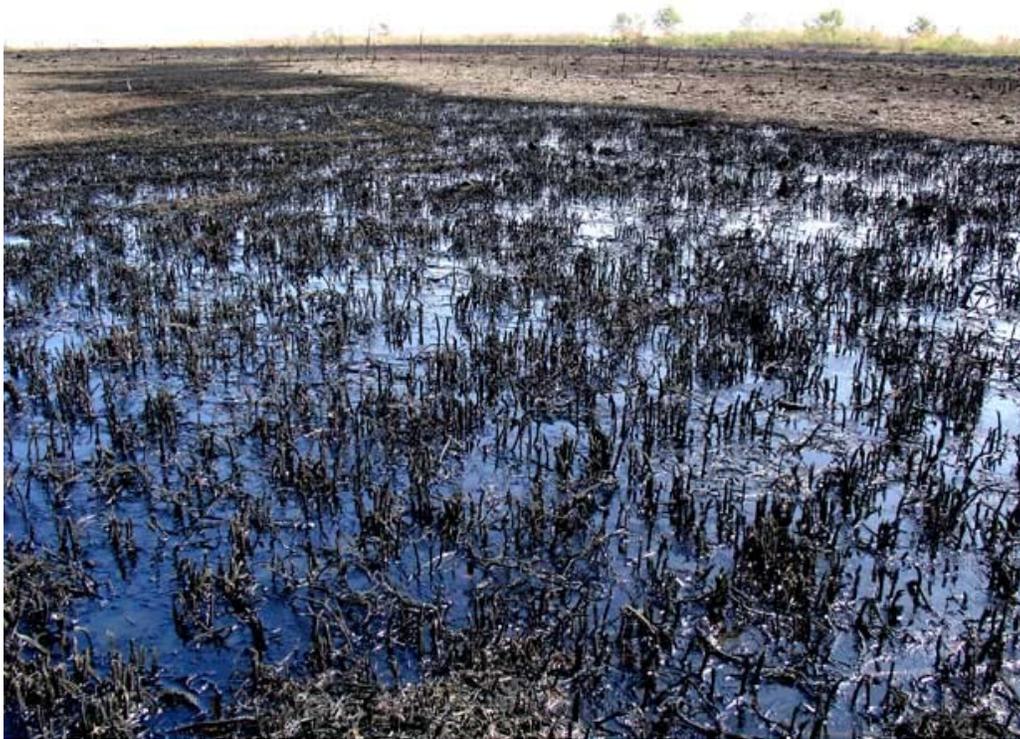
Figure 10. Post Burn, Zone 4 (October 13, 2005). Note root stumps (*Scirpus*) and residual oil/residue on the surface of the water.

Small amounts of mobile oil remained in the original pools. This was most prevalent in Zones 1 and 4. The residual oil was not burnable because its change in chemical composition (loss of lower molecular weight compounds), and burn residue was observable. However, the remaining oil was recoverable with sorbent material or netting. The remaining residue was “sticky” and presented a hazard to wildlife, especially opportunistic birds that will prey on the crab carcasses and live crabs that no longer have pre-burn protection from vegetation. Immediately after the smoke abated, shorebird individuals were observed to forage in Zone 1.

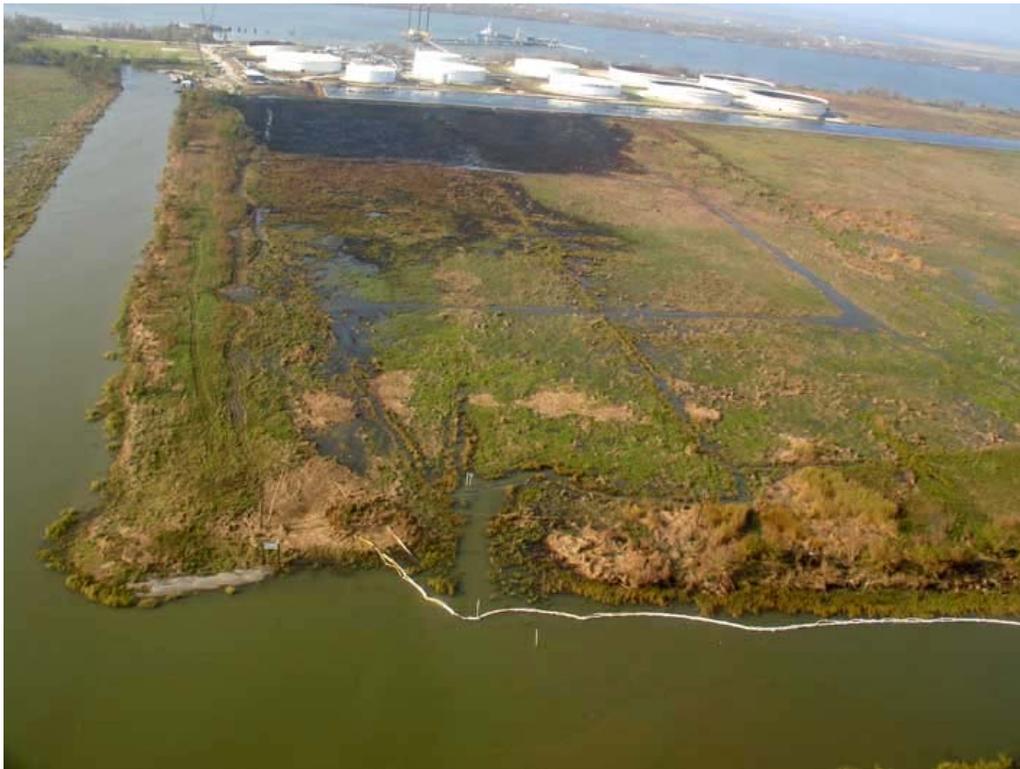
Figure 11. Post-Burn Day 1 (October 12, 2005). All zones are clearly visible. Burned Zones: 1 and 4. Oil contamination visible in Zones 2 and 5. Zones 3 and 6 are in the fore front.

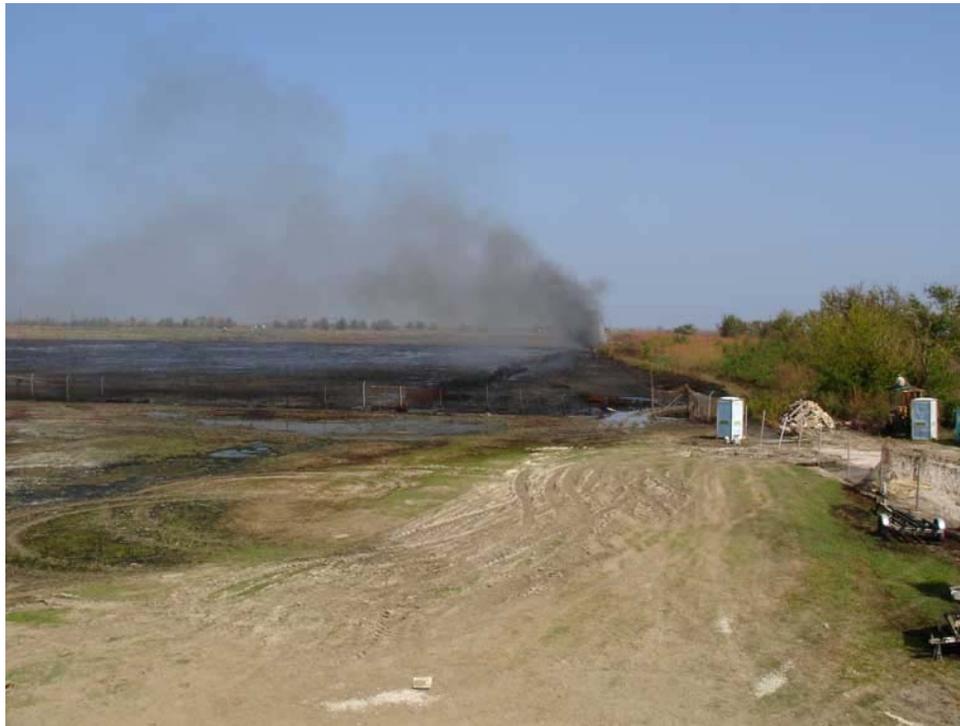
Figure 12. Day 2. 1 minute post-start of burn (October 13, 2005).

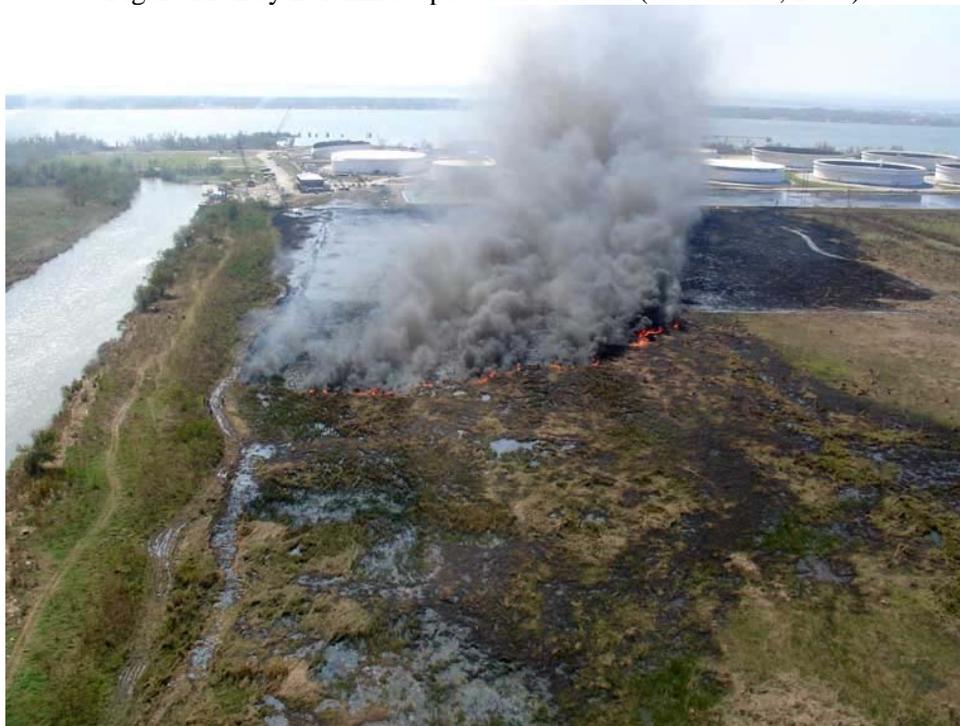
Figure 13. Aerial photo 1.1 hours into the burn (October 13, 2005). The fire is in Zone 2. The leading edge is almost in Zone 5. Note the difference in smoke volume, density and color from Day 1.

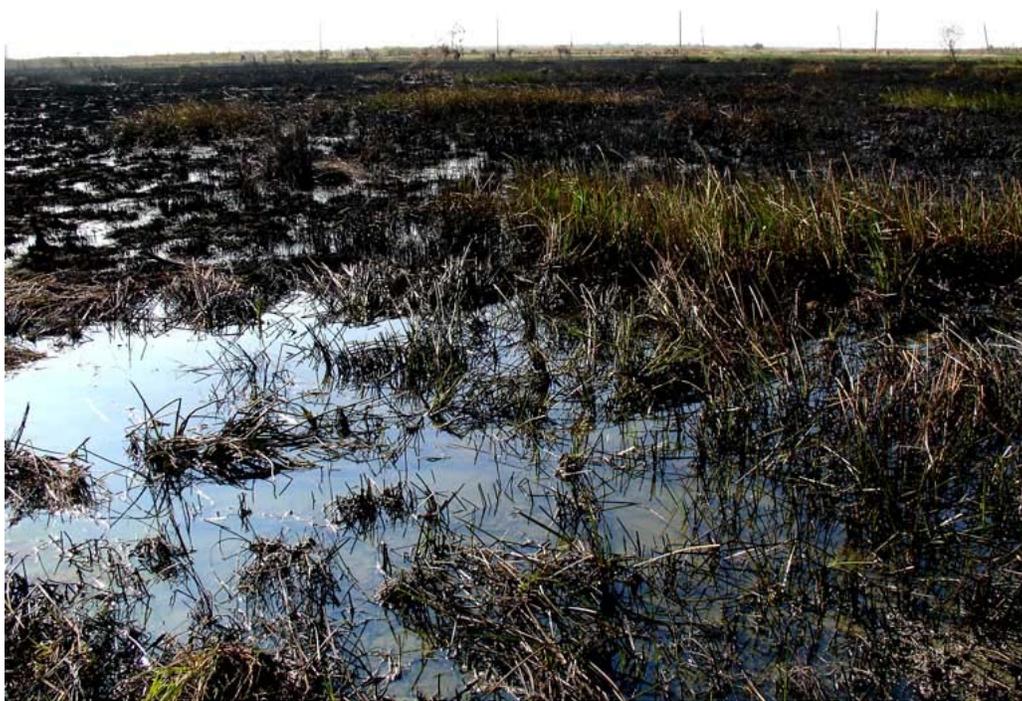
Figure 14. Post-Burn, Day 2 (October 13, 2005), Zone 2. Note the amount of remaining, unburned vegetation and water levels.

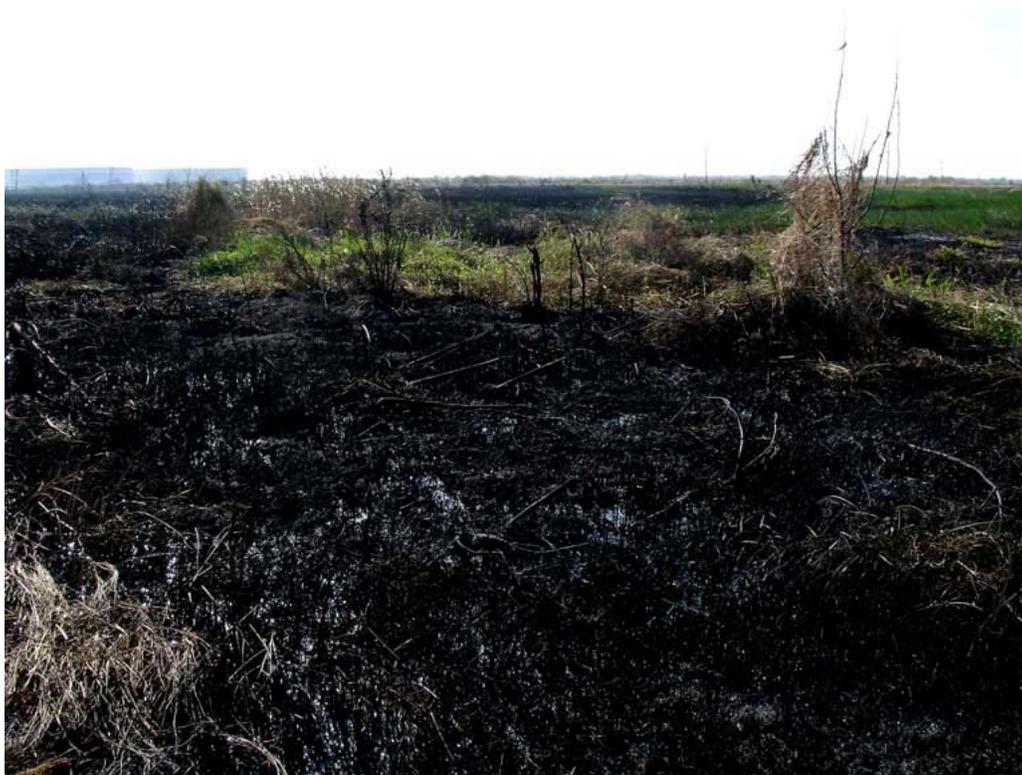
Figure 15. Post-Burn Day 2, Zone 2.

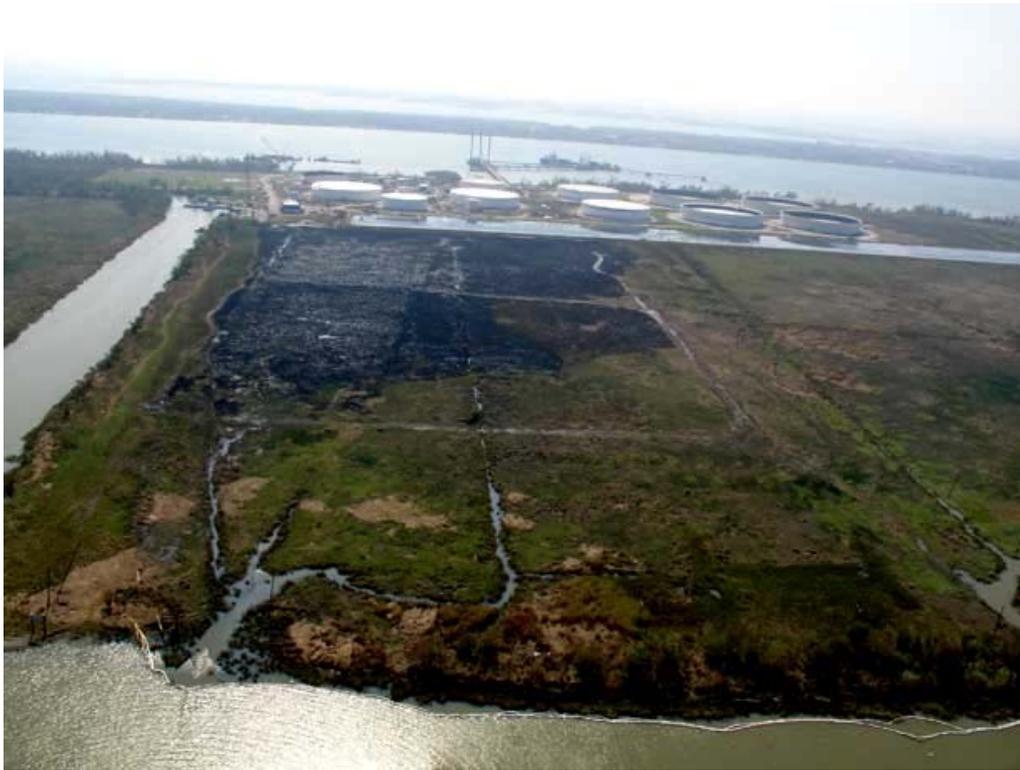
Figure 16. Final Footprint of the burn area. Note Zone 2 is about 85% burned, but Zone 5 only about 50% is burned.

By 1240, roughly an hour after the start of the burn, thirty percent of Zone 2 had burned. This was determined during an overflight, and quickly communicated back to the ground crew to make sure they were oriented correctly within their zones. The fire was continuously re-started throughout the day. The burning was ceased at 1500 after it was determined that most of the combustible oil/oiled vegetation had been burned. Eighty-five percent of Zone 2 was burned, and only about 50% of Zone 5 was burned (Figure 16). The total burned area was about 28 acres.

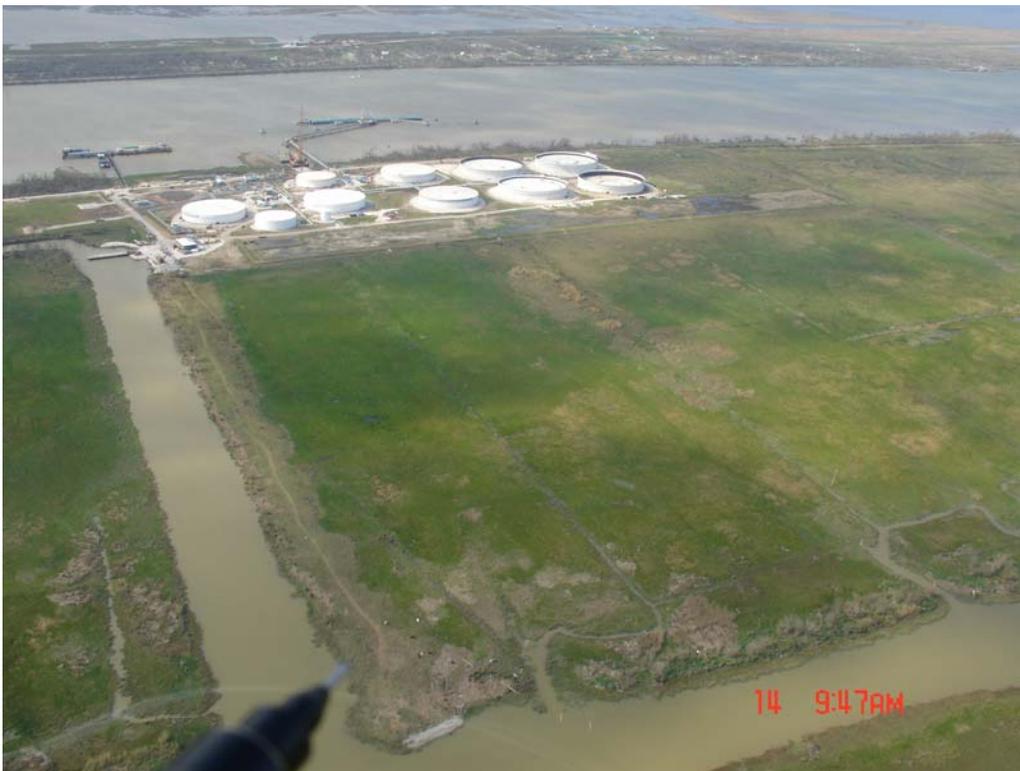
Figure 17. Aerial photo of burn site, March, 16, 2006, 5 months post-burn. Photo credit: Gary Shigenaka (NOAA)

Preliminary observations (photo-documentation) show signs of rapid recovery suggesting that burning was the most appropriate decision. NOAA has continued to monitor the site opportunistically during overflight missions for marine debris and hazardous debris cleanup operations. See Figure 17.
