Oil Spills in Wadis: Access, risk assessments and clean up Technique

Aaron Montgomery – Spill Response Specialist

Mukalla checkpoint initial Assessment

Wadi Mukalla Initial assessment

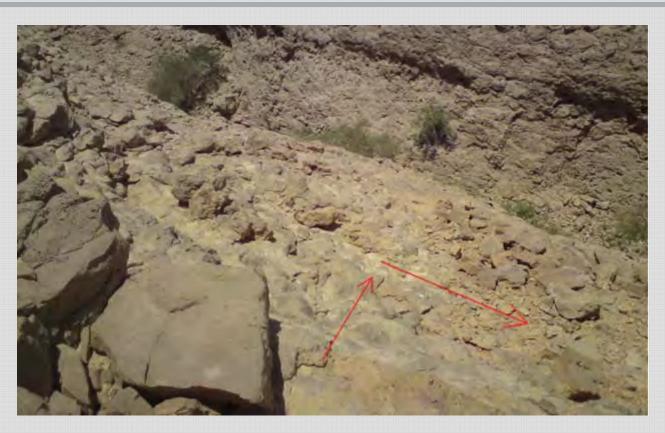
Main access for Wadi Mukalla. Picture shows rock steps and right hand turn to traverse.

- Task
 - Entrance/exit to the upper portions of the Wadi.
- Details
 - The entrance to the upper portions of the Wadi consists of a small descent of 1meter on natural rock steps before a 20m traverse.
 - The traverse is made across a 3m wide path with a gentle gradient towards the Wadi floor.
 - After the traverse there is a 180° turn before another traverse. This is down a gradient of approximately 40°-45° with a 0.5m wide path.
 - Finally a small 1m descent of rock steps to the Wadi floor. There are minimal opportunities for hand holds.

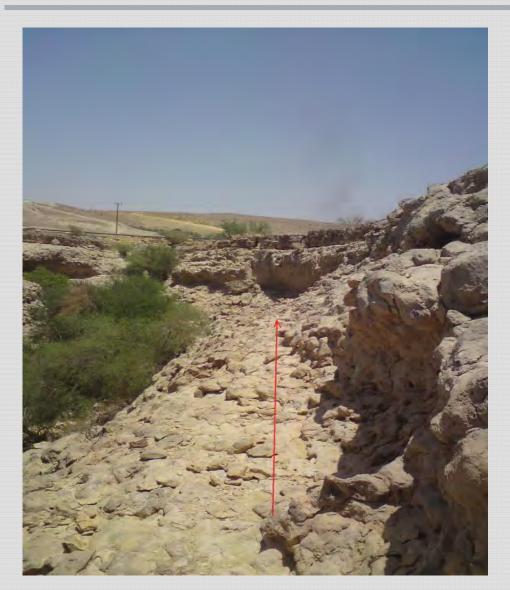
Main access for Wadi Mukalla.
 Picture shows View of traverse.

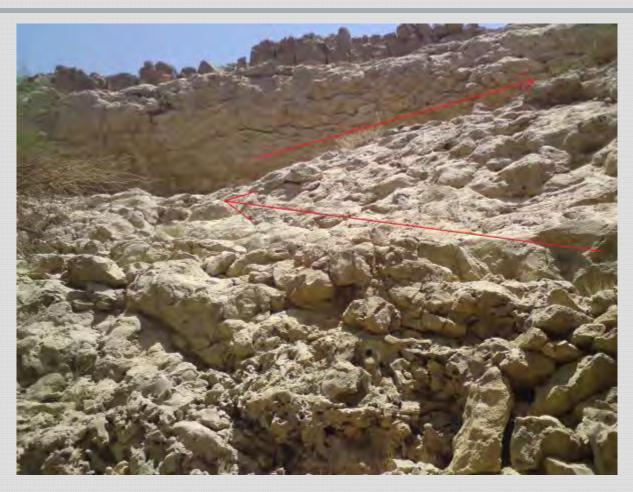
View back at the main access for Wadi Mukalla

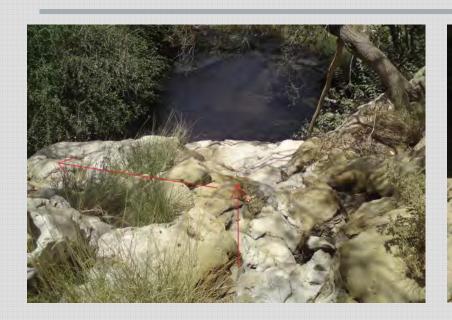
Access to Proposed ladder position

View down proposed ladder site.

- Task
 - Entrance/exit to the lower portion of the Wadi.
- Details
 - Entrance to the lower portion of the Wadi is to be made from the Wadi floor of the upper section. From this area personnel will descend a 3-4 meter vertical face via ladder to gain access to the lower portions of the Wadi.
