# Marathon Mt. Erie Pipe Line Release

## Case Study

On August 10, 2008 sometime before 0730, an oil pipeline failure occurred releasing approximately 5,790 barrels (or 243,180 gallons) of Mississippi Sweet Crude Oil

The release occurred in a rural area 6 miles east of Fairfield, IL in Wayne County

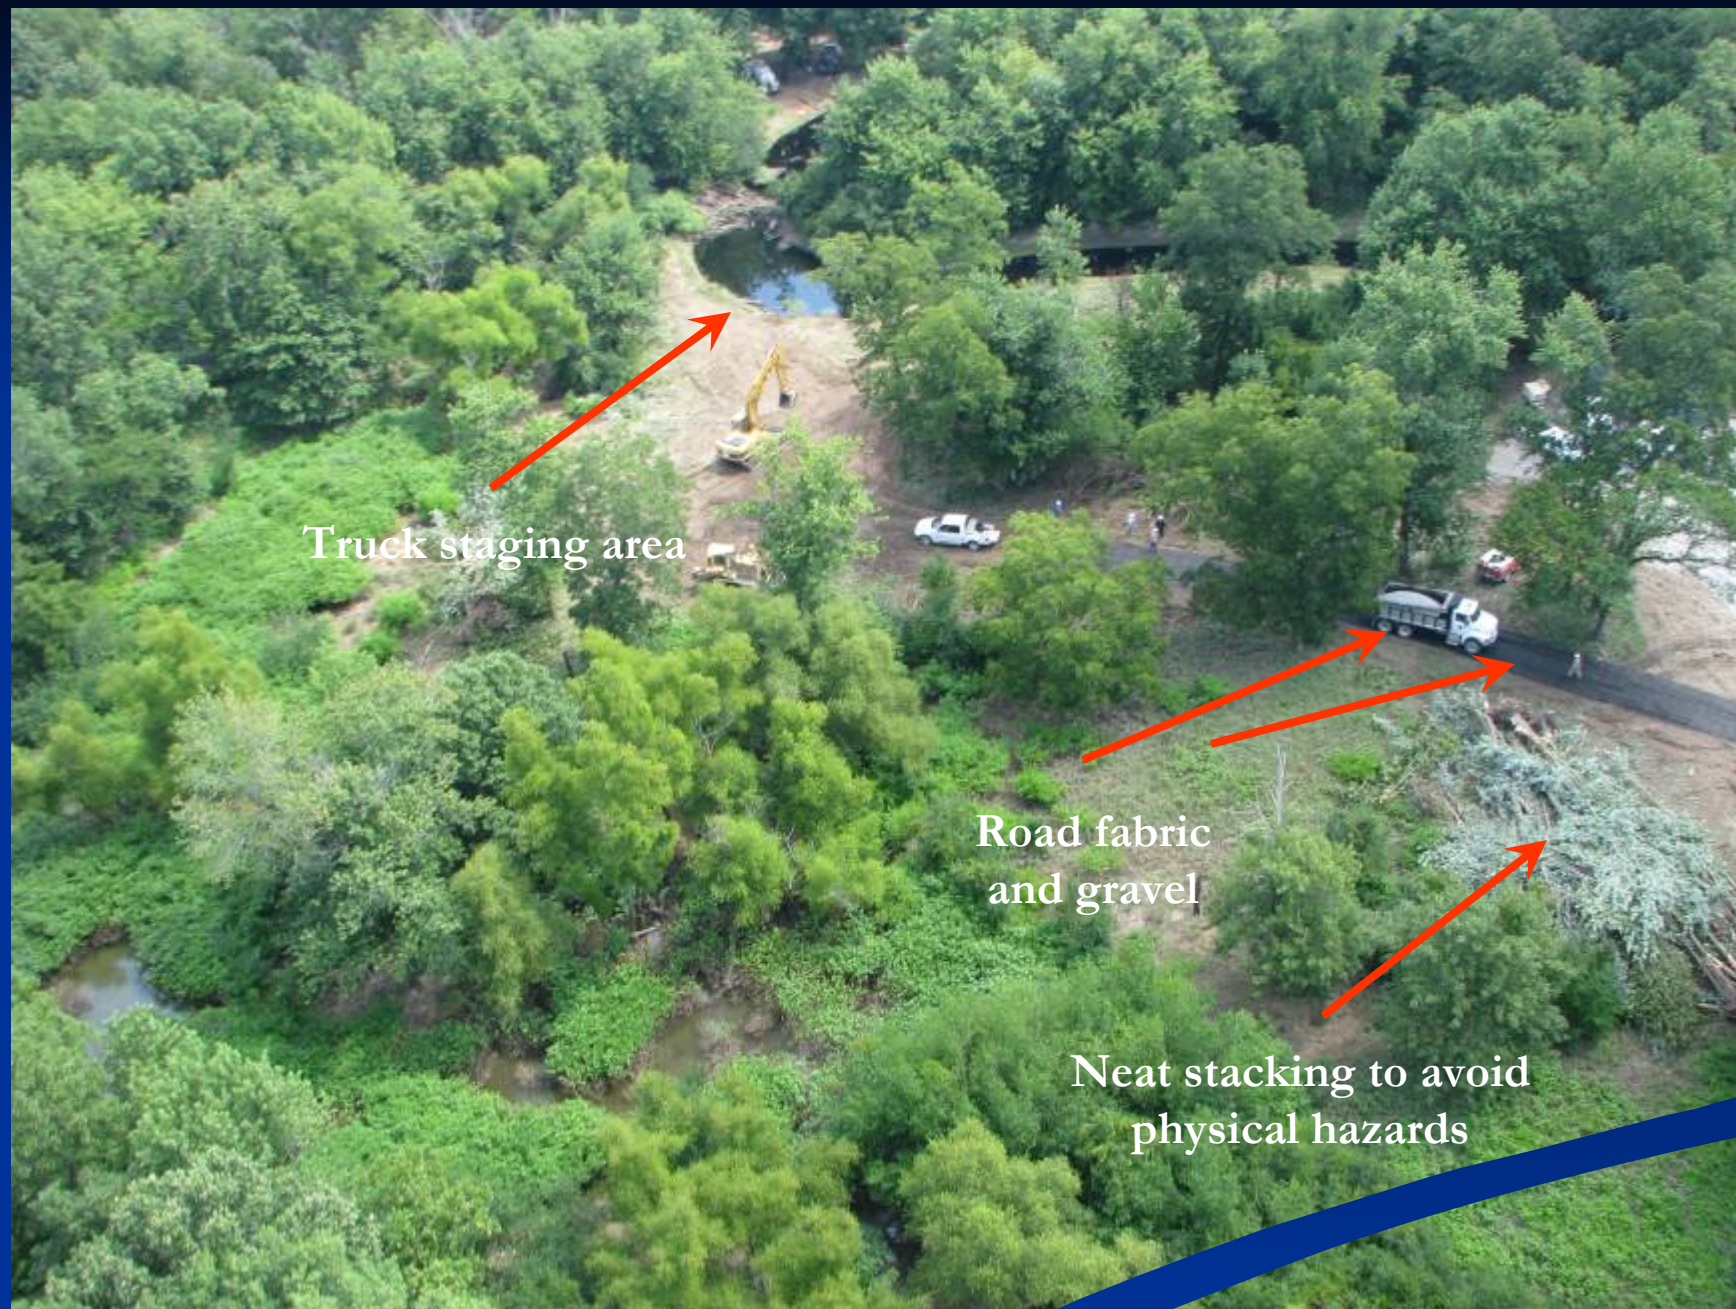
Truck staging area

Road fabric  
and gravel

Neat stacking to avoid  
physical hazards

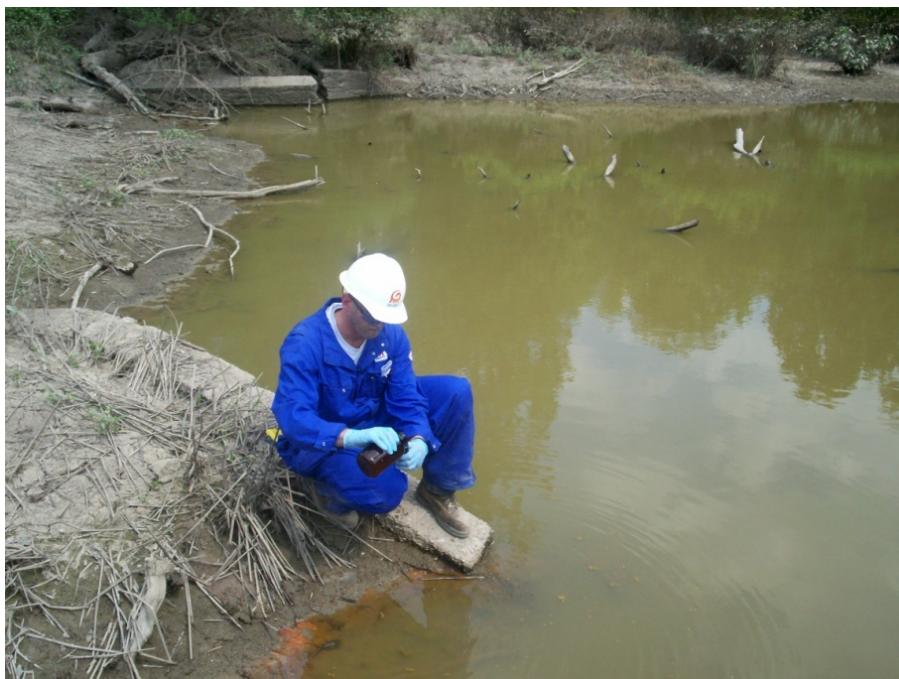
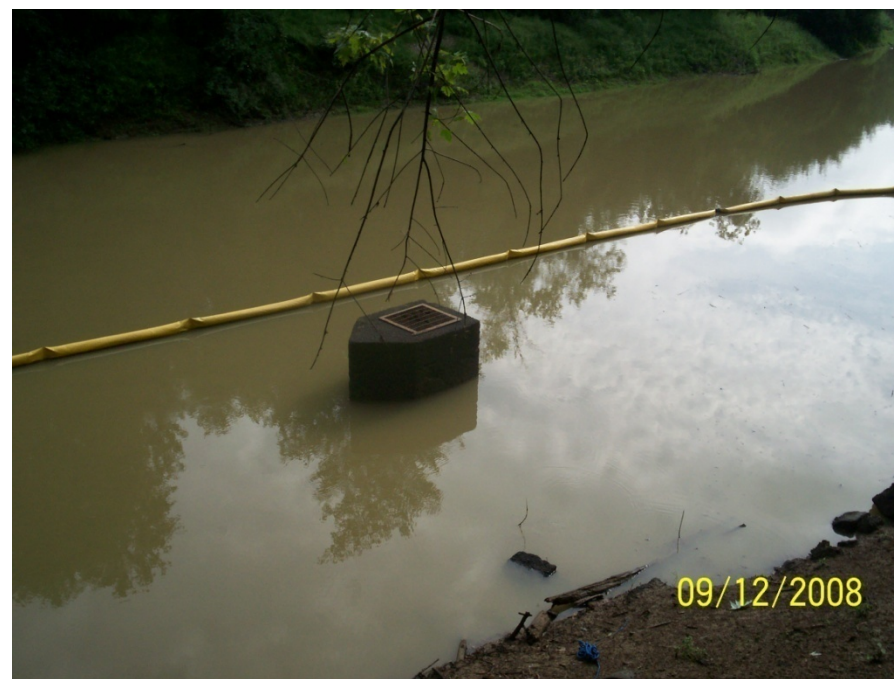
# Surface Water Sampling --- Phased Approach

- 12 locations, daily sampling --- August 2008
  - VOCs, SVOCs, Metals, TSS, BOD, COD, and TPHs
- 6 locations, weekly --- Sept. to Dec. 2008
  - VOCs and TPH GRO / DRO
- 4 locations, bi-weekly --- Jan. 2009 through present
  - BTEX, Naphthalene, TPH DRO, 2-methylnaphthalene

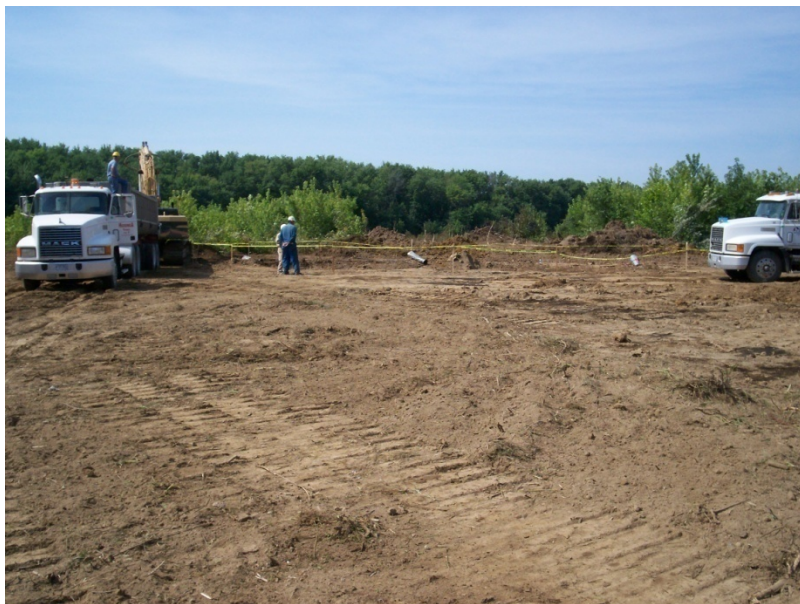
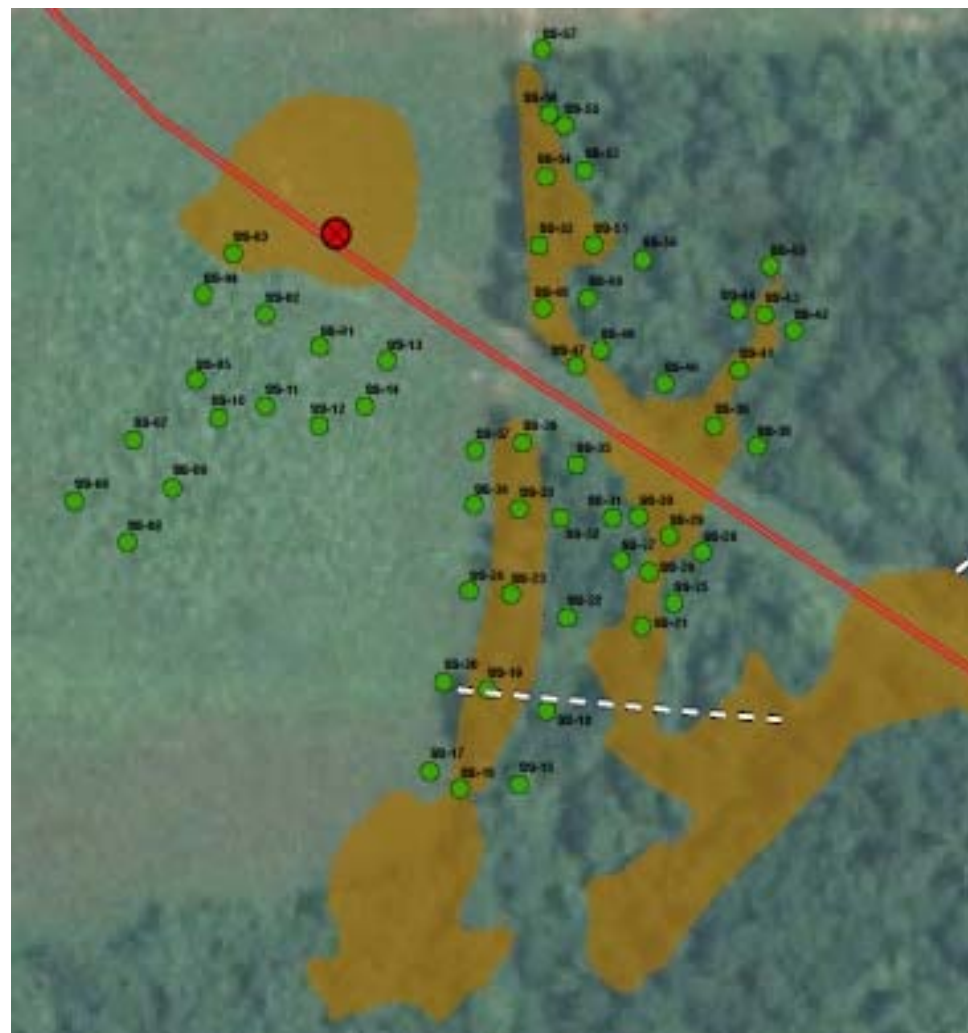
# Surface Soil Sampling

*Approach* --- Areas where oil was released, with minimal absorbent exposure time

- 57 locations sampled
- BTEX, PAHs, TPH DRO / GRO / ERO
- 11 BTEX and 18 TPH exceedances

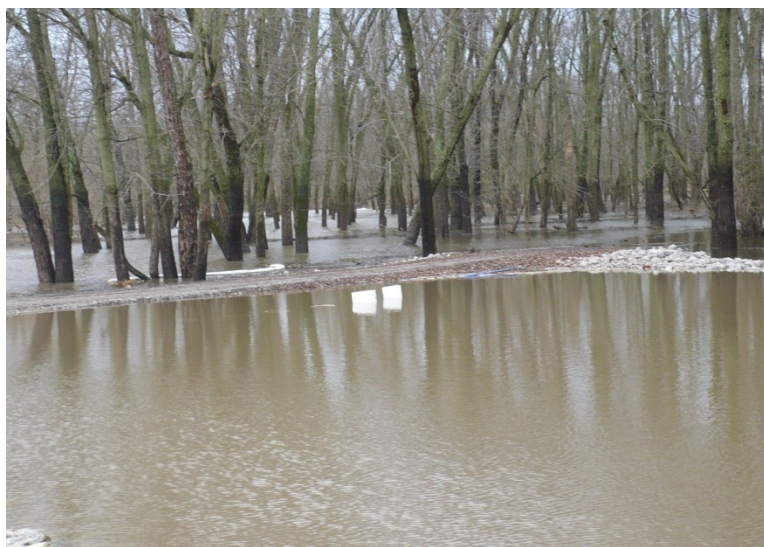
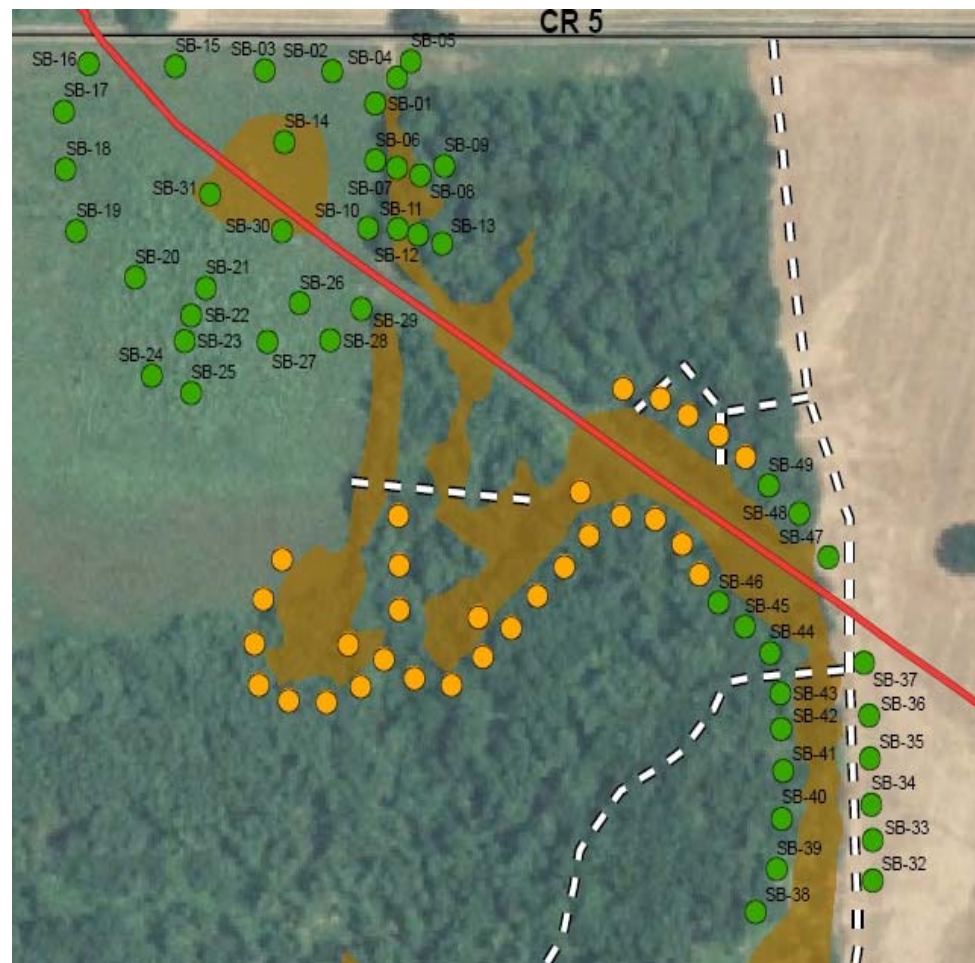
# Subsurface Soil Sampling

*Approach* --- Perimeter delineation with “step-out” methodology; define “pooled” areas.

- 49 locations sampled
- Minimum 2 samples per boring
- BTEX, PAHs, TPH DRO / GRO / ERO
- 18 BTEX and 5 TPH exceedances
- No PAH exceedances
- Test pits to be completed
- 30 soil borings to be completed (has been hindered by flooding)

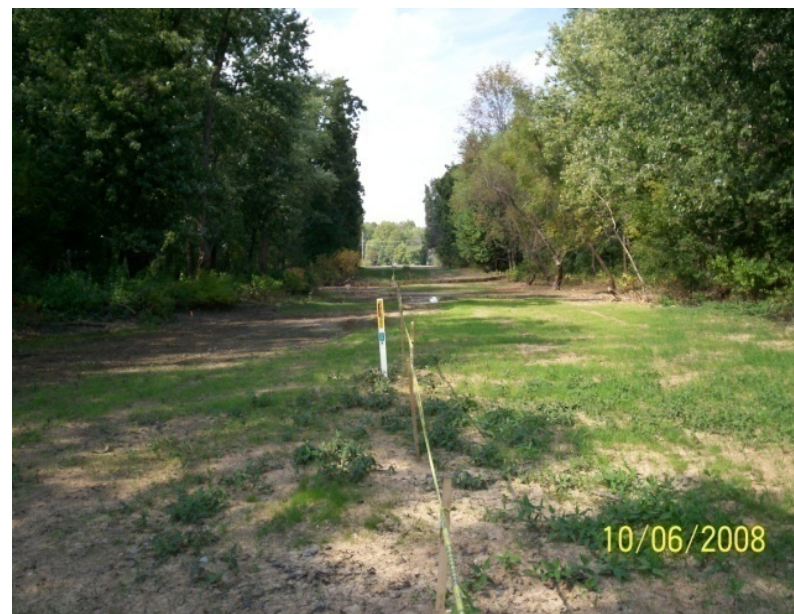
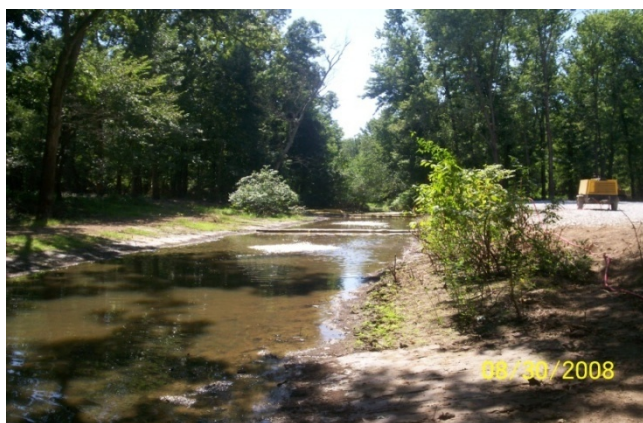
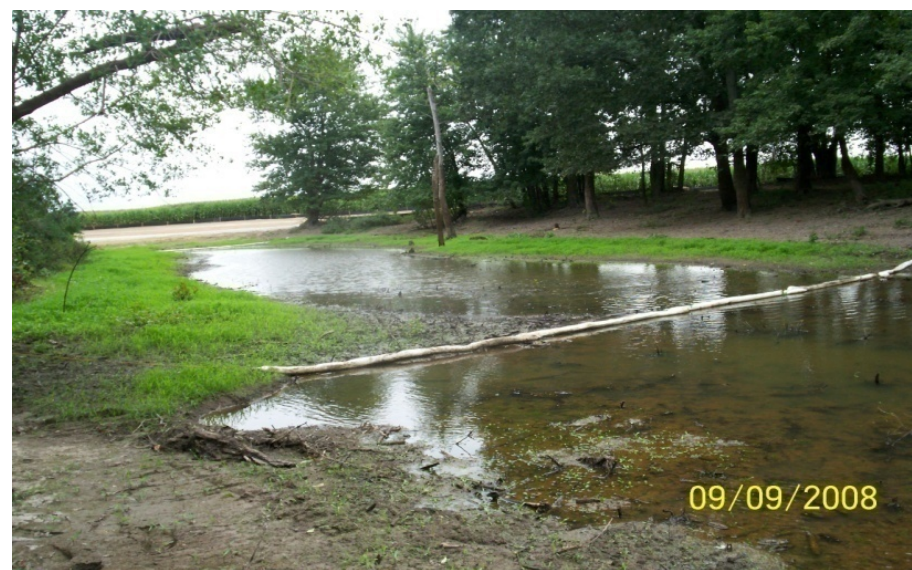
# Groundwater Sampling

*Approach* --- Residential wells in area; 5 grab samples for preliminary screening

- [Six residential properties sampled](#)
- BTEX, MTBE, Naphthalene, trimethylbenzene, PAHs, Metals
- No detections greater than Federal MCLs
- Five grab samples from soil borings
- BTEX, PAHs, TPH DRO / GRO / ERO
- Benzene exceedance
- Permanent monitoring wells to be installed

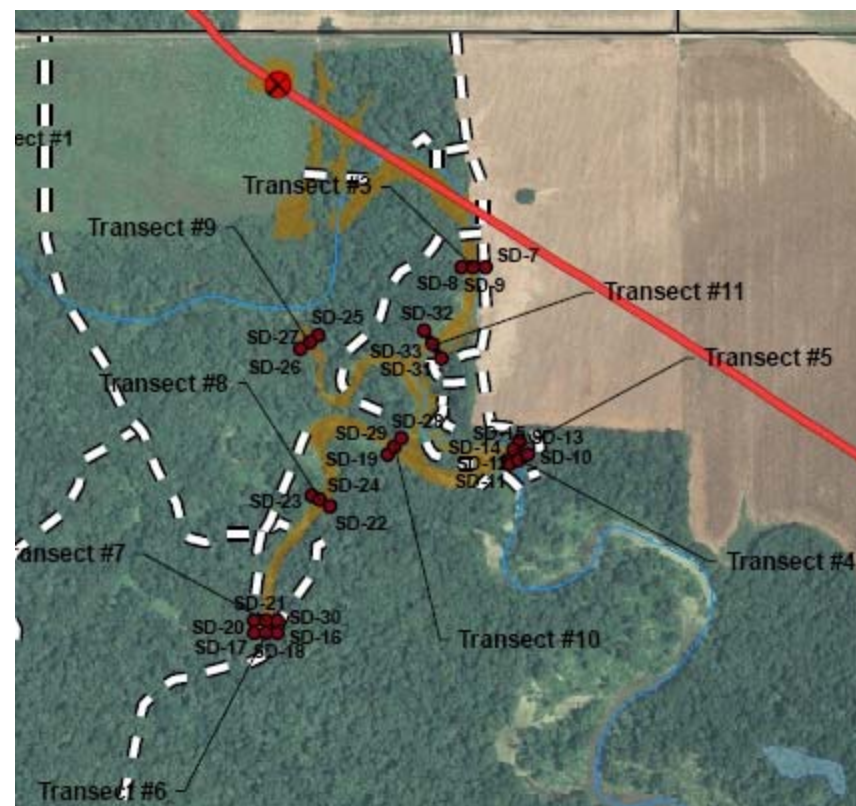
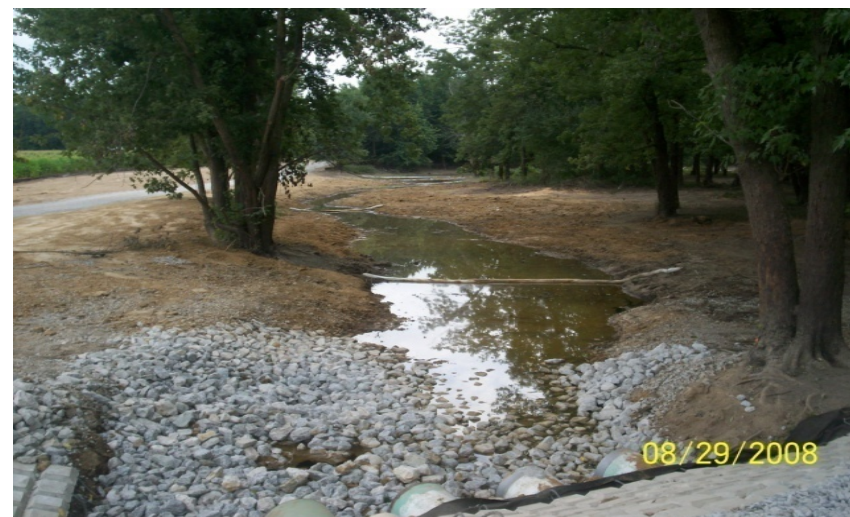
# Sediment Sampling

*Approach* --- 14 “transects” sampled; off-site reference sample locations also sampled

- 9 transect locations “on-site”
- 5 reference “off-site” locations
- 3 samples collected per transect
- BTEX, PAHs, TPH DRO / GRO / ERO
- One exceedance --- 2-methylnaphthalene
- Additional sampling to include benthic macro invertebrate sampling coupled with chemical data ---- used for NRDA assessment

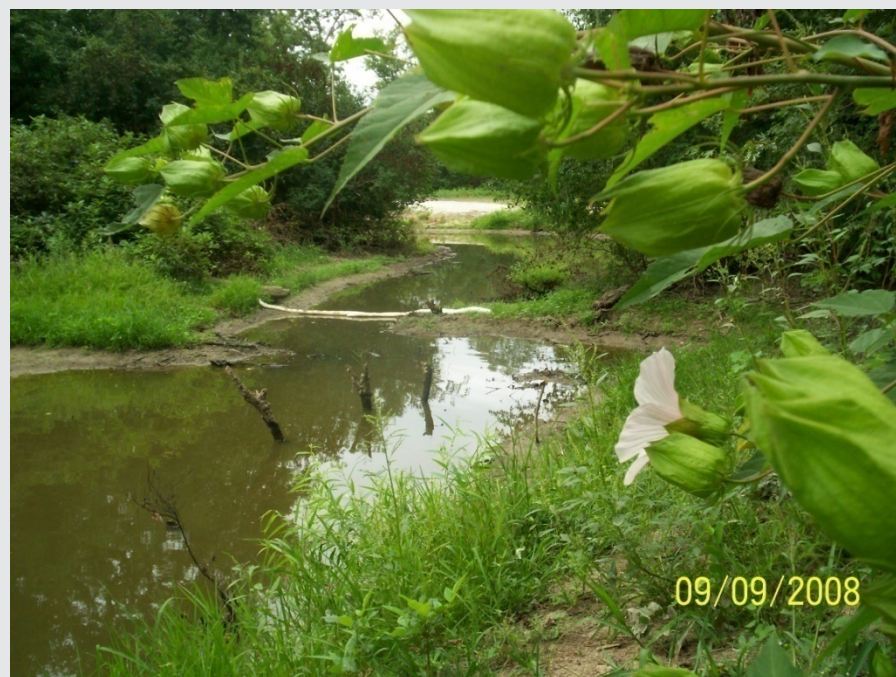
Day 27 After Release  
(day prior to "emergency response  
phase" completion)

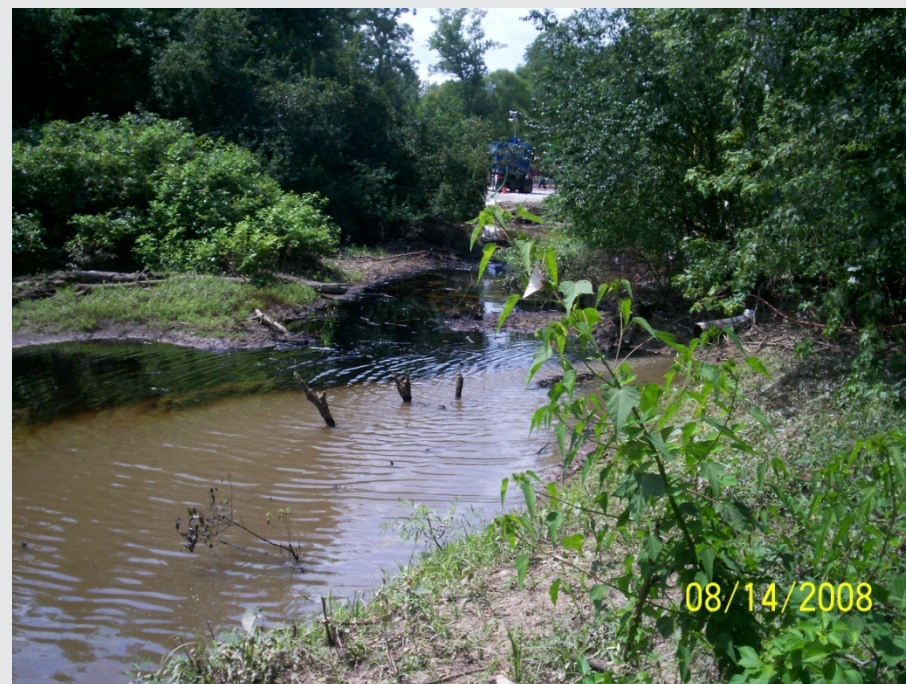
Day 1 After Release
