Georgian Well Blow-Out 2004

Paul Foley

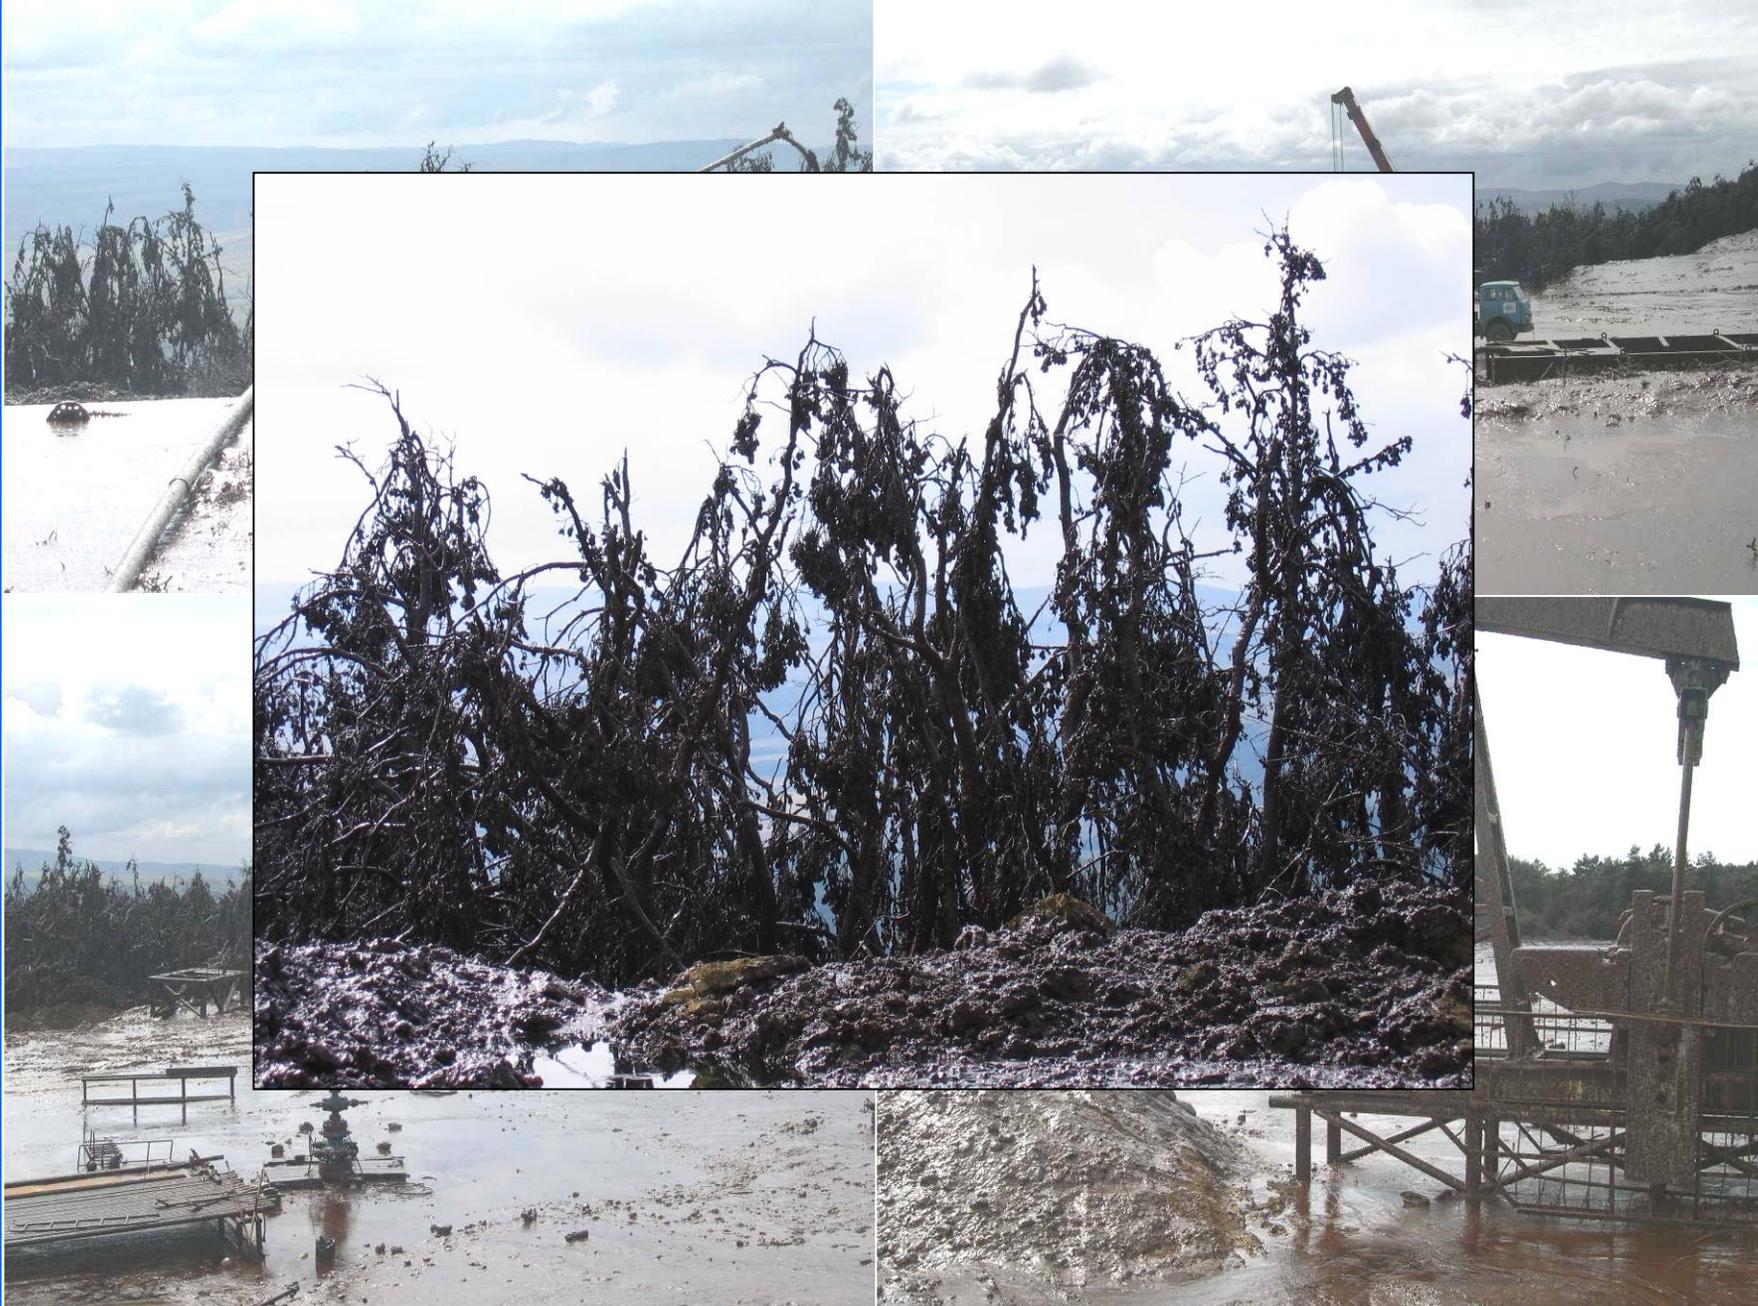
N100 Wellhead Site

Initial Actions (0 - 4 Days)

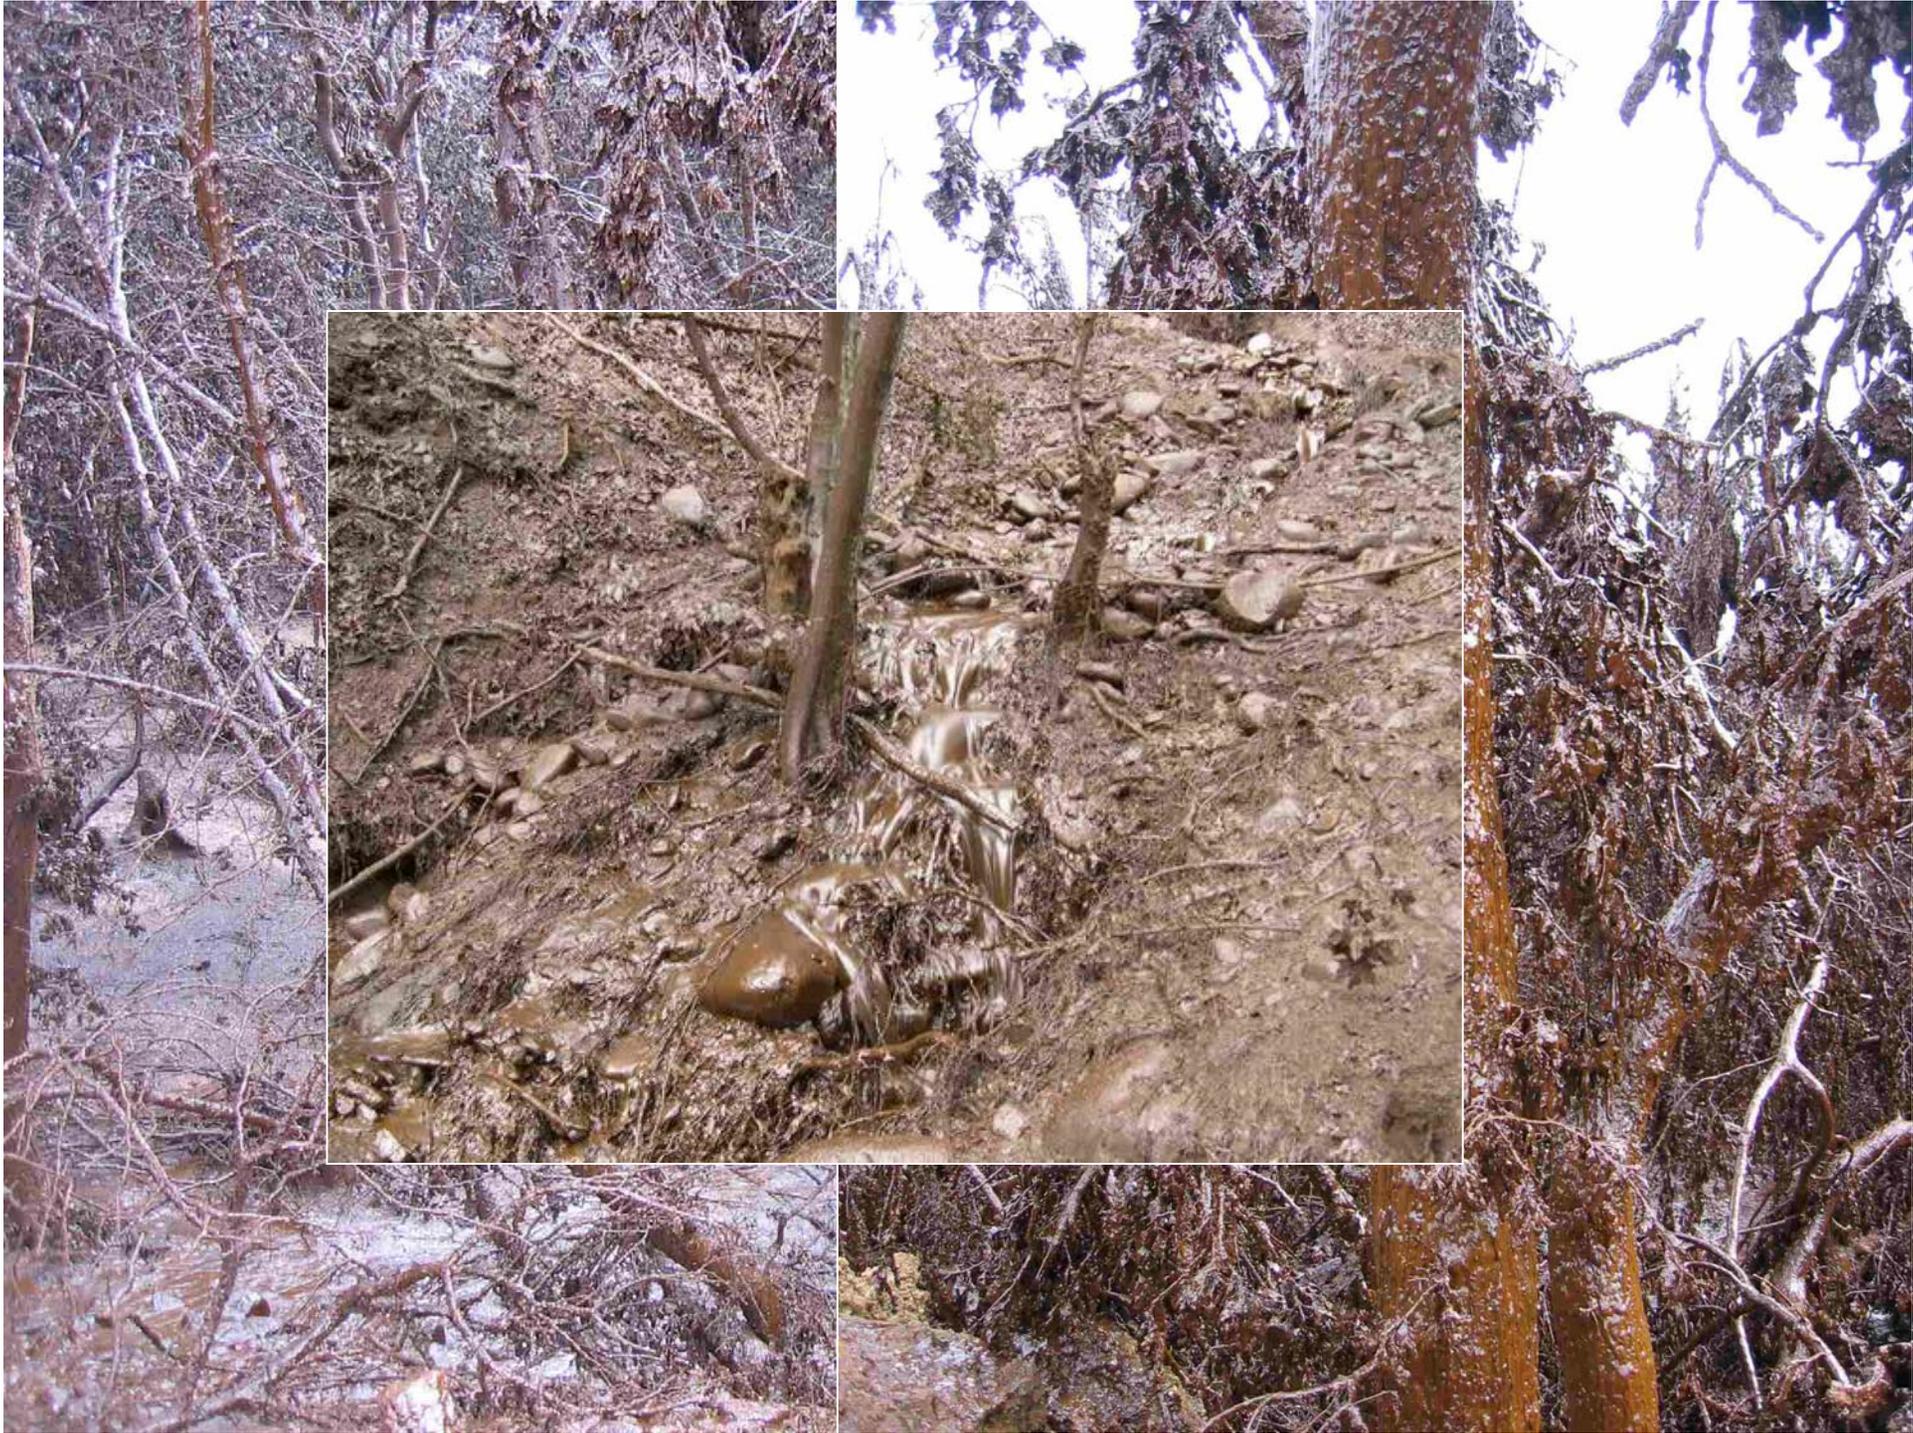
The Environment

- 🔥 Deciduous trees and shrubs
- 🔥 Ecosystem disturbance
- 🔥 Potential contamination of food crops
- 🔥 Potential contamination of water for livestock and crop irrigation

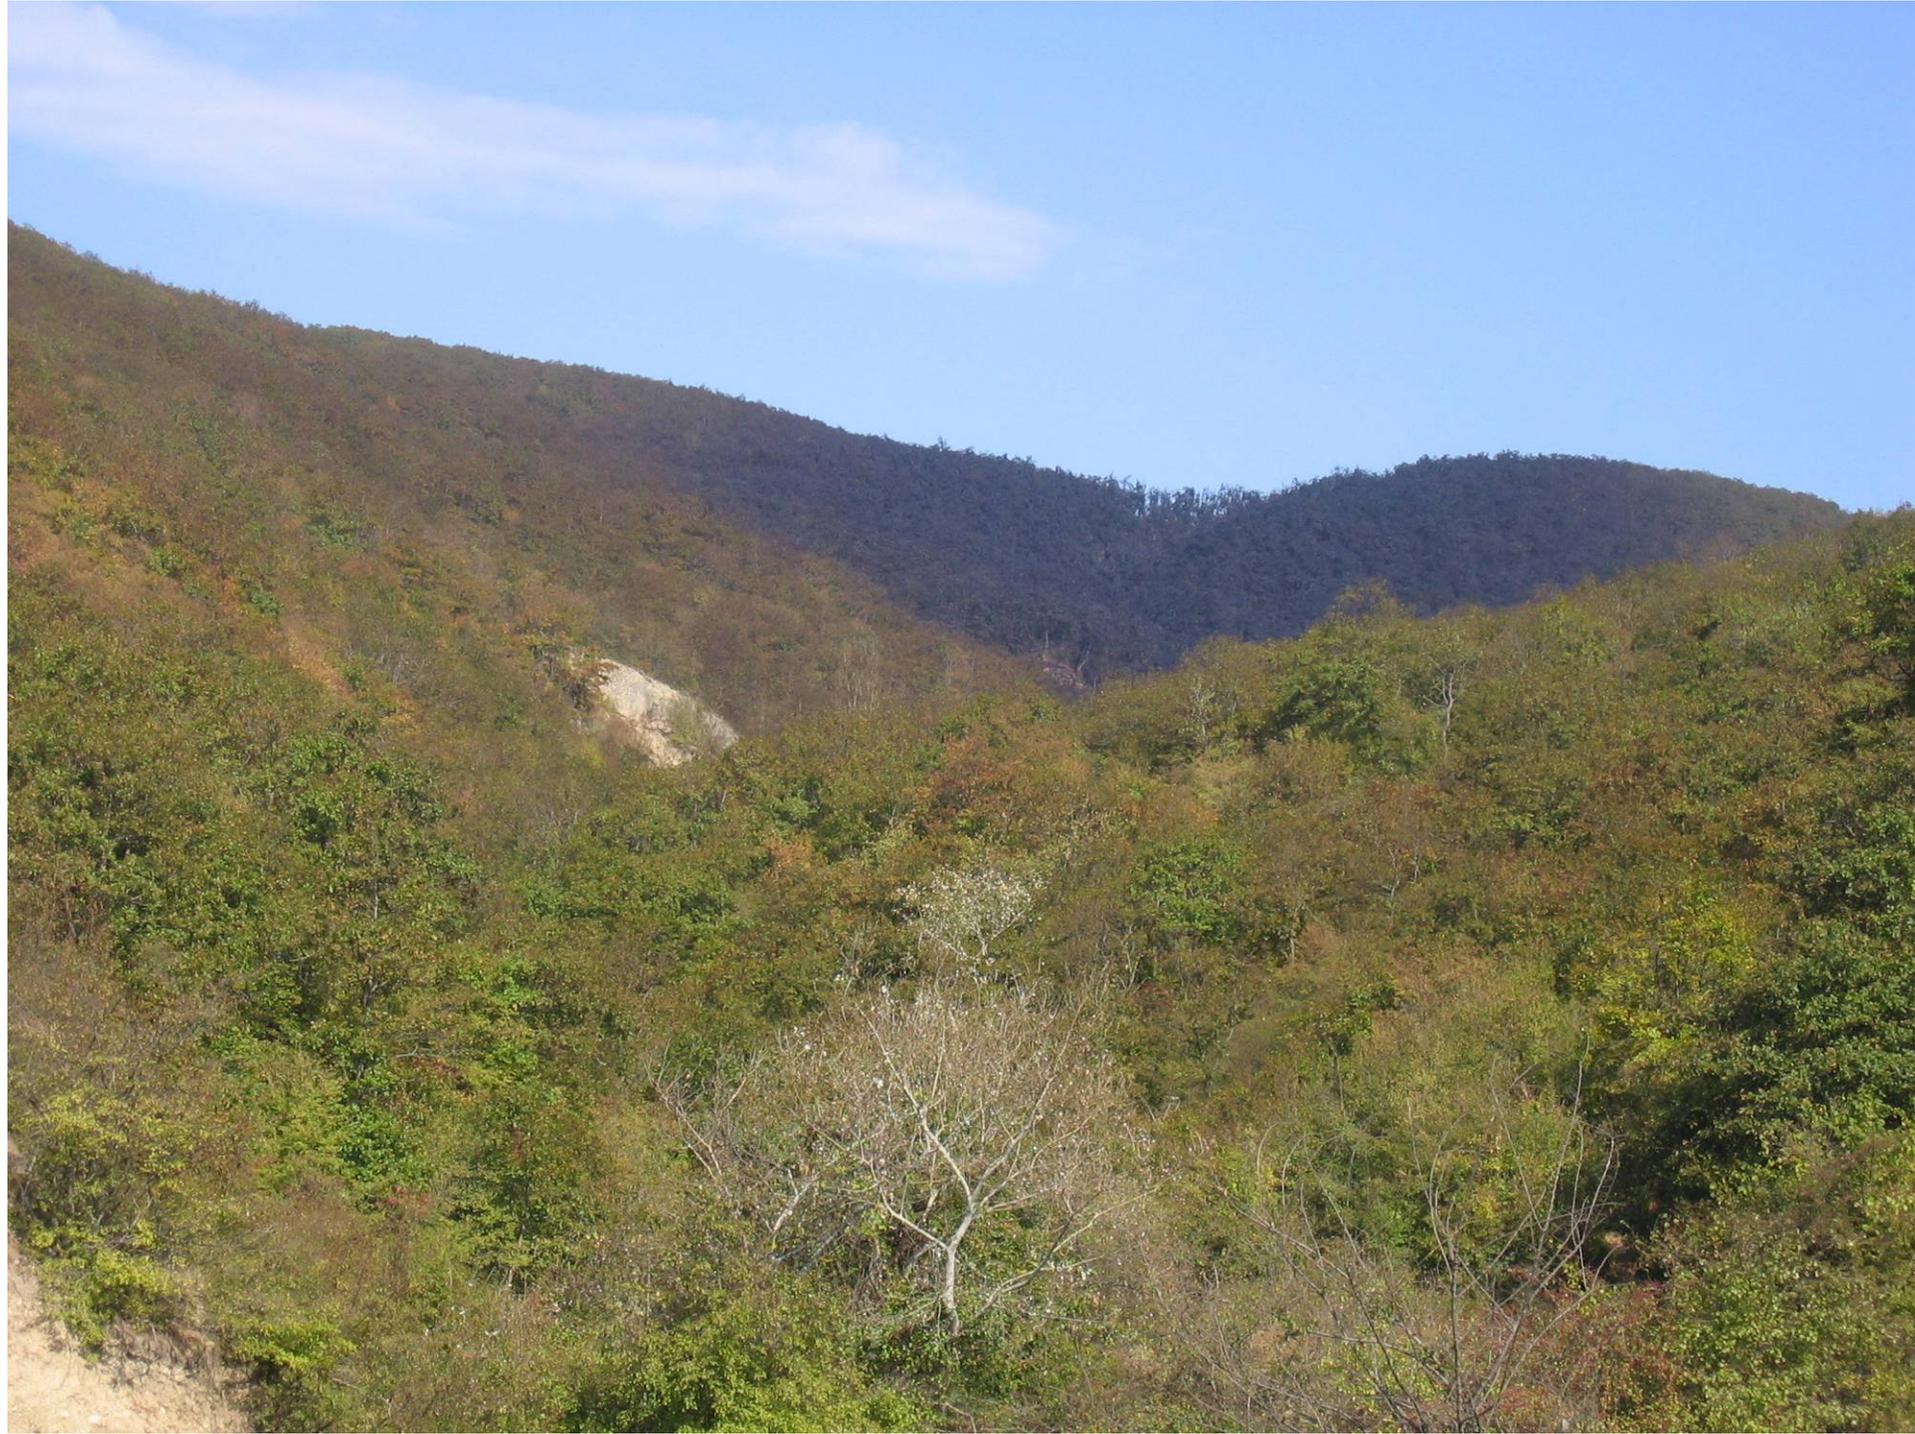
Weather and Topography

- 🔥 Warm and dry in September
- 🔥 Freshwater stream
- 🔥 Clay substrate
- 🔥 Deep water tables
- 🔥 Poor accessibility

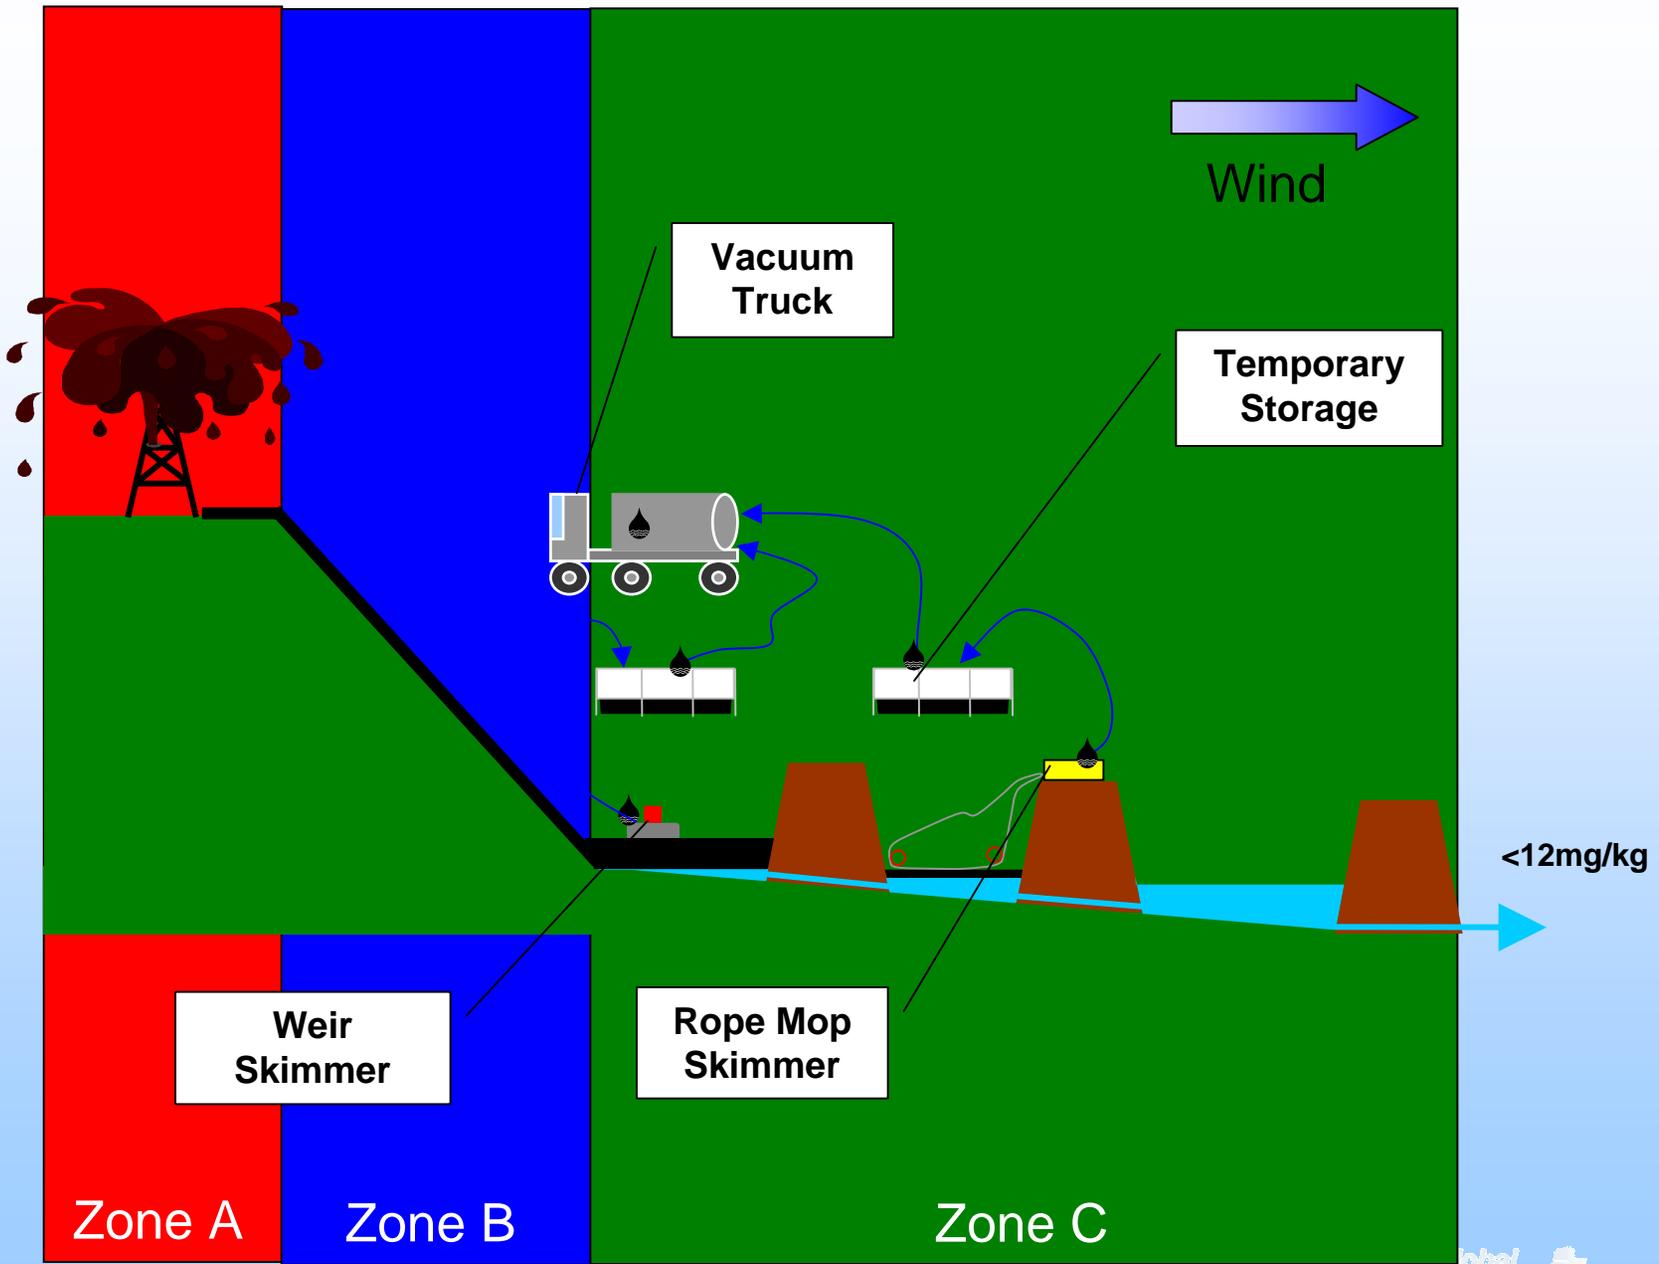
Site Layout

- 🔥 Build an ICS to integrate with company's management
- 🔥 Minimise impact and spread of oil
- 🔥 Remove gross oil from the wellhead and then the woodland
- 🔥 Final cleaning
- 🔥 Site surveys established 3 work areas:
 - **Zone A:** Wellhead area
 - **Zone B:** Woodland
 - **Zone C:** Separator pits and storm gully

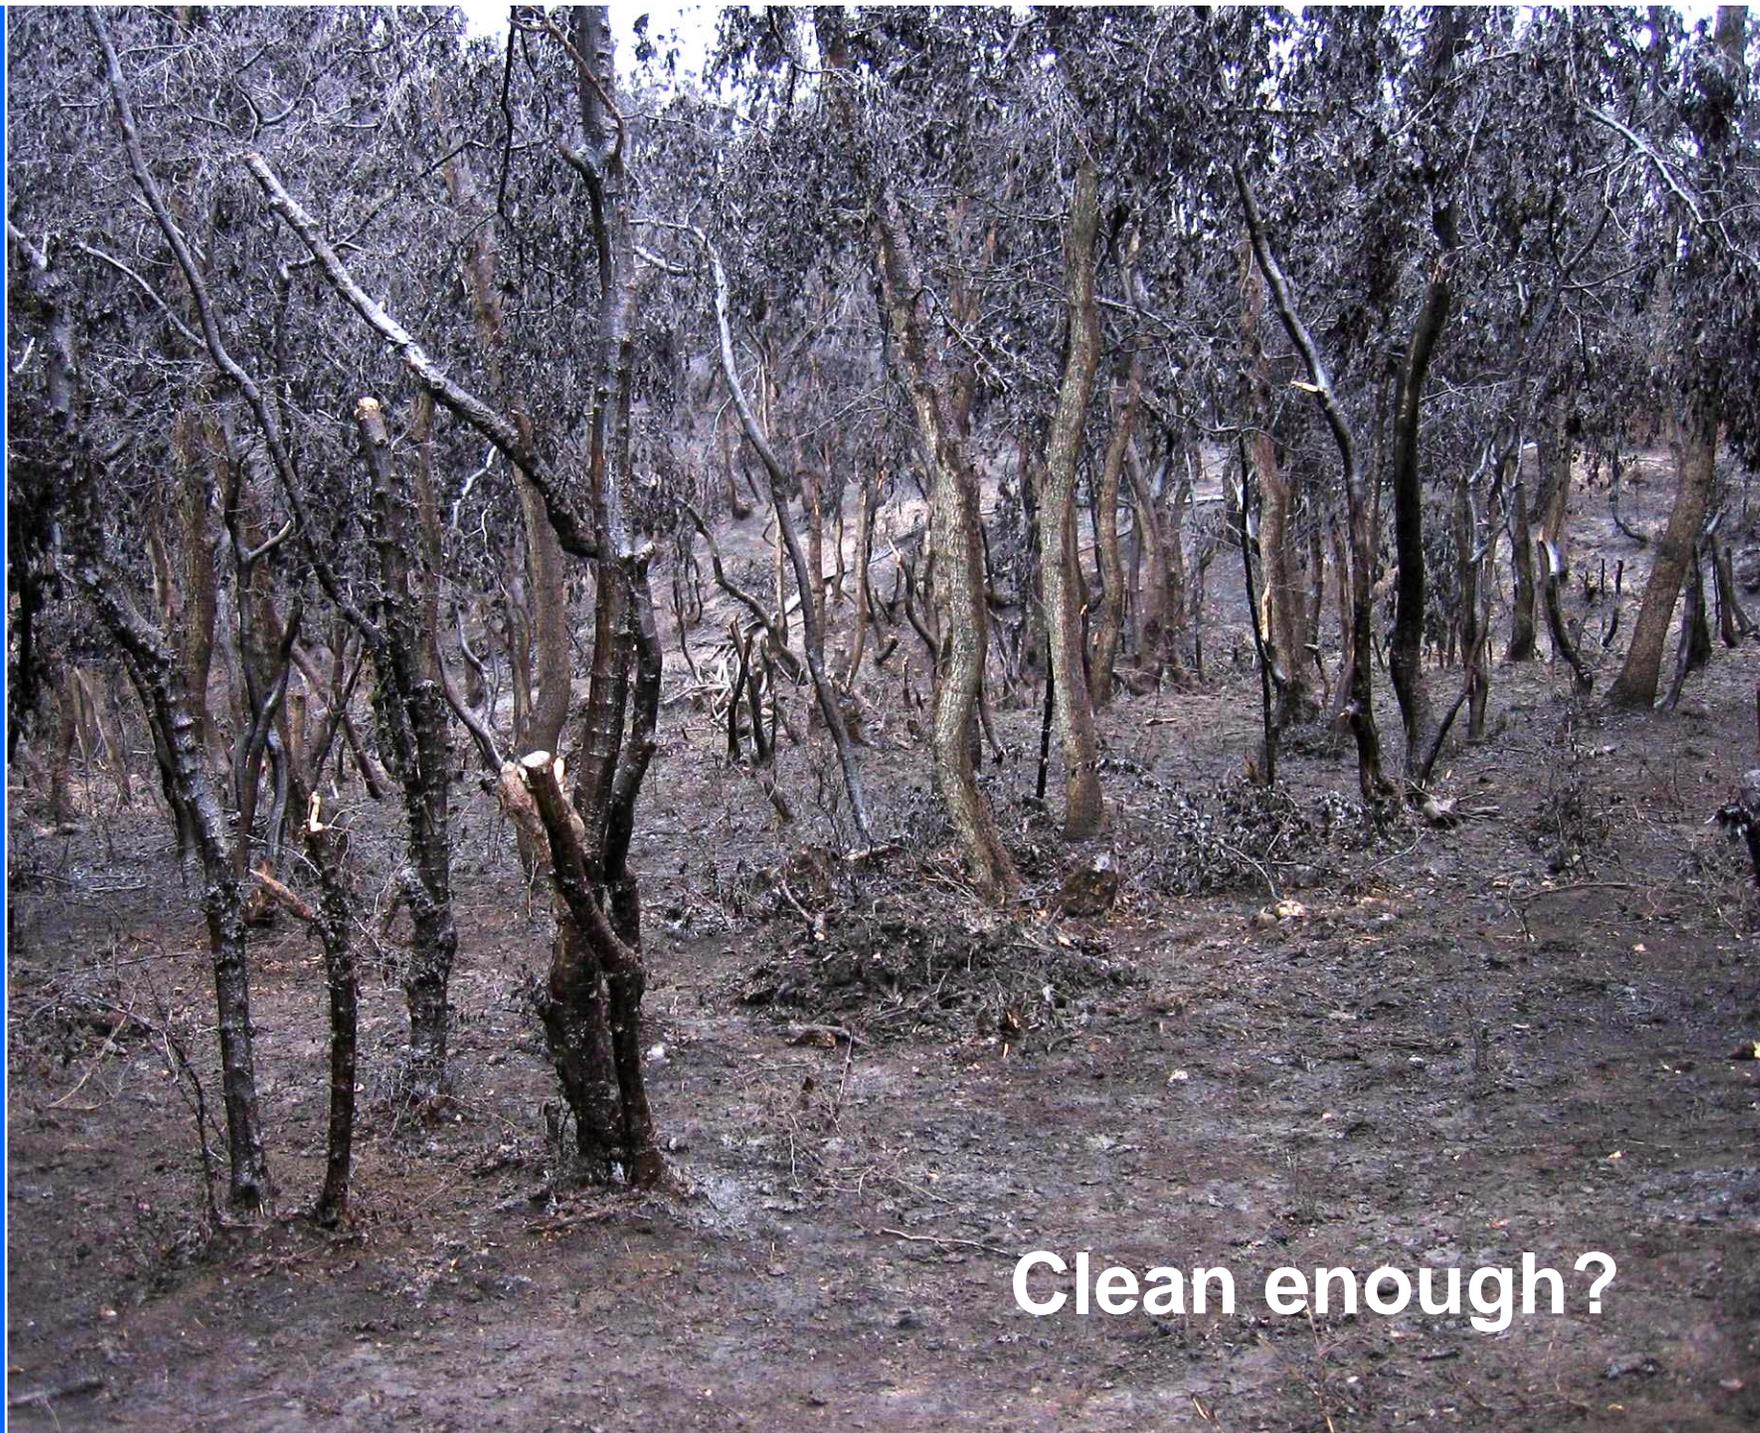
Zone B – Woodland

- Flushing and manually re-mobilising the bulk oil
- Manual recovery of the heavily oiled leaf litter
- Structured and managed felling and lopping
- Regeneration program

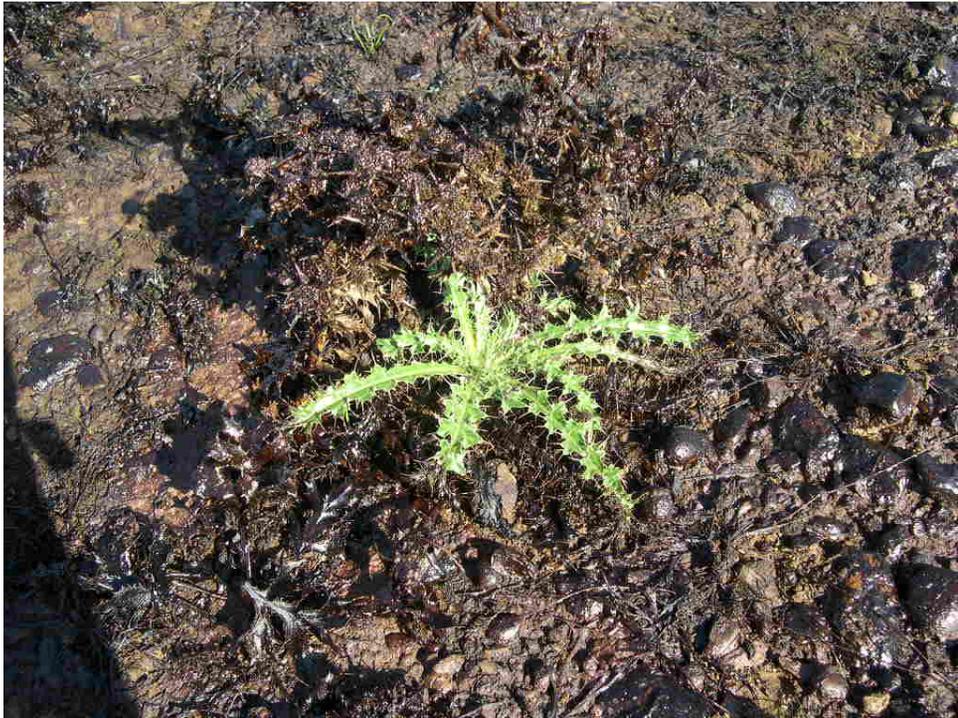
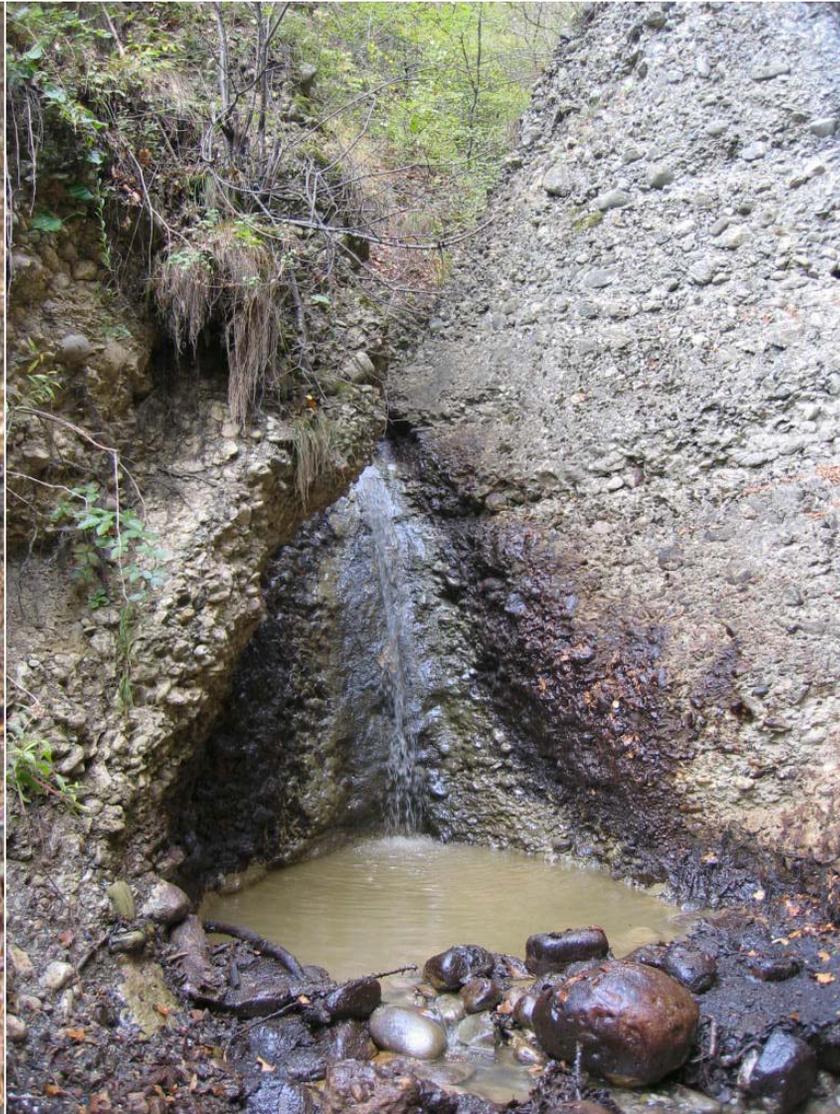
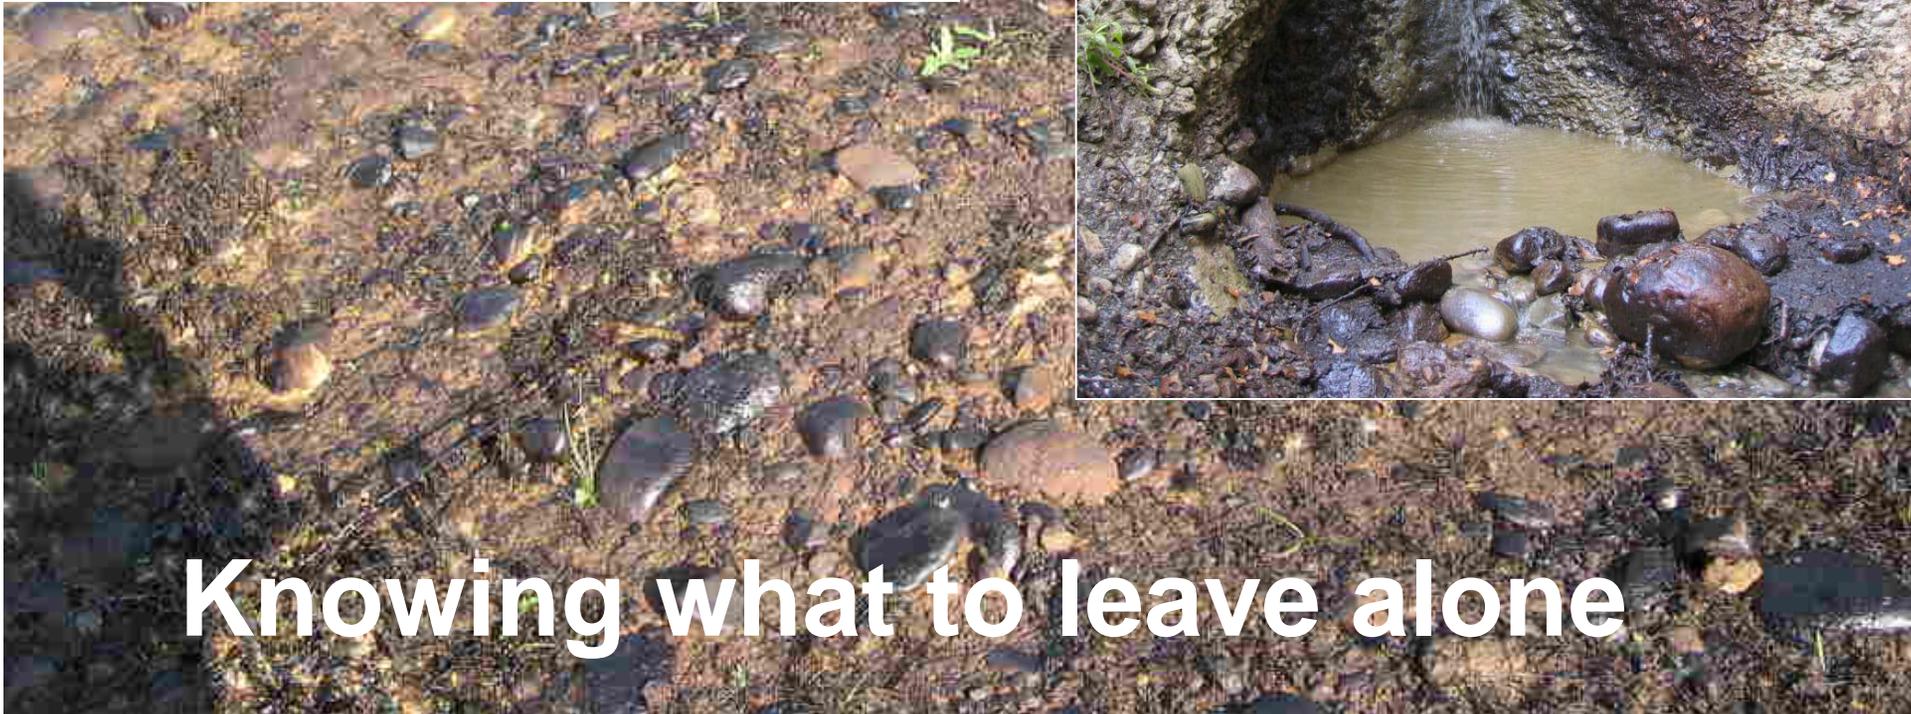
Clean enough?

Knowing what to leave alone

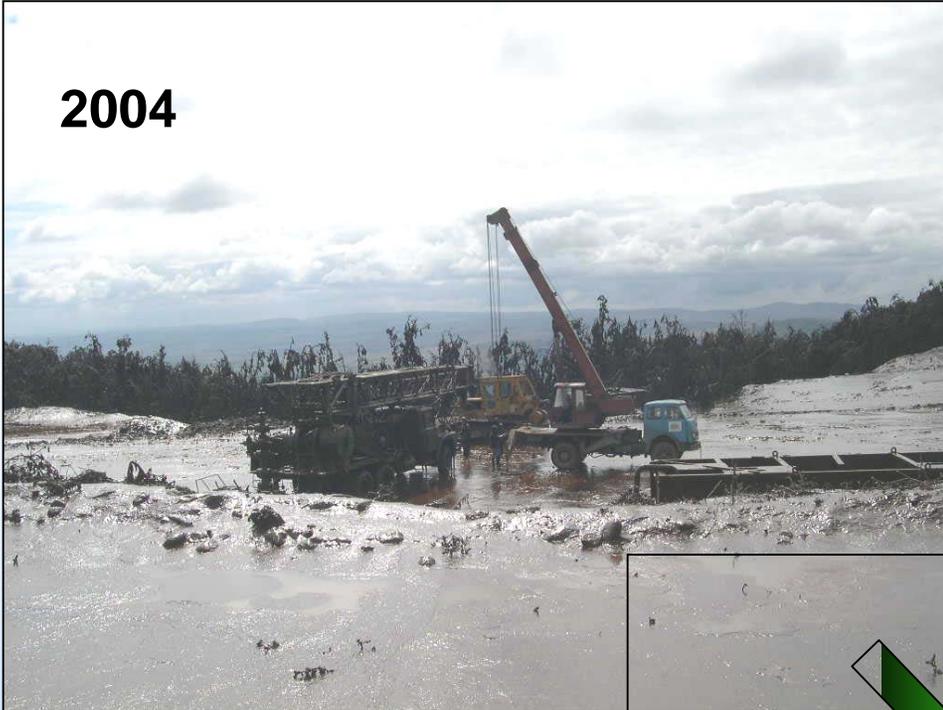
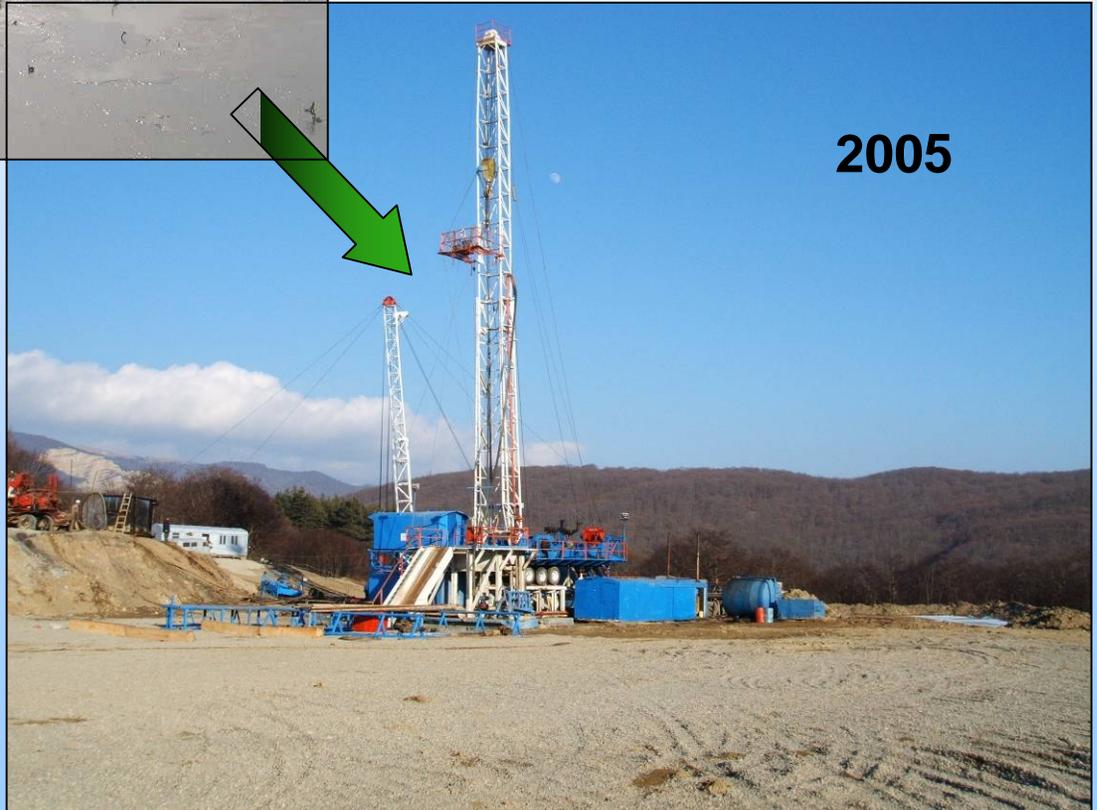
Post Spill (Well Head)

- 🔥 Continued site rehabilitation
- 🔥 Selective felling & oiled debris removal
- 🔥 Continued monitoring of water quality
- 🔥 Bioremediation scheme ongoing
- 🔥 Replanting scheme planned
- 🔥 Drinking water well drilled
- 🔥 Well N100 still producing

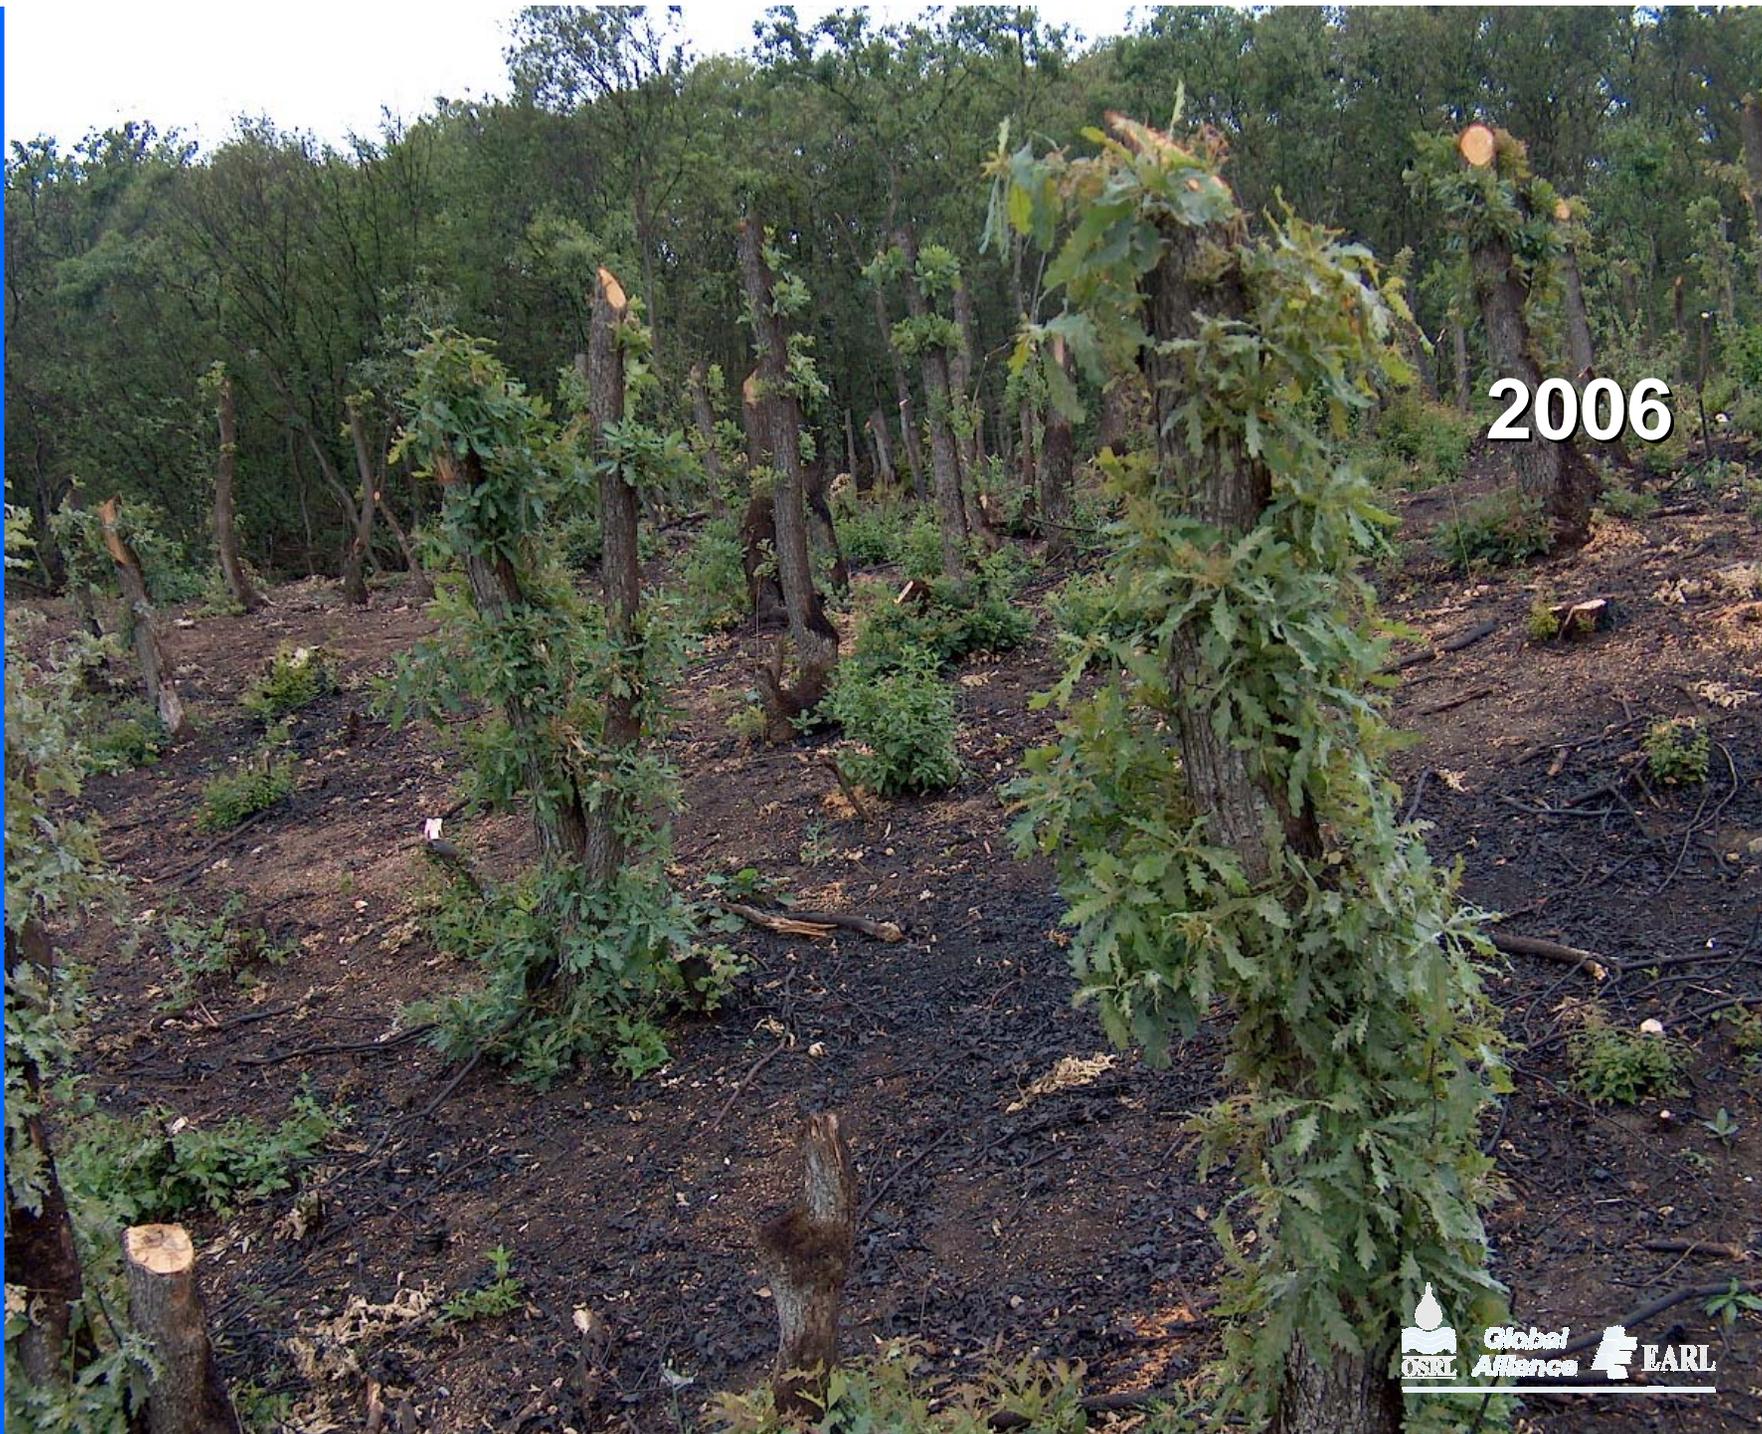
Post Spill (Forest)

2006
