Monitoring Crude Oil Spill Components with the ORSANCO Organics Detection System

**Jerry G. Schulte
Ohio River Valley Water Sanitation
Commission**

Mid Valley Pipeline Spill

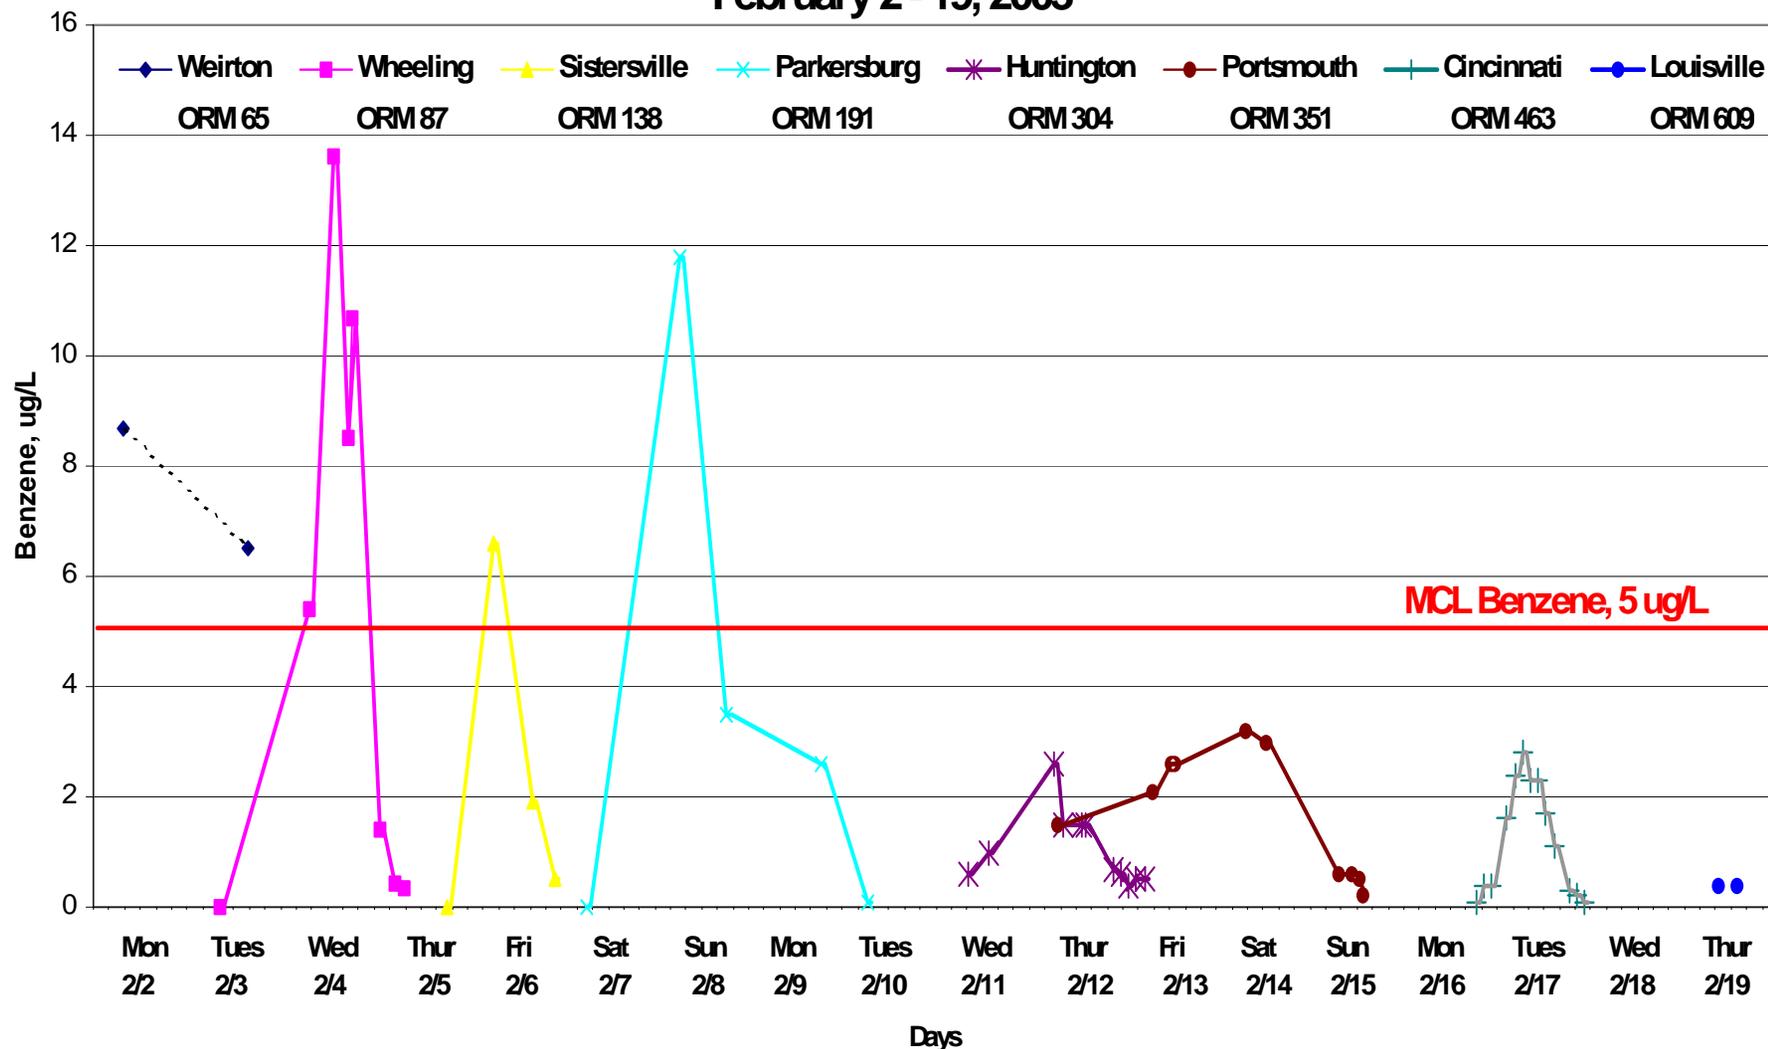
ORSANCO ODS Benzene Detections
February 2 - 19, 2003

Spill Detection Program, Volatile Organics

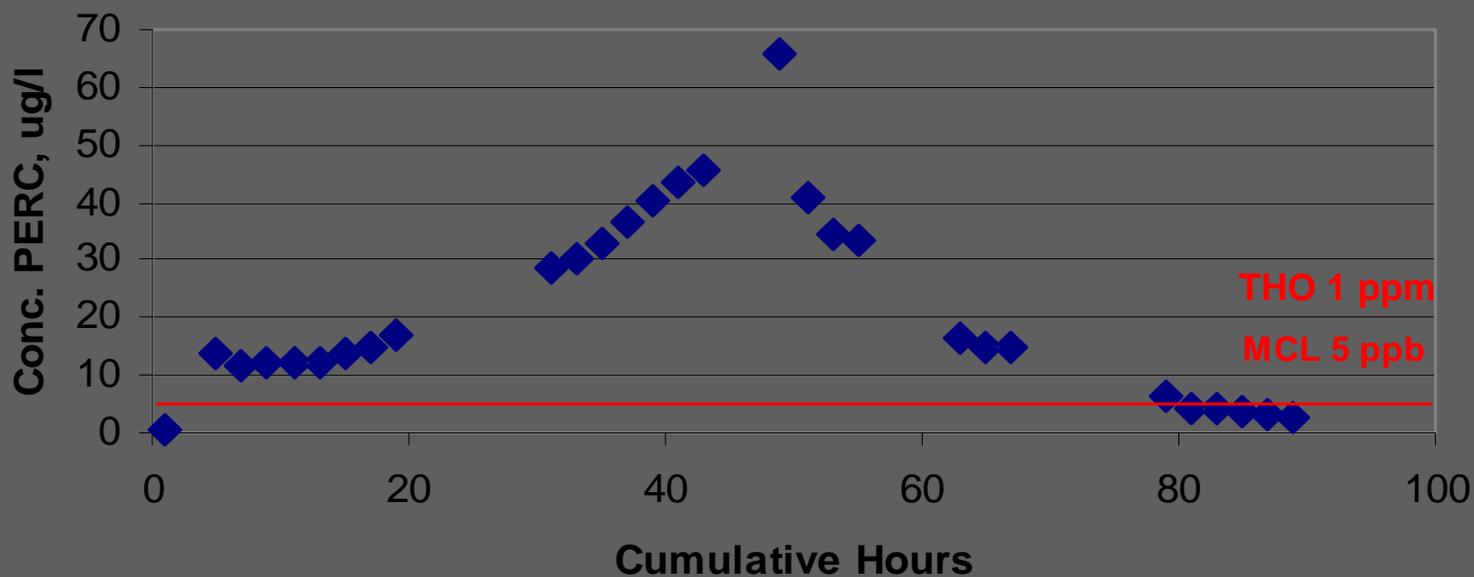
Perchloroethylene Detections
January 30 - February 3, 2004

ODS Spill Detection

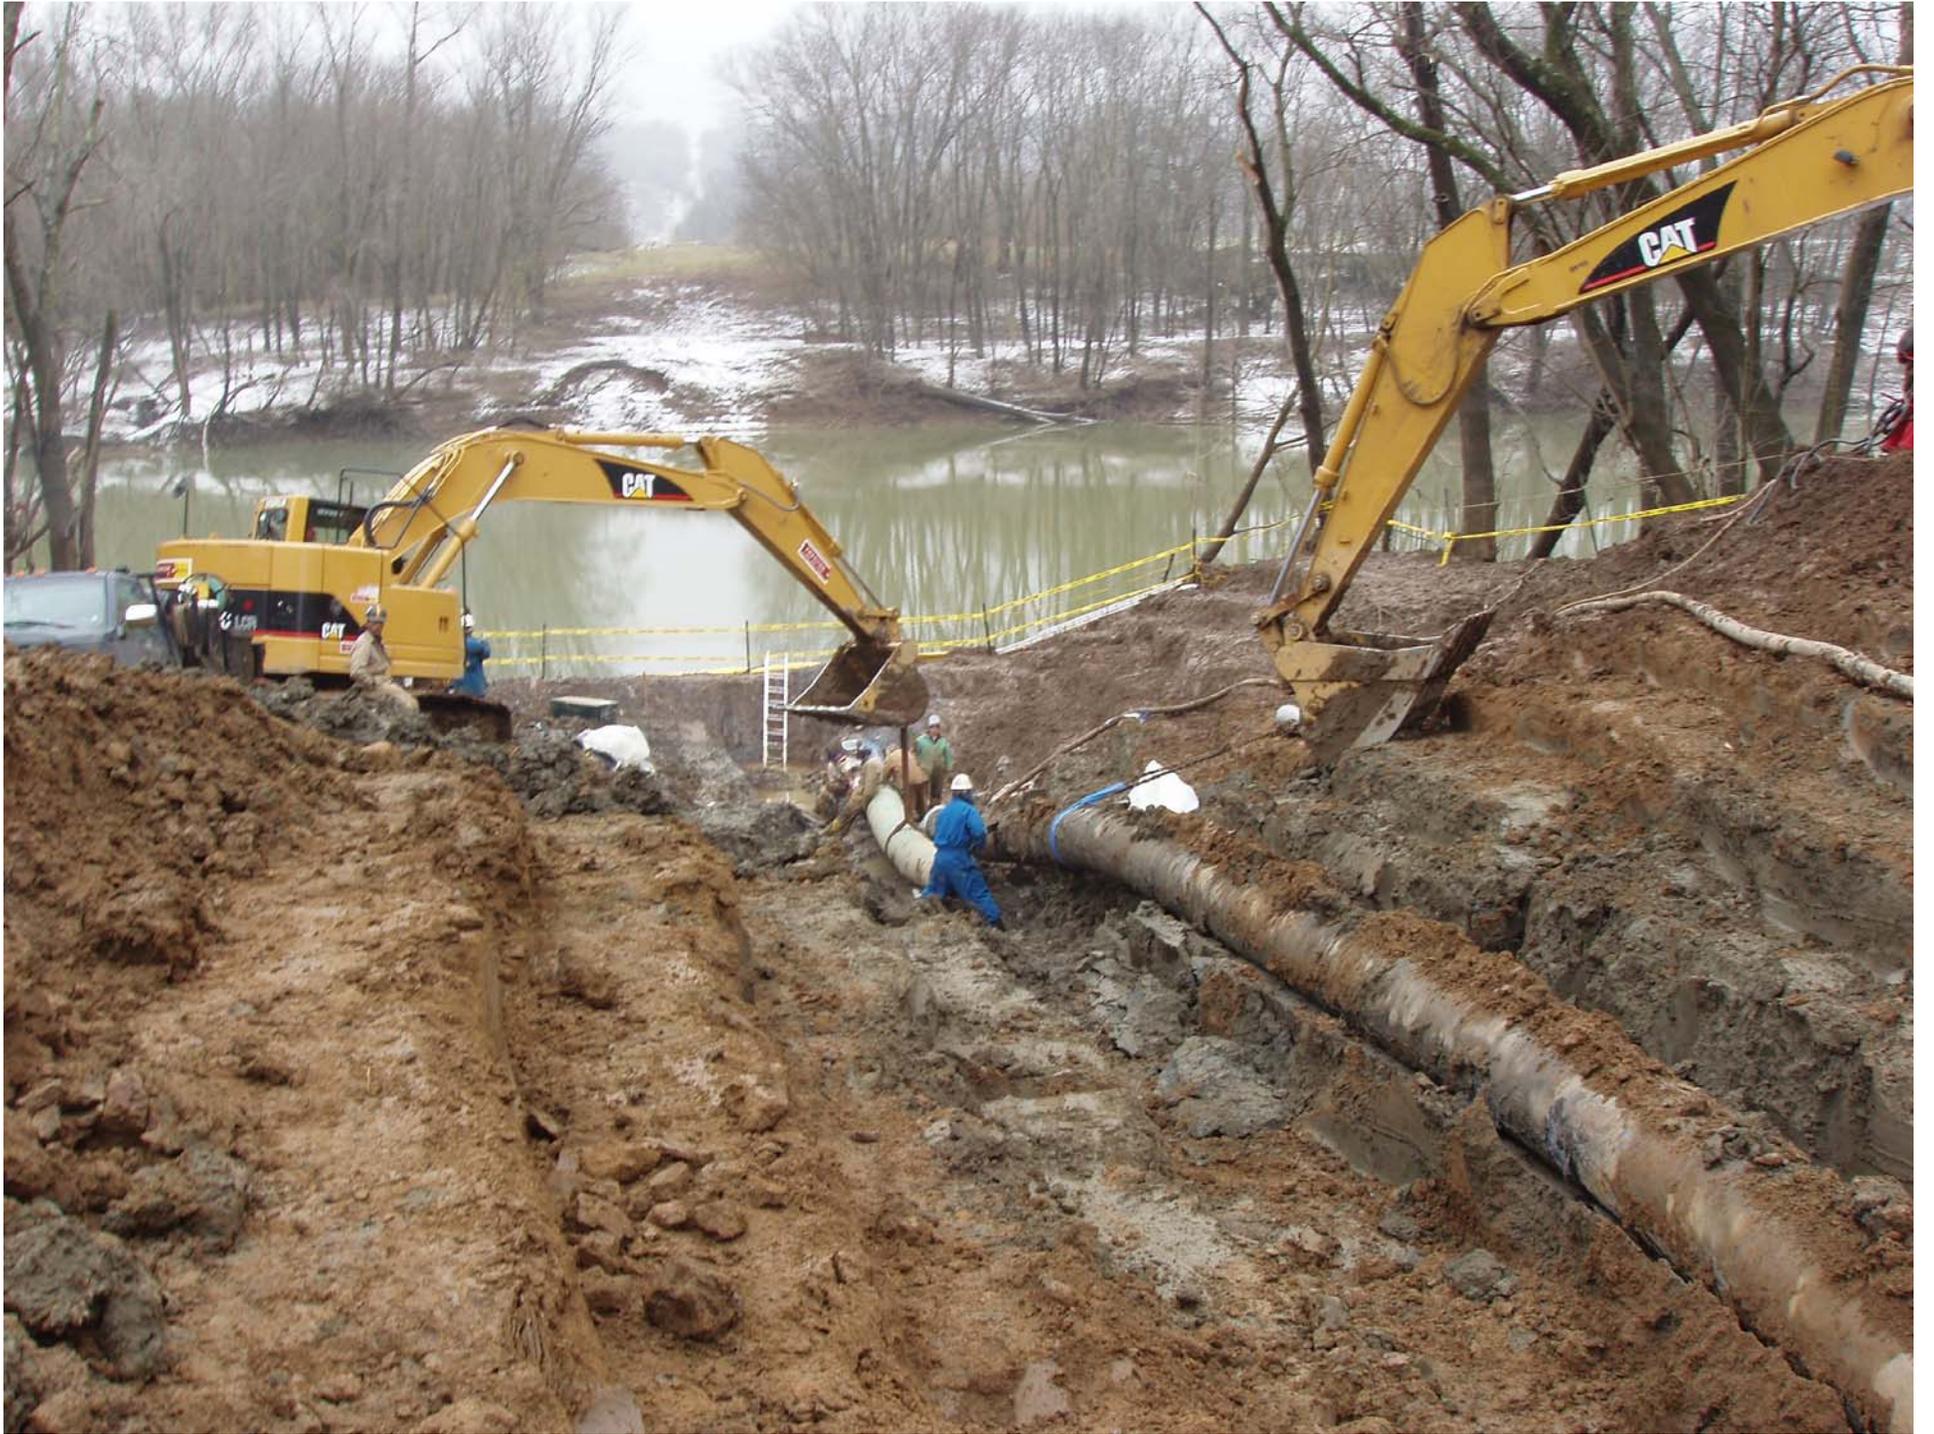
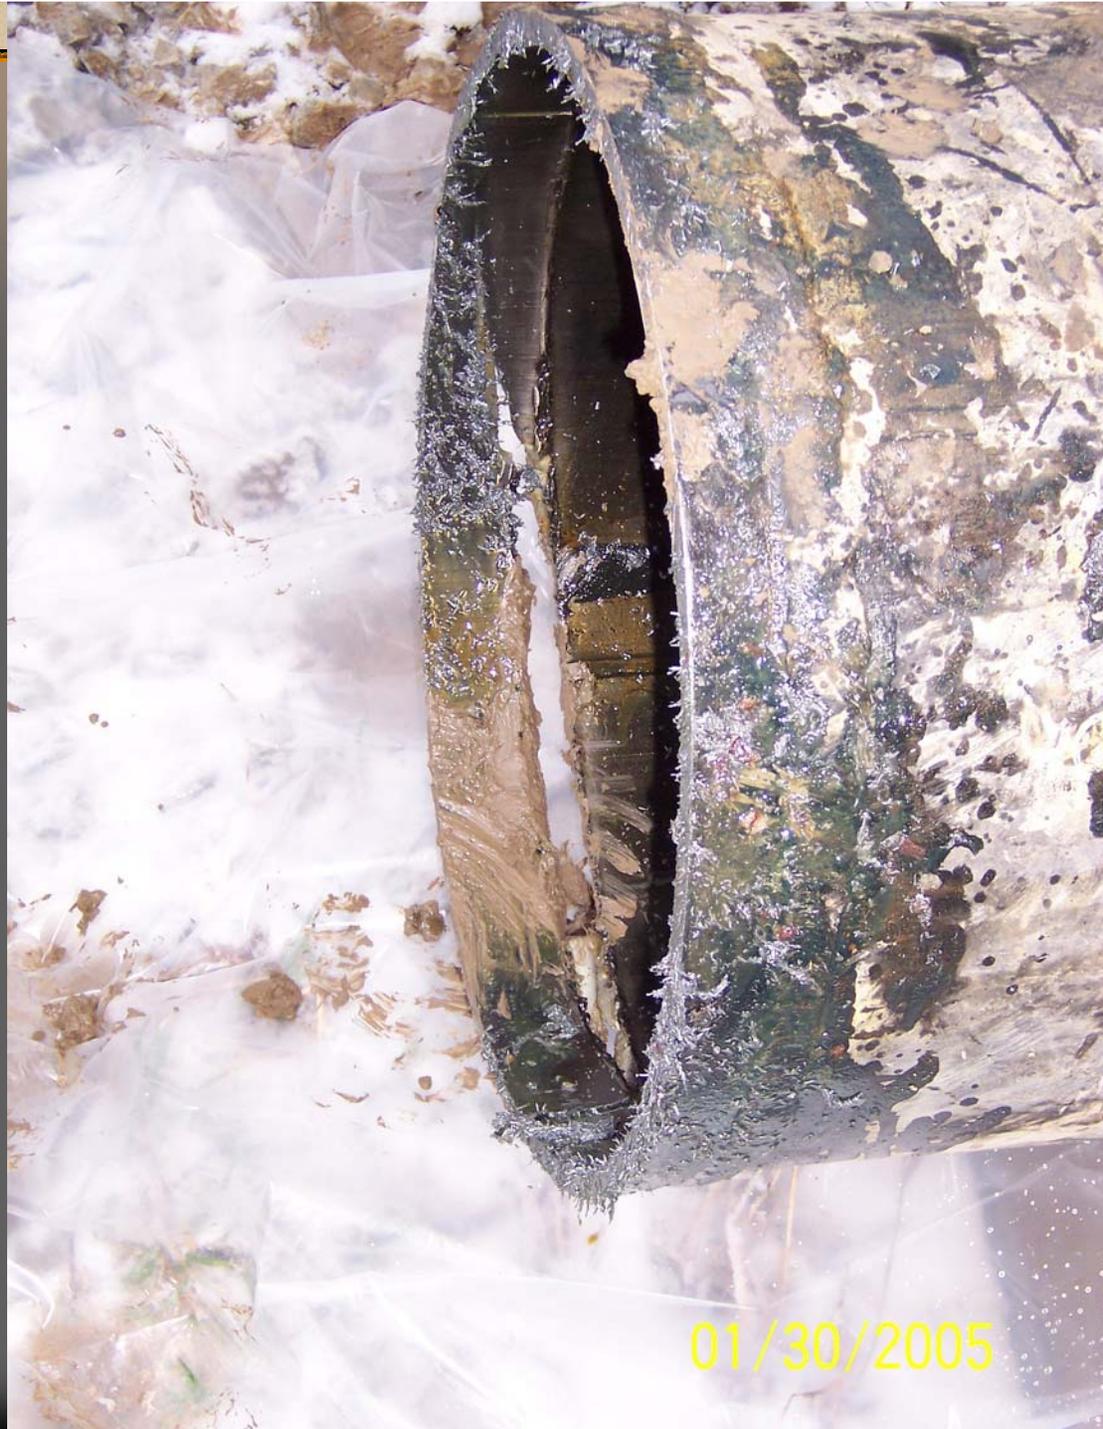
01/30/2005

- ➔ Break caused by erosion of soil around pipeline under stream bed and shore
- ➔ Subsidence caused pipe to bend, then break at weld seam
- ➔ Took approximately 4 days to secure leak and replace broken section of pipe

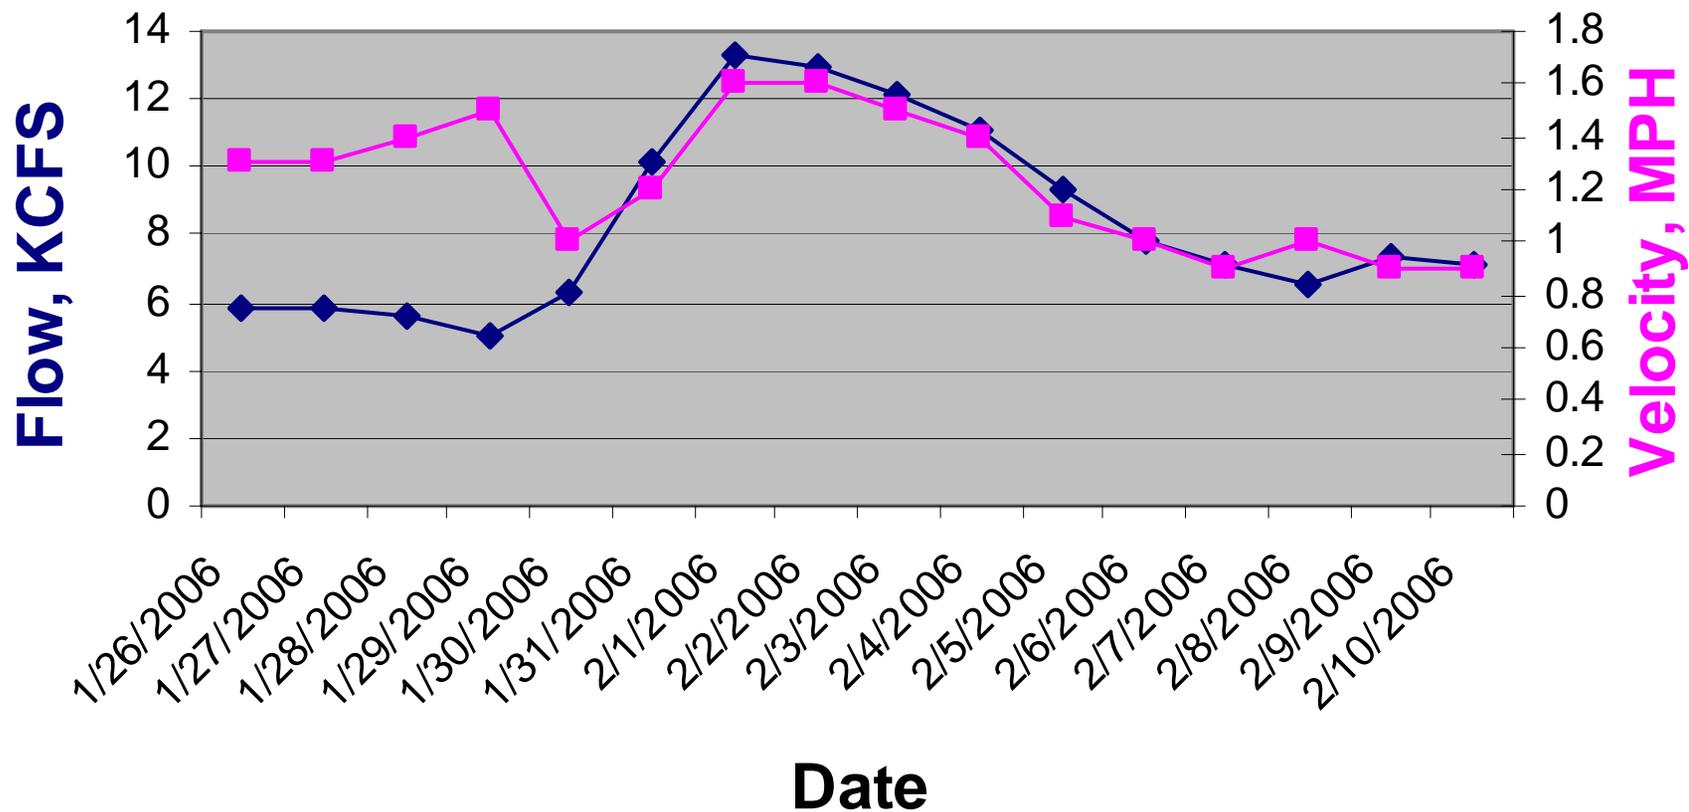
Kentucky River Flow and Velocity January 26 - February 10

- ⇒ Containment of oil successful until flows increase in Kentucky River on 1/30 – 1/31 following a rain event
- ⇒ Increased debris loads break booms
- ⇒ Oil escapes to Ohio River 1/31

- ➔ Detections confirm projections based on flow/velocity information
- ➔ 0.5 mph for Kentucky River
- ➔ 2.7 mph for Ohio River
- ➔ Louisville Water ODS detects low levels of BTX for weeks
- ➔ Evansville Water detects BTX on 1/31

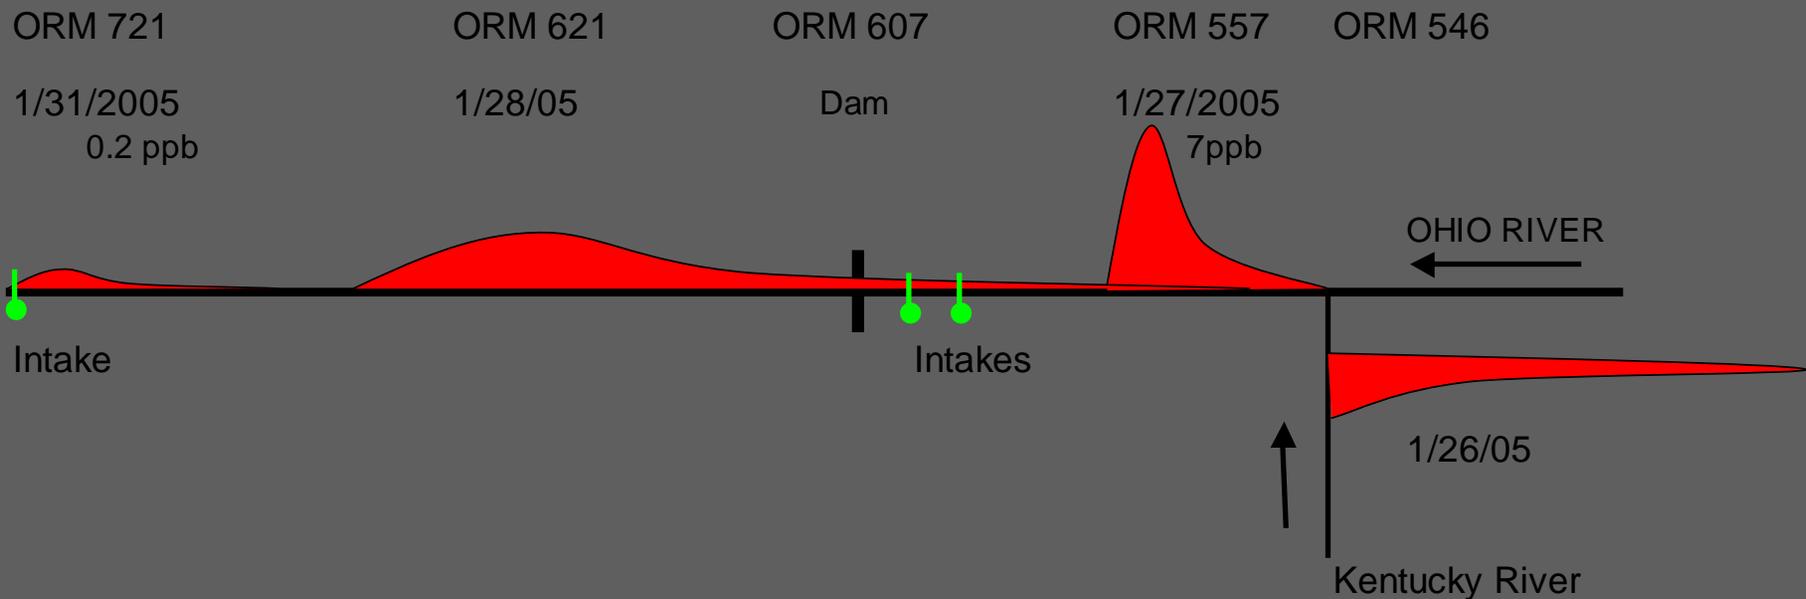
BTX PLUME

- ➔ Louisville Water Co. begins shore-based sampling activities from several locations immediately following release notification
- ➔ Analysis finds BTX compounds in Ohio River ahead of any noticeable sheens
- ➔ First BTX detection 13 miles downstream of confluence, Jan. 27, 1200 hrs. in Ohio River, 7ppb
 - Booming operations held until 1/31
