# GASCO: The First Portland Harbor Early Action In Review

Sean Sheldrake  
EPA Region 10

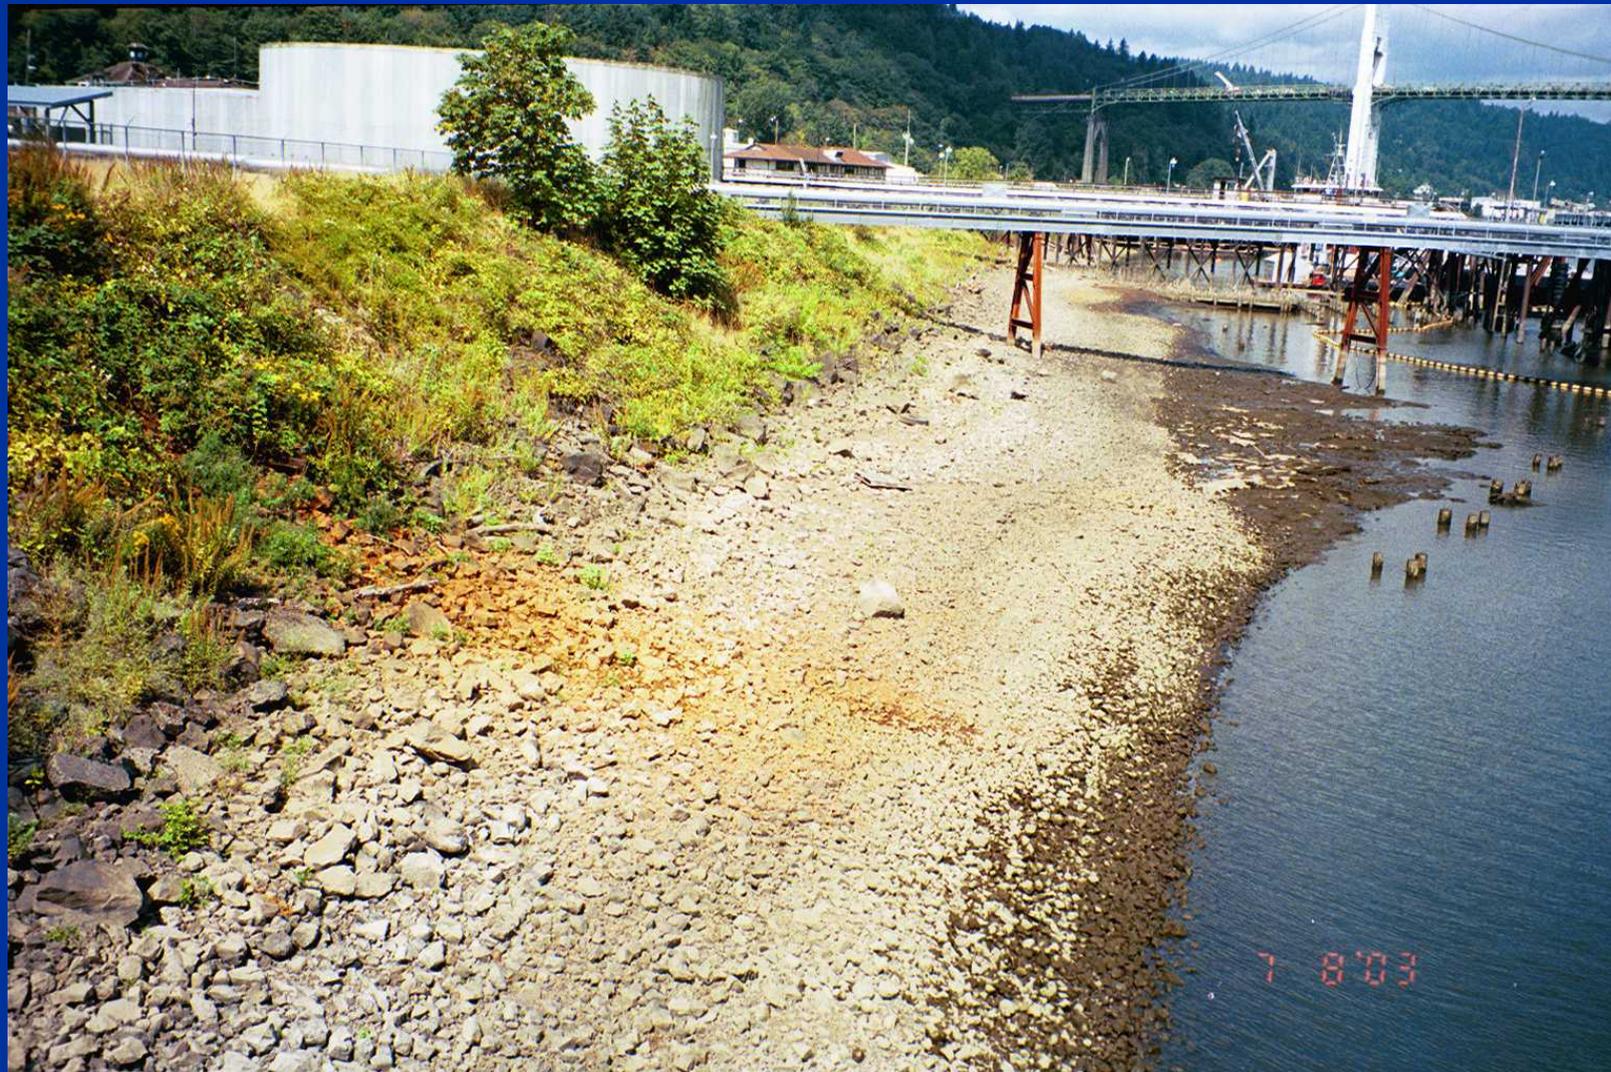
# GASCO; Willamette River mile 6.5 on the south side

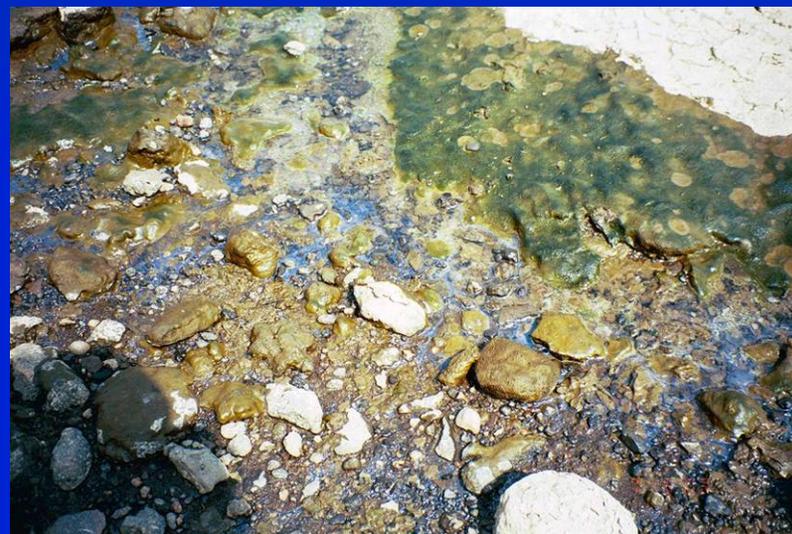
- **15,000 cubic yards** (500 truckloads) of highly contaminated tar was removed from the Willamette River, taken to a hazardous waste landfill, and the area capped.
- An actively eroding tar mass has been stabilized.

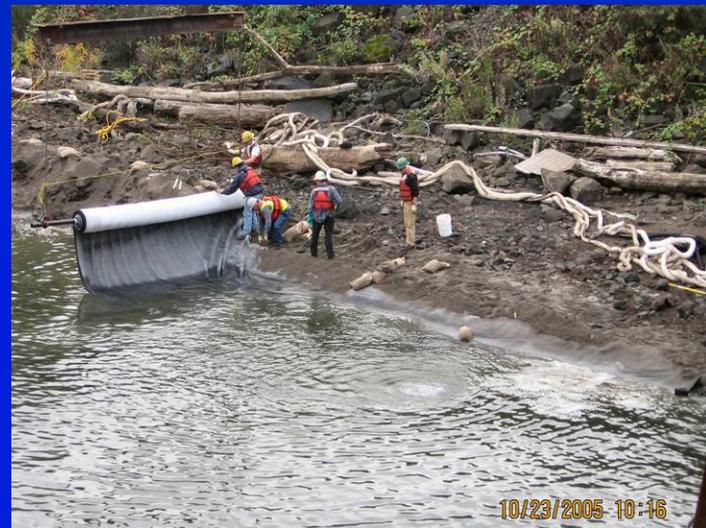
Removing the tar gave EPA new information about:

- the presence of liquid phases in the tar, which are present in the uplands as well.
- the mobility of the tar material for future work.

The pilot cap will help us understand how quickly nearby contamination and flux of contaminants will recontaminate a clean cap.

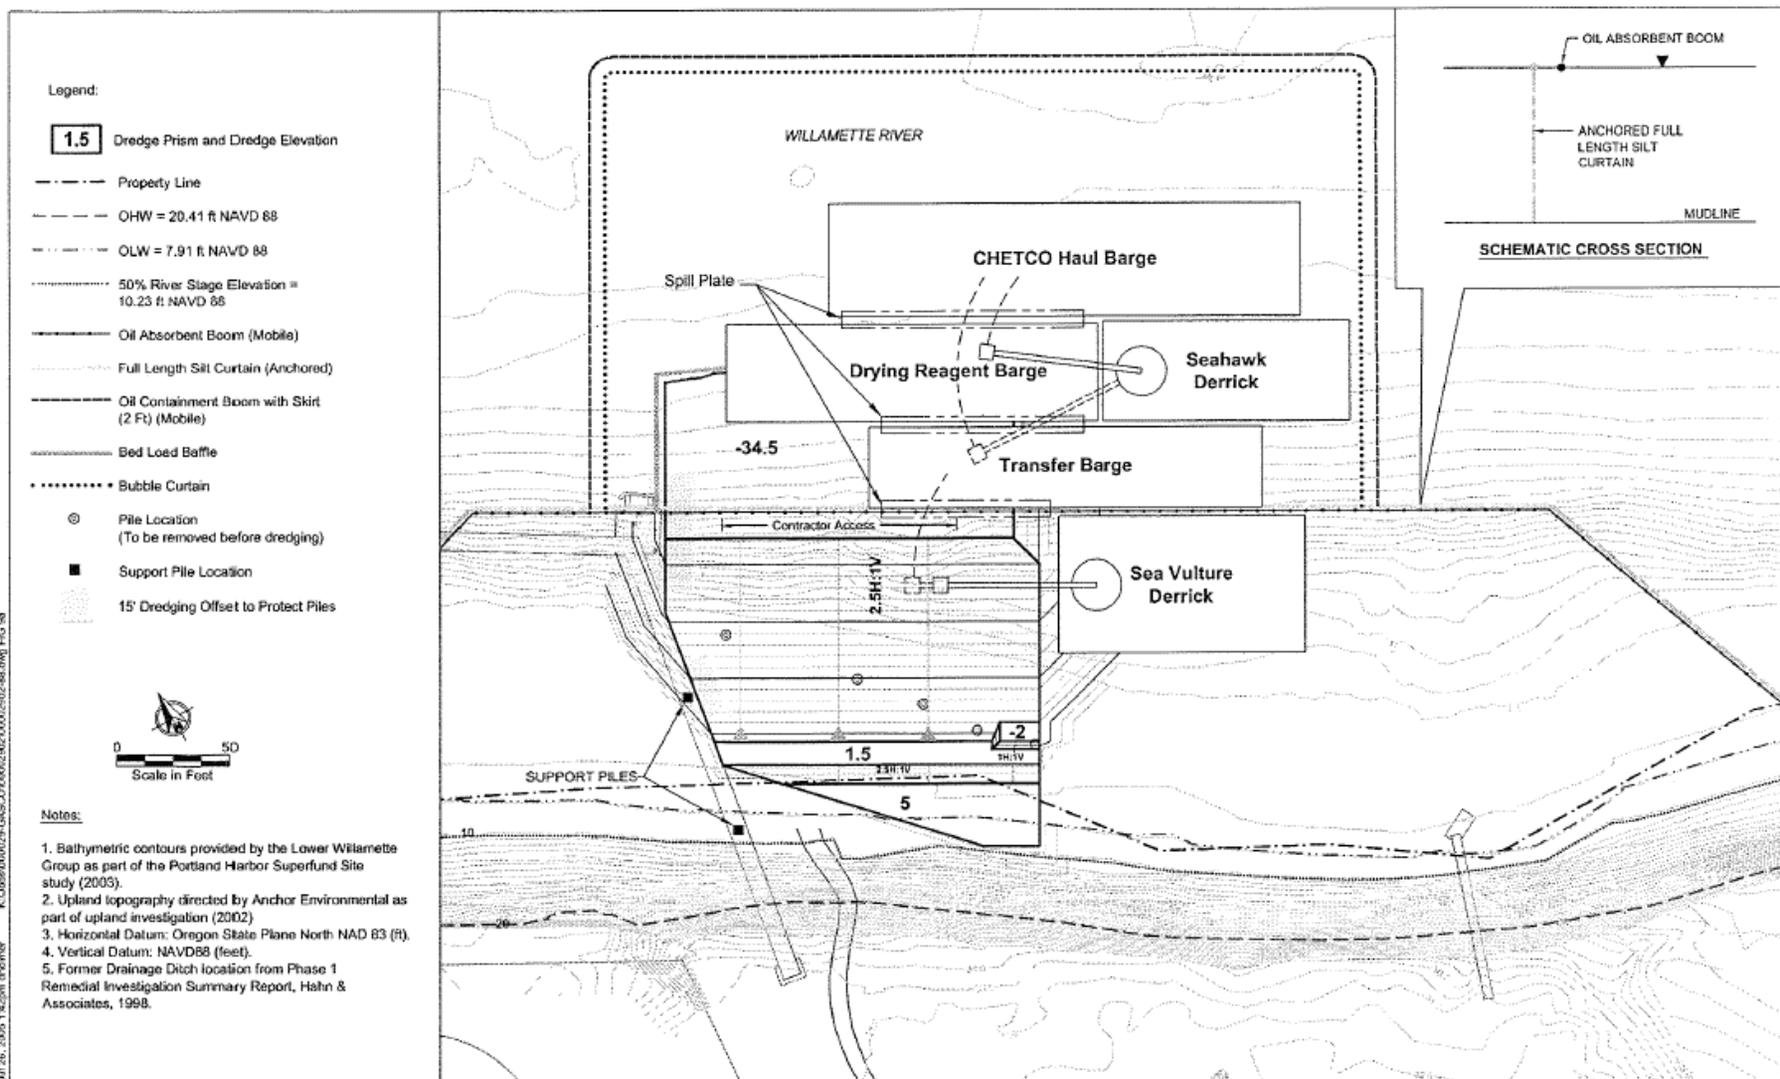
Figure 9a  
Inner Removal Area - Haul Barge Holding Area and Transfer Location  
NW Natural "Gasco" Site

# How was the Removal accomplished? Inner Containment Area

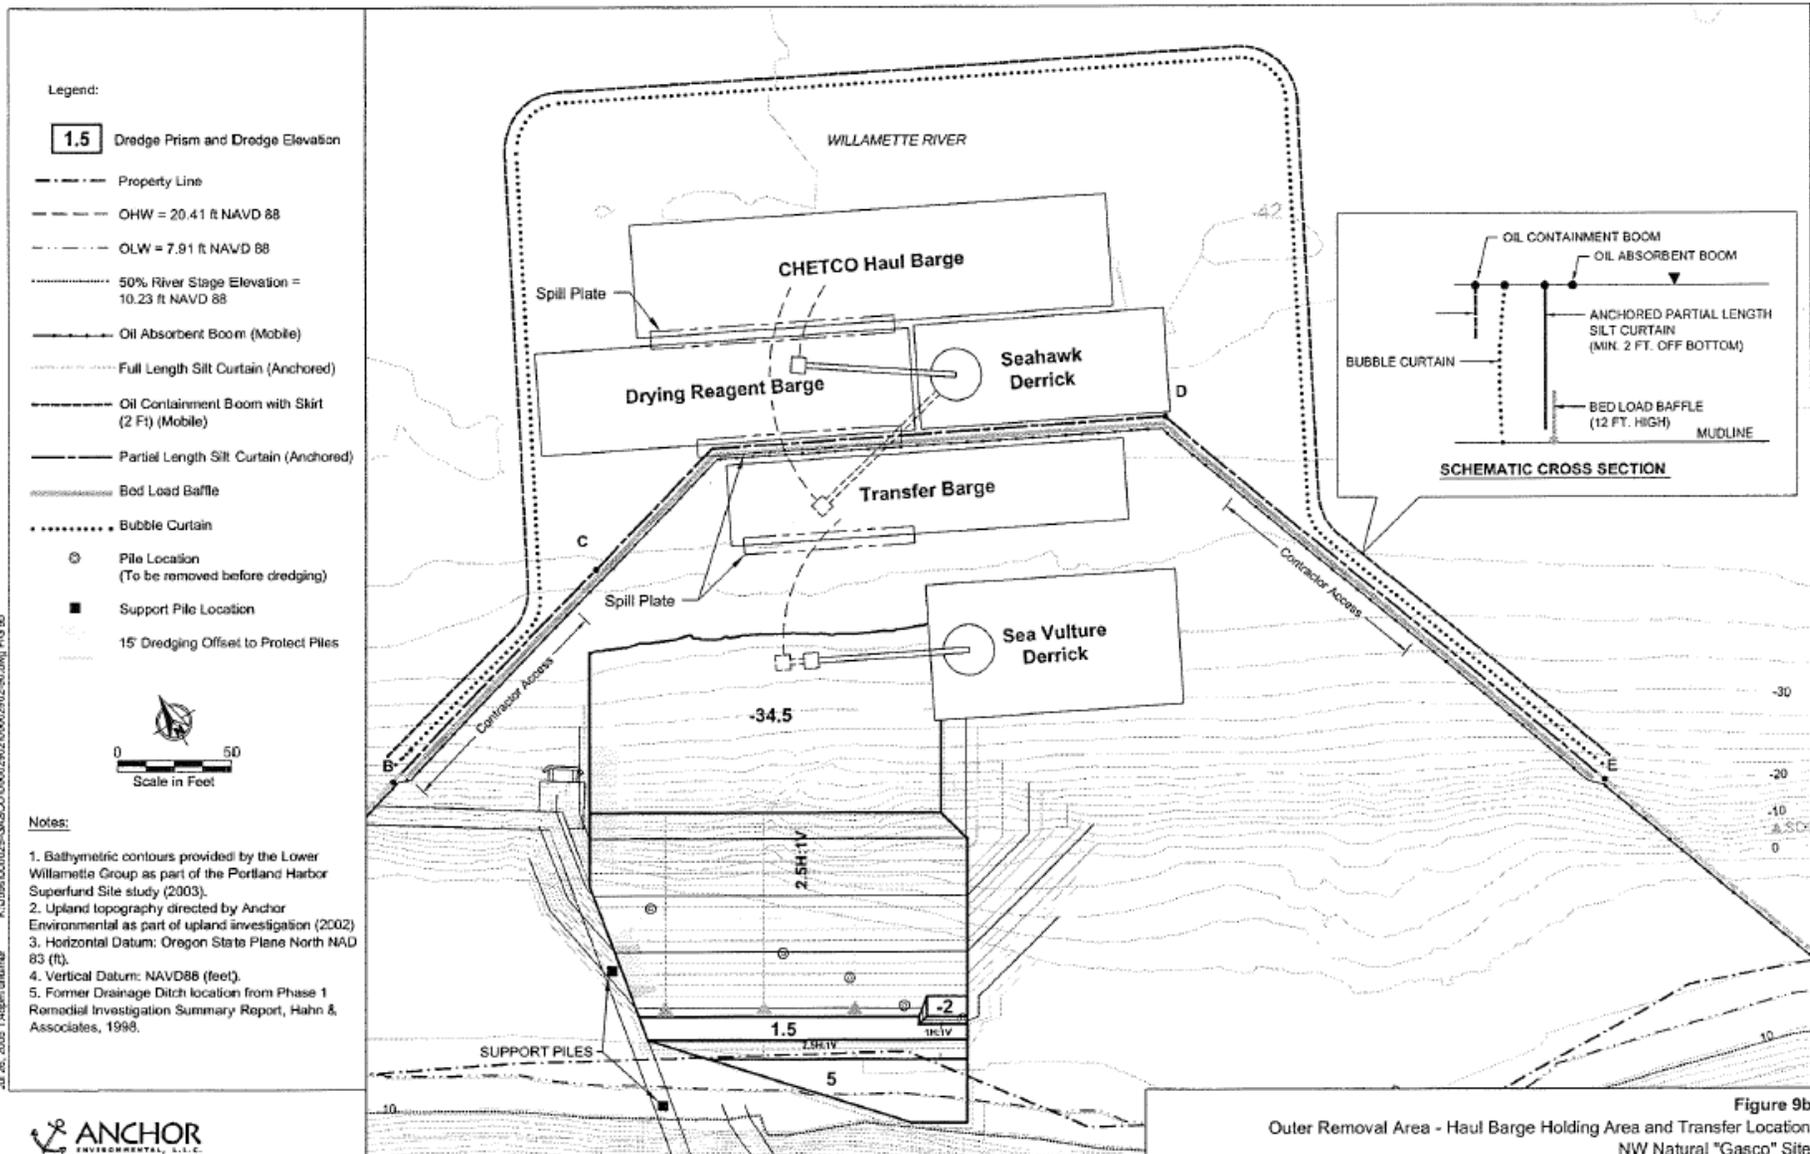
3/4/2005 1:45pm d:\user\KJ\Jobs\000005-04\SCD\000020202\00002003.dwg FIG 9b

# How was the Removal accomplished? Outer Containment Area

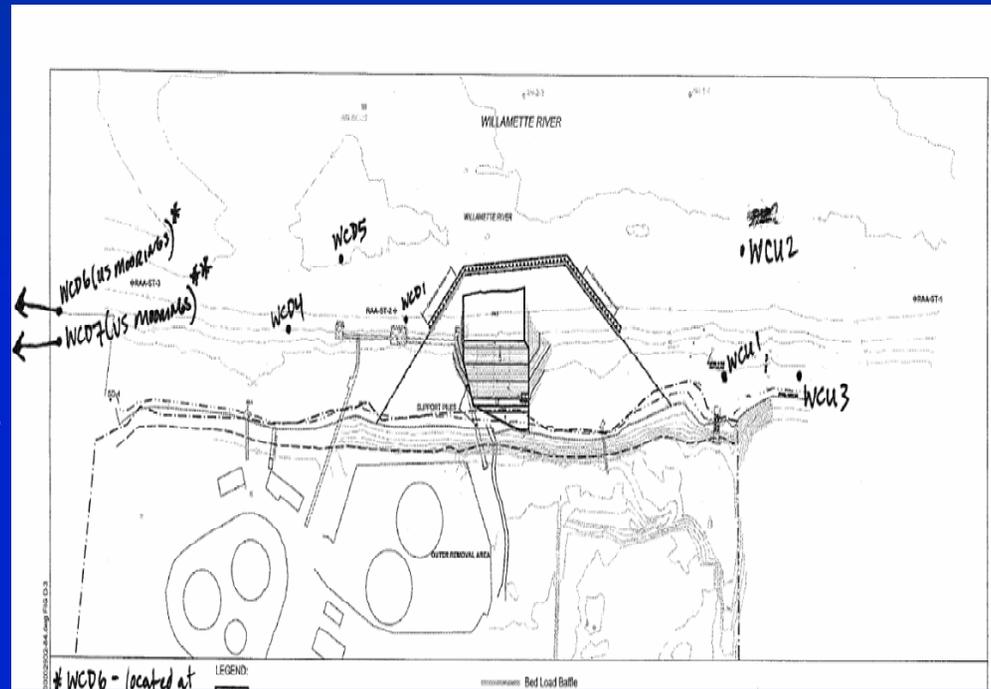
Water quality criteria adjacent to the dredging operation may not be the best judge of acceptable short term impact, especially when the site exceeds chronic standards every day ABSENT any action.

DRET testing/subsequent modeling did not accurately predict water column impacts.

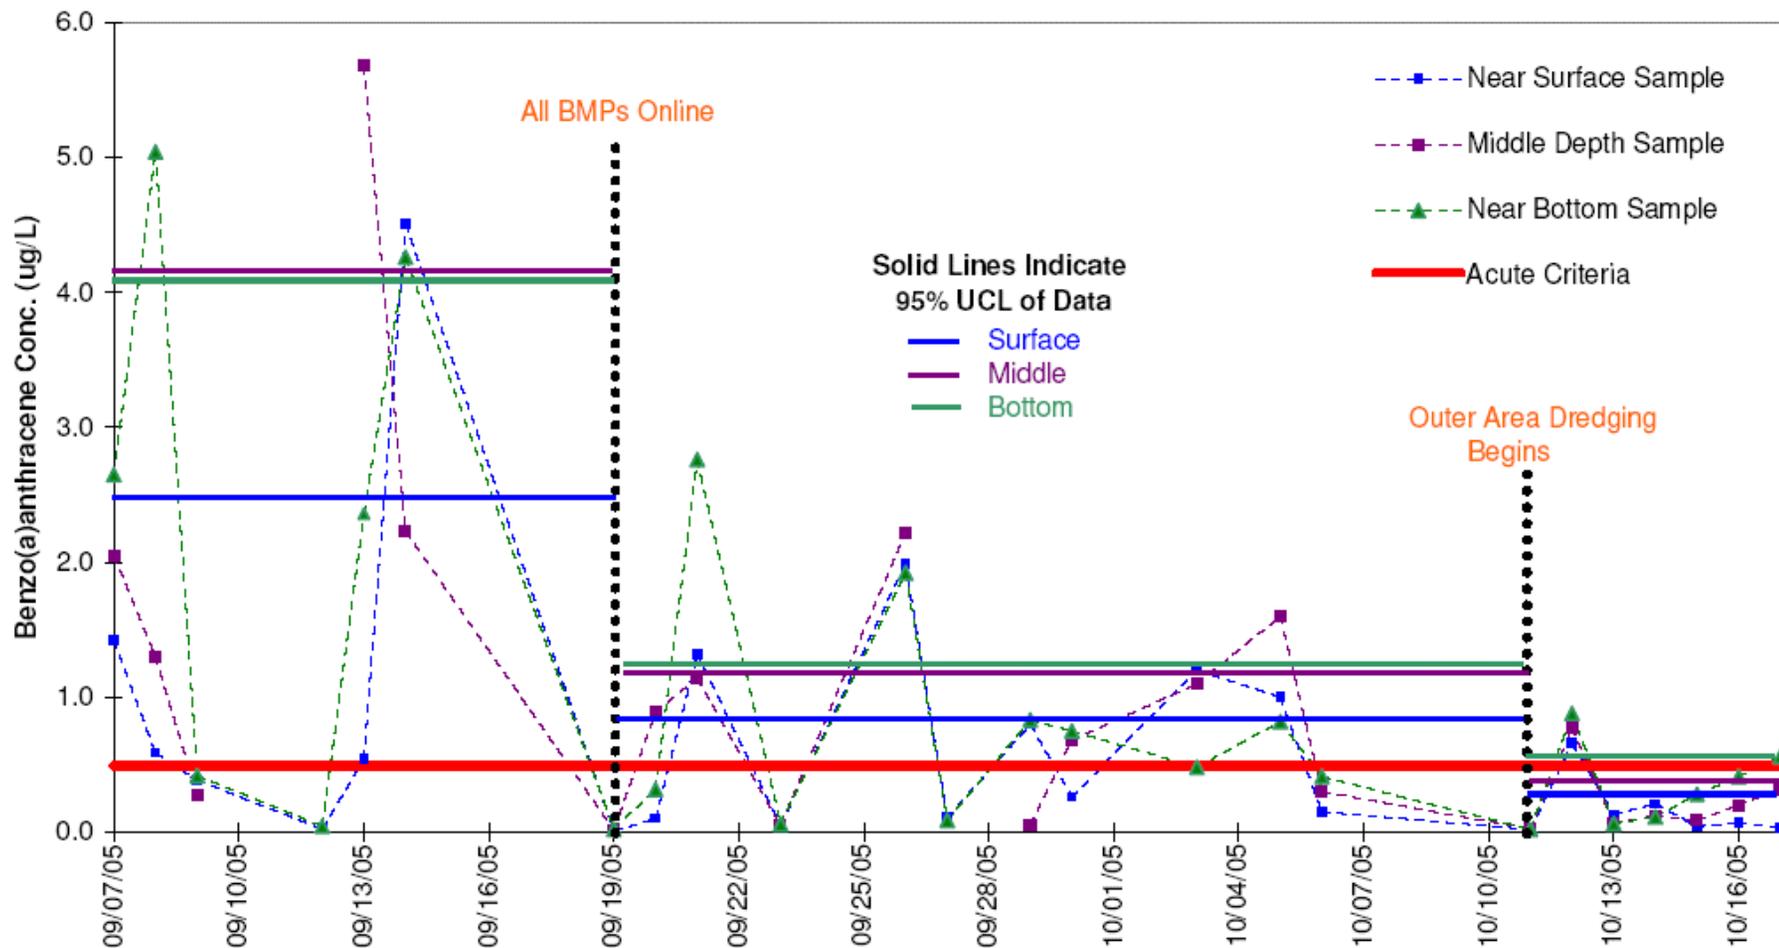
GASCO Removal Action  
 Benzo(a)anthracene Concentration  
 Approximately 150 feet Downstream of Containment

**BMPs=Best Management Practices. These included slowing dredge bucket movement and treating barge dewatering water. All contingency BMPs were used due to WQ exceedances.**

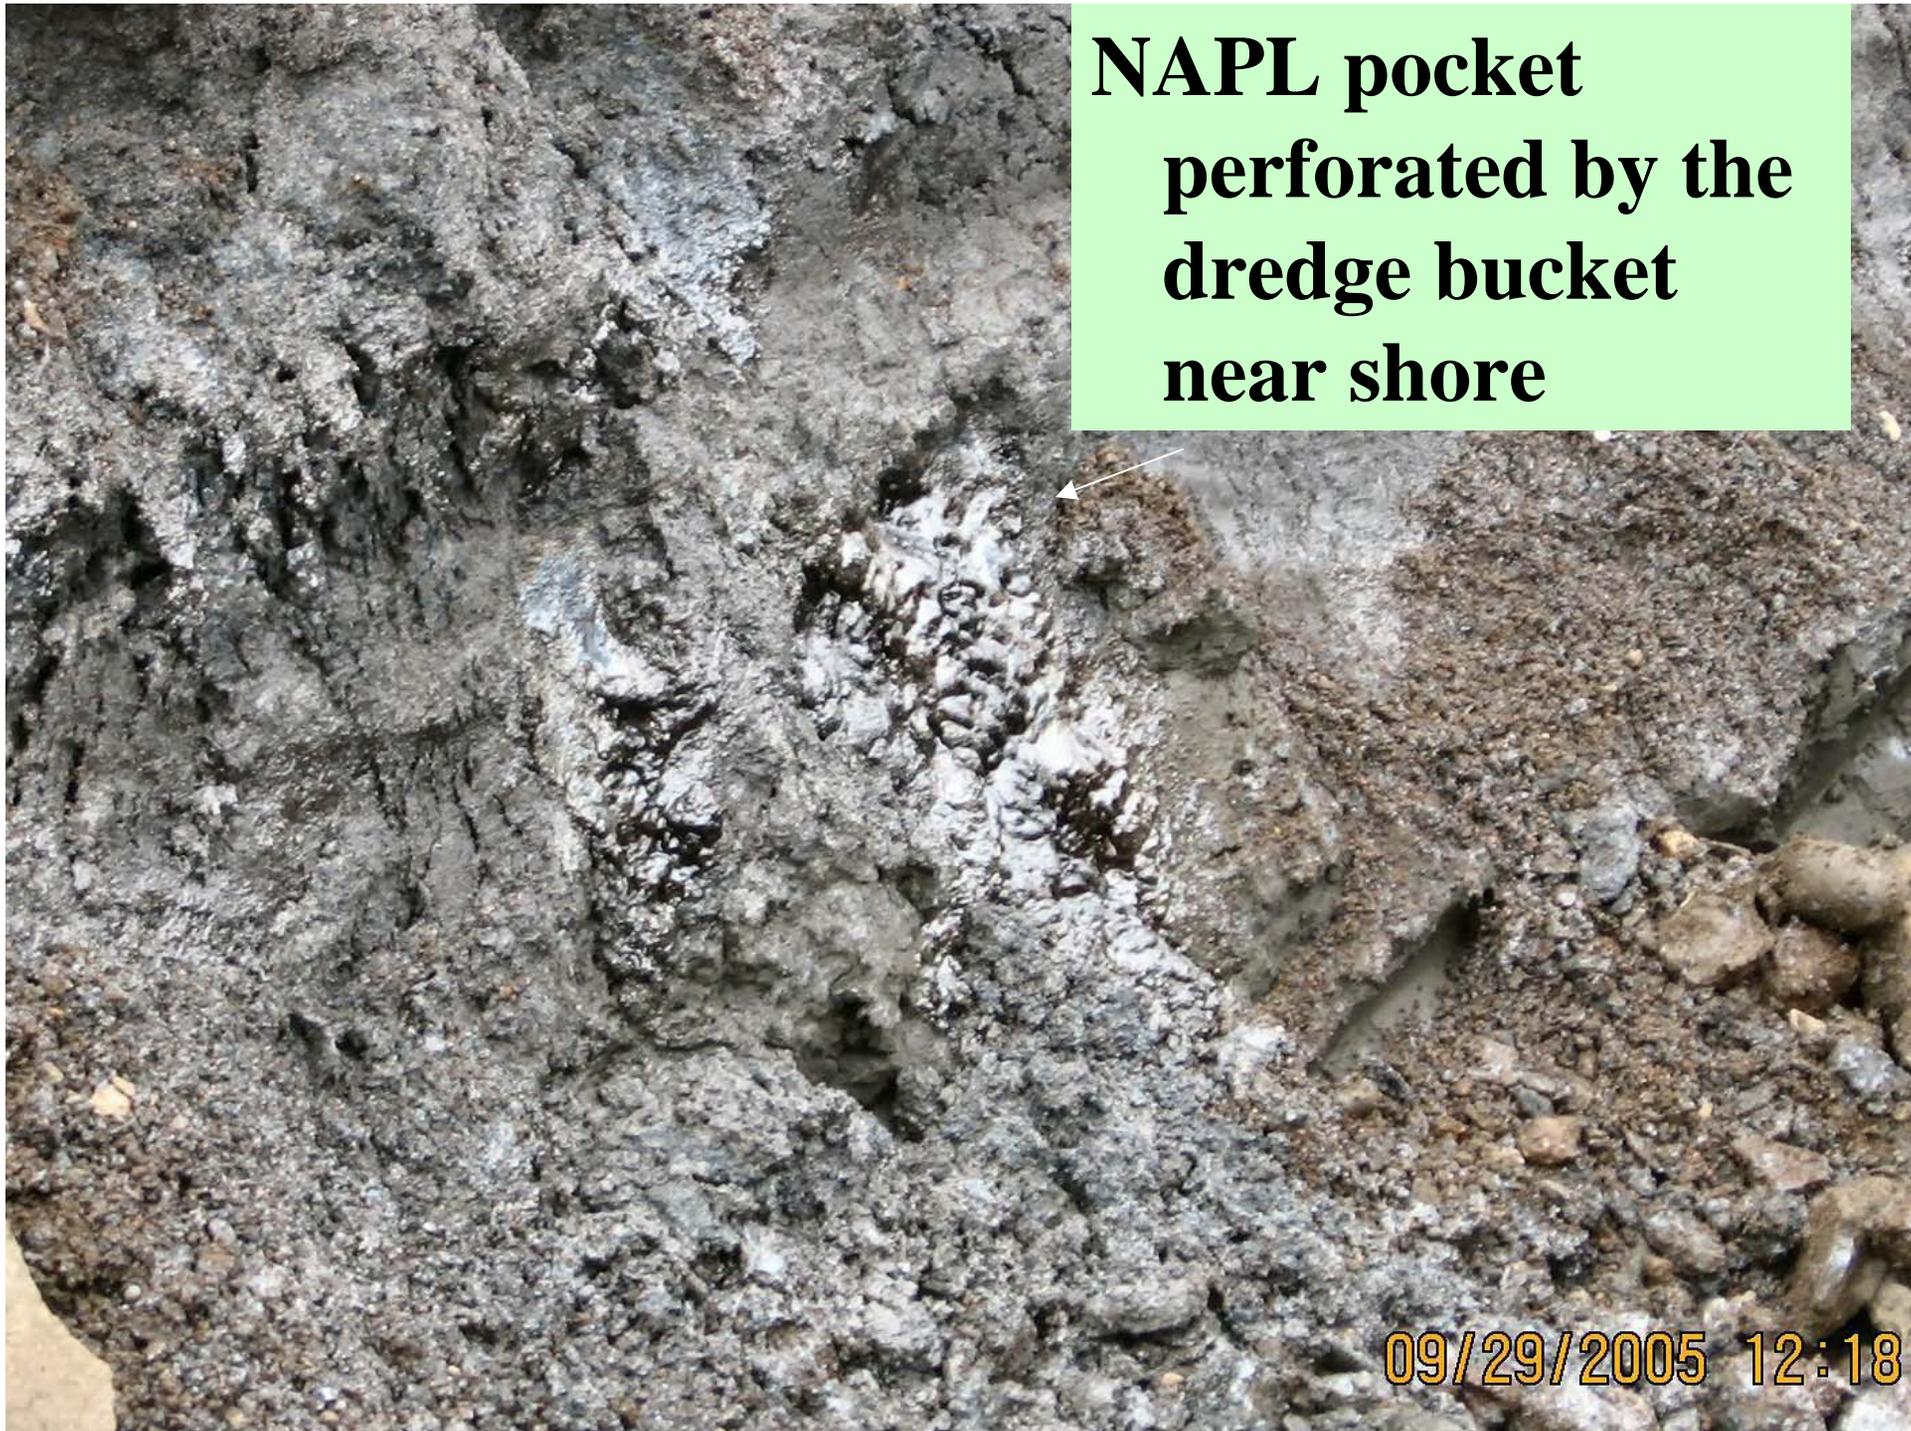
09/29/2005 12:18

**NAPL pocket  
perforated by the  
dredge bucket  
near shore**

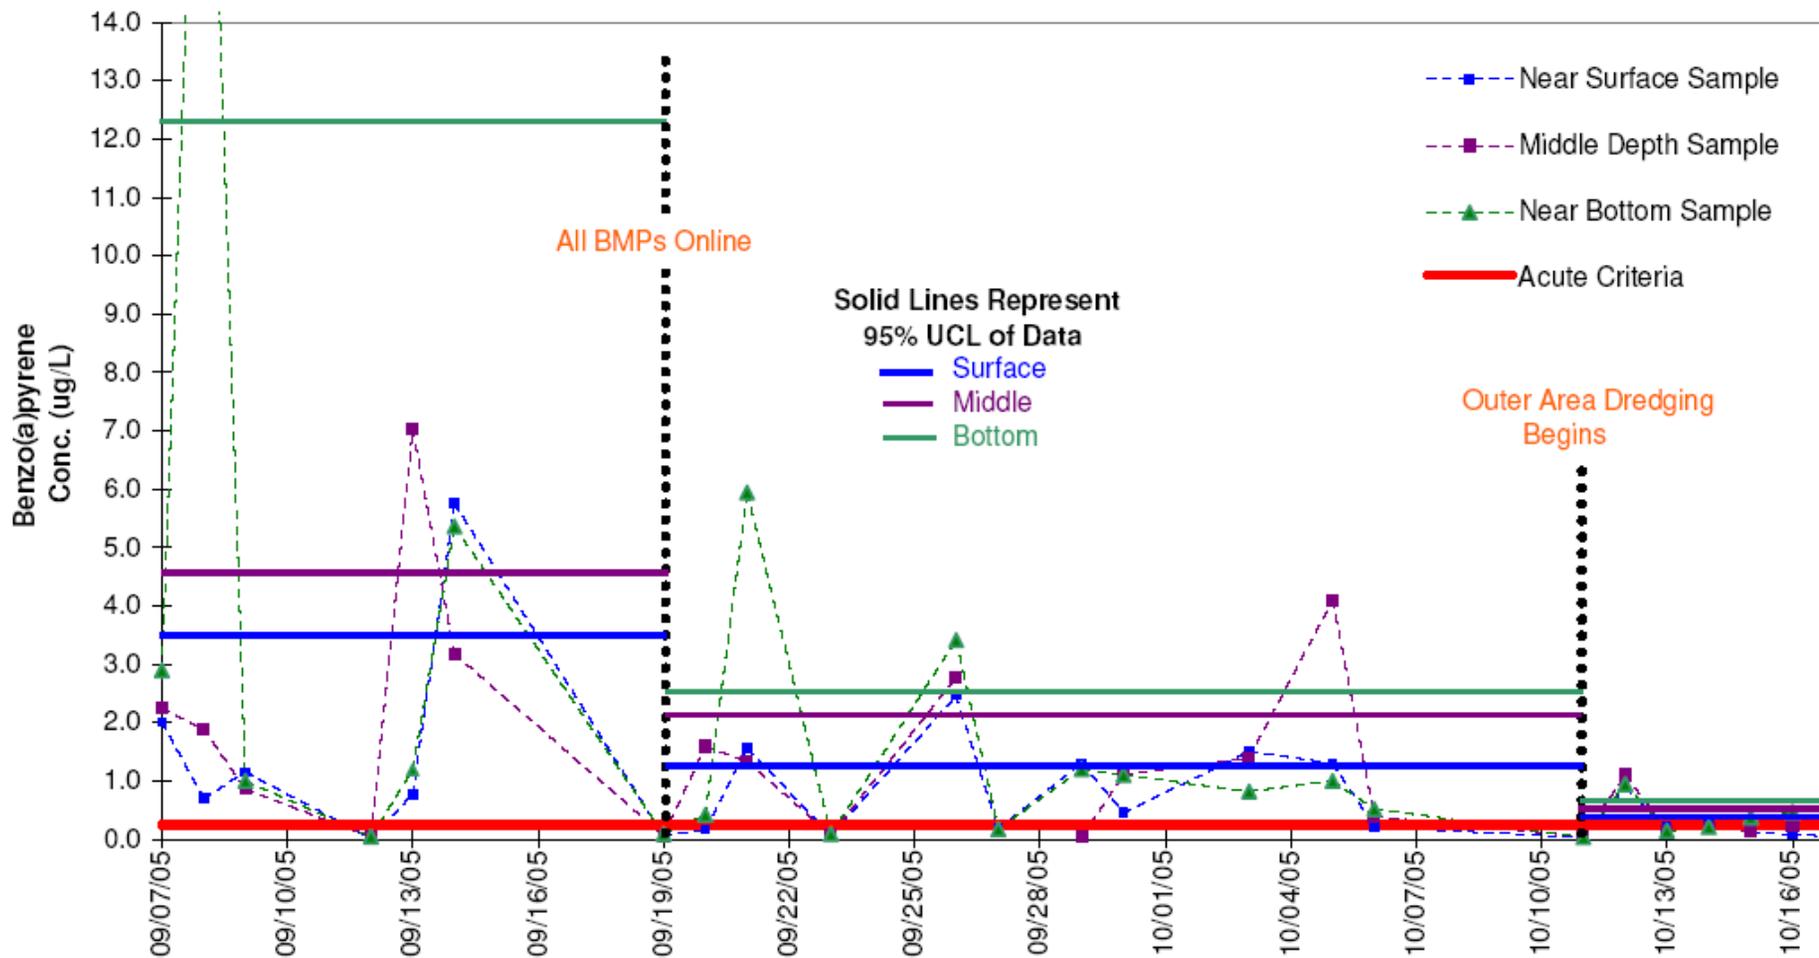
GASCO Removal Action  
 Benzo(a)pyrene Concentration  
 Approximately 150 feet Downstream of Containment

Note that levels dropped substantially with BMP introduction and changing from the inner to the outer containment systems.

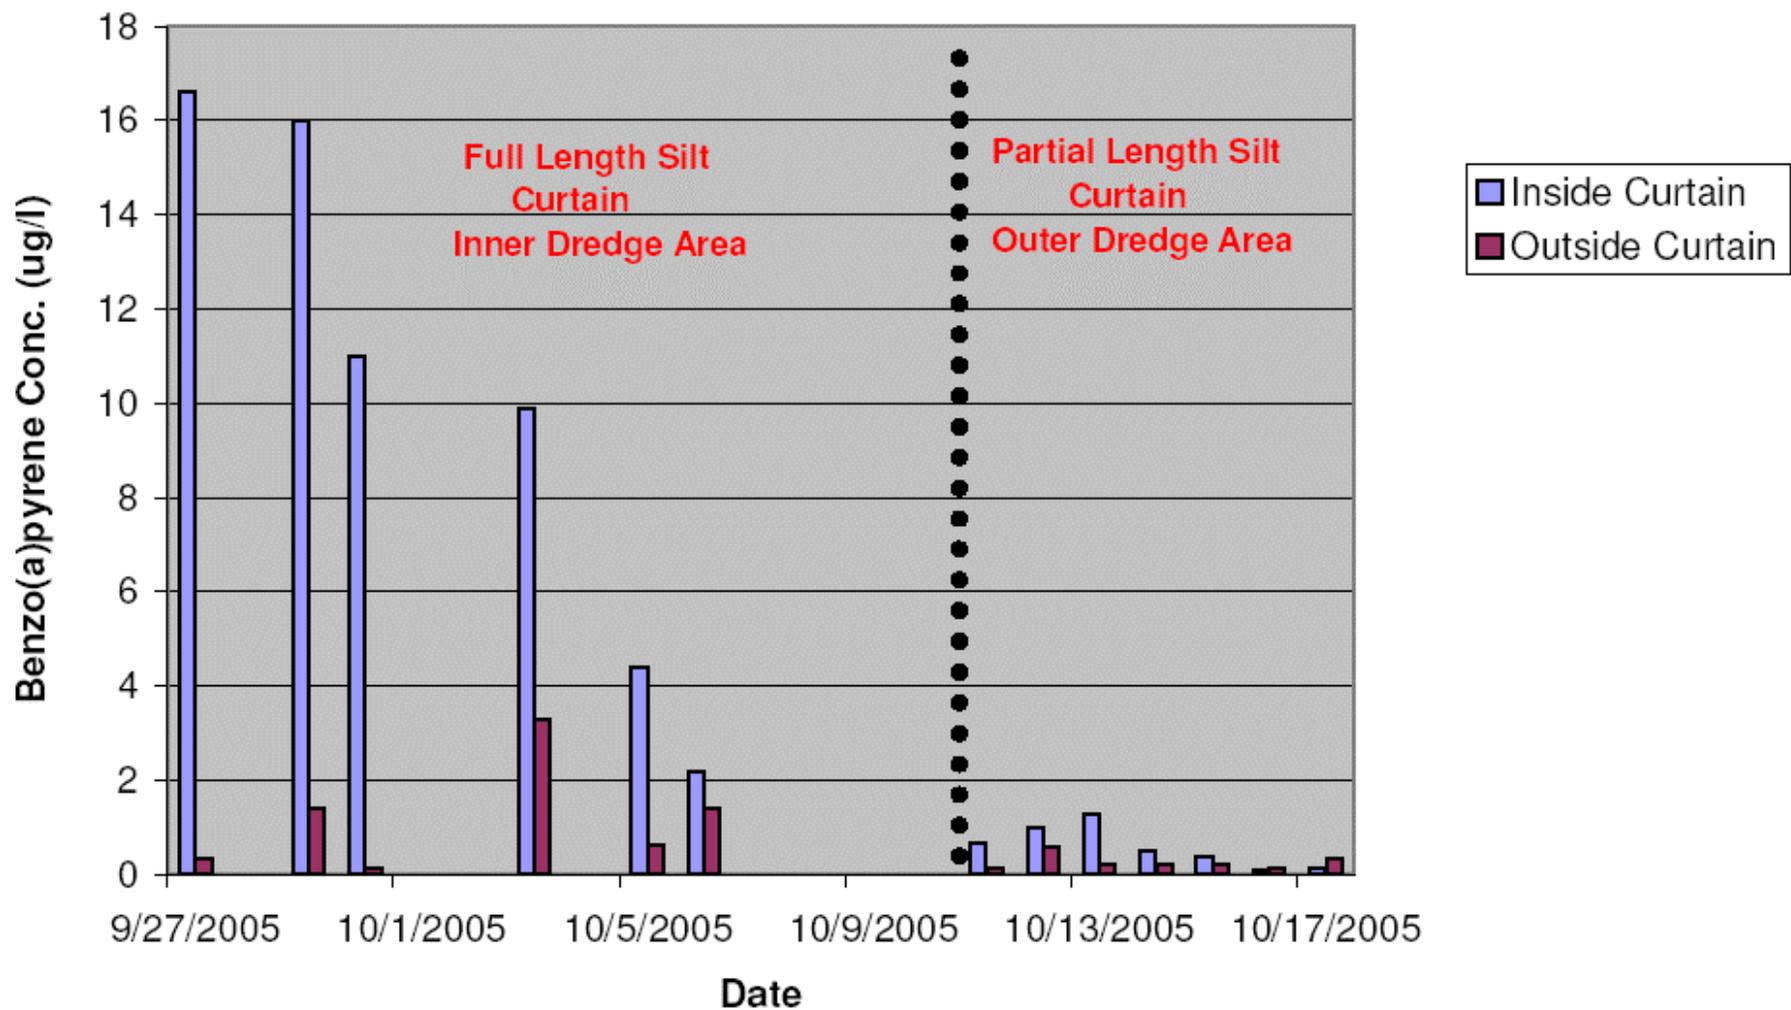
### Benzo(a)pyrene Distribution Near Silt Curtain

Silt curtain containment did show far lower concentrations inside versus outside.

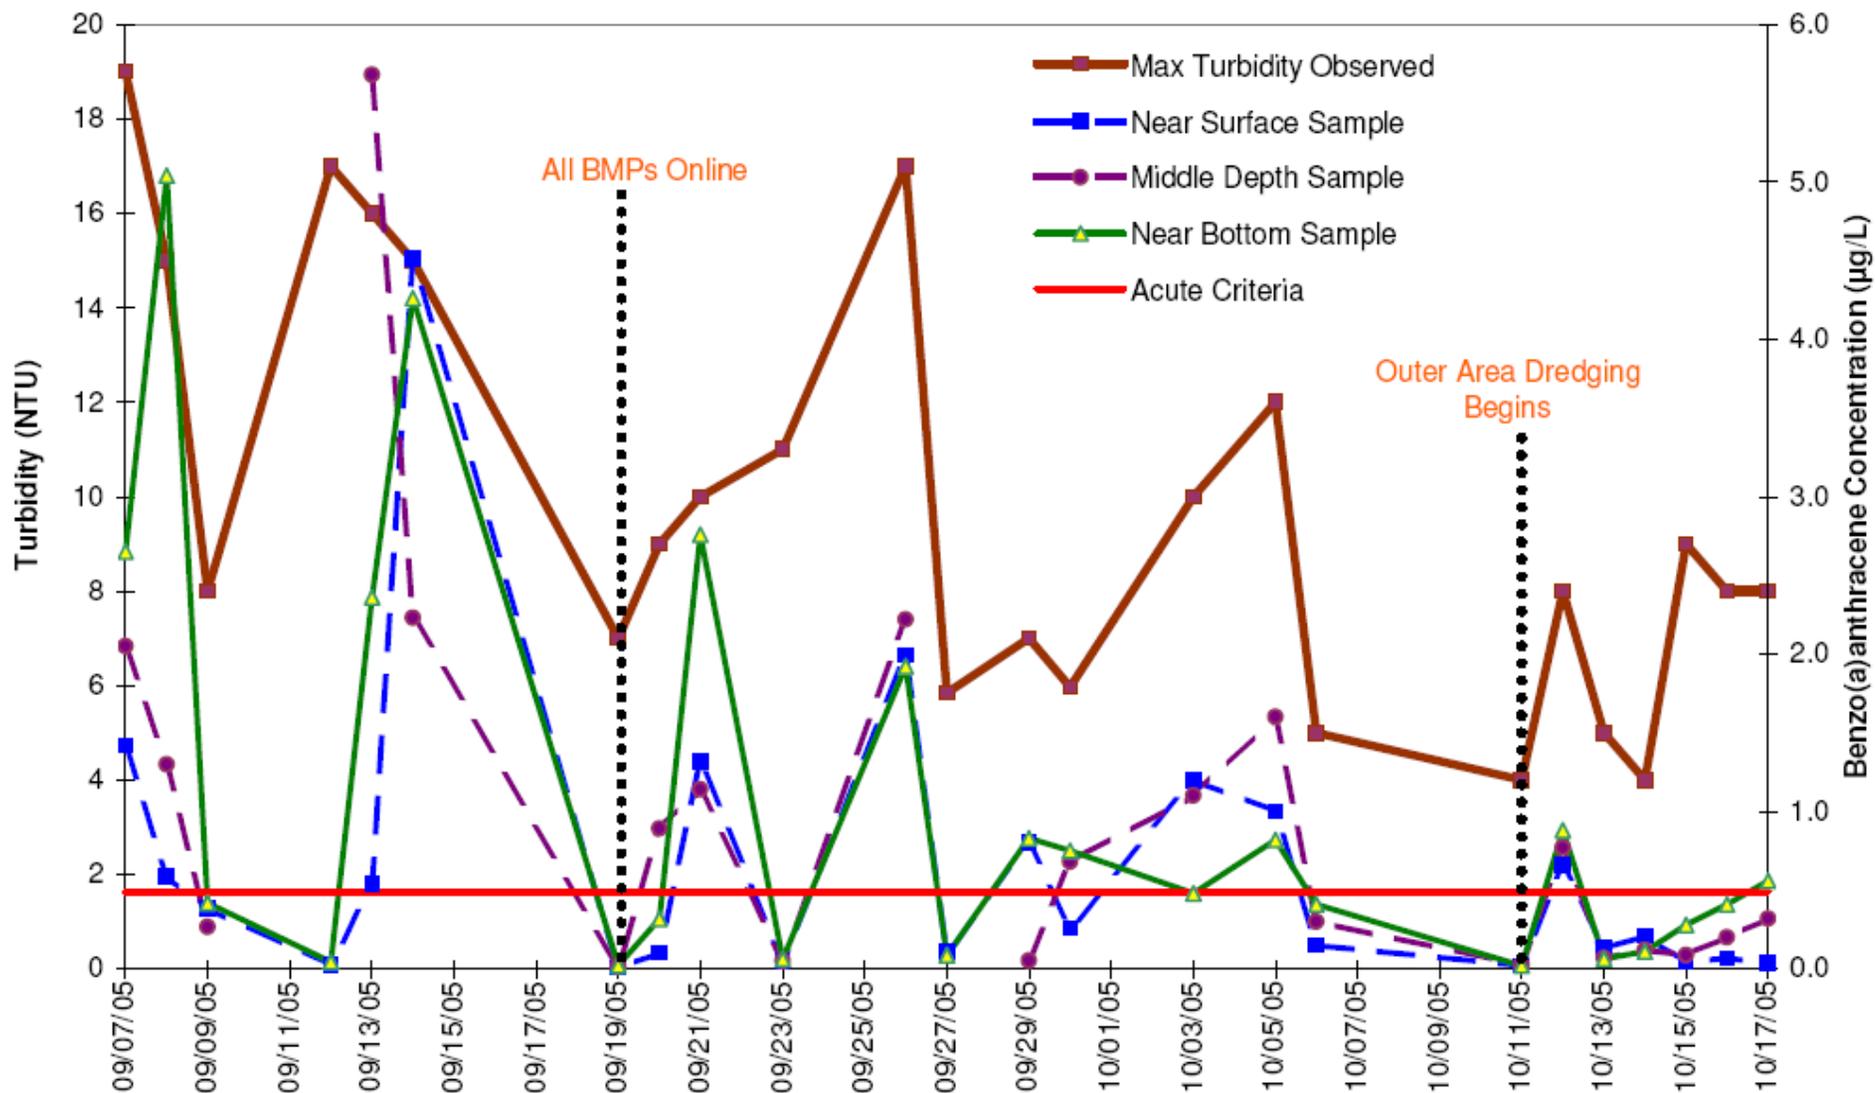
GASCO Removal Action  
 Daily Maximum Turbidity and Benzo(a)anthracene Concentration  
 Approximately 150 feet Downstream of Containment

Turbidity tracked with dissolved contaminants, but not to the degree that it could be used as a stand alone surrogate predictive of overall WQ, contrary to the popular wisdom of most CWA 401 certifications.
