RE: RCRA 3008 (h) Administrative Order EPA ID: OHD 000 804 682
BASF Corporation Facility, 1000 Harvard Avenue, Cleveland Ohio
Description of Current Conditions Report

Draft Description of Current Conditions

Prepared for:
BASF
Florham Park, NJ

Prepared by:
AECOM
Pittsburgh, PA
6-154775-130
June 17, 2010

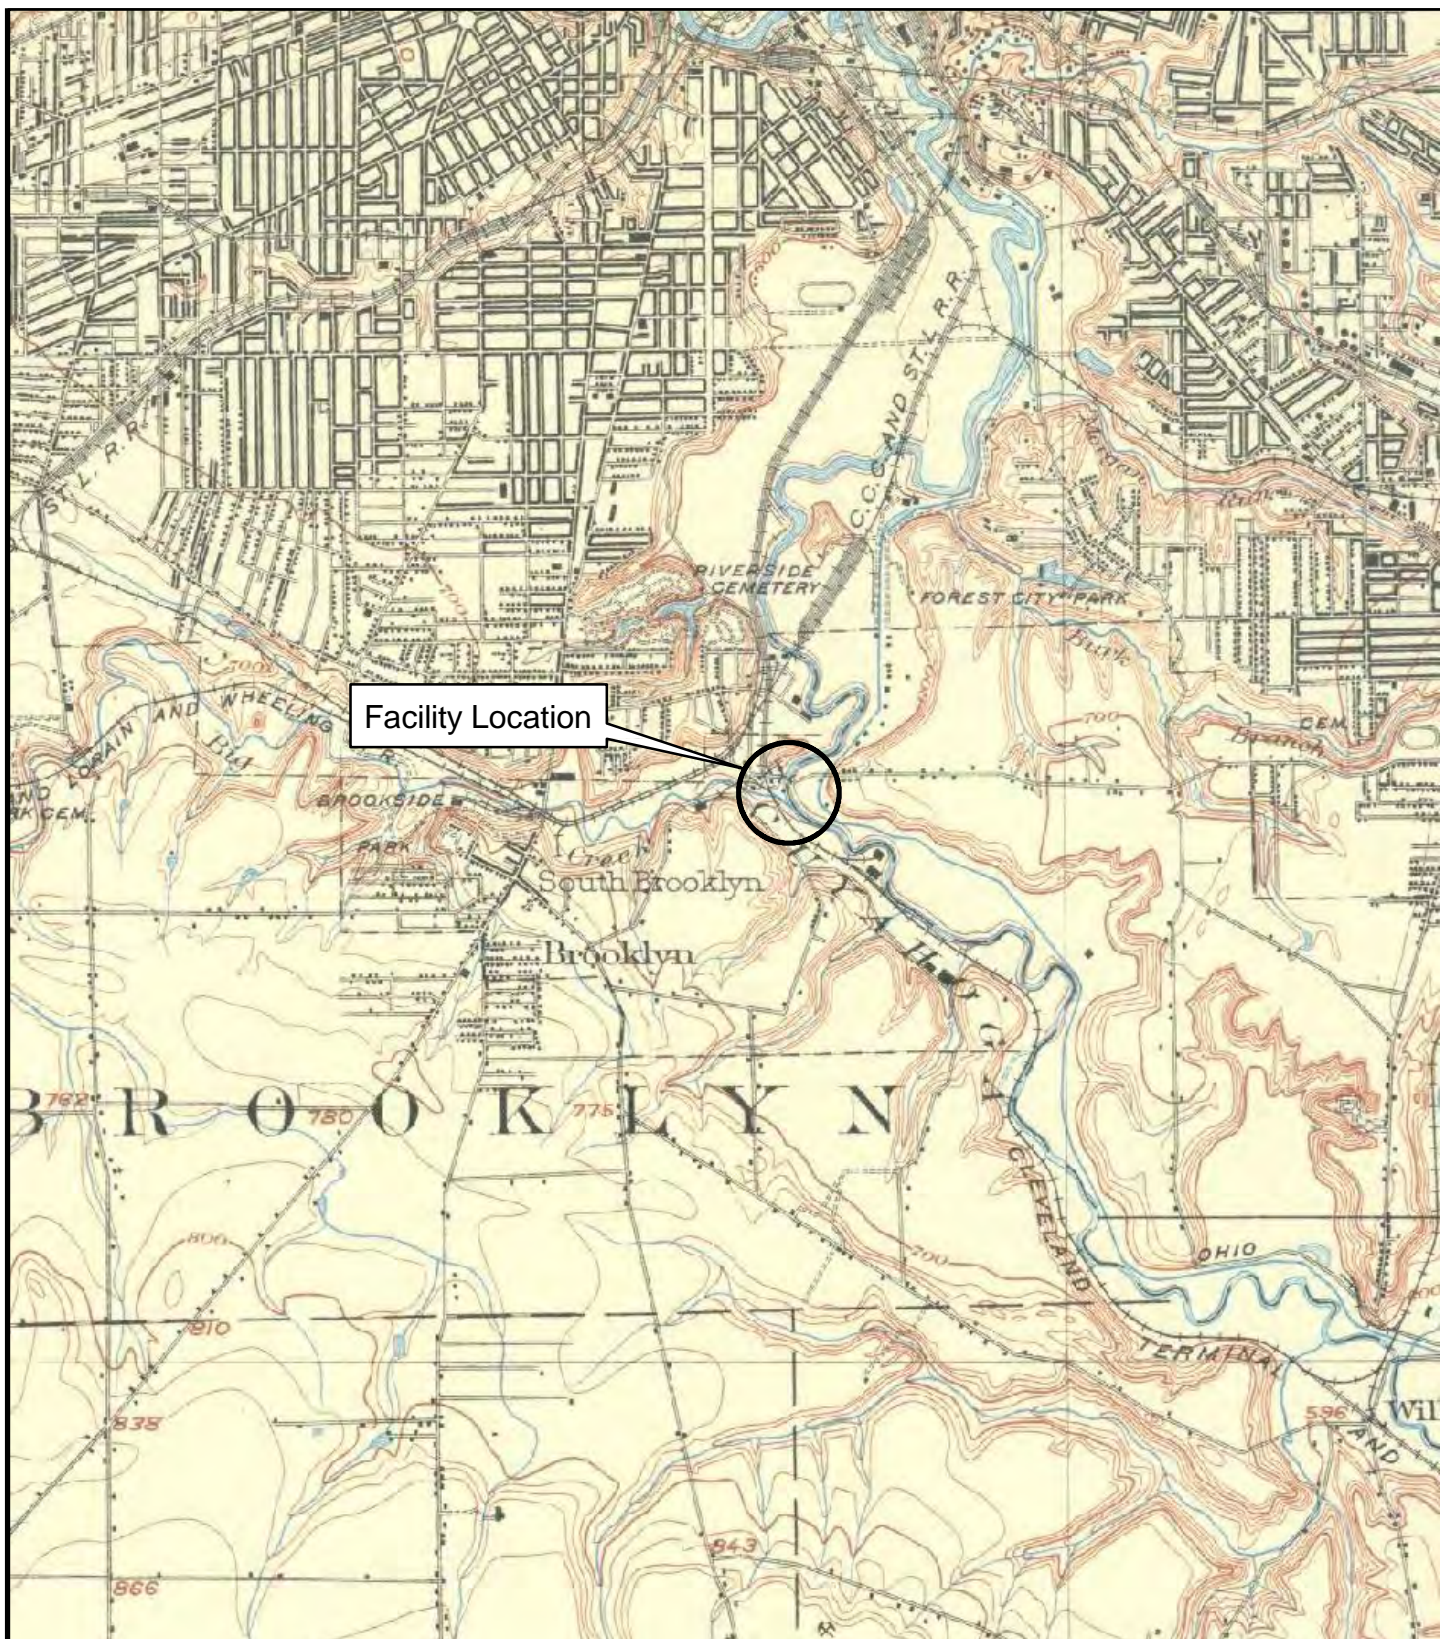
Source: SAIC Remedial Investigation Report, 2006, Figure 2-6

Monitoring well DM-14 is located in the northeastern portion of SWMU 26. Wells RMW-35 and RMW-39 are located east of SWMU 26 at distances of 40 feet and 70 feet, respectively, on the opposite side of the beltline sewer (sanitary sewer) (Figure 2-6). Recovery wells #2 and #3 are situated 50 feet northeast and 25 feet southeast of the SWMU. Dames & Moore collected soil samples during the installation of DM-14 and groundwater samples following well installation and development, and analyzed the samples for selected metals, pH, chloride and sulfate. A summary of the initial soil and groundwater analyses are provided in Tables 3-4 and 3-1, respectively. Concentrations of nickel in soil at this well location decreased with depth, and ranged from 30,000 mg/kg at 1 to 3 feet bgs to 30 mg/kg at 15 to 17 feet bgs. Soil concentrations of sulfate remained elevated with depth, with concentrations decreasing from 92,000 mg/kg at 11 to 13 feet bgs to 1,300 mg/kg at 17 to 19 feet bgs. Concentrations of dissolved nickel, chloride and sulfate in groundwater collected from DM-14 on April 8, 1987 were 2,600 mg/L, 120 mg/L, and 9,800 mg/L, respectively (Table 3-1). Historic analytical results for nickel in groundwater collected from DM-14, RMW-35, and recovery wells #2 and #3 are summarized in Table 3-2. Dissolved nickel concentrations in groundwater collected from DM-14 reflect a gradual decrease in concentration between October 1985 (5,800 mg/L) and April 1998 (220 mg/L). Dissolved nickel concentrations in groundwater collected from RMW-35 and RMW-39 on April 29, 1998 and August 7, 1998 ranged from 2.5 mg/L to 3.6 mg/L.
