## Koppers Open House - July 16, 2013 and Protective Clean-up Overview

### Former Koppers Wood Treating Site

Carbondale, Illinois

July 2013

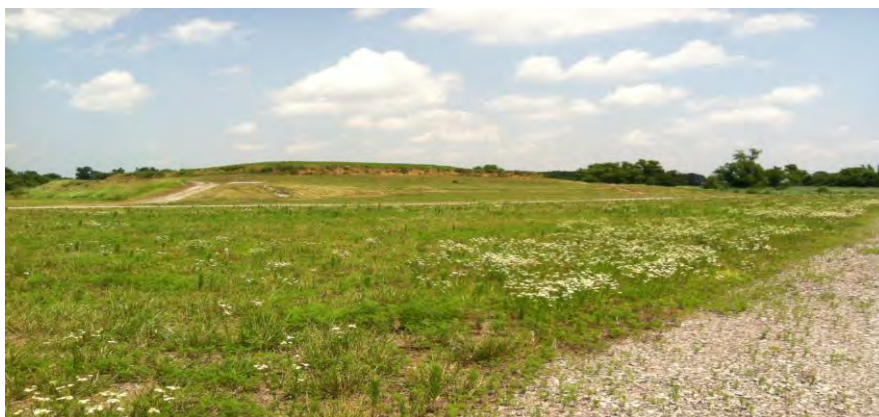
*The three-acre CAMU in the background, looking north from the western soil cover. The CAMU contains contaminated materials dug up at the site and has a leak monitoring and collection system.*

**CAMU:** An engineered containment unit called a Corrective Action Management Unit ("CAMU") was constructed on top of an area of already contaminated soil. The CAMU holds 30,000 cubic yards of materials from around the site. The CAMU design includes a double liner and liquid collection system that is routinely monitored and maintained to prevent buildup of liquids. It also includes a soil cover system to reduce rainwater infiltration and to prevent people and wildlife from coming into contact with materials in the CAMU. Regular inspections ensure that the cover system remains in place.

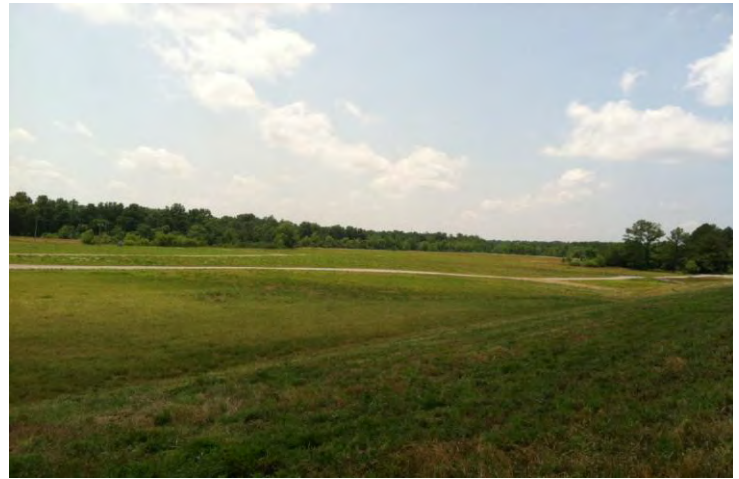
*Western soil cover, looking southwest from the CAMU. The adjacent neighborhood is on the other side of the tree-line.*

**Soils:** Soils stained with creosote were removed and placed in the CAMU. Also, about 37 acres of contaminated soils are contained beneath a low-permeability cover. Some of the cover areas include a high-density polyethylene liner for additional isolation. All of the covers have one foot of soil, and grass or roadway surfaces. Covers do not destroy or remove contaminants. Instead, they isolate them, keep the soil in place, and prevent people and wildlife from coming into contact with contaminants.

A cover is effective as long as it does not erode, develop holes or cracks, and stays in place. Regular inspections will continue to be required at Koppers to make sure that weather, plant roots, wildlife or humans have not damaged the soil cover. Also, groundwater monitoring wells are placed around the cover areas and the site itself. The wells are sampled to ensure that contamination does not spread beyond the site boundaries.
