**U.S. EPA Region 8
RCRA Corrective Action Program**

**RCRA Cleanup Reforms
Success Story**

**Containment / Stabilization of Subsurface Hydrocarbon Contamination
at
Texaco Refinery
Casper, Wyoming**

February 2001

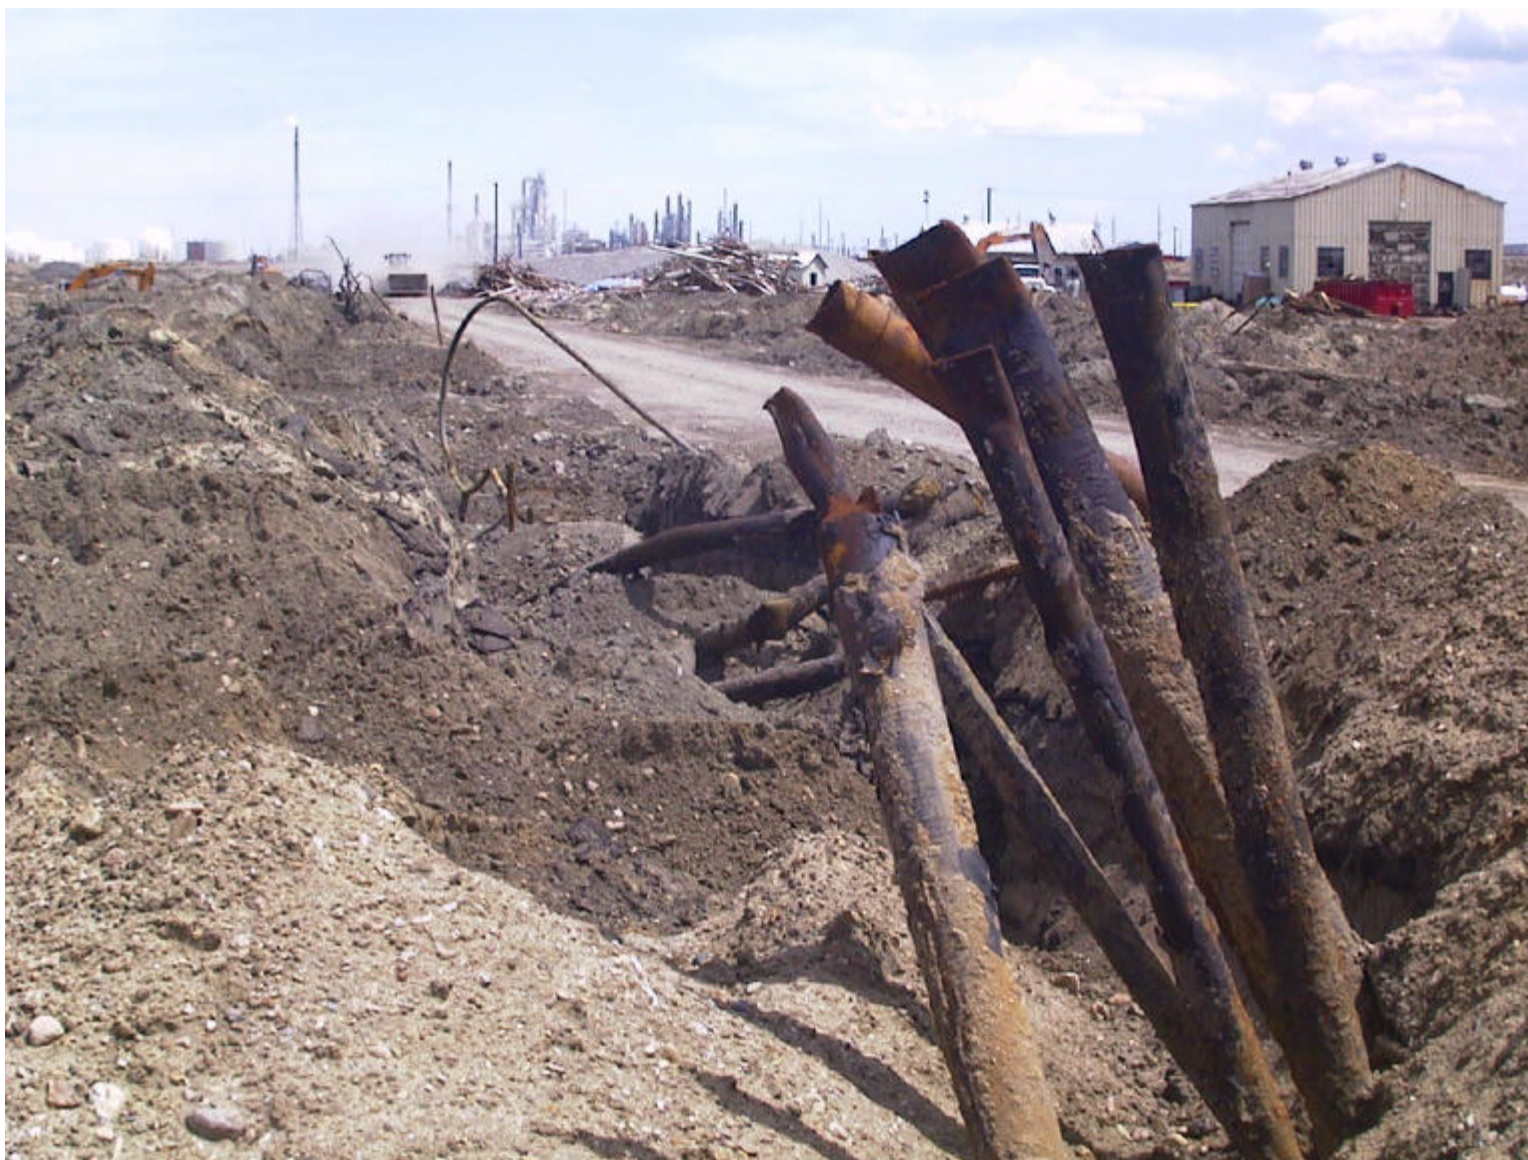
Underground piping removal in progress, Former Texaco Casper Refinery

After the piping and structures in a specified area had been isolated and drained, excavation equipment was used to completely expose all piping and structures to be removed from the subsurface. Depending on the types of piping and structures present, additional equipment including hot and cold cutting tools, track mounted shears, track mounted demolition hammers and conventional excavating equipment were deployed to cut and/or break the piping and structures into pieces of manageable size. Most of the piping larger than three-inch nominal diameter was carefully removed in segments up to 40 feet long, sorted by size and type, and then delivered for reconditioning and resale to used piping suppliers. Other metal material such as small-diameter piping, re-bar and structural steel were segregated and sorted by size and type for recycling. Concrete structures such as slabs, curbing, footings and foundations were broken up, removed, and crushed into gravel for use

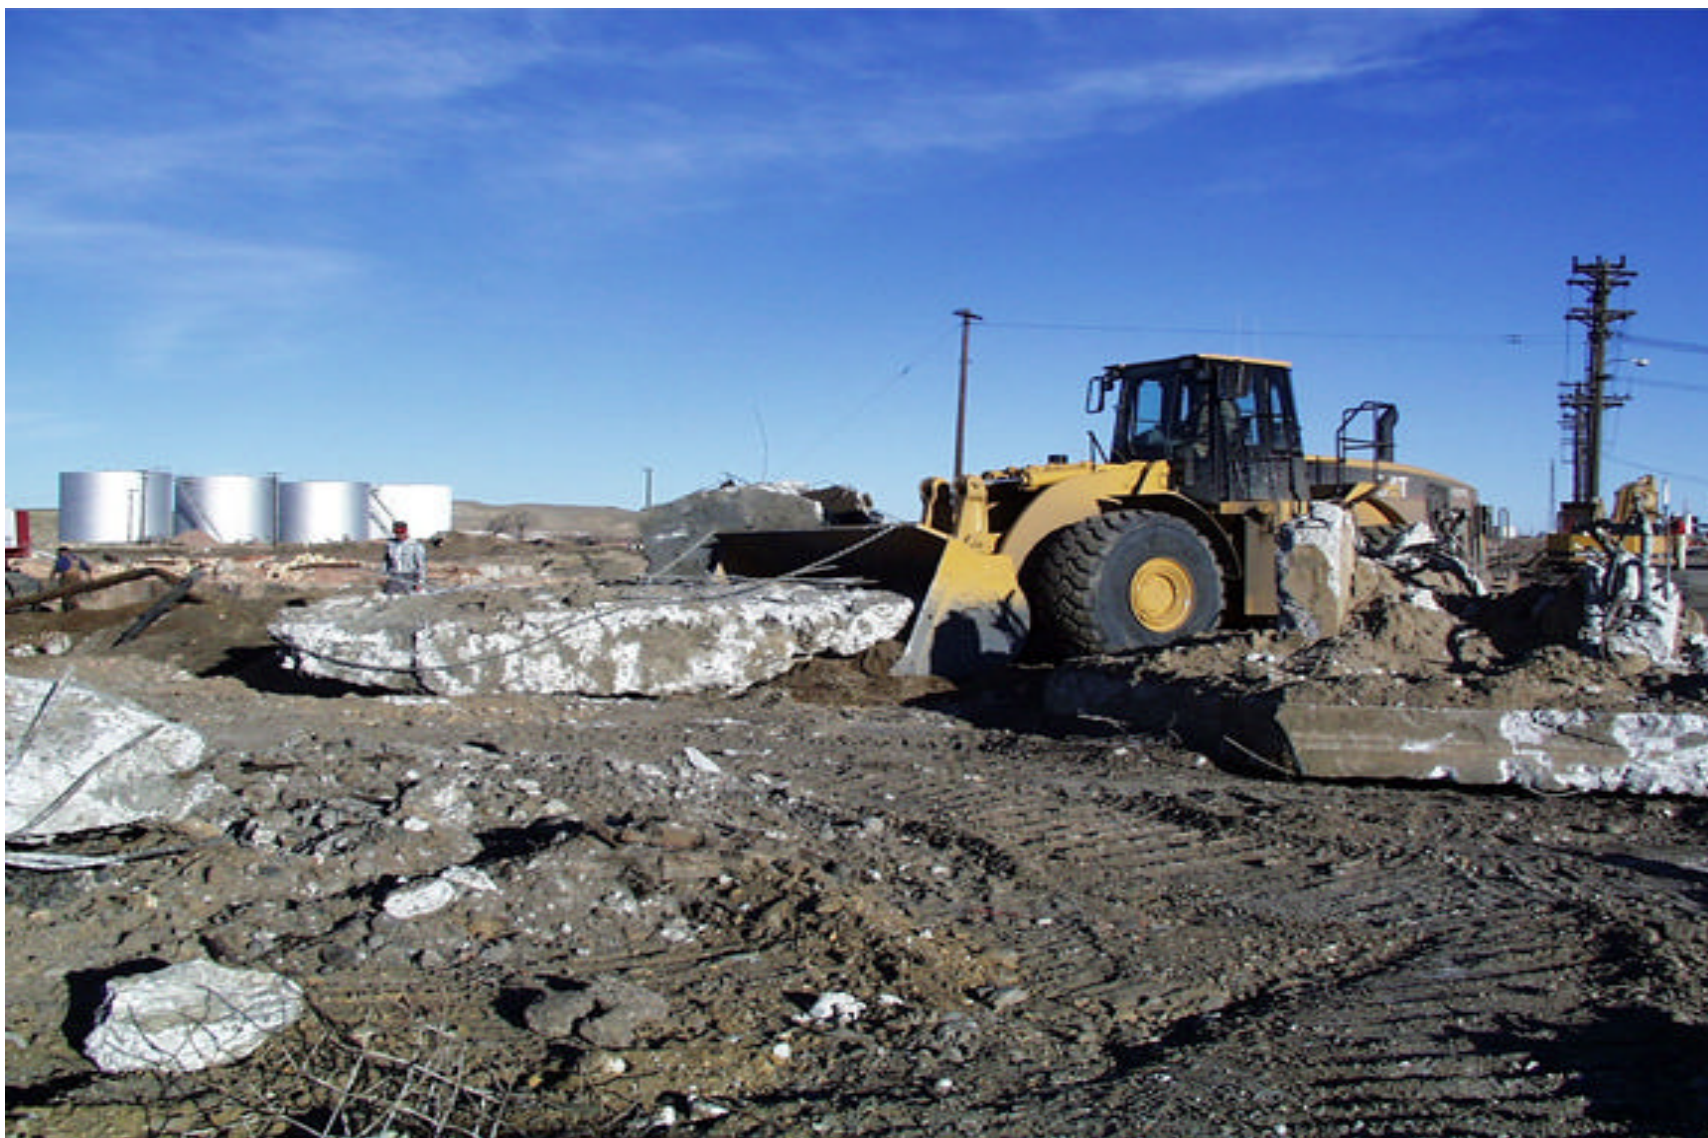
Excavation and removal of subsurface footings and foundations in progress, Former Texaco Casper Refinery

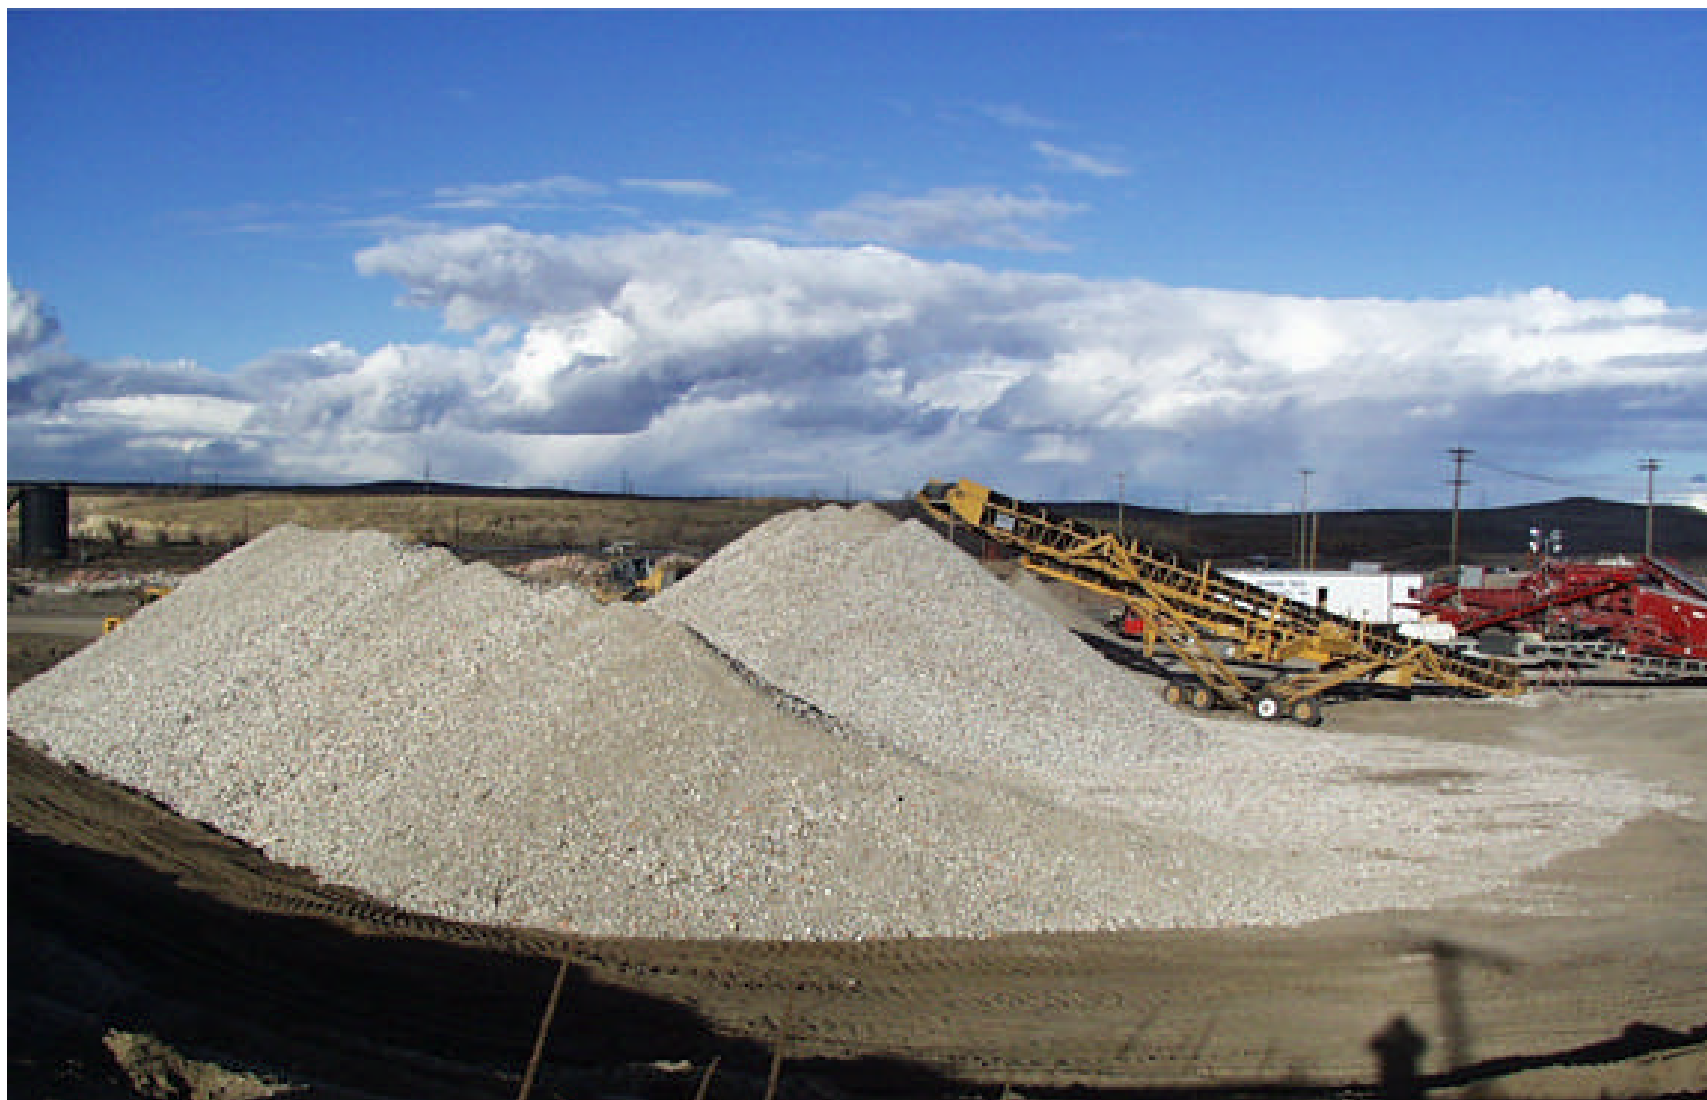
Concrete crushing operation in progress, Former Texaco Casper Refinery

in maintaining on-site roadways, erosion controls and drainage systems. Based on plant drawings, measured weights and other information gathered during this phase of the project, Texaco estimates that more than 210 miles of piping were removed from the subsurface and approximately 100,000 tons of concrete were excavated, crushed and beneficially re-used onsite.

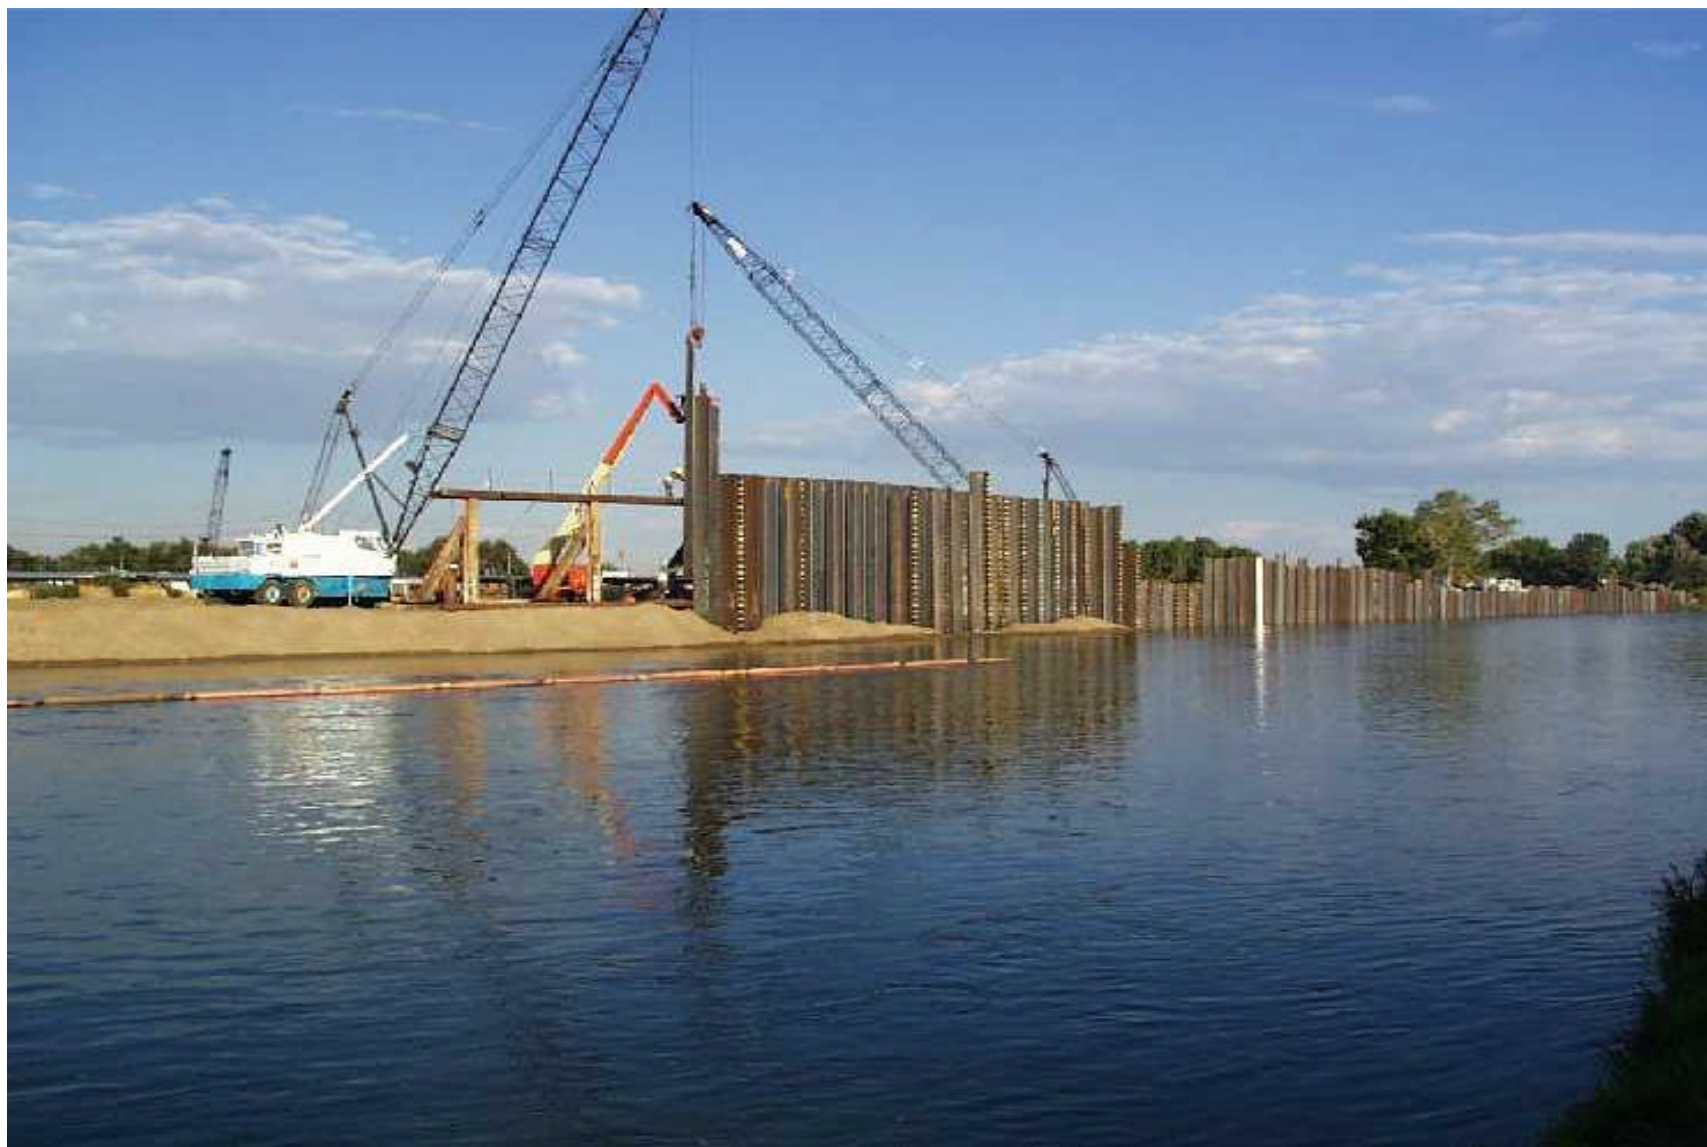
Construction of Sealed-Joint Piling Barrier along south bank of the North Platte River, Former Texaco Casper Refinery

Installation of the sheet piling commenced at the western terminus of the barrier in mid July 1999. Construction of earth-fill work platforms commenced along the south bank of the river at approximately that same time, and had advanced downstream, approximately to the Texaco Bridge, by the time sheet piling crews had reached the south bank of the river in mid August. Sheet pile

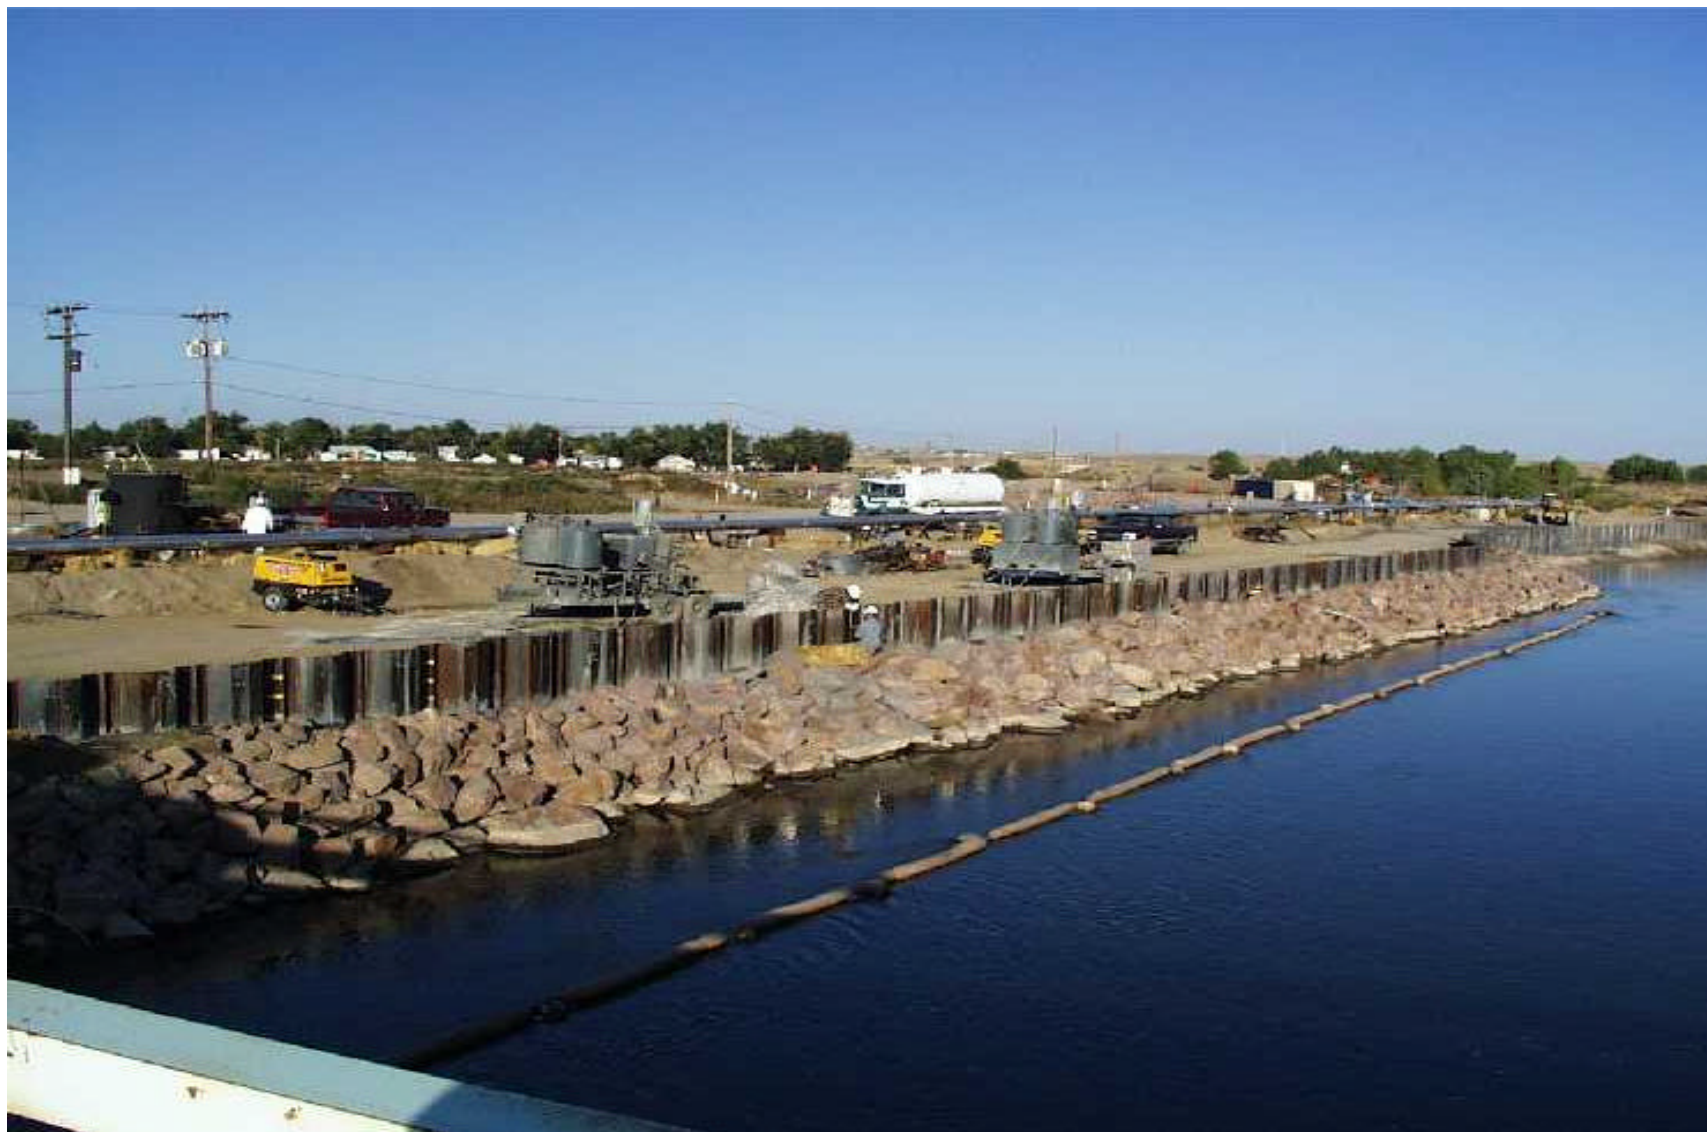
Grouting and sealing operation in progress for sealed joint piling barrier, Former Texaco Casper Refinery

Jetting, quality assurance inspections and sealing operations for the sheet piling joints were staged such they remained at least 400 feet behind all driving operations and other work that could result in minor movement or vibration of the installed sheet piling panels. This staging was necessary in order to ensure that the integrity of sealed joints would not be compromised by other construction activities. In addition to the joint-depth measurements collected during jetting and flushing, Texaco video logged every 50th panel joint in order to provide an added measure of quality assurance to the joint inspection and sealing process. The inspection and sealing operations were completed by late October with a 100 percent success rate in sealing every joint to total depth. Based on bedrock profile data and driving logs for the sheet piling panels, the barrier is keyed from one to four feet into the shale bedrock underlying the alluvial aquifer.
