RE: Plan for Addressing Recommendations in the Site Assessment Report
Electric Energy, Inc., Joppa Power Station.

**GLOBAL STABILITY EVALUATION
EAST ASH POND
EEI JOPPA POWER GENERATING FACILITY
JOPPA, ILLINOIS**

GEOTECHNOLOGY, INC.
St. Louis, Missouri

November 10, 2010

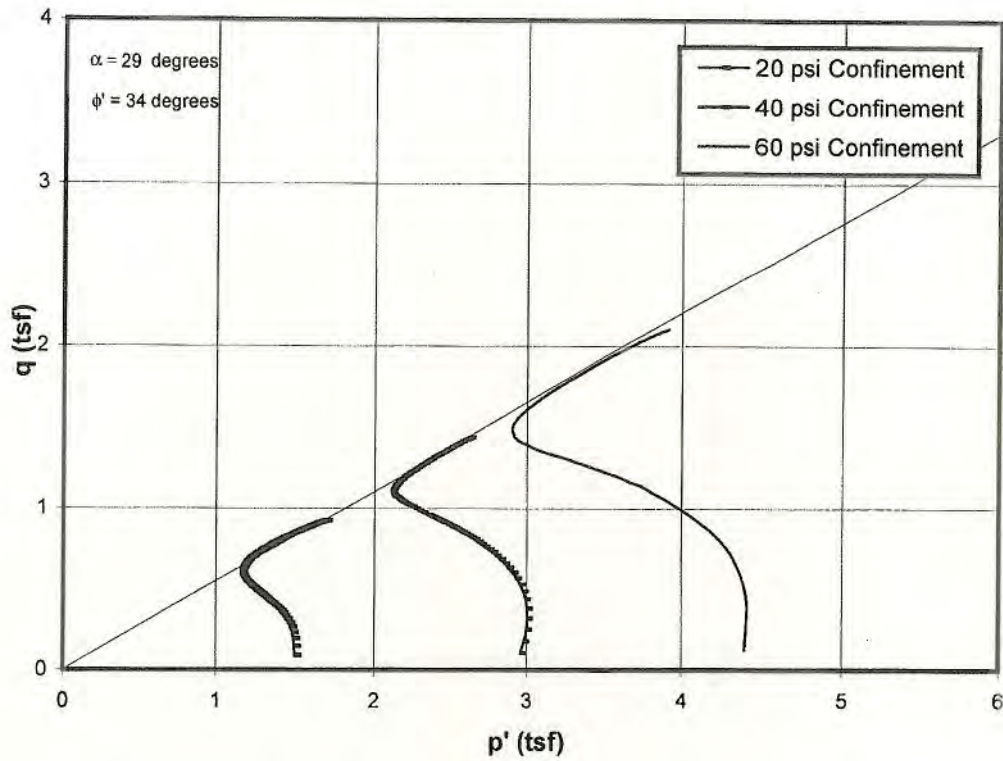
CONSOLIDATED UNDRAINED TRIAXIAL COMPRESSION TEST

ASTM D 4767

Boring: B-1

Sample: ST-9, ST-8, ST-8 - Depth: 27, 25, 25

Laboratory testing was performed to estimate pertinent engineering and index properties of the soil. Moisture contents were determined for cohesive soil samples, and Atterberg limits tests were accomplished on selected samples. Consolidated-undrained triaxial and unconfined compression tests were performed on representative samples. Laboratory test results are presented in Appendices B and C.

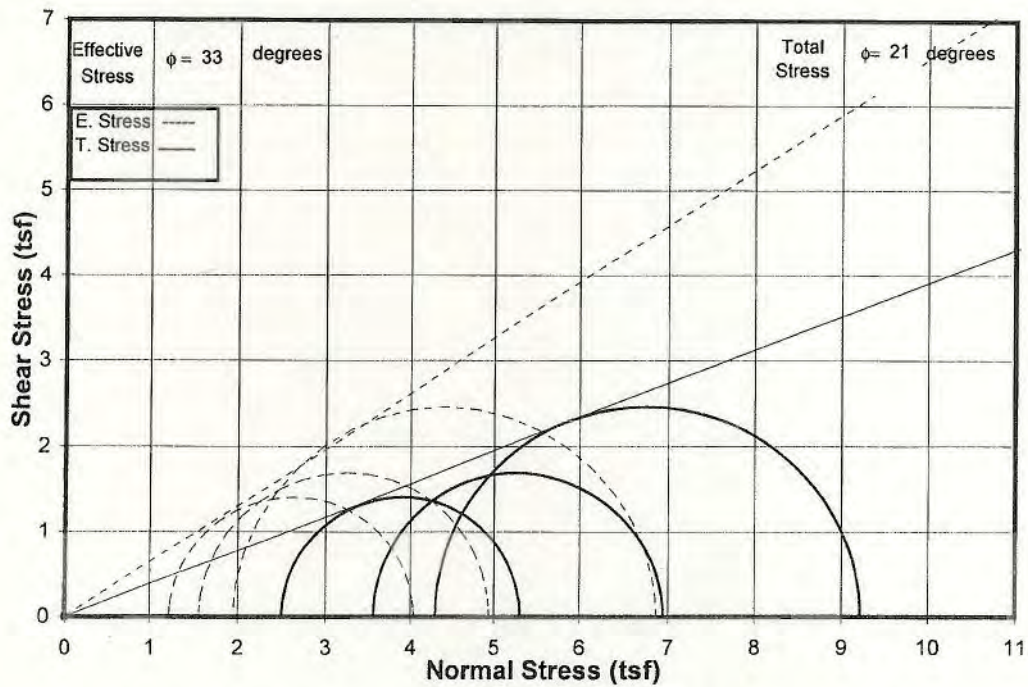
CONSOLIDATED UNDRAINED TRIAXIAL COMPRESSION TEST
ASTM D 4767

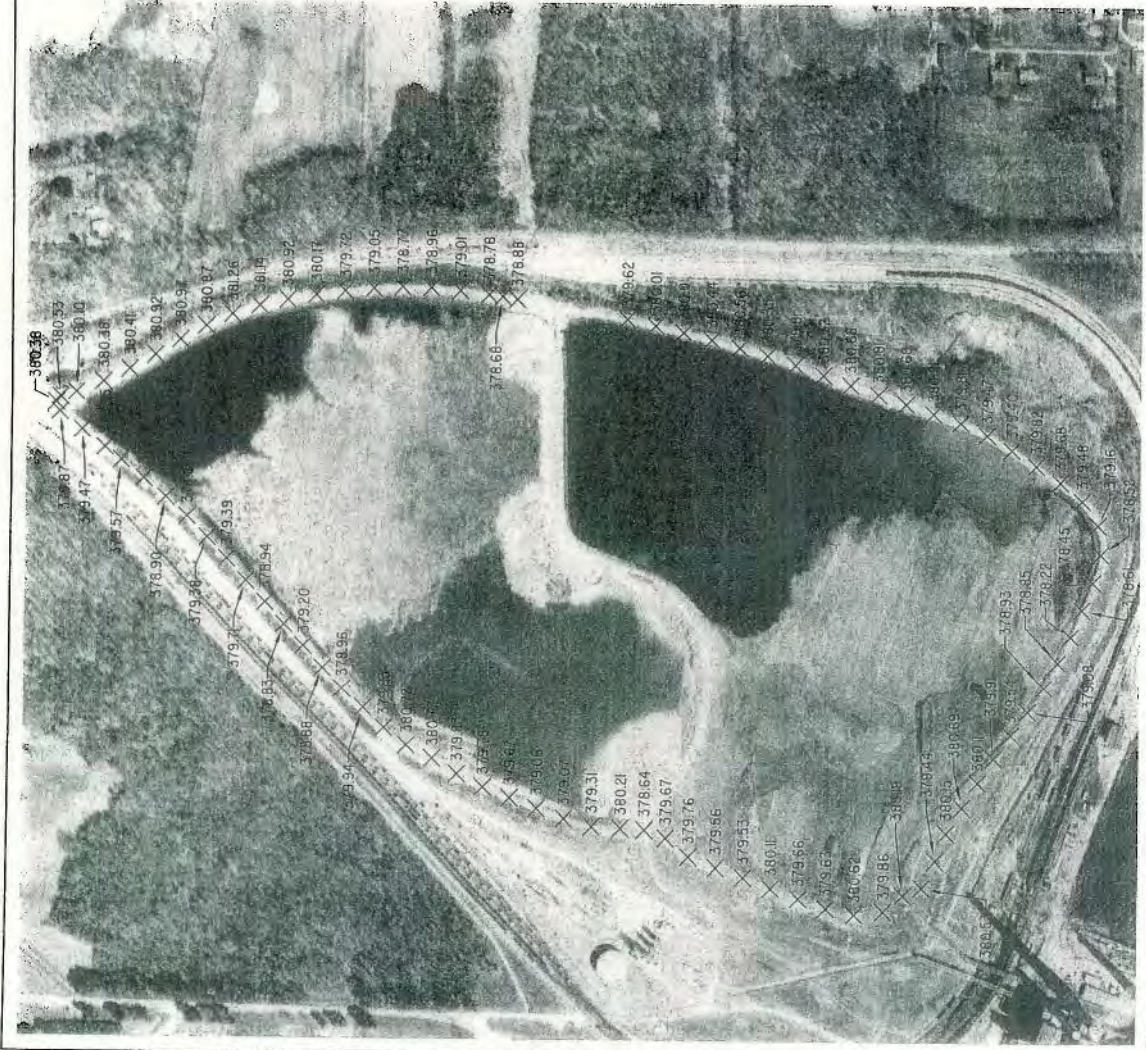
APPENDIX E
SURVEY DATA

MILANO & GRUNLOH ENGINEERS, LLC 14 MILLINGTON P.O. BOX 887 EFFINGHAM, ILLINOIS 62401 Phone: (217) 347-7262 Fax #: (217) 342-3433 Web Address: www.mge.com Design Firm #: 184-003108
	File name: S:\D\6\10\10165807\dwg\Elevations.dwg Plot date: 10/27/10 at 14:45 P.8 628

The field exploration consisted of drilling six borings, designated as Borings B-1 through -5 and -2A, at approximately the locations shown on Plate 2. Boring B-2A was drilled adjacent to Boring B-2 to obtain a Shelby tube sample. The borings were located in the field by Geotechnology by measuring distances from existing site features. Subsequently, the boring locations were surveyed by Milano & Grunloh Engineers LLC, and the location coordinates and elevations were provided to Geotechnology. The spot elevations surveyed along the crest of the embankment is included in Appendix E.

As part of the embankment evaluation, slope stability analyses were performed. Current topographic plans were not provided. However, the project surveyor provided the latitude, longitude and the surface elevation of the boring locations. This information was used to develop the slope profile. Results of the analysis are discussed in subsequent sections.
