**Coal Combustion Waste Impoundment  
Round 5 - Dam Assessment Report**

*E. C. Gaston Steam Plant*

*Fly Ash Dam  
Alabama Power  
Wilsonville, Alabama*

Dewberry & Davis, LLC  
Fairfax, Virginia

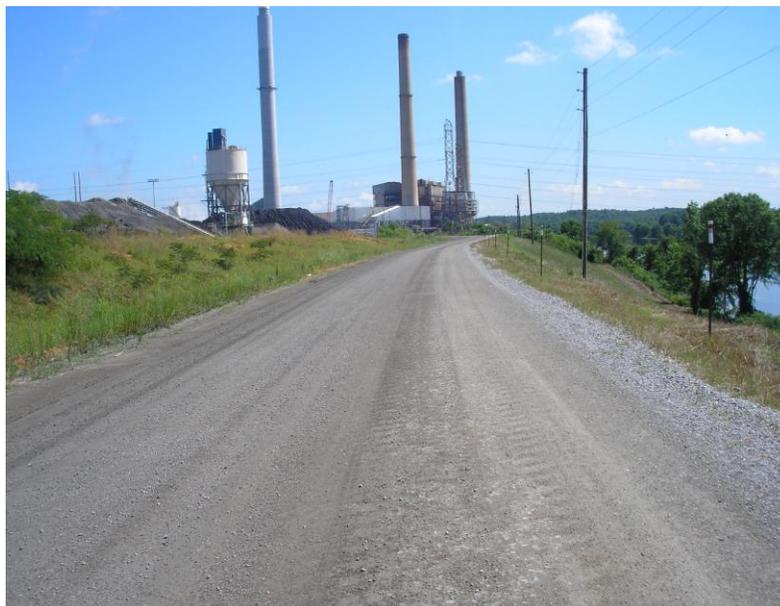
Figure 5.2.1.1. Photo Showing Crest of East Dike

The crest of each dike had no signs of depressions, tension cracks or other indications of settlement or shear failure. Previous inspection reports reviewed by Dewberry did not indicate issues concerning crest of any of the dikes. Figure 5.2.1-1 shows the condition of the crest of the east dike. Photographs 1 – 3, Appendix B provide additional views of the crest of the east dike.

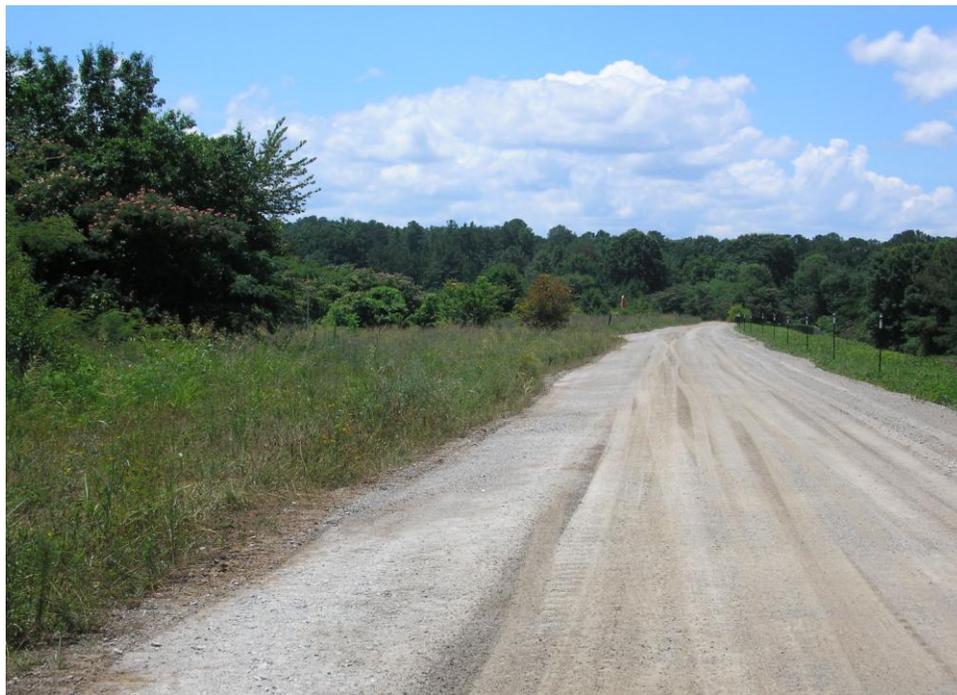
Figure 5.2.1-2 Photo Showing Dam Crest of West Dike (Upstream/Interior on Left)

Figure 5.2.1-2 shows the condition of the crest of the west embankment.

The crest at the south end of the west embankment is planted with bamboo, and Bradford Pear and Mimosa trees as a “green wall”. The owner’s 2010 Inspection Report (See Appendix A – Doc. 15) noted the green wall and recommended that it extend no further than 5 ft. below the crest of the dike. The report indicates the green wall is undergoing further review. Results of the review were not available to Dewberry at the time of this inspection. Photographs 4 and 5, Appendix B provide additional views of the crest of the west dike.

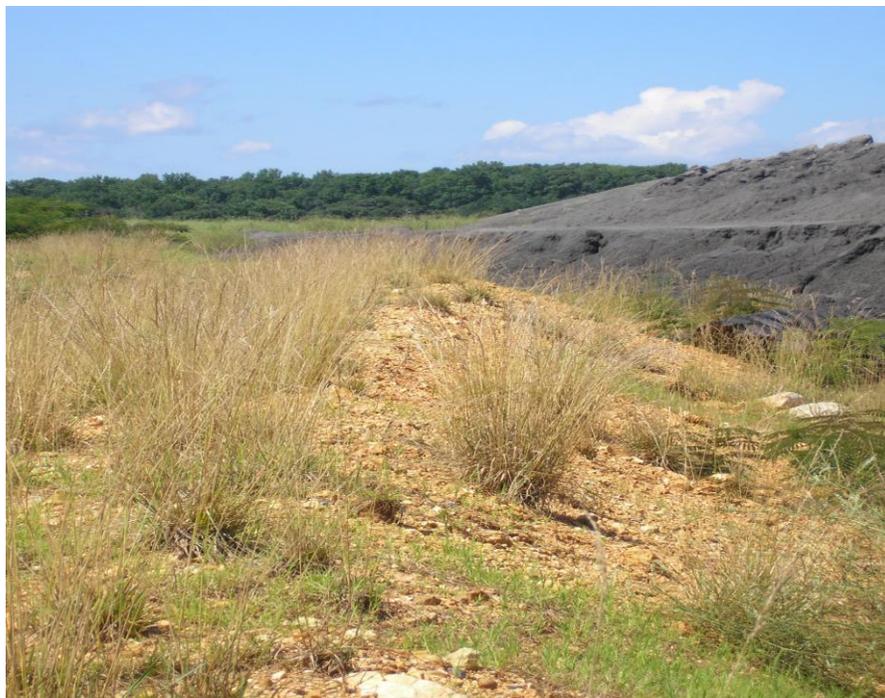
Figure 5.2.2-1 Photo Showing Upstream/Interior Slope of East Dike.

The upstream slope of the east dike is bare earth with spotty areas of tall grass or weeds. There were no observed scarps, sloughs, bulging, cracks, scarps, depressions or other indications of slope instability or signs of erosion. Figure 5.2.2-1 shows a representative section of the upstream slope of the east dike.

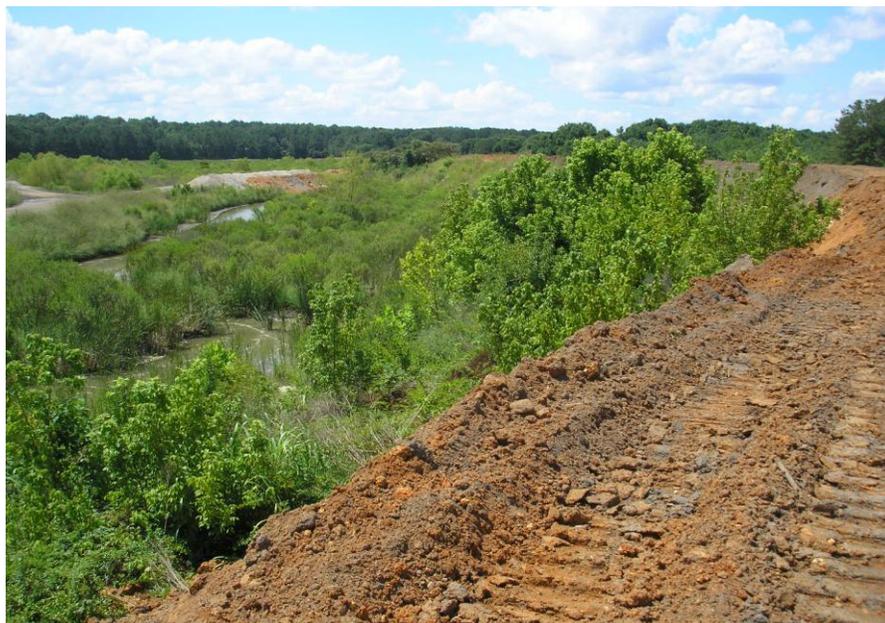
Figure 5.2.2-2 Photo Showing Upstream/Interior of West Dike

The upstream slope of the west dike is bare earth and areas of scrub grass, bushes and small trees. There were no observed scarps, sloughs, bulging, cracks, scarps, depressions or other indications of slope instability or signs of erosion. Figure 5.2.2-2 shows a representative section of the upstream slope of the west dike. Photographs 6 – 8, Appendix B provide additional views of the upstream slopes of the west dike.

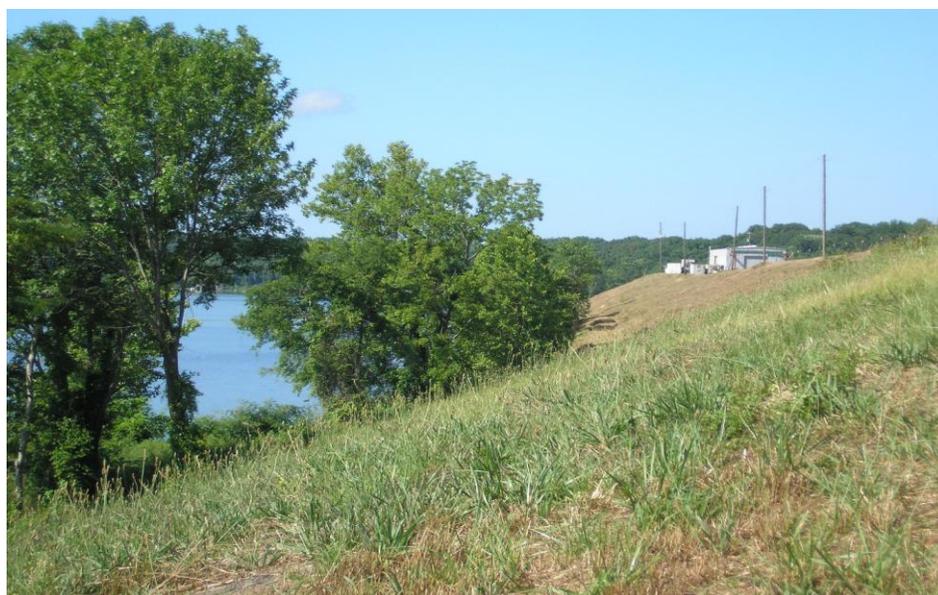
Figure 5.2.3 -1 Photo Showing Downstream Slope of East Dike.

The downstream or exterior slope of the east dike is protected with several species of grass and weeds. No major scarps, sloughs, depression or other indication of slope instability or signs of uncontrolled seepage were observed. Figure 5.2.3-1 shows a representative section of the downstream slope of the east dike. Trees shown in the photograph are located on the natural slope beneath the fill embankment. The southwestern end of the east dike downstream slope is more heavily vegetated than the main dike length.

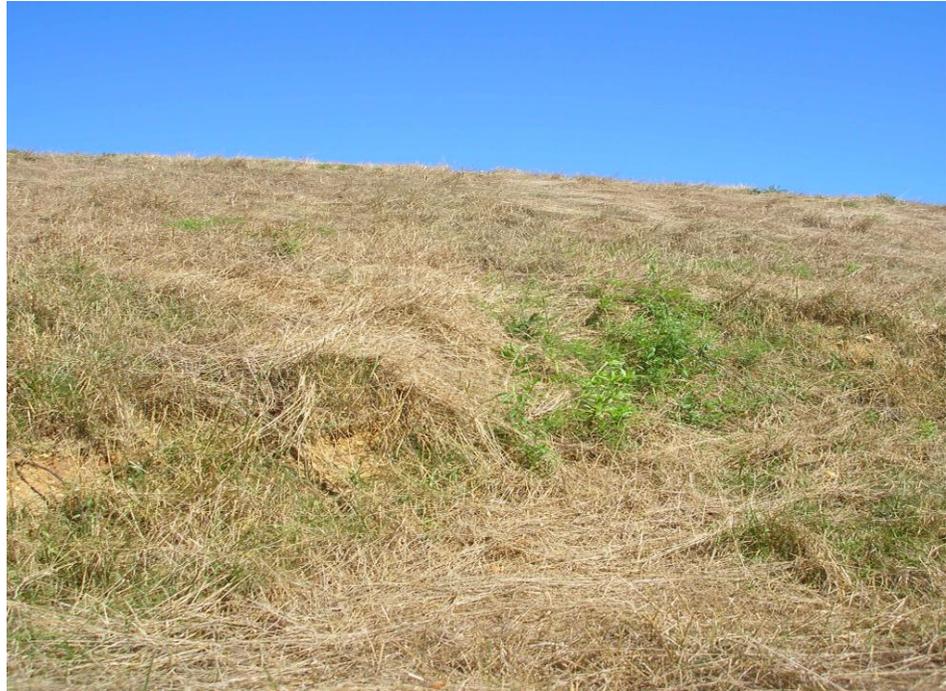
Figure 5.2.3-2 Photo Showing Small Area Mid-Slope Sloughing on East Dike Downstream Slope

Small areas of sloughing and small erosion rills were observed along the downstream slope of the east dike. The erosion rills were discussed in the owner's 2010 Inspection Report. Figures 5.2.3-2 and 5.2.3-3 show an area of sloughing and a typical erosion rill, respectively.

- Repair shallow sloughs and erosion rills along the embankment downstream slopes
- Maintain open interior drainage channels to the south settling pond (i.e., control beaver dams).
- Review the acceptability of the “green wall” plantings at the crest near the south end of the west embankment with Southern Company Hydro Services Dam Safety.
  - Subsequent to the site visit Dewberry received information that the acceptability of “green wall plantings” was evaluated and concluded to be acceptable. The conclusion was based on the use of shallow rooted trees along a portion of the crest where the water elevation would be below the expected root depth. Failure of a tree was not expected to affect the stability of the embankment. The “green wall” was deemed an important part of the dust and noise control for residents living in near the impoundment.

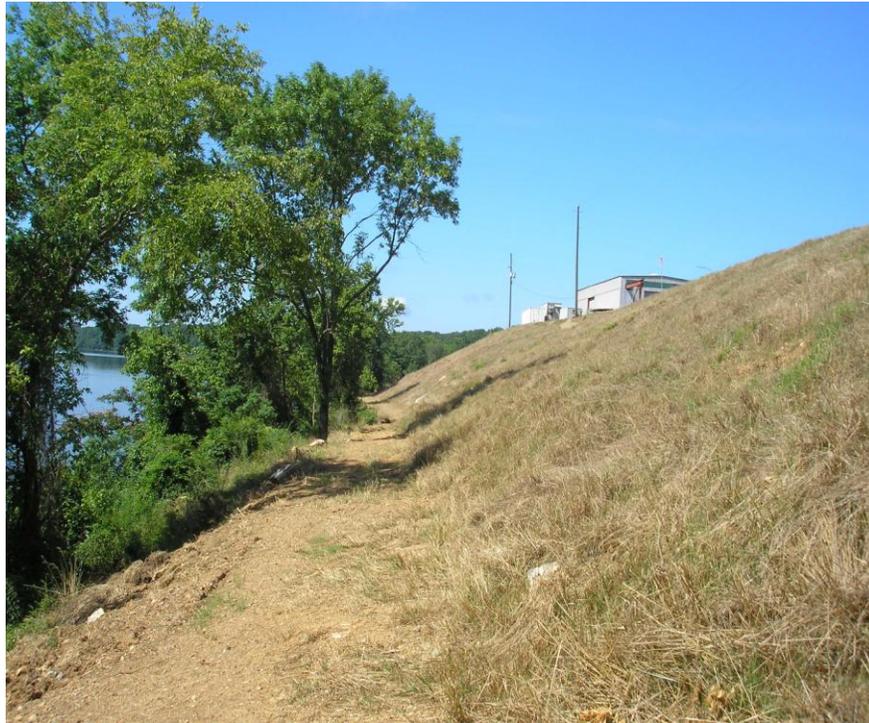
Figure 5.2.3-4 Photo Showing Toe of East Dike Downstream Slope

No areas of seepage or soft soils were observed along the toe of the east bank downstream slope. Photographs 9 – 17, Appendix B provide additional views of the downstream slopes of the east dike. Figure 5.2.3-4 shows the central length of the east dike downstream slope toe. Photograph 18, Appendix B provides an additional view of the toe of the east dike.

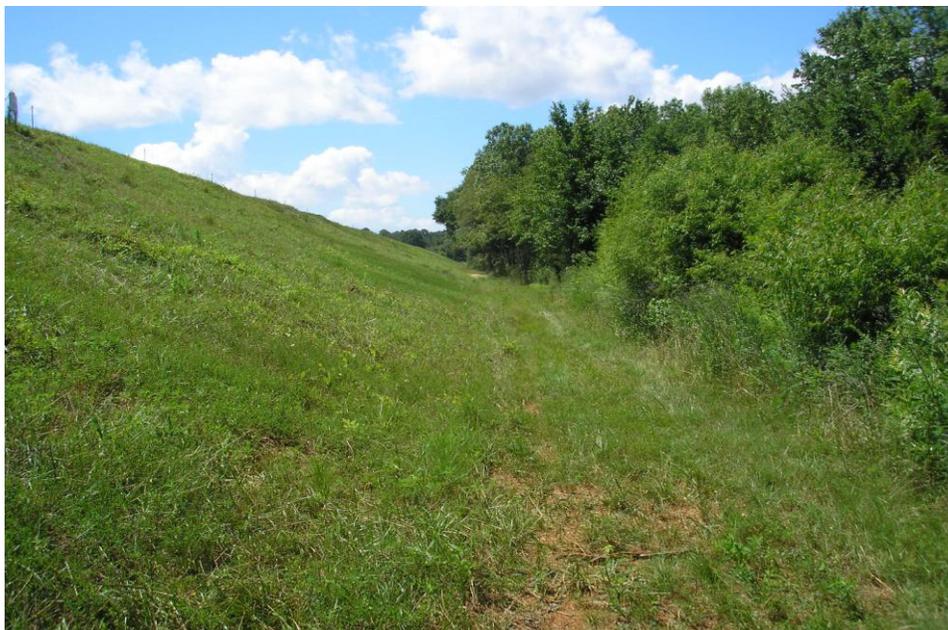
Figure 5.2.3-5 Photo Showing West Bank Downstream Slope

The downstream or exterior slope of the west dike is protected with several species of grass and ivy. There were no observed scarps, sloughs, bulging, cracks, scarps, depressions or other indications of slope instability or signs of erosion. Figure 5.2.3-5 shows a representative section of the upstream slope of the west dike. Trees shown in the photograph are located in an adjacent low lying area adjacent to the embankment.

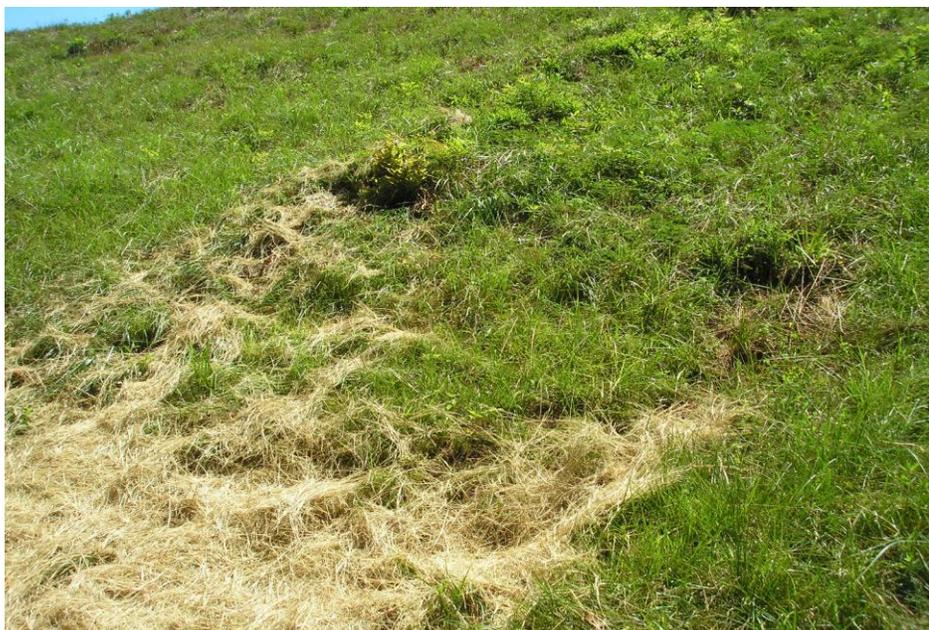
Figure 5.2.3-6 Photo Shows Small Area of Sloughing on West Dike Downstream Slope.

One are of sloughing was observed along the west dike downstream slope. Figure 5.2.3-6 shows the observed sloughing. The sloughing was not cited in the owner's 2010 Inspection Report; therefore it is expected to be relatively new. Photographs 19 – 21, Appendix B provide additional views of the downstream slope of the west dike.

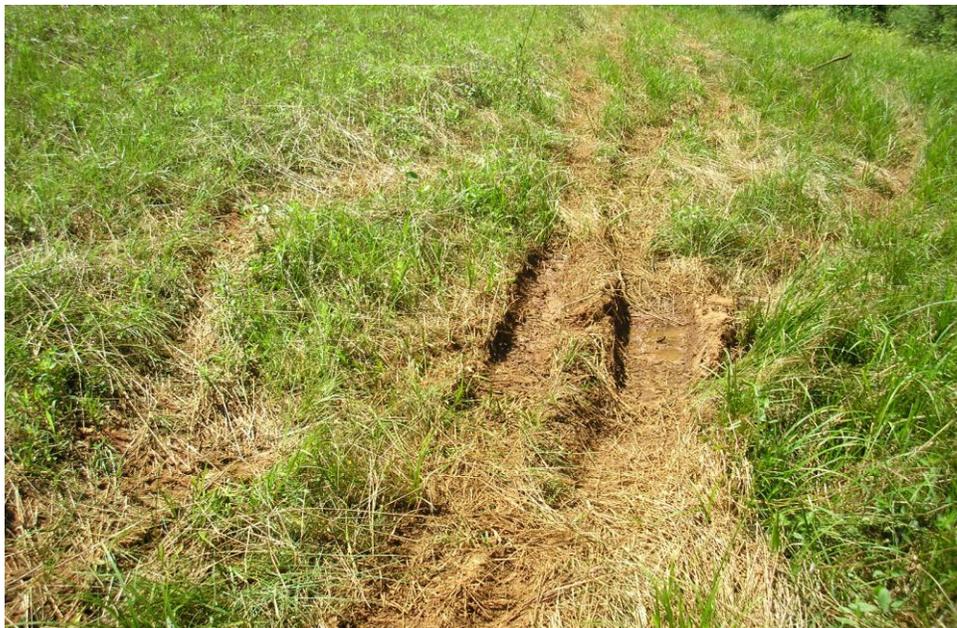
Figure 5.2.3-7 Photo Showing Small Wet Area West Dike Downstream Toe

The toe of the west dike downstream slope is generally free of seepage and soft soils. One small area of standing water was observed. The owner's 2010 Inspection Report reported two small wet zones, one of which was observed in this inspection. The Inspection Report recommended monitoring the wet areas as part of weekly inspections. Figure 5.2.3-7 shows the wet area observed by Dewberry. The conditions observed by Dewberry were similar to those shown in photographs included in the 2010 Inspection Report. The difference being that there was less water observed by Dewberry than shown in the 2010 Inspection Report photographs. Photographs 22 - 25, Appendix B present additional views of the toe of the west dike.

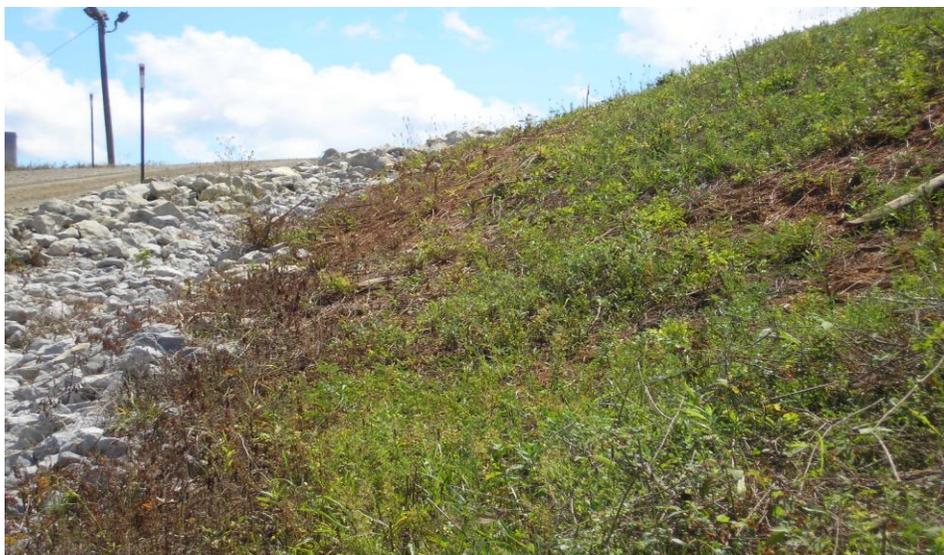
Figure 5.2.3-8 Photo Showing West End of North Embankment Downstream Slope

The downstream or exterior slope of the north dike is protected with several species of tall grass. There were no observed scarps, sloughs, bulging, cracks, scarps, depressions or other indications of slope instability or signs of erosion. Dewberry did not observe the shallow slide face on the downstream slope included in the owner's 2010 Inspection Report. No areas of seepage or soft soils were observed along the toe of the north dike downstream slope. Figure 5.2.3-8 shows the west end of the north embankment downstream slope.

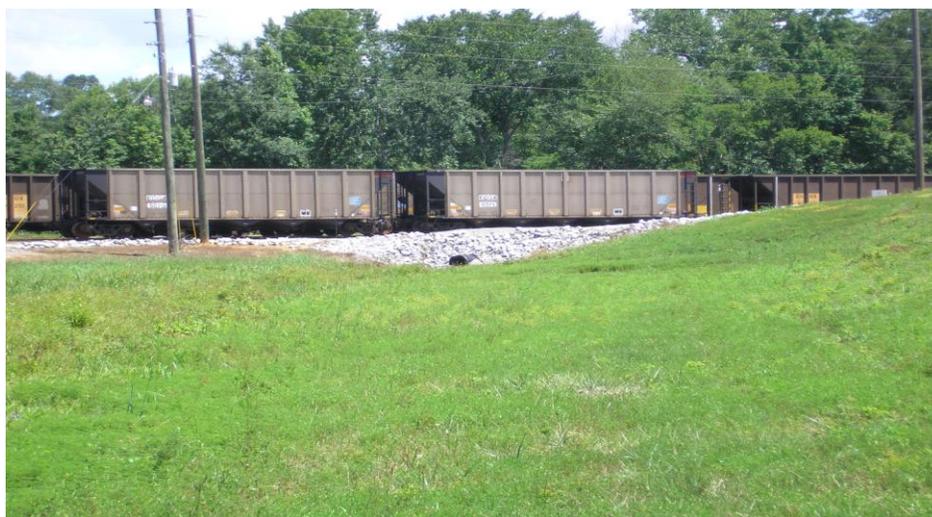
Figure 5.2.4-1 Photo Showing North End Groin Area of West Dike.

Erosion or uncontrolled seepage was not observed along the groins. Abutments and groin areas appeared to be in good condition. Groin slopes are protected with the same vegetative cover as the adjoining slope. Figure 5.2.4-1 shows the west embankment to north embankment groin area. Photographs 26 and 27, Appendix B provide additional views of the groin area formed by the intersection of the west and north dikes.

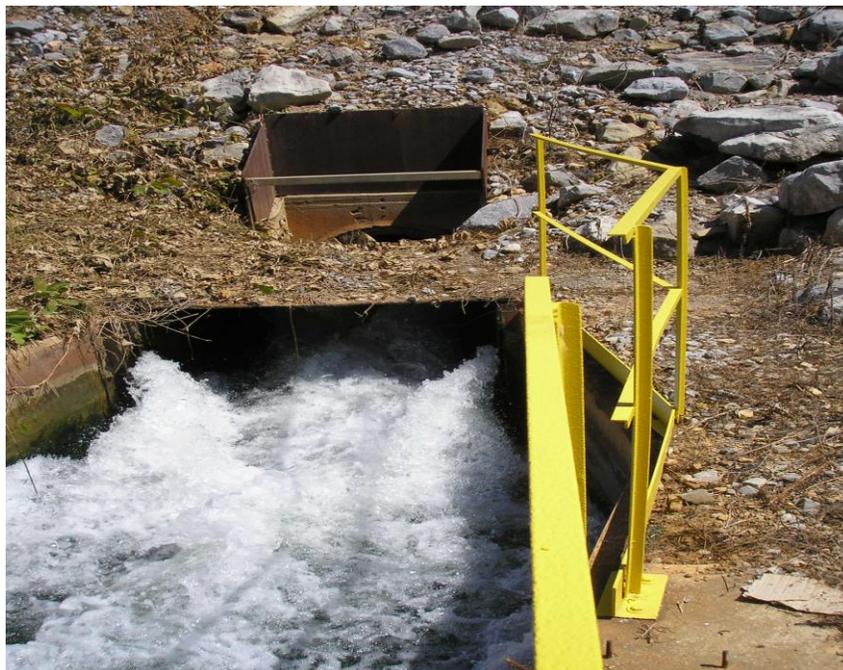
Figure 5.3.2-1 Photo Showing Water Discharge from Outlet Pipe.

The outlet conduit appeared to be in good condition and operating normally with no sign of clogging. Water flowing from the outlet was clear. Figure 5.3.2-1 shows the water discharging from the outlet pipe.

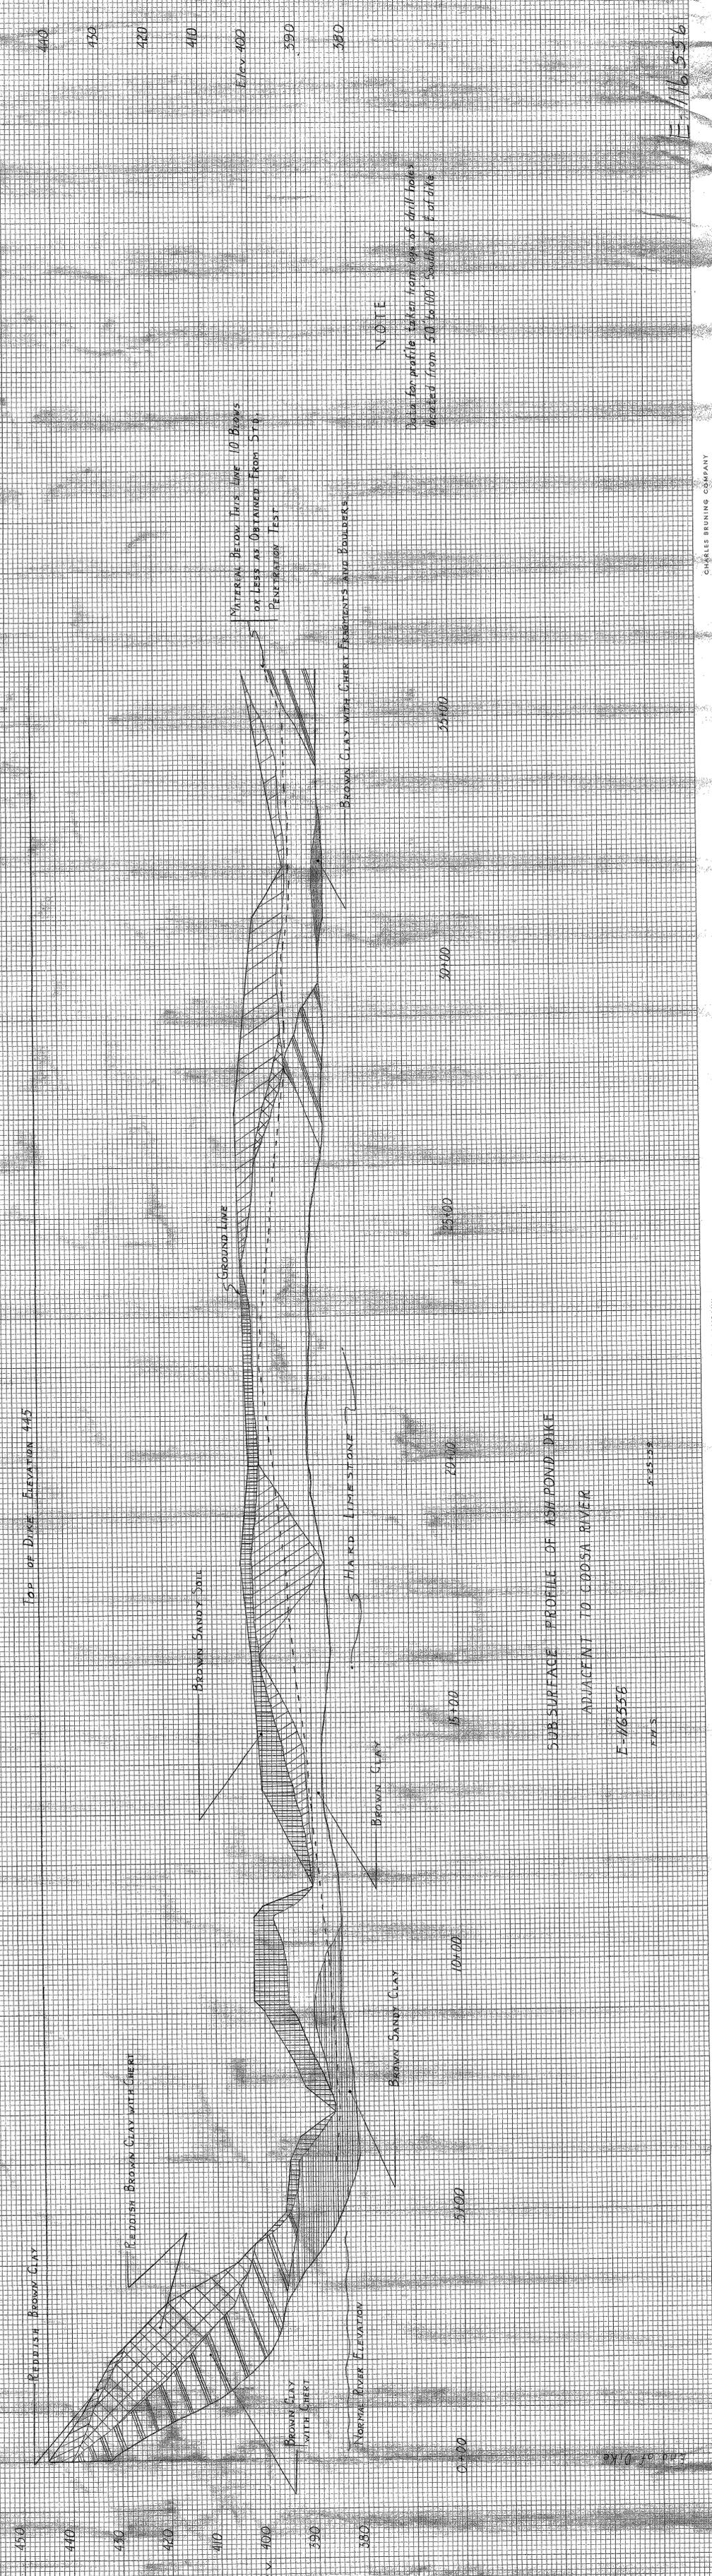
SUBSURFACE PROFILE OF ASH POND DIKE  
ADJACENT TO COOSA RIVER

Data for profile taken from logs of drill holes located from 50' to 100' South of E of dike

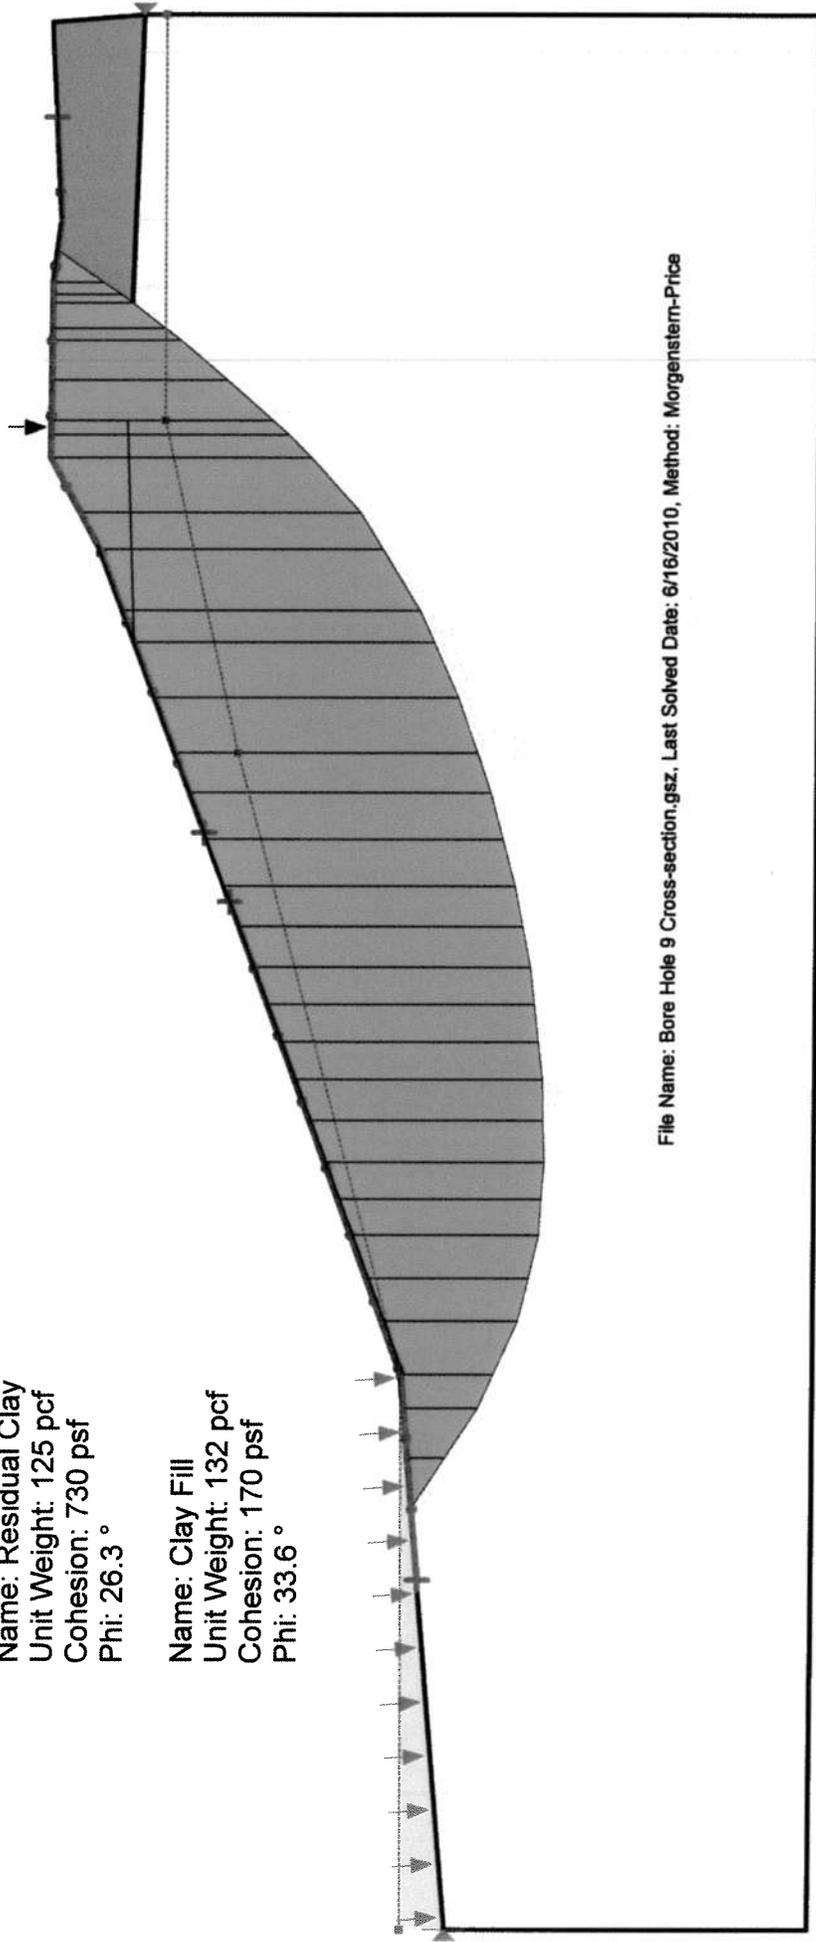
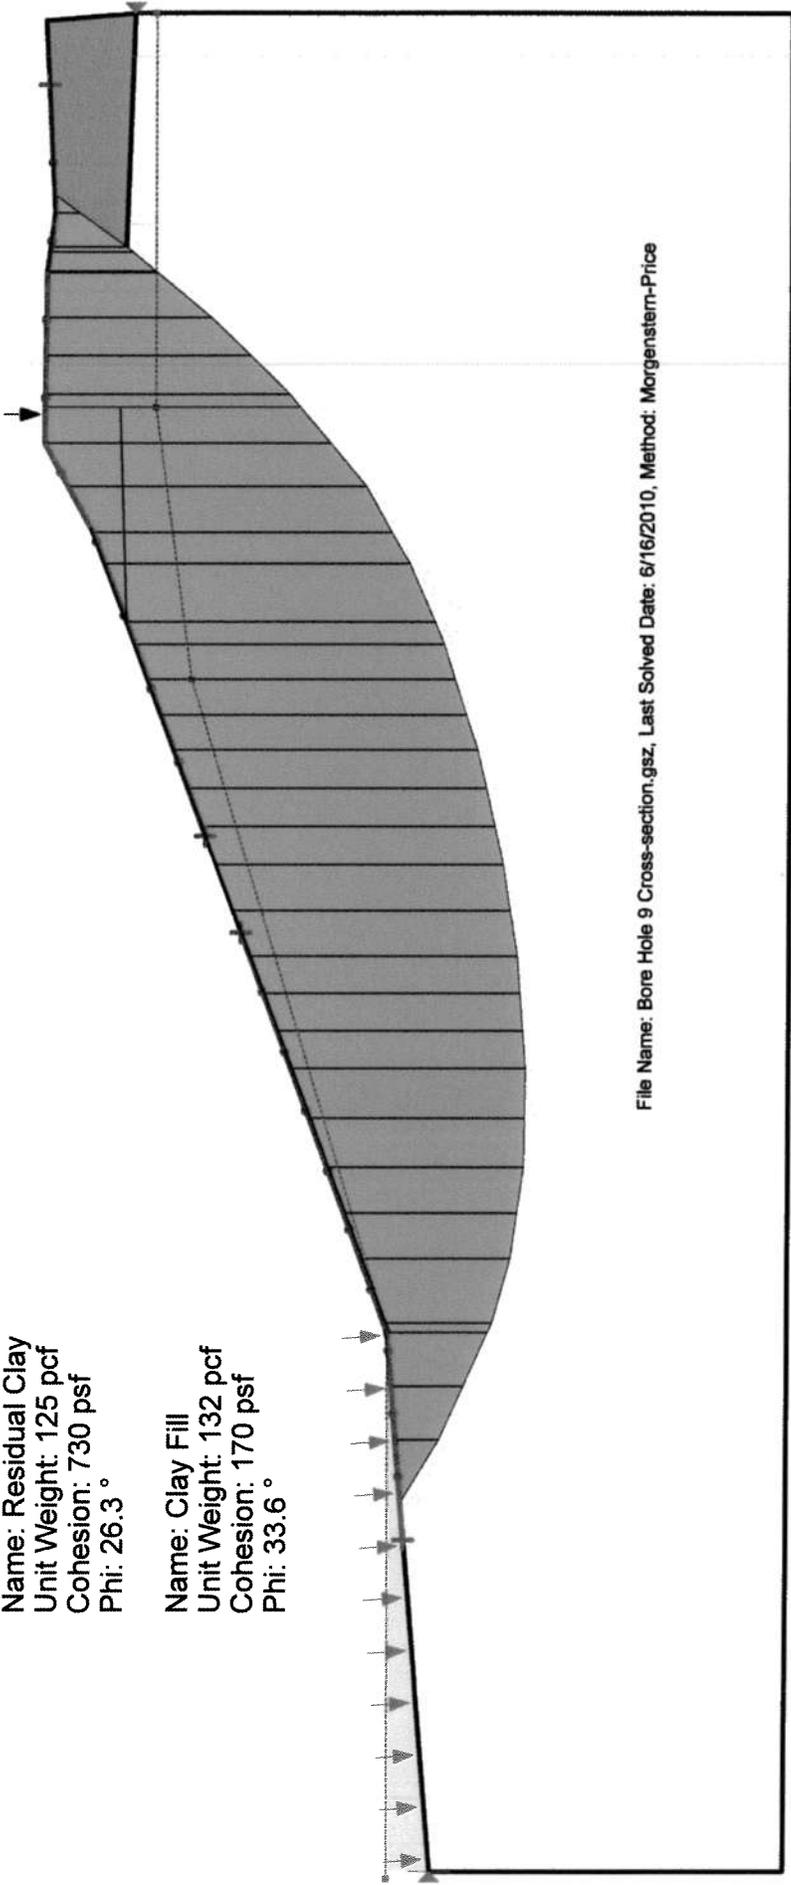
Name: Clay Fill  
Unit Weight: 132 pcf  
Cohesion: 170 psf  
Phi: 33.6 °

File Name: Bore Hole 9 Cross-section.gsz, Last Solved Date: 6/16/2010, Method: Morgenstern-Price

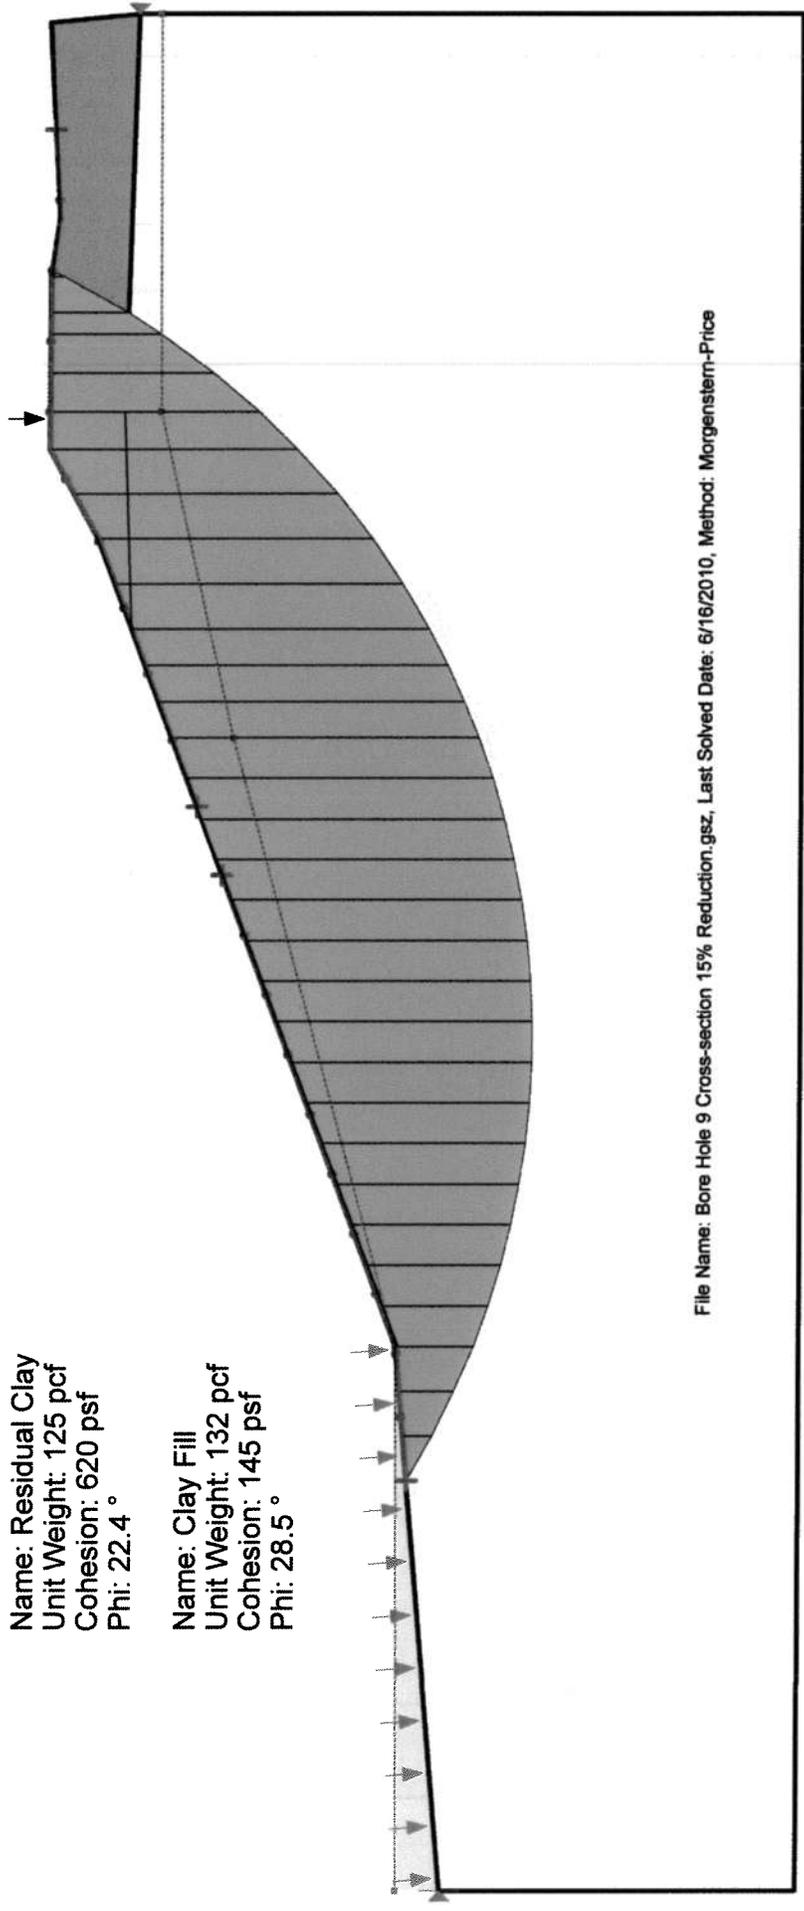
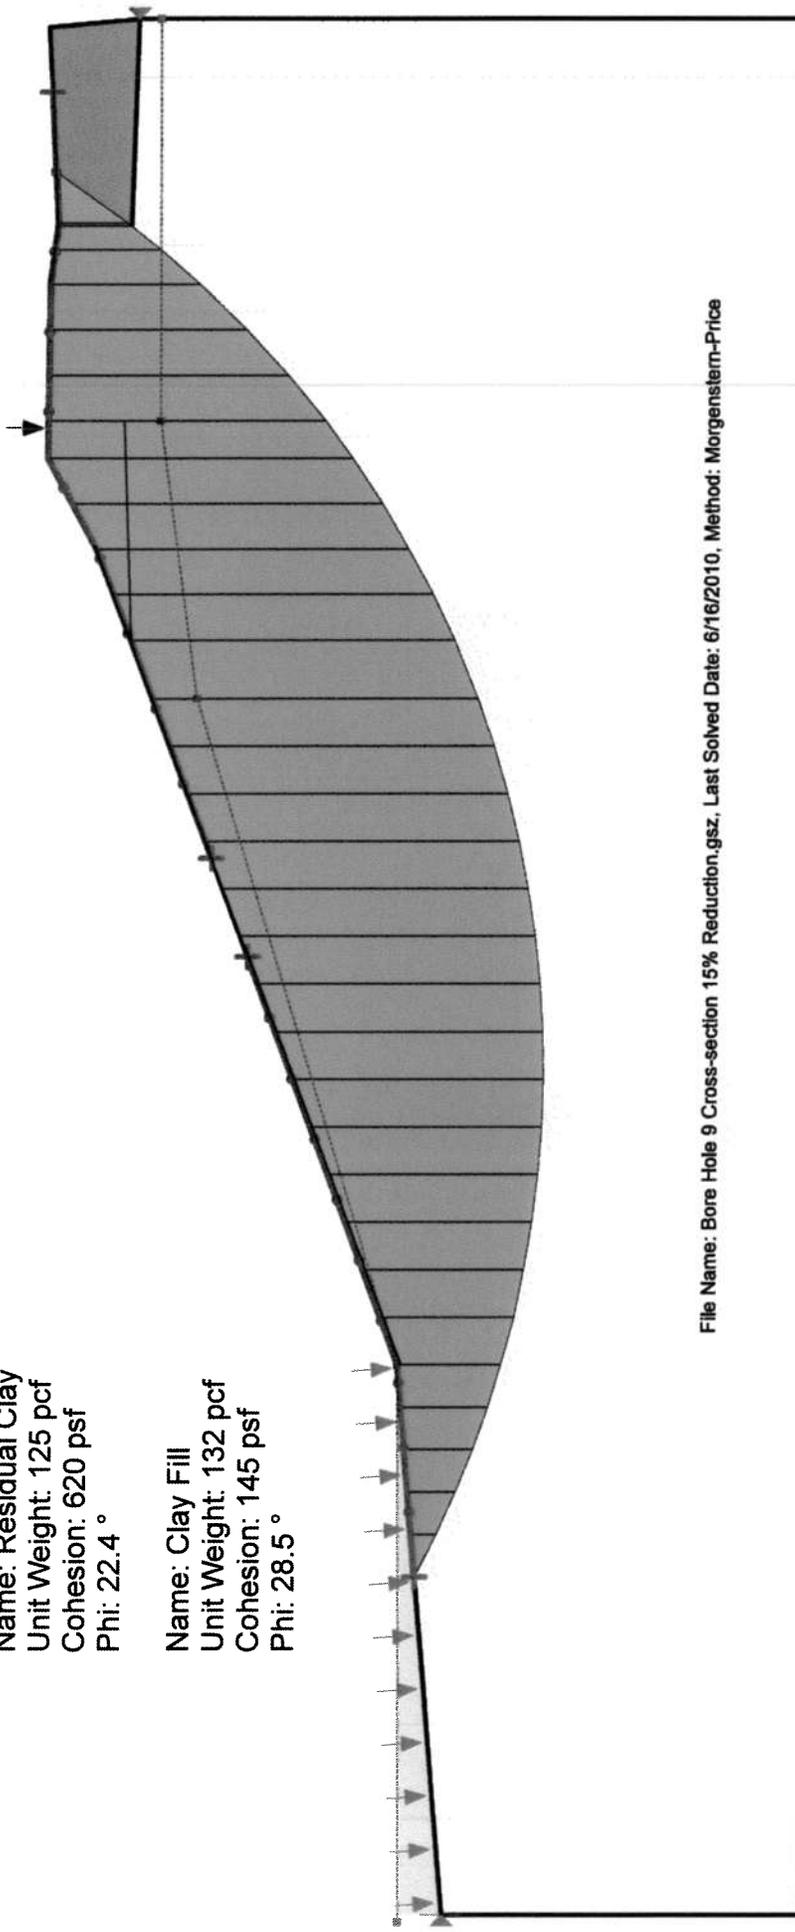
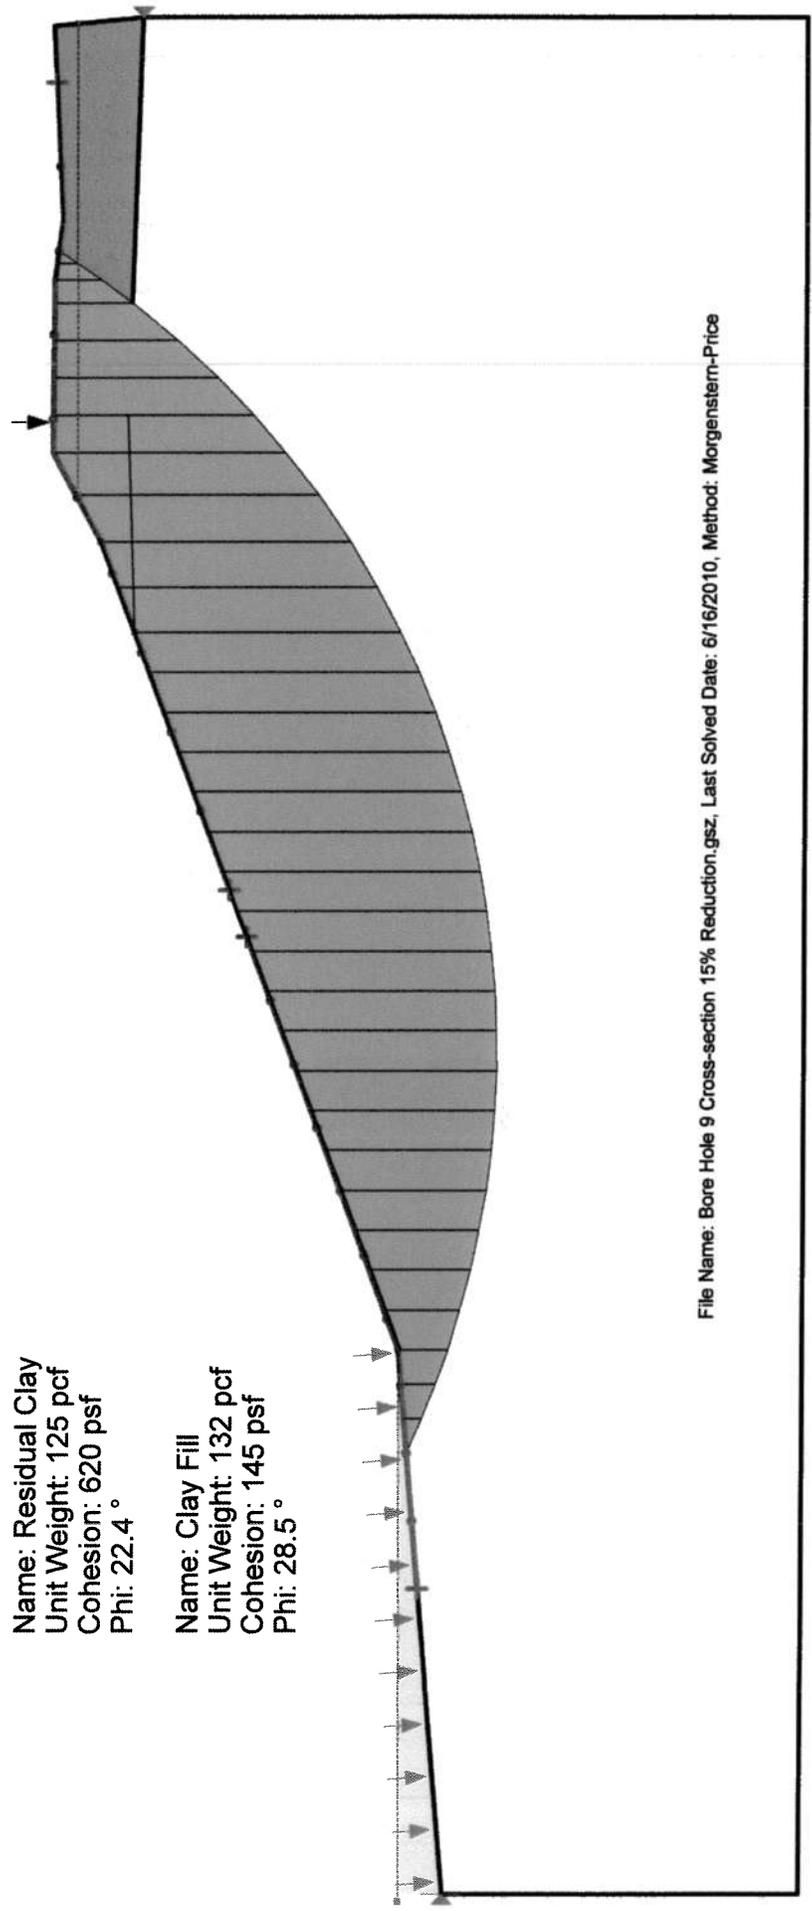
Name: Clay Fill  
Unit Weight: 132 pcf  
Cohesion: 145 psf  
Phi: 28.5°

File Name: Bore Hole 9 Cross-section 15% Reduction.gsz, Last Solved Date: 6/16/2010, Method: Morgenstern-Price

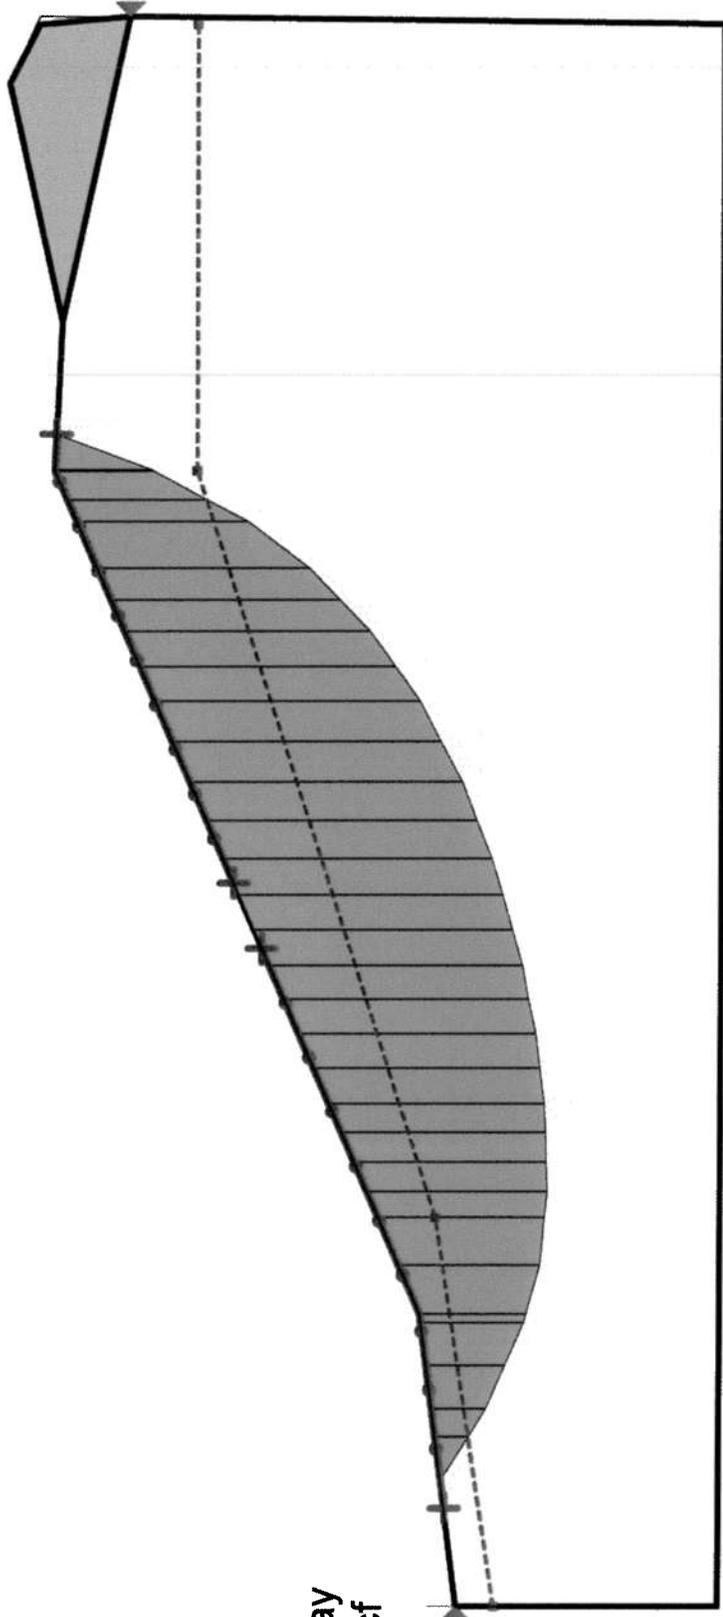
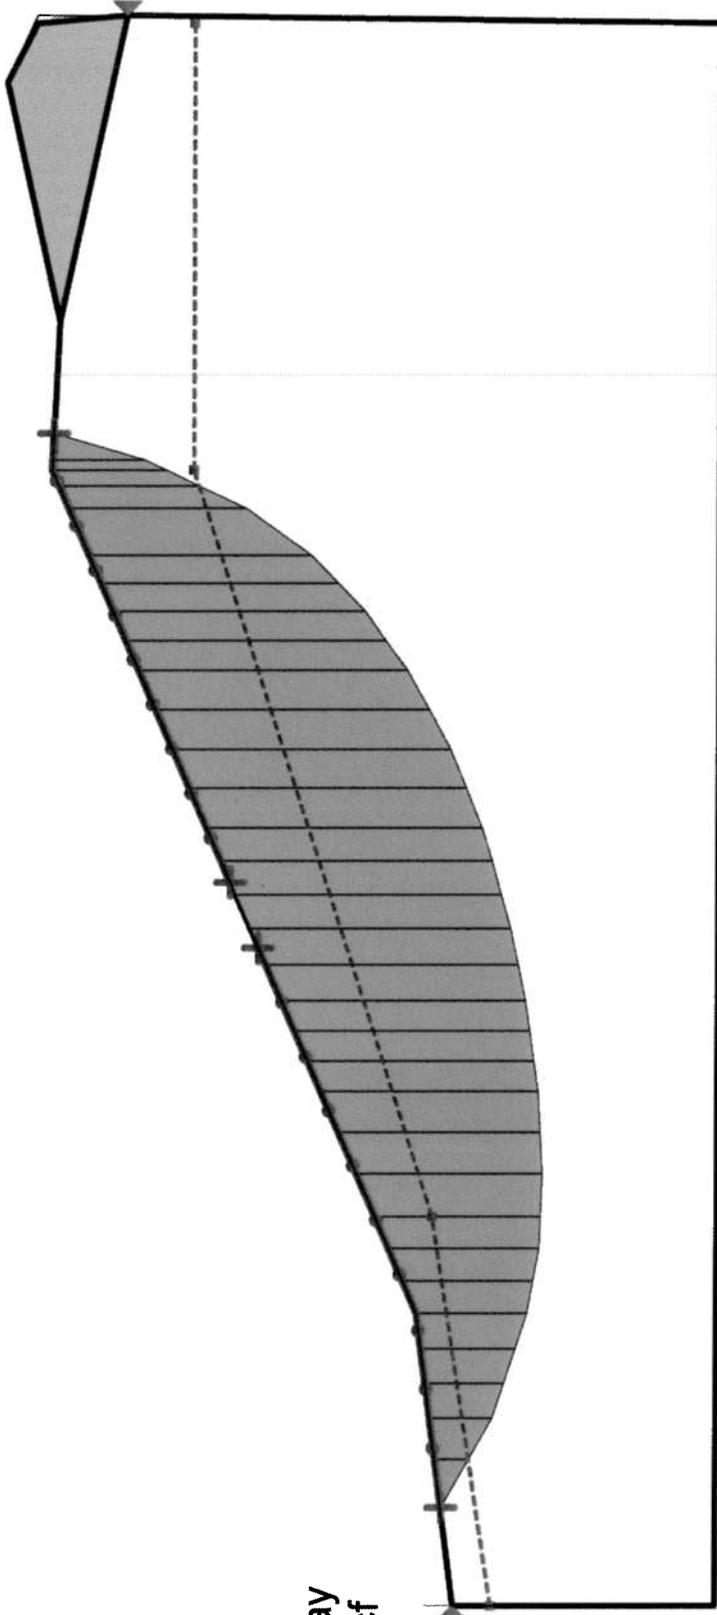
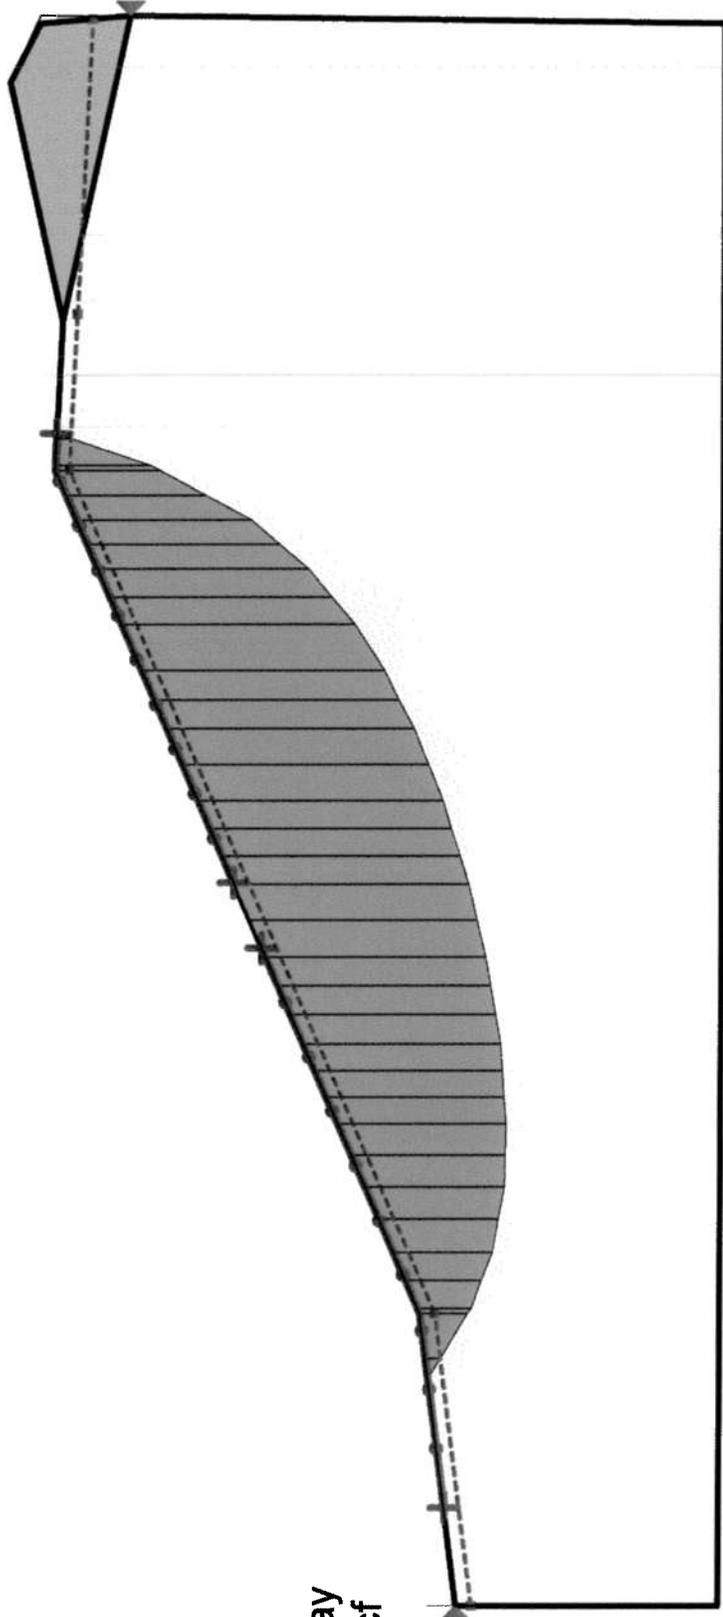
Name: Ash  
Unit Weight: 95 pcf  
Cohesion: 100 psf  
Phi: 22 °

File Name: Bore Hole 10 Cross-section.gsz, Last Solved Date: 10/9/2009, Method: Morgenstern-Price
