**Coal Combustion Waste Impoundment  
Round 5 - Dam Assessment Report**

*E. C. Gaston Steam Plant*

*Fly Ash Dam  
Alabama Power  
Wilsonville, Alabama*

Dewberry & Davis, LLC  
Fairfax, Virginia

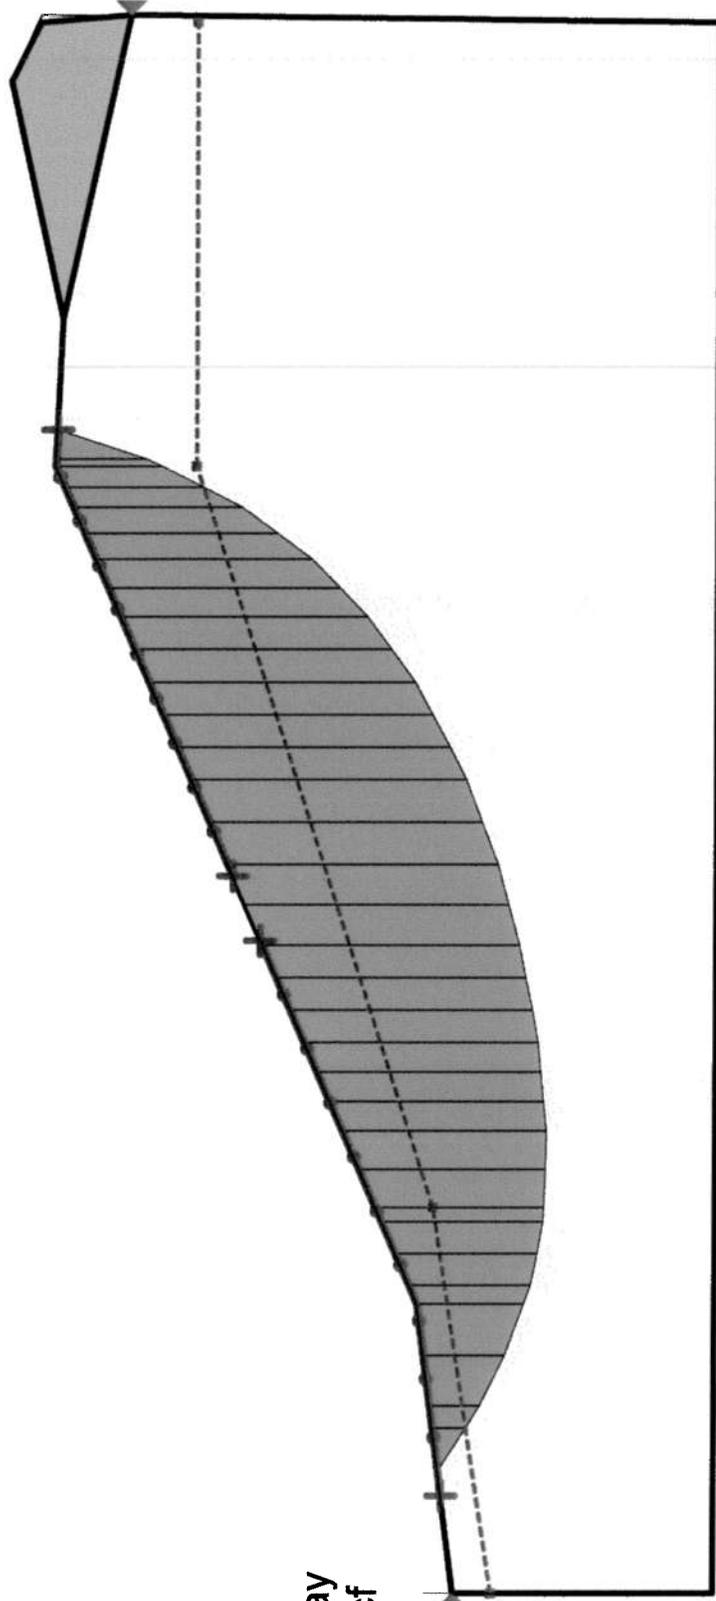
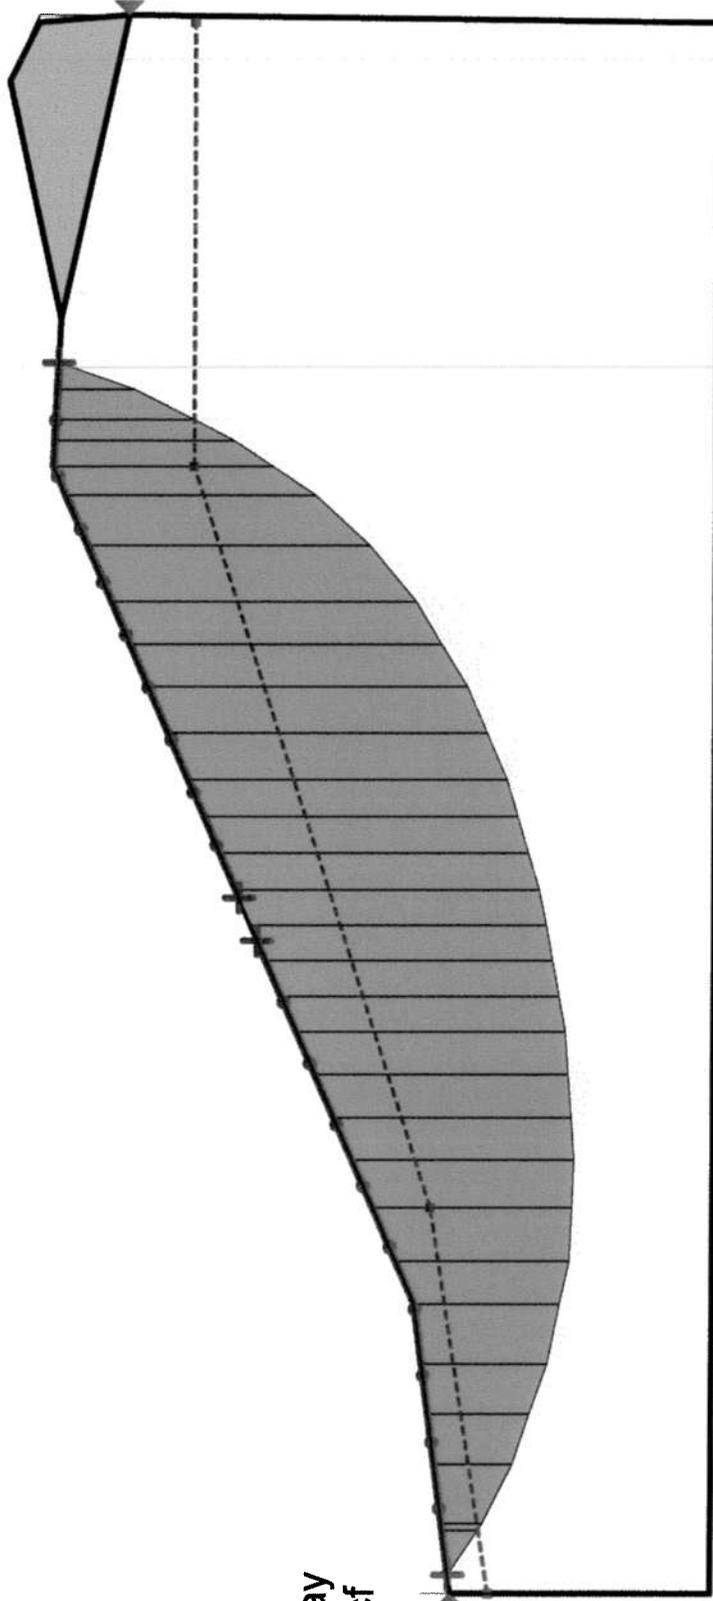
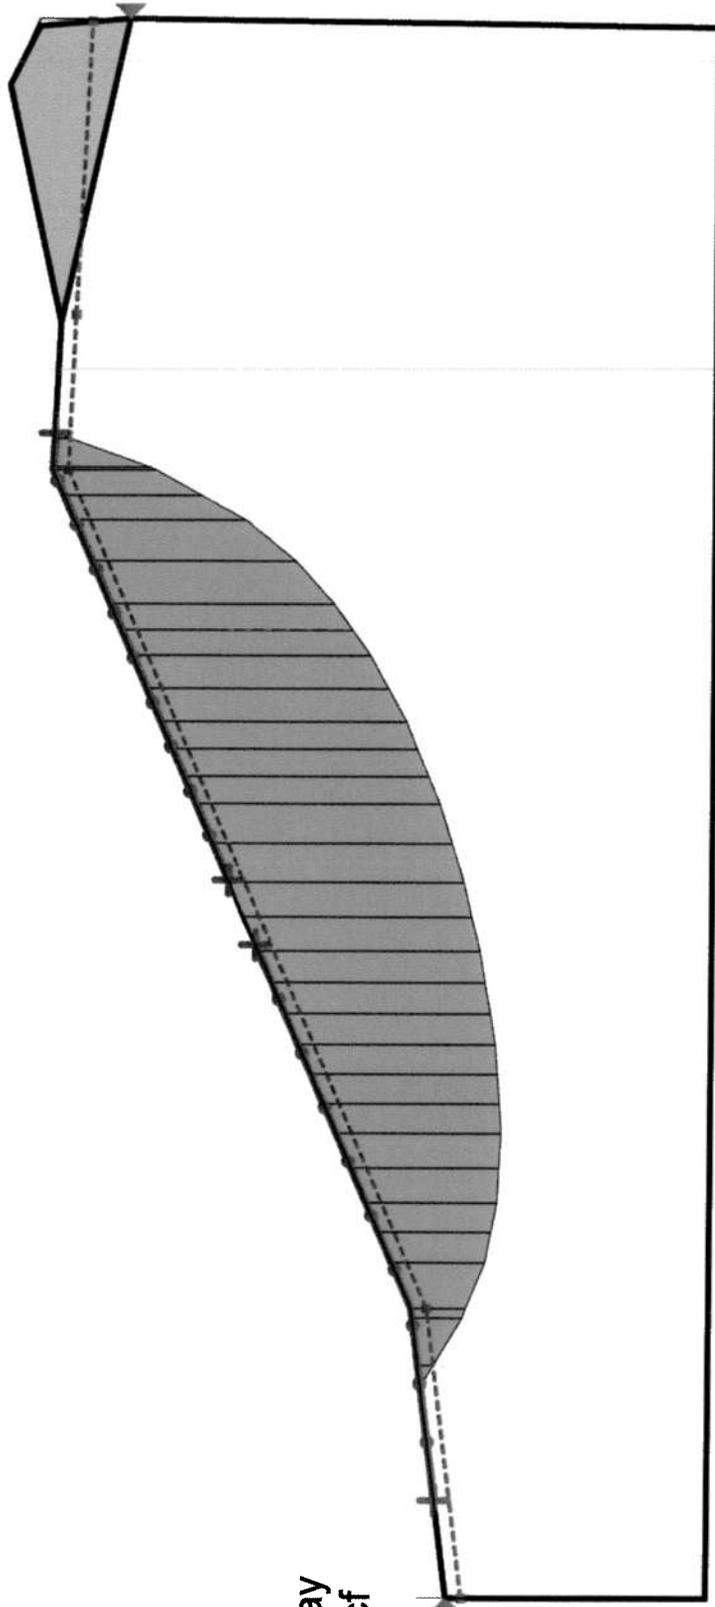
Name: Ash  
Unit Weight: 95 pcf  
Cohesion: 85 psf  
Phi: 18.7 °

File Name: Bore Hole 10 Cross-section 15% Reduction.gsz, Last Solved Date: 10/9/2009, Method: Morgenstern-Princ
